| 4. Title and Subtitle Reflectivity Retention of Reflective Raised Pavement Markers | | | | 5. Report Date October 1986 | |
| 7. Author(s) Roger W. McNeese and James S. Noel | | | | 8. Performing Organization Report No. Research Report 322-2 | |
| 9. Performing Organization Name and Address Texas Transportation Institute The Texas A&M University System College Station, Texas 77843 | | | | 10. Work Unit No. | |

Research Report 322-2
Study Number 2-18-322-2

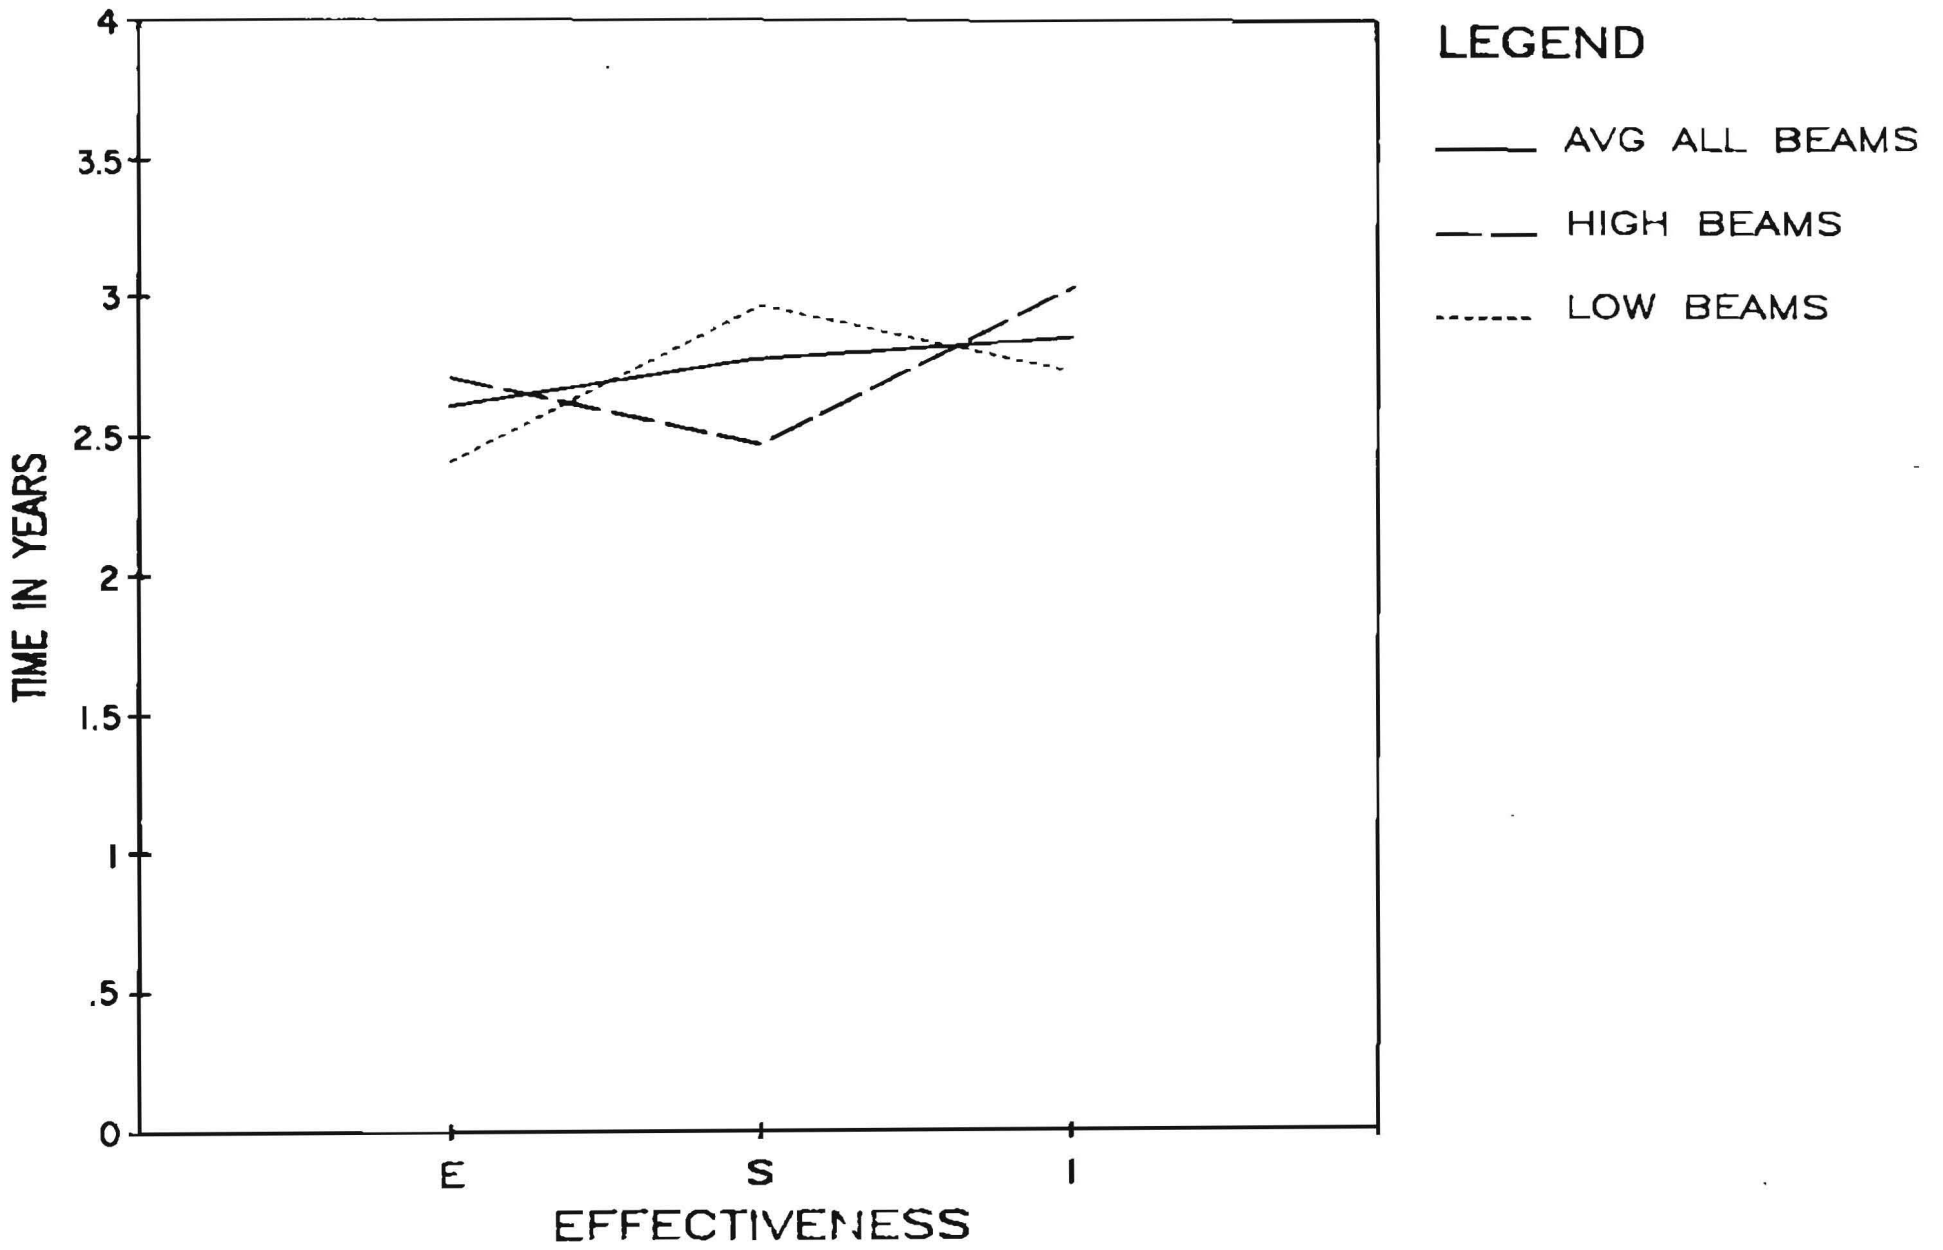
Figure 4. Time On The Road Versus Effectiveness.

Figure 4, relates the judged effectiveness of the marker system to the length of time the markers are on the roadway. The figure relating system effectiveness with time uses (1) high beams, (2) low beams and (3) an average of both high and low beams. The average of both beams is a better indicator because it tends to average (or smooth out) individual site specific differences. Both the effective and ineffective sites where high beam were used were on the road for longer periods of time than at those sites where low beams were used. The low beams resulted in less reflectance than high beams, therefore markers which have been on the roadway longer will appear as bright or brighter with high beams than when low beams are used. This was not the case for those sites the experts rated as semi-effective. Those sites rated semi-effective where low beams were used were placed on the roadway at least six months earlier than those sites where high beams were used. However, the average of both beams indicate a steady increase in the number of years on the road as the effectiveness of the markers decrease. It appears that markers become totally ineffective the second and third year the markers are in place.

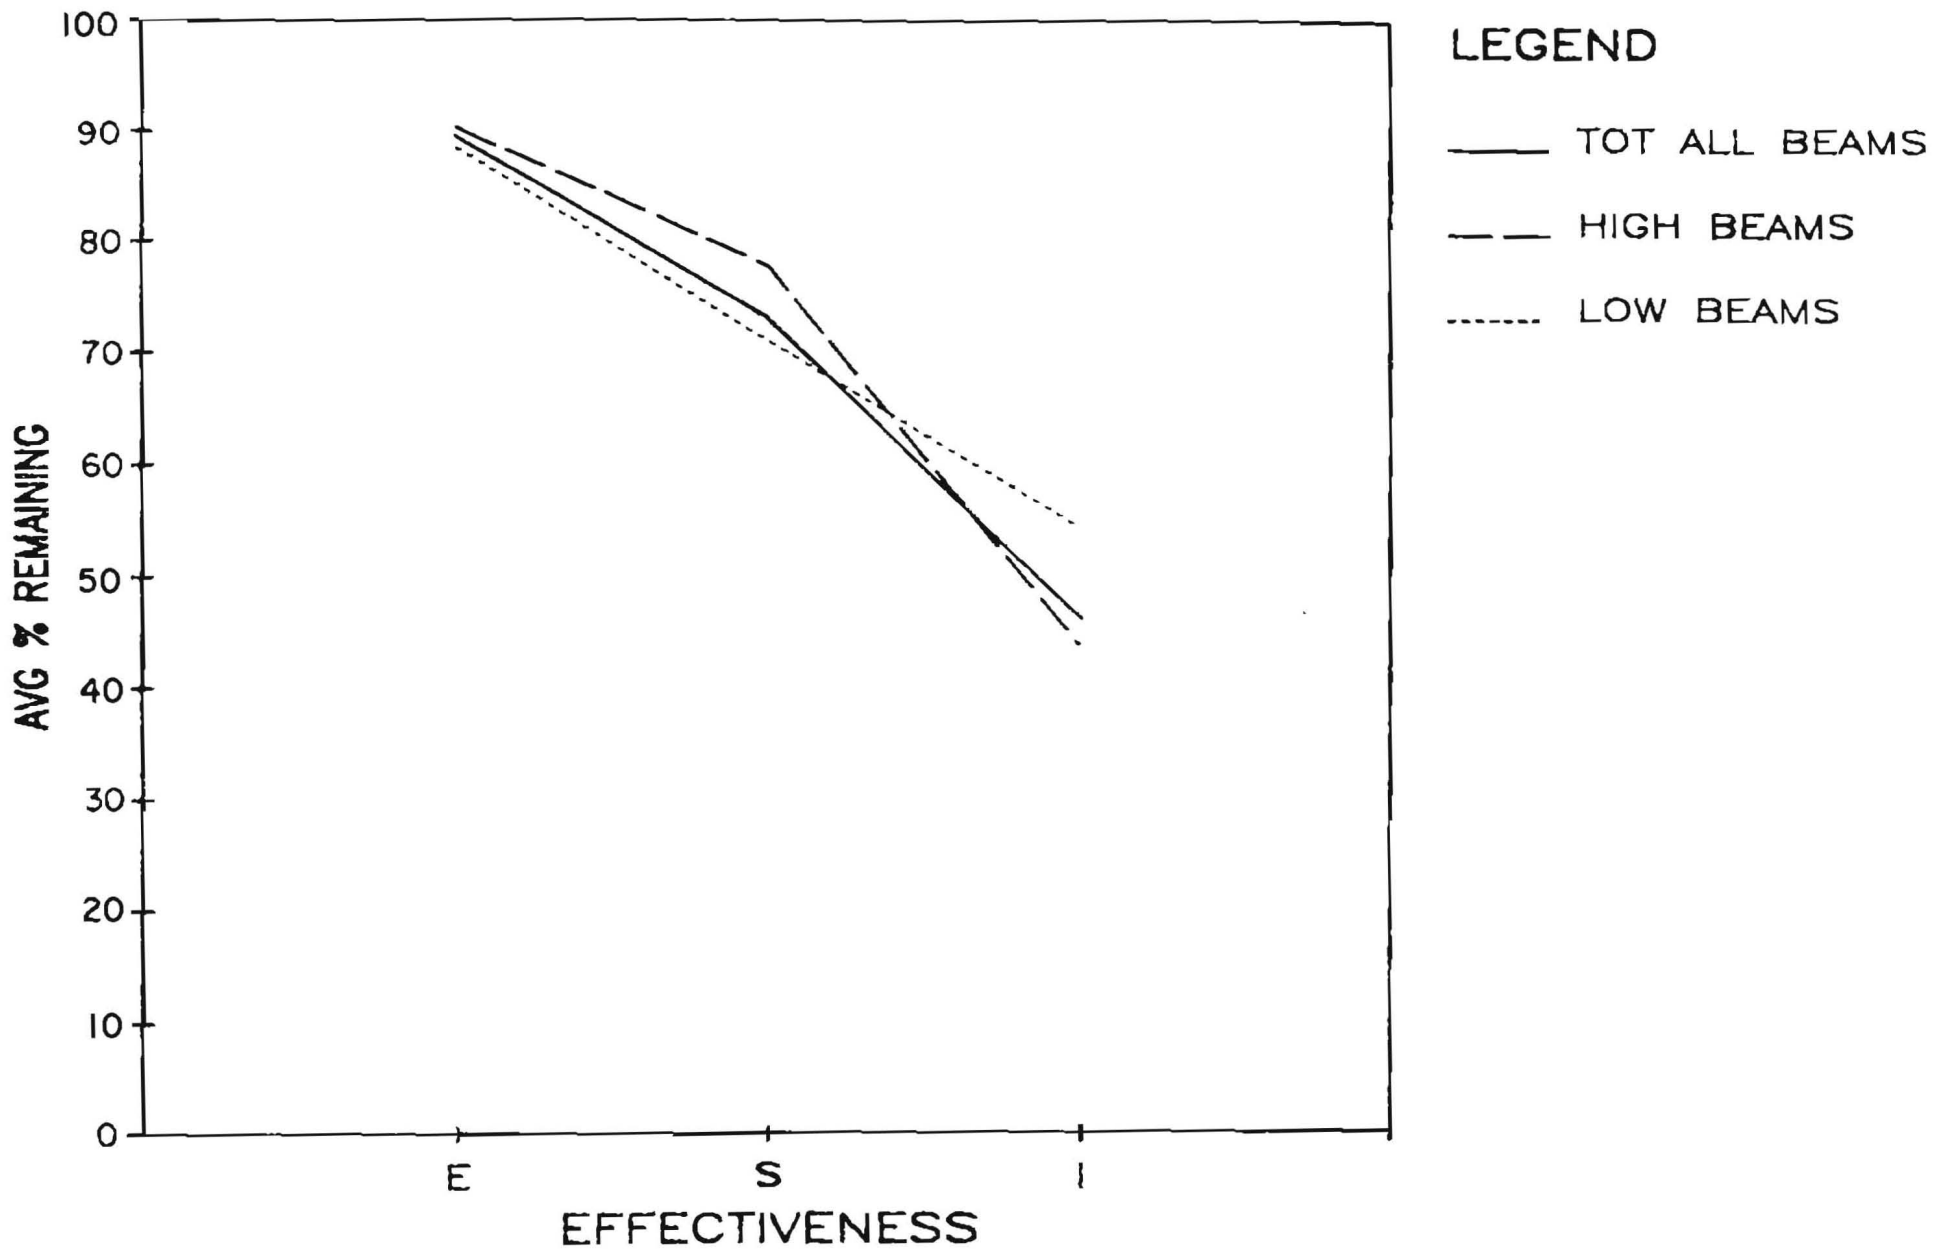
Figure 6. Average Percent Remaining Versus Effectiveness.

An analysis was performed to determine the percent of missing markers which affected the marker system level of effectiveness. The results of this analysis are presented in Figure 6. The average of both low and high beams is a better indicator of the markers functionality. The change in the level of effectiveness is a function of the number of missing markers. A marker system is considered effective when 73 percent or more of the markers are in place, semi-effective when the number of markers in place range between 75 percent and 45 percent and ineffective when less than 45 percent of the markers are remaining.

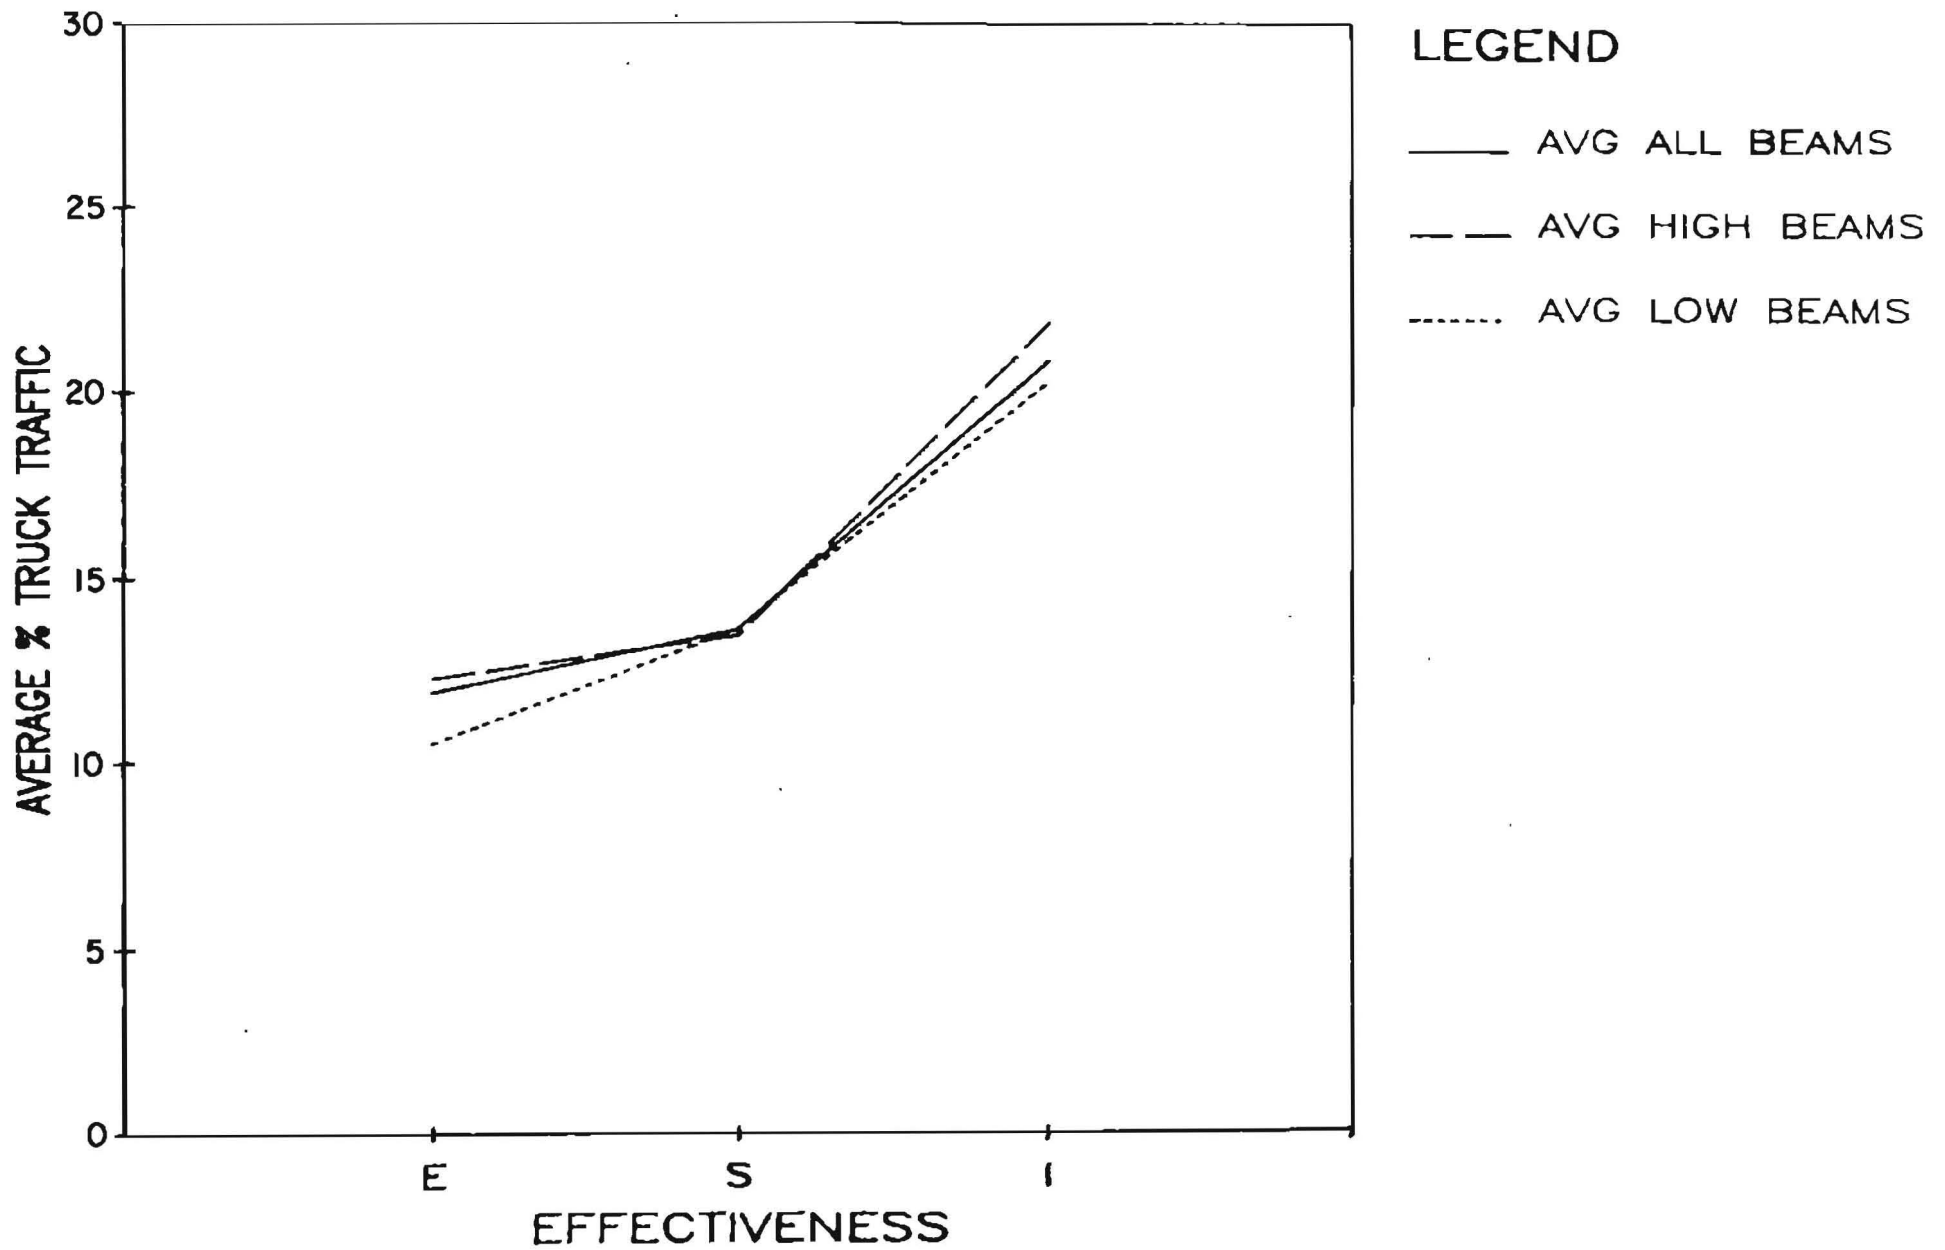
Figure 8. Percent Truck Versus Effectiveness.

Figure 8, presents the rated effectiveness of the markers as a function of the percentage of trucks in the traffic flow with high and low headlamp beams. Sites rated effective on low beams had 10 percent truck traffic. Sites rated effective with high beams had 13 percent trucks. Those sites evaluated to be semi-effective with both high beams and low beams were characterized by a traffic mix containing 14 percent trucks. These are not significant differences. Those sites judged as ineffective were characterized with a traffic mix of 20 percent at the low beam sites and 23 percent at the high beam site.

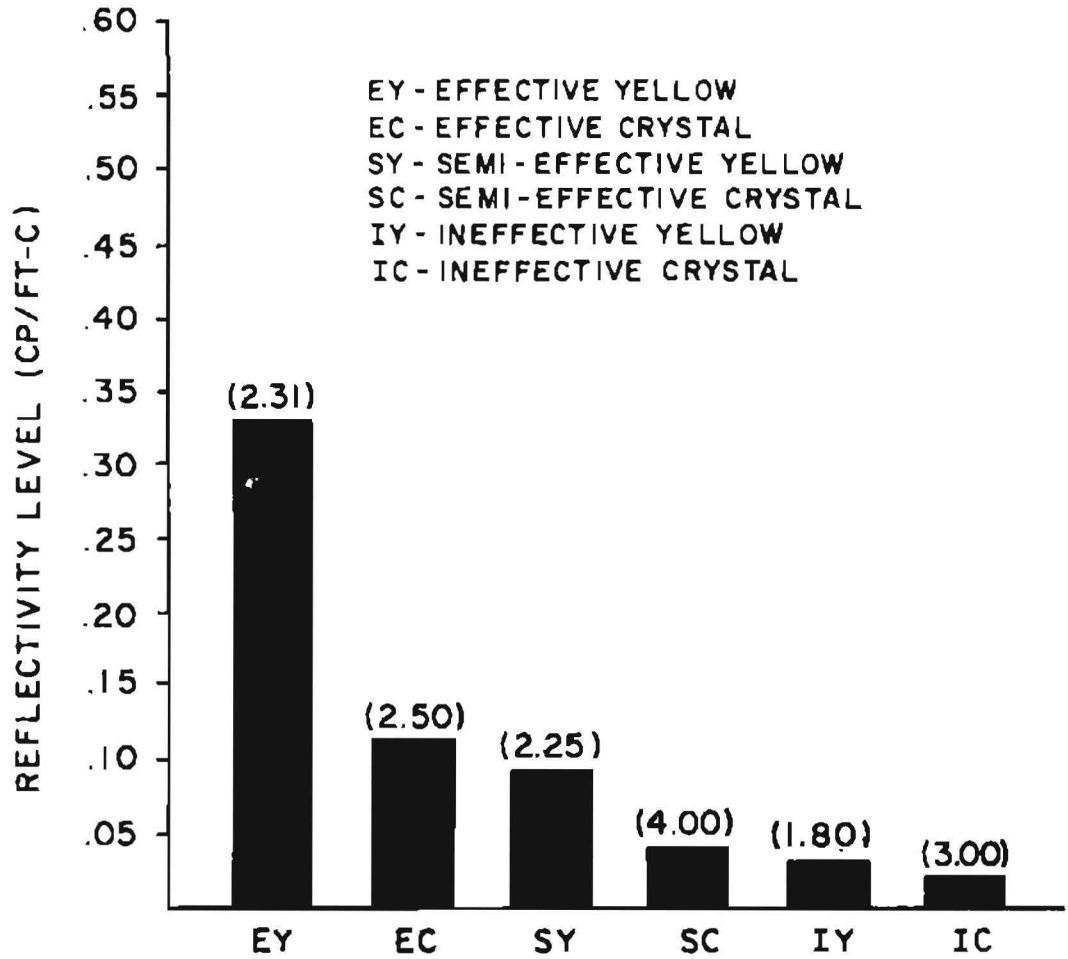
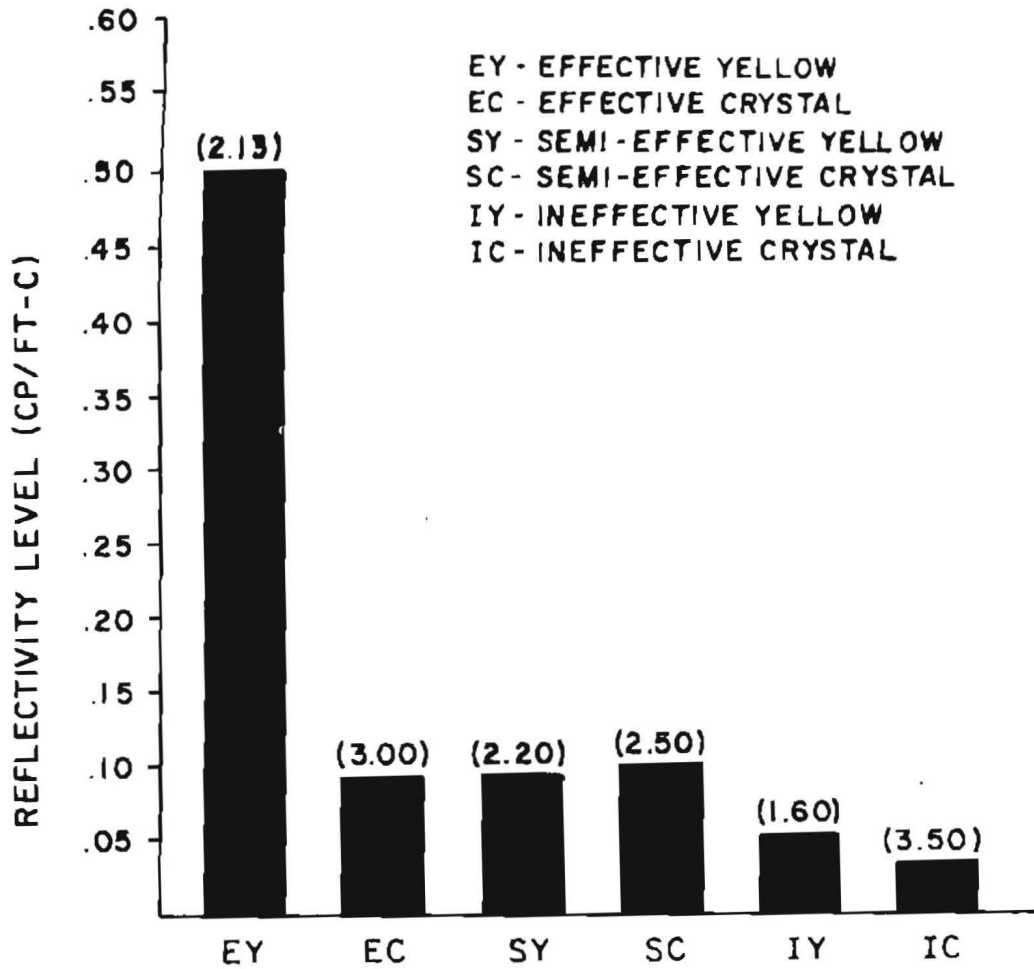
Color of the markers and vehicle headlight beam have an effect on the overall effectiveness of the markers. Figures 14 and 15 relate reflectivity levels to levels of effectiveness, color of marker, number of years in service and vehicle headlamp beam. These figures emphasize that the color of the marker has a significant effect on the effectiveness of the marker. The markers have been segregated into the two primary colors (yellow and crystal) which are directly related to centerline and laneline patterns. Besides being segregated by colors the level of effectiveness has been combined so a direct comparison by color, effectiveness and specific intensity may be performed. Numbers enclosed in parentheses are the average number of years the markers have been in service.

Figure 14. Reflectivity Levels Of Yellow And Crystal Markers For High Beams, At 20° Incidence Angle And Number Of Years In Service.

Figure 15. Reflectivity Levels Of Yellow And Crystal Markers With Low Beams At An Incidence Angle Of 20° And Number of Years In Service.

Figure 15, presents the corresponding data with headlamps on low beam. The intensity levels of all markers were higher than the corresponding sites with high beams. Two exceptions were noted first the effective crystal marker with low beams were .12 (CP/FT-C) and its corresponding site with high beams were .09 (CP/FT-C). Semi-effective yellow markers were .09 (CP/FT-C) with both low and high beams. The effective crystal markers and semi-effective yellow and crystal markers did not have significantly different S.I. values. However, at these extremely low S.I. values significant differences

may be difficult to detect with the human eye. At this point, the number of missing markers or the condition of the paint stripes will have more of an effect on the effectiveness of the marker system than the brightness level. This analysis points out that the reduction in headlamp intensity requires that the pavement markers must have a corresponding increase in intensity to remain at the same effectiveness level. The yellow markers evaluated as effective on low beams had 1.5 times higher S.I.'s than those evaluated with bright lights. The semi-effective crystal markers were 2.5 times brighter than those evaluated with bright light and those evaluated ineffective with low lights were 1.67 times brighter (yellow) and 2.0 times brighter (crystal) than yellow and crystal markers evaluated with high beams. Color of the markers and headlamp beams have a significant effect on the required levels of reflectivity of the markers. Markers regardless of colors lose between 90 and 98 percent of their initial brightness level in a short period of time (2.5-3.0 years). They can lose approximately 30 percent of their original intensity and still remain effective on low beams with yellow markers and 60 percent with high beams. The crystal markers can lose 90 percent of their original brightness level and remain effective for both high and low beams. These results indicate that all markers reflectivity is diminished after two years and in some cases after six months.

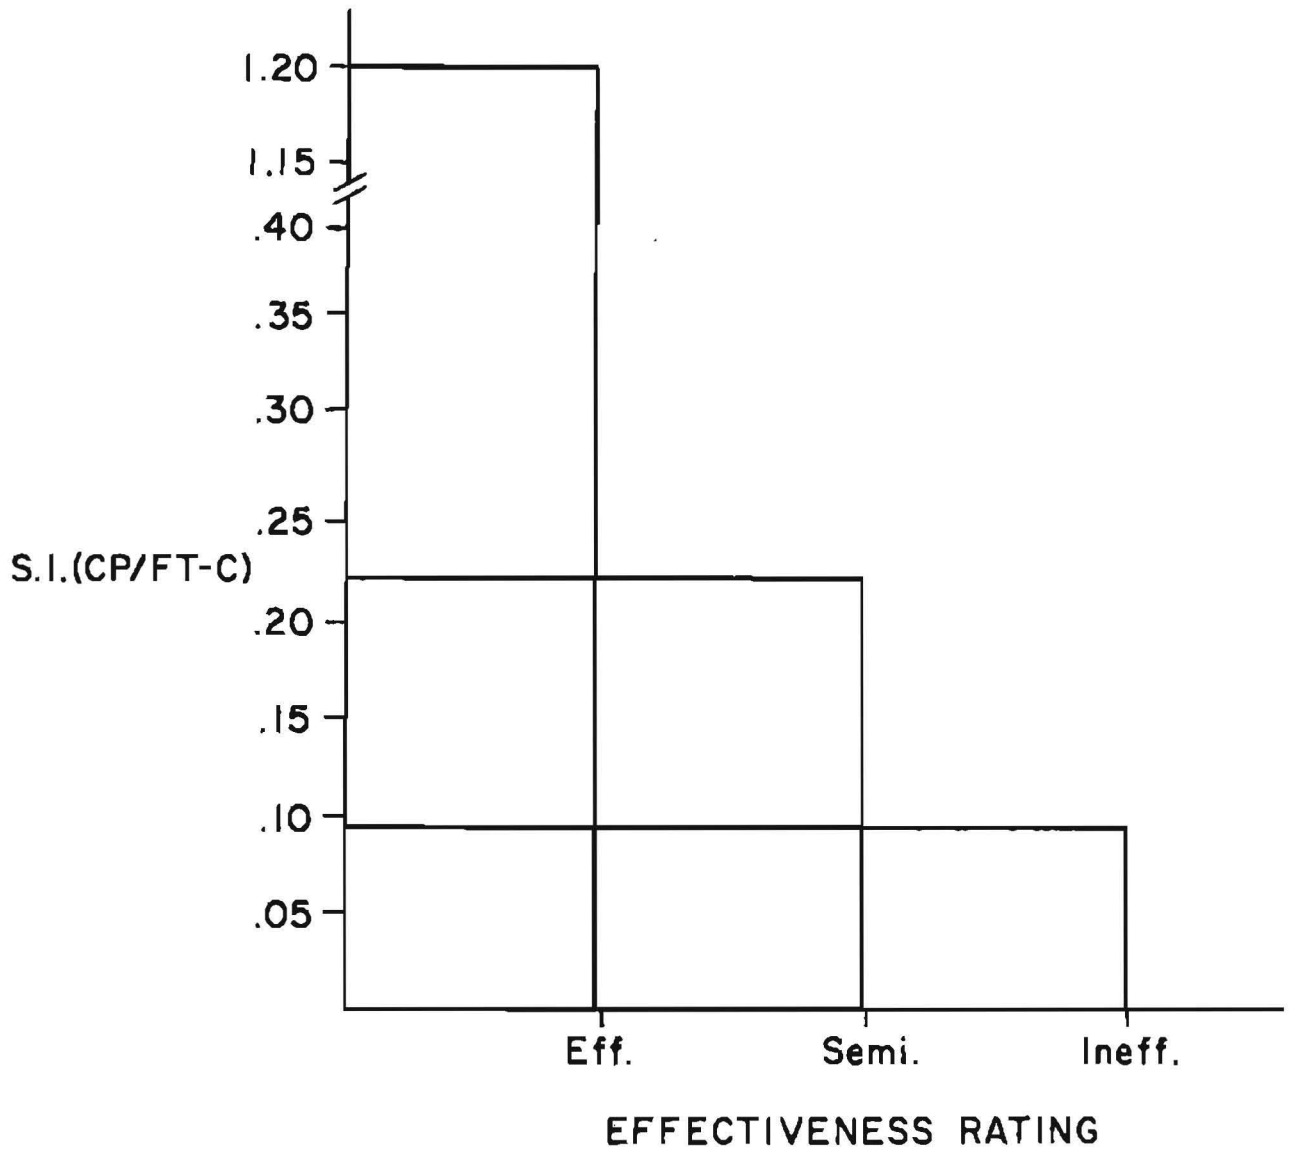
Figure 18. Specific Intensity (S.I.) Values Versus Expert Effectiveness Ratings For ALL MARKERS. Unwashed Markers At 20° Angle.

Figure 18 illustrates unwashed markers remain effective with a specific intensity of .23 CP/FT-C. Markers become ineffective with specific intensity of .09 CP/FT-C or less. It should be pointed out that specific intensity alone does not determine effectiveness. The number of missing markers and the condition of the other pavement markings affect the effectiveness of any marking system. These two factors could not be eliminated. Therefore, the S.I. values stated as break values for the various levels of effectiveness take these two factors into consideration.
