**RETENTION OF REFLECTIVE RAISED PAVEMENT MARKERS**

Research Report 322-3  
Research Study Number 2-18-82-322

State Department of Highways and  
Public Transportation  
In Cooperation with the  
U.S. Department of Transportation  
Federal Highway Administration

October 1986

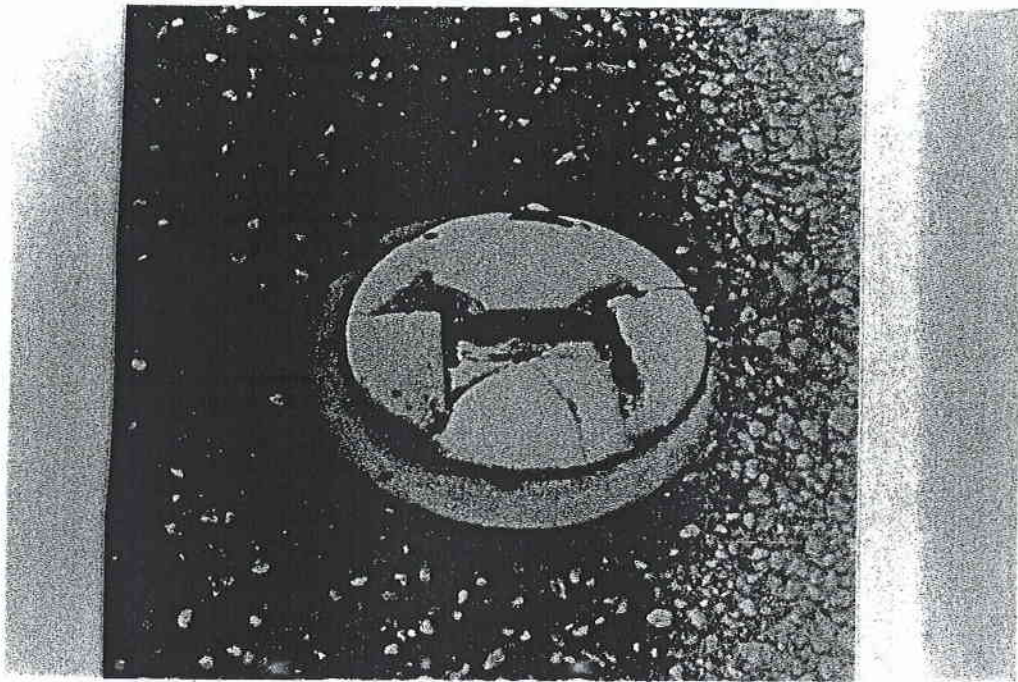
Figure 13. RTB, Type I-C, Badly Broken and Worn.  
Lens is Completely Missing.

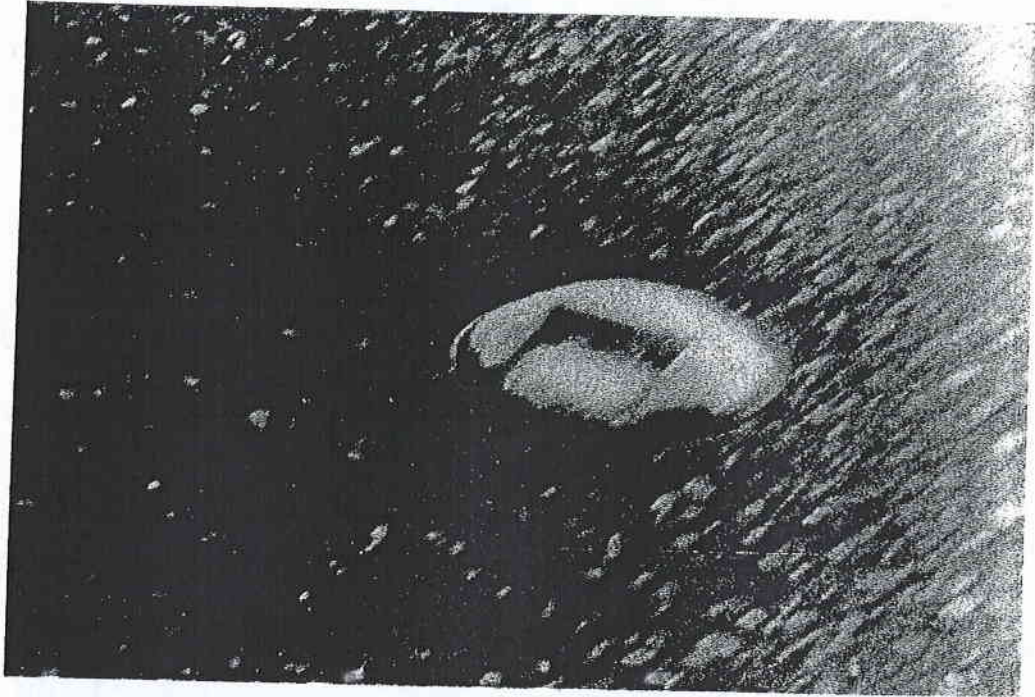
Figure 15. A RTB Submerged Into the Asphalt Pavement.

Examples of loss of reflectivity due to wear and breakage are plentiful wherever markers have been in extended service. Worn lenses (Figure 11), missing lenses (Figure 12), cracked bodies (Figure 13) and dirt-covered lenses (Figure 14) are more often the rule than the exception on Texas highways. Sometimes the reflectivity is degraded when the marker is pounded down vertically into the pavement as shown in Figures 15 and 16. Large rolls of extruded epoxy in front of the marker can similarly degrade its reflectivity.
