PAVEMENT EDGES AND VEHICLE STABILITY -
A BASIS FOR MAINTENANCE GUIDELINES

Research Report 328-1
Research Study Number 2-18-81-328
Pavement Edges, Roadway Discontinuation and Vehicle Stability

Sponsored by the State Department of Highways
and Public Transportation

September 1982

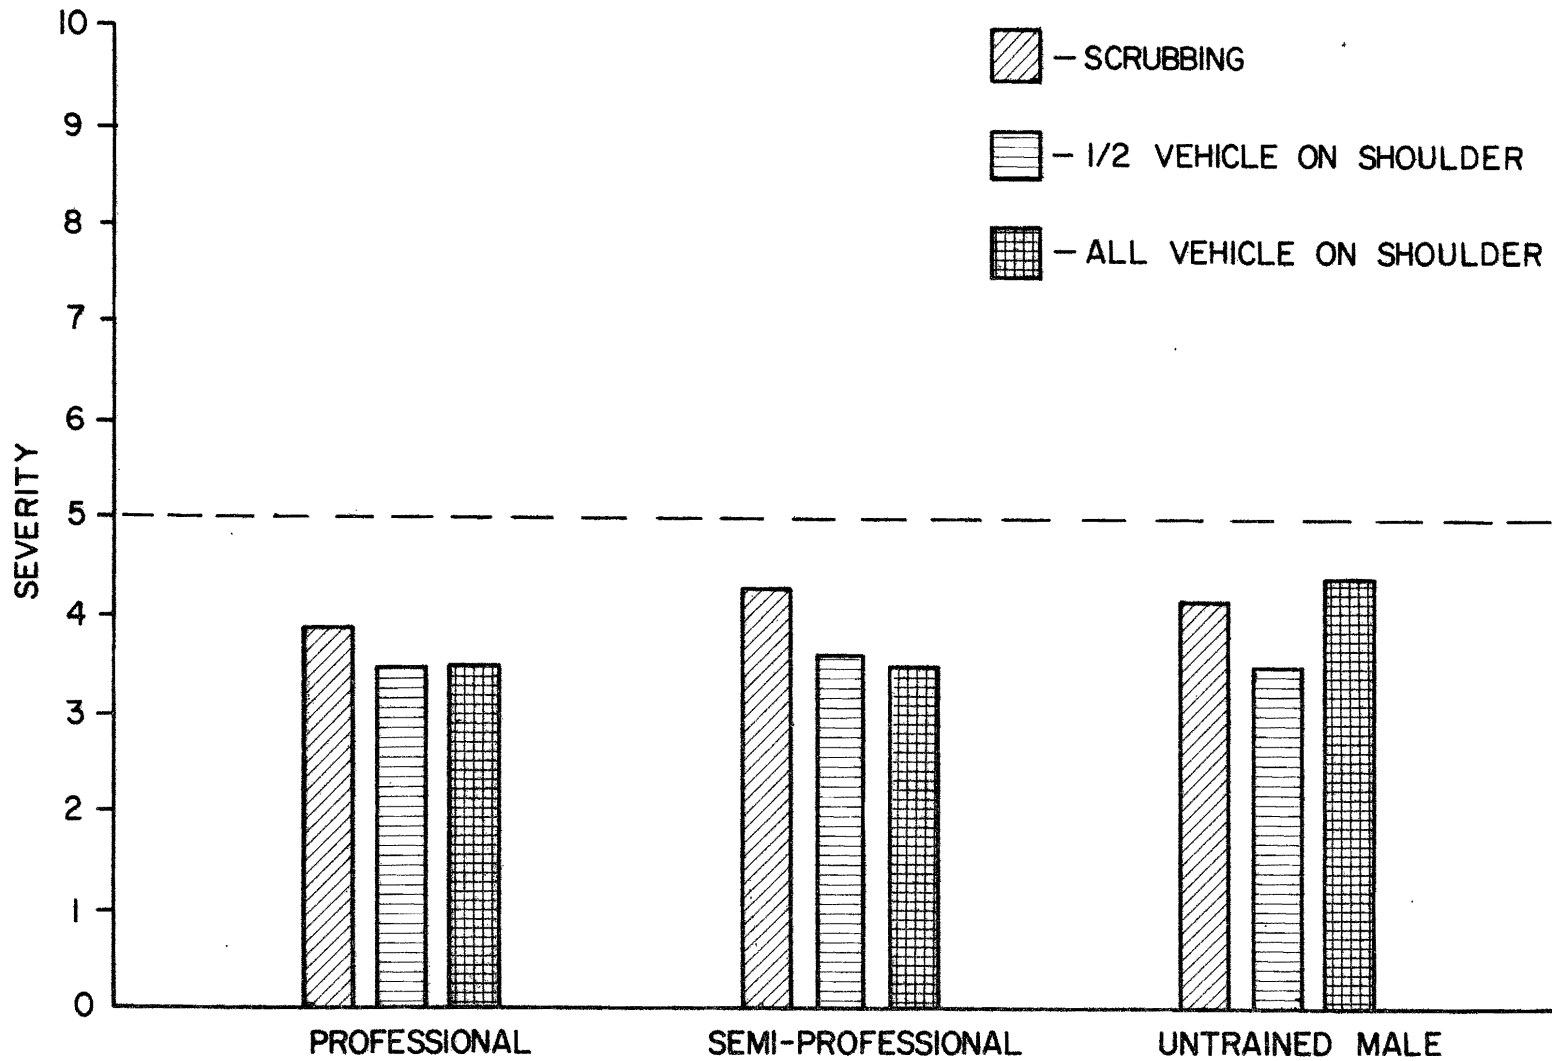
Figure 10. DRIVER COMPARISON
Average Severity - 3 in. Drop Off
All Vehicles at 35, 45 & 55 mph
Rounded Edge - Figure 5

To determine the influence of driver skill level, average severity levels were obtained from three drivers (professional, semi-professional and the untrained male). Data from all vehicles at each test speed on the 3 inch edge height were summarized. As can be seen in Figure 10, the average values for each driver under each pre-return condition were fundamentally equal. The exception is the untrained male with the full vehicle on the shoulder. This is a typical result believed to be due to the relatively rough shoulder surface.

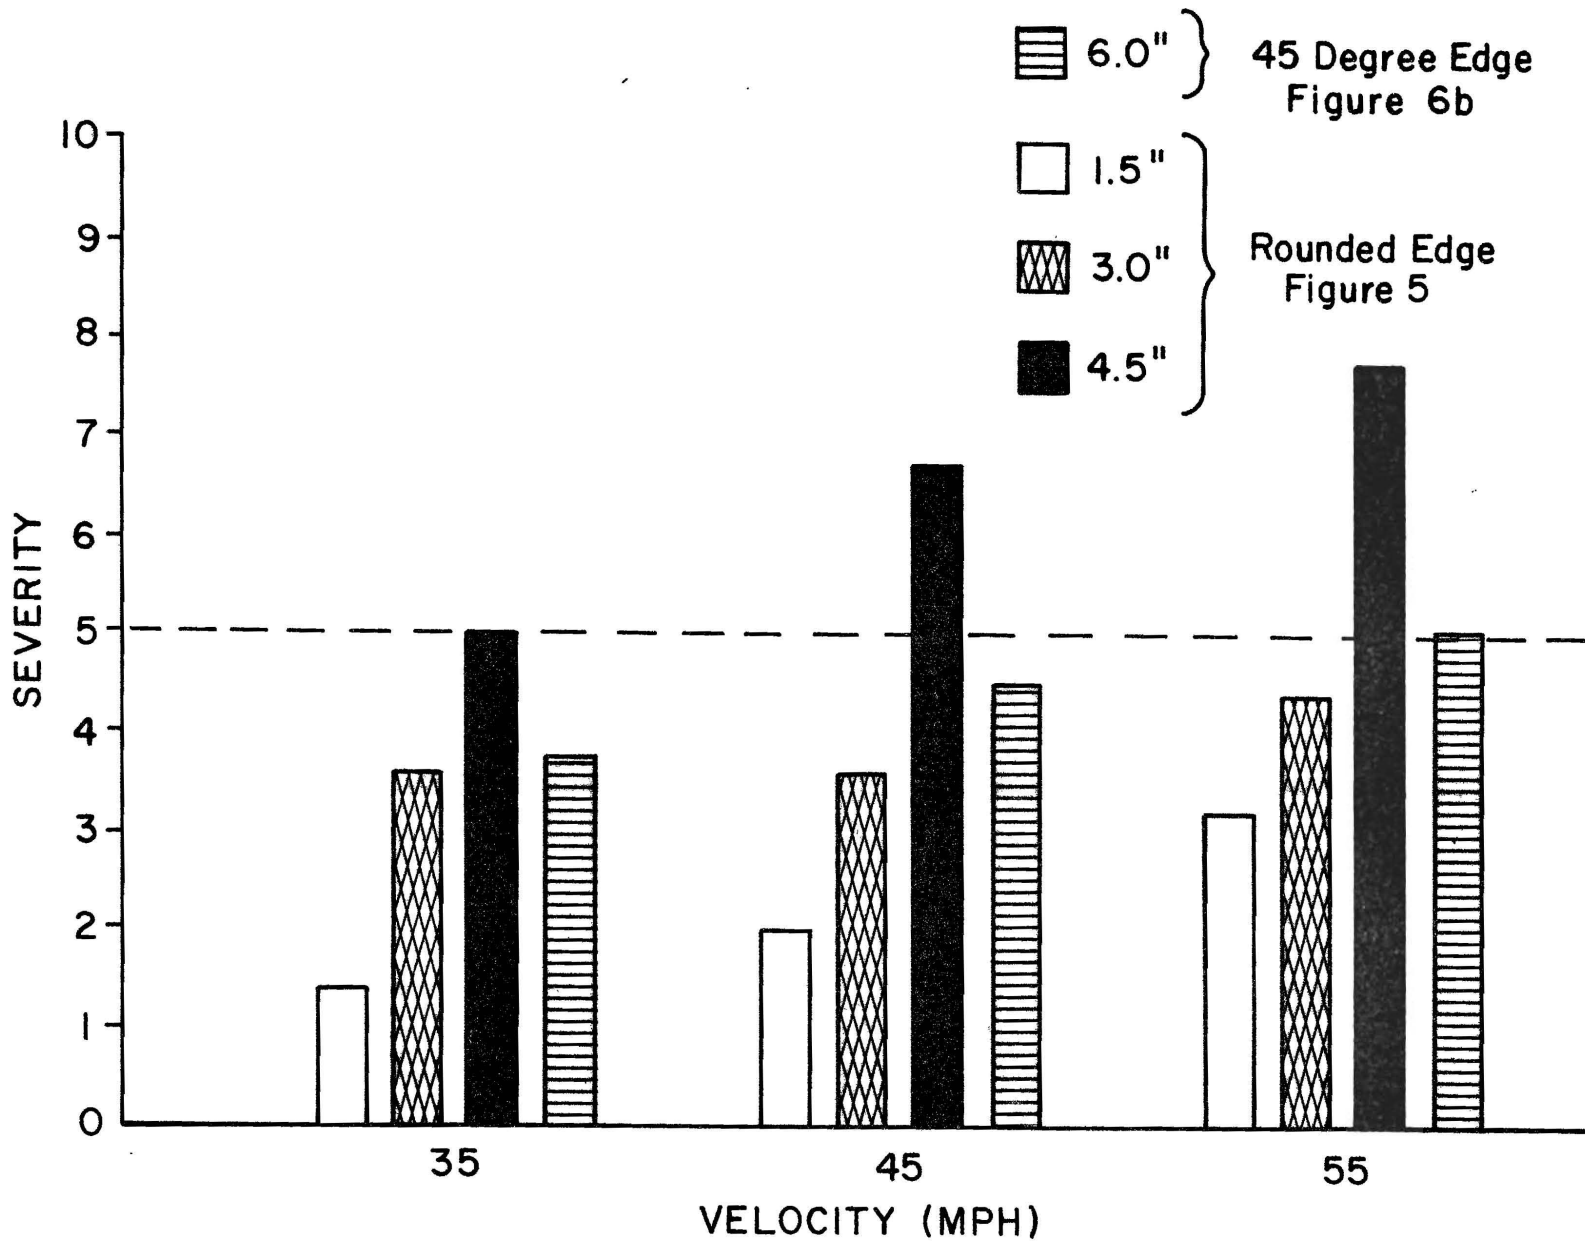
Figure 12. VEHICLE COMPARISON
Driver 1
All Vehicles, Scrubbing

Finally the effect of speed at which the vehicle returned to the roadway was considered in Figure 12. Only the runs made by the professional driver were evaluated to maximize the scope of the comparison. Also, only the scrubbing condition was considered since it has been shown to lead to the most hazardous conditions. All vehicles were averaged since vehicle differences were shown to be small. As Figure 12 shows, a nearly linear increase in severity occurs as the speed is increased within each edge height condition. As before, the 4.5 inch edge height is a potentially unsafe condition, even at the 35 mph speed. Also note the 45 mph and 55 mph are above the critical speeds found by Klein(5). In the case of a 6 inch 45 degree edge a condition approaching the "Marginally Safe" zone occurs as the vehicle speed approaches 55 mph.

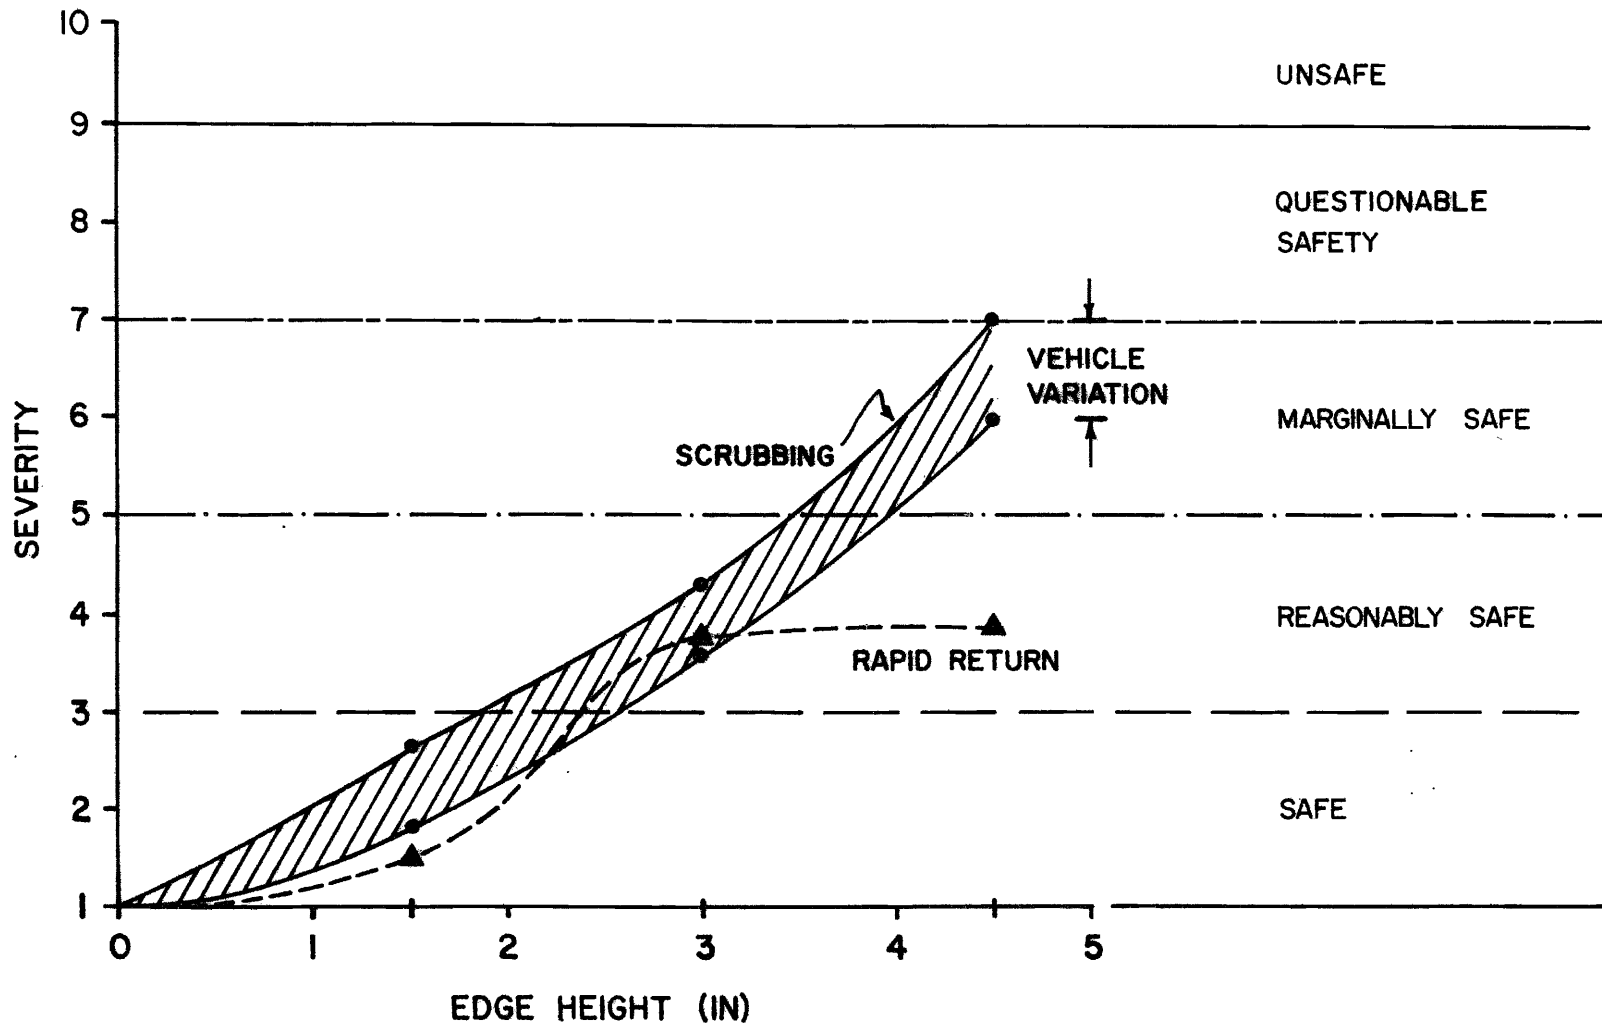
Figure 14. SUMMARY OF SEVERITY LEVELS

Figure 14 summarizes the subjective severity levels obtained by the professional driver, at 35, 45, and 55 mph, using all test vehicles. The 1.5 inch, 3 inch and 4.5 inch edge heights with a 1.5 inch radius edge are included. The dashed curve represents the return condition where the ve-

hicle is approximately half on the shoulder and half on the roadway and returns to the roadway without scrubbing at a comfortable rate. The solid curves represent the scrubbing condition. This is where the right wheels were in contact with the edge for some distance prior to returning.

In both cases, the 1.5 inch height produced levels that were considered mild by the driver. The 3 inch condition also produced similar results from both curves. It was considered to have a definite jerk or slight jolt, but it did not constitute a real safety problem. The 4.5 inch condition shows a definite divergence between the curves, with the rapid return remaining at the same level as the 3 inch but with the scrubbing condition producing high severities. Some runs produced lane violations and slip out. The difference between these two edge heights is illustrated in Figures 15 and 16. Figure 15 shows the results of a typical run made at 55 mph with the intermediate size vehicle and the professional driver returning to the pavement over a 3 inch drop height. Figure 16 shows the results of exactly the same conditions except at the 4.5 inch edge height condition. Notice the extreme arm movements of the driver at 4.67 and 5.75 seconds in Figure 16.

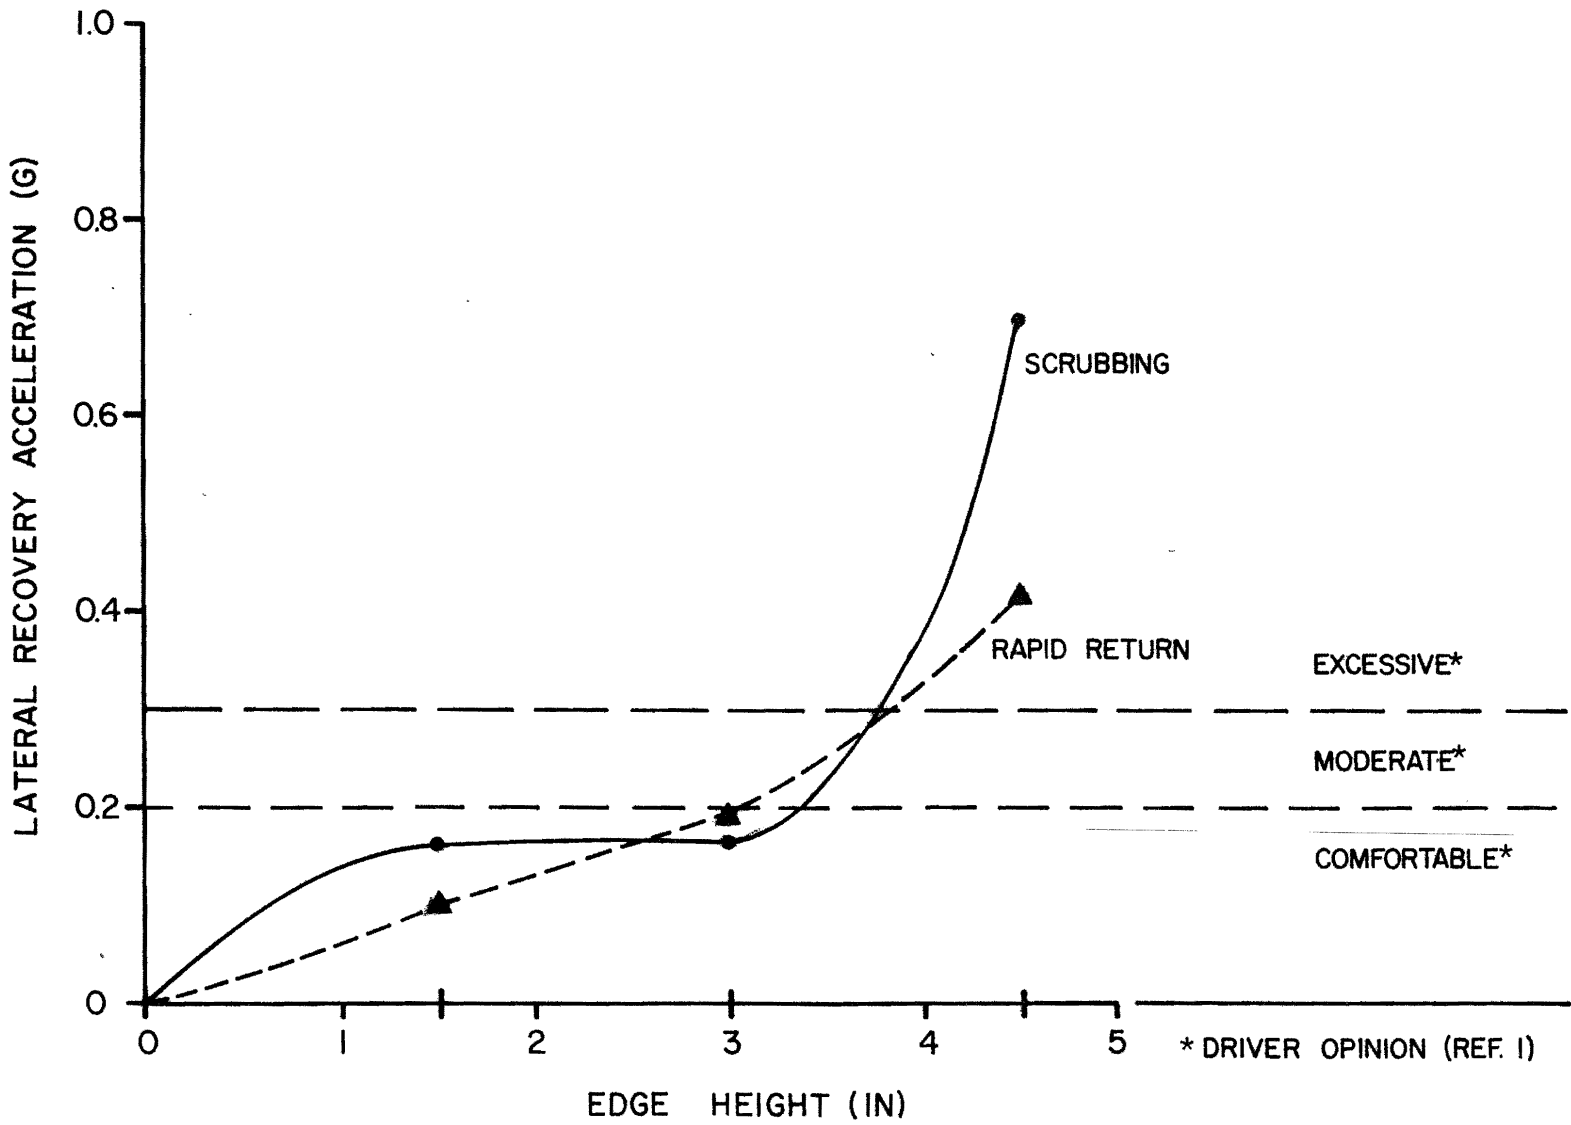
Figure 17. Maximum Lateral Acceleration and Edge Height

most drivers, who may not attempt to develop all of the available friction to remain in their lane of traffic. As in Figure 14, both return conditions show similar values at the 1.5 inch and 3.0 inch conditions and increase into the excessive region at the 4.5 inch condition. The scrubbing condition produced quite high values of 0.7 to 0.8g which proved to be near the maximum available friction levels, since lane violations and slipouts did occur.
