TRANSITWAY WIDTH ASSESSMENT

by
Timothy J. Lomax
Assistant Research Engineer

Research Report 339-3
Improving Mobility Through Application of High-Occupancy
Vehicle Priority Treatments
Research Study 2-10-84-339

Texas Transportation Institute
Texas A&M University System
College Station, Texas 77843

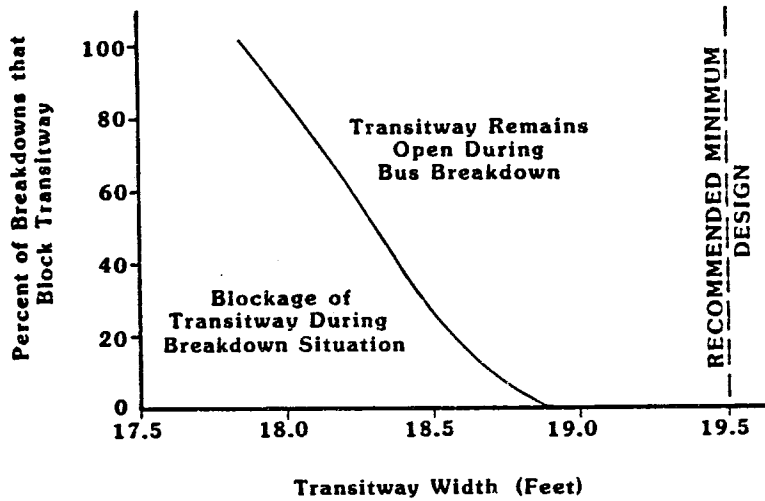
Note: Assumes 9.5 feet of clear space necessary for bus to pass stalled vehicle.

Figure S-1. Bus Breakdowns That Block Transitway

Minimum and desirable transitway widths were determined using passing speed information, delay estimates, and cost estimates of a bus breakdown for various transitway widths (Figure S-2). Table S-1 summarizes these quantities for the recommended minimum and desirable configurations. The widths

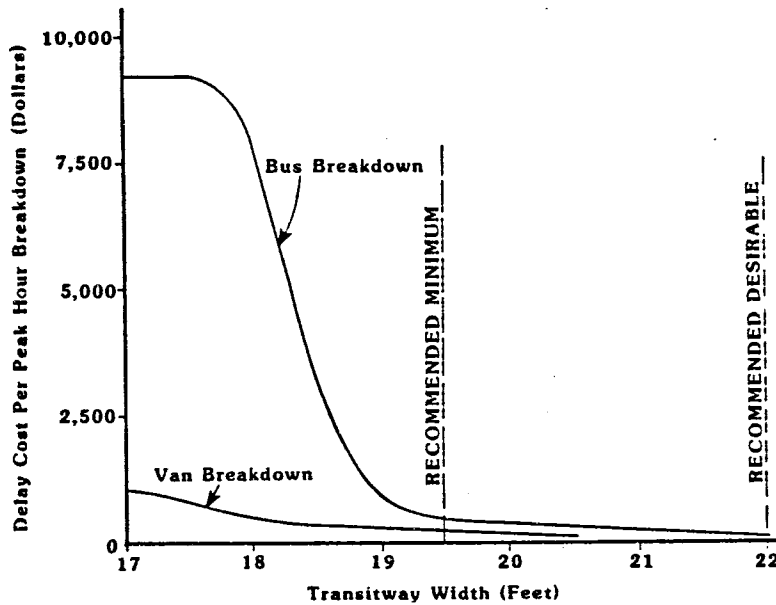
Note: Assuming typical breakdown rates, 15 bus breakdowns and 75 van breakdowns can be expected per year. The delay cost is calculated by multiplying the probability of the event (lane closed or open) to the value associated with that event. Peak-hour volumes of 50 buses and 300 vanpools were combined with an incident time of 30 minutes. Values of \$50 per bus operating hour and \$7 per passenger hour were used to assess the cost of delay.

Figure S-2. Delay Cost of a Peak-Hour Breakdown on Tangent Transitway

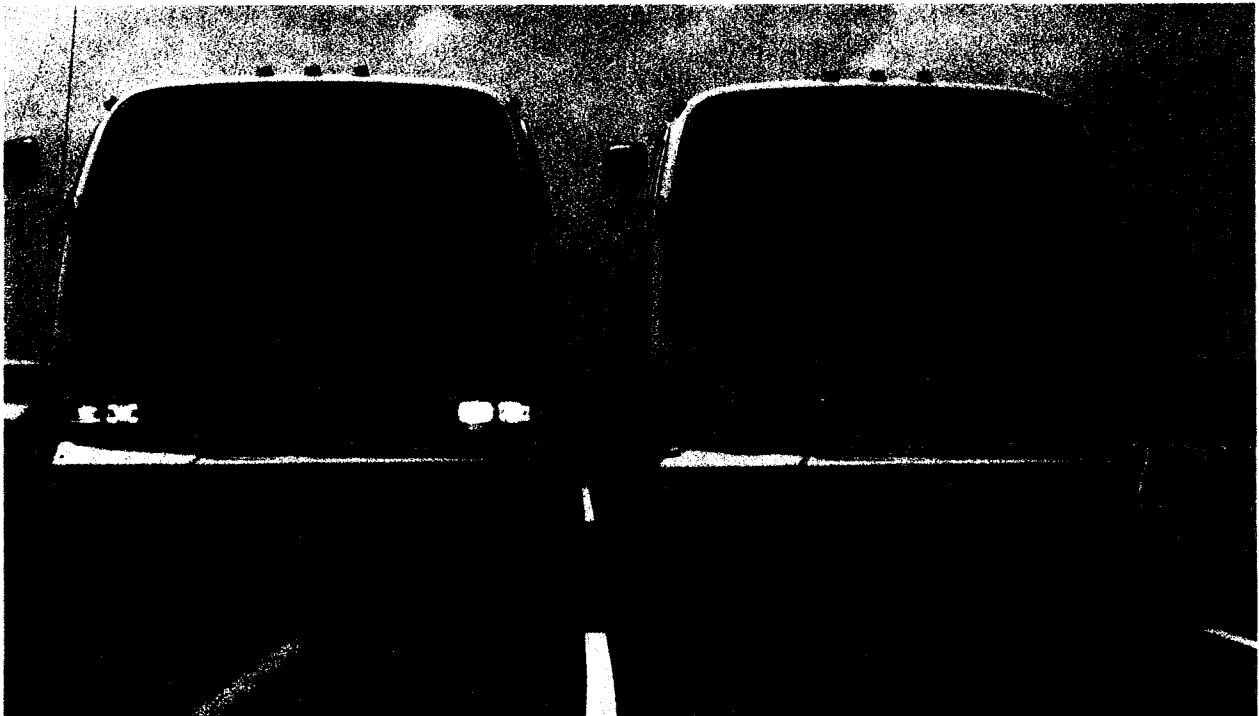
Note: The distance between the buses is approximately equal to that experienced in the 19.5-foot transitway.

Figure 1. Relative Mirror Position During Bus Passing Maneuver

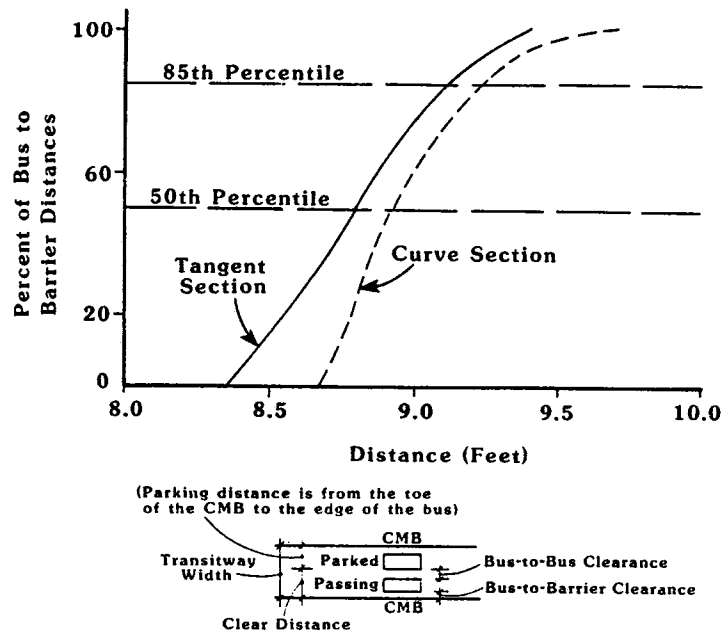
Note: Due to the shape of the bus and the shape of the concrete barrier, it is possible for the measured distance to be less than the 8.5-foot bus width.

Figure 10. Summary of Transit Bus Breakdown Parking Test Data

Figure 42 utilizes the parking distances on tangent transitway sections illustrated in Figure 10 to estimate the percentage of controlled bus breakdowns that might block narrow transitways. According to the collected data, any transitway wider than 19.0 feet would never be blocked due to a non-

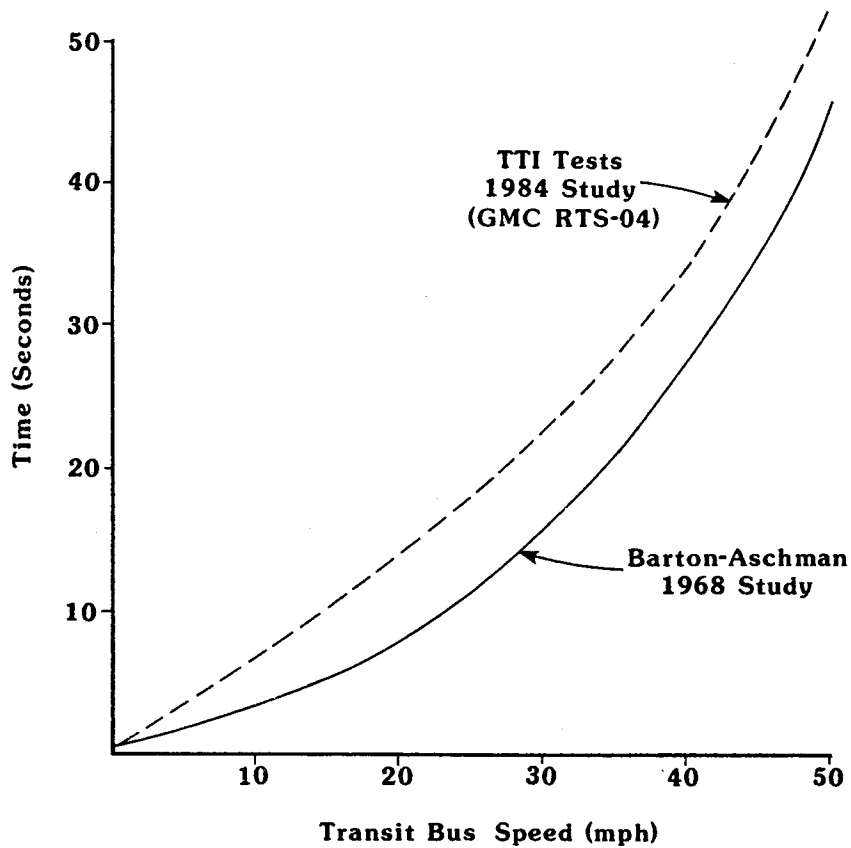
Figure 13. Comparison of Acceleration Characteristics of Old and New Transit Buses

Figure 13 compares the observed time to accelerate from 0 to 50 mph observed at the Texas A&M Research Annex to the characteristics of a GMC transit coach reported in a 1968 study (9). Almost 10 seconds more is required to reach 50 mph in the newer, heavier GMC coaches. The acceleration time curve begins to climb noticeably after a speed of 30 mph is reached

(Figure 13). The newer bus only requires 22 seconds to reach 30 mph from a stopped start, but another 30 seconds to accelerate from 30 mph to 50 mph.

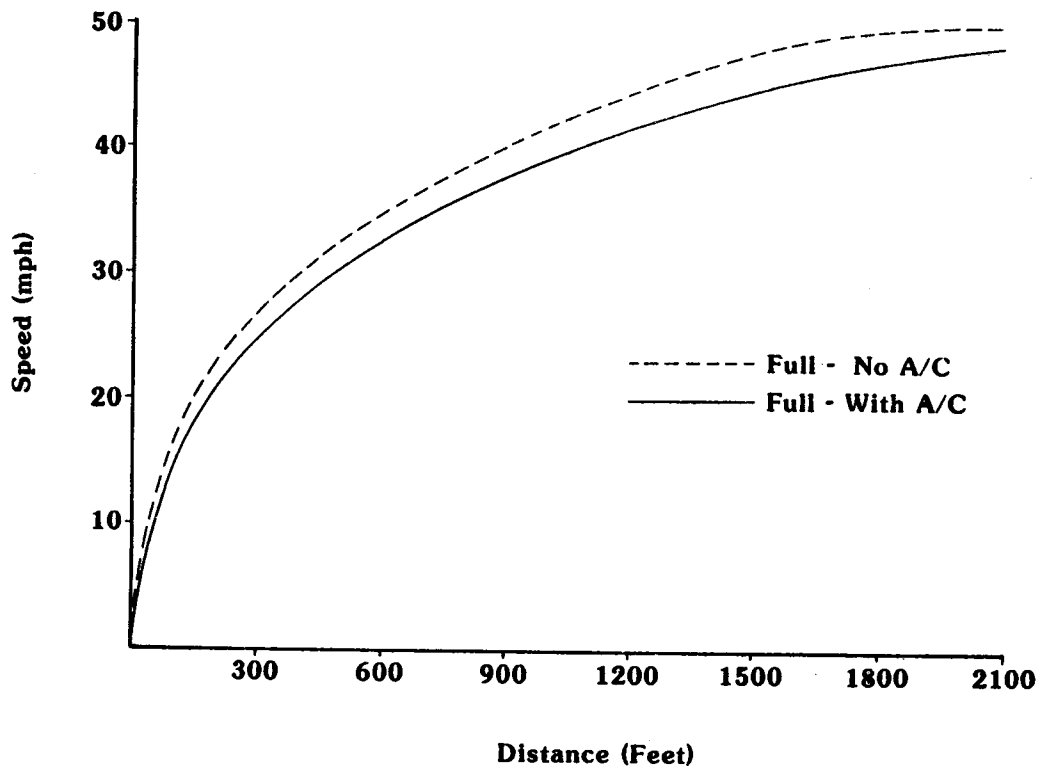
Figure 14. Effect of Air-Conditioner Operation on Transit Bus Acceleration

Figure 14 illustrates the effect of air-conditioner operation on an empty bus at full acceleration. More than 300 feet less is required to reach 50 mph without air-conditioning, with the gap between curves widening noticeably at the upper end of the speed range.

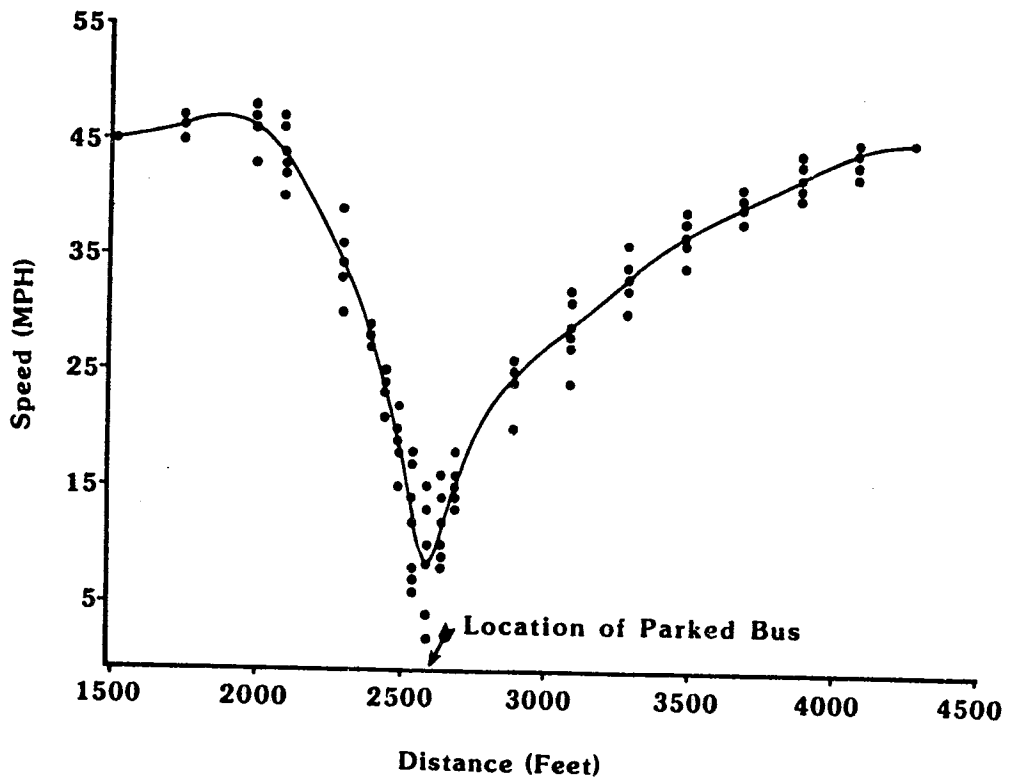
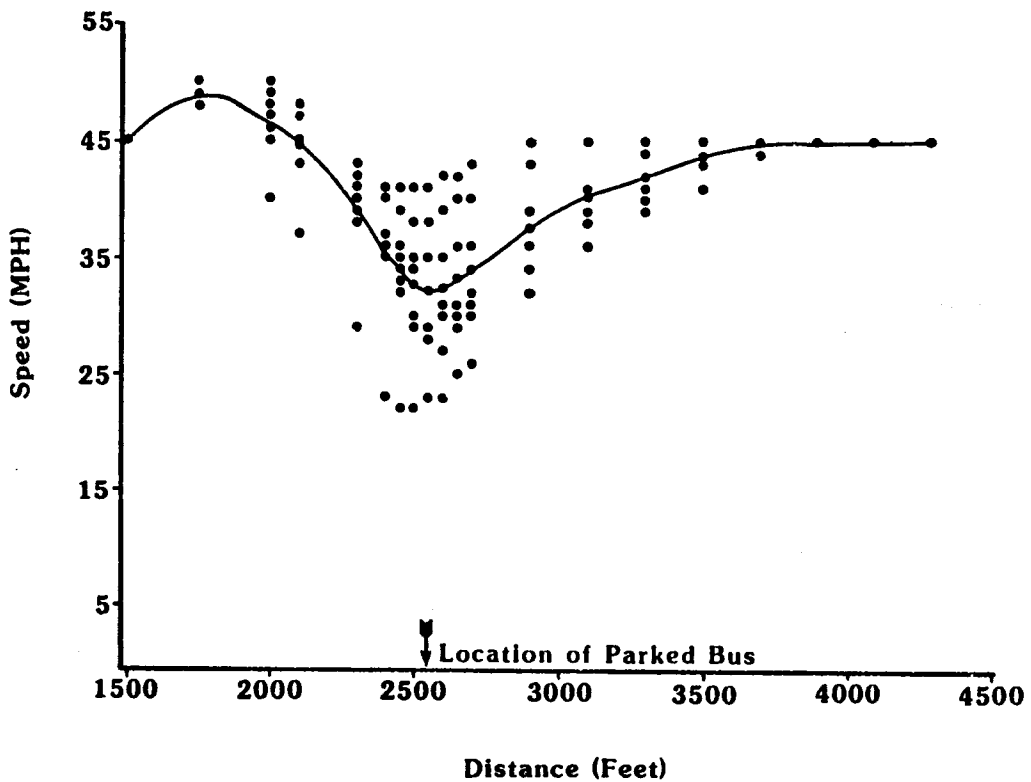
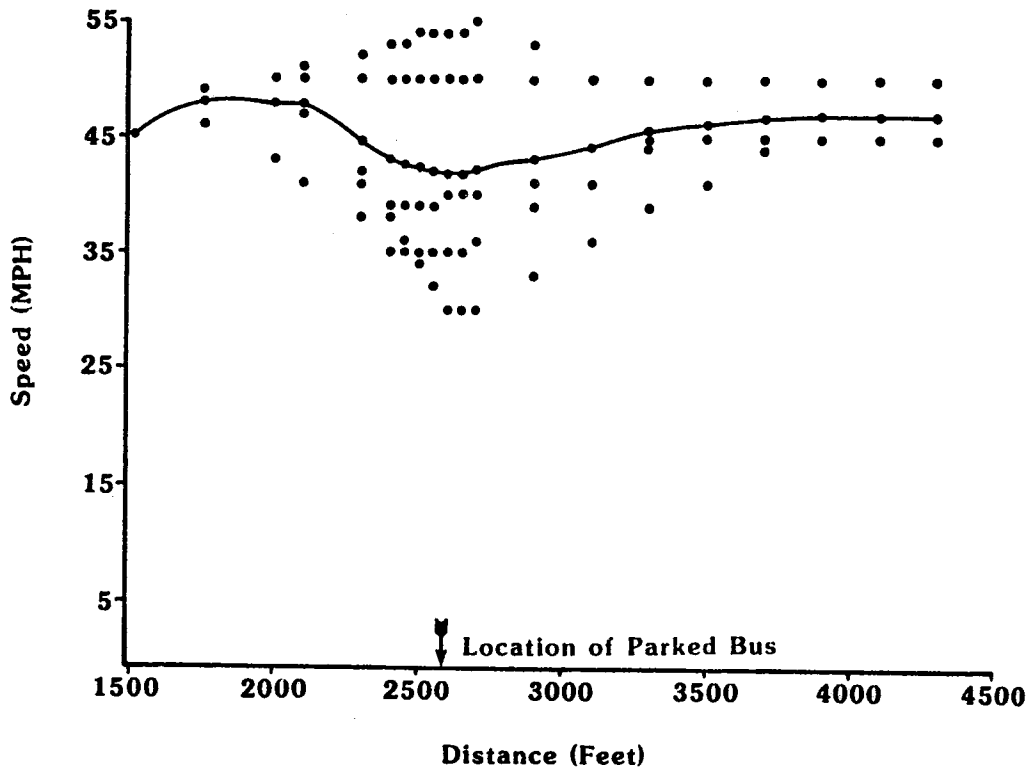
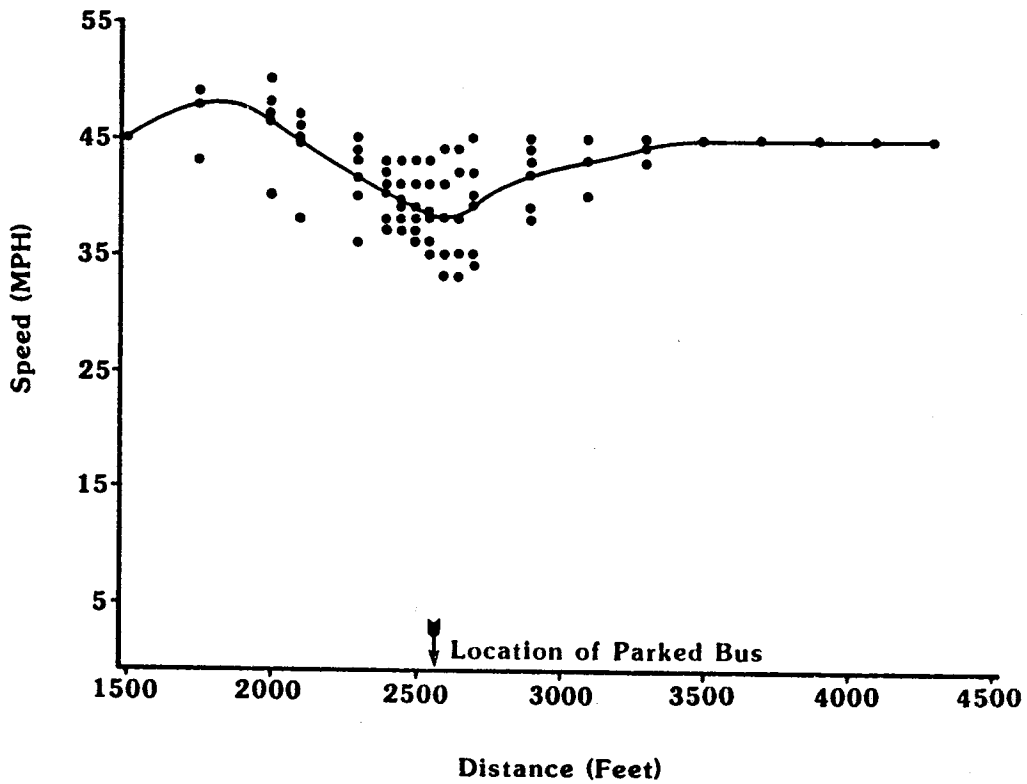
Figure 15. Passing Speed On 19.5-Foot One-Way Transitway--Tangent Section -- All Data Points

Figure 16. Passing Speed On 19.5-Foot One-Way Transitway -- 3° Curve Section -- All Data Points

Figure 17. Passing Speed On 20.5-Foot One-Way Transitway -- Tangent Section -- All Data Points

Figure 18. Passing Speed On 20.5-Foot One-Way Transitway -- Tangent Section -- All Data Points

Figure 19. Passing Speed On 22.0-Foot, One-Way Transitway -- Tangent Section -- All Data Points

Figure 20. Passing Speed On 22.0-Foot, One-Way Transitway -- 3° Curve Section -- All Data Points

Figure 21. Passing Speed On 34.0-Foot, Two-Way Transitway -- Tangent Section -- All Data Points

The data presented in Figures 15 through 21 represent the speed versus distance relationships observed during the actual testing period for each of the widths shown in Table 4. The acceleration portion of the data (from 0 to 1500 feet) is not present, but the section of curve from 1500 to 2000 feet does show some effect from the test conditions since the increase in speed would not actually be present during normal transitway operation as the buses would be traveling at 50-55 mph. The arrow at the bottom of each graph indicates the position of the parked (stalled) bus, and thus, the location of the constriction in the simulated transitway. The relatively close proximity of the two buses to barriers and each other for the 19.5-foot test is illustrated in Figure 22.

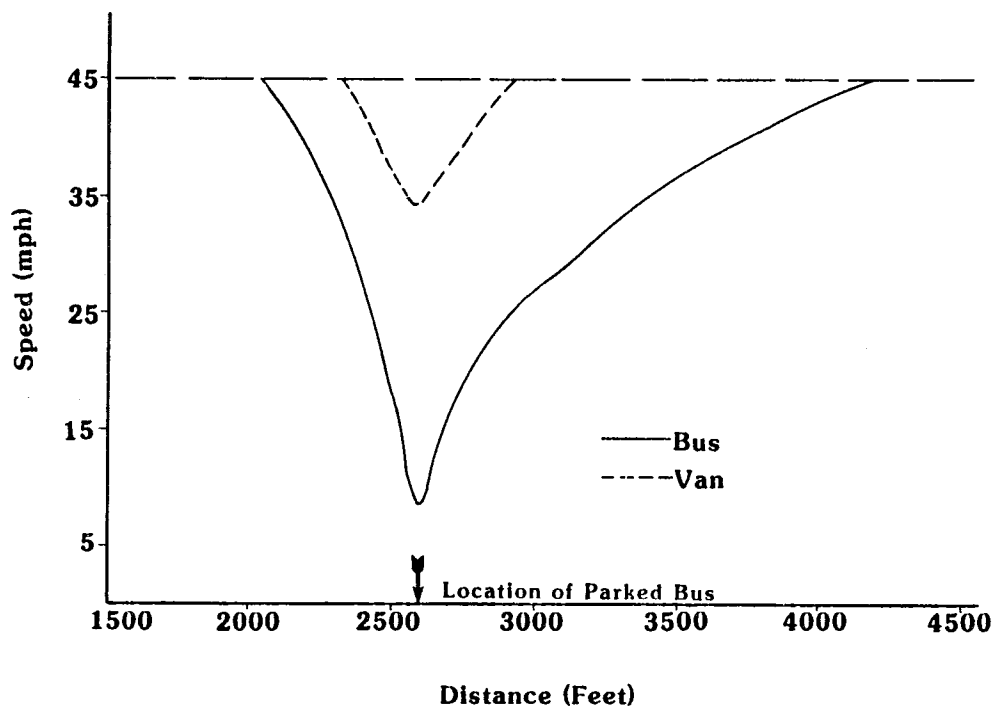
Figure 23. Comparison of Speed Profiles of Transit Bus and Van Passing a Parked Bus in a 19.5-Foot Tangent Transitway

Figure 23 illustrates the relationship between the passing speeds for buses and vans on the narrow transitway simulation. The passing speed of a novice van driver in this constricted situation is significantly higher than professional bus drivers. This relationship (van to bus passing speeds) held throughout the testing period. A 50 mph van passing speed was attained in all but the narrowest transitway clearances. The condition of a van passing a bus will not control the operation of a transitway under breakdown conditions. The relationship between the passing van and parked bus is shown in Figure 24.

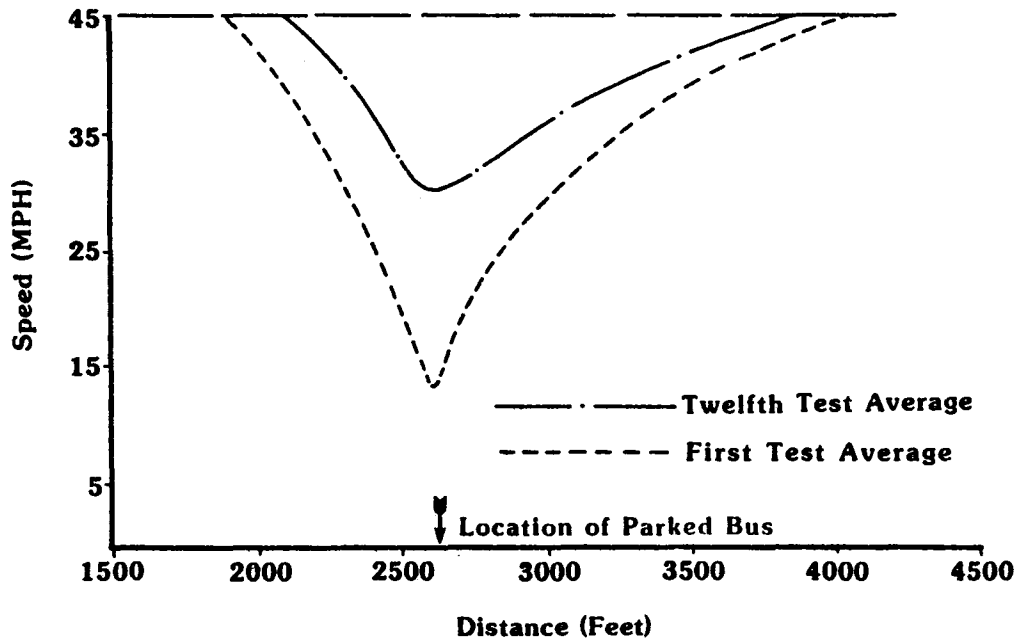
Figure 25. Impact of Approximately 45 Test Passes on Speed Profile of Transit Bus on 20.0-Foot Tangent Transitway

Passing tests were conducted at the beginning and near the end of the week for a simulated transitway width of 20.0 feet. The difference resulting from experience gained in approximately 45 test runs, as illustrated in Figure 25, resulted in a doubling of passing speeds on a tangent alignment. The relationship in this figure is used in all of the following graphs to adjust the actually collected data to two conditions defined for this test. Only that portion of the graph below 45 mph is shown. The plot between 45 mph and 50 mph is, as has already been seen, long and almost identical among

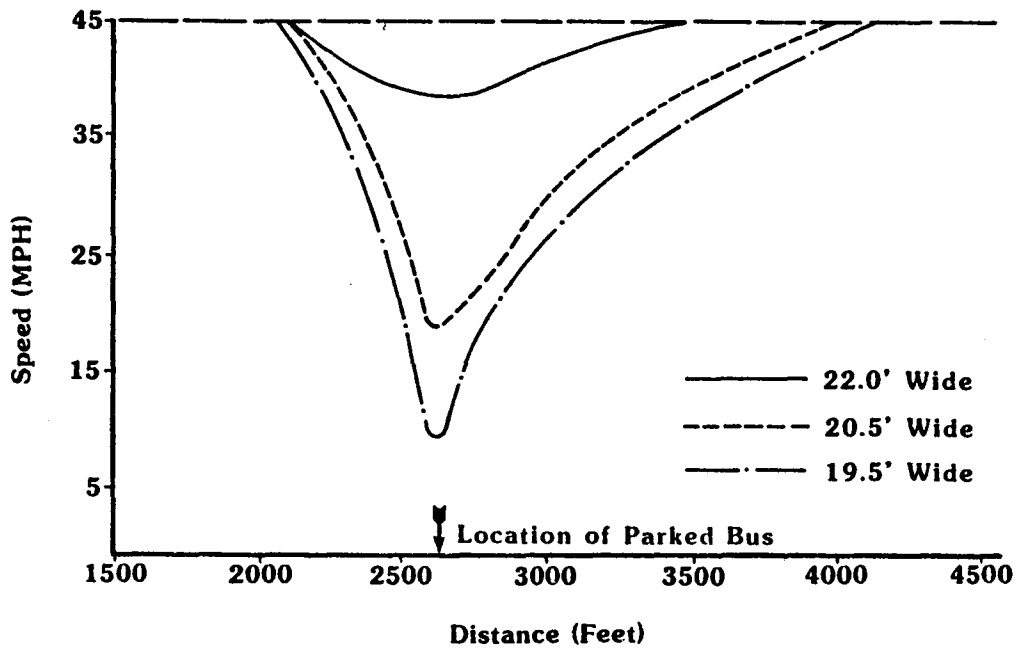
Figure 26. Novice Driver Speed Profiles On Tangent Sections of Transitways

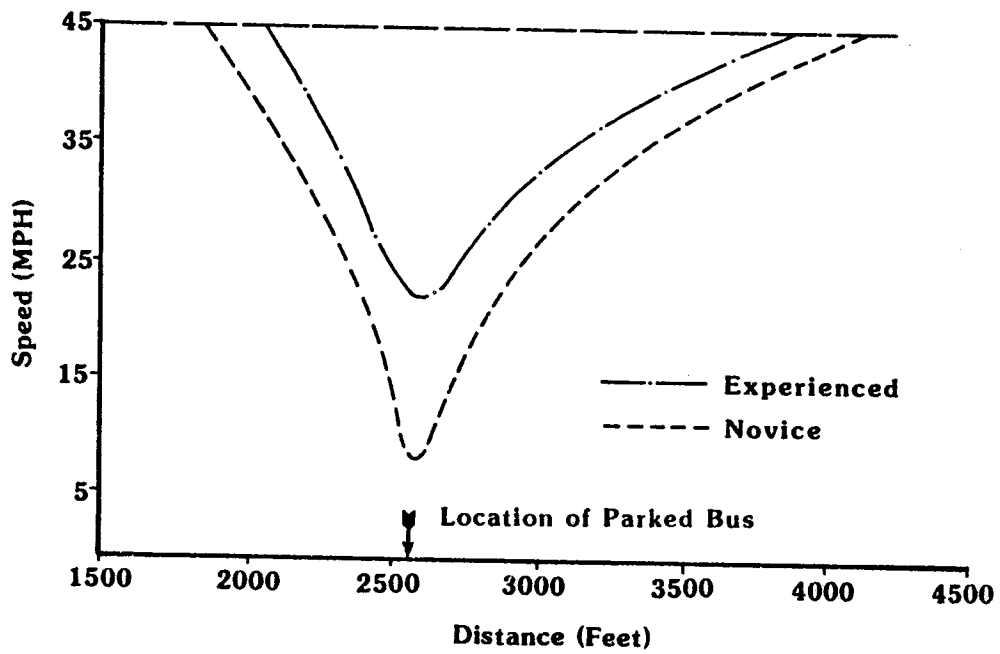
Figure 33. Speed Profile Comparison On 19.5-Foot Tangent Transitway -- Novice vs. Experienced Driver

Figure 34. Speed Profile Comparison On 19.5-Foot 3° Curve Transitway -- Novice vs. Experienced Driver

Figure 35. Speed Profile Comparison On 20.5-Foot Tangent Transitway -- Novice vs. Experienced Driver

Figure 36. Speed Profile Comparison On 20.5-Foot 3° Curve Transitway -- Novice vs. Experienced Driver

Figure 37. Speed Profile Comparison On 22.0-Foot Tangent Transitway -- Novice vs. Experienced Driver

Figure 38. Speed Profile Comparison On 22.0-Foot 3° Curve Transitway -- Novice vs. Experienced Driver

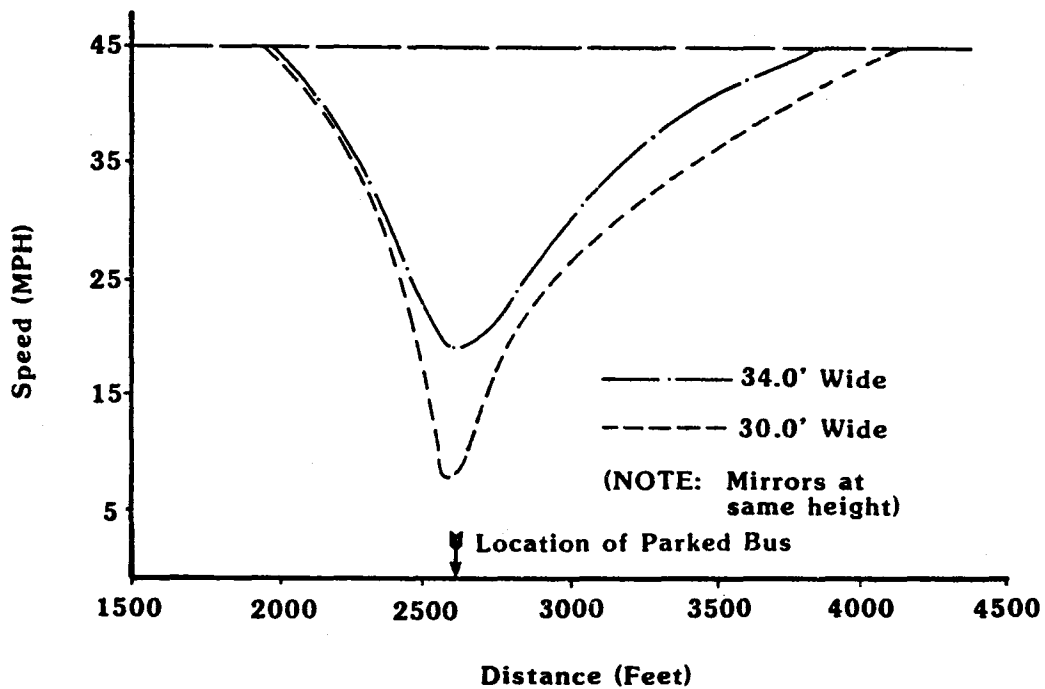
Figure 39: Speed Profile Comparison For Novice Driver on Two-Way Transitway -- 34.0 Feet vs. 30.0 Feet

Figure 39 illustrates the estimate of novice driver behavior for two different widths of two lane transitways. The 34.0-foot graph was developed from the only actual two-way test conducted during the week. One transit bus was parked in the middle of the 10-foot breakdown shoulder. The passing vehicle used one of the 12-foot lanes (Figure 8) to simulate a passing maneuver. The parked vehicle was facing the passing bus so that mirrors were, as discussed in the problem statement, at the same height rather than

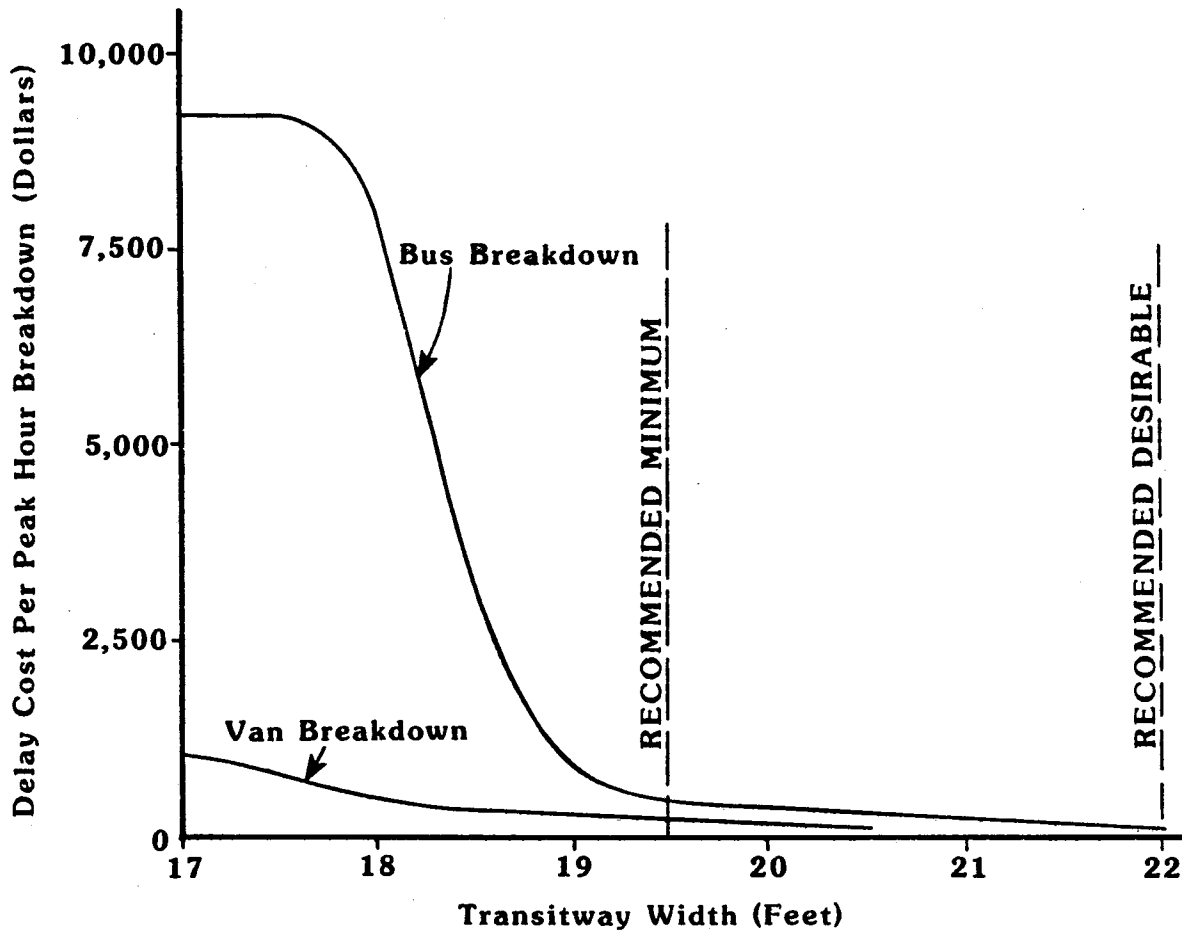
Note: Assuming typical breakdown rates, 15 bus breakdowns and 75 van breakdowns can be expected per year. The delay cost is calculated by multiplying the probability of the event (lane closed or open) to the value associated with that event. Peak-hour volumes of 50 buses and 300 vanpools were combined with an incident time of 30 minutes. Values of \$50 per bus operating hour and \$7 per passenger hour were used to assess the cost of delay.

The sharp curve at 19.0 feet in the bus breakdown line in Figure 43 reflects the increasing probability that the transitway will be blocked as the width decreases. The lane blocking incident simulation estimated 70 vehicle-hours of delay and a queue in excess of 1 miles for each transitway closure. The probability of this occurrence was multiplied by the value of that delay (\$9250) and added to the remaining probability and an estimated passing delay if the lane were not blocked (see note in Figure 43). The estimated increase in delay cost from less than \$500 per incident on a 19.5-foot lane to \$3000 for an 18.5-foot lane and to more than \$7500 on an 18.0-foot transitway illustrates the importance in maintaining sufficient width on all sections of the transitway for stalled bus parking. This curve is utilized in the determination of minimum and desirable transitway widths.

The travel speed and delay values summarized in Table 6 and the delay cost curve in Figure 43 are used to develop the minimum and desirable widths for reversible and two-direction transitways. The widths presented in Table 8 for tangent sections are between the toes of two concrete median barriers. The 19.5-foot dimension allows one bus to park on the left side of the transitway and another bus to pass on the right. Parking test data indicate that, under controlled breakdown (non-accident) situations, the clearance between the right side of the parked bus and the barrier will allow a slow passing maneuver to be accomplished by transitway drivers. The extra 2.5
