1. Report No. FHWA/TX-87/28+339-9		2. Government Accession No.		3. Recipient's Catalog No.	
4. Title and Subtitle The North Freeway Transitway: Evaluation of the First Year of Barrier-Separated Operation				5. Report Date February 1987

**The North Freeway Transitway:  
Evaluation of the First Year of Barrier-Separated Operation**

Research Report 339-9

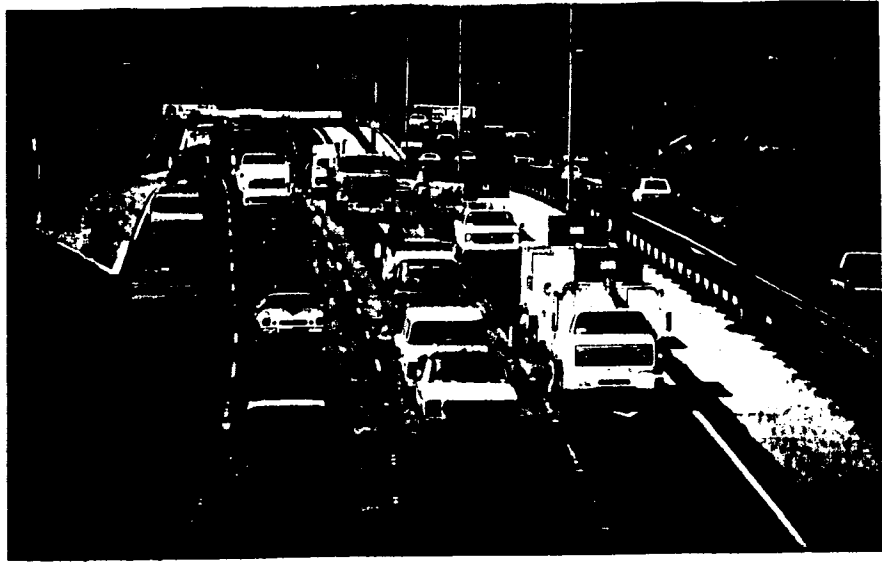
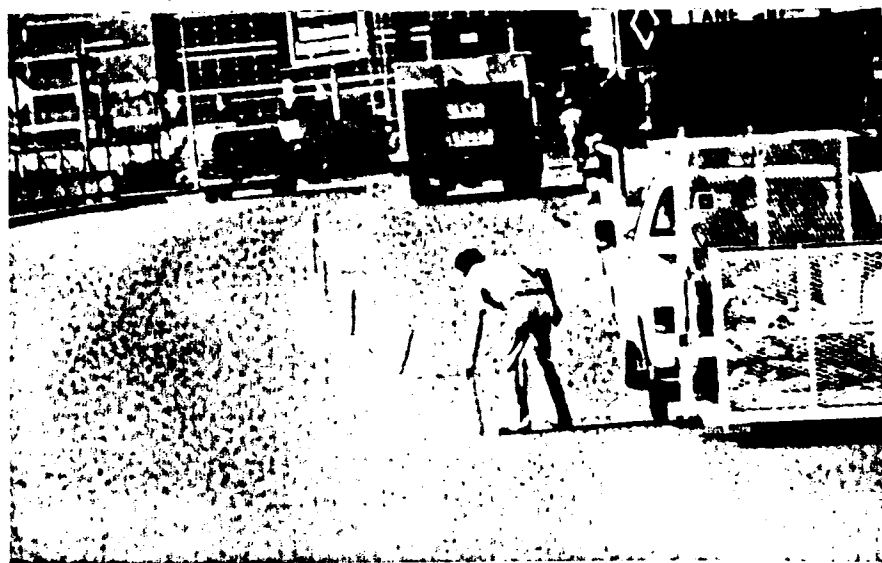
Figure 7. Contraflow Set-Up and Take-Down

METRO field crews were responsible for manually setting up and taking down the lane as well as for operating the entrance ramp gates that controlled entry into the CFL (Figure 7). Transit police, (city police in the early years) were also stationed at the entry points to enforce authorized use of the facility. A combination of stationary signs with flashing yellow beacons, lane control signals placed over the CFL and adjacent lanes at critical locations, white diamond pavement markings designating the reserved lane, various fixed and changeable message signs near the approach to the CFL project, and yellow plastic pylons which were inserted into holes in the pavement at 40-foot intervals (20-foot intervals within critical freeway sections) were used to provide adequate warning, guidance, and general information to CFL and non-CFL motorists alike. These treatments are illustrated in Figures 8 through 12.

during which the innermost off-peak direction traffic lane was not available to mixed-flow traffic to 4:30 am to 10:00 am and 2:30 pm to 8:00 pm. The setup of the contraflow lane was accomplished with the flow of traffic, and the take-down was accomplished against the flow of traffic in order to minimize traffic disruption while protecting the CFL operating crew performing the setup and takedown tasks.

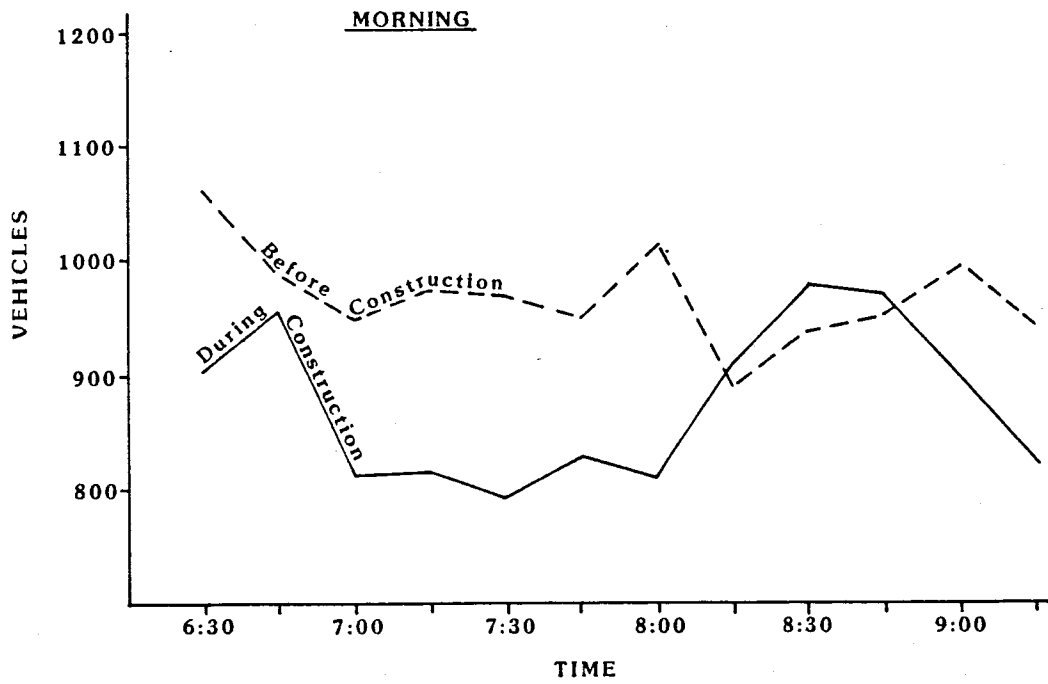
Figure 31. Average Mainlane Vehicle Volumes (Before vs. During Construction)

Mainlane vehicle flow rates dropped noticeably during the construction period by as much as 210 vehicles (21%) in a single 15-minute period at a three lane section of the morning inbound lanes. A smaller decrease of

approximately 18% was also observed during the afternoon peak-period. A great deal of the mainlane decrease in both the morning and the afternoon peak periods has been absorbed by the parallel freeway frontage roads. Peak-period frontage road volumes increased an average of 11% in the morning and 7% in the afternoon. In addition to experiencing a higher absolute decline in 15-minute flow rates, the morning decline in vehicle flow rates was also consistently lower than preconstruction levels over an entire peak-hour of operation, from 7:30 am to 8:30 am (Figure 31). Both morning and afternoon peak-hour flow rates declined by less than 5% during construction. Morning peak-hour flow rates declined from a preconstruction average of 1330 vehicles per hour per lane to a during construction average of 1260 vehicles per hour per lane. In the afternoon, average peak-hour flow rates dropped from 1400 vehicles per hour per lane to 1350 vehicles per hour per lane. Overall, peak-period vehicle volumes dropped from an average of 1300 vehicles per hour per lane to 1170 vehicles per hour per lane in the morning and from 1330 vehicles per hour per lane to 1270 vehicles per hour per lane in the afternoon. Passenger flow rates as illustrated in Figure 32, reflected the same trends associated with vehicle flow rates.

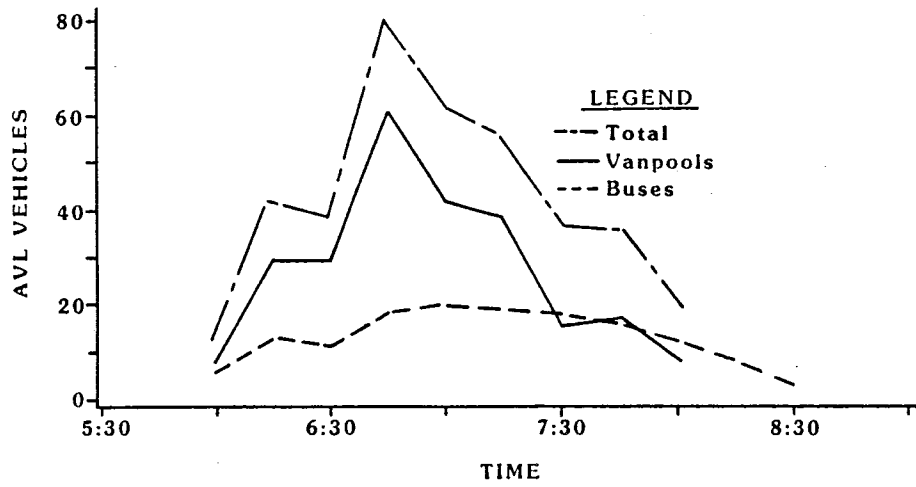
Figure 43. North Transitway Morning Distribution of Volume

Transitway vehicle demand has exhibited relatively consistent peaking patterns throughout the first year of transitway operation. Bus volumes in particular changed very little from month to month. As illustrated in Figures 43 and 44, approximately 50% of total peak period bus volumes may be observed on the facility during a typical peak hour of operation and about 14% in the peak 15-minutes of operation. Vanpools, on the other hand, exhibited sharper peaking patterns. Between 20% to 30% of total peak period vanpools used the facility during a typical peak 15-minutes of operation. More than 65% used the facility during a typical peak hour of operation. Overall, about 60% of all peak-period transitway vehicles utilized the facility during the peak hour of operation.

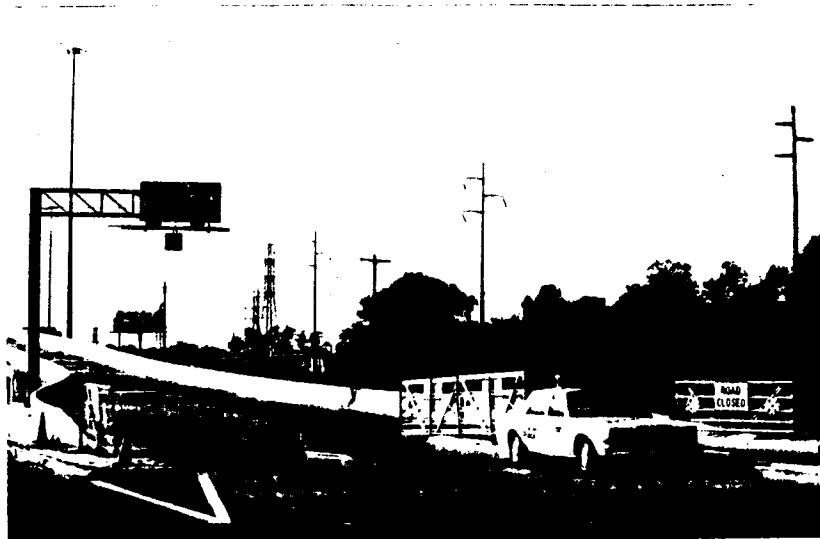
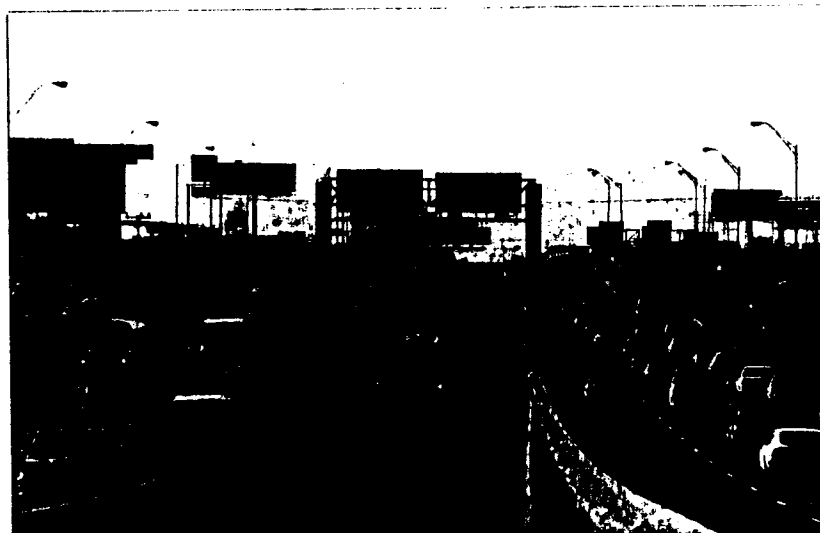
Figure 49. Transitway Entry Gates As Implemented On Katy Transitway

- 1) Overhead Lane Control Signals (Figure 47),
- 2) Changeable Message Signs (Figure 48),
- 3) Pavement Vehicle Detection Loops,
- 4) Entry authorization gates and metering devices (Figure 49),
- 5) Closed Circuit Television Surveillance (Figure 50),
- 6) Fiber Optic Communications, and
- 7) Centralized Computer Controls (Figure 51).

The overhead lane control signals will provide directional information, and the changeable message signs will satisfy various other user and non-user information needs. The detection loops will provide operational data such as the volume, density, speed, and types of vehicles using the facility. Closed circuit television will provide a visual means to verify incidents that have been identified by the pavement detection loops. Finally, the entire network of overhead lane control signals, changeable message signs, vehicle detection loops, and closed circuit television will be integrated through a fiber-optic communications line and transmitted from an unmanned "satellite" control center. The unmanned control center will be located near the transitway underneath the I-45N/I-610 interchange, and the central control center is expected to be built within the existing Kashmere bus facility (Figure 52).

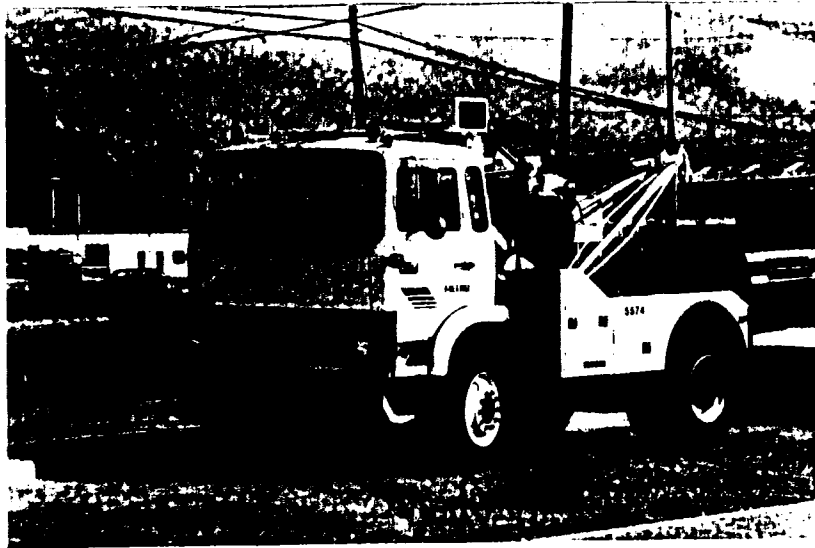
Figure 53. METRO Transitway Wrecker

The transit police employ a roving vehicle with no permanent enforcement station to patrol the transitway. A specially designed METRO wrecker is situated at the southern terminus in the morning and at the northern terminus

in the afternoon to respond to any incidents within the facility. The wrecker has been provided with an unusually short wheel base in order to provide it with the capability to turn around within the transitway (Figure 53).

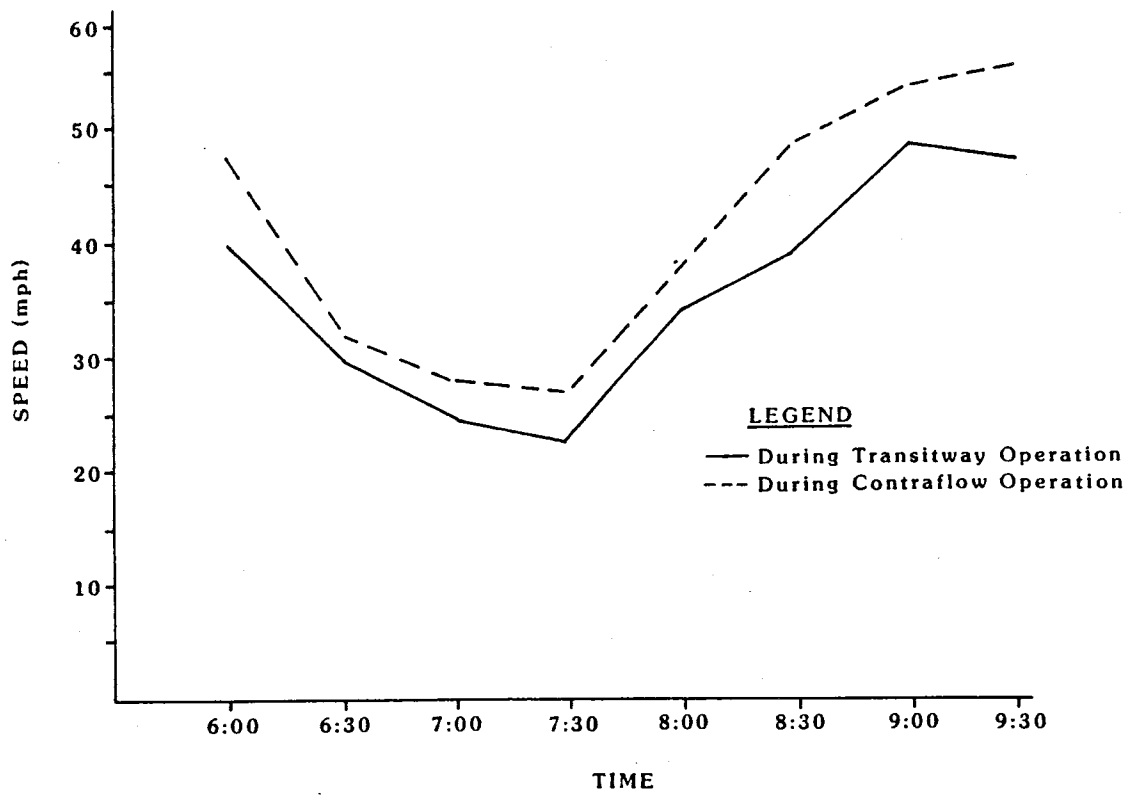
Figure 59. Average Morning Inbound Mainlane Speeds (Before vs. After Construction)

Since the completion of Phase 1 construction, the North Freeway mainlanes has returned to pre-transitway construction operating conditions in the peak directions. As illustrated in Figures 59 through 62, afternoon speeds are almost identical between the pre- and the post-transitway construction periods, although both are almost 6 mph slower than the speeds observed during construction of the transitway 30 mph before and after versus 36 mph during transitway construction. In the morning, peak-period speeds are still an average of 5 mph slower than before transitway construction (32 mph after versus 37 mph before transitway construction); however, average peak-period peak direction operating speeds have improved by 4 mph over the speeds observed during construction which averaged about 28 mph.
