MOISTURE PROTECTION FOR CONCRETE

A study made by the Texas Transportation Institute
for the Texas Highway Department under Bureau
of Public Roads Project Number HPR-1 (3)

September 5, 1963

Texas Transportation Institute
College Station, Texas

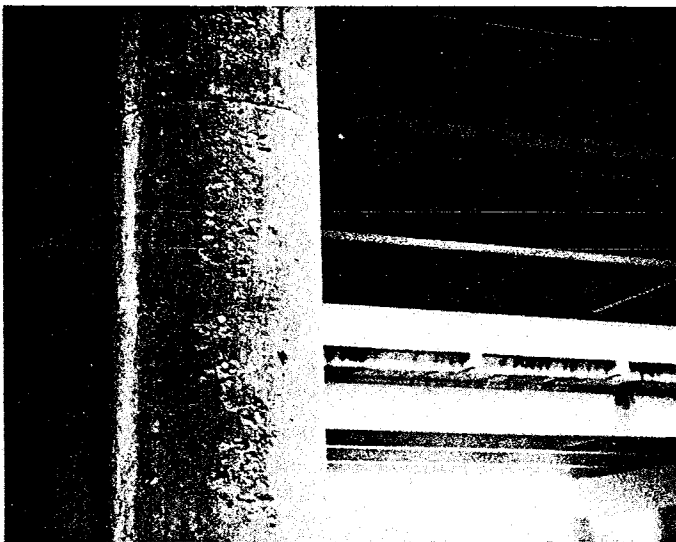
Figure 1. Some typical surface deterioration in reinforced concrete bridges.

(a) Deck wearing surface.

(b) Guard wall in splash zone.

(c) Pier below opening in deck.

In general, the deterioration problem encountered in concrete bridge decks involves shallow to deep surface scaling, surface spalling in which relatively large unpatterned chunks of concrete break out, slab cracking in both the transverse and longitudinal directions, breaking out of patterned blocks of concrete bounded by checkerboard cracks sometimes to the depth of the top layer of steel, and nonpatterned cracks. Figure 1 shows some typical surface deterioration of reinforced concrete bridges.

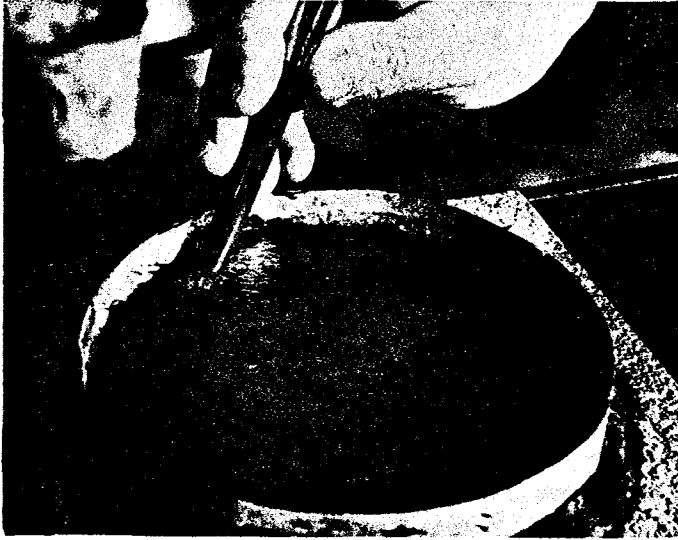
Figure 6. Freeze-Thaw series B specimens early in the test.

(a) Frozen specimen

(b) Thawed specimen

(c) Handling rack with four thawed specimens

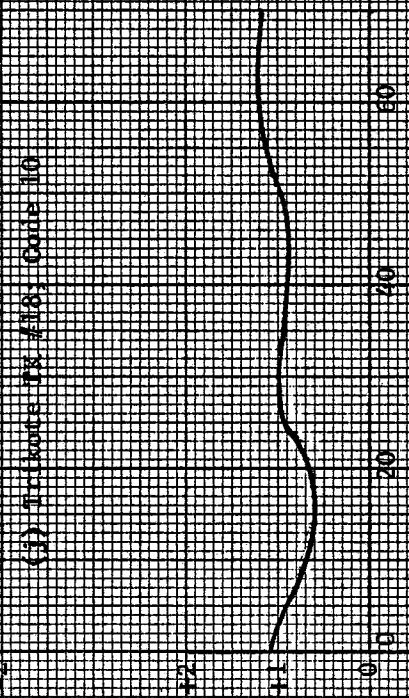
Figure 10. Percentage Moisture Absorbed against Age of Test.
 Wet-Dry Series-B

(e) DC 770, Code 5

(f) DC 774, Code 6

(g) Hydrex, Code 7

(h) Hydrex-a-crates, Code 8

Figure 10 (continued). Percentage Moisture Plotted Against Age of Test
Wet-Dry Series B

Curves of moisture absorption versus age of test are shown in Figures 9 and 10. Those curves have been smoothed in among individual day by day points that are not shown in those figures.

Series B. Because of the consistency of moisture change of individual specimens of a set in series A, only one specimen of each treatment was used in series B. Specimens were handled the same as in series A except that the top surface, as cast in the form, was sandblasted on the 53rd and 62nd day after the test began. Moisture curves are shown in Figure 10. Some specimens were placed in the test later than others. For that reason some specimens had not been cycled as many times as others had when they were sandblasted.

The control specimen—no treatment—jumped from 1.13 average percent moisture with no sandblasting (series A) to 1.96 percent with sandblasting—a gain of 0.83 percent. This would indicate that a dense surface film existed on the top surface of the specimen before it was abraded. None of the treated surfaces changed that much after sandblasting.

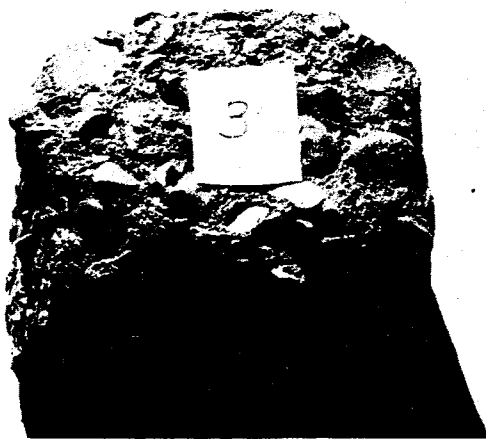
Figure 11. Freeze-Thaw Series A specimens

(a) Code 1 - No treatment
(21 cycles)

(b) Code 2 - Linseed oil and
kerosene (23 cycles)

(c) Code 4 - Linseed anti-spall
compound. (23 cycles)

(d) Code 5 - DC 770
(23 cycles)

(e) Code 6 - DC 772
(21 cycles)

(f) Code 7 - Hydrozo
(21 cycles)

All specimens of this series had deteriorated to some degree at 18 freeze-thaw cycles, and most of these were well on their way to destruction by that time. Photographs of typical specimens are shown in Figure 11. Break down began at corners and edges—see, for example, Figure 11 (d). The concrete first began to flake off, then it began to crumble along the edges. Failure progressed from the crumbled edges along immersed surfaces until, in some cases, the entire bottom surface was undermined and broke away.

Some of the epoxies stood up well, as did the two linseed oil treatments. The first sign of deterioration was noted at five cycles. After eight cycles coatings 1, 6, 7, 8, 13, and 16 all showed corner and edge chipping. At 11 cycles the first signs of deterioration showed up in coatings 2, 4, and 5. Some specimens were so badly deteriorated at 21 cycles that they were withdrawn; all cycling was stopped at 25 cycles.

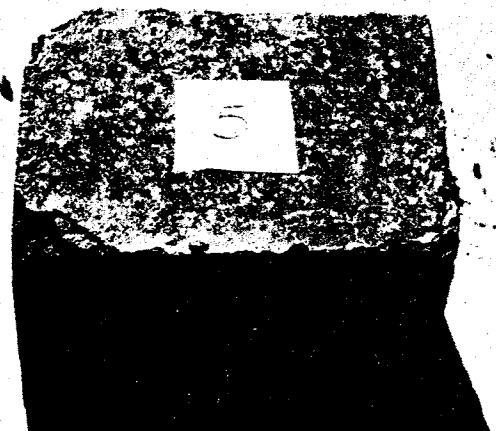
(h) Code 12 - Thiokol D183-601-1
(25 cycles)

Figure 11 (continued). Freeze-Thaw Series A specimens.

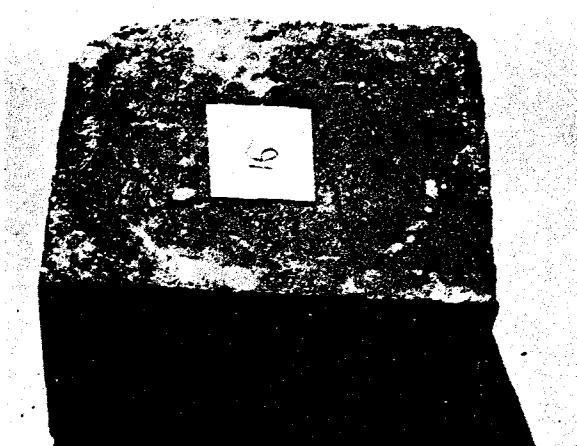
(k) Code 17 - Protex-a-cote
TAC-T-185 NYS
(25 cycles)

Figure 11 (continued). Freeze-Thaw Series A specimens

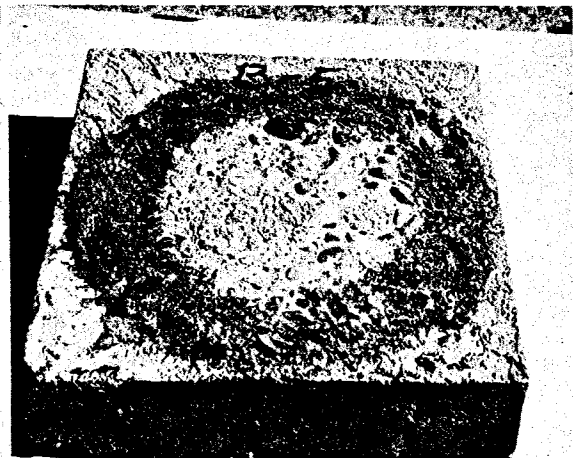
Figure 12. Freeze-Thaw Series B specimens

(a) Code 1 - No treatment

(b) Code 2 - Linseed oil and kerosene

(c) Code 3 - Linseed oil (hot)

(d) Code 4 - Linseed anti-spall compound

(e) Code 5 - DC 770

(f) Code 6 - DC 772

Photographs of all specimens taken after cycling was discontinued are shown in Figure 12; Table III gives information on deterioration. Treatments 4, 9, 10, 12, 13, 14, and 18 showed little or no sign of deterioration of the coating itself, but in some of these cases deterioration occurred under and outside the ring. It cannot be said definitely that 18 had its initial failure under the ring, but it appears that was the case. When brine found its way under the sealing mastic, it penetrated uncoated concrete and deterioration set in. It appears now that the entire top surface of all specimens should have been treated before the ring was attached.

Coatings 9, 14, and 18 could probably have been cycled longer had the failure under the ring not occurred. Of the one-component coatings 2 through 10, the linseed oils and Trikote TK#18 performed best. Designations higher than 10 are two component treatments, and most of those held up well in the test.

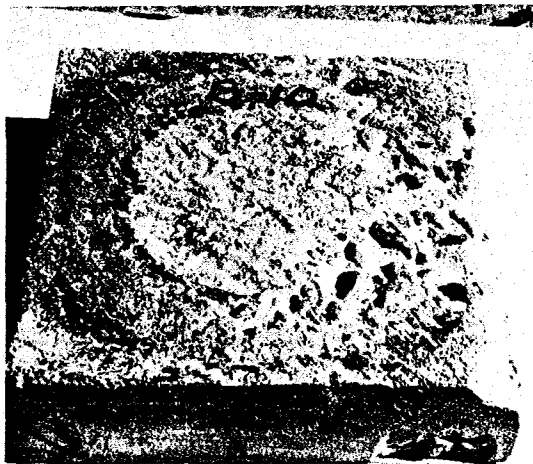
(i) Code 9 - Chempol 32-1010

Figure 12 (continued). Freeze-Thaw Series B specimens

9. Chempol 32-1010	11th cycle	54 cycles	Failure under ring
10. Trikote TK #18	8th cycle	97 cycles	Good condition
11. Chempol 31-10006	47th cycle	77 cycles	Surface scaling

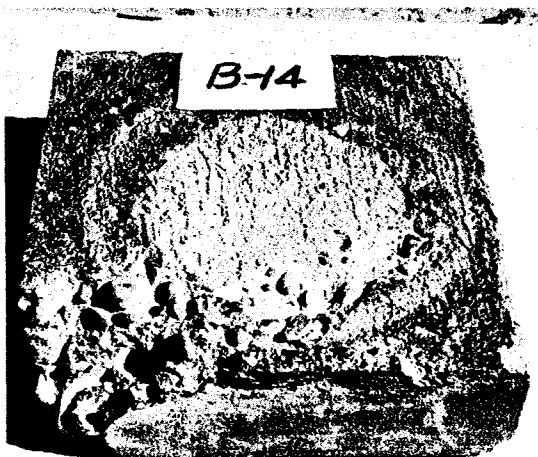
(q) Code 18 - Sika Colma protective coating

Figure 12 (continued).
Freeze-Thaw Series B
specimens

15. Premaspray CPB 102	21st cycle	23 cycles	Severe surface scaling
16. Protex-a-cote porselon epoxy	6th cycle	41 cycles	Surface scaling
18. Sika Colma coating	15th cycle	59 cycles	Failure under ring

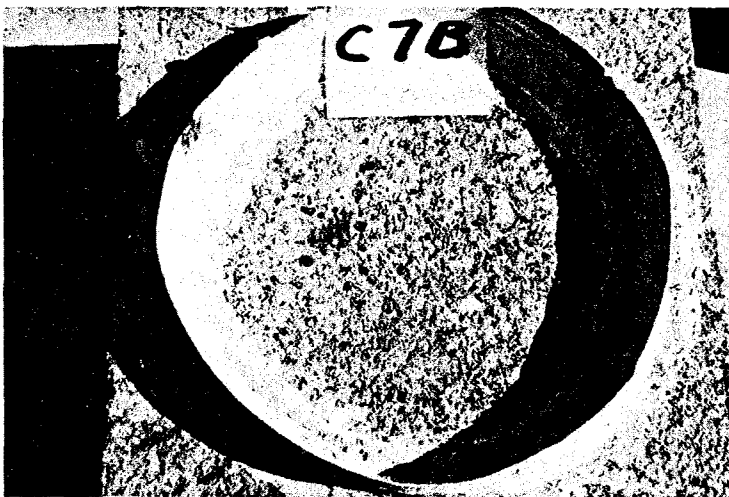
(a) No treatment

(b) Hydrozo treatment

(c) Protex-a-crete treatment

Figure 13. Specimens from FT-C series showing condition at end of test after 28 days of exposure under the sky and 28 freeze-thaw cycles.

Two specimens were used for most of the treatments tested. Table IV gives information on specimens, and Figure 13 shows the end-of-test condition of the three specimens that began to break down before the test was terminated.

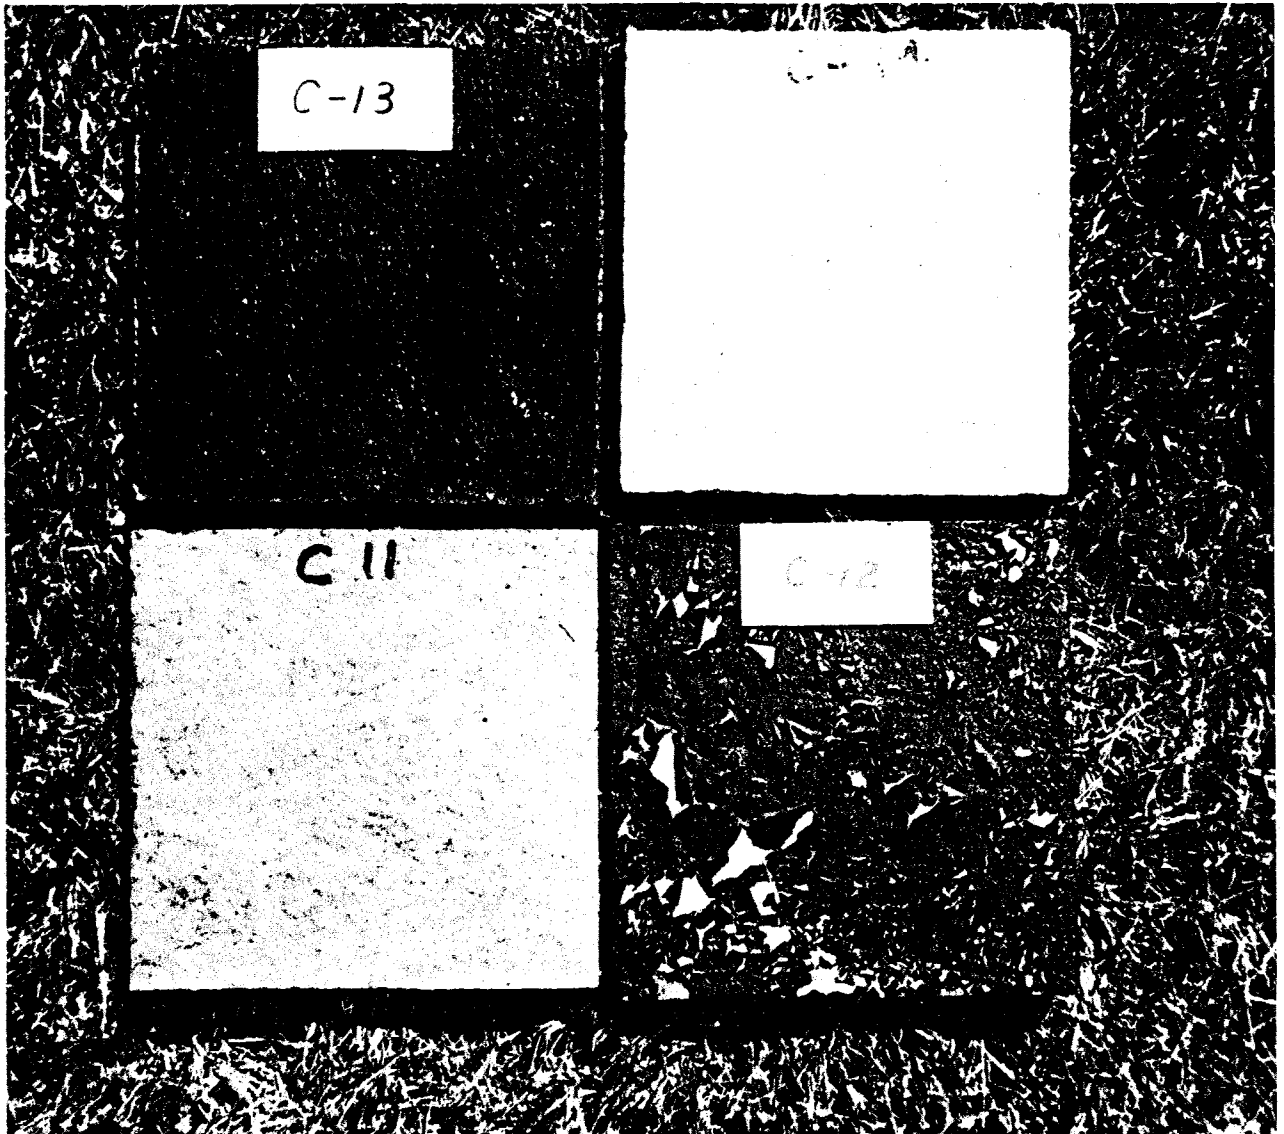
Figure 14. Freeze-Thaw Series C specimens after four days of exposure to sun. Coating labeled 12-C (Permaspray) has cracked and is peeling away from the concrete.

On the second day of exposure the Permaspray coating began to crack; the next day it began to curl up in small sheets. It was thought that the condition could possibly be caused by fines floated to the top during the finishing operation; therefore, all specimens of the series were withdrawn from test. The rings were removed and the top treated surfaces were sandblasted, re-coated over the entire top surface, and the rings were then set back into position.

All specimens were exposed outside for 28 days and were carried through 28 freeze-thaw cycles. Figure 14 shows four specimens after four days of exposure to the sun. The specimen marked 12-C in that figure shows Permaspray coating peeling away from the concrete.

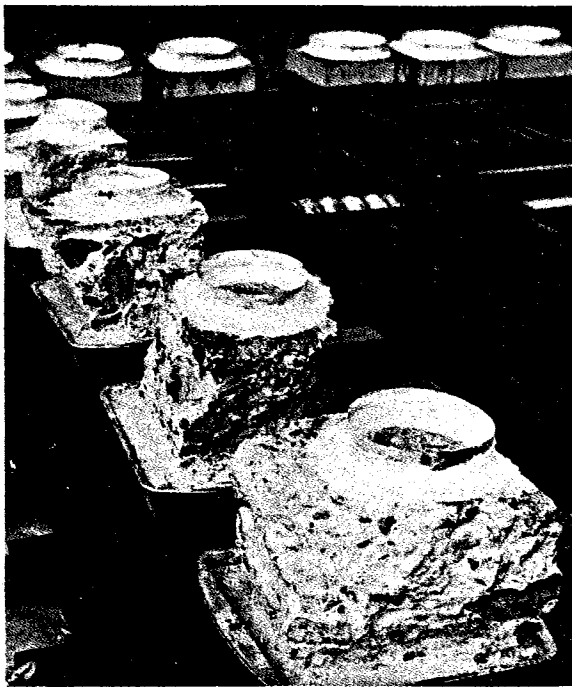
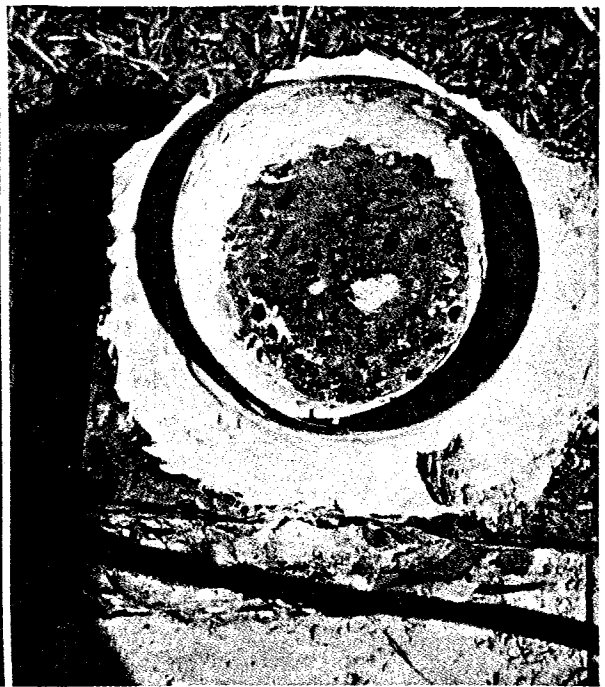
Figure 15. Freeze-Thaw specimens Series D at end of cycling

(a) View of the four specimens

(b) Code 2 - Linseed oil and kerosene

(c) Code 9 - Chempol 32-1010

(d) Code 3 - Linseed oil (hot)
