PERFORATED TENSION FUSE PLATE
FOR BREAKAWAY ROADSIDE SIGNS

Research Report No. 343-3F
on
Improved Design of Lightpoles, Guardrails,
and Other Appurtenances
Research Study No. 2-18-83-343

Texas Transportation Institute
The Texas A&M University System
College Station, Texas 77843

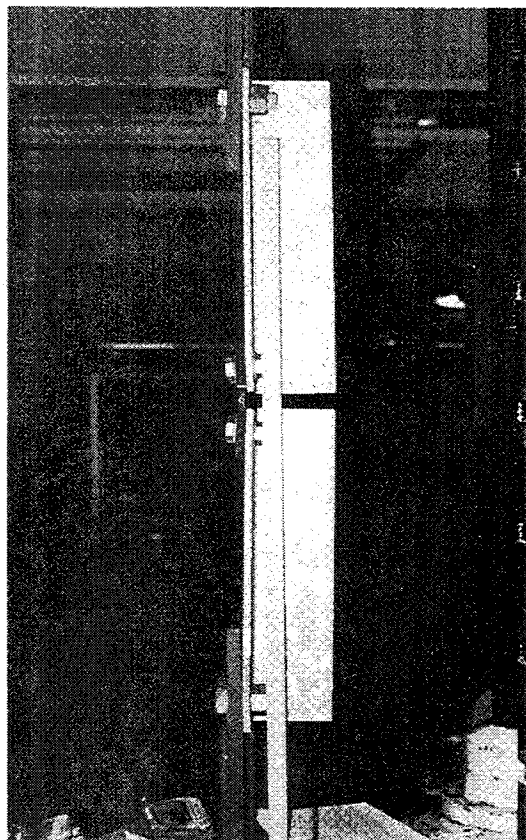
Figure A2. 1/2" Plate Before and After Test 1.

When a load of 65 kips was achieved two bolts holding the T-beam to the testing machine broke. These were replaced and testing resumed. At a load of 72.5 kips the plate failed along the weakened section. The specimen elongated 0.52 inches. There was a bearing failure in the 7/16" flange (1/8" deformation) of the T-beam the 3/4" bolts were fastened through.

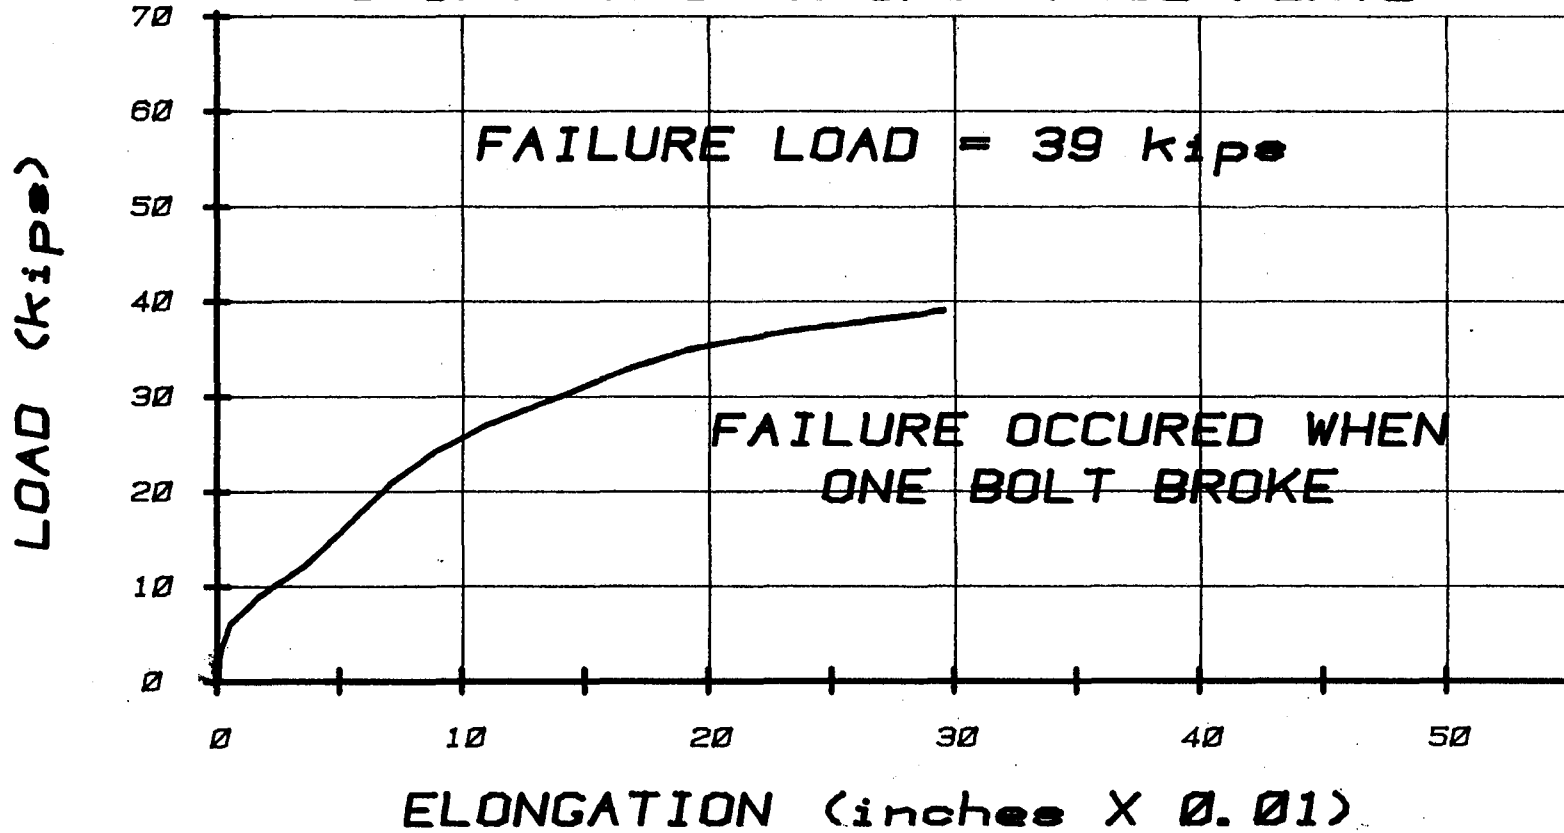
WEAKENED SECTION CONTAINED --
FOUR 1" dia. HOLES

MATERIAL -- ASTM-A441 STEEL

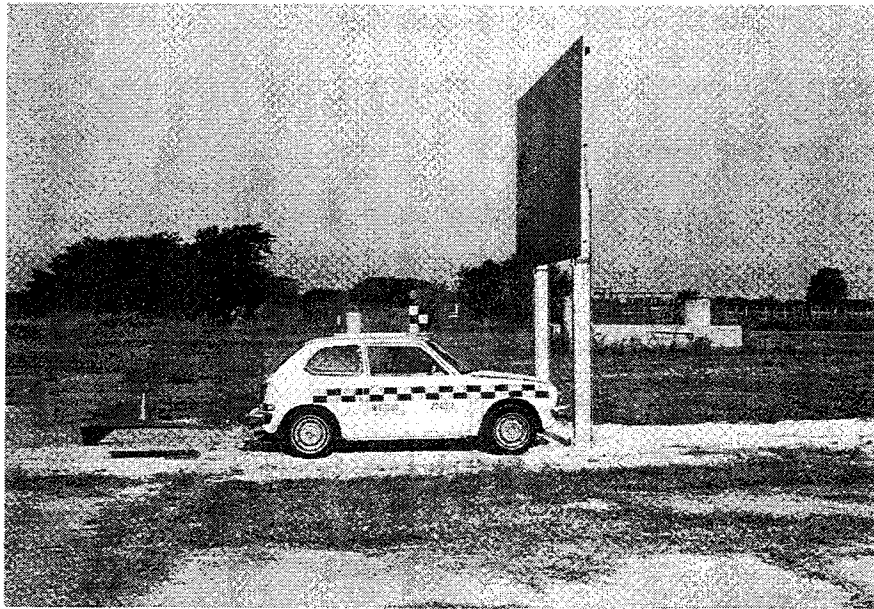
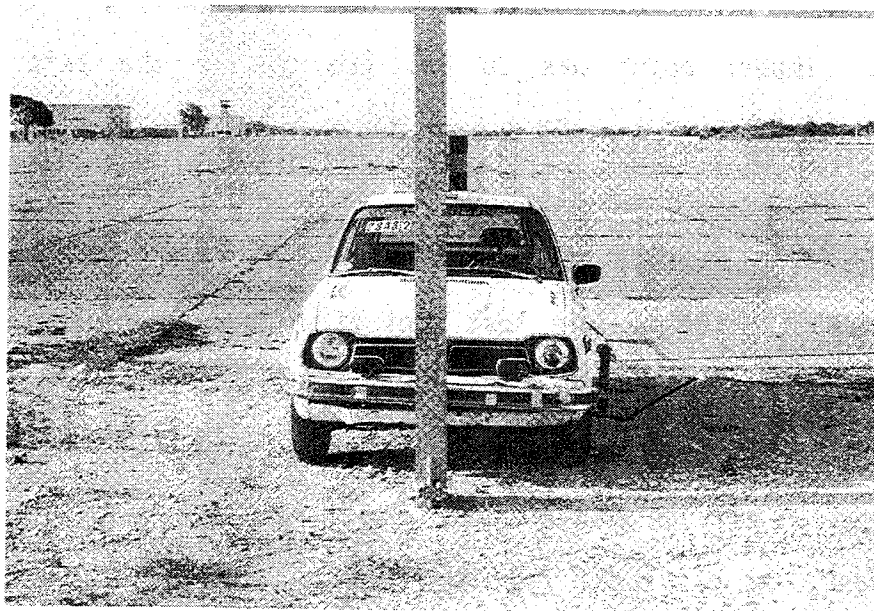
Figure C4. Relative Position of Vehicle and Sign

The slip base began to break away from the stub post at 0.038 sec after impact. The vehicle lost contact with the support post at 0.138 sec with a speed of 16.7 mph (26.9 kph). The slip base had been displaced a distance of 2.7 ft. (0.8 m) when the vehicle lost contact. The lower wind clamp pulled through the extruded aluminum wind beam at 0.325 sec after the slip base had displaced 7.0 ft. (2.1 m). The middle wind clamp pulled through at 0.388 sec following a slip base displacement of 7.9 ft. (2.4 m). The vehicle stopped 69 ft. (21 m) from the impact point.

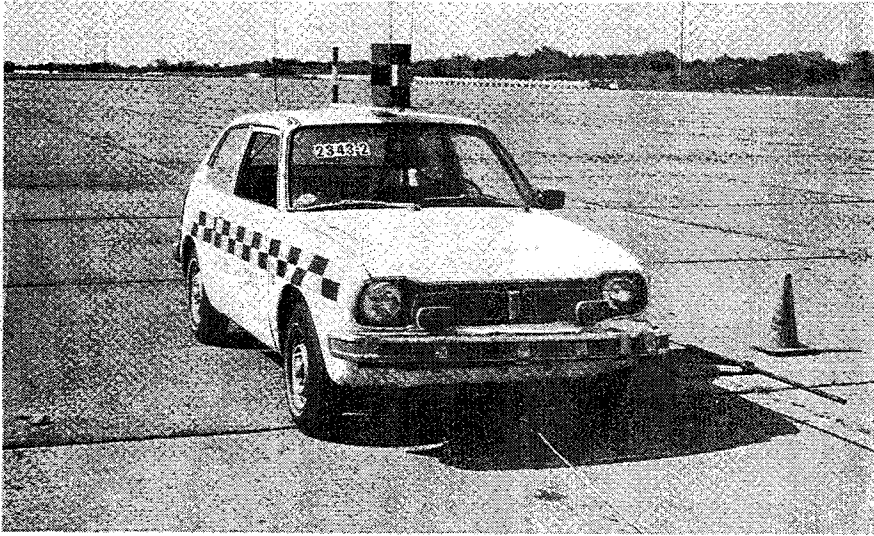
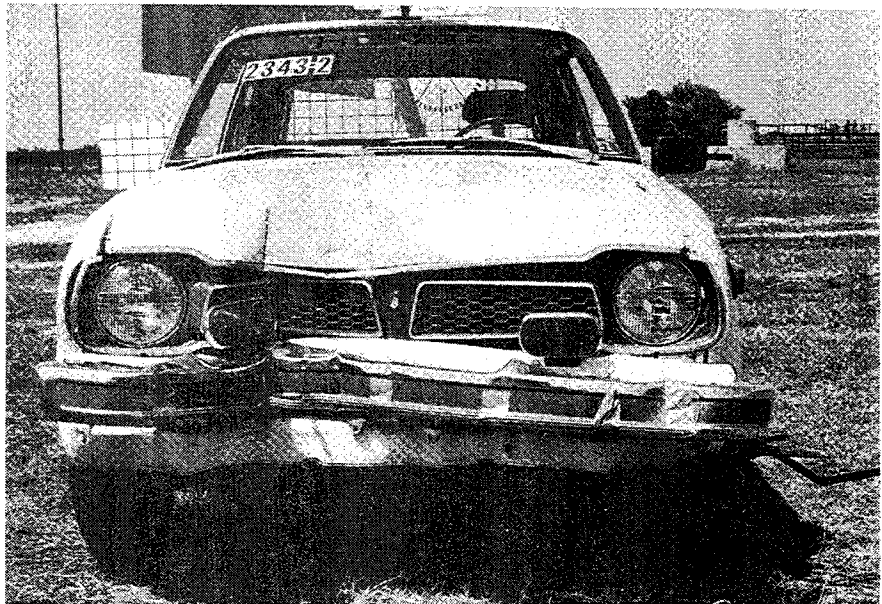
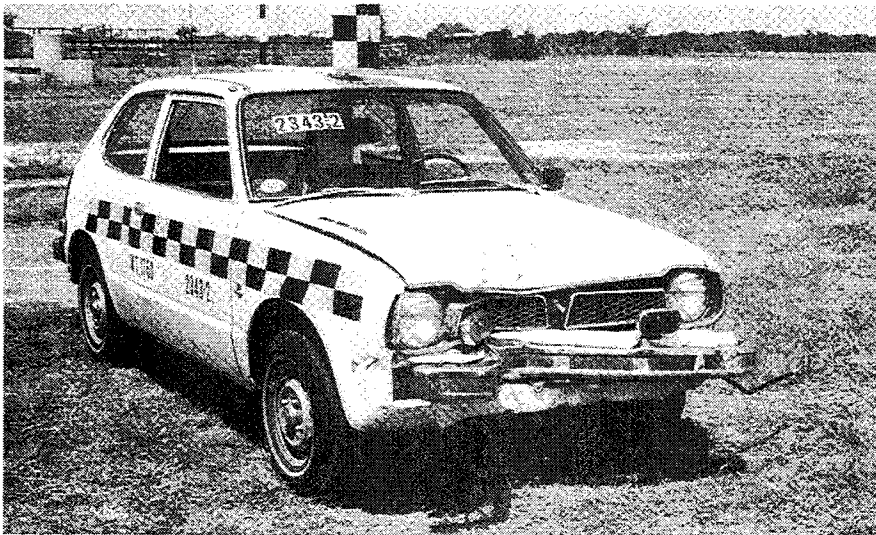
Figure C6. Vehicle Before and After Test 2343-2

Vehicle Damage Classification
 TAD 12FC3
 SAE 12FCEN2

Yielding occurred through the weakened section of the fuse plate but separation did not take place. The sign and support posts remained intact as shown in Figure C5. Damage to the vehicle was minor as depicted in Figure C6.
