1. Report No. TX-00/3903-S		2. Government Accession No.		3. Recipient's Catalog No.	
4. Title and Subtitle IN-PLACE ENGINEERING PROPERTIES OF RECYCLED AND STABILIZED PAVEMENT LAYERS				5. Report Date December 1998

**IN-PLACE ENGINEERING PROPERTIES OF RECYCLED
AND STABILIZED PAVEMENT LAYERS**

Report 3903-S
Project Number 7-3903
Research Project Title: Determining In-Place Engineering Properties of
Lime or Cement Stabilized Pavements Layers

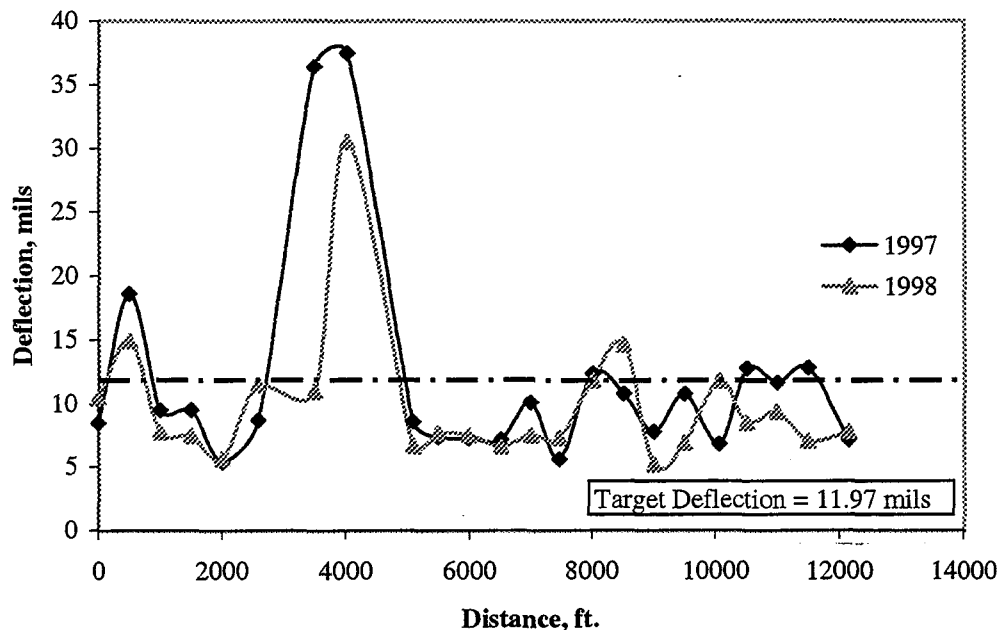
Figure 11. Target Deflection Profile for FM 149.

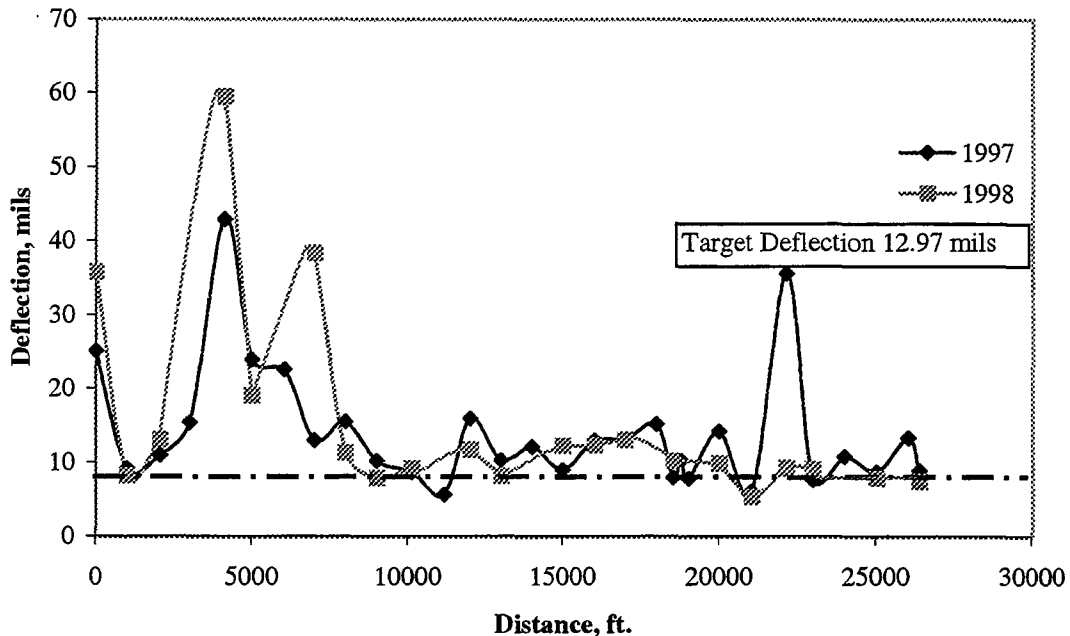
Figure 13. FM 1486, Target Deflection Analysis.

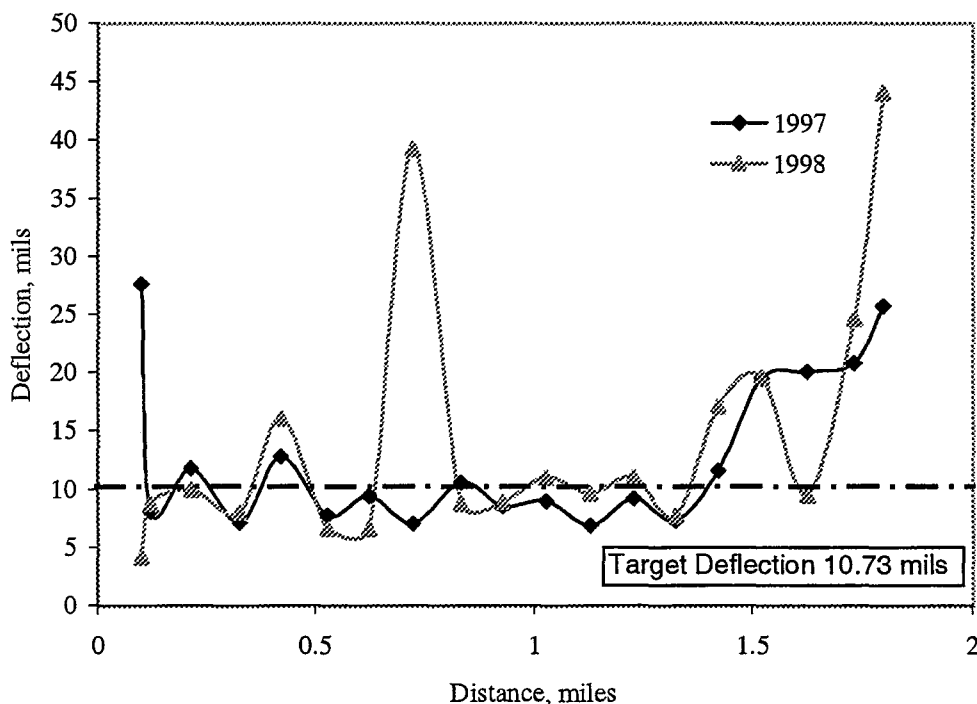
Figure 22. FM 1124, Target Deflection Analysis.

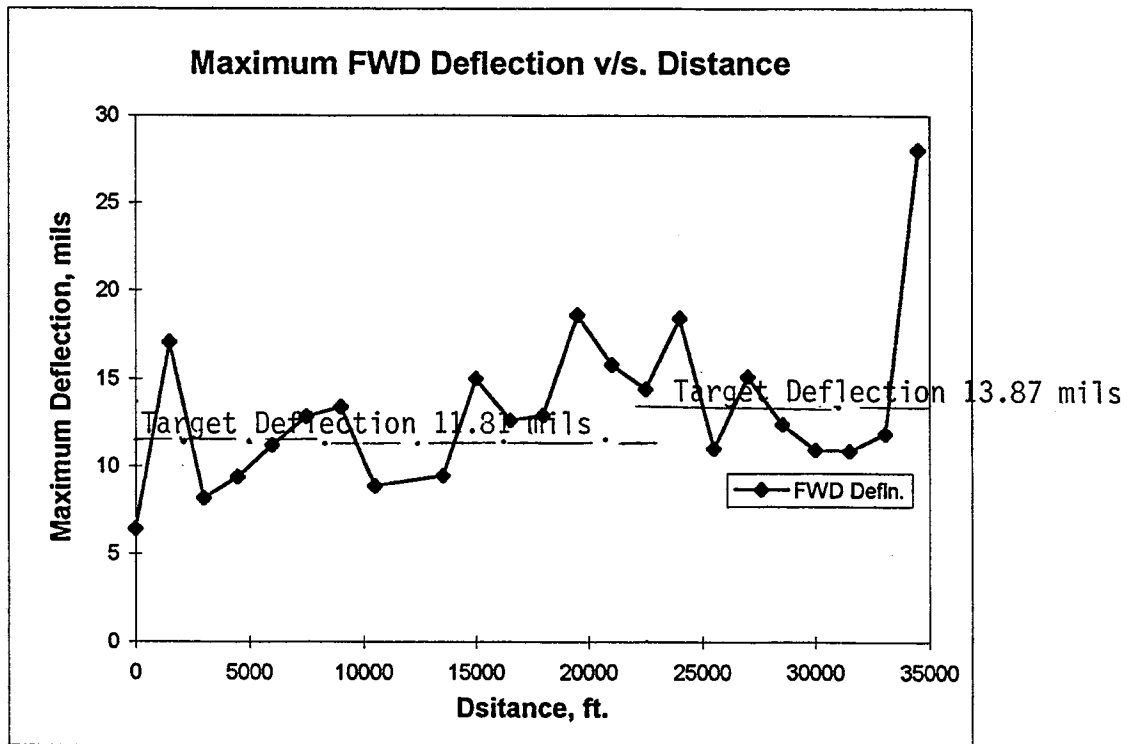
Figure 24. FM 2223, Target Deflection Analysis.

No problems were detected in the GPR. The base and subbase were dry, and no distress was observed in this pavement in either survey. This pavement is performing well. Figure 24 summarizes the deflection profiles for FM 2223, and Tables 17 and 18 summarize the analysis of the 1997 FWD data for this project.

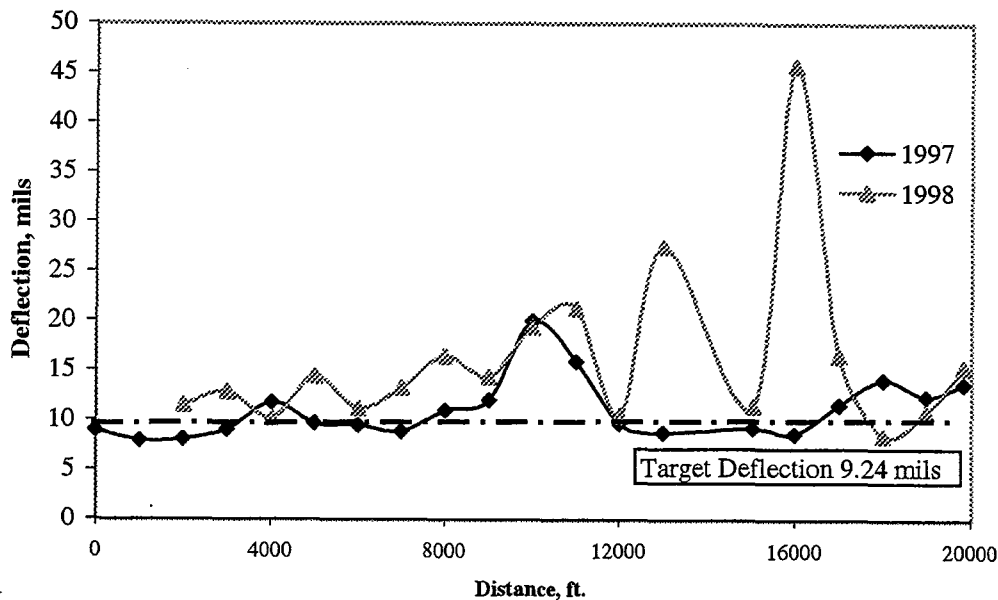
Figure 25. FM 1687, Target Deflection Analysis.

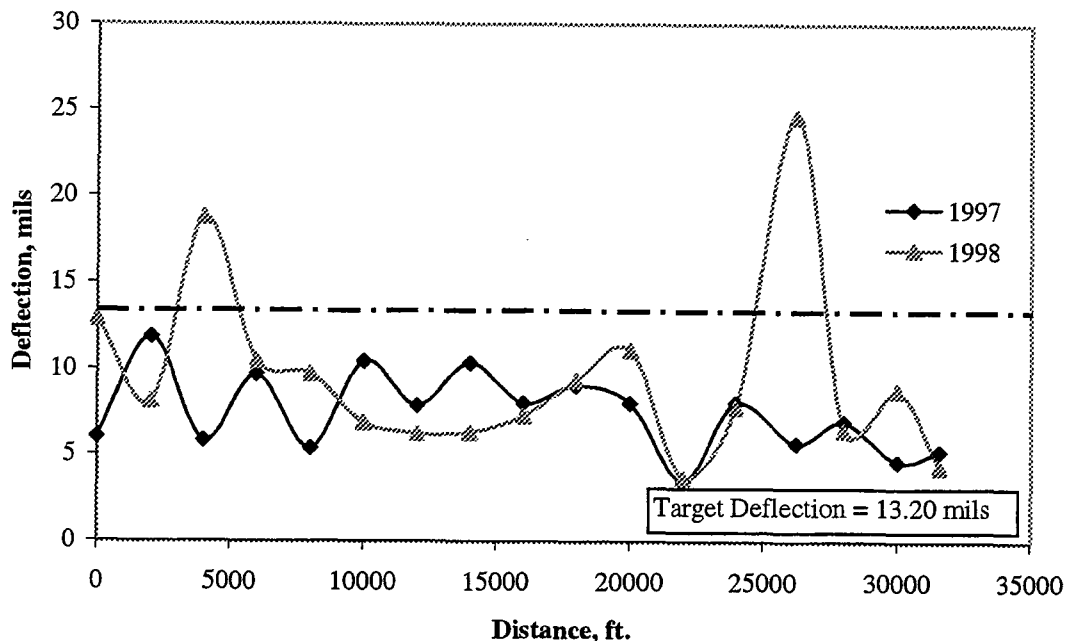
Figure 28. FM 1373, Target Deflection Analysis.

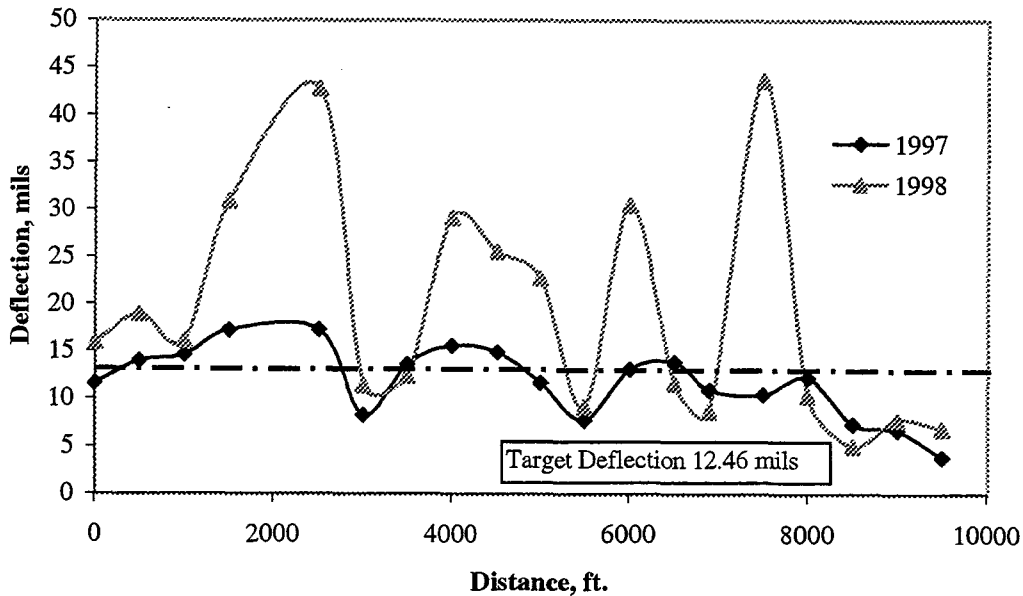
Figure 31. FM 1935, Target Deflection Analysis.

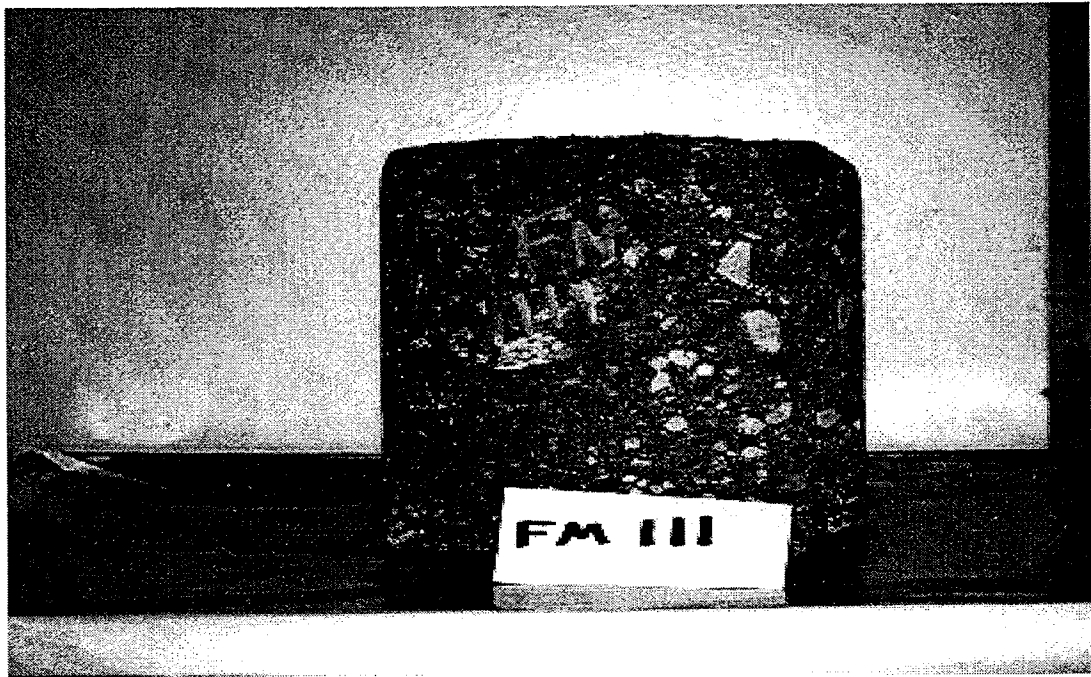
Figure 35. Core from FM 111.

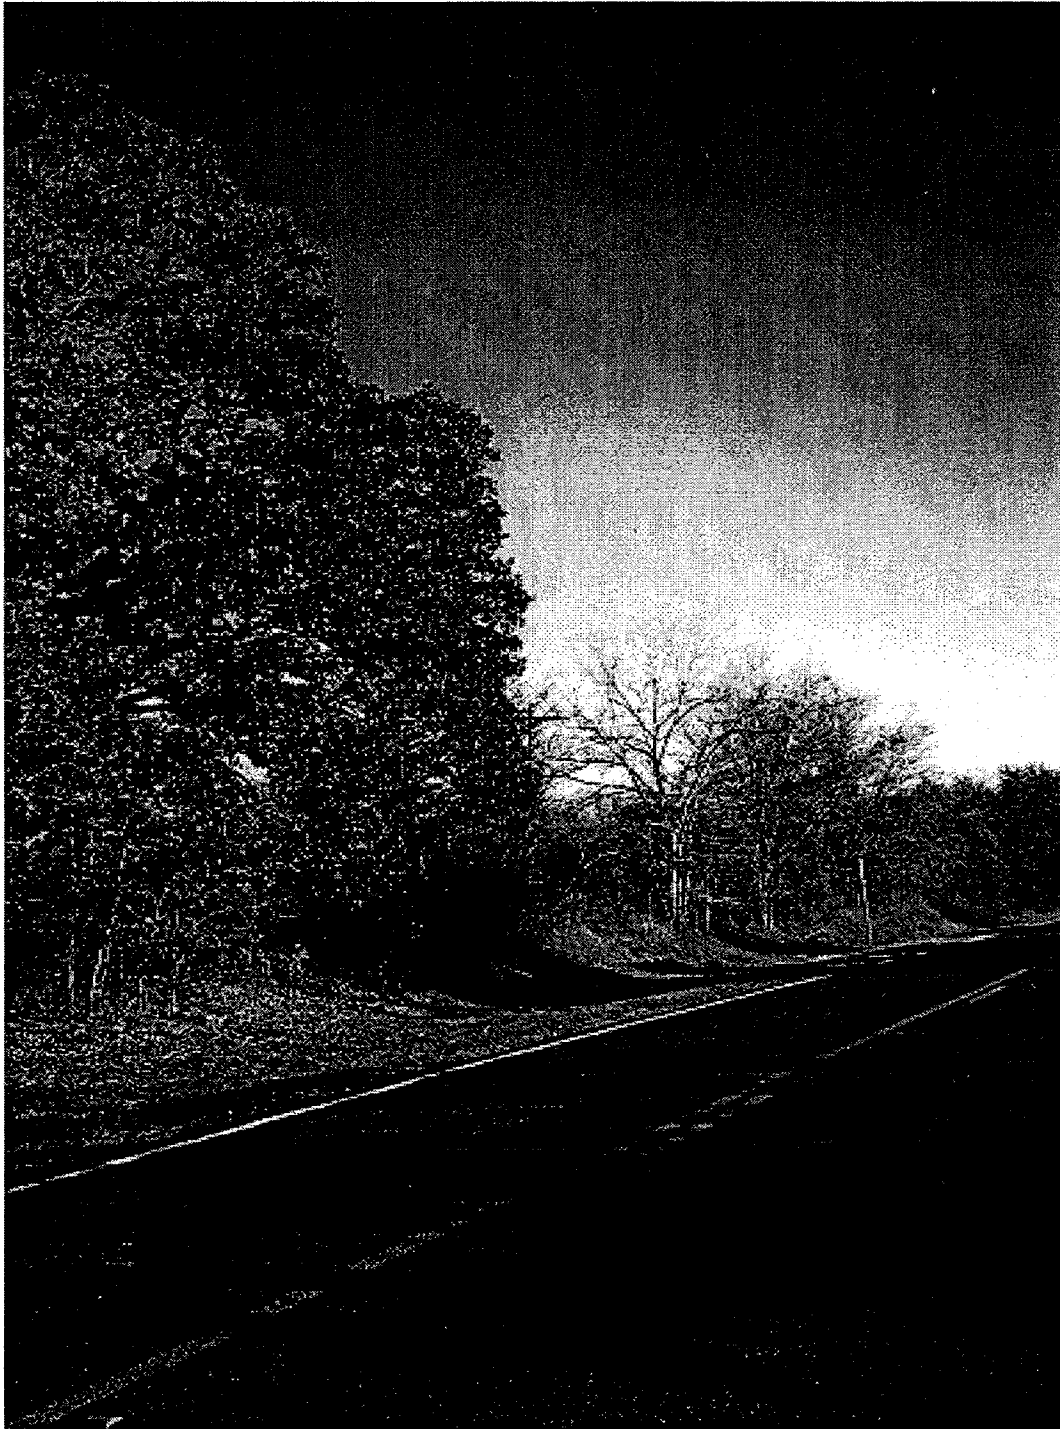
Figure 40. Large Trees Adjacent to the Cracked Section.

Action Item 1 *On problem sections (high PI, steep slopes, trees close to roadway), consider adding new base prior to stabilization. This will permit the use of lower levels of stabilizer.*

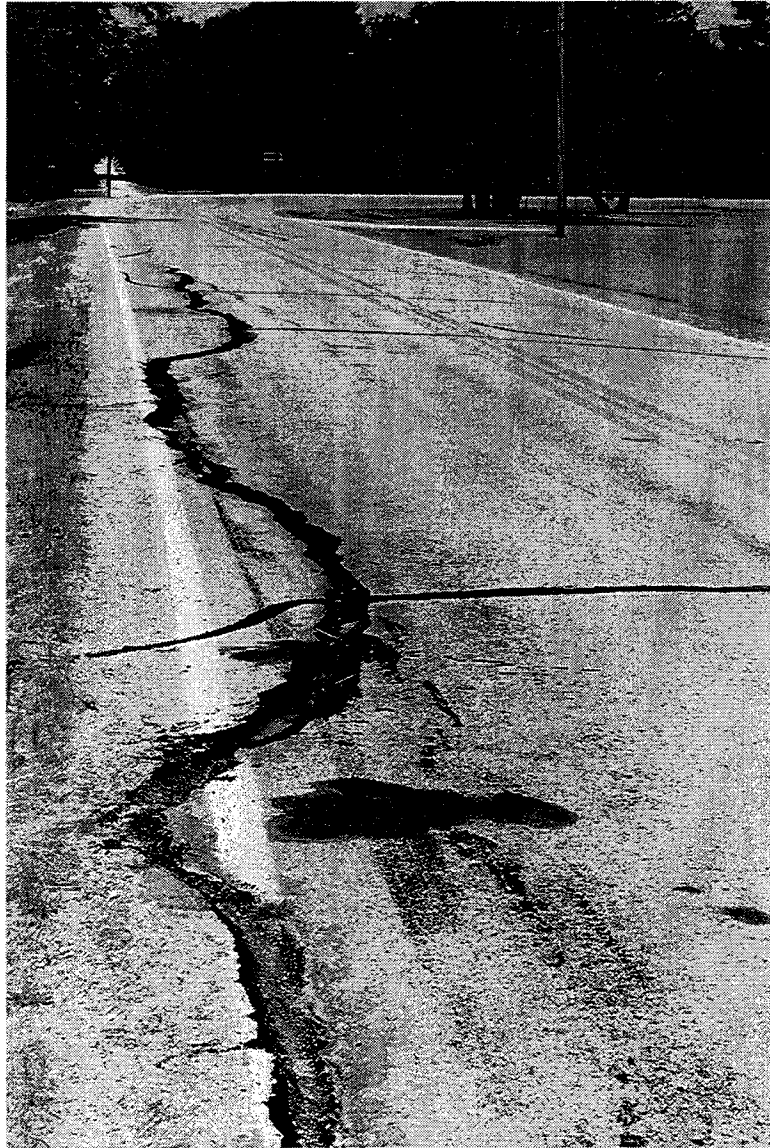
- 1.3 - 2.3 Several crack sealing operations, extensive longitudinal and transverse.
Some long-edge cracking; severe problems close to trees.
Looks like traditional stabilization block cracking. (CH, PI > 35).

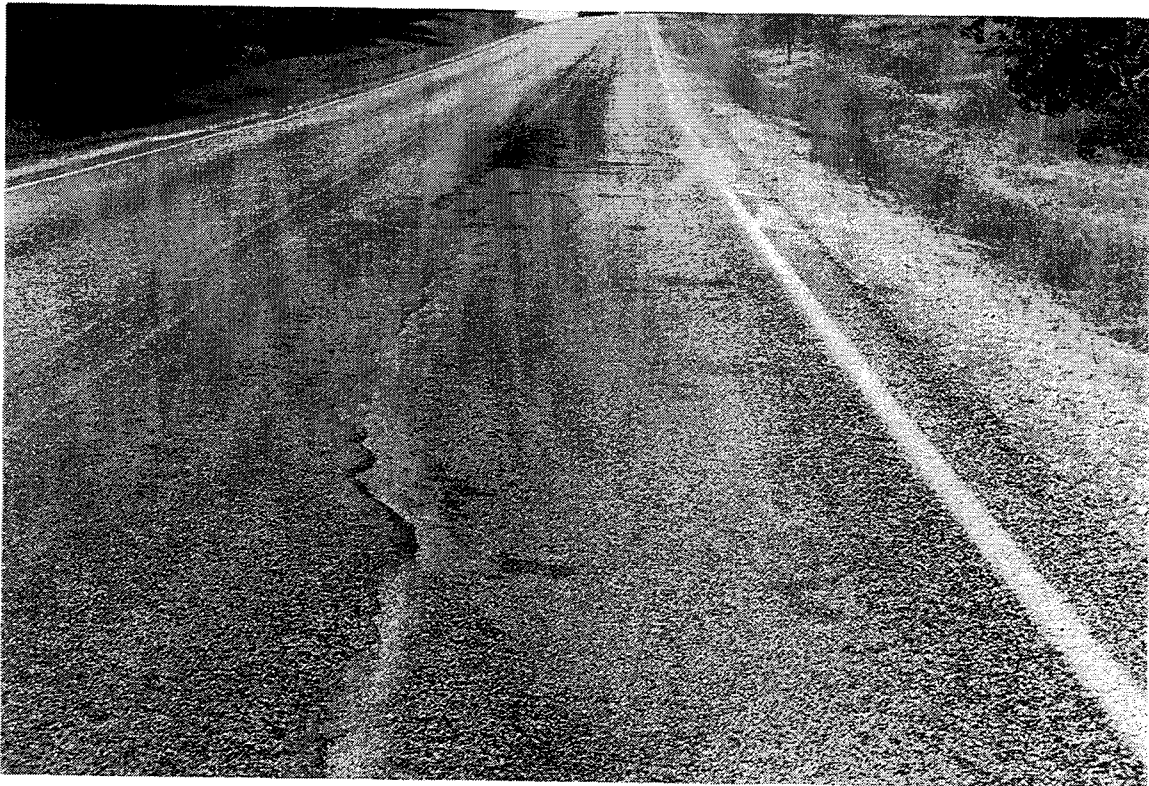
2.0 - 2.2 Some severe edge deterioration after bridge next to large oak trees. (CH, PI > 45).

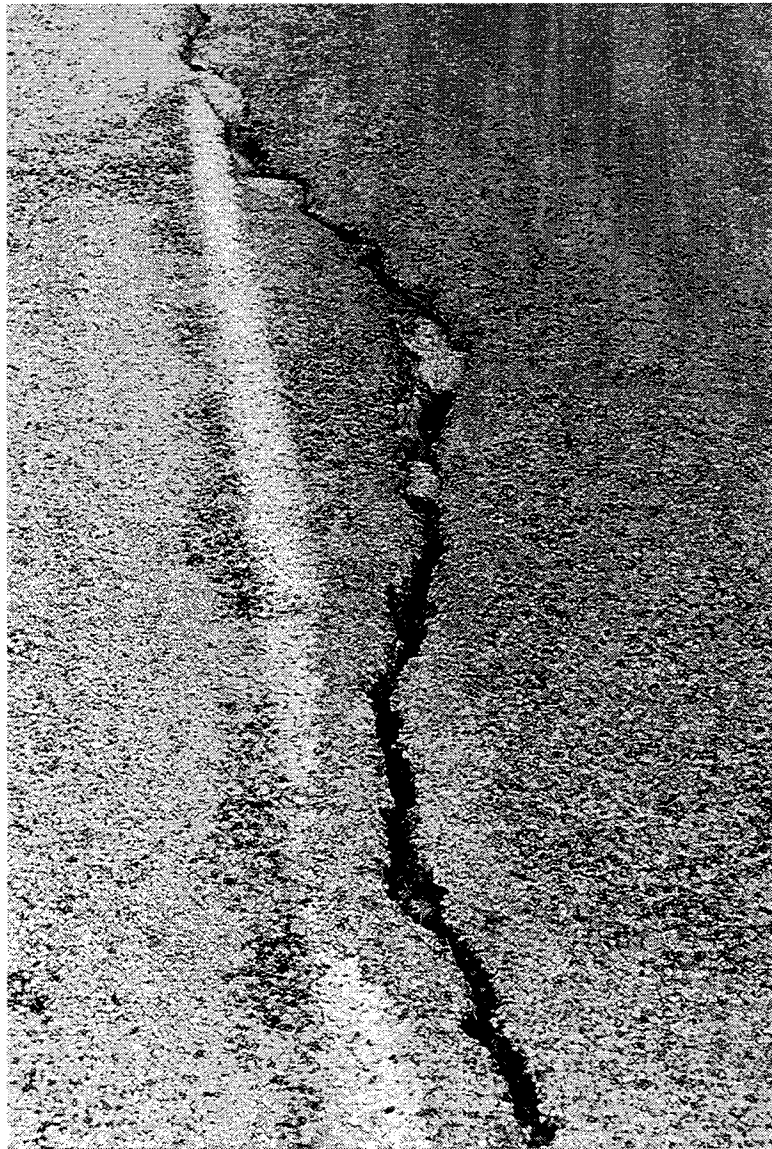
- 3.0 - 3.6 Moderate cracking whenever tree line comes close to road.
- 3.4 Major crack on curve, steep slopes, and many trees. (CL, CH PI 20-38).

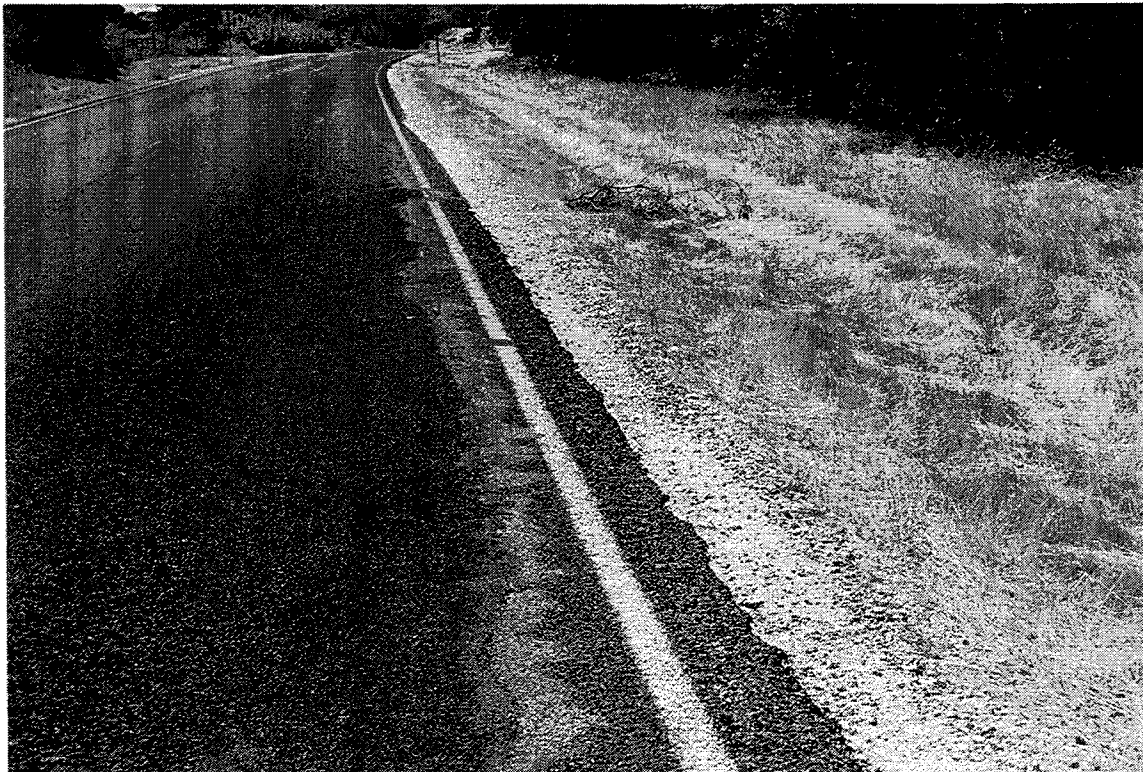
0.2 - 1.1 Longitudinal cracking along tree line. Cracks filled HMAC - Some severe, some loss in ride around 0.8 - 0.9 problem area. Some edge failures. (CH, PI > 55).

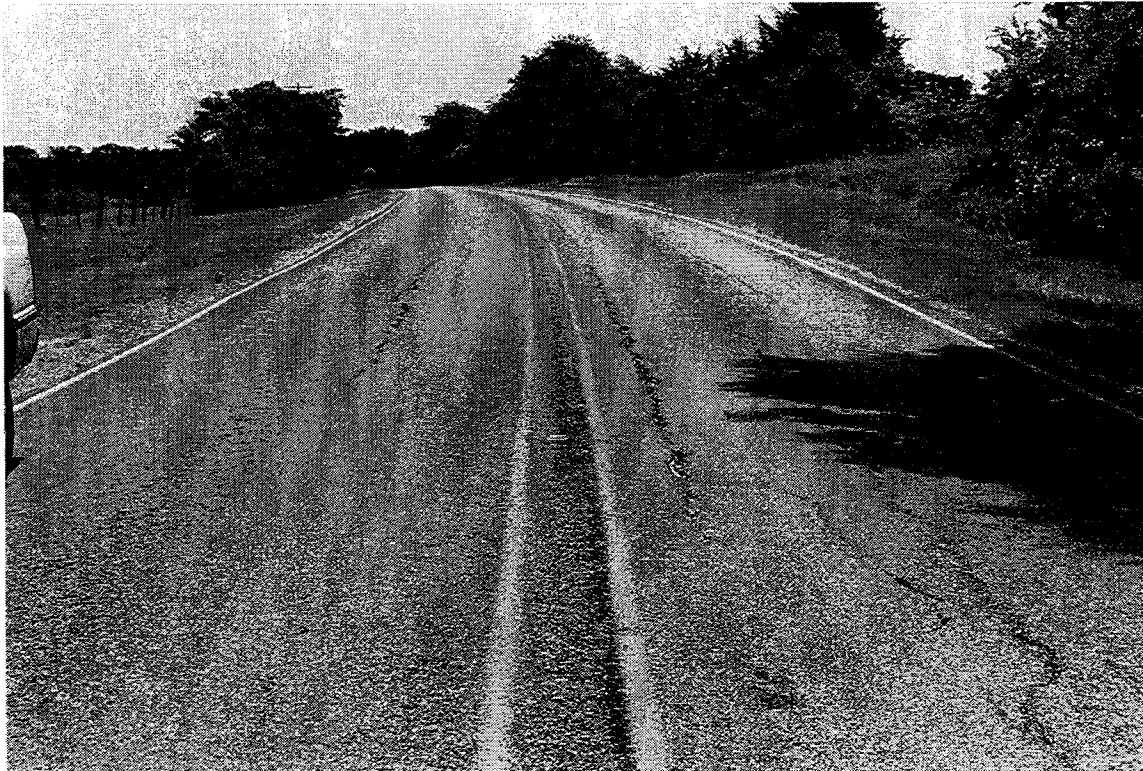
- 0.6 - 1.0 Ok, no problem.
- 1.0 - 1.25 Edge cracking on tree line, some severe. (CH PI > 35).
- 1.3 - 1.5 Major cracks close to tree - stiff base. Very bad.
