1. Report No. FHWA/TX-03/4048-3		2. Government Accession No.		3. Recipient's Catalog No.	
4. Title and Subtitle ADDITIONAL CHARACTERISTICS OF CRASHES ON RURAL TWO-LANE HIGHWAYS				5. Report Date September 2002

**ADDITIONAL CHARACTERISTICS OF CRASHES ON
RURAL TWO-LANE HIGHWAYS**

Report 4048-3
Project Number 0-4048
Research Project Title: Low-Cost Design Safety Improvements for Rural Highways

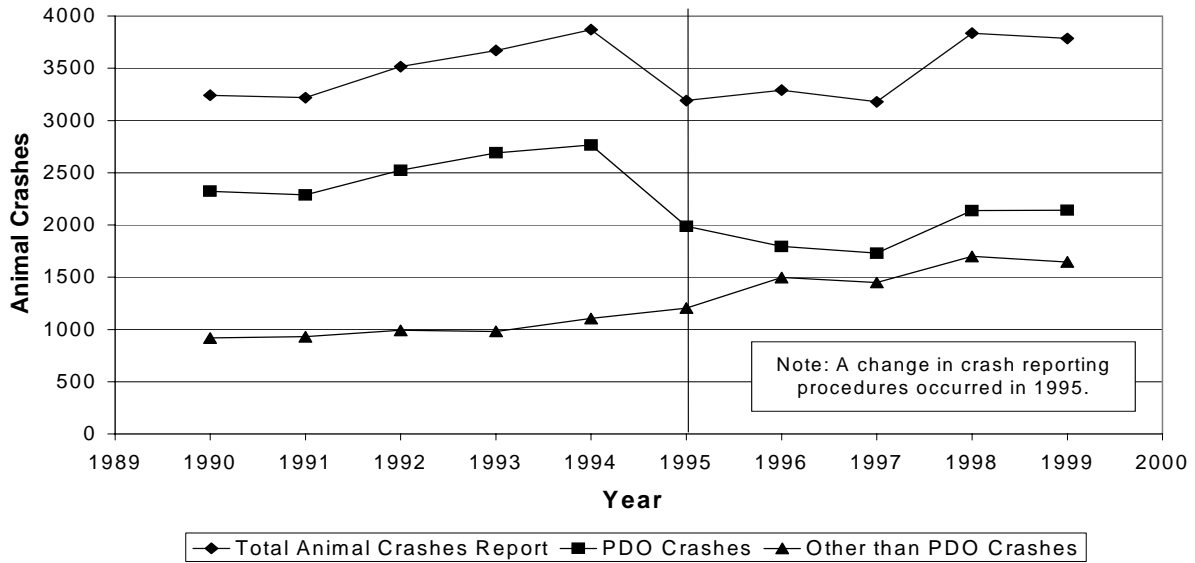
Figure 1. Animal Crashes on Texas On-System, Rural Highways.

Figure 1 shows the total number of animal crashes along with the number of PDO crashes and the number of other than PDO crashes (i.e., possible injury, non-incapacitating, incapacitating, and fatal). The effects of the change in reporting procedures is clearly shown in the PDO crashes line – a large decrease from 2764 PDO crashes in 1994 to only 1986 PDO crashes in 1995 to 1793 PDO crashes in 1996. The other than PDO crash plot shows a continual increase in the number of animal injury/potential injury crashes.

Table 2 lists the number of crashes along with the crash rate, while Figure 1 shows the number of animal crashes per year. Note that in 1995 a change occurred in the crash-reporting procedures. On July 1, 1995, there was a change in the Texas crash-reporting threshold. On that date, the Department of Public Safety (DPS) began reporting only those crashes in which (a) one or more people involved in a crash were killed or injured and/or (b) one or more crash-involved vehicles had to be towed from the scene. Property Damage Only (PDO) collisions that do not result in a vehicle being towed from the scene are no longer reported by DPS. As a result, statewide traffic crashes in the second half of 1995 decreased by about 30 percent compared to the first half of the year. The result in this study is that it appears that there was a large decrease in animal crashes in 1995 when the decrease was a reflection of the reporting change. Therefore, any review that includes both pre-and post-1995 data must consider the change in reporting procedure.

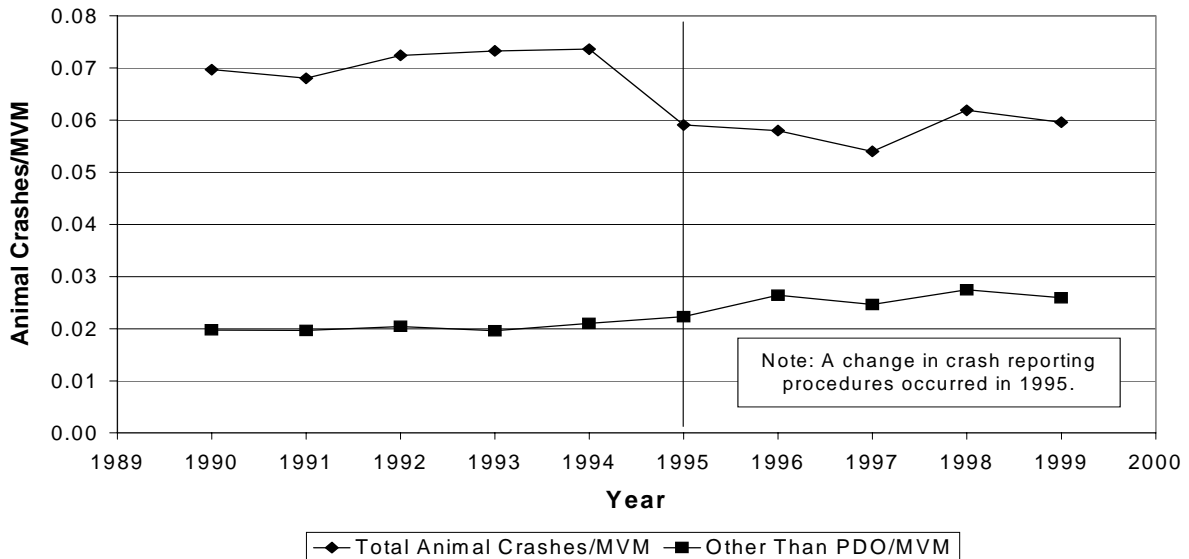
(1 mi = 1.6 km)
Figure 2. Animal Crash Rate.

Figure 2 shows the animal crash rate per million vehicle miles traveled by year. The vertical line at 1995 serves as a division between the two reporting practices. The total number of animal crashes was fairly constant between 1995 and 1997 and then jumped by about 650 crashes in 1998 (see Figure 1). Accompanying the increase in total number of crashes was an increase in the amount of miles being driven in the rural areas. Therefore, some of the increase in number of animal crashes can be explained by the increase in miles driven. An increase in the rate of animal crashes can be seen in Figure 2.

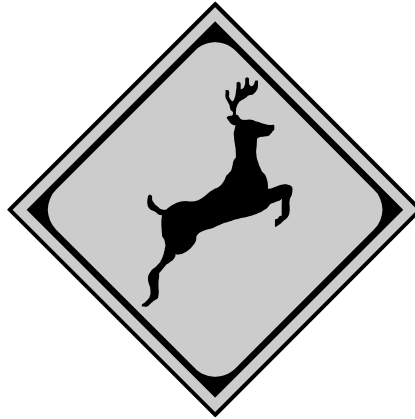
Figure 5. Example of Wildlife Sign.

Application: Signs are mounted to alert drivers of wildlife in the area (see [Figure 5](#)).

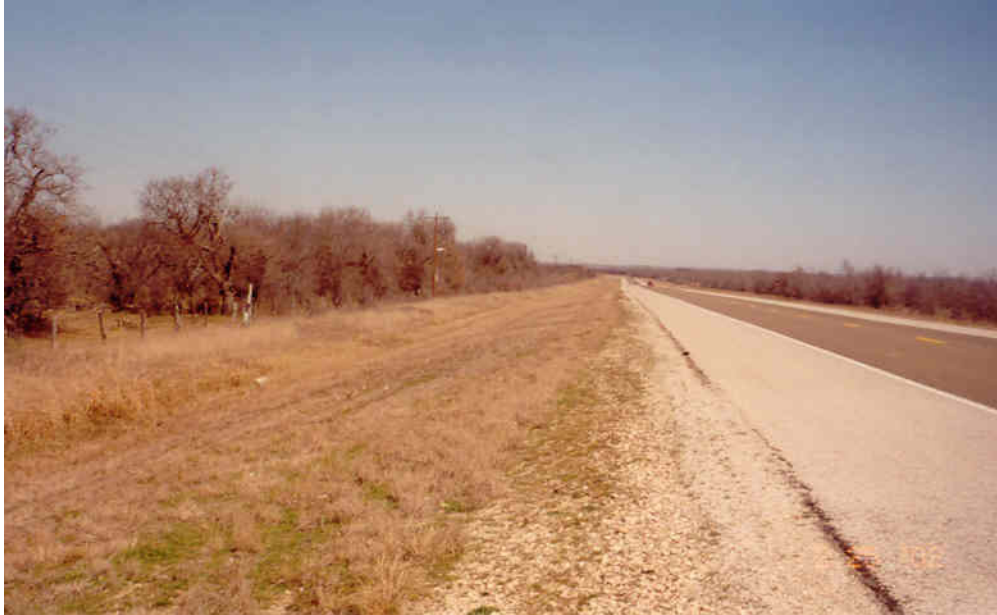
Figure 6. Photograph of a Potential Site for an Installation of an Animal Crash Countermeasure.

Straight line diagrams were developed for several of these control sections, along with control sections with a high number of animal crashes. For many sites, the straight line diagrams revealed sections with multiple animal crashes that occurred within a half-mile segment. Members of the research team visited several of these sites in the field. The field visits revealed sites that would be associated with deer movement by having trees and shrubs on one side of the road and grain fields on the other. [Figure 6](#) is an example of the trees and shrubs along one side of a roadway where several animal crashes have occurred. Deer crossed the road to move from

their sleeping areas to grazing areas. As the opportunity becomes available, one or more of the animal crash countermeasures will be installed at selected sites for testing.

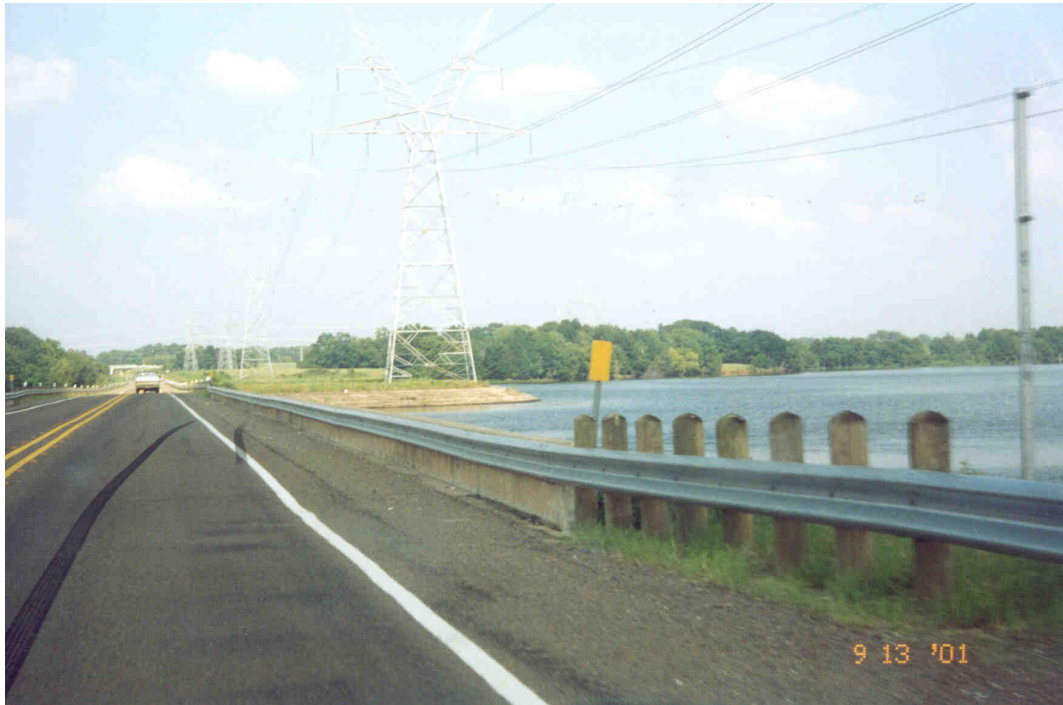
Figure 10. View of Bridge on Lake.

Description of Site. This site is on a rural two-lane farm-to-market highway with a 2002 ADT of approximately 2600. The location under evaluation, shown in Figures [10](#) and [11](#), is a 1.5-mile (2.4 km) section containing a bridge over a lake that is near a power plant. The power plant feeds into the lake, causing the lake water to be warm, and inducing fog under certain weather conditions. Thus, this section of roadway has been subject to heavy fog, which greatly reduces visibility near the bridge. TxDOT personnel were looking for a low-cost means of providing better information to drivers in the area. They had considered installation of a full-function weather station with variable message signs; however, the cost for such a treatment was

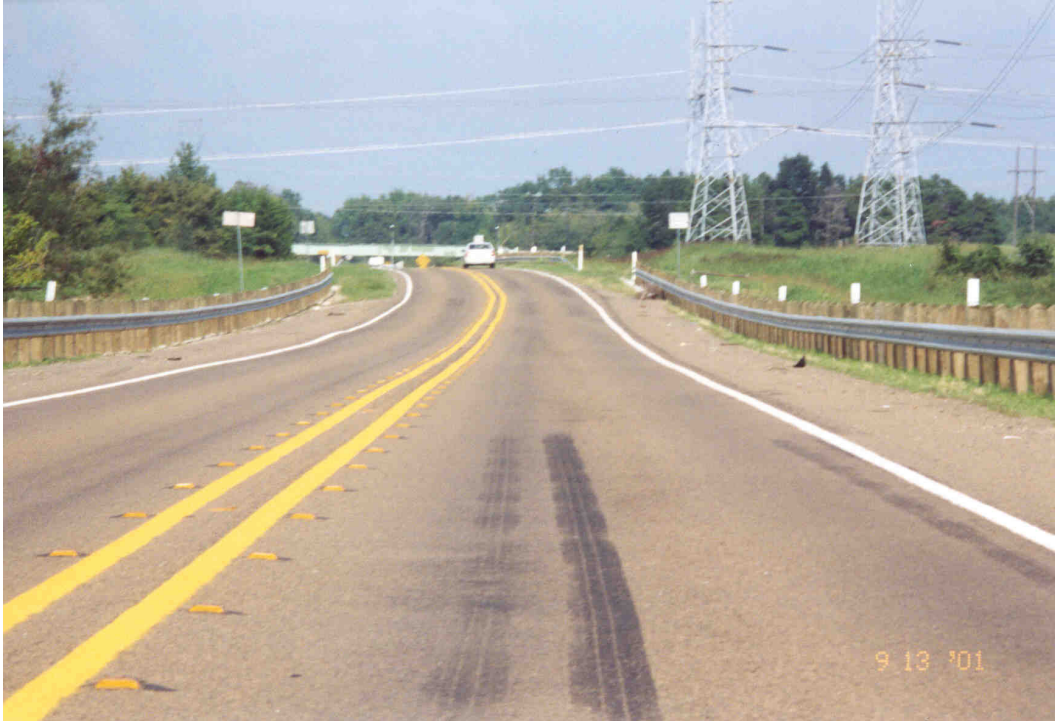
Figure 11. View of Added Raised Pavement Markers and Delineation.

Description of Treatment. Raised reflective pavement markers and additional delineation along the bridge rails and guardrails were installed throughout the 1.5-mile (2.4 km) section. Raised reflective yellow pavement markers were installed beside the centerline of the road on the outside edge of both solid yellow lines. These markers begin about 100 ft (30.4 m) in advance of the beginning of the guardrail and continue throughout the section to the other side of the bridge. The delineators, rectangular white or yellow reflectors on metal posts, were attached to wooden guardrail posts at regular intervals throughout the length of the guardrail (see [Figure 10](#)); white delineators were used throughout the length of the guardrail, while yellow ones were used at the last guardrail post to signify the end of the guardrail.

Installation. Based on maintenance diary records, the installation of the improvements was completed in October 1996, at an estimated cost of \$3000-5000.

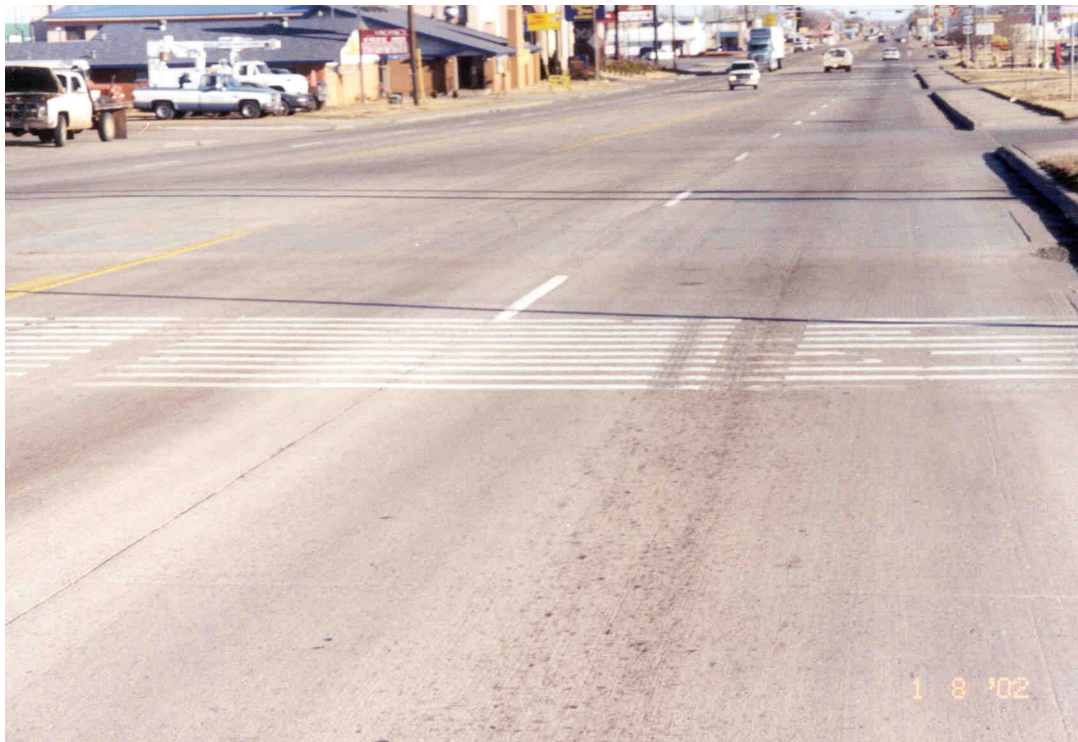
Figure 12. View of Approach Rumble Strips.

Installation. The rumble strips, installed in August 1997, were placed in two sets. Each set consisted of 10 strips, 24 ft × 4.5 inches (7.3 m × 11.4 cm), with a space of 9.5 inches (24.1 cm) between each strip. A close-up view of the rumble strips is shown in [Figure 14](#). The first set is 1236 ft (377 m) from the traffic signal, and the second set is 480 ft (146.3 m) from the traffic signal. There is also a 36 ft × 36 ft (91.4 cm × 91.4 cm) “RUMBLE STRIPS AHEAD” sign located 985 ft (300 m) west of the first set of rumble strips. The cost to install the rumble strips and advance sign amounted to approximately \$500. The strobe lights, installed in March 1997, are mounted to the red lenses of the traffic signals. The cost of purchasing and installing the strobe lights was approximately \$3200.

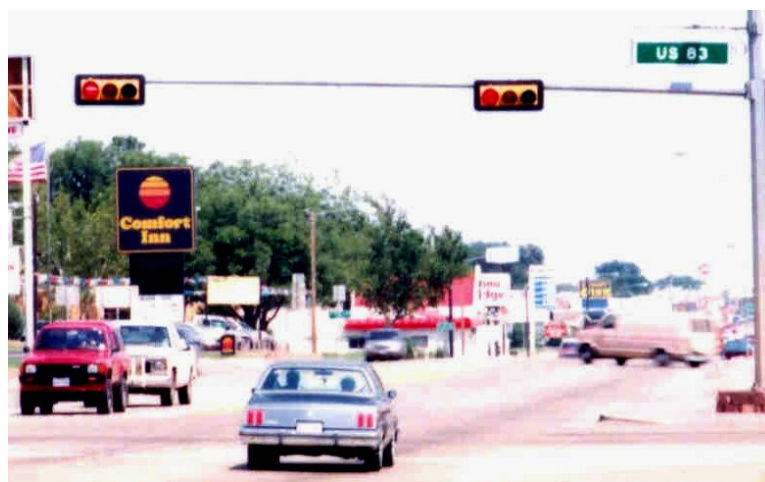
Figure 13. Strobes in Signal Heads.

Note that the high-intensity strobe device is experimental. When considering new technologies not included in the TMUTCD, a request for experimentation is to be submitted to the Traffic Operations Division of TxDOT and approved before installation of the device.

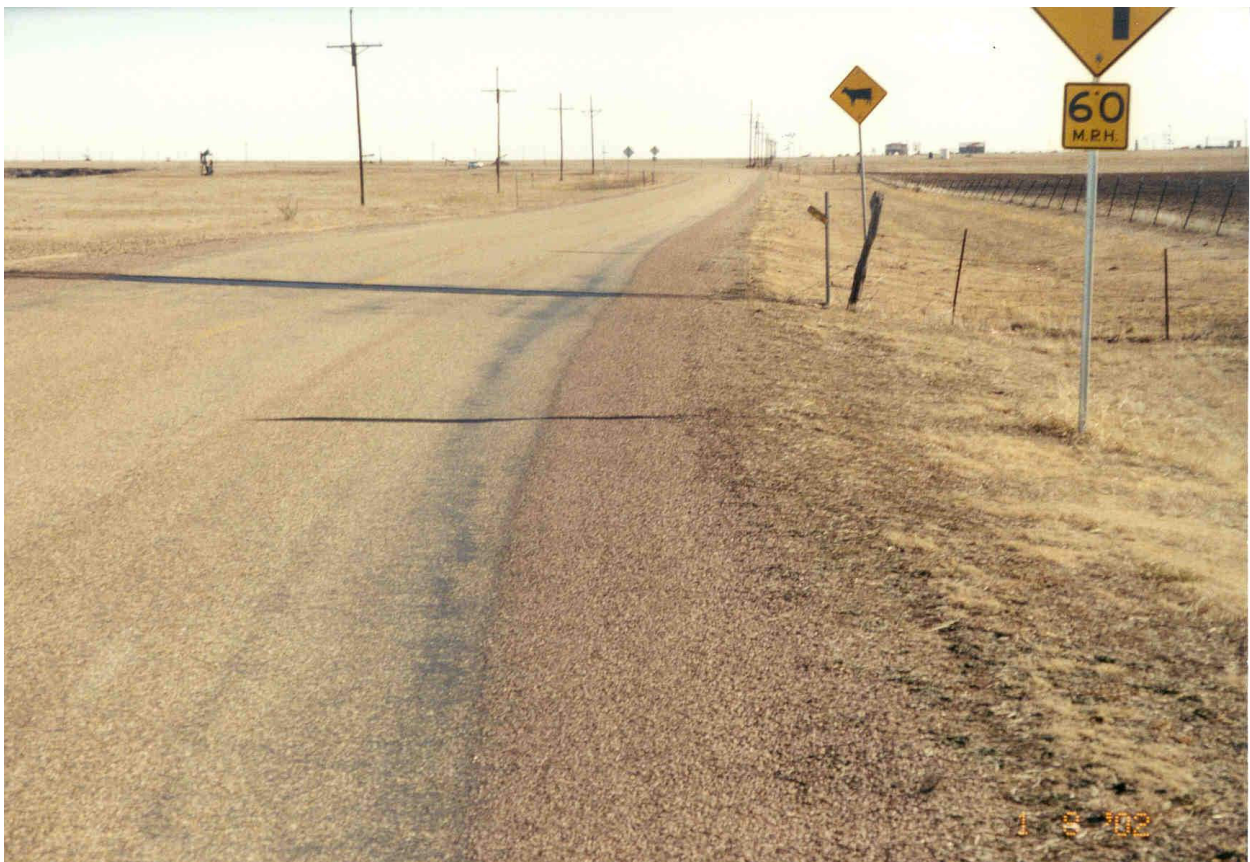
Figure 16. View of Comparison Site near Site with Roadway Widening.

Comparison Site. Another section of the same highway south of the study site was chosen for a comparison site. This site consists of a 2.8-mi (4.5-km) section where no improvements took place during the six-year crash history evaluation period. The comparison site section is similar to the study site in terrain and volume. A view of the comparison site is shown in [Figure 16](#).

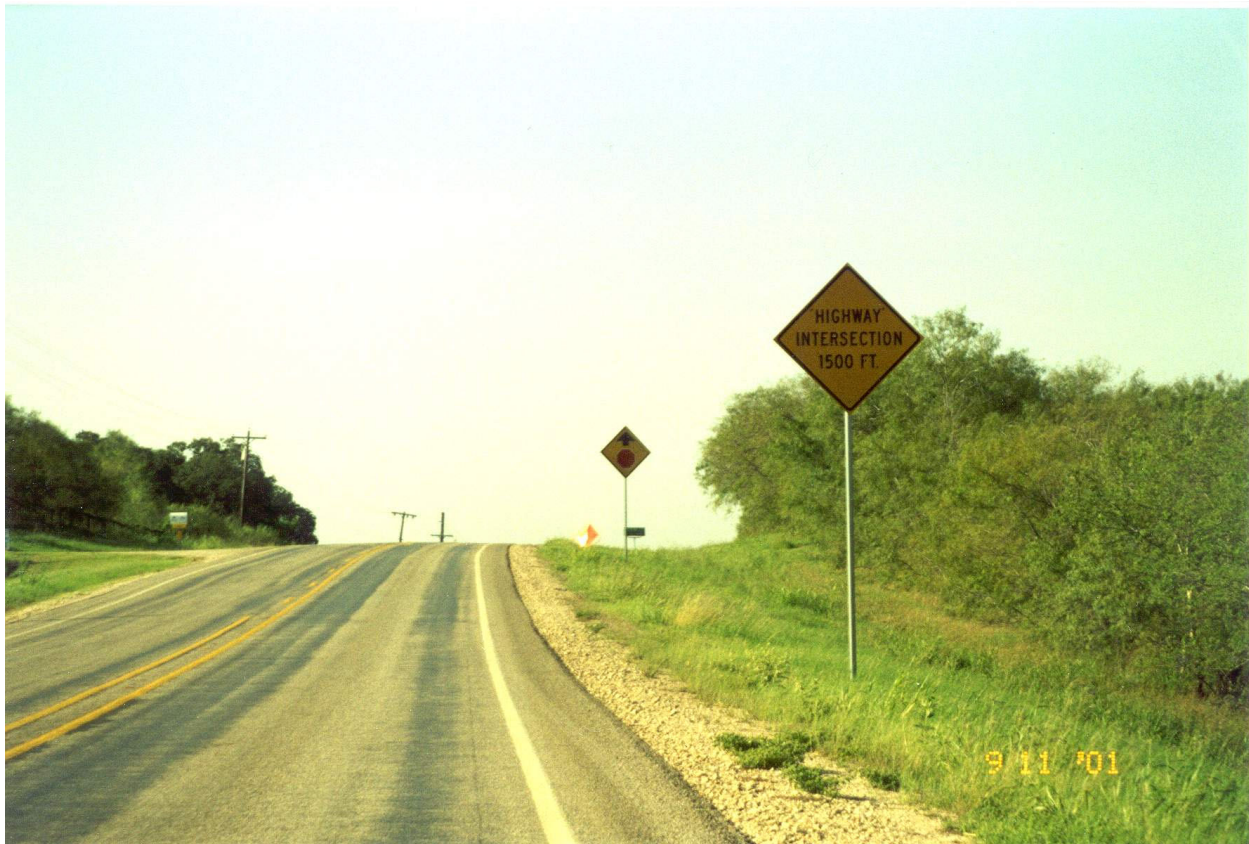
Figure 18. Advance Warning Signs for Approach to Intersection.

Installation. According to the maintenance diary, district maintenance personnel completed installation of signs in September 1996.
