1. Report No. FHWA/TX-02/4104-1		2. Government Accession No.		3. Recipient's Catalog No.	
4. Title and Subtitle A FOLLOW-UP EVALUATION OF HOT-MIX PAVEMENT PERFORMANCE IN NORTHEAST TEXAS				5. Report Date April 2002 Resubmitted: July 2002

**A FOLLOW-UP EVALUATION OF HOT-MIX PAVEMENT  
PERFORMANCE IN NORTHEAST TEXAS**

Report 4104-1  
Project Number 0-4104  
Research Project Title: An Evaluation of Factors Affecting Moisture  
Susceptibility of Pavements in Northeast Texas

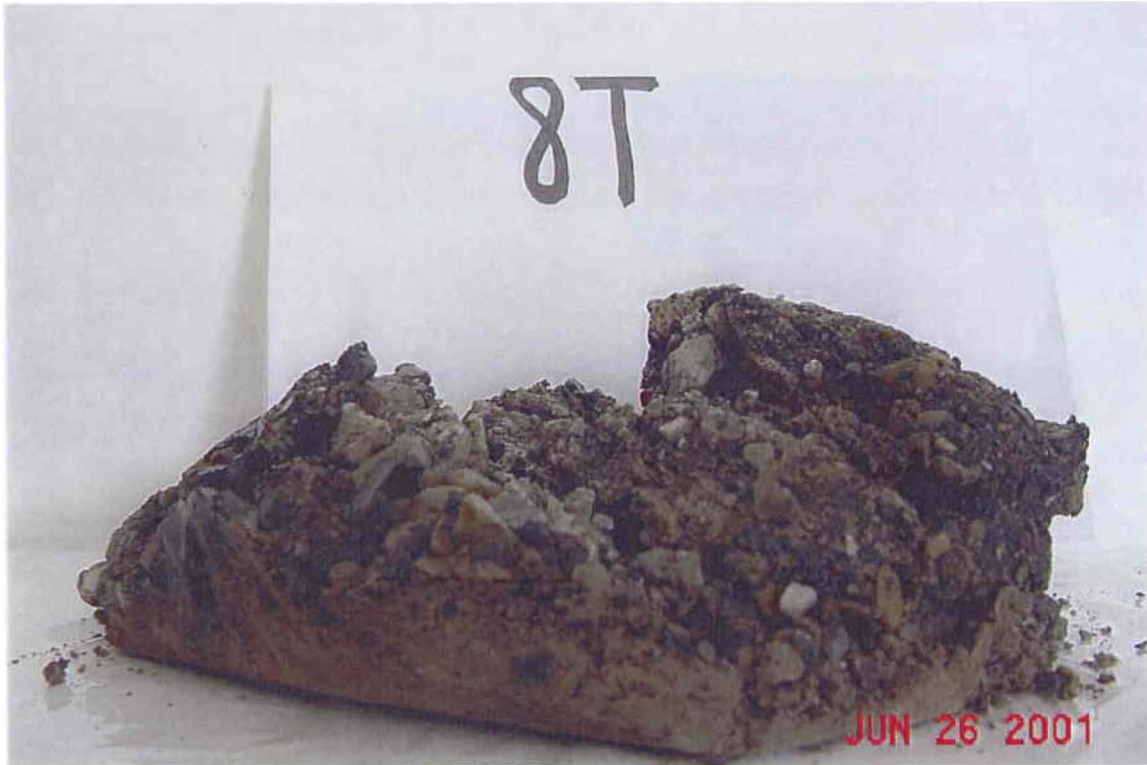
**Figure B32. Photographs of the Cores after Hamburg and TSR Tests  
(Tyler – Section 8 – US 271).**

**Note:** No TSR sample available.

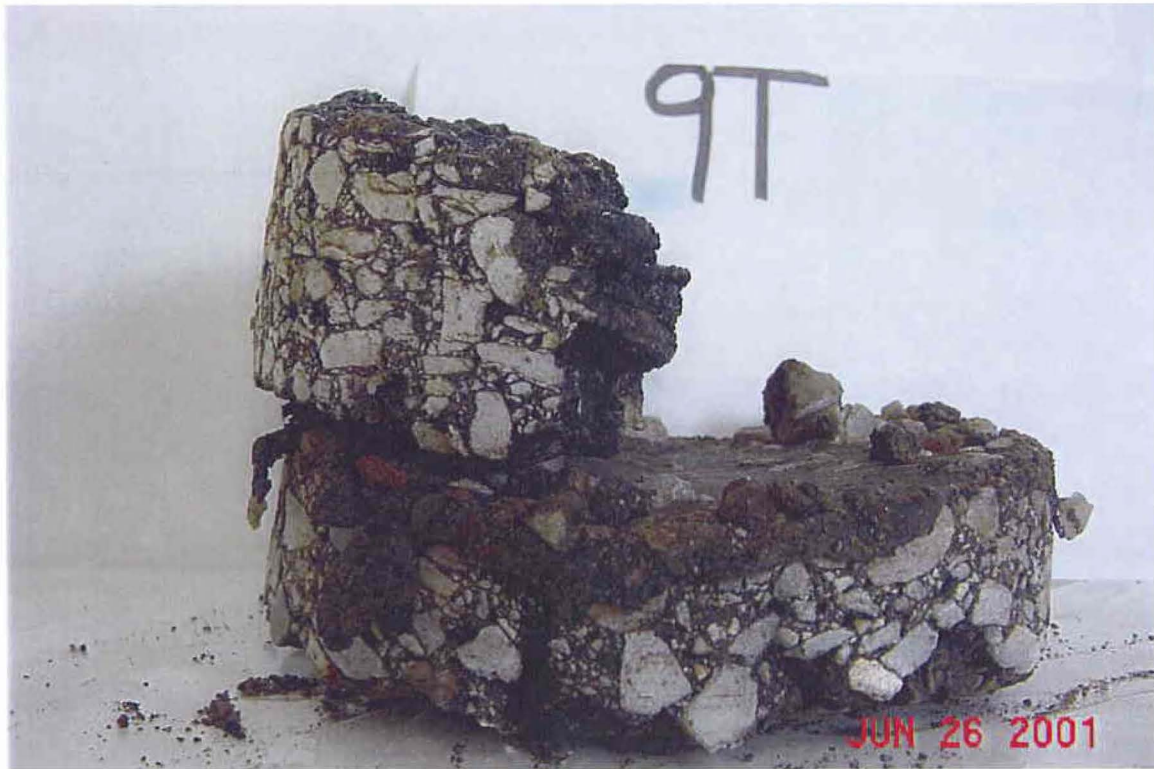
**Figure B33. Photographs of the Cores after Hamburg and TSR Tests  
(Tyler – Section 8 – US 250).**

**Note:** No TSR sample available.
