1. Report No. FHWA/TX-02/4162-1		2. Government Accession No.		3. Recipient's Catalog No.	
4. Title and Subtitle EVALUATION OF TEXAS GRID-SLOT PORTABLE CONCRETE BARRIER SYSTEM				5. Report Date April 2002

EVALUATION OF TEXAS GRID-SLOT PORTABLE CONCRETE BARRIER SYSTEM

Report 4162-1
Project Number 0-4162
Research Project Title: Evaluation of Barrier Systems
and Placement Issues

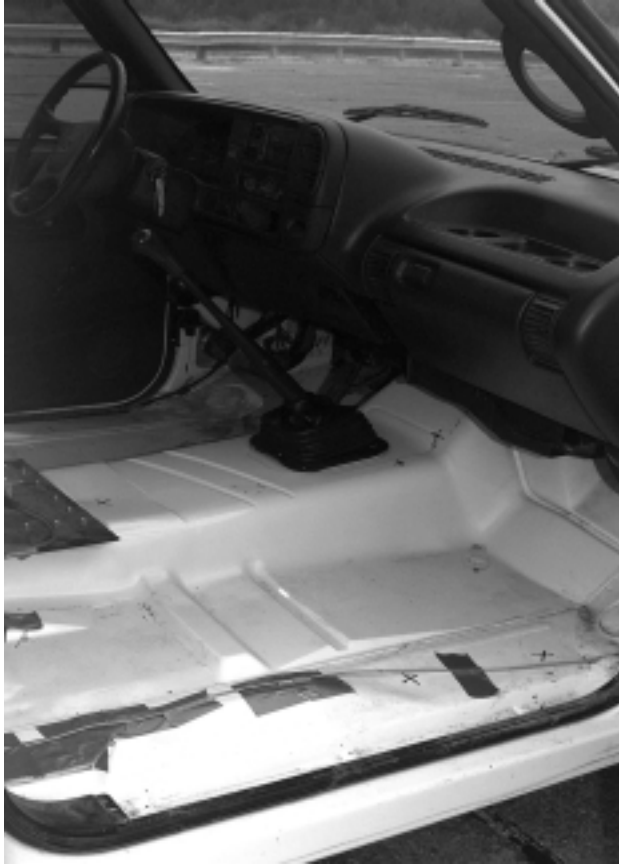
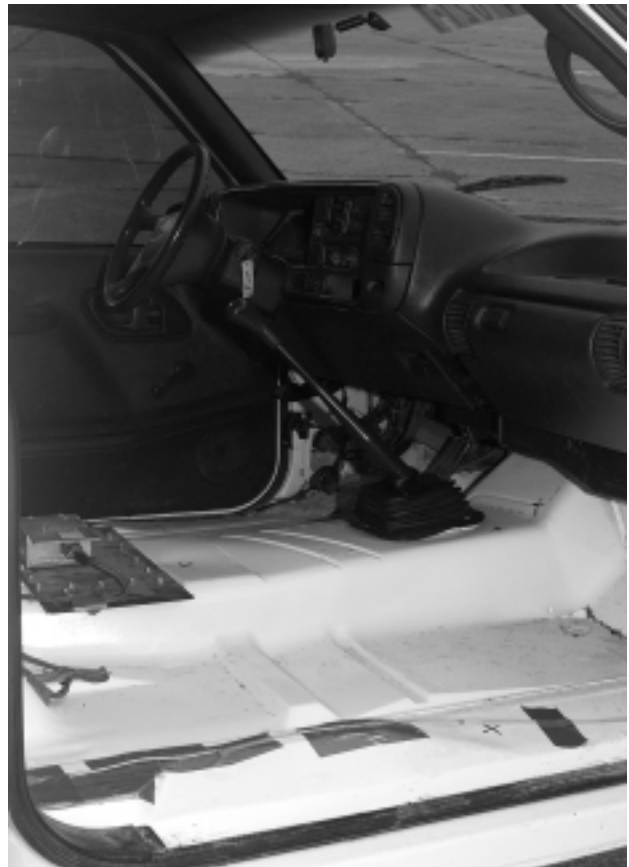
Figure 9. Interior of Vehicle for Test 441621-1.

Before Test

After Test

Damage to the vehicle is shown in Figure 8. Structural damage was imparted to the left upper and lower A-arms, left side rod ends, stabilizer bar, left front frame, floor pan, and fire wall. Also damaged were the front bumper, hood, fan, radiator, left front quarter panel, left door, and the left front and rear tires and wheel rims. Maximum exterior crush to the front plane of the vehicle at the left front corner was 18.5 in. Maximum exterior crush to the side plane of the vehicle at the left front corner was 13.8 in. Maximum occupant compartment deformation was 3.2 in. in the left fire wall area. Photographs of the interior of the vehicle are shown in Figure 9. Exterior crush measurements and occupant compartment measurements are detailed in Appendix B, Tables 4 and 5.

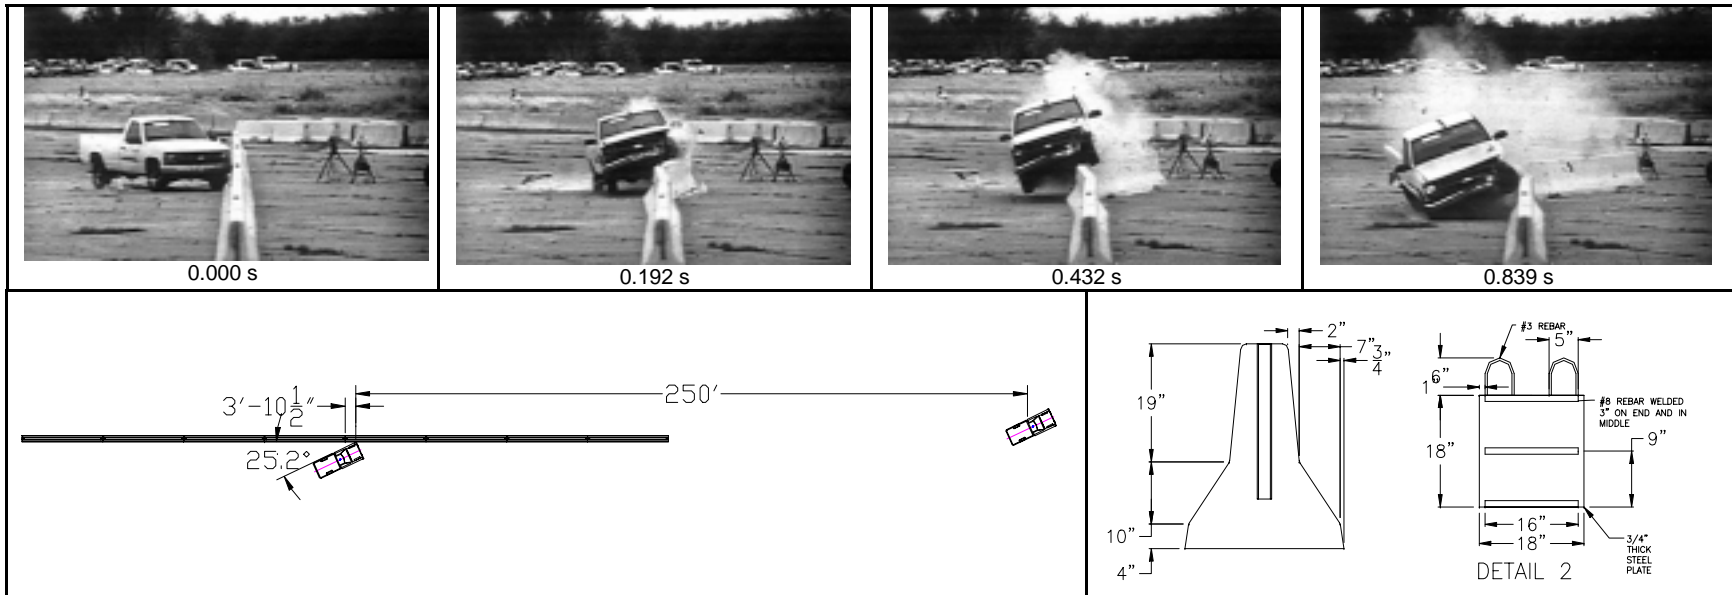
General Information		Impact Conditions		Test Article Deflections (m)	
Test Agency	Texas Transportation Institute	Speed (km/h).....	101.3	Dynamic	2.74
Test No.....	441621-1	Angle (deg)	25.2	Permanent	2.72
Date.....	02/28/01	Exit Conditions		Working Width	2.95
Test Article		Speed (km/h).....	N/A	Vehicle Damage	
Type	Temporary Concrete Barrier	Angle (deg)	N/A	Exterior	
Name.....	TxDOT Grid Slot	Occupant Risk Values		VDS	11LFQ4
Installation Length (m)	45.7	Impact Velocity (m/s)		CDC	11FLEK3
Material or Key Elements.....		x-direction	4.2	Maximum Exterior	
Soil Type and Condition.....		y-direction	6.2	Vehicle Crush (mm).....	470
Test Vehicle		THIV (km/h)	26.2	Interior	
Type	Production	Ridedown Accelerations (g's)		OCDI.....	LF0011000
Designation	2000P	x-direction	-2.5	Max. Occ. Compart.	
Model	1996 Chevrolet 2500 Pickup Truck	y-direction	8.7	Deformation (mm)	81
Mass (kg)		PHD (g's)	8.9	Post-Impact Behavior	
Curb	2105	ASI	1.32	(during 1.0 s after impact)

Test Inertial.....	2000	Max. 0.050-s Average (g's)		Max. Yaw Angle (deg)	22
Dummy.....	No dummy	x-direction	-6.1	Max. Pitch Angle (deg)	7
Gross Static.....	2000	y-direction	10.3	Max. Roll Angle (deg).....	28
		z-direction	-5.4

[Table 1](#) provides an assessment of the test based on the applicable *NCHRP Report 350* safety evaluation criteria. In summary, the modified Texas grid-slot portable concrete barrier with steel connector plate met *NCHRP Report 350* evaluation criteria. Although one of the barrier joints separated, the test vehicle was contained and redirected. The maximum lateral barrier movement experienced in the test (9 ft) should be given due consideration if this system is implemented in the field.

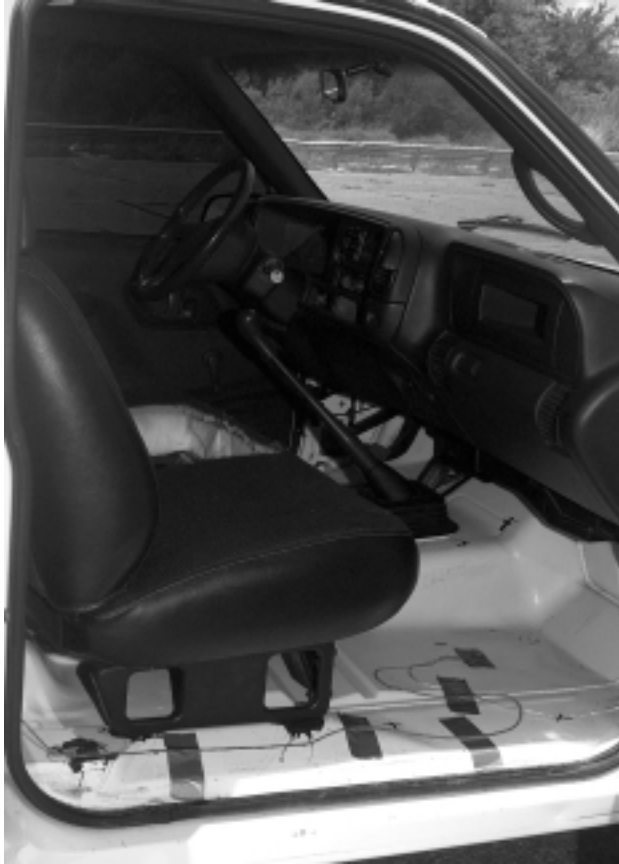
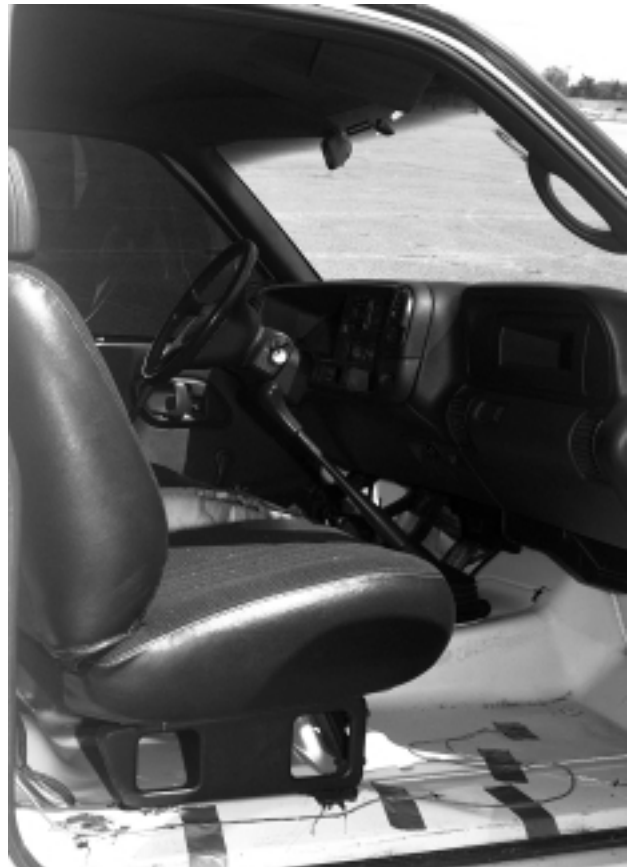
Figure 18. Interior of Vehicle for Test 441621-2.

Before Test

After Test

Damage to the vehicle is shown in [Figure 17](#). Structural damage was imparted to the stabilizer bar, left upper and lower A-arms, left side tie rod ends, the left front frame and the left front tire and wheel. Also damaged were the front bumper, fan, radiator, left front quarter panel, left door, and left rear bed. The right side door was jammed. Maximum exterior crush to the vehicle was 15.75 in. at the left front corner at bumper height. The left side of the floor pan and firewall were deformed. Maximum occupant compartment deformation was 0.6 in. at the left side instrument panel area. Photographs of the interior of the vehicle are shown in [Figure 18](#). Exterior crush and occupant compartment measurements are shown in Appendix B, Tables [6](#) and [7](#).

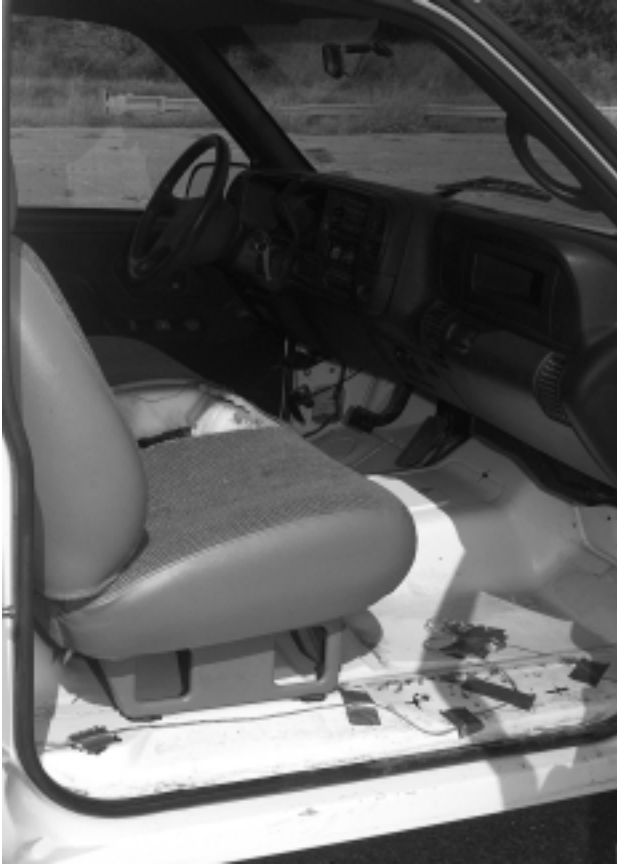
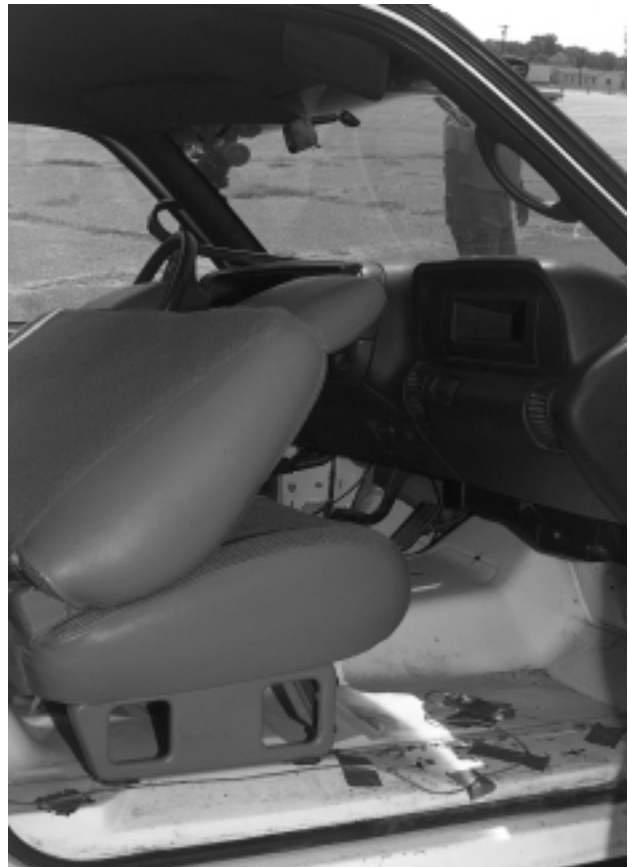
Figure 27. Interior of Vehicle for Test 441621-3.

Before Test

After Test

Damage to the vehicle is shown in Figure 26. Structural damage included deformation of the stabilizer bar, upper and lower A-arms, left ball joints and tie rod ends, and the left front of the frame. Also damaged were the front bumper, hood, fan, radiator, left front quarter panel, left door, right front quarter panel and the left front and rear wheel rims and tires. Maximum exterior crush to the vehicle was 17.3 in at the left front corner at bumper height. Maximum occupant compartment deformation was 6.3 in. at the lower left firewall near the floor pan. Photographs of the interior of the vehicle are shown in Figure 27. Exterior crush and occupant compartment measurements are shown in Appendix B, Tables 8 and 9.
