1. Report No. FHWA/TX-03/4182-1		2. Government Accession No.		3. Recipient's Catalog No.	
4. Title and Subtitle FIELD PERFORMANCE AND DESIGN RECOMMENDATIONS FOR FULL DEPTH RECYCLING IN TEXAS				5. Report Date March 2003

**FIELD PERFORMANCE AND DESIGN RECOMMENDATIONS FOR
FULL DEPTH RECYCLING IN TEXAS**

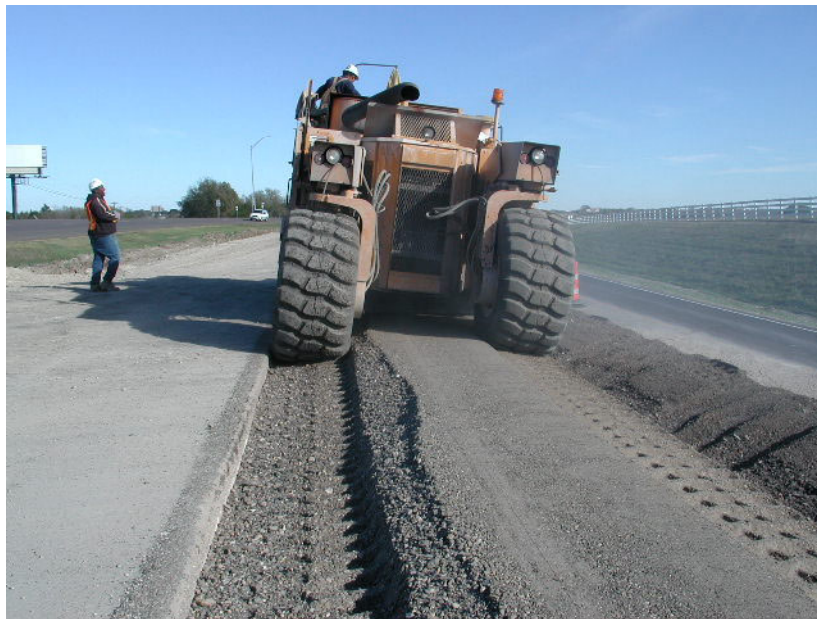
Figure 1. FDR on US 290 in the Bryan District.

The first step in the construction sequence is to pulverize the existing pavement as shown in [Figure 1](#). A second pass is often made to add the required stabilizer. In Texas a range of traditional stabilizers have been used including cement, lime fly ash, and asphalt emulsions. Curing and priming practices are known to vary substantially around the state and are subject to external factors such as the need to open the highway to traffic as soon as possible. In many areas in East Texas the highways are normally subjected to traffic at the end of a day's construction.

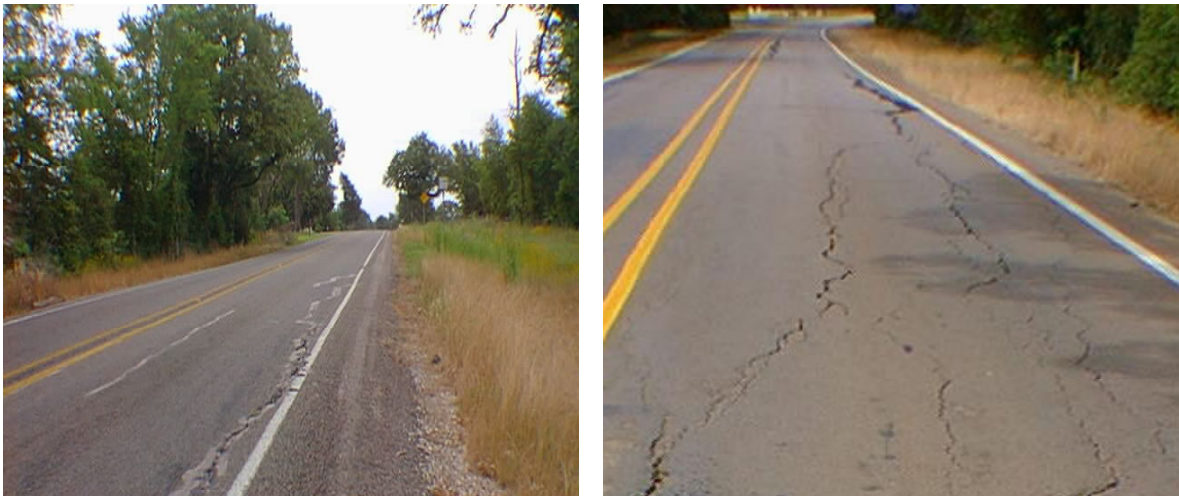
Figure 13. Severe Longitudinal Cracking Problems in Some of the Initial Recycled Pavements in the Bryan District.

As described above, the major concern in the initial studies was the performance of the sections built over highly plastic clay material. Severe longitudinal cracking problems were encountered on several projects, and these cracks were documented to be occurring in the subgrade soils as a result of subgrade drying during summer drought periods. Examples of this type of distress are shown in [Figure 13](#).

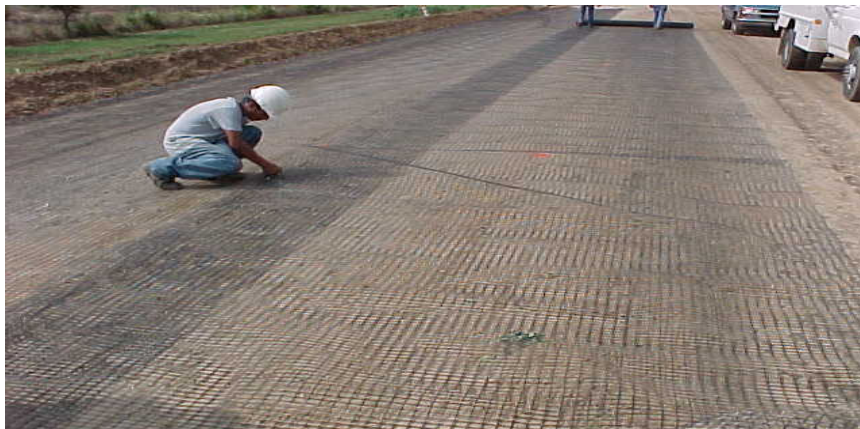
Figure 15. Geogrid Reinforcement on Expansive Soils.
Schematic courtesy of Darlene Goehl, P.E.

layer but would provide a slippage plane so that any movements from lower layers would not reflect through the upper layers.

It was clear to Bryan personnel that the design methodology would need to be modified to minimize the impact of edge drying. Based on the recommendations of TTI Project 0-3903 ([Syed and Scullion, 2000](#)) the district experimented with the use of geogrids. It was proposed that the grid would be placed on top of the stabilized layer and beneath the granular base layer as shown in [Figures 14](#) and [15](#). The idea was that the fabric layer would not reinforce the base

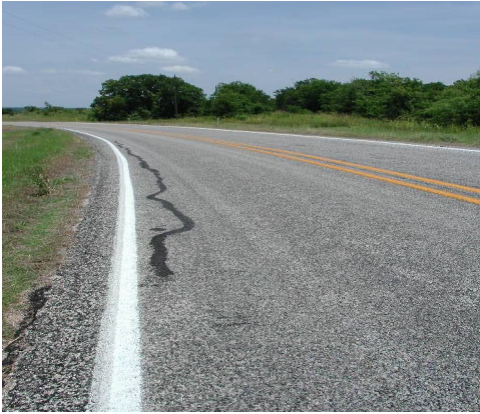
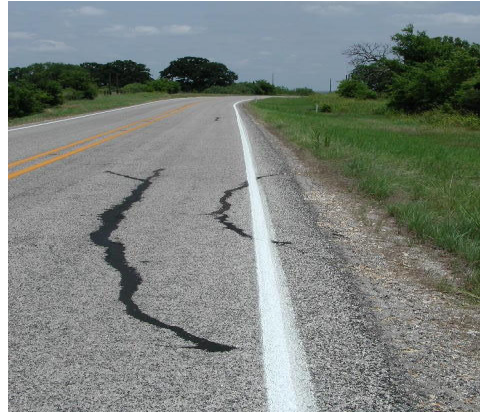
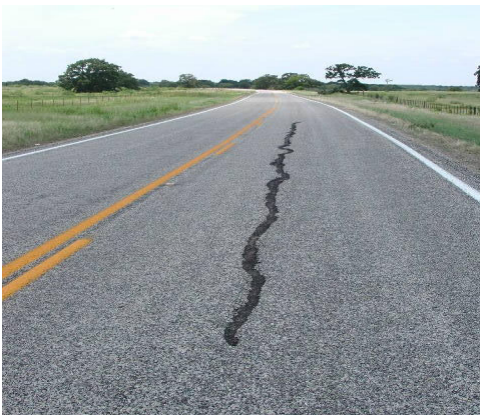
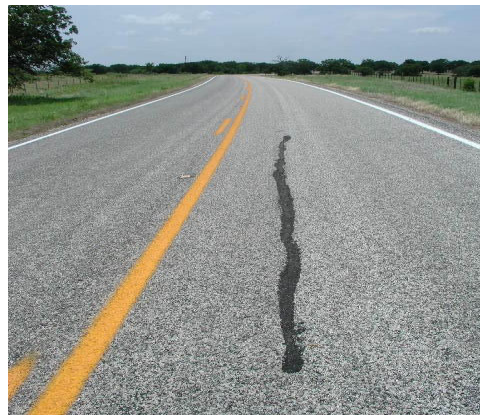
Figure 16. Longitudinal Cracking in Control Section (no grid) of FM 1915 after 3 Years in Service.

Overall the second grid section had no signs of distress and is performing better than the first grid section. Both grid sections are performing much better than the section without any grid reinforcement. The control section without the grid has numerous longitudinal cracks. In this section the grid reinforcement has shown to be quite effective at reducing longitudinal cracking.

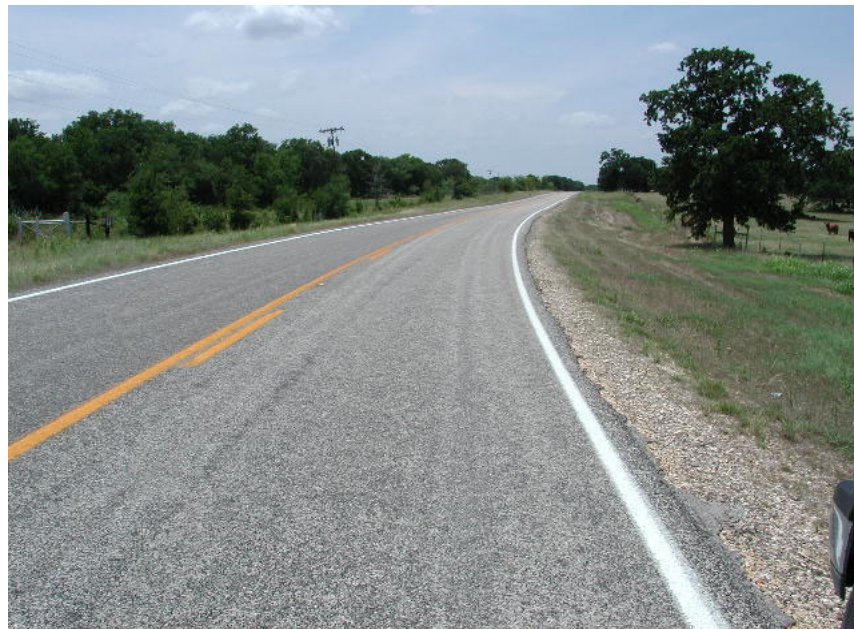
Figure 17. Condition of Second Geogrid Section on FM 1915 (No Distress after 3 Years in Service).

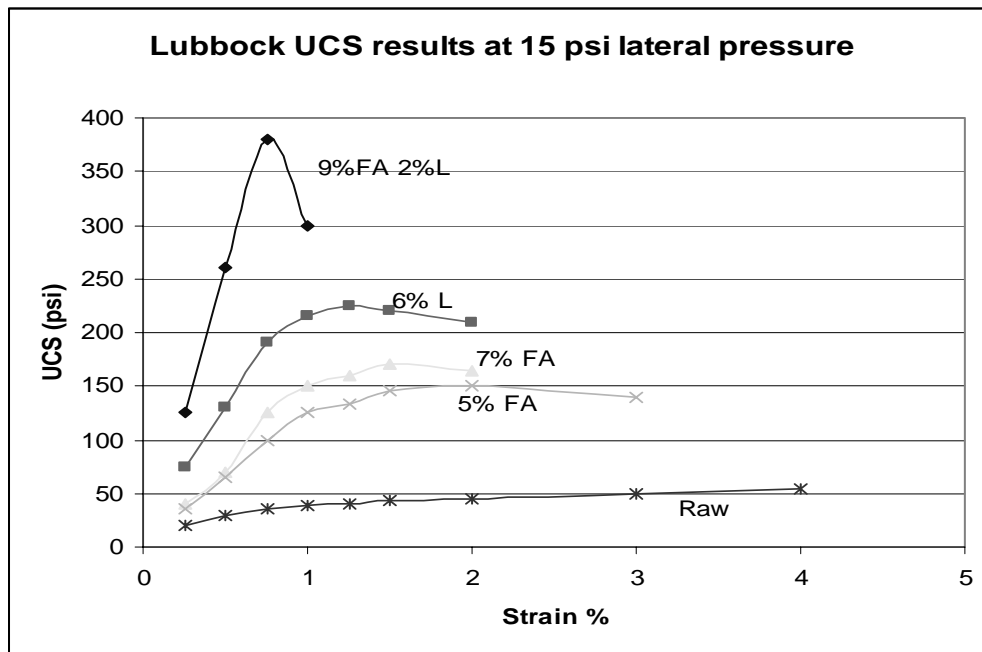
Figure 18. Lubbock Stress Strain Curves for Various Stabilizers (Baker, 1995).

In the early 1990s the district lab did a series of Texas triaxial tests with local materials with different levels of stabilizer and stabilizer types. A typical series of strength test results are shown in [Figure 18](#). In all cases the treated materials were tested in accordance with Tex-121-E.

They were dry cured and then subjected to a 10-day capillary rise. The district based its decision on optimum stabilizer content on the 15 psi confined strength data. The district noted that it is possible to get high initial compressive strengths for any material by simply increasing the stabilizer content. However, they noted that in the laboratory the failure mode for the high-strength samples changed to sudden brittle failure. The district engineers concluded that this failure mode was undesirable and that the lack of flexibility would cause problems in the field. They opted for lower compressive strengths in a hope to achieve a balance between strength and flexibility. The current criterion they specify is strength of 175 psi at 15 psi confining at the end of the 10-day capillary rise. In the initial projects the stabilizer of choice was fly ash because of its availability and low cost (40 to 50 percent cost of lime or cement, based on 1997 data).

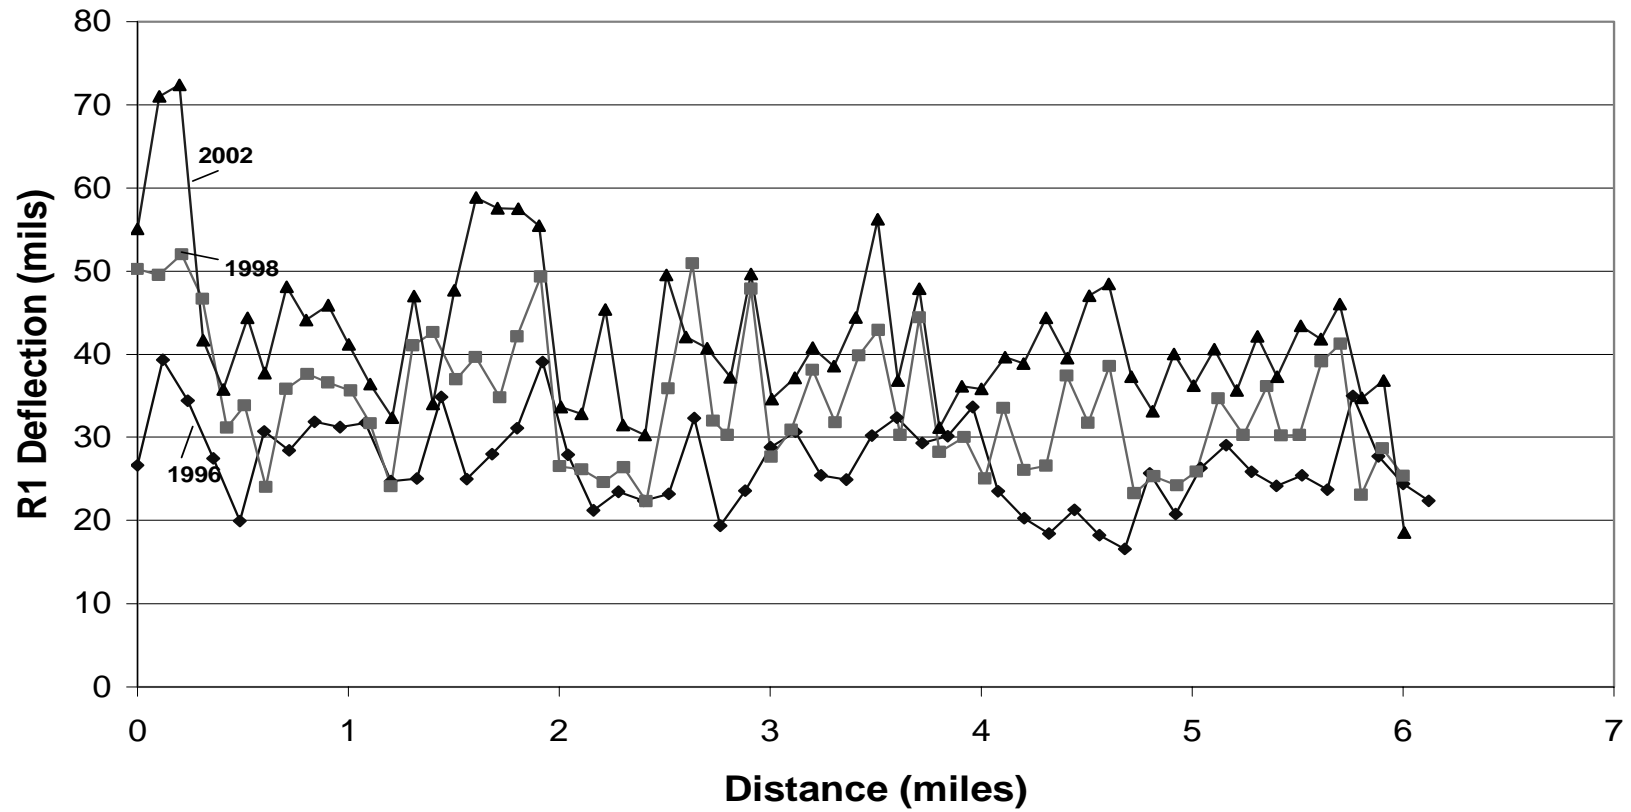
Figure 20. Maximum Deflections Measured at 9000 lb Design Load from 1996 to 2002 for FM 211 in Lynn County.

To further demonstrate the concerns with the 5 percent stabilizer level, the FWD data from FM 211 in Lynn County are shown in [Figures 20 and 21](#). In both cases it is clear that the structure is getting weaker with time. The deflections shown in [Figure 20](#) are increasing with time, and the base modulus shown in [Figure 21](#) is decreasing. For this site the average deflection increased from 26.8 mil in 1996 shortly after construction to over 42 mil in 2002. The average base modulus dropped from over 80 ksi in 1996 to less than 42 ksi in 2002.

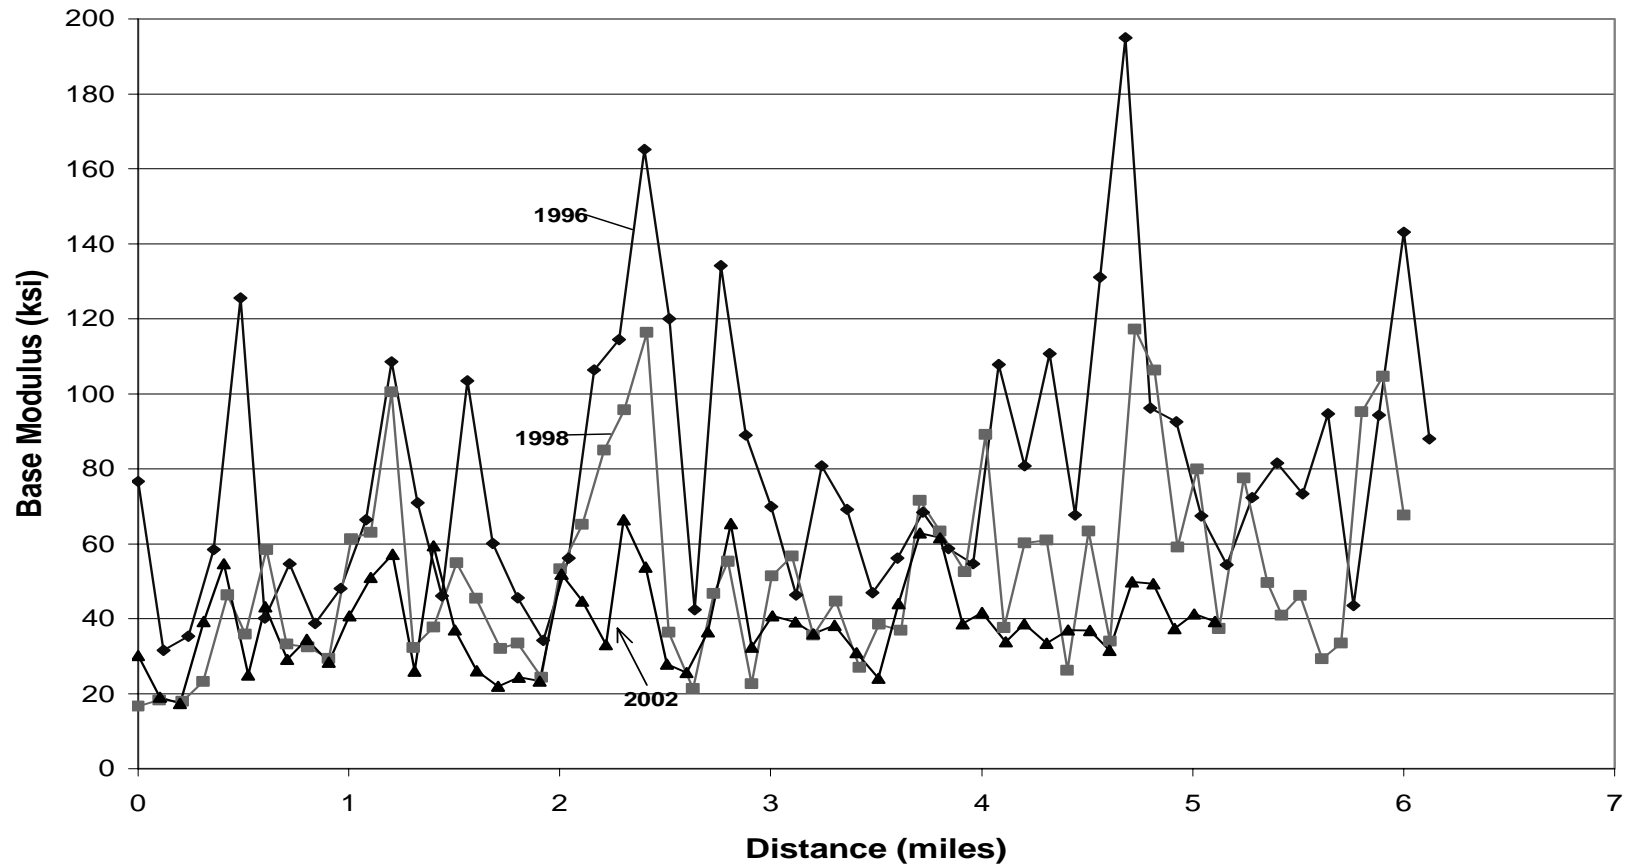
Figure 21. Backcalculated Base Moduli Value from 1996 to 2002 for FM 211 in Lynn County.

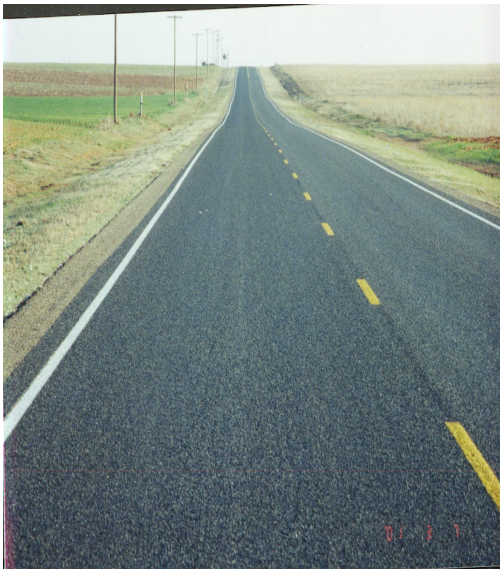
**Figure 22. FM 301 10% Fly Ash
Excellent Condition.**

After 7 years in service the Lubbock District is happy with the performance of these fly ash treated sections; none of the sections have received any additional rehabilitation and only minor maintenance. From a review of the 2001 PMIS data and from visual inspections, little or no distress was apparent on any of the sections. The majority of the sections were in excellent condition as shown in [Figure 22](#). At the 5 percent level the only distress found was minor rutting. FM 97 in Floyd County in a few locations was measured to have 10 percent minor rutting (0.5 to 1 inch) and 5 percent major rutting. An example of the minor rutting from FM 399 in Garza County is shown in [Figure 23](#). This section is approximately 4 miles long, and the only distress found was the 300- to 400-ft section of shallow rutting.

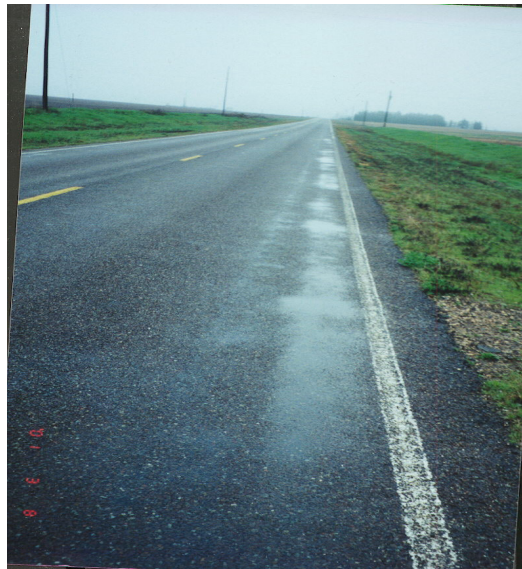
**Figure 23. Minor Rutting on FM 399
Garza County.**

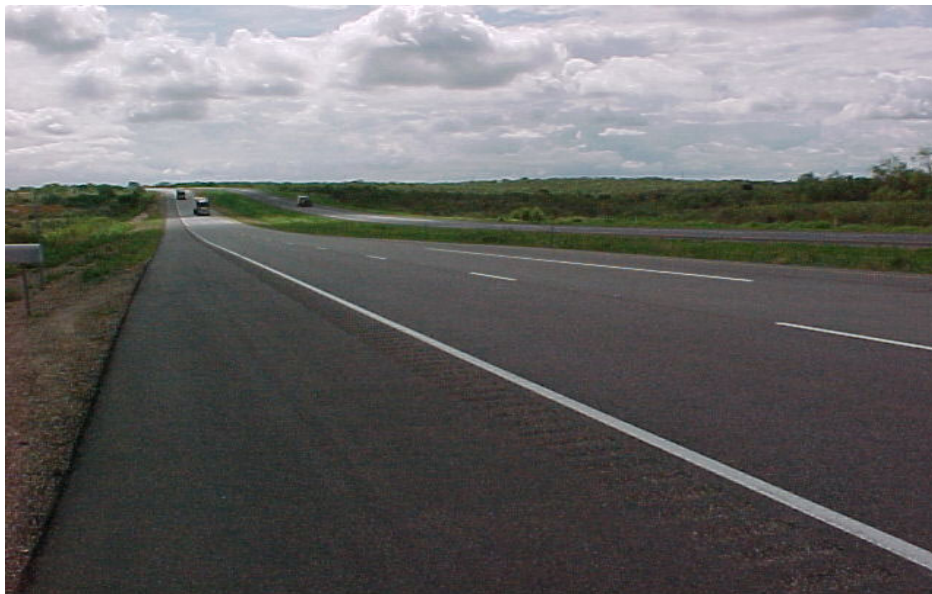
Figure 24. US 287 near TRM 216 (10 inch Fly Ash Base (6% FA), 2 inch HMA Constructed Summer 1998, Heavy Traffic, Excellent Condition).

The Childress District has been actively recycling pavements since the early 1990s. The district generally has very good subgrade support conditions. The main stabilizer used in the Childress District is fly ash from the Tolk power station near Amarillo. The same fly ash is used in the Lubbock and Amarillo Districts. Unlike several other districts, the Childress District's experience with fly ash stabilization has been extremely positive. As will be described below, the district does not restrict its use to the low-volume roadways, and many sections of US 287 have fly ash treated bases and relatively thin surfacing. Several of these sections with 20-year design traffic in excess of 7 million 18 kips ESALs are more than 5 years old and have performed well with little or no distress, as shown in [Figure 24](#).

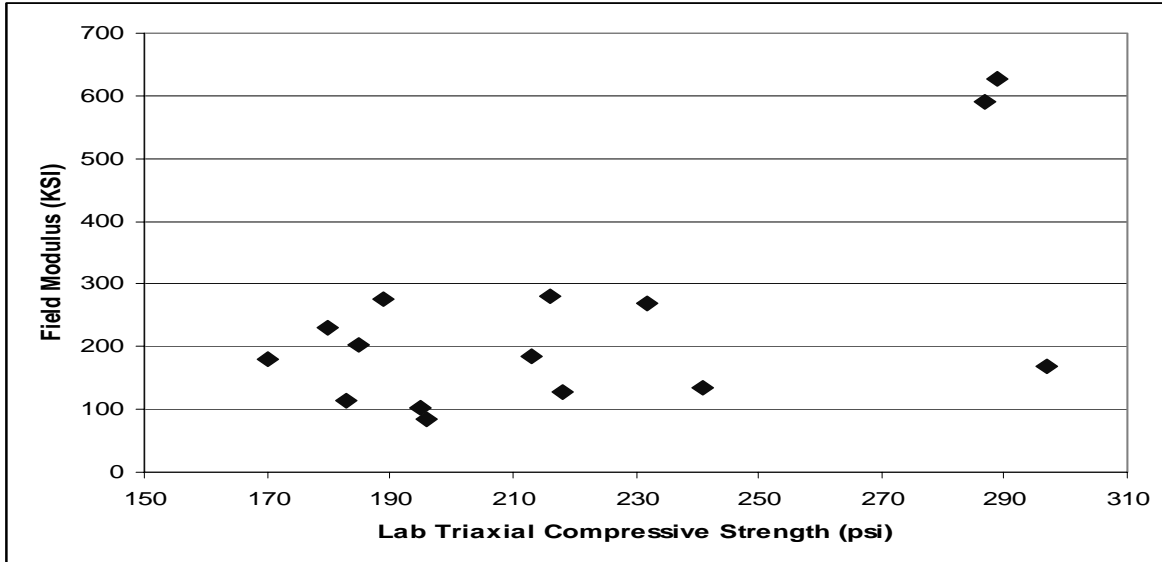
Figure 25. Average Base Modulus (ksi) Backcalculated from FWD Data Against Laboratory Design Compressive Strength Data (psi) (Texas Triaxial Test at 15 psi Confining).

- 4) The relationship between eventual field modulus and laboratory design strengths is shown in [Figure 25](#). There is a general increase in field modulus with increase in laboratory strength. The one outlier in the data is section 5, where the confined design strength was 297 psi but the field modulus was only 168 ksi. The other two sections with similar laboratory strengths resulted in field moduli values close to 600 ksi. One possible explanation is that the aggregates used in section 5 had a high affinity for moisture.

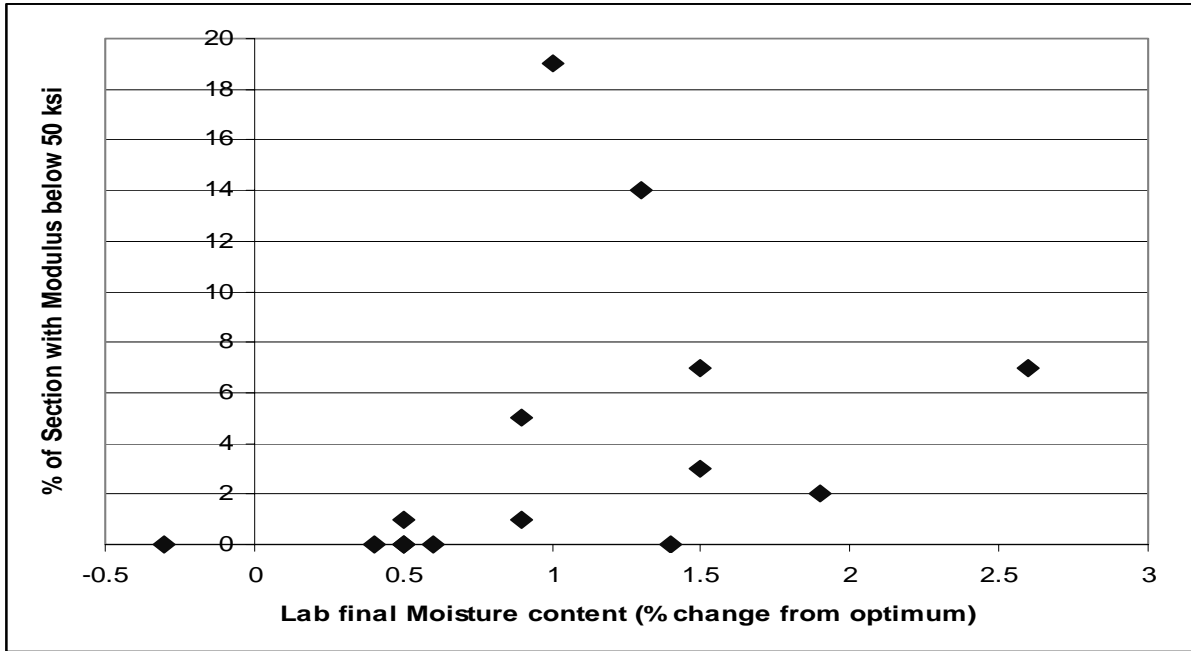
Figure 26. Percentage of Section with Backcalculated Modulus less than 50 ksi against Moisture Susceptibility of Base (Increase in Moisture Content in % above Optimum after 10 Day Capillary Rise).

It is also noted that all of the bases on high-volume roadways (sections 2, 6, 12, 15, and 17) had moisture increase on average of 0.4 percent. It seems that this would be a reasonable value to set as design criteria on future high-volume projects.

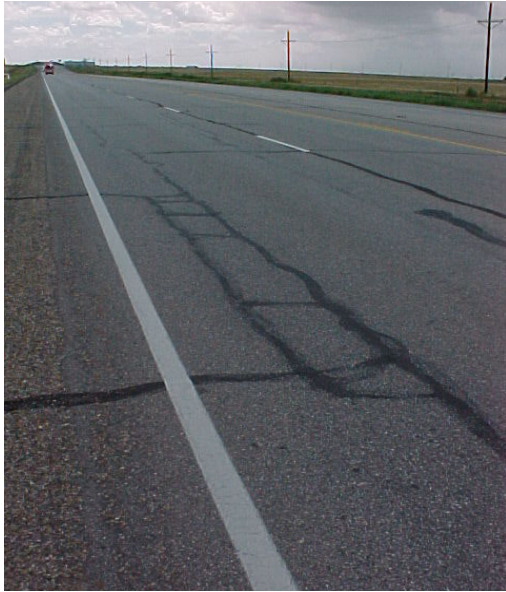
**Figure 27. Loop 335 NB
CTB Structural Damage.**

The Amarillo District has been constructing full depth recycling projects since the early 1990s. The performance of the majority of these sections has been less than satisfactory. The early efforts focused on the use of cement, lime, and fly ash stabilizers. In several instances blends of these stabilizers, for example cement/fly ash, were used. The cement sections were initially designed to have high early compressive strength (TxDOT specifications typically require 7-day strengths of 500 psi). These stiff bases were covered by thin HMA surfacing typically around 2 to 3 inches. All of the cement treated bases (CTB) initially developed a shrinkage crack pattern of transverse cracks at typically 10- to 15-ft intervals. These cracks are not typically a problem if they are sealed and provide good load transfer. However, in Amarillo the preliminary cracks let moisture into the pavement and on high-volume roadways this clearly led to severe structural problems. Examples of these problems are shown in Figures 27 and 28. The secondary distresses were the results of moisture ingress and heavy truck loads leading to structural failure in the wheel paths. The cement treated base on IH 40 was eventually completely replaced with full depth concrete after less than 5 years in service.

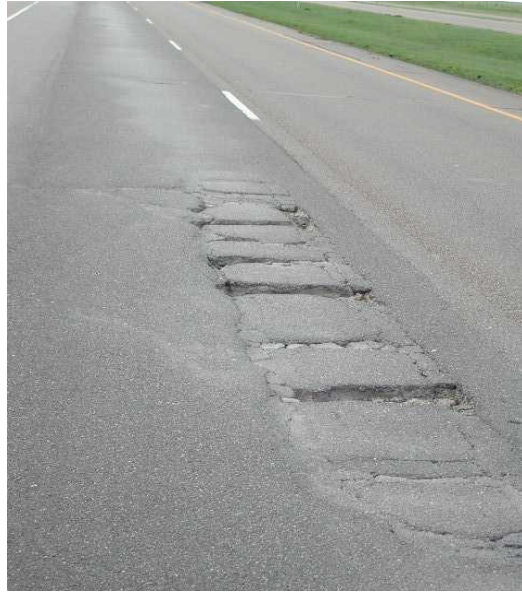
**Figure 28. IH 40 EB
CTB Structural Failure.**

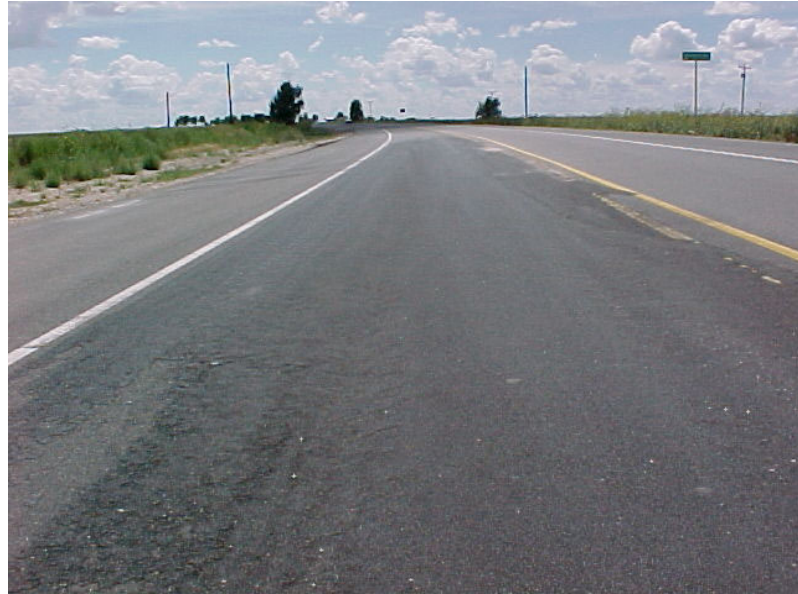
Figure 29. Section 1 SH 207 Hutchinson County – Cement/Fly Ash Base.
Patched area, initial problems relating to slippage between the base and surface.

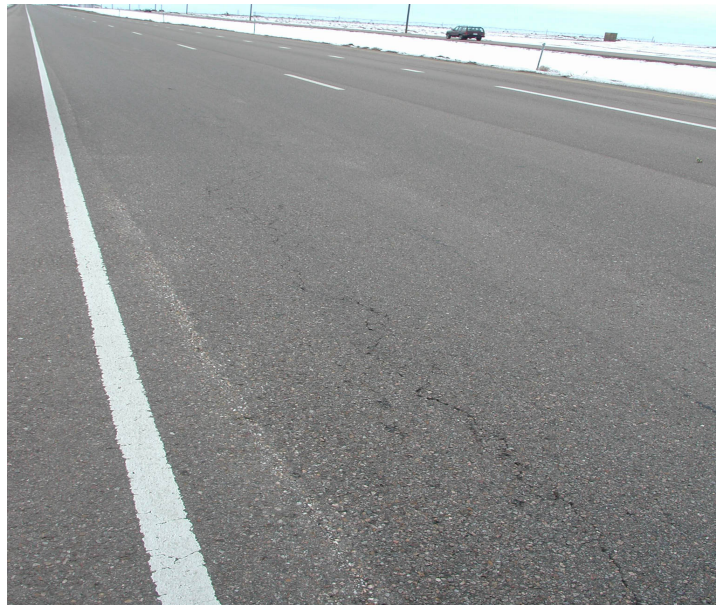
Figure 30. Section 5 US 87 SB Dalhart to Hartley (Last overlay 2 years old).
Emulsion stabilization (2%). FWD indicated that the stabilized layer is weak. Structural damage apparent after 7 years.

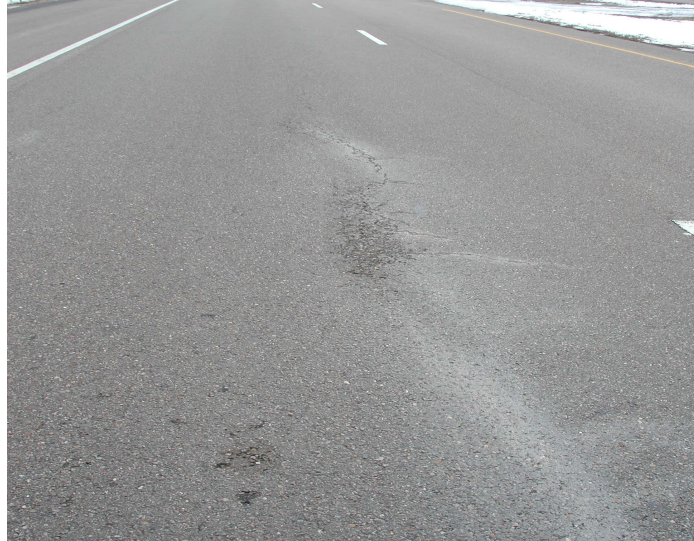
Figure 31. Section 6 US 287 NB Hartley to Dalhart (2 years old).

Eight-inch fly ash treated flexible base with underseal and thin surfacing. Evidence of base pumping several places throughout project. FWD indicated that the base strength was reasonable. Problems assumed to be caused by a lack of bonding of base to surface.

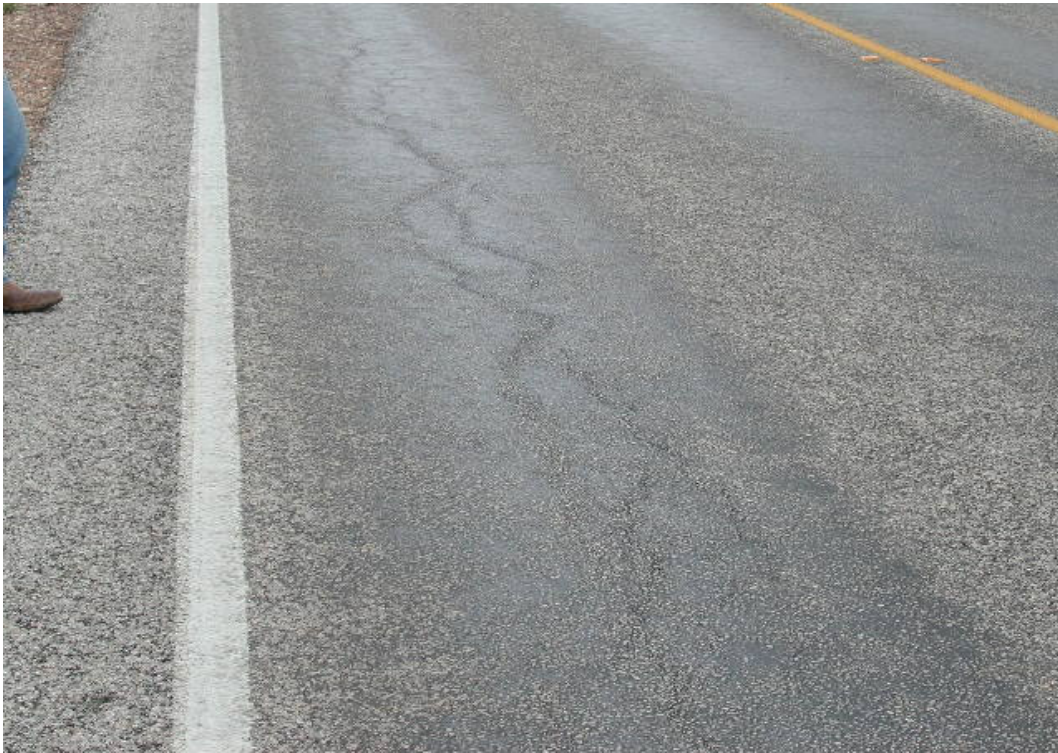
Figure 33. Wheel Path Cracking in the ATB Section.

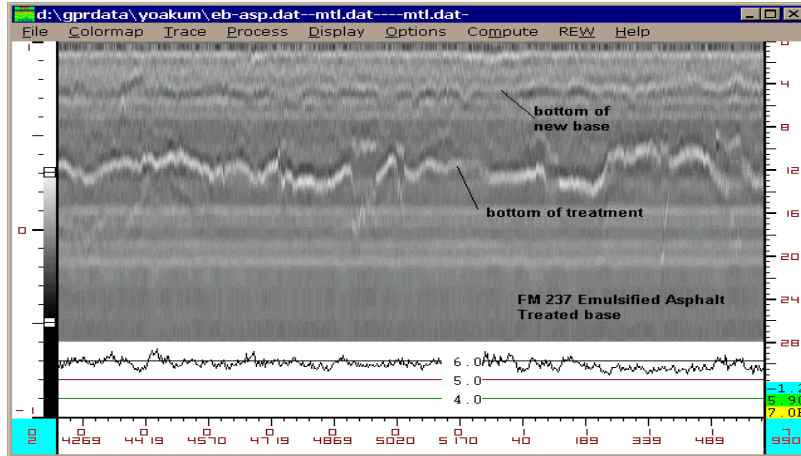
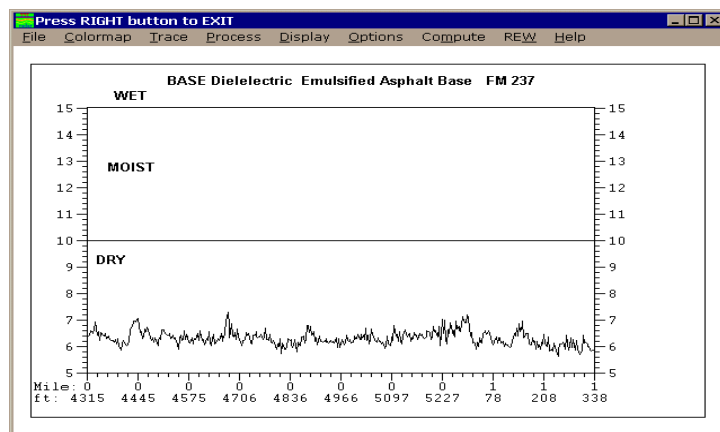
a) COLORMAP Display (All Interfaces Clear).

b) Calculated Layer Thicknesses.

c) Base Dielectric (Indicates Base Is Very Dry, No Moisture Retention Problems).

Figure 36. GPR Data from Emulsified Asphalt Base Section on FM 237.

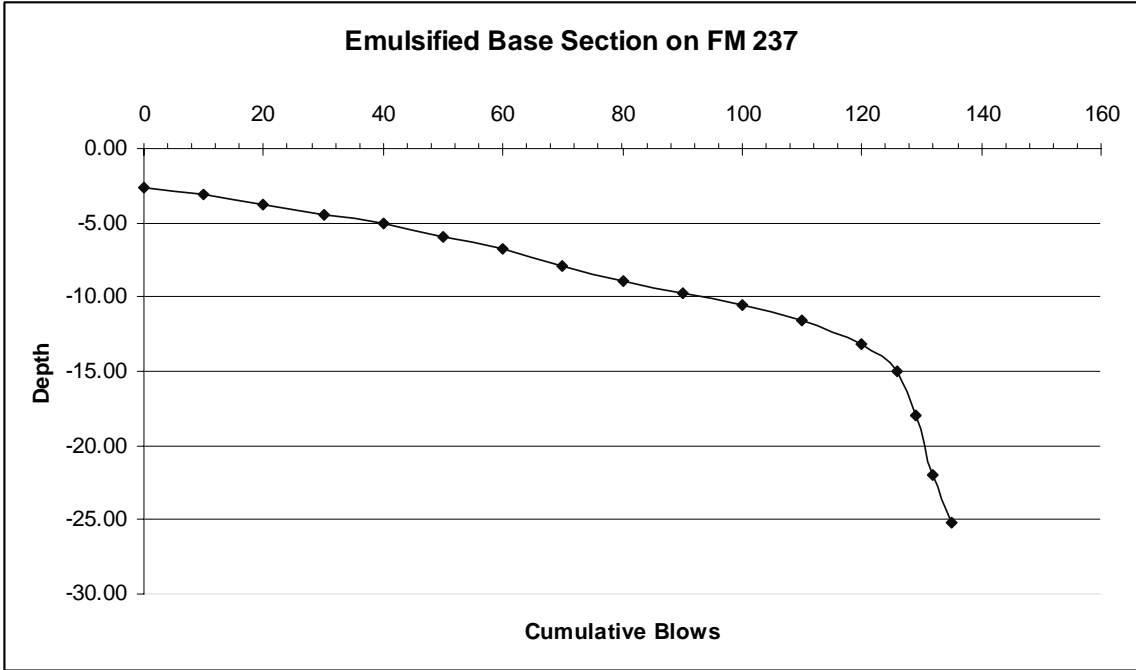
Figure 37. Dynamic Cone Penetration Data from FM 237.

The dynamic cone penetrometer confirmed that the ATB has similar properties to that of a good flexible base. One set of data is shown in [Figure 37](#). It was relatively easy to penetrate with penetration rates of 2.3 and 3.1 mm/blow. This translates to a California Bearing Ratio (CBR) value of 114 and 82, both typical of Texas Triaxial Class 1 material. Dynamic cone penetrometer data were obtained for one test location in the eastbound direction. The graph shows the rate of penetration through each layer in the pavement structure. Significant changes in slope indicate a transition into another layer. The faster the penetration, the weaker the layer. Changes in slope were detected at approximately 11 and 15 inches beneath the surface. Using standard equations the penetration rate can be converted into CBR and resilient modulus values. For the ATB at this location the average slope was 2.3 mm/blow, which computes to a CBR value of 114 and a resilient modulus of 52 ksi. (This 52 ksi is in the ballpark of the values computed later from the FWD data.)

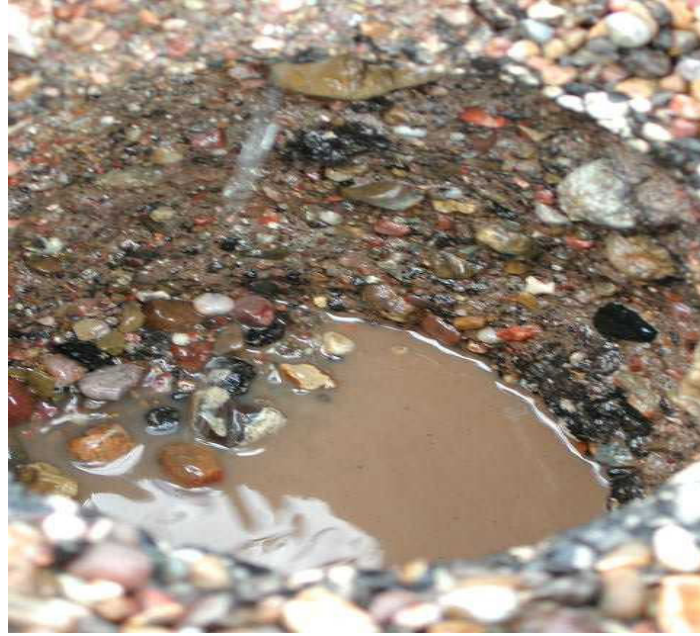
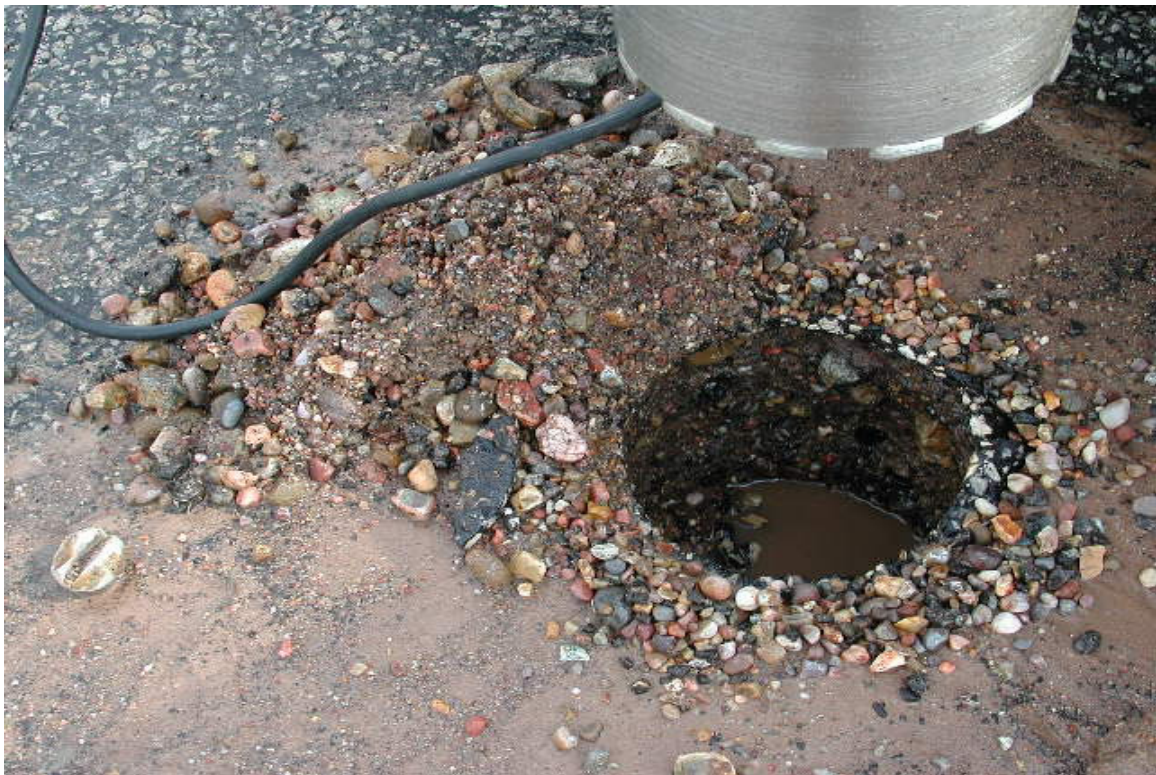
Figure 38. Coring Emulsified Base (No Evidence of Base Stabilization).

Figure 38 shows photographs obtained during the coring operation. The ATB totally disintegrated and from down-hole observations it did not appear that the asphalt had coated many of the aggregates. It was very difficult to see any evidence of asphalt treatment. More asphalt is probably needed to coat this material.

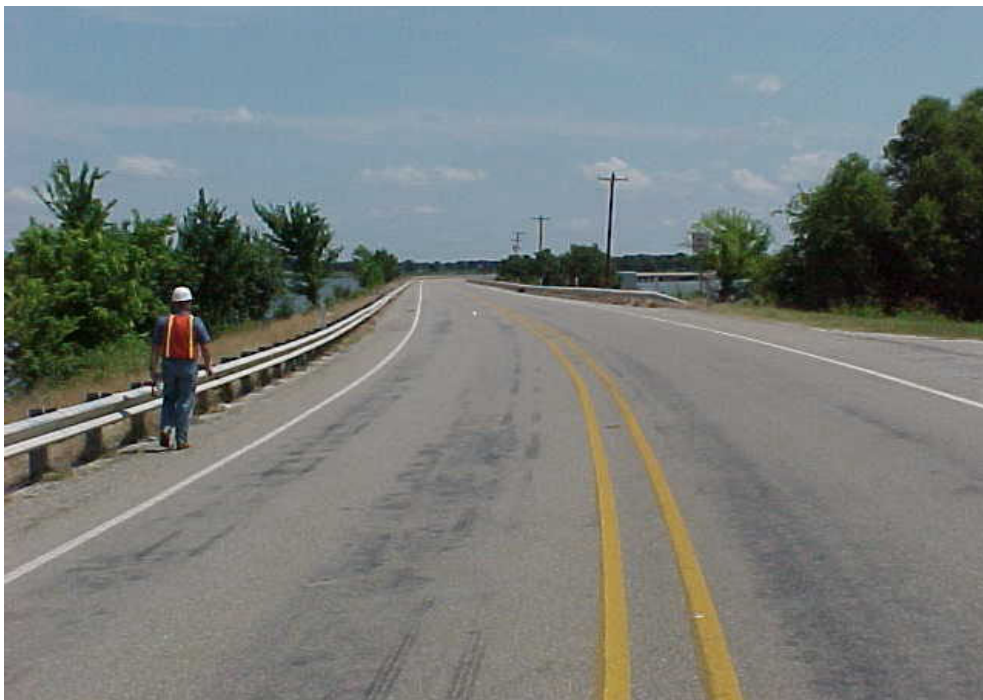
Figure 39. View of Sections 1, 2, and 3 in June 2002.

One of the district's main objectives was to determine if the fly ash by-product could be used successfully to replace the traditional crushed limestone. The construction sequence and preliminary observations were provided in a TxDOT technical report "Demonstration Project Report on the Use of Fly Ash Base" (Kennedy, 2000). A view of the completed section is shown in Figure 39.

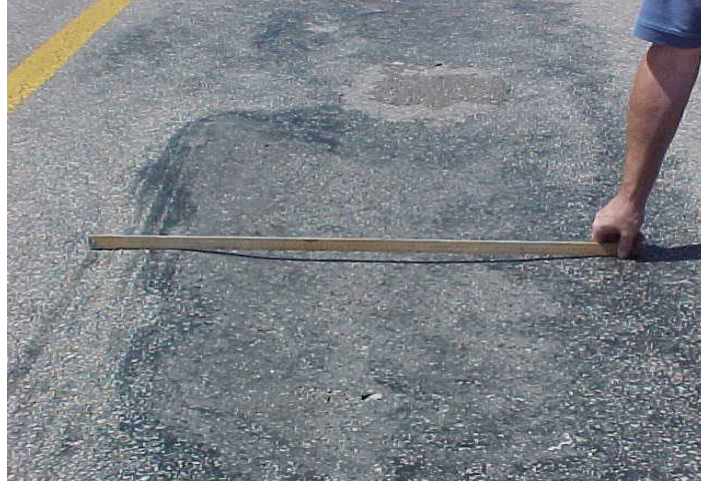
a) Section 1 Roadbond Treated

Figure 40. Typical Distresses on FM 3371.

From the visual inspections two of the four sections appear to be experiencing structural base failures. Photographs of typical distress patterns are shown in [Figure 40](#). The Roadbond section is experiencing localized rutting in the inside wheel path at several locations. The most severe structural problems are in the fly ash base section; these would be classified as base failures using TxDOT standard distress classifications. Both the control section and the cement stabilized section show no major distresses. However, in the cement stabilized section a few localized areas of block cracking were observed. There were no distresses in the control section.

Section	Treatment	Max Average Deflection (mil)	Average Base Modulus (ksi)	Design Base Modulus *(ksi)	% of Base Modulus below 50 ksi
1	Roadbond	37.1	45	20	58
2	Control	19.1	110	83	0
3	Cement	10.5	659	470	0
4	Fly Ash	36.5	39	21	71

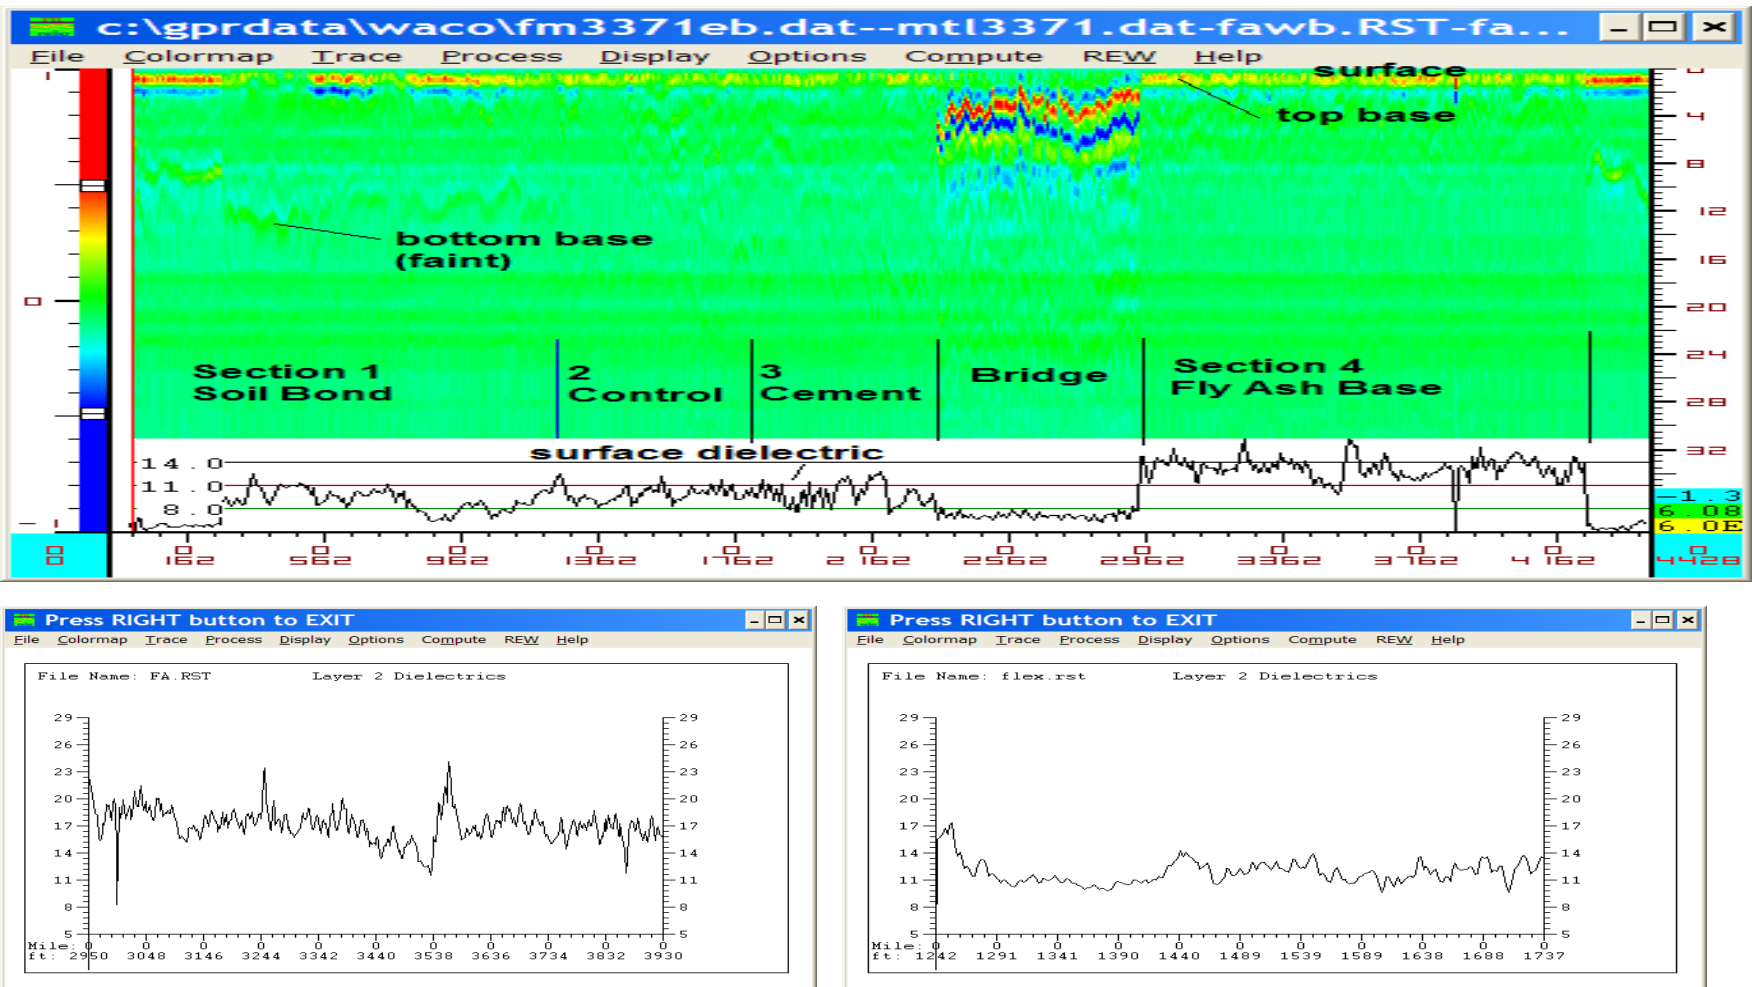
Figure 41. GPR Data from FM 3371.

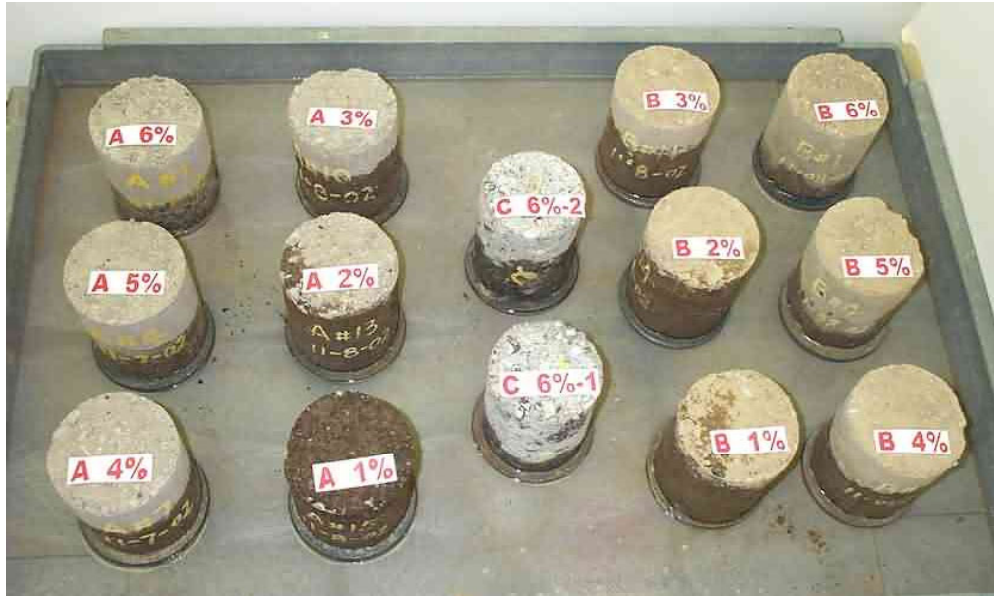
Figure 46. TST Setup for Stabilized Base Idaho Samples.

environmental loading (Scullion and Saarenketo, 1997). This test has recently been adapted as an indicator of stabilized base durability. When running the test the stabilized samples stand in a water bath as shown in Figure 46. The moisture susceptibility ranking is based on the final surface dielectric values of compacted specimens after a 10-day capillary soak.

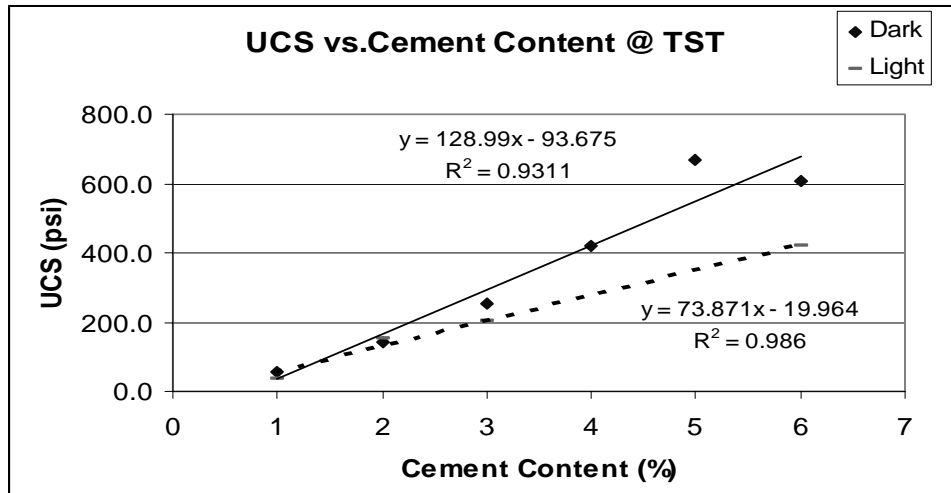
Figure 48. Effect of TST on UCS.

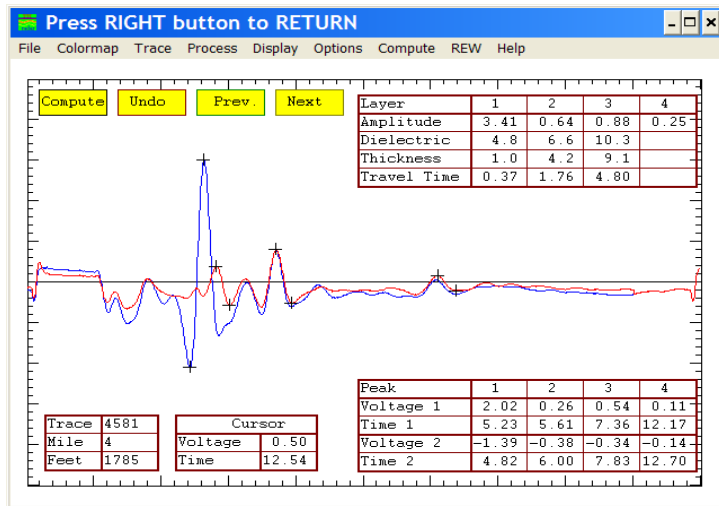
Figure B4. GPR Data from Section 2, Amarillo.
