1. Report No. FHWA/TX-03/4182-1		2. Government Accession No.		3. Recipient's Catalog No.	
4. Title and Subtitle FIELD PERFORMANCE AND DESIGN RECOMMENDATIONS FOR FULL DEPTH RECYCLING IN TEXAS				5. Report Date March 2003

**FIELD PERFORMANCE AND DESIGN RECOMMENDATIONS FOR
FULL DEPTH RECYCLING IN TEXAS**

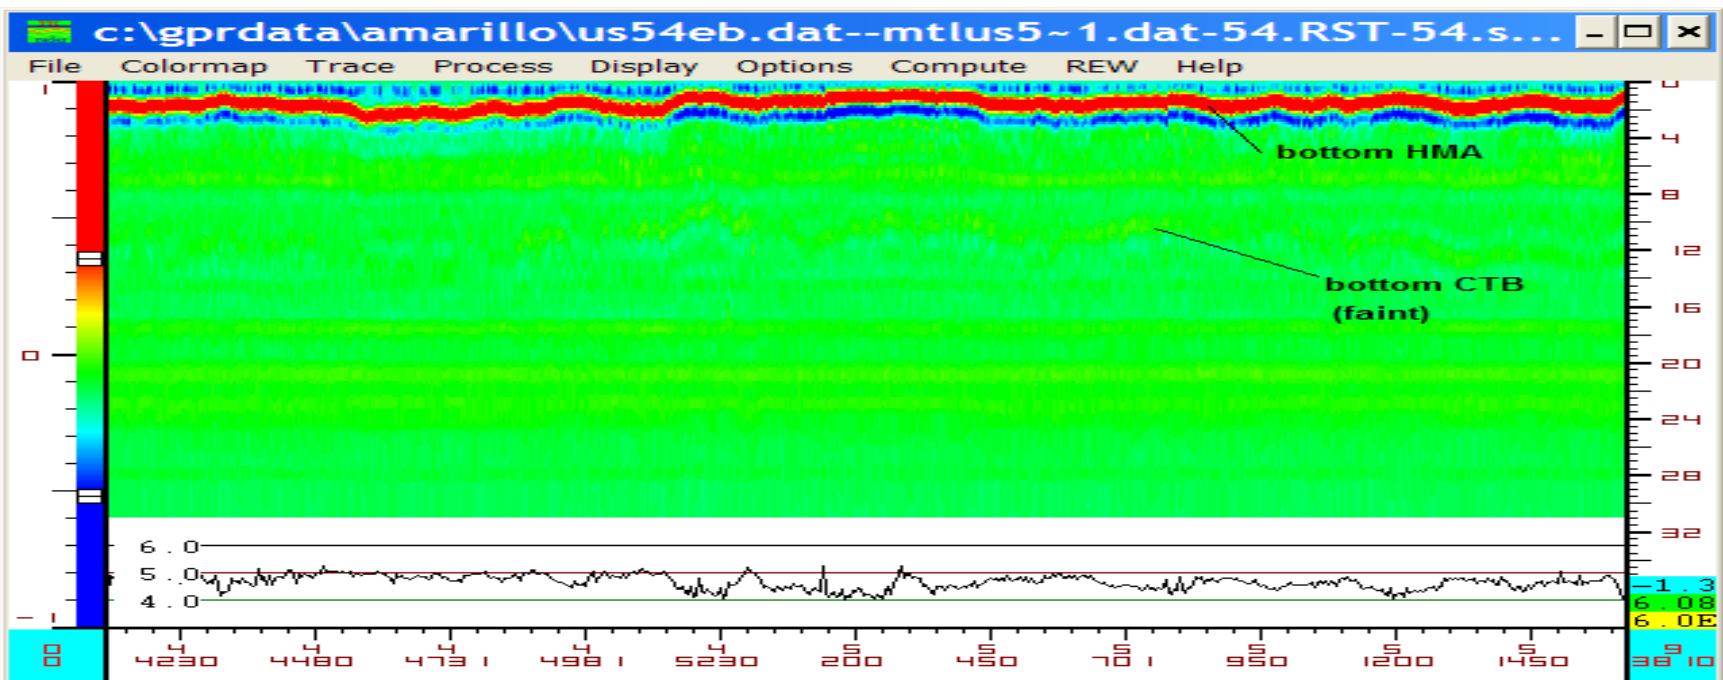
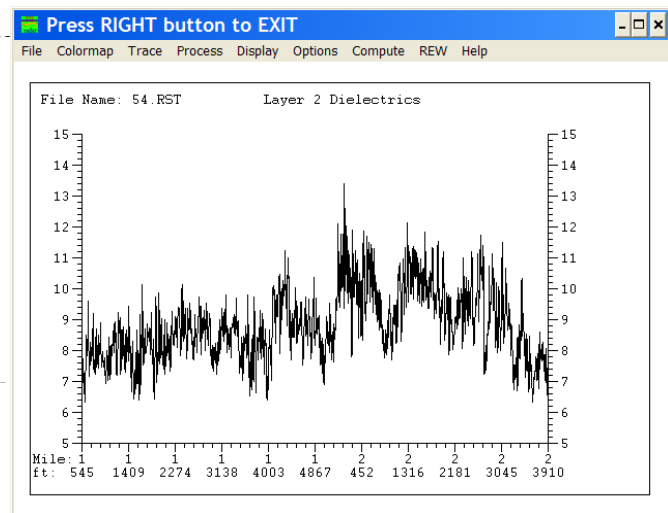
Figure B8. GPR Data from Section 4, Amarillo. No defects apparent in data.

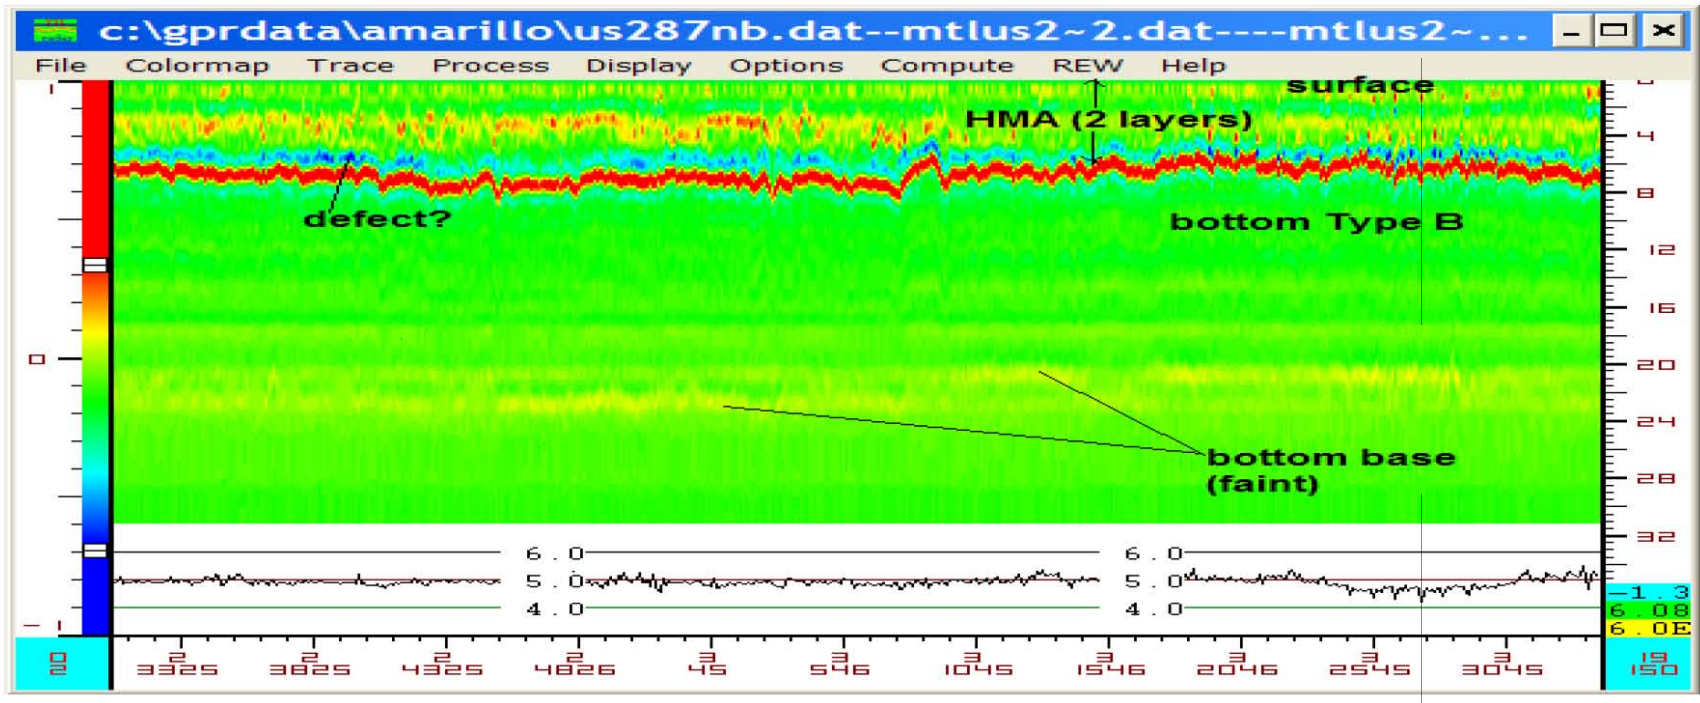
Figure B13. GPR Data from Section 7, Amarillo.
No problems in GPR data, both top and bottom of base can be located.

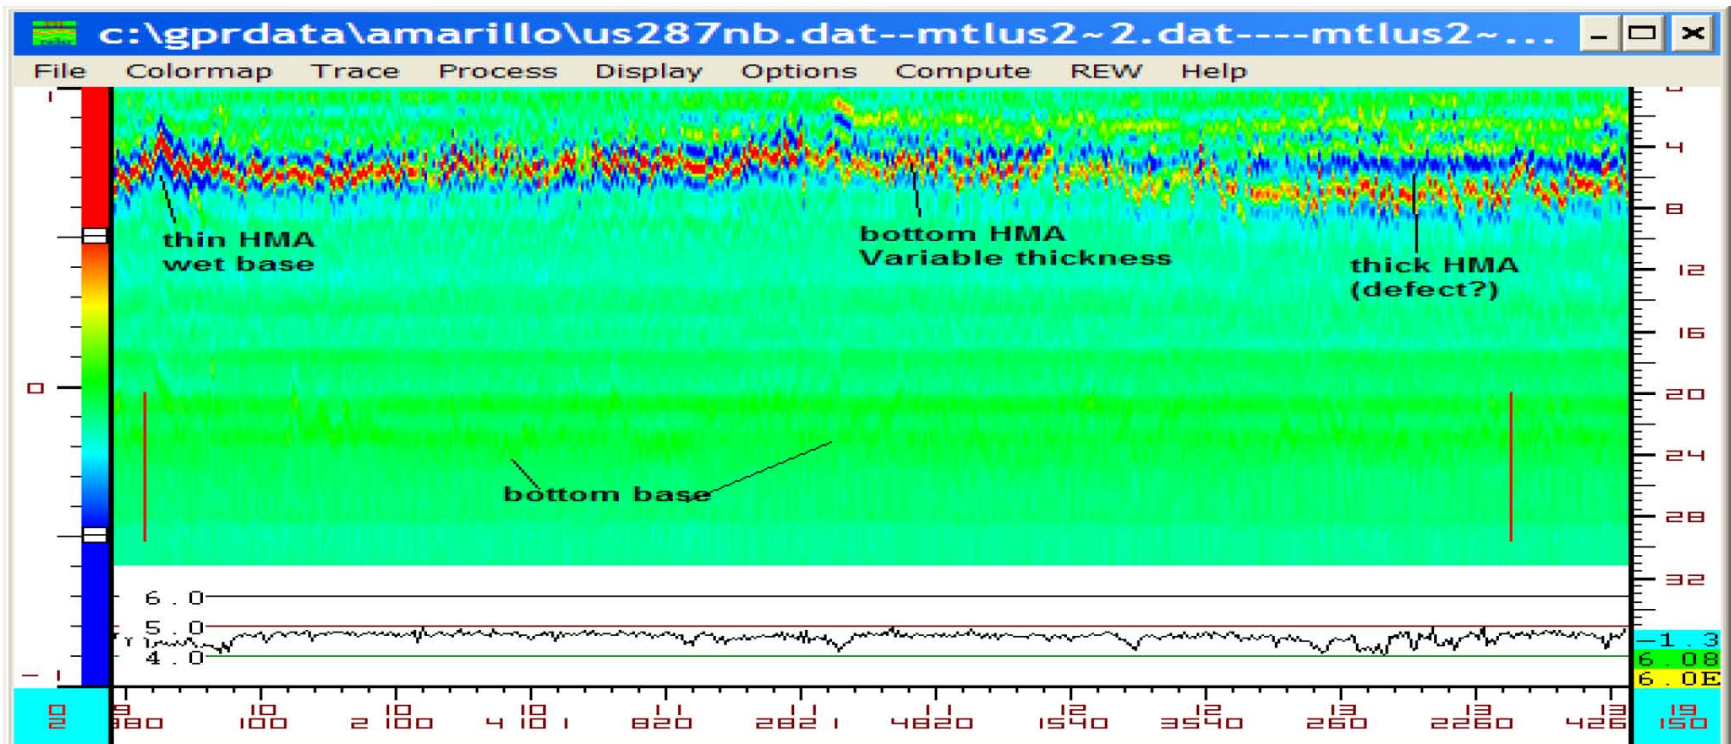
Figure B15. GPR Data from Section 8, Amarillo. Base looks good. In this area there is a concern about the lower Type B layer. The blue interface could be areas of low density or segregated mix.
