1. Report No. FHWA/TX-08/5-4084-01-1		2. Government Accession No.		3. Recipient's Catalog No.	
4. Title and Subtitle APPLYING TECHNIQUES TO INCREASE WARNING OF SIGNALS BEYOND VERTICAL CURVES				5. Report Date September 2007 Published October 2007

# **APPLYING TECHNIQUES TO INCREASE WARNING OF SIGNALS BEYOND VERTICAL CURVES**

Report 5-4084-01-1  
Project 5-4084-01  
Project Title: Improving Driver Awareness  
of Signals Beyond Vertical Curves

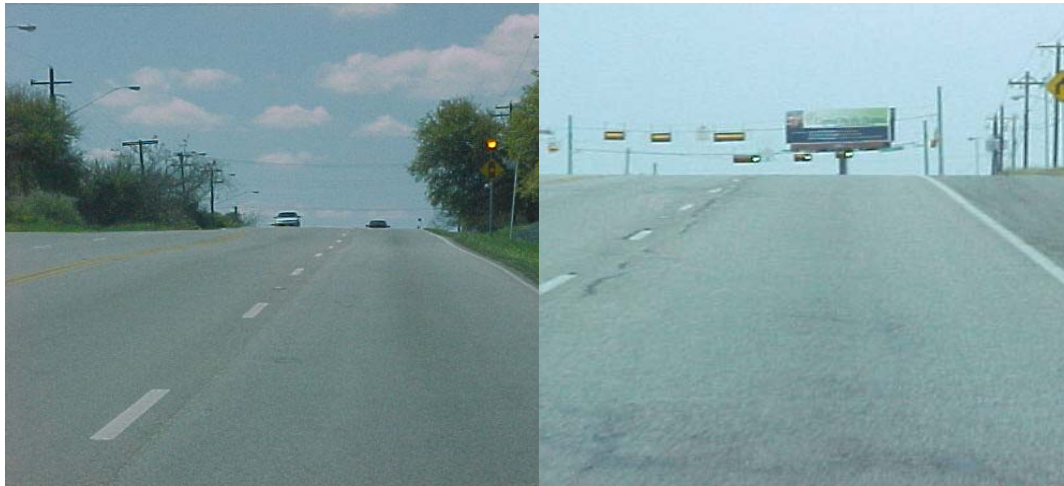
**Figure 1. Reduced Sight Distance at Signalized Intersections near Vertical Curves.**

Over the course of project 0-4084, researchers analyzed the range of vertical profile geometric conditions that could exist along a roadway approach to a traffic signal. The situation of most interest to researchers for this investigation was that depicted in Figure 1, wherein approaching motorists cannot see either the signal (a) or the queue from the signal (b).

Along the entire length of any roadway, geometric design principles ensure that stopping sight distance (SSD) is available to the motorist. SSD is the distance a driver would need to perceive an unexpected hazard (such as an object) in the road, react to the situation by pressing the brake, and stop the vehicle before reaching the hazard. Additional distance, known as decision sight distance (DSD), is required where the driver must perceive the need to change speed or path (i.e., lane change) and execute the appropriate action upstream of an intersection or decision point. Since intersections involve both a potential stop situation and decision-making regarding their route, longer sight distances (such as DSD) are desired.

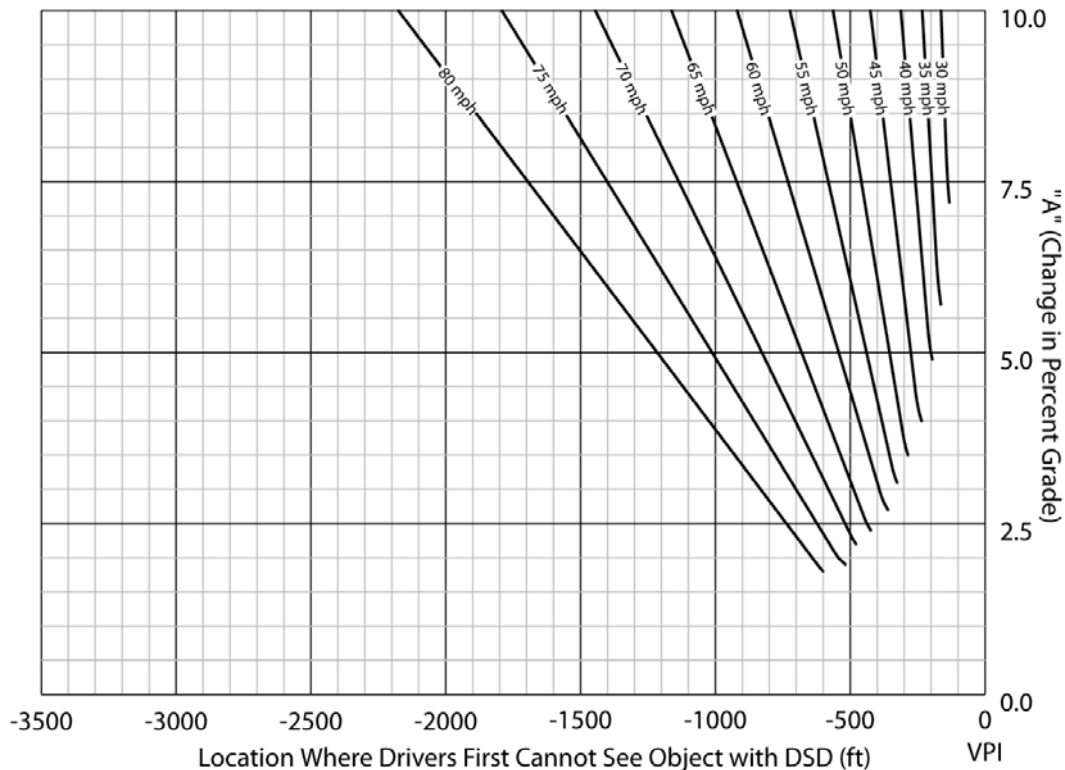
**Figure 5. Countermeasure Placement Location for Rural Roadway Applications.**

The researchers emphasized that in all cases, the RDZ definition and advanced warning sign locations are recommended as a supplement to the information contained in the TMUTCD. The guidelines developed under project 0-4084 apply only to the supplemental BE PREPARED TO STOP signing. The TMUTCD stipulates that BE PREPARED TO STOP signs only be used at locations where SIGNAL AHEAD signing is also used, and that the BE PREPARED TO STOP signing is intended for situations where the driver needs additional warning about stopped or queued traffic near traffic signals where queues occur regularly. Also, flashing beacons may be used to supplement the BE PREPARED TO STOP warning sign. In situations where the flashing beacons are connected with the traffic signal, the TMUTCD encourages (though does not require) the use of a WHEN FLASHING plaque.

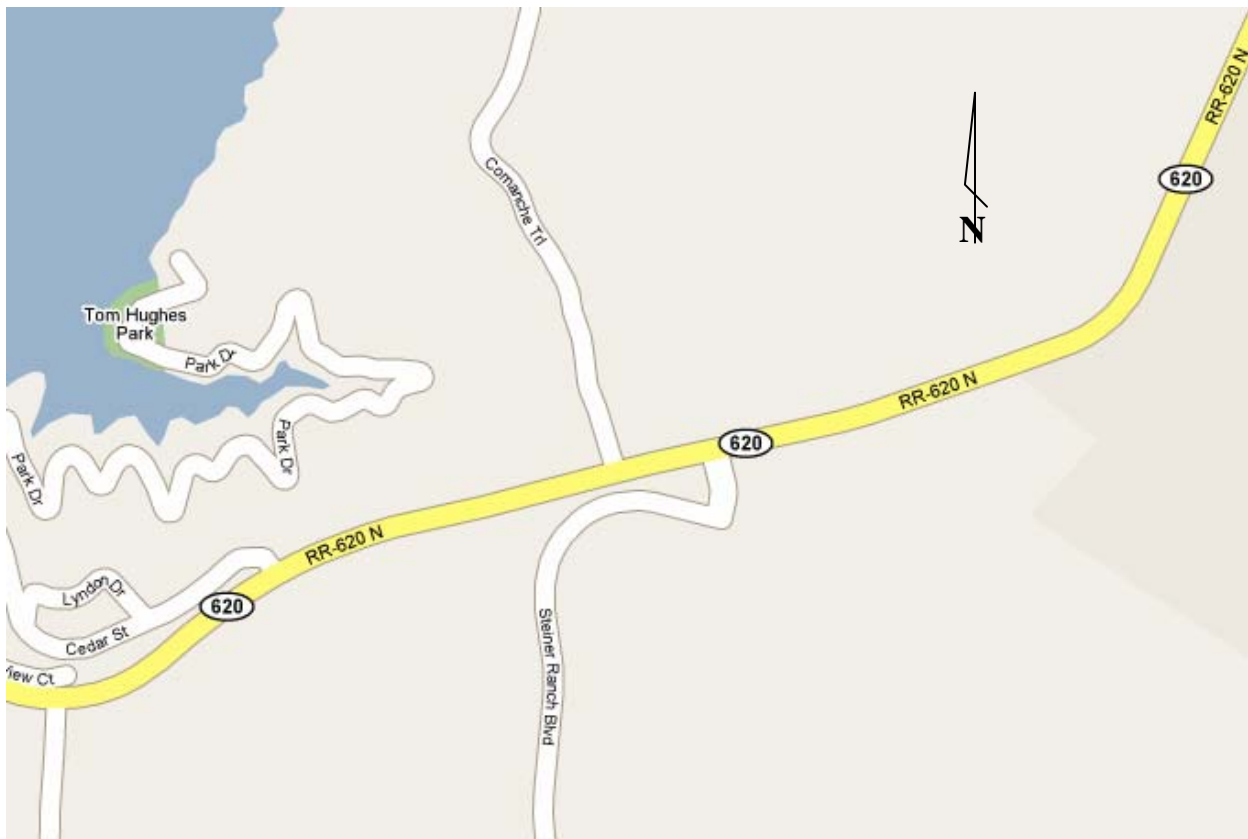
**Figure 6. RM 620/Comanche Trail Junction in Austin, Texas (6).**

RM 620 is a circumferential route around western Austin, Texas. Due to the hilly terrain west of Austin, roadways in the region frequently feature vertical curves and sometimes form intersections with crossing roadways at non-ideal locations either on hillsides or between hills. One such location is the junction of RM 620 and Comanche Trail, which is east of Lake Travis and is located just west of a hilly ridge (Figure 6). Westbound traffic cannot easily see the intersection due to the crest vertical curve formed as the roadway passes over the ridge (see Figure 6). Average annual daily traffic (AADT) on RM 620 near this intersection is approximately 27,000 vehicles per day according to 2005 data from TxDOT's Transportation Planning and Programming Division (5). Figure 7 contains photographs along the westbound RM 620 approach to Comanche Trail as a vehicle approaches the intersection.

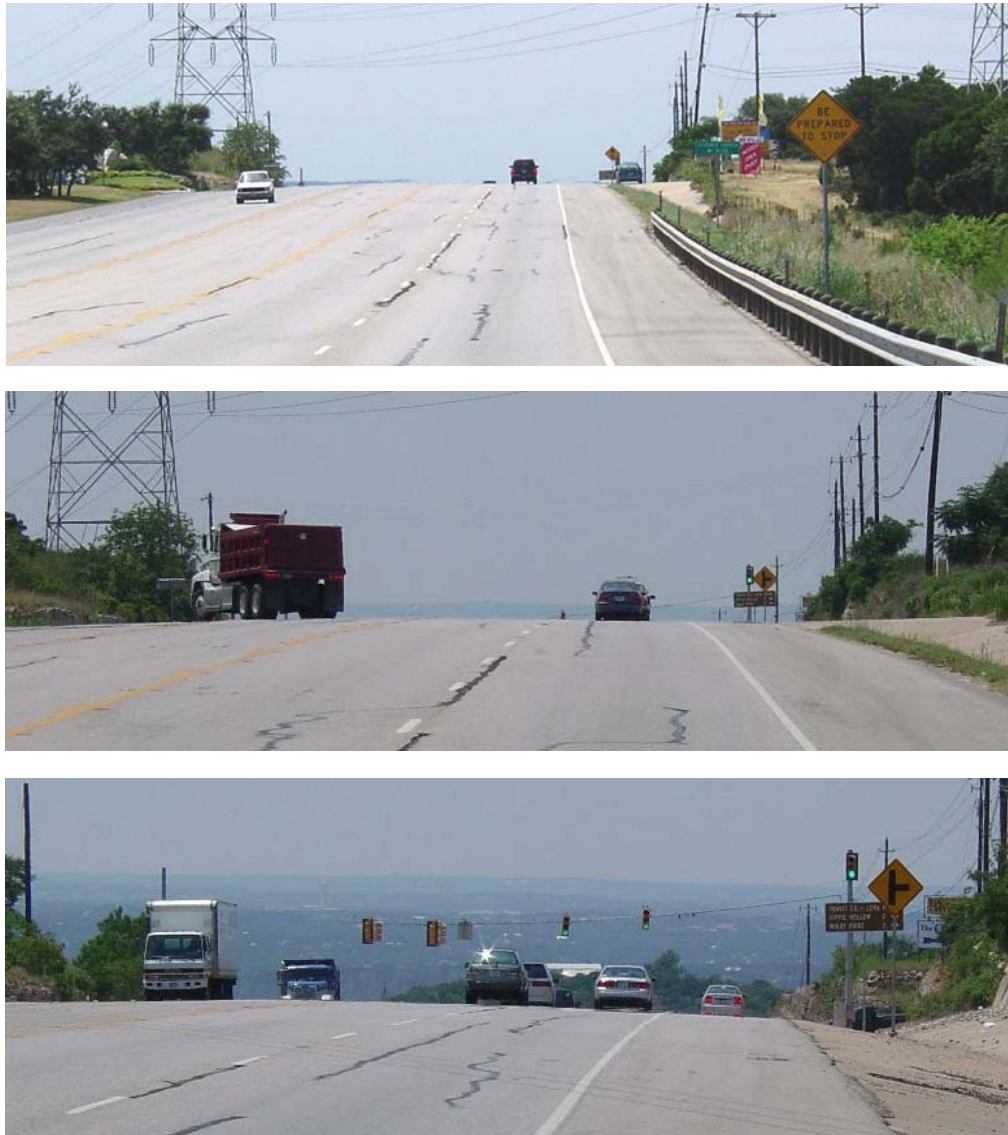
**Figure 7. Westbound RM 620 Approaching Comanche Trail.**

This site was previously a study site for the original 0-4084 research project and already featured the recommended BE PREPARED TO STOP sign (see top frame, Figure 7) at a location between the project 0-4084 recommended distances for urban and rural conditions. The current implementation project upgraded this installation from a static sign to one supplemented by active flashers, and located the sign closer to the signalized intersection to bring the location in better compliance with the rural sign location curves (Figure 5) recommended by project 0-4084.

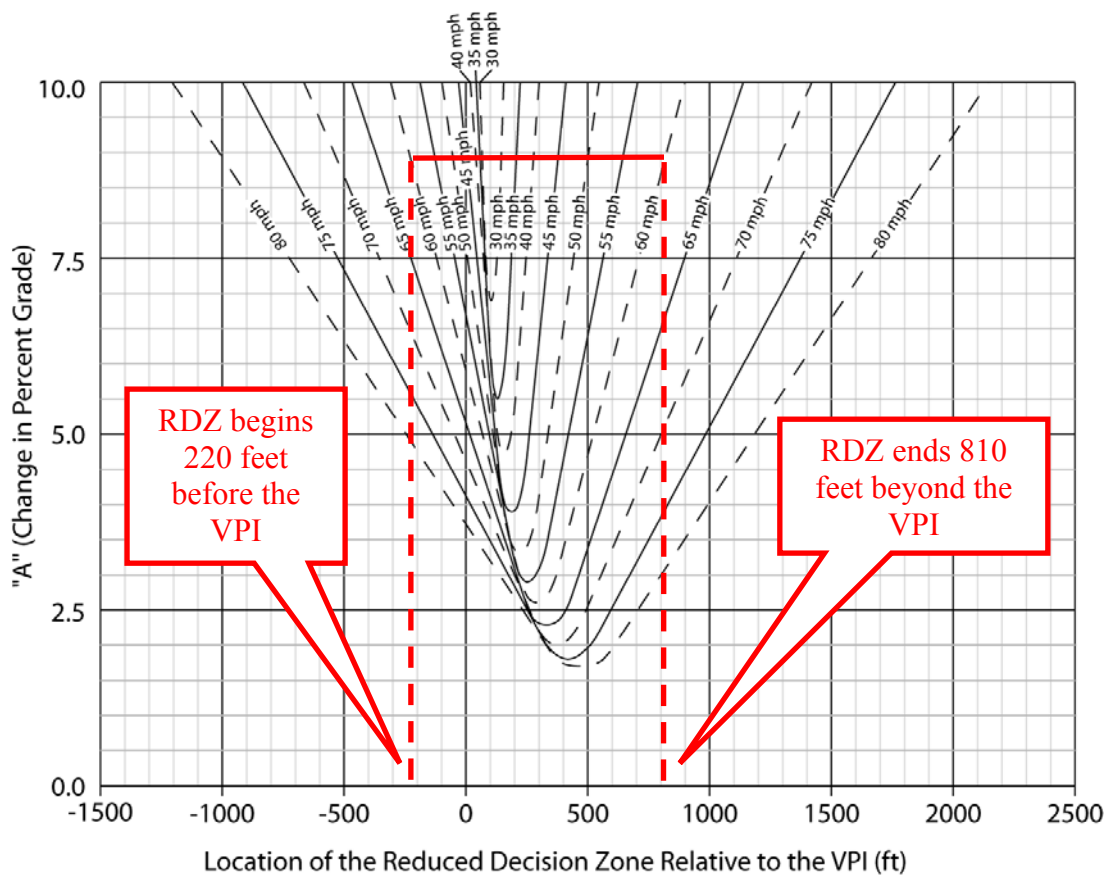
**Figure 8. Project 0-4084 Rural Curves for Identifying the RDZ.**

Note that the supplemental BE PREPARED TO STOP sign's current location is roughly midway between the urban and rural locations recommended in the guidelines of project 0-4084. However, since the sign foundation and support had to be completely changed for the addition of the solar powered flashing assembly, the new sign was installed 450 feet closer to the intersection at the location specified by the rural curve in the project 0-4084 guidelines.

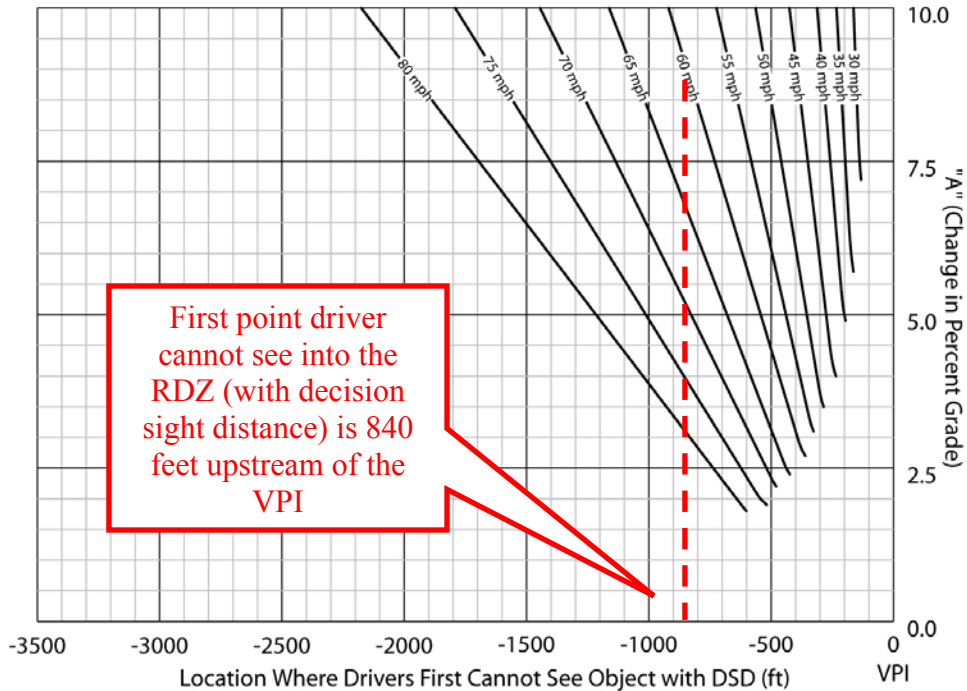
**Figure 9. Project 0-4084 Rural Curves for Locating the Supplemental Warning Sign.**  
*(Note: Sign location is actually 175 feet (the sign legibility distance) closer to VPI)*

The design plans revealed that the vertical curve preceding the signal on westbound RM 620 was created by a slight uphill grade of 1.17 percent followed by a steep downgrade of 7.69 percent. The vertical point of intersection (VPI) of the grade line tangents for this curve was located approximately 300 feet upstream of the stop bar for westbound RM 620. The algebraic difference in grade for this condition was computed as 8.86 percent. When this information was combined with the speed limit of 60 miles per hour (mph), use of the project 0-4084 curves revealed both the location of the RDZ (see Figure 8), which is from 520 feet upstream of the stop bar to 510 feet beyond the stop bar, and the recommended warning sign location (see Figure 9; driver location at first RDZ visibility point is 1140 feet upstream of the stop bar). Note that a sign legibility distance of 175 feet is subtracted from the driver location in Figure 9 to get the desired sign location, which is 965 feet upstream from the stop bar.

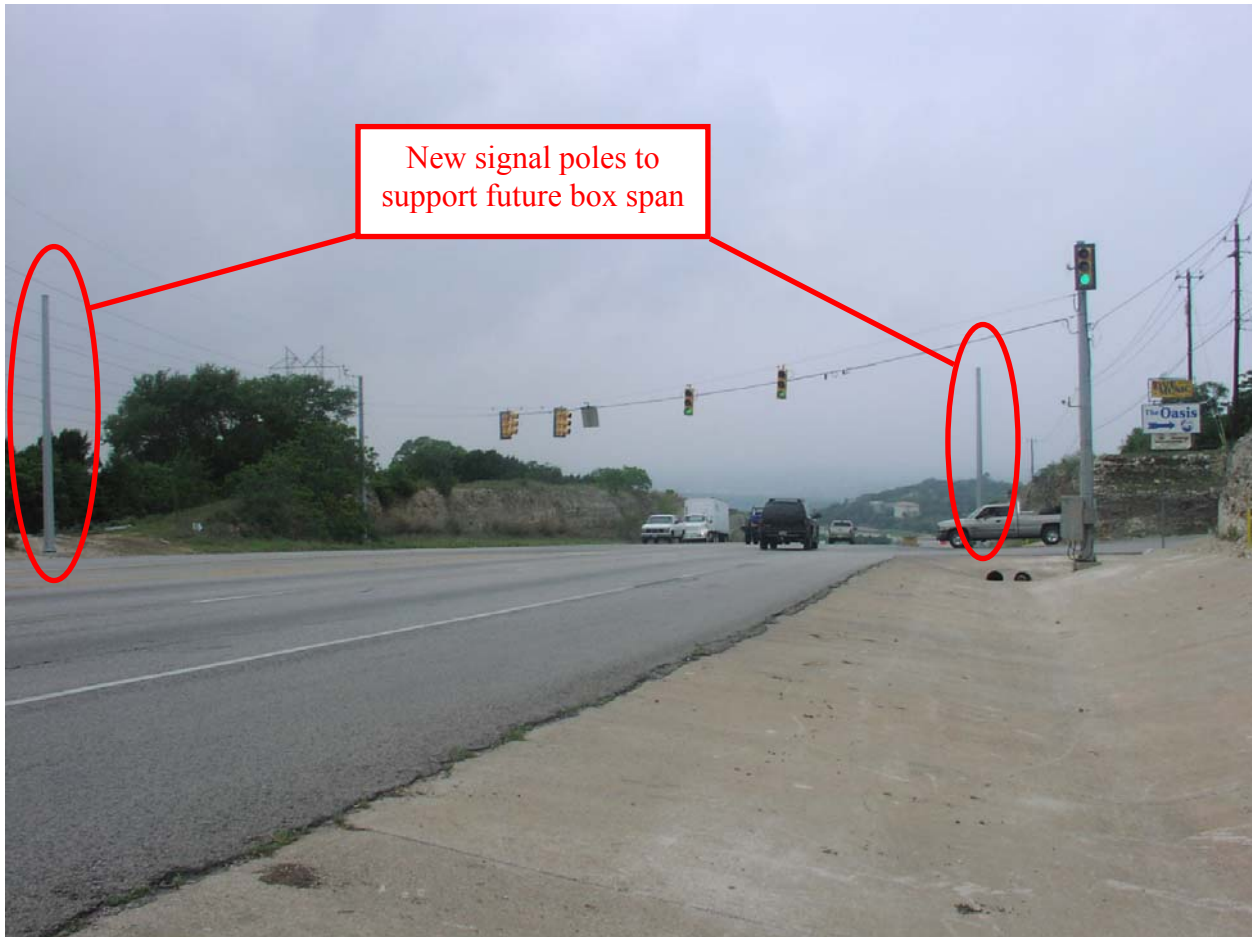
**Figure 10. Westbound Approach to RM 620/Comanche Trail Intersection.**

During the site visit, the intersection of RM 620 and Comanche Trail was in the middle of a signal upgrade project. The existing single diagonal span wire design (see [Figure 10](#)) was being replaced by a box span, which relocated the signal heads for westbound RM 620 traffic slightly to the west, at the western edge of the signalized intersection. Note that the near side supplemental signal head for westbound traffic and the signal pole on which it is mounted remained as components of the new design. Because of the signal upgrade, TTI staff waited until the new signal heads were installed for westbound RM 620 traffic before making clearance/height measurements for these heads.

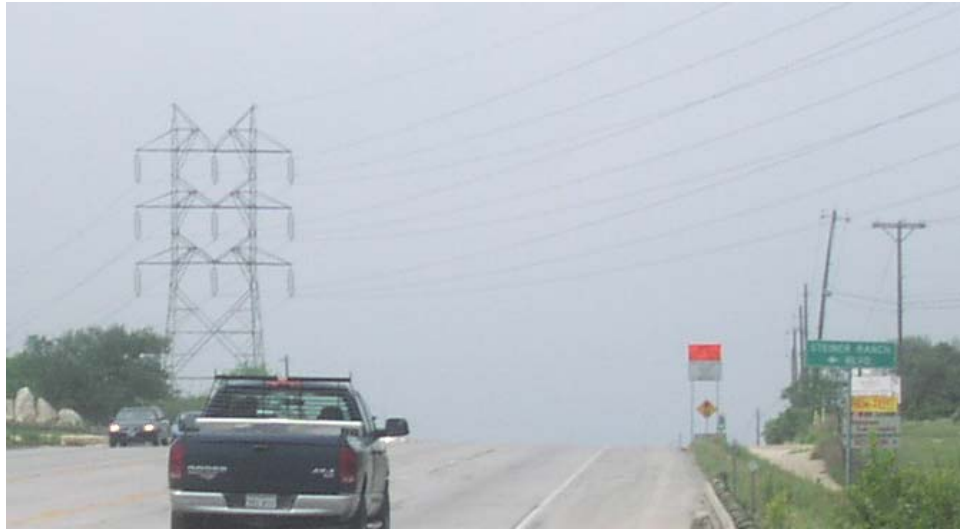
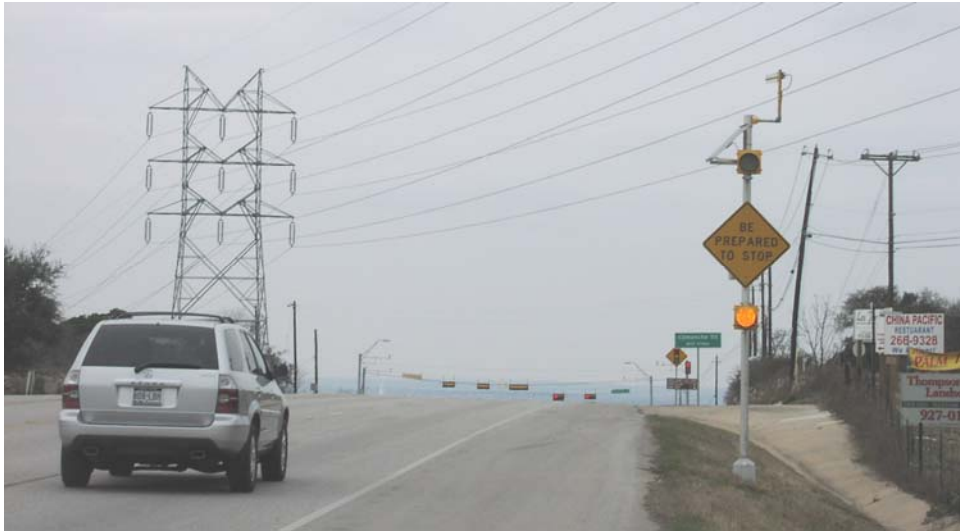
**Figure 11. Before and After Site Conditions on Westbound RM 620 At Comanche Trail.**

As per the research project 0-4084 rural guidelines, the active, supplemental advanced warning signing was located 965 feet upstream of the intersection stop bar. Before and after conditions are compared in Figure 11. The batteries, controller, and radio for the solar powered remote sign are found in a small box behind the warning sign.

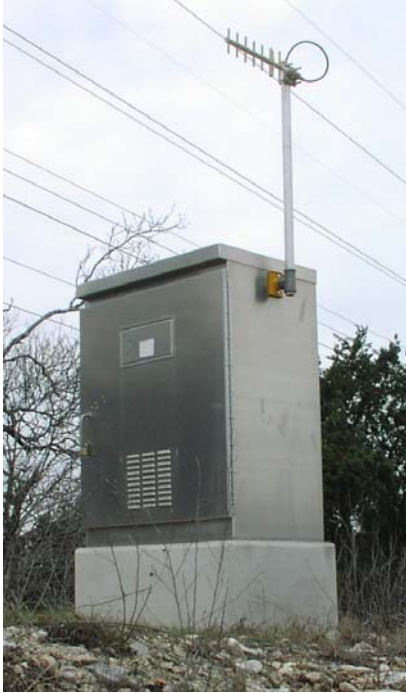
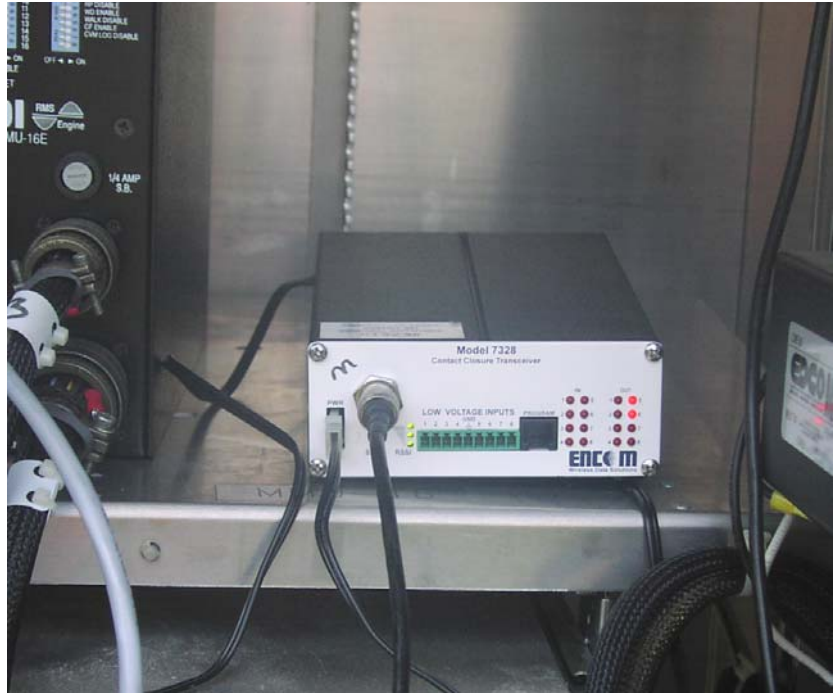
Antenna Mounting

Spread Spectrum Contact Closure Radio

120V Phase 6 Red and Yellow Connection Outputs

Red and Yellow Radio Inputs

**Figure 12. Signal Cabinet Active Flasher Equipment Components.**

All of the signal controller components utilized for the radio connection to the remote sign are shown in [Figure 12](#). Note that the antenna coaxial cable and power connect to the front of the radio unit and the red and yellow wires connected to the load switch (120V) outputs for the westbound through phase (Phase 6) red and yellow indications connect to the back of the radio on the input (bottom) bank. [Figure 13](#) displays all of the active sign components at the remote sign location. Note the red and black connections to the radio from the output (top) bank and these same wires connecting to the remote flasher's traffic control input.

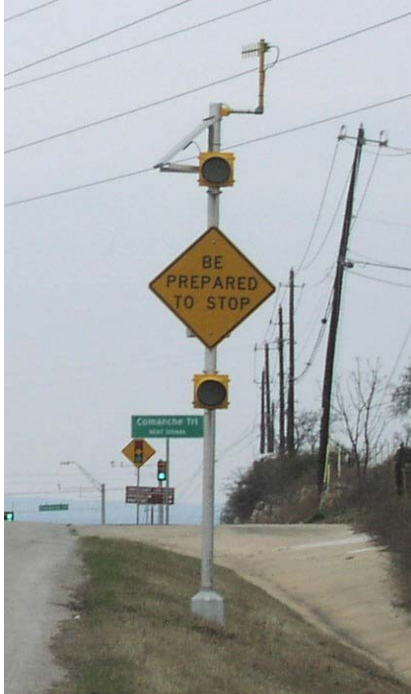
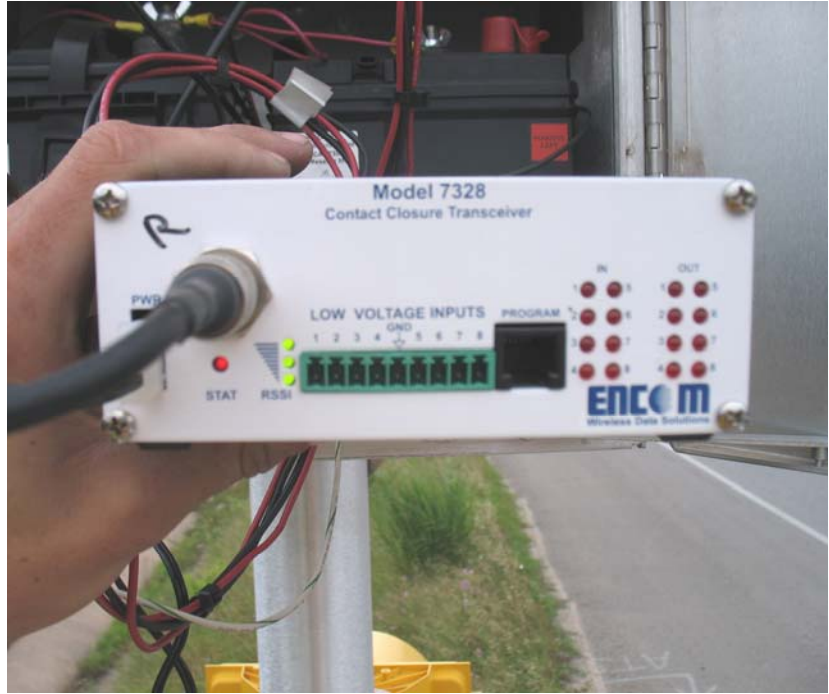
Antenna and Solar Panel

Spread Spectrum Contact Closure Radio

Flash Control Inputs

Radio Outputs for Flash Control

**Figure 13. Remote Active Sign Components.**

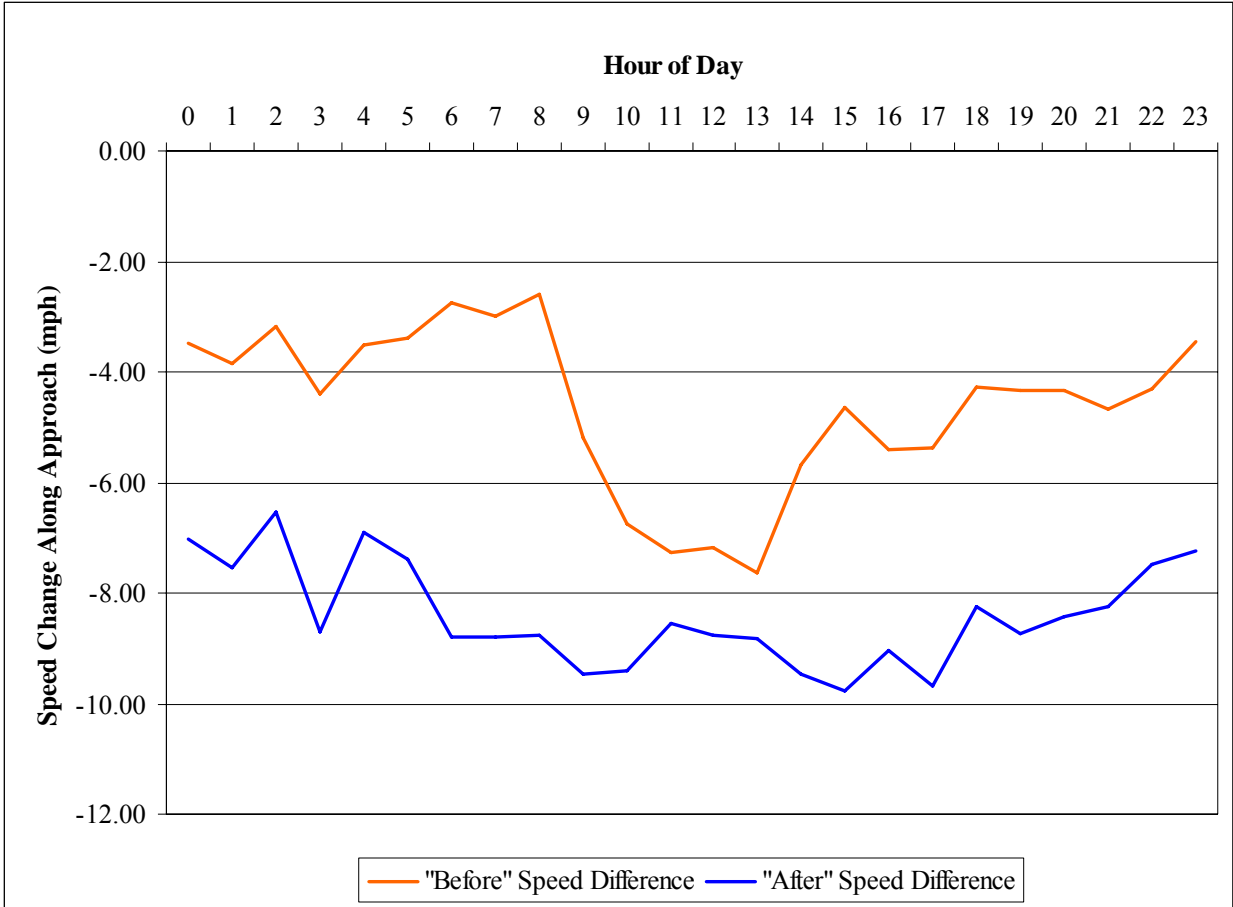
**Figure 14. Speed Change along Westbound RM 620 Approaching Comanche Trail.**

[Figure 14](#) details the changes in speed along the westbound RM 620 approach to Comanche Trail for both before and after conditions. Note when observing the figure that the average speed changes for each hour of the day are represented and that each line of data is the average speed difference of motorists at the sign’s location versus 400 feet downstream of the sign. Before the sign was installed, motorists changed speed (or slowed down) an average of 4.6 mph between the sign’s installation location and a point 400 feet downstream of where the sign would be installed. After sign installation, motorists slowed down an average of 8.4 mph between these same two locations. Notice that the greater average decrease in speed of 3.8 mph (approximately 4 mph) for after conditions occurs across all times of the day, indicating a motorist impact of the sign’s presence under both day- and night-time lighting conditions.

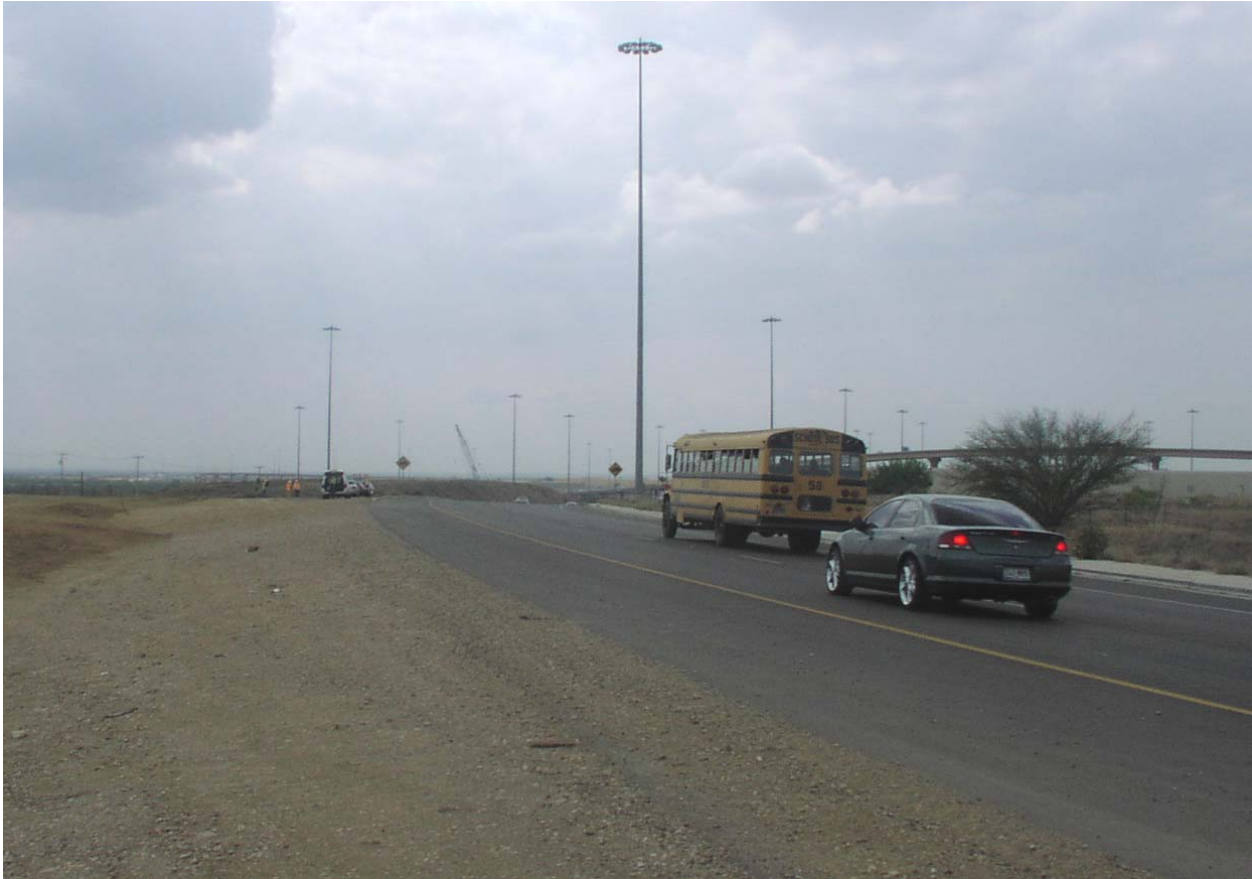
**Figure 16. Westbound Loop 20 Approaching Interstate 35 in Laredo, Texas.**

Figure 16 shows the approach condition that existed before sign implementation. Both vertical and horizontal curves impede approaching motorists’ view of any queue that may be formed downstream. The warning signs to either side of the road indicate trucks ahead, and the junction of the roadway Grand Central with westbound Loop 20 is just past the horizontal curve (see Figure 20). Once drivers pass the vertical and horizontal curves, they are on a downgrade approaching the Loop 20/I-35 interchange (see Figure 19). Note that the railroad overpass bridge further limits motorists’ view of the signals controlling the interchange.

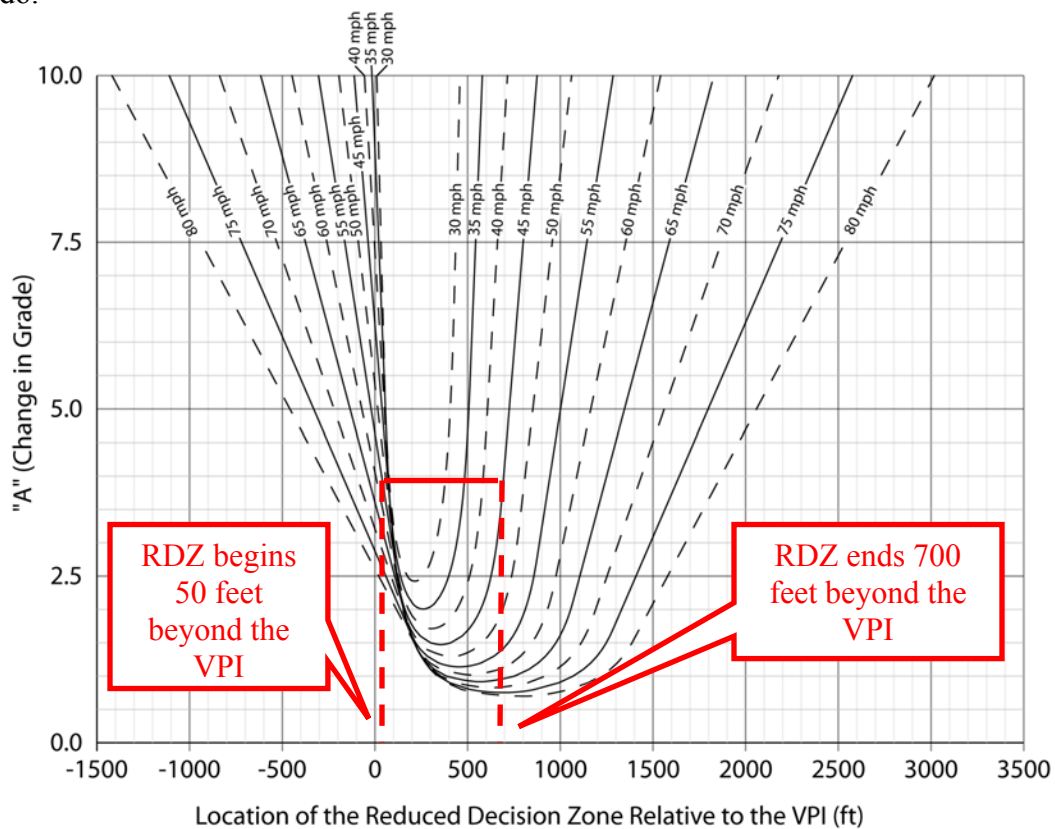
**Figure 17. Project 0-4084 Urban Curves for Identifying the RDZ.**

Cross section, plan, and profile details for the westbound Loop 20 frontage road were provided on engineering design plans for Loop 20 obtained from the TxDOT Laredo District. The plans were developed for TxDOT by consulting firm Brown and Root, and they pertain to Control Section Job 0086-14-023; the plans were dated under professional engineering seal on March 6, 2000. Researchers and TxDOT staff used details from the plans in conjunction with the supplemental advanced warning sign location guidelines from project 0-4084 to determine the RDZ (Figure 17) and the location of the supplemental warning signs themselves (Figure 18). Note that the project 0-4084 urban curves were used since this location is in the urbanized area of Laredo.

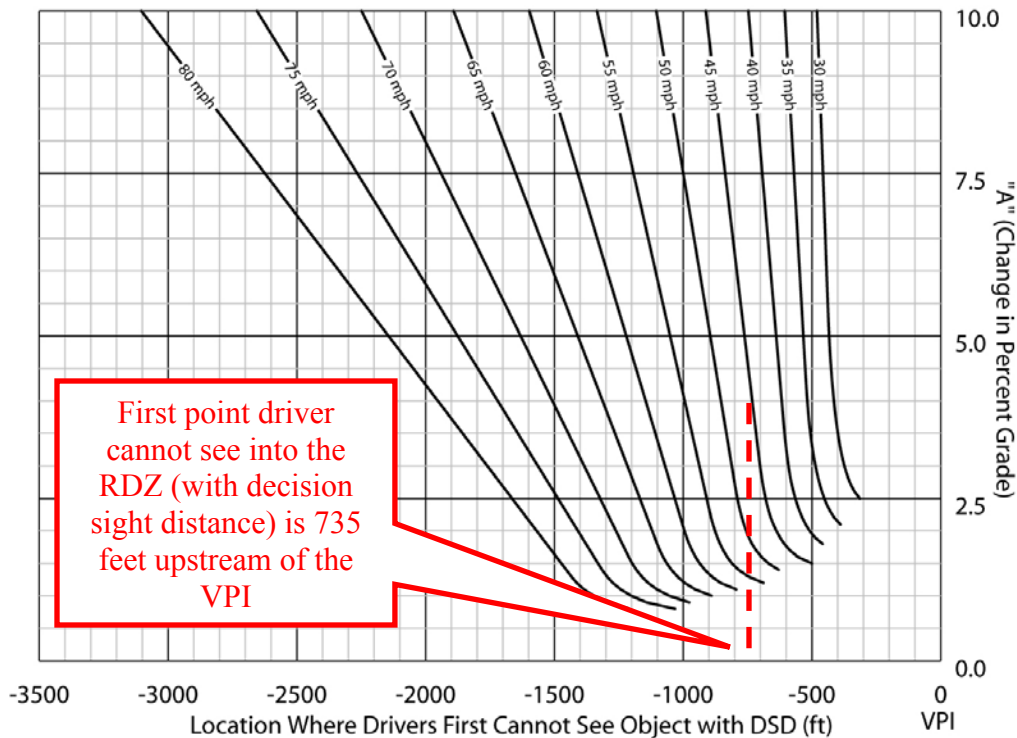
**Figure 18. Project 0-4084 Urban Curves for Locating the Supplemental Warning Sign.**  
*(Note: Sign location is actually 175 feet (the sign legibility distance) closer to VPI)*

The design plans revealed that the vertical curve preceding the signal on westbound Loop 20 was created by a downgrade of 0.61 percent followed by a much steeper downgrade of 4.50 percent. The vertical point of intersection (VPI) of the grade line tangents for this curve was approximately 1900 feet upstream of the stop bar for westbound Loop 20 approaching the I-35 northbound frontage road. The algebraic difference in grade for this condition was computed as 3.89 percent. When researchers combined this information with the speed limit of 45 miles per hour, the project 0-4084 curves revealed that the RDZ exists from 1200 to 1850 feet upstream from the stop bar, and the recommended supplemental advanced warning sign location is 2460 feet upstream of the stop bar. Note that a sign legibility distance of 175 feet is subtracted from the driver location of 2635 feet (VPI location of 1900 feet upstream of the stop bar plus driver location 735 feet upstream of VPI) in Figure 18 to get the desired sign location, which is 2460 feet upstream from the stop bar.

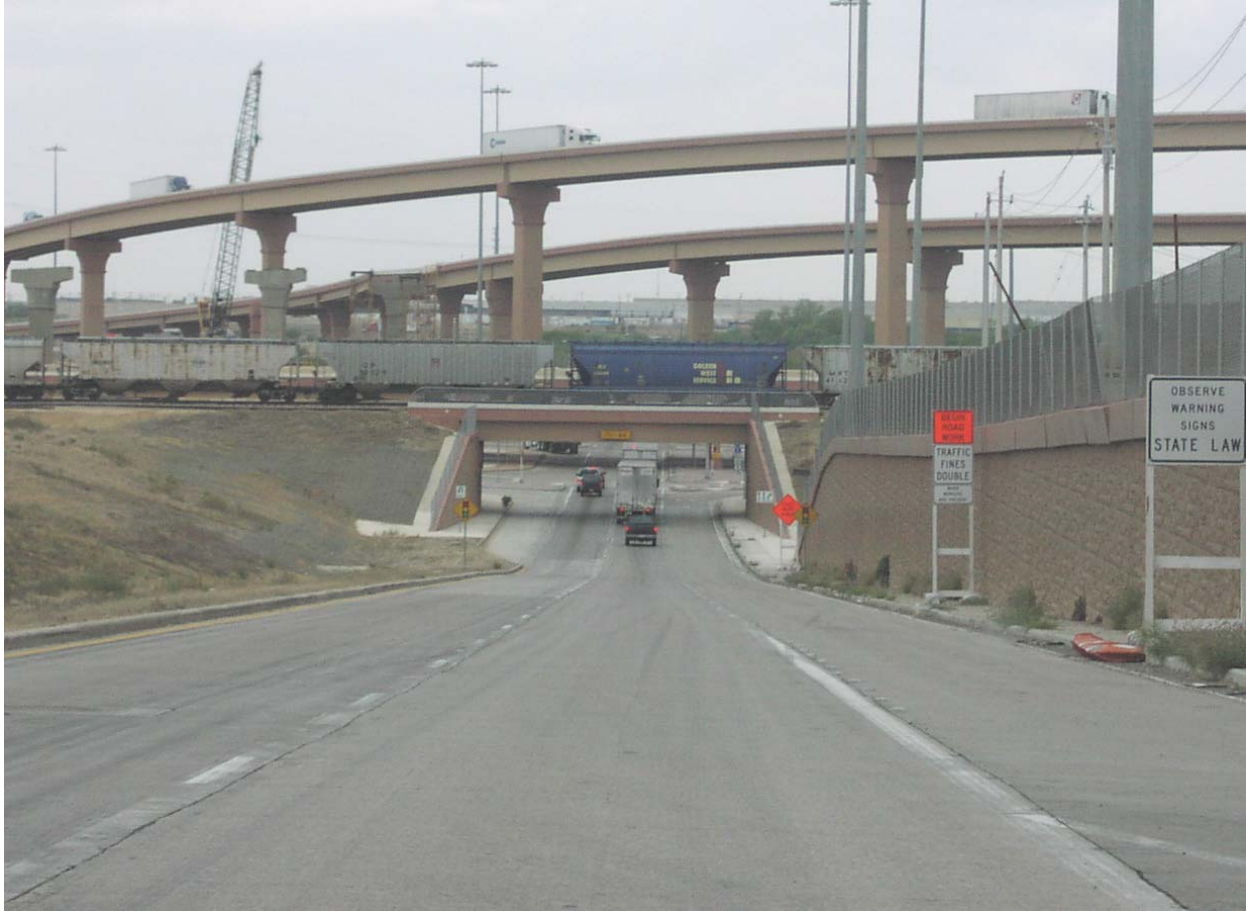
**Figure 19. Westbound Loop 20 Approaching the Union Pacific RR Bridge and I-35.**

An additional factor affecting sight distance to the signal heads along Loop 20 in the westbound direction is a Union Pacific railroad bridge that overpasses the Loop 20 westbound frontage road approaching I-35. The centerline of the bridge is approximately 180 feet east of the stop bar of westbound Loop 20 approaching the northbound I-35 frontage. The proximity of the bridge, coupled with the bridge's clearance and height, presents a direct sight line obstacle for westbound motorists (see Figure 19).

Height of the bridge was measured in the field to verify the bridge's posted clearance of 17 feet 4 inches. The height of the bridge structure was measured to be 8 feet 4.5 inches and the width of the structure (parallel to Loop 20) was measured to be 40 feet. The fact that the railroad bridge obscures the sight line to the signal heads for approaching Loop 20 motorists led to the installation of the symbolic SIGNAL AHEAD signs visible in Figure 19. The signs being installed by the current implementation project are supplemental to these advance warning signs and alert approaching motorists of the potential queue located in the RDZ that they cannot see from the upstream side of the vertical curve. This site is located near an international bridge (i.e., the World Trade Bridge) with Mexico that carries the majority of the commercial traffic in the Laredo region. As a result of these factors, this site has a high percentage of heavy vehicles and experiences long queues, especially during peak traffic hours of the day.

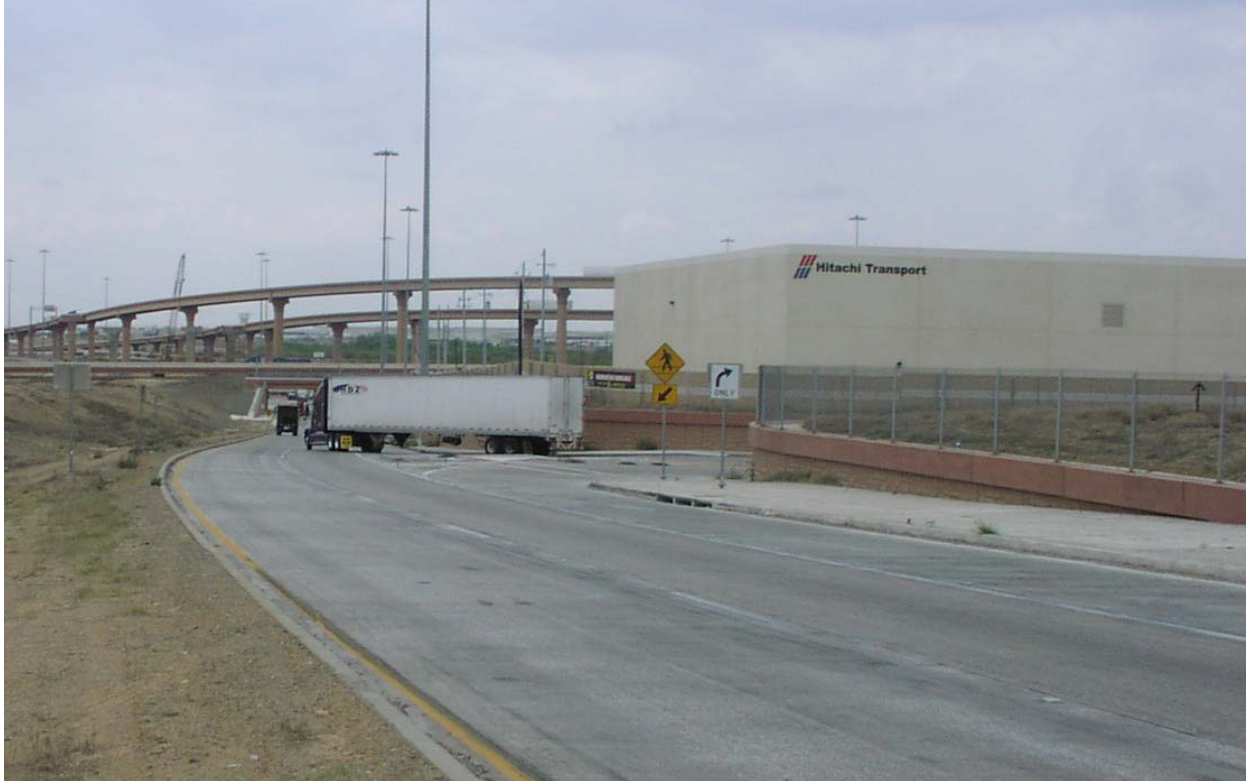
**Figure 20. Warehousing Building North of Loop 20 Westbound Approaching I-35.**

- A right-hand horizontal curve (see [Figure 20](#)) along the Loop 20 westbound frontage road approaching I-35 between the remote sign location and the intersection (where the cabinet is located);
- A large warehousing building located north of the Loop 20 westbound frontage road that is inside of the vertical curve referred to above (see [Figure 20](#));
- The vertical curve along the approach to the signal (i.e., the impetus for the project);
- High-volume heavy vehicle, or truck, traffic along westbound Loop 20 and along Grand Central, which intersects Loop20 between the sign location and the intersection;
- The Union Pacific railroad bridge located near the signalized intersection; and
- Train locomotives and cars along the Union Pacific railway, which effectively raise the height of the bridge by an additional 15 to 20 feet (during train passage).

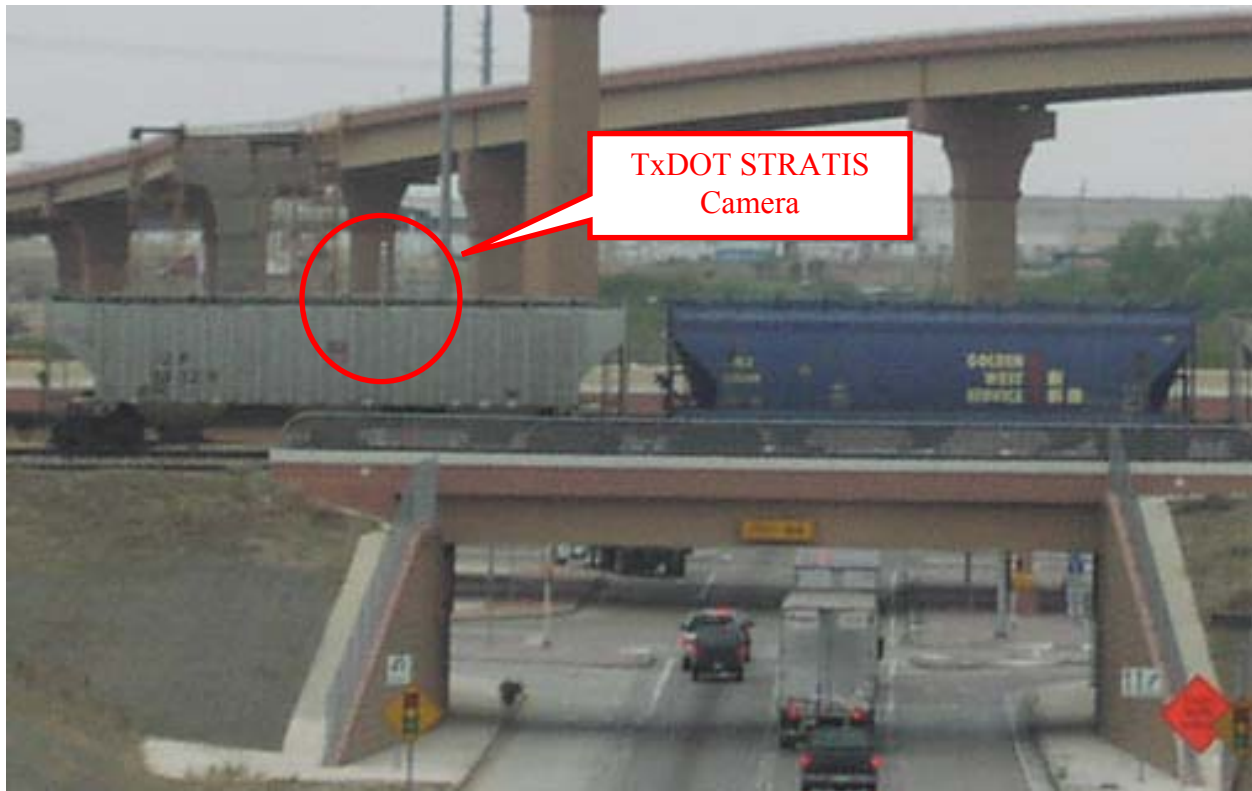
**Figure 21. TxDOT STRATIS Camera and Pole Above UP Train and Tracks.**

Fortuitously, the research team captured a site photograph from the top of the vertical curve during the time a train was occupying the UP tracks. Zooming in on a portion of the photograph (see [Figure 21](#)) revealed that a TxDOT South Texas Regional Advanced Traveler Information System (STRATIS) traffic monitoring camera and its pole were visible above the train, indicating that line of sight would be possible in terms of vertical clearance above the train and tracks. TxDOT staff identified a pole supporting the camera as one possible solution for antenna mounting for the project's communication needs. Another alternative was to use an existing TxDOT radio repeater station (i.e., a transceiver) located proximate to the southeast quadrant of the Loop 20/I-35 interchange that was used for communications between Loop 20's I-35 and McPherson interchanges. The project team concluded that further consultation with TxDOT Laredo District staff and Traffic Operations Division staff was necessary to identify the best solution for the communications issues at the site.

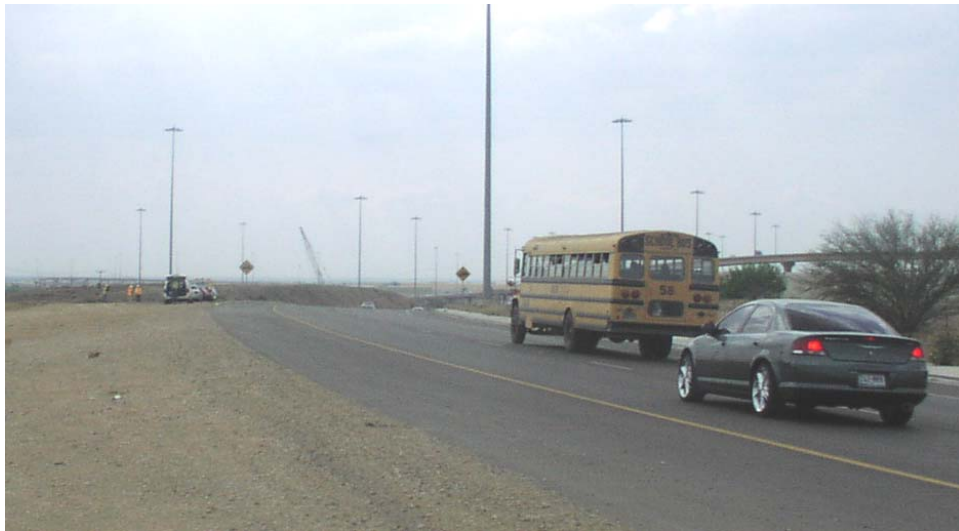
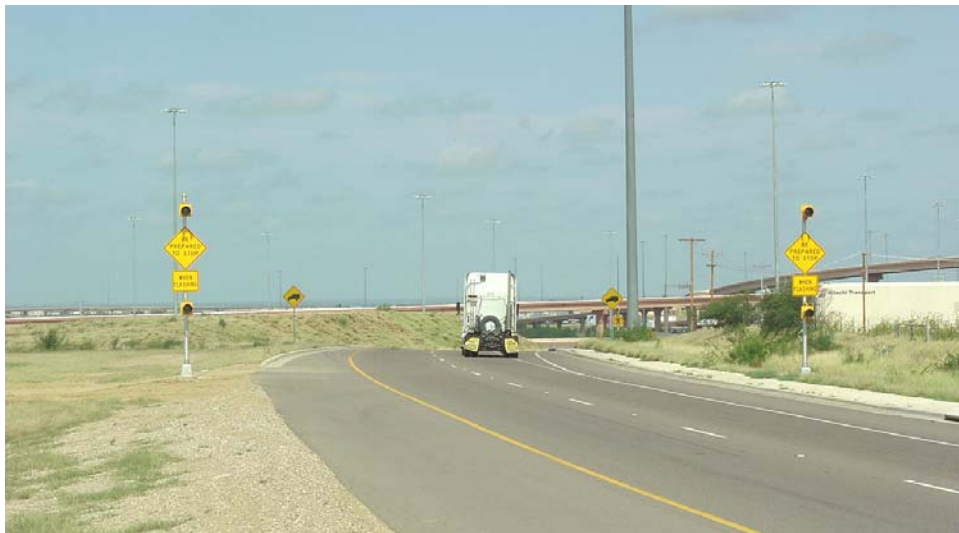
**Figure 22. Before and After Site Conditions on westbound Loop 20 Approaching I-35.**

As per the research project 0-4084 urban guidelines, TxDOT staff attempted to locate the active, supplemental advanced warning signs 2460 feet upstream of the stop bar. However, existing symbolic INTERSECTION AHEAD warning signs were already located 2600 feet upstream of the stop bar. Using engineering judgment, TxDOT staff decided to install the project’s signs 300 feet upstream of the intersection ahead signs, which was 260 feet closer to the VPI than the project 0-4084 nomographs indicate. Before and after conditions are compared in [Figure 22](#). Note that this installation is more complex than the Austin site due to the need to elevate the antenna on a 40-foot timber pole and the placement of the batteries in underground vaults. Also, it was necessary to bore underneath the Loop 20 westbound lanes in order to provide cabling for the batteries and flasher activation for the flasher assembly on the south side of the roadway.

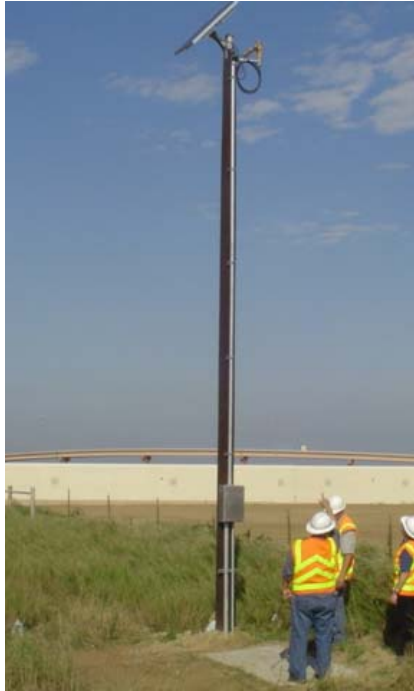
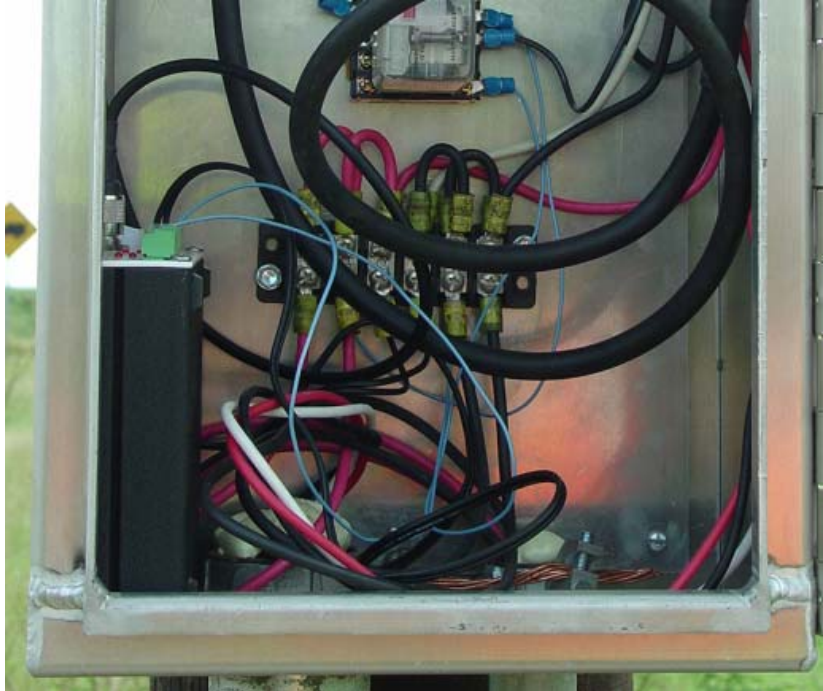
Antenna and Solar Panel

Spread Spectrum Radio (left)

Radio Flash Control Inputs (blue wires from bottom) and Flash Control Relay (bottom center)

**Figure 24. Remote Active Sign Components.**
