1. Report No. FHWA/TX-08/5-4084-01-1		2. Government Accession No.		3. Recipient's Catalog No.	
4. Title and Subtitle APPLYING TECHNIQUES TO INCREASE WARNING OF SIGNALS BEYOND VERTICAL CURVES				5. Report Date September 2007 Published October 2007

# **APPLYING TECHNIQUES TO INCREASE WARNING OF SIGNALS BEYOND VERTICAL CURVES**

Report 5-4084-01-1  
Project 5-4084-01  
Project Title: Improving Driver Awareness  
of Signals Beyond Vertical Curves

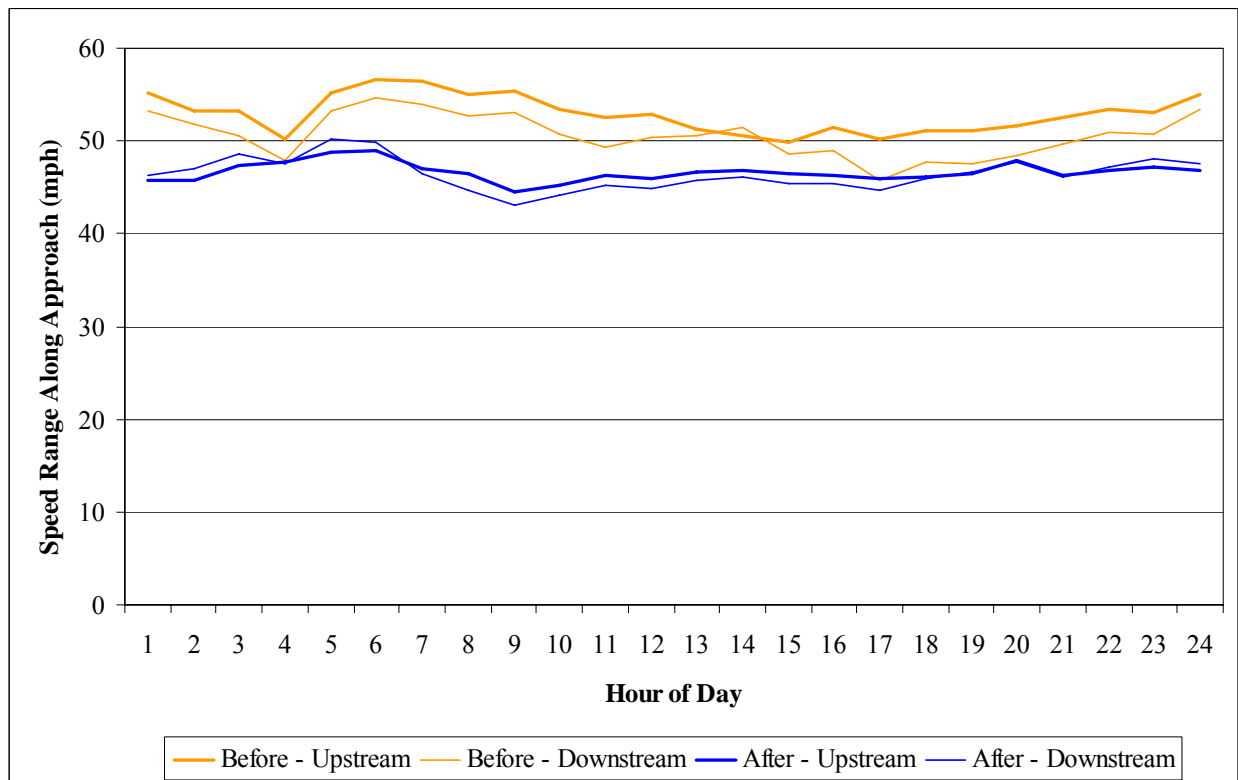
Figure 25. Before and After Speed Range Comparison Along Westbound Loop 20.

Figure 25 compares before and after speed ranges observed in the field along the westbound Loop 20 approach to Interstate 35. Data collection locations were the same for both the before and after studies and were 300 feet upstream (the thicker lines in the figure) and 200 feet downstream (the thinner lines in the figure) of the signs installed for the implementation project. From Figure 25 it is clear that there is a significant speed reduction for the after condition for all times of day (i.e., all lighting conditions). While Figure 25 compares the upstream and downstream before and after speeds to establish a speed range in the vicinity of the installed signs, Figure 26 shows a direct comparison between before and after overall average speeds. The average speed change brought about by the signs was 5.3 mph. This result compares favorably with the approximate 4 mph relative speed reduction observed at the Austin site, but direct comparison is not possible given the differences in site conditions and the analytical approach employed at each location.

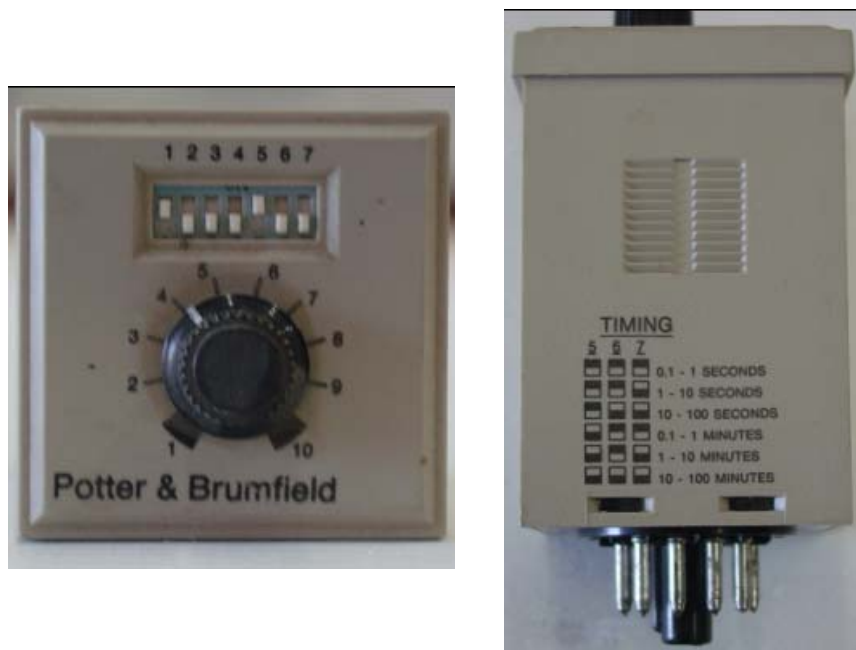
**Figure 27. Time Delay Flasher Control Relay.**

In addition to the above concern regarding motorists passing the supplemental advanced warning signing while it is inactive but still being in a situation to stop at the signal, there exists the possibility of the active flashers ceasing operation at a time when an approaching motorist reaches an end of queue that has not started moving for the downstream signal's green indication (i.e., before the queue has had a chance to begin clearing). As the original research points out – and as is mentioned further below – the optimum solution for this situation is to install a queue detection system along the approach where the supplemental advanced warning signing with active flashers is located. When either the downstream through phase is yellow or red OR a queue is present, the active flashers are in operation. Alternatively, if the queue size and its dissipation rate are fixed and stable over time, a time delay relay can be used to activate remote flasher control and extend activation beyond the end of green for the through phase. As shown in Figure 27 below, such relays can be programmed for a variety of durations that correspond to the (known) queue dissipation time, thus keeping the active flashers operational a fixed time after the downstream through phase has ended.
