**STATEWIDE IMPLEMENTATION OF PAVE-IR IN THE TEXAS
DEPARTMENT OF TRANSPORTATION**

Report 5-4577-05-1

Project Title: State-Wide Implementation of Pave-IR into HMA QC/QA

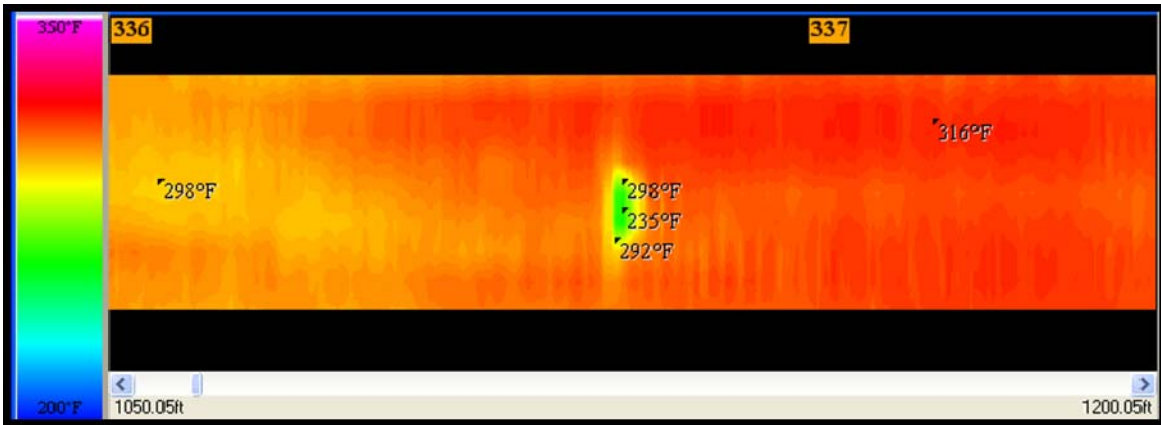
Figure 6. Artificial Cold Spot from Water Cooler Detected by Pave-IR Automated Processing.

- Figure 6 shows an interesting case where water spilled from the cooler on the paver resulted in an isolated artificial cold spot. In this case, the automated processing approach used in Pave-IR was insensitive to this artificial cold spot, and the calculated temperature differential for the profile was 23°F.

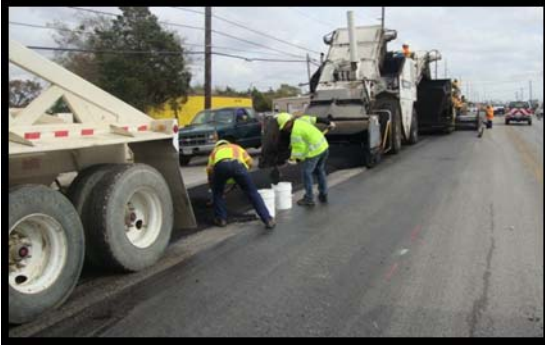
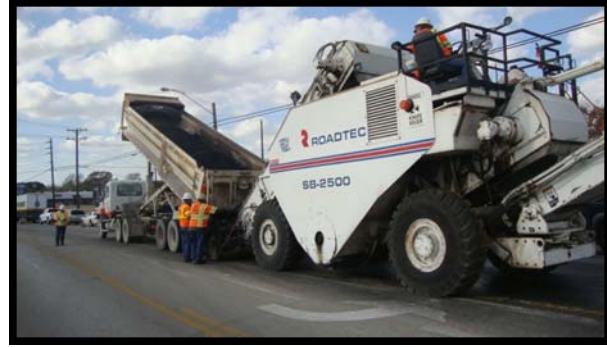
Figure 7. Paving Operation on FM 158.

The contractor used belly dump trucks when placing the mix profiled on December 10, 2010. On that day, the contractor placed an 18 ft wide mat to include the westbound inside lane and half of the center turn lane; the Pave-IR system was set up to profile the inside lane and ignore the turn lane. Due to problems with the material transfer device, the next day of placement profiled on December 15 used end dump trucks. On December 15, the placement width was approximately 14 ft. In all cases, a Roadtec SB 2500 transferred the mix into a Cat AP 1000D paver. The CAM mix was produced locally and hauled approximately 6 miles to the job site. [Figure 7](#) shows the paving operation, [Figure 8](#) shows the limits of data collection on December 10, and [Figure 9](#) shows the limits of data collection on December 15.

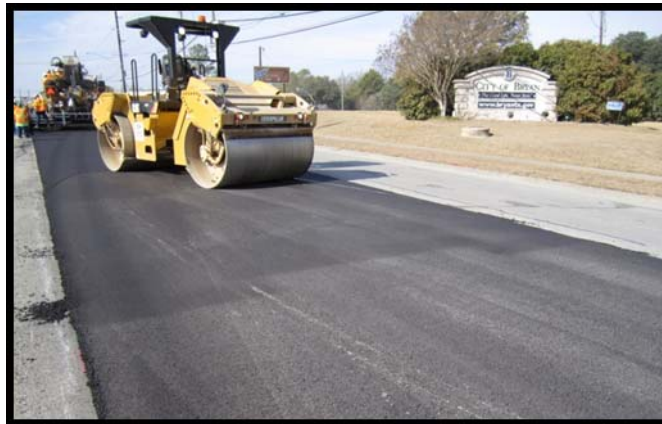
Figure 12. Pattern of Screed Left in Completed Mat due to Long Paver Stop.

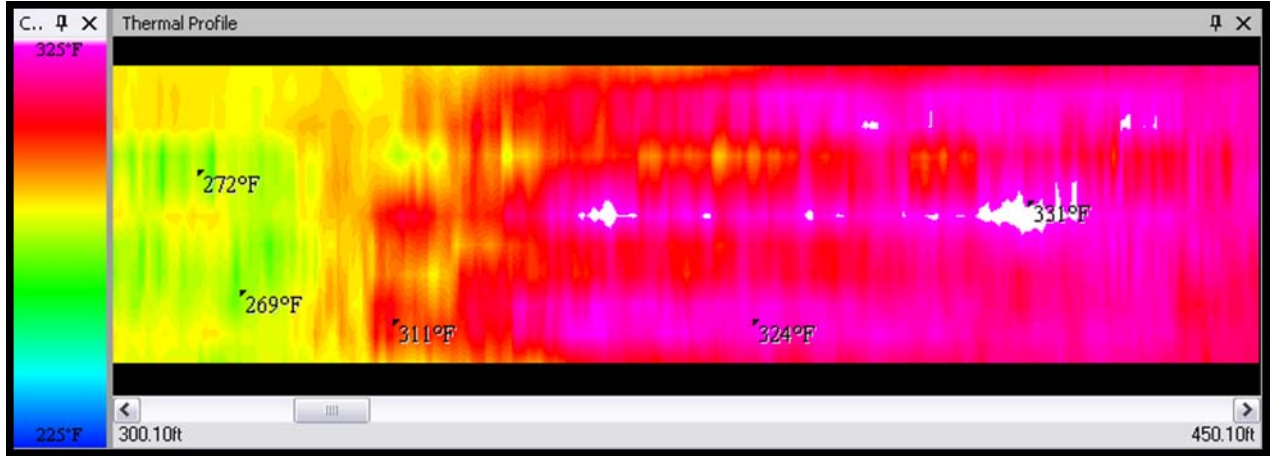
Figure 14. Thermal Segregation due to Increase in Mean Mixture Temperature on FM 158.

- The severe thermal segregation in profile 3 clearly resulted from a shift in mean mixture temperature as Figure 14 shows.
- Figure 15 shows profile 10 from December 15. This profile contained two paver stops as annotated. Since TxDOT specifications handle paver stops separately, the limits of the paver stop are excluded from the thermal profile analysis in Test Method Tex-244-F. Figure 15 also highlights that, in general, the thermal irregularities observed on this project could be classified as random.

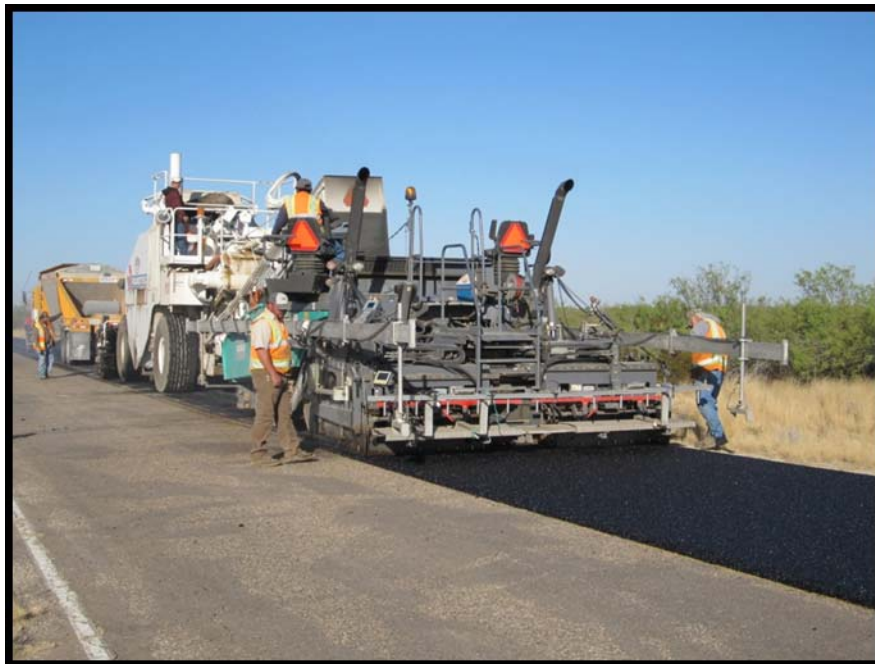
Figure 16. Paving Operation on Pecos Test Sites.

The contractor used tarped belly dump trucks to haul the mix from Midland to the job site, resulting in a haul distance of approximately 100 miles. At the job site, a Roadtec Shuttle Buggy SB 2500D transferred the windrows to a Vogele Vision 5203 paver. [Figure 16](#) shows the paving operation.

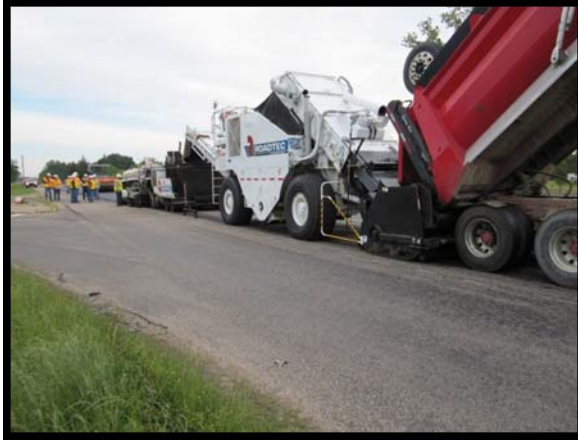
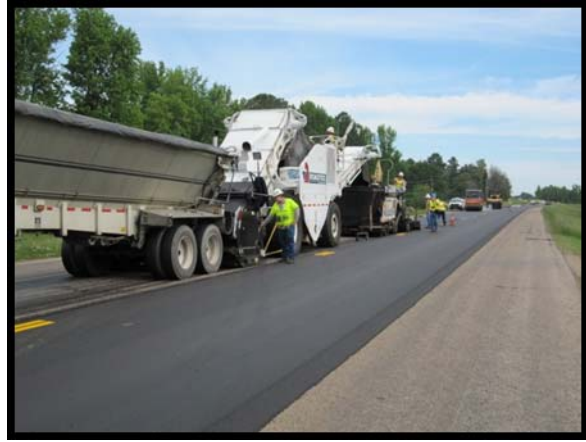
Figure 21. Paving Operation on SH 8.

The contractor used end dump and flow boy trucks to transport the mix from the plant in Texarkana to the job site, resulting in a haul distance of approximately 25 miles. The mix was Type D HMA with PG 64-22 binder; recycled asphalt shingles (RAS) and reclaimed asphalt pavement (RAP) was also included in the mix design. The trucks offloaded into a Roadtec SB 2500D, which then transferred the mix into a Roadtec paver. The mat width was 12 ft.

[Figure 21](#) shows the paving operation, and [Figure 22](#) shows Pave-IR data collection taking place.

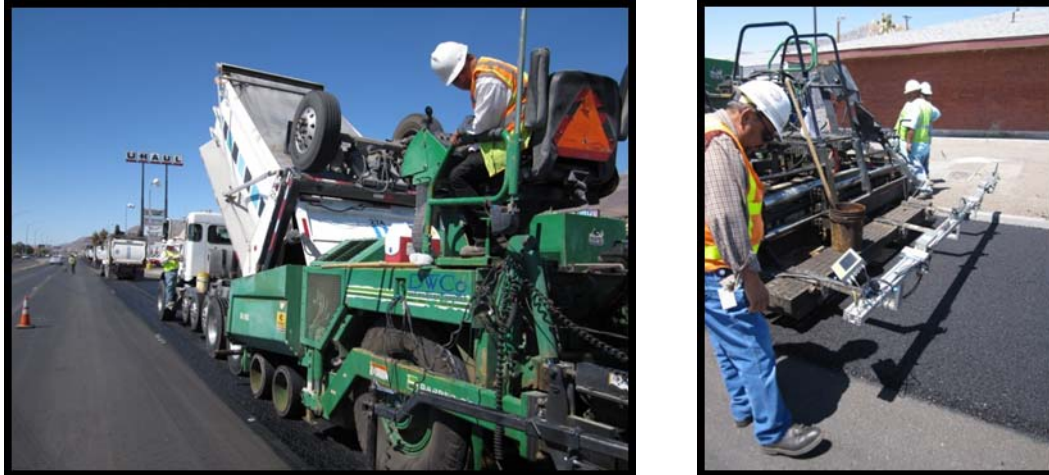
Figure 28. Paving TY C Mix on Dyer Street.

The producer used end dump trucks to transport the mix from the plant to the job site, resulting in a haul distance of approximately 15 miles. The planned compacted thickness was 2 in., and the mat width was approximately 10.5 ft. The air temperature was 57°F when placement began. The trucks offloaded into a Barber Green BG-260C paver to place the mix. [Figure 28](#) shows the paving operation with Pave-IR data collection taking place.

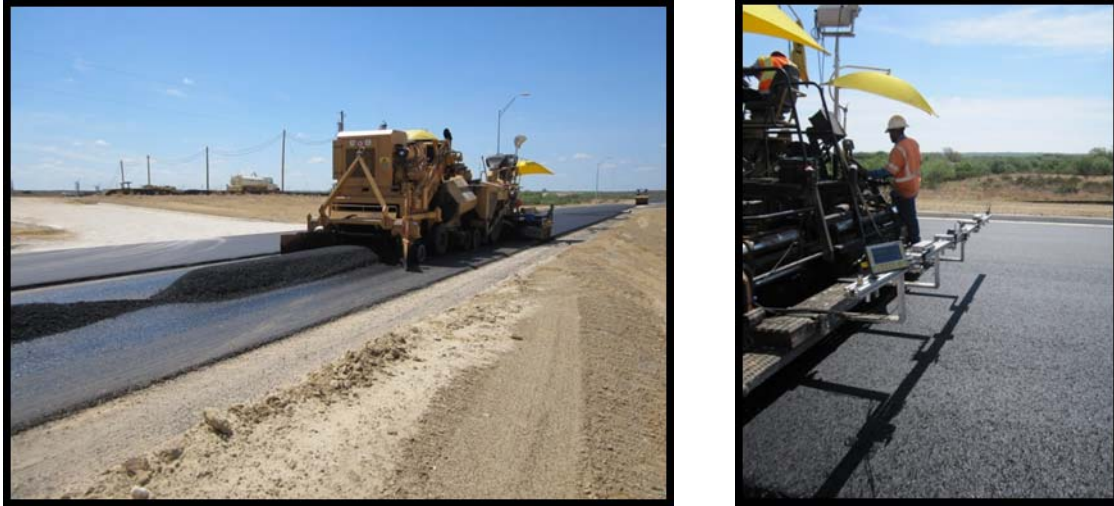
Figure 33. Paving TY C Mix on SL 20.

Belly dump trucks transported the mix from the plant to the job site, resulting in a haul distance of approximately 20 miles. A Lincoln 660 AXL windrow elevator transferred the mix into a Cat AP 1000D paving machine. The planned compacted thickness was 2 in., and the mat width was approximately 15 ft. [Figure 33](#) shows the paving operation with Pave-IR data collection taking place.

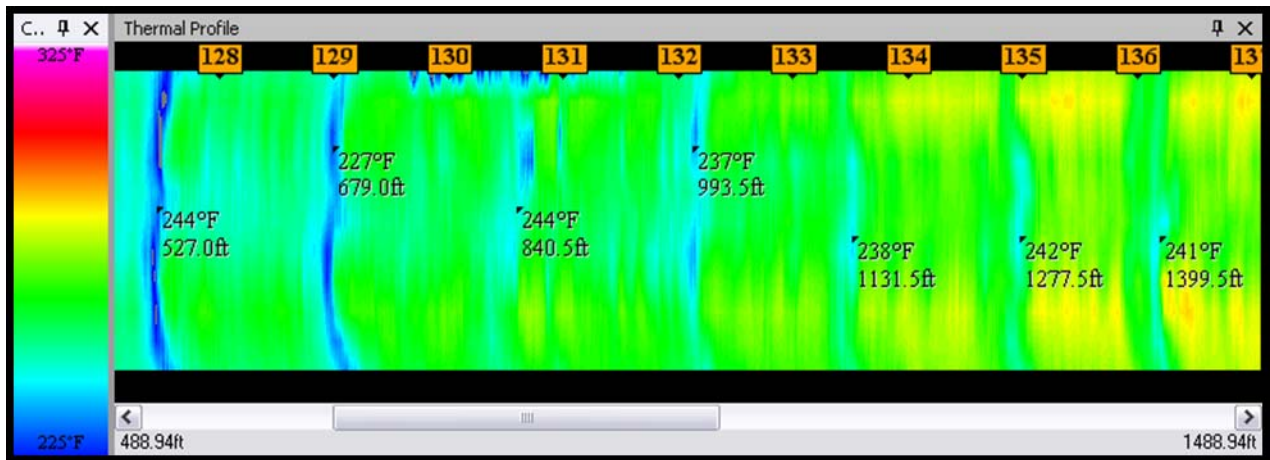
Figure 39. Cyclical Nature of Thermal Segregation on SL 20.

- [Figure 39](#) shows 1,000 ft of paving from the first pull and illustrates that truck-end thermal segregation dominated the pattern observed from the paving operation. Cyclical cold spots appeared at intervals approximately 140 ft apart throughout the paving operation.

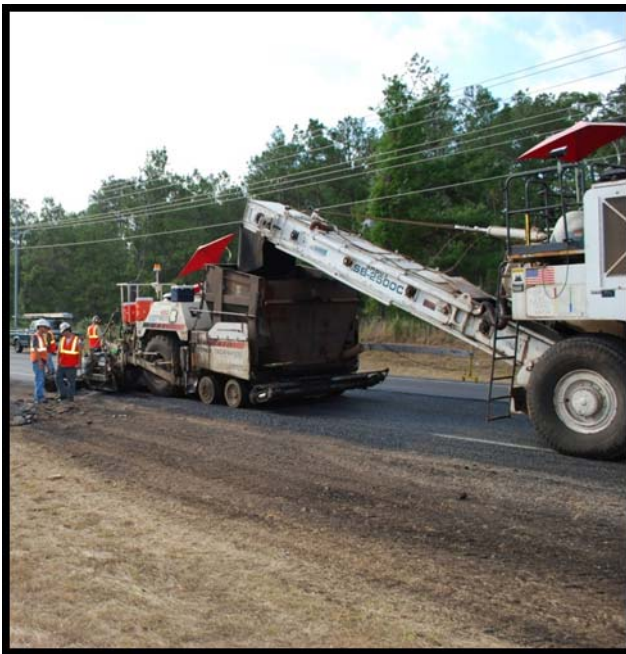
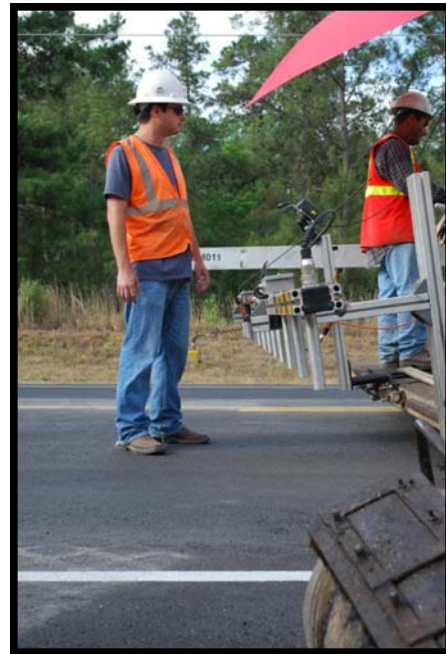
Figure 41. Paving on FM 2854 with Pave-IR Data Being Collected.

The mix was produced with PG 64-22 binder and transported approximately 12 miles from the plant to the project site. No RAP and RAS was used. At the job site, a Roadtec SB-2500C transferred the mix to a Cedarapids 452 paver. The planned compacted thickness was 2 inches. [Figure 41](#) shows the paving operation with Pave-IR data collection taking place.

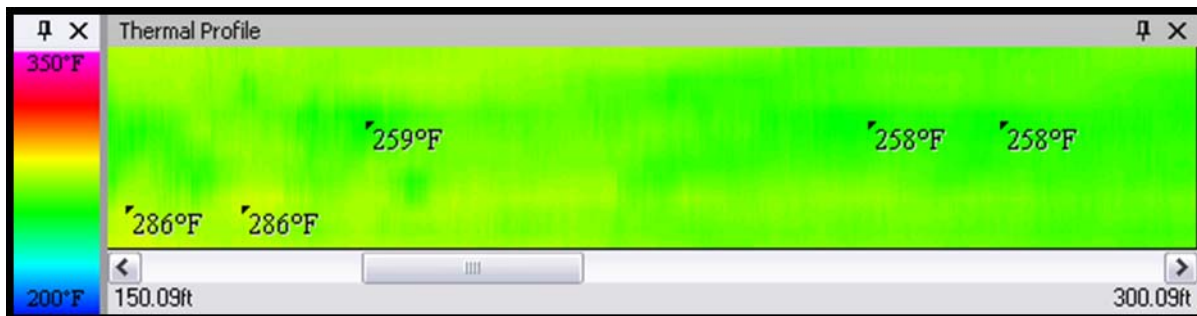
Figure 47. Moderate Thermal Segregation Barely Exceeding 25°F Threshold on Loop 340.

Figure 47 shows the second thermal profile exhibiting moderate thermal segregation, which is defined as temperature differentials exceeding 25°F but not exceeding 50°F. However, in Figure 47 the temperature differential barely exceeds the 25°F threshold. This also is not cause for great concern.

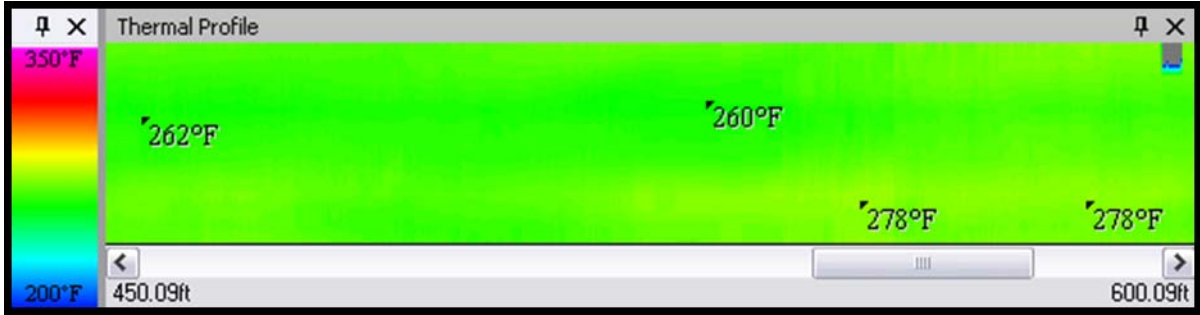
Figure 48. Representative Thermal Profile on Loop 340.
Note: profile 4 shown.

The remaining profiles were free of thermal segregation. Figure 48 shows an example profile. The data suggest that, once the paving train was in normal production, thermal segregation concerns did not exist.
