RUBBLIZATION AND BASE OVERLAY OF FM 912 AND FM 1155

Report 5-4687-01-1
Project 5-4687

Project Title: Pilot Implementation of Rubblization for Rehabilitation of Concrete Pavements

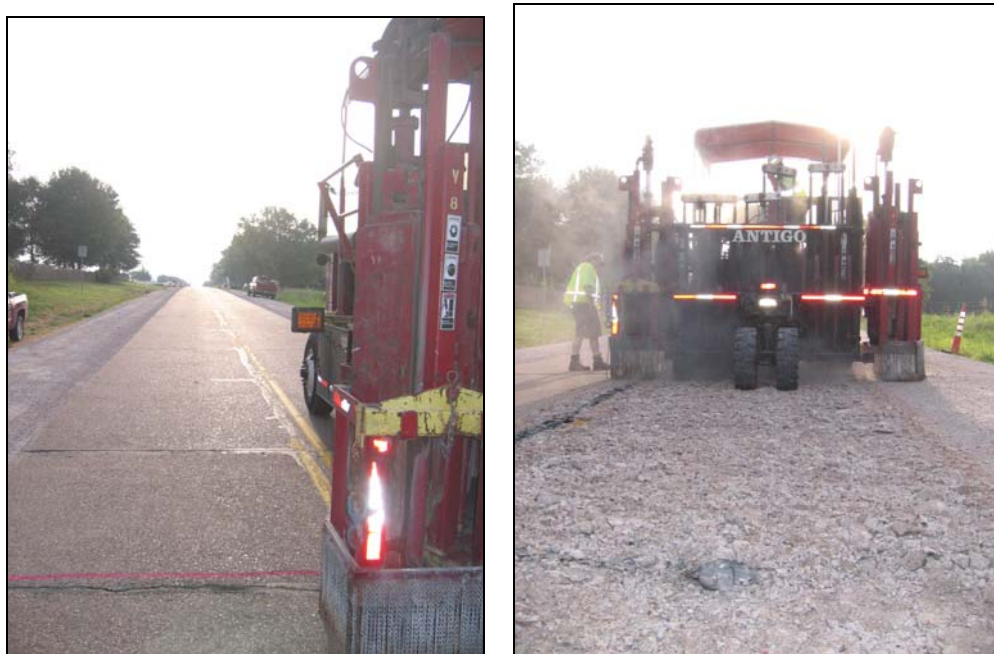
Type II rubblization, employing a multiple head breaker, took place June 23–27, 2008. The Type II equipment rubblizes the entire lane width in one pass. Antigo Construction performed the Type II rubblization, with planned station limits from 105+00 to 169+00. Figure 2.1 shows the unfractured concrete ahead of the breaker, along with the surface view of the rubblized concrete after the operation.

Figure 2.1. Unfractured (Left) and Rubblized (Right) JCP during Type II Rubblization.

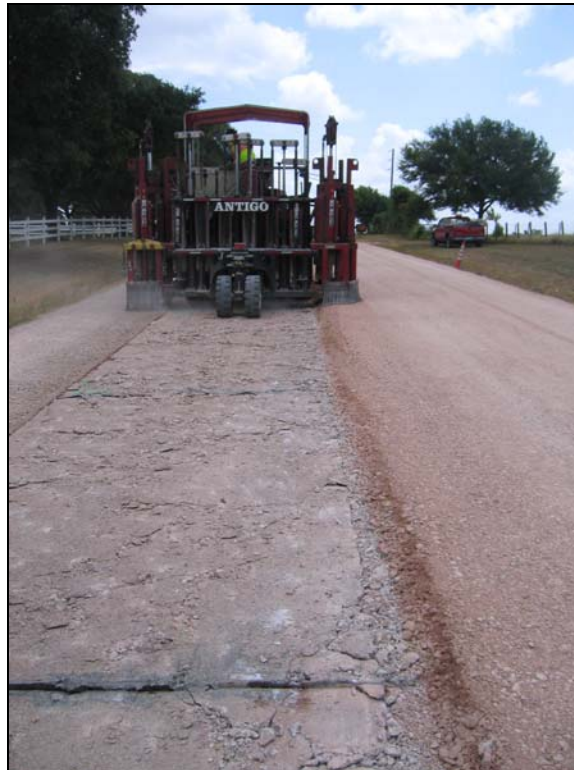
Clearly full-depth repair involves extra labor and cost on a project, so after discussion with the TxDOT engineer, the decision was made to utilize a reduced break pattern on sections at high risk of instability after rubblization. Such an approach relies largely on the operator of the rubblizing equipment, who through experience must assess the machine's operation to determine whether a reduced break pattern is necessary. The goal of the reduced break pattern is to adequately fracture the concrete to eliminate slab action, yet retain stability. Such a pattern could be thought of as between crack-and-seat and rubblization. Figure 2.5 shows a section employing the reduced break pattern. Table 2.3 summarizes the locations on the project known to receive the reduced break pattern.

Figure 2.5. Modified Break Pattern with Type II Rubblization.

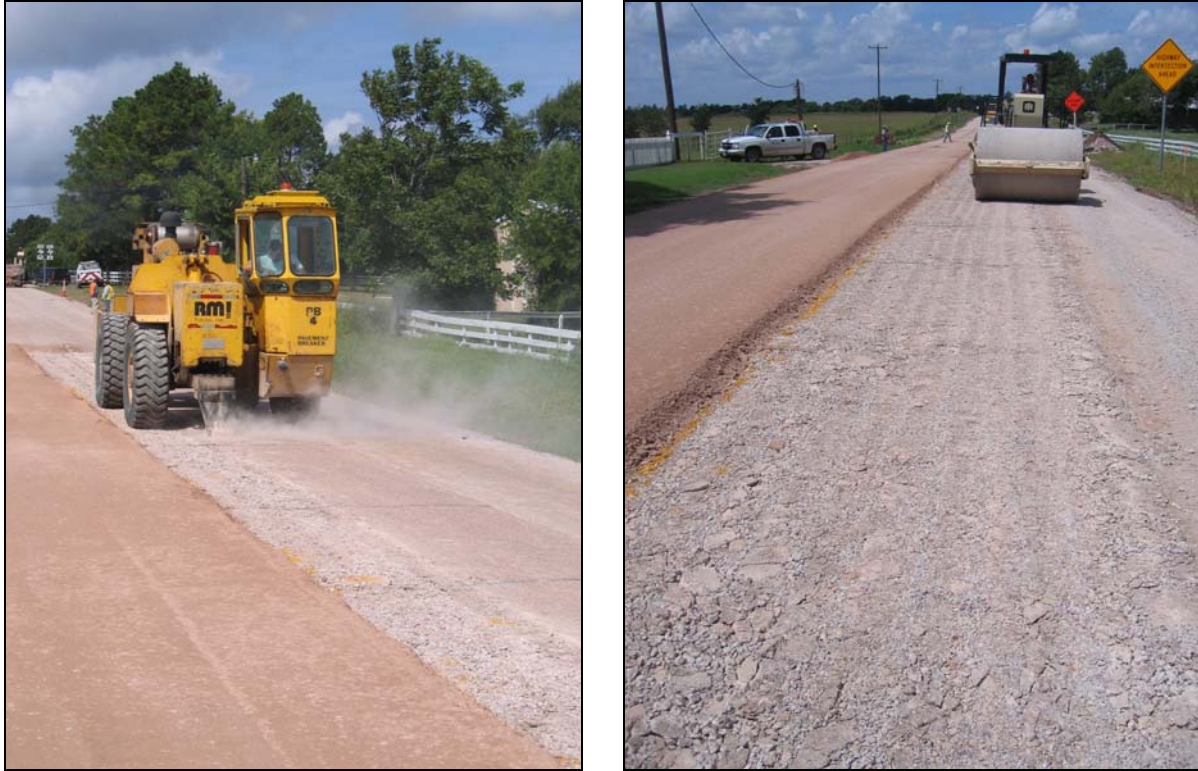
Type I rubblization, employing a resonant breaker, took place August 4–8, 2008. The Type I rubblizer uses a vibrating shoe to impact and fracture the concrete. RMI Worldwide performed the Type I rubblization, with planned station limits from 169+00 to 230+00. Figure 2.7 shows the Type I rubblization in progress along with a representative completed section.

Figure 2.7. Type I Rubblization in Progress and Completed Section.

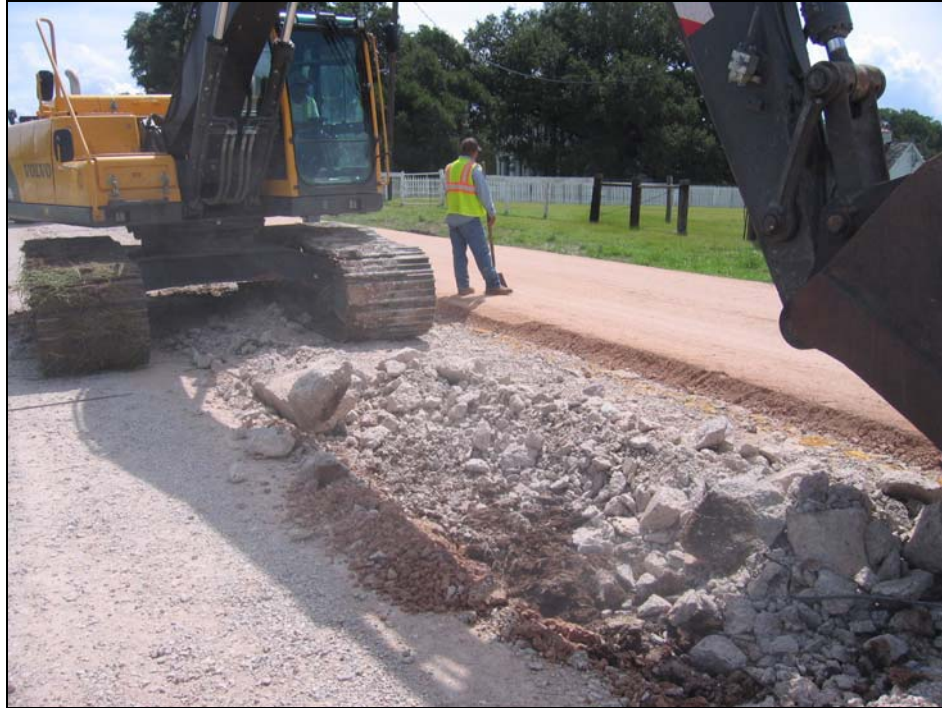
TxDOT elected to not specifically conduct a test pit upon startup of the Type 1 rubblization. Instead, they used the observed break pattern at the first location needing full-depth repair as the test pit. [Figure 2.8](#) shows an excavation of the JCP rubblized with the Type I equipment. When contrasted with the excavation from the Type II equipment shown in [Figure 2.2](#), the JCP rubblized with Type I equipment was easier to excavate and exhibited a finer gradation through the depth profile.

Figure 2.8. Test Pit with Type I Equipment.

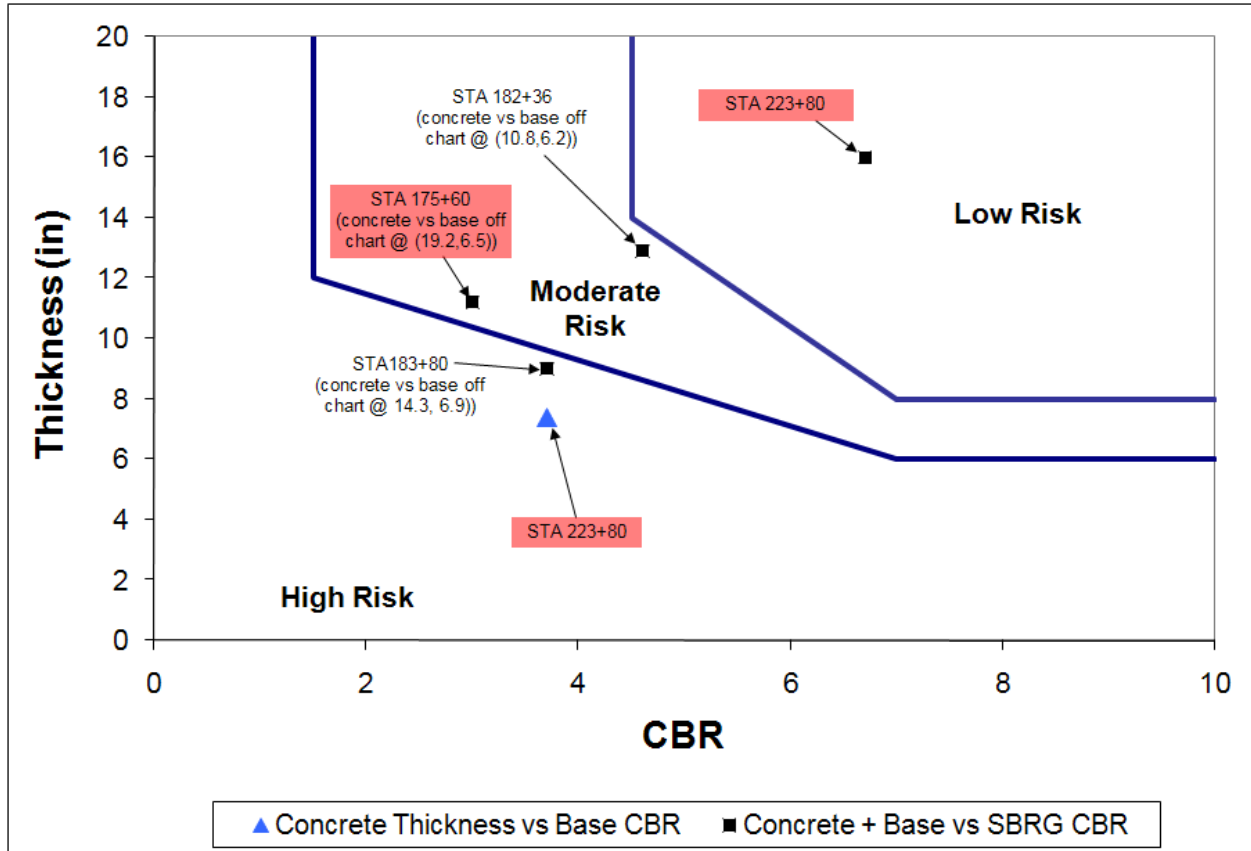
TTI researchers sought to evaluate how the rubblization selection chart compared with field experience for the Type I rubblizer. [Table 2.6](#) presents data collected at five locations, two of which required removal and replacement after proof rolling. [Figure 2.11](#) plots these data on the rubblization selection chart. Locations noted in red required removal due to instability after rubblization. The field experiences match the chart reasonably well, with both locations requiring removal having at least one data point in the High Risk zone of the selection chart.

Figure 2.11. Selection Chart Data from Construction for Type I Rubblization.

Note: Locations highlighted in red required full-depth repair.

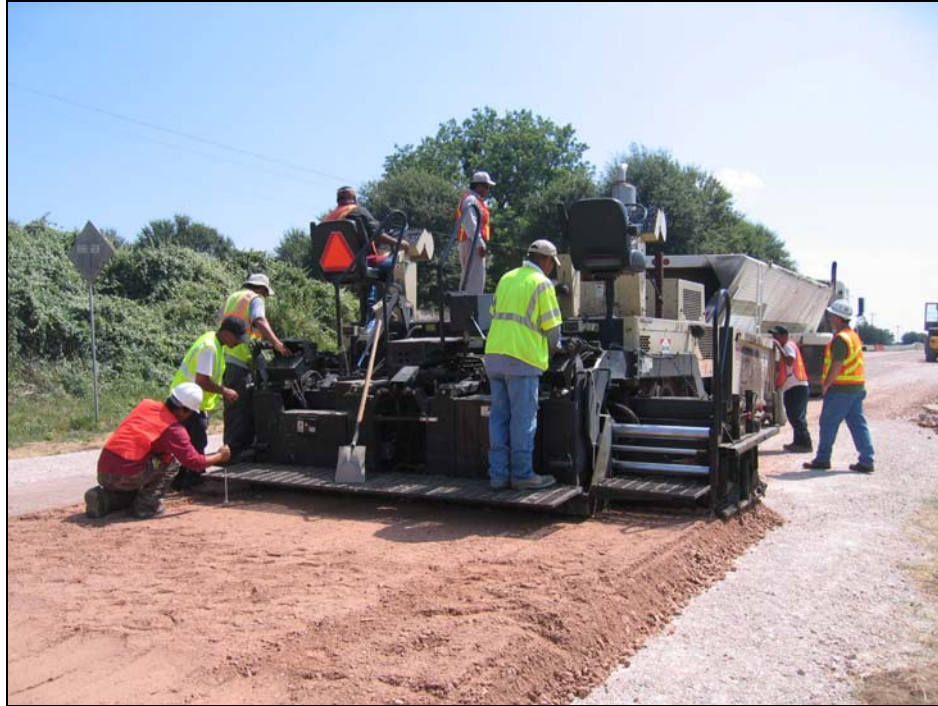
Regardless of the type of rubblization employed, the flexible base was wetted in a pugmill then placed at the site with an asphalt paver, as Figure 2.12 shows. Instead of blade-spreading the base, a paver was used in attempts to minimize segregation of the base at the project site. A pneumatic and steel wheel roller compacted the base, as Figure 2.13 shows.

Figure 2.12. Placing Base with Paver.

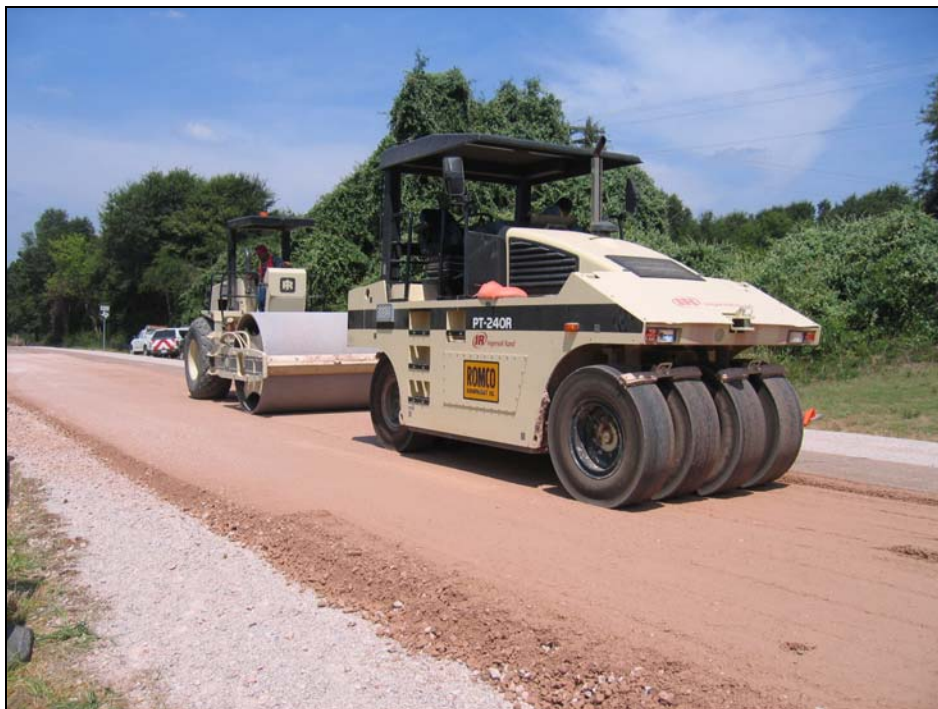
Figure 2.13. Compacting Base with Pneumatic and Steel Wheel Rollers.

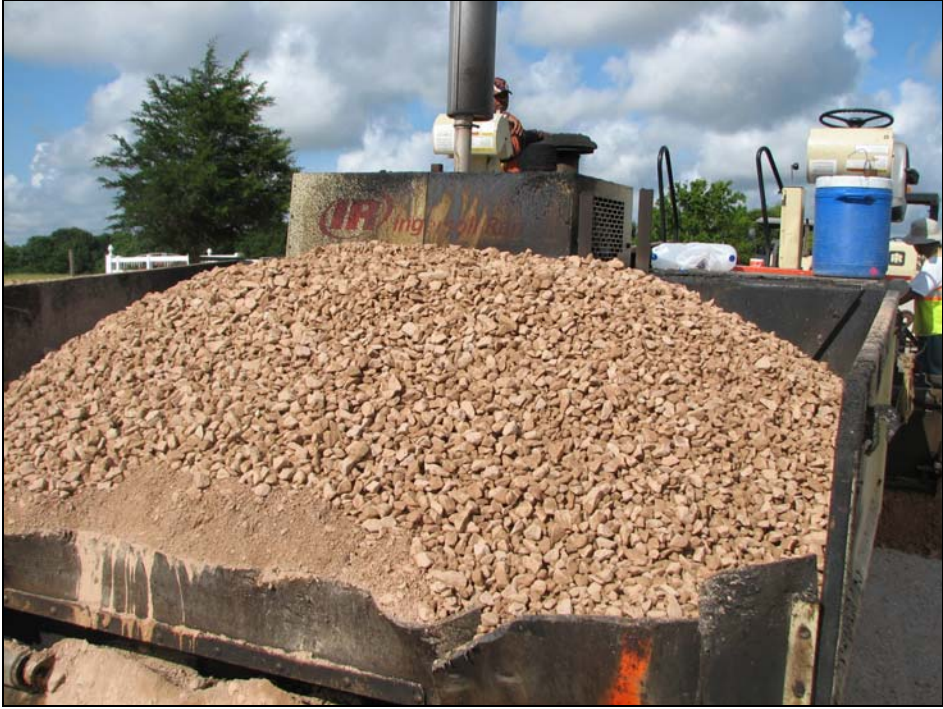
This handling did result in segregation of the base both inside the paver hopper and on the ground as [Figures 2.14](#) and [2.15](#), respectively, illustrate. Additionally, traffic had to be allowed on the base after compaction, and the drainable base tended to ravel, particularly at the segregated locations, as [Figure 2.16](#) illustrates. To remedy the deterioration in surface finish, the contractor re-worked the surface immediately prior to sealing.

Figure 2.14. Segregation of Grade 4 Base in Paver Hopper.

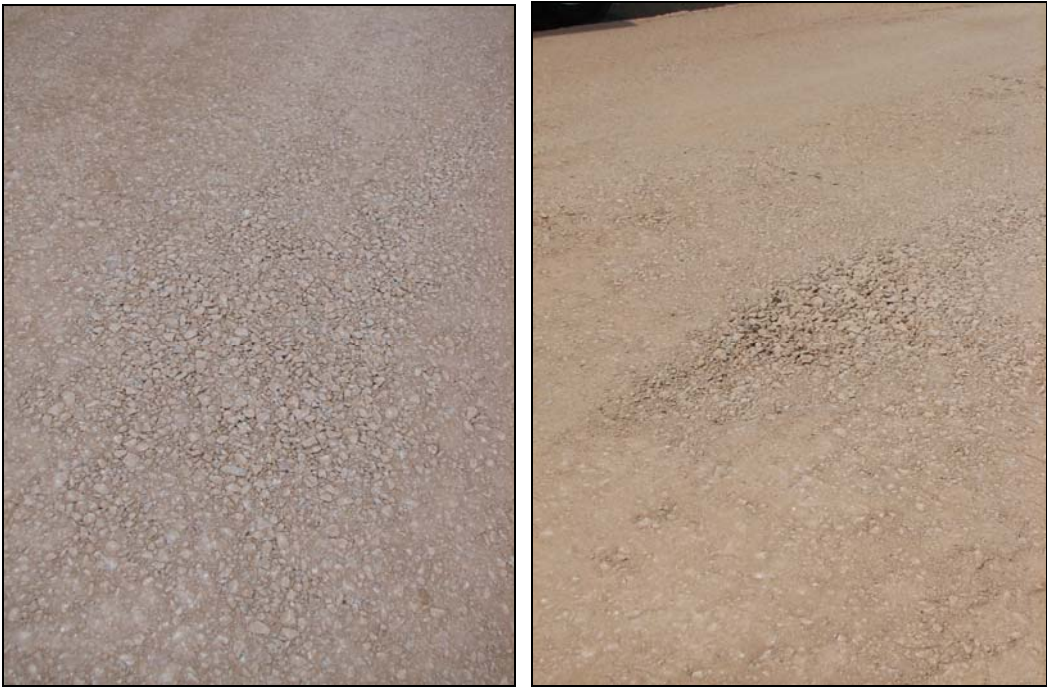
Figure 2.15. Segregation of Grade 4 Base after Placement.

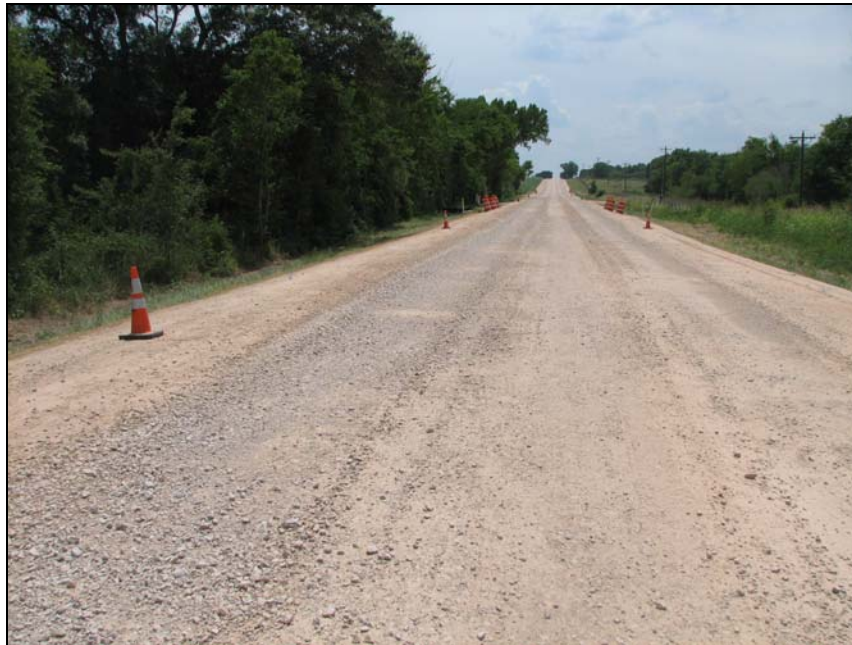
Figure 2.16. Raveling and Loss of Surface Finish of Grade 4 Base under Traffic.

On this project the main difference observed between the two bases involved finishing. The Grade 4 drainable base tended to segregate during placement and ravel while under traffic prior to construction of the surface treatment, as [Figures 2.15](#) and [2.16](#) showed. The data do not suggest either base produced a different modulus value for comparable support conditions; the only observed differences in base modulus value appeared attributable to varying modulus of the material beneath the base.

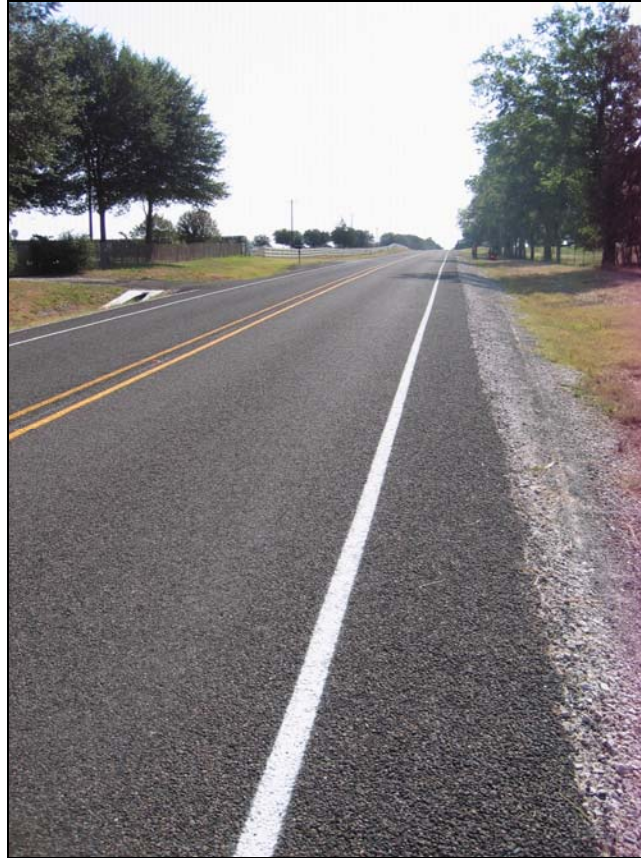
Figure 3.4 shows the start of the section rubblized with Type II equipment looking northbound. The GPR data in this section, as Figure 3.5 represents, revealed nothing unusual. The waviness of the surface reflection indicates pavement roughness, and the locations of full-depth repairs are typically evident.

Figure 3.4. Start of Type II Rubblization.

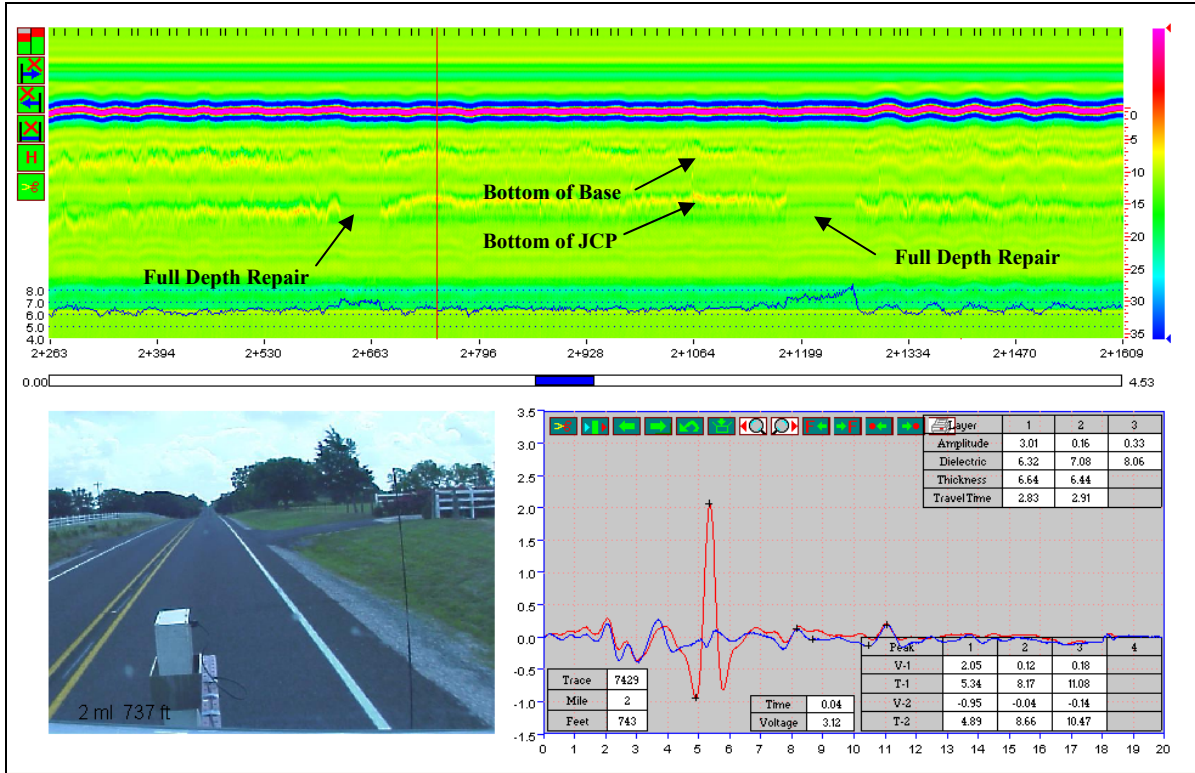
Figure 3.5. Representative GPR from Type II Rubblization.

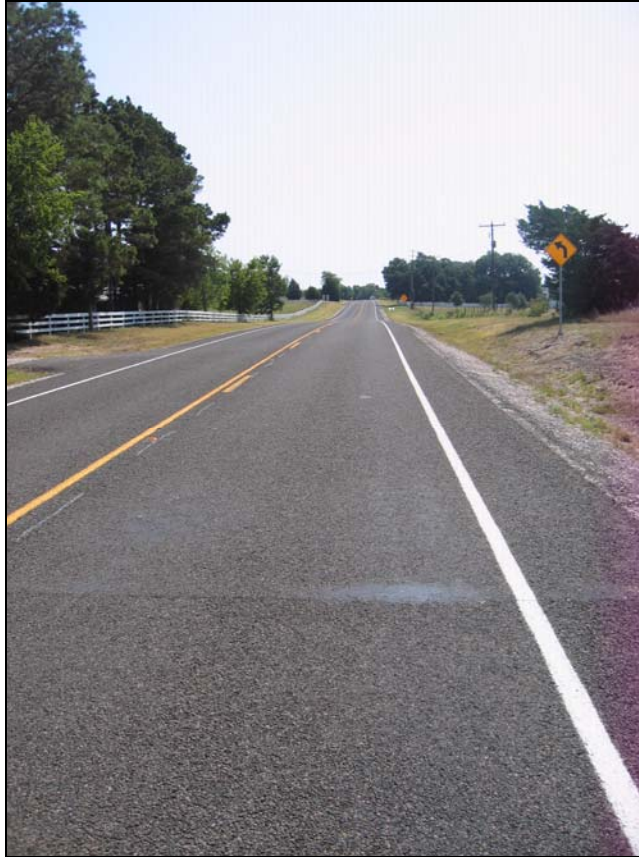
Figure 3.6 shows the start of the section rubblized with Type I equipment looking northbound, and Figure 3.7 shows representative GPR from this section. Similar to the data from the section rubblized with Type II equipment, the GPR data are clean and do not indicate any problems within the pavement structure. Again, roughness in the surface reflection is evident and scrolling through the data reveals locations evident of full-depth repair.

Figure 3.6. Start of Type I Rubblization with Grade 2 Base Overlay.

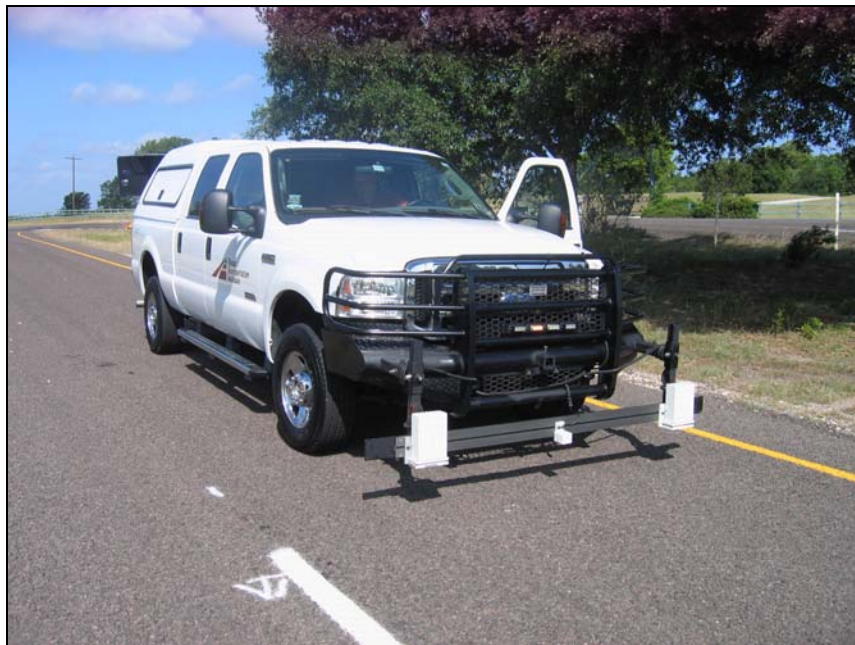
TTI collected ride results on the pavement using the profiler shown in [Figure 3.8](#). [Table 3.1](#) shows the ProVAL 2.7 analysis output. To evaluate the results researchers first evaluated the left and right wheel path results for equivalence with a paired t-test; the result showed the left and right wheel path results were not equivalent. Therefore, researchers segmented the data according to treatment (omitting the segment from 8448 to 8976 feet due to a bridge) then evaluated IRI among the treatments for the left and right wheel paths independently. Analysis of variance results showed that, for both wheel paths, the mean IRI was equivalent among all the treatments. [Figure 3.9](#) shows the mean IRI values. Since this entire project received a flexible base overlay and only a surface treatment, the ride quality largely depends on the smoothness of the finished base and in the longer term could be impacted by movement in the subgrade soil.

Figure 3.8. TTI Profiler.

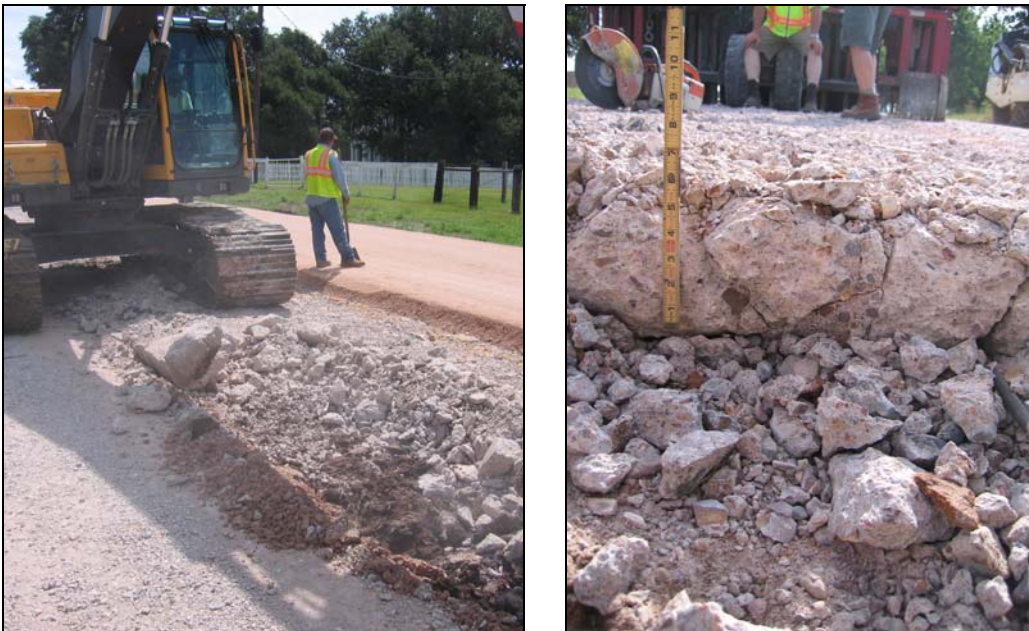
As on other projects, the Type I (resonant breaker) machine was observed to produce a smaller particle size throughout the depth profile of the concrete as compared to the Type II (multiple head breaker) equipment, as [Figure 4.1](#) illustrates. Additionally, with both pieces of equipment, the break pattern serves as a first indicator of stability. While break pattern alone cannot serve as the only stability check, both machines produce break patterns with significantly larger particles at areas of poor stability, as [Figure 4.2](#) shows.

Figure 4.1. Rubblized Product from Type I (Left) and Type II (Right) Equipment.

particle size requirements. On this project, which had marginal subgrade support, the depth of smaller particles with the Type II equipment was judged adequate even though that depth did not reach half the slab thickness (see [Figure 4.1](#)). It is recommended therefore that the particle size requirements be modified to relax the minimum required depth of the smallest particles to the top third of the slab thickness, instead of half the slab thickness, as [Table 4.1](#) shows. [Appendix B](#) of this report presents a revised construction specification with the rubblization requirements modified as discussed.

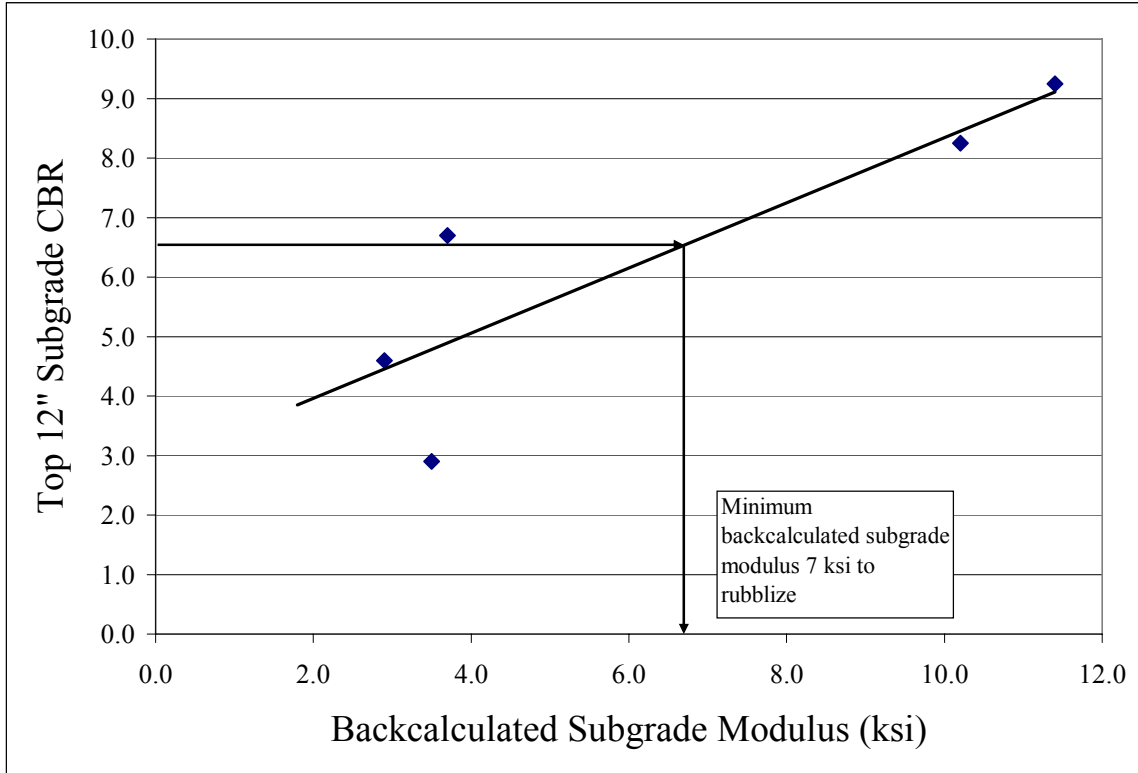
Figure C.5. Relationship between DCP and FWD on FM 912.

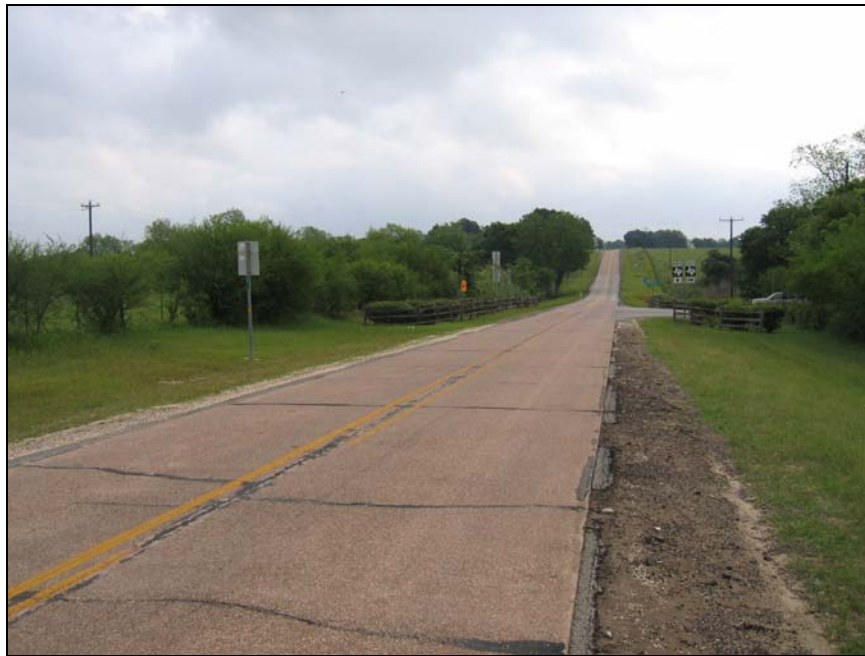
Based on the field investigation, the structure consists of approximately 7 to 8 inches of JCP over the subgrade. [Figure D.1](#) shows the pavement section looking northbound from RM 631 on FM 912.

Figure D.1. JCP Pavement Tested for Suitability for Rubblization.

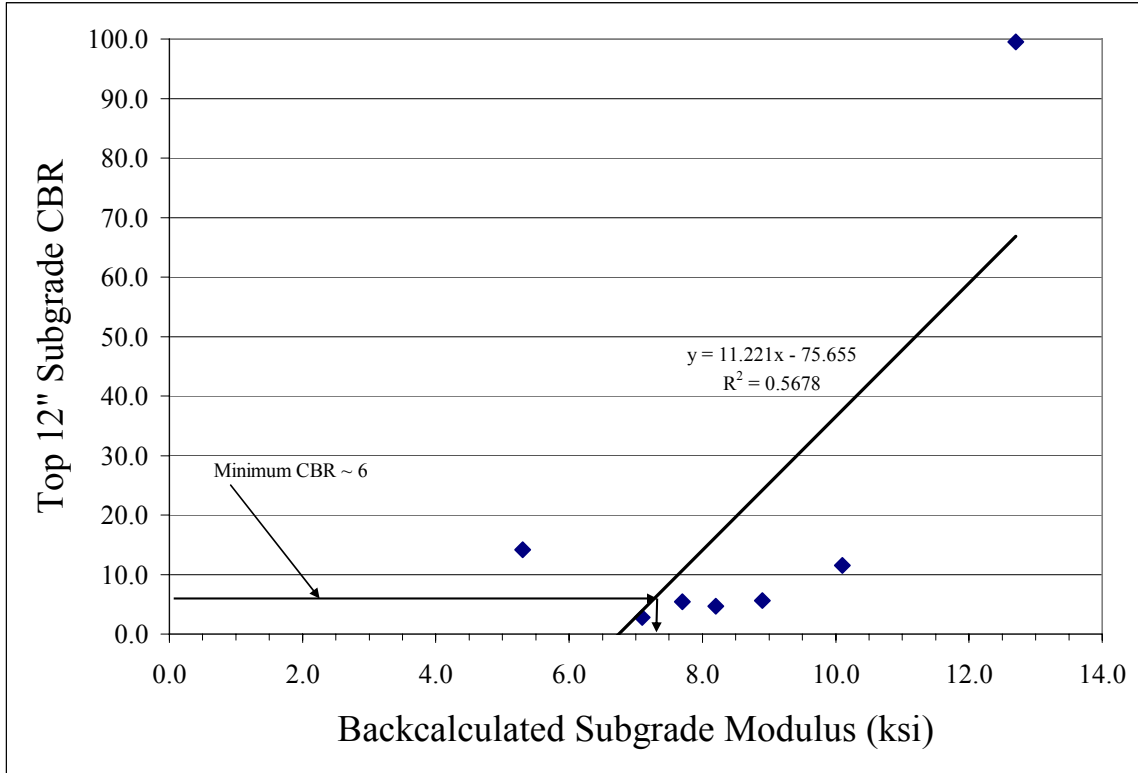
Figure D.5. Subgrade CBR vs. Subgrade Modulus for FM 1155.
