# Implementing Rubblization and Drainage Improvement Techniques on Severely Distressed Concrete Pavements: Technical Report

Implementation Report Report 5-4687-03-R1

Project Title: Implementing Rubblization and Drainage Improvement Techniques on Severely  
Distressed Concrete Pavements

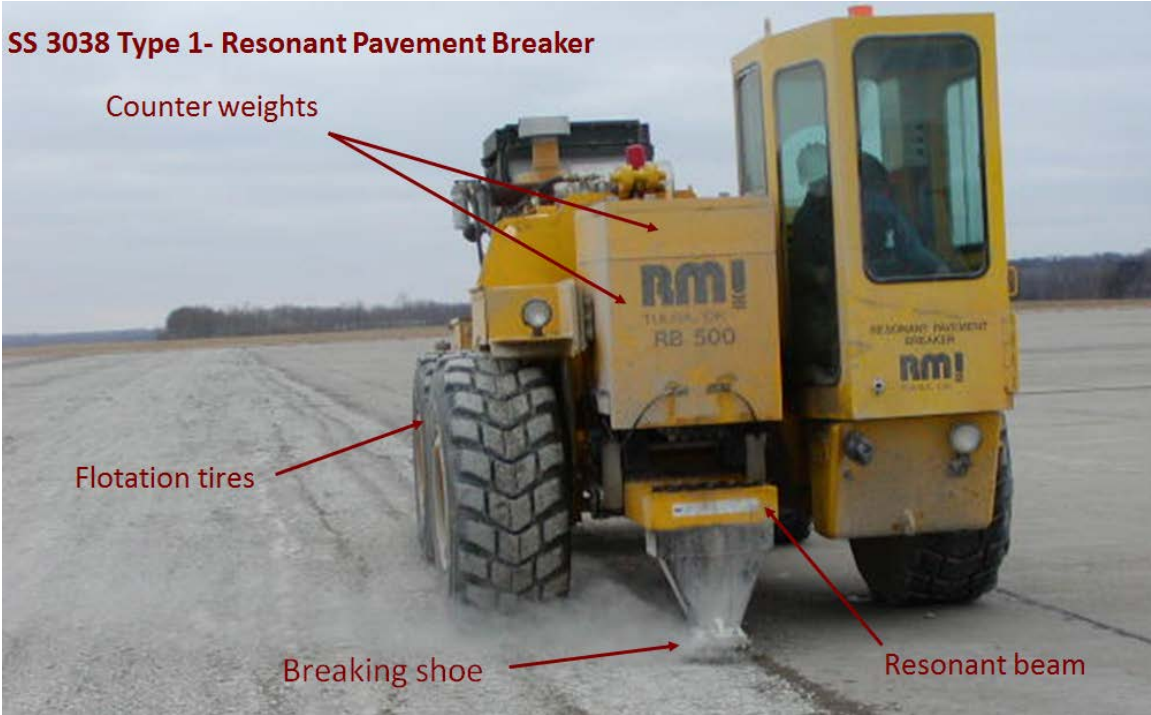
**Figure 1. Resonant Machines Inc's Breaker.**

Two primary pieces of equipment are available for rubblization, and both are permitted to be used in TxDOT specifications. As shown in Figure 1, the resonant breaker method used by Resonant Machines, Inc. (RMI) employs a high-frequency, low-amplitude tamper to fracture the pavement. More details of the equipment are available on the company's website (1). The other common rubblizing equipment is the multi-head breaker (MHB) used by Antigo Construction as shown in Figure 2. This equipment uses 12 drop hammers that impact the pavement to accomplish rubblization. More details of this equipment are available at Antigo's website (2). The end result of both machines is to reduce the concrete to a very high quality base layer. Both sets of equipment normally target one lane mile for rubblization in one day. The RMI is reported to provide a more uniform slab fracturing with depth, whereas the Antigo unit can change the drop heights, so it can impart a lower impact if less fracturing is required. No matter what, both units have to meet the fracturing specified in the prevailing specification.

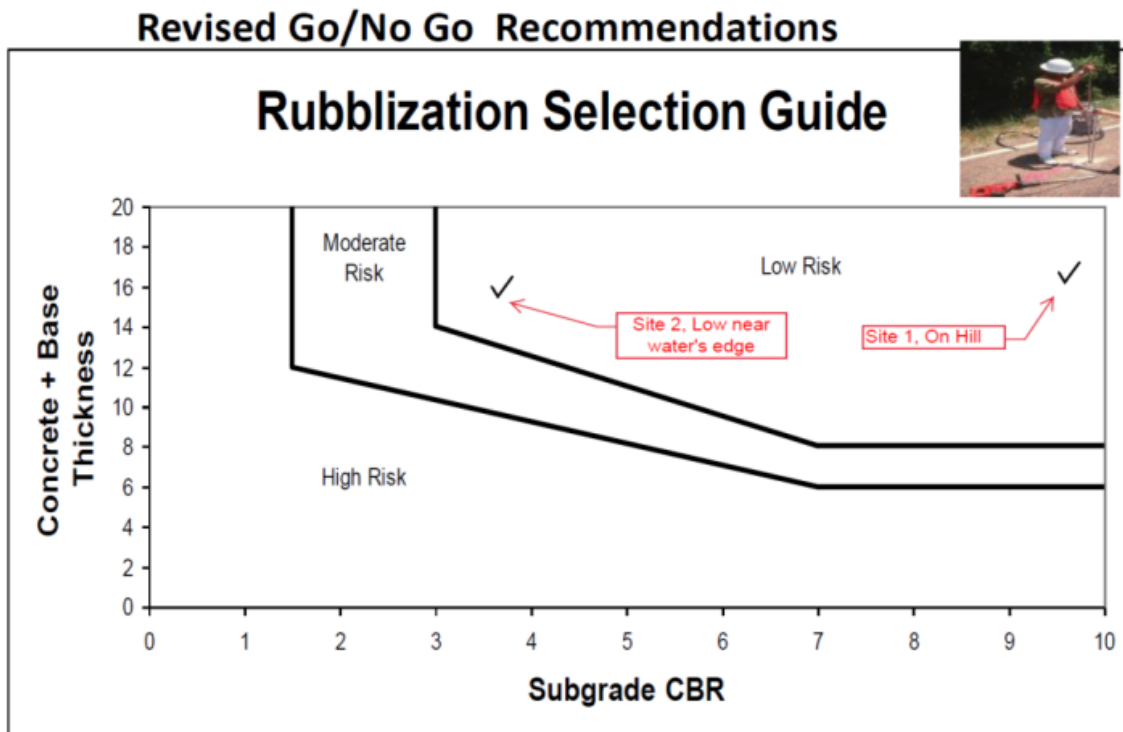
**Figure 4. DCP Criteria to Evaluating the Risk Associated with Rubblization Based on Base Support as Measured by the DCP.**

Full details are provided on each of these steps in the workshop materials that were also developed as part of study 5-4687-03, a summary of the required steps will be described below. The first step is to determine if the deteriorated concrete pavement is a good candidate for rubblization. As will be demonstrated in the case studies, this involves testing with ground penetrating radar (GPR) and falling weight deflectometer (FWD). The key requirement is to have reasonable support directly below the existing concrete slab, without which the slab cannot be adequately broken. The support is judged by the dynamic cone penetrometer (DCP) testing of the 6 to 12 in. of material under the slab; Figure 4 presents the proposed criteria. These recommendations were initially proposed by Marshall Thompson for the Illinois DOT (3, 4), and they were subsequently modified and validated for use in Texas in study 0-4687-2 (5).

The biggest concern with rubblization in Texas was the poor performance of the first few projects attempted in the 1990s. Texas has many miles of old thickened edge jointed pavements constructed from 1920 to 1940. These are known as the 9-6-9 pavements, often only 18- to 20-ft wide. The edges are 9 in. thick and reinforced; and the center of the slab is only 6 in. thick. The biggest problem is that these 9-6-9 pavements were constructed on a select fill layer that was often low plasticity index sand. Over the years, this sand has been contaminated with the clay materials it is sitting on. Rubblization is only effective when the concrete slab is sitting on something solid so that it can be fractured. Basically 9-6-9 pavements are not good candidates for rubblization. When this work was started in the 1990s, TxDOT did not have a good procedure for evaluating candidate projects to determine if rubblization is even feasible. This was developed as part of research study 0-4687; this is the criteria described earlier and summarized in Figure 4.

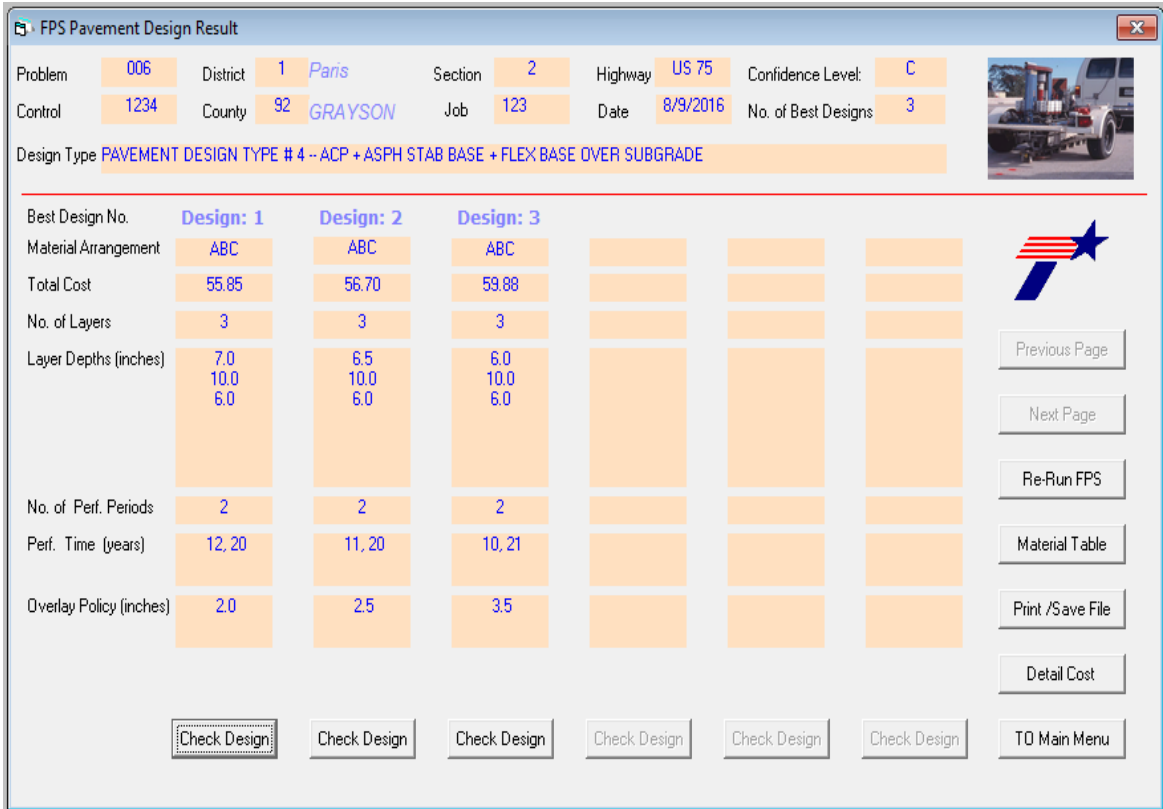
**Figure 10. HMA Design Options.**

Figure 10 shows the acceptable designs that will meet the input time to first overlay of 10 years. The 7 inches of HMA design was selected for further evaluation.

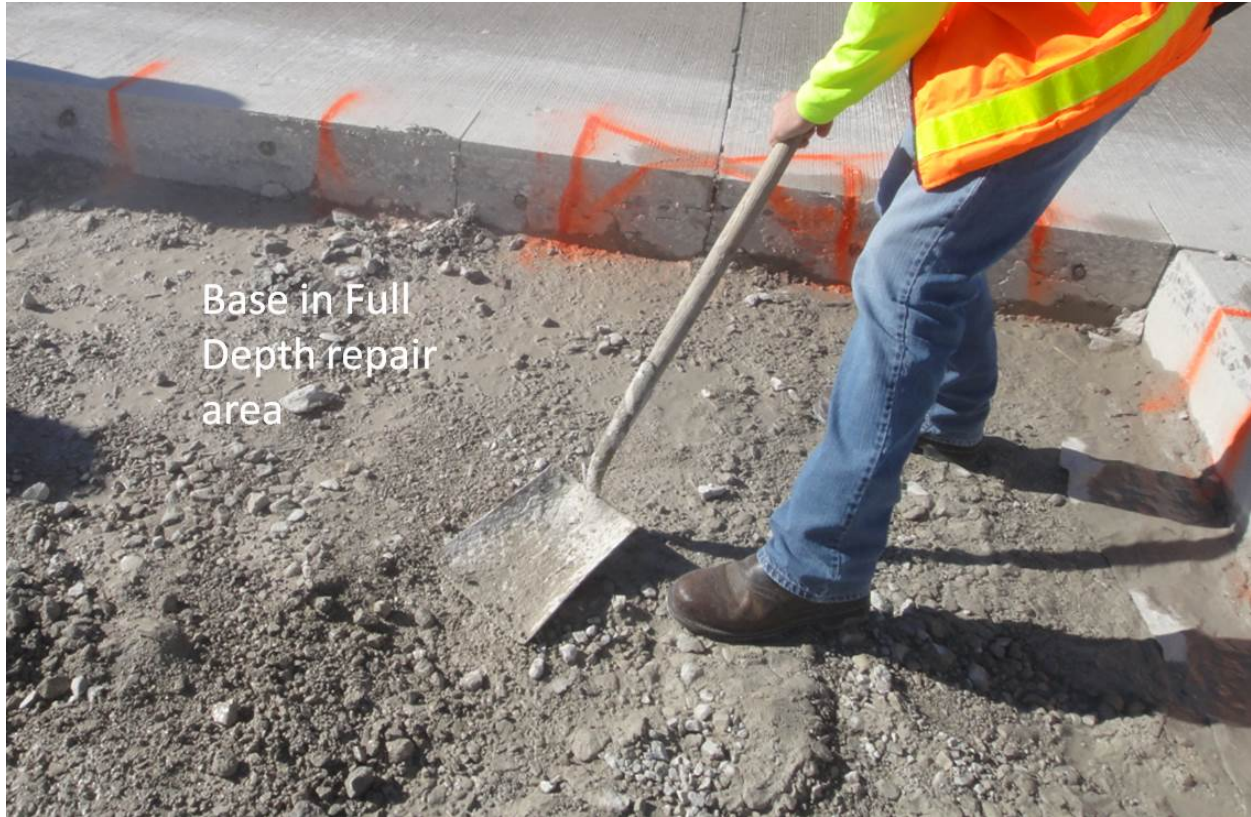
Figure 14 shows a photo of the flexible base under the slab on US 75. The base is fairly good quality material. The problem with the base is that it is saturated with water entering the pavement at the lane/shoulder longitudinal joint. Work is underway to install edge drains to remove this trapped water. No pavement design will work without a successful installation of an operational drain.

**Figure 14. Existing Base on US 75 (Good Quality).**

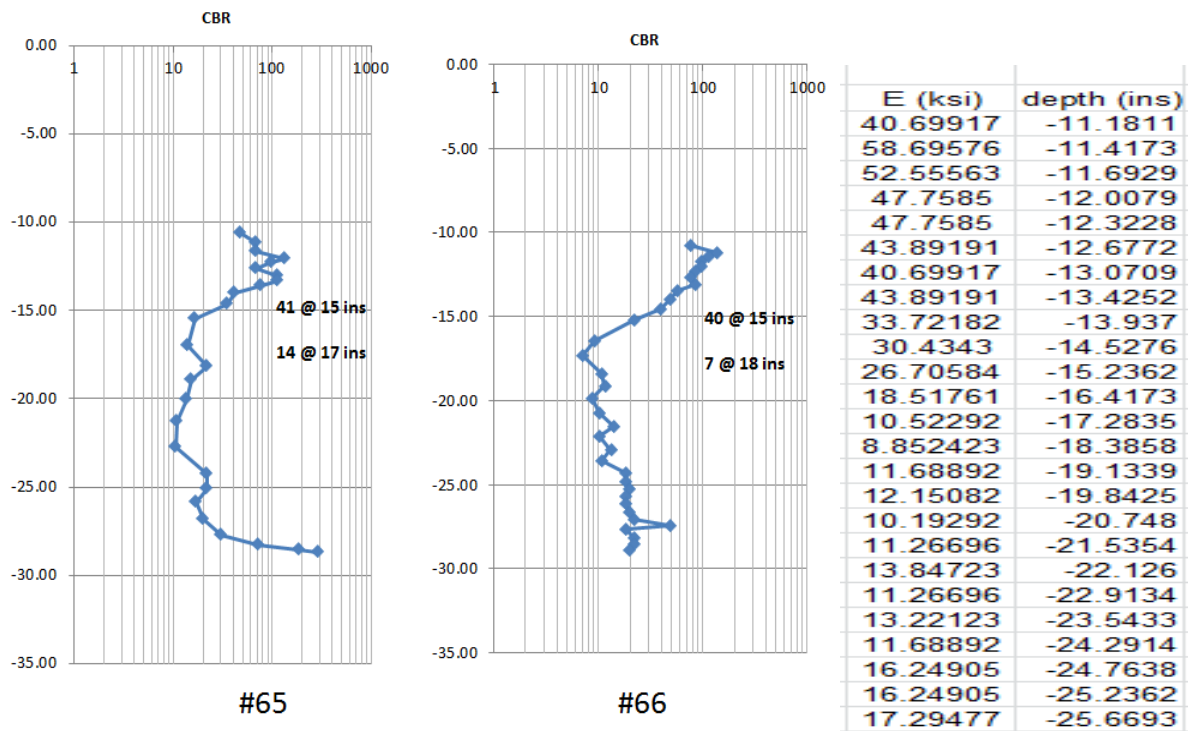
Figure 15 shows DCP data from two locations tested in the areas proposed for the rubblization test section. An access hole was drilled through the concrete slab, and penetration testing started at the top of the base. The two graphs show the California Bearing Ratio plots with depth. The worst results were from location #66. The tables of numbers show the depth below the surface and the modulus value predicted from the DCP data using the procedures documented in TxDOT pavement design manual. The base is typically running around 40 ksi, and the lowest value in the subgrade was 8 ksi. These values were used in the FPS 21 design. These values are conservative, as once the base is drained, it is anticipated that these values will increase.

**Figure 15. DCP Data on Base and Subgrade (Stiff Layer Encountered 30 Inches Down).**

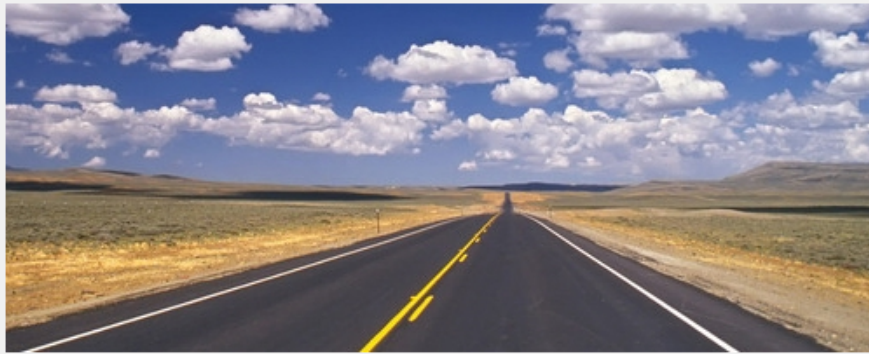
Rubblization Design for US96  
6.88 million ESAL, 11,400 (current) and 15, 800 (20 yrs). Truck 13.1%

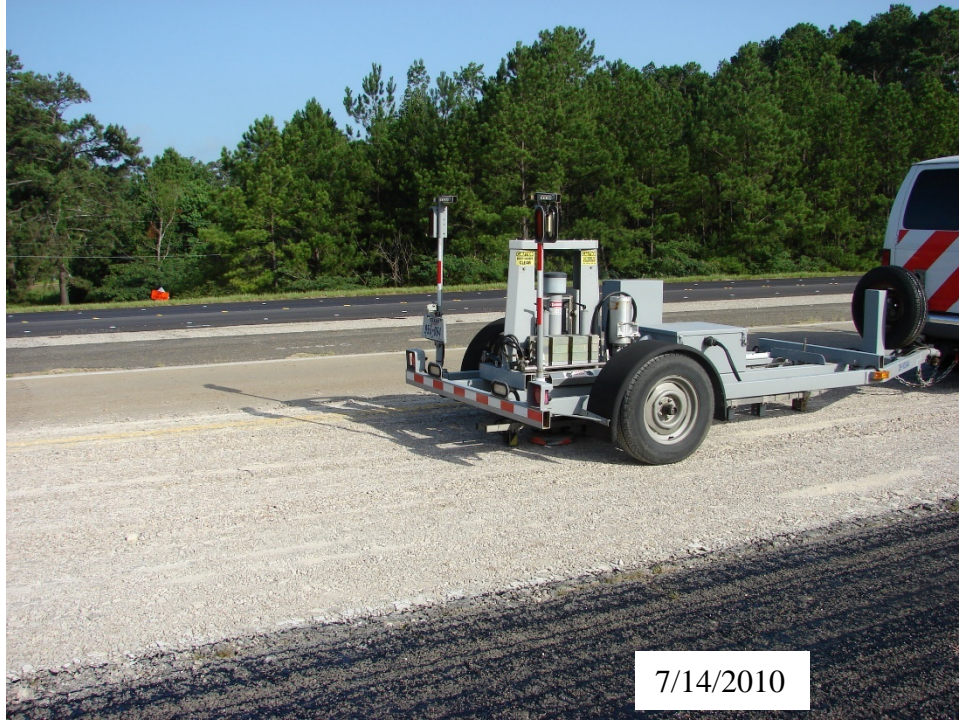
Figure 23 and Figure 24 show FWD testing on top of rubblized concrete (rubble) and conditions on one of the worst joints during rubblization in July 2010. Figure 25 illustrates the comparisons of FWD maximum deflections (normalized to 9000 lb) between those from on top of rubblized concrete (rubble) and immediately after a 4.5-inch HMA overlay. Significant deflection reductions were observed. Figure 26 shows the backcalculated modulus values from 2010

**Figure 23. FWD Testing on Top of Rubblized Concrete (Rubble).**

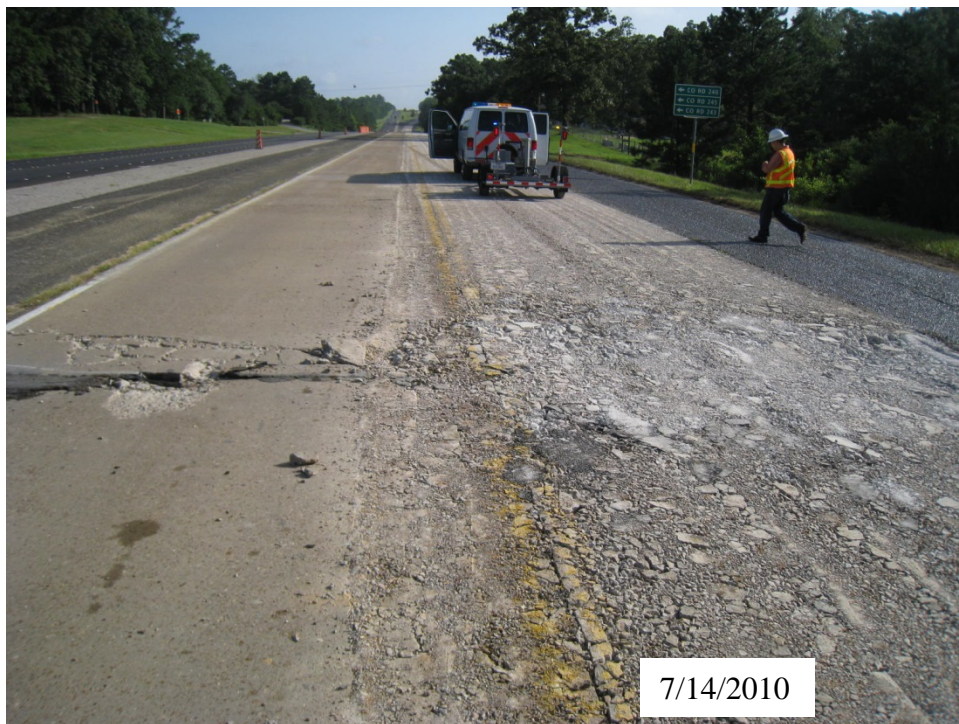
**Figure 24. Rubblized (rubble) Concrete Conditions on One of the Worst Joints.**

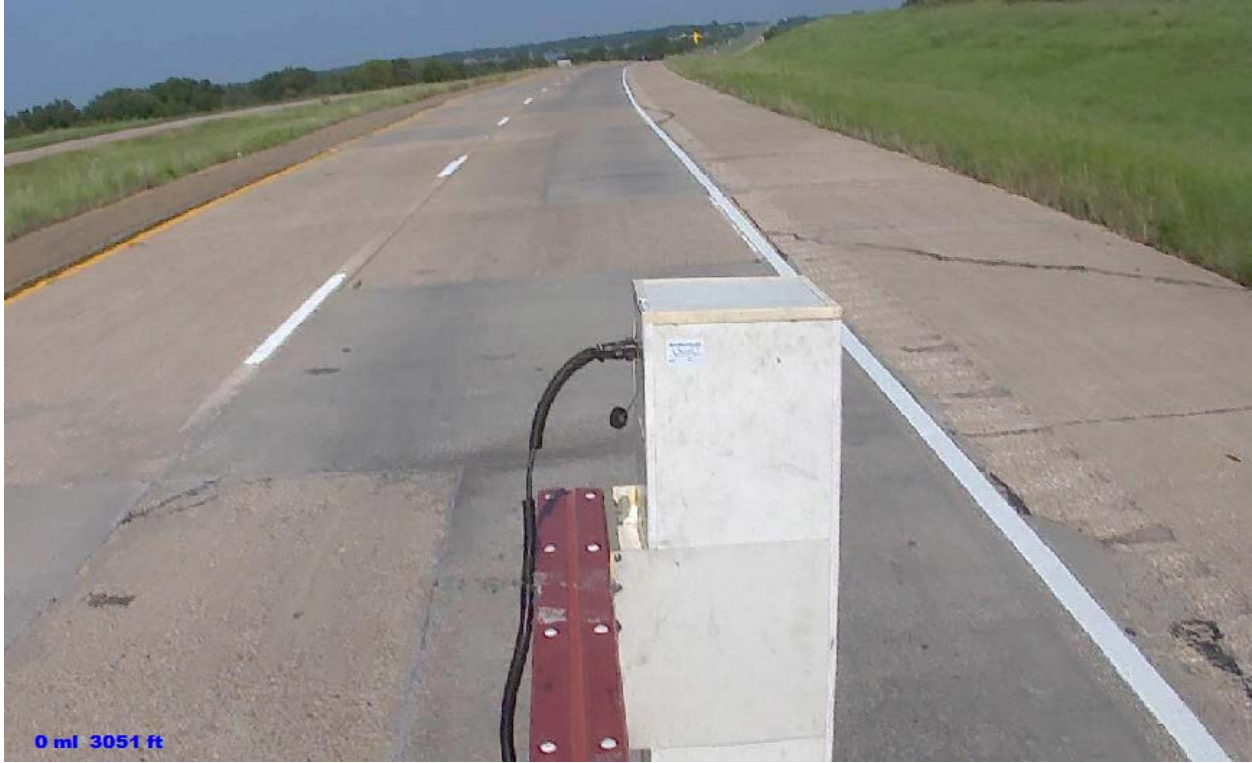
Figure 28 and Figure 29 show the sites of the proposed rubblization test sections. The first is about 2 miles north of Mabank. It is extensively patched because of cracking and roughness. This patching gives the section a very low Pavement Management Information System score. About 0.5 miles farther north just after the first bridge, the roadway has numerous wide longitudinal cracks. The patched and cracked sections are long, so it should be straightforward to select a 500- to 1000-ft rubblization test section.

**Figure 28. Rubblization Candidate Section 1 about 2 Miles North of Mabank.**

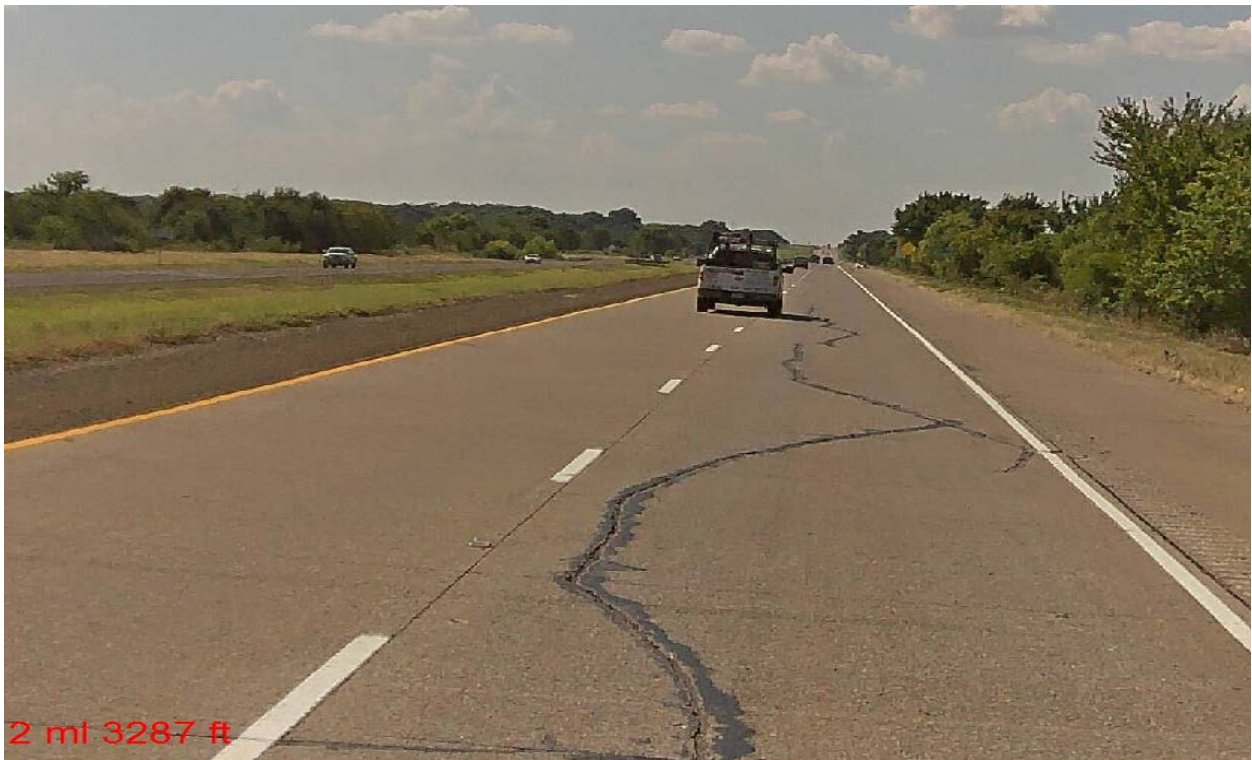
**Figure 29. Candidate Section 2 on US 175 about 2.5 Miles North of Mabank.**

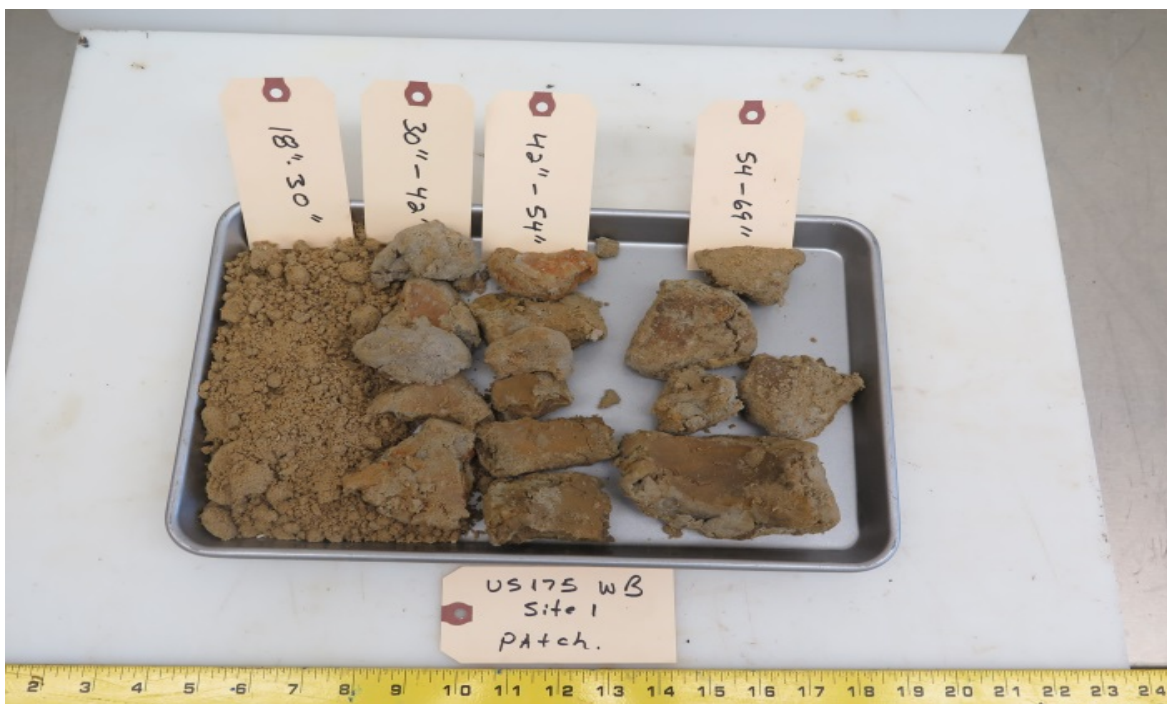
Figure 32. The Subgrade on Each Site Was Found to be a Tan Sandy Clay.

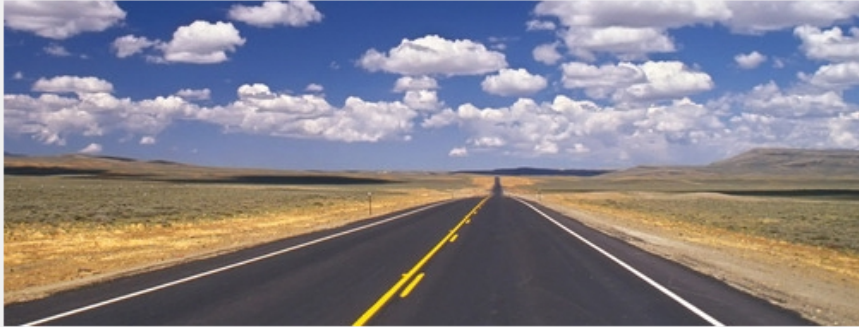
**Figure 33. Screen 1 in FPS for US 175 Rubblization Design.**

COMMENTS Rubblization Design for Test section on US 175  
Traffic 5.3 million ESAL 16.3k to 22.6k with 7.6% trucks  
Slab thickness 12 inches with variable Modulus 200-500 ksi  
Subgrade 6 ksi from DCP, existing HMA base at 50 ksi  
Traffic growth 2%

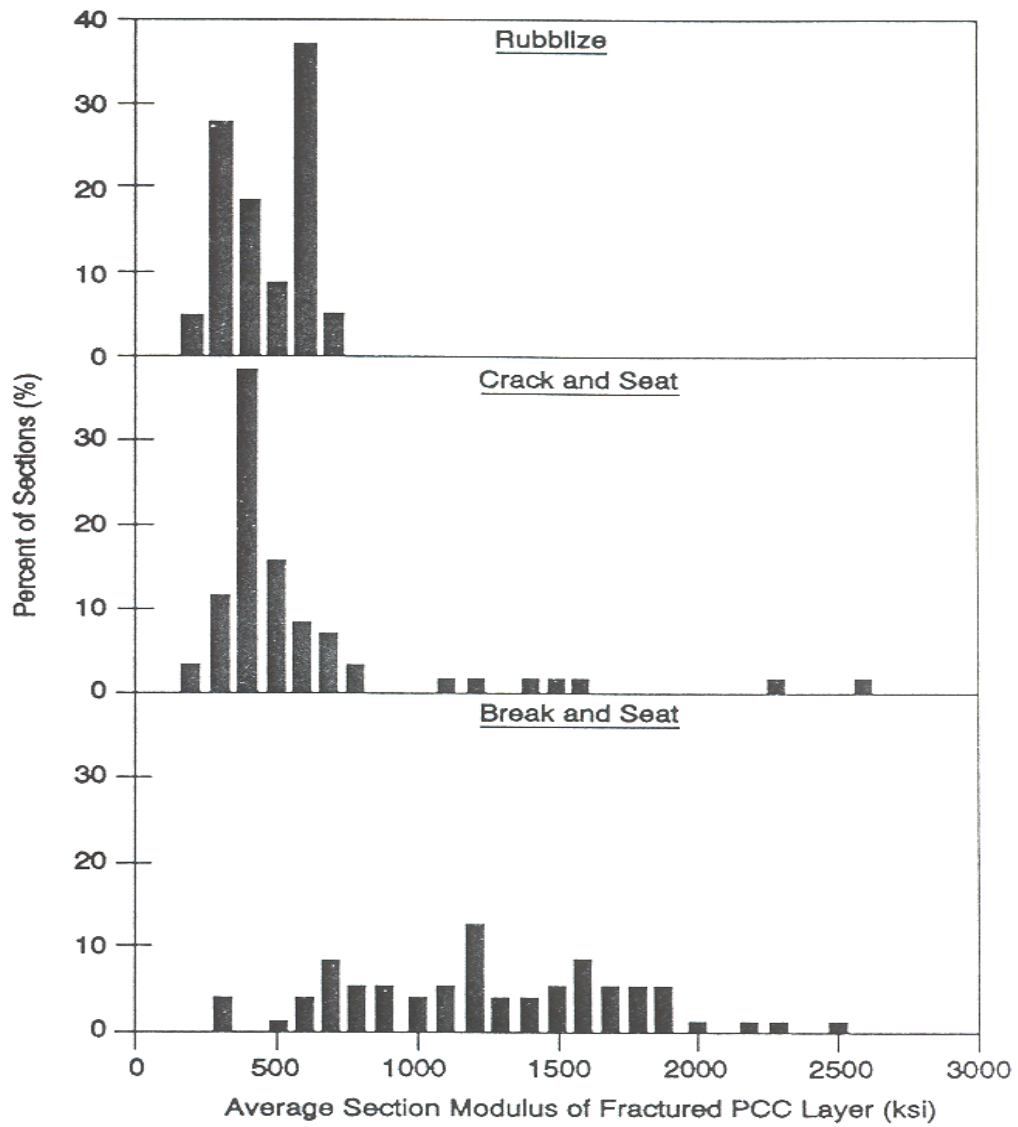
Figure 40 shows the results from a previous national study showing what moduli values can be anticipated for fractured concrete. The top graph shows the values found by the research team. The range they reported was from 200 to 700 ksi. The biggest challenge in performing this pavement design is to arrive at a reasonable conservative design value for the rubblized concrete on US 175.

**Figure 40. National Study Recommendation on Moduli of Rubblized Layers.**
