# **IMPLEMENTATION OF TEXAS ASPHALT CONCRETE OVERLAY DESIGN SYSTEM**

Report 5-5123-03-1

Project 5-5123-03

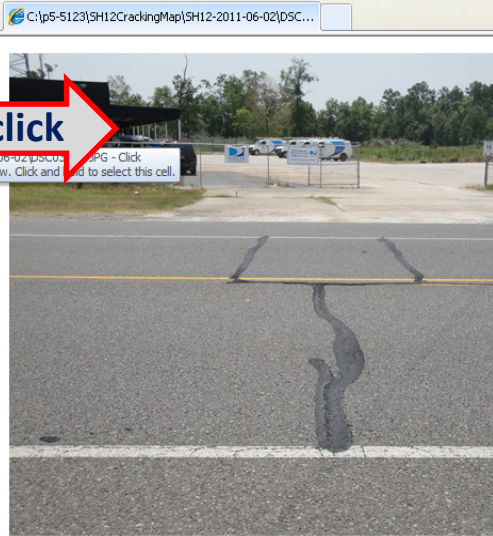
**Figure 3-1. Cracking Data Format.**

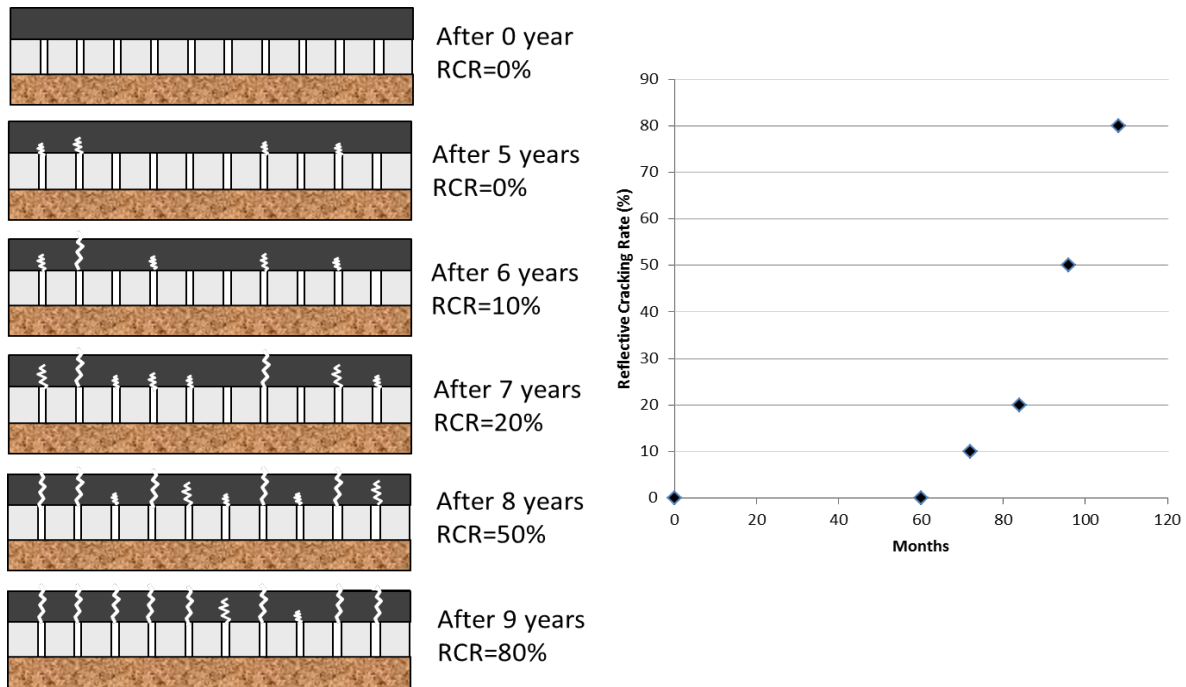
The RCR (%) is defined by the percentage ratio of reflected crack number over existing crack number. Although the concept is straightforward, it still needed some clarification before field surveys and data analysis. [Figure 3-2](#) illustrates the RCR concept. In [Figure 3-2](#), the existing crack number (or joint number for Portland cement concrete [PCC]) is 10. After five years, although some cracks propagated in the vertical direction, no crack propagated to the surface, which means no crack could be observed from the surface. Thus, the RCR is still 0 percent. After six years, one crack propagated to the surface, and the RCR becomes 10 percent. If a crack propagated to the surface and could be clearly observed during the survey, it was counted as one reflected crack, regardless of its length or width. Furthermore, if a crack exhibited double or multiple lines, it was still counted as one crack if the lines were less than 5 ft apart.

**Figure 3-2. RCR Concept.**

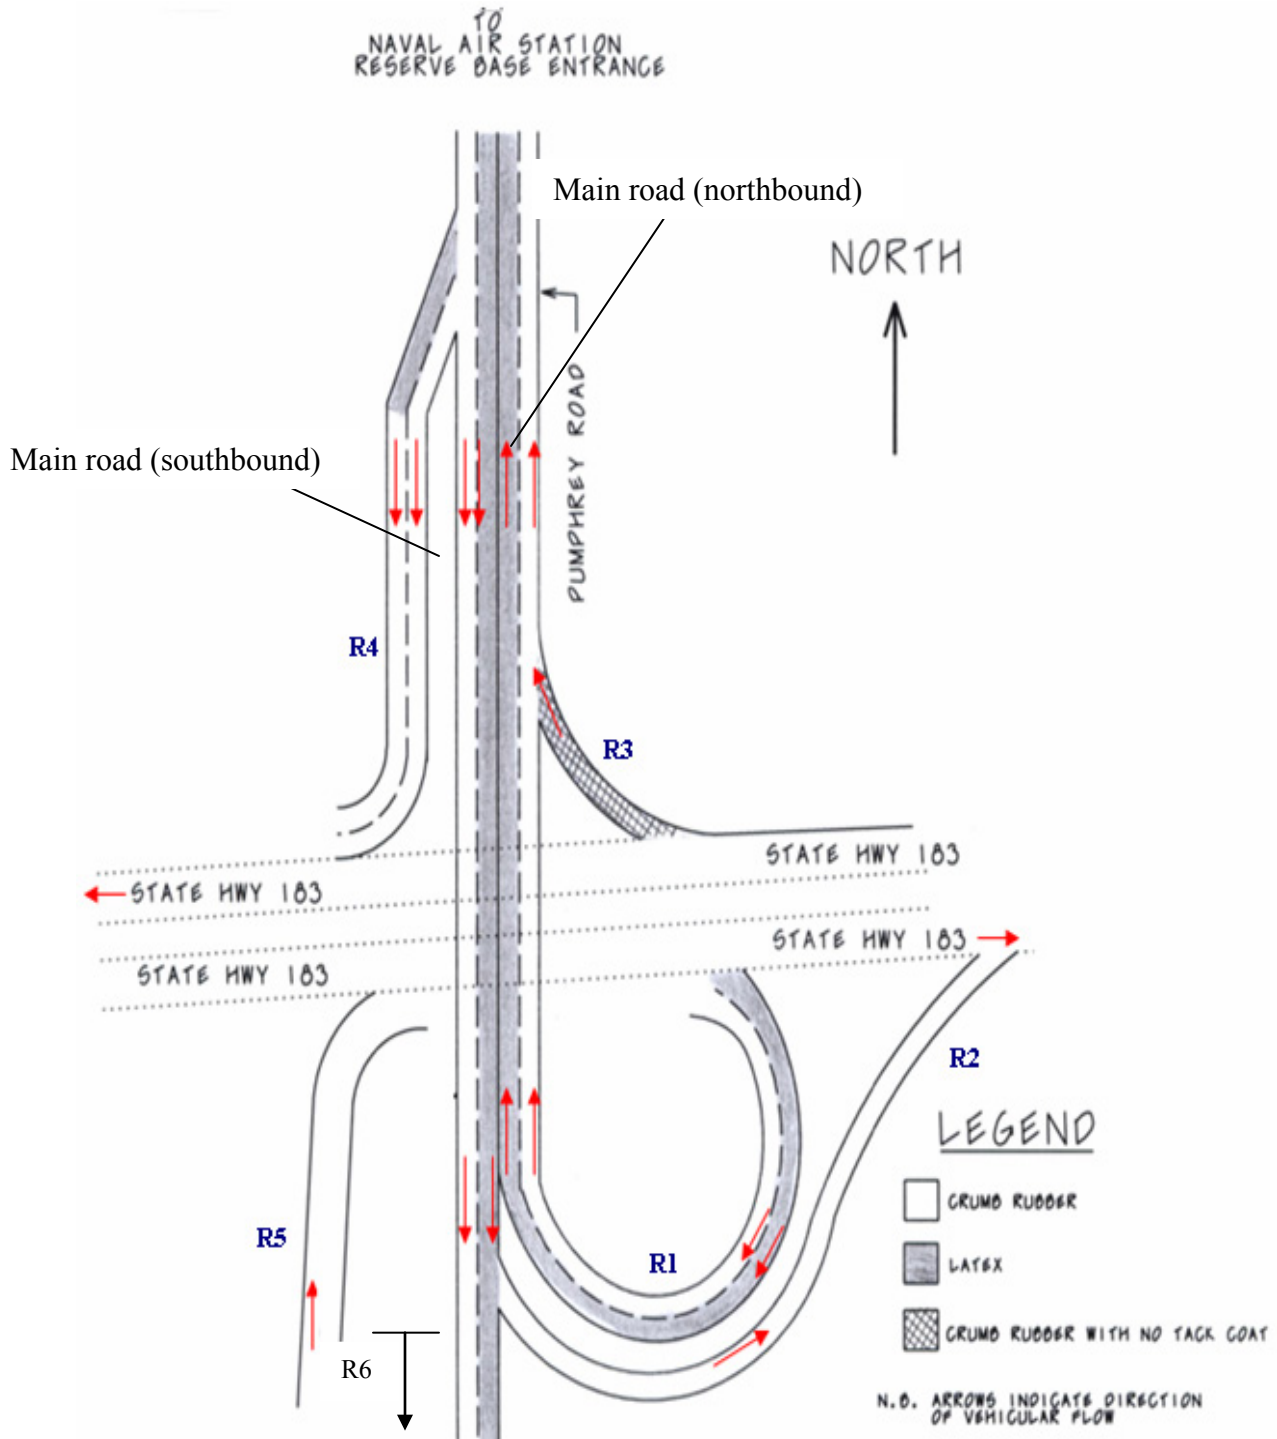
mix was modified with 7 percent crumb rubber (mainly used in the outside lane of the main road), and the other was modified with 3 percent styrene-butadiene rubber (SBR) latex (mainly used in the inside lane of the main road). [Figure 3-4](#) shows the plan view of the main road (southbound and northbound) and ramps (from R1 to R6). A total of eight test sections were surveyed.

Figure 3-4. Plan View of Pumphrey Street Sections (drawing not to scale).

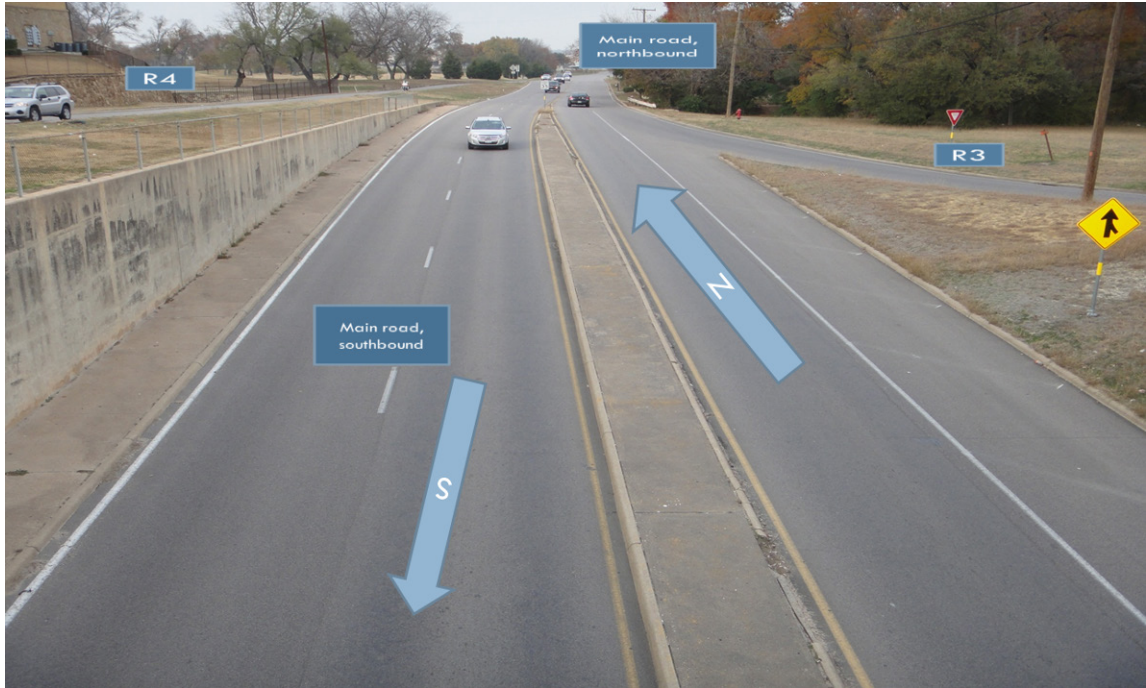
**Figure 3-5. Photo of Pumphrey Street Sections (taken from overpass, facing north).**

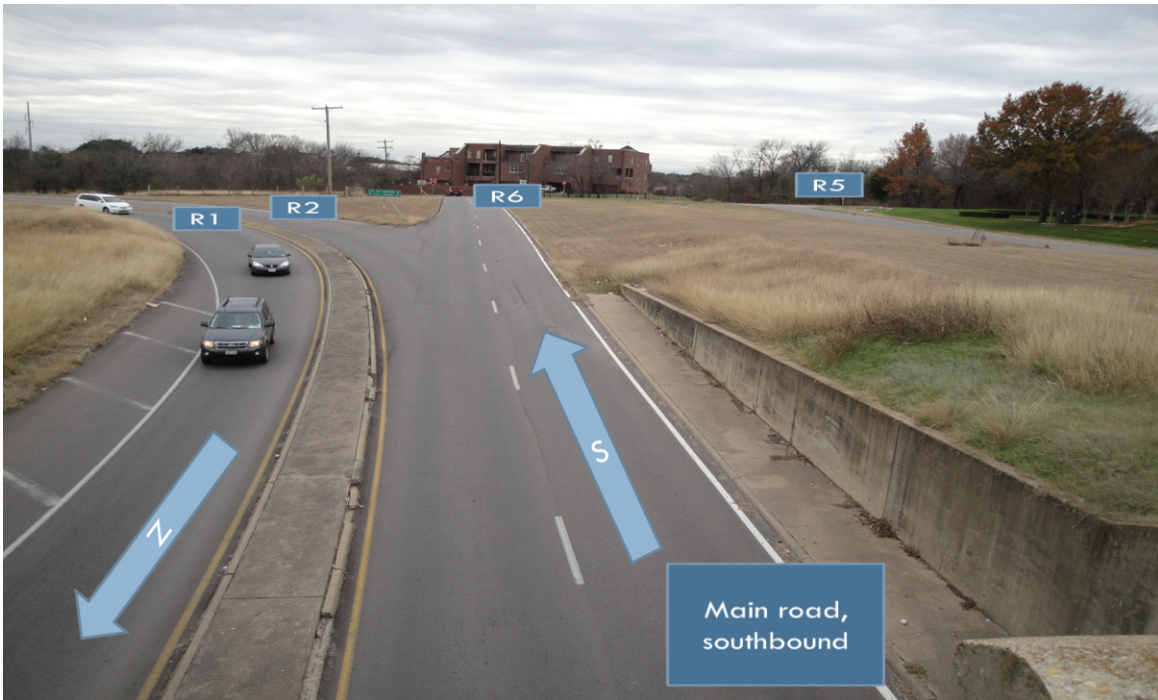
**Figure 3-6. Photo of Pumphrey Street Sections (taken from overpass, facing south).**

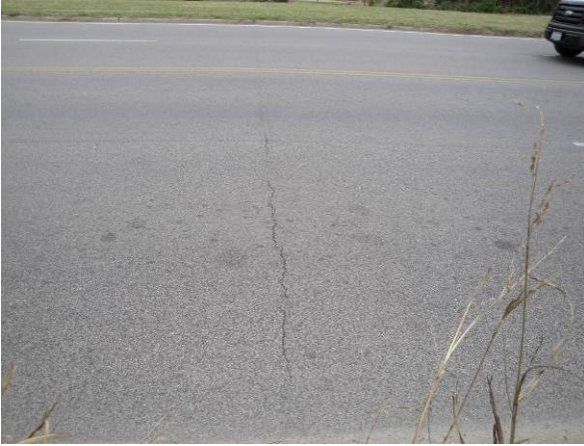
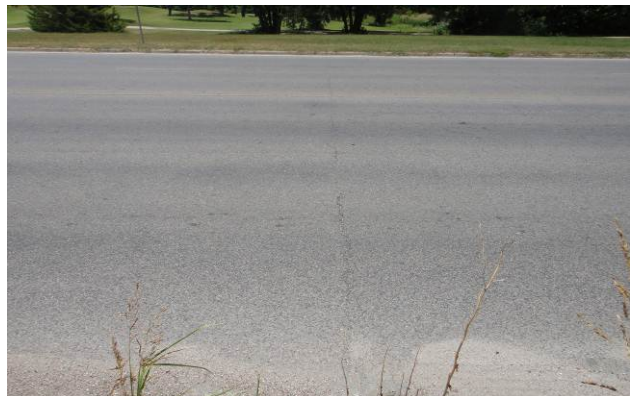
**Figure 3-7. Photos of the Same Crack in Pumphrey Street on Each Survey Date.**

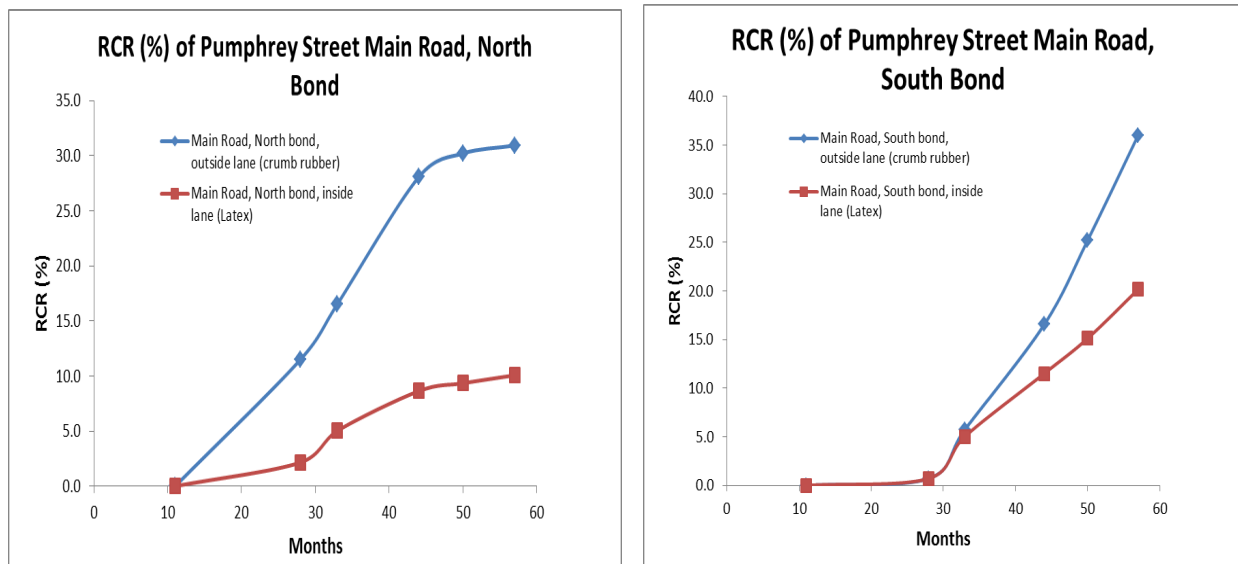
Figures 3-8 to 3-9 show the RCR developing curves of the Pumphrey Street sections. These figures show that the RCR on the ramps was much larger than on the main lanes. The reason might be that the existing layer on the main lanes was pre-treated before asphalt overlay, and the LTE at joints was improved. Another finding was that the outside lanes in both directions (southbound and northbound) had higher RCR than the inside lanes, which implies that the latex mix performed better than the crumb rubber mix in terms of cracking resistance.

**Figure 3-8. RCR vs. Months of Pumphrey Street Main Road Sections.**

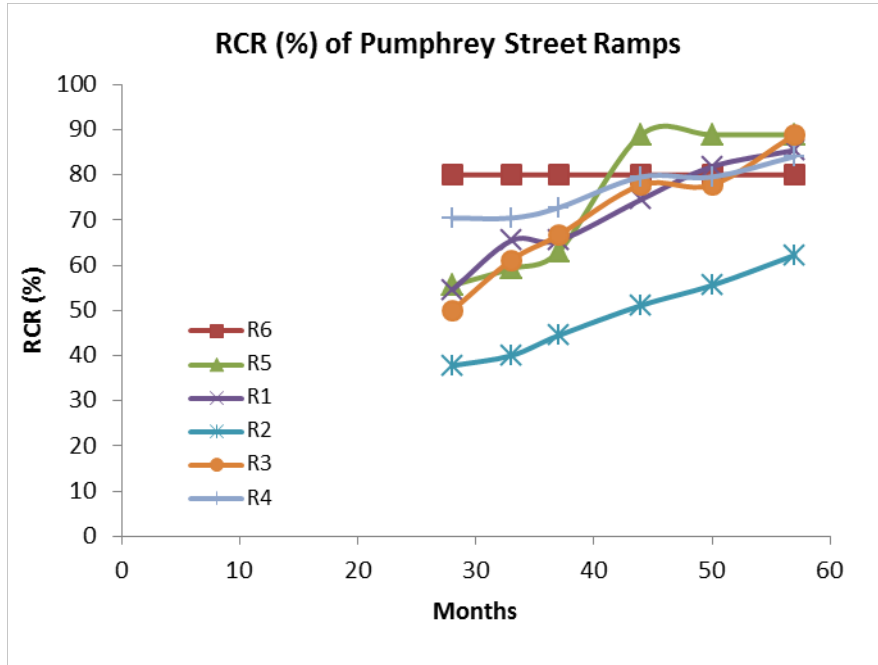
**Figure 3-9. RCR vs. Months of Pumphrey Street Ramp Sections.**

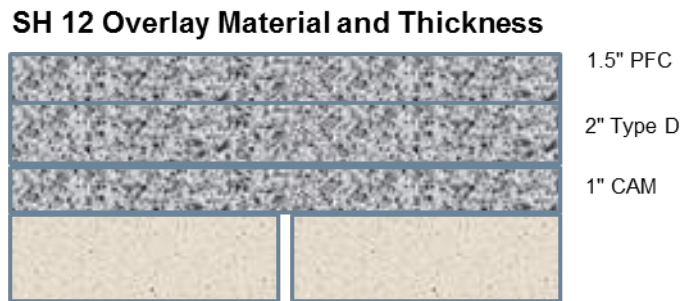
The overlay section on SH 12 was constructed in September 2006 with 1 inch crack attenuation mix (CAM), 2 inch Type D, and 1.5 inch porous friction concrete (PFC). See [Figure 3-10](#).

**Figure 3-10. Schematic Diagram of SH 12 Pavement Structure.**

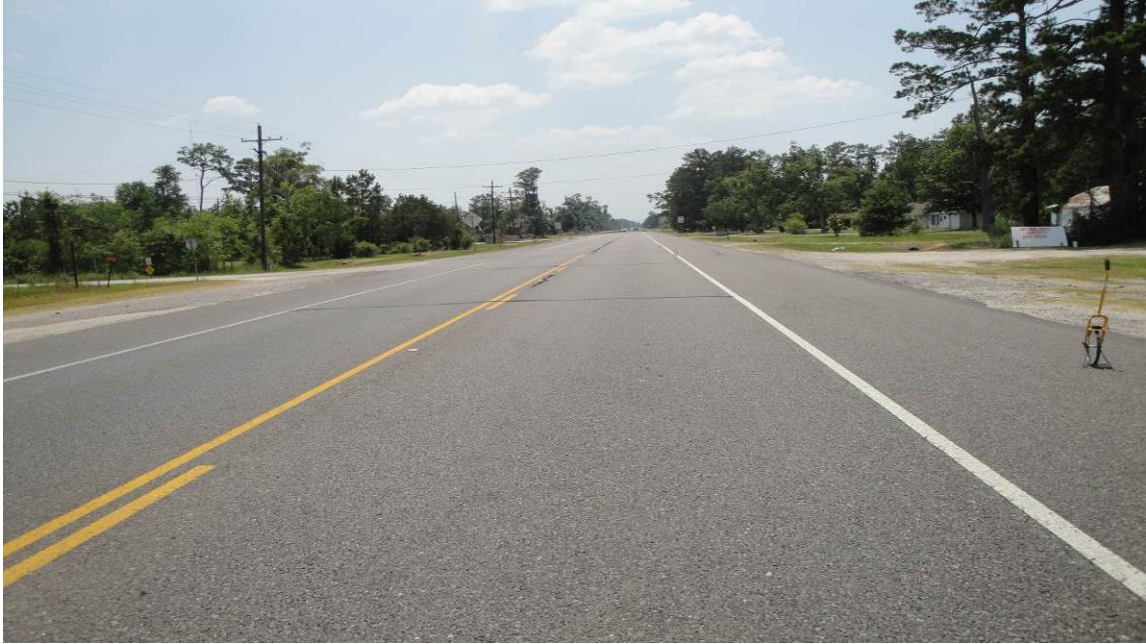
[Figure 3-11](#) shows the overview of this section.

**Figure 3-11. SH 12 Test Section Overview.**

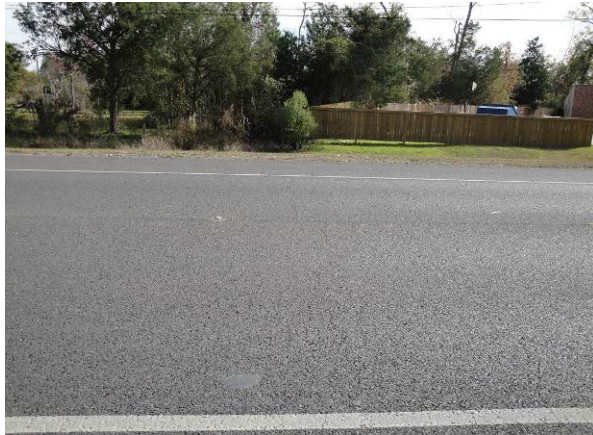
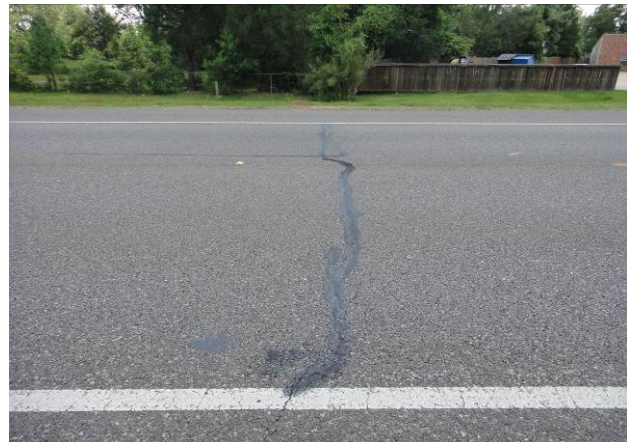
The surveys were conducted on December 9, 2009, April 23, 2010, December 9, 2010, June 2, 2011, October 13, 2011, and May 17, 2012. [Figure 3-12](#) shows the photos of the same crack during each survey on SH 12. All the observed reflective cracks had already been sealed with crack sealant in the spring of 2011.

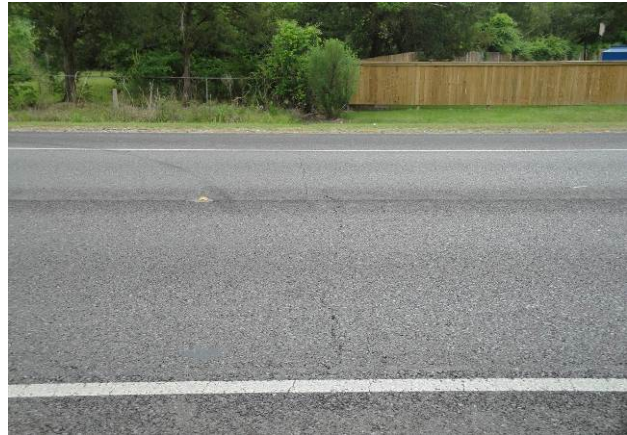
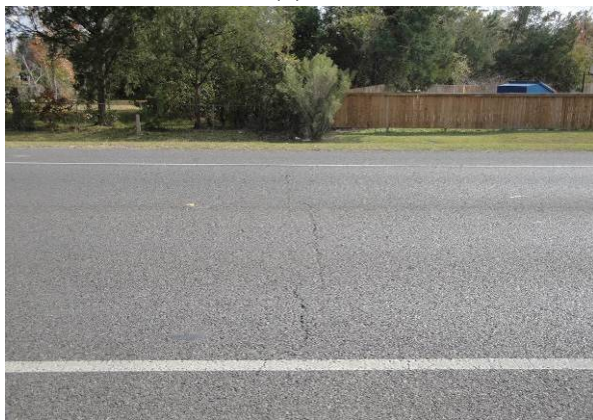
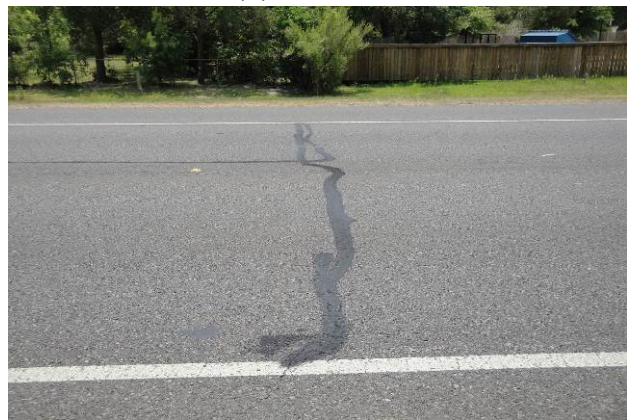
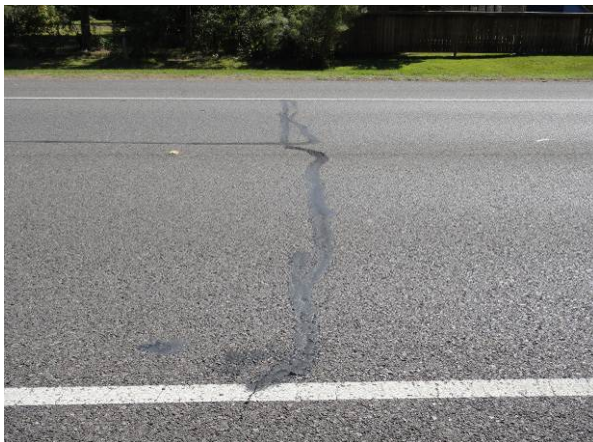
**Figure 3-12. Photos of the Same Crack in SH 12 on Each Survey Date**

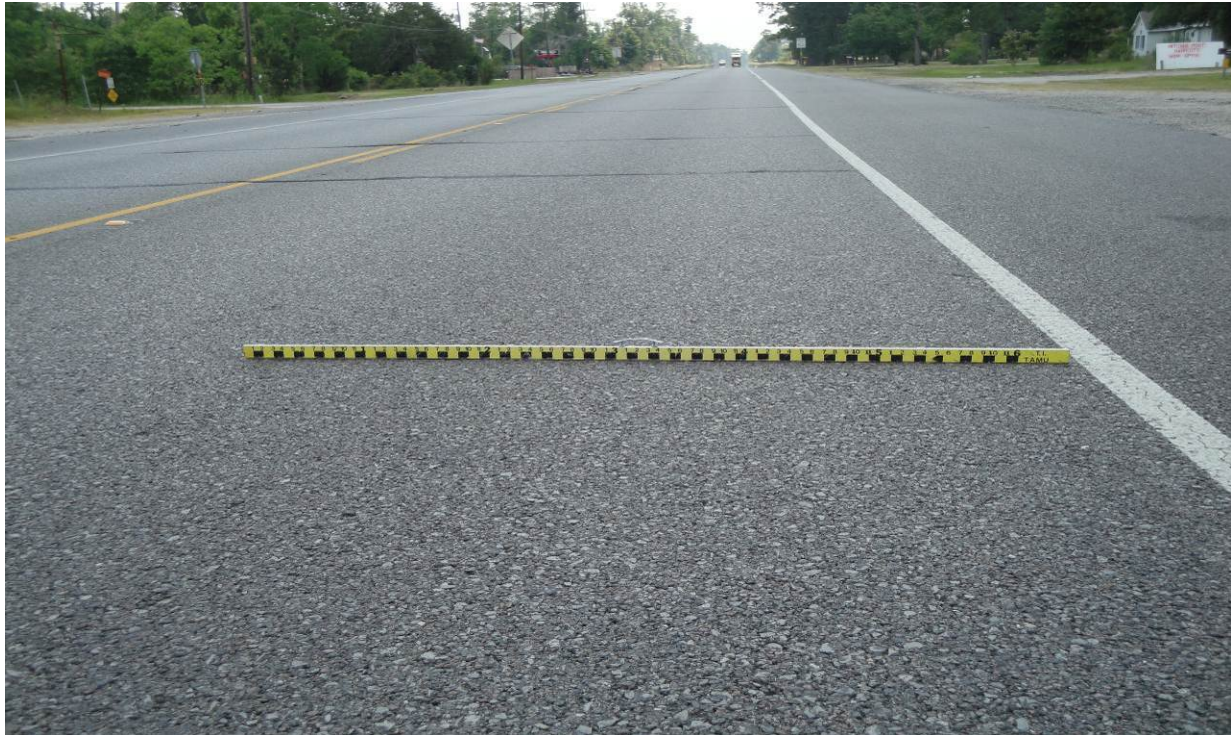
No rut was found in this section. See [Figure 3-13](#).

**Figure 3-13. Rut Measurement on SH 12.**

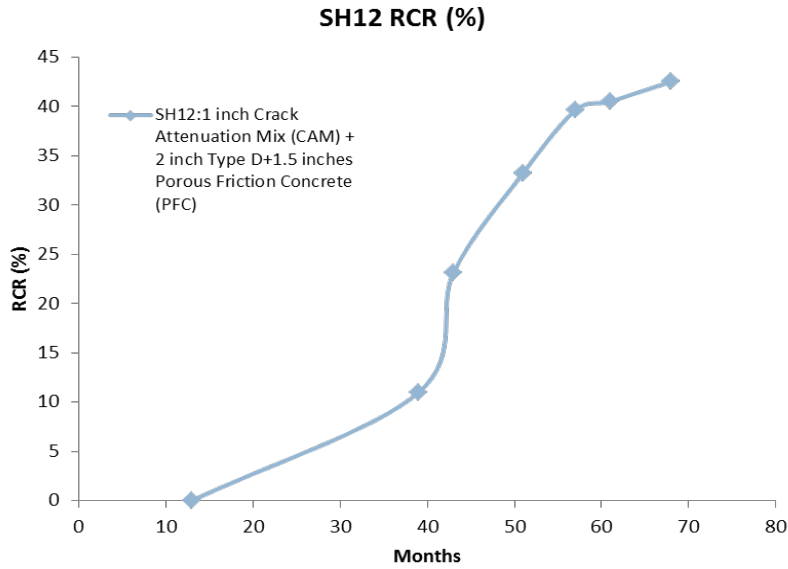
Figure 3-14 shows the curve of RCR vs. months.

**Figure 3-14. SH 12 RCR (%) vs. Months.**

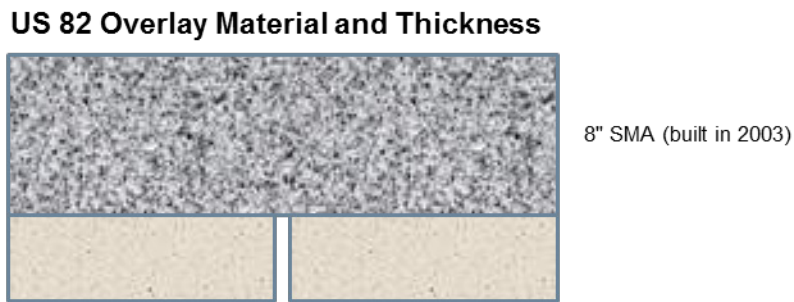
This section had 8 inch stone mastic asphalt (SMA) overlay and was constructed in 2003.

**Figure 3-15. Schematic Diagram of US 82 Pavement Structure.**

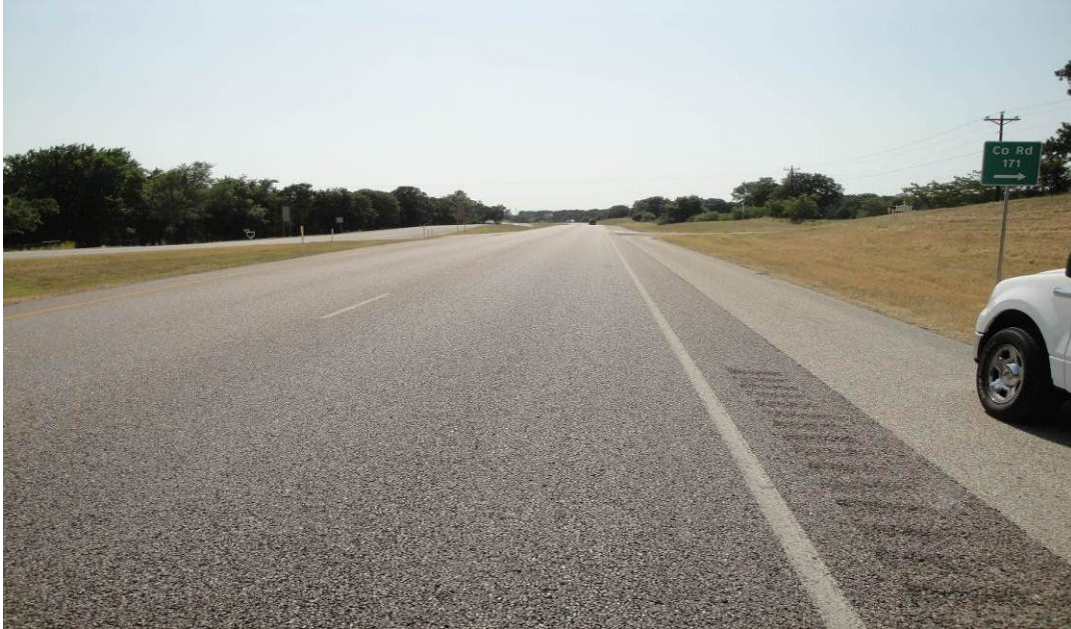
The surveys were conducted on December 17, 2009, April 30, 2010, December 16, 2010, June 17, 2011, December 8, 2011, and July 19, 2012. After 9 years of service under heavy traffic, there were still no cracks observed on the surface. See [Figure 3-16](#).

**Figure 3-16. US 82 Overlay Section Overview.**

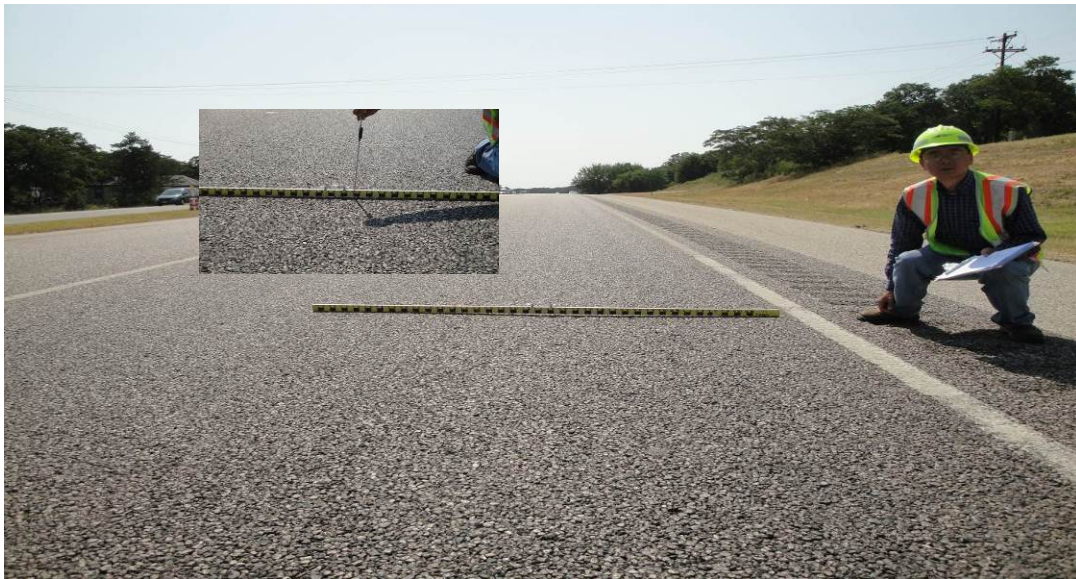
However, in some areas, especially uphill areas, some rutting did exist. See [Figure 3-17](#).

**Figure 3-17. US 82 Rut Measurement.**

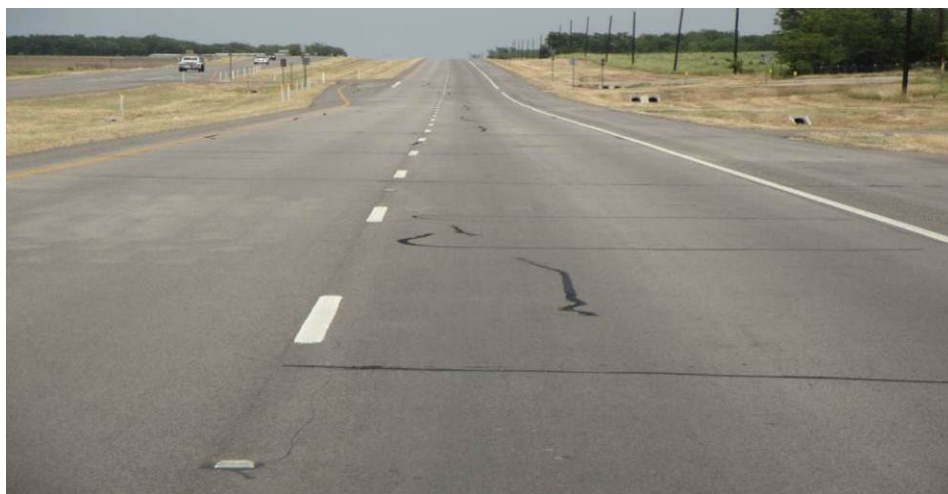
[Figure 3-19](#) shows the overview of the SH 24 test section.

**Figure 3-19. Overview of SH 24 Test Section.**

The SH 24 test section consisted of a 2.5 inch Type D mix, 3 inch Type B asphalt concrete, 11 inches of cement-treated base, 8 inches of lime treated subgrade, and natural subgrade. See [Figure 3-18](#). The 2.5 inch Type D overlay was constructed in July 2009.

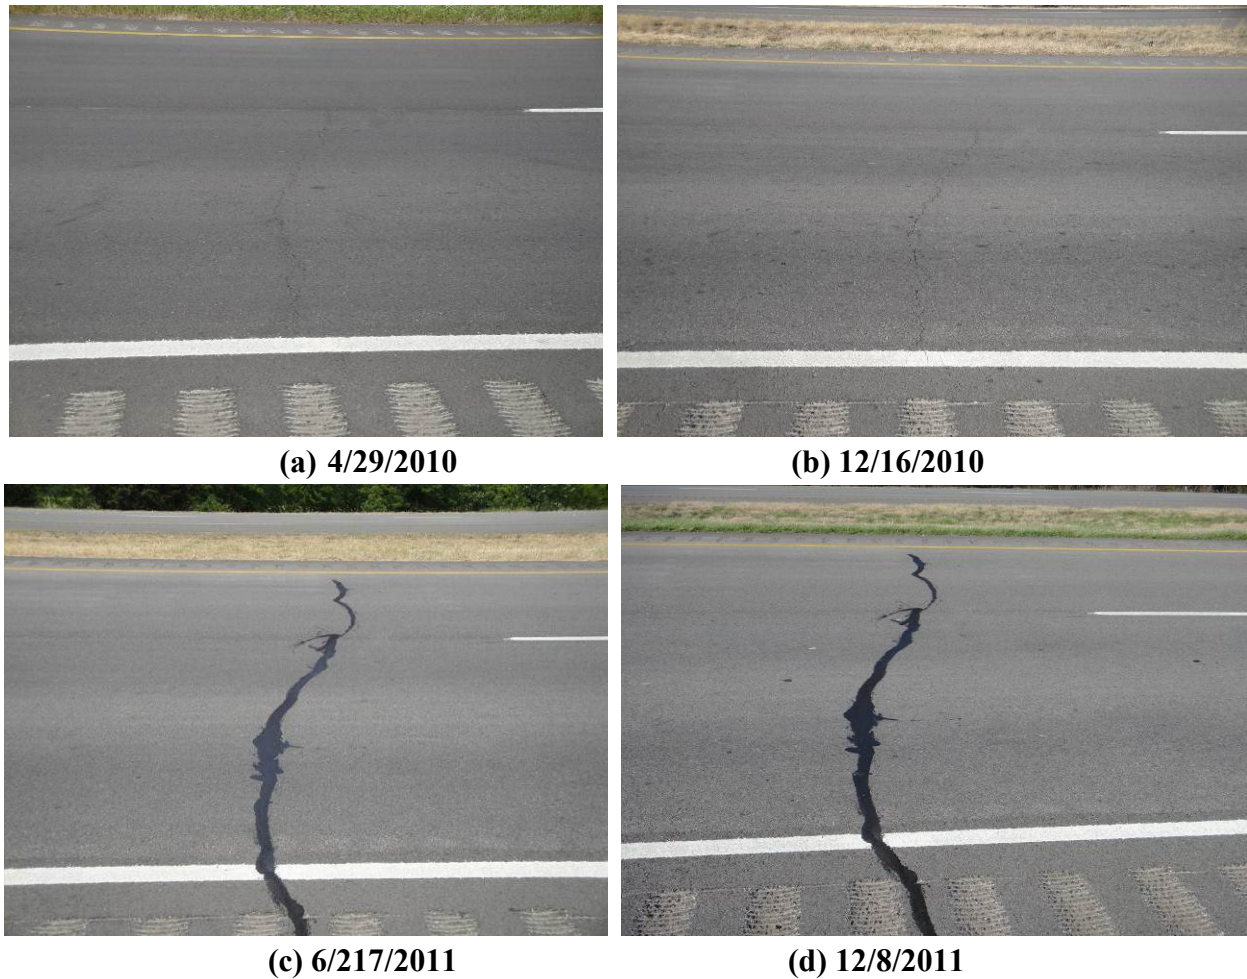
The surveys were conducted on April 29, 2010, December 16, 2010, June 17, 2011, and December 8, 2011. [Figure 3-20](#) shows the photos of the same crack during each survey.

**Figure 3-20. Photos of the Same Crack in SH 24 on Each Survey Date.**

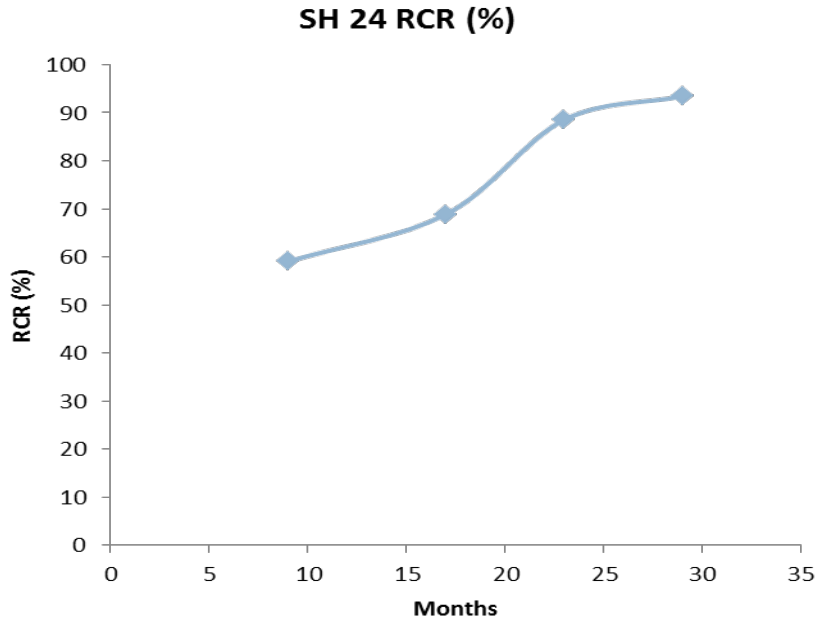
[Figures 3-21](#) illustrates the curves of RCR vs. months on SH 24.

**Figure 3-21. SH 24 RCR (%) vs. Months.**

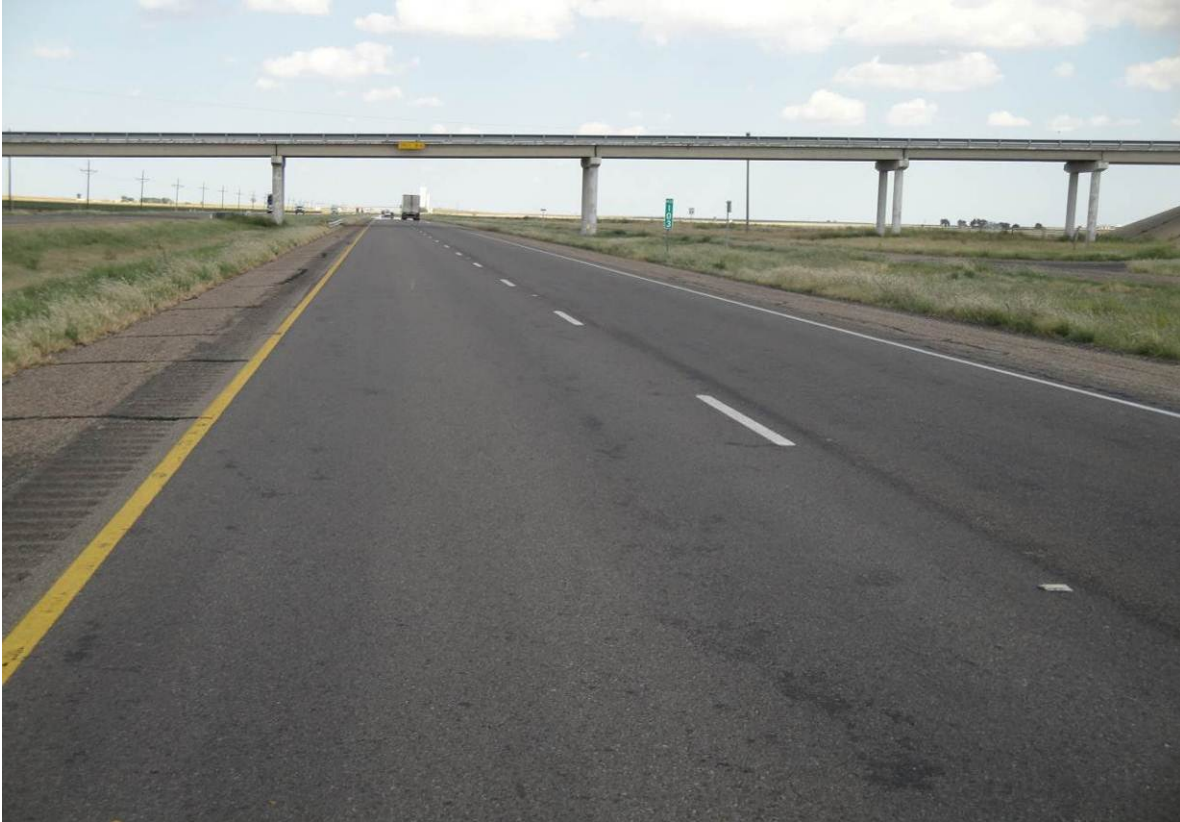
[Figure 3-23](#) shows the overview of the IH 40 test sections.

**Figure 3-23. Overview of IH 40 Test Sections.**

Four test sections were constructed in August 2009 on IH 40 eastbound. The overlay mixtures were regular 20% RAP with PG 64-28 binder designed by the contractor (section 0), 0% RAP with PG 64-28 binder designed by the contractor (section 1), 35% RAP with PG 58-28 binder designed by the Texas A&M Transportation Institute (TTI; section 2), and 20% RAP with PG 64-28 binder designed by TTI (section 3). See [Figure 3-22](#).

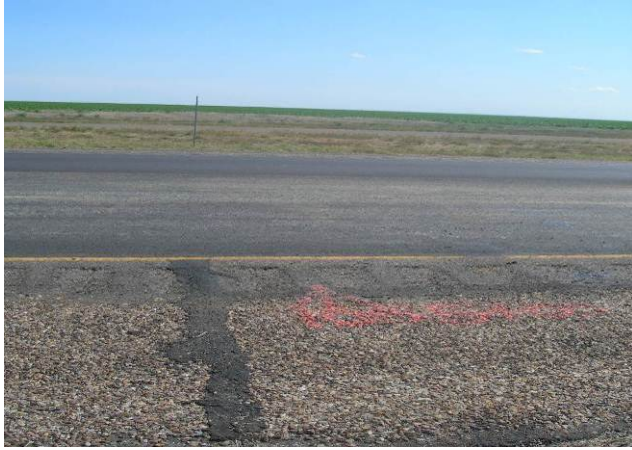
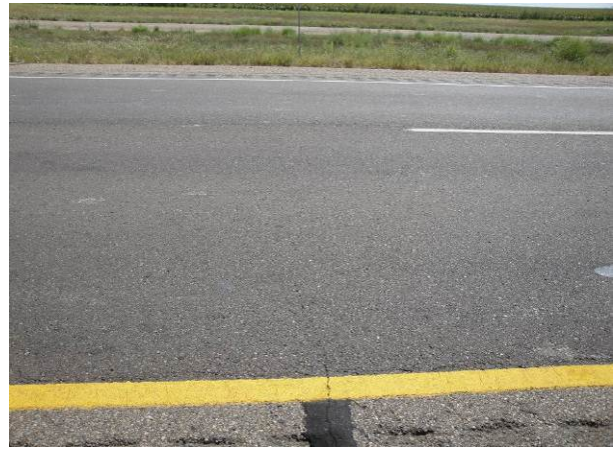
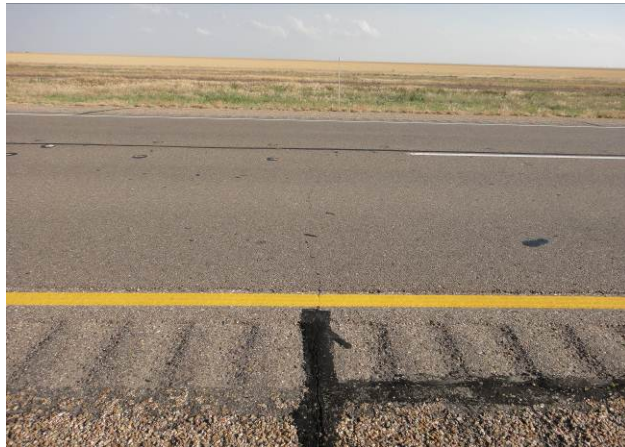
The surveys were conducted on April 22, 2010, September 8, 2010, April 5, 2011, December 15, 2011, and May 30, 2012. [Figure 3-24](#) shows the photos of the same crack during each survey. In April 2011, the westbound lanes of IH 40 in this area were under construction, so the eastbound lanes were divided into two directions of traffic, as seen in [Figure 3-24\(c\)](#).

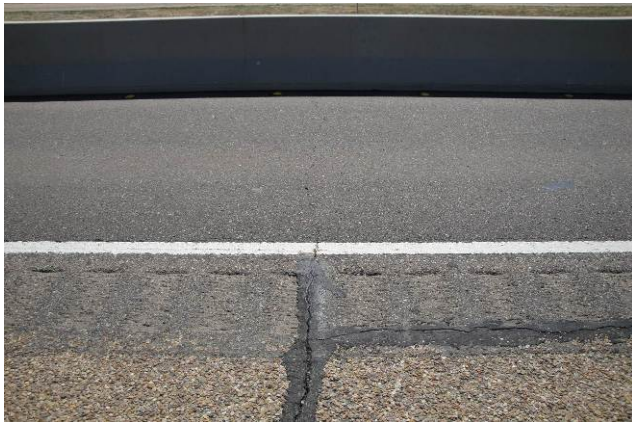
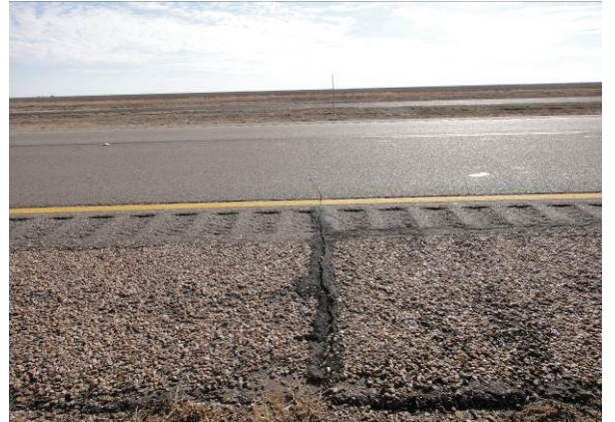
**Figure 3-24. Photos of the Same Crack on IH 40 on Each Survey Date.**

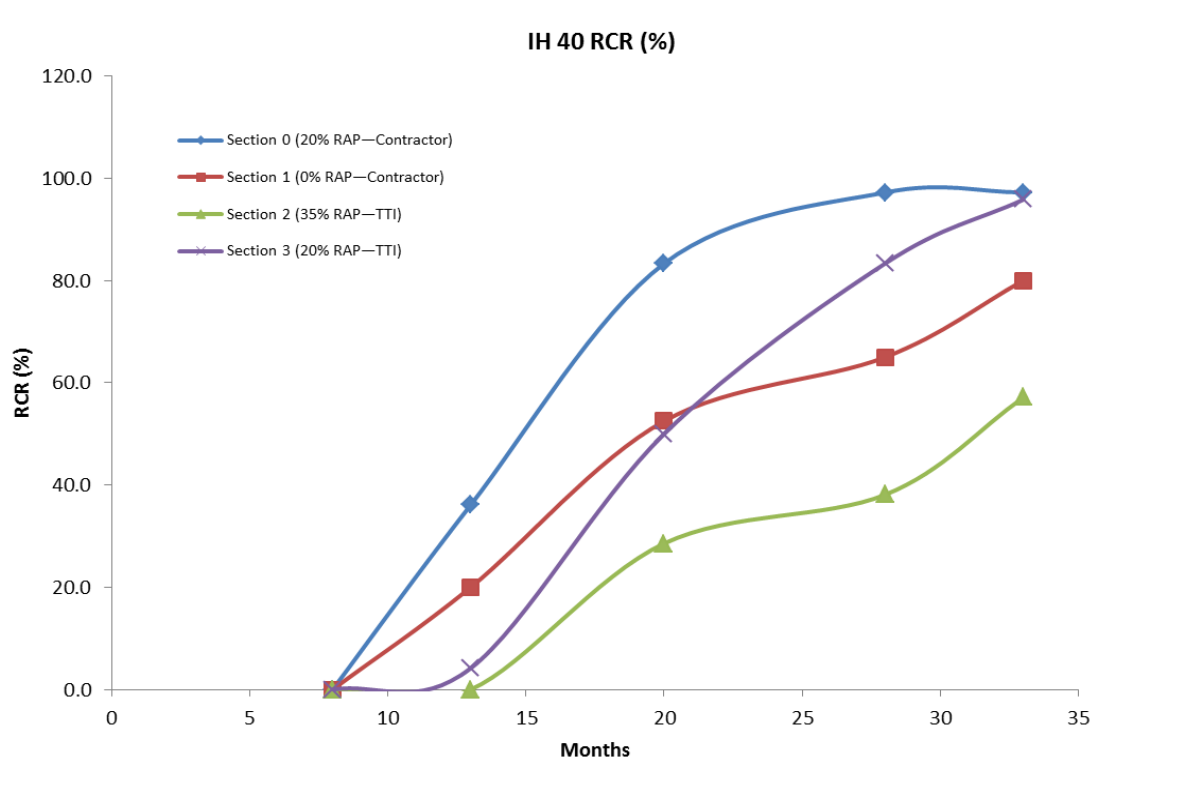
Figure 3-25 shows the curves of RCR vs. months for the IH 40 test sections.

**Figure 3-25. RCR vs. Months on IH 40 Test Sections.**

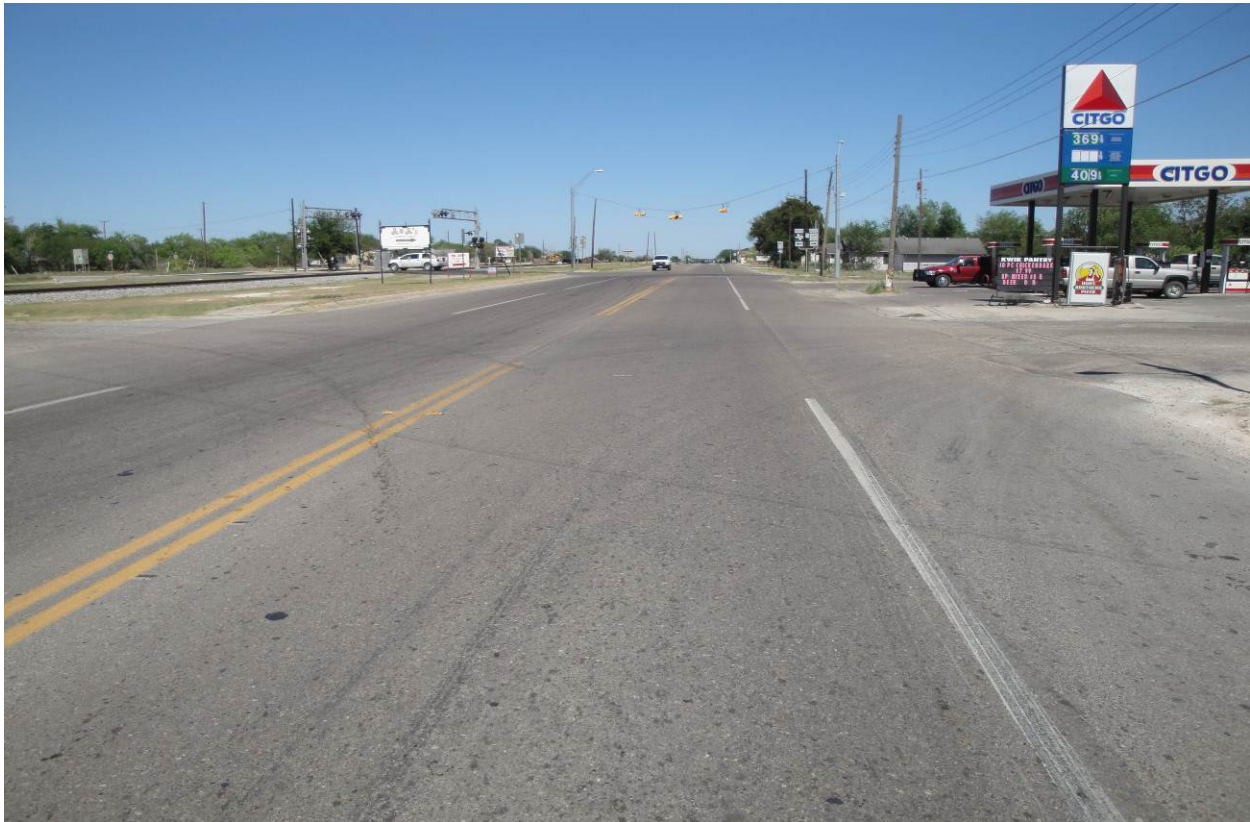
[Figure 3-27](#) shows the overview of the SH 359 test section.

**Figure 3-27. Overview of SH 359 Test Section.**

An asphalt overlay test section with 20 percent RAP was constructed on SH 359 eastbound in March 2009. The overlay thickness was 3 inches. See Figure 3-26.

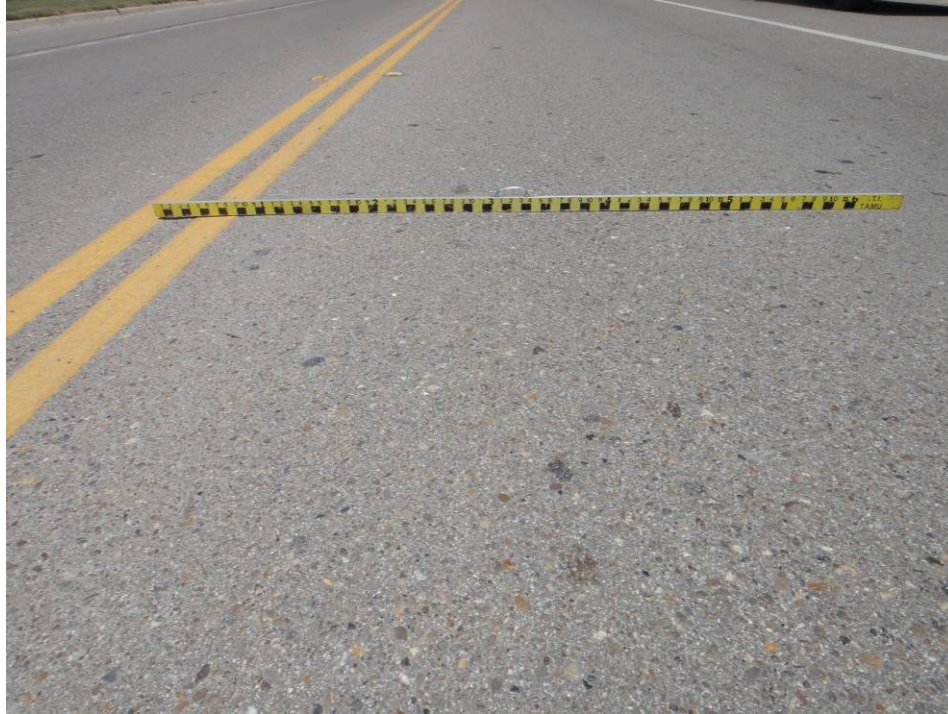
The surveys were conducted on December 20, 2010, April 11, 2011, December 19, 2011, and May 24, 2012. No cracking or rutting was found during these surveys. See [Figure 3-28](#).

**Figure 3-28. No Crack, No Rutting in SH 359 Test Section, as of 5/24/2012.**

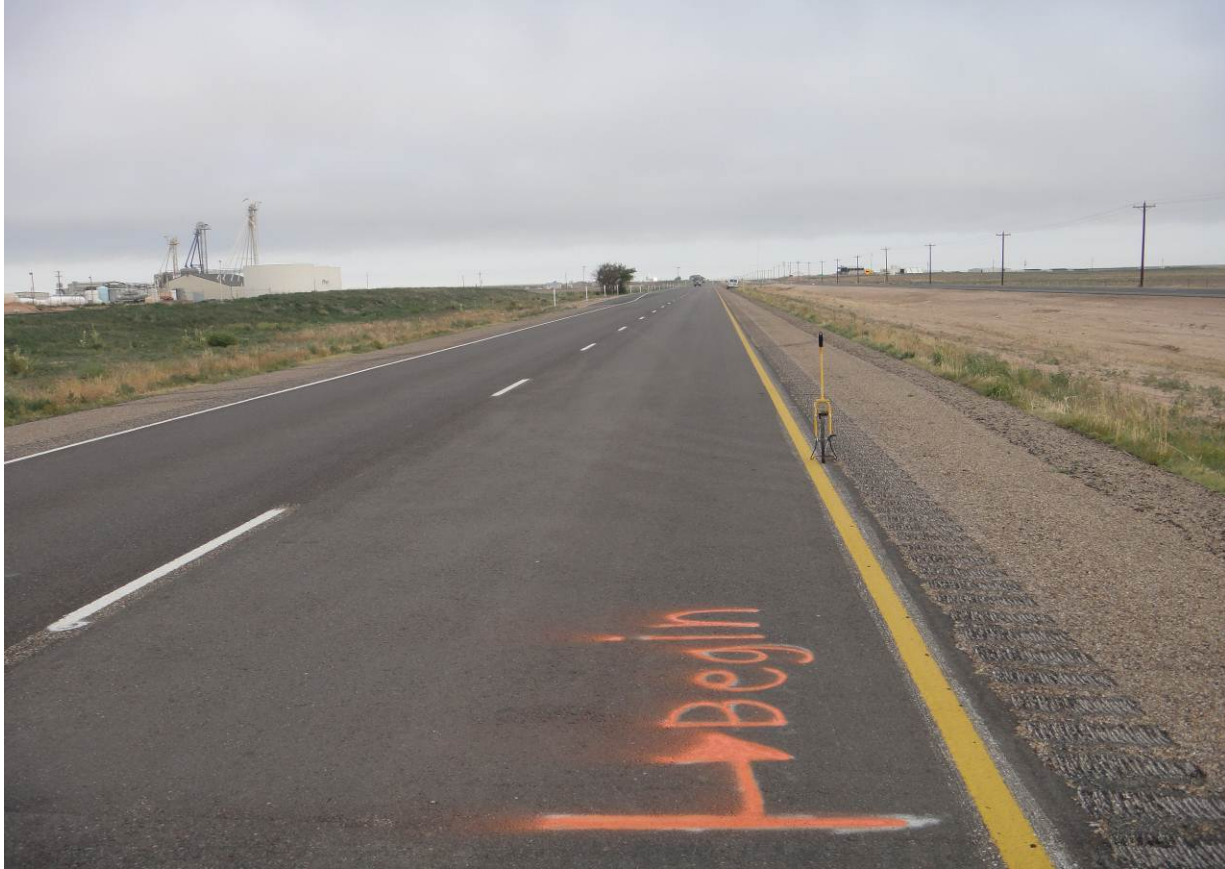
[Figure 3-30](#) shows the overview of the US 87 test sections.

**Figure 3-30. Overview of US 87 Test Sections.**

There were two test sections on US 87; one mixture was contractor designed with regular asphalt content, and the other mixture was TTI designed with a higher asphalt content. The overlay thickness was 3 inches and was placed in October 2010. See [Figure 3-29](#).

The surveys were conducted on October 20, 2010 (construction date), April 5, 2011, December 15, 2011, and May 30, 2012. In these test sections, the traffic was closed from July 2011 until April 2012. Before April 2012, these test sections functioned as a two-way road, and after that, they functioned as a one-way road since the construction of the other direction of US 87 was finished and opened to traffic.

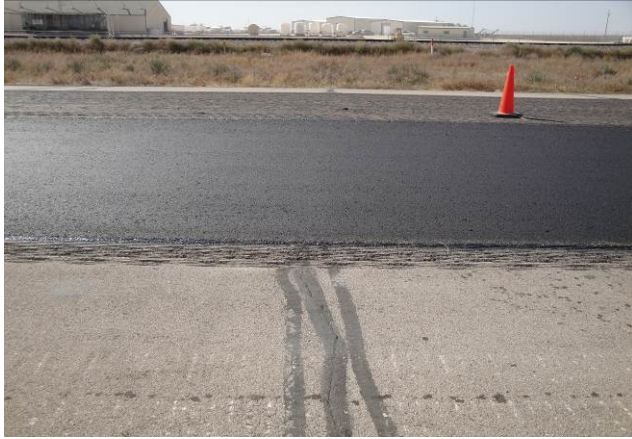
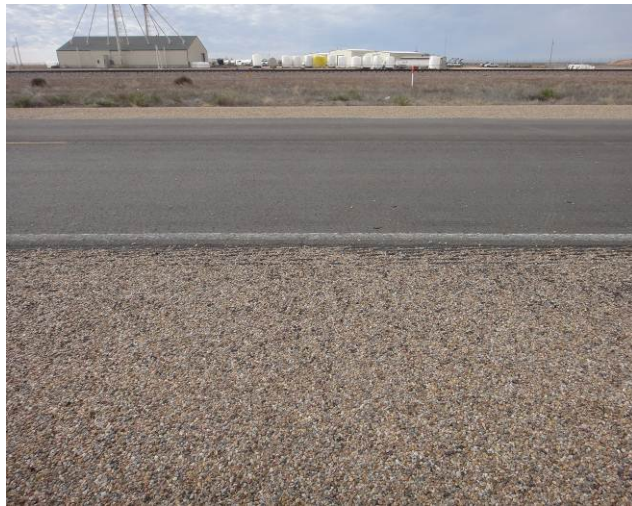
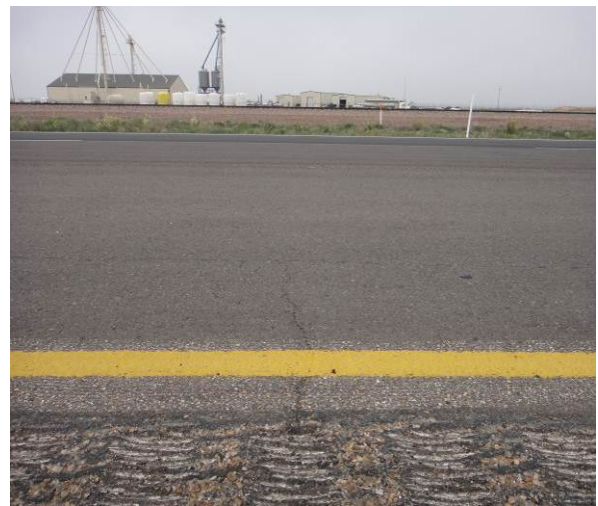
Figure 3-31 shows the photos of the same crack during each survey. Figure 3-31(a) is the photo taken just after the overlay construction, and the crack in the shoulder implies the location of the existing crack. In Figure 3-31(b), no crack was observed in the overlay lane. In Figure 3-31(c), the shoulder was repaved, but the shoulder crack could still be traced. Figure 3-31(d) clearly shows that the existing crack reflected into the overlay.
