# **IMPLEMENTATION OF TEXAS ASPHALT CONCRETE OVERLAY DESIGN SYSTEM**

Report 5-5123-03-1

Project 5-5123-03

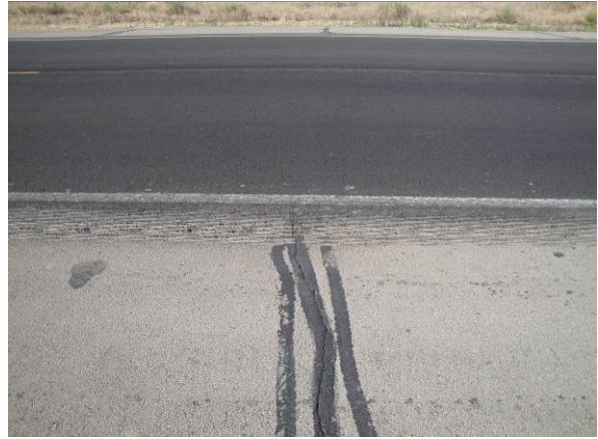
**(a) 10/20/2010**

The surveys were conducted on October 20, 2010 (construction date), April 5, 2011, December 15, 2011, and May 30, 2012. In these test sections, the traffic was closed from July 2011 until April 2012. Before April 2012, these test sections functioned as a two-way road, and after that, they functioned as a one-way road since the construction of the other direction of US 87 was finished and opened to traffic.

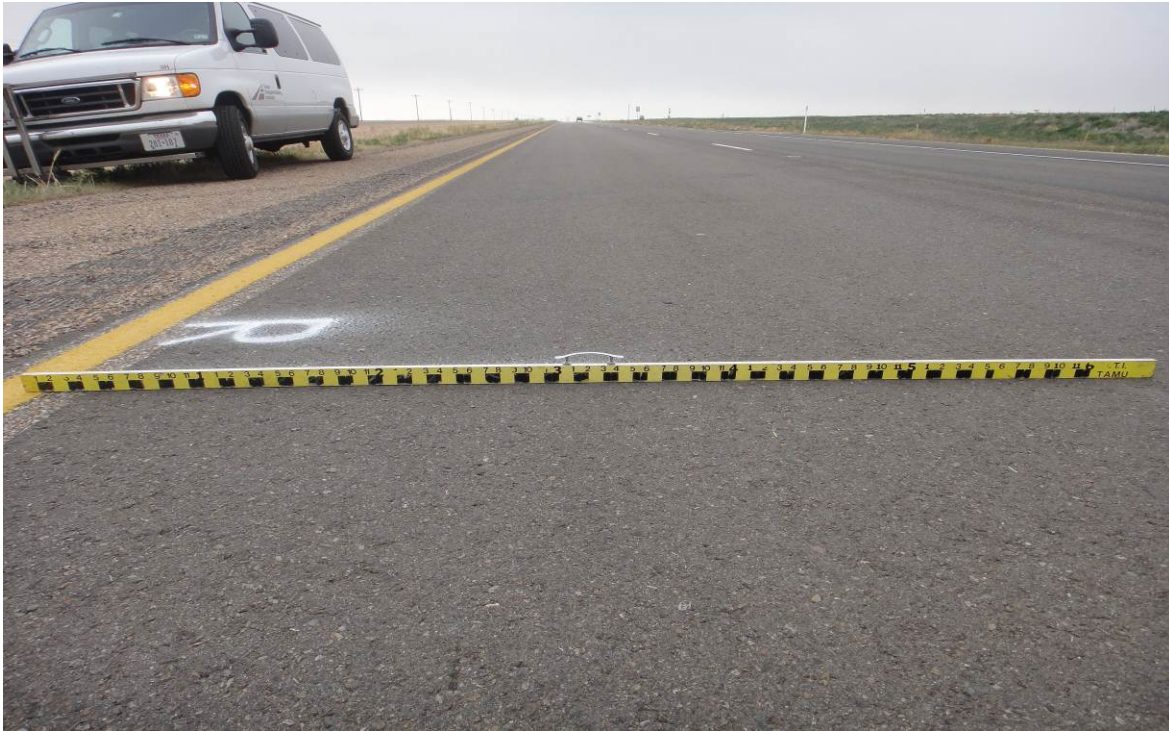
No rutting was found during these surveys. See [Figure 3-32](#).

**Figure 3-32. No Rutting in US 87 Test Sections, as of 5/30/2012.**

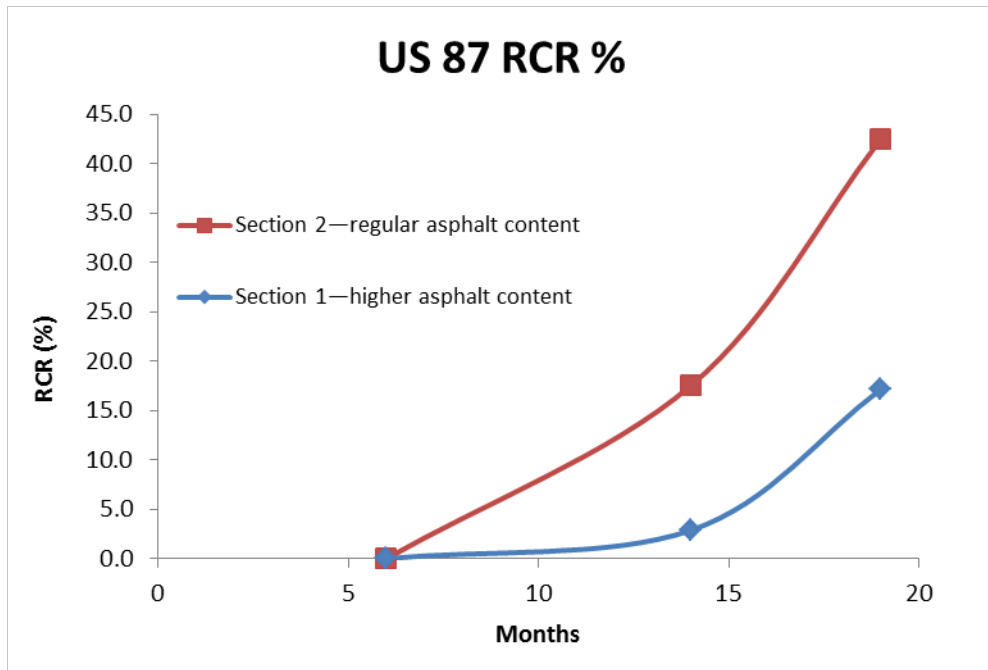
[Figure 3-33](#) shows the curves of RCR vs. months for US 87 test sections.

**Figure 3-33. RCR vs. Months for US 87 Test Sections.**

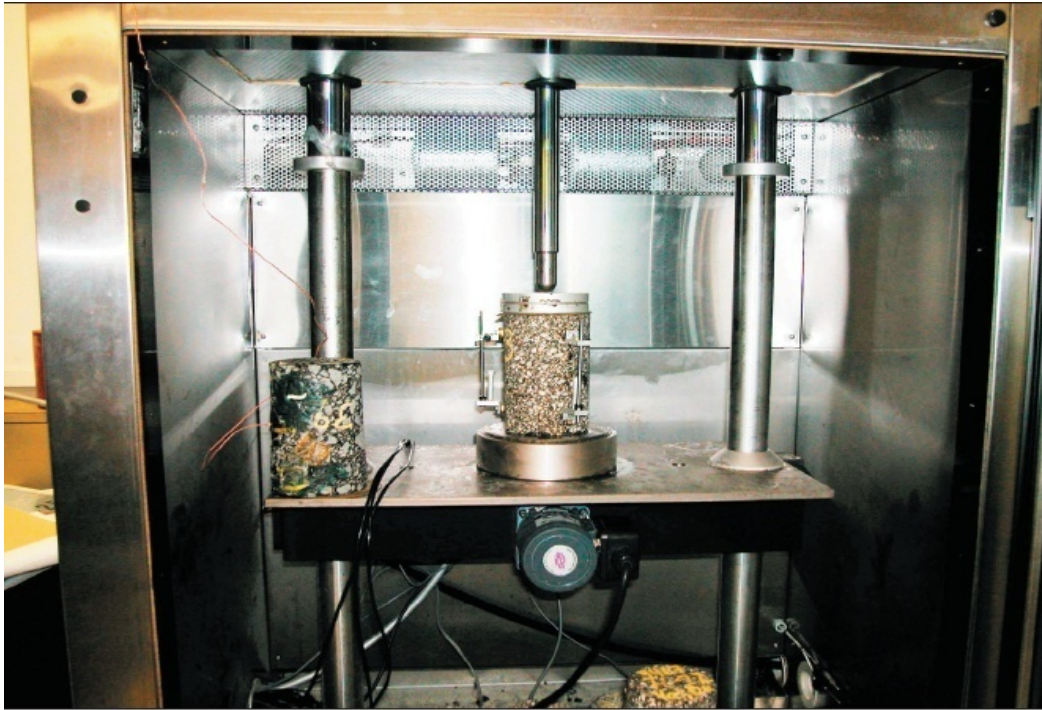
The dynamic modulus test (2) is widely accepted by state highway agencies for mechanistic-empirical pavement design. Figure 4-1 shows the test machine and the specimen for the dynamic modulus test. The specimen size is a 4 inch diameter by 6 inch height. Three linear variable differential transformers (LVDTs) are attached on the specimen to measure the strain responses.

**Figure 4-1. Dynamic Modulus Test Equipment and Specimen.**

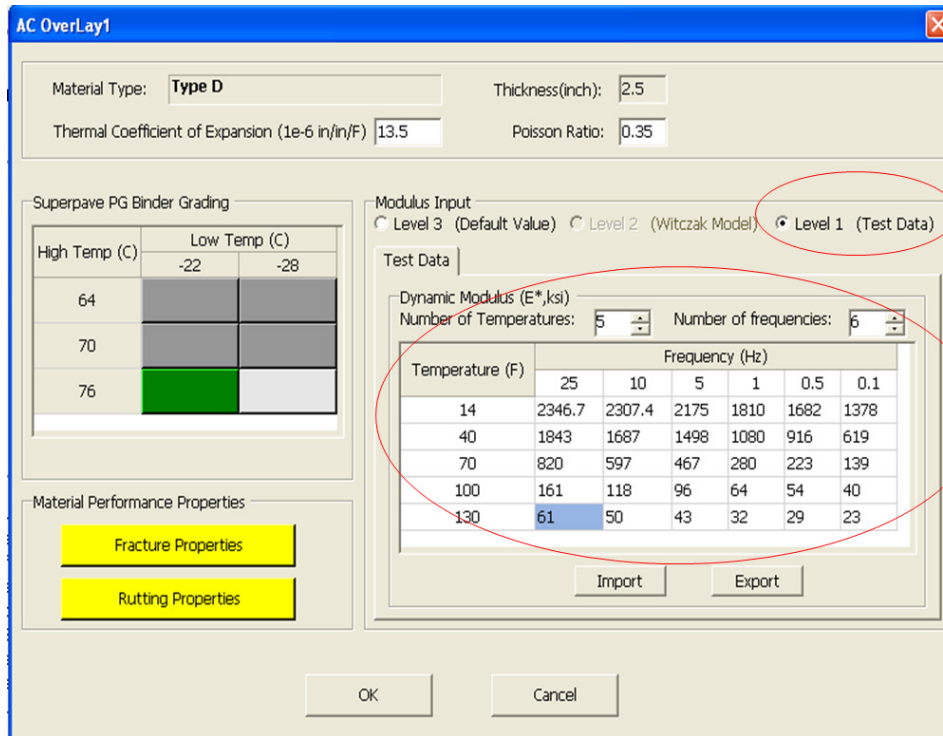
[Figure 4-2](#) shows the interface of  $|E^*|$  inputs in the TxACOL as a Level 1 input.

**Figure 4-2. Dynamic Modulus Input Interface.**

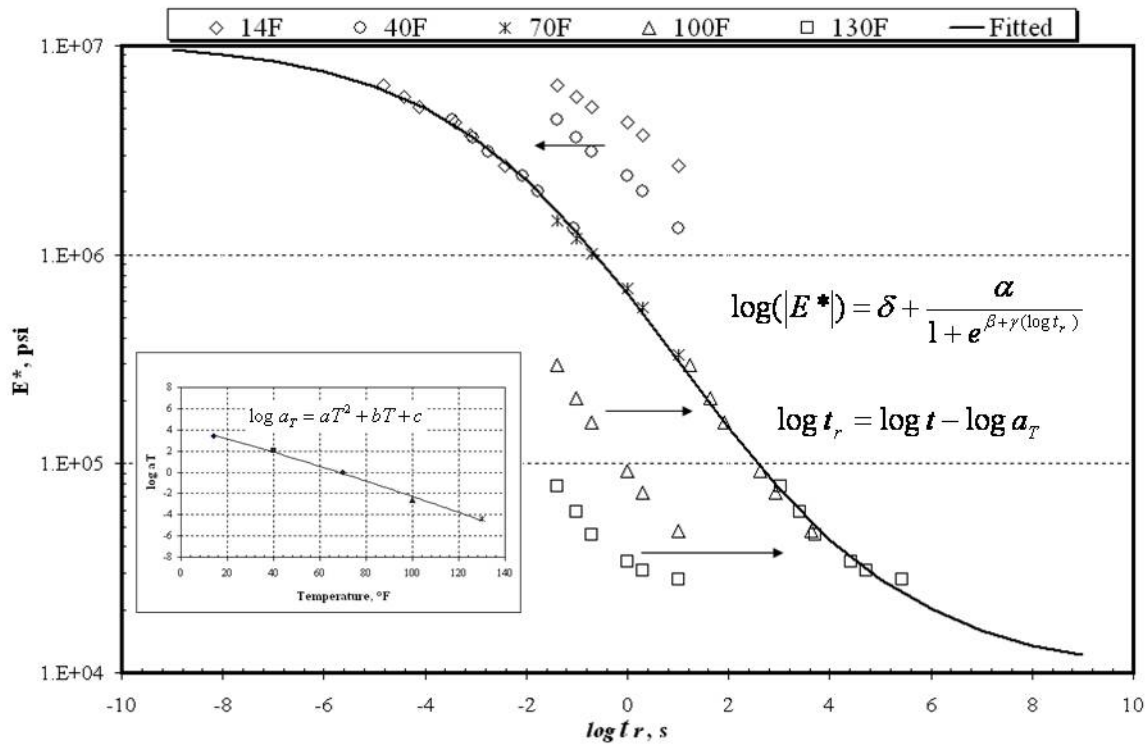
TxACOL automatically determines the master curve parameters and shift factors corresponding to these dynamic modulus values. Figure 4-3 illustrates the shifted master curve, corresponding equations, and parameters. Based on these determined master curve parameters,  $\delta$ ,  $\alpha$ ,  $\beta$ , and  $\gamma$ , and shift factor parameters,  $a$ ,  $b$ , and  $c$ , TxACOL will calculate the asphalt overlay modulus at any overlay depth, temperature, and vehicle loading frequency. The asphalt layer modulus combined with other layer thickness and modulus is used to predict cracking propagation, reflective cracking development, and the growth of rut depth.

**Figure 4-3. Dynamic Modulus Master Curve and Equations.**

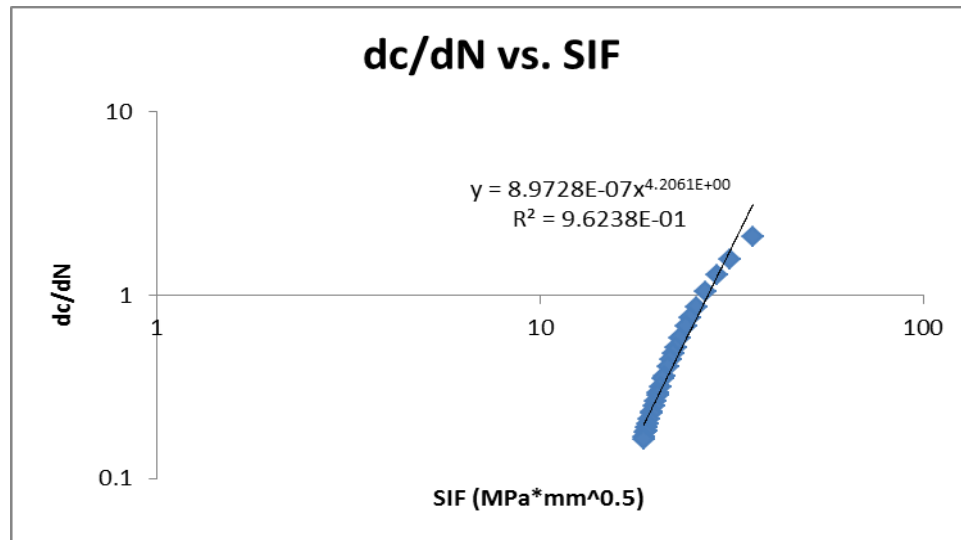
Figure 4-4 presents the final fitting parameters for  $dc/dN$  vs. SIF curve. In this case,  $A = 8.9728E-7$ , and  $n = 4.2061$ .

**Figure 4-4. A and n Determination.**

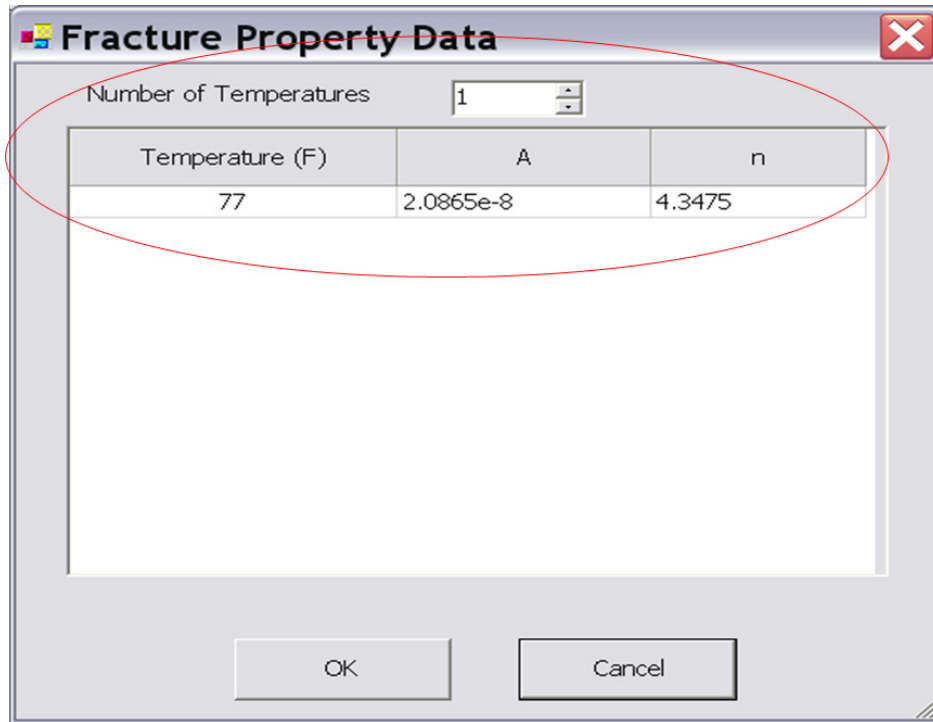
Figure 4-5 shows the input interface for cracking properties. TxACOL provides the option for multiple cracking property inputs if the OT was conducted under different temperatures. However, calibration here was conducted based on the  $A$  and  $n$  values at 77°F alone.

**Figure 4-5. A and n Input Interface.**

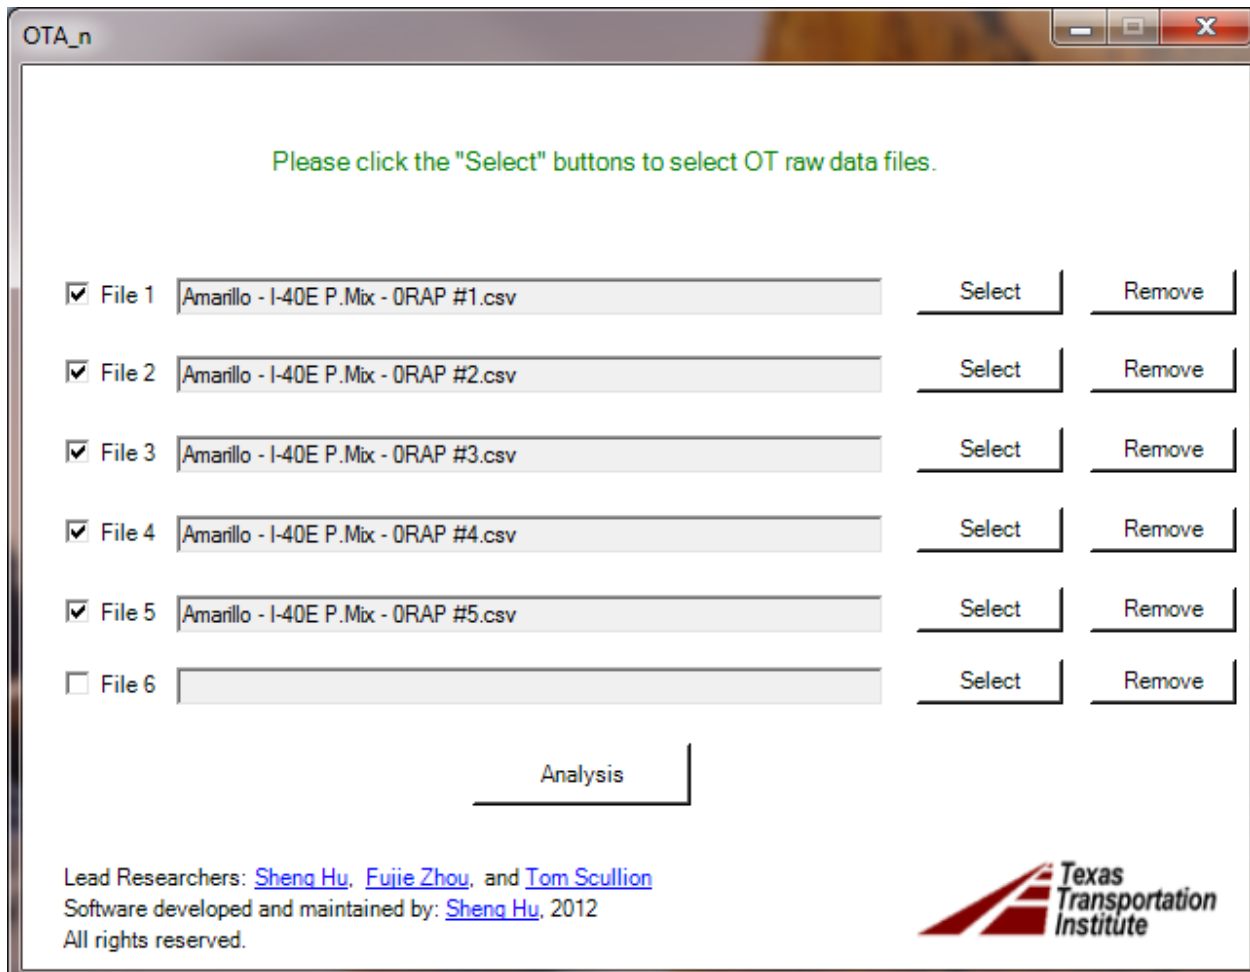
It is recommended to test five replicates to determine the cracking property. To simplify the process of determining reasonable A and n values, the research team developed a new tool to handle multiple OT data files and automatically determine the A and n values based on the OT files. Users can select single or multiple files by checking/unchecking the checkbox shown in [Figure 4-6](#). [Figure 4-7](#) presents the output of the analysis result.

**Figure 4-6. Interface of A and n Analysis Tool with Multiple OT Data File Handling.**

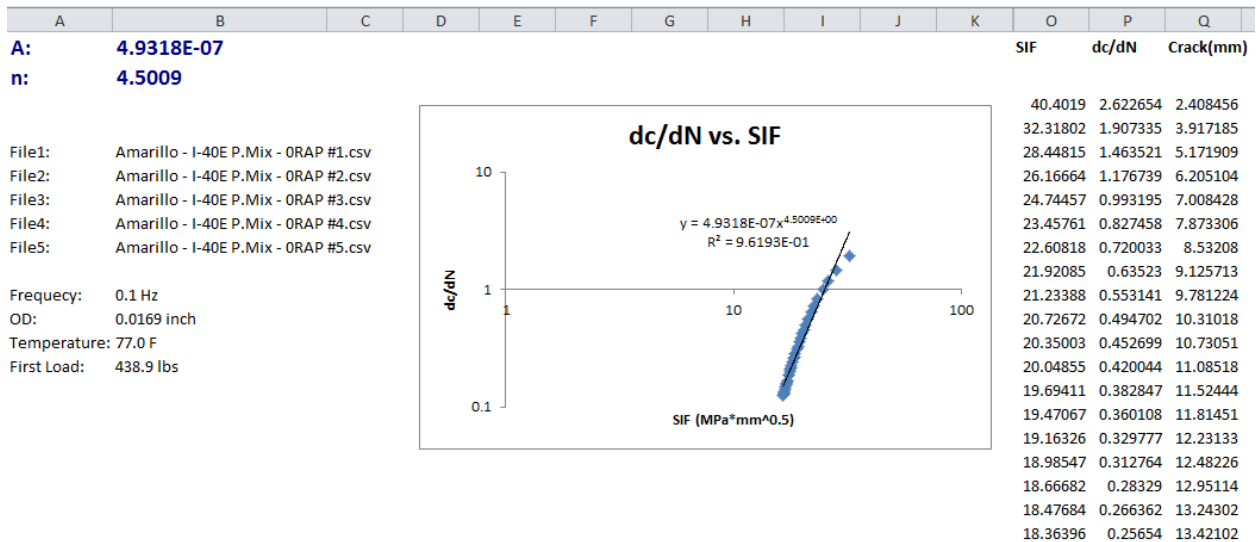
**Figure 4-7. Output of the OT A and n Analysis Tool.**

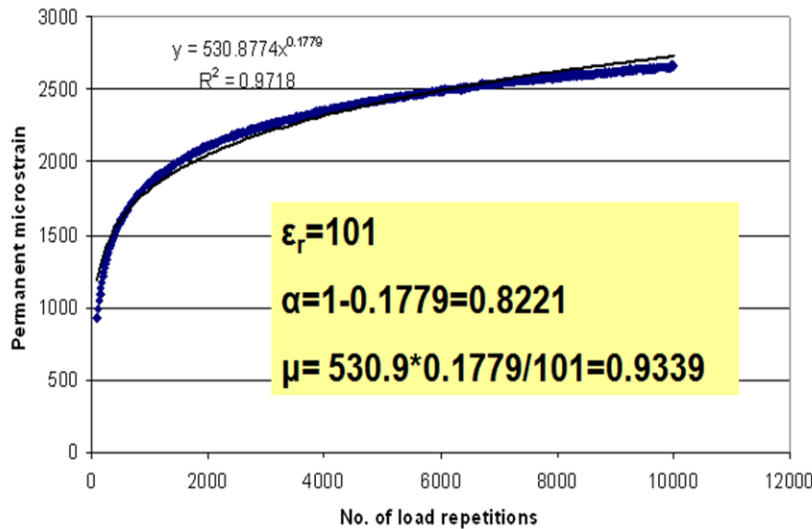
Figure 4-8 shows the curve of permanent microstrain vs. number of load repetitions. The determination method of rutting properties  $\alpha$  and  $\mu$  is illustrated in this figure as well. Note that in Figure 4-8,  $\epsilon_r$  is resilient microstrain; the curve fitting parameters  $a$  and  $b$  are 530.877 and 0.1779, respectively.

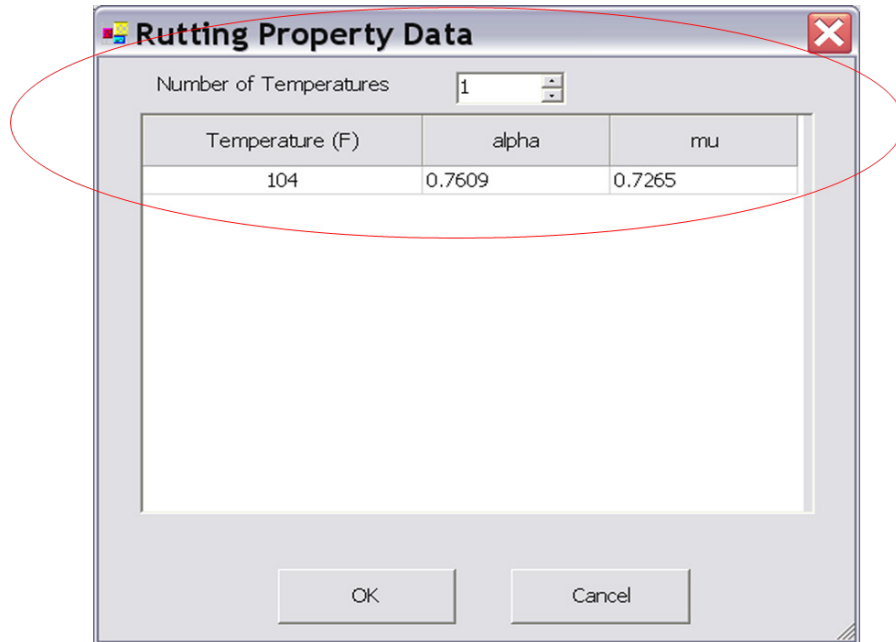
Figure 4-9 shows the input interface for rutting properties. Similar to the input of cracking properties, TxACOL provides the option for multiple rutting property inputs if the repeated load test is conducted at different temperatures. Currently, the test temperature for the repeated load test is preferred to be 104°F.

**Figure 4-9. Rutting Property Input Interface.**

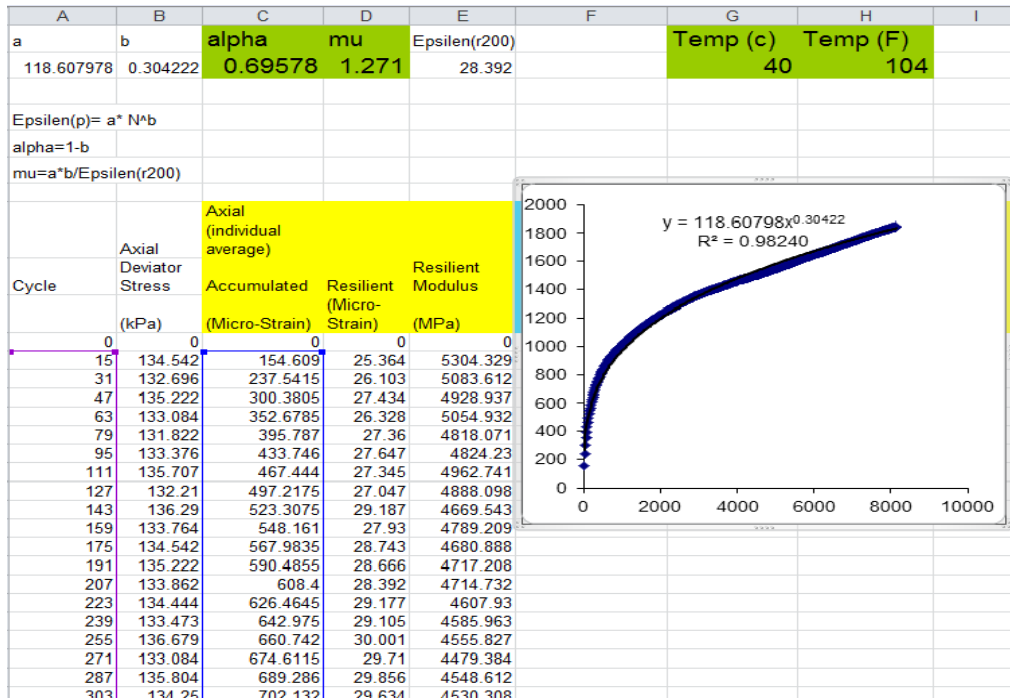
The researchers also developed an Excel macro to automatically process the repeated load test data and determine the rutting properties  $\alpha$  and  $\mu$ . See [Figure 4-10](#). For two replicates, researchers recommend determining  $\alpha$  and  $\mu$  for each replicate and then averaging  $\alpha$  and  $\mu$ , respectively.

**Figure 4-10. Excel Macro for Determining Rutting Properties.**

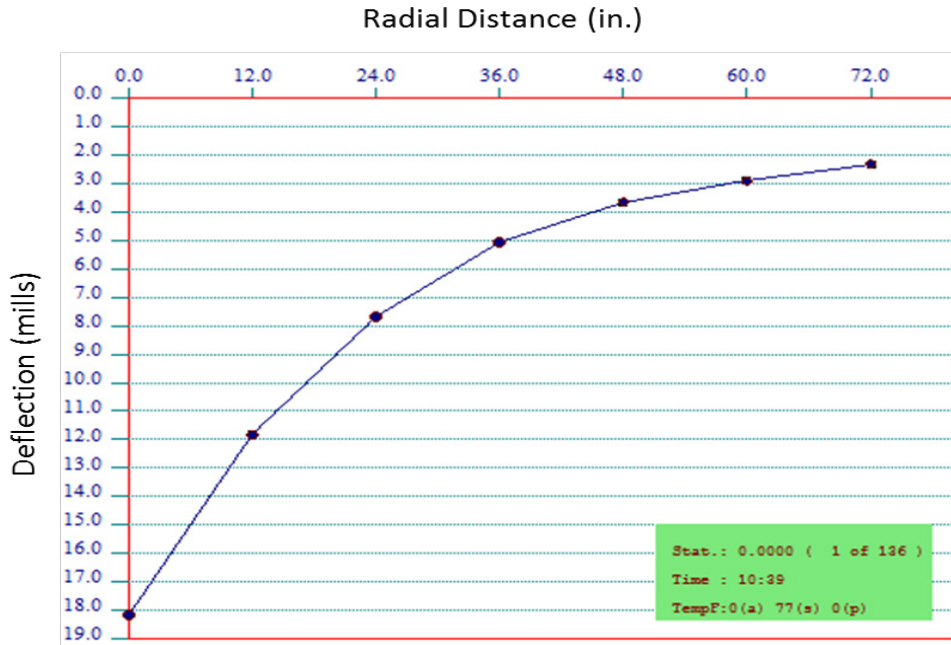
Figures 4-11 and 4-12 present examples of regular and irregular deflection basins.

**Figure 4-11. An Example of Regular Deflection Basin.**

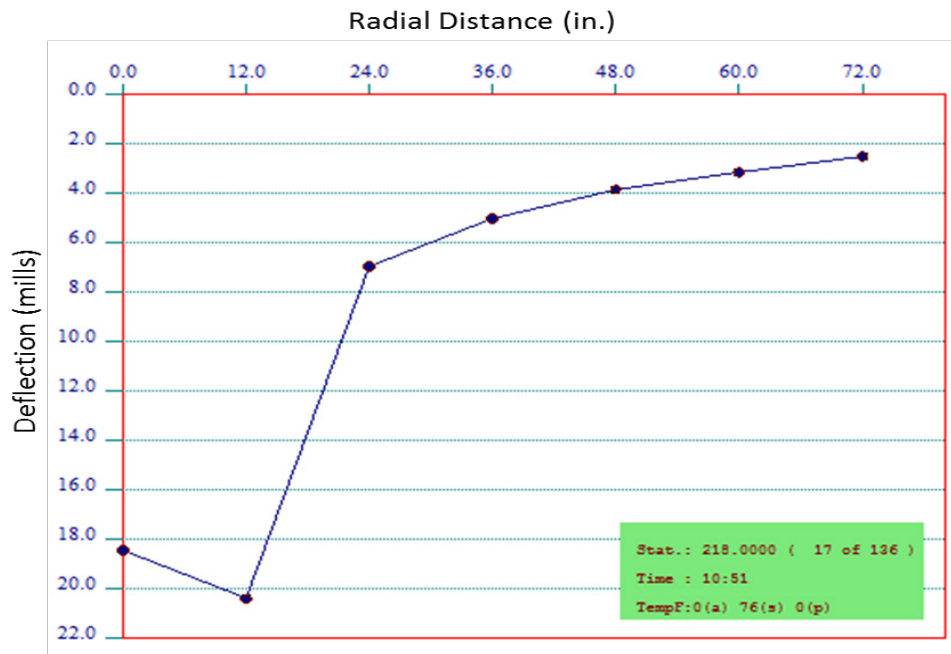
**Figure 4-12. An Example of Irregular Deflection Basin.**

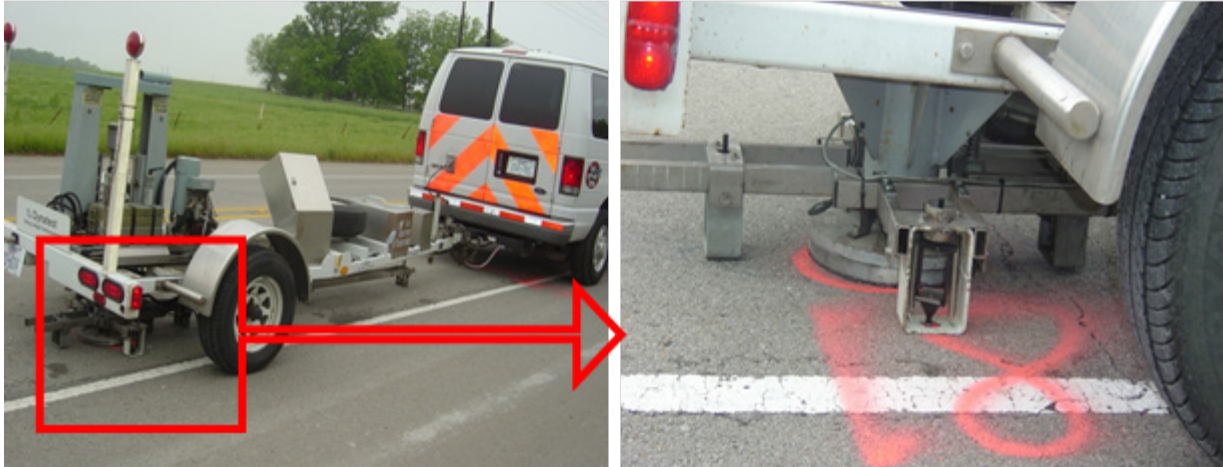
When the FWD load is applied on the center of a slab and on one side of an existing crack or joint (Figure 4-15), the FWD data can be used to determine the LTE value.

**Figure 4-15. FWD Test with the Loading Plate at One Side of Crack.**

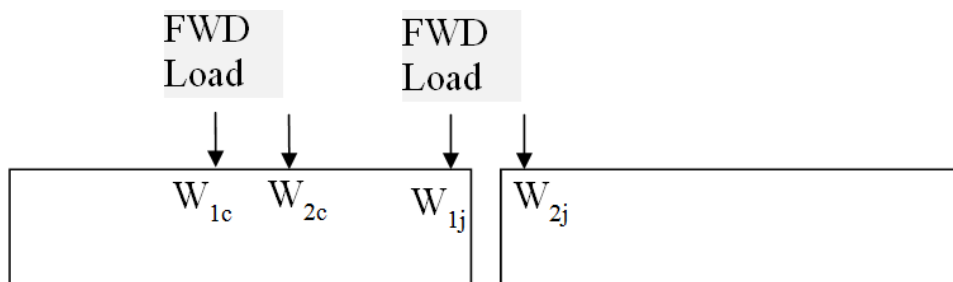
Figure 4-16 presents the schematic diagram of the relative location of  $W_{1c}$ ,  $W_{2c}$ ,  $W_{1j}$ , and  $W_{2j}$ .

**Figure 4-16. Schematic Diagram of  $W_{1c}$ ,  $W_{2c}$ ,  $W_{1j}$ , and  $W_{2j}$ .**

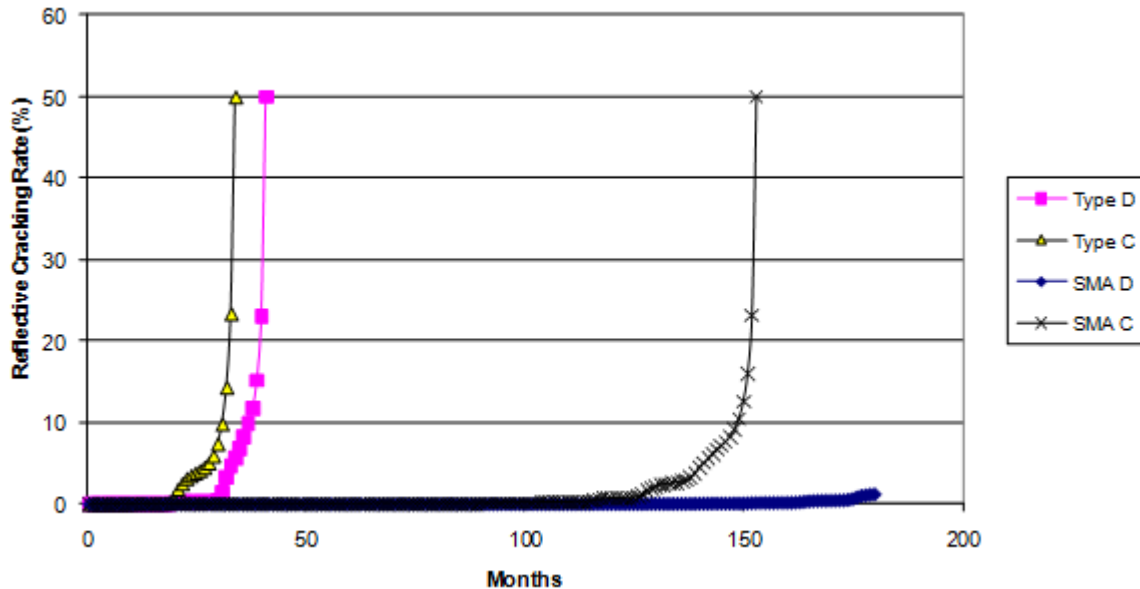
Since  $\sum \Delta C$  cannot be larger than  $h$ , the maximum  $D$  is 1; thus the maximum RCR is 50 percent according to Equation (5-1). The common curves of RCR vs. month predicted by the previous TxACOL are illustrated in Figure 5-1 (1).

Figure 5-1. RCR Curves Determined by Previous TxACOL, after (1).

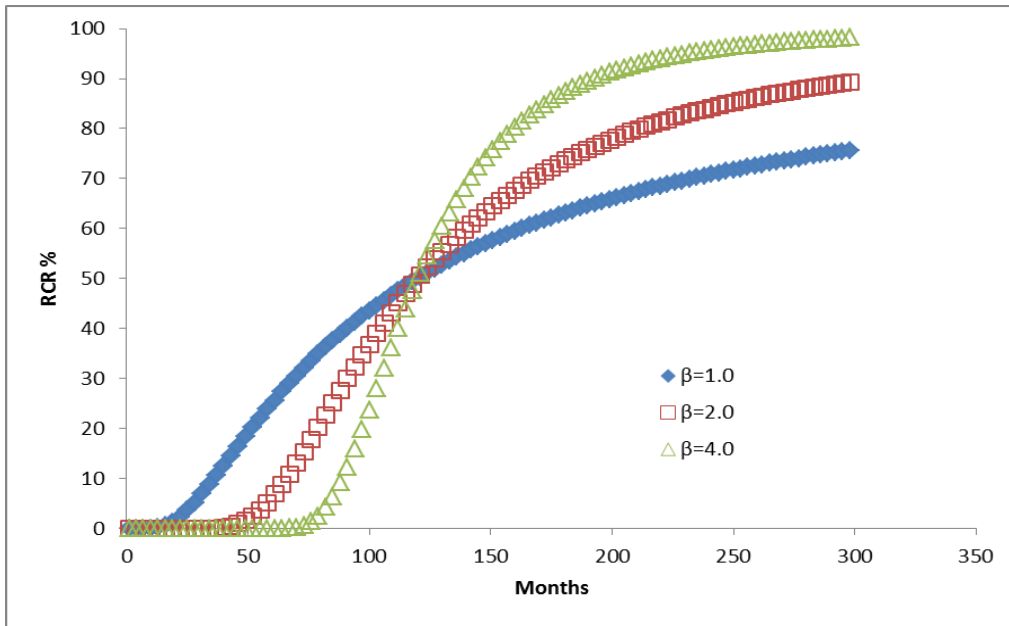
Figure 5-2 illustrates the curves following this  $\rho$ - $\beta$  model. In this figure, three curves have the same  $\rho$  values (120 months) but different  $\beta$  values. This figure shows that these curves can be much flatter than previous TxACOL predictions and can predict the RCR values beyond 50 percent. It is believed that most of the previous surveyed curves can be better fitted by this model.

**Figure 5-2. Curves of RCR Model ( $\rho = 120$ ).**

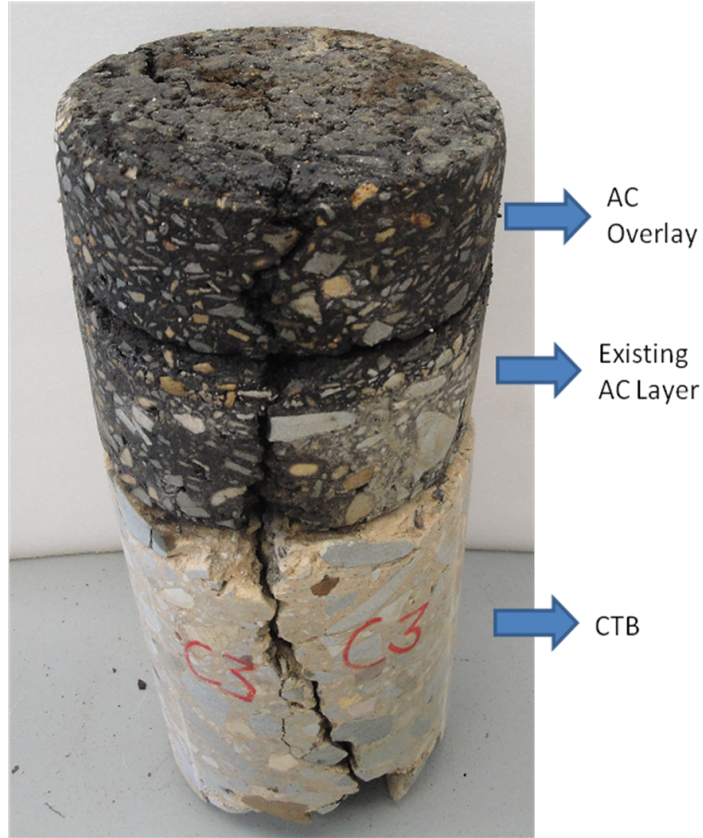
In Project 0-5123, the researchers employed a two-layer pavement structure (Asphalt overlay over existing Asphalt layer or PCC layer) to develop thermal SIF models (*1*). This structure implies an assumption that the layers under this two-layer structure are motionless under thermal variations and thus can be ignored. This assumption is appropriate for most cases since the thermal variation is not significant after a certain depth and the impact of base thermal movement can be ignored, especially for the granular base layer. However, as could be seen in some pavement structures, such as the SH 24 test section, the existing asphalt concrete (AC) layer was thin (3 inches), and the CTB layer on SH 24 was very thick (11 inches), over-cemented, and fully cracked ([Figure 5-3](#)), so the impact of thermal movement of this layer needed to be considered to make a more accurate prediction.

**Figure 5-3. Cracked CTB Layer.**

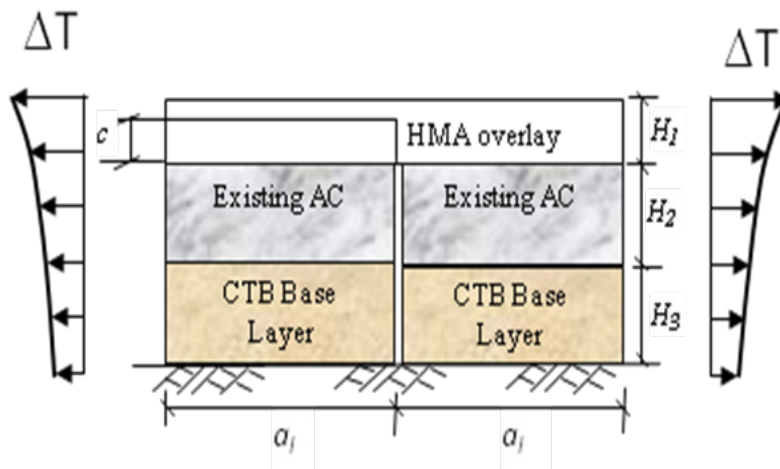
To address this issue, a three-layer AC/existing AC/CTB pavement structure, as shown in Figure 5-4, was considered, and the corresponding thermal SIF equations were developed.

**Figure 5-4. Three-Layer AC/Existing AC/CTB Pavement Structure Thermal SIF Model.**

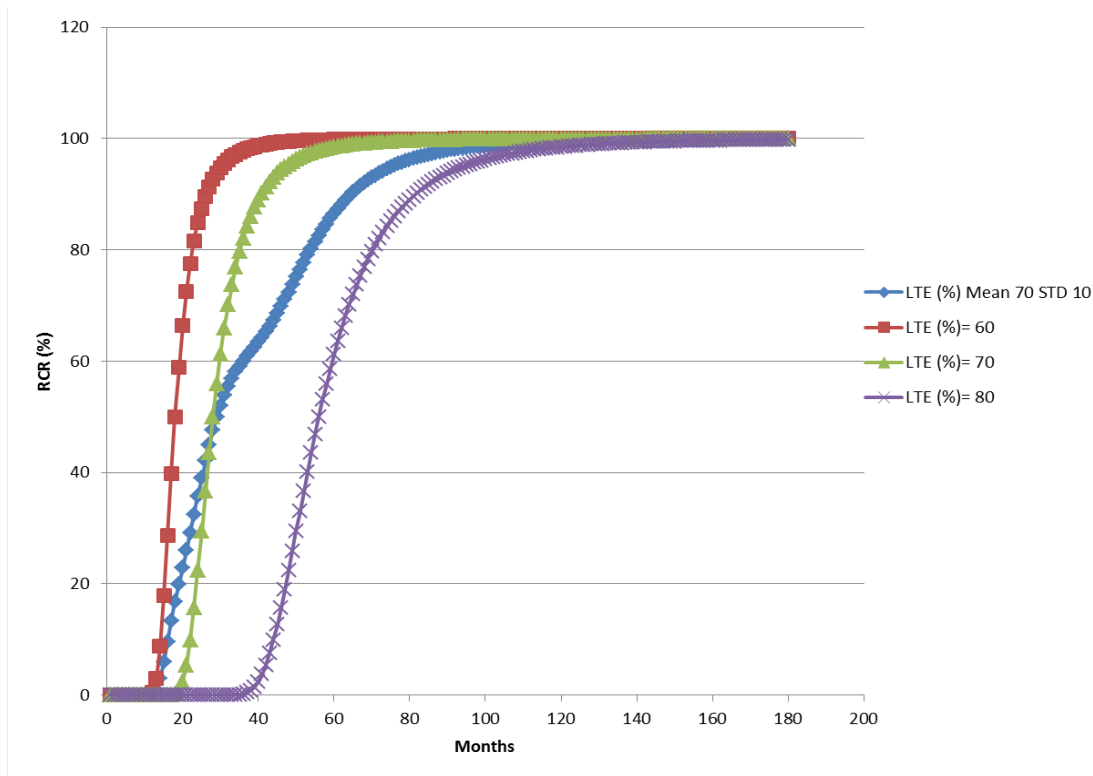
**Figure 5-6. RCR Curves Accounting for LTE STD.**

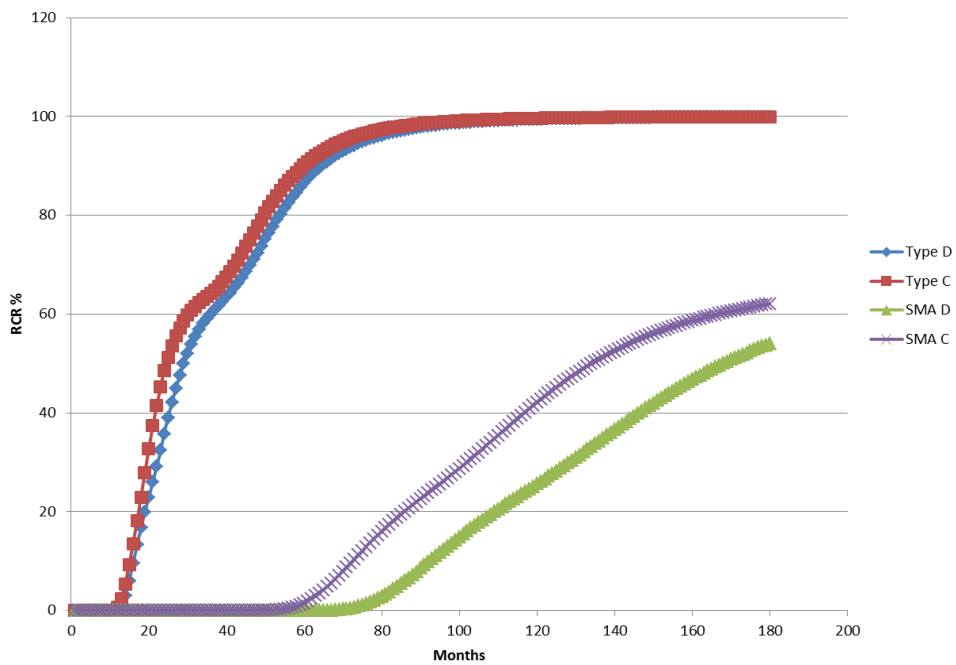
**Figures 5-7. Influence of Overlay Mix Type.**

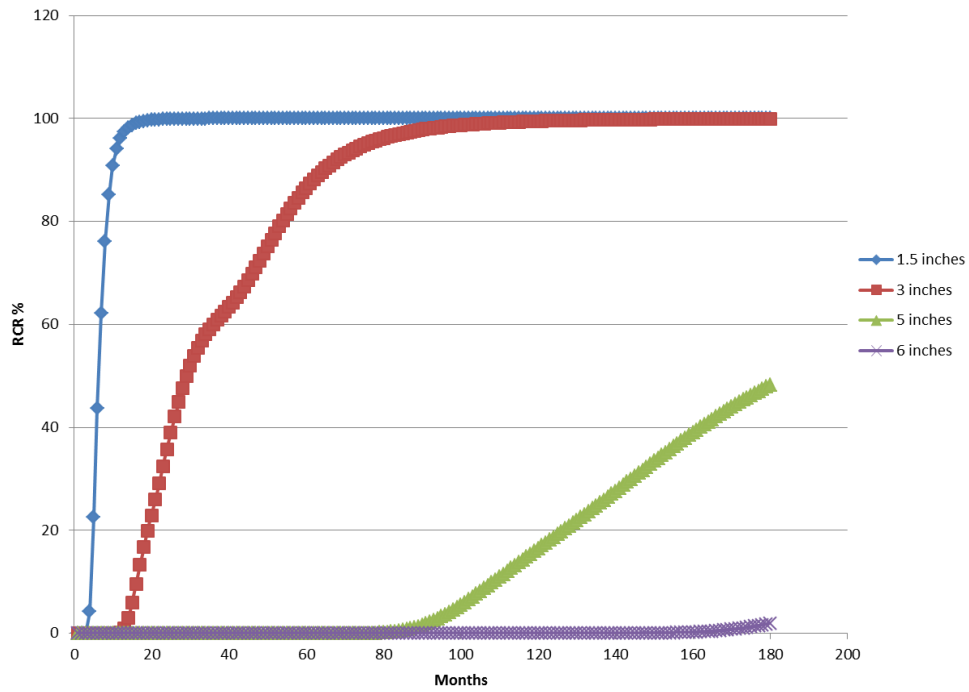
Figure 5-8 shows the influence of overlay thickness. The other main input parameters are the same as in Figure 5-7, except the AC type is fixed to Type D.

**Figures 5-8. Influence of Overlay Thickness.**

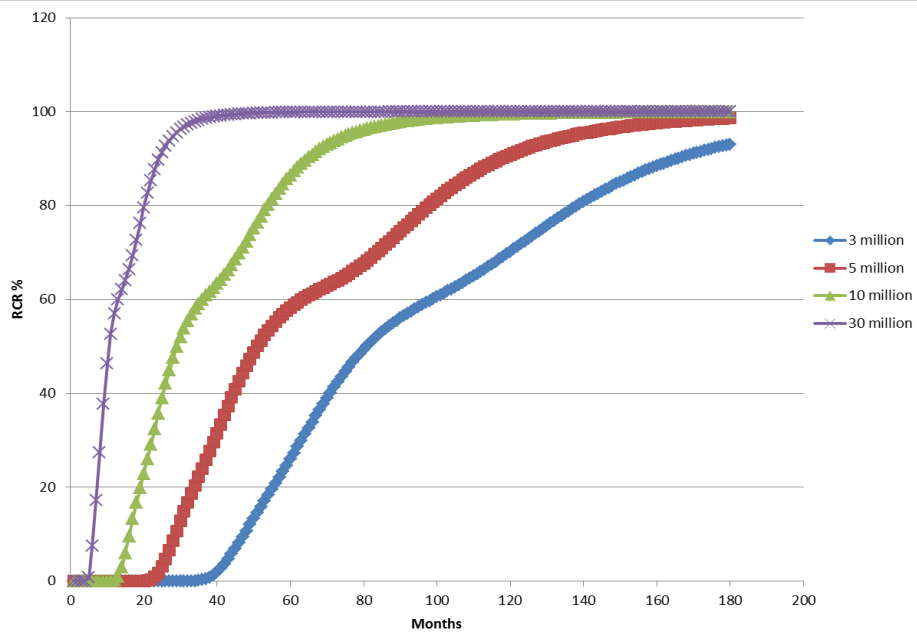
**Figure 5-9. Influence of Traffic.**

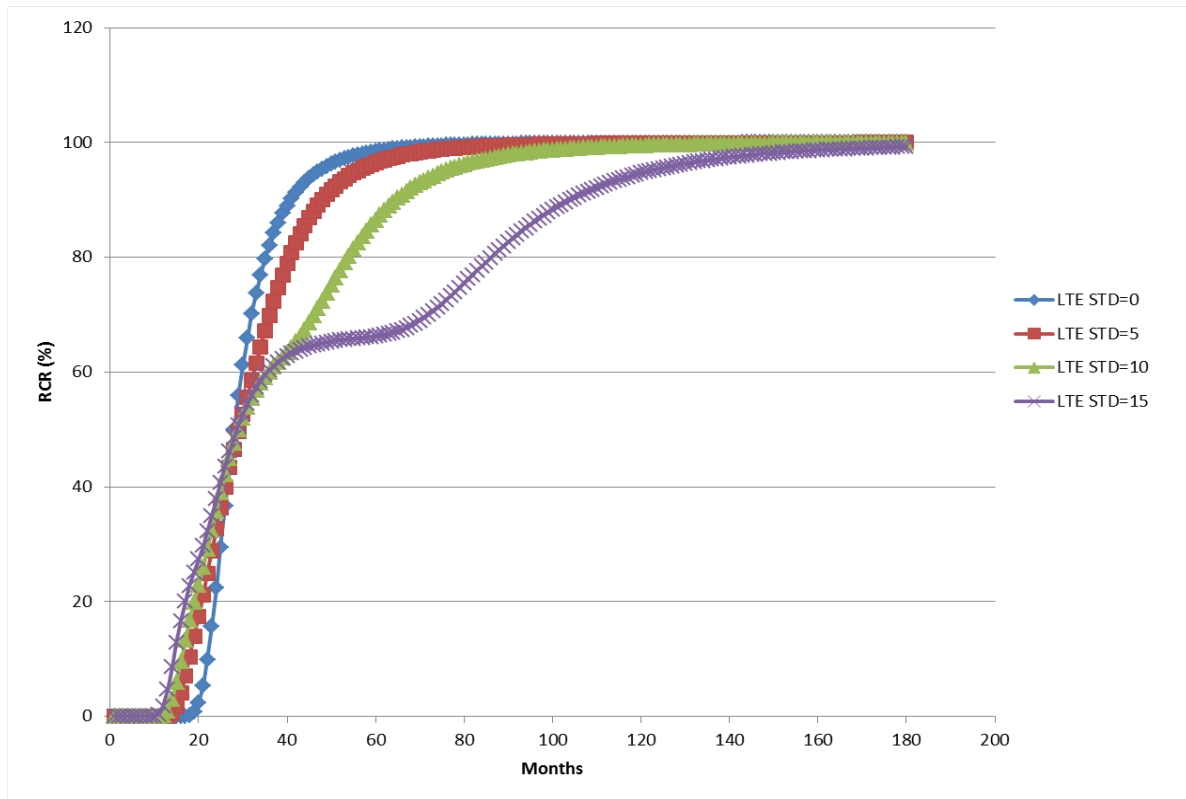
**Figure 5-10. Influence of LTE STD.**

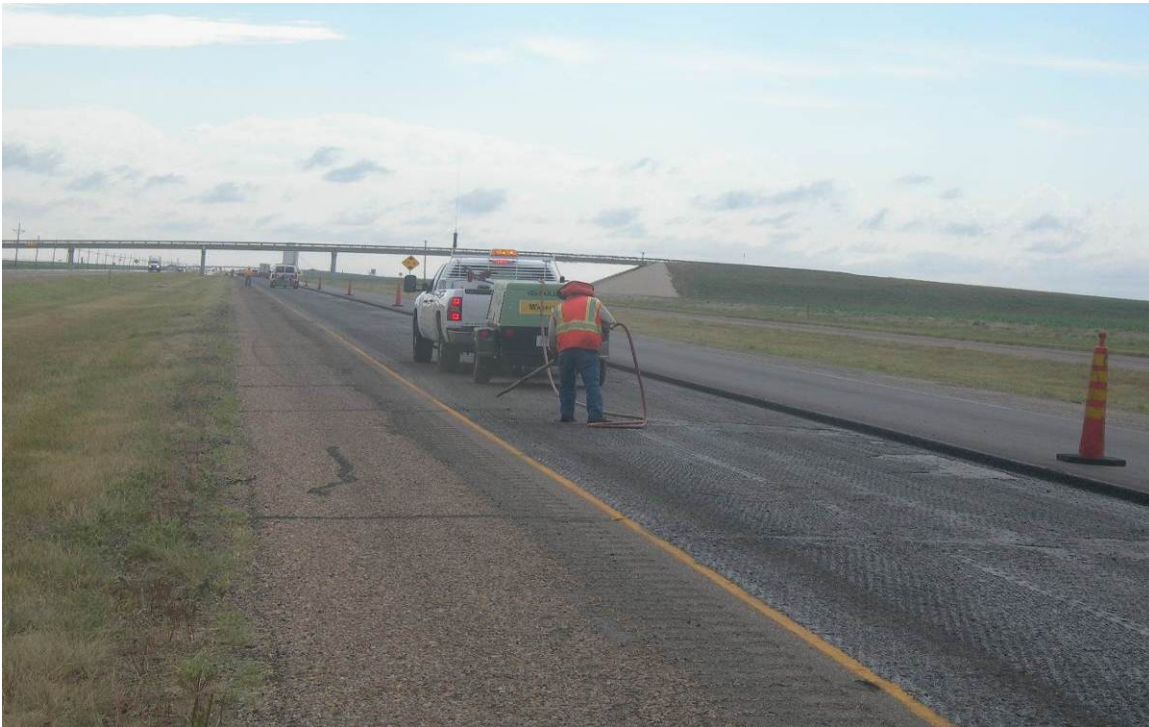
**Figure 6-1. Existing Pavement Condition of IH 40 Test Sections.**

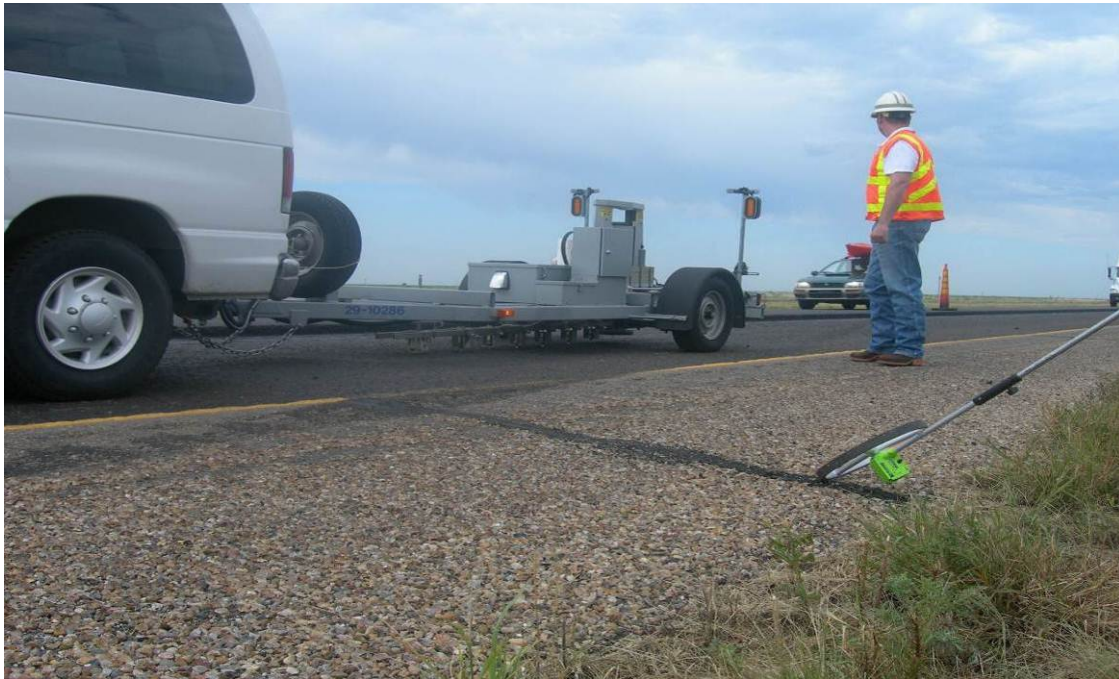
**Figure 6-3. FWD Test on IH 40 Test Sections.**

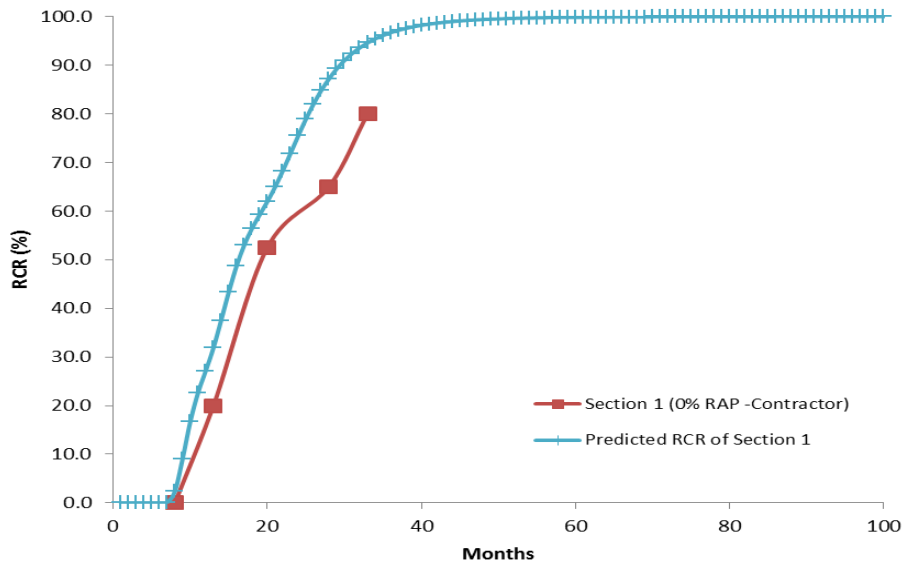
**Figure 6-7. RCR Prediction and Survey Result of IH 40 Test Section 1.**

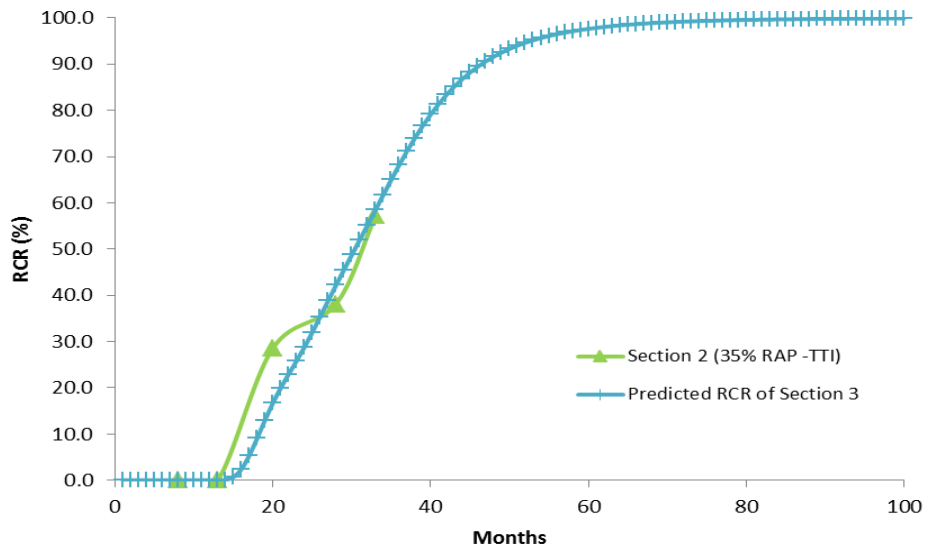
**Figure 6-8. RCR Prediction and Survey Result of IH 40 Test Section 2.**

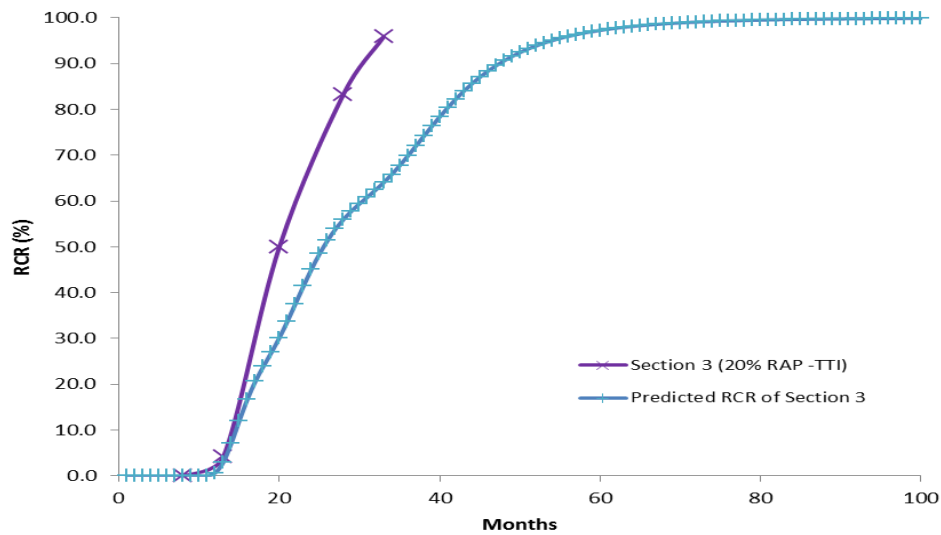
**Figure 6-9. RCR Prediction and Survey Result of IH 40 Test Section 3.**

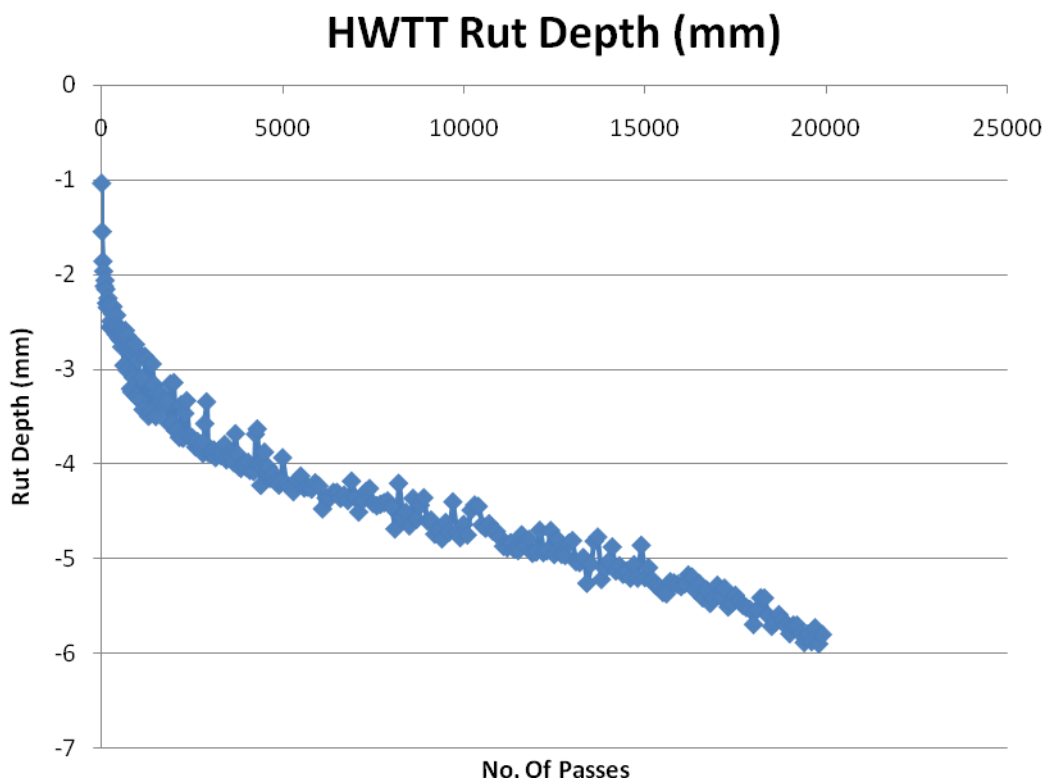
Figure 6-12. HWTT Results.
