# **IMPLEMENTATION OF TEXAS ASPHALT CONCRETE OVERLAY DESIGN SYSTEM**

Report 5-5123-03-1

Project 5-5123-03

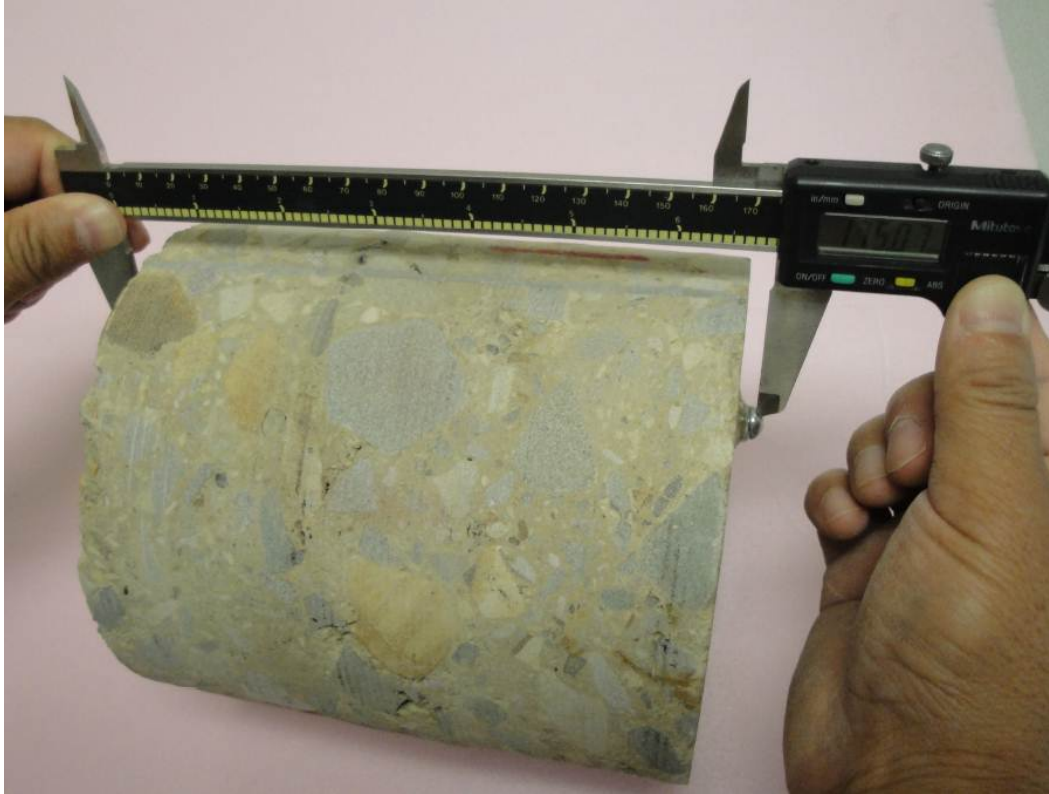
**Figure 6-13. CTE Measuring of CTB Material.**

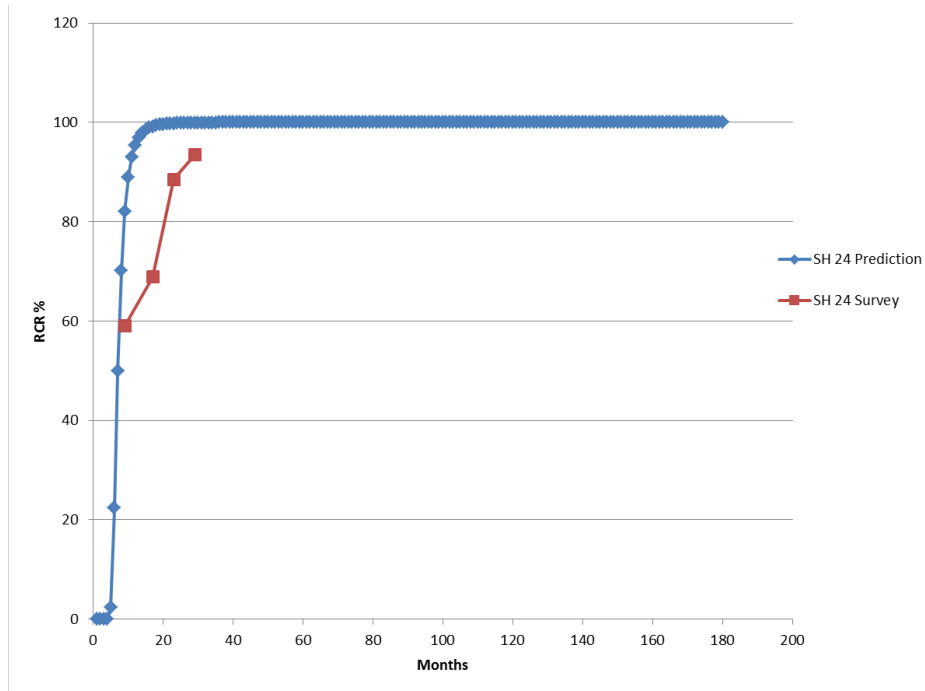
**Figure 6-14. RCR Prediction and Survey Result of SH 24 Test Section.**

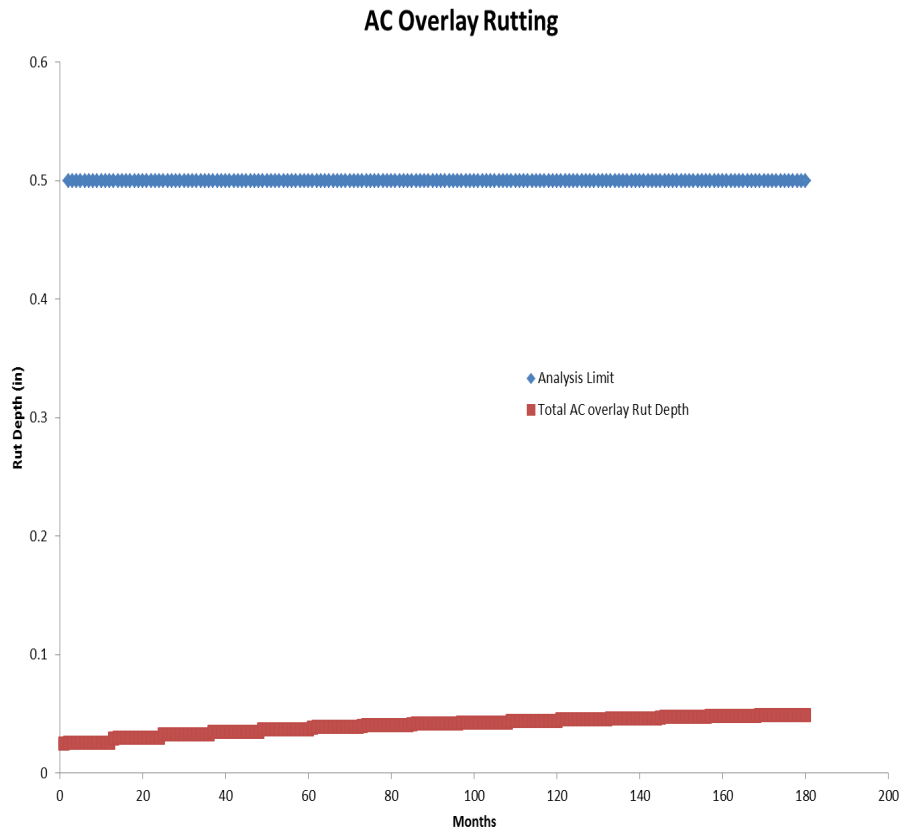
**Figure 6-15. SH 24 Rut Prediction Result.**
