1. Report No. FHWA/TX-12/5-5597-01-1		2. Government Accession No.		3. Recipient's Catalog No.	
4. Title and Subtitle LABORATORY AND FIELD PERFORMANCE MEASUREMENTS TO SUPPORT THE IMPLEMENTATION OF WARM MIX ASPHALT IN TEXAS				5. Report Date February 2012 Published: July 2012

**LABORATORY AND FIELD PERFORMANCE MEASUREMENTS TO
SUPPORT THE IMPLEMENTATION OF WARM MIX ASPHALT IN
TEXAS**

Report 5-5597-01-1
Project 5-5597-01
Project Title: Evaluation of Warm Mix Asphalt

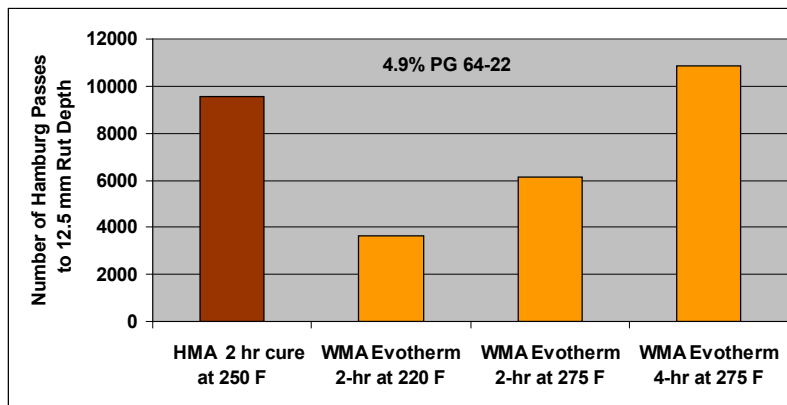
Figure 2.1. Effect of Curing Time and Temperature on Lab Mixed Evotherm WMA Hamburg Wheel Tracking Test Results (Estakhri et al. 2010).

Research project 0-5597 showed that WMA Hamburg Wheel Tracking Test results are significantly affected by the temperature and amount of time for oven curing the loose mix prior to sample molding as shown in Figures 2.1 and 2.2 (Estakhri et al. 2010). Data generated in study 0-5597, as well as TxDOT in-house evaluation, and field performance characteristics of warm mix, lead to TxDOT adopting a 4-hr curing time at a temperature of 275°F for warm mix. A summary of how curing temperature and time is selected is presented in Figure 2.3.

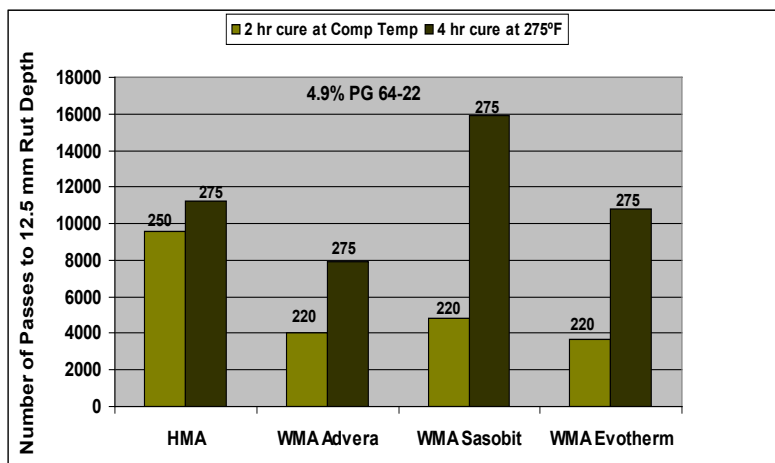
Figure 2.2. Effect of Curing Time and Temperature on Hamburg Wheel Tracking Test Results for Different Types of Lab Mixed WMA (Estakhri et al. 2010).

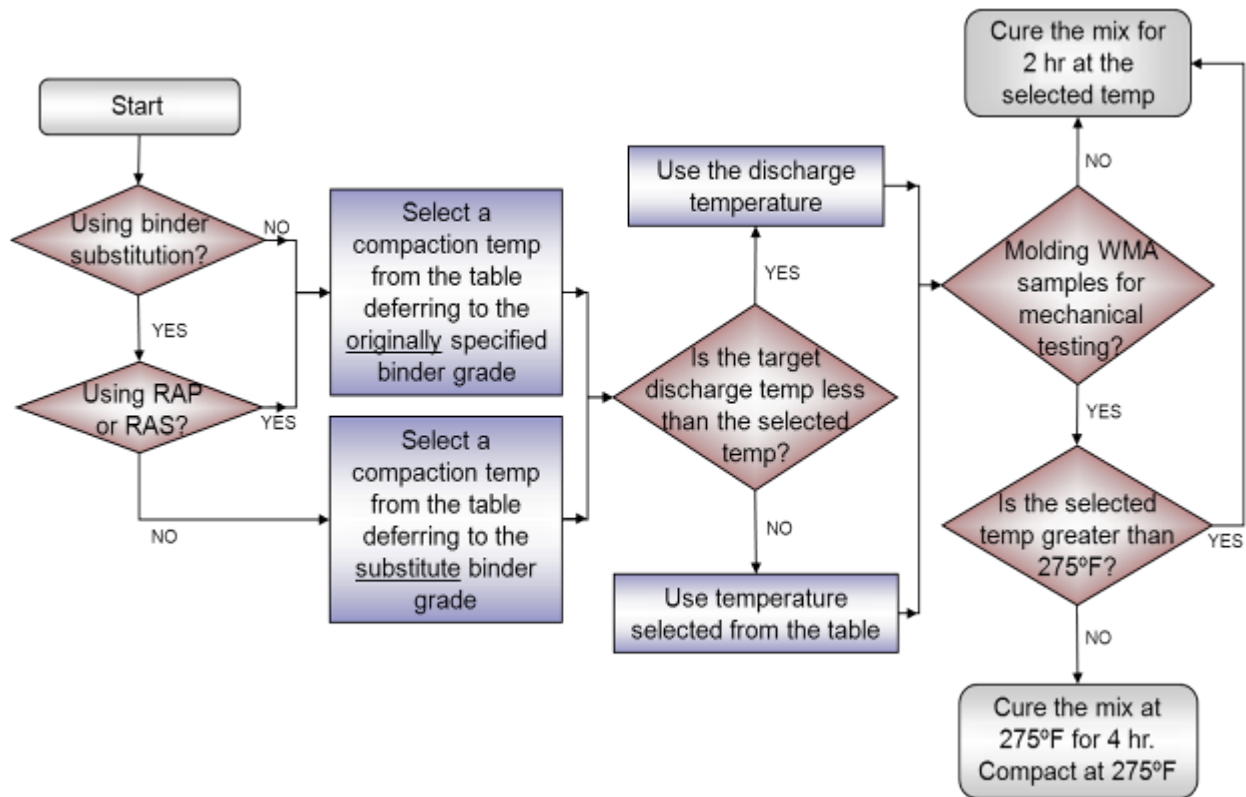
Figure 2.3. Curing Time and Temperature Selection according to Tex 206-F and Tex 241-F (Figure provided by Gisel Carrasco, TxDOT Construction Division, Feb02012).

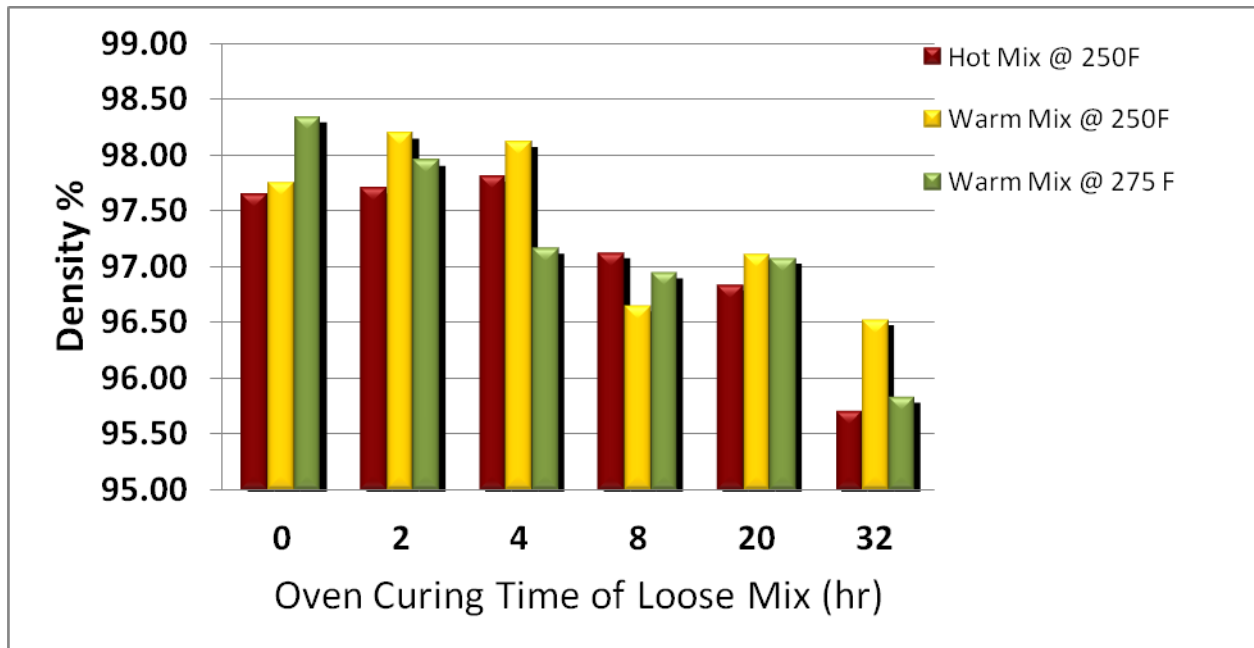
Figure 2.7. SH 21 Lab Molded Density versus Oven Curing Time for HMA and WMA (Texas Gyrotory Compactor).

Samples were molded in the Texas Gyrotory Compactor (TGC) and densities were determined based on standard TxDOT procedures. All of the mixtures that were compacted at the two key curing times (2 hr and 4 hr) showed similar lab molded densities ranging from 97.1 to 98.2 percent. Only after extended curing times of 32 hr did the lab molded densities drop significantly (Figure 2.7).

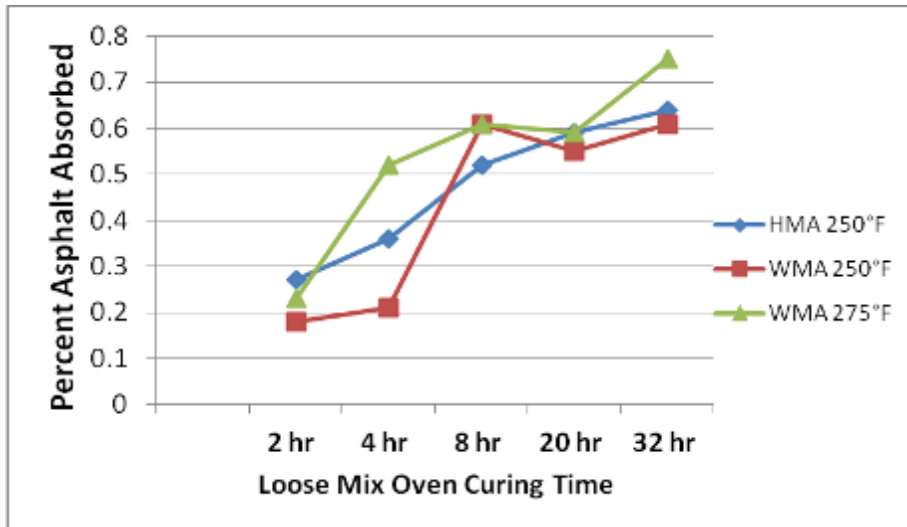
Figure 2.8. SH 21 Percent Asphalt Absorption for HMA and WMA Cured at Different Times and Temperatures.

Asphalt absorption was measured as a function of curing condition as shown in Figure 2.8. As expected, asphalt absorption increased with increased time in the oven for all the mixes. The WMA cured at 275°F had a generally higher asphalt absorption than both the WMA and HMA cured at 250°F for most of the curing times. Two hours of curing produced similar asphalt absorption for all of the mixes; however, four hours at 275°F WMA exhibited significantly more absorption than the HMA and WMA cured at 250°F.

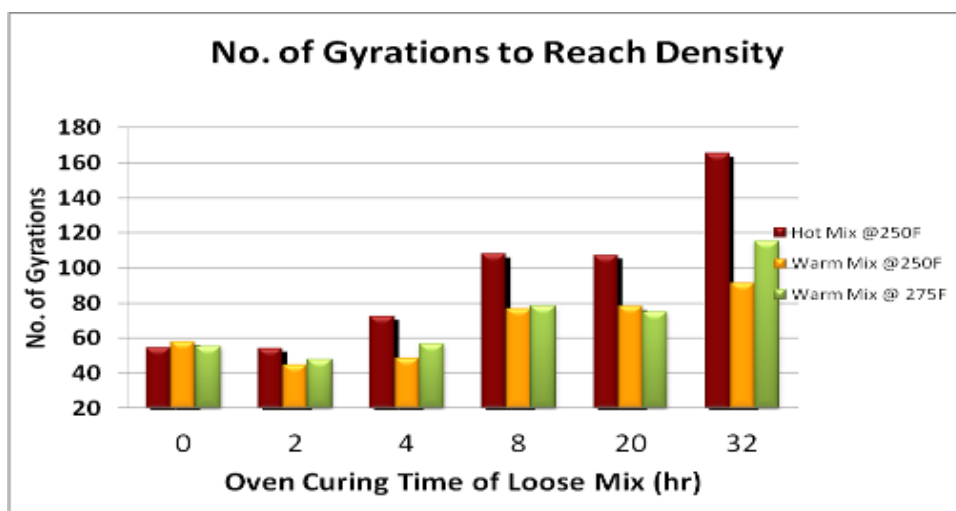
Figure 2.9. Number of Superpave Compactor Gyrations to Achieve 93 Percent Density for Molding Hamburg Specimens.

When preparing specimens for Hamburg testing, researchers recorded the number of gyrations required to reach 93 percent density in the Superpave Gyratory Compactor (SGC) (Figure 2.9). The warm mix was easier to compact at all curing times and a surprising finding was that even after 32 hr of oven curing, the warm mix was significantly easier to compact than the hot mix. This indicates some of the moisture from the foaming process is still available in the mixture.

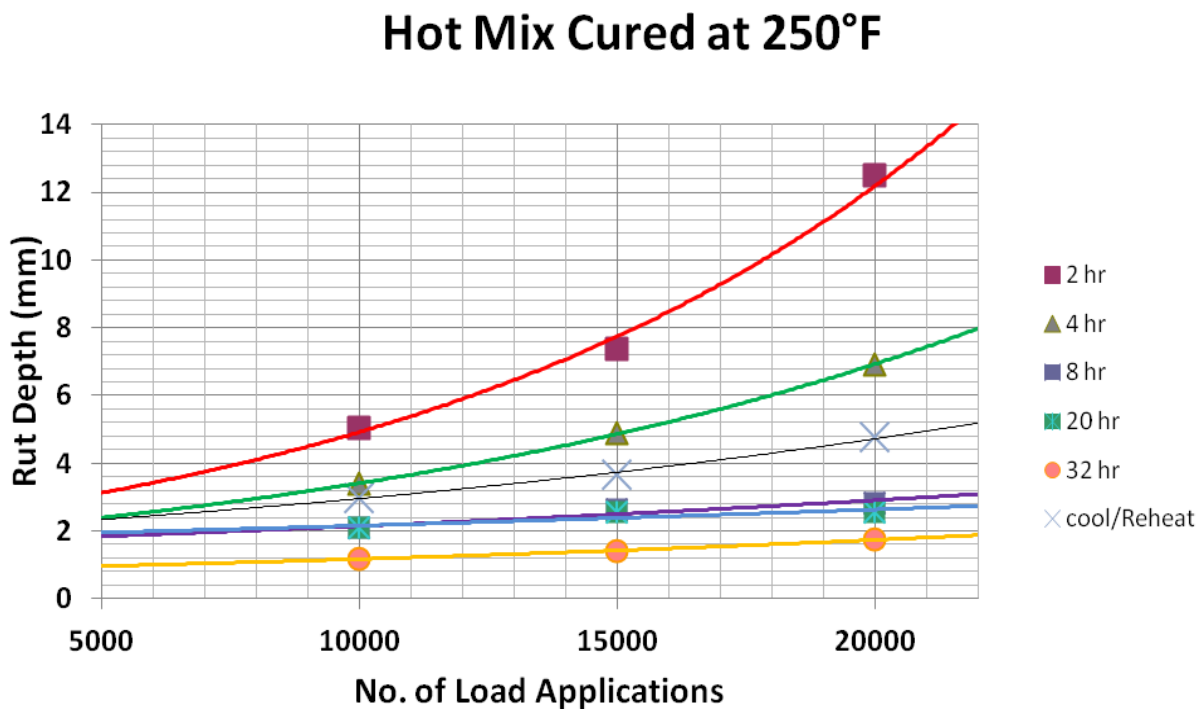
Figure 2.10. SH 21 Hamburg Wheel Tracking Test Results for Hot Mix Cured at 250°F.

Figures 2.10 through 2.14 show hot mix and warm mix cured at the different conditions. No significant changes in Hamburg Wheel tracking tests are noted after 4 hr of curing regardless of the mixture type of curing temperature. A set of loose mix WMA and HMA samples were also left at room temperature for one week, then heated just to the compaction temperature and molded. For the HMA, these specimens had lower rut depths than those cured at 2 and 4 hours (Figure 2.10). On the other hand, cooled/reheated WMA samples had higher rut depths.

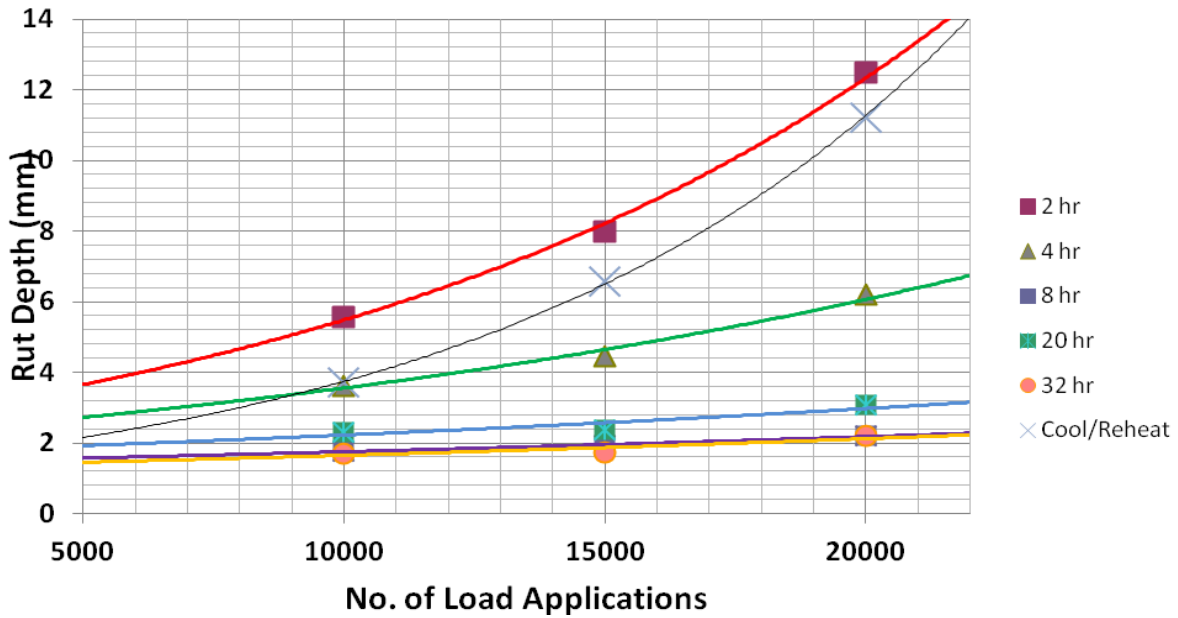
Figure 2.11. SH 21 Hamburg Wheel Tracking Test Results for Warm Mix Cured at 250°F.

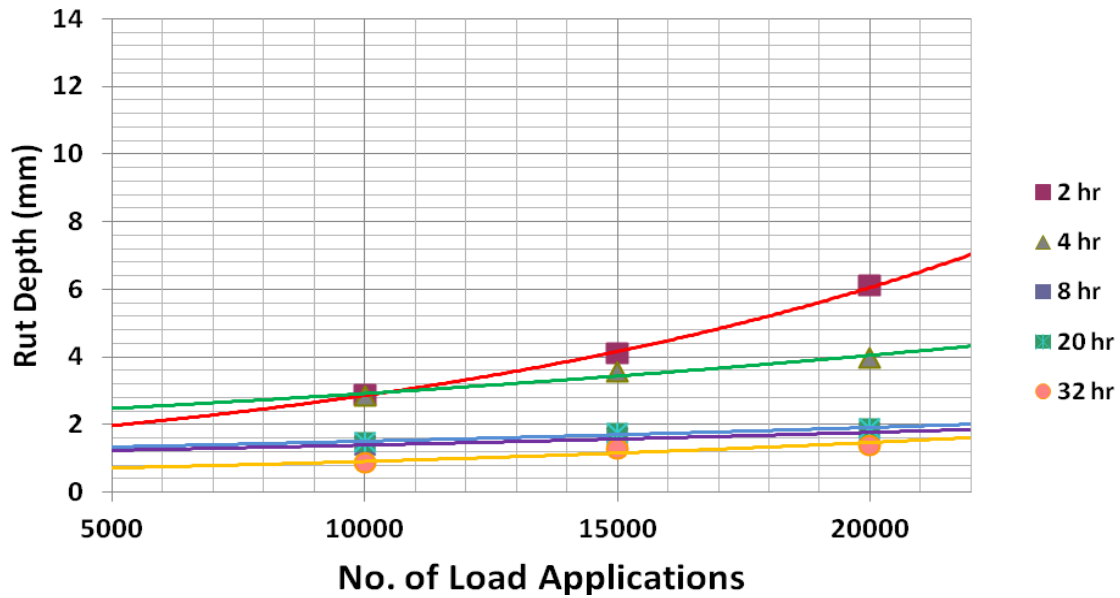
Figure 2.12. SH 21 Hamburg Wheel Tracking Test Results for Warm Mix Cured at 275°F.

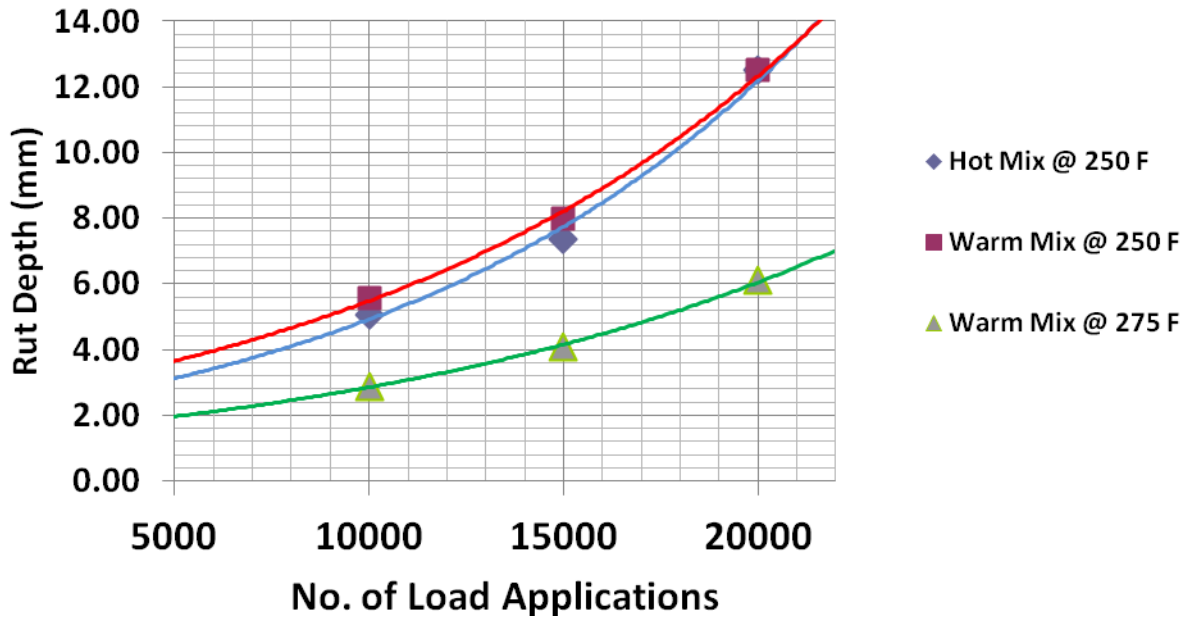
Figure 2.13. SH 21 Hamburg Wheel Tracking Test Results for HMA and WMA Cured for 2 Hours at Different Temperatures.

The HMA and WMA cured at 250°F had similar Hamburg rut depths for both 2 and 4 hour curing times (Figures 2.13 and 2.14); whereas, the WMA cured at 275°F was stiffer at both curing times.

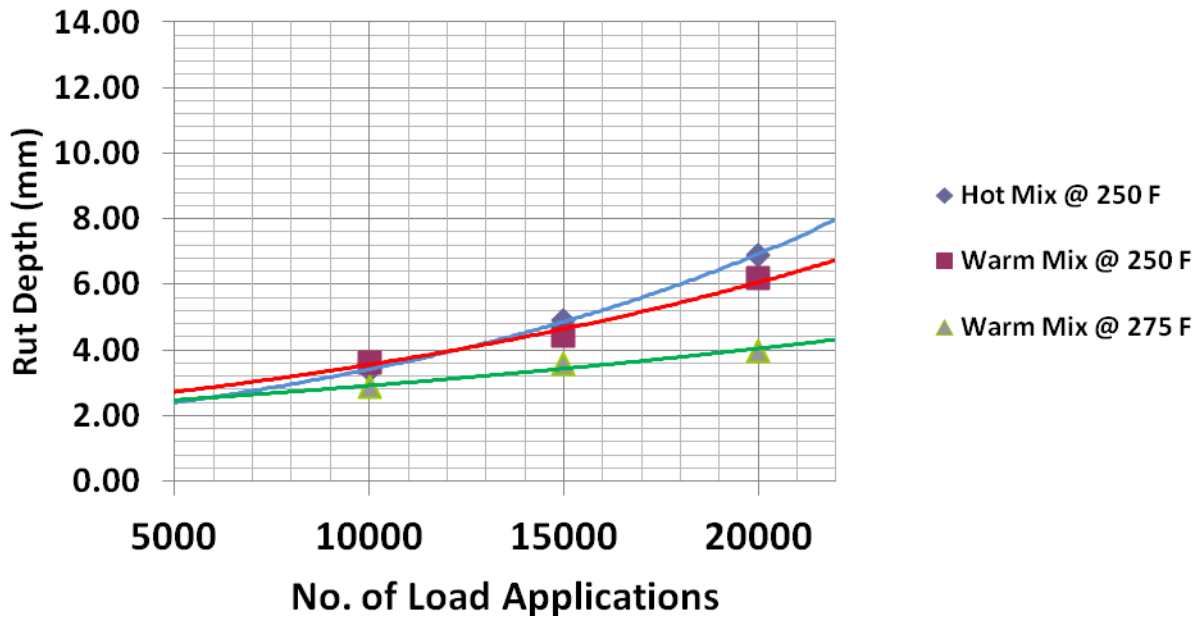
Figure 2.14. SH 21 Hamburg Wheel Tracking Test Results for HMA and WMA Cured for 4 Hours at Different Temperatures.

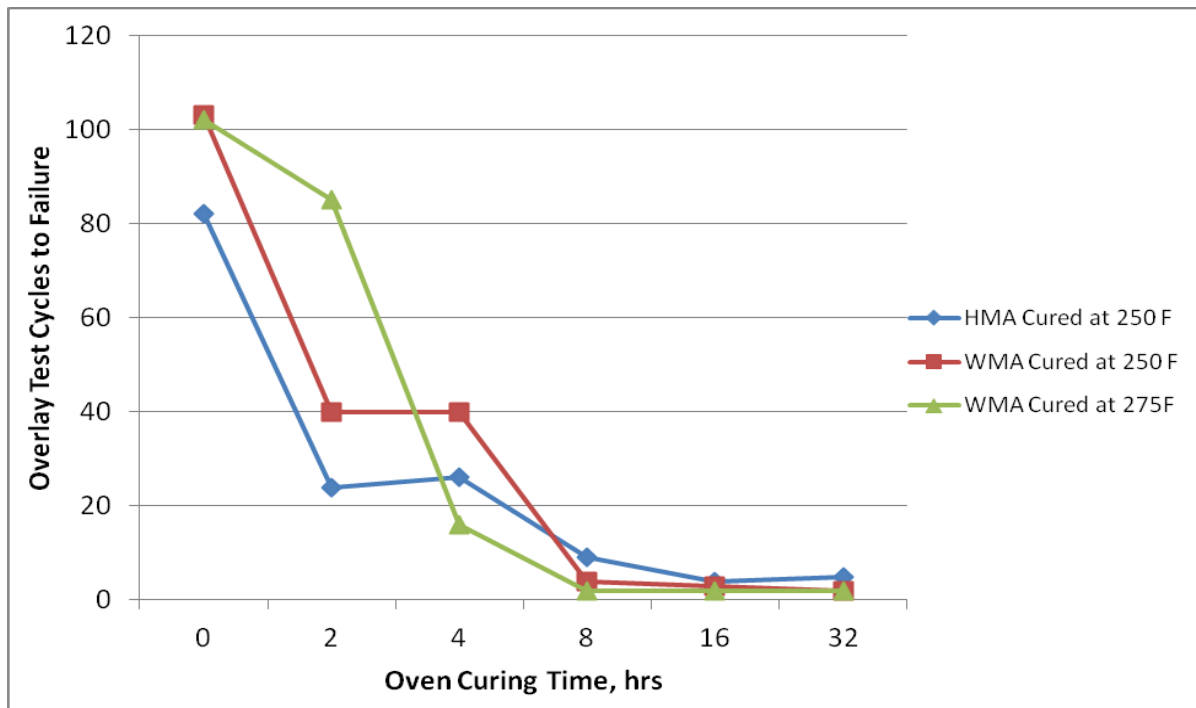
Figure 2.15. SH 21 Overlay Test Results for HMA and WMA Cured at Different Times and Temperatures.

Overlay test results are presented in [Table 2.3](#). Average results for each curing condition are plotted in [Figure 2.15](#). Results indicate a decrease in cracking resistance as curing time increases. Variability in the data makes it difficult to draw conclusions regarding curing temperature on cracking resistance; however, it is clear that cracking resistance as measured in the overlay tester can be significantly affected by curing time. The WMA mixes seem to initially have better cracking resistance but this better performance disappears with increased curing times.

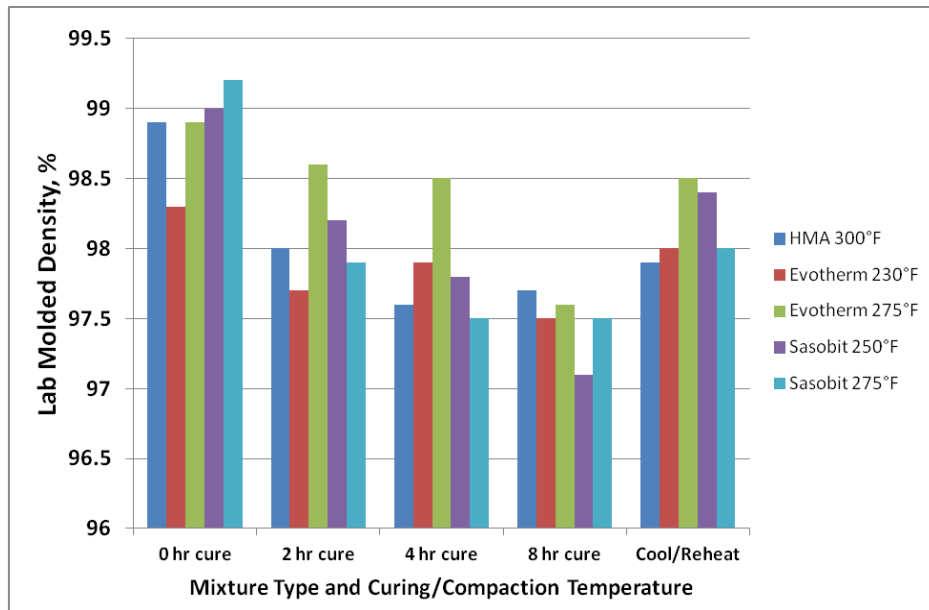
Figure 2.18. IH 37 Lab Molded Density for HMA and WMA Cured at Different Times and Temperatures.

Samples were molded in the TGC and densities were determined based on standard TxDOT procedures (Figure 2.18). At both the 2 hour and 4 hour curing time, the Evotherm mix compacted at 275°F had higher lab molded densities. The Evotherm mix cured at 230°F which was the target discharge temperature at the plant had a lab molded density comparable to the hot mix. These data support TxDOT’s current criteria (Figure 2.3) that states that the compaction temperature for the mix should be based on the target discharge temperature for determination of lab molded density. Mixtures which were allowed to remain at room temperature for one week and the reheated long enough to reach the compaction temperature had similar lab molded densities to those cured for 2 hours (as opposed to 0 hours). This would indicate that when reheating samples for determining lab molded density, no additional curing is needed

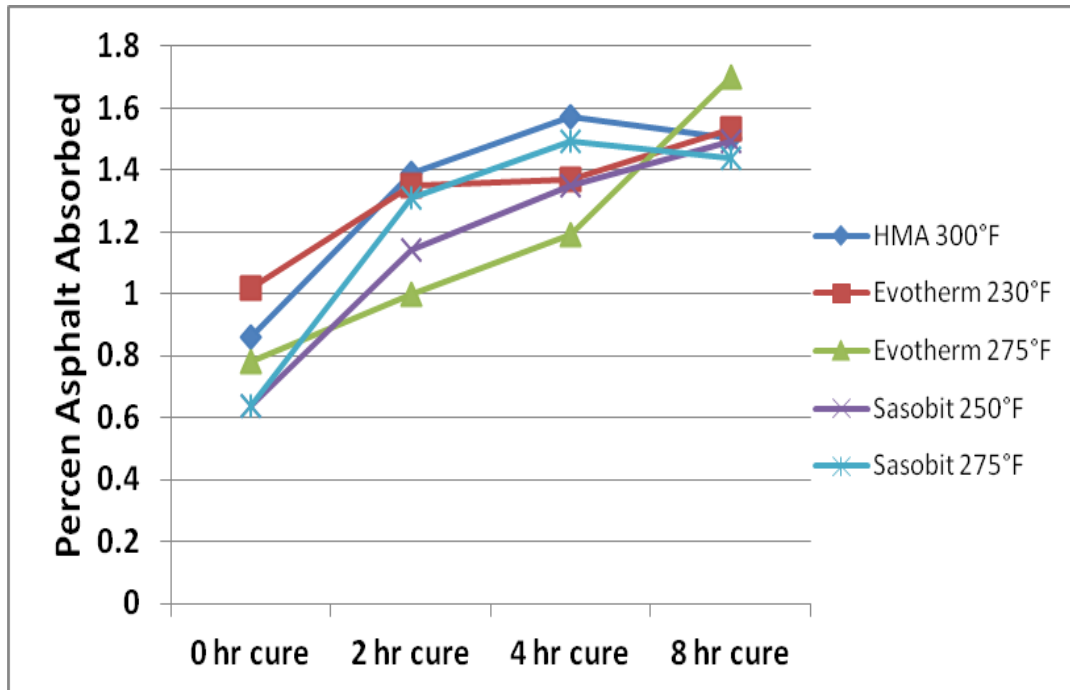
Figure 2.19. IH 37 Asphalt Absorption for HMA and WMA Cured at Different Times and Temperatures.

Asphalt absorption increased as a function of curing time as expected. However, the higher curing temperatures did not always produce the higher rates of absorption (Figure 2.19). Absorption varied significantly among all the mixes at 0, 2, and 4 hour curing times, but by 8 hours most of the mixes had about the same absorption.

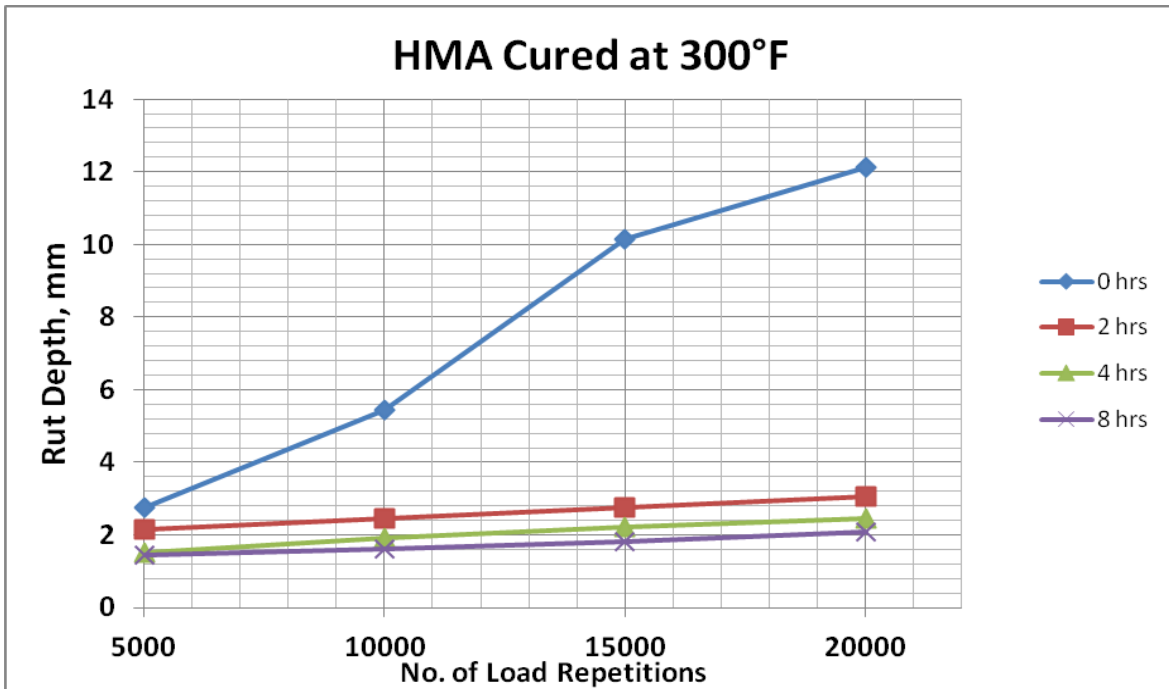
Figure 2.20. IH 37 Hamburg Wheel Tracking Test Results for Hot Mix Cured at 300°F.

Hamburg Wheel tracking results are presented in Figures 2.20 through 2.26. Figure 2.20 shows the HMA cured at 300°F and the significant effect of oven curing time. With no curing, the mix would almost fail the Hamburg criteria of not more than 12.5 mm rut depth at 20000 cycles and with just 2 hours of oven curing the rut depth is reduced to 3 mm. No significant change occurs in the HMA with increased oven curing time. The Evotherm mix cured at 230°F shows some propensity for rutting at 0 and 2 hours but at 275°F curing time the mix behaves very similarly to the HMA cured at 300°F. The Sasobit mix cured at both 250 and 275°F was very rut resistant at curing times of 2 hours and greater.

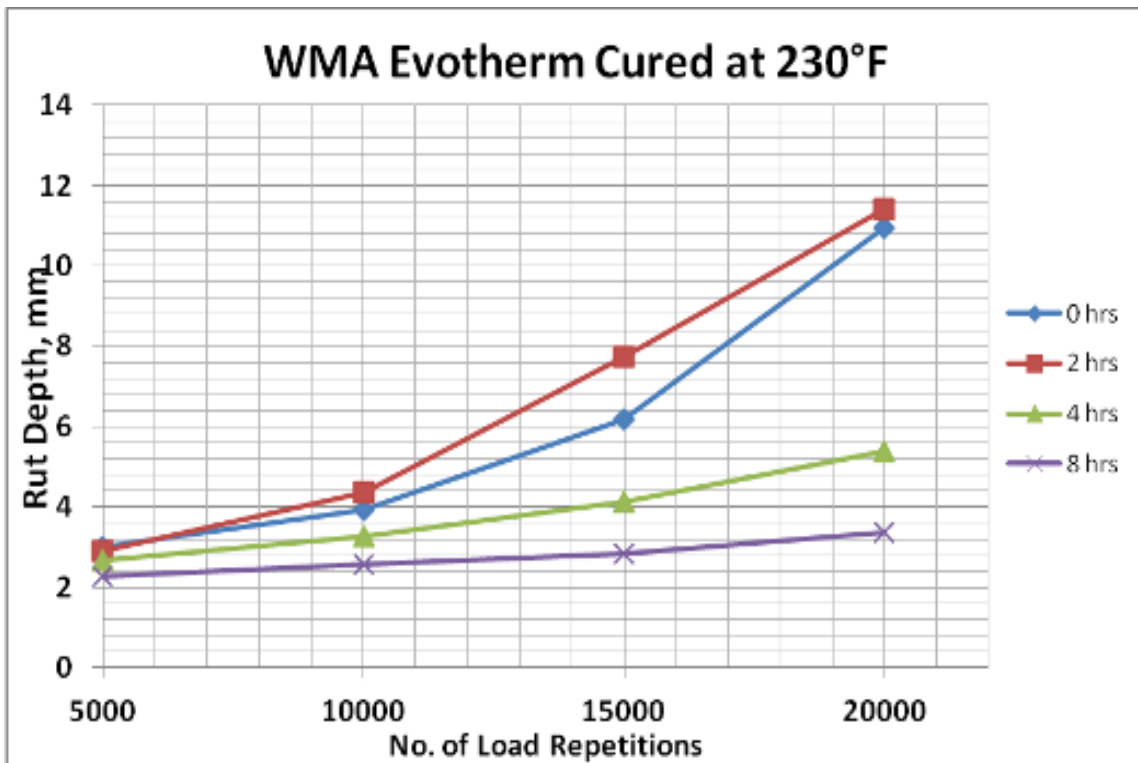
Figure 2.21. IH 37 Hamburg Wheel Tracking Test Results for WMA Evotherm Cured at 230°F.

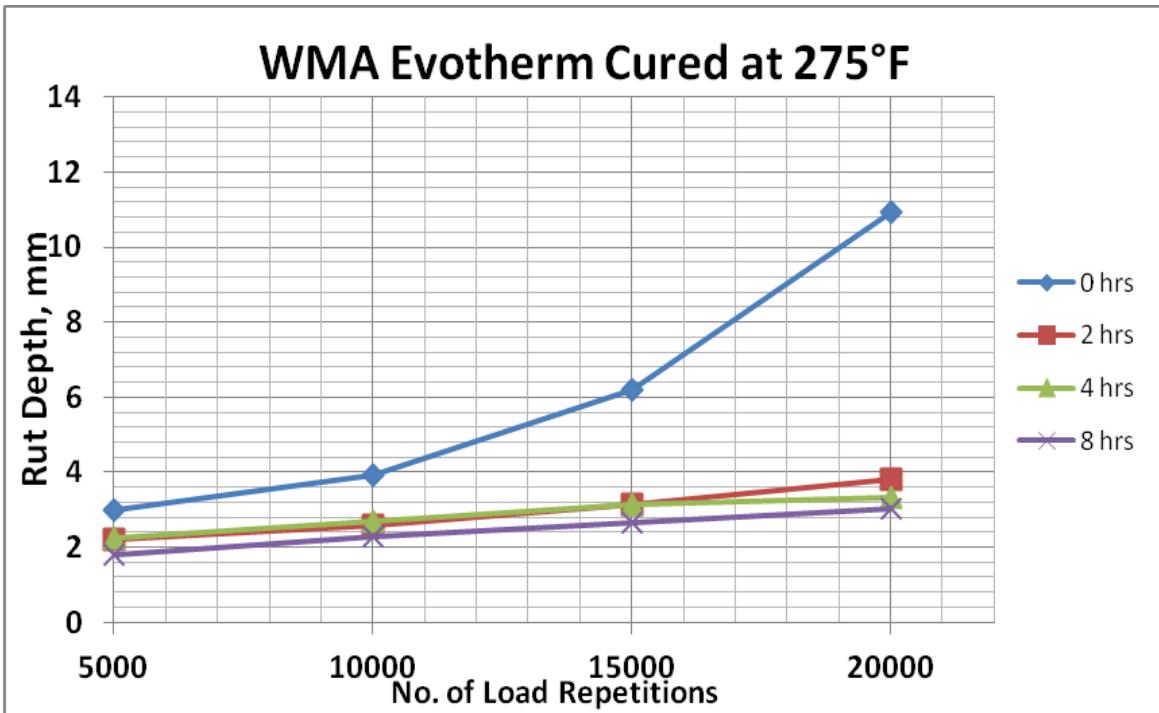
Figure 2.22. IH 37 Hamburg Wheel Tracking Test Results for WMA Evotherm Cured at 275°F.

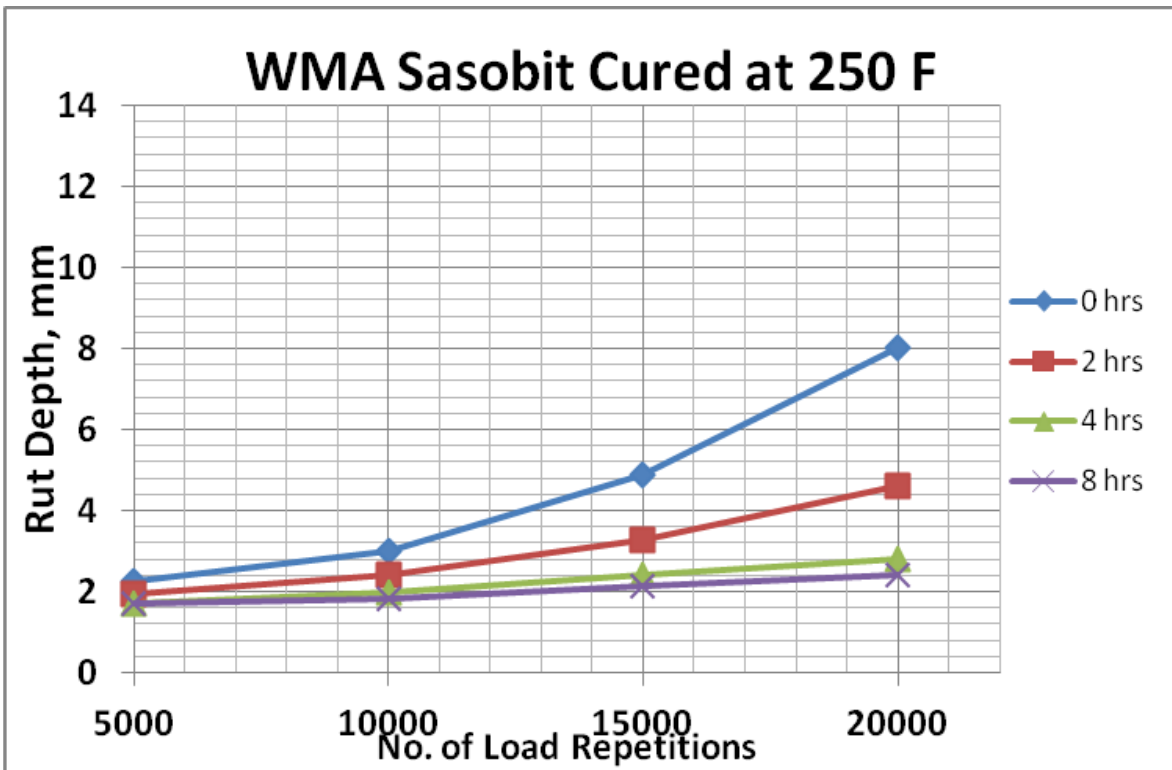
Figure 2.23. IH 37 Hamburg Wheel Tracking Test Results for WMA Sasobit Cured at 250°F.

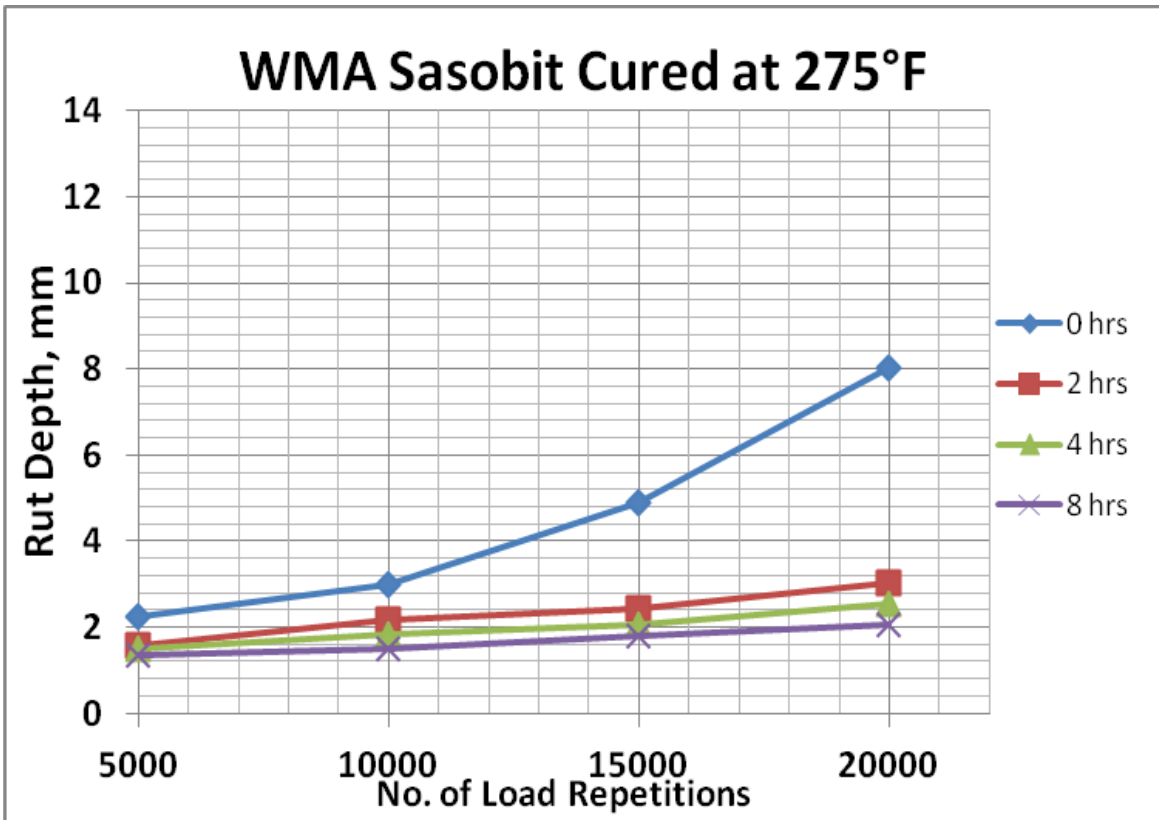
Figure 2.24. IH 37 Hamburg Wheel Tracking Test Results for WMA Sasobit Cured at 275°F.

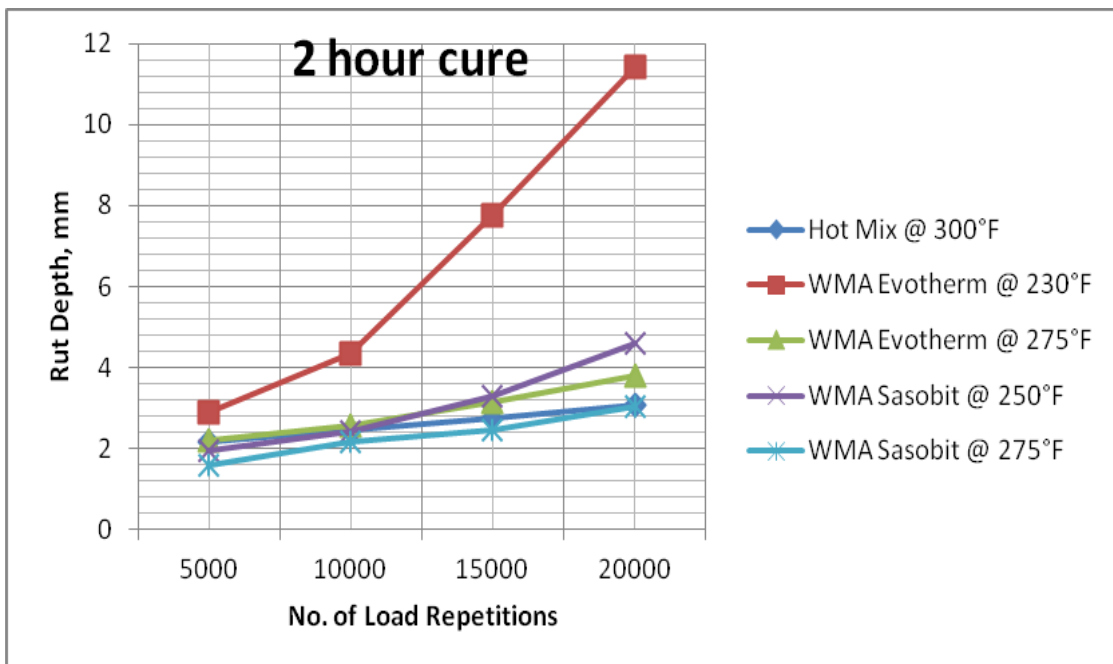
Figure 2.25. IH 37 Hamburg Wheel Tracking Test Results for HMA and WMA Cured for 2 Hours at Different Temperatures.

Figures 2.25 shows all of the different mixtures for the 2 hour cure and Figure 2.26 shows the mixtures all at the 4 hour cure. With the exception of the Evotherm mix cured at the low temperature of 230°F, a 2 hour cure was sufficient to produce Hamburg results similar to the hot mix.

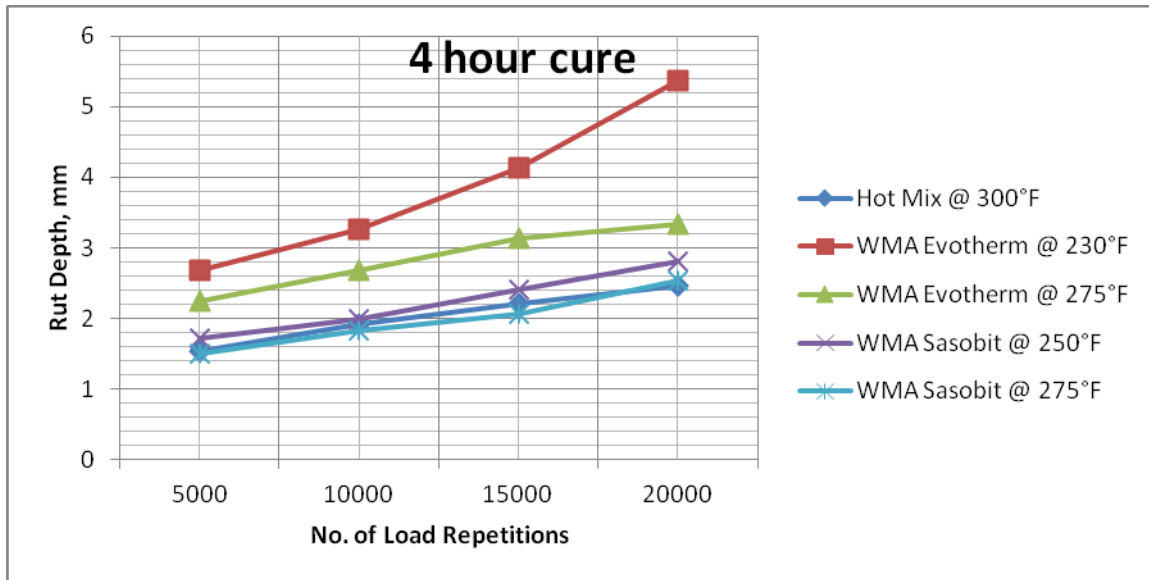
Figure 2.26. IH 37 Hamburg Wheel Tracking Test Results for HMA and WMA Cured for 4 Hours at Different Temperatures.

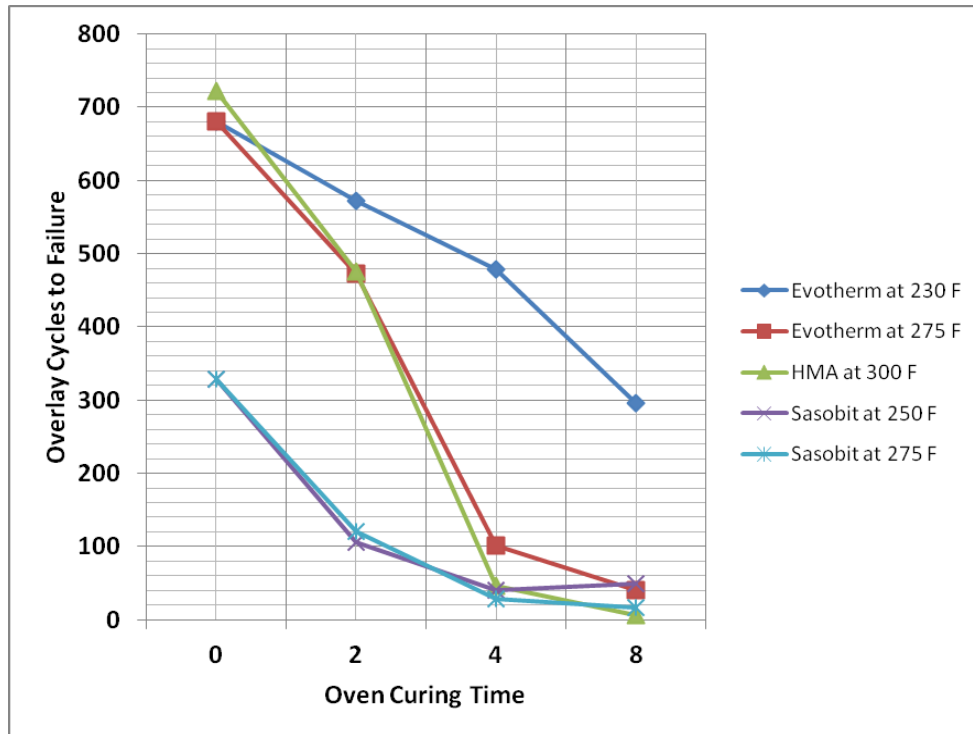
Figure 2.27. IH 37 Overlay Test Results for HMA and WMA Cured at Different Temperatures and Times.

Overlay test results are presented for all of the mixes in [Figure 2.27](#). With no curing the mixes had very high cracking resistance with as much as 700 cycles to failure for the Evotherm and HMA and over 300 for the Sasobit mixes. The Sasobit mixes cured at both 250 and 275°F had similar cracking resistance at all curing times. The Evotherm mix cured at 275°F had very similar cracking resistance to the HMA cured at 300°F for all curing times. However, the Evotherm mix cured at 230°F had the best cracking resistance even out to 8 hours of curing time.

These data indicate that the overlay test is very sensitive to curing time. The data also point to using caution when evaluating a mixture's cracking resistance in the laboratory since it is highly dependent on curing time and temperature which has yet to be strongly correlated to field conditions.

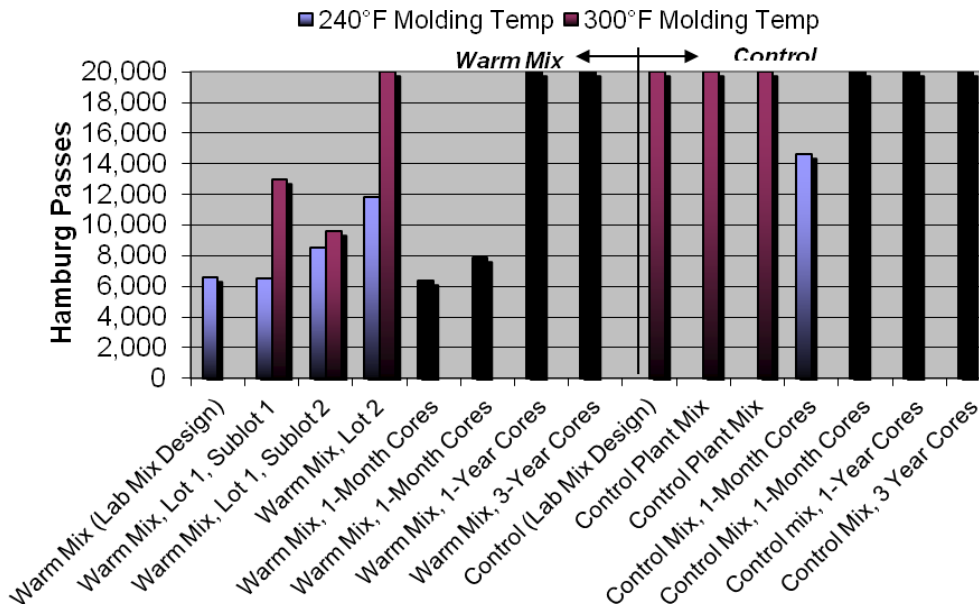
Figure 3.2. Hamburg Wheel Tracking Test Results for Lab Molded Warm Mix and Hot Mix Compared to Roadway Cores for Loop 368.

Hamburg wheel tracking test results are presented in [Figure 3.2](#). This chart includes samples which were molded during production at 2 different molding temperatures: 240 and 300°F. Generally, the warm mix samples compacted at 300°F performed better in the Hamburg than those compacted at 240°F. All of the warm mix samples failed the Hamburg test with the exception of the samples compacted at 300°F from the second night of warm mix production. Hamburg test results for the one-month roadway cores are compared to the lab molded plant mix samples in [Figure 3.1](#). As mentioned previously, some improvement is observed in the warm mix samples compacted at 300°F versus those compacted at 240°F. However, the warm mix cores taken at one month did not indicate that the mix improved with time (in terms of rut or moisture susceptibility resistance) compared to the lab molded samples. All of the cores taken at one year and beyond showed equivalent rut resistant of the WMA and HMA with both mixes lasting 20,000 cycles.

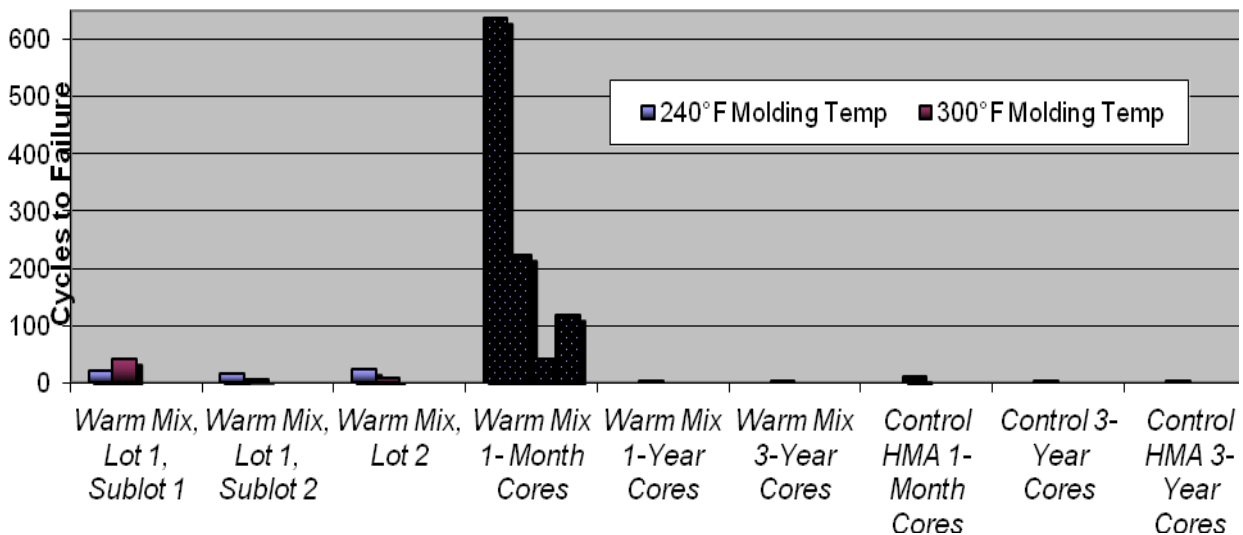
Figure 3.3. Overlay Test Results for Lab Molded Warm Mix and Control Mixes Compared to Roadway Cores for Loop 368.

The Overlay test results are shown in [Figure 3.3](#) for both the warm mix and the control mix and these data are typical of many current TxDOT dense graded mixes. All of the lab molded warm mix and control HMA specimens performed poorly in the Overlay test. However, there was a significant improvement seen in the some of the cores taken at one month from the warm mix sections. But in the cores taken at one year and afterward, there did not seem to be any improvement in cracking resistance.

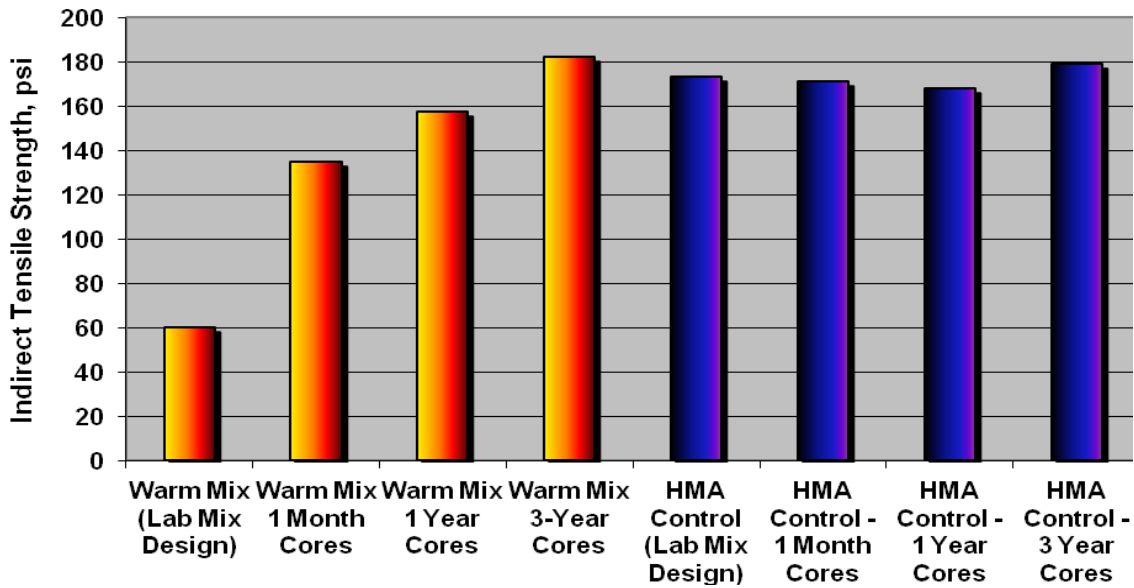
Figure 3.4. Indirect Tensile Strength Test Results for Lab Molded Warm Mix and Control Mixes Compared to Roadway Cores for Loop 368.

Indirect tensile strength tests are shown in [Figure 3.4](#) for both the warm mix and control HMA mix. The tensile strengths of the warm mix cores taken at one month show a significant improvement over the tensile strength of the warm mix during the mix design process (which was 60 psi for the WMA and 170 psi for the HMA). Average tensile strengths showed that the WMA cores taken at one month had a lower strength than the HMA cores at one month. But at one year and beyond the HMA and WMA are comparable to each other in terms of tensile strength.

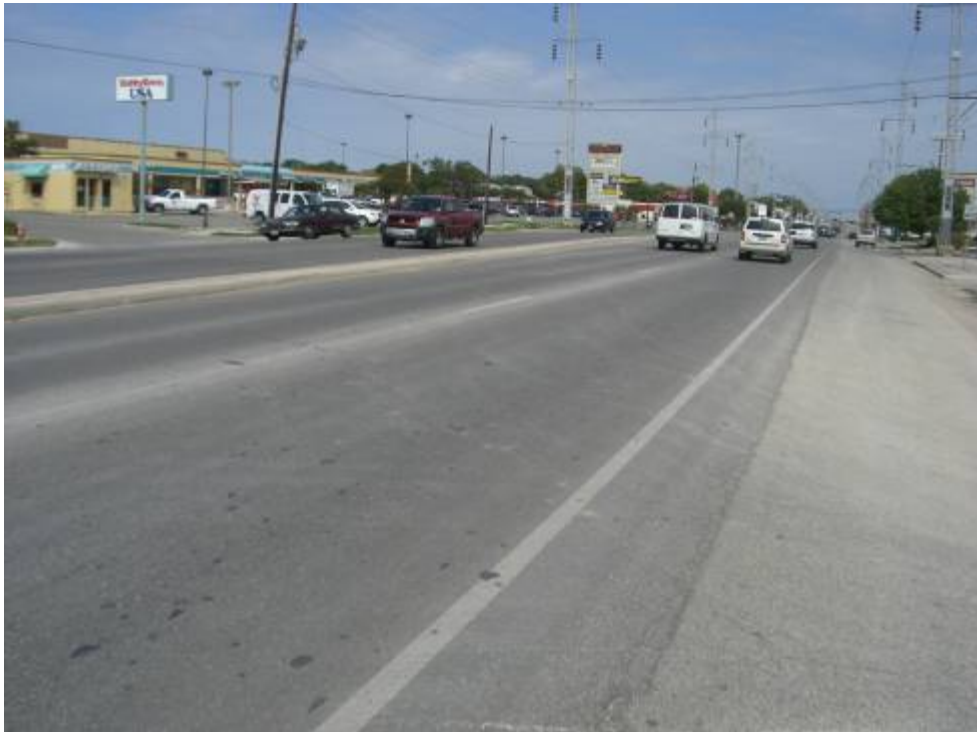
Figure 3.5. San Antonio Warm Mix Section after 3 Years of Service.

Figure 3.5 shows the Loop 368 project after 3 years of service. Some cracking is beginning to appear in both the WMA and HMA sections as shown in Figure 3.6 and as noted in Table 3.2. However, there is no evidence of any rutting in either WMA or HMA sections and both of the sections are performing comparably.

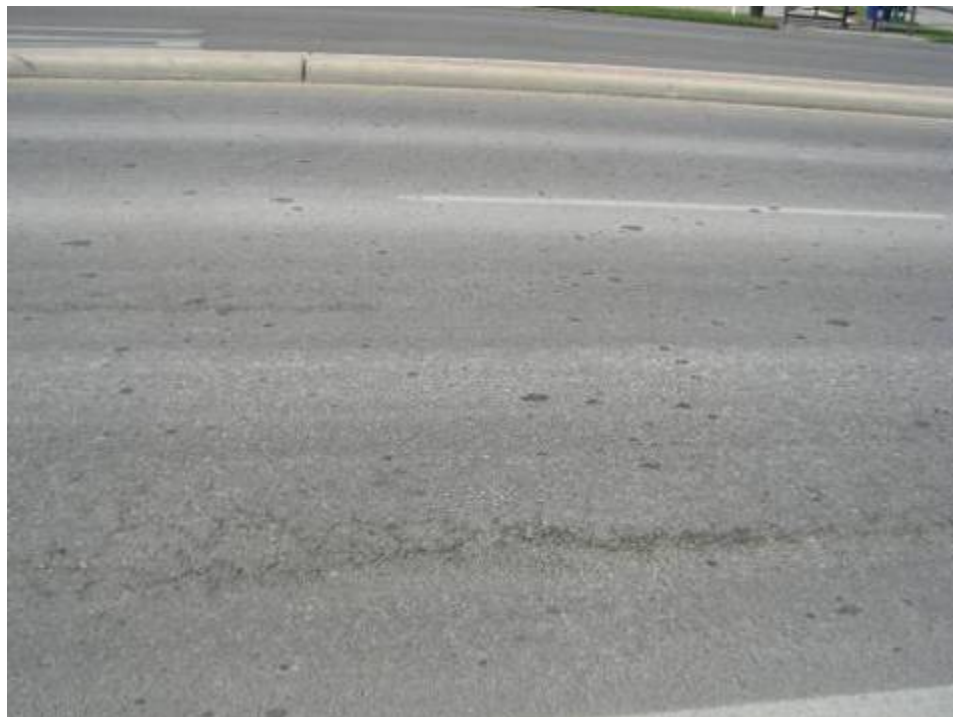
Figure 3.6. Evidence of Longitudinal Cracking Appearing in Both WMA and HMA Sections.

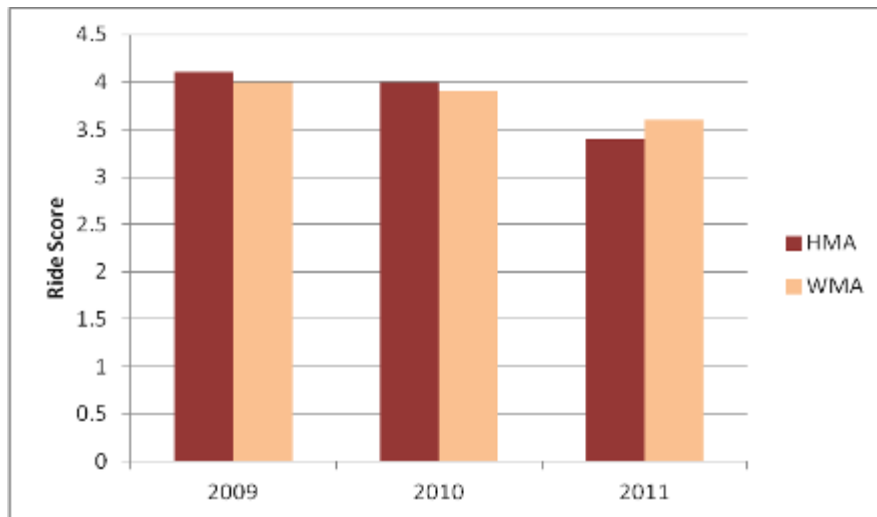
Figure 3.7. Ride Score Measurements for Loop 368.

Ride score measurements are shown in [Figure 3.7](#) for both the HMA and WMA sections for 2009 through 2011. Some decrease in ride is observed with time; however, the WMA and HMA sections are performing similarly.
