1. Report No. FHWA/TX-12/5-5597-01-1		2. Government Accession No.		3. Recipient's Catalog No.	
4. Title and Subtitle LABORATORY AND FIELD PERFORMANCE MEASUREMENTS TO SUPPORT THE IMPLEMENTATION OF WARM MIX ASPHALT IN TEXAS				5. Report Date February 2012 Published: July 2012

**LABORATORY AND FIELD PERFORMANCE MEASUREMENTS TO
SUPPORT THE IMPLEMENTATION OF WARM MIX ASPHALT IN
TEXAS**

Report 5-5597-01-1
Project 5-5597-01
Project Title: Evaluation of Warm Mix Asphalt

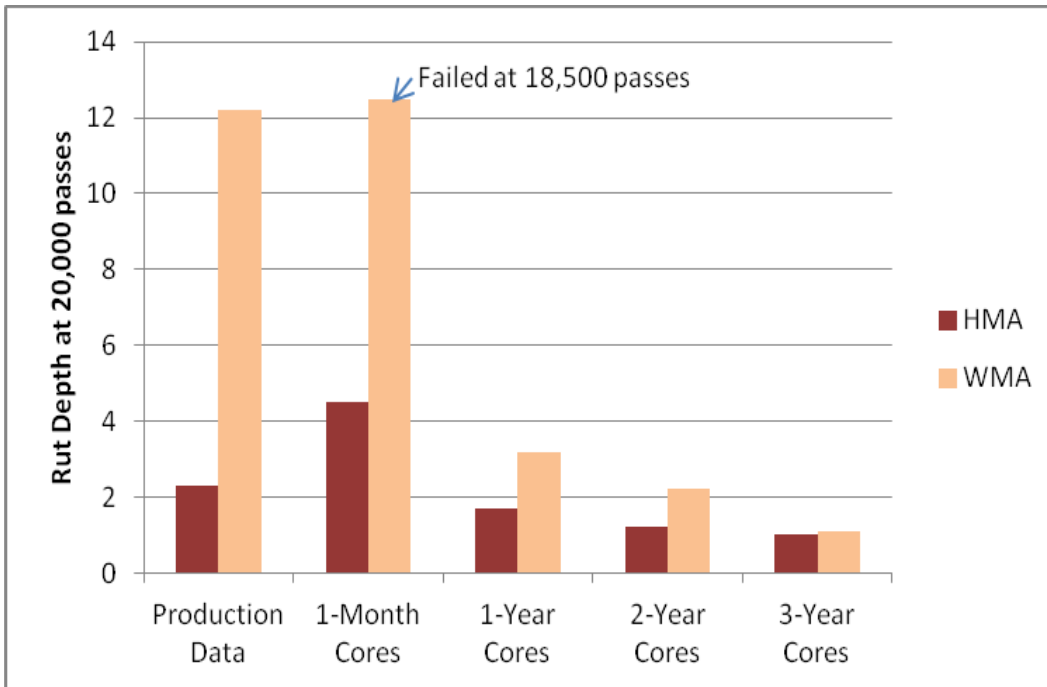
Figure 3.9. Hamburg Wheel Tracking Test Results for Lab Molded Warm Mix and Hot Mix Compared to Roadway Cores for US 71.

Hamburg wheel tracking test results are presented in [Figure 3.9](#). During production there was significant difference in the HWTT rutting resistance between the HMA and WMA. This, however, was before the 4 hour curing time of 275°F had been implemented by the Department. Cores taken at one month showed that the WMA was still somewhat rut susceptible and in fact failed the HWTT. By one year and beyond, however, the WMA rutting resistance was similar to the HMA.

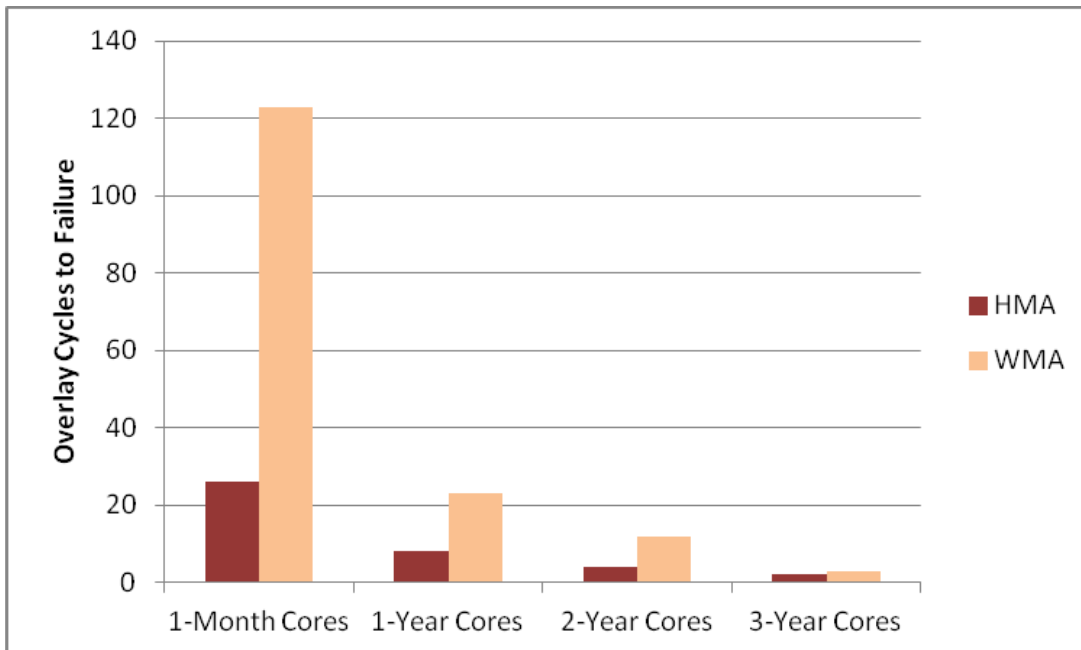
Figure 3.10. Overlay Test Results for HMA and WMA Roadway Cores for US 71.

The Overlay test results are shown in [Figure 3.10](#). The WMA cores taken at one month showed better cracking resistance as well as lower indirect tensile strength ([Figure 3.11](#)) than the HMA cores at one month. At one year and beyond, the WMA and HMA showed similar tensile properties.

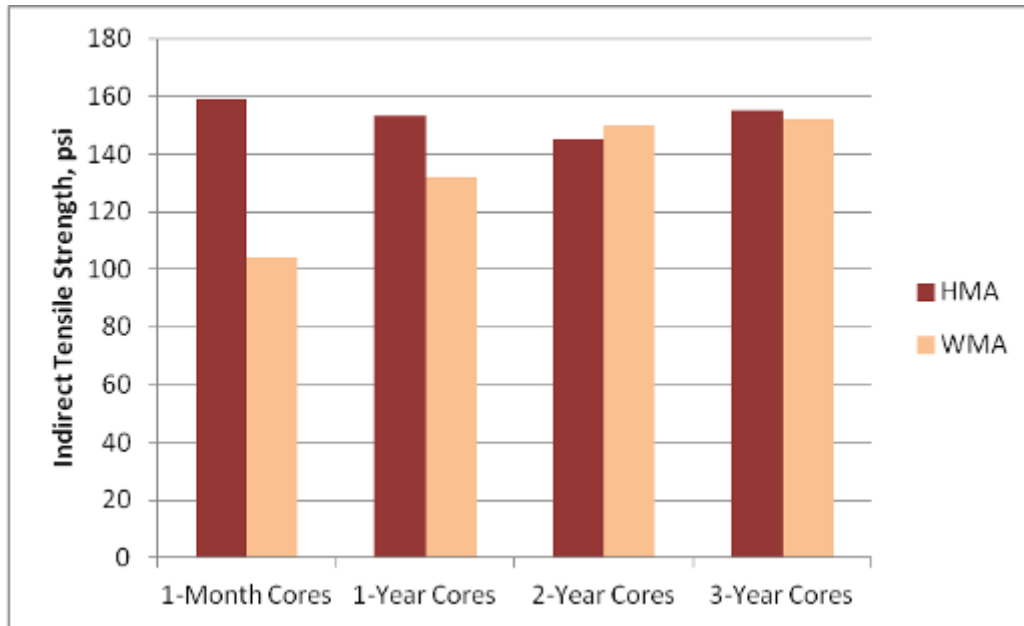
Figure 3.11. Indirect Tensile Strength Results for HMA and WMA Roadway Cores for US 71.

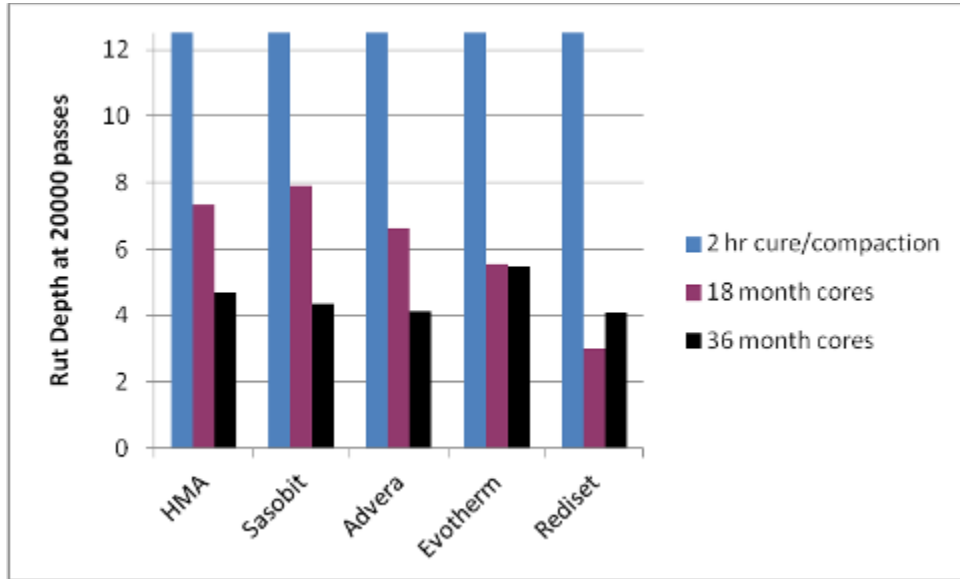
Figure 3.14. Hamburg Wheel Tracking Test Results for Lab Molded Warm Mix and Hot Mix Compared to Roadway Cores for FM 324.

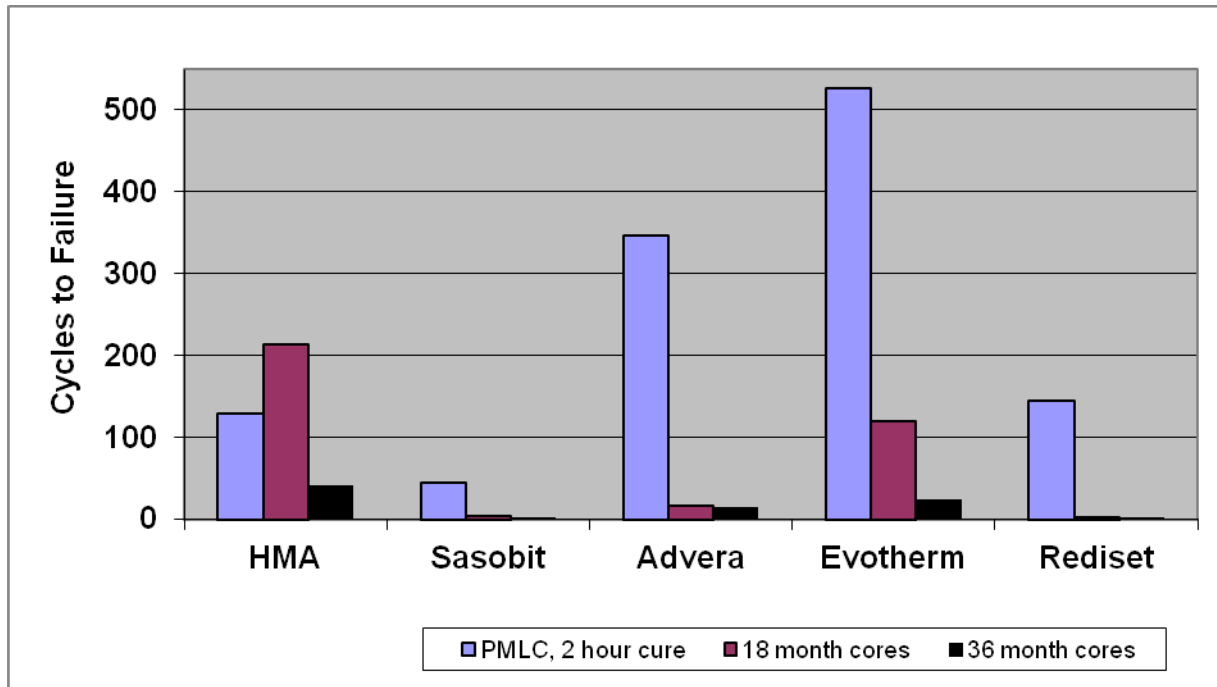
Figure 3.15. Overlay Test Results for Plant Mix-Lab Compacted HMA and WMA and Roadway Cores for FM 324.

The Evotherm and Advera WMA showed better cracking resistance in the overlay test ([Figure 3.15](#)). With increasing age, the cracking resistance dissipated.

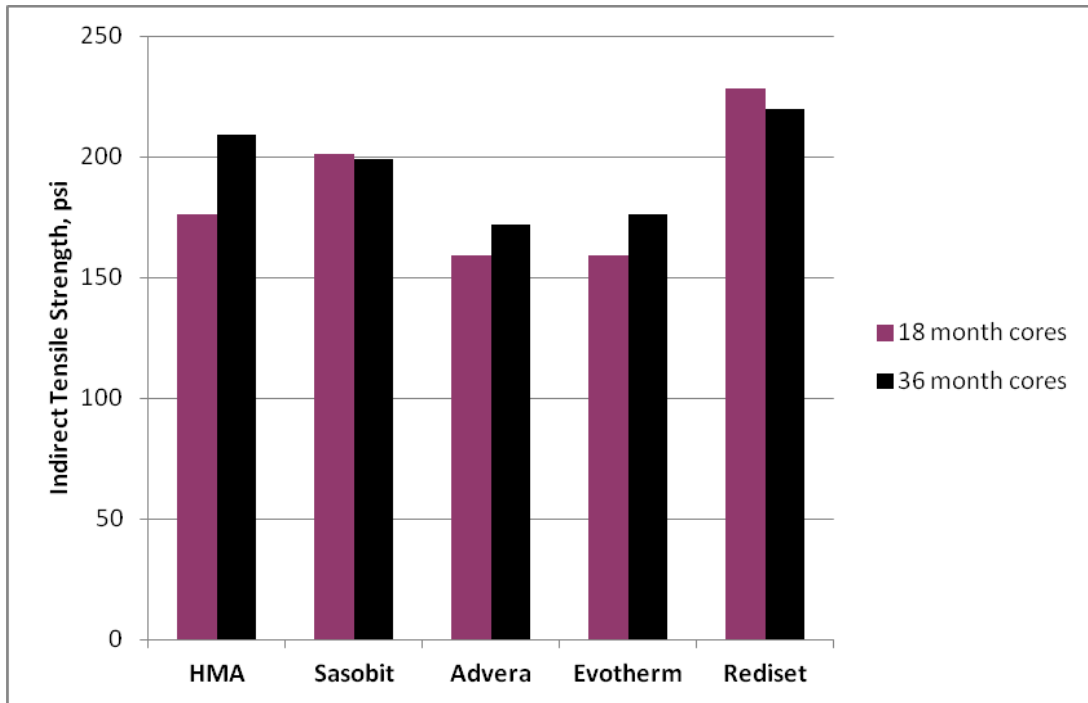
Figure 3.16. Indirect Tensile Strength Results for HMA and WMA Roadway Cores for FM 324.

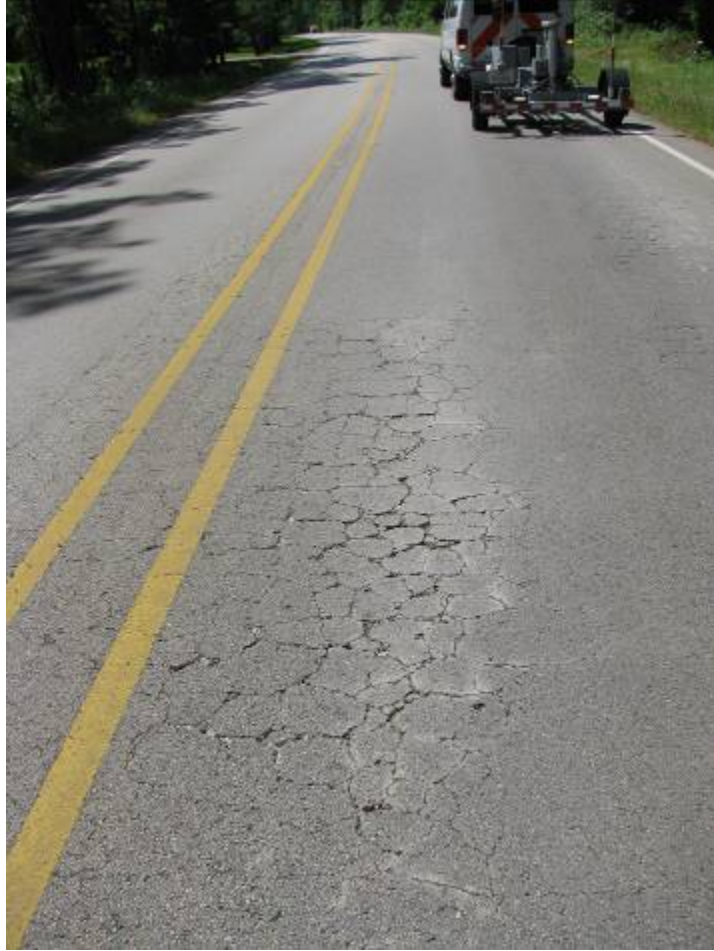
Figure 3.17. Alligator Cracking at South End of Project.

While the Rediset mix is somewhat stiffer than some of the other mixes (IDT results), the measured properties of the field cores for all of the mixes are similar and would not explain the alligator cracking seen in [Figure 3.17](#). This extensive cracking is attributed to the high deflections in the base layer in this portion of the project.

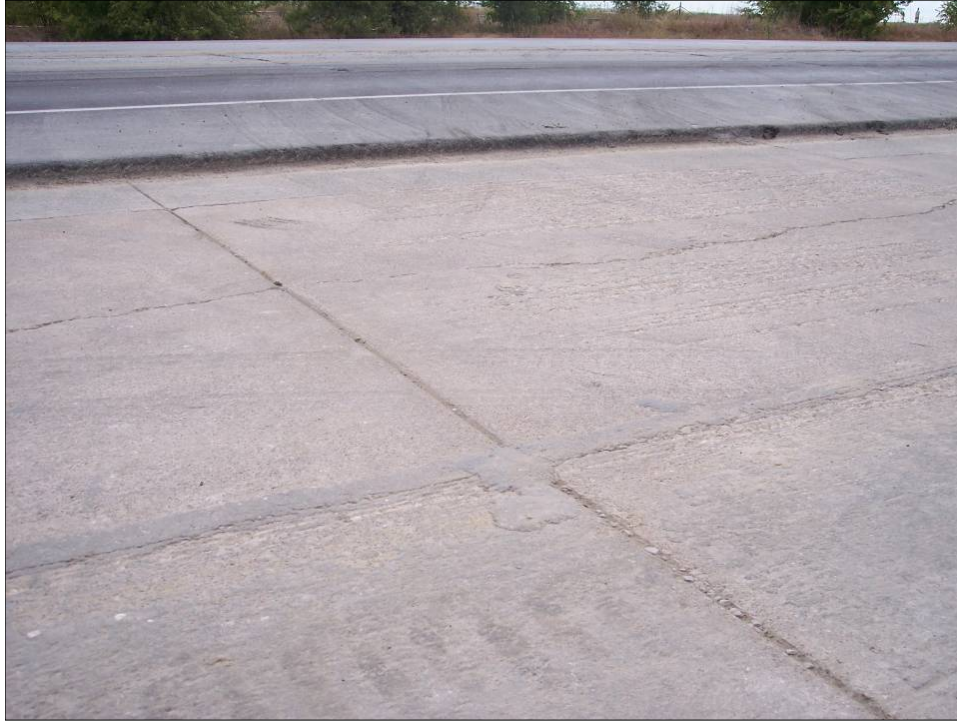
Figure 3.18. BU 287 Jointed Concrete Pavement prior to Type D WMA Overlay.

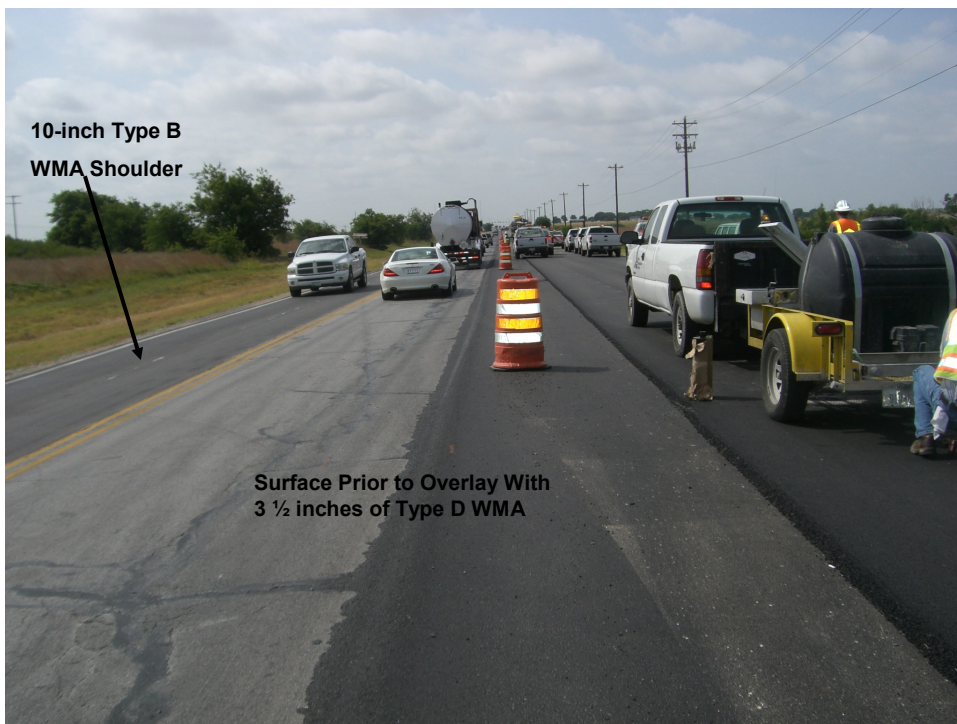
Figure 3.19. BU 287 Type B WMA Base Mix and Type D WMA Overlay.

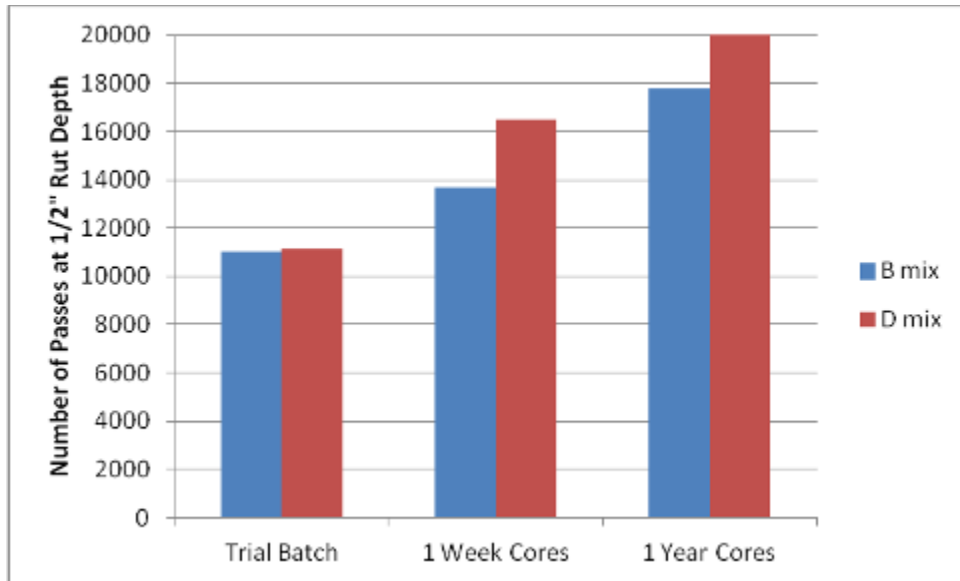
Figure 3.20. Hamburg Wheel Tracking Test Results for Type B and Type D WMA on BU 287.

Laboratory and field performance properties are shown in Figures 3.20, 3.21, and 3.22. HWTT results showed a somewhat rut susceptible mix in the trial batch; however, this was prior to adopting the 4 hour at 275°F curing conditions. Cores taken soon after construction showed better rutting performance than the trial batch and after one year the mixtures exhibited good rutting resistance. Overlay test results showed very poor cracking resistance for the mixes beginning immediately after construction.

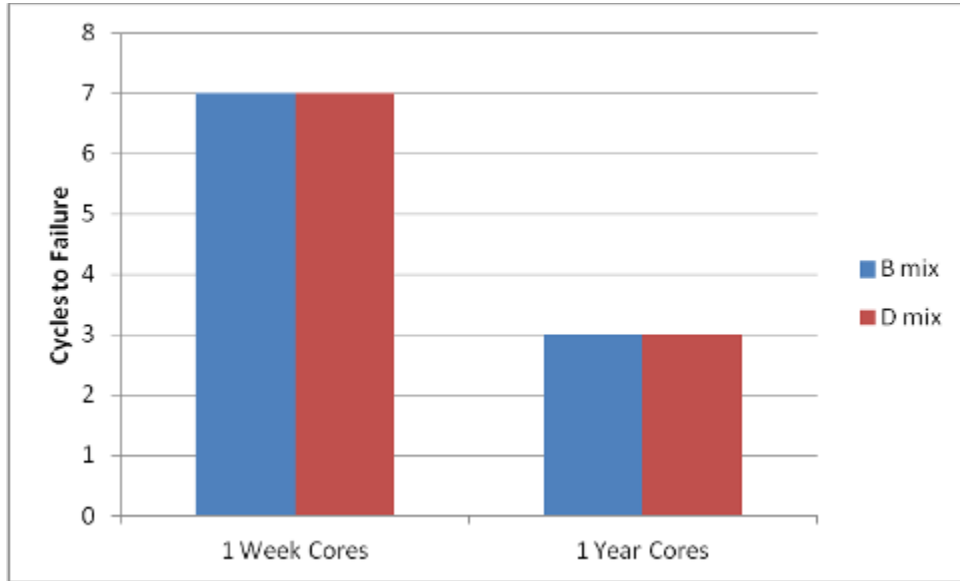
Figure 3.21. Overlay Test Results for Type B and Type D WMA on BU 287.

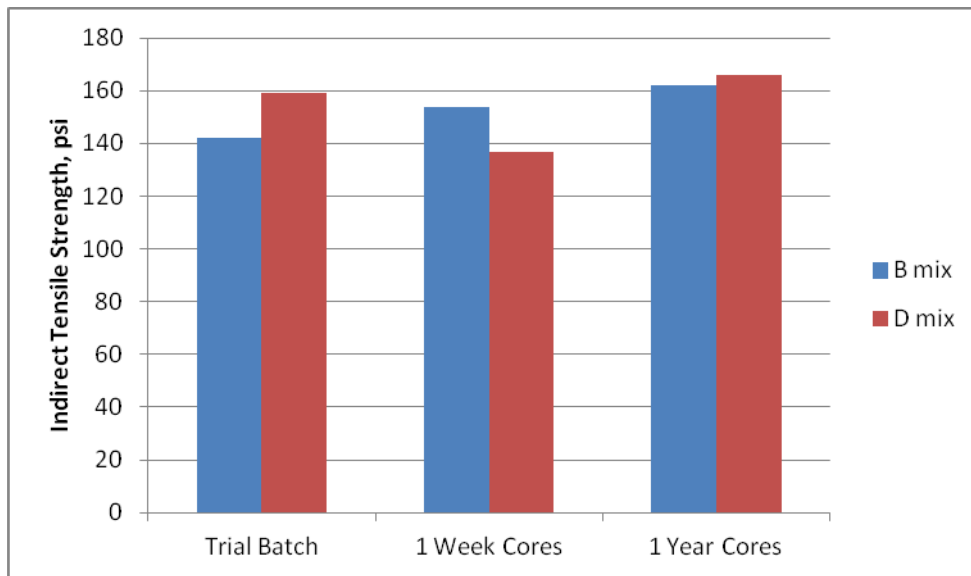
Figure 3.22. Indirect Tensile Strength Results for Type B and Type D WMA for BU 287.

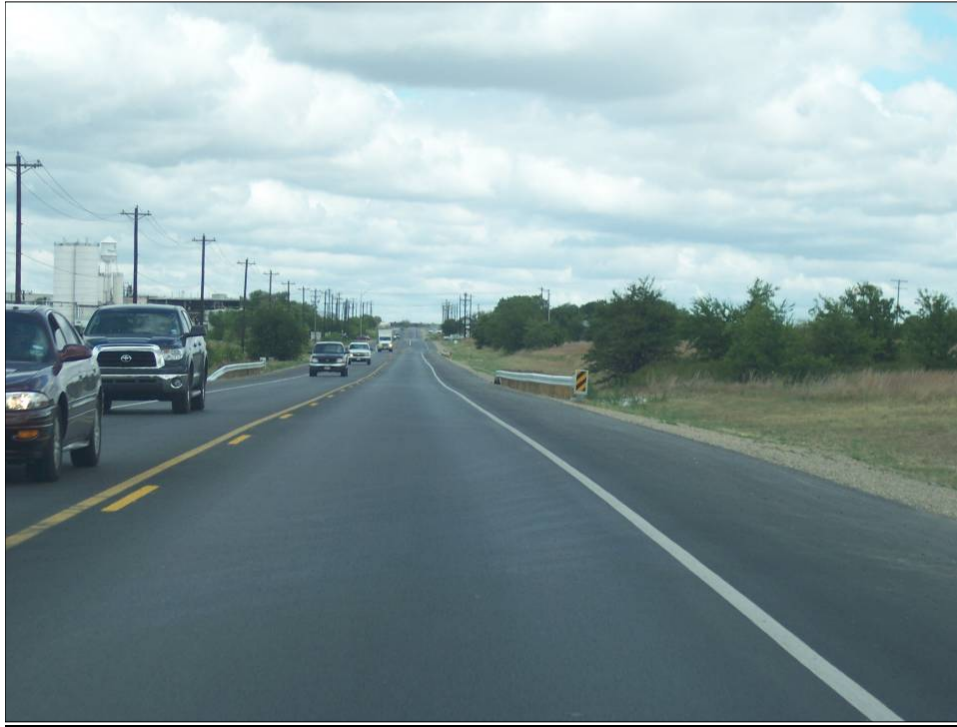
Figure 3.23. Fort Worth BU 287 WMA Project after One Year of Service.

Field performance on the project has been good with no evidence of rutting or cracking distress (Figure 3.23). Ride quality as shown in Figure 3.24 has also remained consistent.

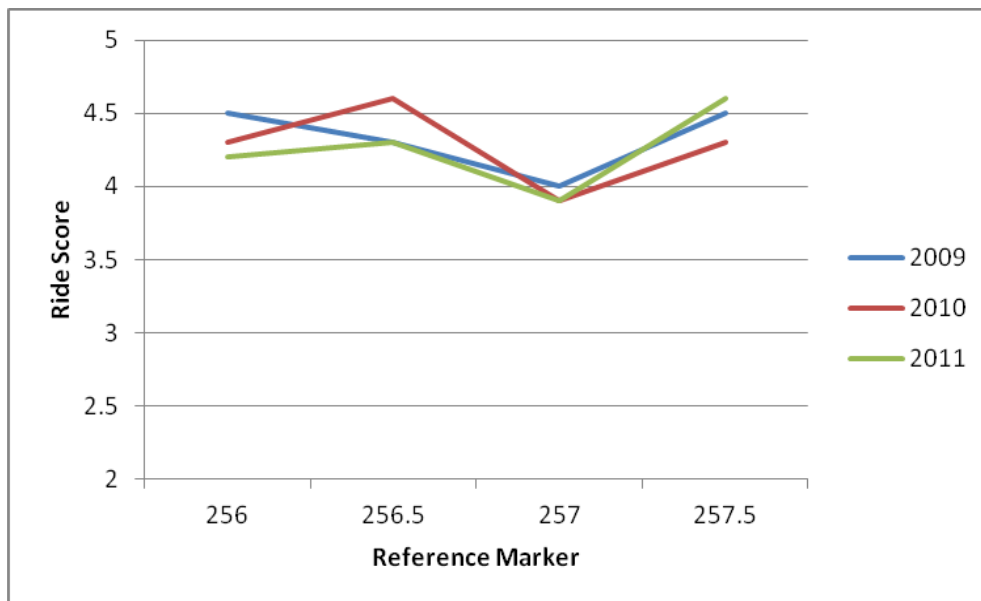
Figure 3.24. Ride Score Measurements for BU 287.

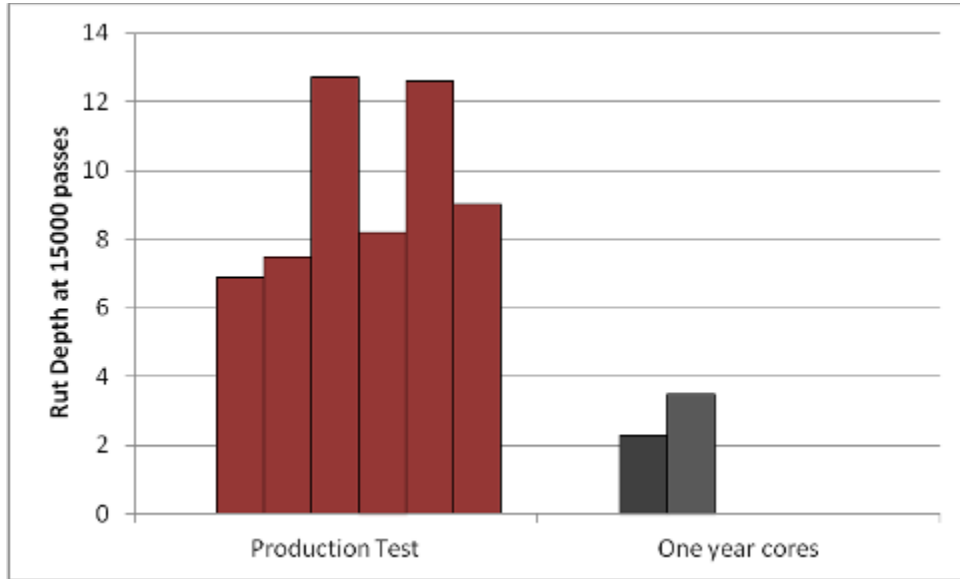
Figure 3.25. Hamburg Wheel Tracking Test Results for US 190.

Hamburg wheel tracking tests are presented in [Figure 3.25](#). During production, two of the samples failed the criteria of no more than 12.5 mm rutting at 15000 passes. Field cores after one year showed adequate rutting resistance.

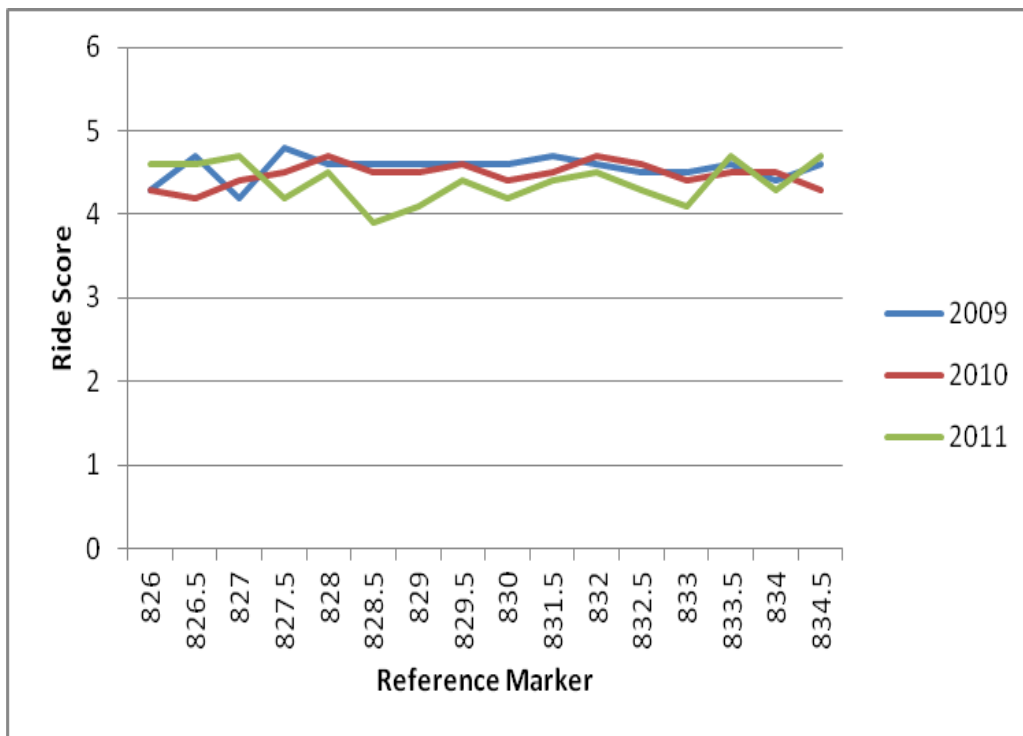
Figure 3.26. Ride Score Measurements for US 190

No rutting or cracking distress was observed throughout the monitoring periods. Ride score data are presented in [Figure 3.26](#). A slight decrease in ride score seems to be occurring from 2010 to 2011.

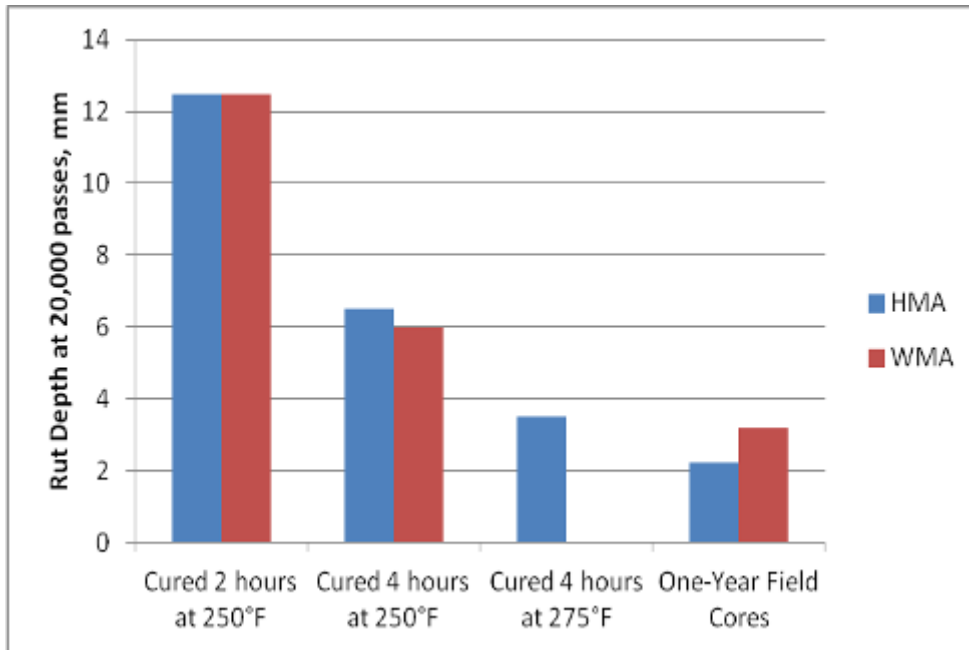
Figure 3.27. Hamburg Wheel Tracking Test Results for SH 21.

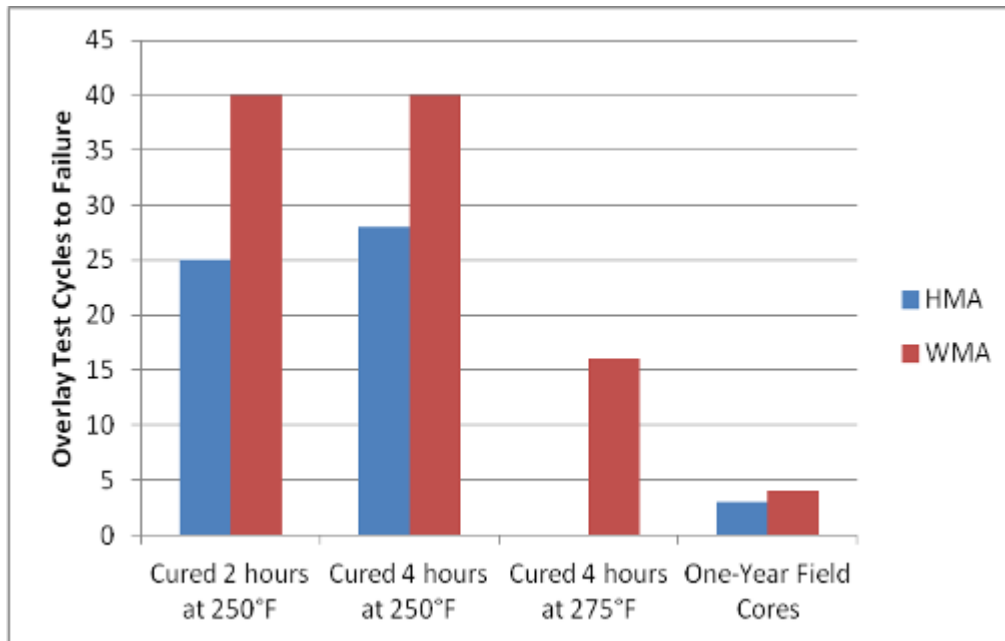
Figure 3.28. Overlay Test Results for SH 21.

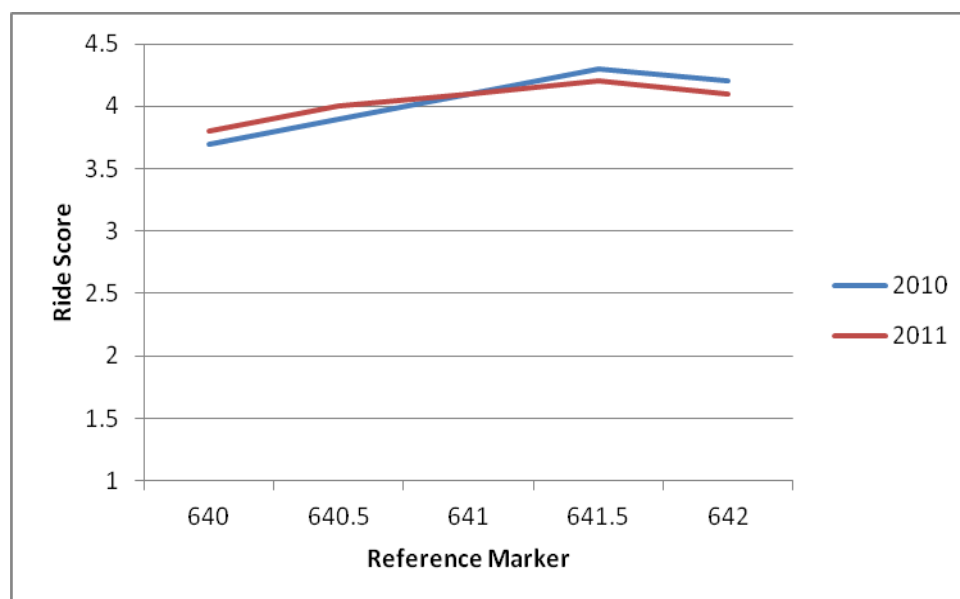
Figure 3.29. Ride Score Measurement for SH 21 WMA.

Both the WMA and HMA portions of SH 21 are performing well with no cracking or rutting distress. Ride quality data are shown in [Figure 3.29](#).

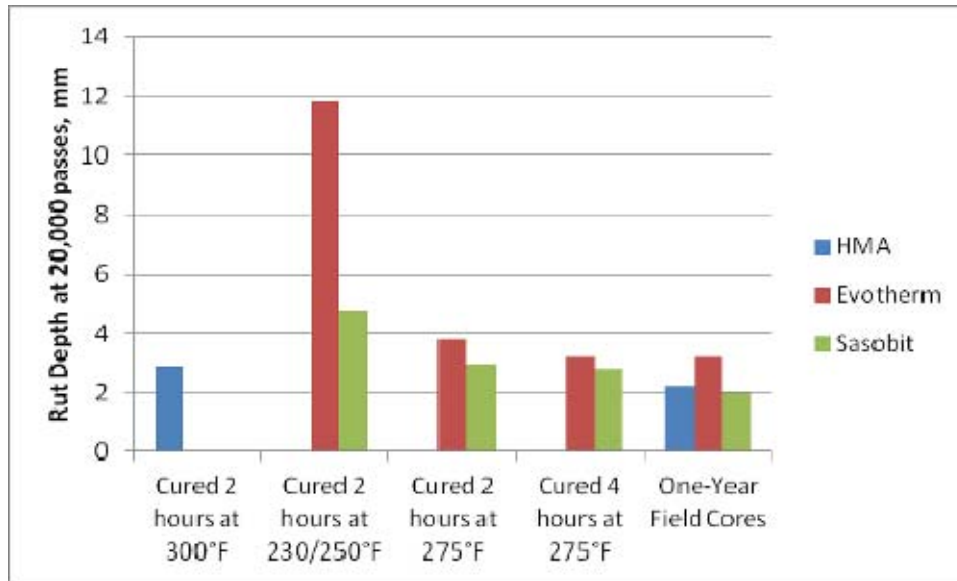
Figure 3.30 Hamburg Wheel Tracking Test Results for IH 37.

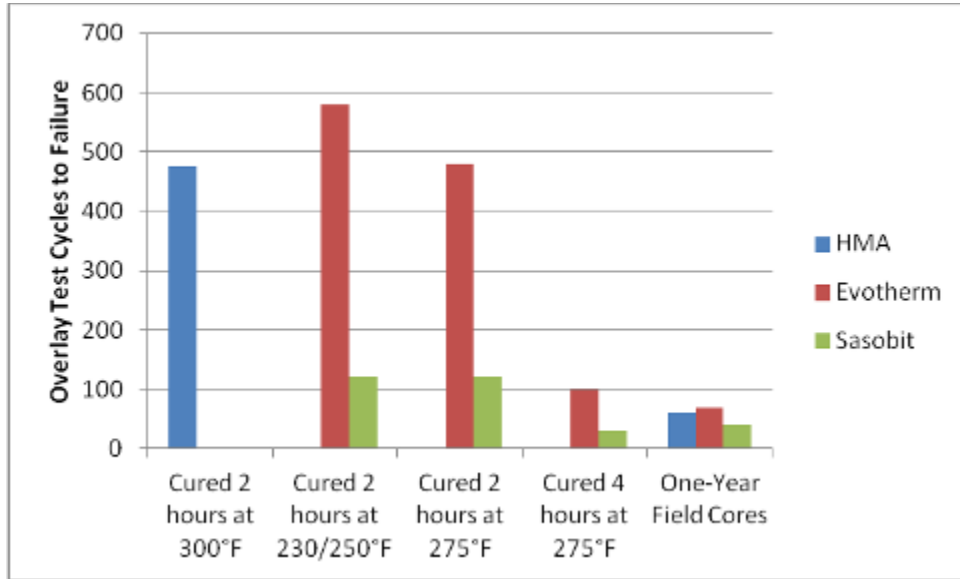
Figure 3.31. Overlay Test Results for IH 37.
Field Performance Evaluation

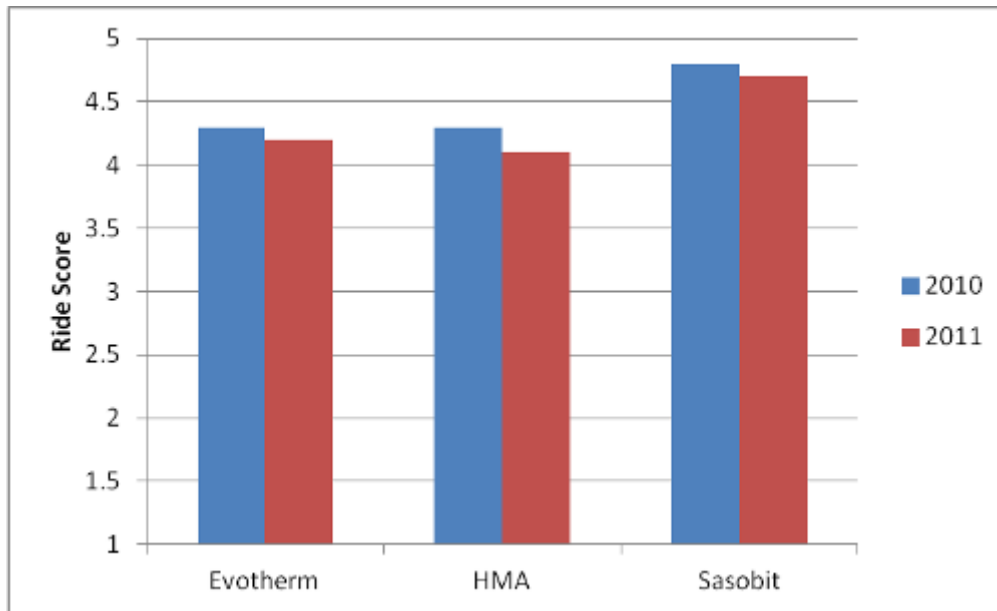
Figure 3.32. Ride Score Data for IH 37.

Both the WMA and HMA portions of SH 21 are performing well with no cracking or rutting distress. Ride quality data are shown in [Figure 3.32](#).

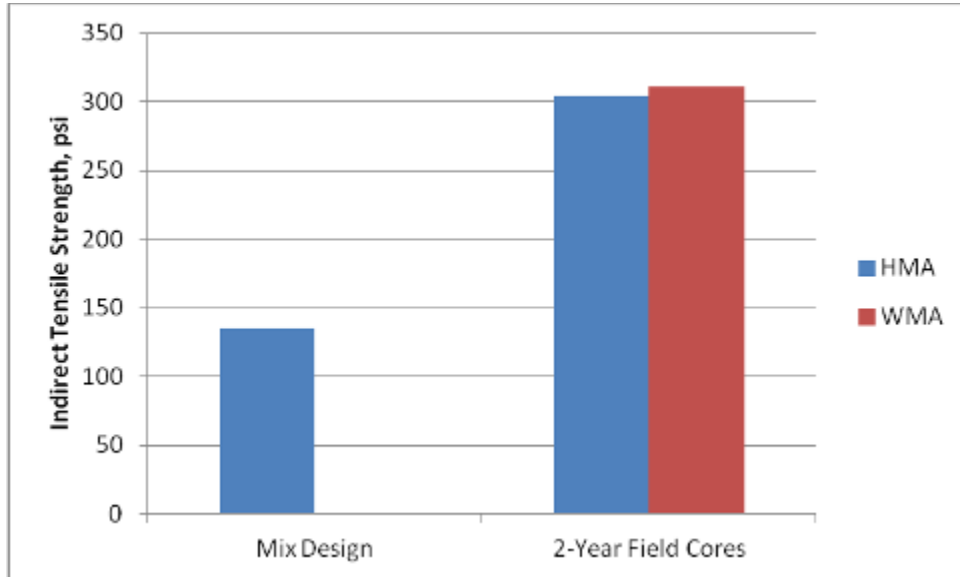
Figure 3.34. Indirect Tensile Strength Results for SH 251.

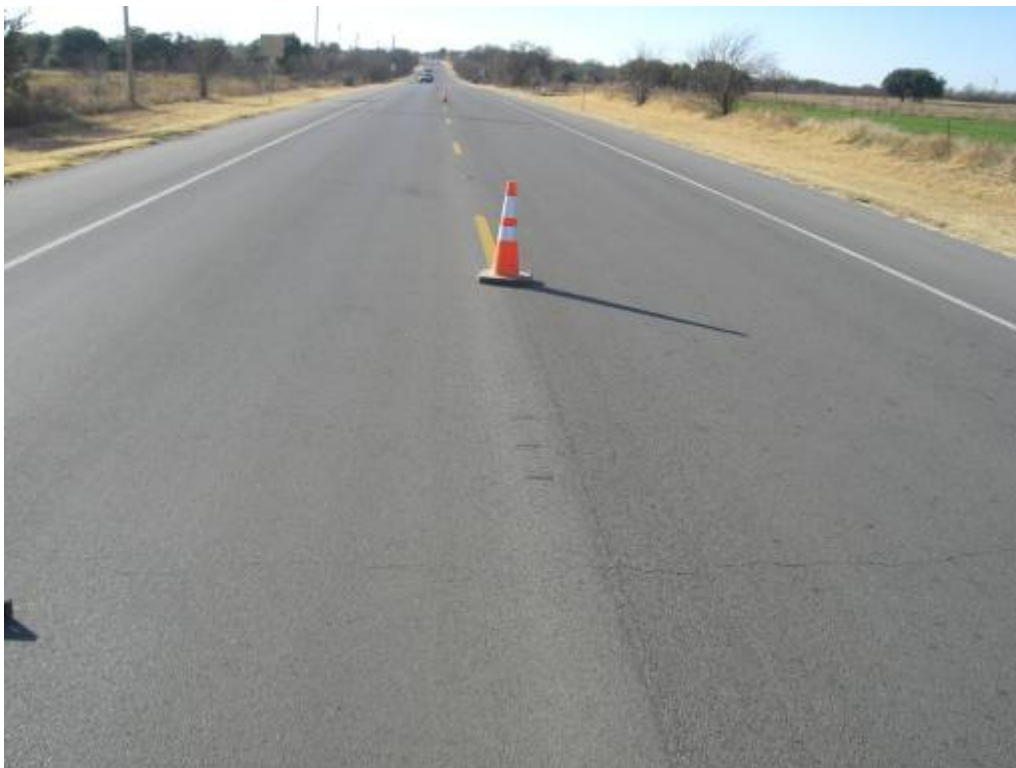
Figure 3.35. Transverse Cracking in both HMA and WMA Sections of SH 251.

Both the WMA and HMA portions of SH 251 are performing well with no rutting. A few slight transverse cracks were observed as shown in the foreground of [Figure 3.35](#). The WMA (right lane) and HMA (left lane) are side by side and the cracks extend full width.

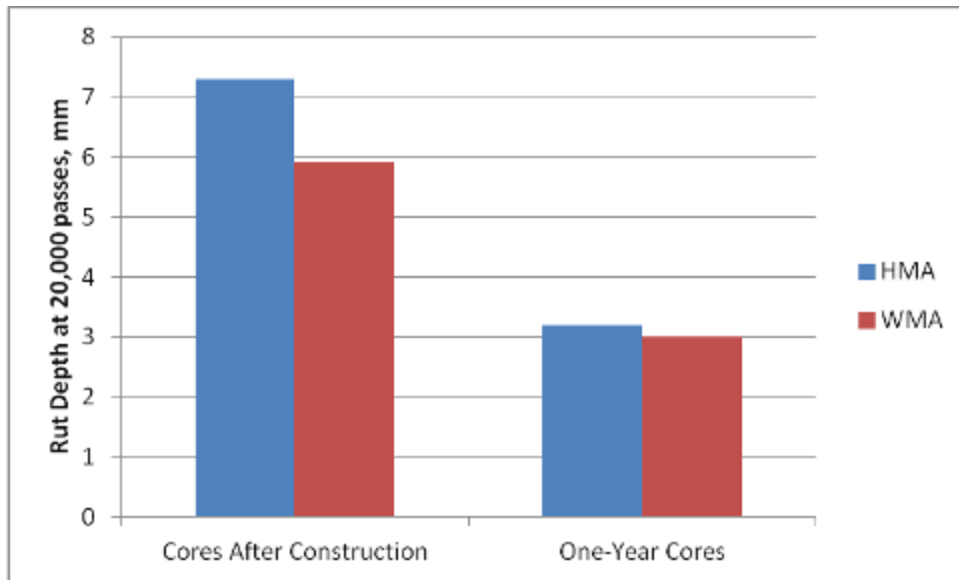
Figure 3.36. Hamburg Wheel Tracking Tests for Riverside Test Sections.

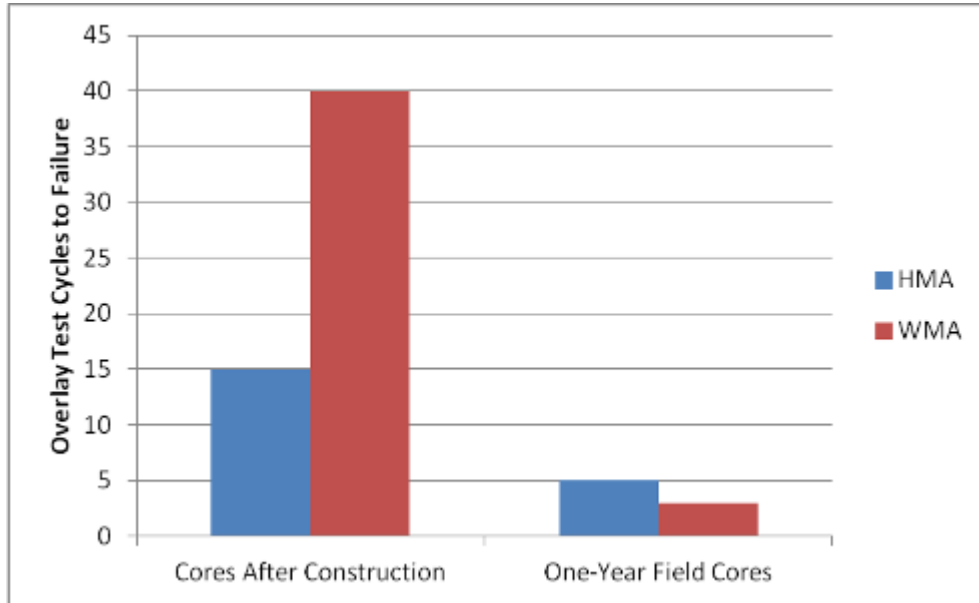
Figure 3.37. Overlay Test Results Tests for Riverside Test Sections.

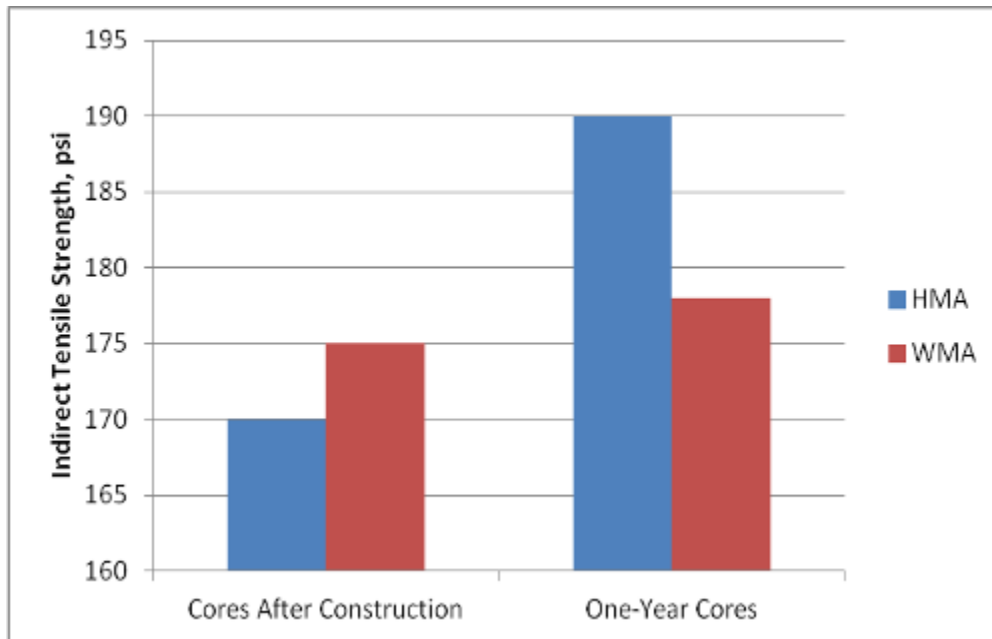
Figure 3.38. Indirect Tensile Strength Tests for Riverside Test Sections.

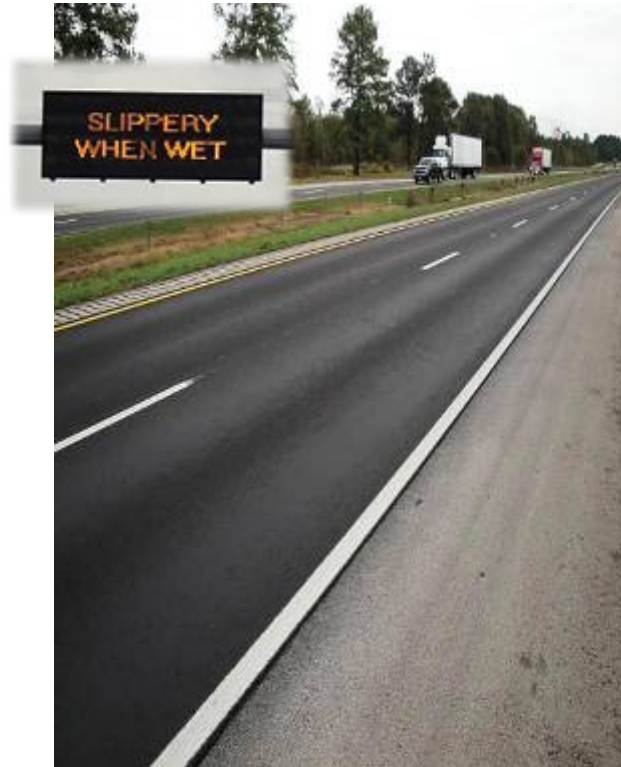
Figure 3.39. Severe Flushing (Atlanta-Fine SMA).

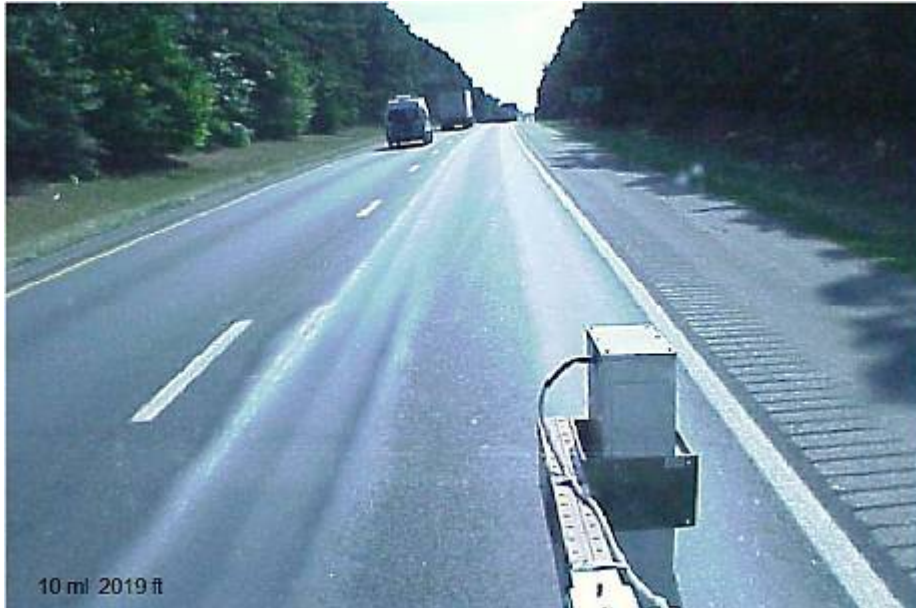
Figure 3.40. Rutting for 2-miles in Westbound Direction (Atlanta-Fine SMA).

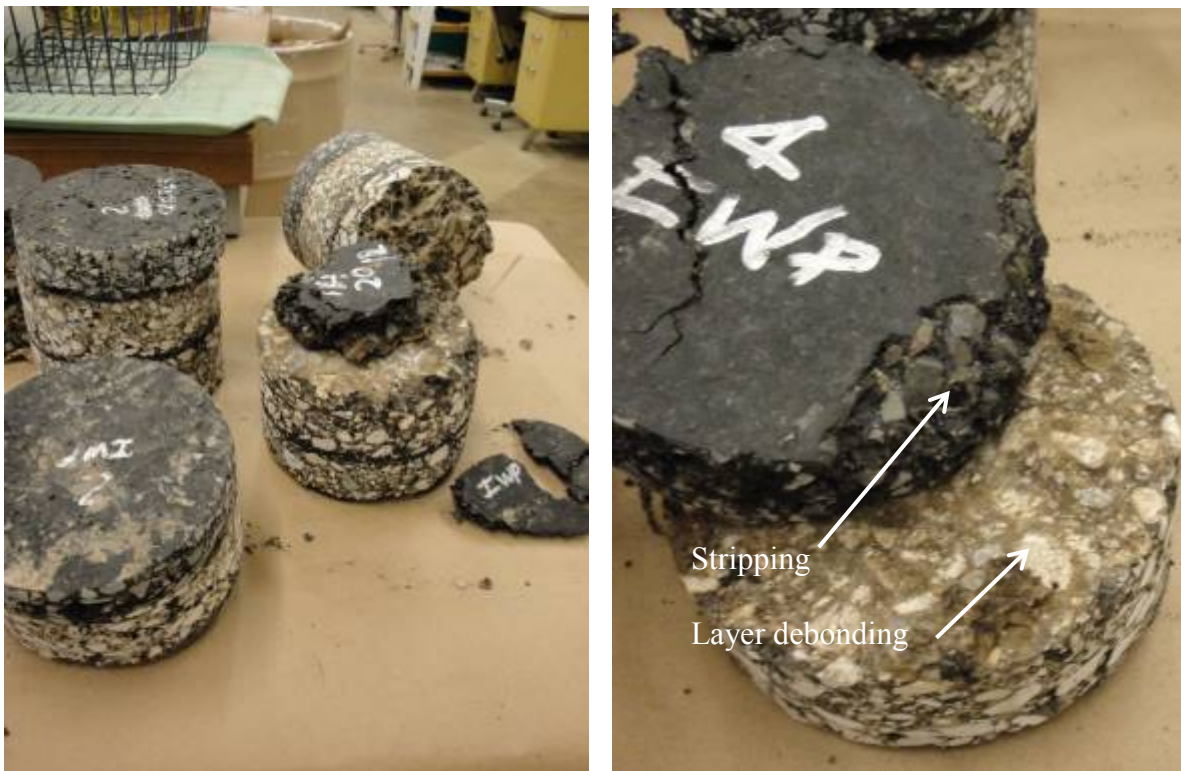
Figure 3.41. Flushed and Moisture Damaged Core Specimens (Atlanta-Fine SMA).

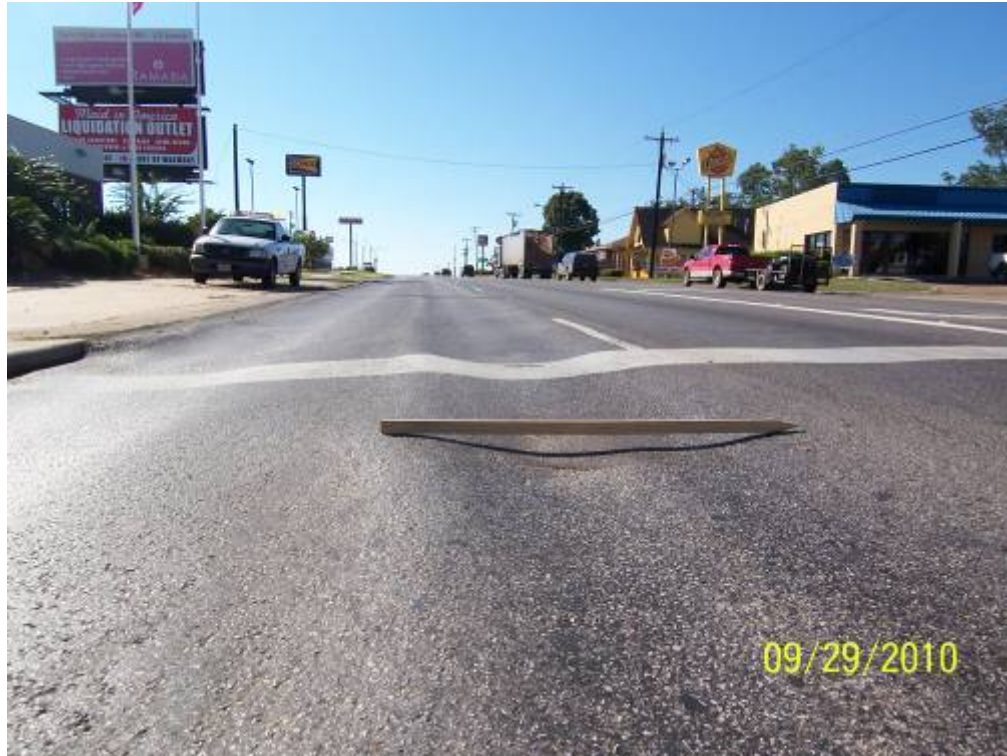
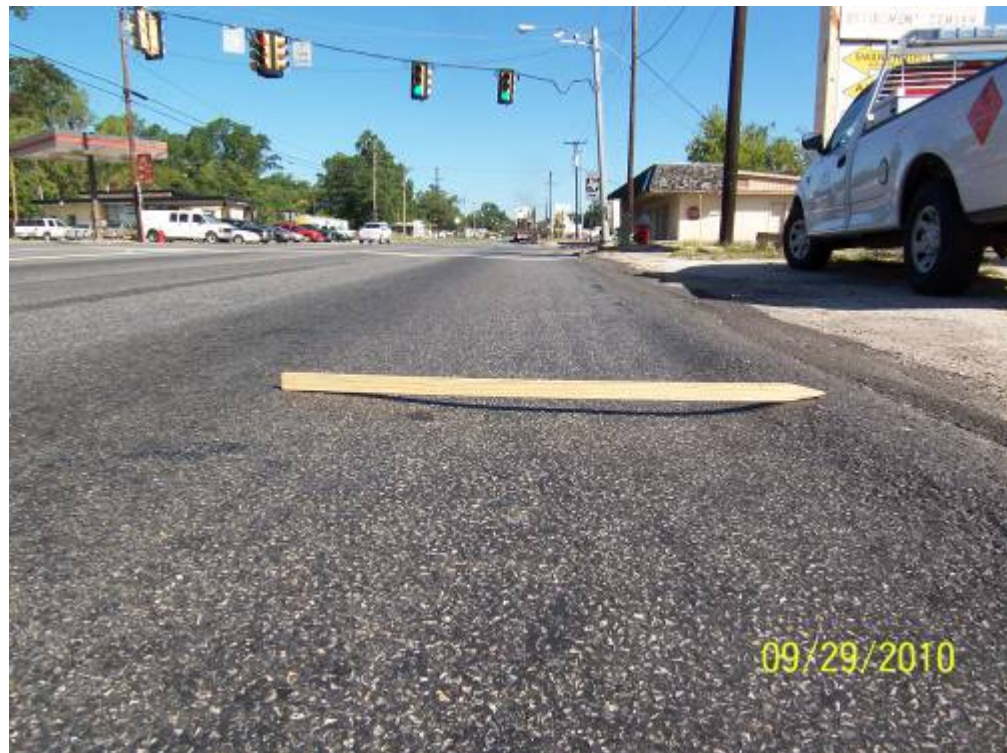
Figure 3.42. Rutting Intersections on US 96.

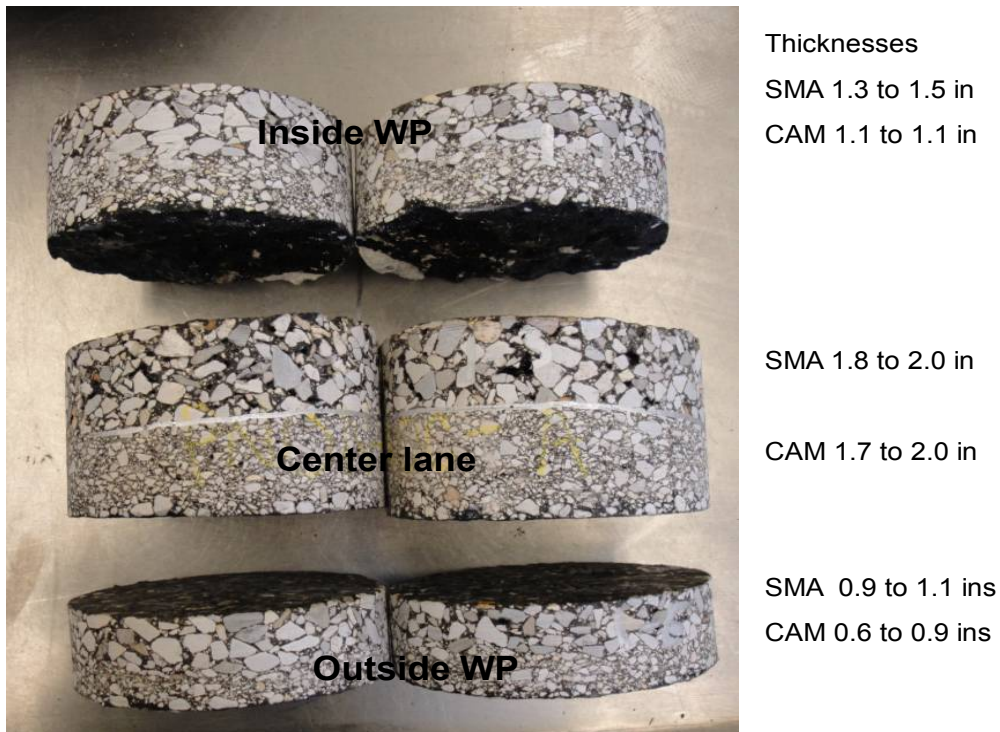
Figure 3.43. Cores Taken from Rutted Intersection on US 96.
