# CONSTRUCTION OF NEW PROFILER CERTIFICATION TRACKS

Report 5-9047-01-1

Project Title: Improvement to TxDOT Certification Program of Inertial Profilers

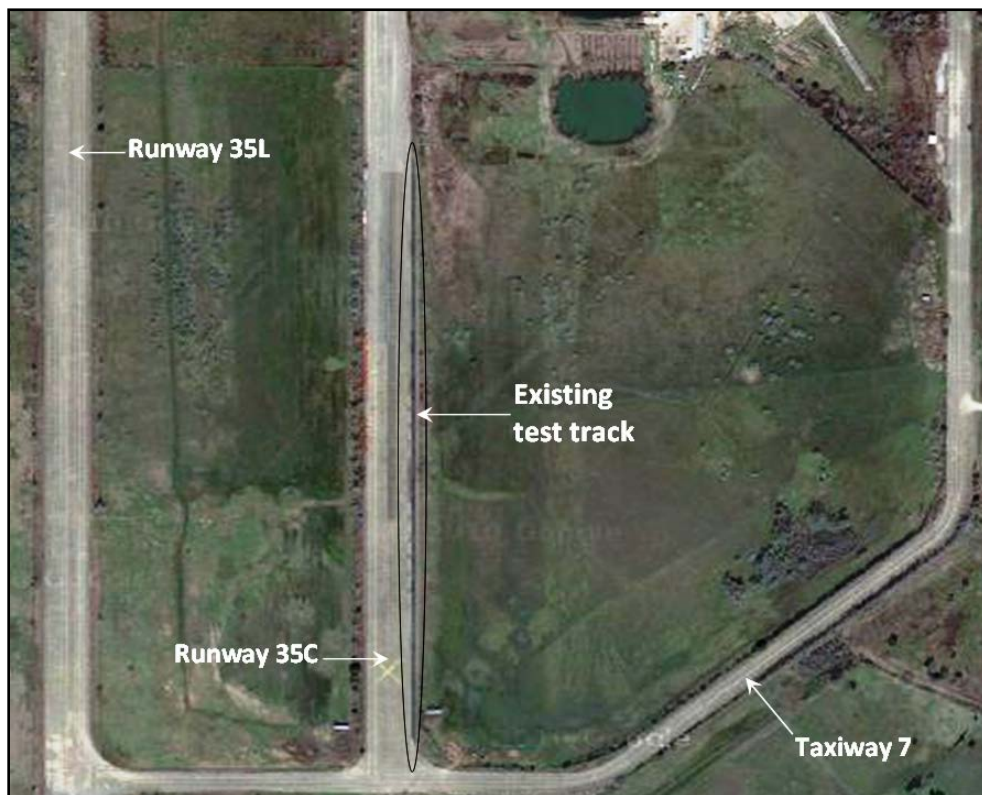
**Figure 1. Existing Test Track Used for Inertial Profiler Certifications.**

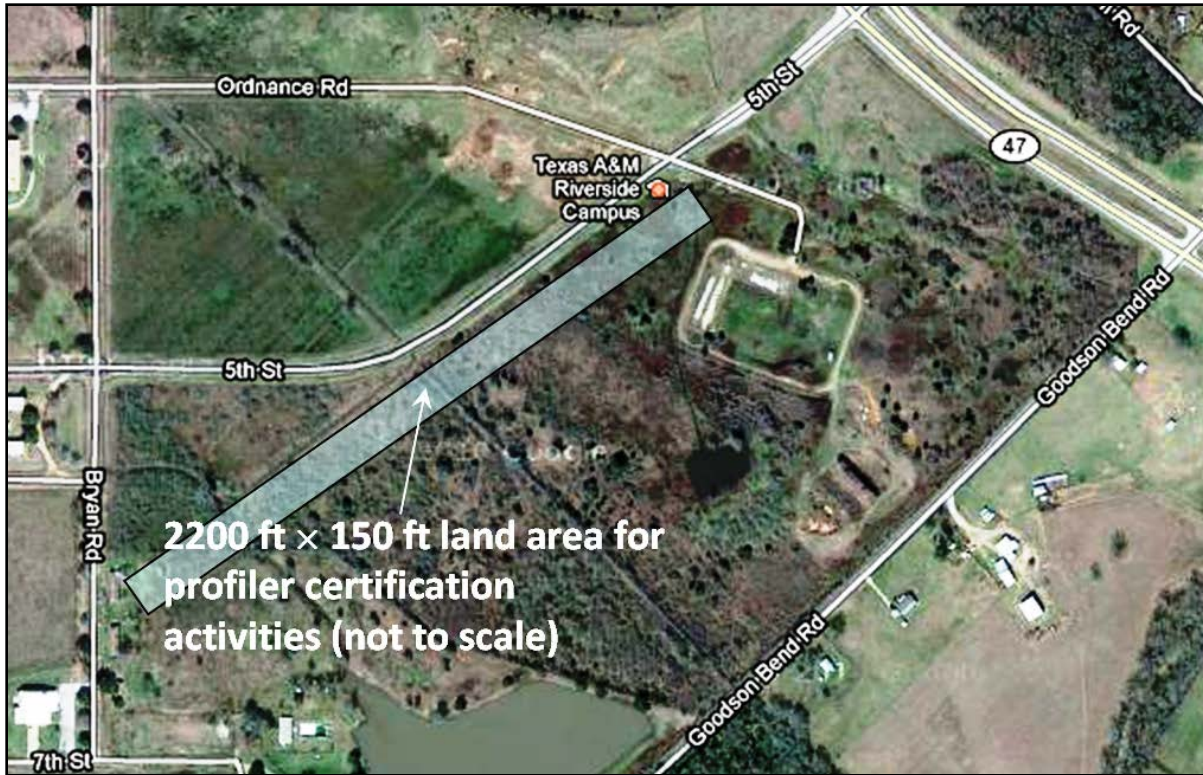
**Figure 2. Candidate Location near Entrance to the Riverside Campus.**

Researchers considered a number of alternative locations on which to build the proposed test tracks within the Riverside Campus. [Figure 2](#) shows one of the candidate locations considered during the project. This location is near the entrance gate to the Riverside Campus and has ample space for constructing new profiler certification tracks. The sandy soil at this site also provides a better foundation material for building the test tracks, compared to the clay soil that is predominantly found within the Riverside Campus. However, researchers did not get approval to use the available area to build the new test tracks as Texas A&M has other plans for using that area.

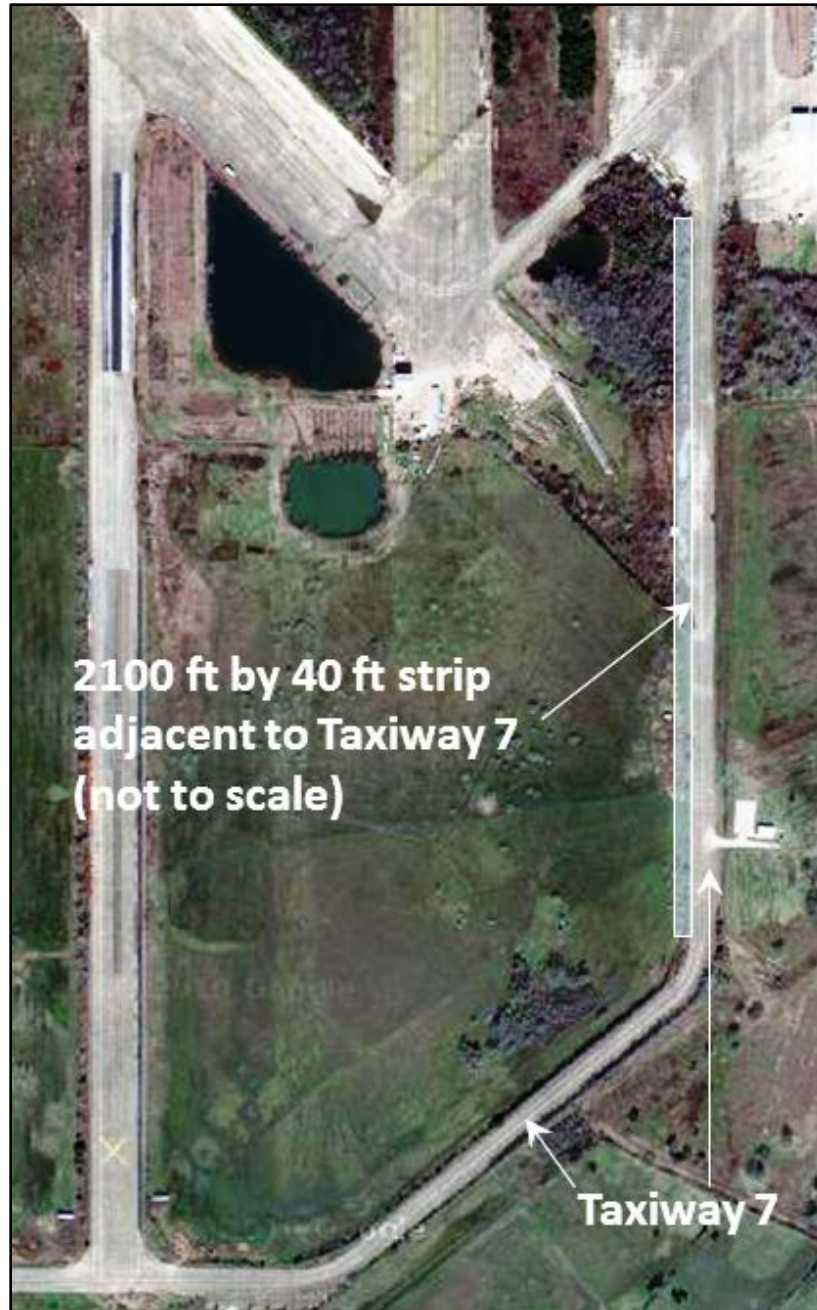
**Figure 3. Approved Site along Taxiway 7 for Construction of New Test Tracks.**

One other alternative that researchers considered was locating the new test tracks along Taxiway 7 of the Riverside Campus. [Figure 3](#) shows this alternate location. To accommodate the proposed construction of new test tracks in this implementation project, the existing fence line at the site needs to be moved about 15 ft west of its current location, which will encroach into the existing pasture that Vet Med Research uses, and will thus require their approval. However, preliminary discussions with Vet Med Research suggested that they can accommodate this change. The alternate location along Taxiway 7 also provides existing concrete pavements that test vehicles can use as a lead-in and a lead-out to get up to speed and to decelerate. It is also near the existing test track along runway 35C. However, this location does not provide space for future growth, and the clay soil at the site will likely require chemical stabilization and a thicker pavement. Nevertheless, among the alternative locations considered within the Riverside Campus, Taxiway 7 provided the least conflict with existing users. Consequently, TTI proposed this site as the location to build new test tracks for inertial profiler certifications. The TTI Facilities Coordinator presented this proposal in a meeting of the Texas A&M Council on the Built Environment (CBE). The Council subsequently submitted its recommendation for the President of the University to approve use of the land space adjacent to Taxiway 7 to build new test tracks for inertial profiler certifications. [Figure 4](#) shows the approval document signed by the Texas A&M University President. Having procured land on which to build new test tracks, the researchers proceeded with developing plans for construction of these tracks.

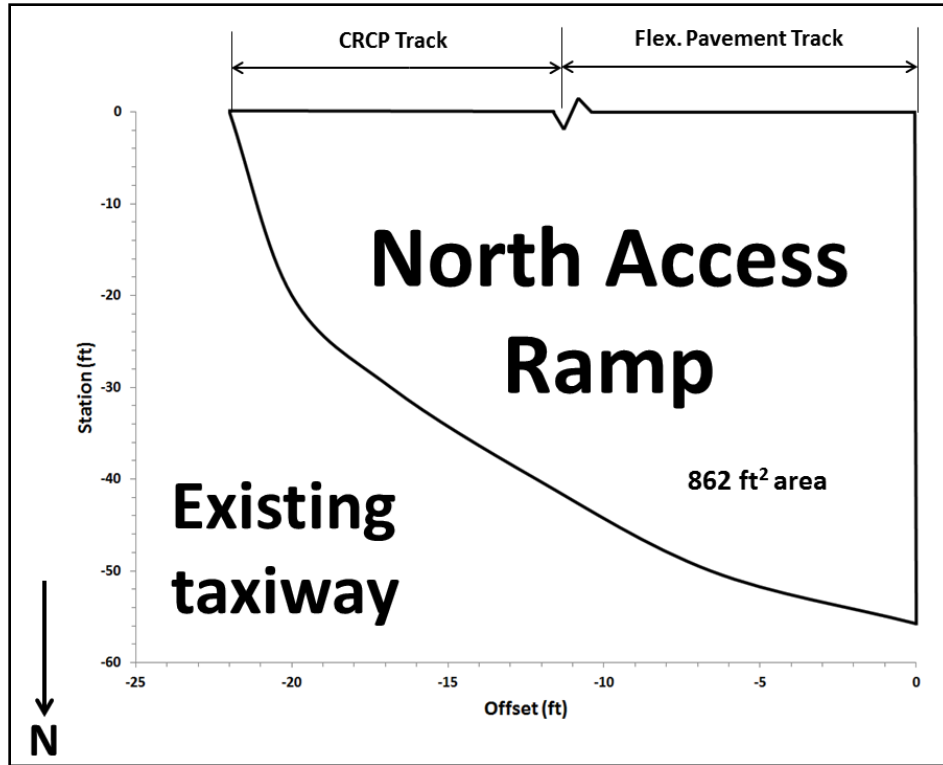
Figure 16. North Access Ramp for Test Tracks.

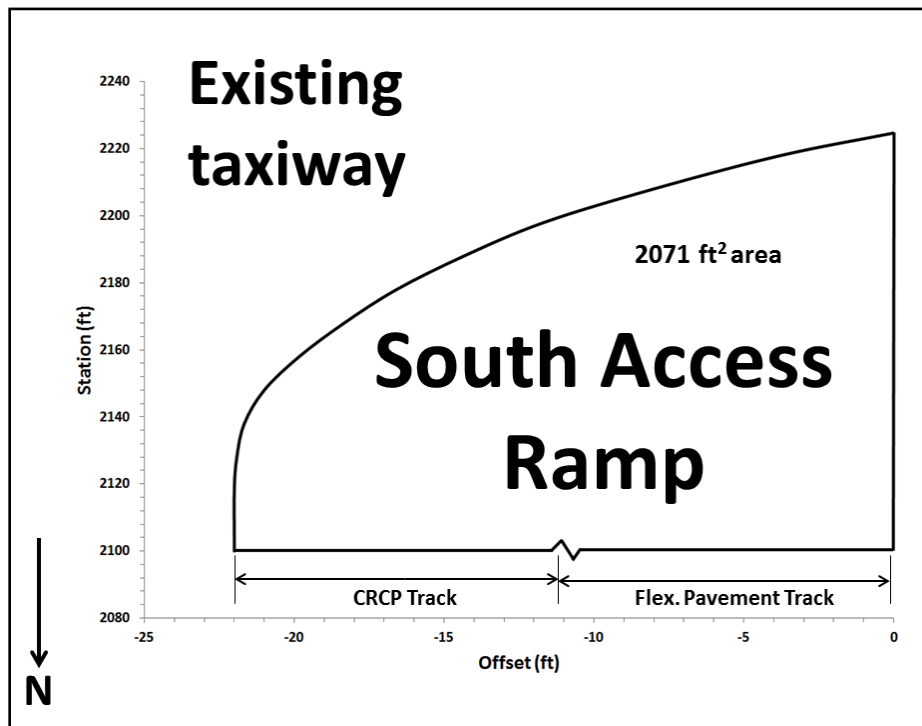
Figure 17. South Access Ramp for Test Tracks.

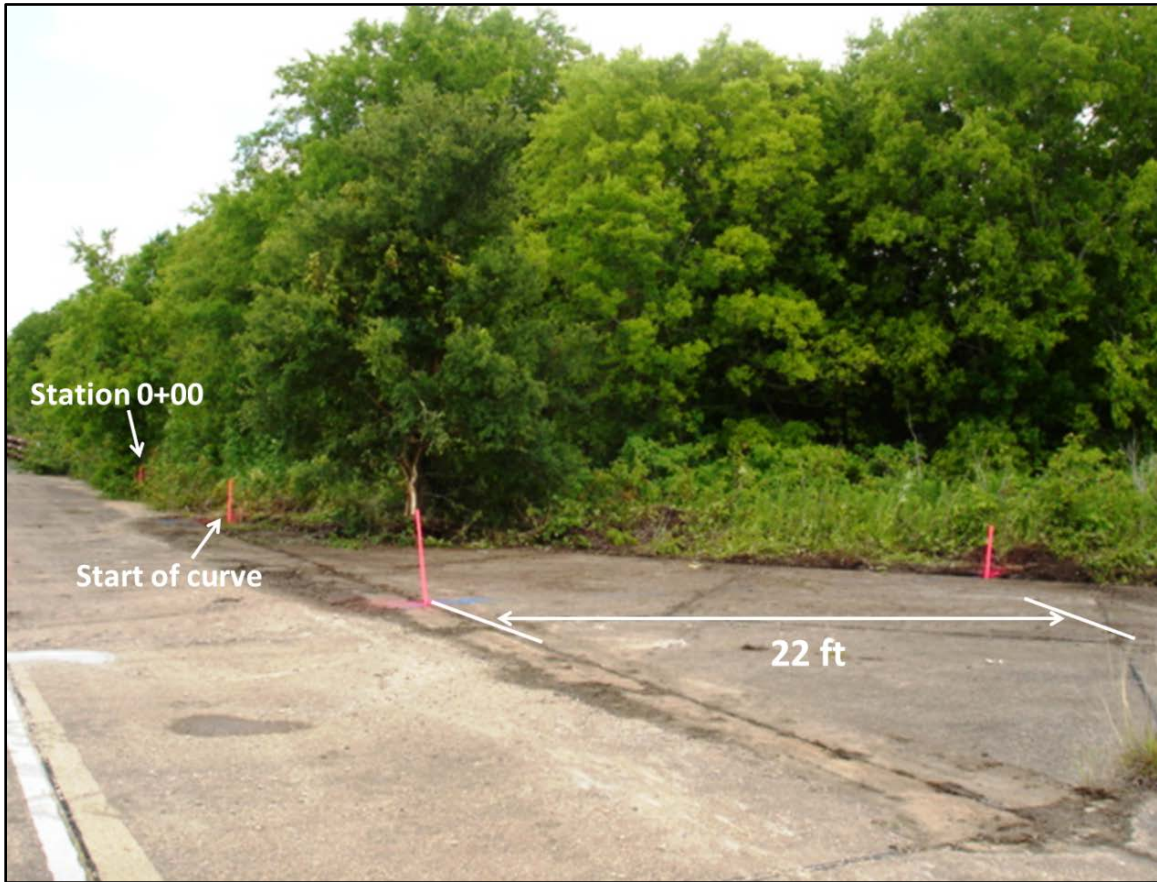
**Figure 22. Picture Showing Vegetation at North End of Construction Site.**

Construction of the new test tracks began on September 4, 2012. The contractor first cleared and grubbed existing vegetation found within the limits of the construction site. [Figure 22](#) shows the north end of the site where the contractor began clearing existing vegetation to make way for the new test tracks. The contractor loaded vegetation removed from the site on trucks and hauled them off the Texas A&M Riverside Campus for disposal. He then placed a 2100-ft silt fence along the west boundary of the construction site before proceeding with the next stage of construction.

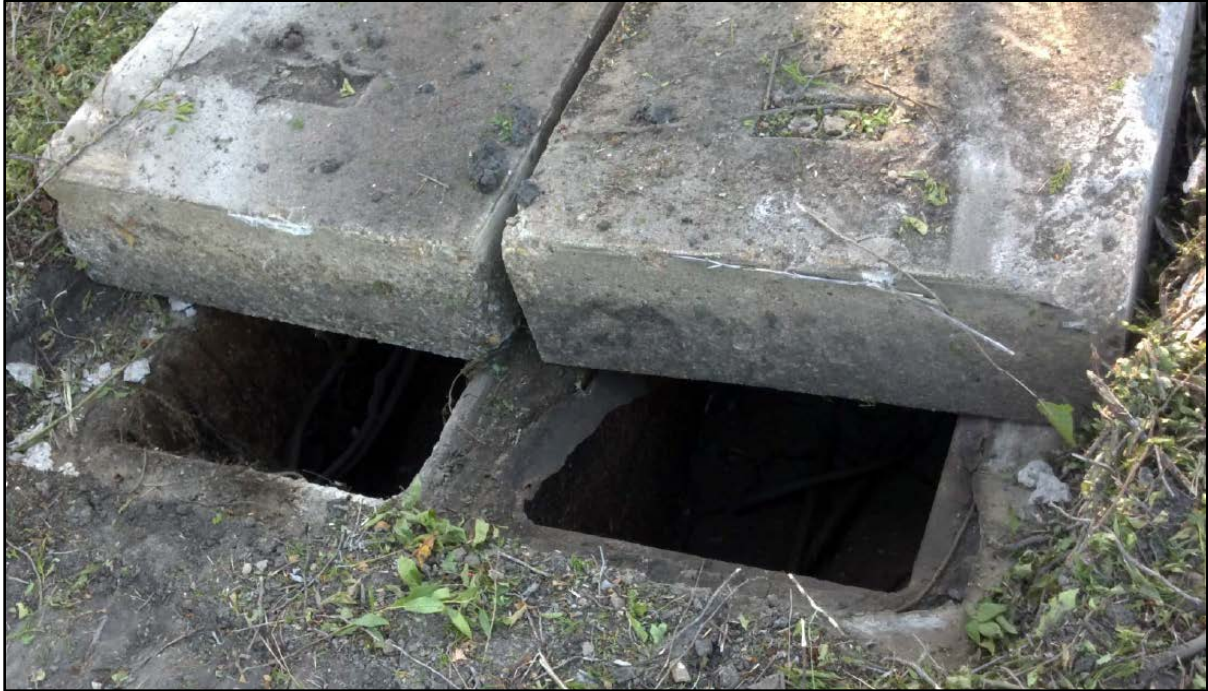
**Figure 23. Utility Box Found within Construction Site.**

In addition, other items required special attention. One such item was an old utility box found at around station 1+50 after the contractor cleared the site of vegetation. This utility box, illustrated in [Figure 23](#), contained cables that might have been used for power or communication at a time when the Riverside Campus was an active U.S. Army airfield base. The contractor removed the utility box and filled the hole after TTI Facilities ascertained with Texas A&M's Utilities and Energy Management (UEM) that this action can be taken.

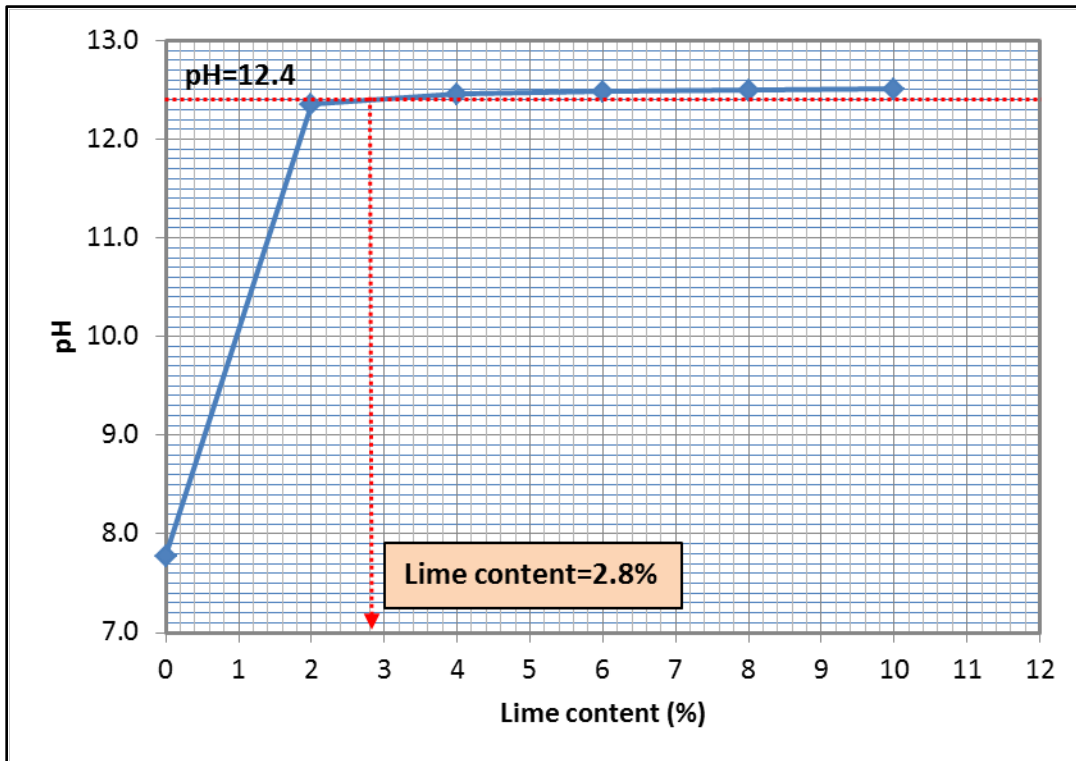
Figure 24. Tex-121-E Test Results Using Clay Samples from Station 4+25.

Figure 25. Tex-121-E Test Results Using Clay Samples from Station 11+25.

Figure 26. Tex-121-E Test Results Using Clay Samples from Station 17+50.

TTI technicians used Part III of TxDOT Test Method Tex-121-E to determine the minimum lime content for stabilizing the clay soil at the construction site. This test is based on determining the minimum percent of lime needed for the soil-lime mixture to attain a pH of 12.4 at which cation exchange occurs. TTI technicians ran tests on samples of the clay material taken at three different locations along the site. From these tests, the minimum lime content was found to vary from 2.8 to

3.4 percent (see Figures 24 to 26). Based on these results, the contractor decided to use 4 percent lime to stabilize the clay soil, requiring about 117 tons of pebble quicklime.

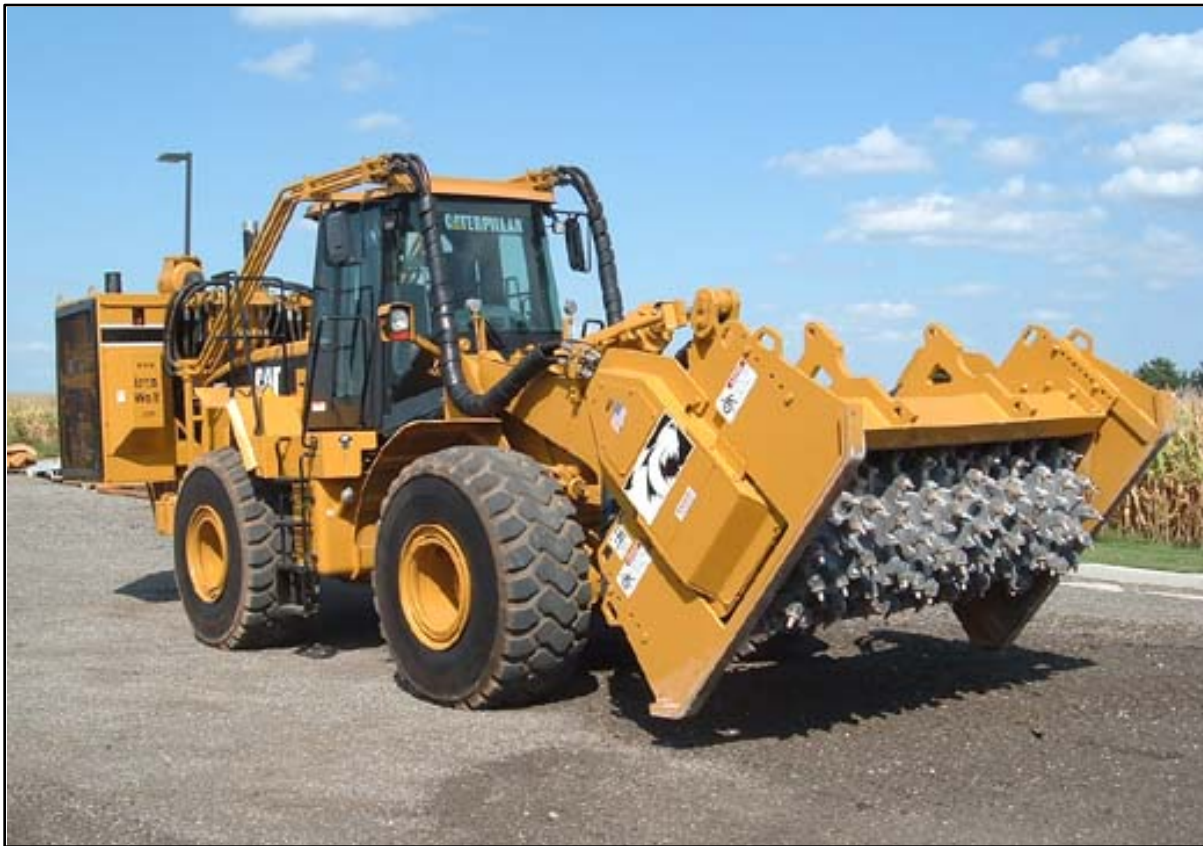
**Figure 27. Equipment Used to Mix Soil with Lime.**

Pneumatic tanker trailers delivered the lime in windrows. The contractor then used a motor grader to spread pebble quicklime on the surface of the subgrade to be stabilized. Water was then added to hydrate the lime. The contractor then started mixing the soil with lime using a Caterpillar SS250 soil stabilizer. During this process, the contractor added water as necessary to achieve complete hydration and thorough mixing of the soil, water, and lime. [Figure 27](#) illustrates the type of mixer that he used.

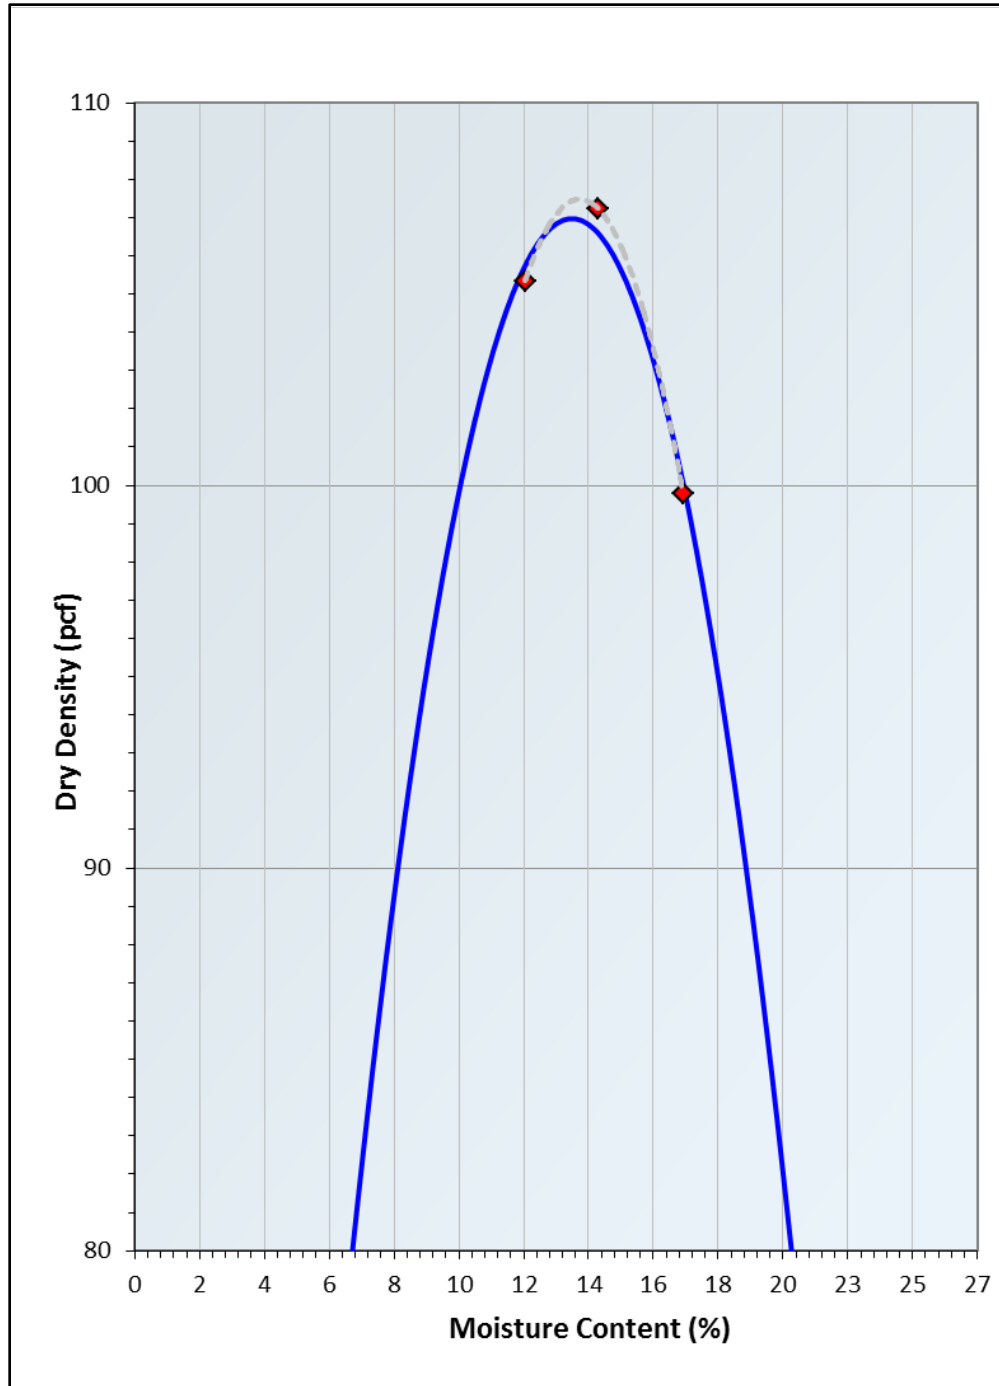
**Figure 28. Moisture-Density Curve for Soil-Lime Mixture Sampled at Station 2+00.**

Figure 29. Moisture-Density Curve for Soil-Lime Mixture Sampled at Station 12+00.

different locations to determine the moisture-density curves shown in [Figure 28](#) and [Figure 29](#). The corresponding maximum densities were then used to check the level of compaction achieved at different stations along the job site. [Table 6](#) summarizes the results from these density tests. As shown, the contractor met the density required in the plans.

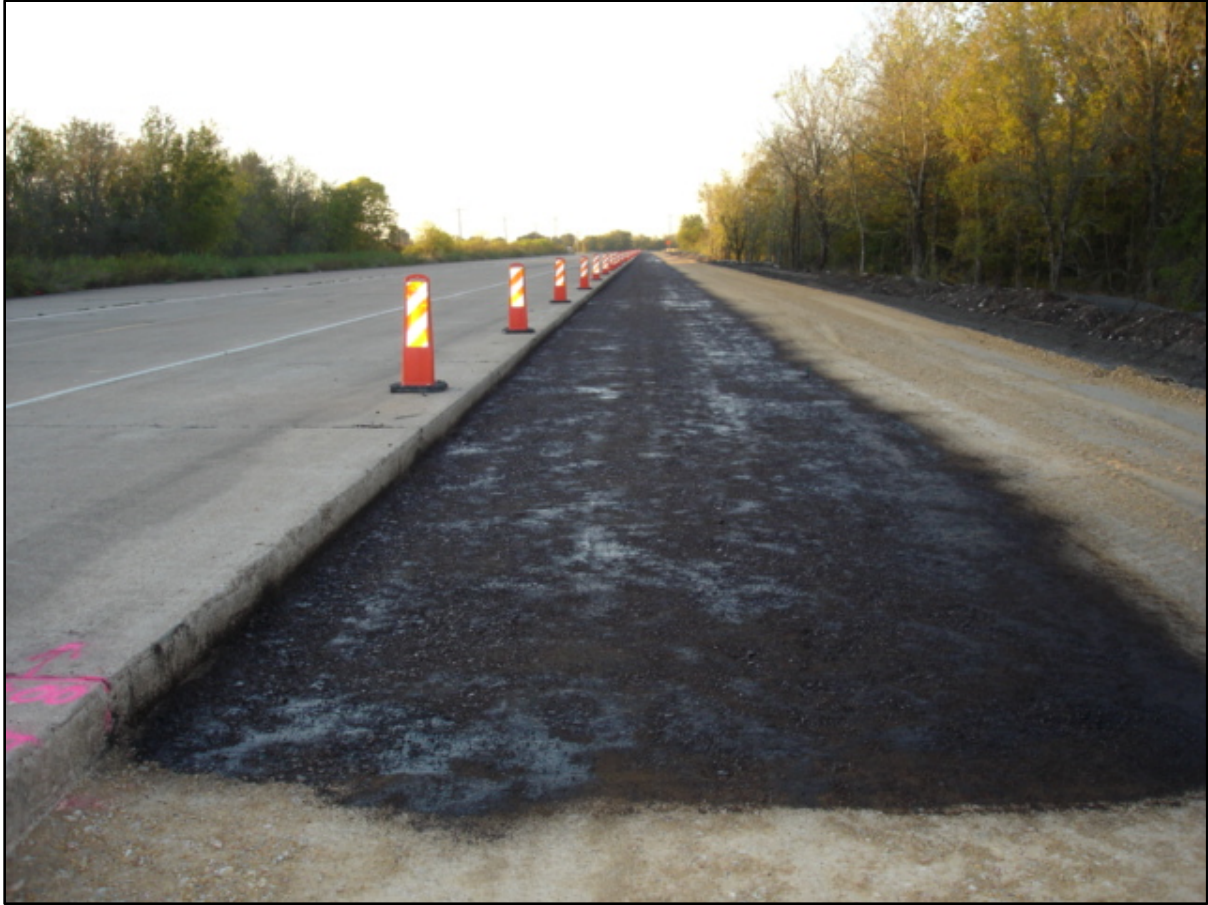
**Figure 30. Tack Coat Applied to Flexible Base.**

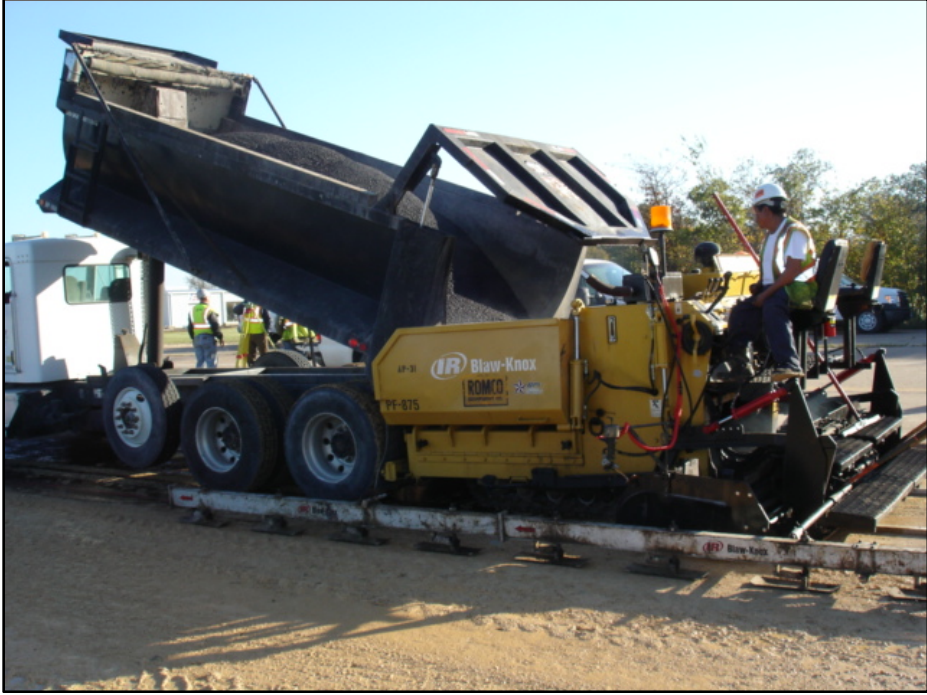
**Figure 31. Paving Machine Used to Place Type C Mix.**

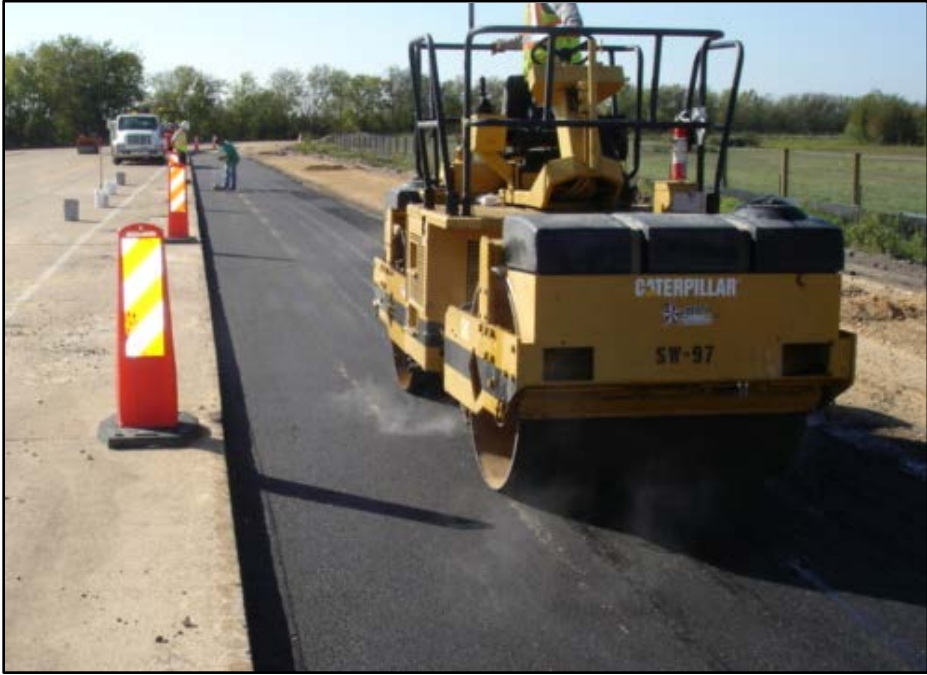
**Figure 32. Steel Wheel Roller Used to Compact Type C Mix.**

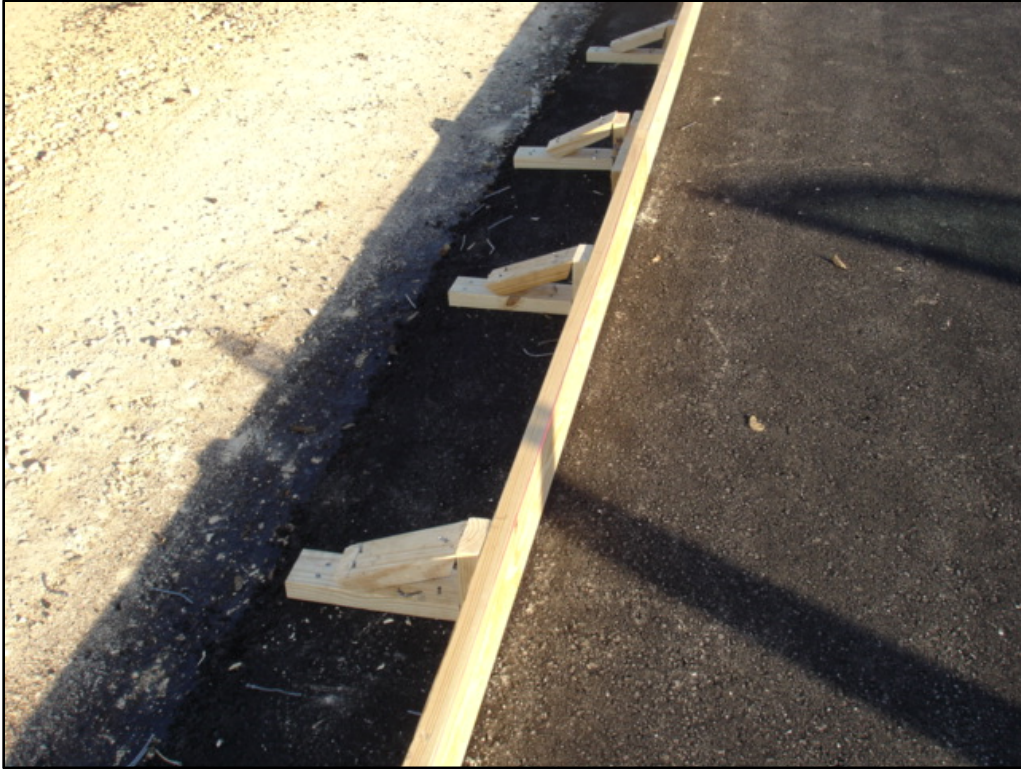
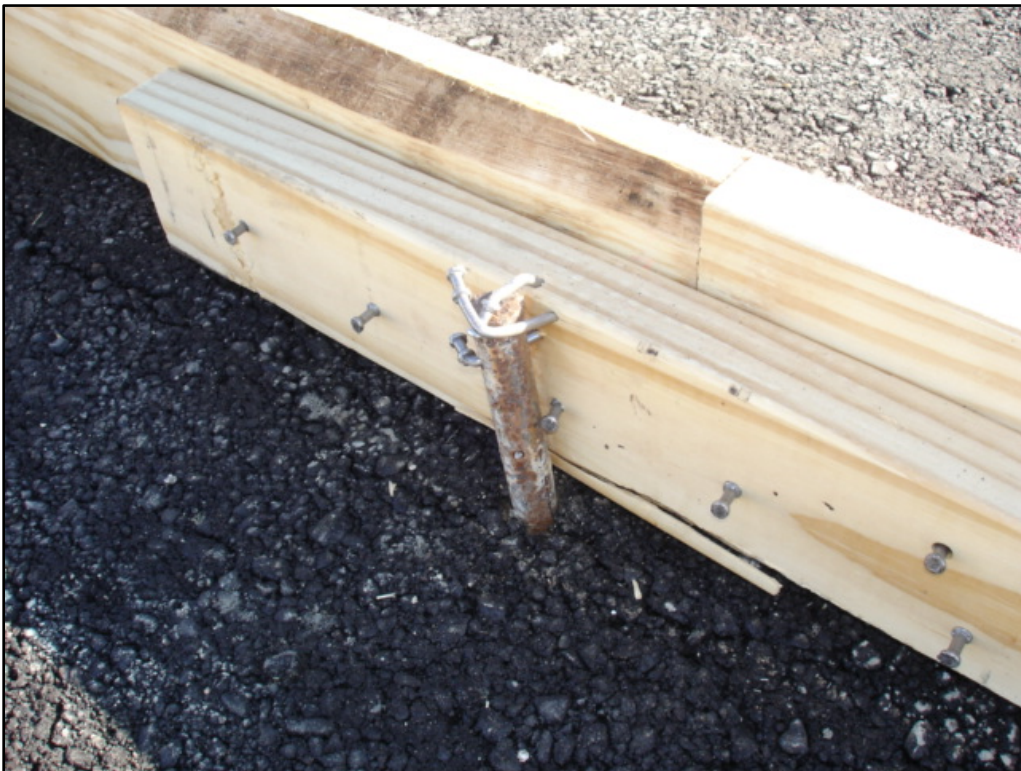
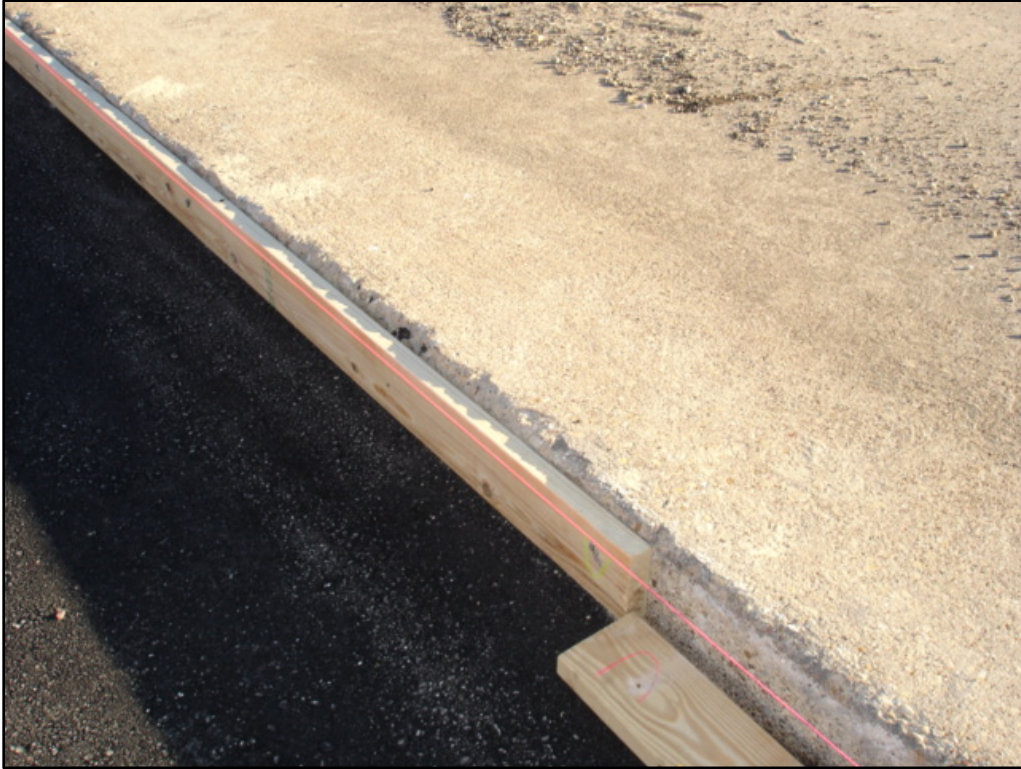
**Figure 33. Form along West Side of Type C Base to Place CRCP.**

**Figure 34. Joint between Form Segments on West Side of Type C Base.**

**Figure 35. Placement of Form along East Side of Type C Base.**

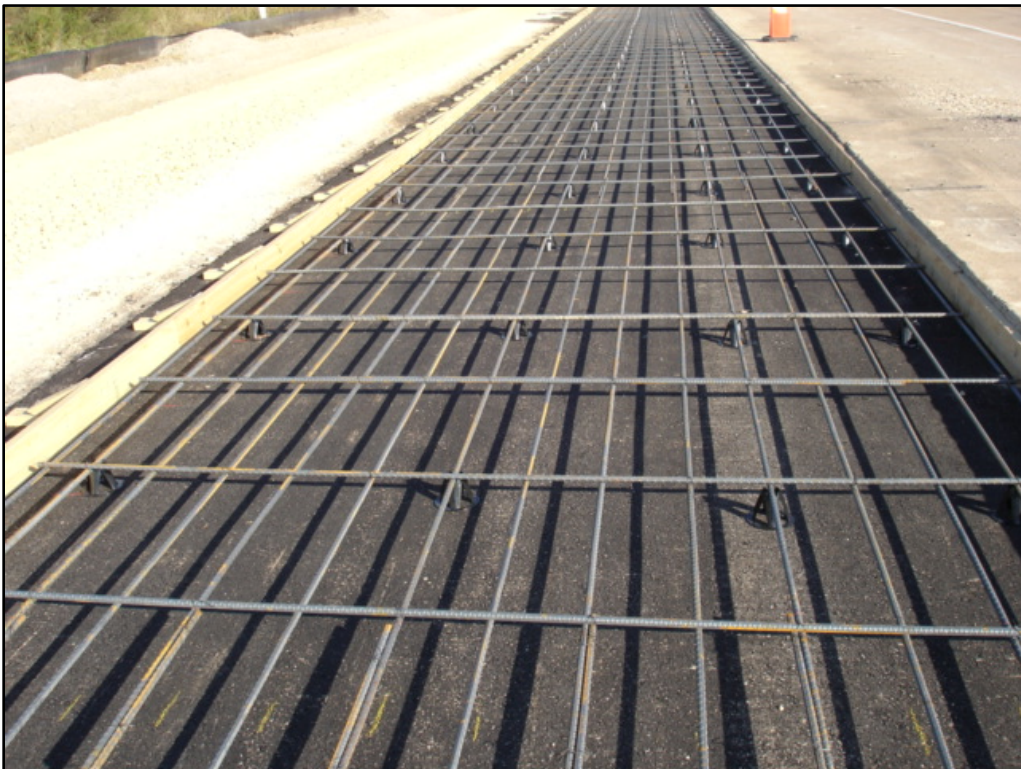
**Figure 36. Reinforcement Placed for CRCP Test Track.**

Once the forms were in place, the contractor began laying out the CRCP reinforcement according to the details given in [Figure 8](#) of [Chapter 3](#). A TTI technician monitored this work, and verified that the reinforcement was placed according to the plans. [Figure 36](#) shows the reinforcement that the contractor placed before the concrete was poured for the CRCP test track.

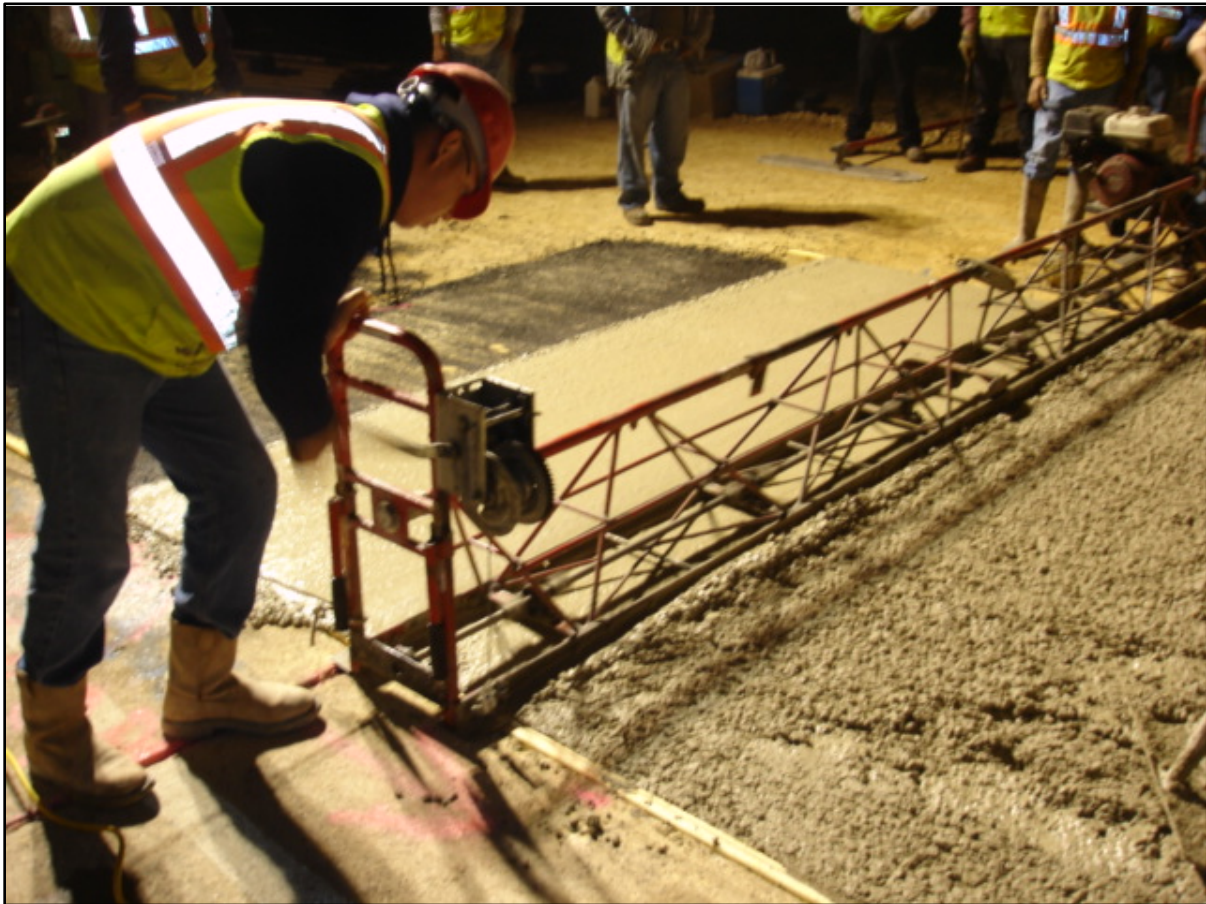
**Figure 37. Vibrating Screed Used to Place the Concrete Mix.**

The contractor scheduled placement of the concrete for the CRCP test track on November 9, 2012. He had his crew and equipment on the job site at midnight that day. TTI technicians were also at the site to monitor the work. The contractor initially sprayed the concrete forms with a releasing agent to facilitate removal of the forms after the concrete was placed. [Figure 37](#) shows the contractor placing his vibrating screed on the form when the concrete pour began. This picture was taken at the south end of the track where the contractor started pouring concrete.

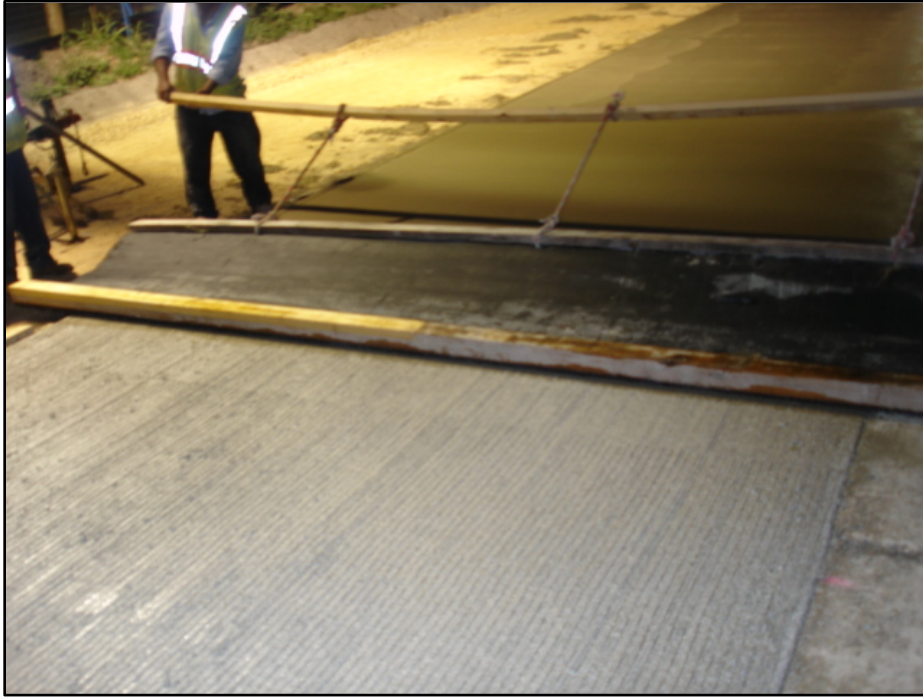
**Figure 38. Concrete Surface Textured with Carpet Drag.**

**Figure 39. Concrete Surface Textured with Longitudinal Tines.**

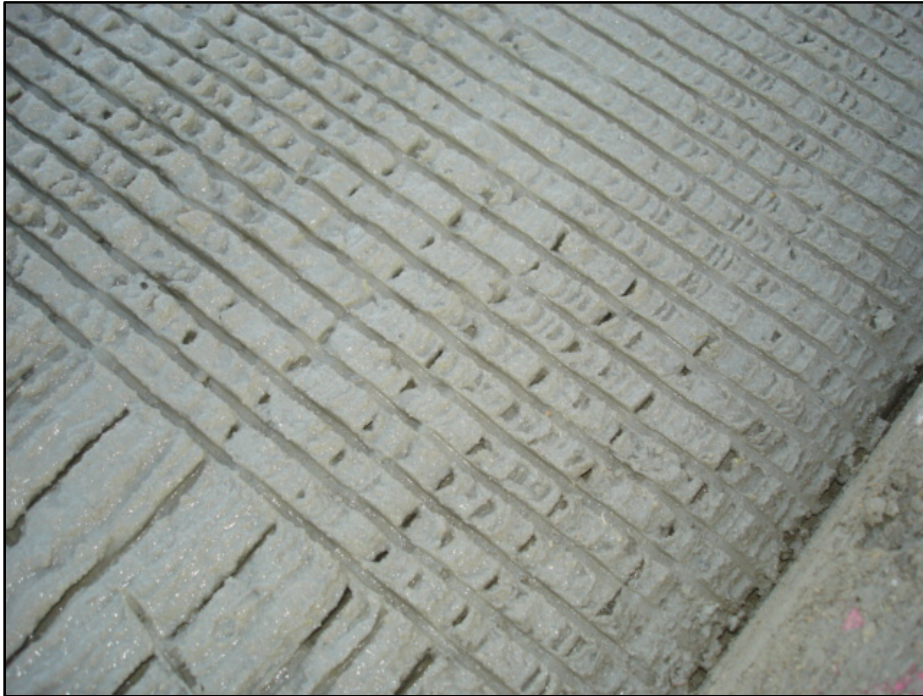
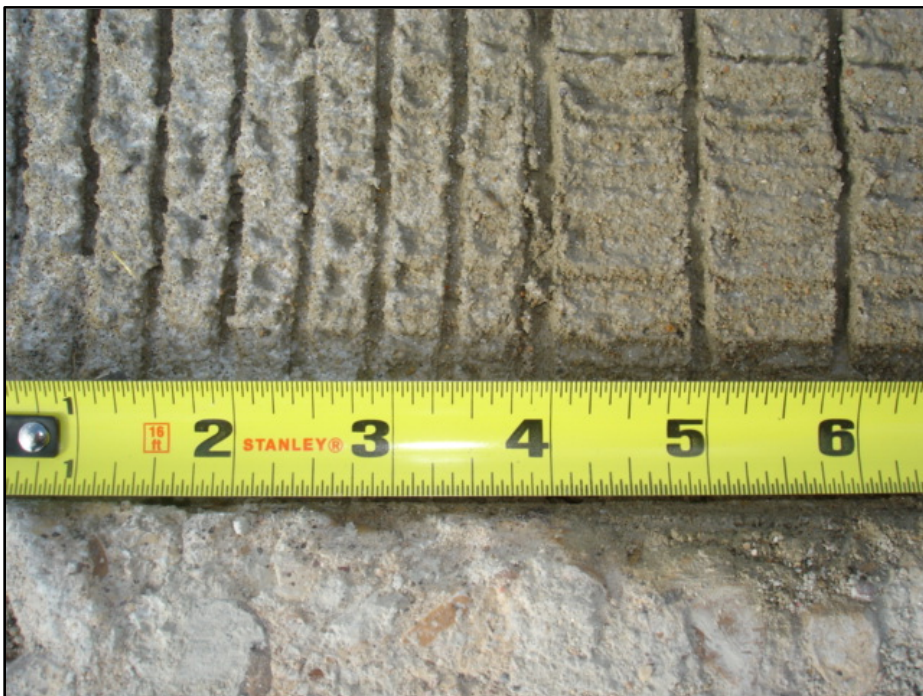
**Figure 40. Change from Longitudinal Tines to 1/2-inch Transverse Tines.**

**Figure 41. Change from 1/2-inch to 1-inch Transverse Tines.**

[Figure 40](#) shows a close-up view of the change from the longitudinally tined section to the half-inch transversely tined section. This photograph was taken at station 14+00. [Figure 41](#) shows the change from the half-inch to the one-inch transversely tined section at station 8+50. The contractor placed 1-inch tines as illustrated in [Figure 42](#). As may be observed in the figure, it was already morning when this picture was taken. The entire process of placing the CRCP—from the time the concrete pour began to the time the concrete was completely tined—took about 12 hours. The contractor imprinted 09-11-12 (dd-mm-yy) as the date of concrete placement at the northwest corner of the CRCP test track.

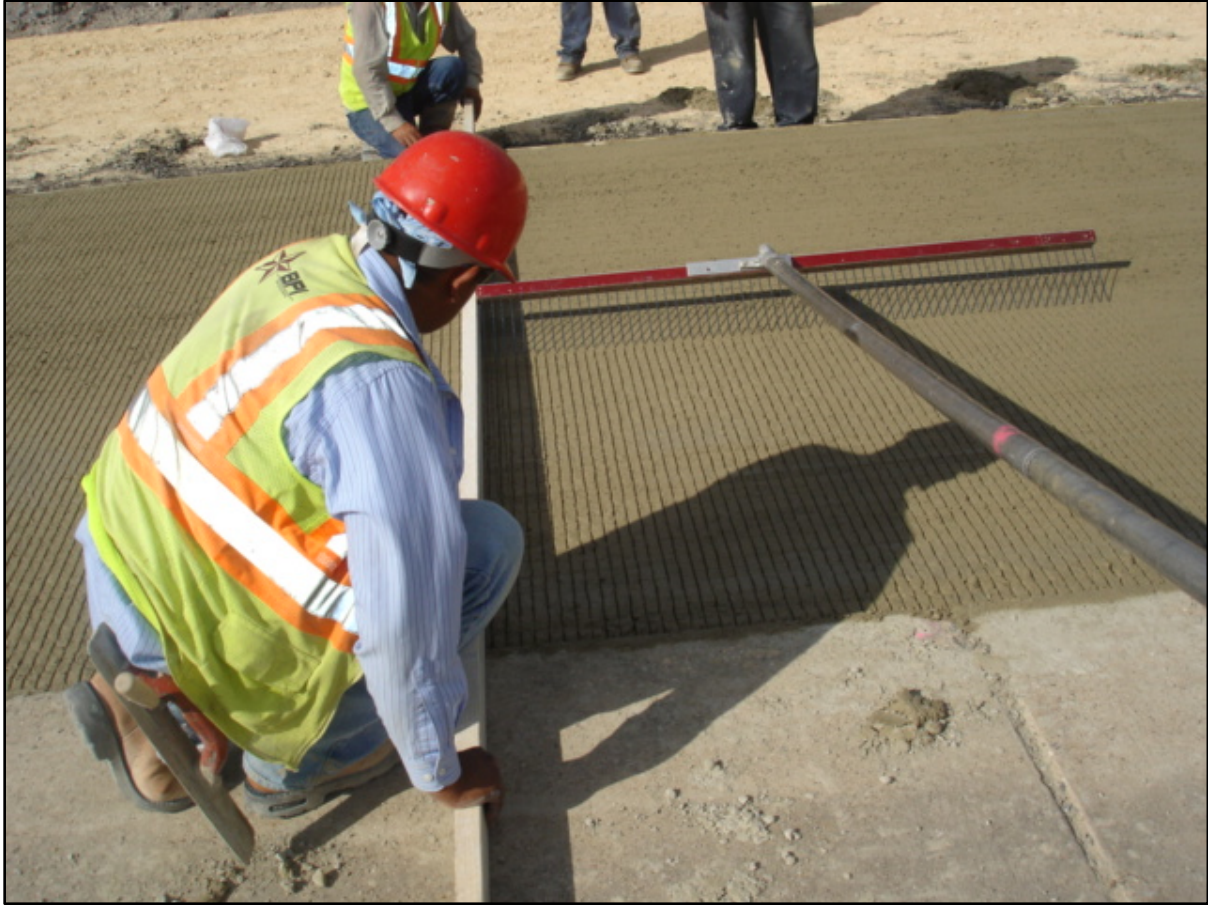
**Figure 42. Concrete Surface Texture with 1-inch Transverse Tines.**

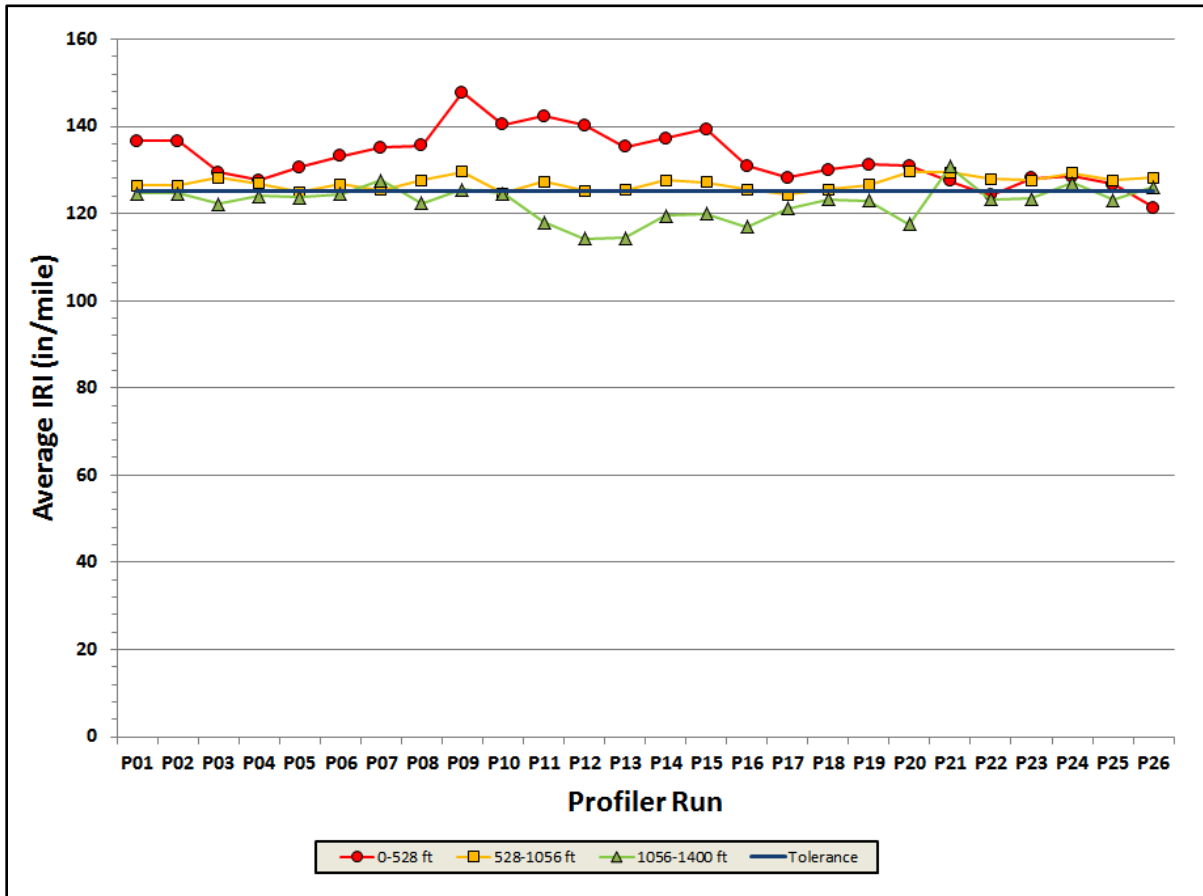
Figure 43. Results from Profile Tests to Check Ride Quality of Flexible Base.

The plans also called for checking the ride quality of the flexible base where the Grade 3 and inverted prime sections would be placed. These sections cover the first 1400 ft of the flexible pavement test track. The contractor spent much time trying to meet the ride quality requirement of TxDOT SP247-011. After placing the CRCP, the contractor found that he had limited space to use equipment with automated grade controls to achieve the required smoothness on the flexible base, and be within 125 inches/mile on the average IRI. Thus, corrections had to be done manually. TTI project staff assisted the contractor in this process by

providing profile measurements and suggesting areas where corrective work should be made. This process required a lot of iterations as can be inferred from Figure 43, which plots the average IRIs with the number of profile runs made to check the ride quality of the flexible base. Most of the work was spent on the first 528 ft of the project. After the 26<sup>th</sup> profile test, the research supervisor deemed the average IRIs to be acceptable. This decision was based on the overall weighted average of the IRIs, which was determined to be 125 inches/mile. With this work behind him, the contractor proceeded to place the surface treatments shown in the plans.
