# CONSTRUCTION OF NEW PROFILER CERTIFICATION TRACKS

Report 5-9047-01-1

Project Title: Improvement to TxDOT Certification Program of Inertial Profilers

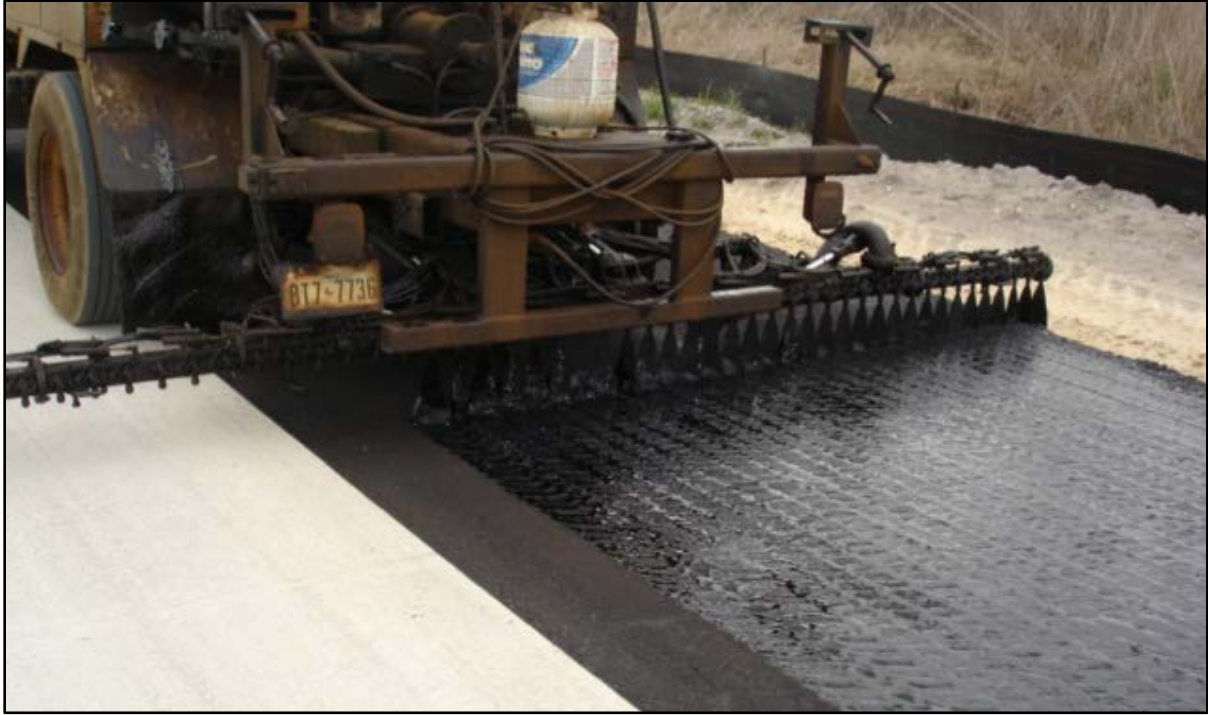
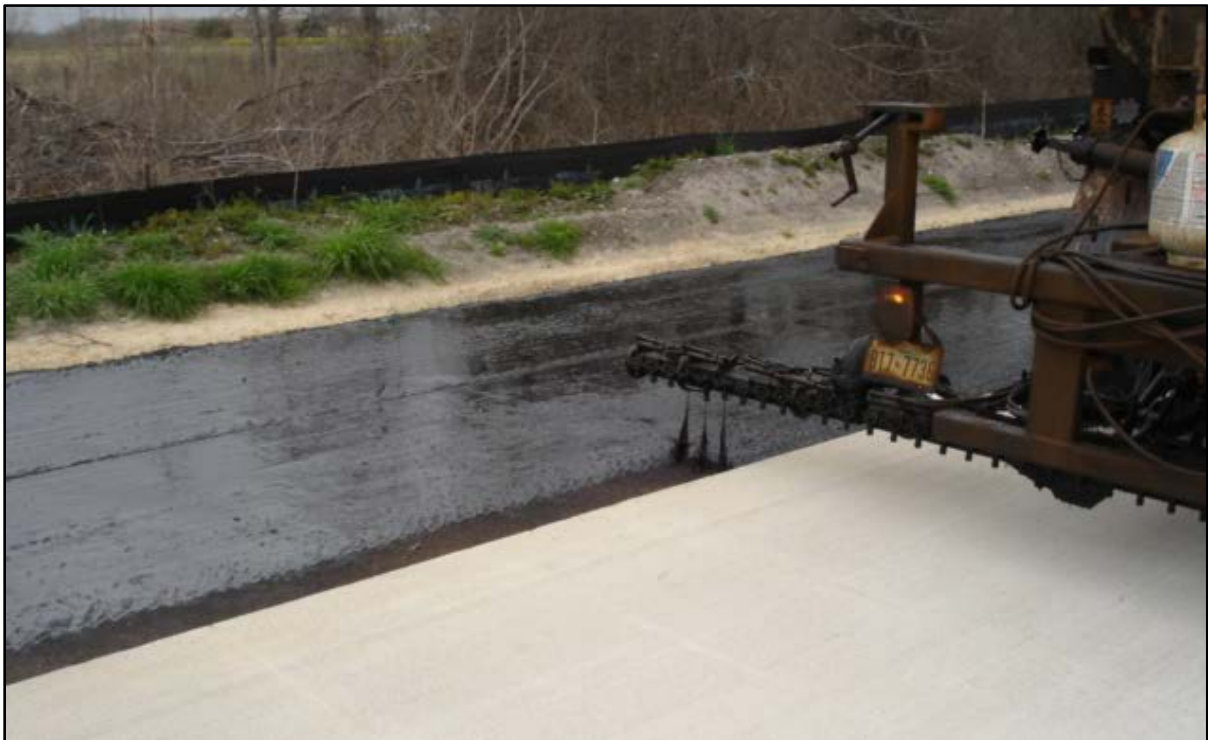
**Figure 44. Asphalt Sprayed on Flexible Base for Surface Treatment.**

**Figure 45. Finishing Asphalt Application on Flexible Base for Surface Treatment.**

The subcontractor hired to place the surface treatments avoided tracking the flexible base wheel paths when he applied the asphalt and aggregates. He was concerned about affecting the profile of the flexible base. Thus, he used the CRCP to place the surface treatments. [Figure 44](#) illustrates how the subcontractor applied the asphalt on the flexible base. His operator drove the distributor truck such that the driver-side tires were on the CRCP, and the right side tires were between the wheel paths of the flexible base. Asphalt was then applied on the base over a 10-ft width. The distributor truck was then driven on the concrete to shoot asphalt over the remaining 1 ft of flexible base (see [Figure 45](#)).

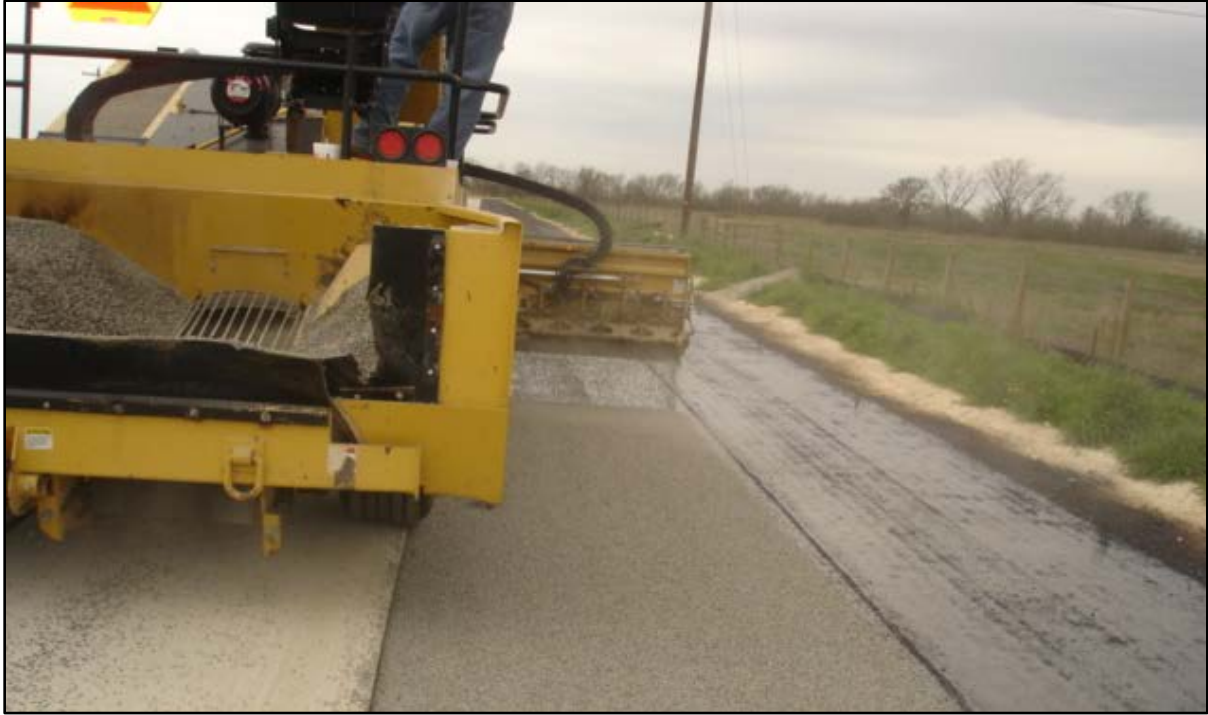
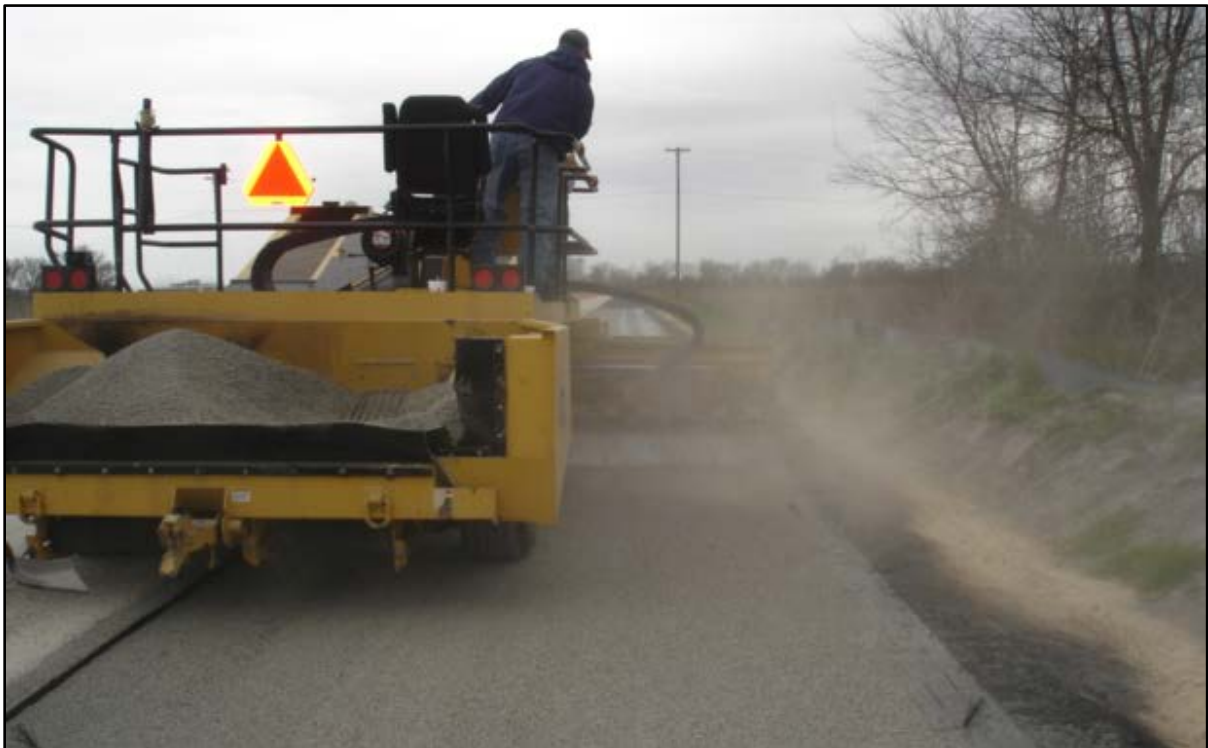
**Figure 46. Chip Spreader Applying Grade 5 on Inside Half of Inverted Prime Section.**

**Figure 47. Chip Spreader Applying Grade 5 on Outside Half of Inverted Prime Section.**

At no time did the subcontractor's equipment drive over the wheel paths of the flexible base sections placed alongside the CRCP. The only areas where his equipment drove over the wheel paths were on the north and south access ramps. At the south access ramp, his chip spreader did peel off about a 10-ft long strip of the Grade 3 course, which wrapped around the tires exposing the flexible base. [Figure 48](#) shows the strip where the Grade 3 course peeled off. The subcontractor had his crew patch up this area before placing the Grade 4 on top of the Grade 3. The subcontractor used a 9-wheel pneumatic tire roller to seat the aggregates.

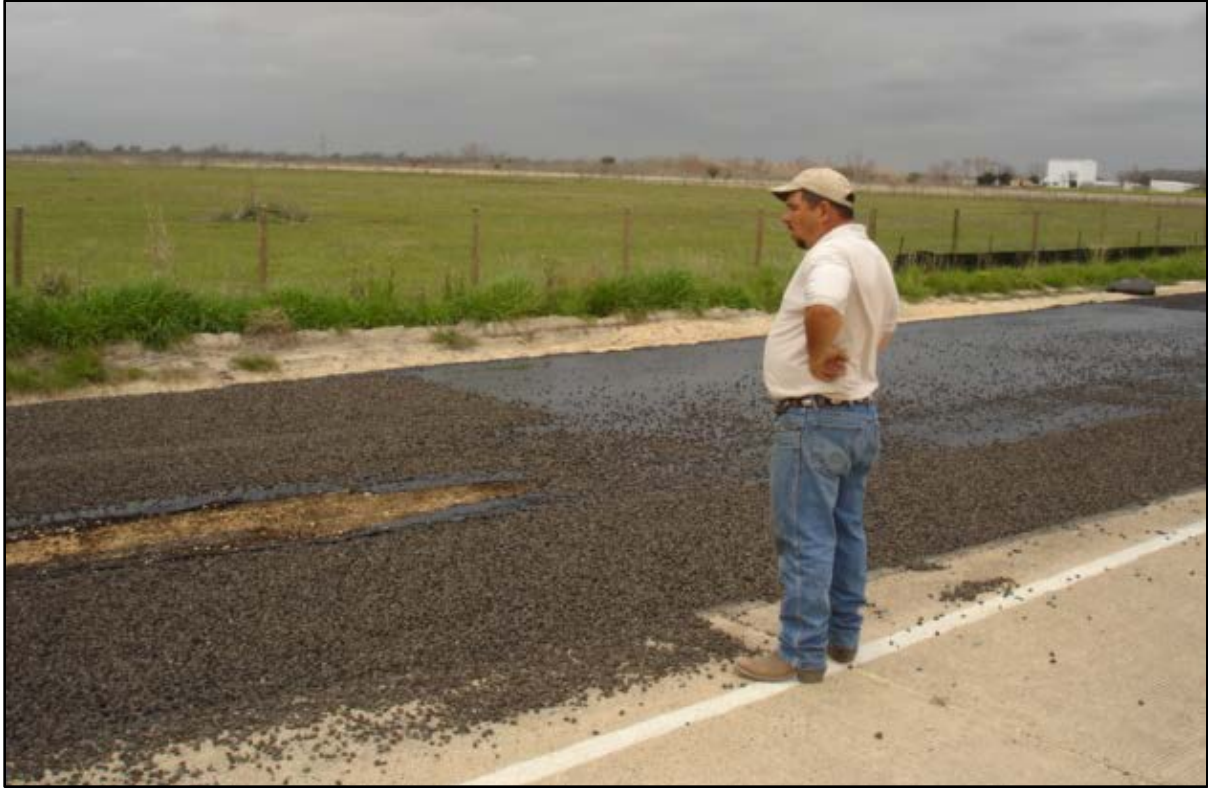
**Figure 48. Strip of Grade 3 Course that Peeled Off at South Access Ramp.**

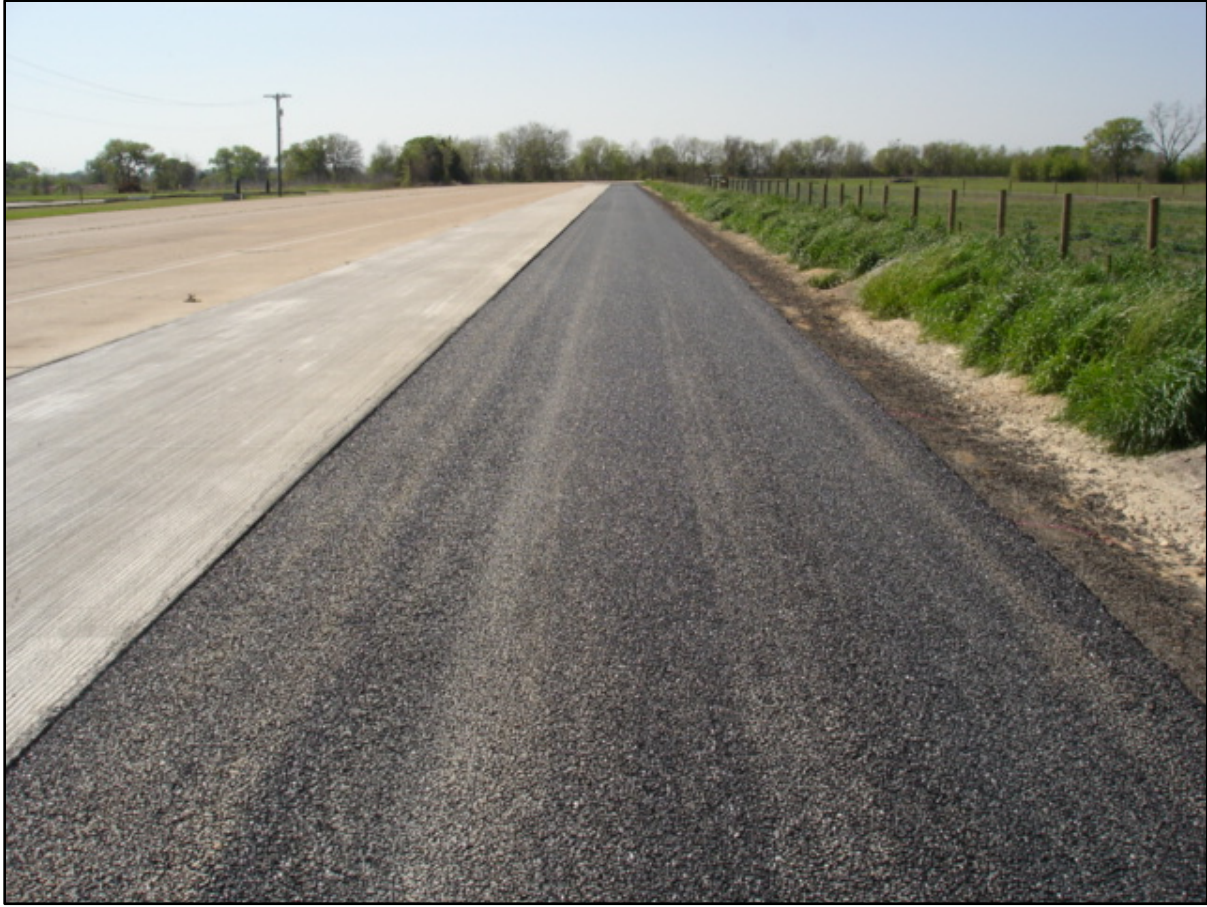
**Figure 49. PFC Section Adjacent to Longitudinally Tined CRCP Section.**

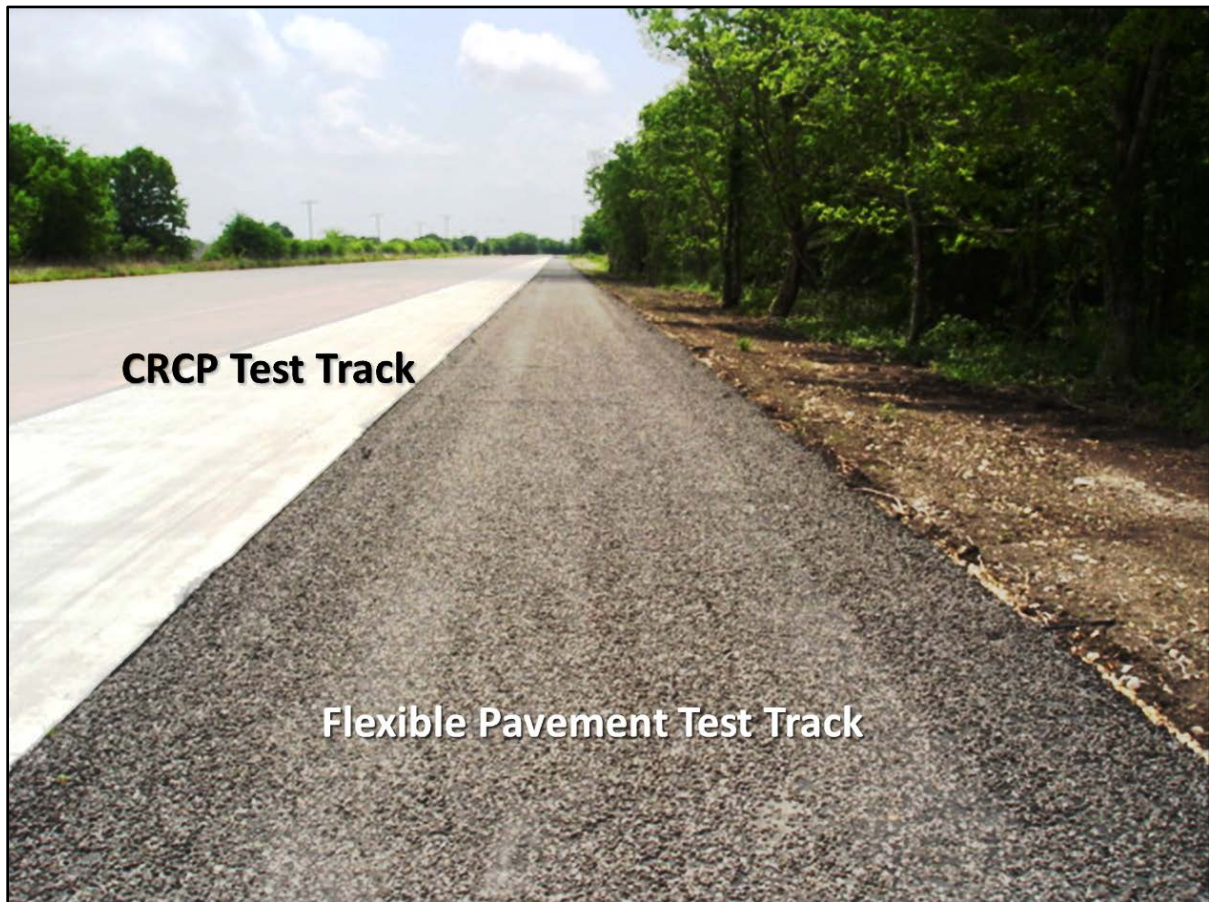
**Figure 50. New Test Tracks for Profiler Certifications.**

This chapter documents the work researchers conducted to collect reference profiles and run preliminary tests to verify the applicability of the existing TxDOT Tex-1001S certification requirements on the new CRCP and flexible pavement test tracks. [Figure 50](#) shows the new test tracks built along Taxiway 7 of the Riverside Campus. [Figure 51](#) to [Figure 56](#) show pictures of the pavement surface on each of the test sections. After construction, researchers collected reference profile measurements on these sections, and tested a number of inertial profilers equipped with different lasers to verify the applicability of TxDOT's current profiler certification requirements on the new pavement surfaces. The tests performed are presented in this chapter.

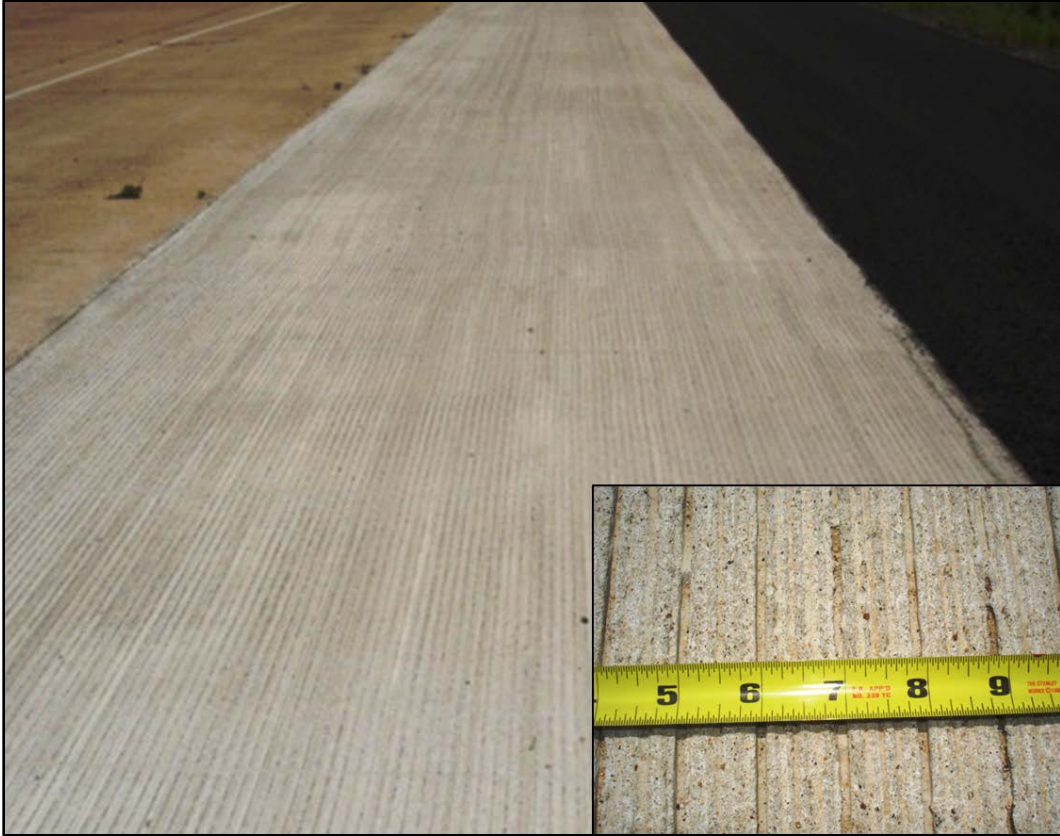
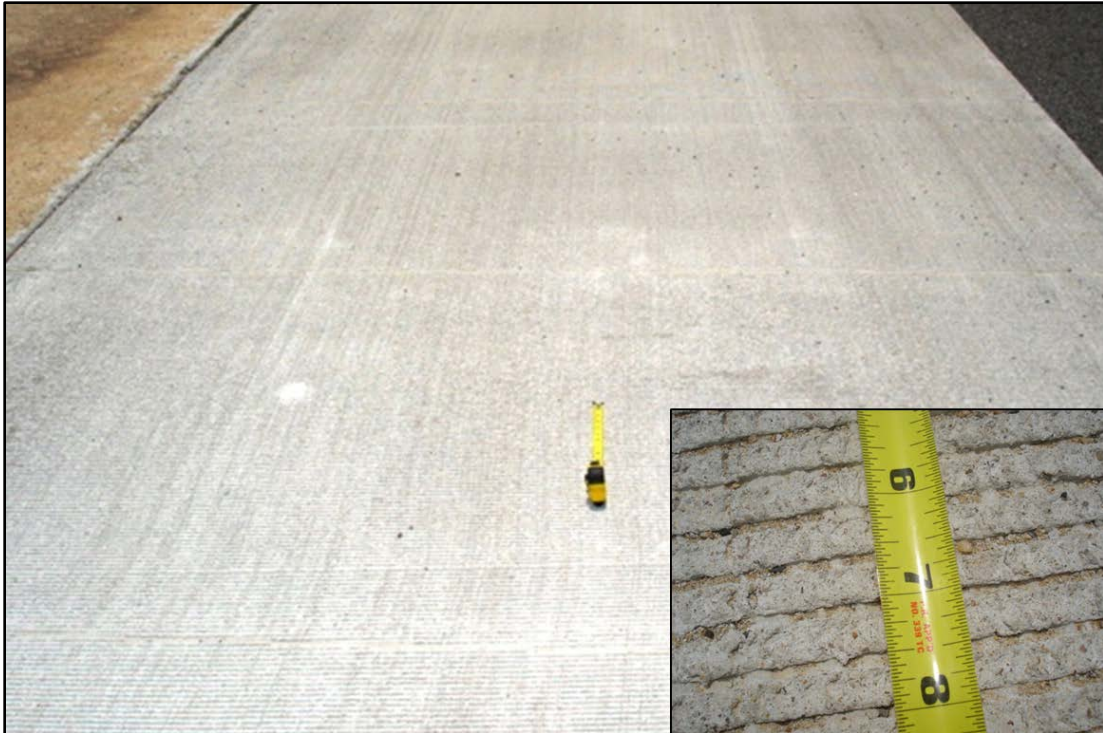
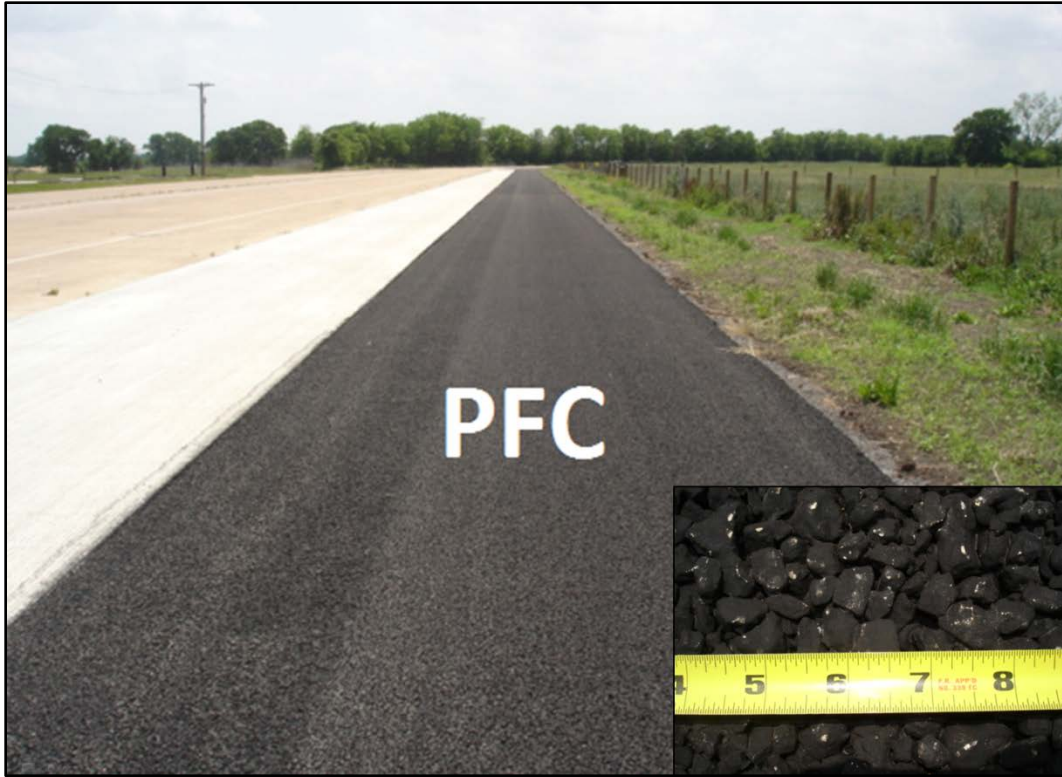
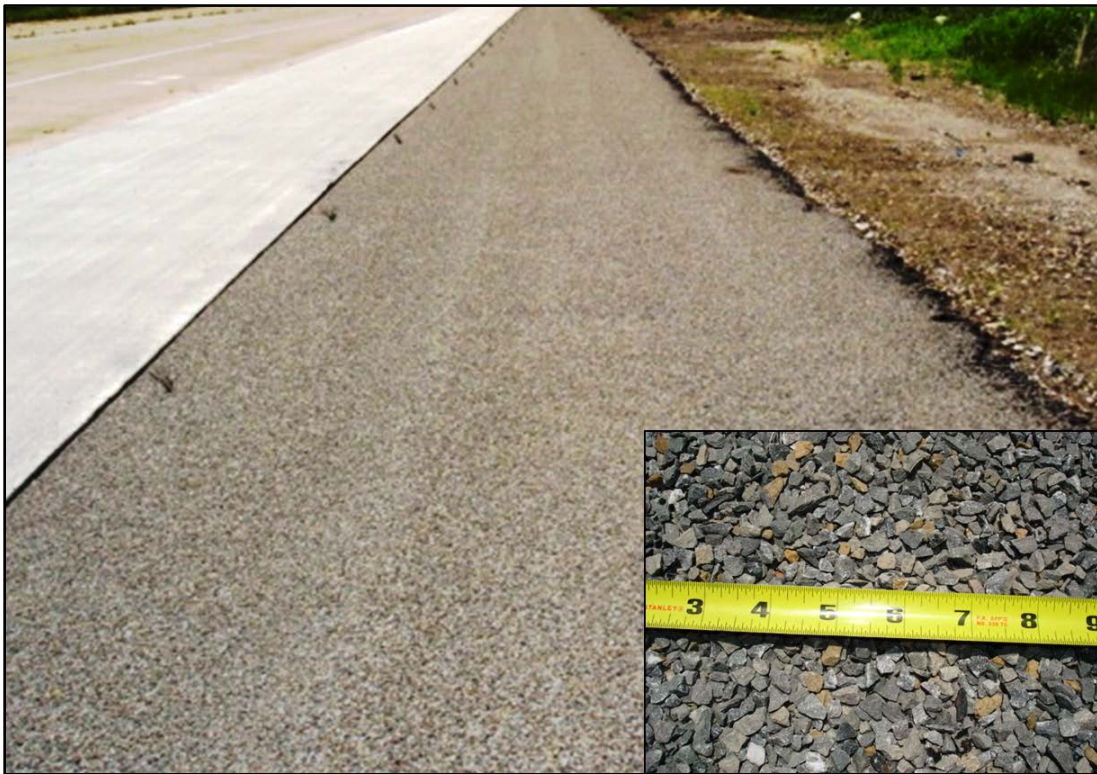
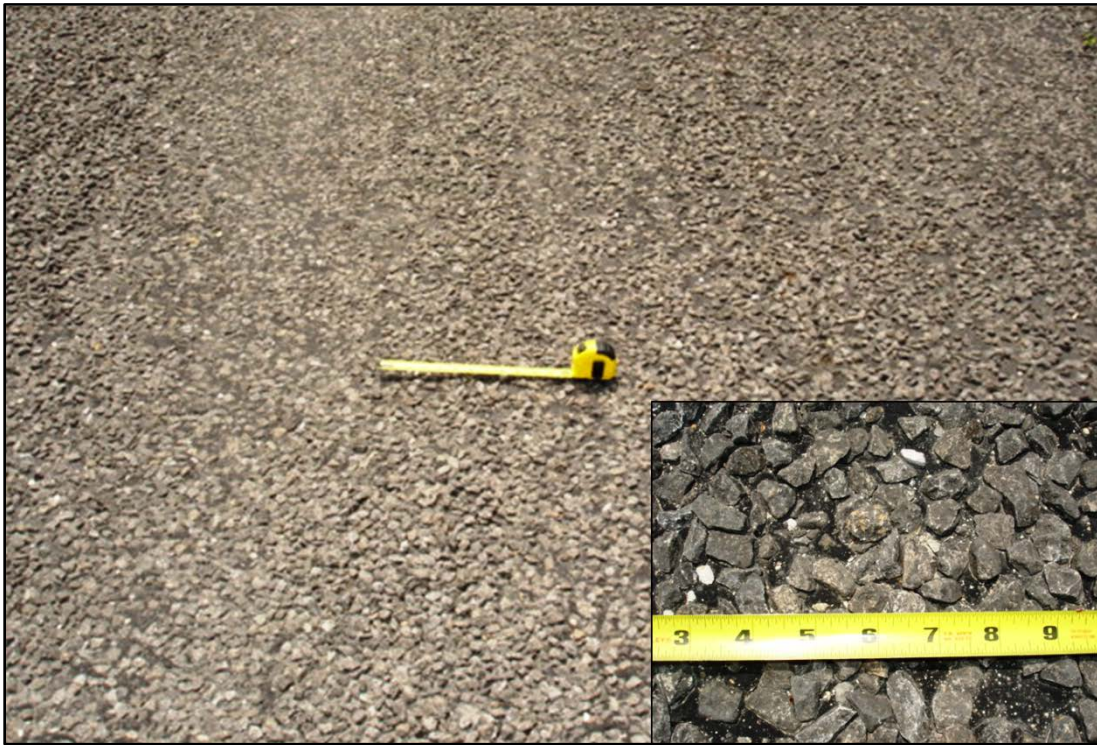
**Figure 51. One-inch Longitudinally Tined CRCP Section.**

**Figure 52. Half-inch Transversely Tined CRCP Section.**

**Figure 53. One-inch Transversely Tined CRCP Section.**

**Figure 54. Permeable Friction Course Section.**

**Figure 55. Inverted Prime Section.**

**Figure 56. Grade 3 Chip Seal Section.**

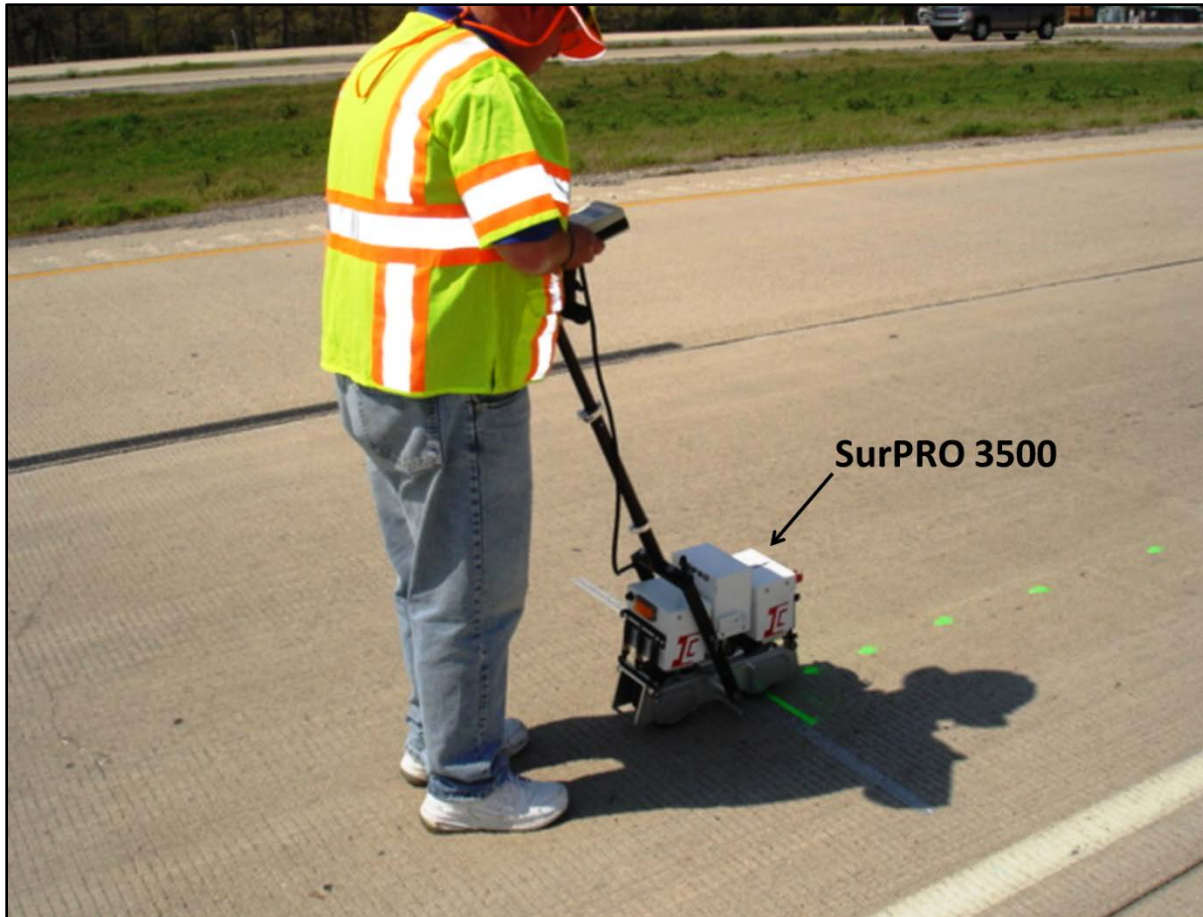
**Figure 57. Instrument Used to Measure Reference Profiles.**

Reference profile measurements were collected using the SurPRO 3500 profiler illustrated in [Figure 57](#). This reference profiler is a product of the Federal Highway Administration (FHWA) pooled fund study TPF-5(063), which conducted an evaluation that assessed the accuracy and repeatability of profiles collected with three different systems provided by equipment developers who participated in that study. Based on the results, FHWA recommended using the SurPRO for evaluating profile measurements collected with inertial profilers. The SurPRO 3500 is the same profiler used to collect reference data on the existing profiler certification track that TTI maintains.

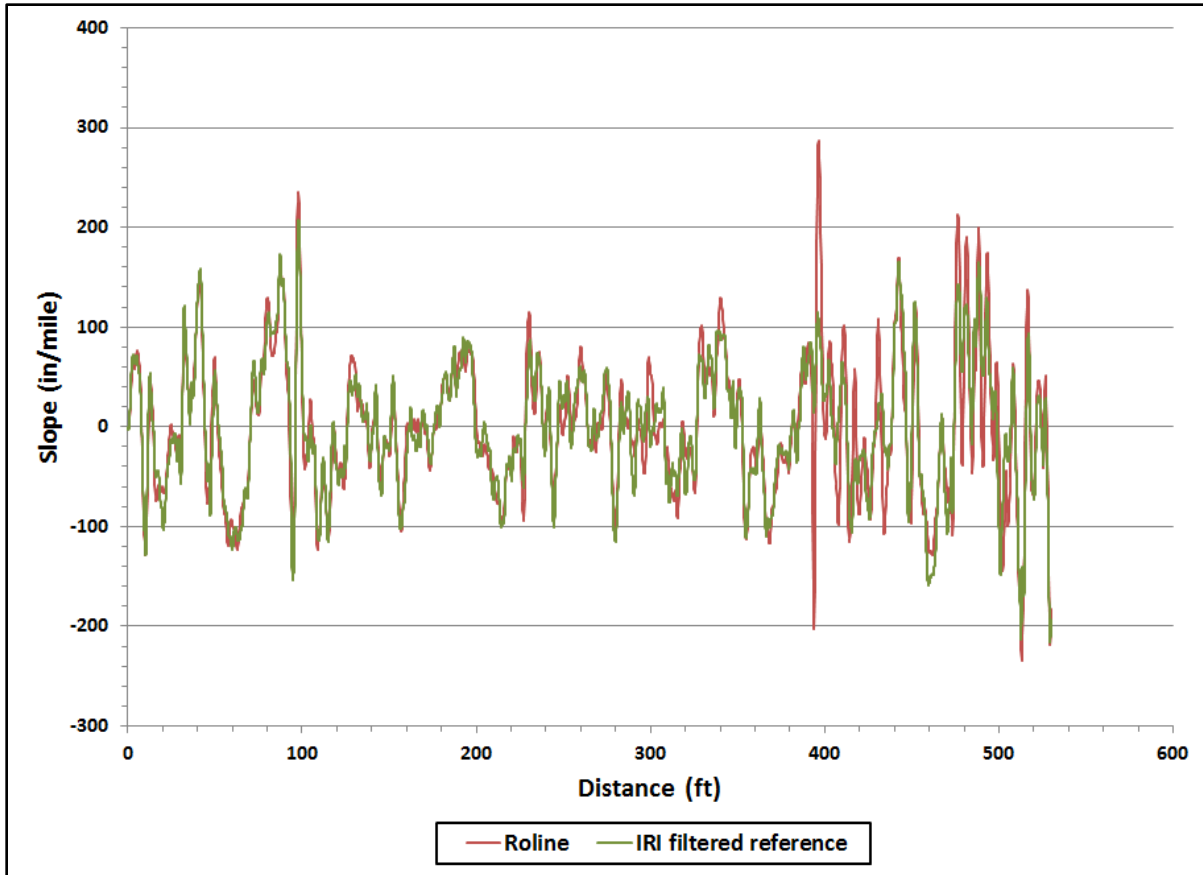
**Figure 58. Comparison of IRI Filtered Profiles on a Section of CRCP Test Track.**

There is evidence from test data that the ½-inch transverse tines affected the Roline measurements on the right wheel path. [Figure 58](#) compares the IRI filtered profile from one of the runs on the CRCP track with the corresponding IRI filtered reference profile along the same interval. The IRI filtered profiles are observed to track each other quite well up to about 390 ft of the measured interval. Thereafter, the IRI filtered Roline profile shows more deviations from the IRI filtered reference profile. Researchers note that the pavement surface changes from 1-inch longitudinal tines to ½-inch transverse tines at about 390 ft on the chart. Within the first 390 ft, the cross-correlation between the IRI filtered profiles is 95 percent. If the cross-correlation is determined over the whole test interval, the cross-correlation drops to 84 percent.
