A LABORATORY AND FIELD EVALUATION OF LIGHTWEIGHT
AGGREGATES AS COVERSTONE FOR SEAL COATS
AND SURFACE TREATMENTS

Research Report Number 51-2

Use of Lightweight Aggregates
Research Project Number 2-14-63-51

TEXAS TRANSPORTATION INSTITUTE
Texas A&M University
College Station, Texas

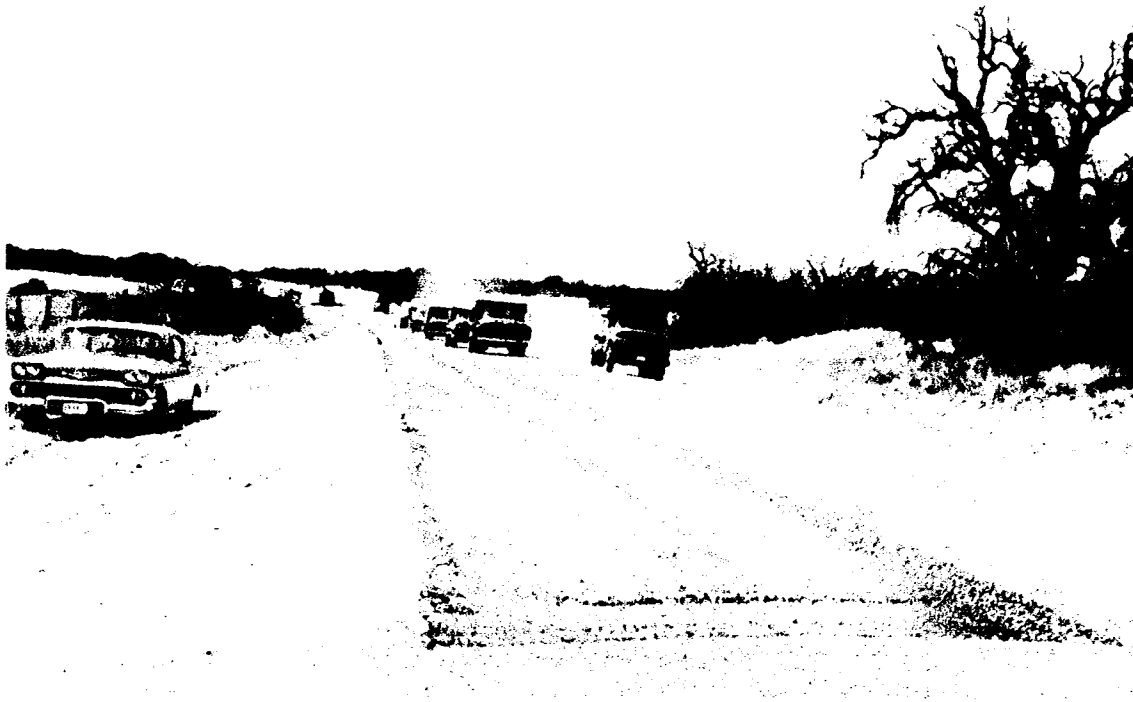
Figure 1. Old surface has variable demand for asphalt from point to point.

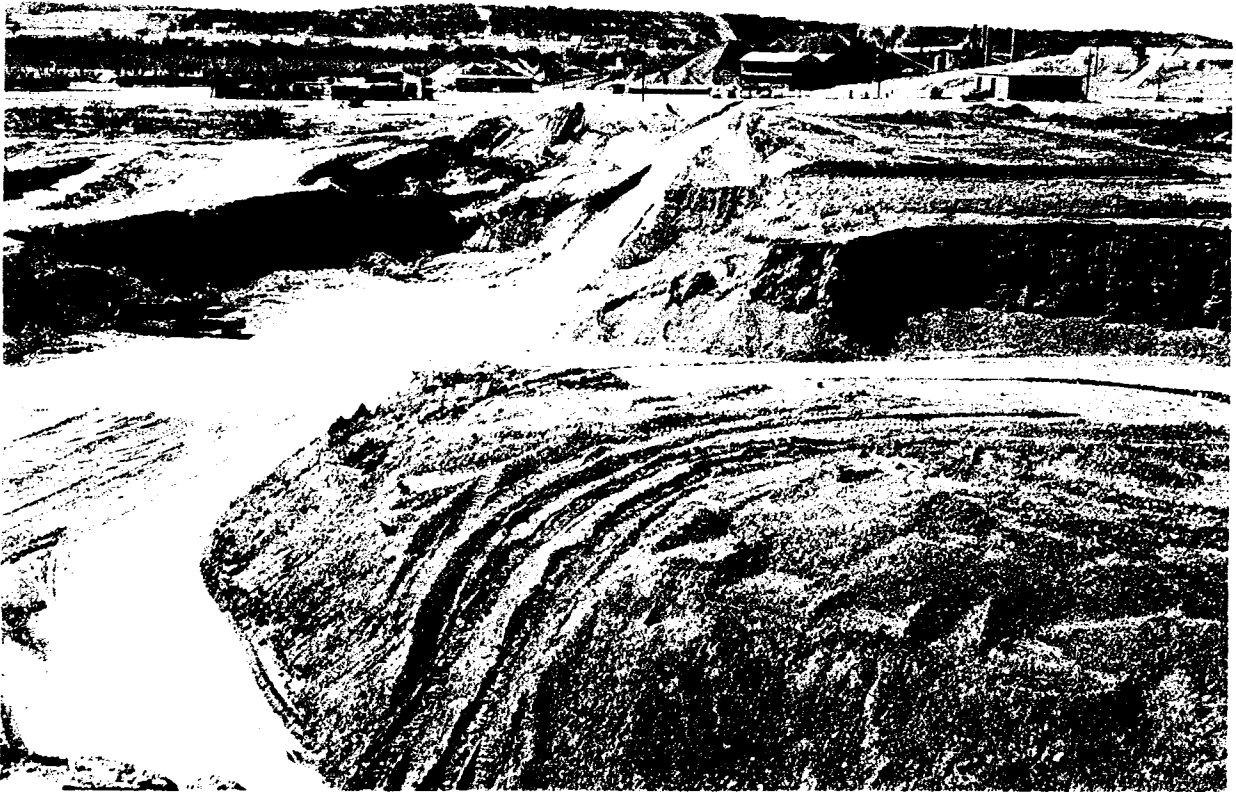
Figure 2. Open pit mining of shale. (Photo by Richardson.)

burden. This operation is shown in Figure 2. It is to be noted that the shale is mined from a vertical bank with a power shovel. This method is used to insure a uniform material of reasonably constant moisture content.

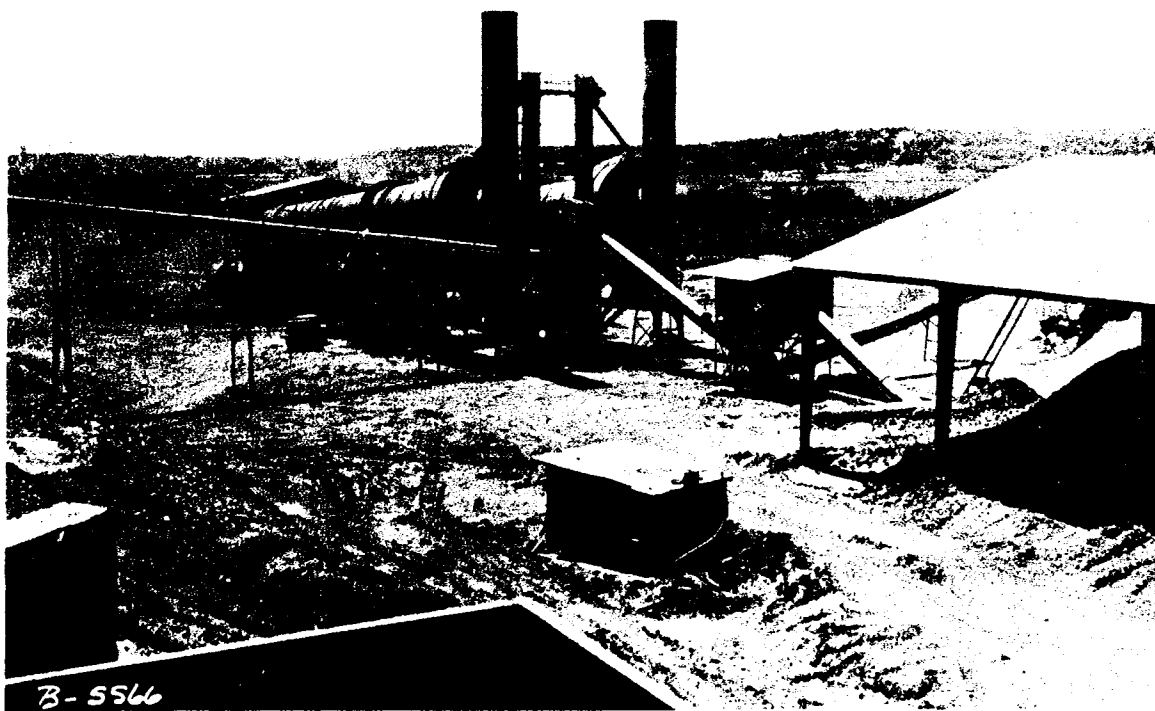
Figure 3. Shale storage and conveyor feed to kilns.
(Photo by Gustafson.)

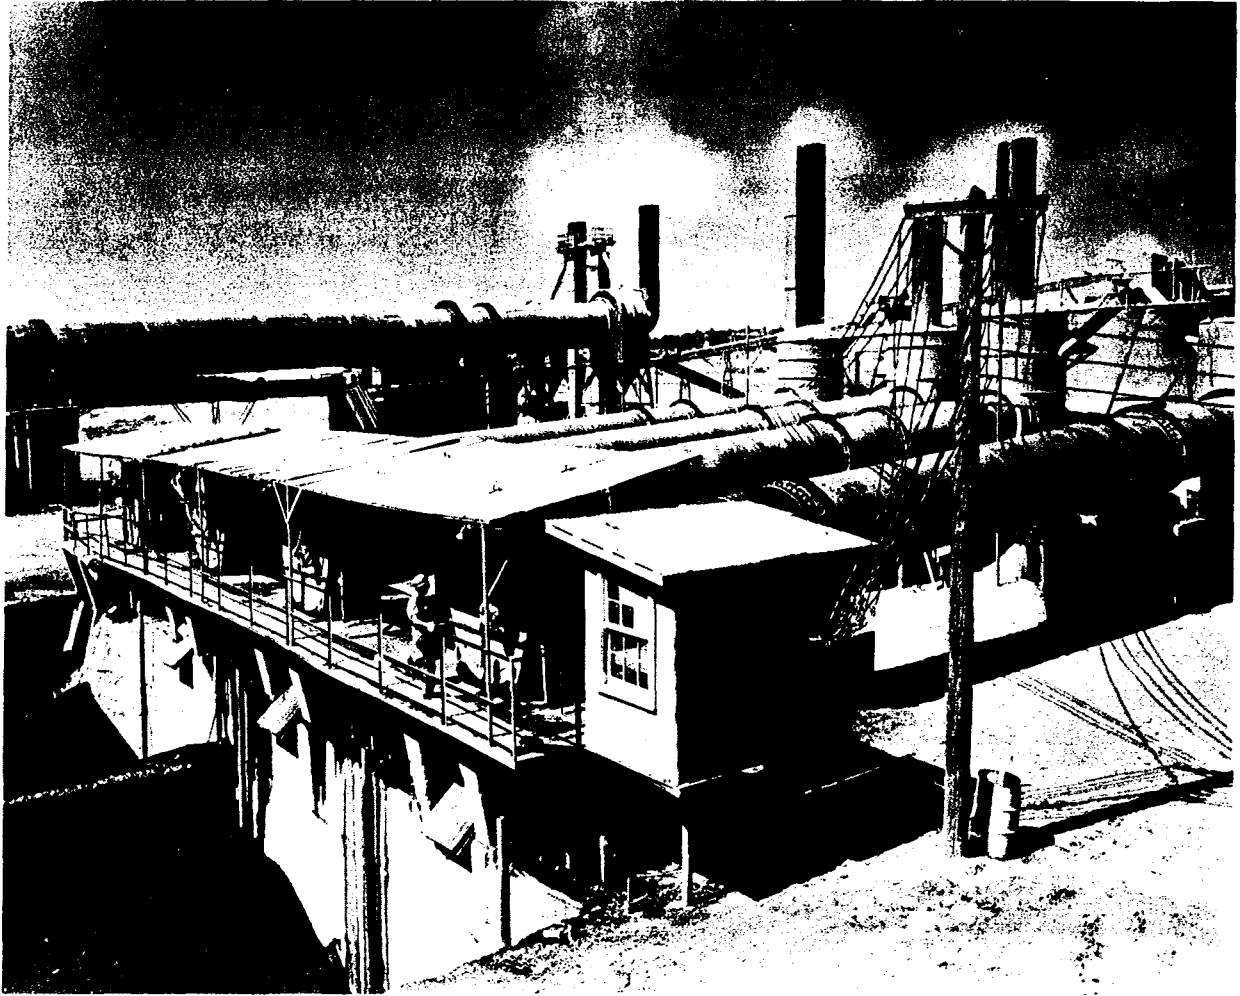
Figure 4. Battery of rotary kilns used to burn shale. (Photo by Richardson.)

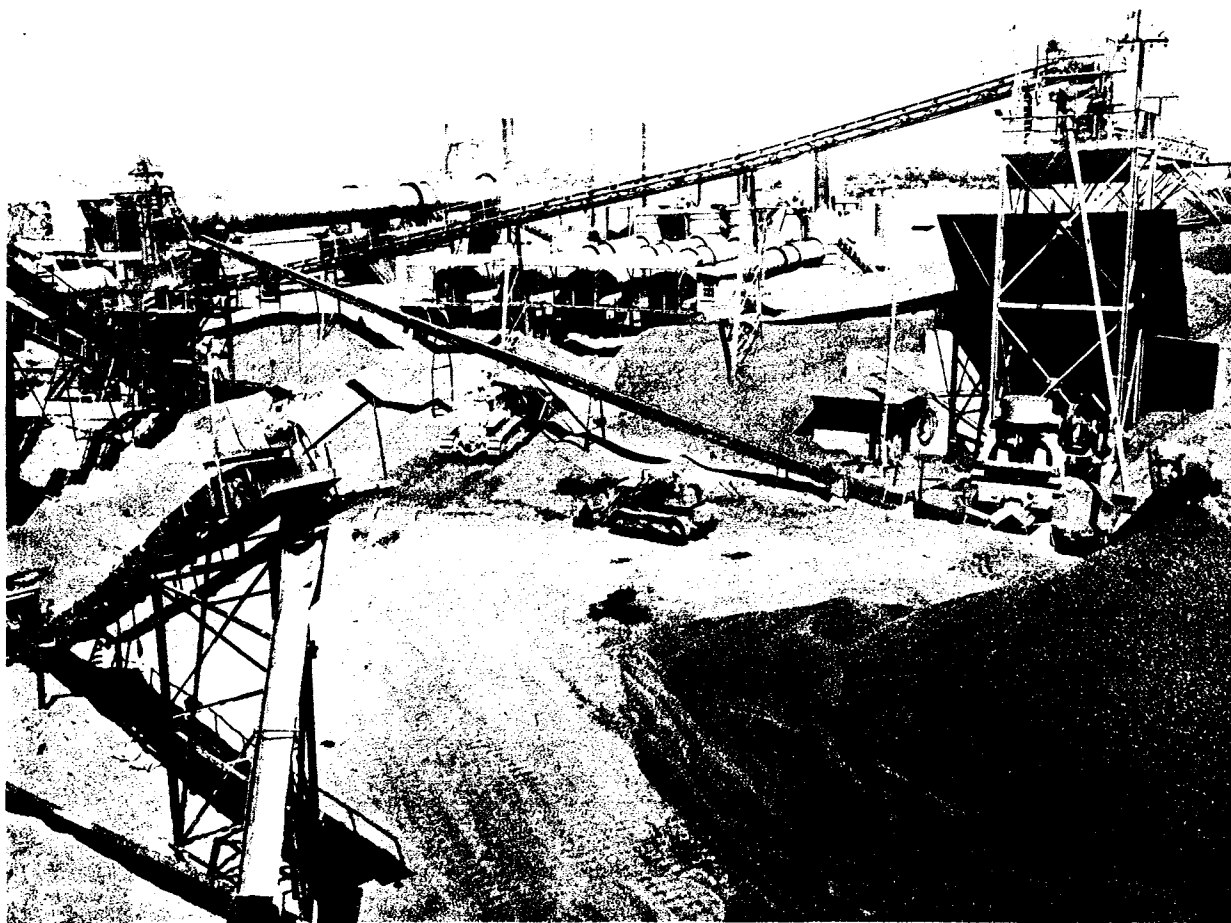
Figure 5. General view of commercial lightweight aggregate plant. Crushing and sieving is in right foreground. (Photo by Richardson.)

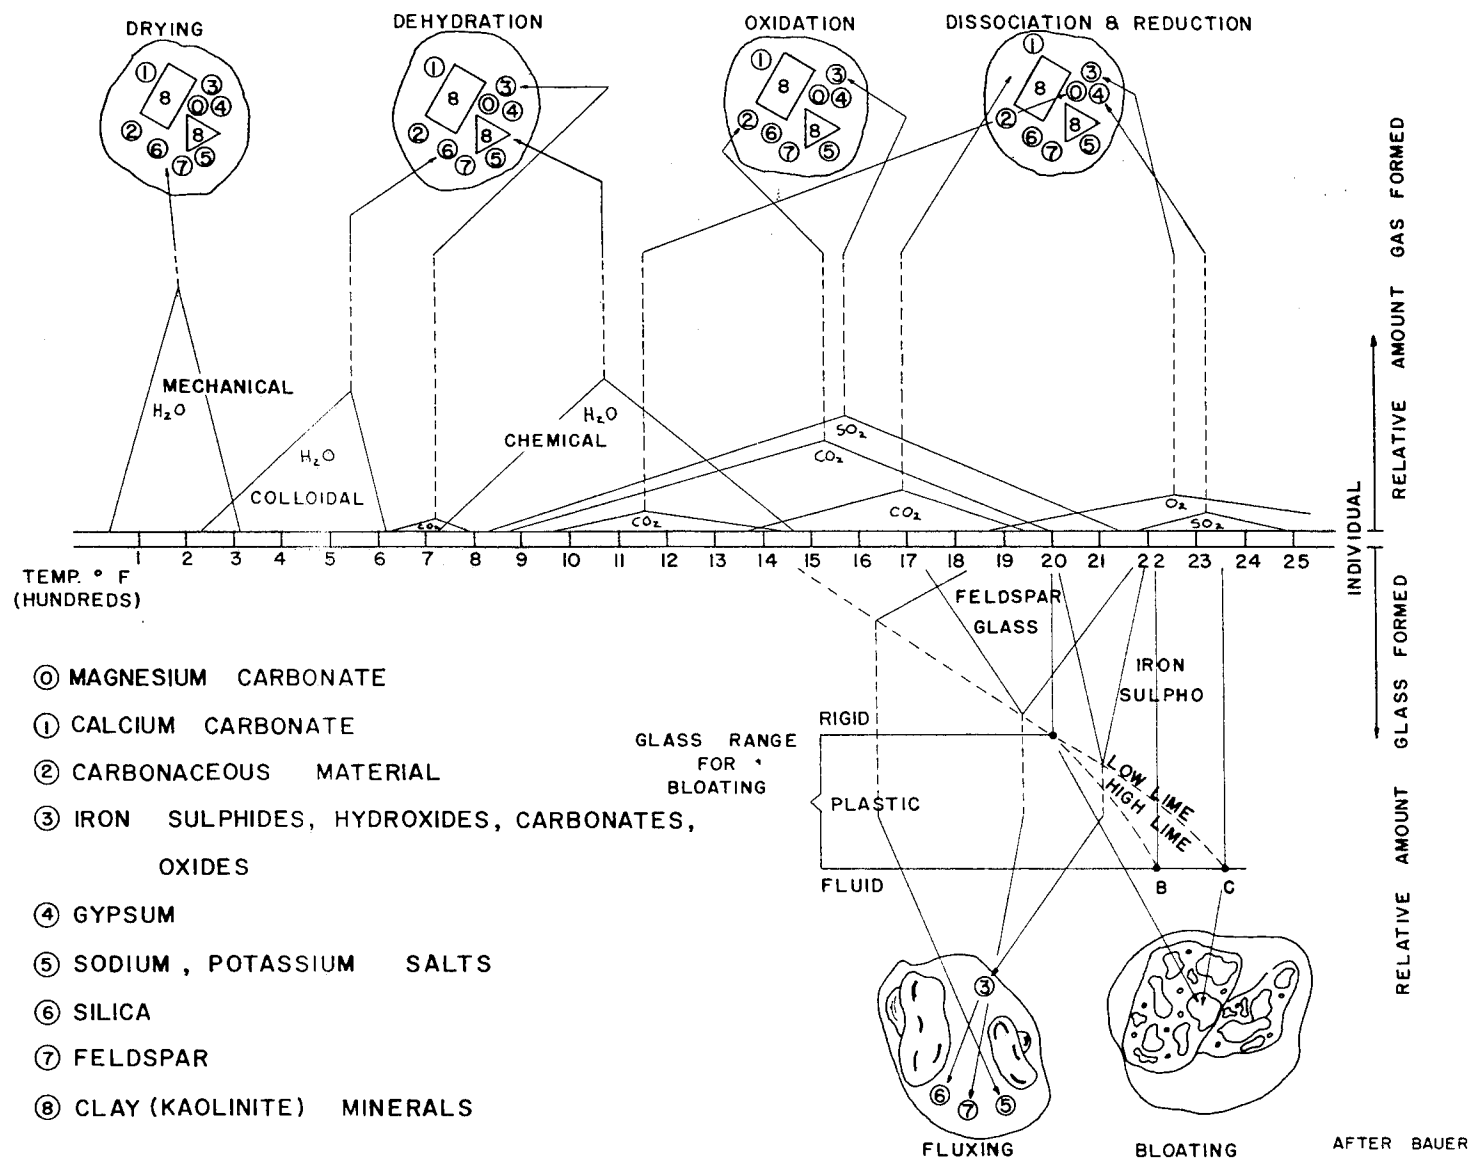
Figure 6. Flow diagram of gas-glass forming versus temperature. (Reference Bauer.)

Figure 6 is a chart showing the principal stages of gas-forming reactions and in turn relates these to the glass-forming reactions along the temperature scale (6). It is evident that most of the reaction periods overlap on the time temperature scale and as the chemistry of the clay or shales changes from one deposit to another many and varied shades of differences may occur. The possible variations multiply as a chemically complex material passes through a rotary kiln where it is subjected to changing conditions from entry to exit of the kiln.

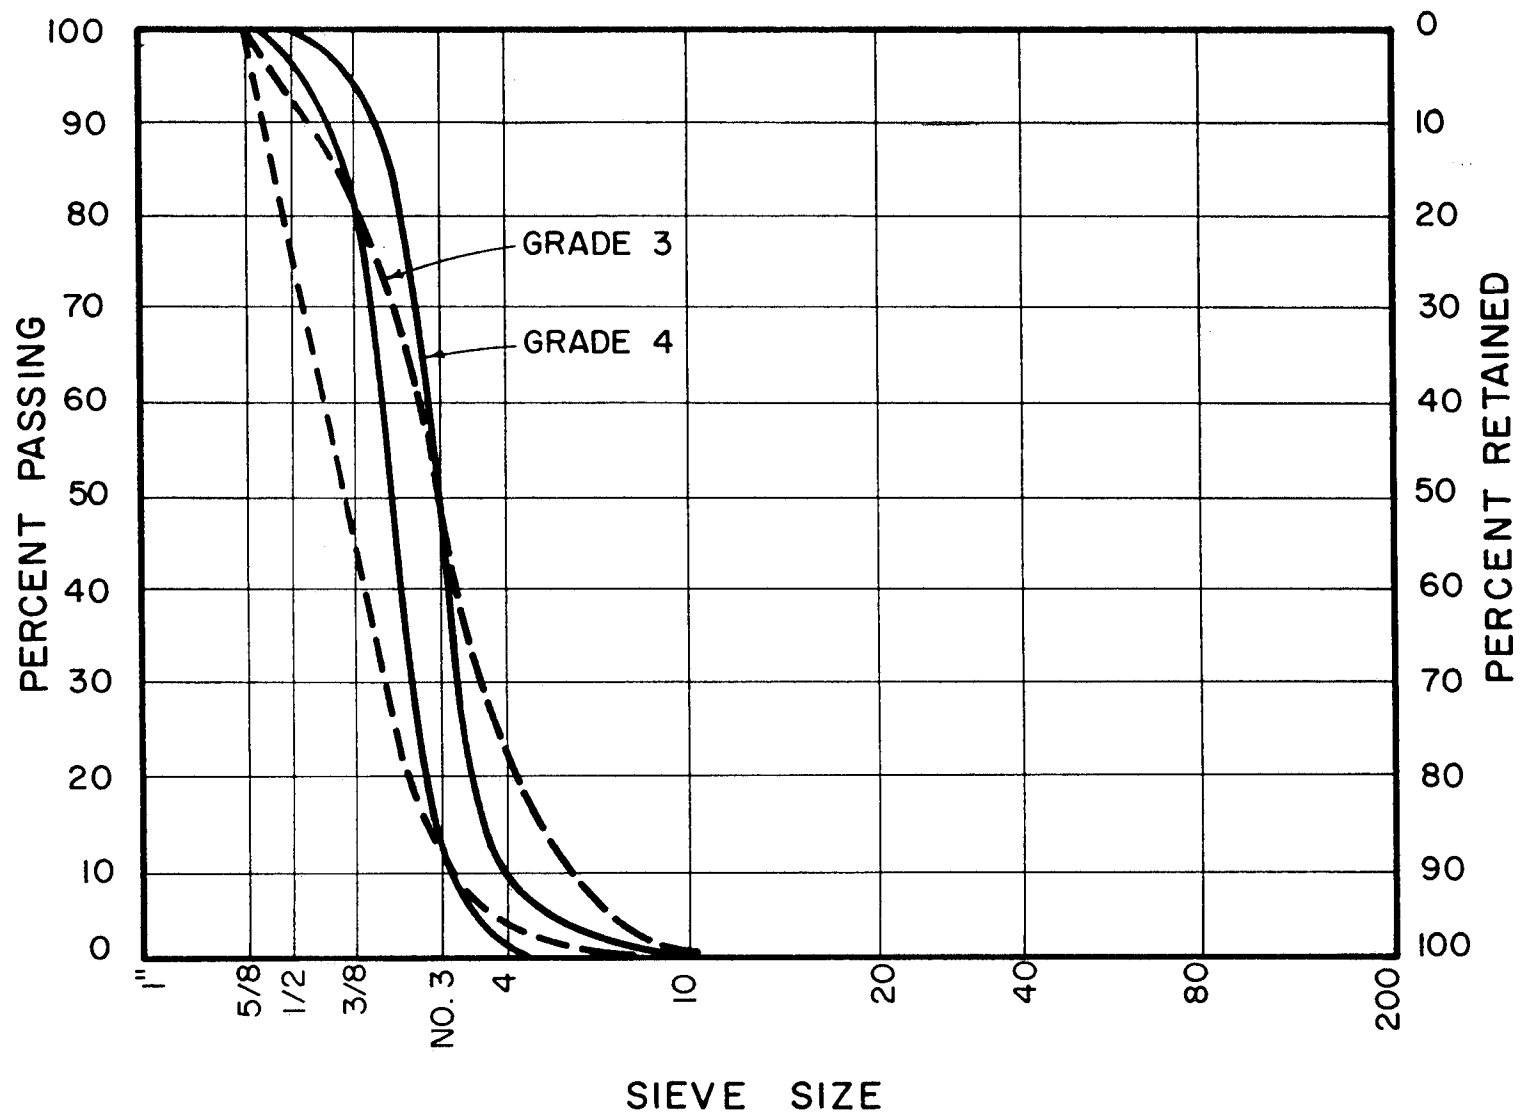
FIGURE 7 GRADING OF STOCKPILE AND PRODUCTION
RUN TYPE F GRADES 3 & 4 MATERIAL

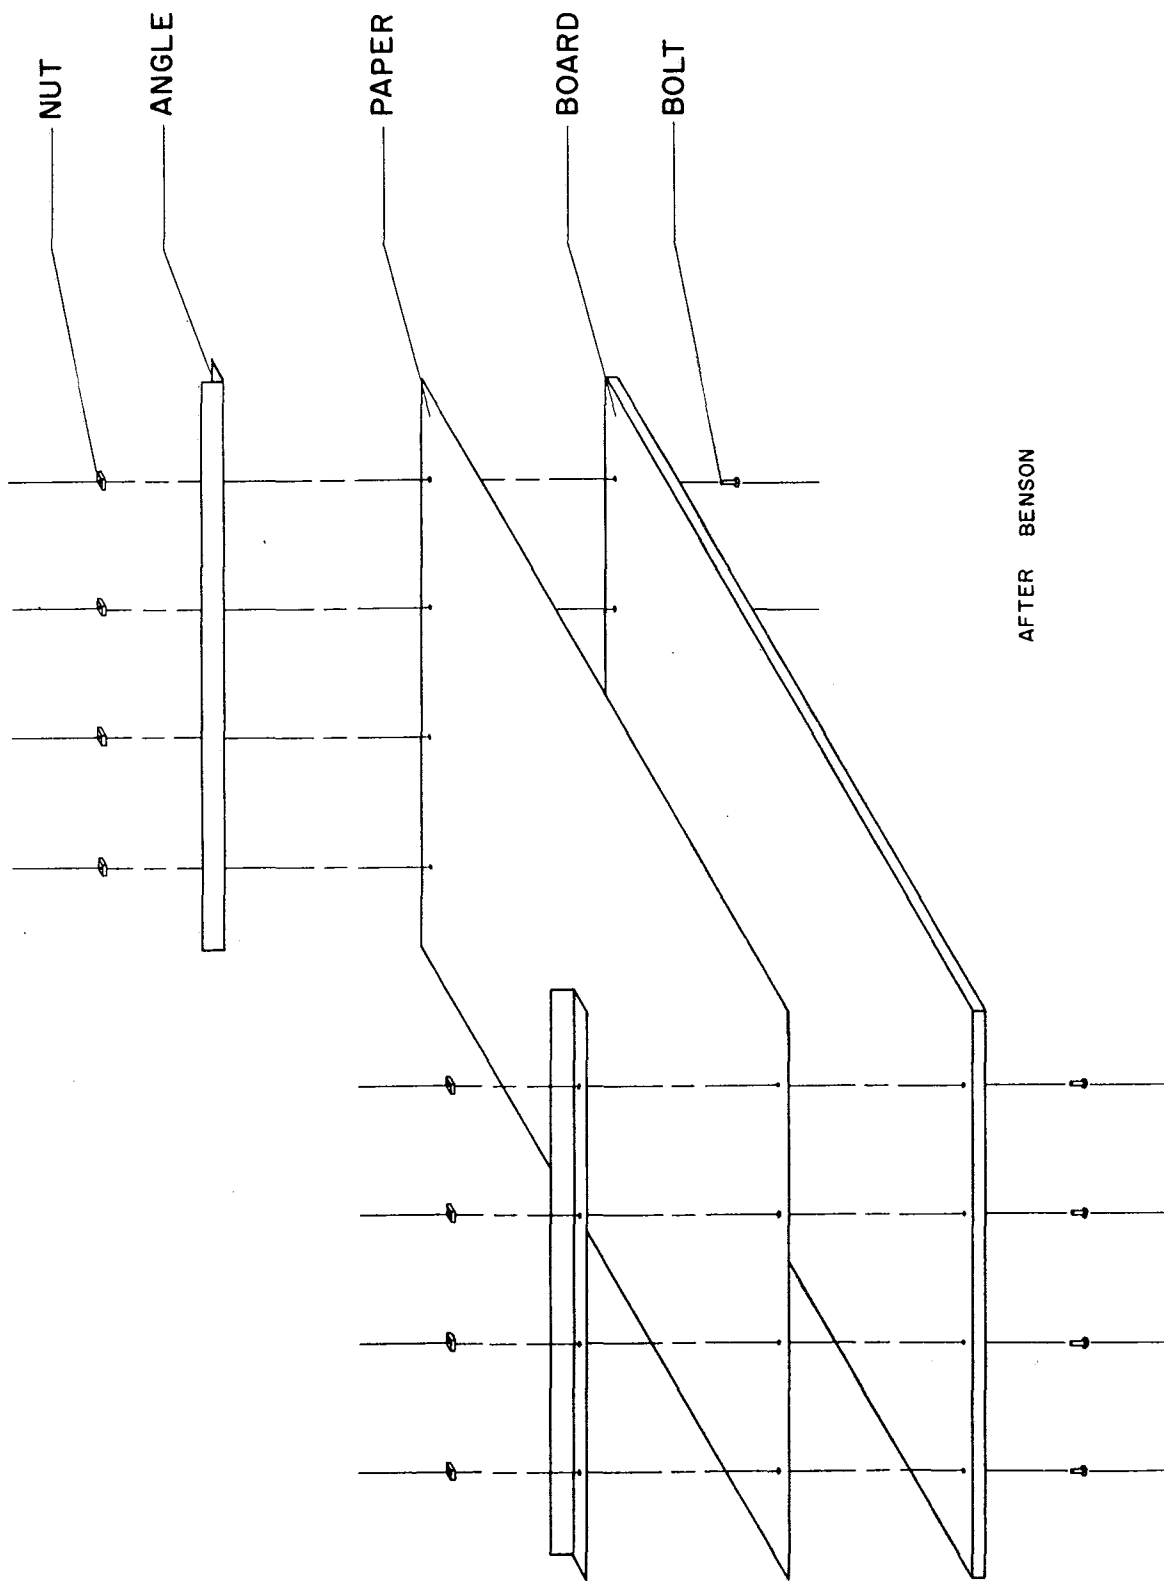
FIGURE 8 "EXPLODED" ASSEMBLY OF BOARD, PAPER AND ANGLES

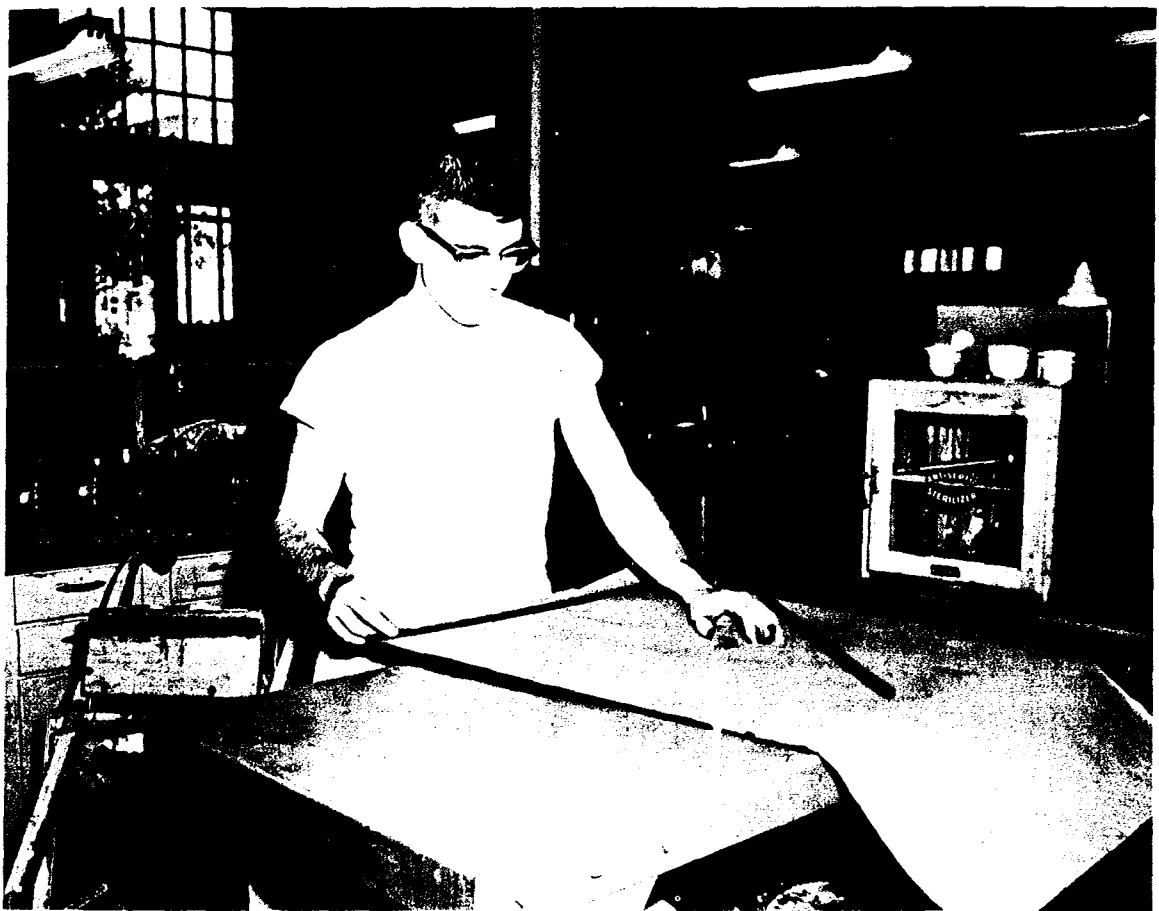
Figure 9. Laboratory surface treatment board being covered with paper

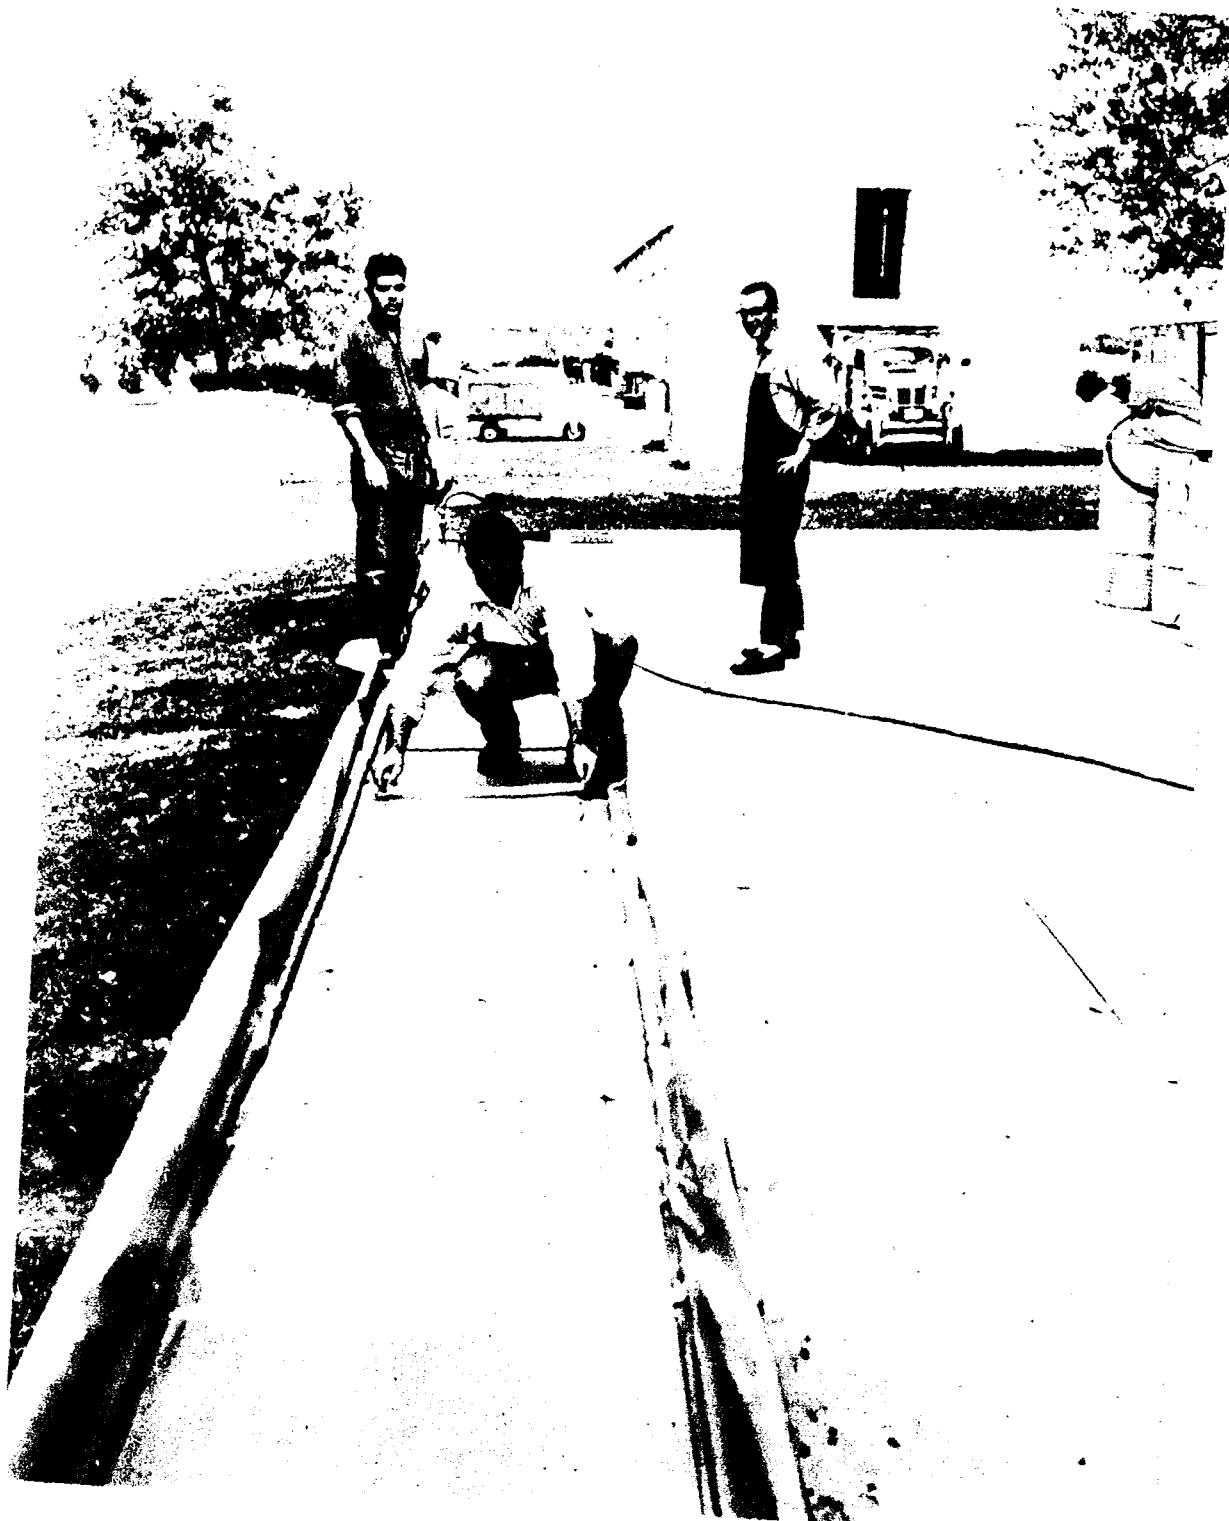
Figure 10. Boards in line for asphalt shot.

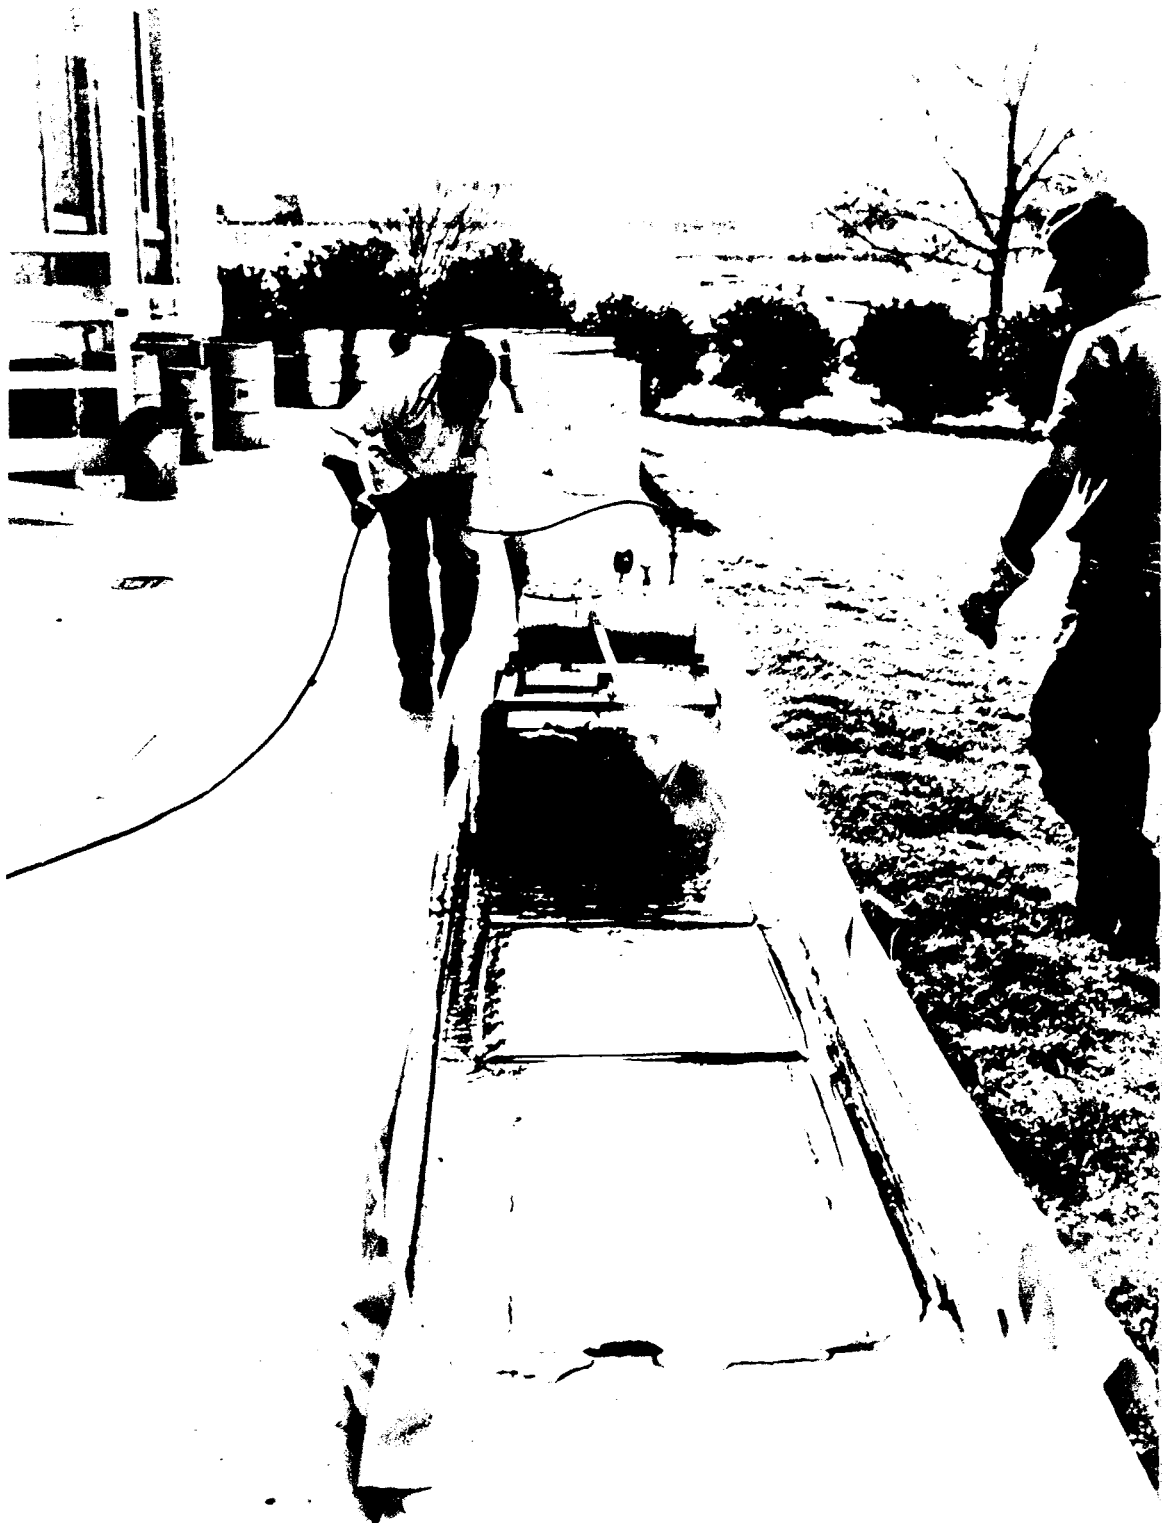
Figure 12. Hot asphalt cement being sprayed from small distributor.

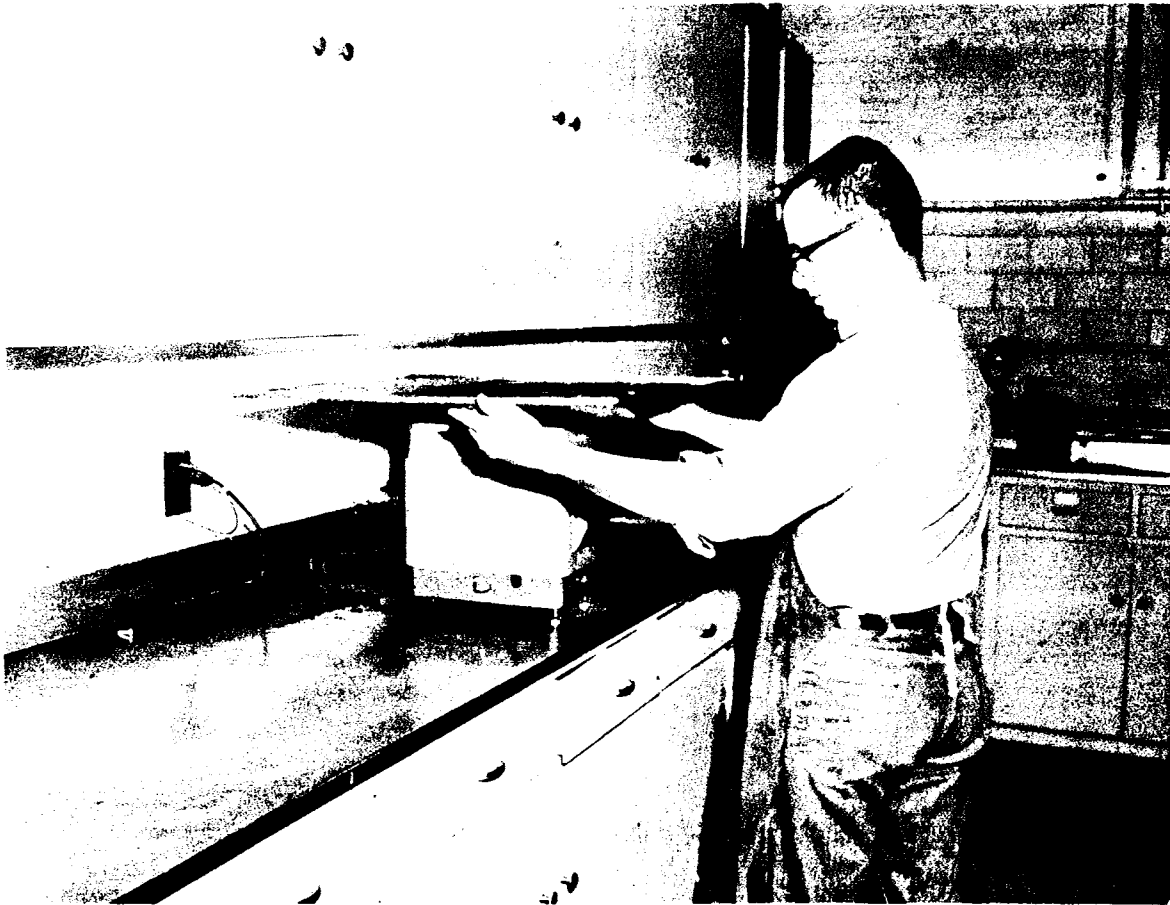
After the asphalt was applied, the exact amount of cement on each board was determined by weighing the board assembly as shown in Figure 13. Following this operation, a weighed quantity of stone was applied as shown in Figure 14. The aggregate was usually applied beginning five minutes after the asphalt was sprayed on the board and this operation was completed in an additional five minutes or less.

Figure 13. Asphalt coated board being weighed to measure application rate.

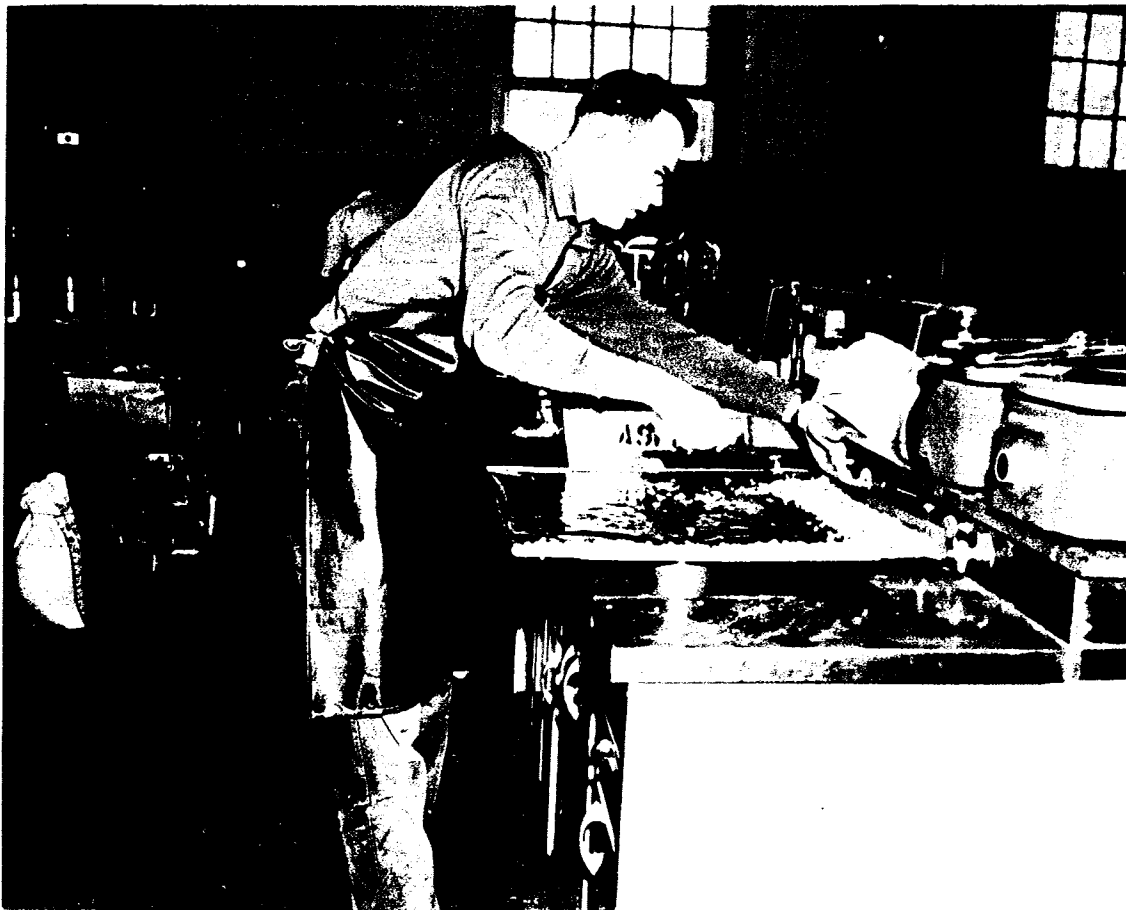
Figure 14. Aggregate being spread by hand on asphalt coated board.

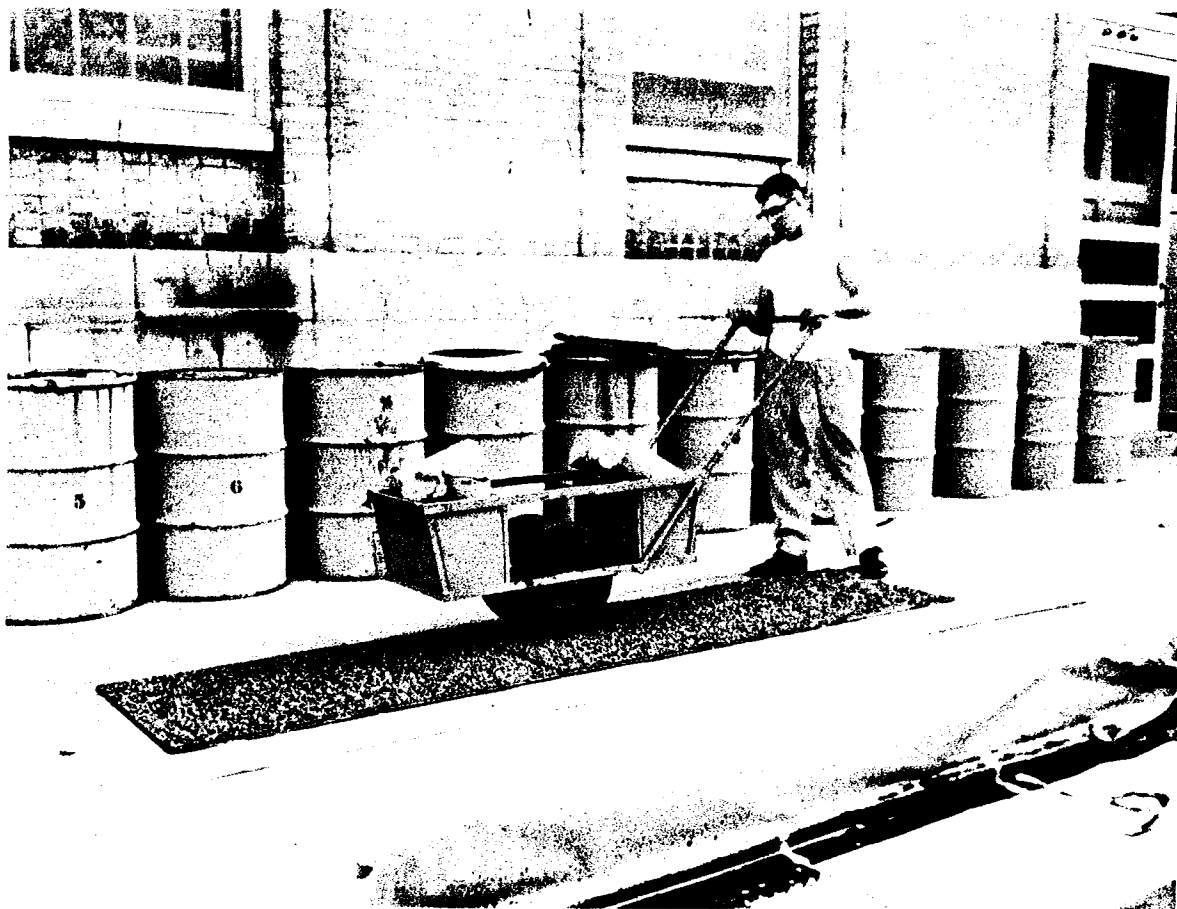
The aggregate covered boards were then placed on heavy paper for the rolling operation. This is shown in Figure 15. During the application of the asphaltic material, the boards were arranged with metal angles abutting each other; whereas, when these same boards are arranged for the rolling operation, the boards are rotated so the angle is at the outside as may be observed in Figure 15. This prevents the angle from being damaged by the roller.

The stone was seated by use of the pneumatic roller shown in Figure 15. The pneumatic tires were inflated to 50 psi and twelve coverages of the roller were used. After rolling was completed, the boards were tilted at an angle of 75° with the horizontal and brushed lightly as shown in Figure 16. Loosely attached and unstuck stone was dislodged in this manner and this material was collected and weighed. Data collection and analysis completed a given test.

Figure 15. Pneumatic roller used to seat stone on laboratory surface treatments.

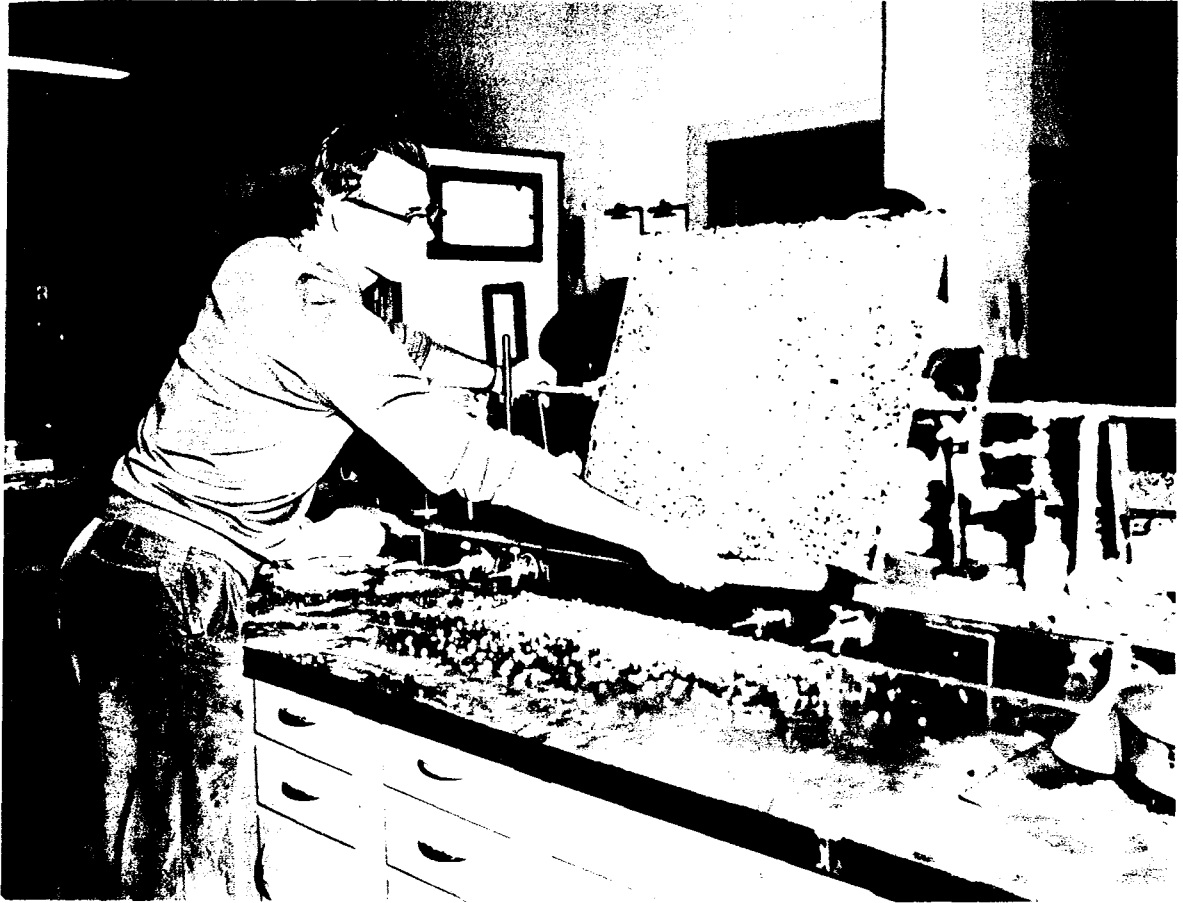
Figure 16. Completed surface is tilted at 75° and brushed to remove loose stone.
