A LABORATORY AND FIELD EVALUATION OF LIGHTWEIGHT
AGGREGATES AS COVERSTONE FOR SEAL COATS
AND SURFACE TREATMENTS

Research Report Number 51-2

Use of Lightweight Aggregates
Research Project Number 2-14-63-51

TEXAS TRANSPORTATION INSTITUTE
Texas A&M University
College Station, Texas

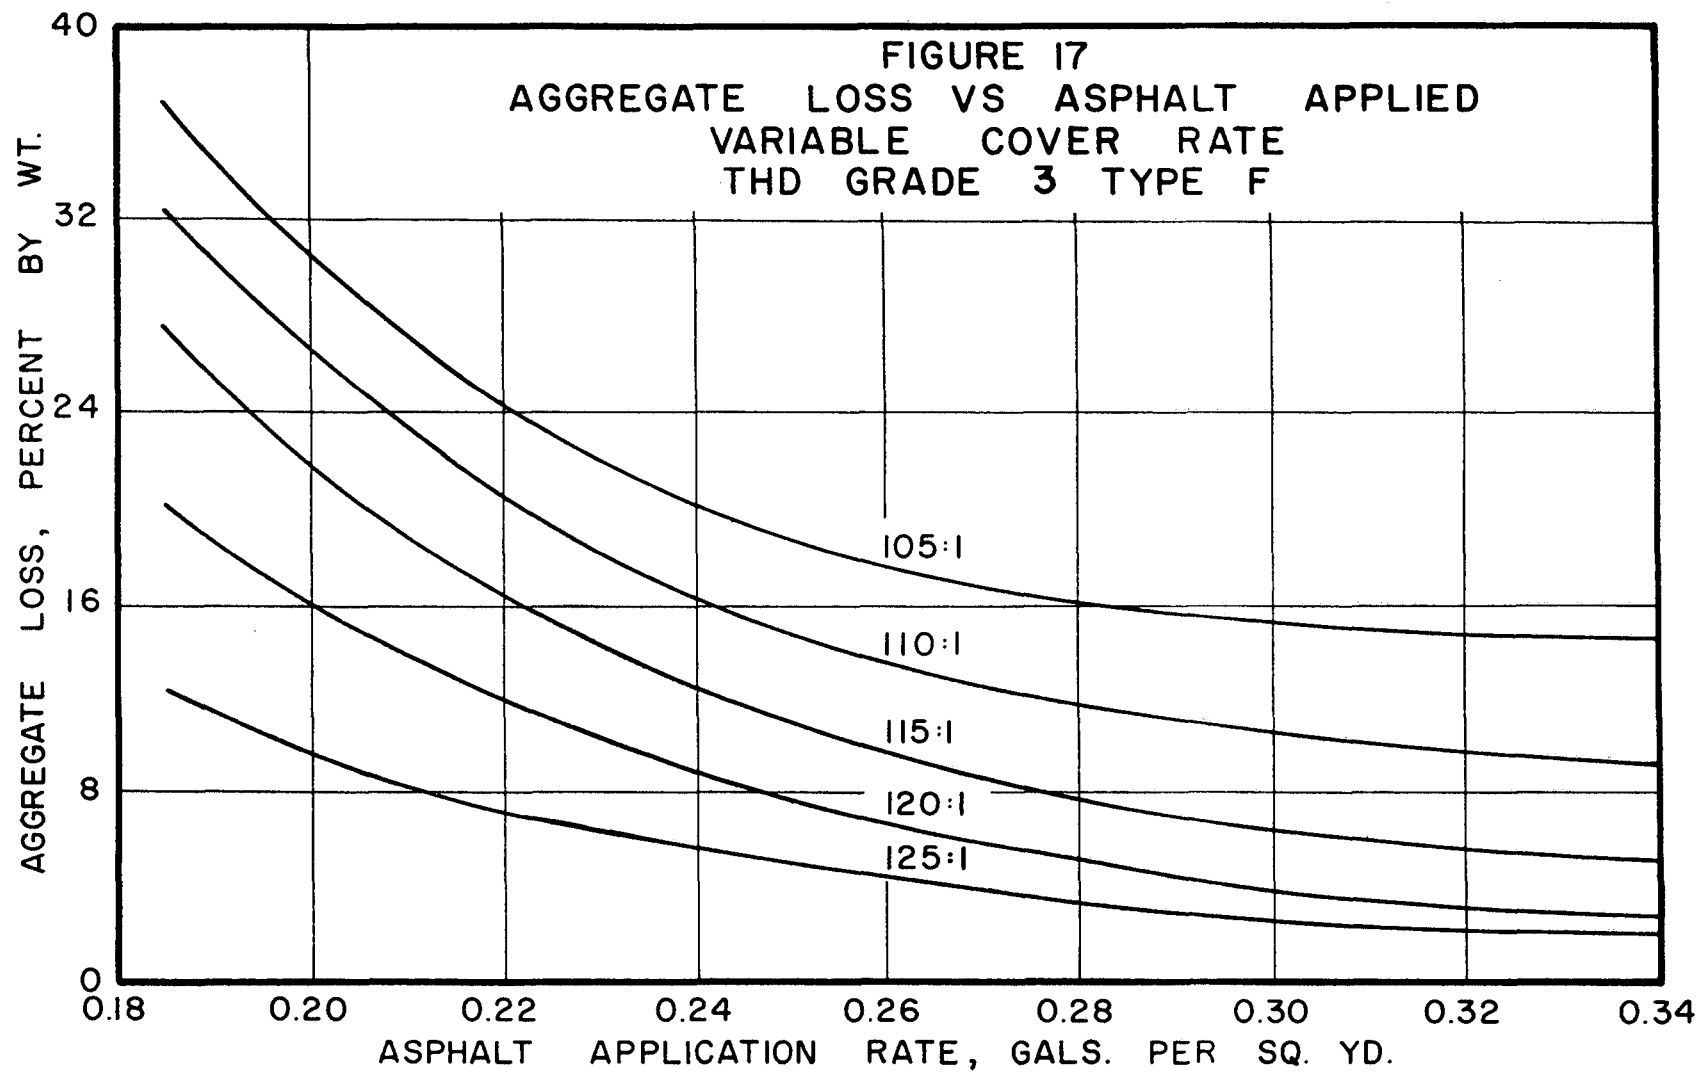
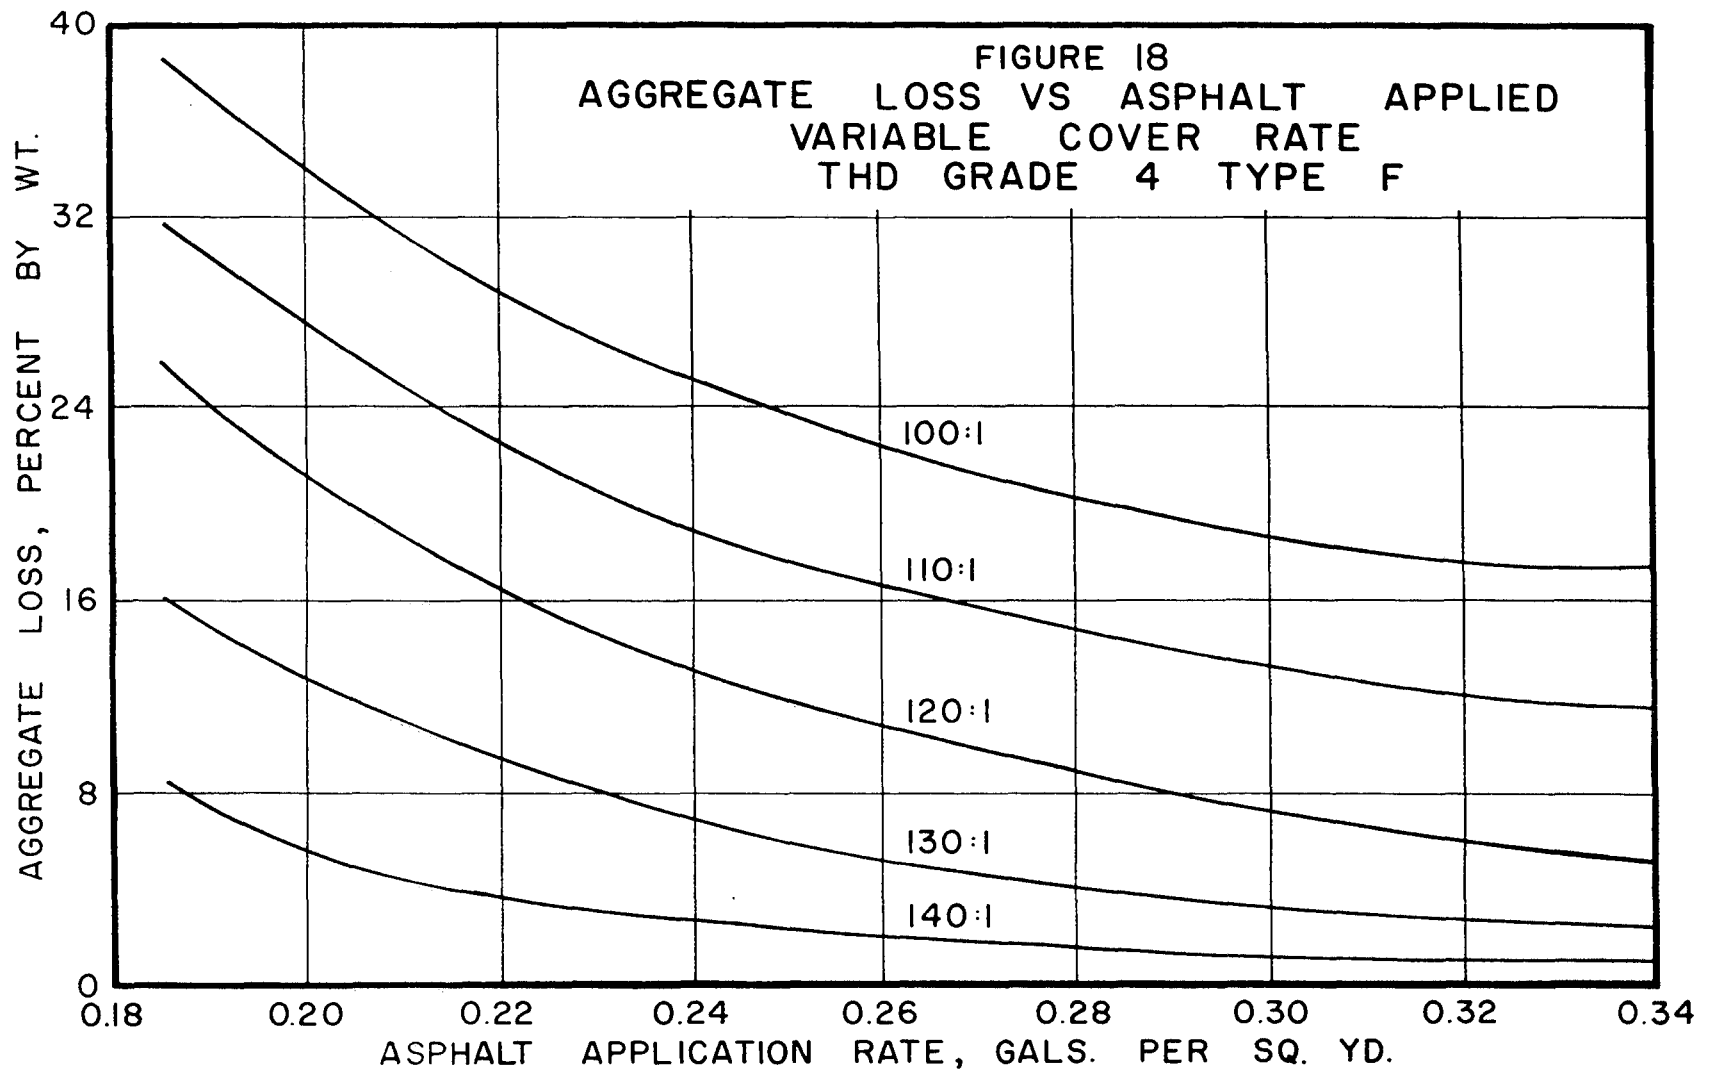
Due to the somewhat greater average particle size for Grade 3 material more stone (weight wise) is required to cover a given unit of surface area. It will be noted from Figure 17 that the rate of application of the coverstone is given on the individual curves as a ratio. This ratio is the number of square yards of surface covered by one cubic yard of aggregate. For example, the uppermost curve in Figure 17 is labeled 105:1 which simply

means that one cubic yard was applied at such a rate as to cover 105 square yards of surface. If it is assumed that this material weighs 43 pcf, then the cover rate would be eleven pounds per square yard. Taking this analysis a bit further, one might assume that asphalt cement is applied at the rate of 0.30 gallons per square yard and find from this curve that about 15 percent by weight of the stone would not be retained under the conditions of the test. On the other hand if the stone is applied at the rate of 120:1 then the loss would be four percent by weight. For the average Grade 3 material tested and for asphalt cement application rates in the range 0.28 to 0.32 the coverstone should be applied at the ratio of 120:1 or there about. Even then not all the stone is retained in the laboratory experiments; although, separate tests on the stone alone indicated that this amount would be retained.

For the segments of the curves to the left of asphalt application rates of about 0.23, the data were quite erratic. However, it is felt that the curves presented are logically located, and too, it is not likely that rates this low and lower would be used in seal coat work for this size and grading of aggregate. It is also to be noted that none of the curves has been extended beyond the 0.34 asphalt application rate. It should not be assumed that for rates above about 0.28 to 0.30 all the curves become rather flat. This is an indication that under the conditions of the test it was difficult to increase the coverstone retention rate by increasing the amount of asphalt applied. There is some small gain in the amount of stone retained as the stone application rate is increased but the excess that is applied is, for all practical purposes, wasted. This aspect of the problem will be further discussed in this report under field operations.

The reader is reminded that the above remarks are relegated to single shots of asphalt and single applications of coverstone with operations done under laboratory controlled conditions. It has, however, been found that with good equipment properly operated under adequate supervision similar results can be obtained in the field. Normally, seal coat work does not require more than a single application of asphalt and coverstone. Should it be considered necessary to place a double application, changes in the design, the details of which will not be given here, are necessary. Further, the trends indicated in the curves of Figures 17 and 18 do not apply to doubles in all their details.

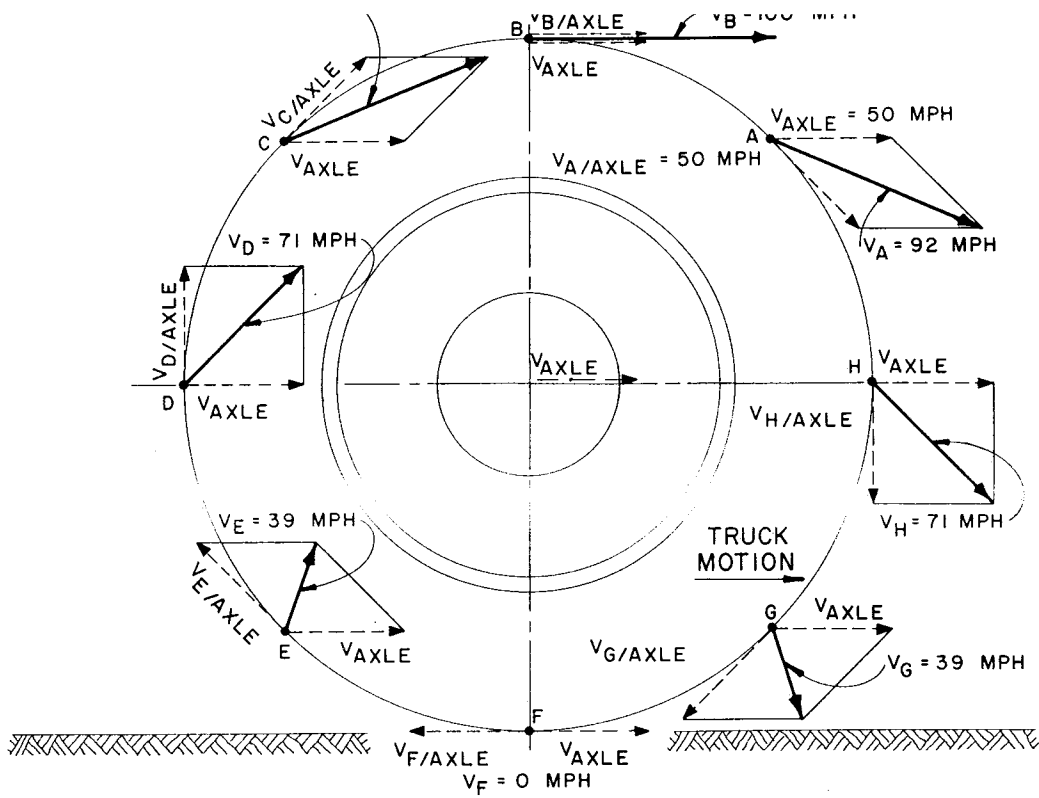
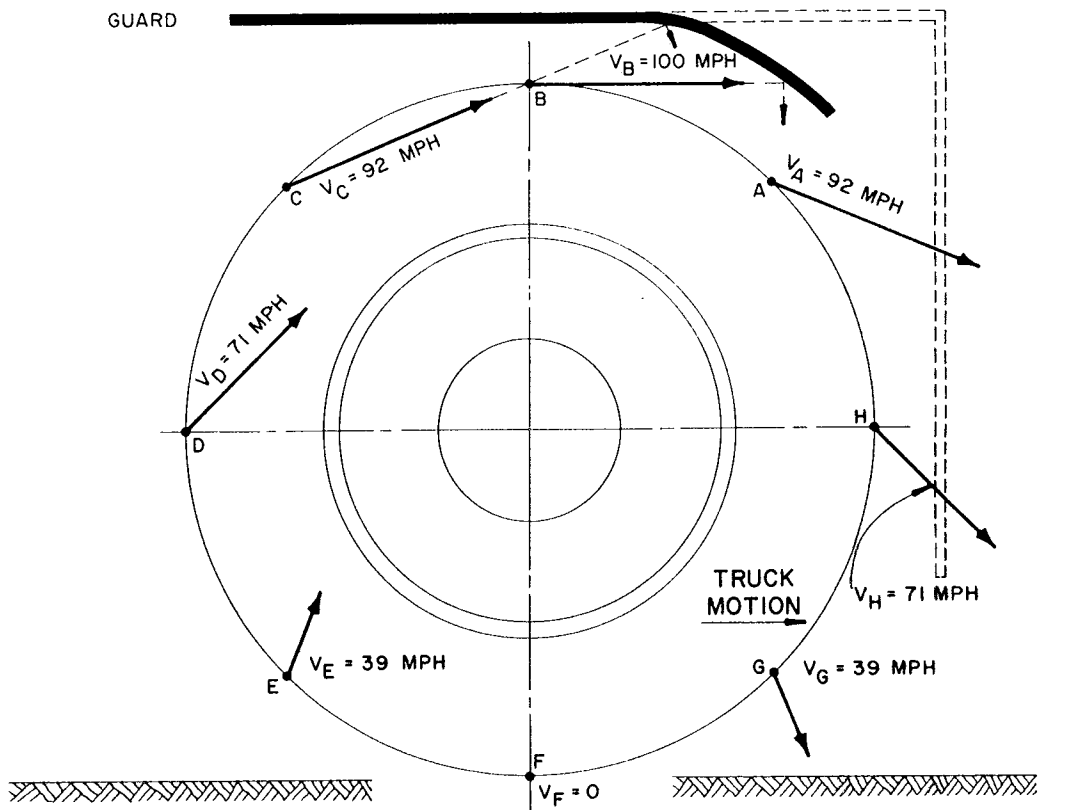
FIGURE 19 STONE MOTION AS IT LEAVES A TRUCK WHEEL

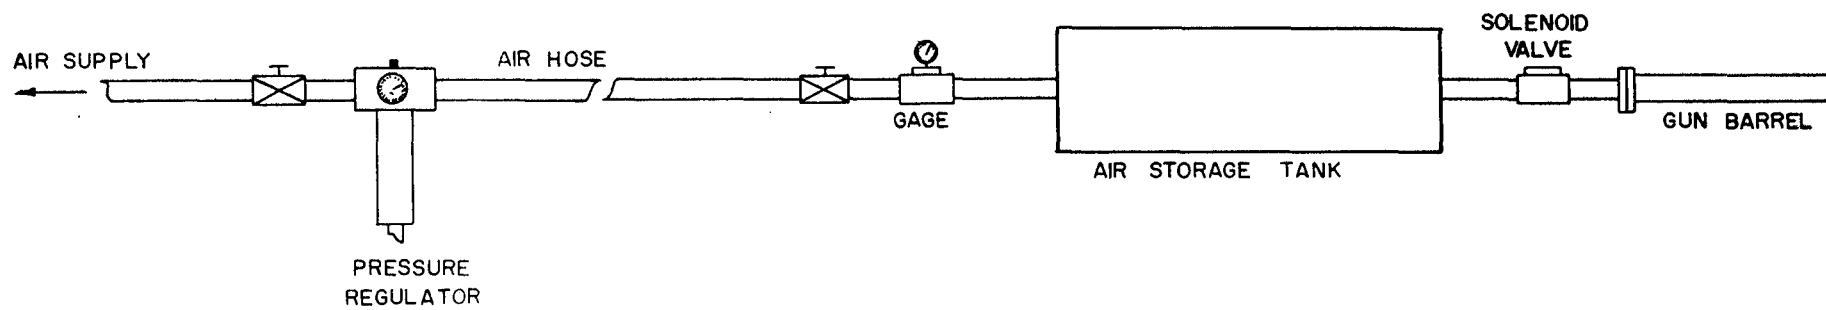
An air gun for shooting the stone was fabricated in the local shop and is shown as a line drawing in Figure 21. This gun is based on a design furnished by Monsanto Company (14). The unit is composed primarily of an air pressure regulator, an air storage tank made from a piece of 4-inch steel pipe, a solenoid valve and the gun barrel which is a 15-inch segment of 1-inch steel pipe. A photograph of the actual gun is shown in Figure 22. The gun is operated by inserting two felt or sponge rubber wads into the barrel and the projectile to be fired is brought in contact with the wadding. The selected air pressure is set on the air regulator and the storage tank is pressurized by opening the gate valve between the regulator and the gage. A shot is then fired by action of the solenoid valve with the aid of an electrical switch.

FIGURE 21 AIR GUN FOR SHOOTING STONES

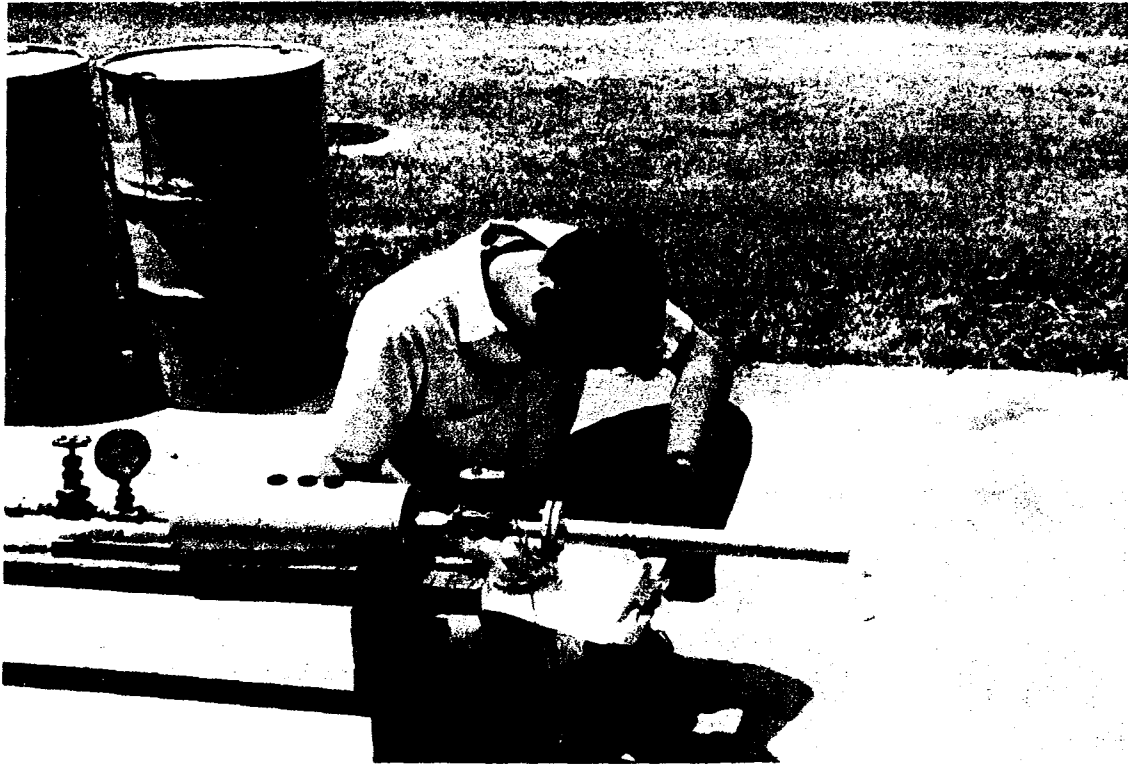
Figure 22. Air powered gun for shooting stones.

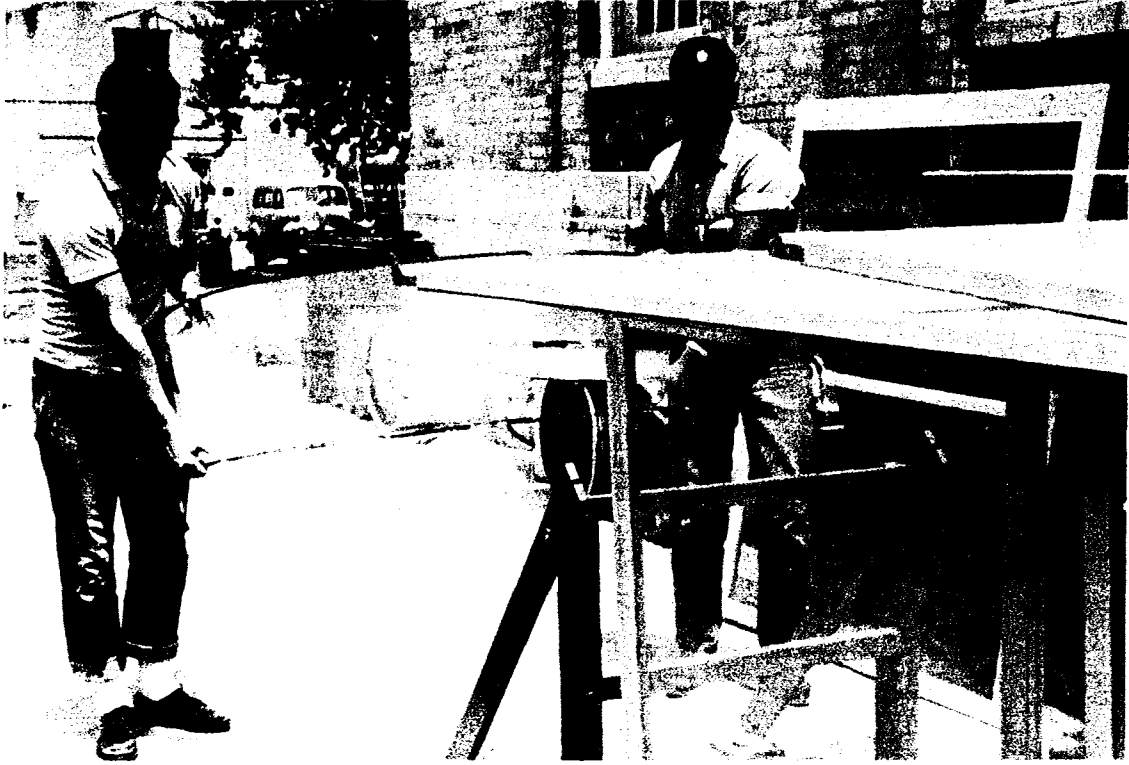
A windshield is being installed on an adjustable rack in Figure 23. These windshields were obtained from local auto glass repair shops and were already damaged in some way. Those that were used in the tests were carefully selected and positioned in testing assembly so damaged areas would not be in the impact area. The gun-muzzle-to-glass distance was set at ten feet and a fly screen enclosure as shown in Figure 25 was built to catch broken stone and glass. This served as a safety precaution and made it possible to recover and examine broken stone. The gun operator was required to wear a face guard or fire the gun while facing away from the windshield. Both safety laminated sheet and safety (tempered) plate glass were tested. The safety plate glass used is sold under the trade number of Herculite (15).

Figure 23. Windshield being placed into position for "flying stone" study.

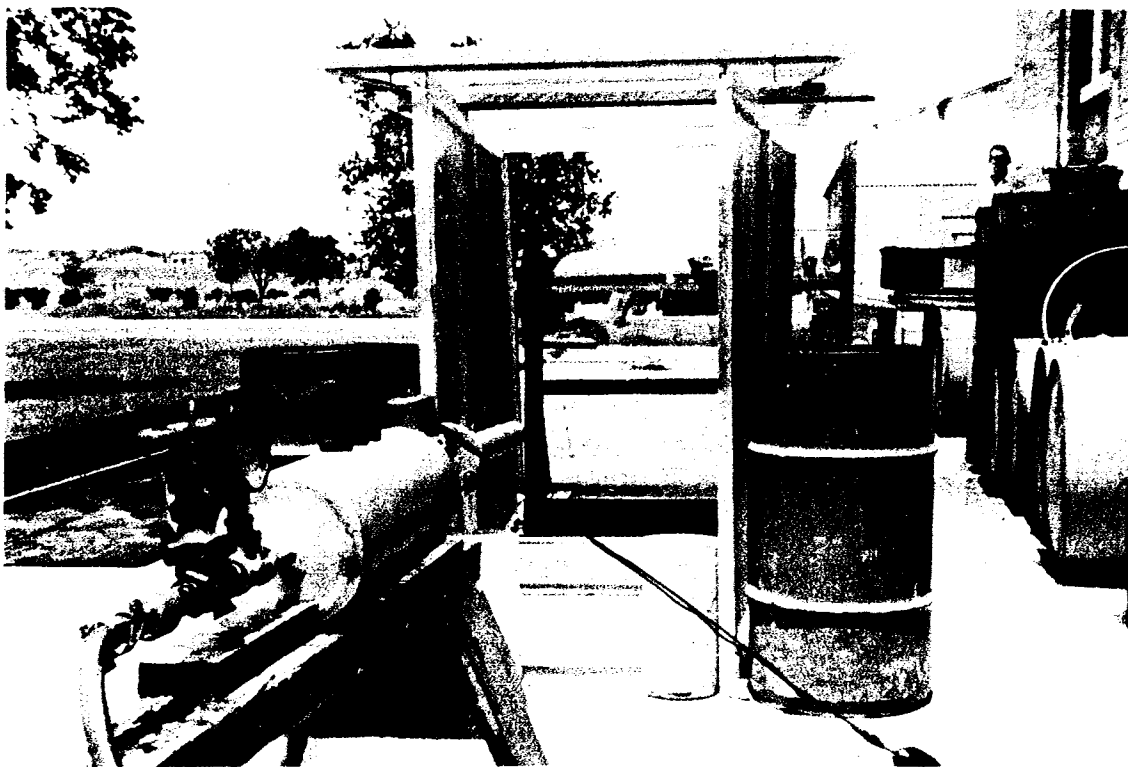
Figure 24. Windshield (target) in screened tunnel from gunner's view.

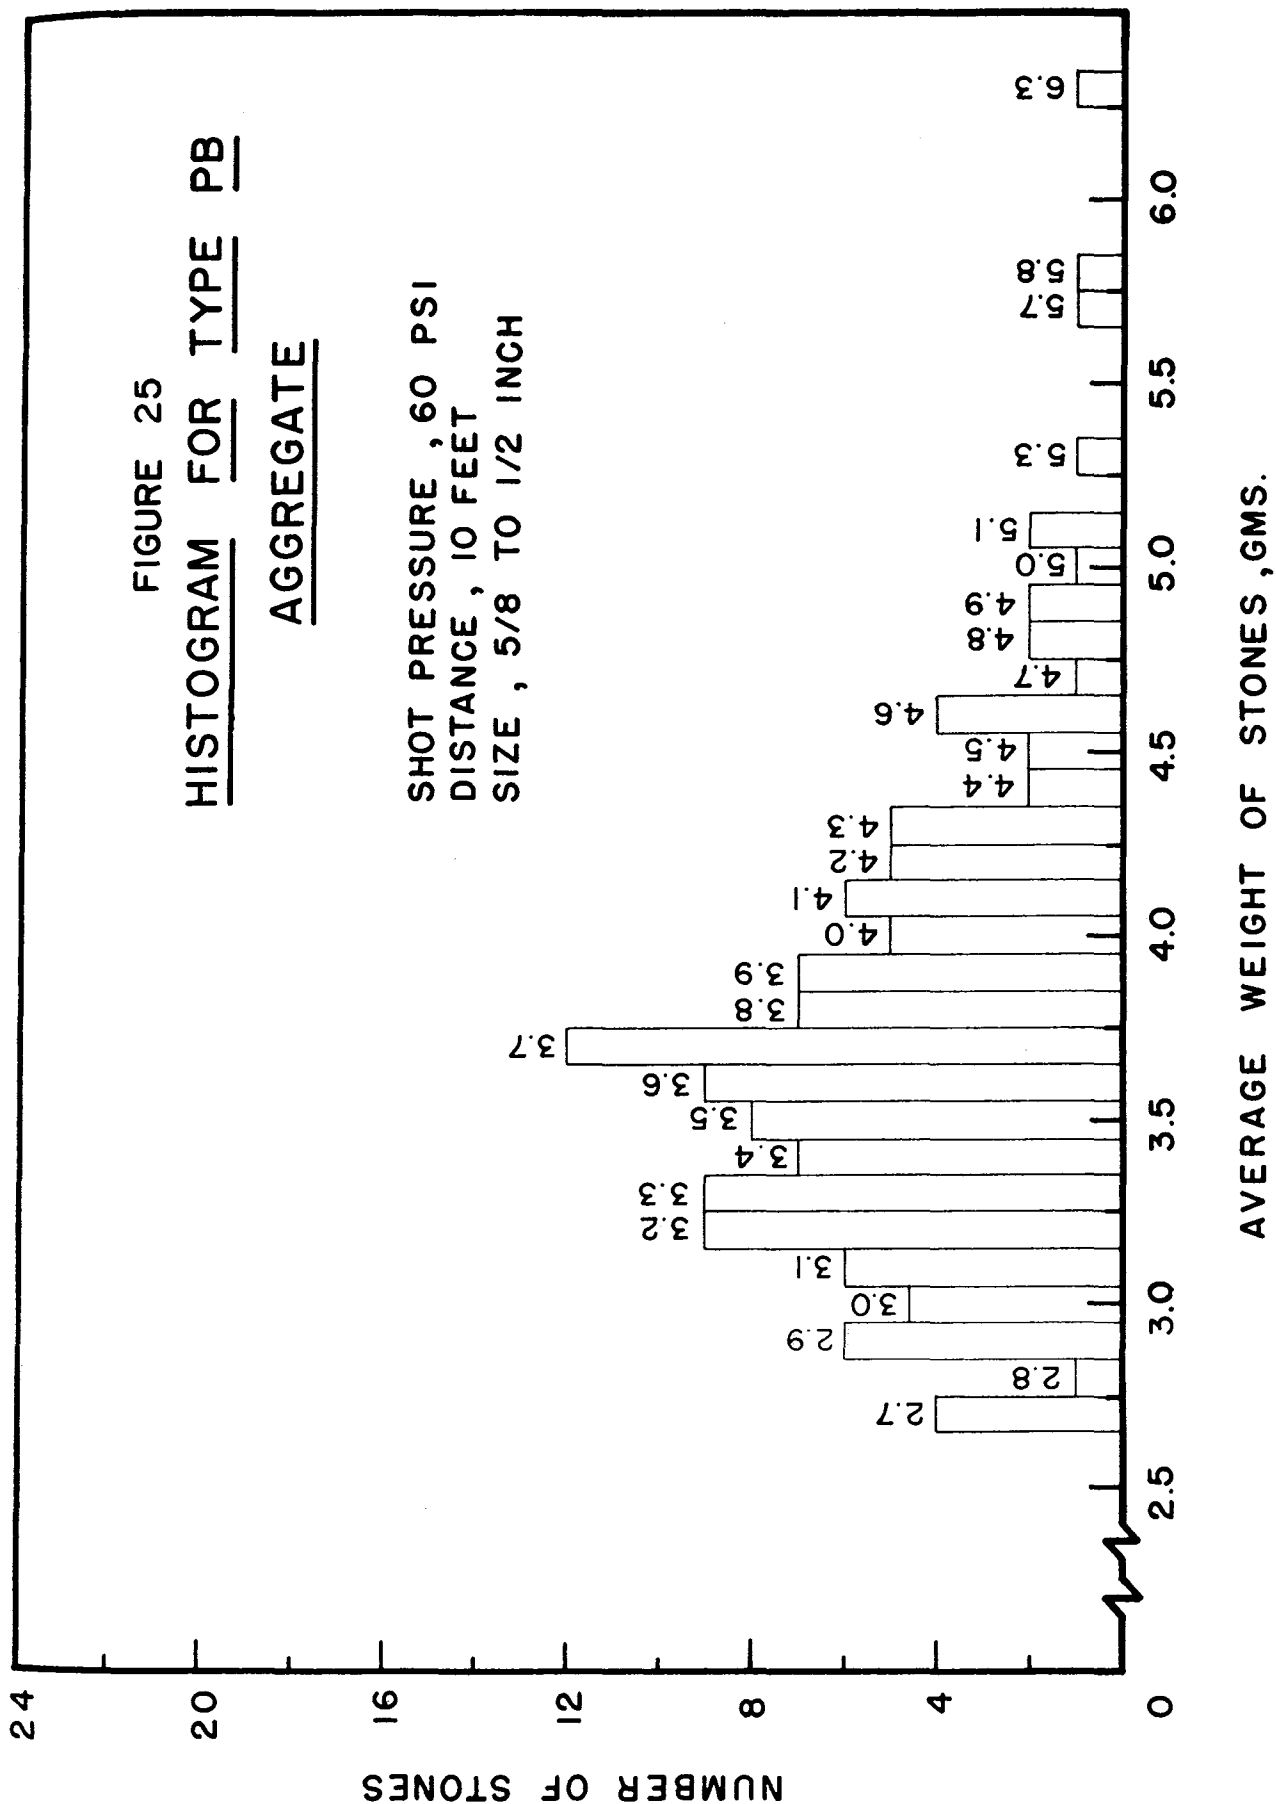
FIGURE 25
HISTOGRAM FOR TYPE PB
AGGREGATE

SHOT PRESSURE, 60 PSI
 DISTANCE, 10 FEET
 SIZE, 5/8 TO 1/2 INCH

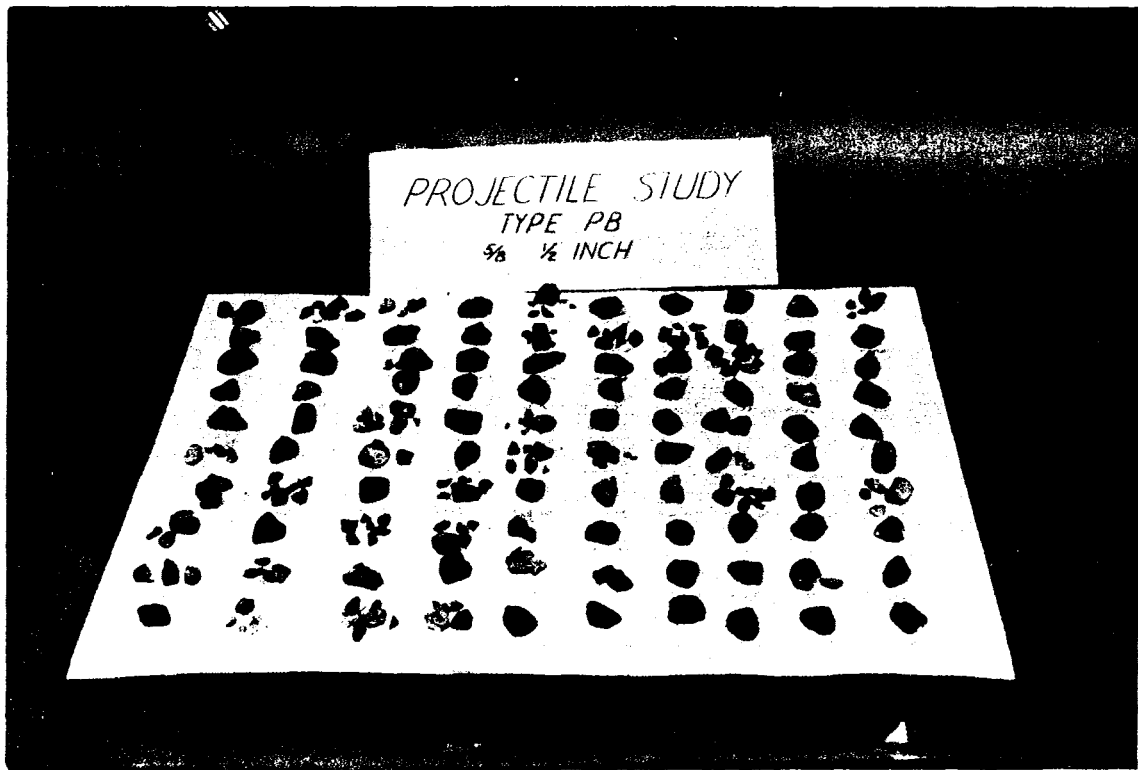
Figure 27. Type PB family of 5/8 to 1/2 inch stones after shooting.

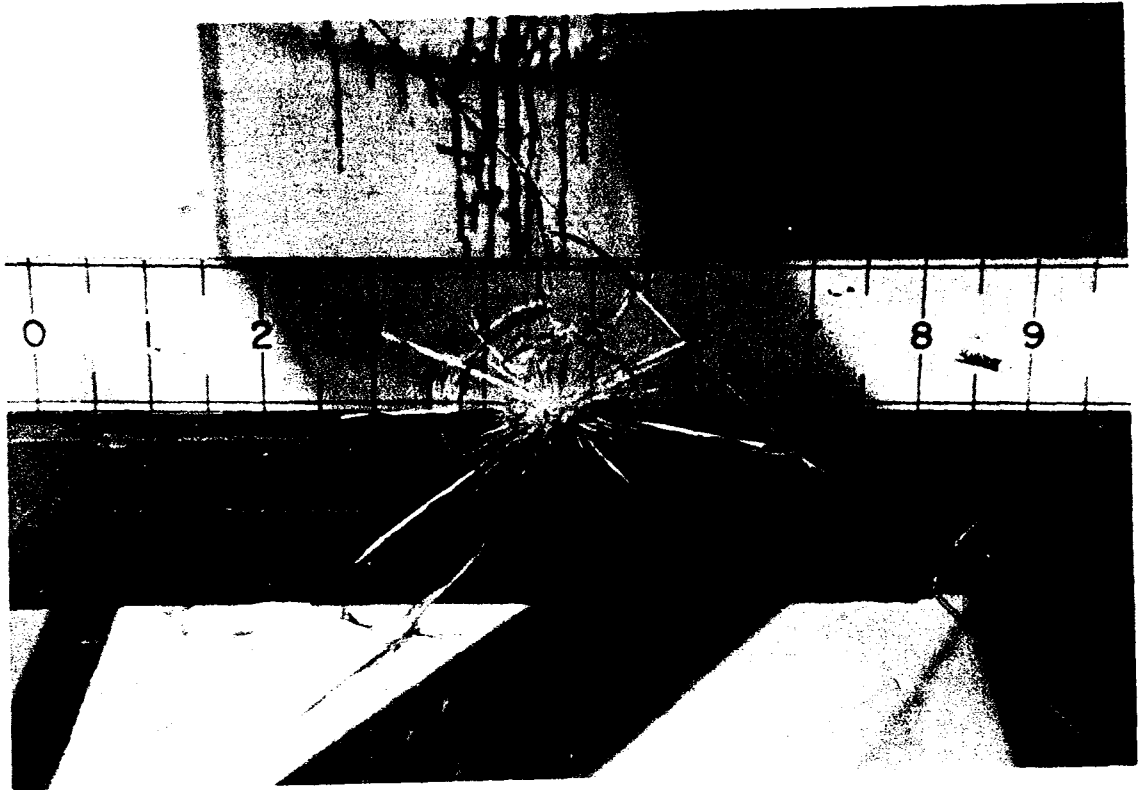
Figure 28. Most severe windshield damage caused by type F material.

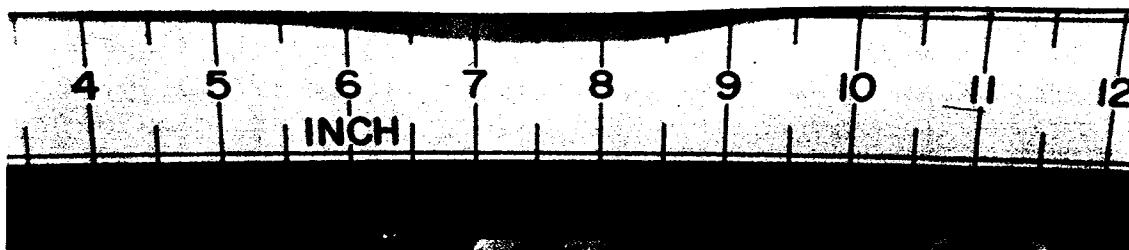
The most common result observed was similar to that shown in Figure 29. Here the stone has been "powdered" on impact and some of the shattered material would usually remain on the glass. In this particular photograph, the scale and sheet of white paper are behind the glass. Also included within the bounds of the picture are numerous invisible points of stone impact. The glass was cleaned by scrapping it with a razor blade and washing it with a glass cleaning liquid after each shot. Usually no visible evidence of the shot remained after the cleaning operation.

Figure 29. Typical "powder burn" of lightweight aggregate on impact into laminated glass windshield.

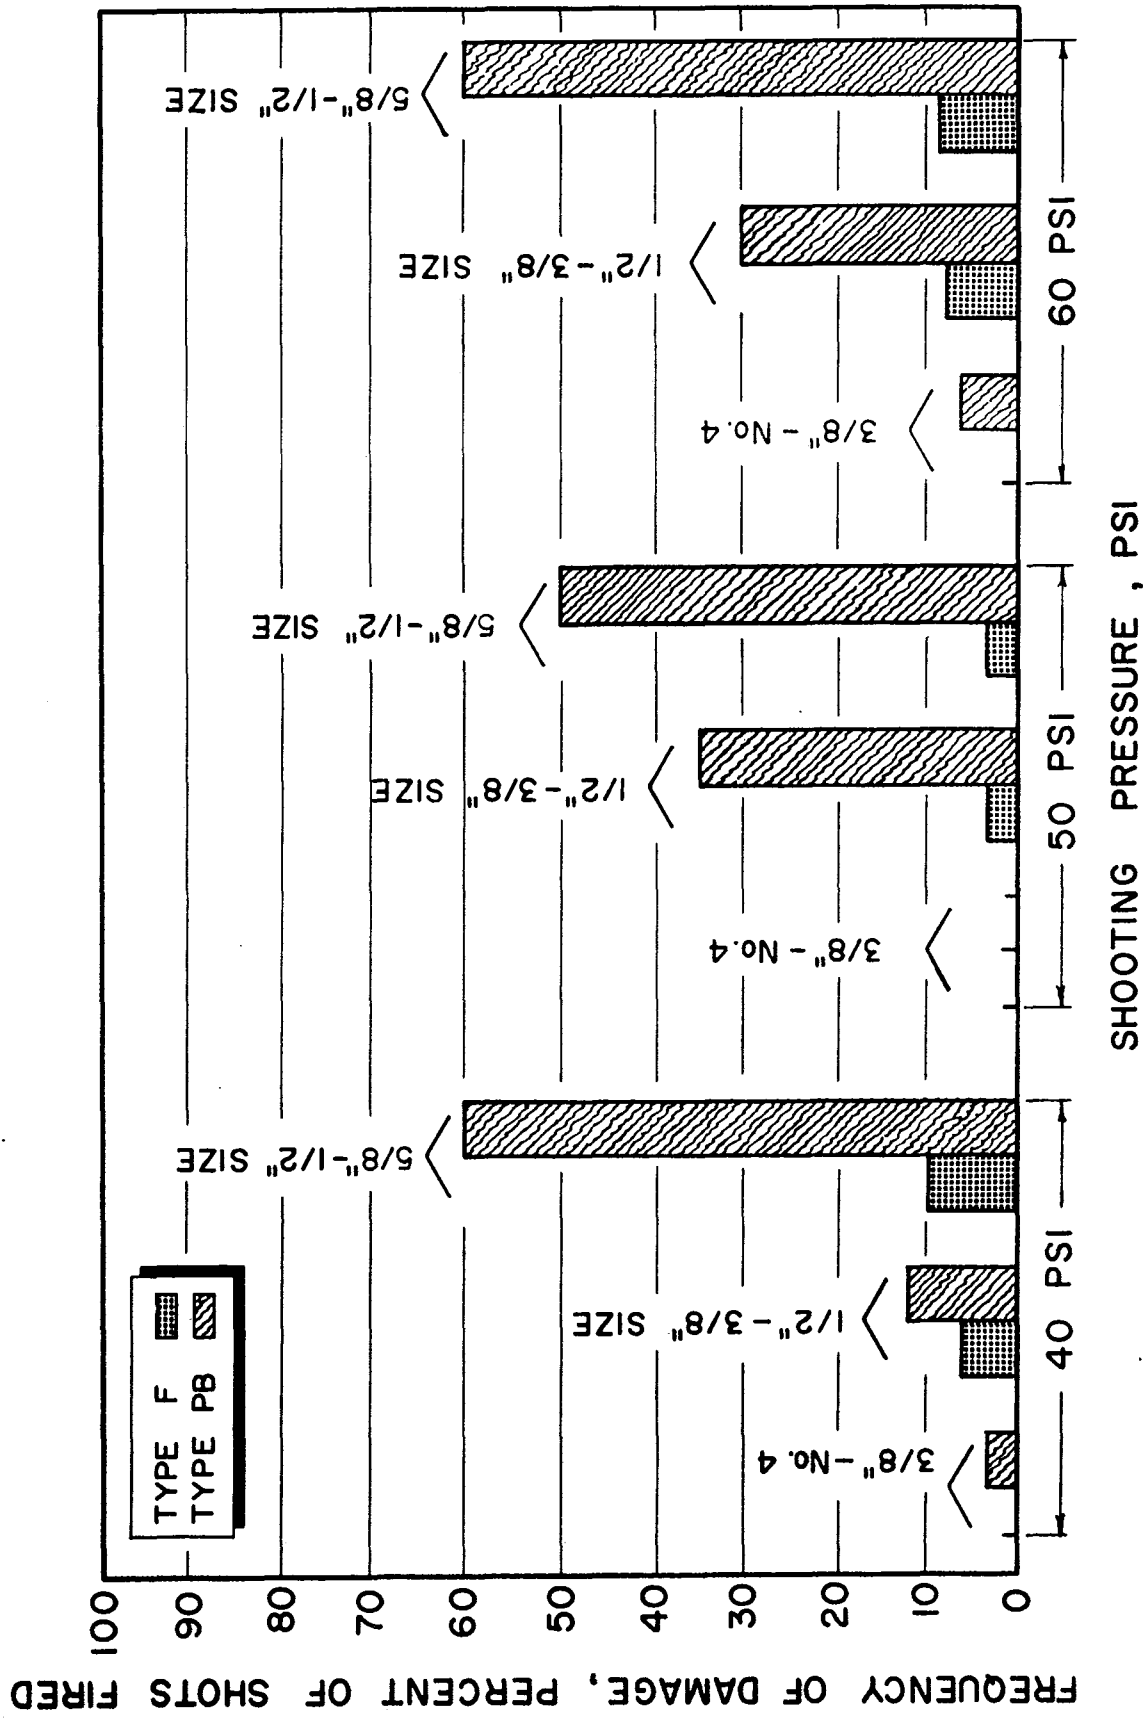
FIGURE 32 COMPARATIVE DAMAGE TO WINDSHIELDS FOR TYPE F AND TYPE PB AGGREGATE SHOT AT DIFFERENT PRESSURES

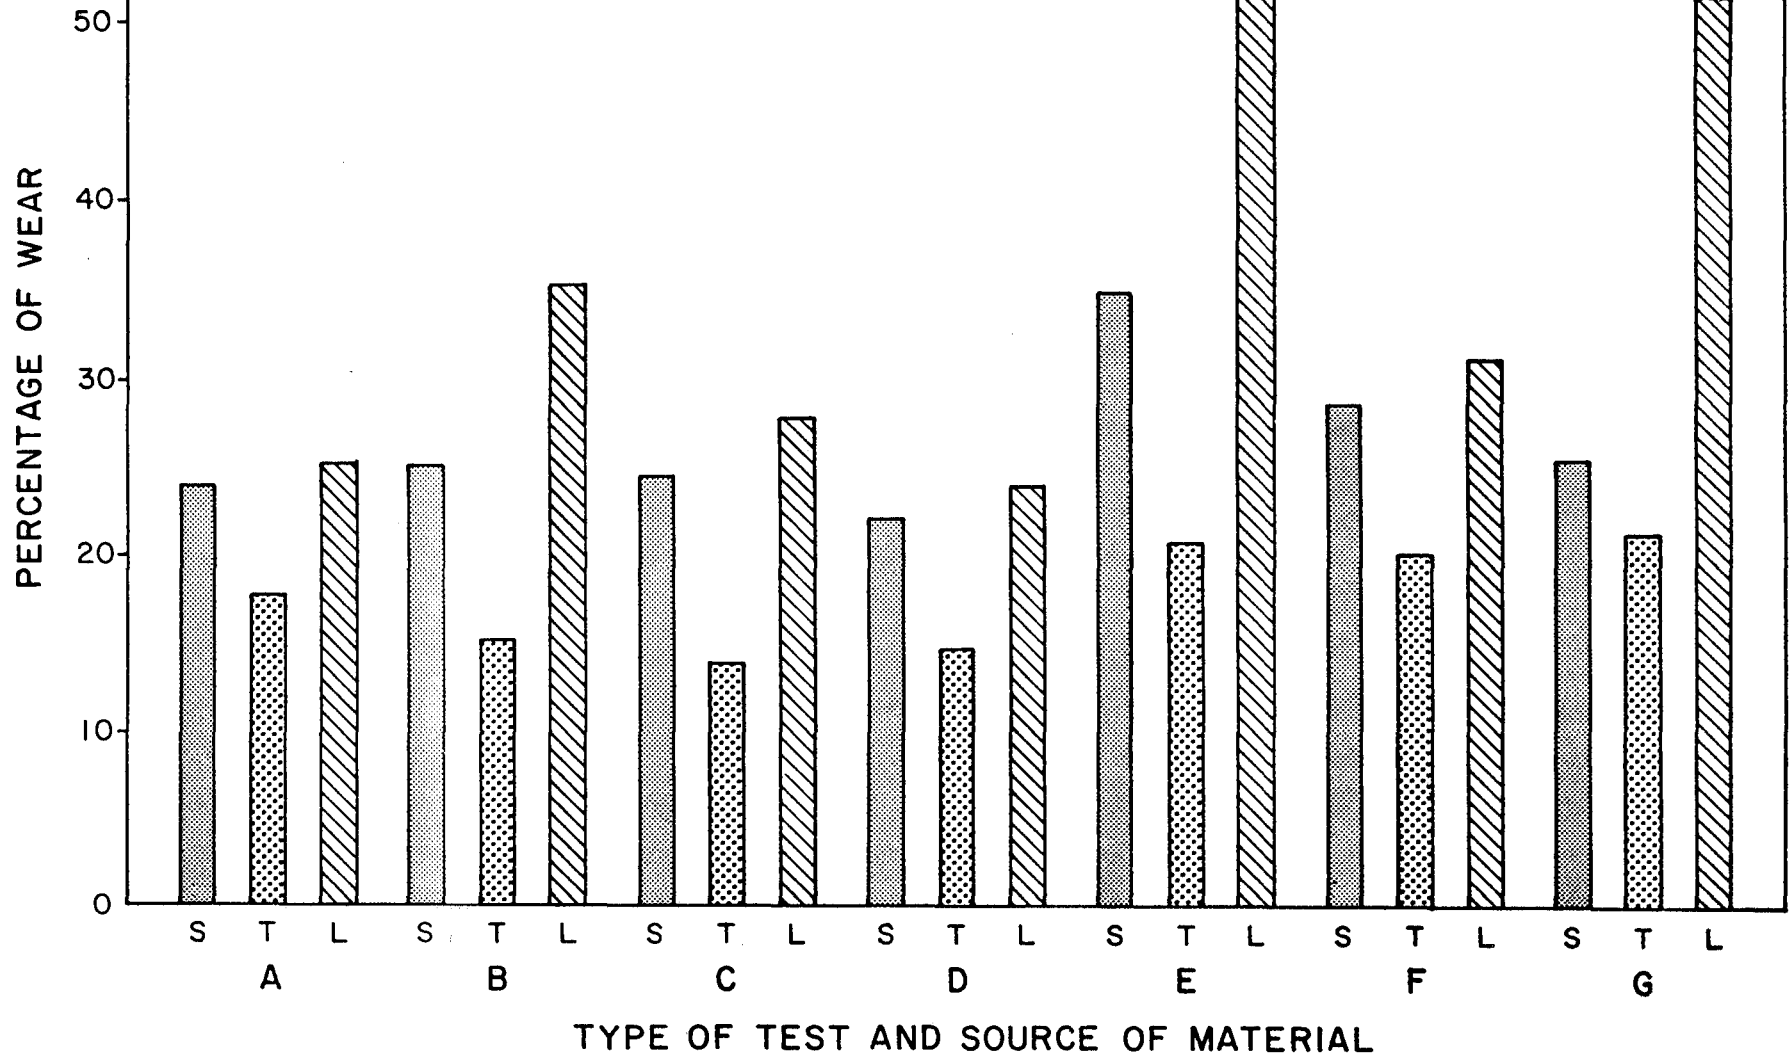
**FIGURE 36 COMPARATIVE LABORATORY ABRASION VALUES FOR
LIGHTWEIGHT AGGREGATES FROM DIFFERENT SOURCES
ASTM C GRADING**

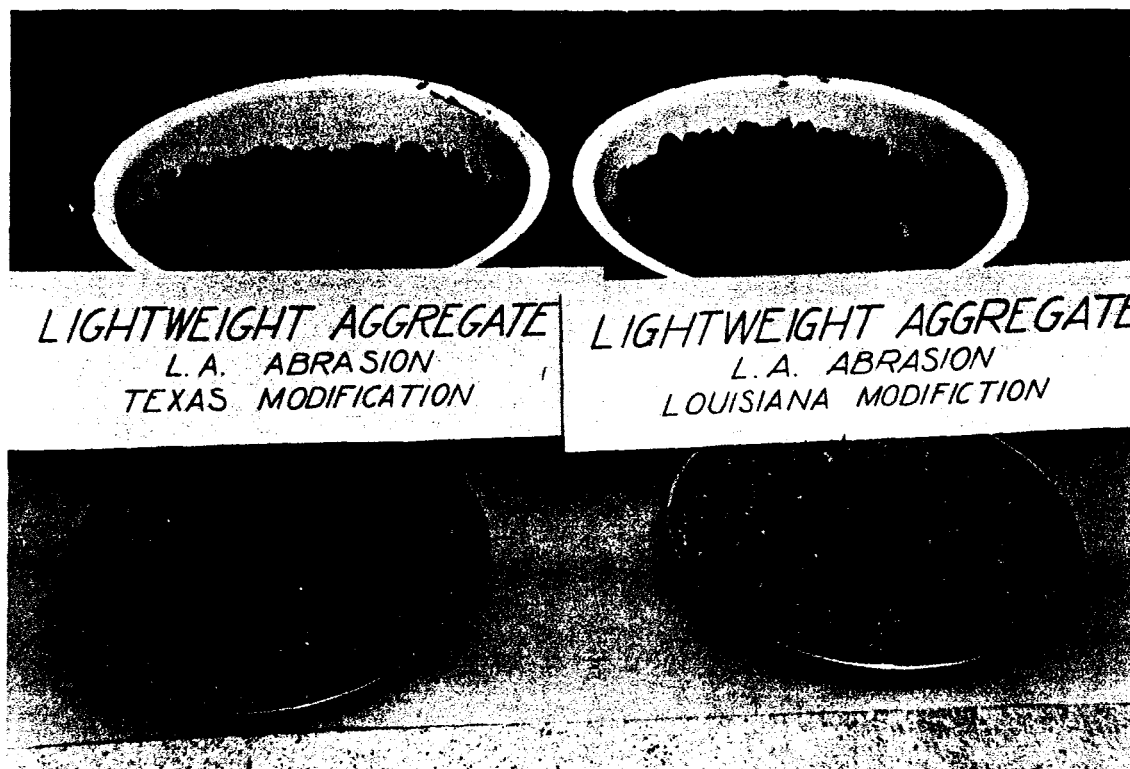
FIGURE 37 Type F materials after testing by Texas and Louisiana methods for L. A. wear.

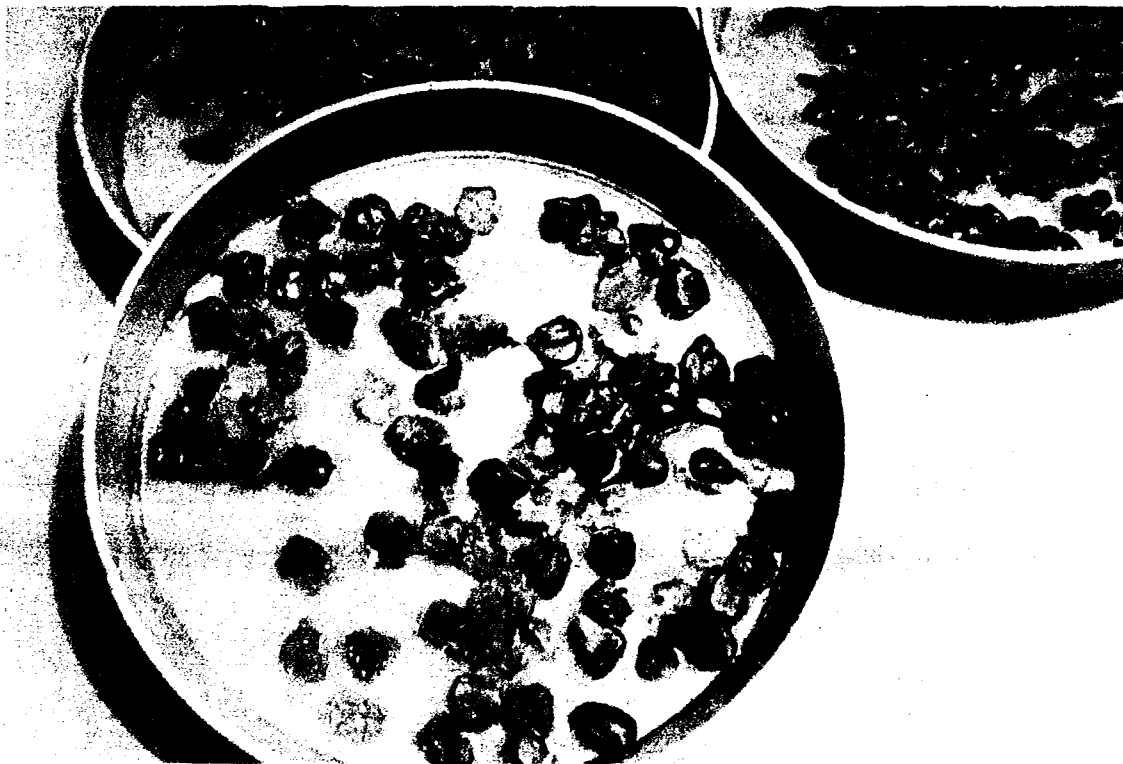
FIGURE 38 Type F material after freezing in water.

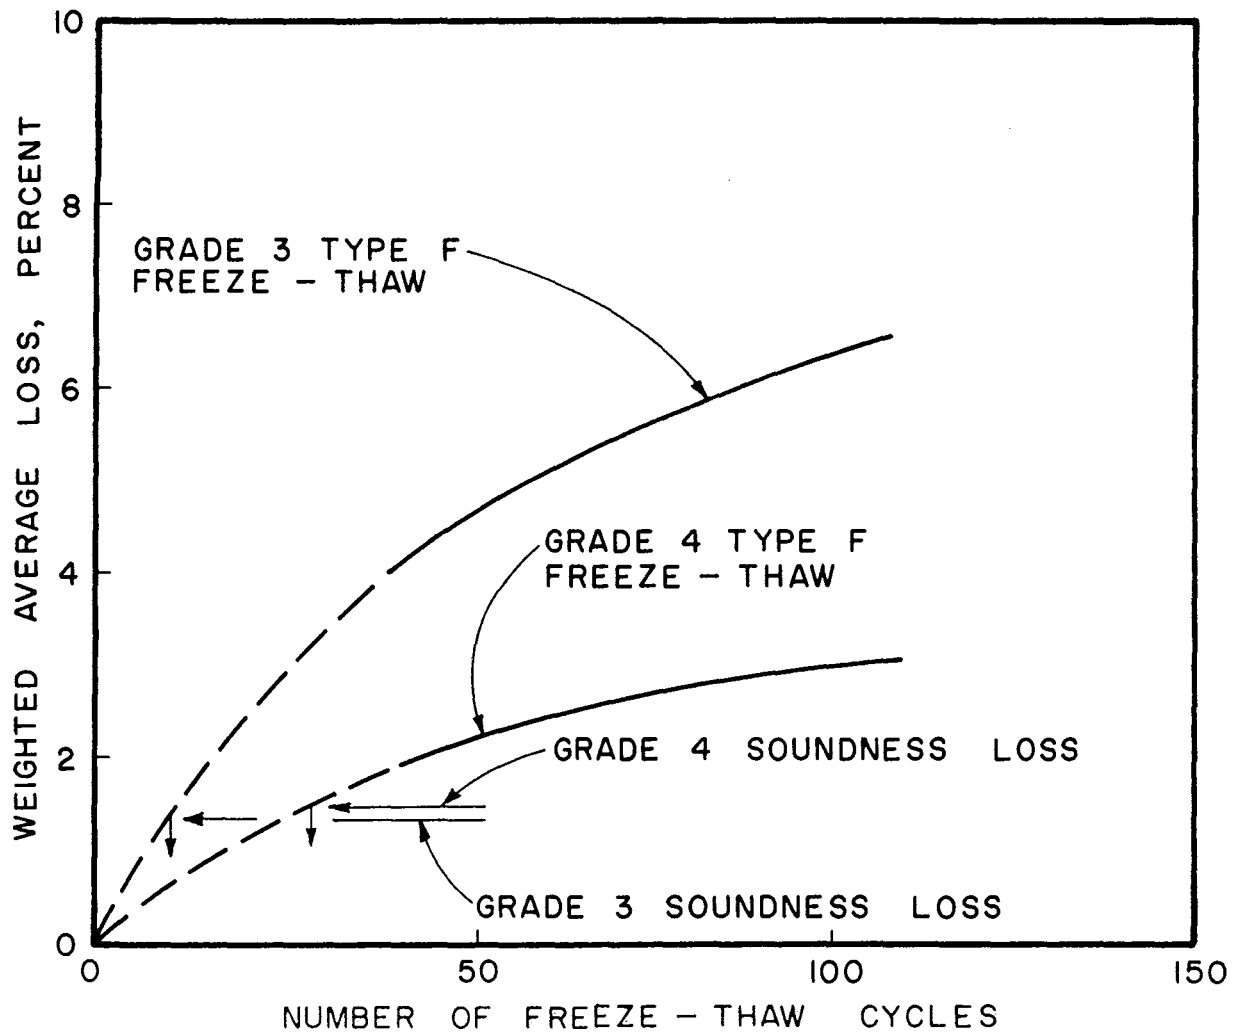
FIGURE 39 COMPARATIVE FREEZE-THAW AND SOUNDNESS LOSSES FOR AGGREGATE "A"

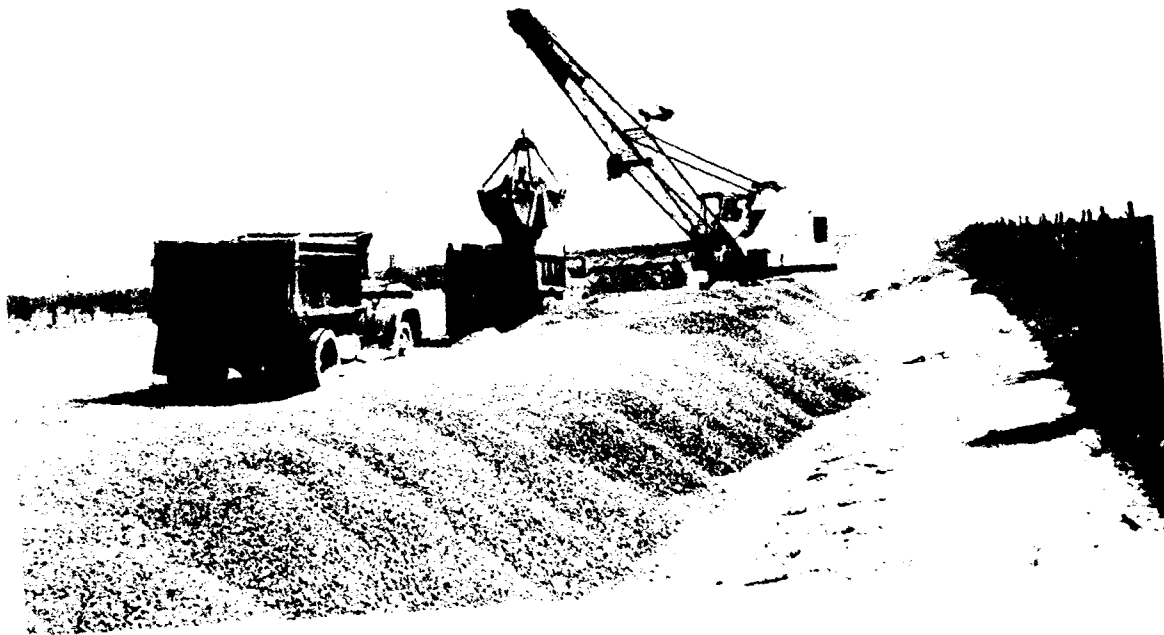
FIGURE 50 Stockpile and loading operation of Type F material.
