A LABORATORY AND FIELD EVALUATION OF LIGHTWEIGHT
AGGREGATES AS COVERSTONE FOR SEAL COATS
AND SURFACE TREATMENTS

Research Report Number 51-2

Use of Lightweight Aggregates
Research Project Number 2-14-63-51

TEXAS TRANSPORTATION INSTITUTE
Texas A&M University
College Station, Texas

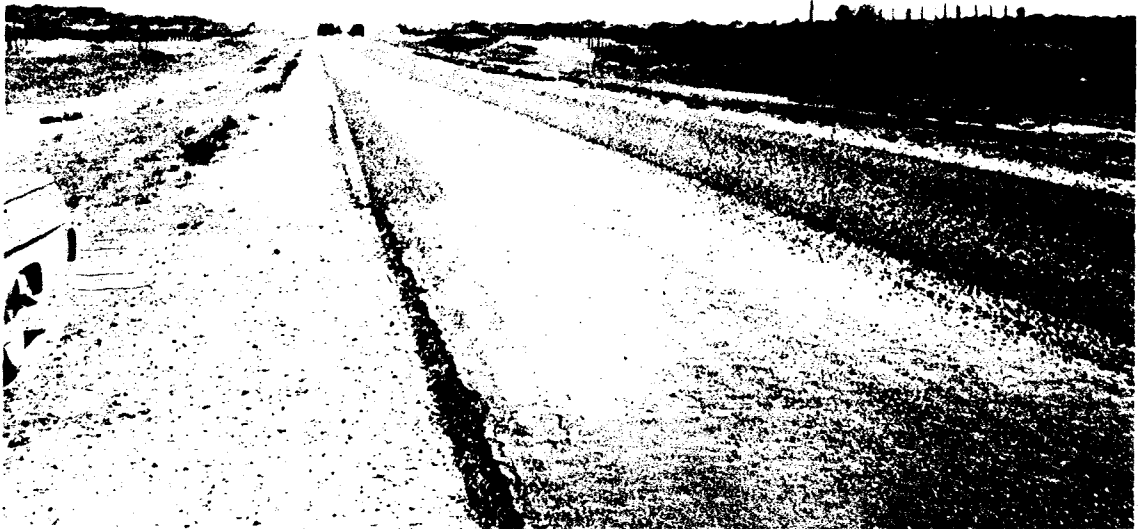
FIGURE 52 Patches create variations in asphalt demand of surface.

Two items of interest appear in Figure 52 where the asphalt cement has been applied and half of the road has been covered with Type F material. These items are the newly patched area at the left edge of the pavement and the striations in the asphalted surface. Striations are caused by poor distribution of asphalt and probably in this case they occurred in a previous application creating a difference in the asphalt absorption demand across the surface. Reasonable proof of this is demonstrated by the dull appearance of the patched area. Here, due to lack of densification, the asphalt demand was high and unsatisfied. As previously mentioned this is a variable difficult to take into practical consideration. Another picture in this series is Figure 53. Here a steel roller is used to "seat the stone." Laboratory and field data strongly indicate that the steel flat wheel roller should not be used on Type F aggregate. Crushing of the aggregate was excessive here in this experimental strip. One year after FM 267 was constructed the pictures appearing as Figure 54 and 55 were taken. This was not in a designated experimental section but represents regular construction control. The excellent appearance of the surface is evident and apparently is also pleasing to the horned toad that has stopped on the highly contrasting white center stripe.

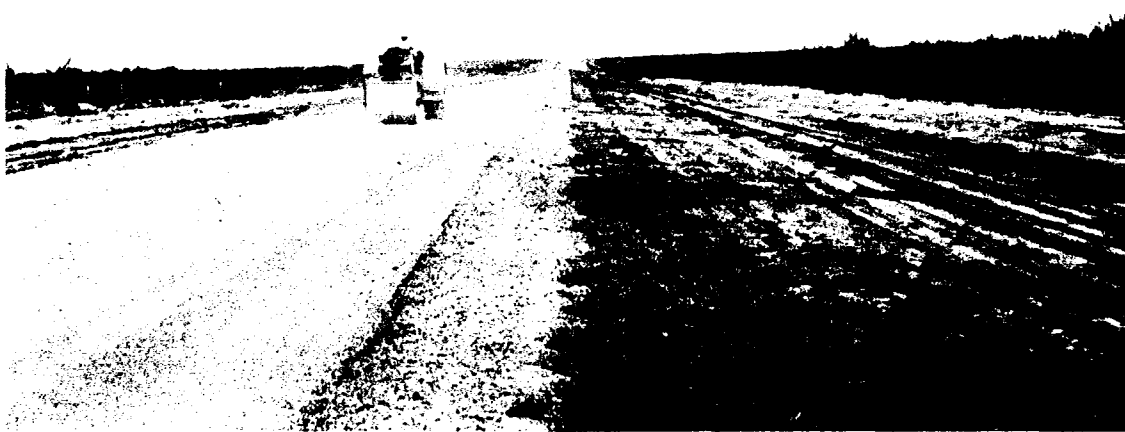
FIGURE 53 Experimental section proves that the use of steel flat wheel roller is not advisable.

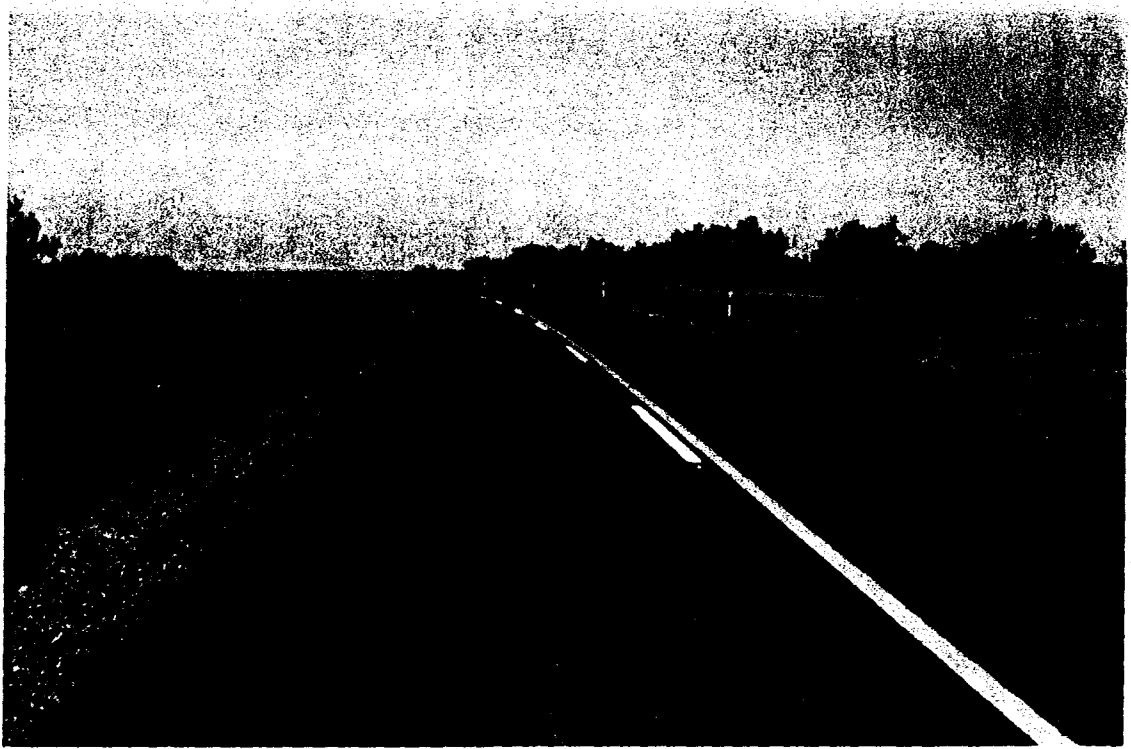
FIGURE 54 Type F material after one year of light traffic.

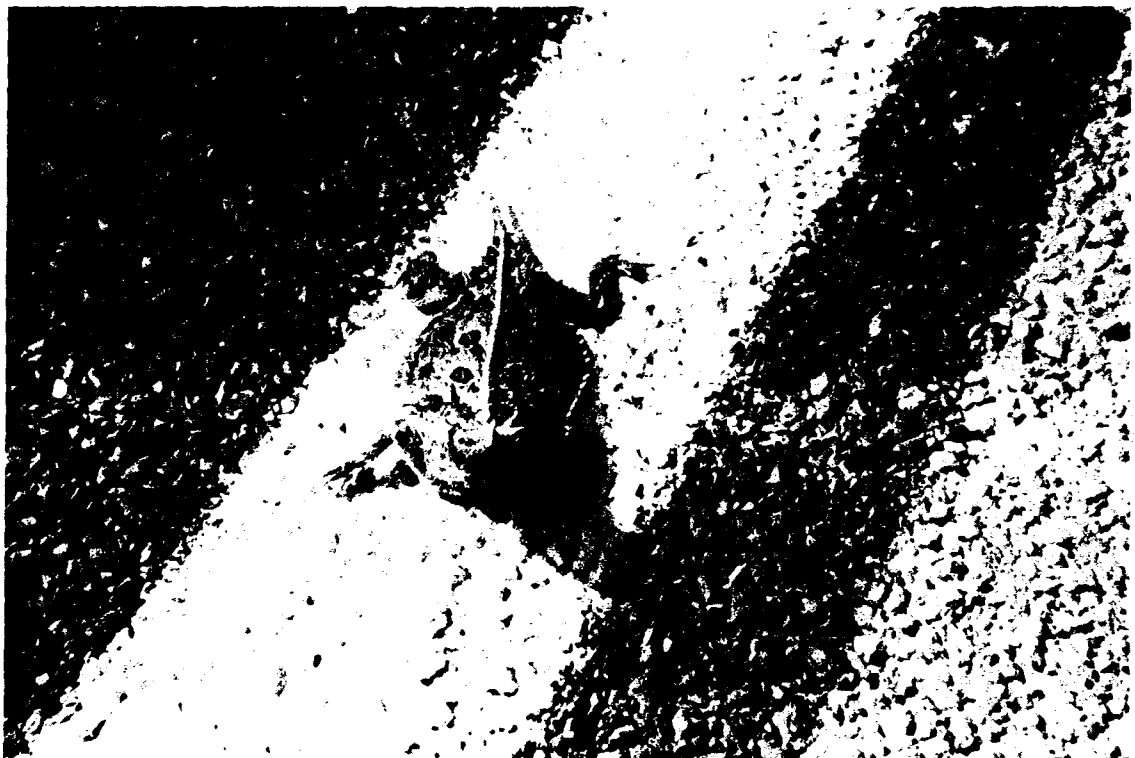
FIGURE 55 Type F material presents a pleasing contrast for center stripe.

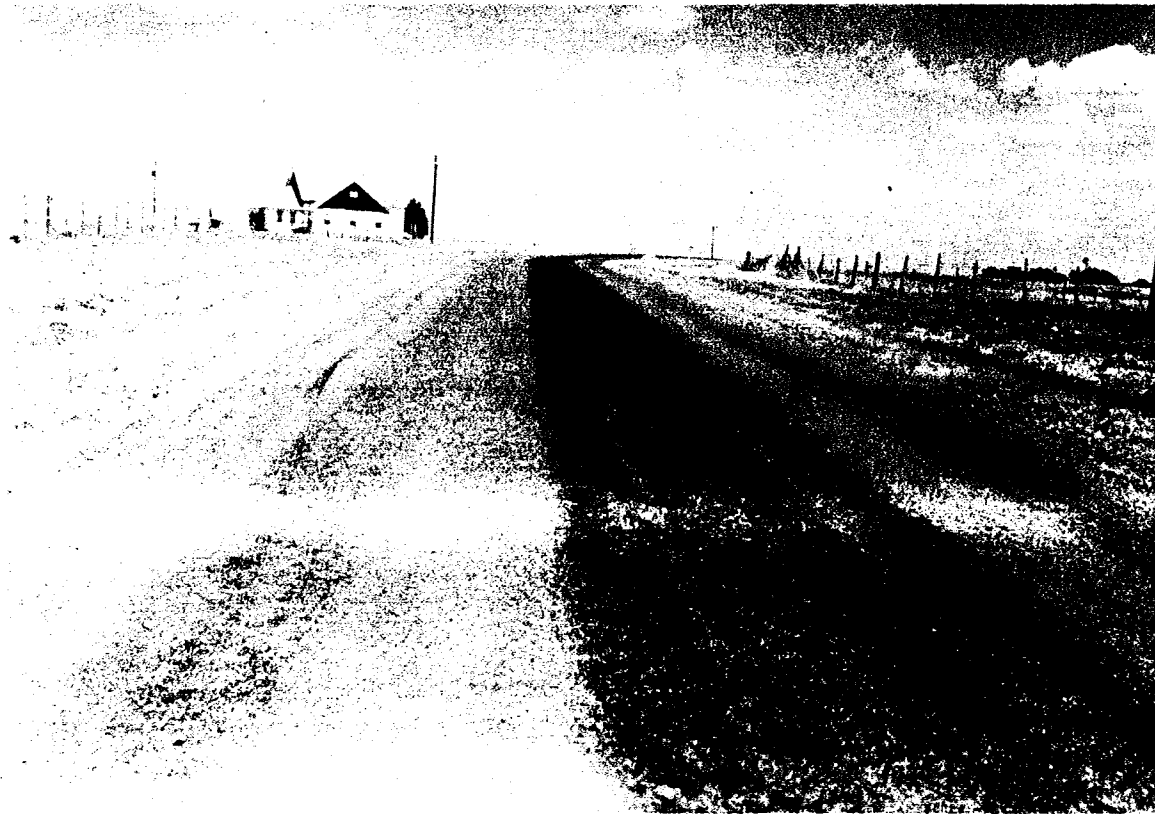
FIGURE 56 No center stripe concentrates traffic in center third of FM 1192. (Photo by Gustafson.)

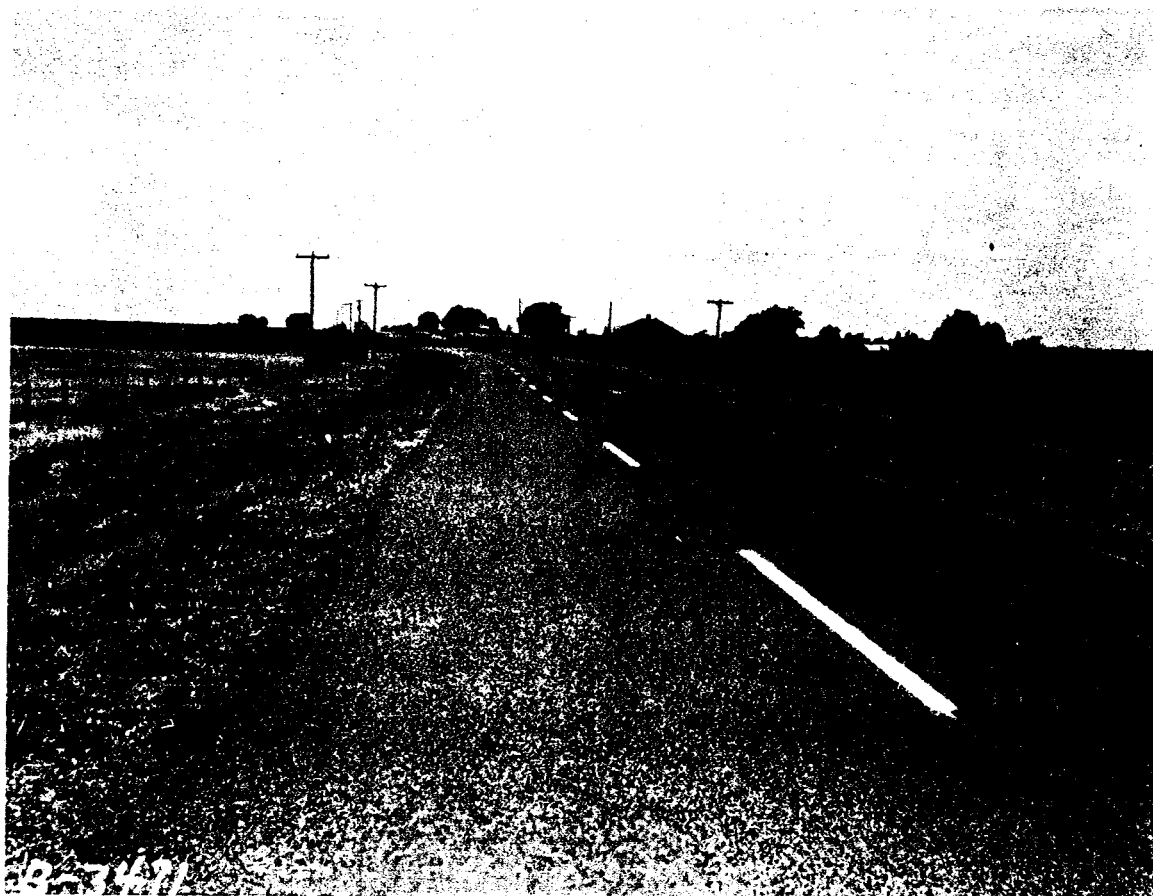
FIGURE 58 Typical farm-to-market road surfaced with Type F material. (Photo by Gustafson.)

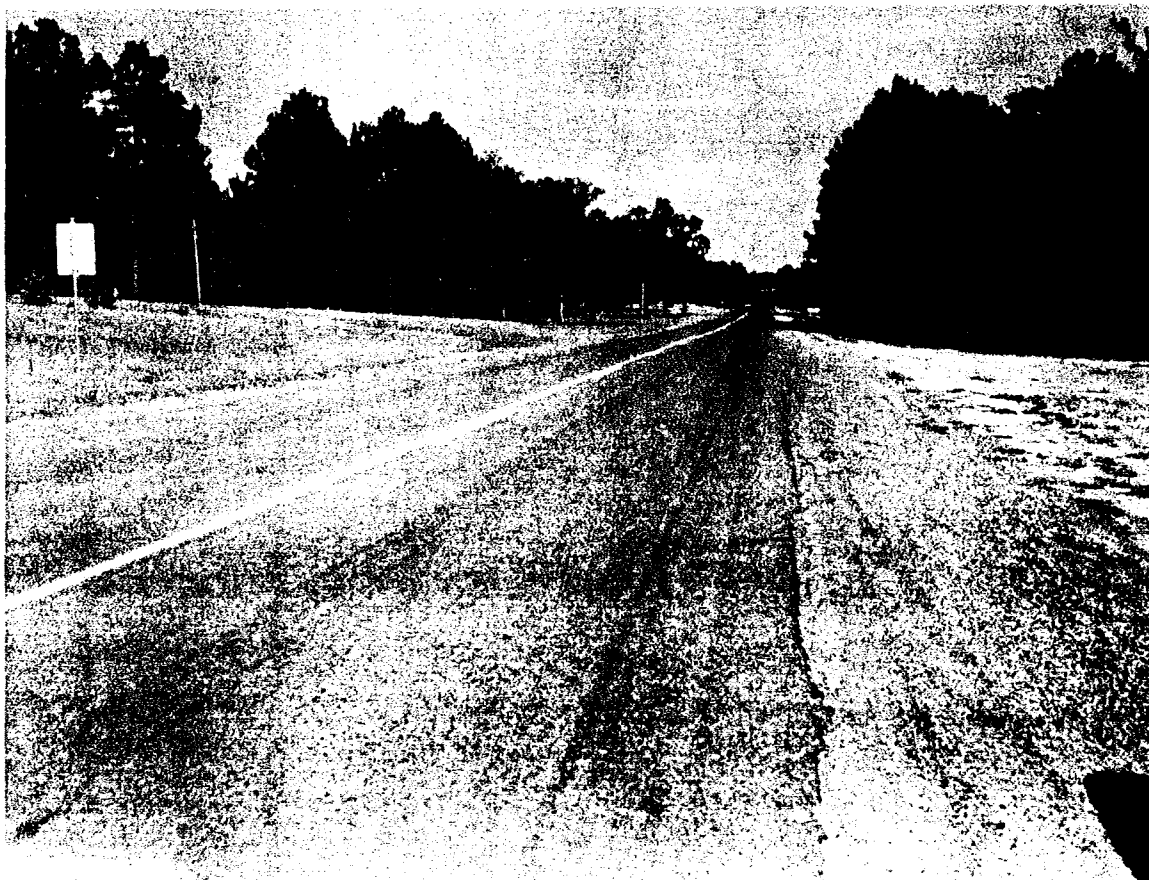
FIGURE 60 Type F cover aggregate in service three months,
1500 vpd, U S 190. (Photo by Gustafson.)

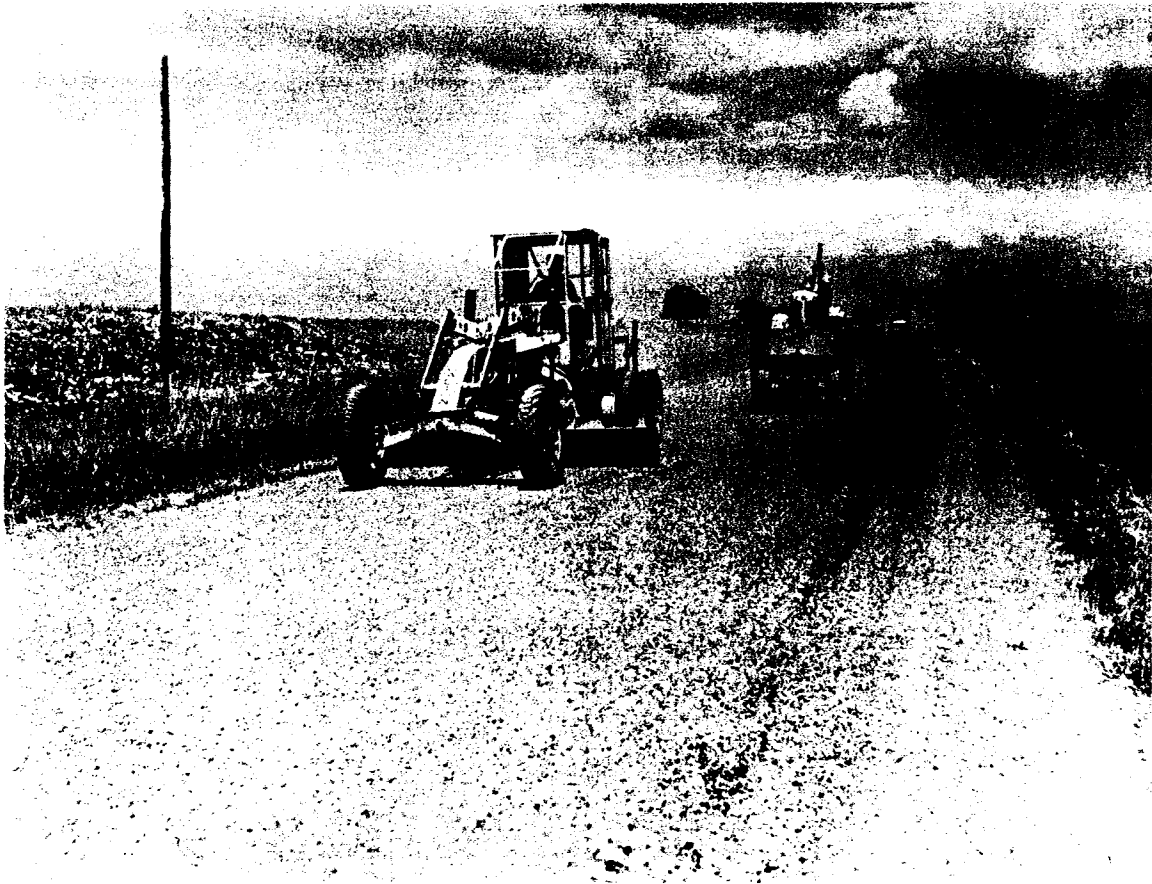
FIGURE 61 Blade broom successfully used on Type F coverstone. (Photo by Gustafson.)

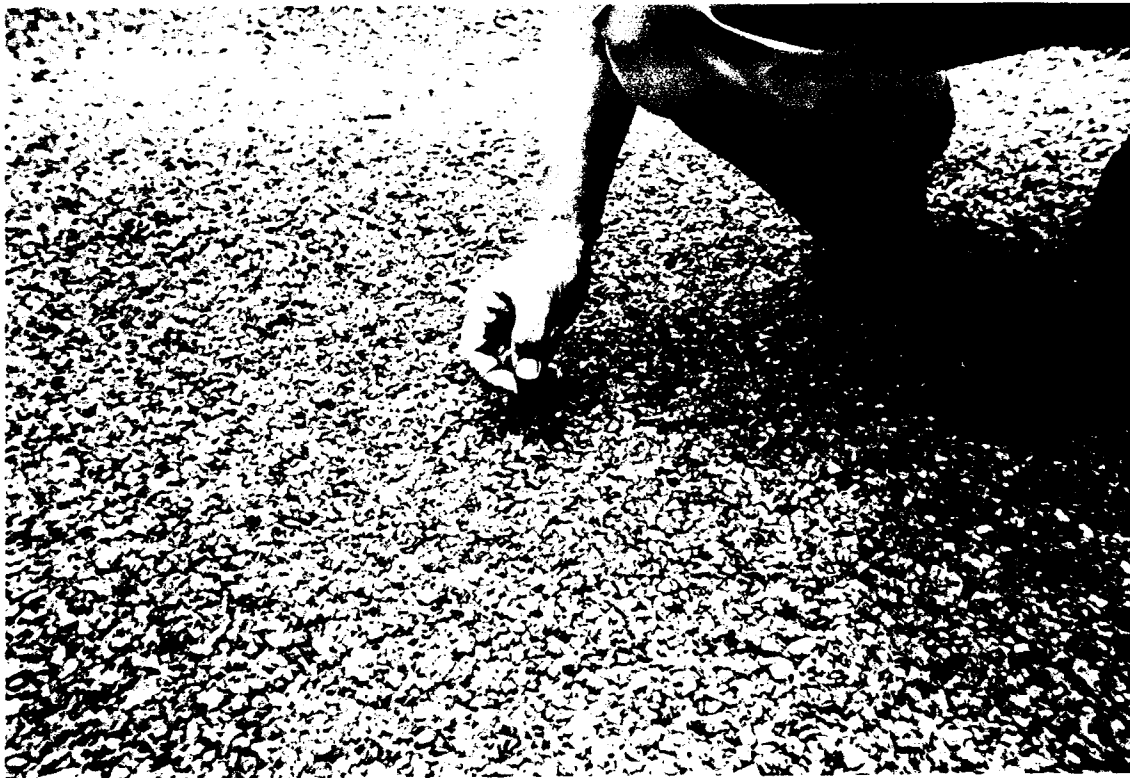
FIGURE 62 Adhesion of asphalt to Type F material is very good.

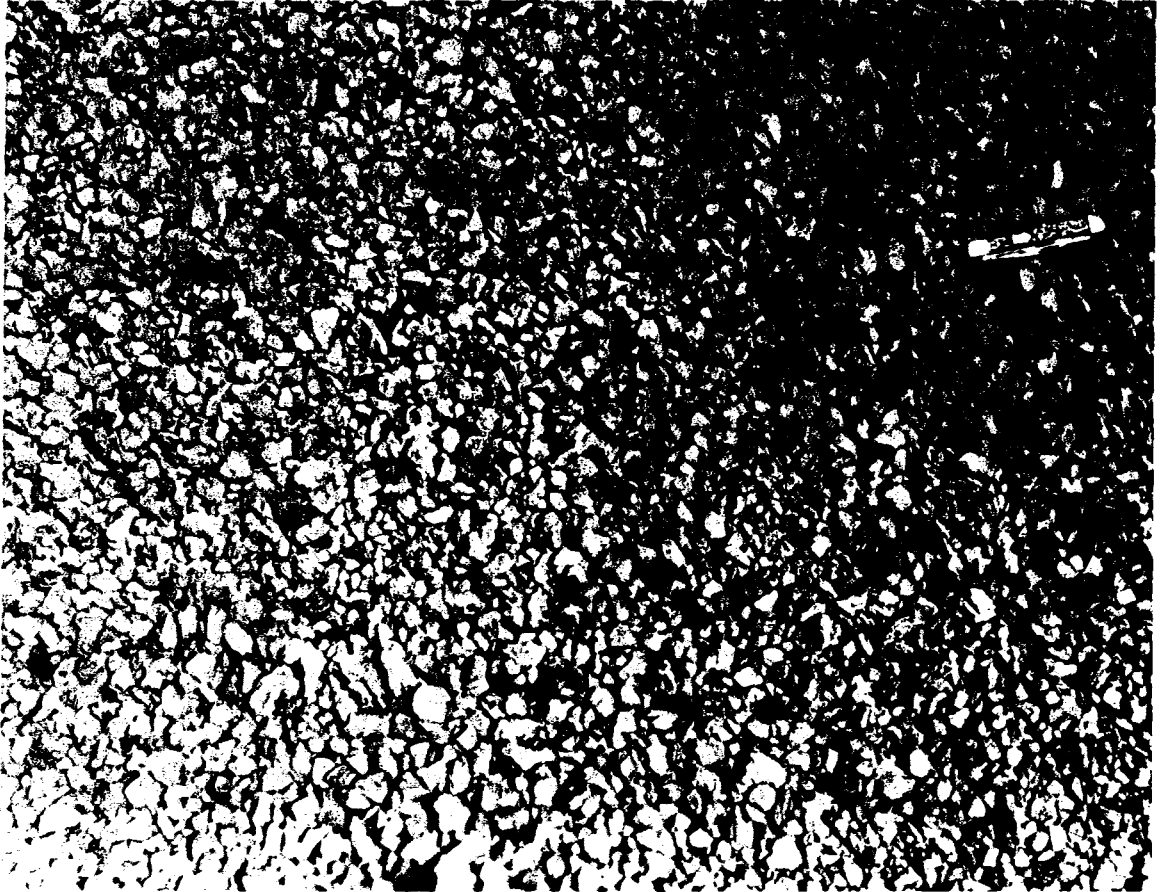
FIGURE 63 Type F Grade 3 after brooming. Spread rate --
130 square yards per cubic yard. (Photo by
Gustafson.)

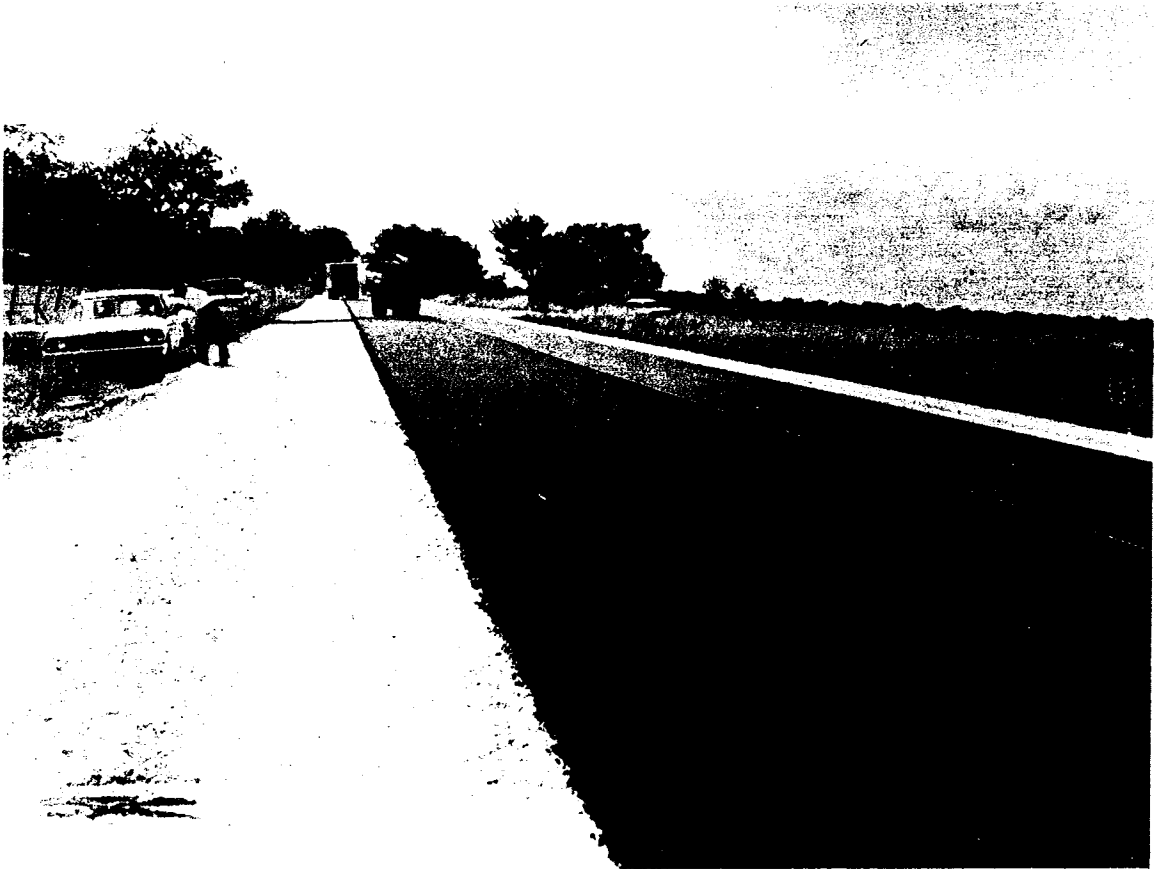
FIGURE 64 Hot-mix with burned clay aggregate placed on
SH 6. (Photo by Gustafson.)

Shown in Figure 64 is an experimental section of hot-mix asphaltic concrete made with burned clay and field sand as the aggregates. This is a section of SH 6 in Ft. Bend County constructed in August of 1963. The hot-mix was placed on a flexible base made with burned clay and sandy clay binder. Limited laboratory tests on the hot-mix from this section indicated that the surface course mix has limited fatigue life. The compacted mix was high in voids and had low flexural strength. A short life is predicted for the surface.

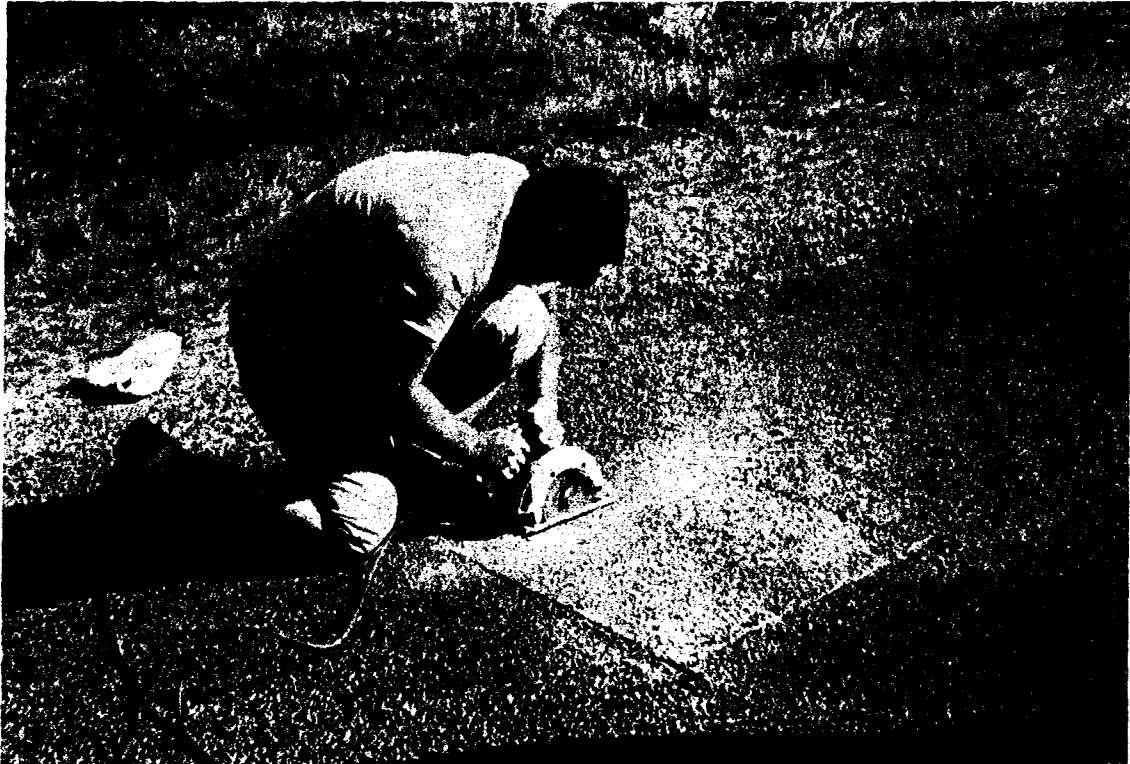
FIGURE 40 Cutting a field sample with a portable saw.

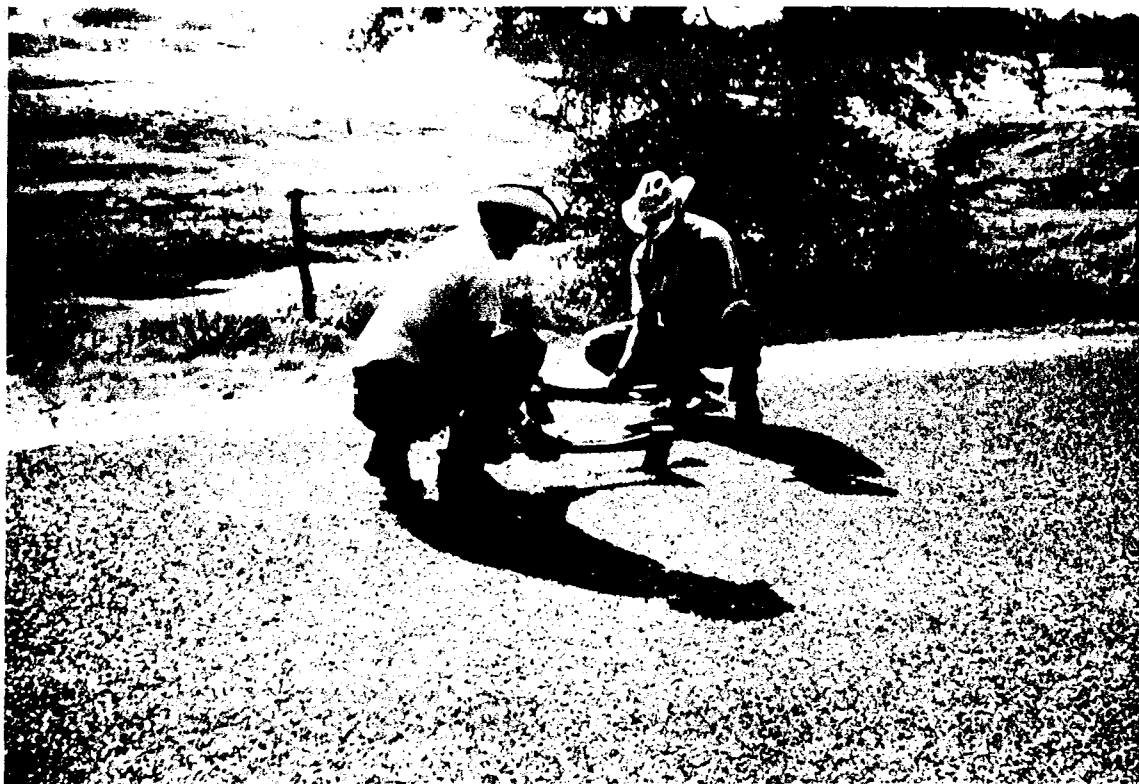
FIGURE 41 Cutting a field sample with an ax.

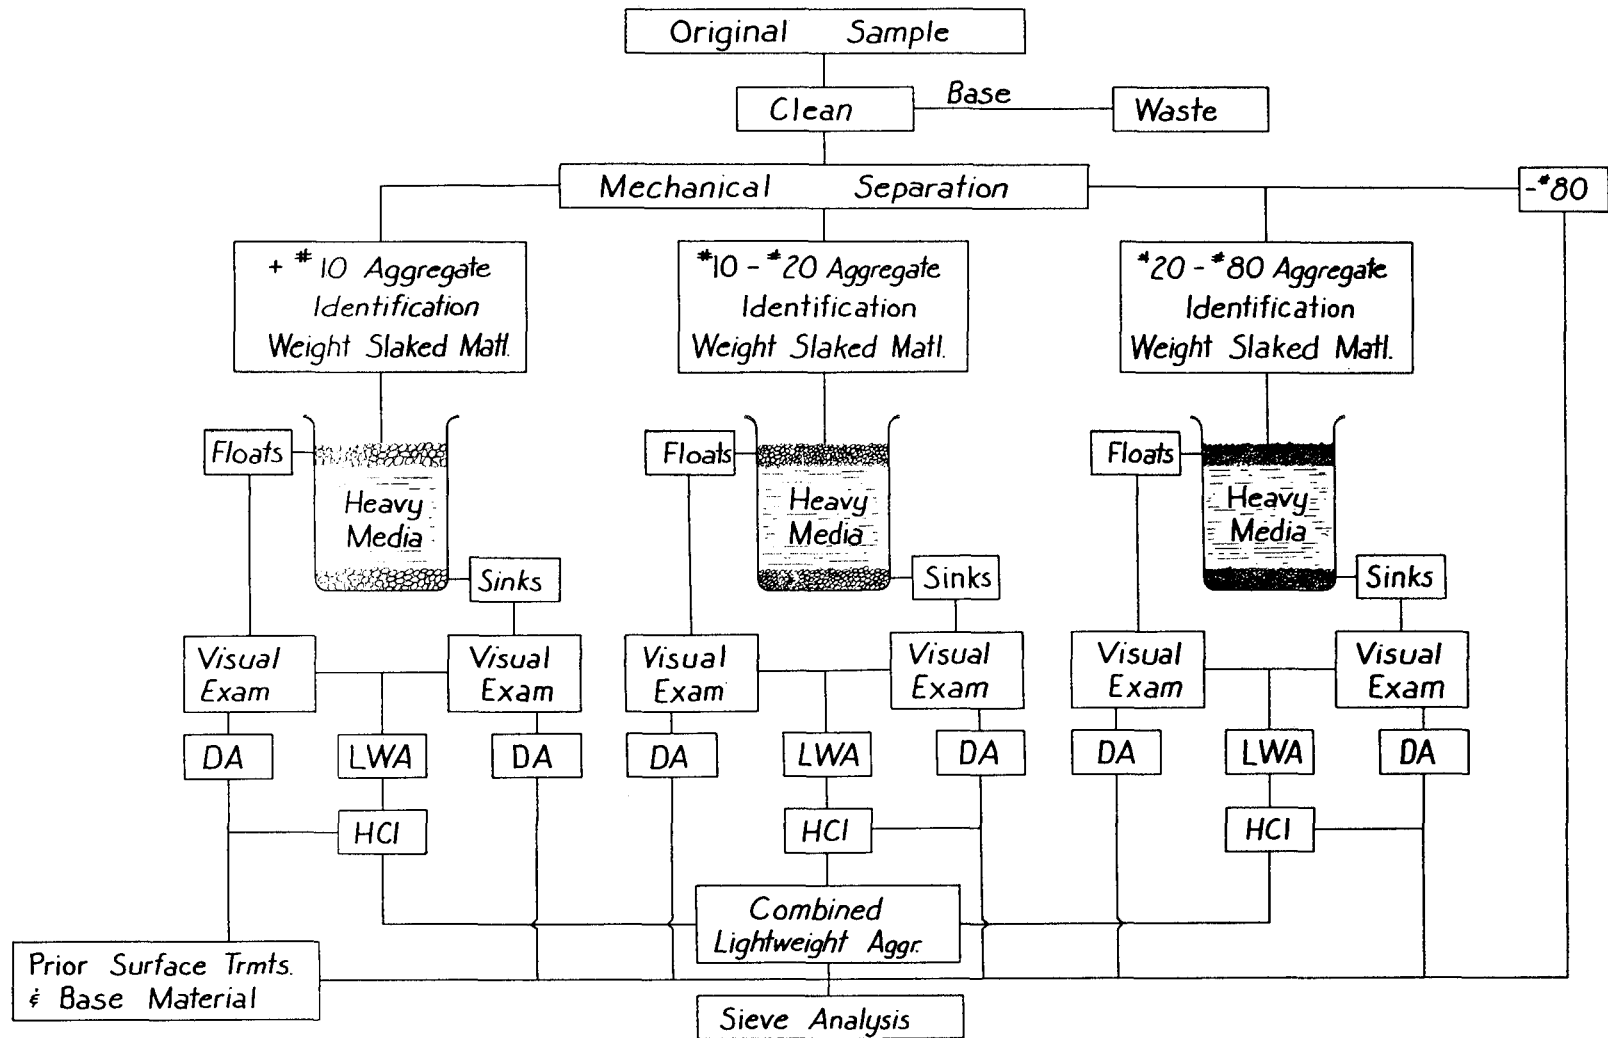
FIGURE 42 Flow diagram for heavy media separation of lightweight aggregates from field samples.

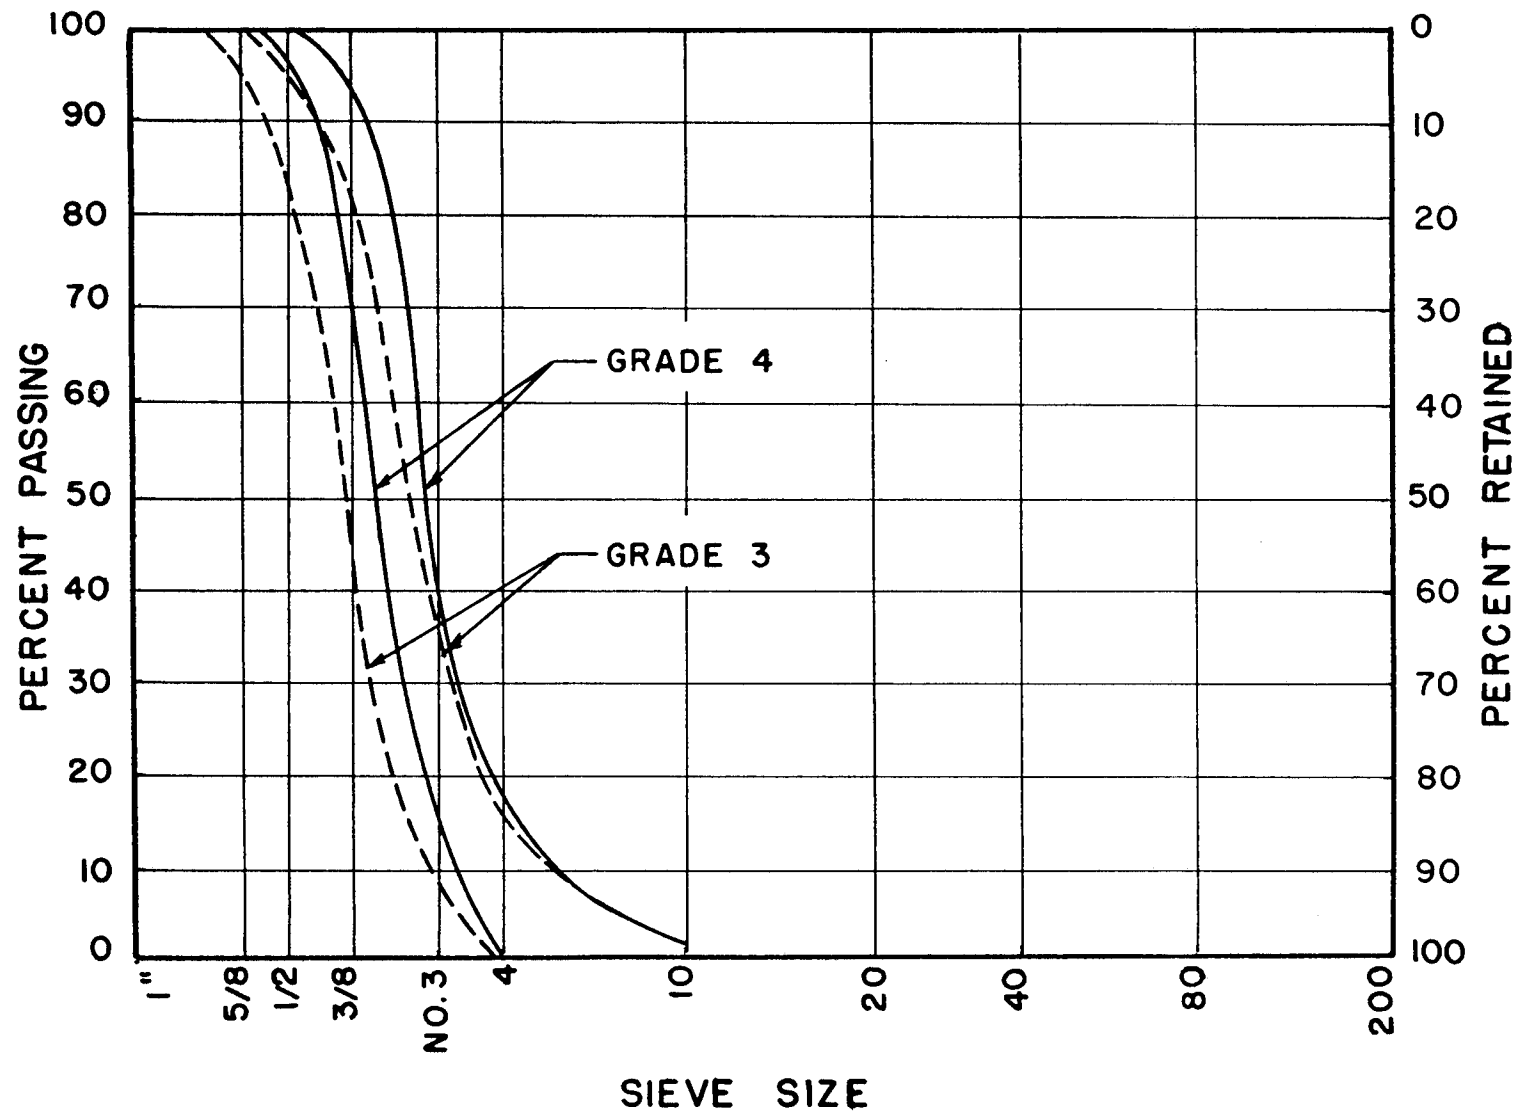
FIGURE 43 GRADATION REQUIREMENTS OF THD
ITEM 302 COVERSTONE, GRADES 3 & 4

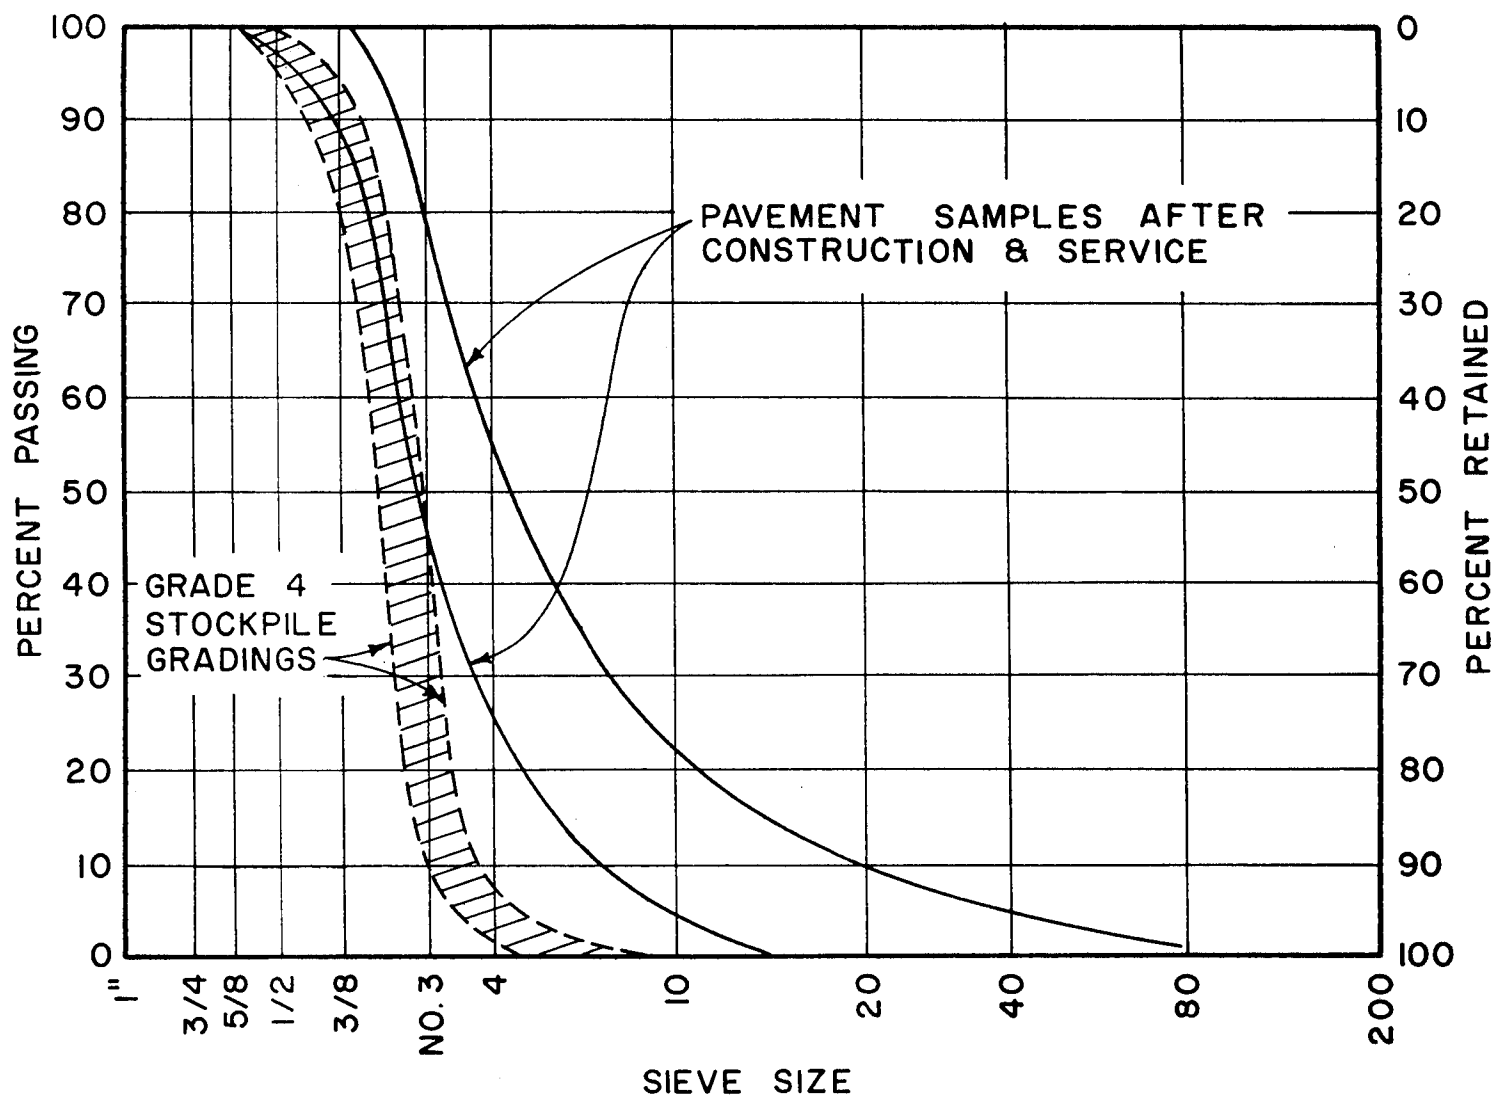
FIGURE 44 COMPARATIVE DEGRADATION OF LIGHT-WEIGHT AGGREGATE DUE TO CONSTRUCTION AND SERVICE

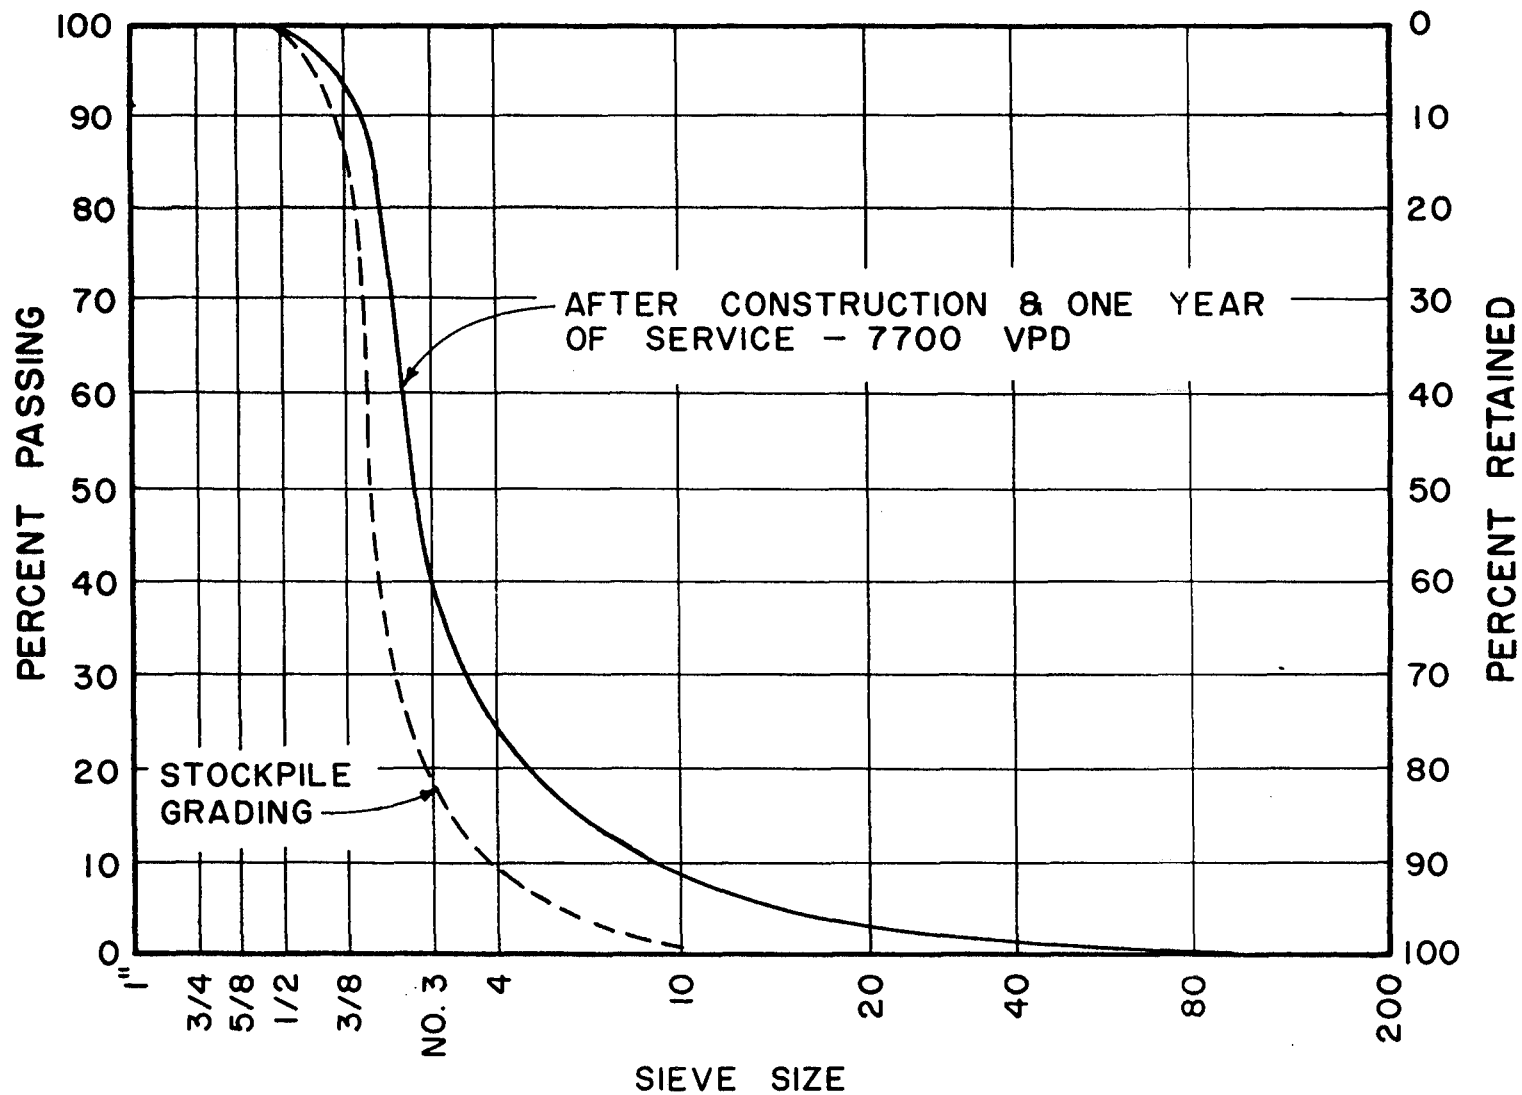
FIGURE 45 TIME AND LEVEL OF SERVICE A MINOR FACTOR IN DEGRADATION OF TYPE F COVERSTONE

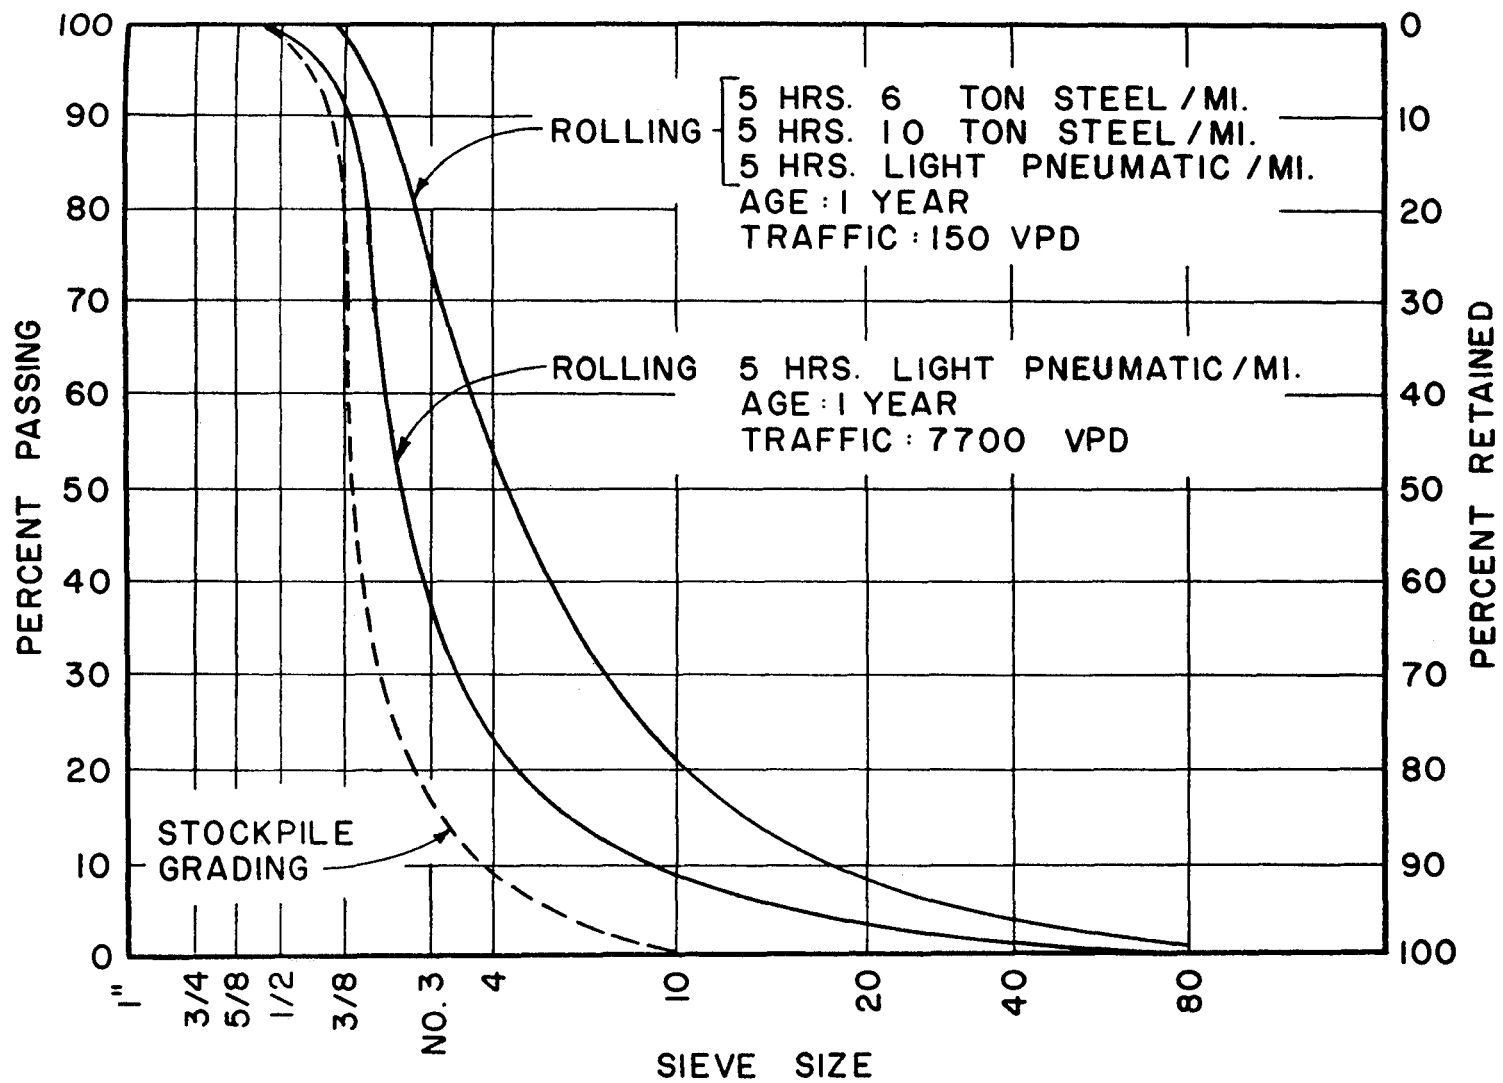
FIGURE 46 DEGRADATION OF TYPE F AGGREGATE
DUE TO CONSTRUCTION AND SERVICE

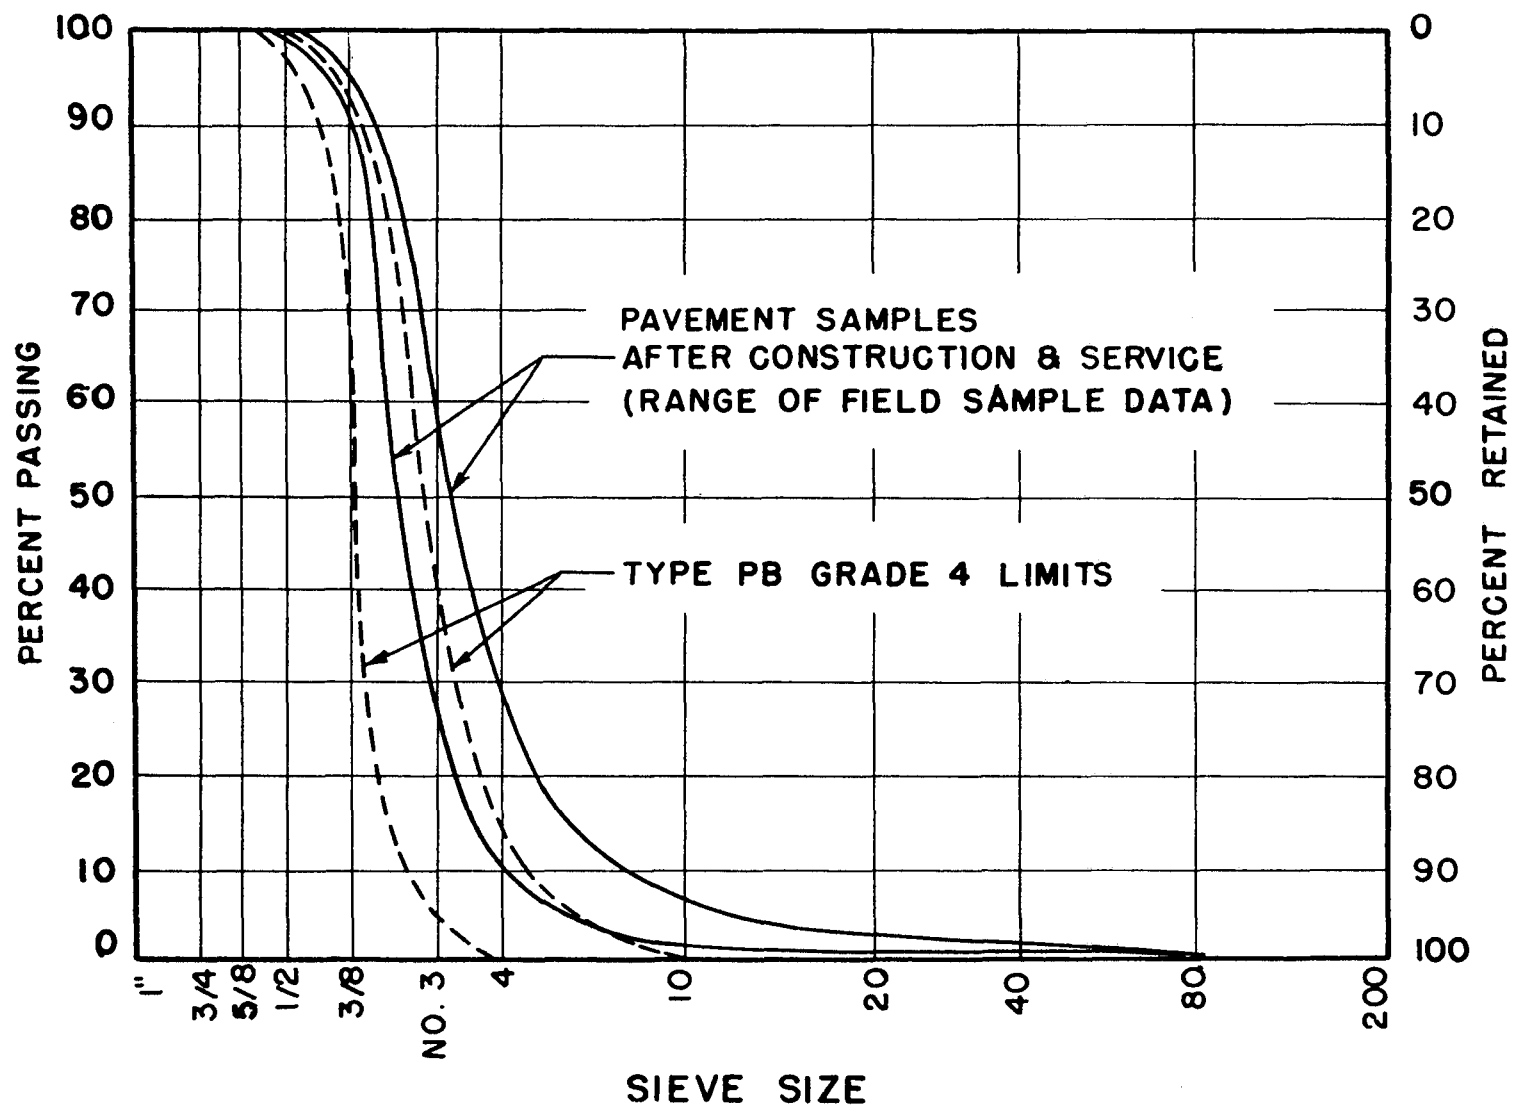
Comparative data on the construction degradation of precoated limestone are shown in Figure 47. It is to be noted from this figure that there is some crushing of the cover material during construction but it is not quite as severe as that for the Type F material subjected to similar rolling equipment. None of the precoated material under study was subjected to the severe steel flat wheel rolling used on some of the test sections involving Type F material so precise comparisons are not made. The range of values for the two materials (shown in Figure 43 and 44) overlap but this, of course, incorporates a number of variables that have their individual effects on the grading of a given material.

FIGURE 47 COMPARATIVE DEGRADATION OF PRECOATED LIMESTONE DUE TO CONSTRUCTION AND SERVICE
