A LABORATORY AND FIELD EVALUATION OF LIGHTWEIGHT
AGGREGATES AS COVERSTONE FOR SEAL COATS
AND SURFACE TREATMENTS

Research Report Number 51-2

Use of Lightweight Aggregates
Research Project Number 2-14-63-51

TEXAS TRANSPORTATION INSTITUTE
Texas A&M University
College Station, Texas

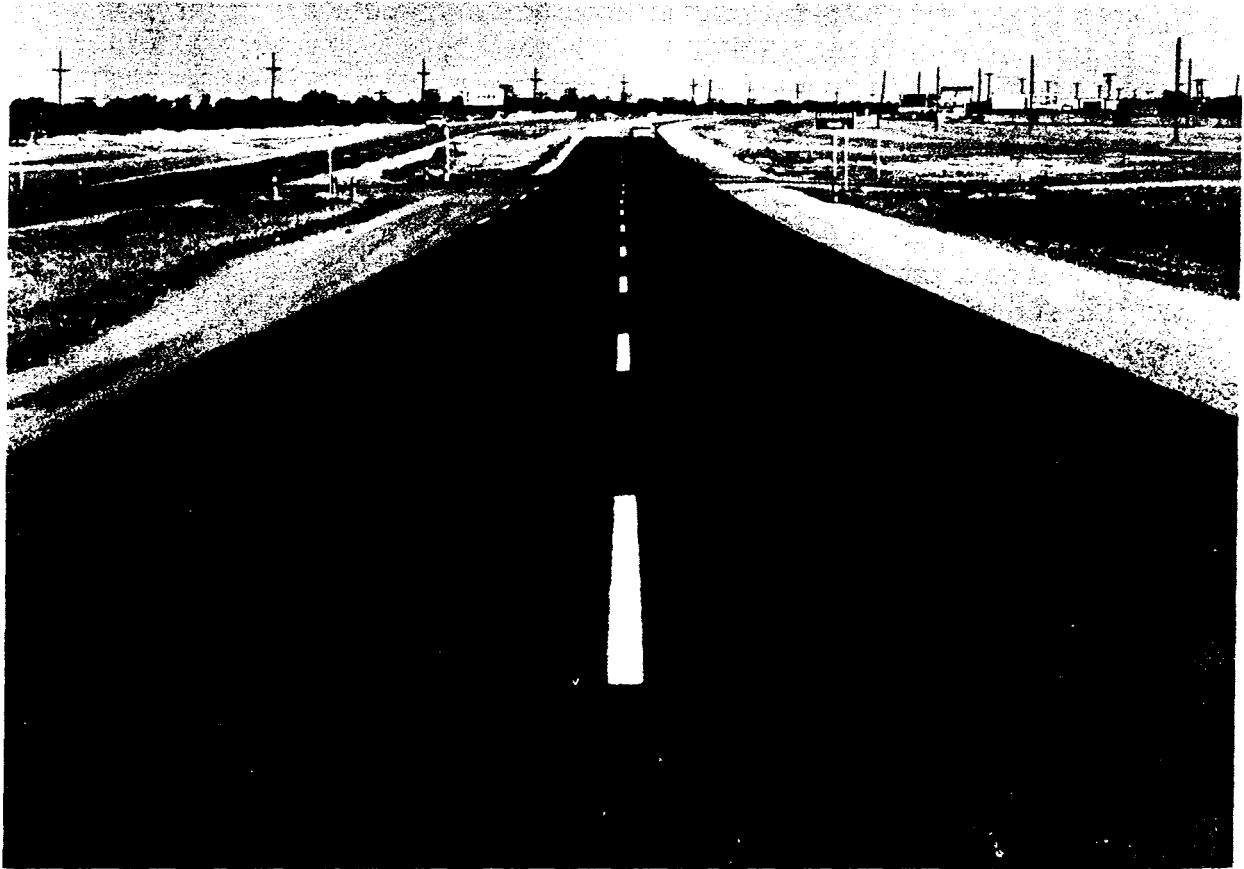
FIGURE 48 Type F seal two years old with 7700 vpd.
(Photo by Billingsley and Plumlee.)
