INSTRUMENTATION AND PHOTOGRAPHIC TECHNIQUES  
FOR DETERMINING DISPLACEMENT, VELOCITY CHANGE,  
AND DECELERATION OF VEHICLES WITH  
BREAK-AWAY SIGN STRUCTURES

Research Report Number 68-3

Sign Support Structures  
Research Project Number 2-5-63-68

TEXAS TRANSPORTATION INSTITUTE  
Texas A&M University  
College Station, Texas

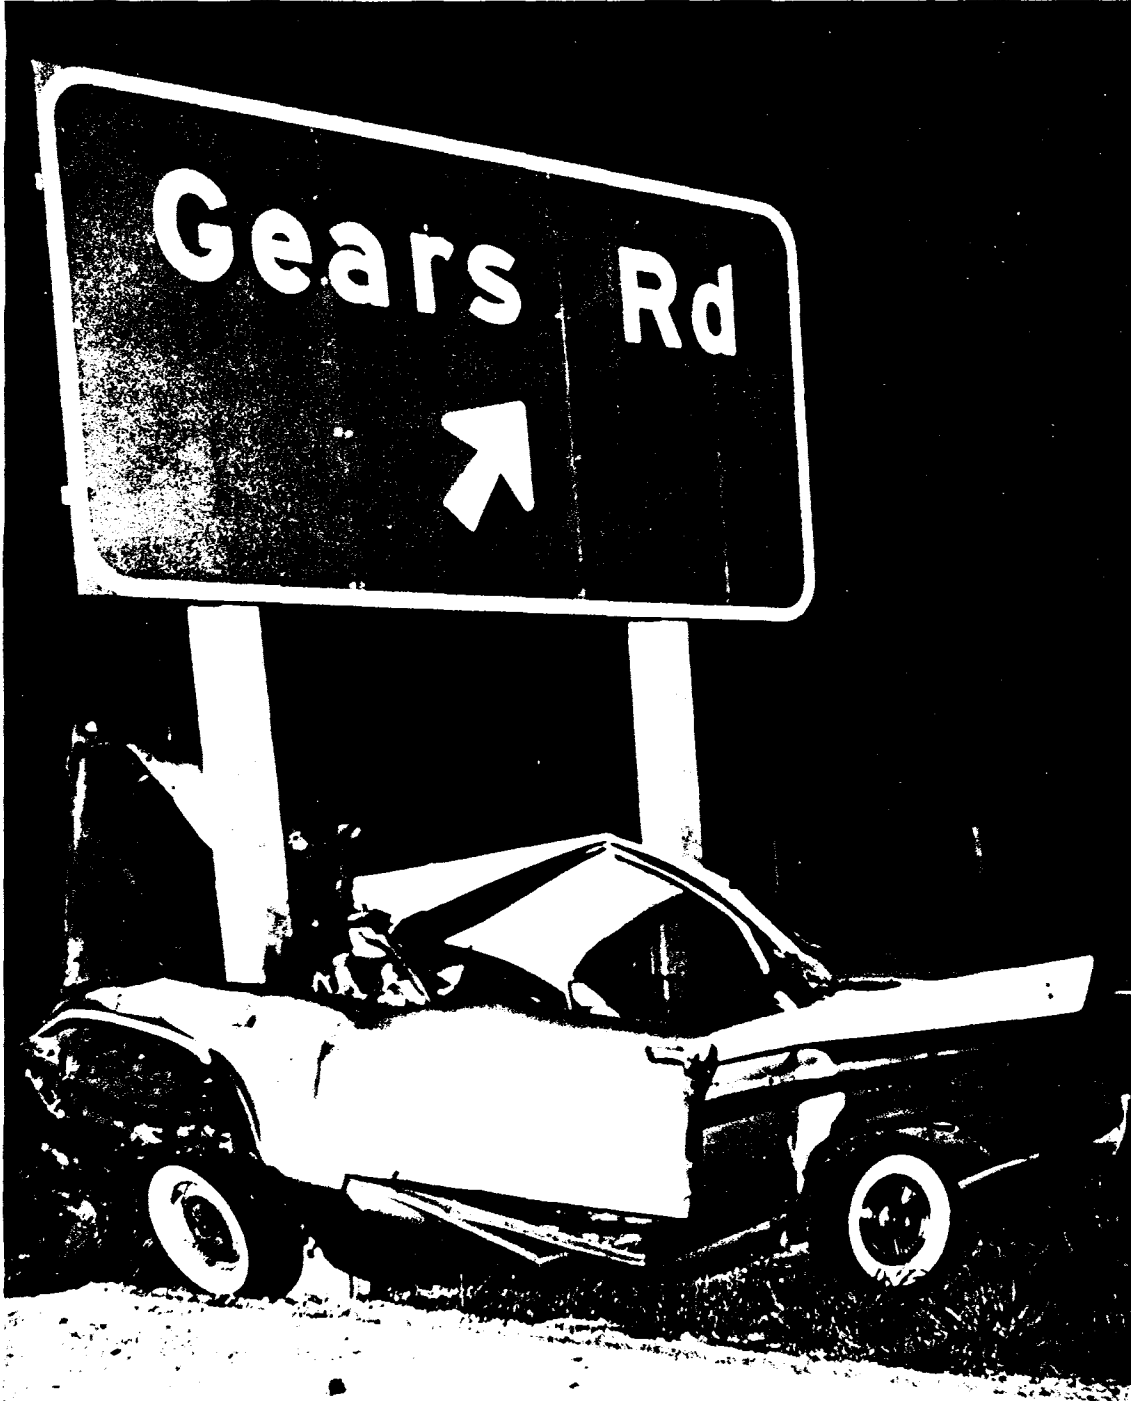
FIGURE I

The two post sign support seen in Figure 1 has been employed in increasing numbers. Many factors have been considered in the selection of this sign support design. It consists of a pair of vertical cantilever wide flange beams which are economical, strong, and stable when subjected to wind forces. It has aesthetic quality, supports a readable sign, and is located adjacent to the roadway. In short, the sign support is excellent in many respects, but can also be lethal. It is this last characteristic which has motivated the present

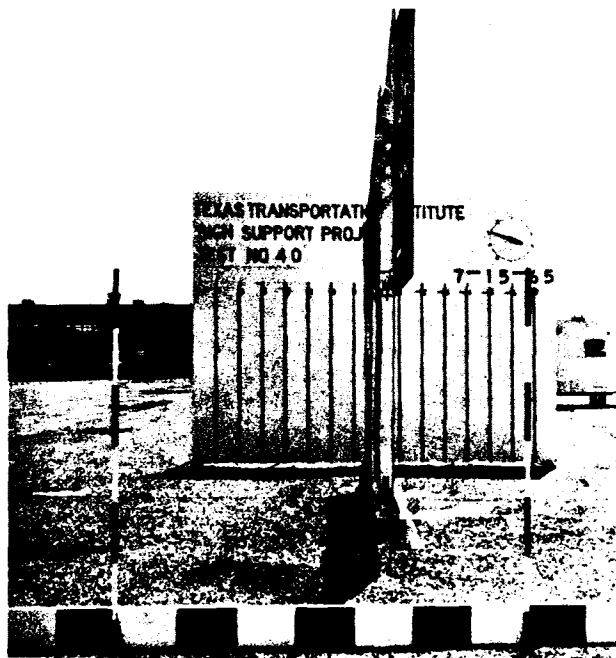
FIGURE 4 - CAMERA FIELDS OF VIEW

the basic photographic equipment. A visual comparison of the photographic field of view in Test 33 and Test 41 is found in Figure 4.

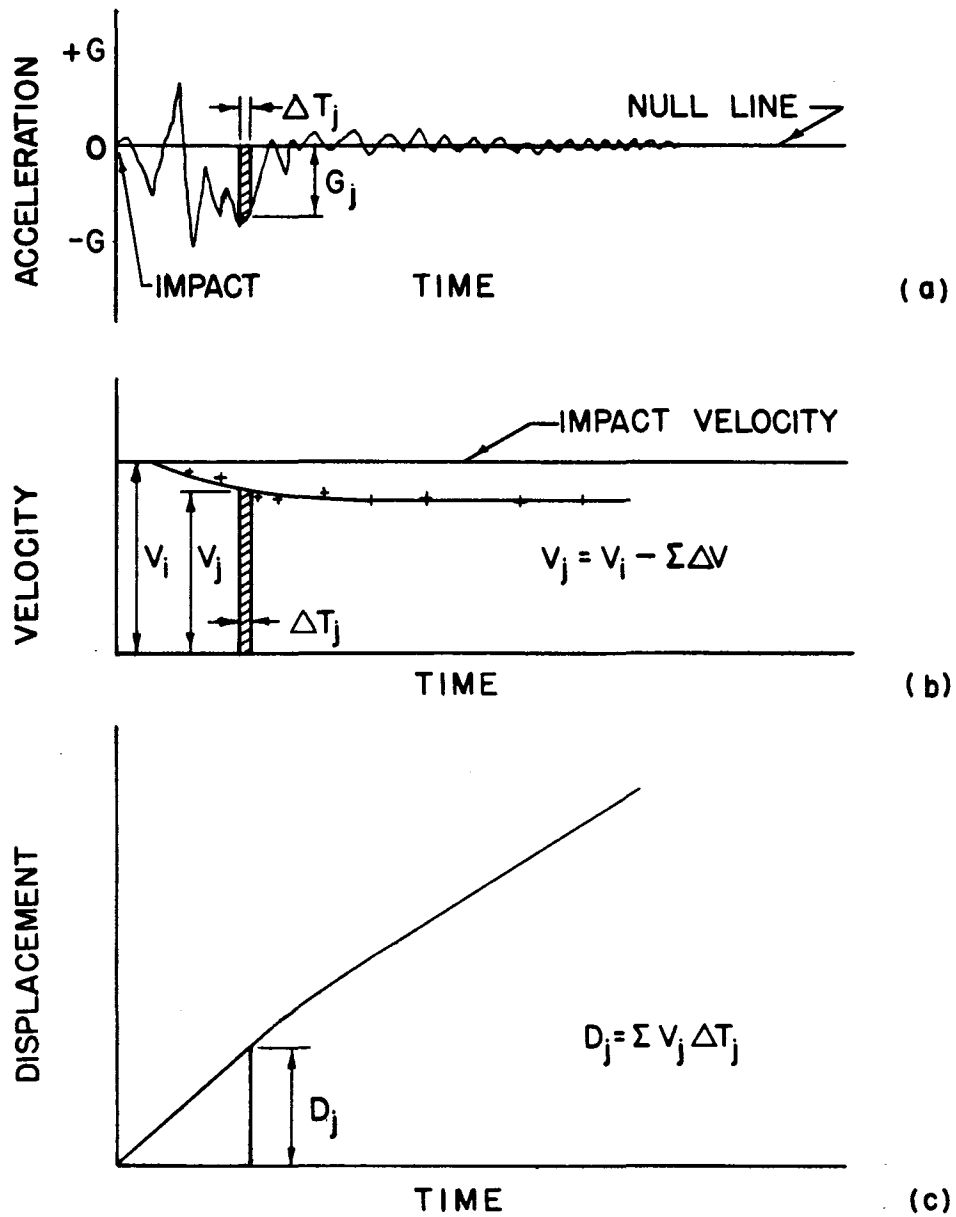
FIGURE 9

An accelerometer was installed on the crash vehicle as described previously. Changes in acceleration with respect to time were recorded on photographic paper by means of a recording oscillograph. The signal transmitted from the accelerometer to a galvanometer produced a trace on light-sensitive paper. The oscillating trace thus produced is a record of the acceleration history of the accelerometer as a function of time. The configuration of this trace is idealized in Figure 9 (a). Changes in vehicle velocity and acceleration can be computed by employing a process of integration. Several methods of reducing data from the accelerometer trace were attempted. These methods included recording offsets from the null line at equal time intervals, measurement of the area bounded by the trace by means of a planimeter, and determination of this area by a graphical technique. The first method required excessive time and resulted in a large number of datum points, each of which was subject to human errors and mistakes. The planimeter method proved unsatisfactory because of the small areas involved. The third method consisted of using a piece of graph paper having squares each side of which had a dimension of one-twentieth of an inch. A light table was employed and the accelerometer trace was superposed on the graph paper. A satisfactory estimate of the areas was thus obtained.

CRASH VEHICLE ACCELEROMETER  
ANALYSIS BY GRAPHICAL INTEGRATION

By a similar process of graphical integration incremental areas of velocity were summed to produce the Displacement-Time curve seen in Figure 9 (c). Actual plots of curves for Tests 33, 35, 40, and 41 are found in Appendix D. Computations were made by using the IBM 7094. A copy of the program and sample output is contained in Appendix E. The computational scheme is straightforward and self-explanatory.
