MULTI-DIRECTIONAL SLIP BASE FOR BREAK-AWAY
LUMINAIRE SUPPORTS

Research Report Number 75-10
Supplementary Studies in Highway Illumination
Research Project Number 2-8-64-75

TEXAS TRANSPORTATION INSTITUTE
TEXAS A&M UNIVERSITY
COLLEGE STATION, TEXAS

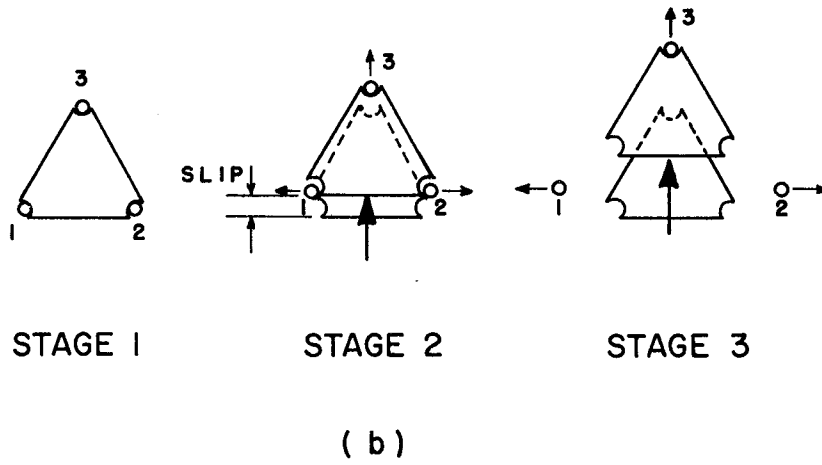
FIGURE 1 — CONCEPT OF SLIP BASE.

The base discussed in this report is referred to as the triangular slip base. The name is derived from the basic geometry of the base bolt placement. As shown in Figure 1 (a), the base bolts are placed in slots at the apexes of an equilateral triangle. This configuration produces a base, which by its symmetry, exhibits identical force-slip characteristics for forces applied in any one of the six 60° segments.

The base is composed of two identical plates. Each plate has slots at the apexes of the triangle. The bottom plate is rigidly attached to the foundation. The top plate is secured to the luminaire support post. Bolts are placed in the slots and tightened to provide the clamping forces. Figure 1 (b) illustrates the behavior of the base under applied load. Stage 1 is the condition before slip occurs. In Stage 2, the top plate is forced by the applied load to move with respect to the restrained bottom plate. This movement causes the bolts, at 1 and 2, to move laterally. This lateral bolt movement is caused by the scissor action of the slots as the top plate slips over the bottom plate. The bolt at 3 is forced out of its slot in the direction of movement. Slip continues until the bolt movement exceeds the limits of the slots as shown in Stage 3. The resistance to slip is composed of the friction of the bolts against the surfaces of the slots, and the bearing of the bolts in the slots. The angle of the slot, angle ϕ in Figure 1 (a), influences the joint slip resistance as does the line of action (angle of incidence) of the applied force. The influence of these two variables was studied in the laboratory using model bases.

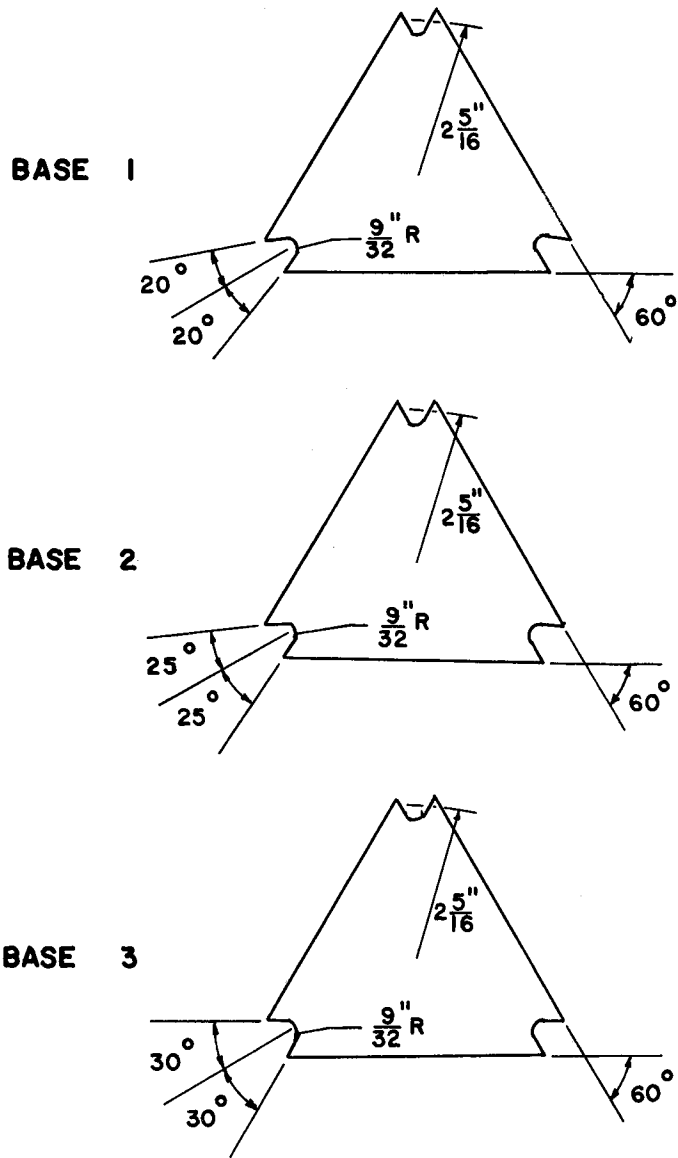
FIGURE 4 -- BASES FOR LABORATORY INVESTIGATION.

Plates with slot angles of 20, 25, and 30° were tested. Figure 4 shows the bases used. The clamping force between the base plates was controlled by torquing each bolt to a prescribed tension. The base bolts used in the tests were instrumented with strain gages and hence could be precisely torqued.

The tests showed that the slot angle is critical to the performance of the base. In the tests on Bases 1 and 2 (slot angle of 20 and 25°, respectively) with a bolt tension of 50 lb., the base did not activate (separate) under the impact at any one of the three angles of incidence. No attempt was made to force the activation of the base by increasing the pendulum drop height, because of the fear of damaging the instrumented bolts. The failure of the base to activate is attributed to the flat slot angle. The bolts locked up after an initial small amount of slip.

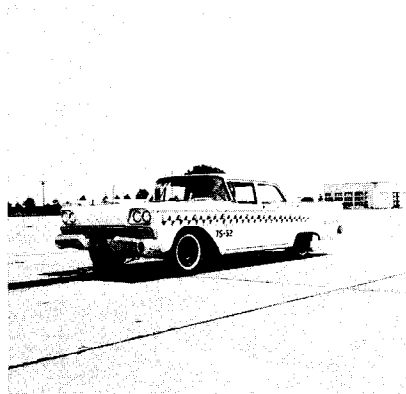
FIGURE 7 -- TEST S2.

Figure 7 is a summary of the qualitative data derived from observations of Test S2. Figure 7 (a) and (b) views show the support before and after the test. Note in (b) that the support post was bent at the lower luminaire arm-to-post connection. This failure occurred when the post struck the ground. Figure 7 (e) shows the post-collision position of the support post, the base bolts, and the point where the simulated luminaire struck the ground. The luminaire struck behind the foundation base plate and to the left of the vehicle path. The three base bolts, numbered 1, 2 and 3, came to rest in the positions shown. Note that the support post landed with its longitudinal axis approximately in line with the vehicle path.

Figure 7 (c) and (d) views show the damage done to the vehicle. The pole did not contact the vehicle after the initial collision. The vehicle struck the support on a vertical line through the left front headlight. Note that the headlight was not broken and that the total vehicle damage was minor.
