## **MASH TEST 3-11 OF THE TxDOT T222 BRIDGE RAIL**

### **Test Report 9-1002-12-13**

# **MASH TEST 3-11 OF THE TxDOT T222 BRIDGE RAIL**

Report 9-1002-12-13  
Project 9-1002-12  
Project Title: Roadside Safety Device Crash Testing Program

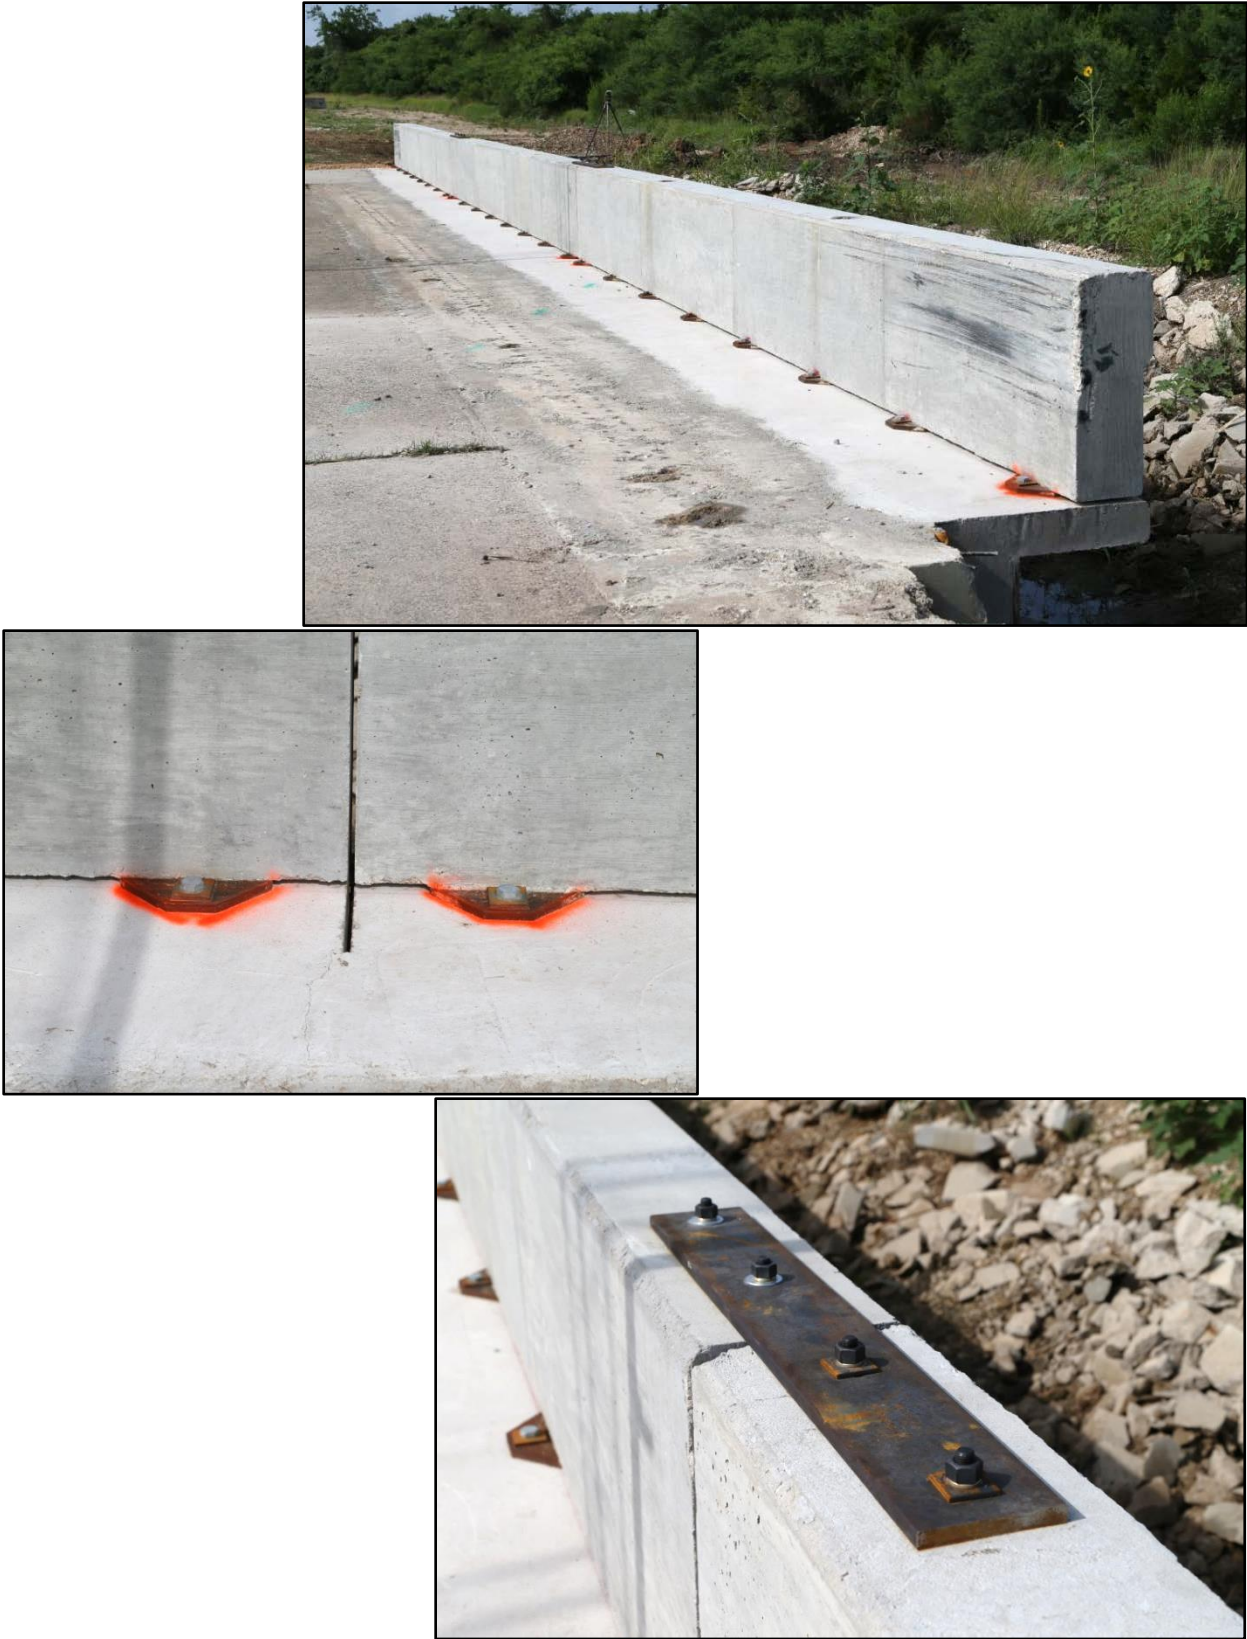
**Figure 2.2. Test Article/Installation before Test No. 490024-2-1.**

Figure 2.1 provides an overall layout of the TxDOT T222 Precast Traffic Rail, and Attachment A provides detailed drawings. Figure 2.2 shows photographs of the installation before testing.

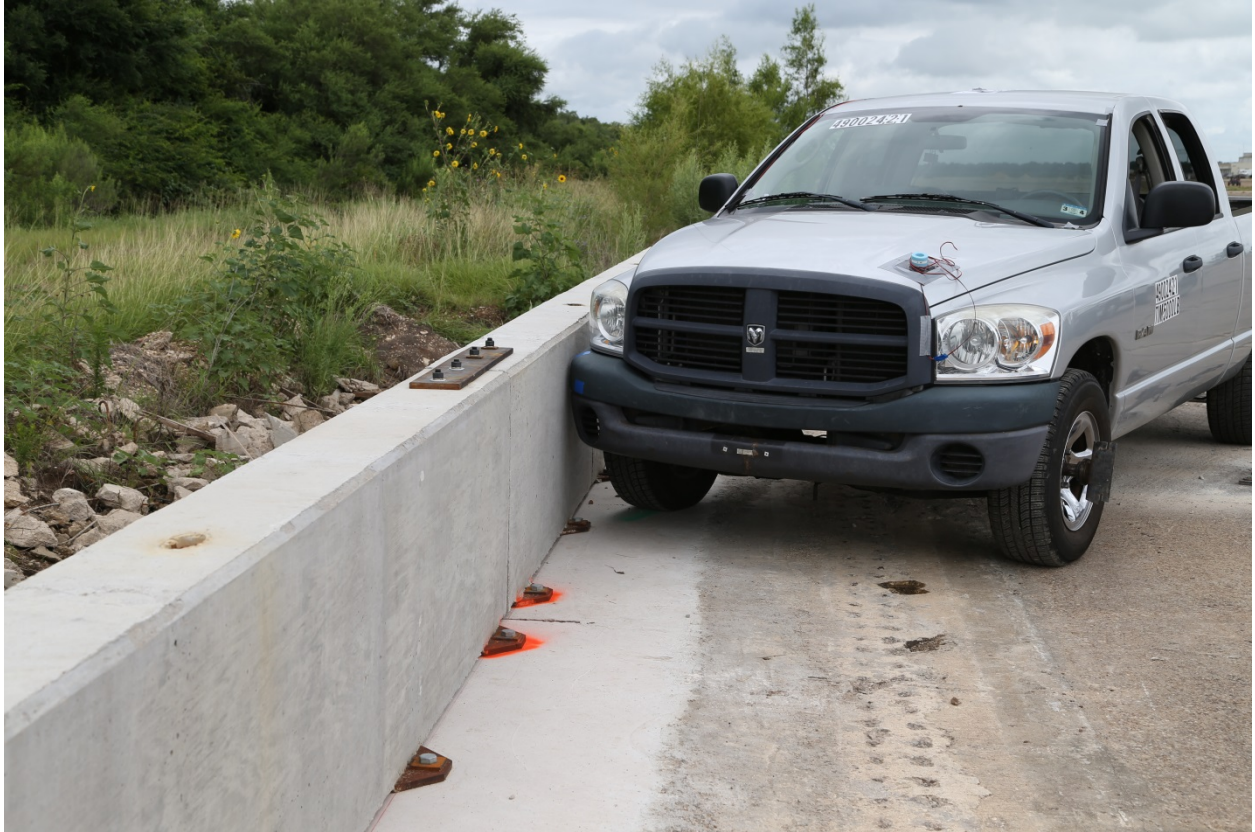
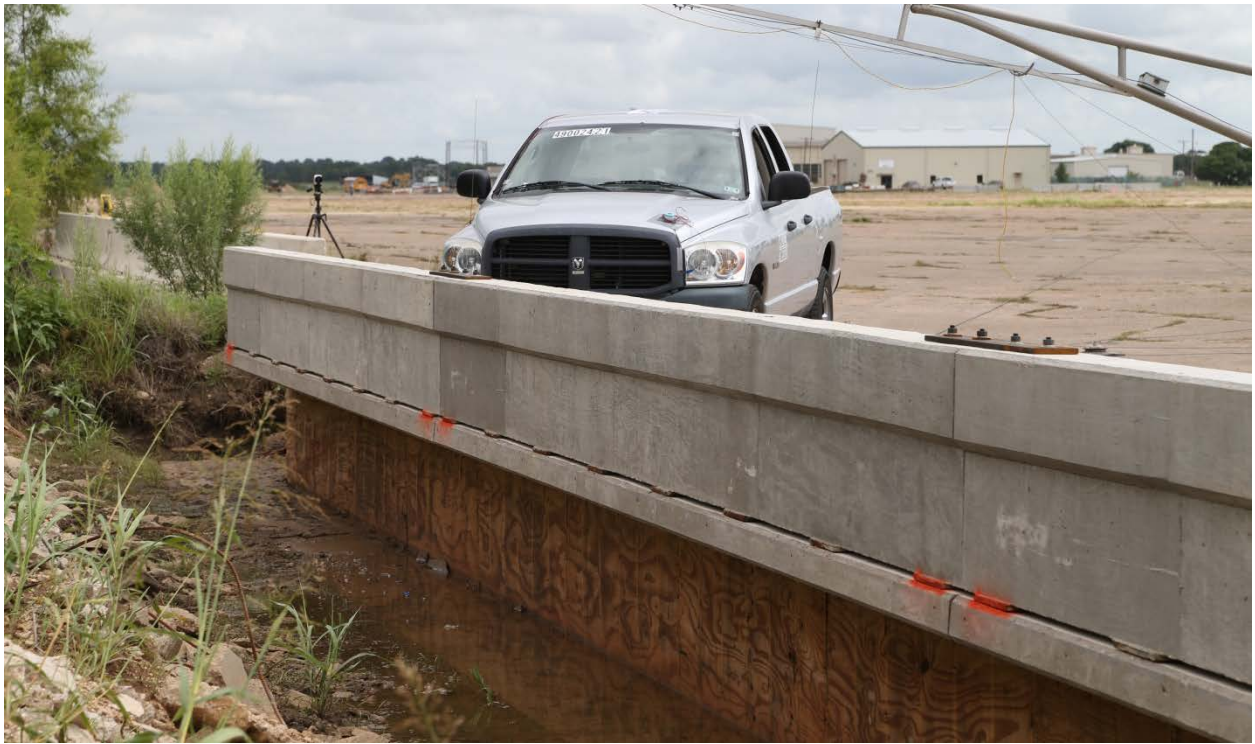
**Figure 5.1. Vehicle/Installation Geometrics for Test No. 490024-2-1.**

The 2008 Dodge Ram 1500 pickup truck, traveling at an impact speed of 64.4 mi/h, contacted the TxDOT T222 Bridge Rail 51 inches (4 ft 3 inches) upstream of the centerline of the joint between barrier segments #1 and #2 at an impact angle of 25.5 degrees. At approximately 0.126 s, the vehicle began to redirect, and at 0.186 s, the rear of the vehicle contacted the bridge rail. The vehicle began traveling parallel with the bridge rail at 0.271 s. At 0.473 s, the vehicle lost contact with the bridge rail and was traveling at an exit speed and angle of 48.6 mi/h and 8.1 degrees, respectively. Brakes on the vehicle were applied at 2.5 s after impact. The 2270P vehicle subsequently came to rest 249 ft downstream of impact and 35 ft toward traffic lanes. Figure D1 in Appendix D shows sequential photographs of the test period.

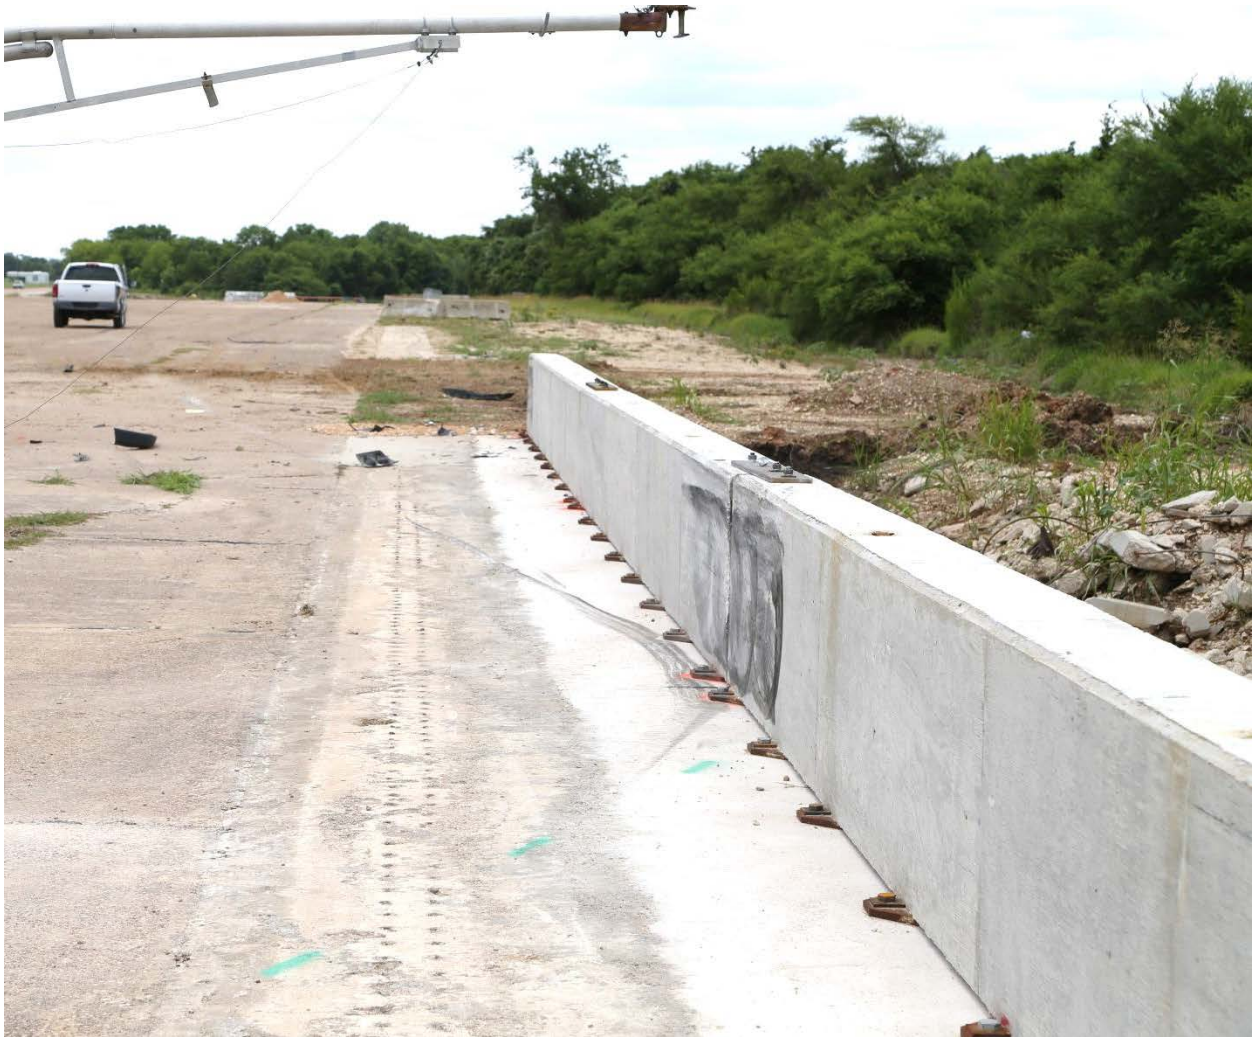
**Figure 5.3. Vehicle/Bridge Rail after Test No. 490024-2-1.**

Figure 5.3 and 5.4 show the damage to the bridge rail. Barrier segment 1 (leading) was pushed toward the field side 0.5 inch at the downstream end, and barrier segment 2 (mid) was pushed toward the field side 0.25 inch on the upstream end. Cracks in the deck were noted upstream of the joint between barrier segments 1 and 2, and there was a 0.75-inch offset between barrier segments 1 and 2 at the joint.

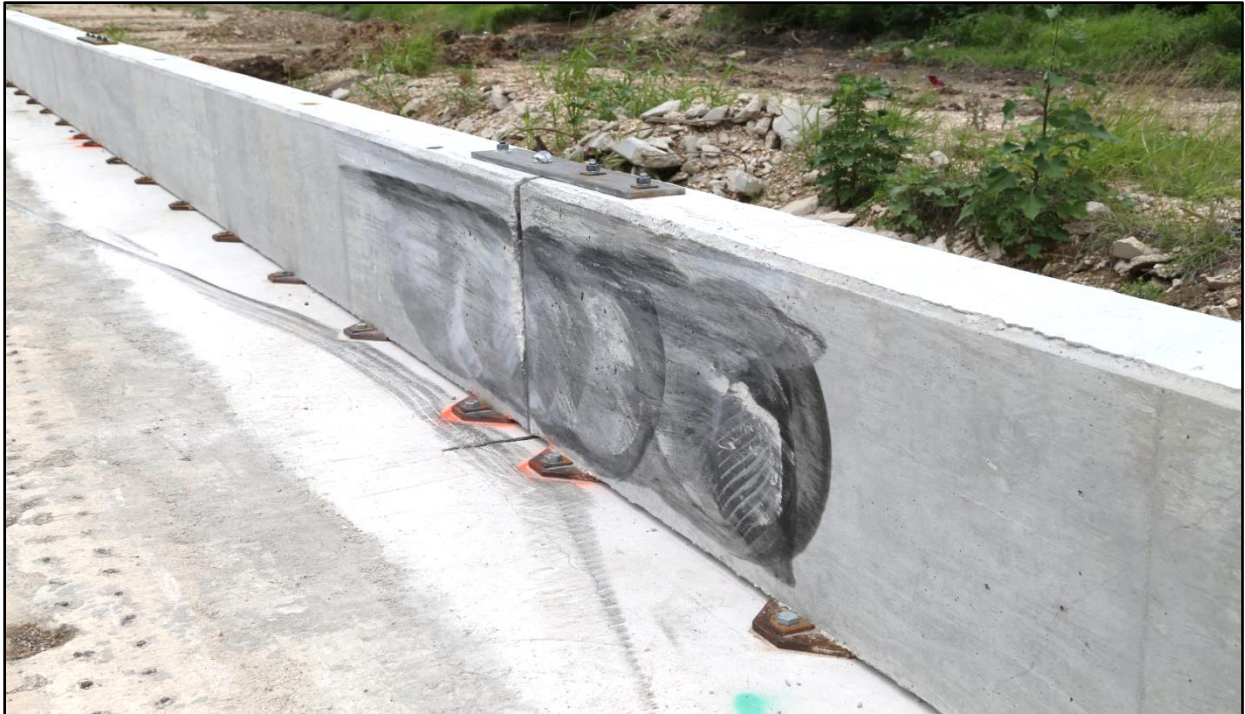
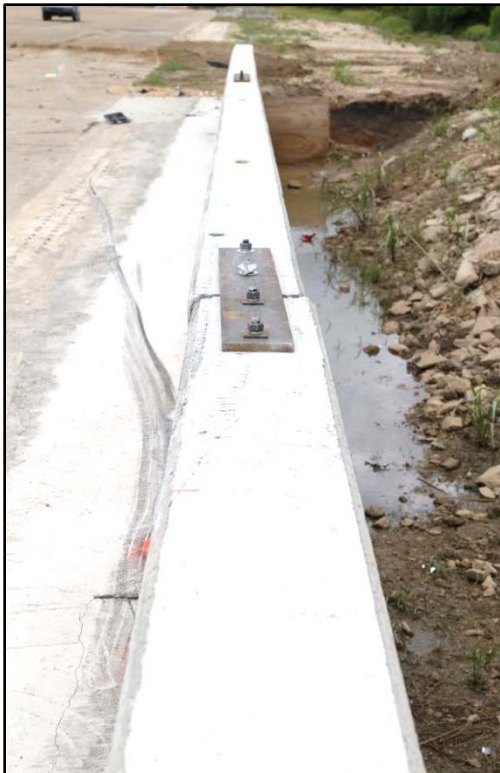
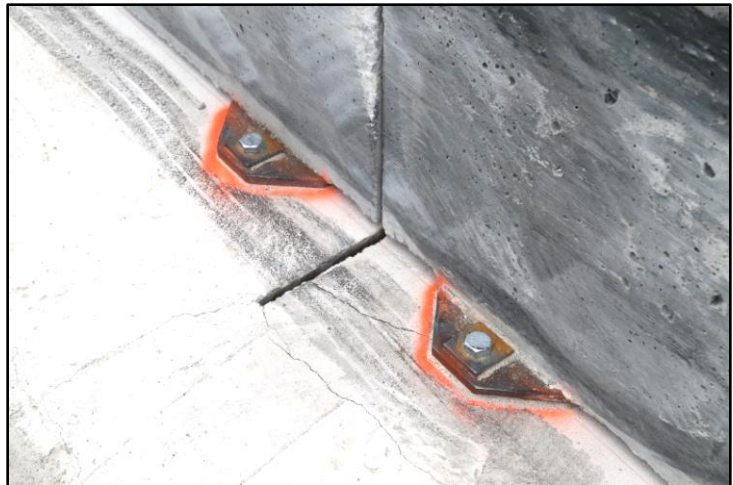
**Figure 5.4. Installation after Test No. 490024-2-1.**

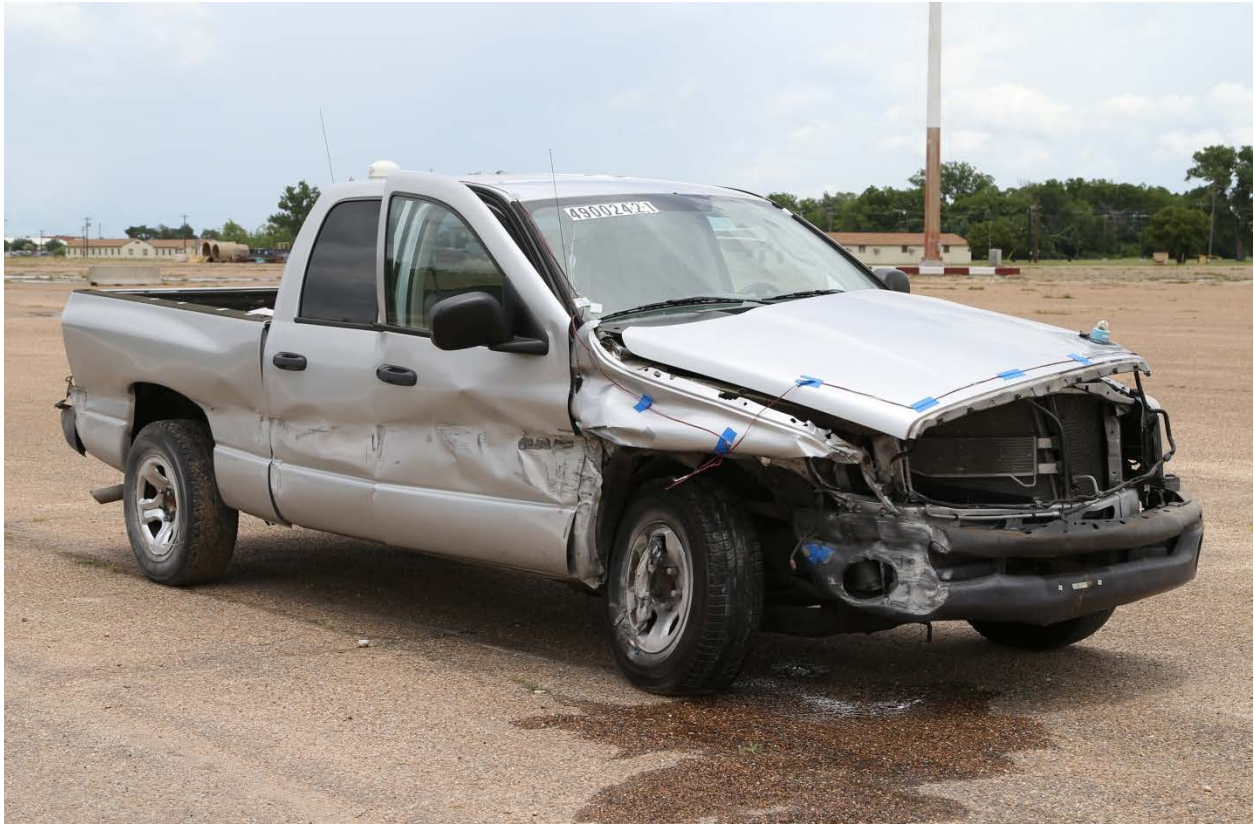
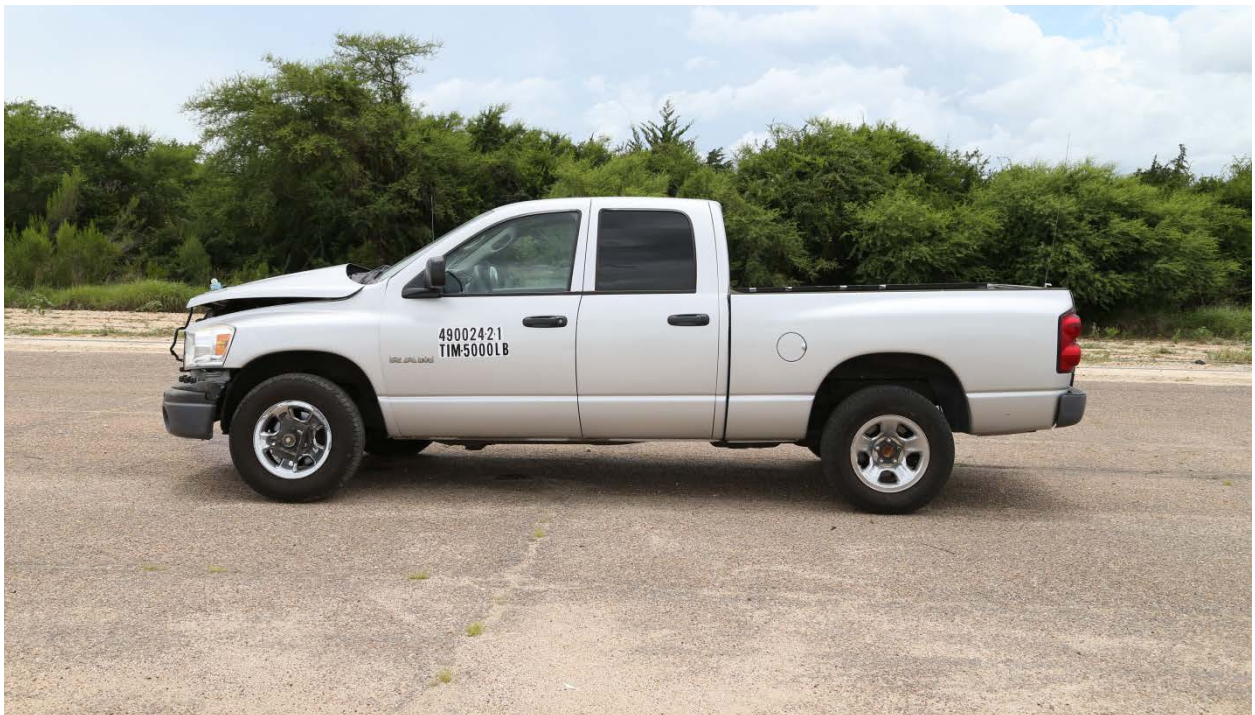
**Figure 5.5. Vehicle after Test No. 490024-2-1.**

Figure 5.5 shows the damage that the vehicle had sustained. The front bumper, grill, radiator, radiator support, right front fender, right front wheel rim (no loss of air), right front and rear doors, right rear cab corner, right exterior bed, right rear tire and wheel rim, rear bumper, and right front floor pan were deformed, and the windshield sustained stress fractures. Maximum exterior crush to the vehicle was 19.25 inches in the side plane at the right front corner at bumper height. Maximum occupant compartment deformation was 4.0 inches in the right front kick panel area near the right front passenger's feet. Tables C3 and C4 in Appendix C provide exterior crush measurements and occupant compartment measurements, respectively.

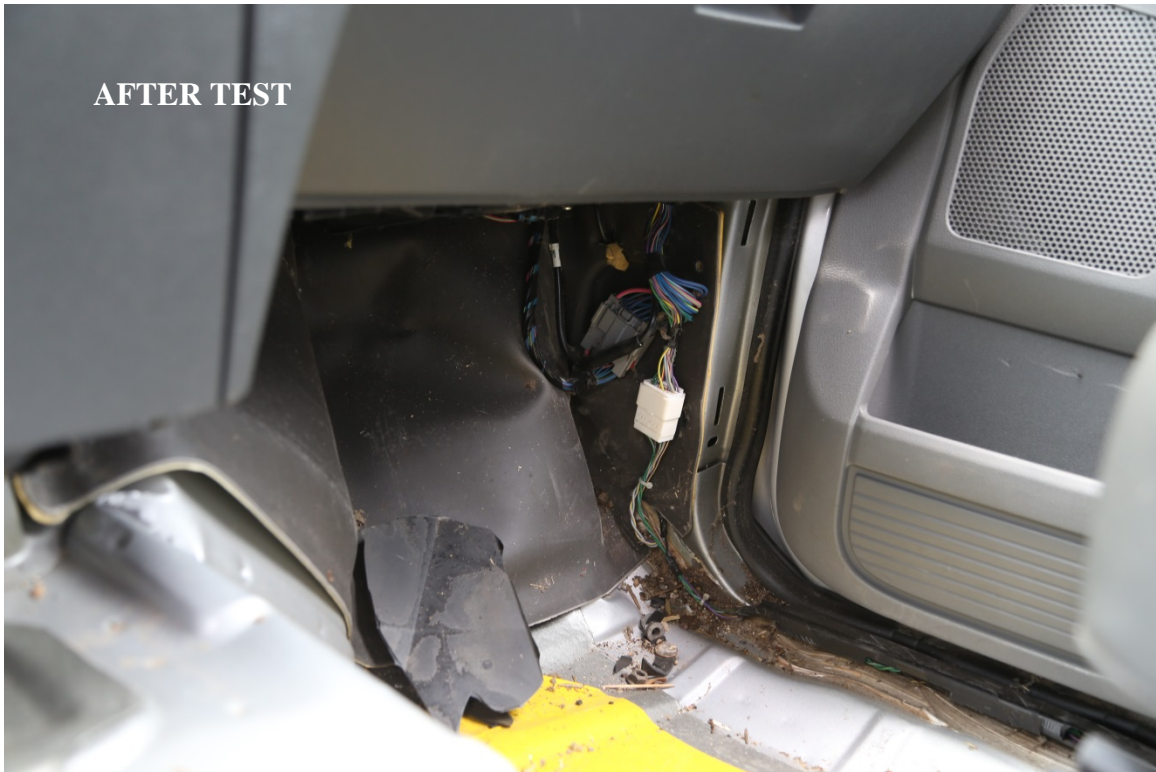
**Figure 5.6. Interior of Vehicle for Test No. 490024-2-1.**

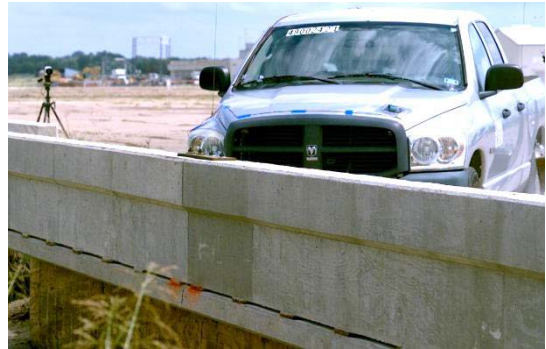
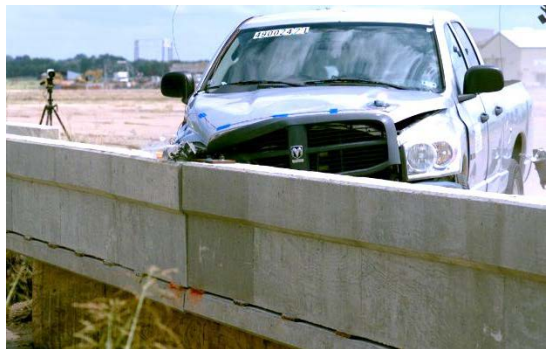
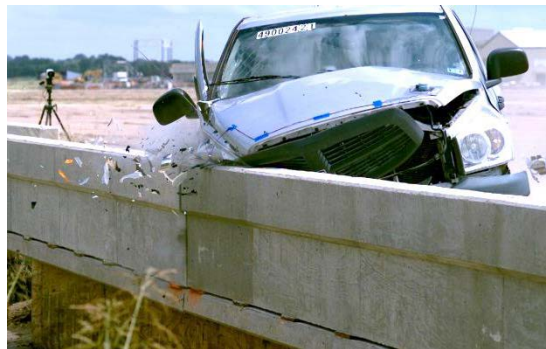
**Figure D1. Sequential Photographs for Test No. 490024-2-1 (Overhead and Frontal Views).**

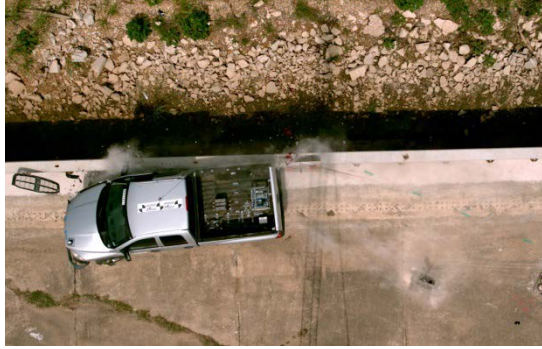
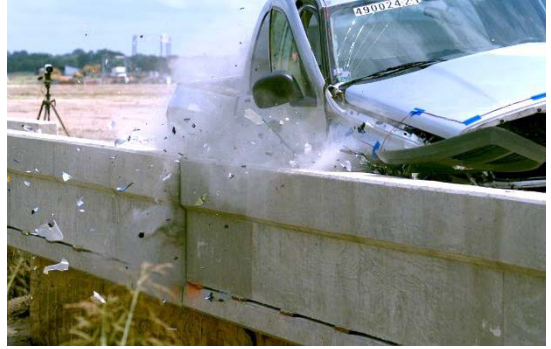
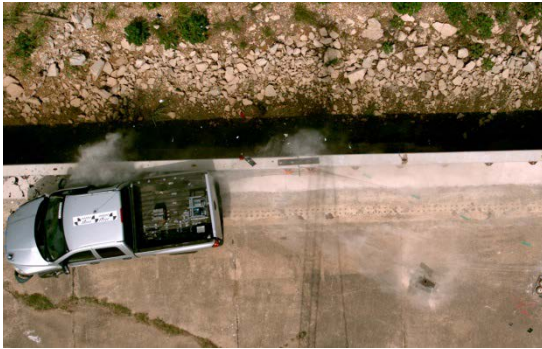
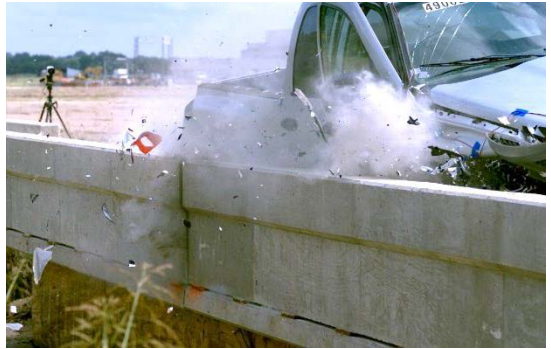
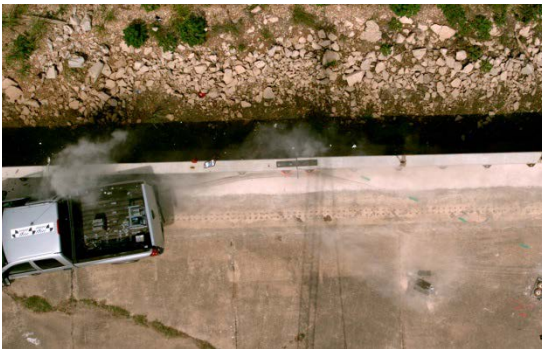
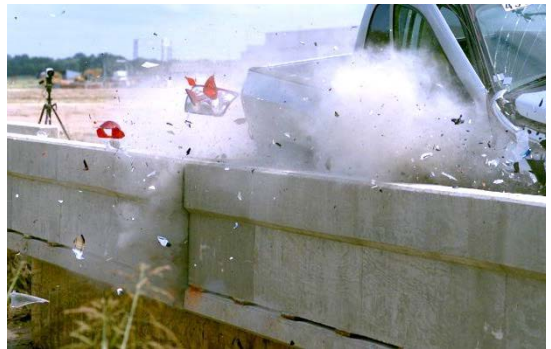
**Figure D1. Sequential Photographs for Test No. 490024-2-1(Overhead and Frontal Views)  
(Continued).**

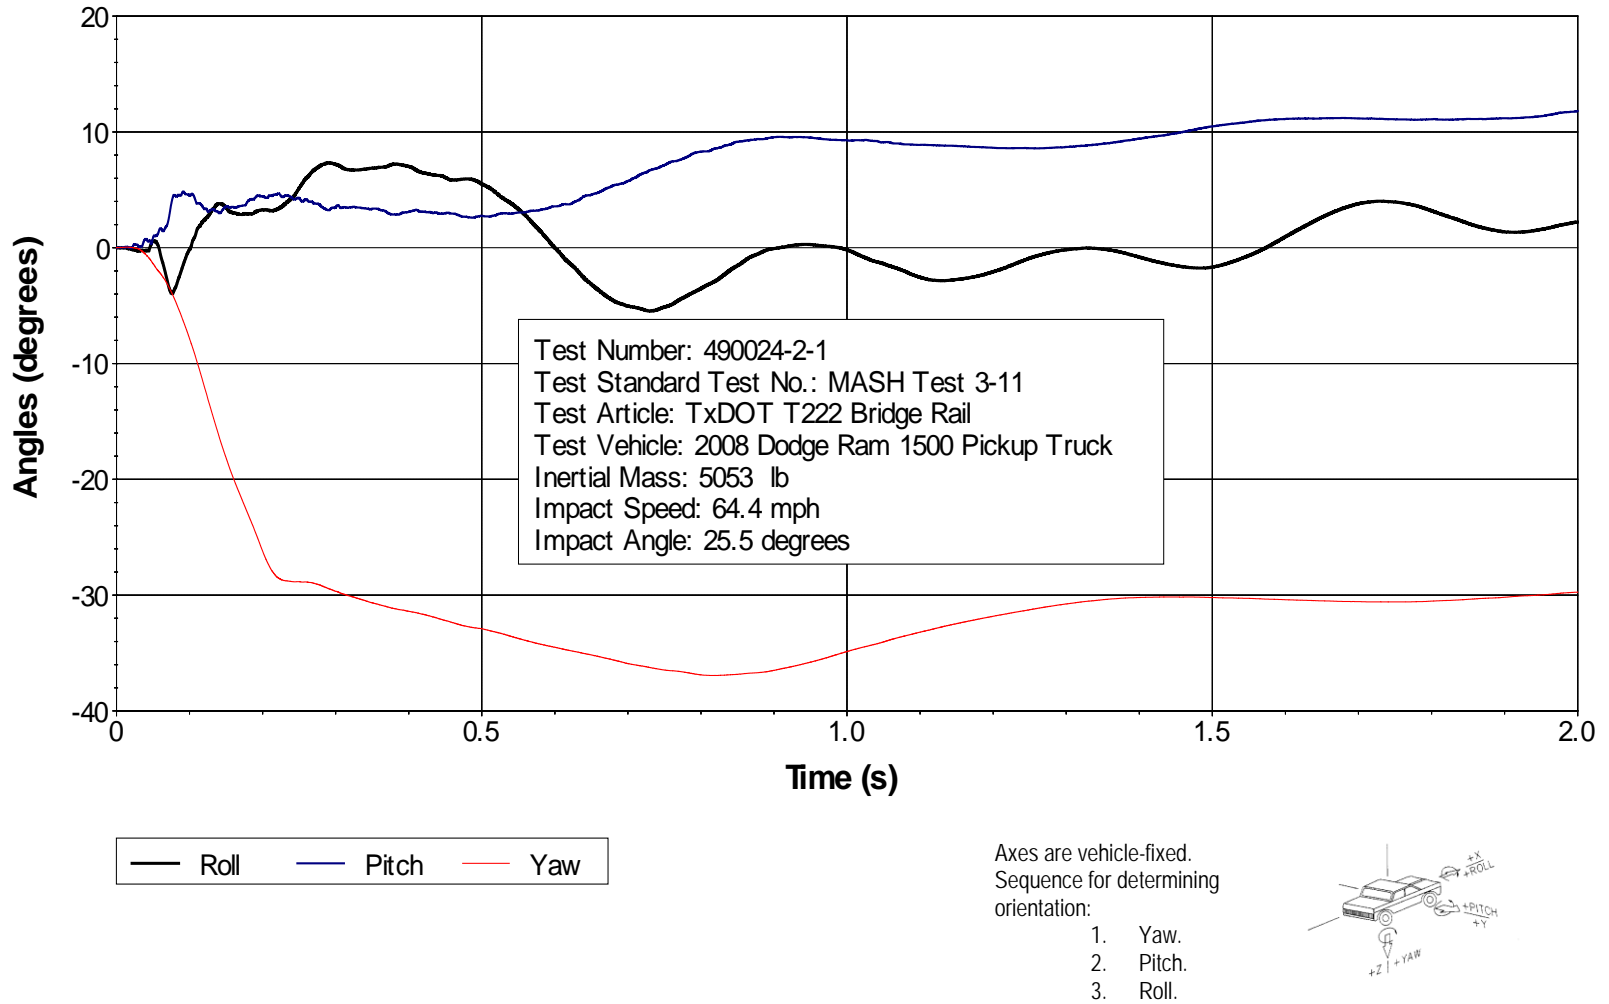
Figure E1. Vehicle Angular Displacement for Test No. 490024-2-1.

Data from the accelerometer, located at the vehicle center of gravity, were digitized for evaluation of occupant risk. In the longitudinal direction, the occupant impact velocity was 21.6 ft/s at 0.097 s, the highest 0.010-s occupant ridedown acceleration was 3.6 Gs from 0.196 to 0.206 s, and the maximum 0.050-s average acceleration was -9.8 Gs between 0.025 and 0.075 s. In the lateral direction, the occupant impact velocity was 26.9 ft/s at 0.097 s, the highest 0.010-s occupant ridedown acceleration was 11.1 Gs from 0.207 to 0.217 s, and the maximum 0.050-s average was -14.1 Gs between 0.041 and 0.091 s. Theoretical Head Impact Velocity (THIV) was 38.0 km/h or 10.5 m/s at 0.094 s; Post-Impact Head Decelerations (PHD) was 11.1 Gs between 0.207 and 0.217 s; and Acceleration Severity Index (ASI) was 1.95 between 0.063 and 0.113 s. Figure 5.7 summarizes these data and other pertinent information from the test. In Appendix E, Figures E1 through E7 show the vehicle angular displacements and accelerations versus time traces.
