MASH TL-4 EVALUATION OF THE TXDOT TYPE C2P BRIDGE RAIL

Test Report 9-1002-15-2 Rev.1

**TEXAS A&M TRANSPORTATION INSTITUTE
COLLEGE STATION, TEXAS**

TEXAS DEPARTMENT OF TRANSPORTATION

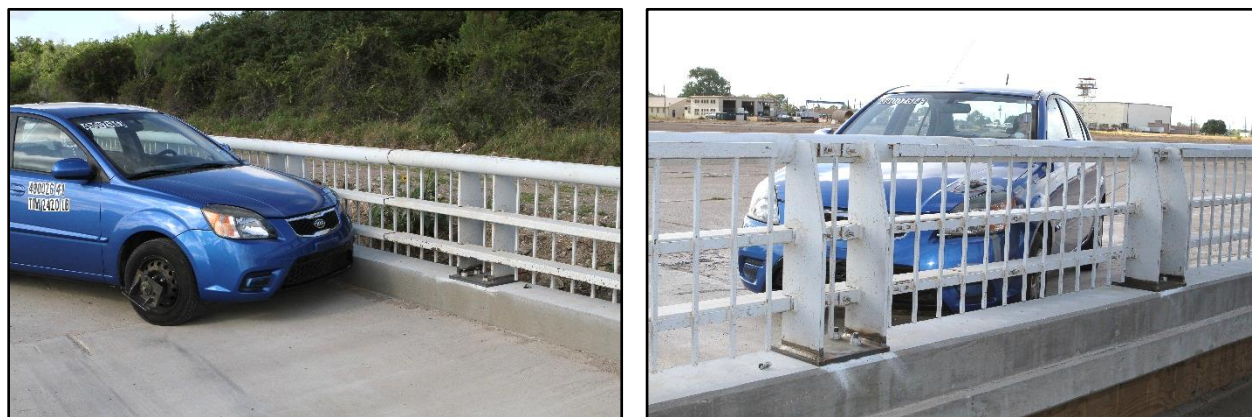
Figure 5-1. TxDOT Type C2P Bridge Rail/Test Vehicle Geometrics for Test No. 490026-4-1.

A 2010 Kia Rio, shown in Figure 5-1 and Figure 5-2, was used for the crash test. The vehicle's test inertia weight was 2433 lb, and its gross static weight was 2598 lb. The height to the lower edge of the vehicle bumper was 7.75 inches and the height to the upper edge of the vehicle bumper was 21.0 inches. Table D-1 in Appendix D1 gives additional dimensions and information on the vehicle. The vehicle was directed into the installation using a cable reverse tow and guidance system, and was released to be freewheeling and unrestrained just prior to impact.

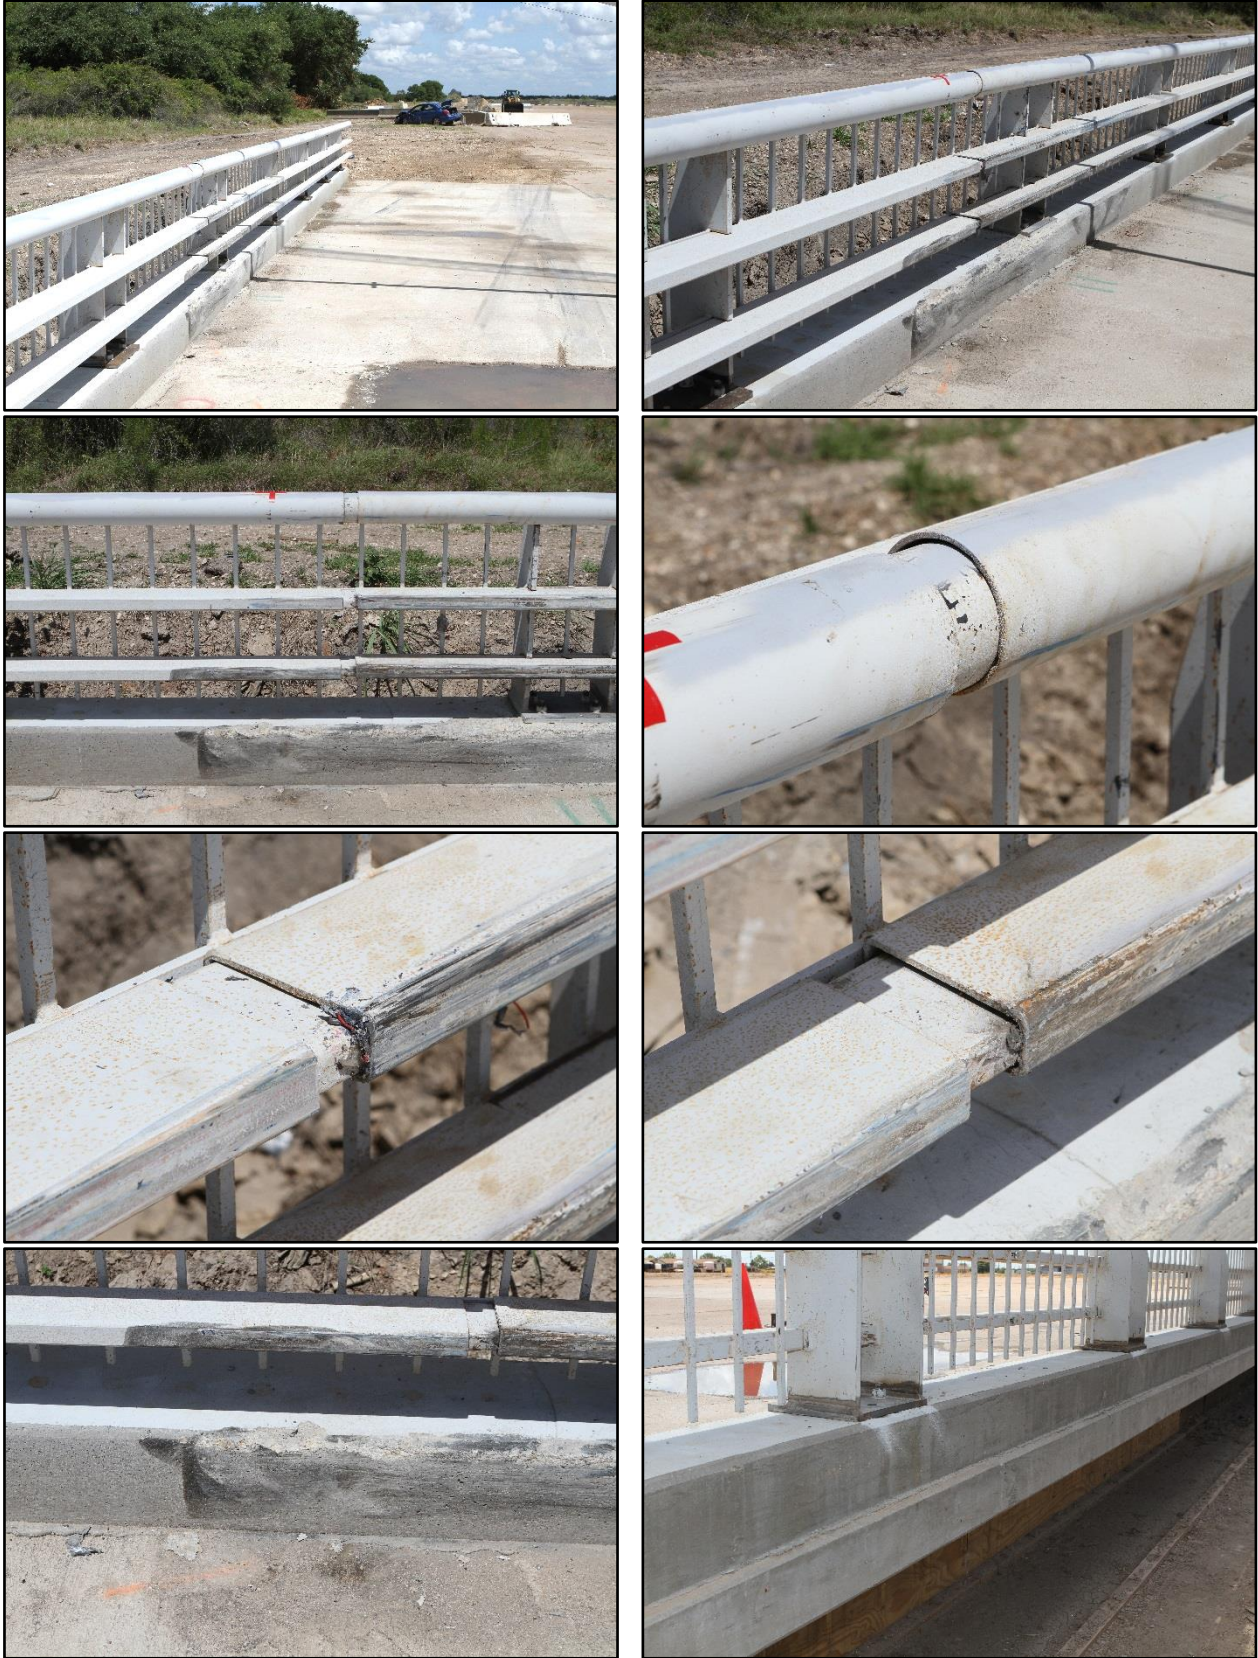
Figure 5-3. TxDOT Type C2P Bridge Rail after Test No. 490026-4-1.

Figure 5-3 shows the damage to the TxDOT Type C2P Bridge Rail. The traffic face of the bridge rail was marred and scuffed, as was the traffic face and top of the curb. Working width was 14.0 inches. Maximum dynamic deflection during the test was 0.8 inch, and there was no notable maximum permanent deformation after the test.

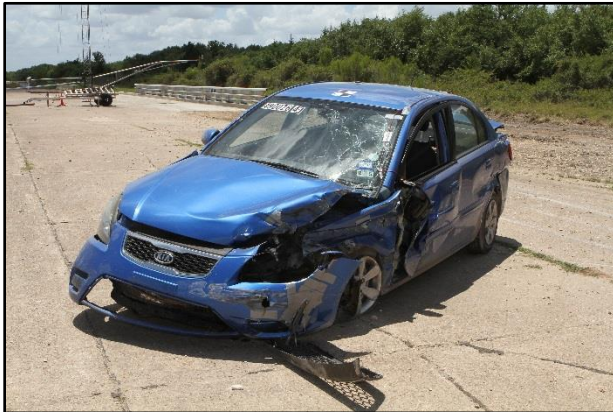
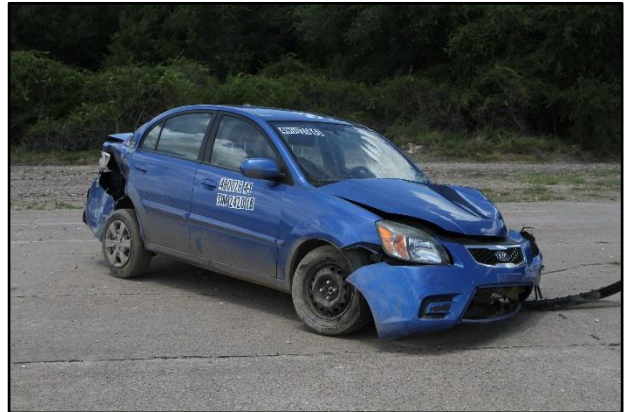
Figure 5-4. Test Vehicle after Test No. 490026-4-1.

Figure 5-4 shows the damage sustained by the vehicle. The front bumper, hood, left front tire and rim, left front strut and tower, left front fender, left front door and window glass, left rear door, left rear quarter panel, and rear bumper were damaged. The windshield was cracked in the left lower corner, and cracks radiated upward and toward the center, and deformation of the windshield was significantly less than 3 inches. Maximum exterior crush to the vehicle was 13.0 inches in the side plane at the left front corner at bumper height. Maximum occupant compartment deformation was 4.0 inches in the left front firewall area near the toe pan. Figure 5-5 shows the interior of the vehicle. Tables C-2 and C-3 in Appendix D1 provide exterior crush and occupant compartment measurements.

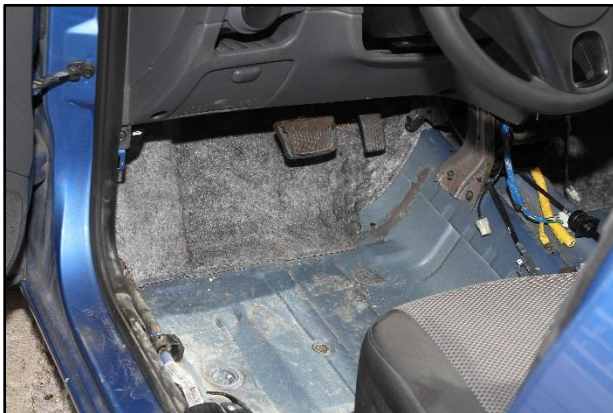
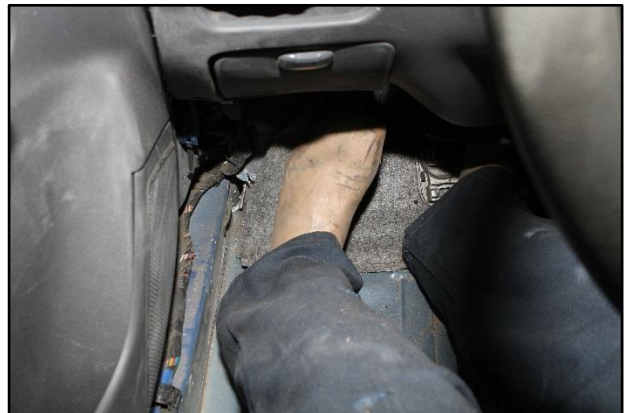
Figure 5-5. Interior of Test Vehicle for Test No. 490026-4-1.

Before Test

After Test

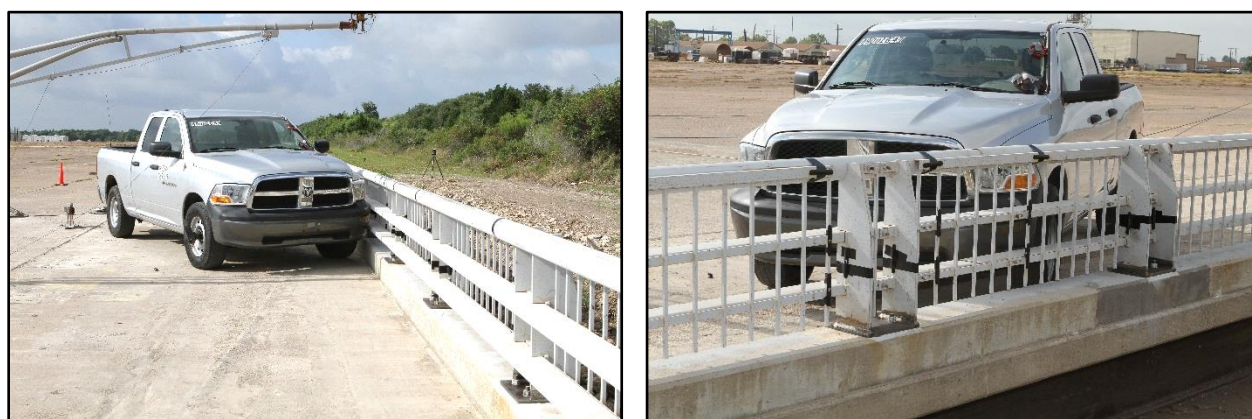
Figure 6-1. TxDOT Type C2P Bridge Rail/Test Vehicle Geometrics for Test No. 490026-4-2.

A 2011 Dodge RAM 1500 pickup truck, shown in Figure 6-1 and Figure 6-2, was used for the crash test. The vehicle's test inertia weight was 5048 lb, and its gross static weight was 5213 lb. The height to the lower edge of the vehicle bumper was 11.75 inches and the height to the upper edge of the vehicle bumper was 26.0 inches. The height to the center of gravity of the vehicle was 28.3 inches. Tables E-1 and E-2 in Appendix E1 give additional dimensions and information on the vehicle. The vehicle was directed into the installation using a cable reverse tow and guidance system, and was released to be freewheeling and unrestrained just prior to impact.

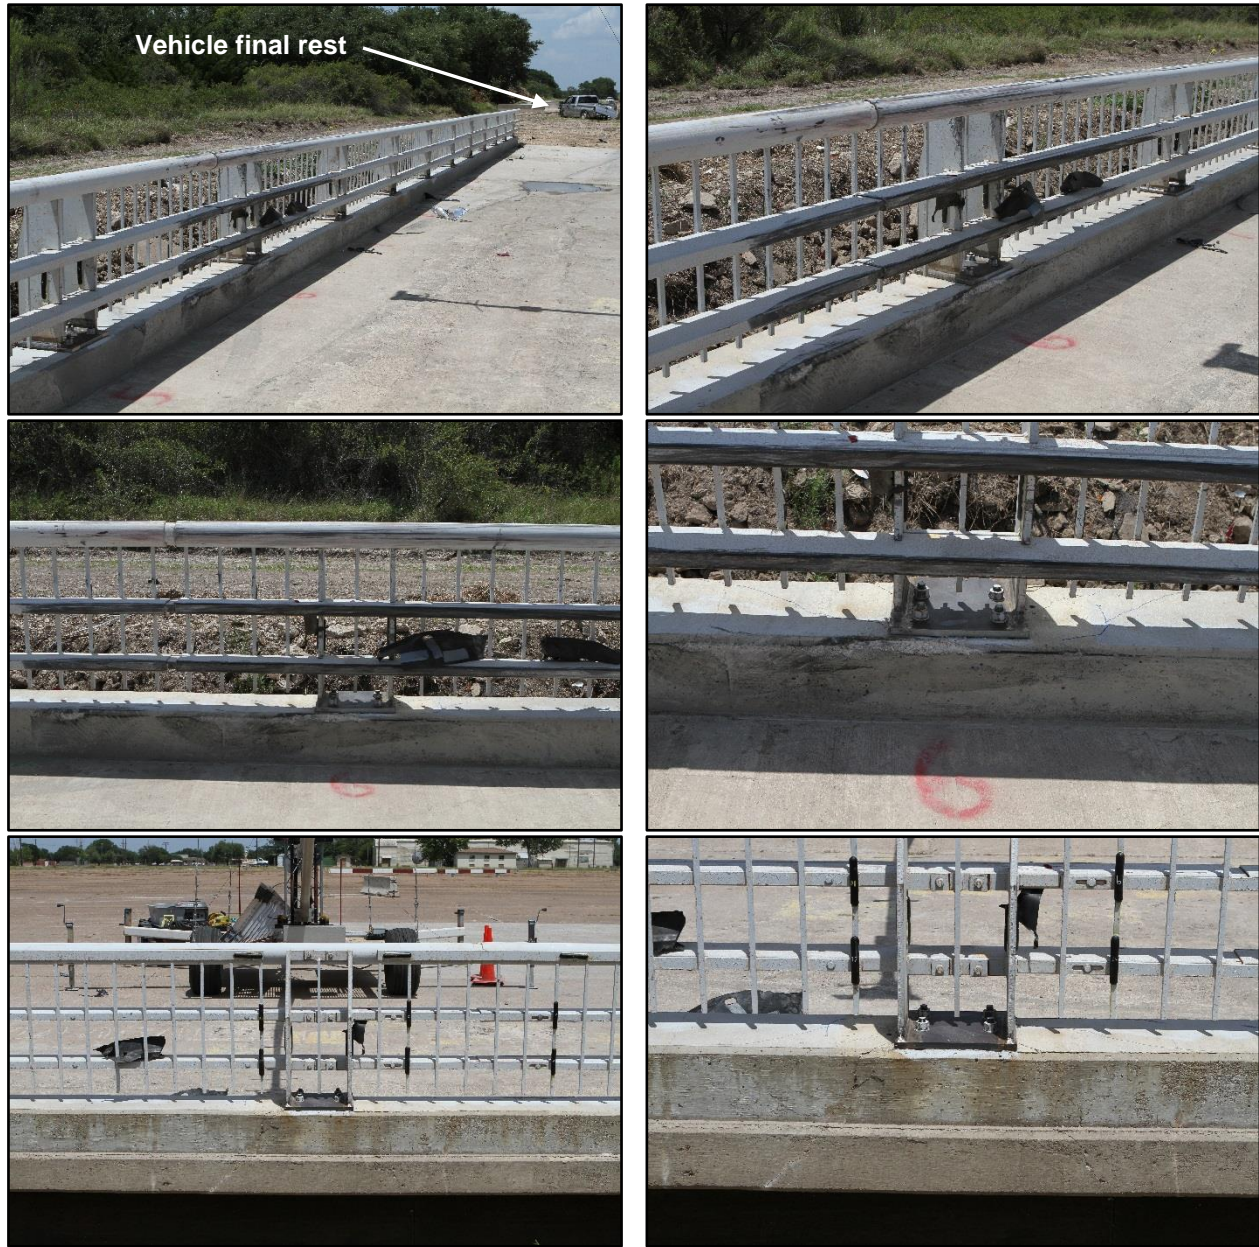
Figure 6-3. TxDOT Type C2P Bridge Rail after Test No. 490026-4-2.

Figure 6-3 shows the damage to the TxDOT Type C2P Bridge Rail. No damage to the posts was noted. Small cracks in the curb radiated from the anchor bolts at post 5, and larger cracks radiated from the anchor bolts at post 6. Working width was 14.0 inches. Maximum dynamic deflection during the test was 2.5 inches, and maximum permanent deformation was 1.4 inches.

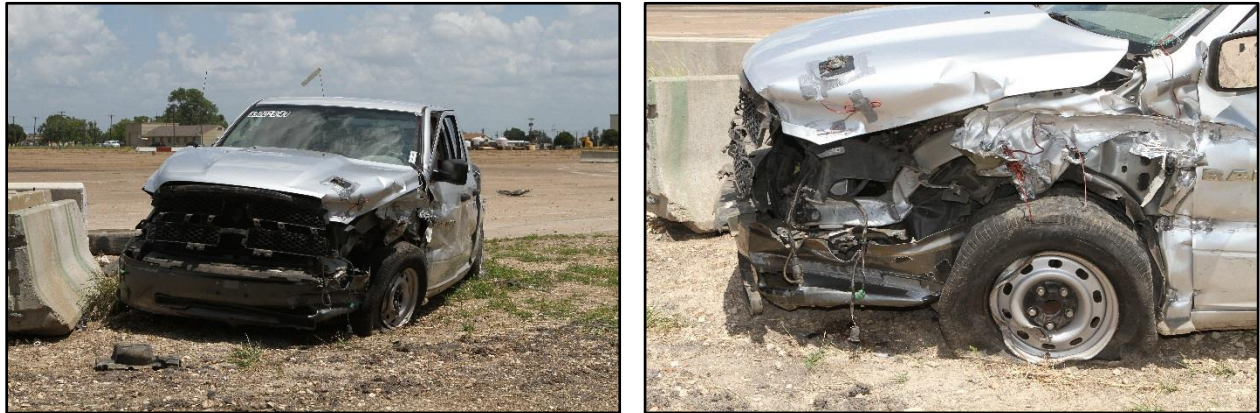
Figure 6-4. Test Vehicle after Test No. 490026-4-2.

Figure 6-4 shows the damage sustained by the vehicle. The front bumper, grill, hood, left front tire and rim, left upper and lower A-arms, left front fender, left front door and window glass, left rear door, left rear cab corner, left rear exterior bed, left rear tire and rim, left rear bumper, and left rear tailgate were damaged. The windshield sustained stress cracks radiating from the lower left corner of the A-pillar, and there was no deformation to the windshield. Maximum exterior crush to the vehicle was 13.0 inches in the side plane at the left front corner at bumper height. Maximum occupant compartment deformation was 2.25 inches in the instrument

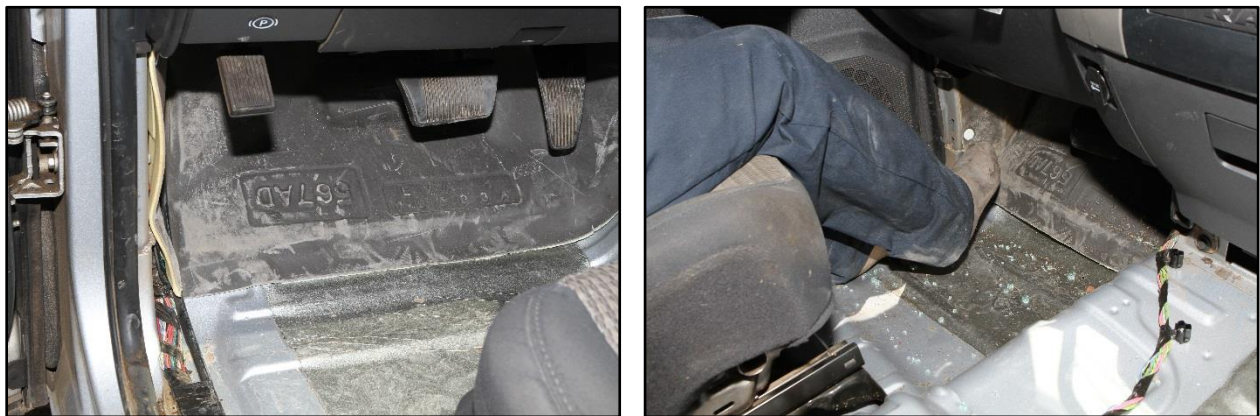
Before Test

After Test

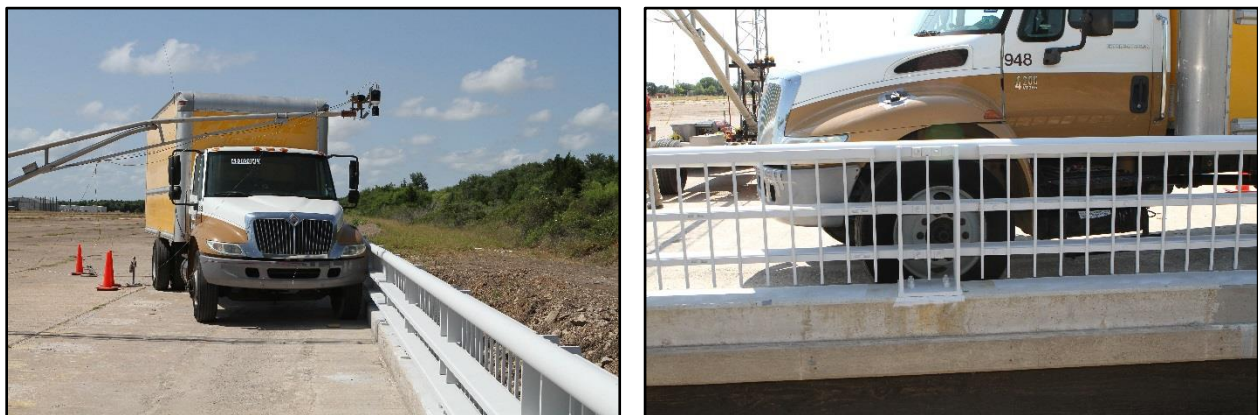
Figure 7-1. TxDOT Type C2P Bridge Rail/Test Vehicle Geometrics for Test No. 490026-4-3.

A 2004 International 4200 single-unit box van truck, shown in Figure 7-1 and Figure 7-2, was used for the crash test. Test inertia weight of the test vehicle was 22,220 lb, and its gross static weight was 22,385 lb. The height to the lower edge of the vehicle front bumper was 19.25 inches and height to the upper edge of the vehicle front bumper was 34.0 inches. Table F-1 in Appendix F1 gives additional dimensions and information on the vehicle. The vehicle was directed into the installation using a cable reverse tow and guidance system, and was released to be freewheeling and unrestrained just prior to impact.

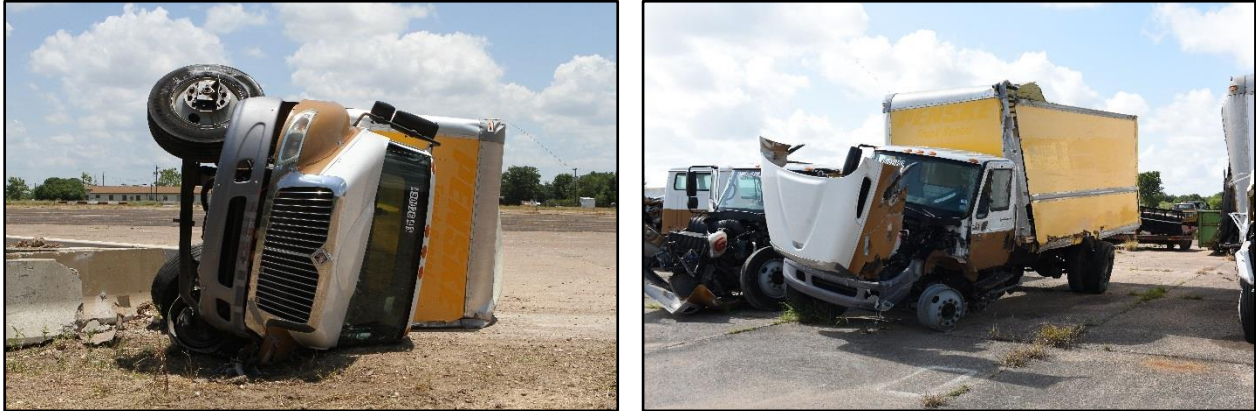
Figure 7-4. Test Vehicle after Test No. 490026-4-3.

Figure 7-4 shows the damage sustained by the vehicle. The front bumper, hood, left front tire and rim, left battery box, left steps, left door and vent glass, left side of the cargo box, left rear outer tire and rim, and roof were damaged. The windshield sustained stress cracks during the test, and there was no deformation to the windshield. Maximum exterior crush to the vehicle was 14.0 inches in the side plane at the left front corner at bumper height. No occupant compartment deformation was noted. Figure 7-5 shows the interior of the vehicle.

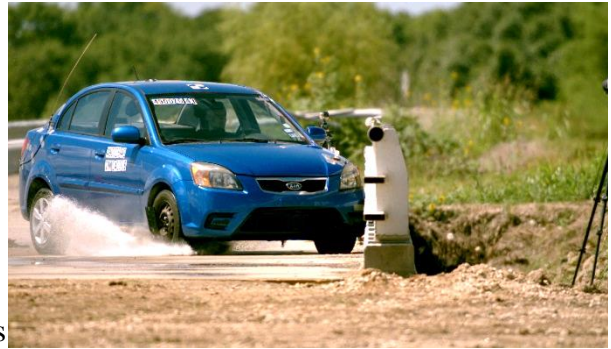
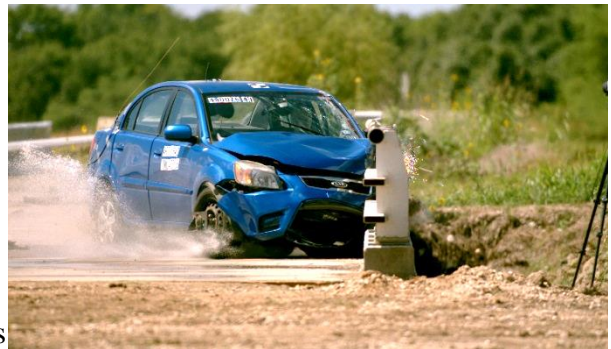
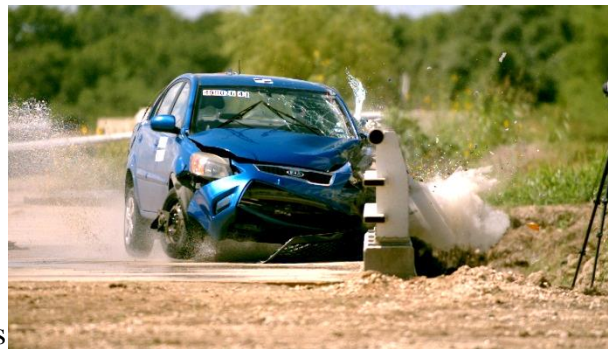
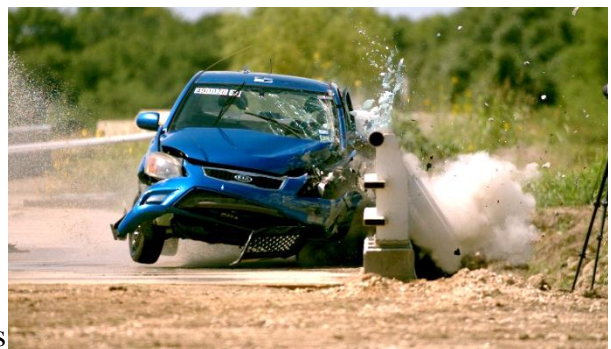
Figure D-1. Sequential Photographs for Test No. 490026-4-1 (Overhead and Frontal Views).

0.000 s

0.060 s

0.120 s

0.180 s

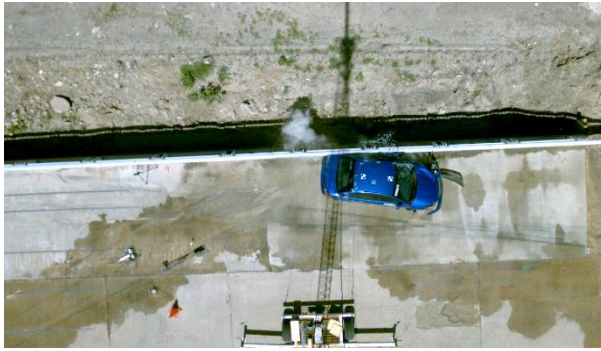
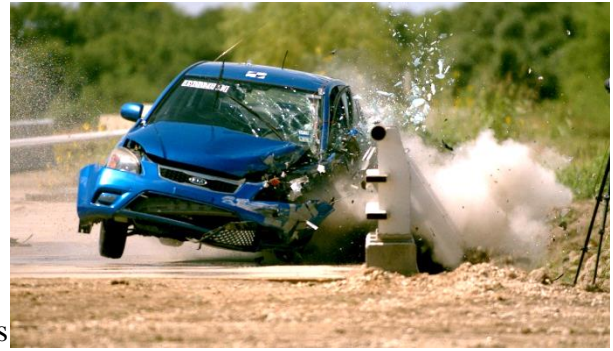
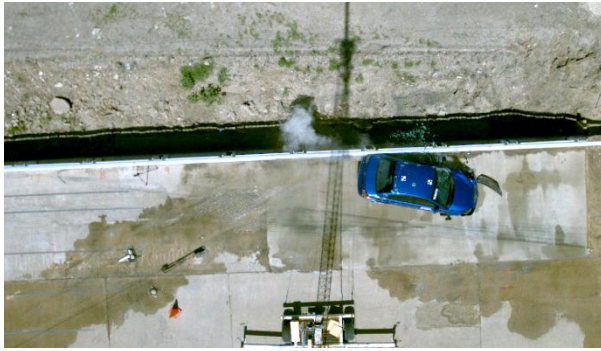
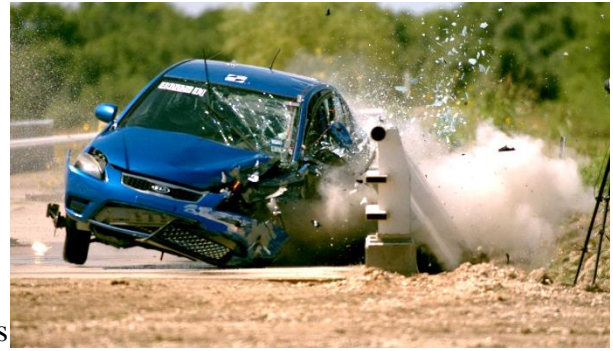
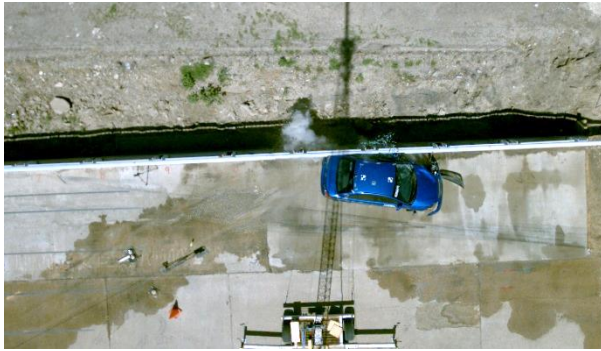
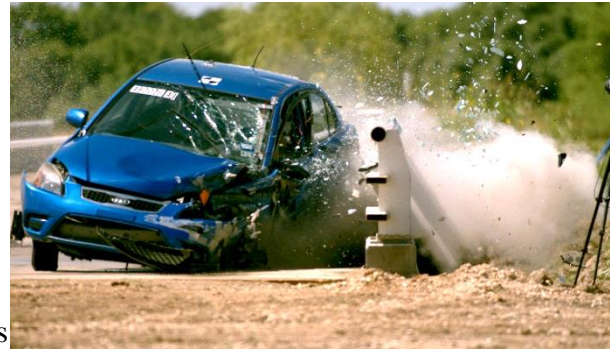
Figure D-1. Sequential Photographs for Test No. 490026-4-1 (Overhead and Frontal Views) (Continued).

0.240 s

0.300 s

0.360 s

0.420 s

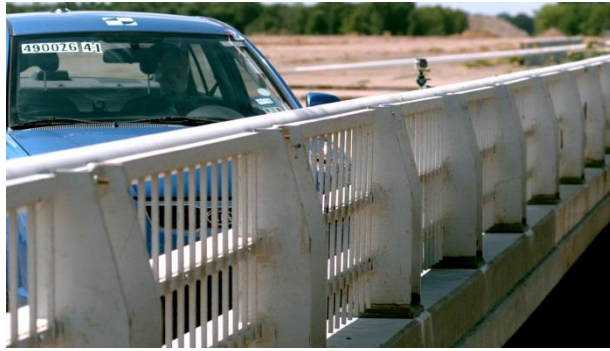
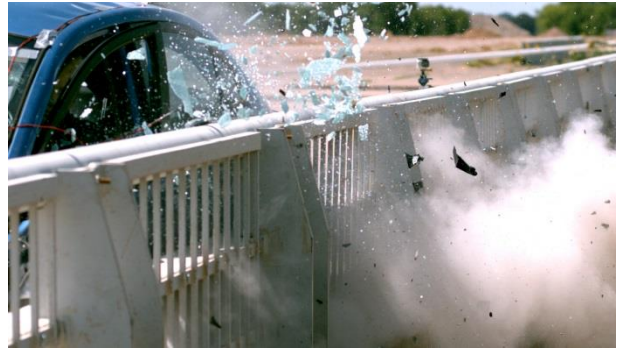
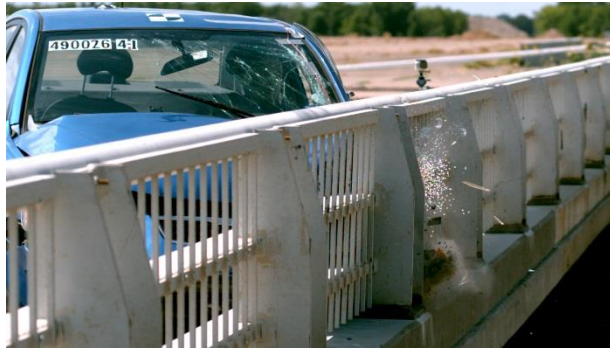
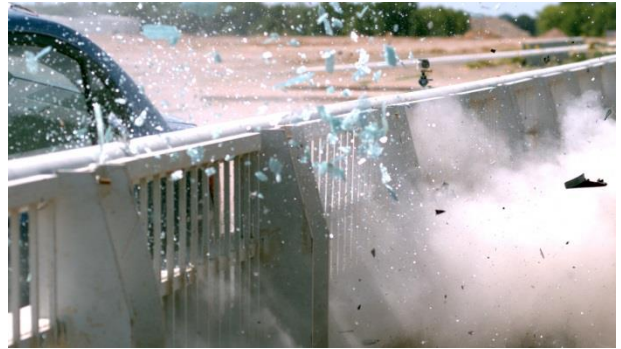
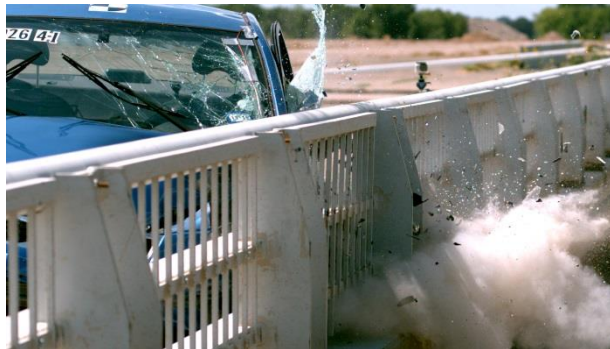
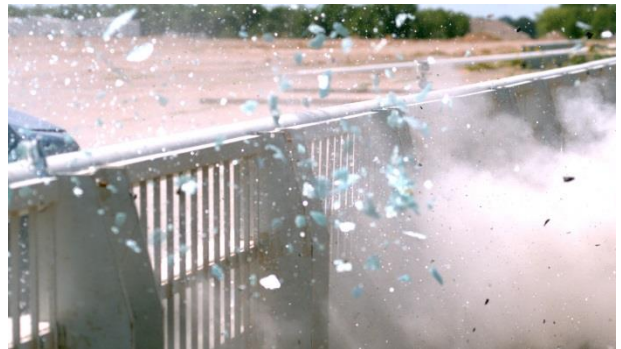
Figure D-2. Sequential Photographs for Test No. 490026-4-1 (Rear View).

0.000 s

0.240 s

0.060 s

0.300 s

0.120 s

0.360 s

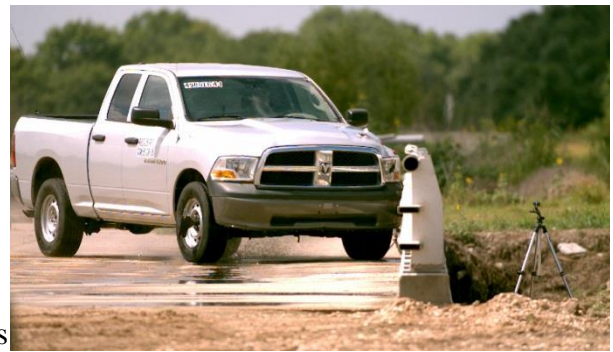
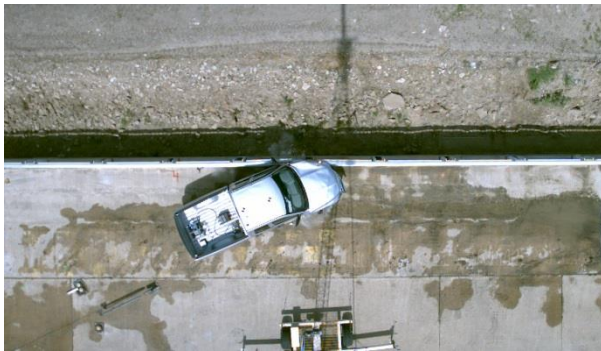
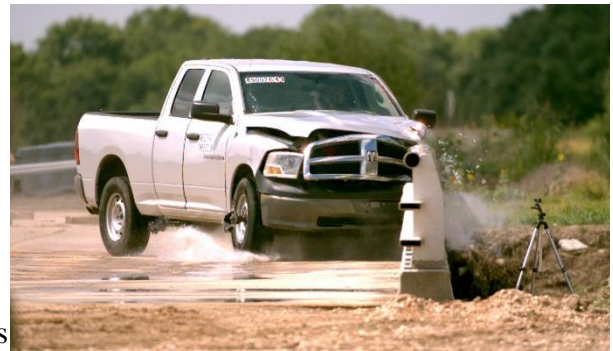
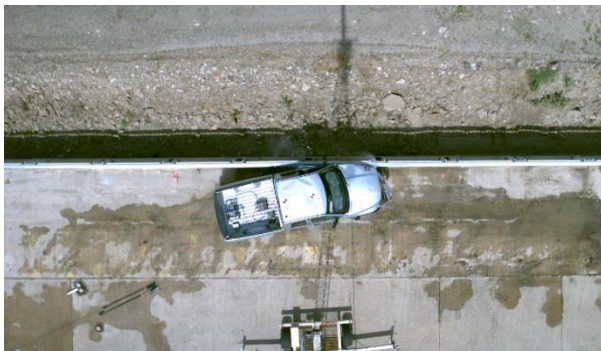
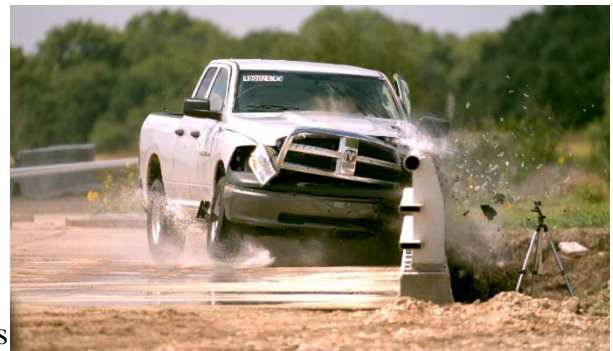
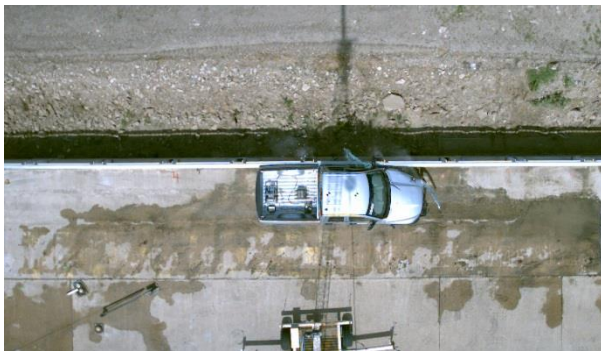
Figure E-1. Sequential Photographs for Test No. 490026-4-2 (Overhead and Frontal Views).

0.000 s

0.060 s

0.120 s

0.180 s

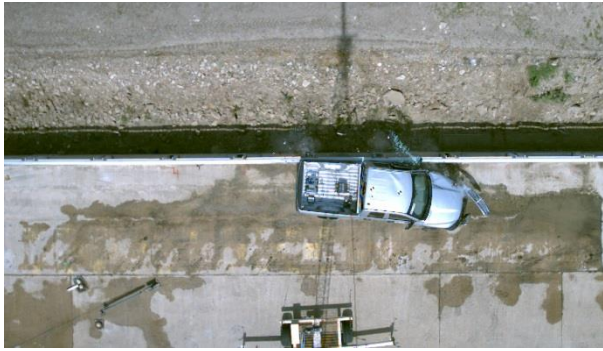
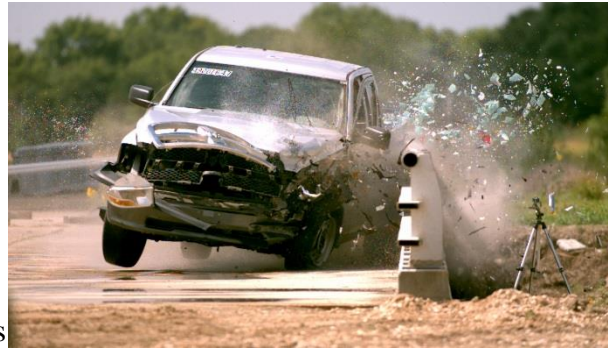
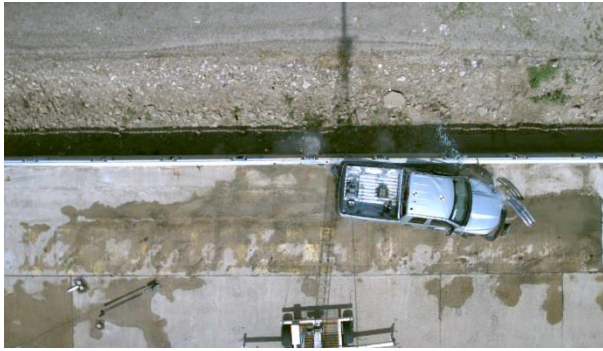
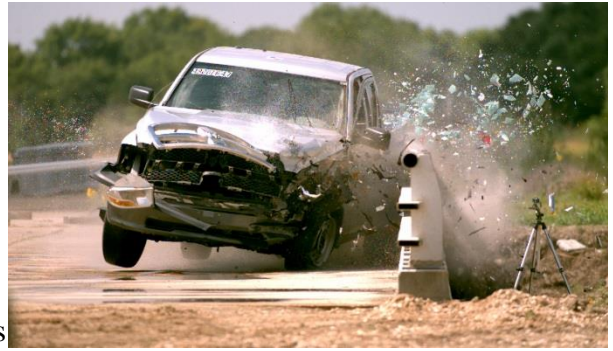
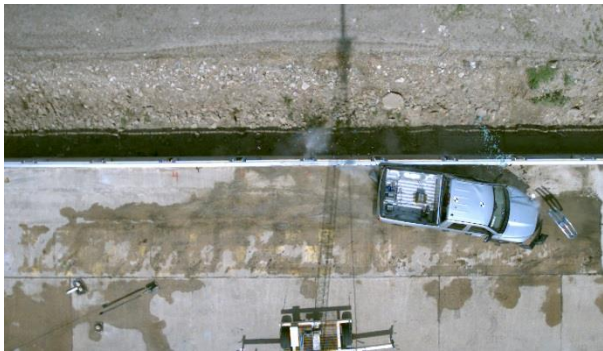
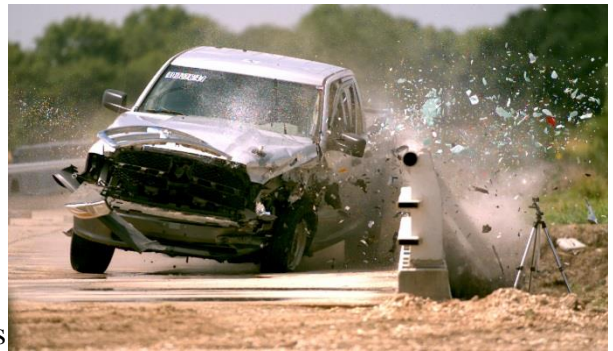
Figure E-1. Sequential Photographs for Test No. 490026-4-2 (Overhead and Frontal Views) (Continued).

0.240 s

0.300 s

0.360 s

0.420 s
