# **MASH TEST 3-11 OF THE TxDOT SINGLE SLOPE BRIDGE RAIL (TYPE SSTR) ON PAN-FORMED BRIDGE DECK**

## **Research/Test Report 9-1002-3**

**TEXAS TRANSPORTATION INSTITUTE  
THE TEXAS A&M UNIVERSITY SYSTEM  
COLLEGE STATION, TEXAS**

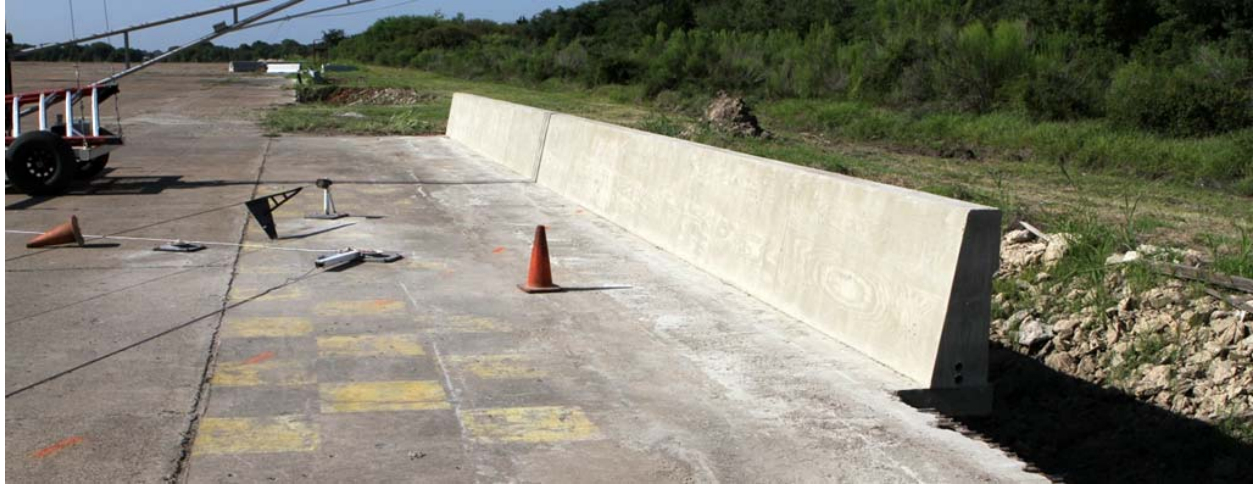
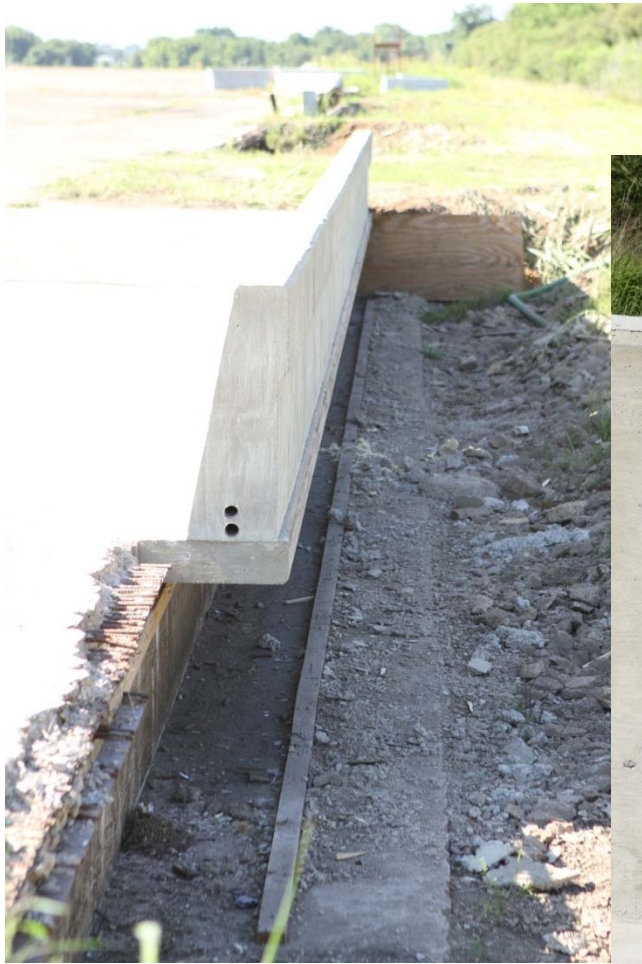
**Figure 2.2. TxDOT Pan-Formed Bridge Rail Installation before Test No. 420020-3.**

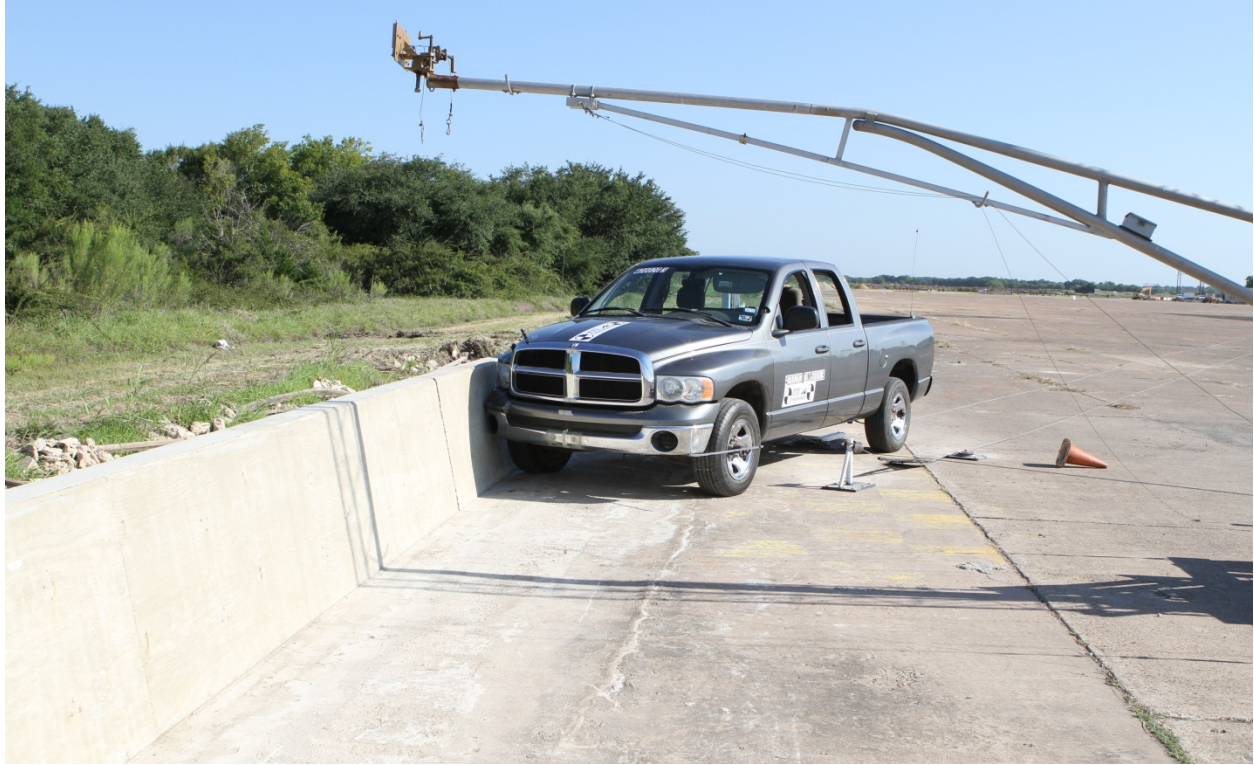
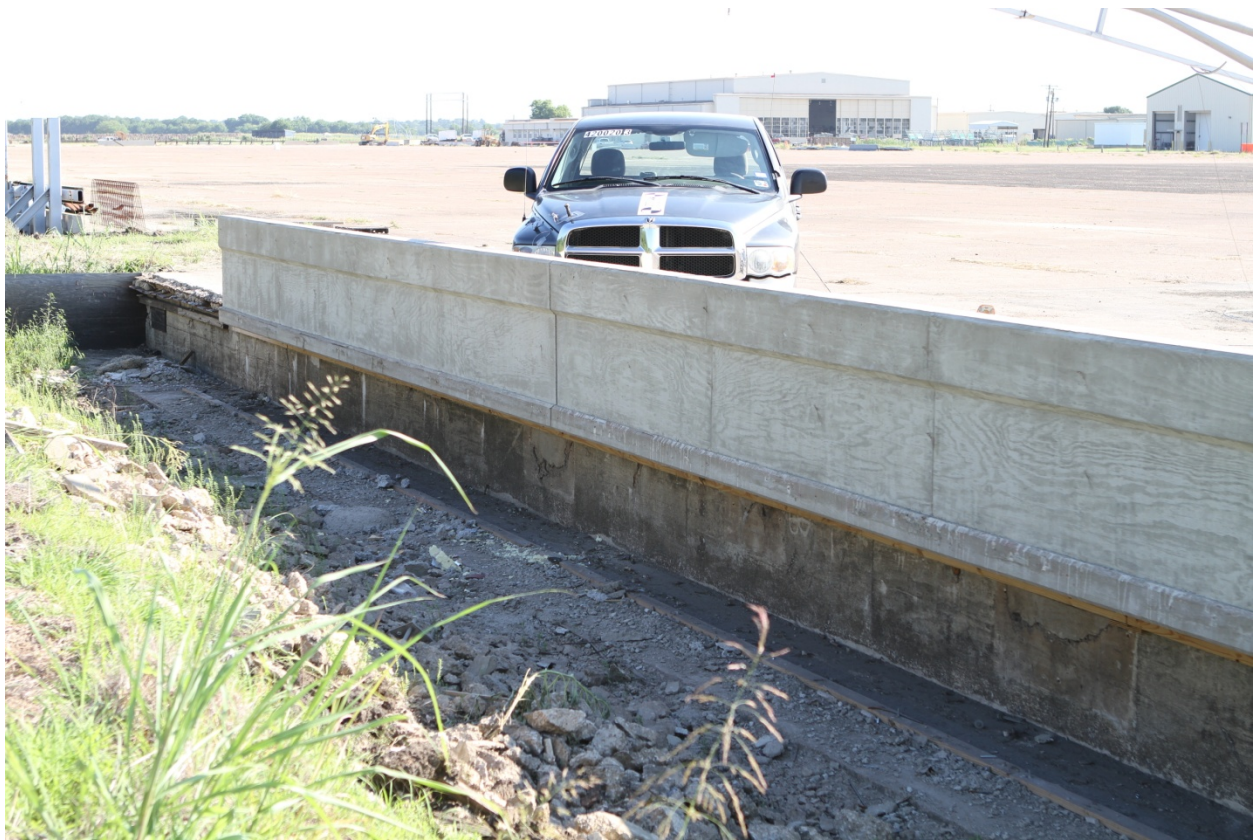
**Figure 5.1. Vehicle/Installation Geometrics for Test No. 420020-3.**

The 2270P vehicle, traveling at an impact speed of 63.8 mi/h, impacted the TxDOT pan-formed bridge rail with the right front corner of the bumper 5.2 ft upstream of the joint centerline in the TxDOT Type SSTR bridge rail at an impact angle of 24.8 degrees. Shortly after impact, the right front tire contacted the bridge rail, and the vehicle began redirection at 0.074 s after impact. The vehicle was traveling parallel with the bridge rail at 0.189 s, and was traveling at a speed of 50.6 mi/h. At 0.430 s, the 2270P vehicle lost contact with the bridge rail, traveling at an exit speed and angle of 49.5 mi/h and 7.2 degrees, respectively. Brakes on the vehicle were applied at 1.2 s after impact. The vehicle subsequently came to rest 170 ft downstream and 6 ft toward traffic lanes. [Figures D1](#) and [D2](#) in [Appendix D](#) show sequential photographs of the test period.

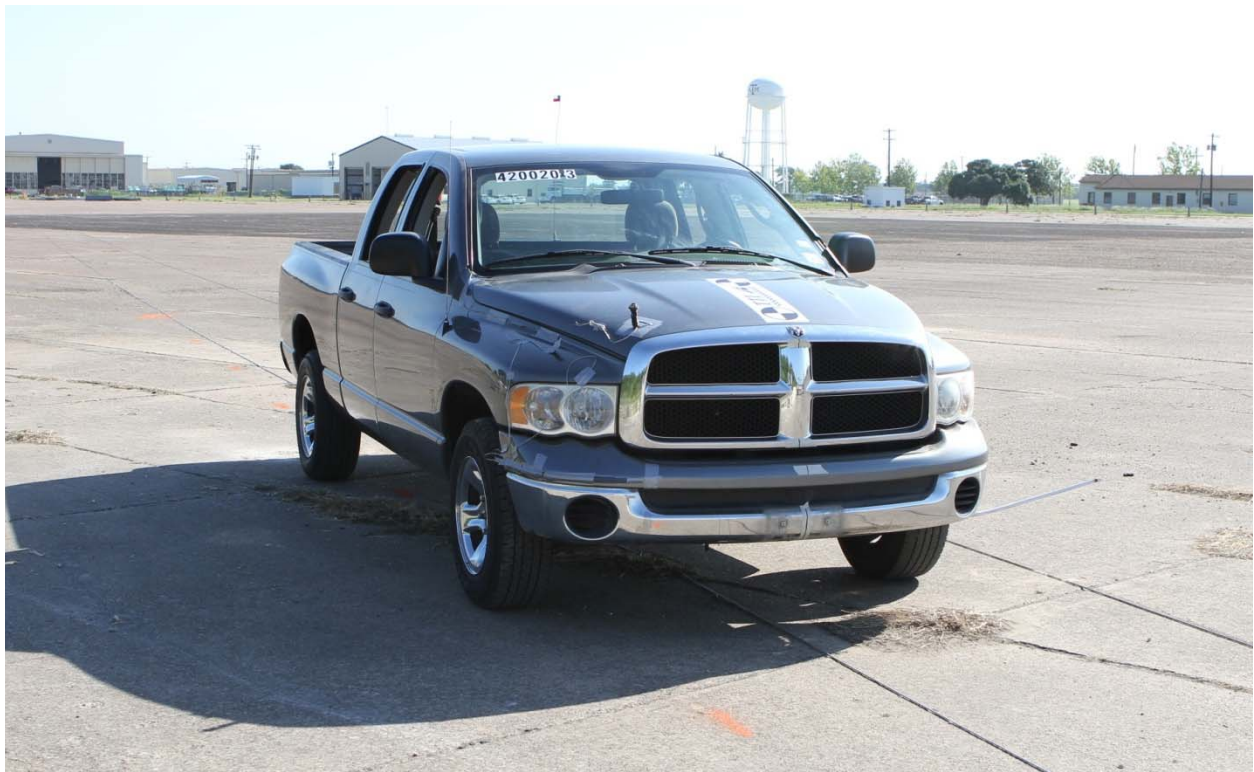
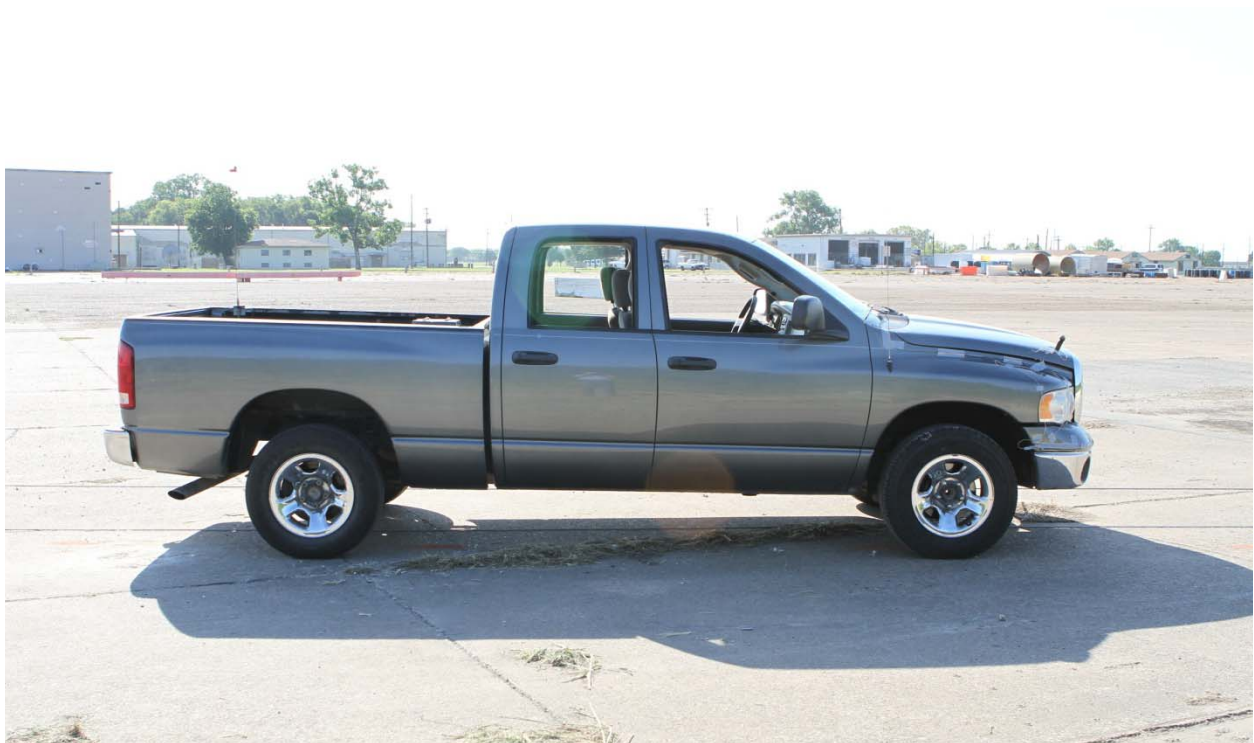
**Figure 5.2. Vehicle before Test No. 420020-3.**

A 2005 Dodge Ram 1500 Quad-Cab pickup, shown in [Figures 5.1](#) and [5.2](#), was used for the crash test. Test inertia weight of the vehicle was 5036 lb, and its gross static weight was 5036 lb. The height to the lower edge of the vehicle bumper was 13.5 inches, and it was 26.00 inches to the upper edge of the bumper. The height of the vertical center of gravity was measured at 28.38 inches. [Figure C1](#) in [Appendix C](#) gives additional dimensions and information on the vehicle. The vehicle was directed into the installation using the cable reverse tow and guidance system, and was released to be free-wheeling and unrestrained just prior to impact.

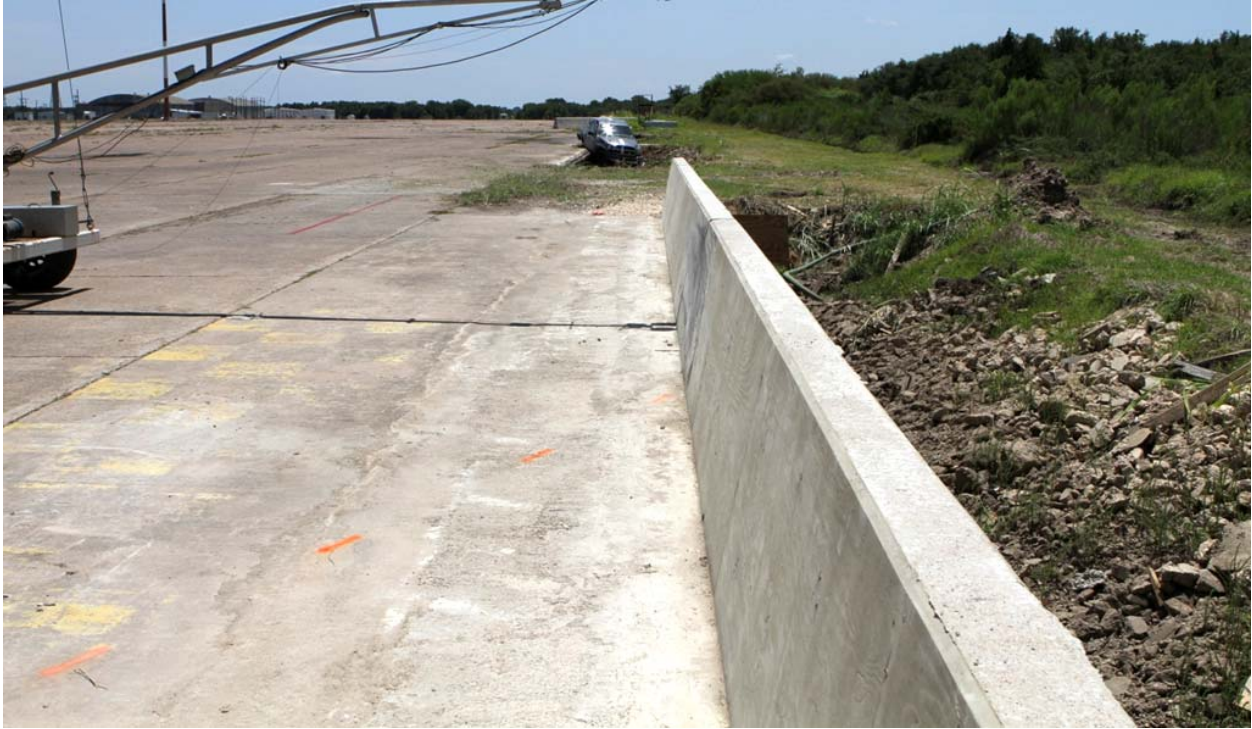
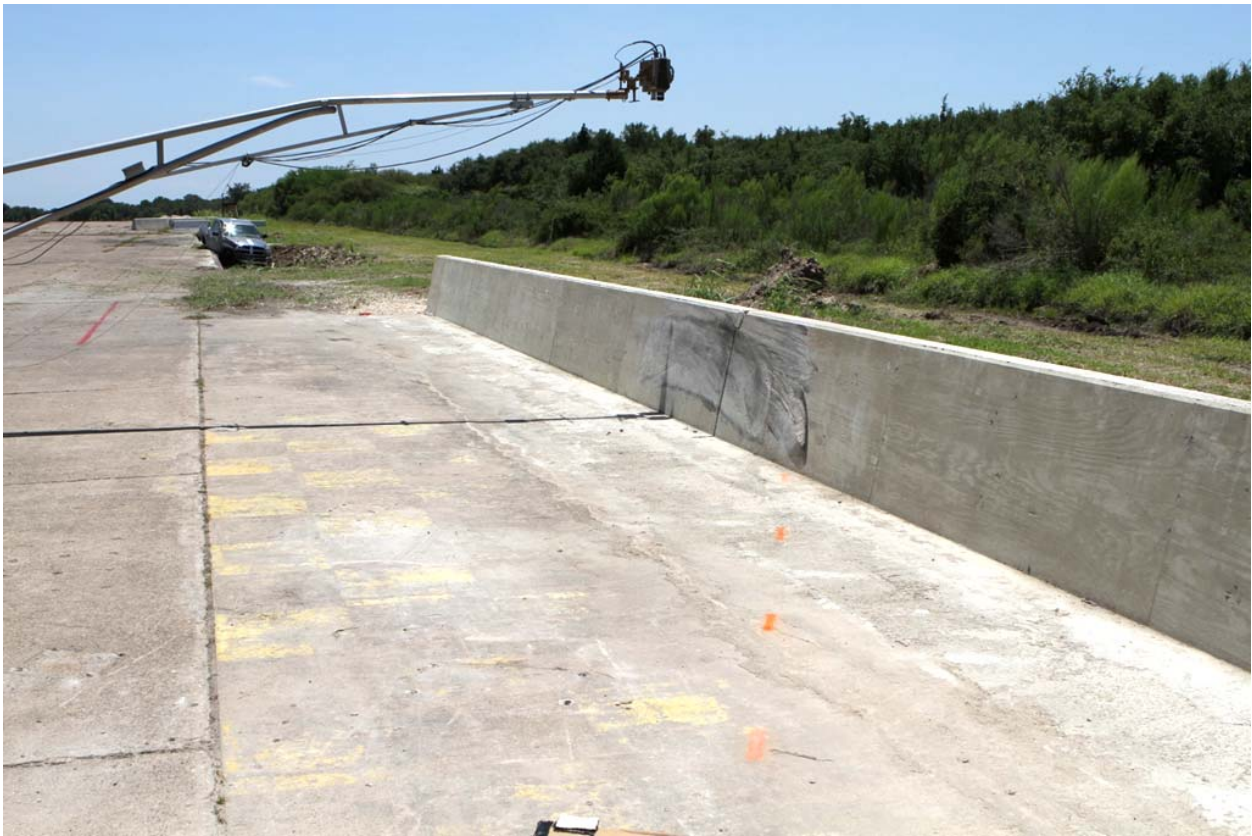
**Figure 5.3. After Impact Vehicle Position for Test No. 420020-3.**

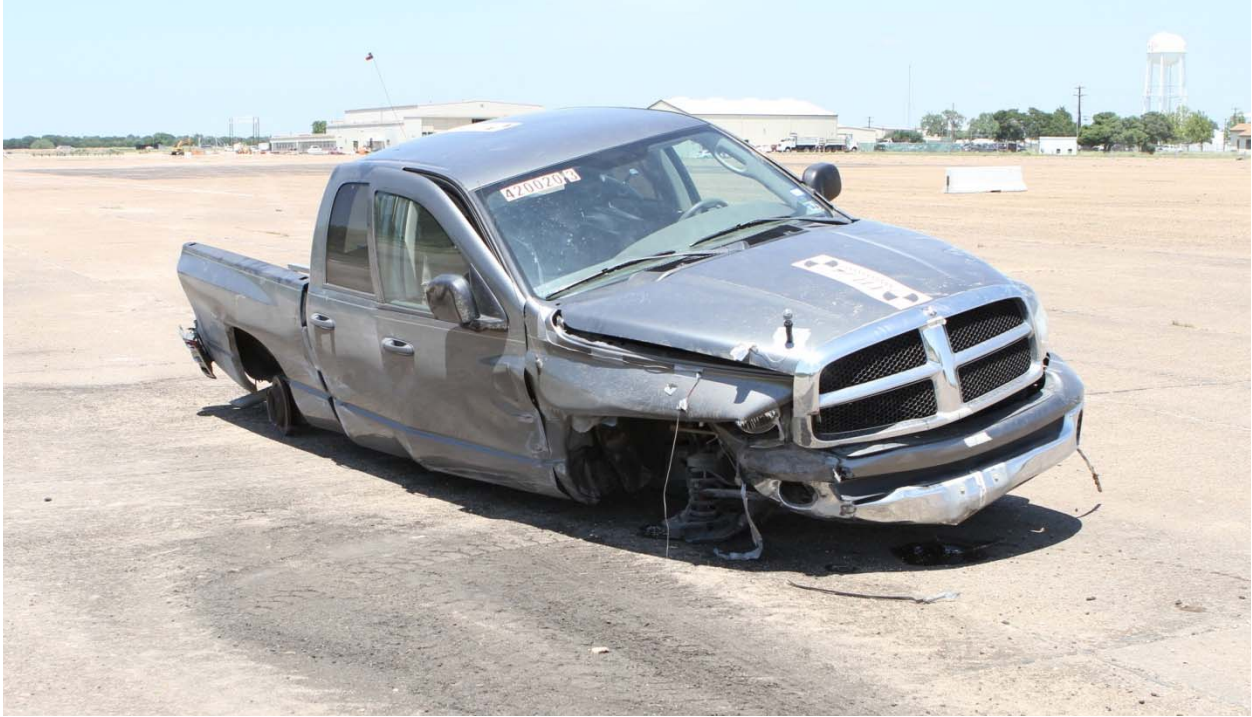
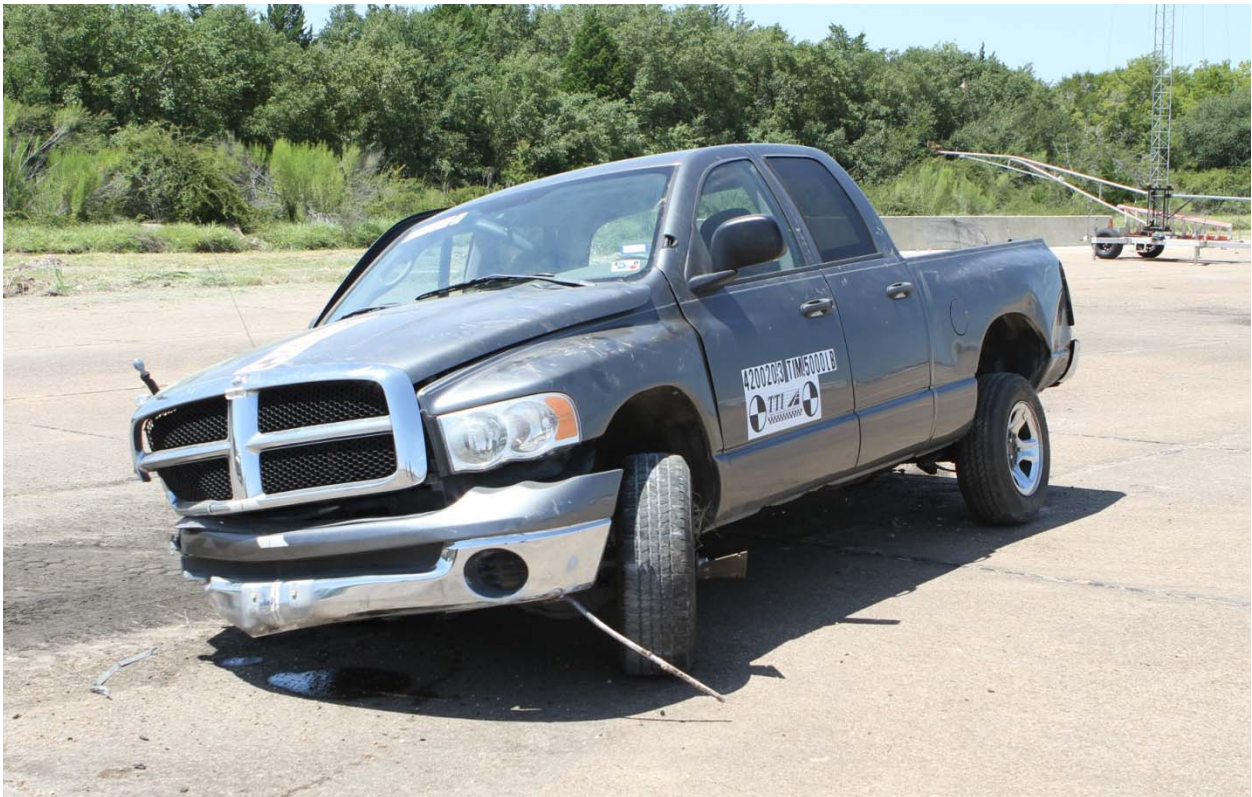
The vehicle sustained damage to the right front quarter and right side, as shown in Figure 5.5. The right upper and lower ball joints, right front frame rail, right front upper and lower A-arms and right rear axle were damaged. Also deformed were the front bumper, hood, grill, right front fender, right front door, right rear door, right rear cab, right rear exterior bed, rear bumper, and tail gate. The right front wheel assembly, tire, and wheel rim separated from the vehicle, and the right rear tire and rim and part of the wheel assembly separated from the vehicle. The windshield sustained stress cracks. Maximum exterior crush to the vehicle in the side plane at the right front corner at bumper height was 18.0 inches. Maximum occupant compartment deformation was 2.75 inches in the firewall area near the toe pan on the right front passenger area. Figure 5.6 shows photographs of the interior of the vehicle. Exterior crush and occupant compartment deformation is provided in Appendix C, Tables C1 and C2.

**Figure 5.5. Vehicle after Test No. 420020-3.**

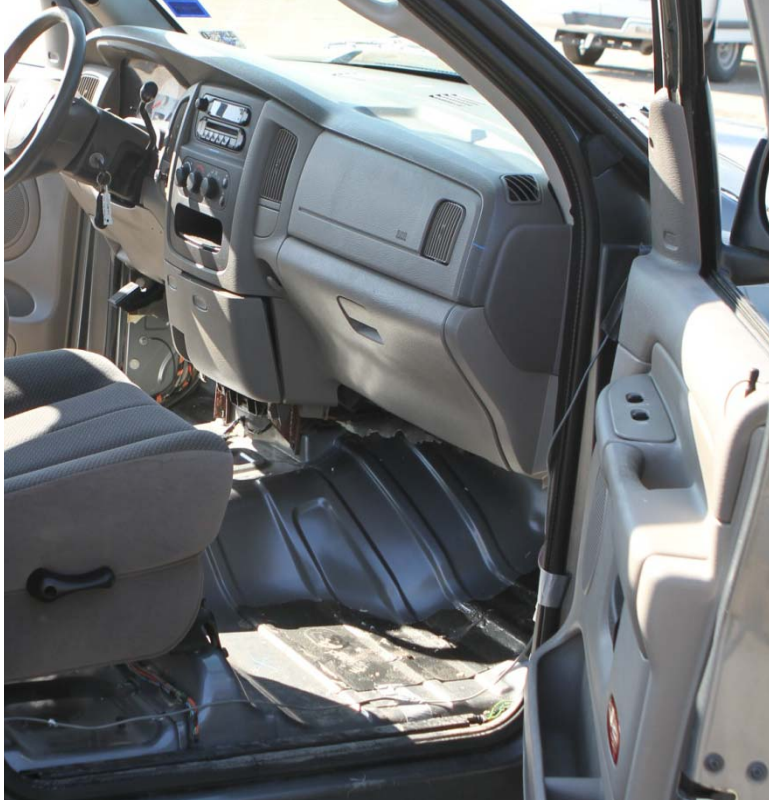
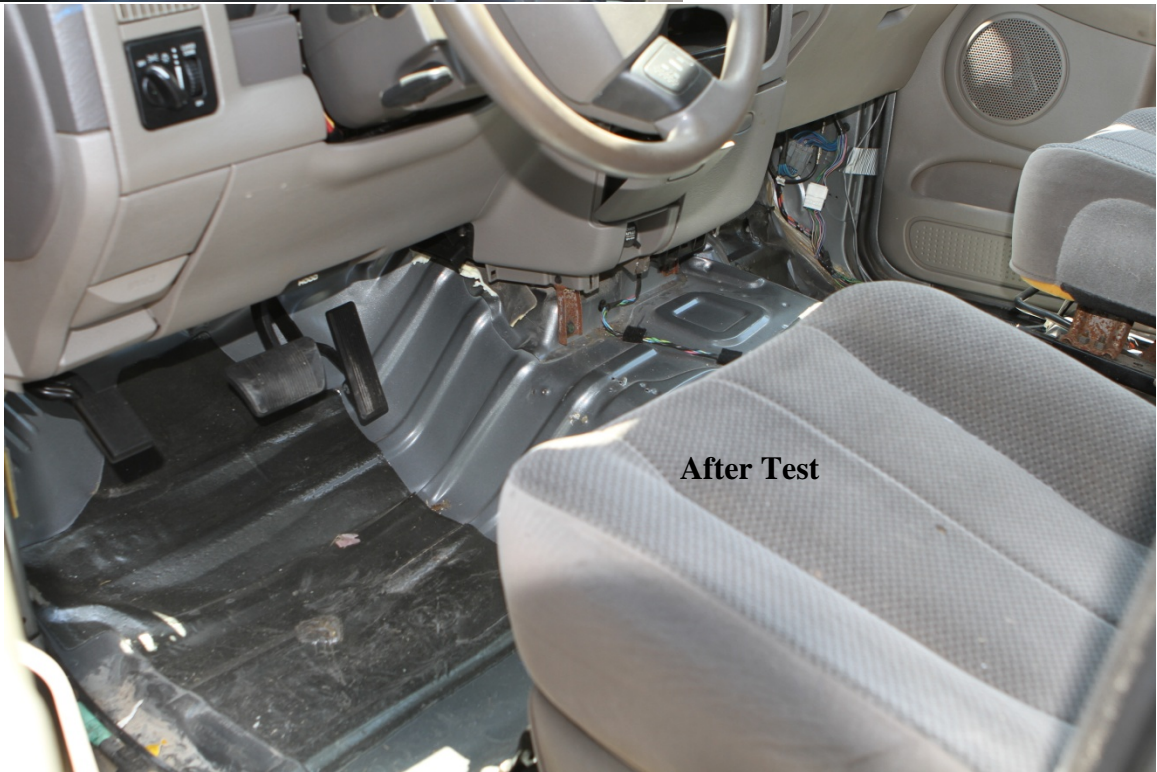
**Figure 5.6. Interior of Vehicle for Test No. 420020-3.**

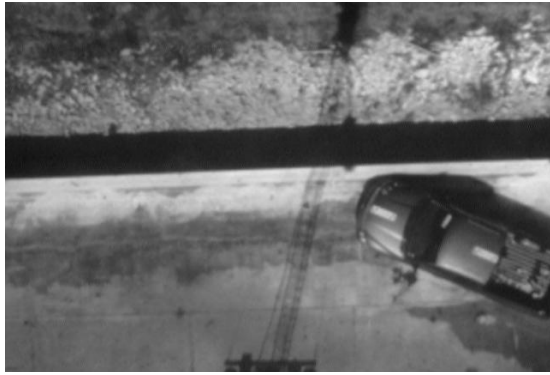
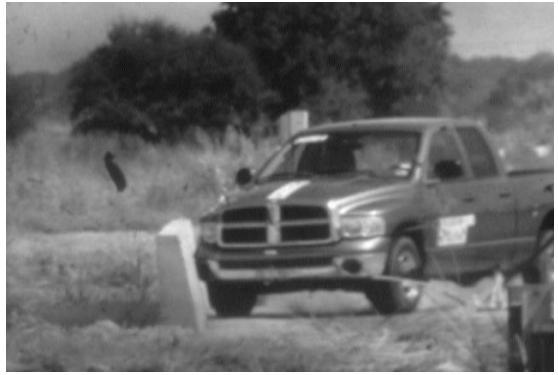
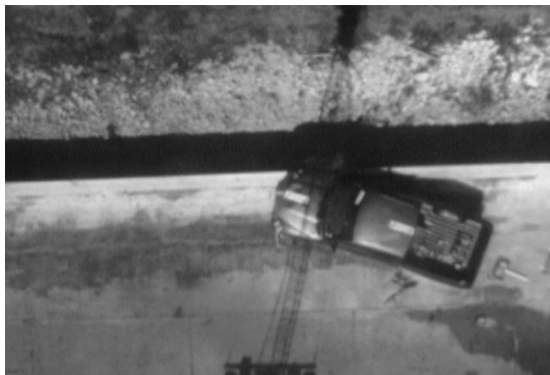
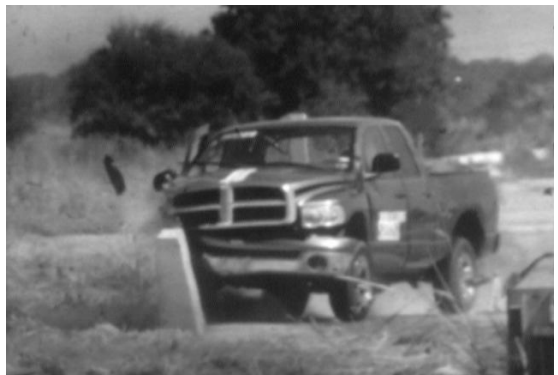
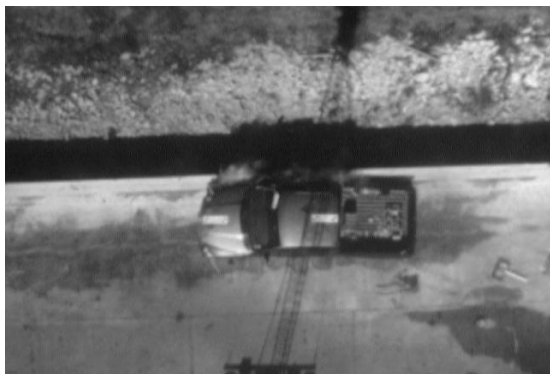
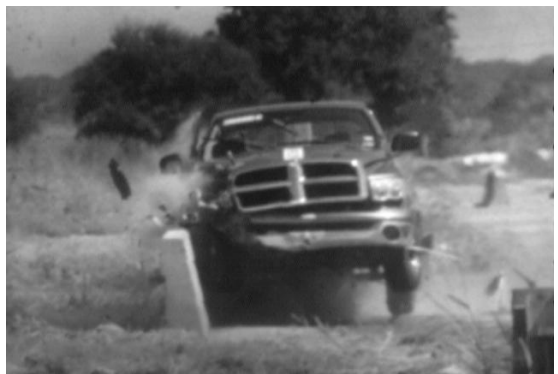
**Figure D1. Sequential Photographs for Test No. 420020-3  
(Overhead and Frontal Views).**

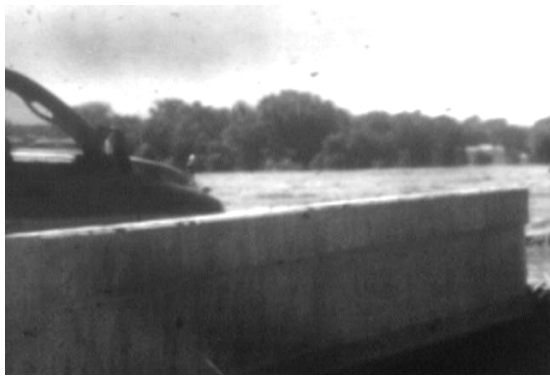
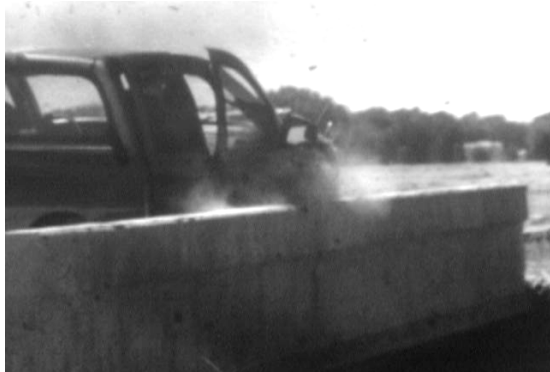
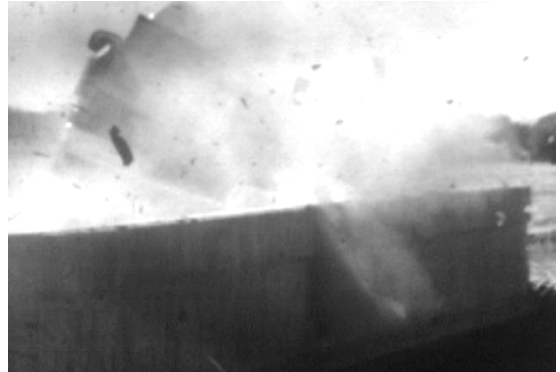
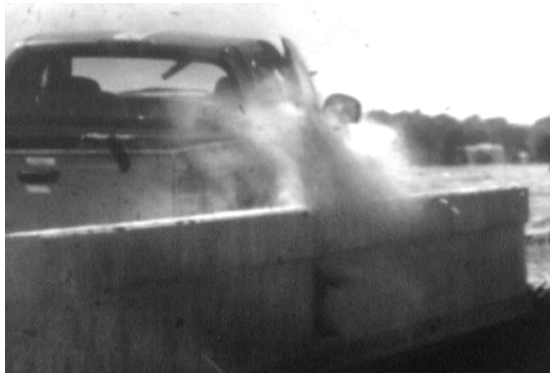
**Figure D2. Sequential Photographs for Test No. 420020-3  
(Rear View).**

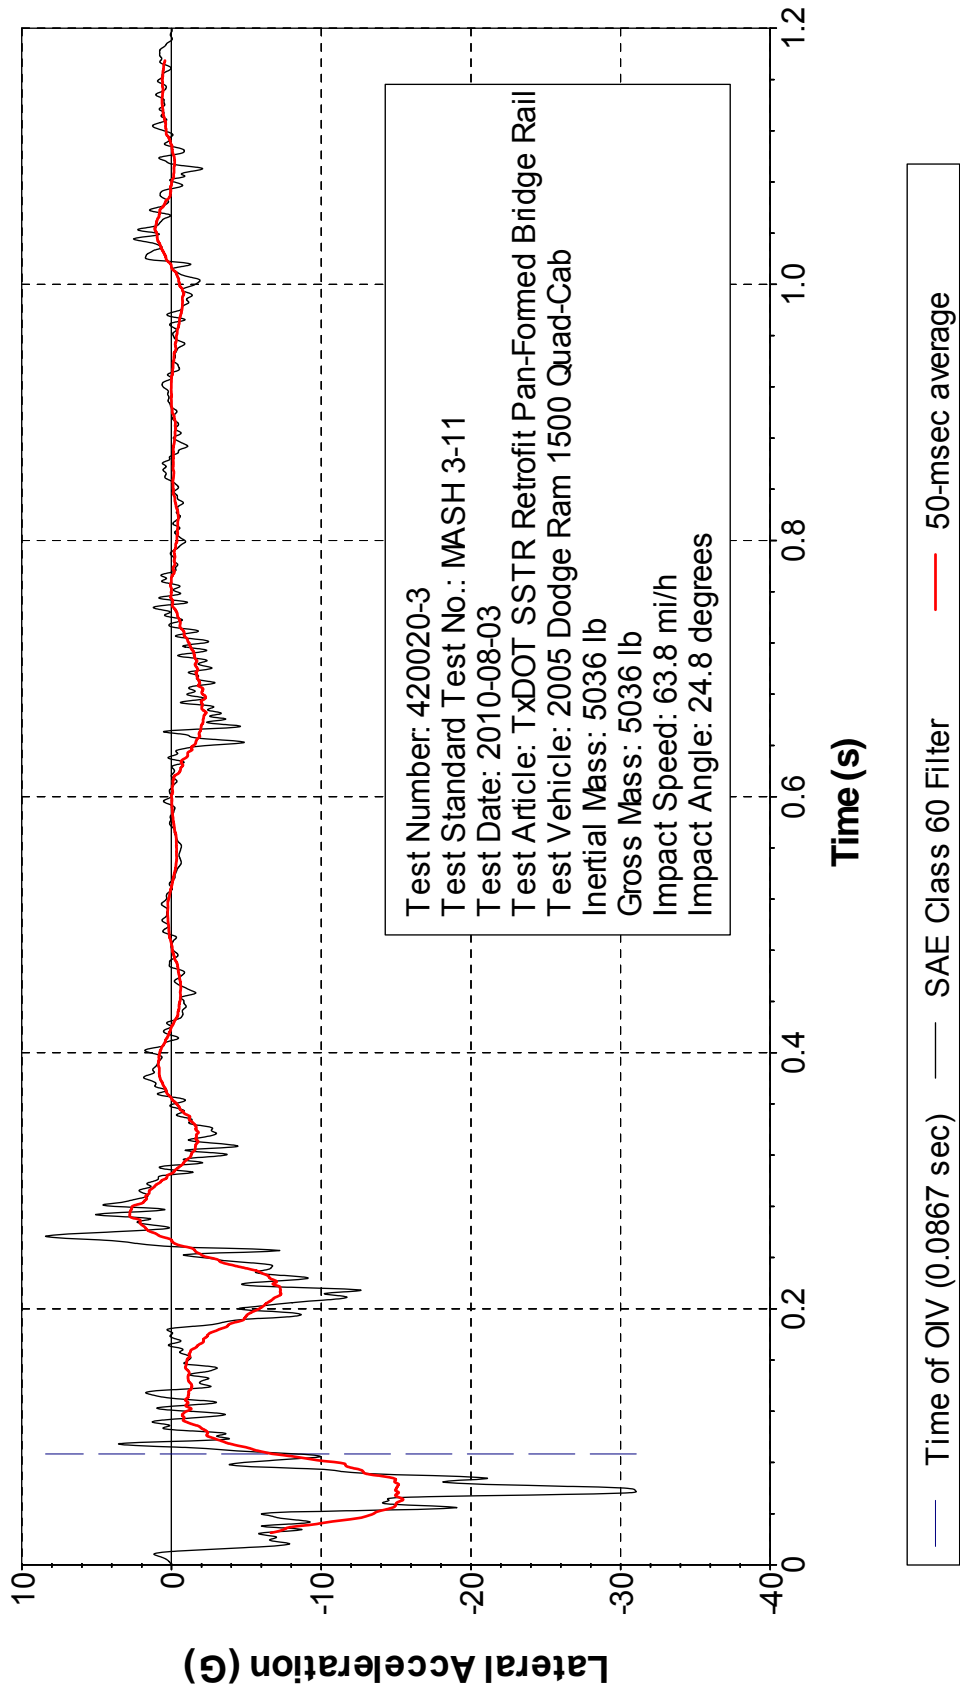
Figure E3. Vehicle Lateral Accelerometer Trace for Test No. 420020-3 (Accelerometer Located at Center of Gravity).
