***MASH TEST 3-37 OF THE TxDOT
31-INCH W-BEAM DOWNSTREAM
ANCHOR TERMINAL***

Test Report 9-1002-6
Cooperative Research Program

Report 9-1002-6
Project 9-1002
Project Title: Roadside Safety Device Crash Testing Program

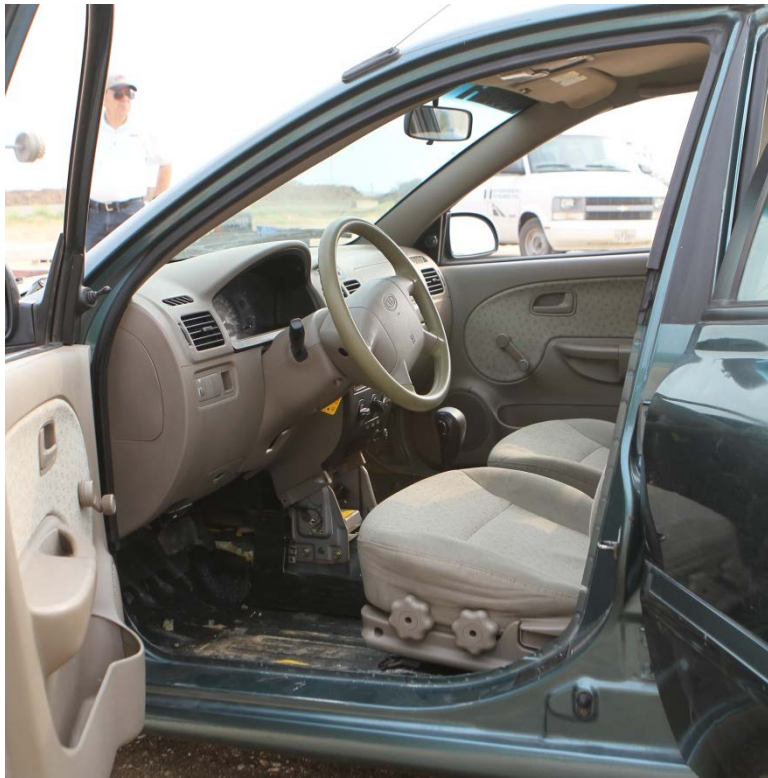
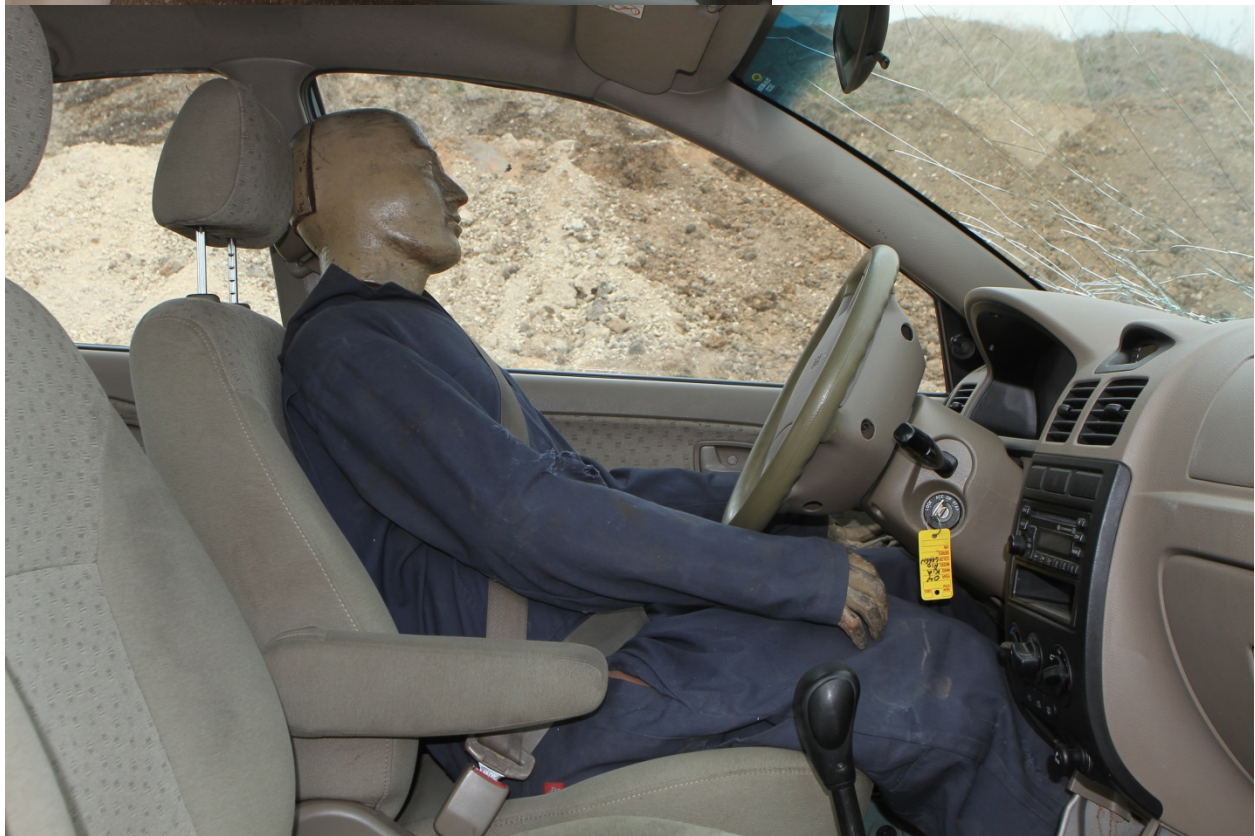
Figure 5.6. Interior of Vehicle for Test No. 420021-1.

Before Test

After Test

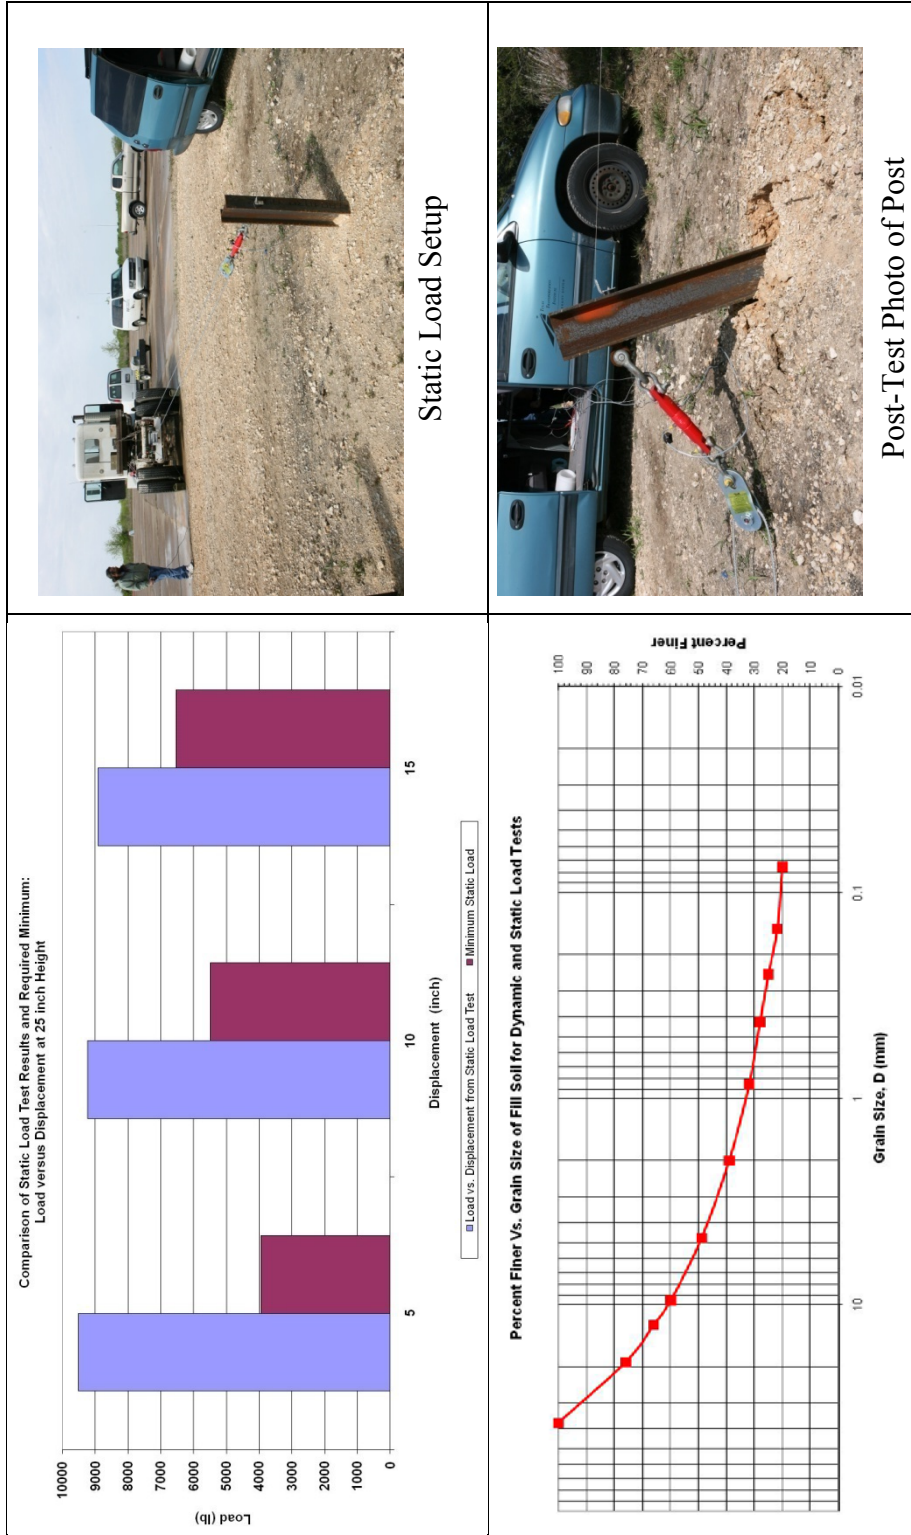
Date 2011-04-20

Fill Material Description (ASTM D2487) and sieve analysis AASHTO Grade B Soil-Aggregate (see sieve analysis)

Description of Fill Placement Procedure 6-inch lifts tamped with a pneumatic compactor

In accordance with [Appendix B](#) of *MASH*, soil strength was measured on the day of the crash test (see [Appendix C](#), [Figure C1](#)). During construction of the TxDOT 31-inch W-Beam Downstream Anchor Terminal for the full-scale crash test, two W6×16 posts were installed in the
