MASH TEST 3-11 ON THE 5-INCH CAST IN PLACE DECK BARRIER ANCHORS

Test Report 9-1002-7

Report 9-1002-7
Project 9-1002
Project Title: Roadside Safety Device Crash Testing Program

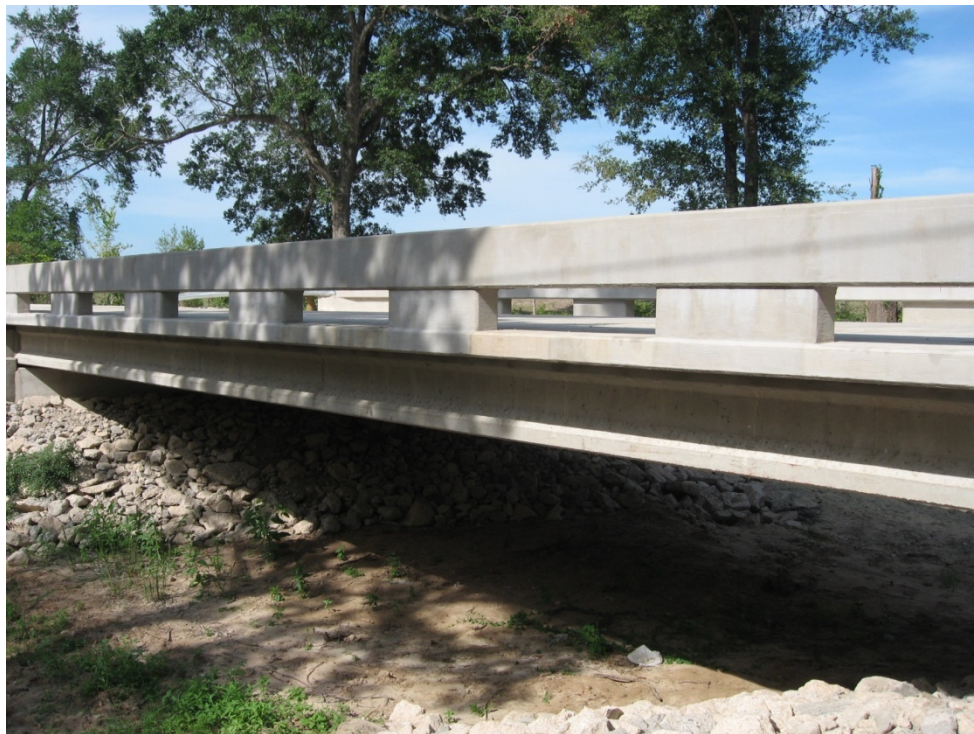
Figure 2.1. TxDOT T223 Barrier.

After evaluation of TxDOT's current barrier standards, only the T223 barrier, shown in [Figure 2.1](#), fits these constraints. This barrier profile is also the primary concrete barrier used by TxDOT in these locations. The selected T223 barrier also provides a worst case for anchorage failure in the event of a vehicle impact when compared to other concrete barrier profiles in TxDOT's current design standards. The narrow thickness and width of the support posts in the T223 design standard provide for a worst case from an anchorage standpoint. The narrow thickness increases the pullout load on the rebar anchors by reducing the moment couple formed by the compression zone of the concrete post and the tension developed in the rebar anchor. The narrow width of the posts localizes the rebar anchors to discrete locations as opposed to being spread along the entire length of the barrier as in a continuous F-shape profile. This again results in an increased load in the rebar anchors.

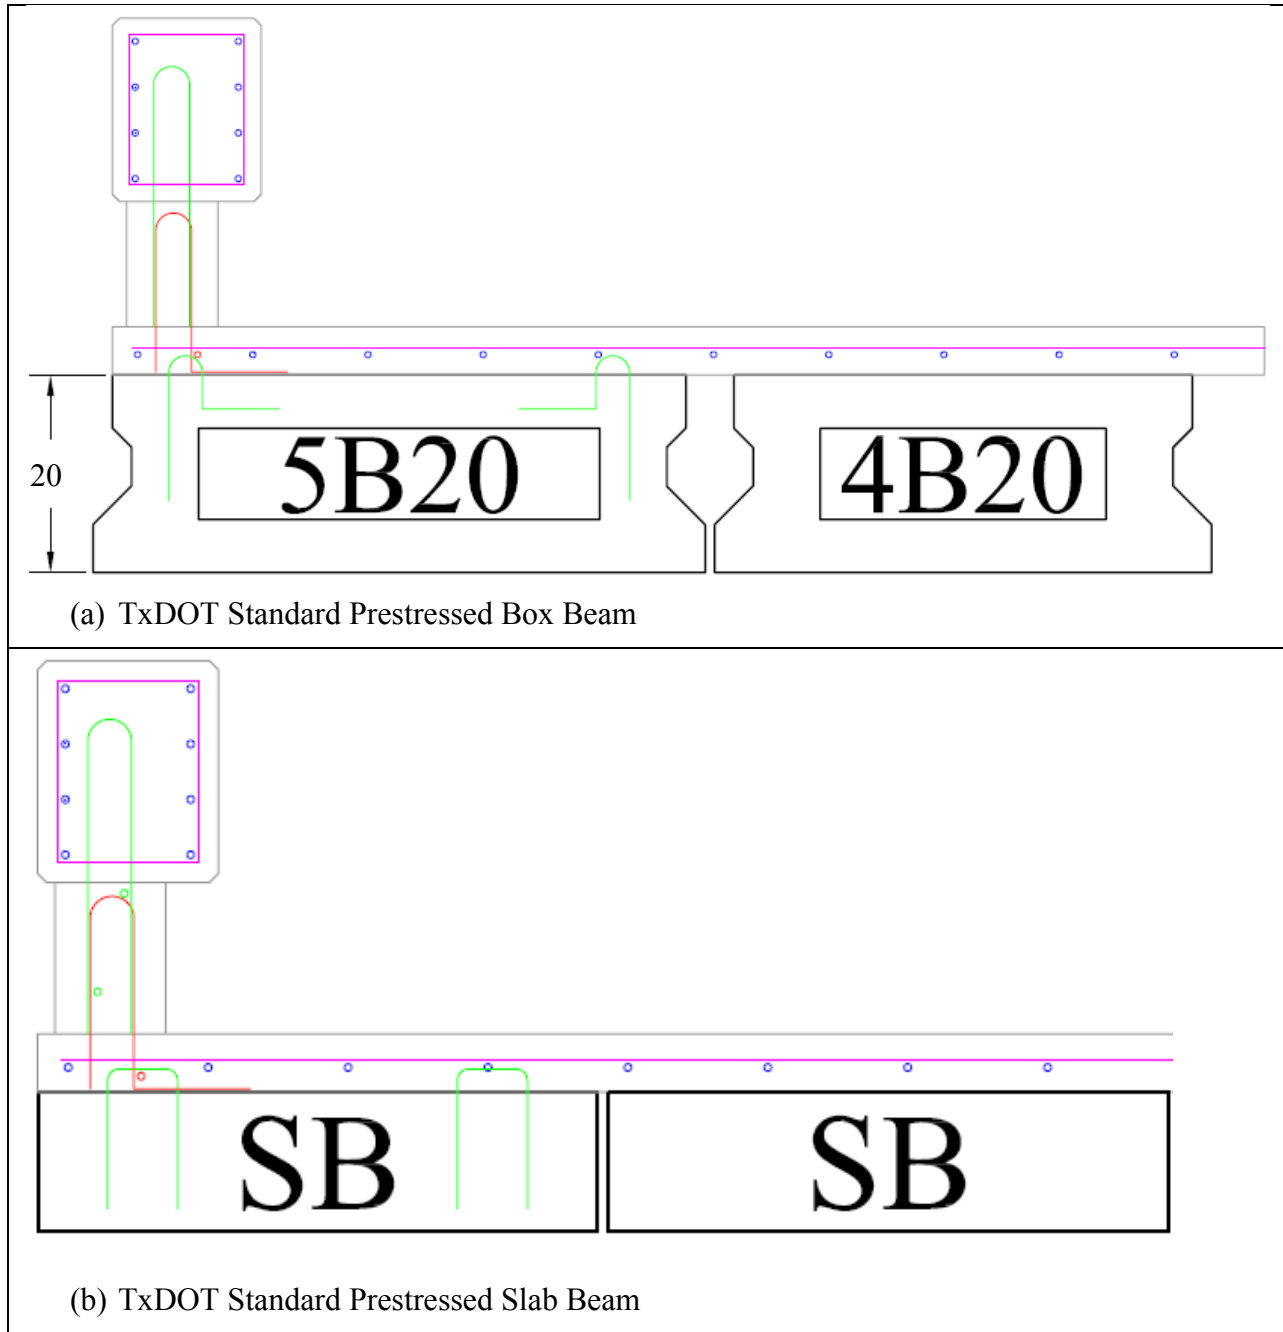
Figure 2.2. Comparison of TxDOT Standard Prestressed Box and Slab Beams.

Both the standard box and slab beam sections, illustrated in Figure 2.2, were evaluated to determine which would provide the worst case for anchorage of the T223 barrier profile. It was concluded that the 5.5-inch thick top flange of the prestressed concrete box beam made it a worst case for anchorage compared to the 12-inch thick uniform prestressed slab beam. Therefore, a simulated concrete box beam was selected for testing in conjunction with a T223 barrier profile anchored into 5-inch thick composite cast-in-place deck (CIPD).

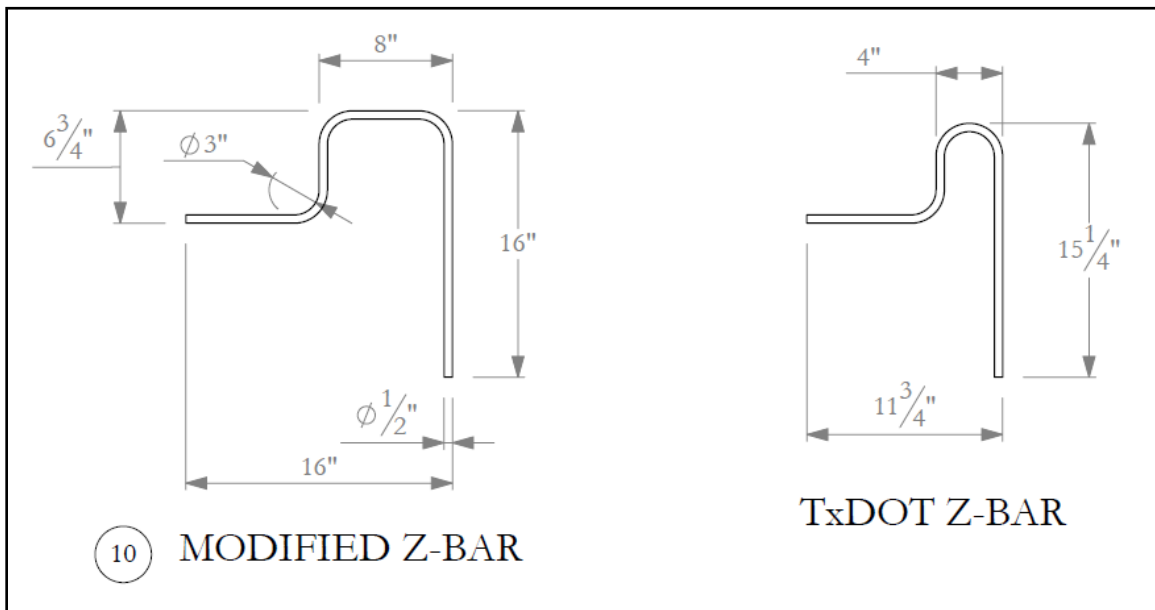
Figure 2.3. Comparison of TxDOT Standard “Z” Bar and Modified “Z” Bar Dimensions.

Third, due to the narrowness of the protruding portion of the “Z” bar, it is not possible for a #5 rebar to be thread through the “Z” bar and still traverse the embedded leg of the “U” bar. For this reason the protruding portion of the “Z” bar was widened, as shown in [Figure 2.3](#).

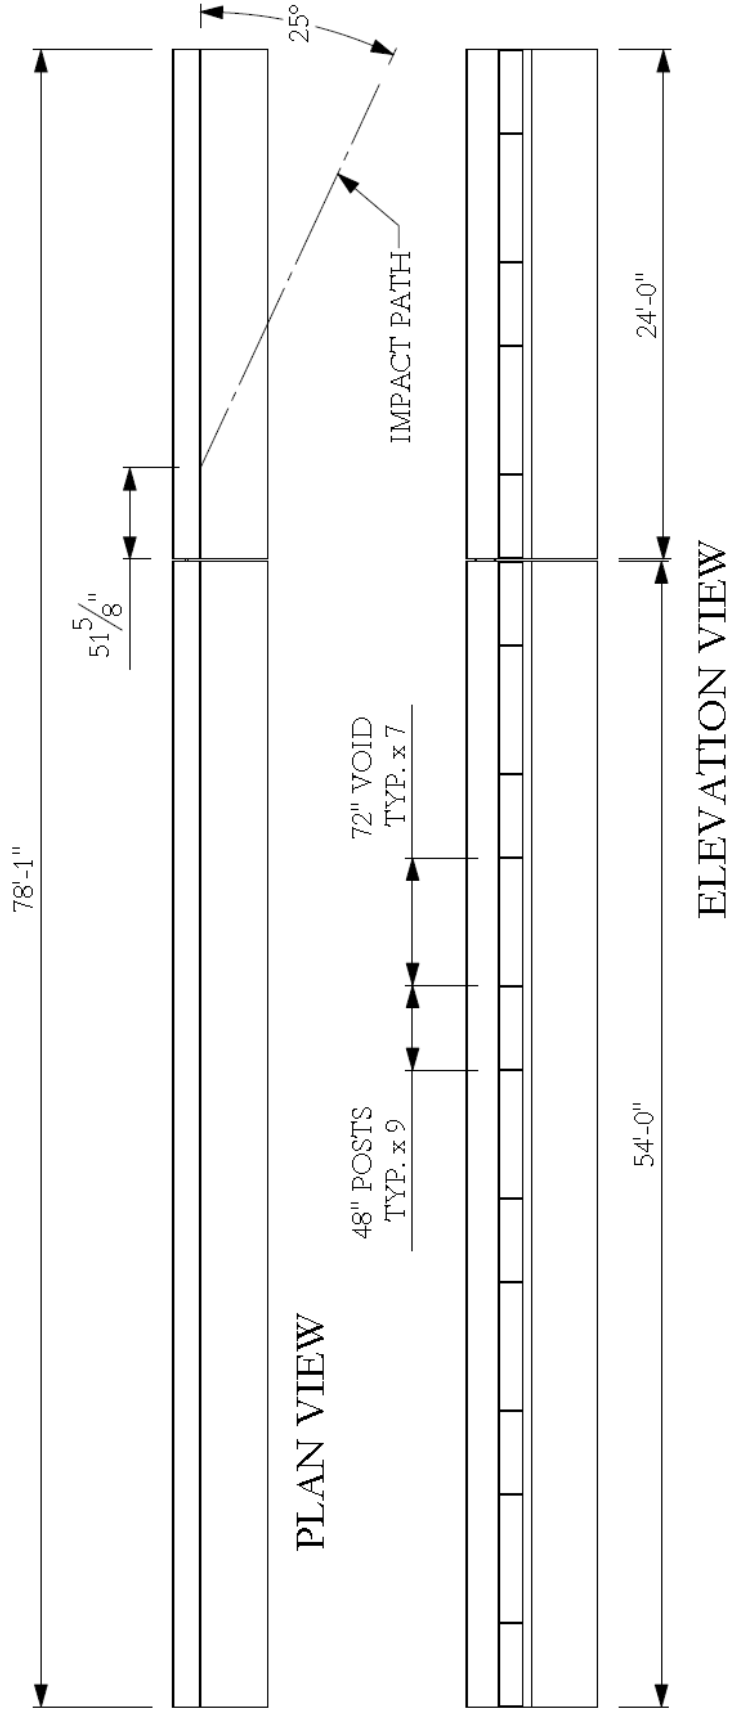
Figure 4.3. Layout of the 5-inch CIPD Barrier Anchor Installation.

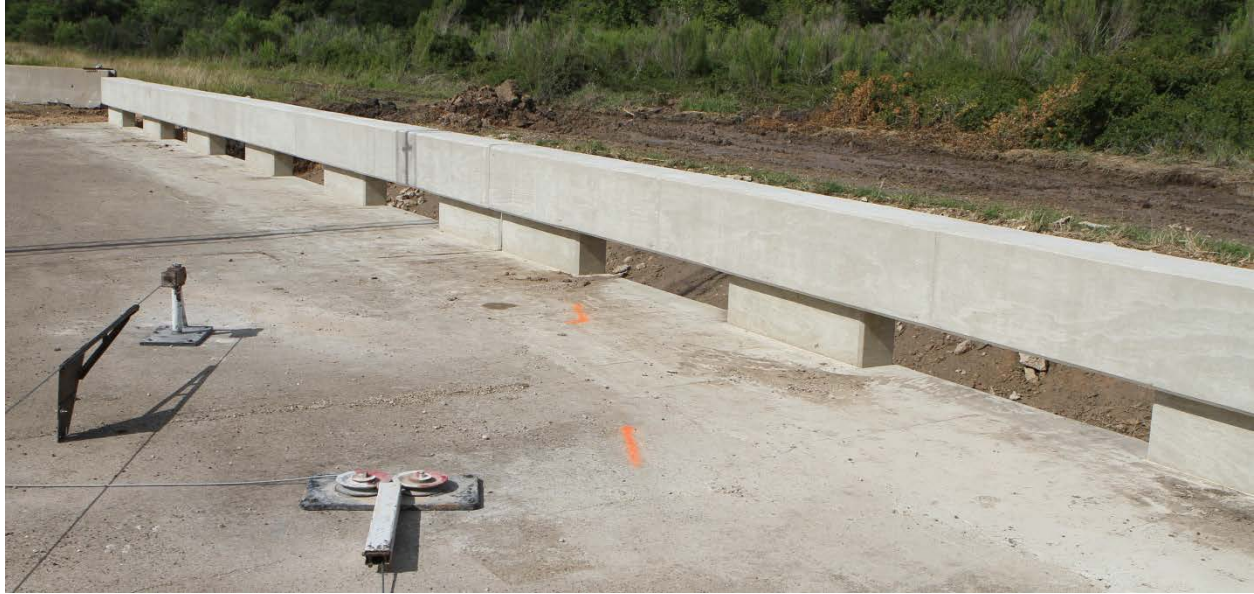
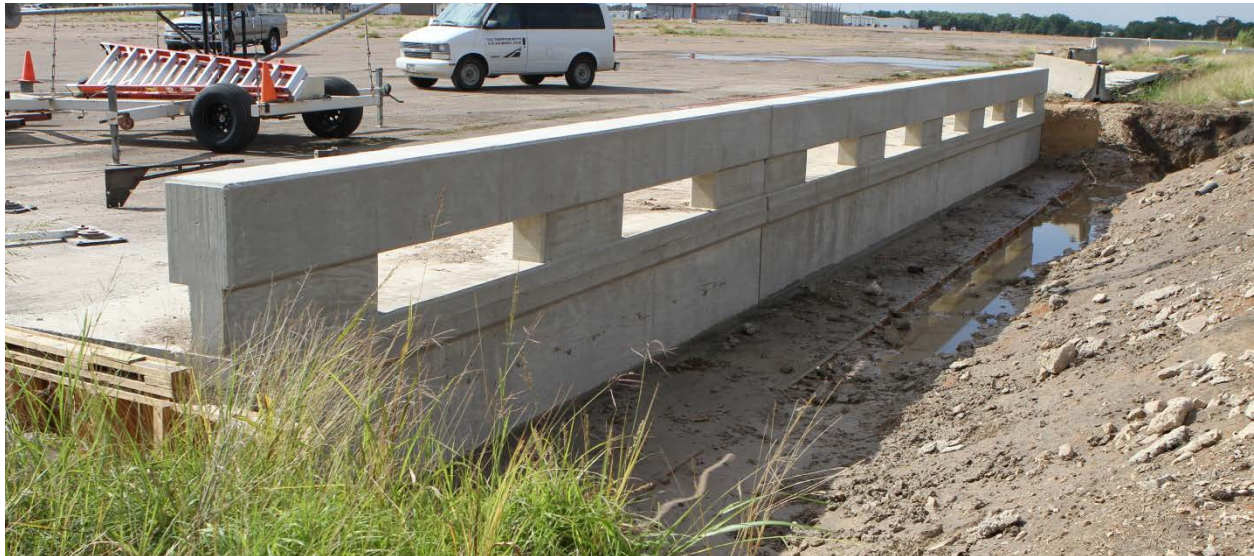
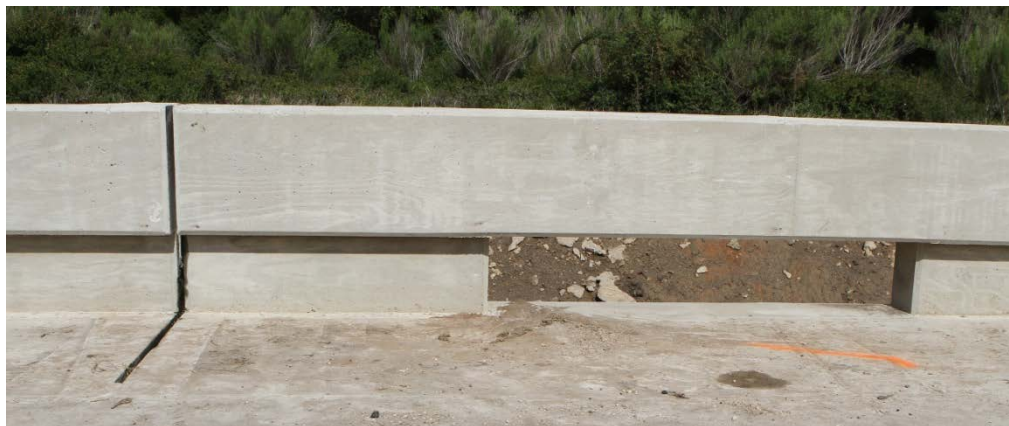
Figure 4.4. 5-inch CIPD Barrier Anchor Installation before Test No. 420021-5.

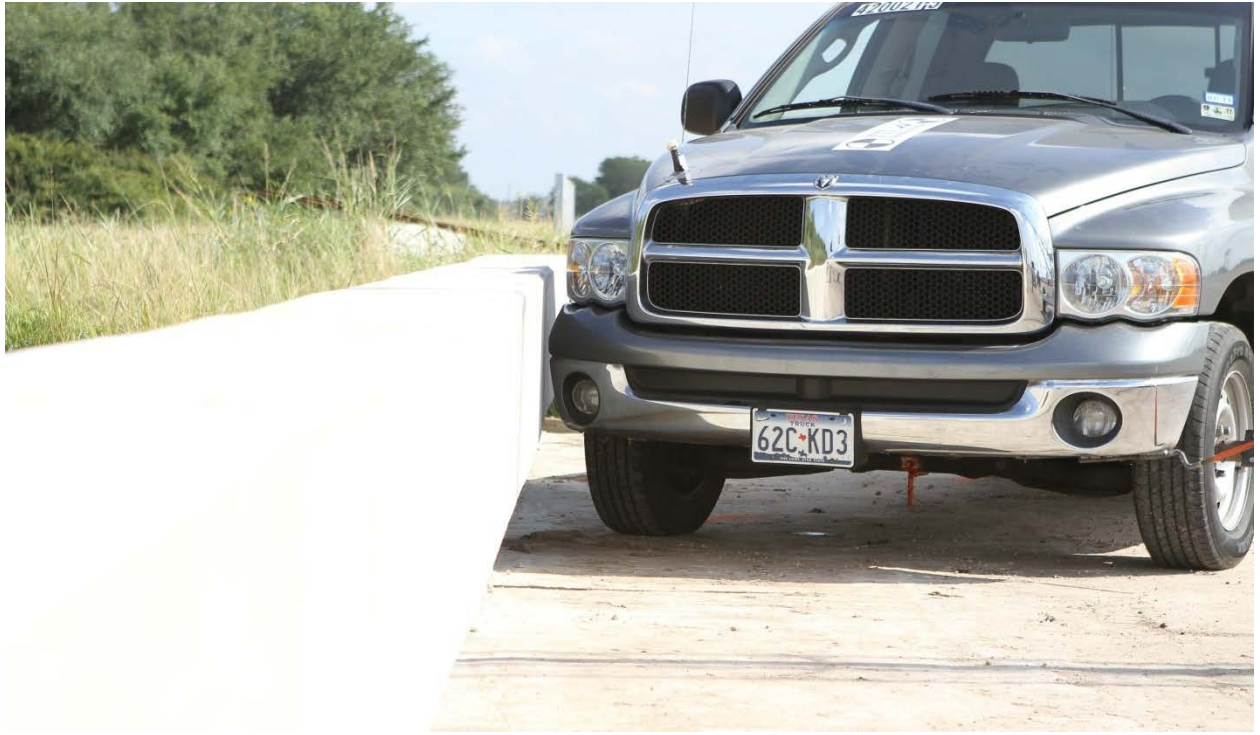
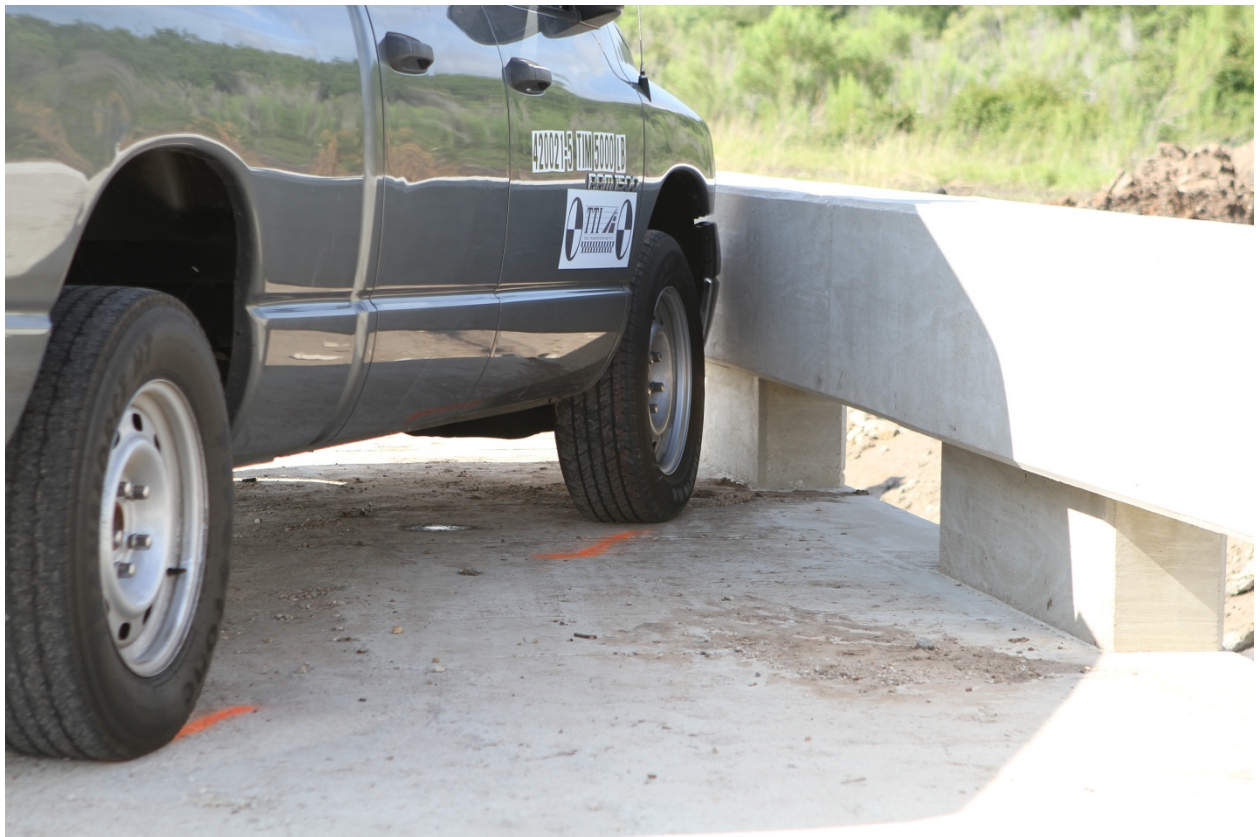
Figure 7.1. Vehicle/Installation Geometrics for Test No. 420021-5.

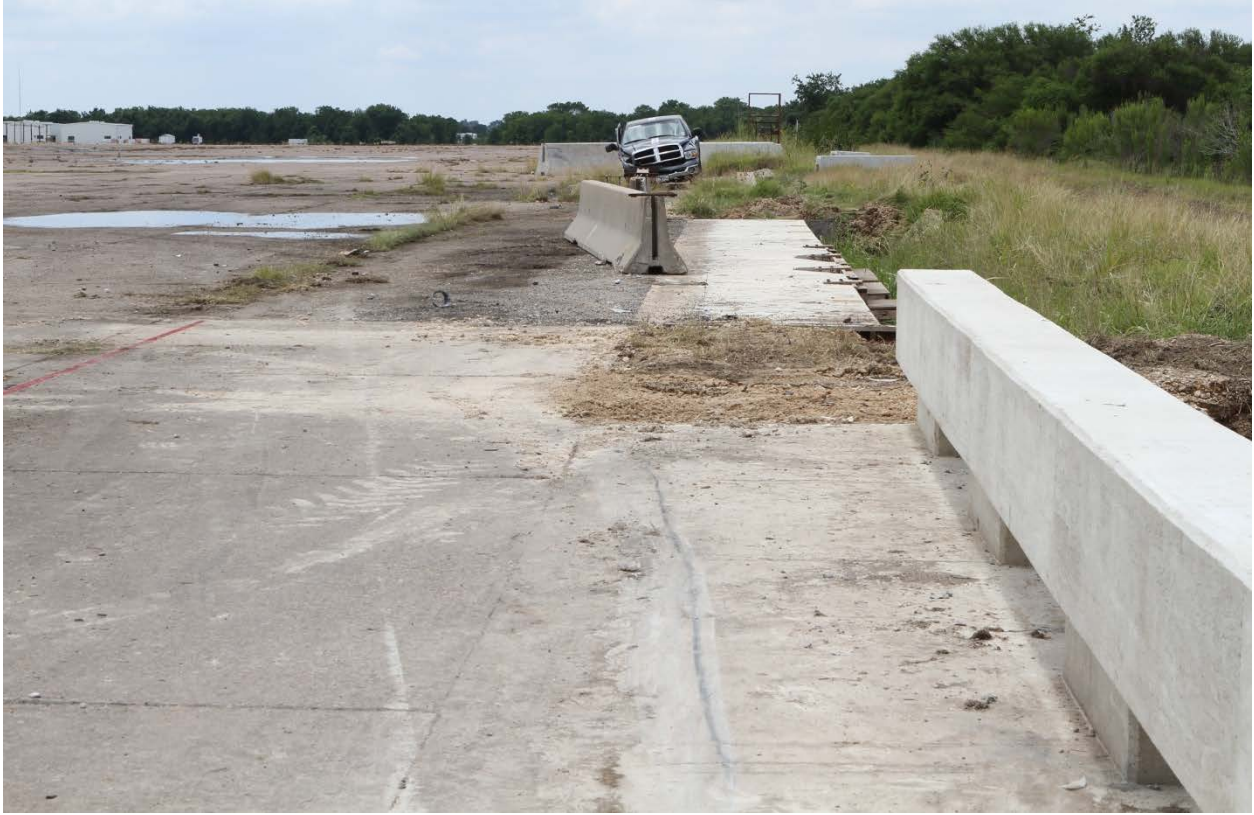
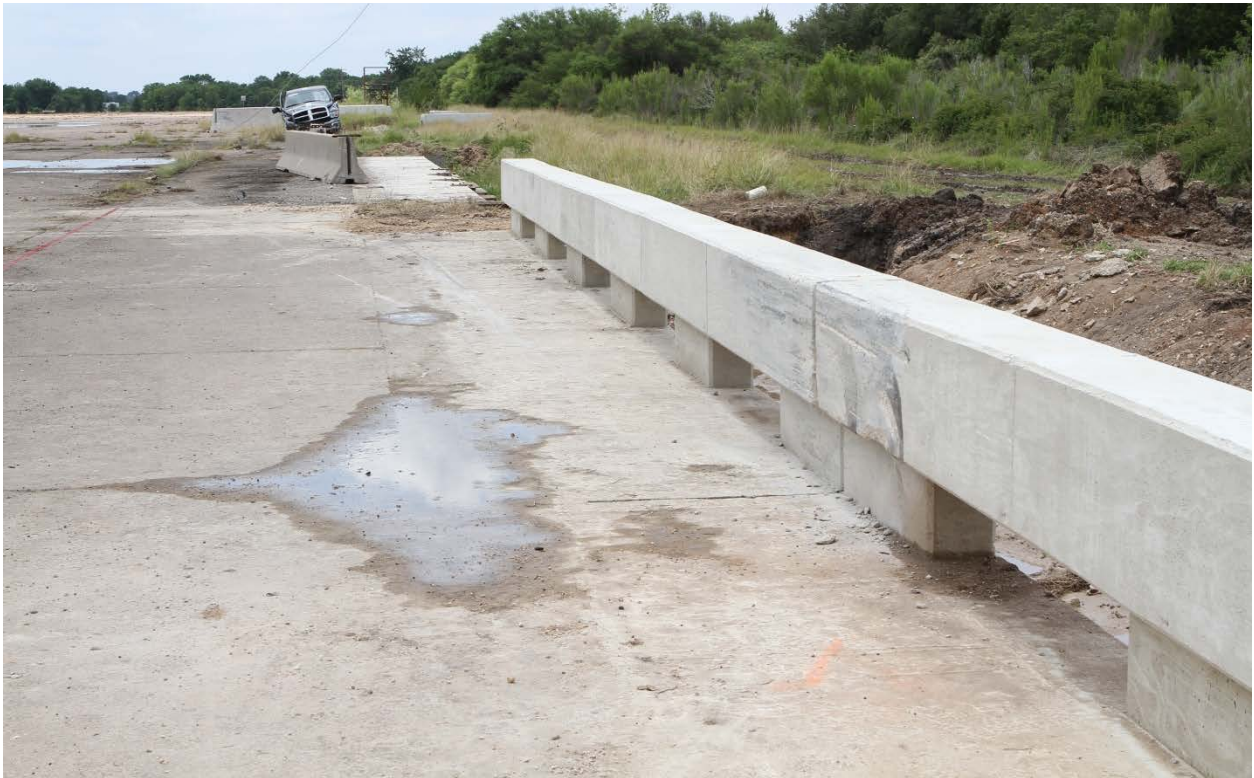
Figure 7.3. After Impact Vehicle/Barrier Positions for Test No. 420021-5.

Figure 7.3 and 7.4 show damage to the TxDOT T223 bridge rail anchored to a 5-inch thick (CIPD). Damage to the barrier was cosmetic in nature with only tire marks and a few gouges observed in the concrete traffic face of the upper beam of the barrier. A few tire scuff marks were noted on the face of posts 3 and 4. No cracks were noted in the beam, posts, or bridge deck. Total length of contact of the vehicle with the barrier was 12.9 ft. The vehicle crossed the exit box 82 ft downstream of impact (≥ 32.8 ft allowed). Working width was 16.0 inches, and maximum deflection of the barrier was 0.9 inch.

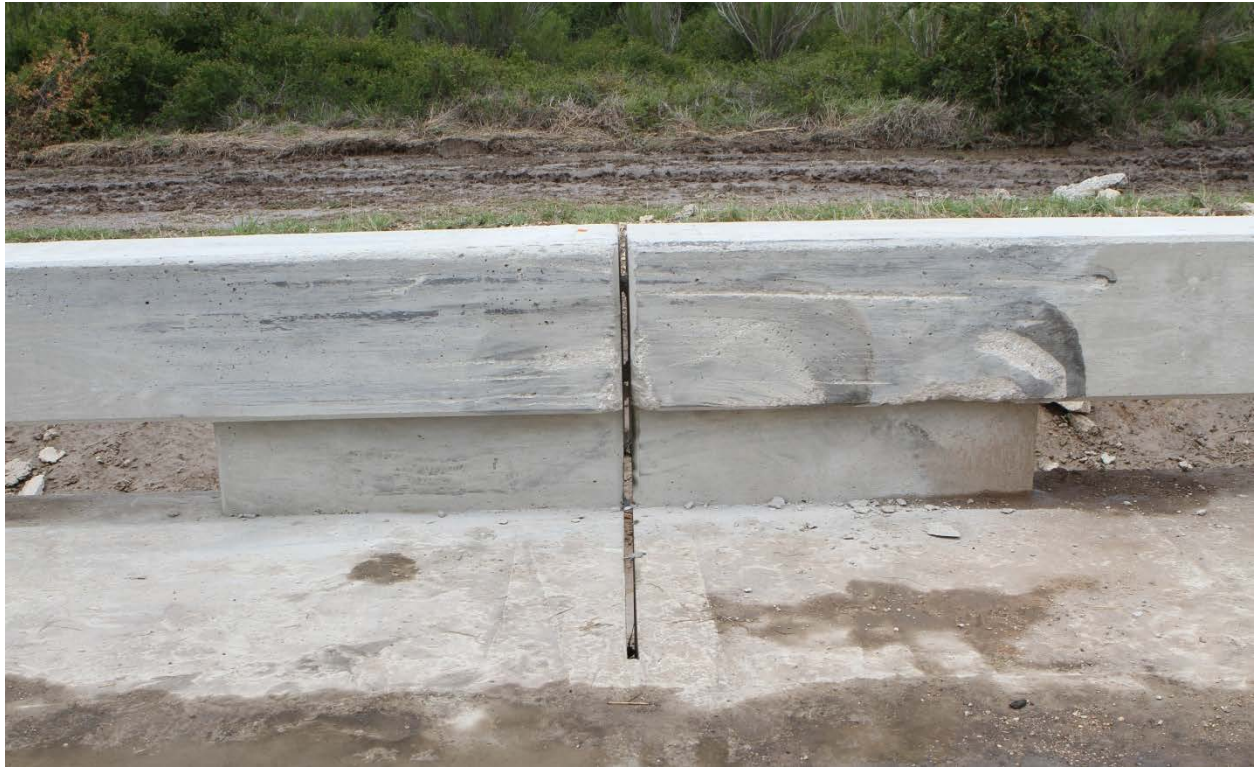
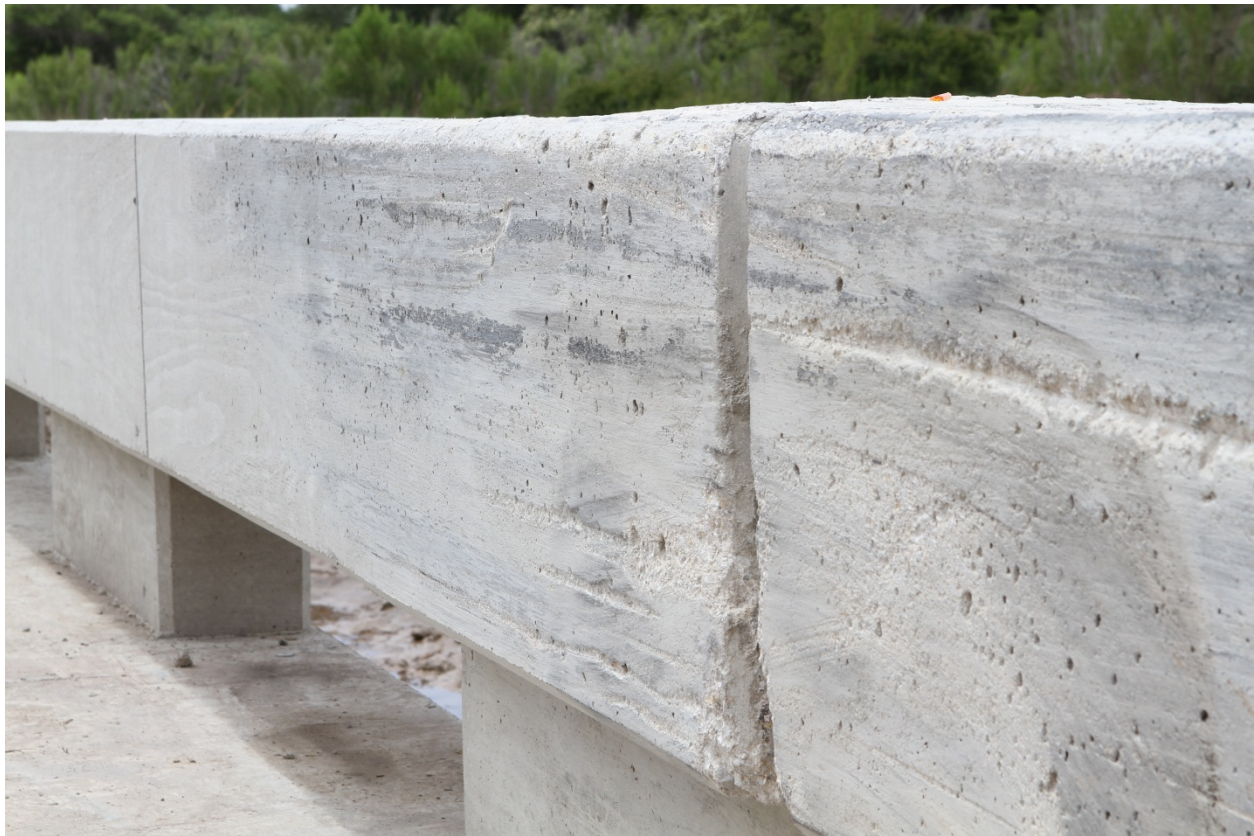
Figure 7.4. Installation after Test No. 420021-5.

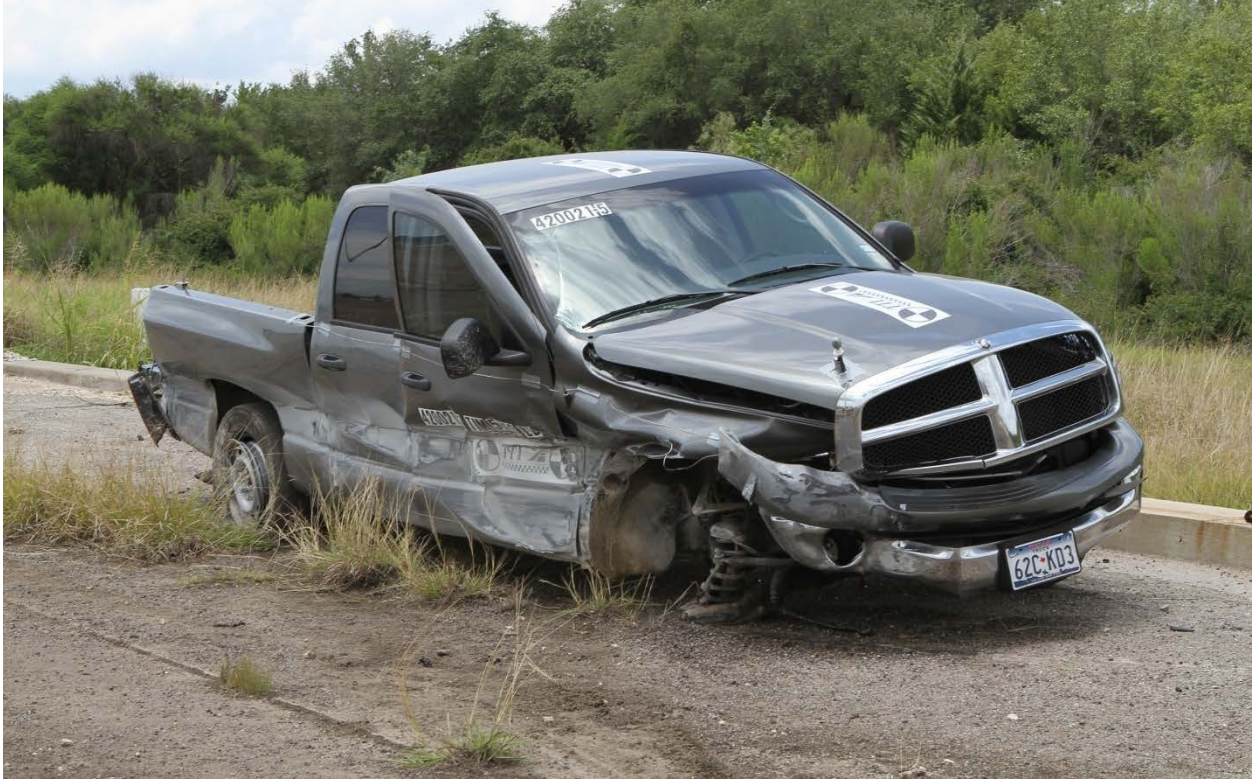
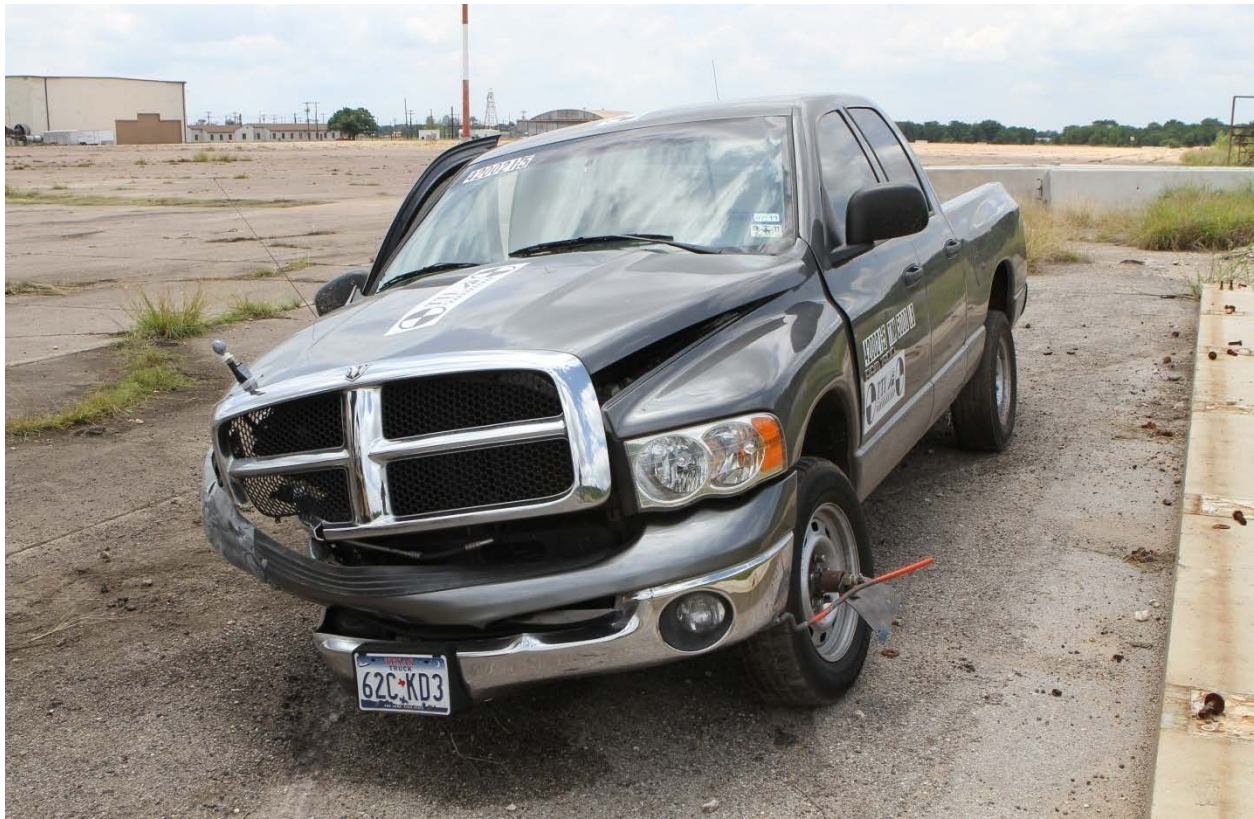
Figure 7.5. Vehicle after Test No. 420021-5.

The 2270P vehicle sustained structural damage to the right frame rail, right upper and lower A-arm, right side sway bar, and right front spring and cup. The right upper ball joint pulled out of the socket and the right lower ball joint broke. Figure 7.5 shows damage to the front bumper, right front fender, right front door, right front tire and wheel rim, right rear door, right rear exterior bed, right rear tire and wheel rim, and the rear bumper. Maximum exterior crush to the 2270P vehicle was 18.0 inches in the side plane at the right front corner at bumper height. Maximum occupant compartment deformation was 5.25 inches in the kick panel laterally across the lower cab near the right front passenger side foot well area. Figure 7.6 shows photographs of the interior of the vehicle. Tables C3 and C4 in Appendix D provide exterior crush and occupant compartment deformation measurements.

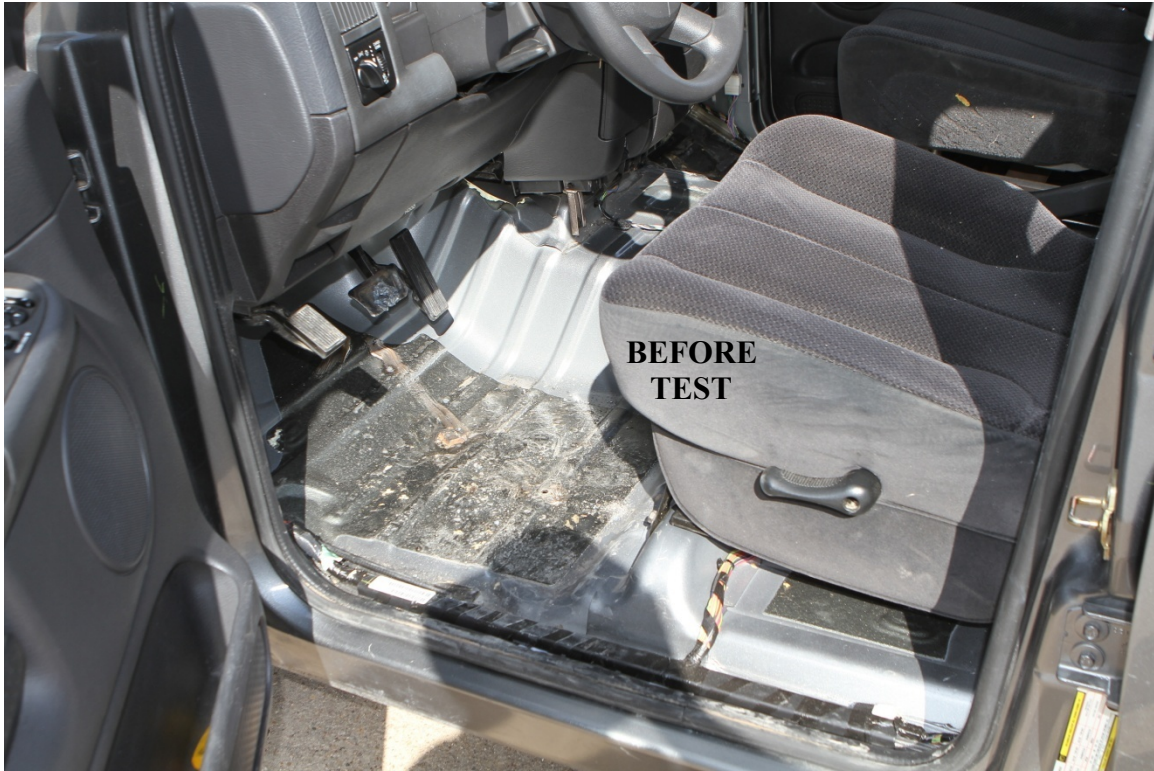
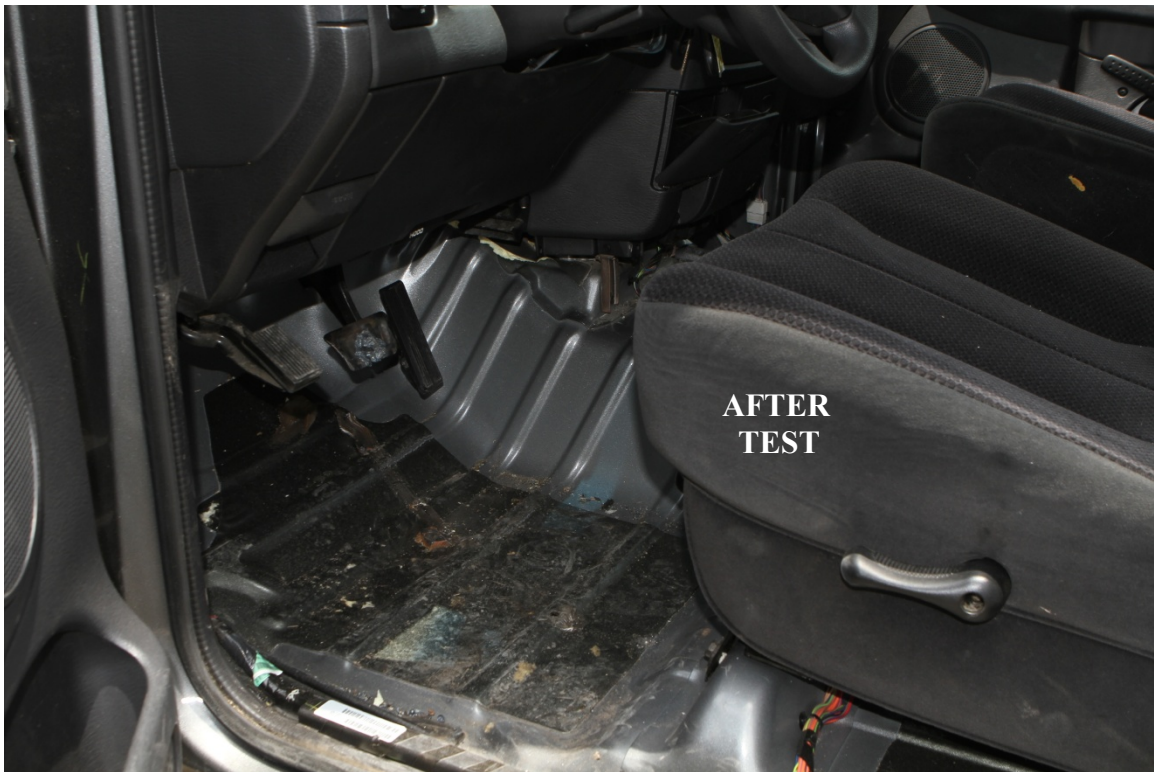
Figure 7.6. Interior of Vehicle for Test No. 420021-5.

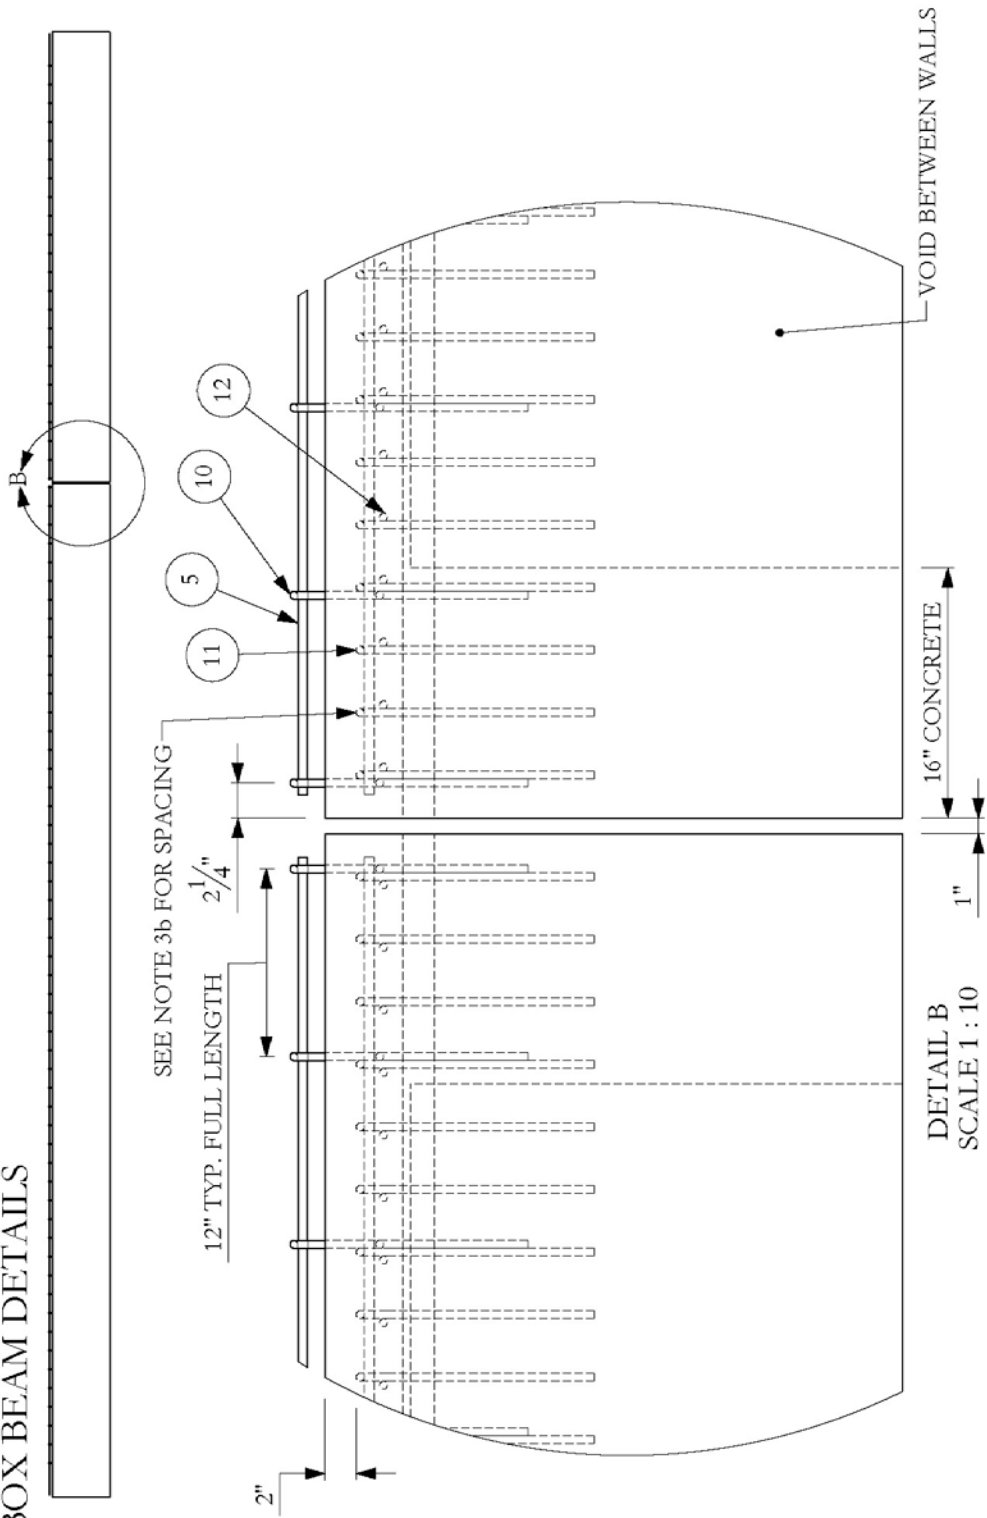
BOX BEAM DETAILS

- 3a. Concrete is Class H.
- 3b. Spacing for Bar A (11) and Bar B (12) is 4" for 48" (12 spaces) each side of the expansion joint, then 6" to each end.
- 3c. Lap for #5 bars is 26", and not permissible within 10' of expansion joint.
- 3d. Rebar and concrete is symmetrical from expansion joint to end of short section.
- 3e. Provide a uniform rough wood float finish for the top surface of the concrete.

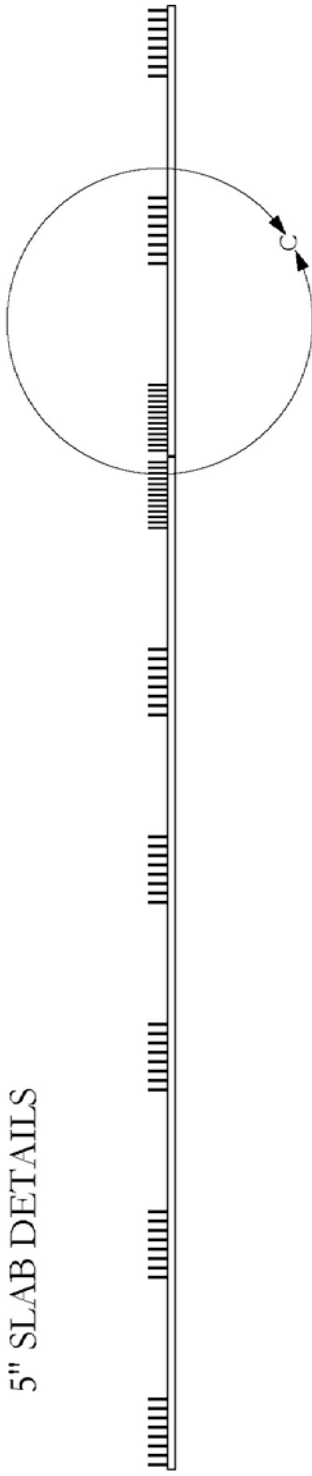
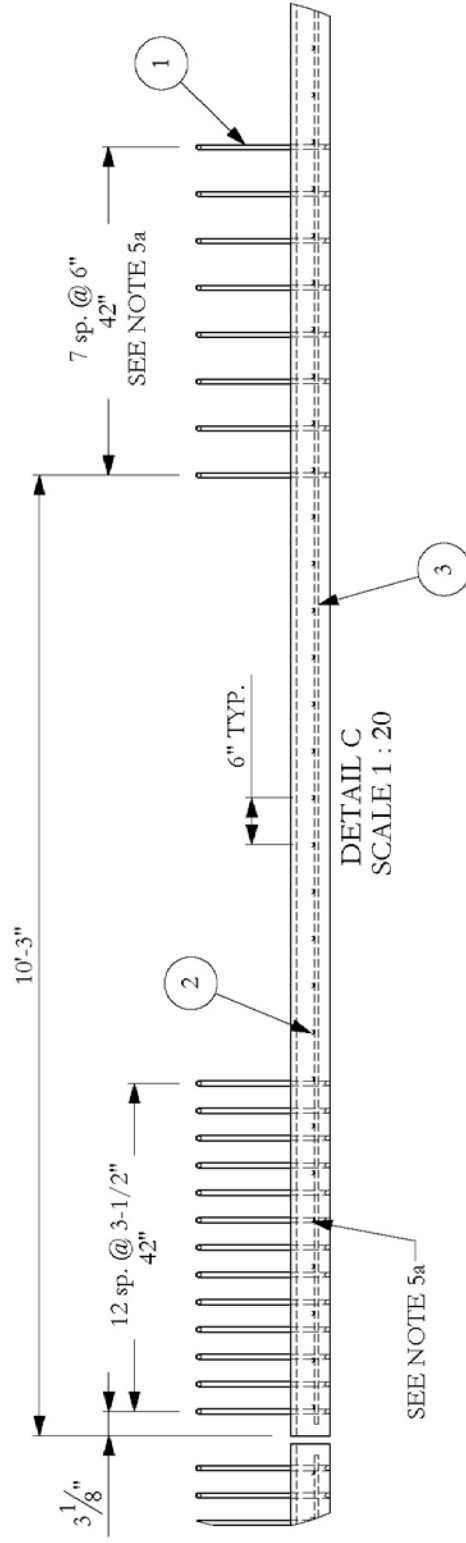
5" SLAB DETAILS

- 5a. U-bar (1) spacing is 3-1/2" at the first post on each side of the expansion joint, U-bar spacing at all other posts is 6". Adjust spacing of transverse bars (2) where necessary to maintain U-bar spacing.
- 5b. Rebar is symmetrical from expansion joint to end of short section.
- 5c. Concrete strength is 4000 psi.
- 5d. Lap for #4 bars is 17", and not permissible within 10' of expansion joint.

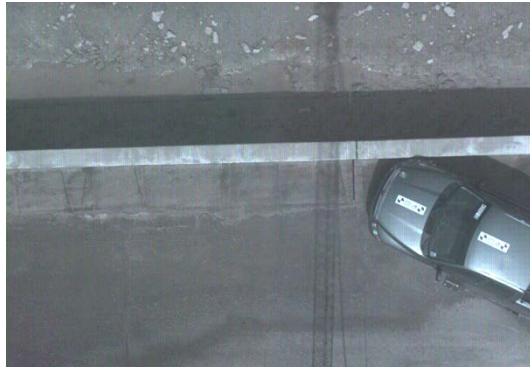
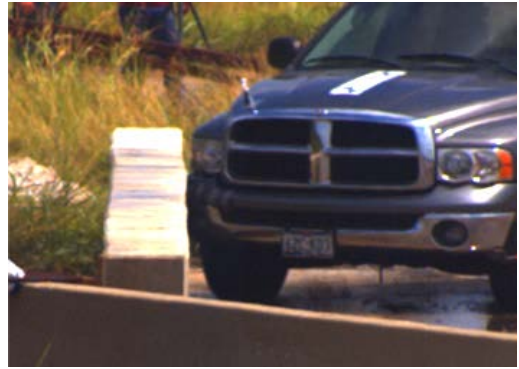
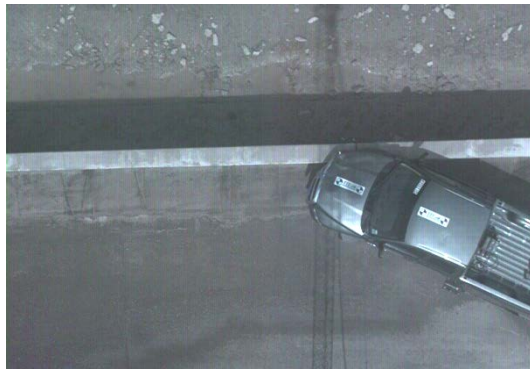
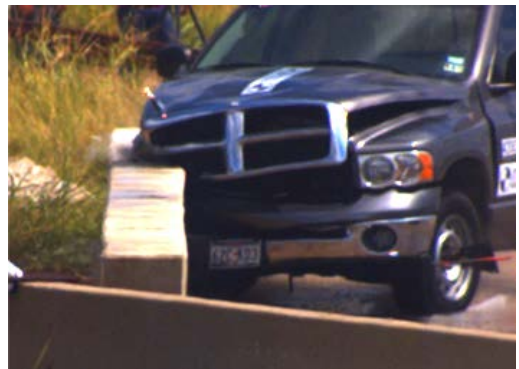
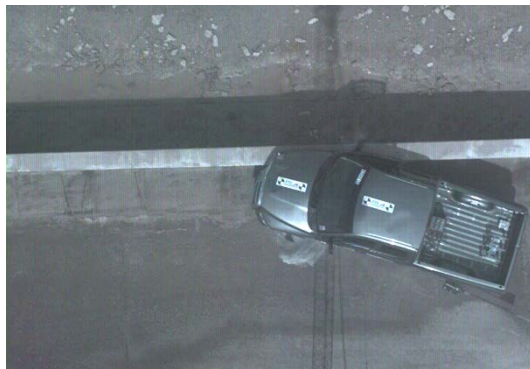
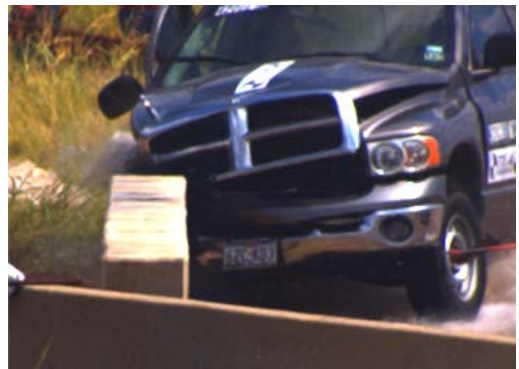
Figure D1. Sequential Photographs for Test No. 420021-5 (Overhead and Frontal Views).

The 2005 Dodge Ram 1500 Quad-Cab pickup truck, travelling at an impact speed of 62.5 mi/h, impacted the TxDOT T223 bridge rail anchored to a 5-inch thick cast-in-place deck 54.5 inches upstream of the expansion joint between posts 3 and 4 at an impact angle of 26.3 degrees. At 0.022 s after impact, the 2270P vehicle began to redirect. The left front wheel steered abruptly clockwise at 0.035 s, and the right front passenger door contacted the barrier at 0.044 s. At 0.187 s, the vehicle was traveling parallel with the barrier at a speed of 50.7 mi/h. The rear bumper contacted the barrier at 0.203 s. At 0.356 s, the vehicle lost contact with the barrier at an exit speed and exit angle of 49.1 mi/h and 9.4 degrees, respectively. Brakes on the vehicle were applied 5.0 s after impact, and the vehicle came to rest 225 ft downstream of impact and 7.0 ft toward traffic lanes. [Figures D1](#) and [D2](#) in [Appendix D](#) show sequential photographs of the test period.

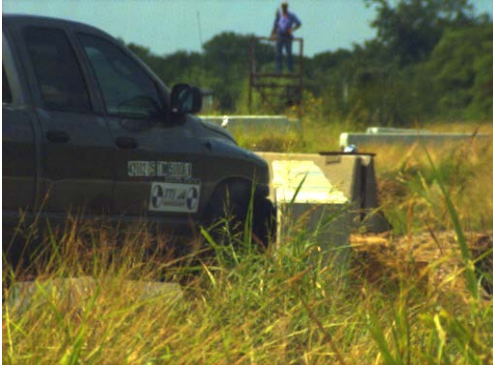
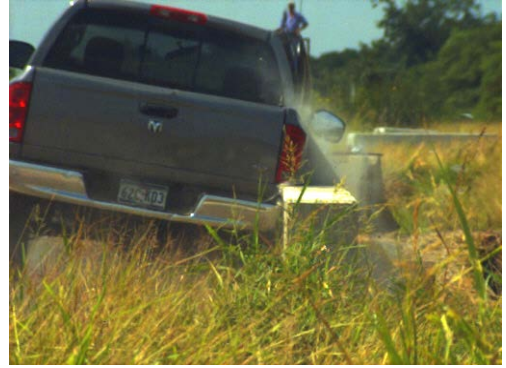
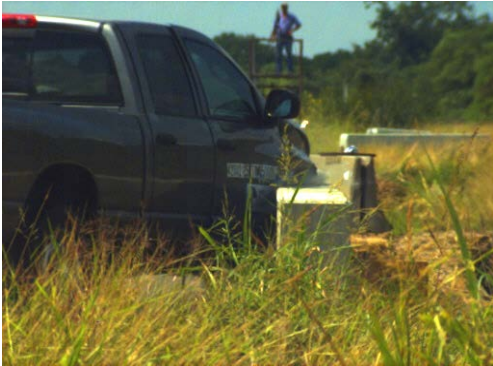
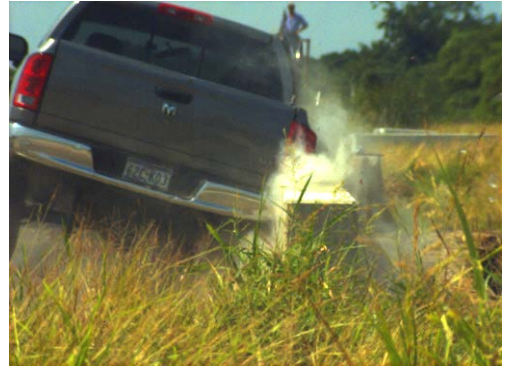
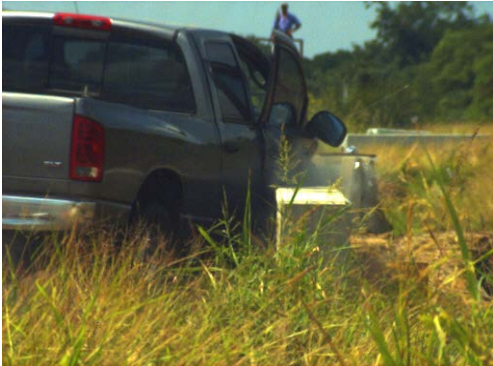
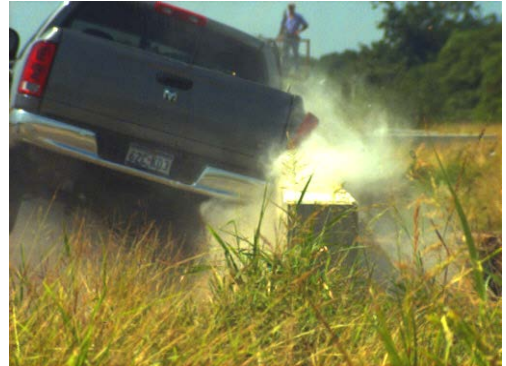
Figure D2. Sequential Photographs for Test No. 420021-5 (Rear View).
