MASH TEST 3-11 ON THE 5-INCH CAST IN PLACE DECK BARRIER ANCHORS

Test Report 9-1002-7

Report 9-1002-7
Project 9-1002
Project Title: Roadside Safety Device Crash Testing Program

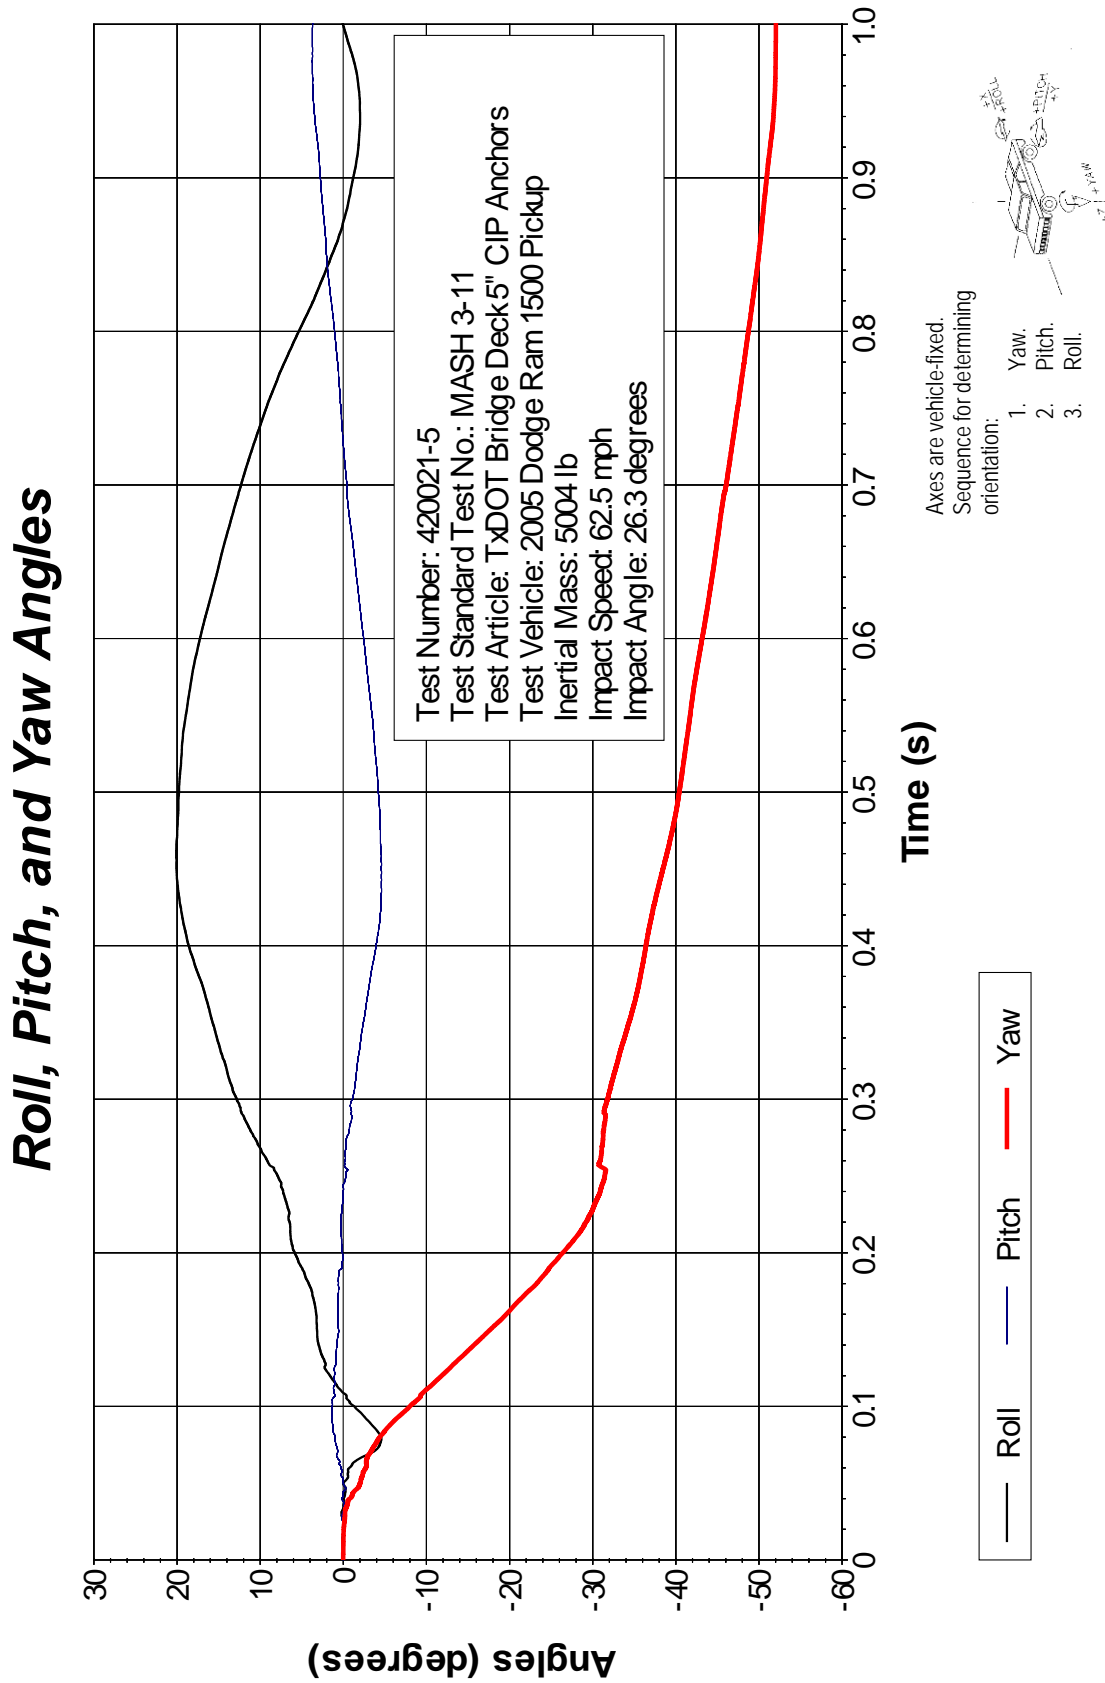
Figure E1. Vehicle Angular Displacements for Test No. 420021-5.

Data from the accelerometer, located at the vehicle center of gravity, were digitized for evaluation of occupant risk. In the longitudinal direction, the occupant impact velocity was 19.7 ft/s at 0.098 s, the highest 0.010-s occupant ridedown acceleration was 5.6 Gs from 0.207 to 0.217 s, and the maximum 0.050-s average acceleration was -9.2 Gs between 0.032 and 0.082 s. In the lateral direction, the occupant impact velocity was 26.6 ft/s at 0.098 s, the highest 0.010-s occupant ridedown acceleration was 7.2 Gs from 0.239 to 0.249 s, and the maximum 0.050-s average was -13.0 Gs between 0.041 and 0.081 s. Theoretical Head Impact Velocity (THIV) was 36.8 km/h or 10.2 m/s at 0.095 s; Post-Impact Head Decelerations (PHD) was 8.4 Gs between 0.210 and 0.220 s; and Acceleration Severity Index (ASI) was 1.62 between 0.033 and 0.083 s. Figure 7.7 summarizes these data and other pertinent information from the test. Vehicle angular displacements and accelerations versus time traces are presented in Appendix E, Figures E1 through E7.

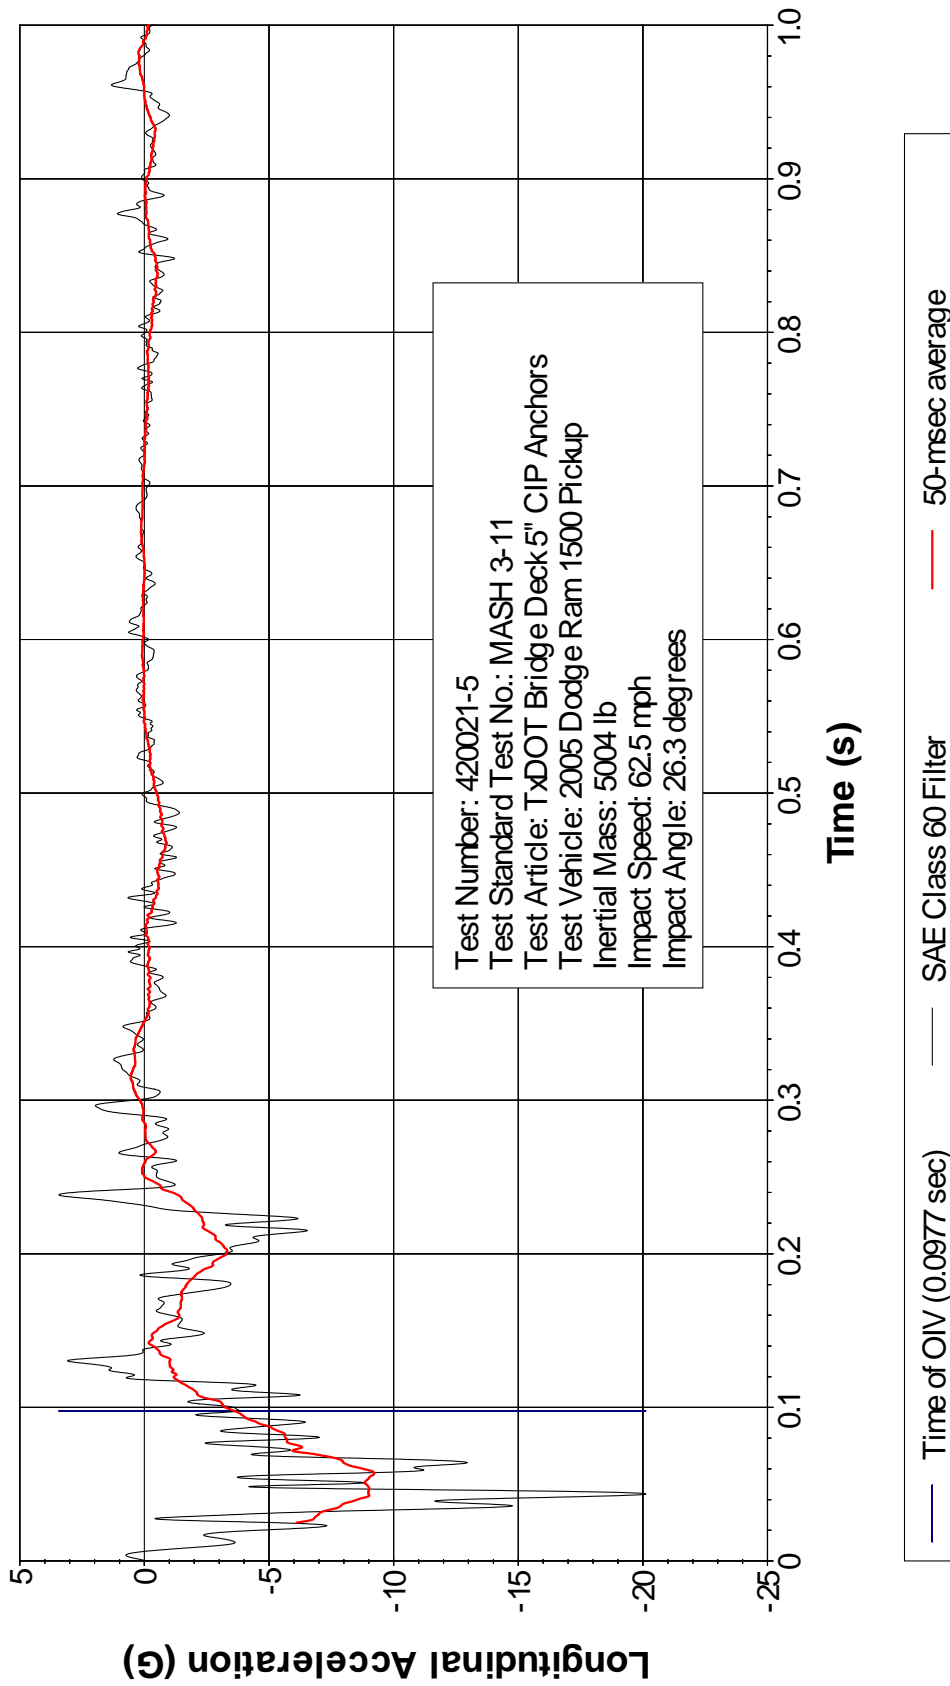
Figure E2. Vehicle Longitudinal Accelerometer Trace for Test No. 420021-5 (Accelerometer Located at Center of Gravity).

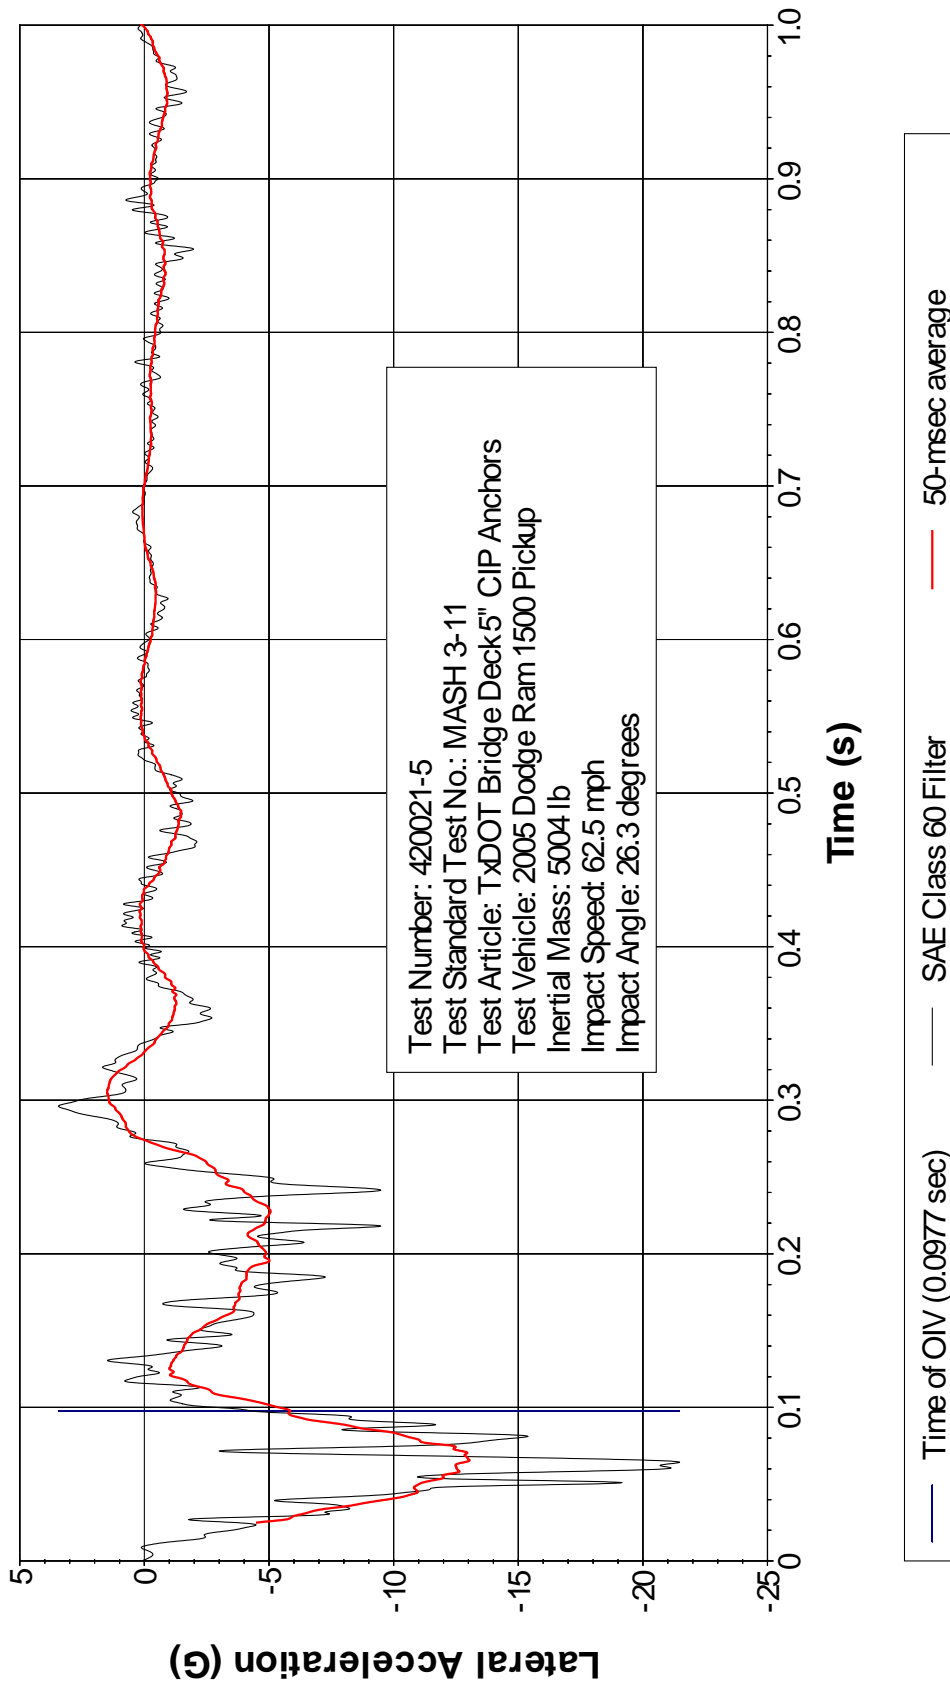
Figure E3. Vehicle Lateral Accelerometer Trace for Test No. 420021-5 (Accelerometer Located at Center of Gravity).

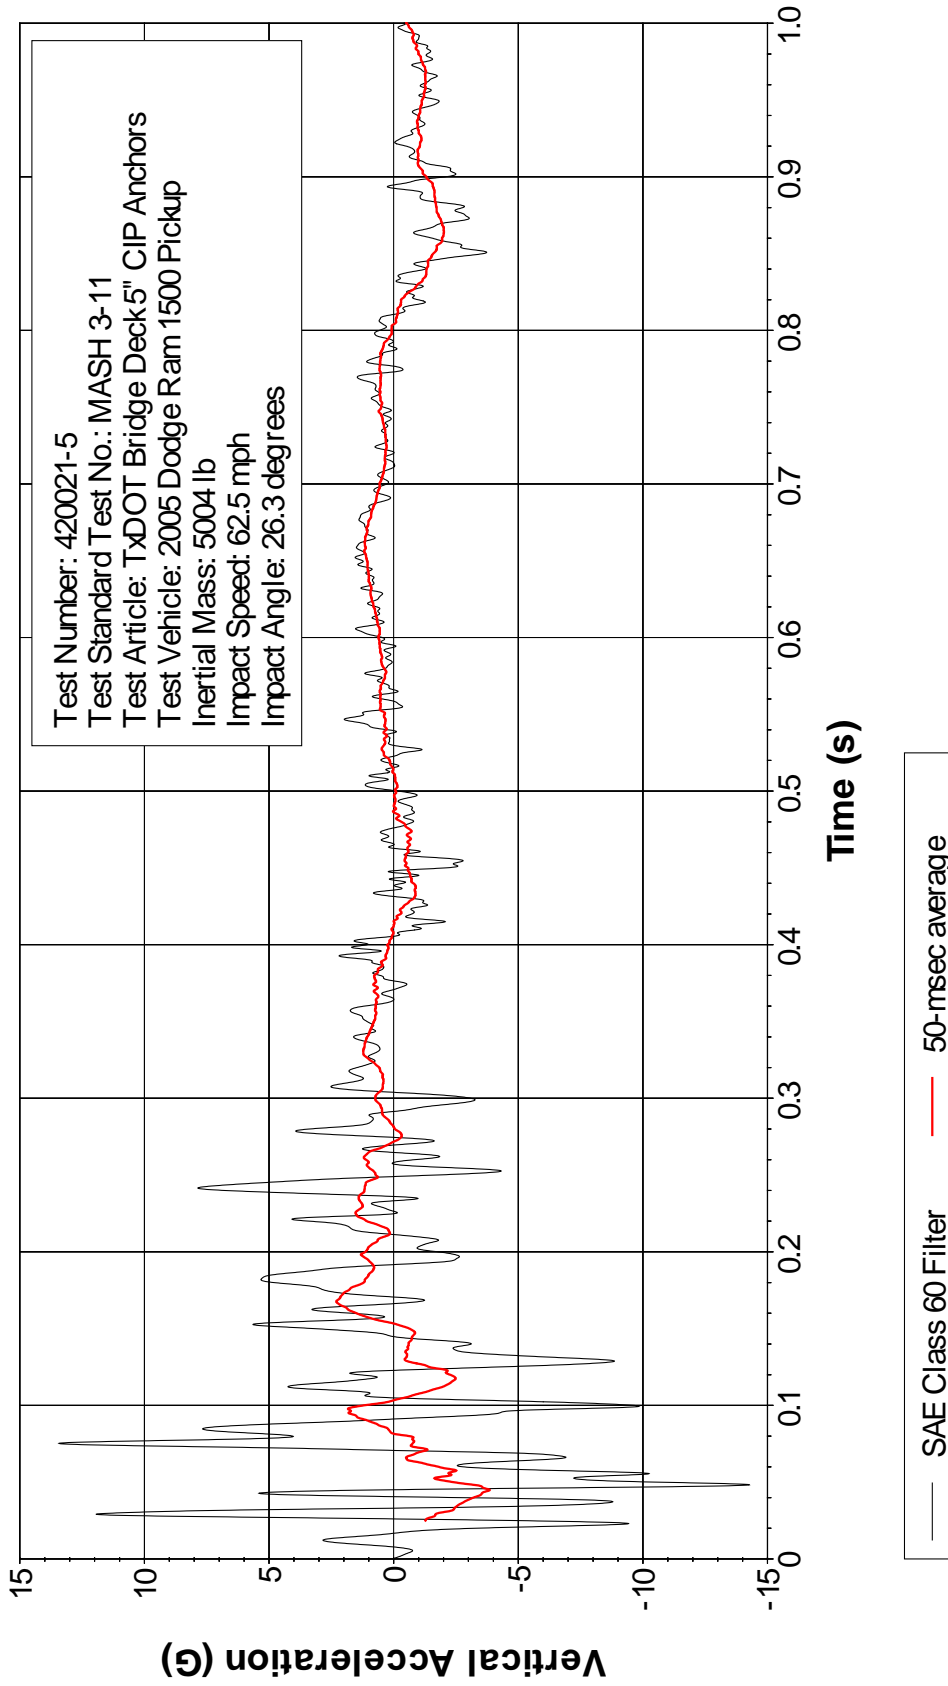
Figure E4. Vehicle Vertical Accelerometer Trace for Test No. 420021-5 (Accelerometer Located at Center of Gravity).

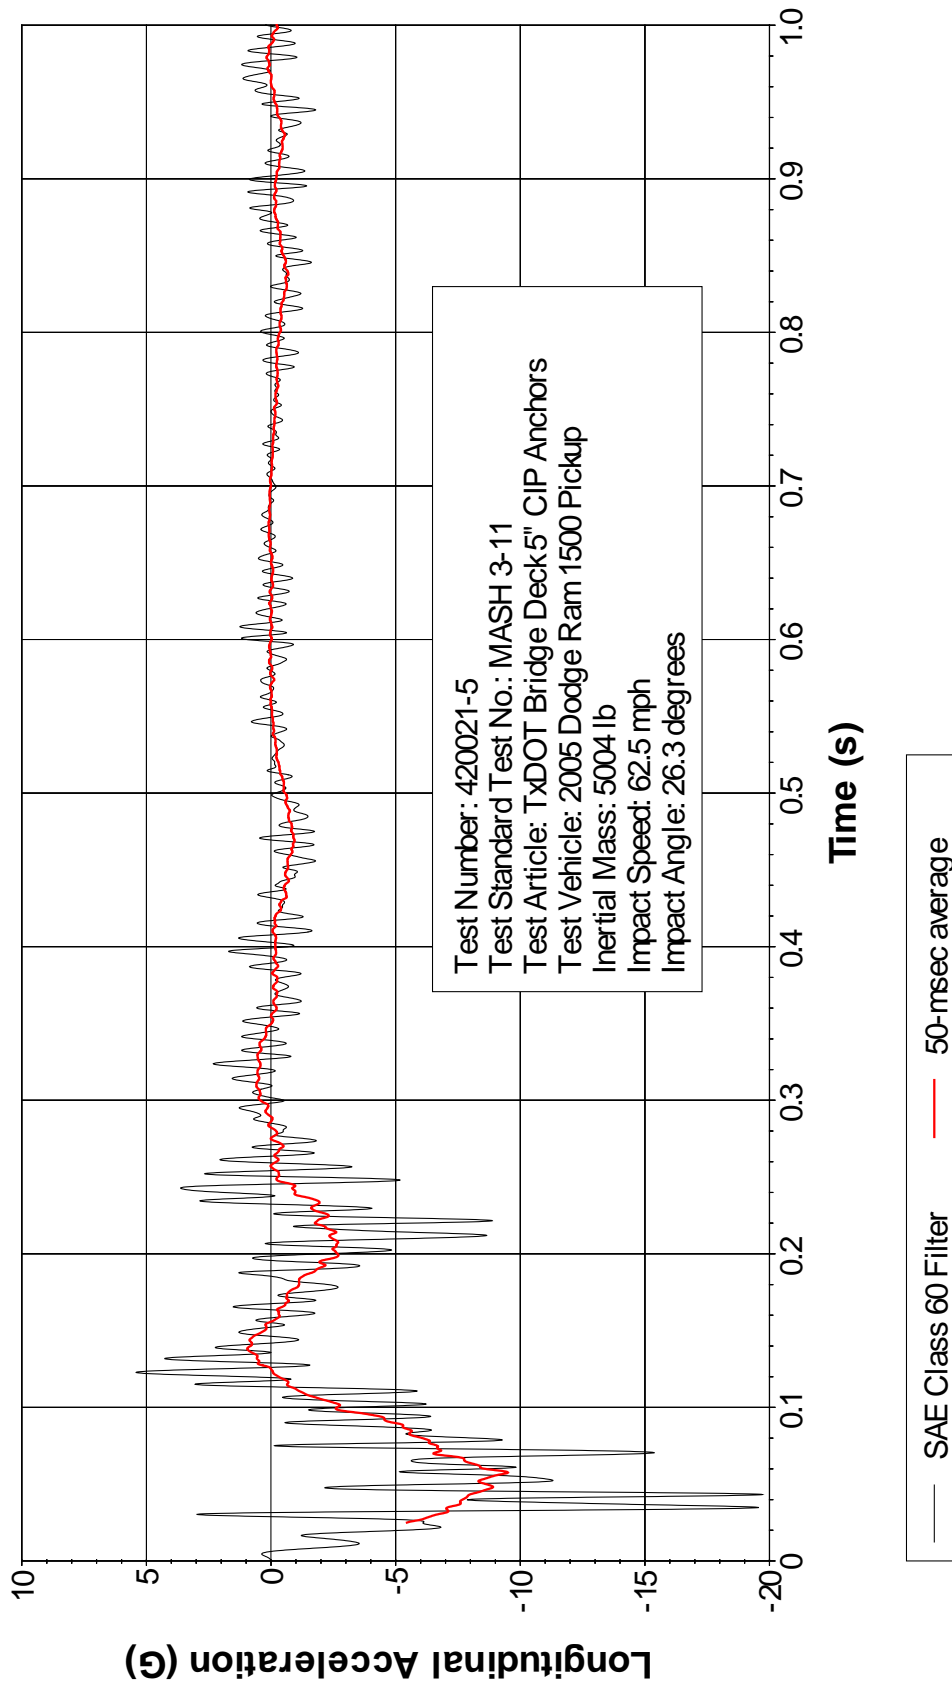
Figure E5. Vehicle Longitudinal Accelerometer Trace for Test No. 420021-5 (Accelerometer Located over Rear Axle).

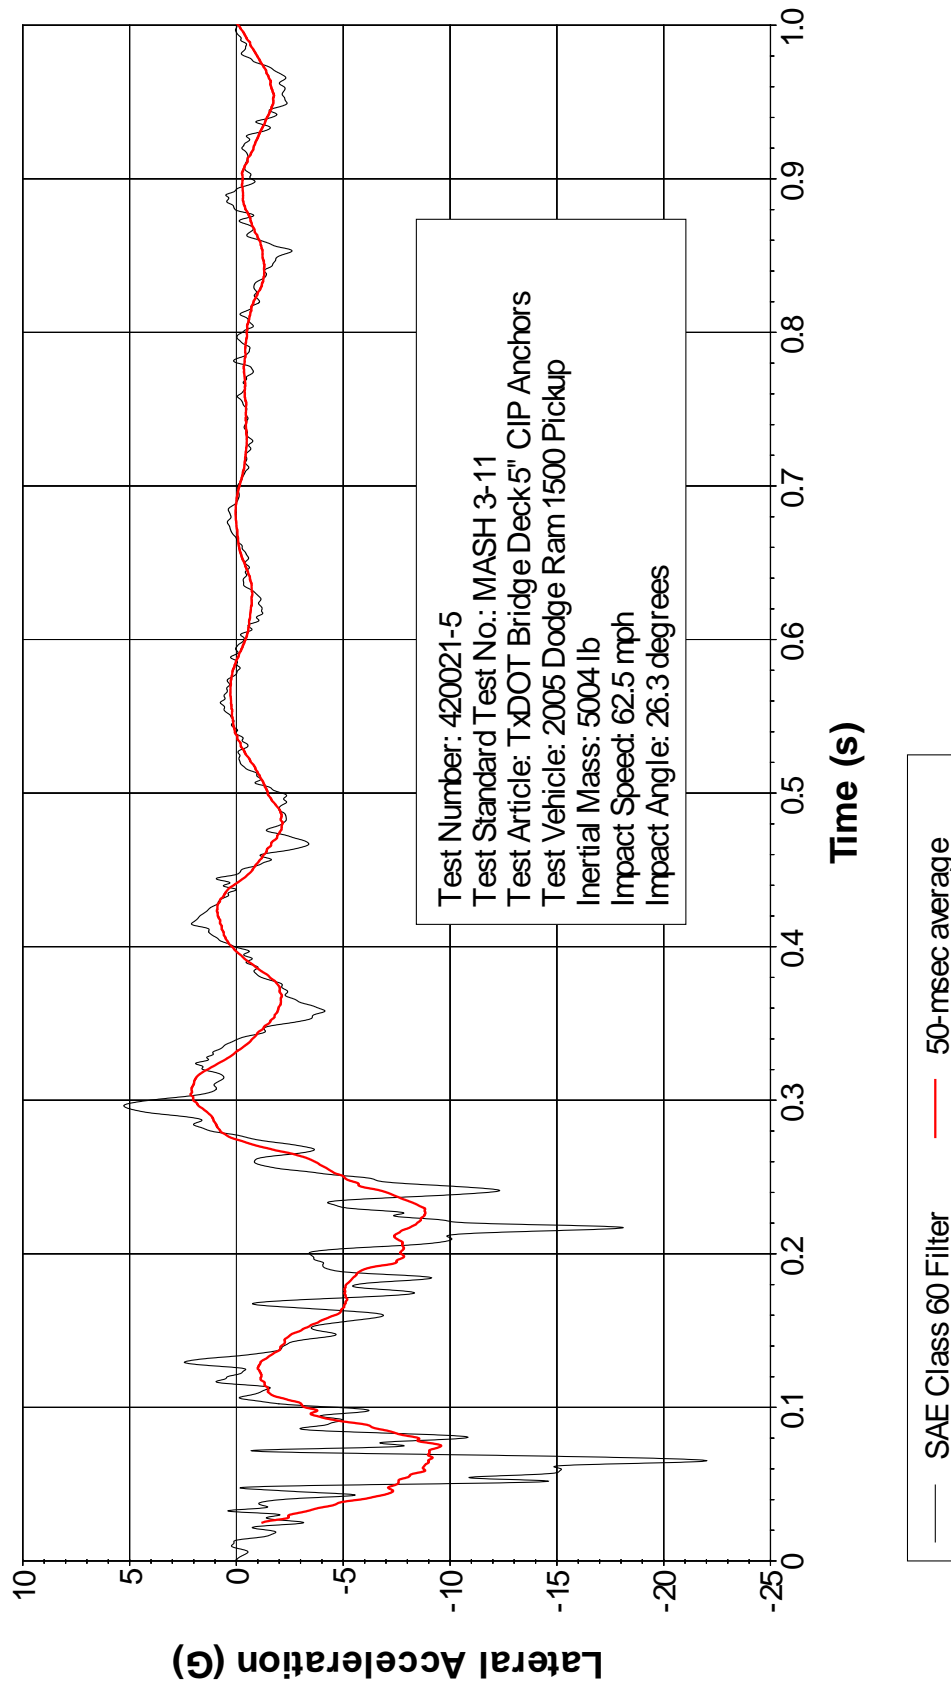
Figure E6. Vehicle Lateral Accelerometer Trace for Test No. 420021-5 (Accelerometer Located over Rear Axle).

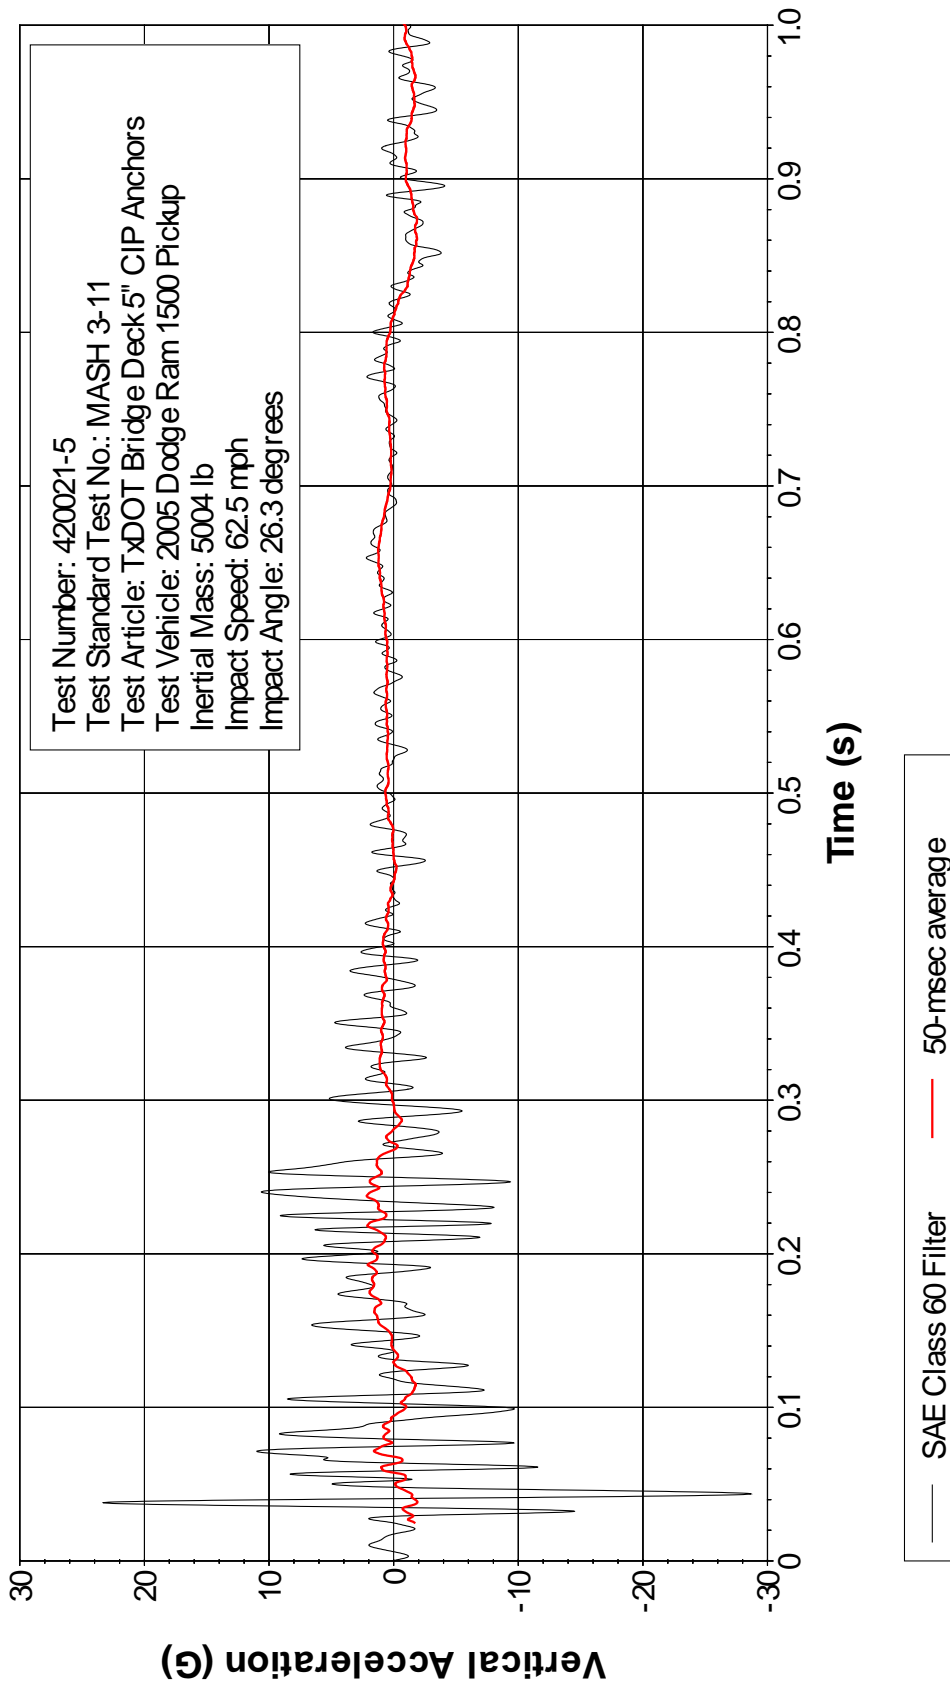
Figure E7. Vehicle Vertical Accelerometer Trace for Test No. 420021-5 (Accelerometer Located over Rear Axle).
