| 4. Title and Subtitle<br>IMPROVEMENTS TO RURAL INTERSECTIONS TO IMPROVE MOTORIST COMPLIANCE | | | | 5. Report Date<br>Published: October 2014 | |

# **IMPROVEMENTS TO RURAL INTERSECTIONS TO IMPROVE MOTORIST COMPLIANCE**

Report 9-1529-1  
Project 9-1529  
Project Title: Low-Cost Safety Solutions, Pavement Preservation and Maintenance Practices for  
Rural Highways

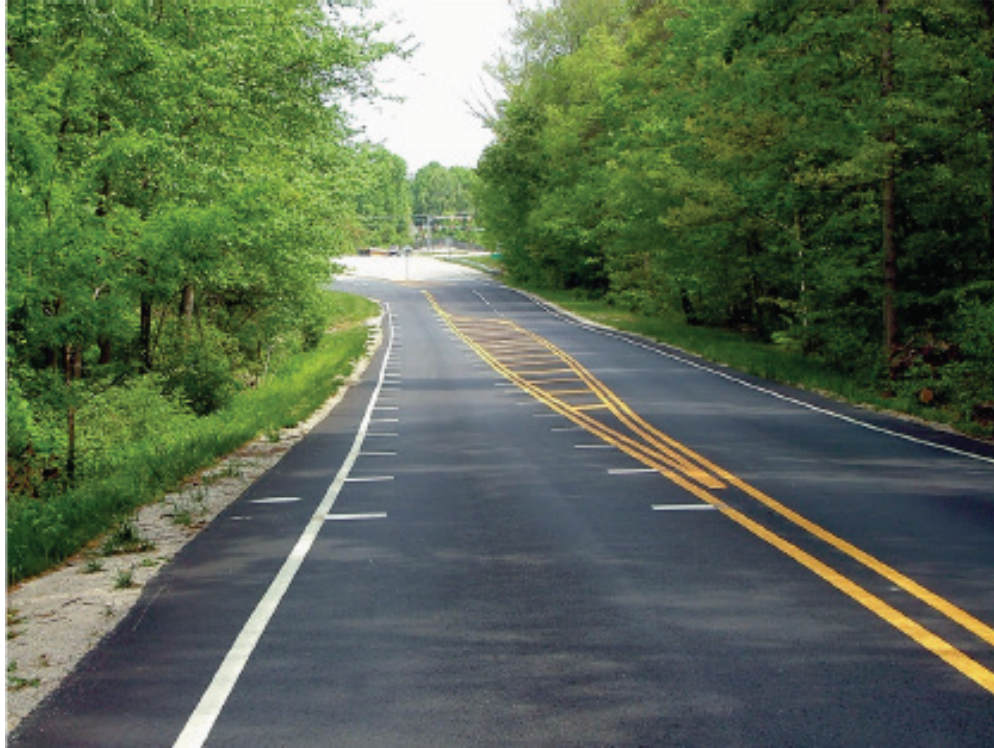
**Figure 1. Example of Optical Bars (3).**

Arnold and Lantz evaluated the use of flashing LED Stop sign and optical speed bars at three locations in Virginia (3). The study showed a statistically significant decrease in approach speeds at the study sites, but questioned the practical significance of the decrease. The speed reductions were observed to be greater during dusk and nighttime. The study recommends the device as a potential countermeasure for accident-prone stop-controlled intersections. Installation of optical bars also saw statistically significant decrease in approach speeds. The study reports that speed decreases were higher when the bars extended across the travel lane. [Figure 1](#) shows an example of optical bars approaching an unsignalized intersection.

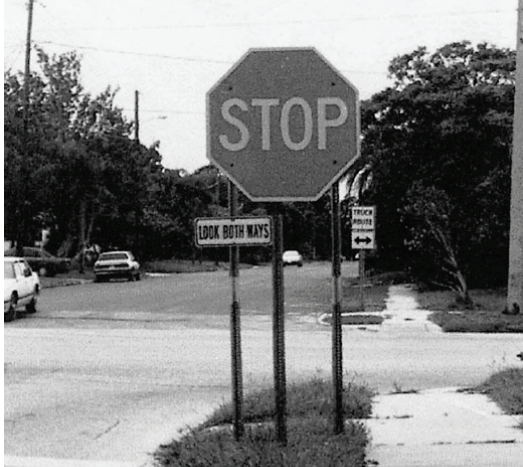
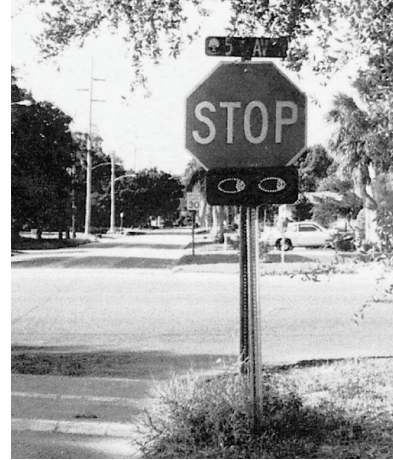
**Figure 2. Look Both Ways Prompt and the Animated Eye Prompt (8).**

Houten and Retting compared effectiveness of using a LED sign that featured animated eyes scanning left and right to prompt drivers to look left and right for approaching traffic with a Look Both Ways supplemental plaque (Figure 2) at three sites (5). The results indicated that introduction of the animated eyes prompt increased the percentage of vehicles coming to a complete stop at all the study sites, whereas, the Look Both Ways sign was not associated with any change in behavior at the one site it was introduced. However, the authors recommended further research to understand sustainable benefits of the improvement.

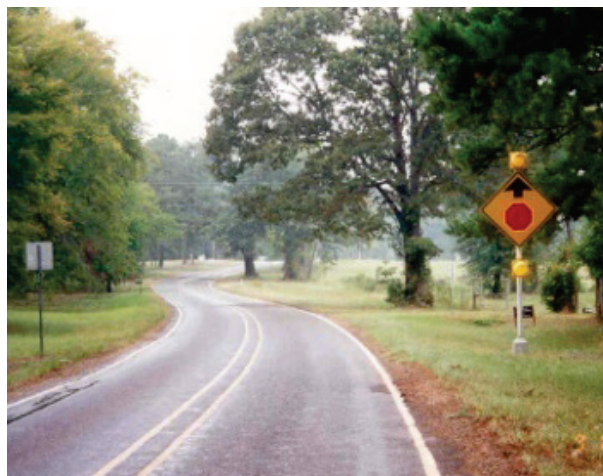
**Figure 3. Stop Ahead Symbol Warning Sign. Source: <http://tti.tamu.edu/documents/4048-2.pdf>**

Zwahlen found that drivers at night approached a stop-controlled intersection at lower speeds when a Stop Ahead text sign was present. The advance warning sign had no noticeable effect on eye glance behavior at night or during the day (6). Hawkins et al. conducted a survey of 1,745 Texas drivers to assess their comprehension of selected traffic control devices. The survey for comprehension of the Stop Ahead symbol sign (W3-1a of the Manual on Uniform Traffic Control Devices [MUTCD]) indicated that 87 percent of the drivers understood the sign (7). Figure 3 shows an example of the Stop Ahead symbol warning sign.

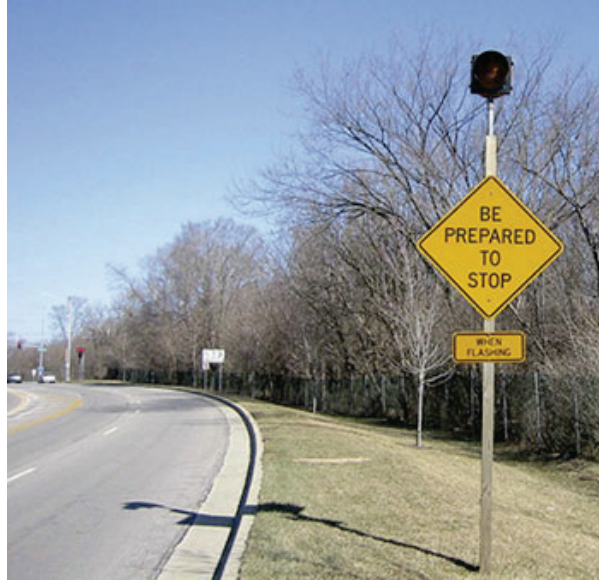
**Figure 4. Example of Yellow Beacon on Advance Warning Stop Sign.**

The addition of a yellow beacon on a Stop Ahead or Intersection Ahead Sign is believed to improve the conspicuity of the advance warning sign. Figure 4 shows an example of an advance warning sign with yellow flashing beacon.

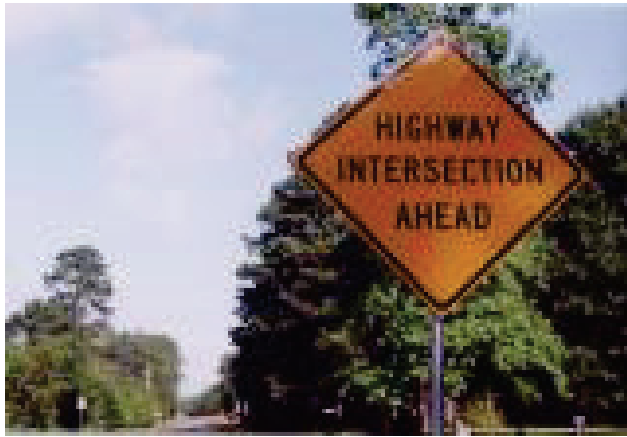
**Figure 5. Example of Intersection Ahead Warning Sign for Major Road.**

Advance Warning for Intersection Ahead Sign is another TCD used to warn major road users to expect cross traffic. [Figure 5](#) shows an example of Intersection Ahead warning sign for major roads.

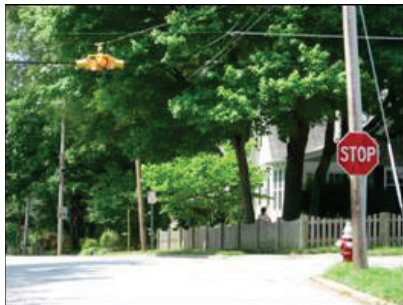
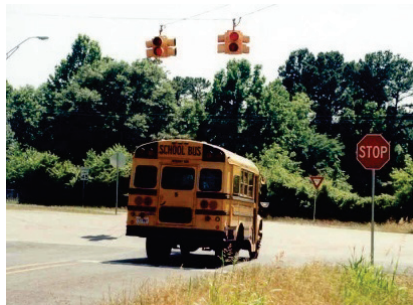
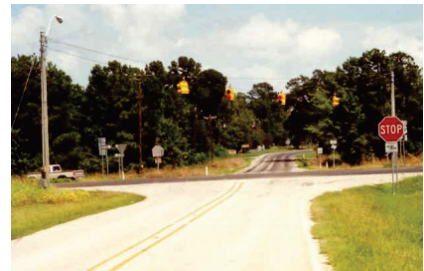
**Figure 7. Examples of Intersection Control Beacon.**

Intersection Control Beacons are used in conjunction with Stop signs at isolated intersections or intersections having sight distance obstructions. Research findings recommend that they not be used at “Y,” offset, or intersections with more than four legs because the geometry of these intersections frequently does not provide an adequate line of sight from all intersection legs to a center-mounted beacon. [Figure 7](#) shows examples of intersection control beacons.

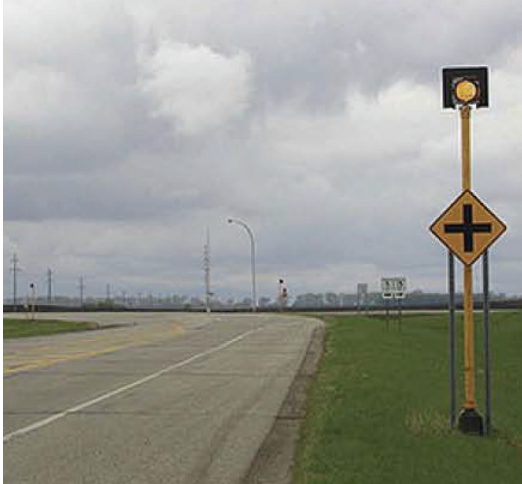
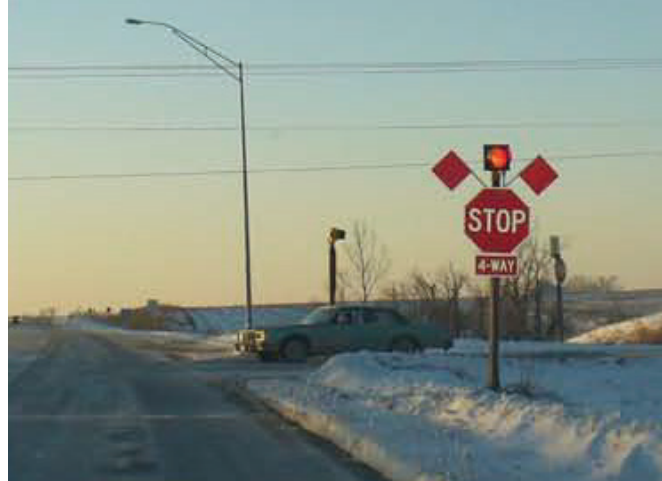
**Figure 8. Examples of Replacement Beacons for Overhead Flashing Beacons.**

Because of concerns that the beacons were giving the false perception that all the flashers were red, the Minnesota Department of Transportation is replacing the four-headed overhead flashing beacons with red flashing beacons mounted on the minor road Stop sign and a yellow flashing beacon mounted on the appropriate intersection warning sign for the major approach (16). The effectiveness of the practice is to be evaluated as part of a pooled fund study per a 2006 *Public Roads* article (16). Figure 8 illustrates examples of the sign-mounted beacons being used to replace overhead flashing beacons.

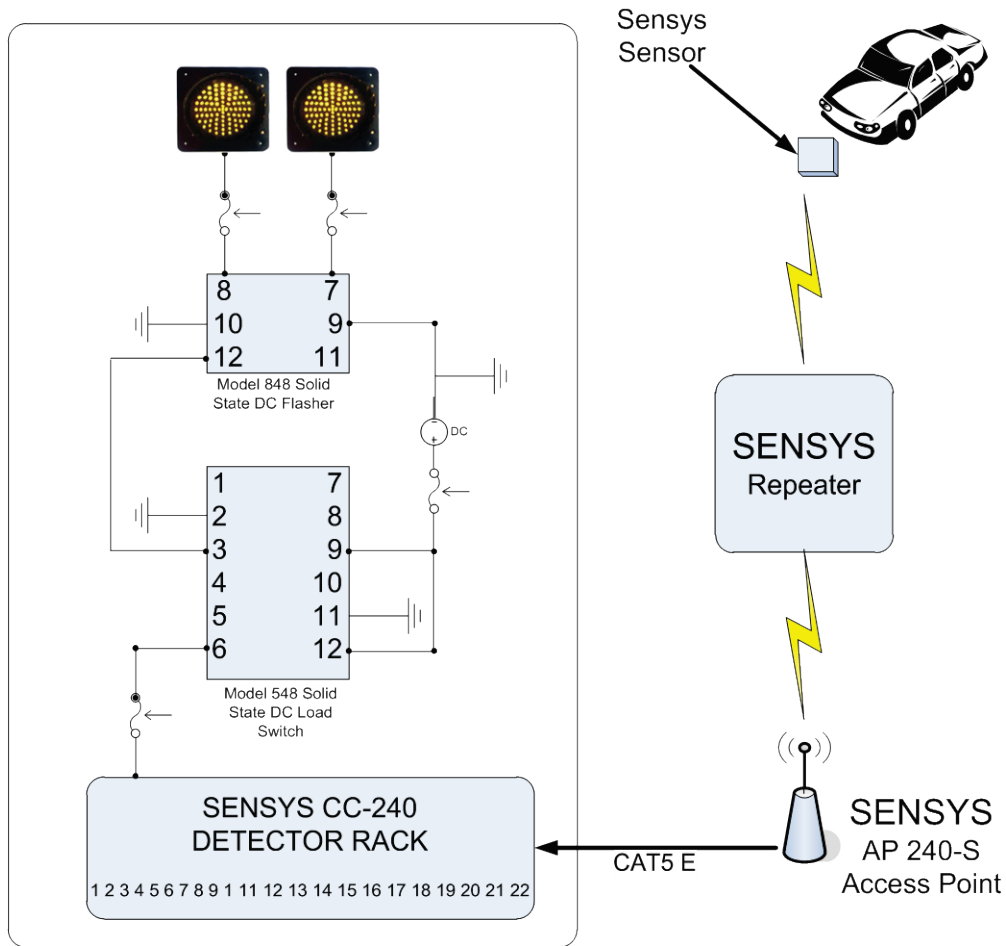
**Figure 10. Sensor-Flasher Panel Configuration.**

The first alternative considered was internally illuminated Stop signs operating in an active manner. K&K Signs and TAPCO signs were operated in an active manner using a pair of wireless Sensys detectors as illustrated in [Figure 9](#). Wireless sensors were located at a distance of approximately 1,000 feet from the intersection. TTI proposed to use Sensys wireless sensors to develop this system as researchers had some experience using them and could get some sensors on a loan basis while developing the system. Sensys sensors detect the vehicles traveling over the sensors and transmit the actuation using a repeater located near the sensors to the Access Point near the Stop sign. A flasher panel that has already been fabricated receives the actuation from the Access Point to trigger the Active Stop signs, as illustrated in [Figure 10](#). [Figure 11](#) illustrates

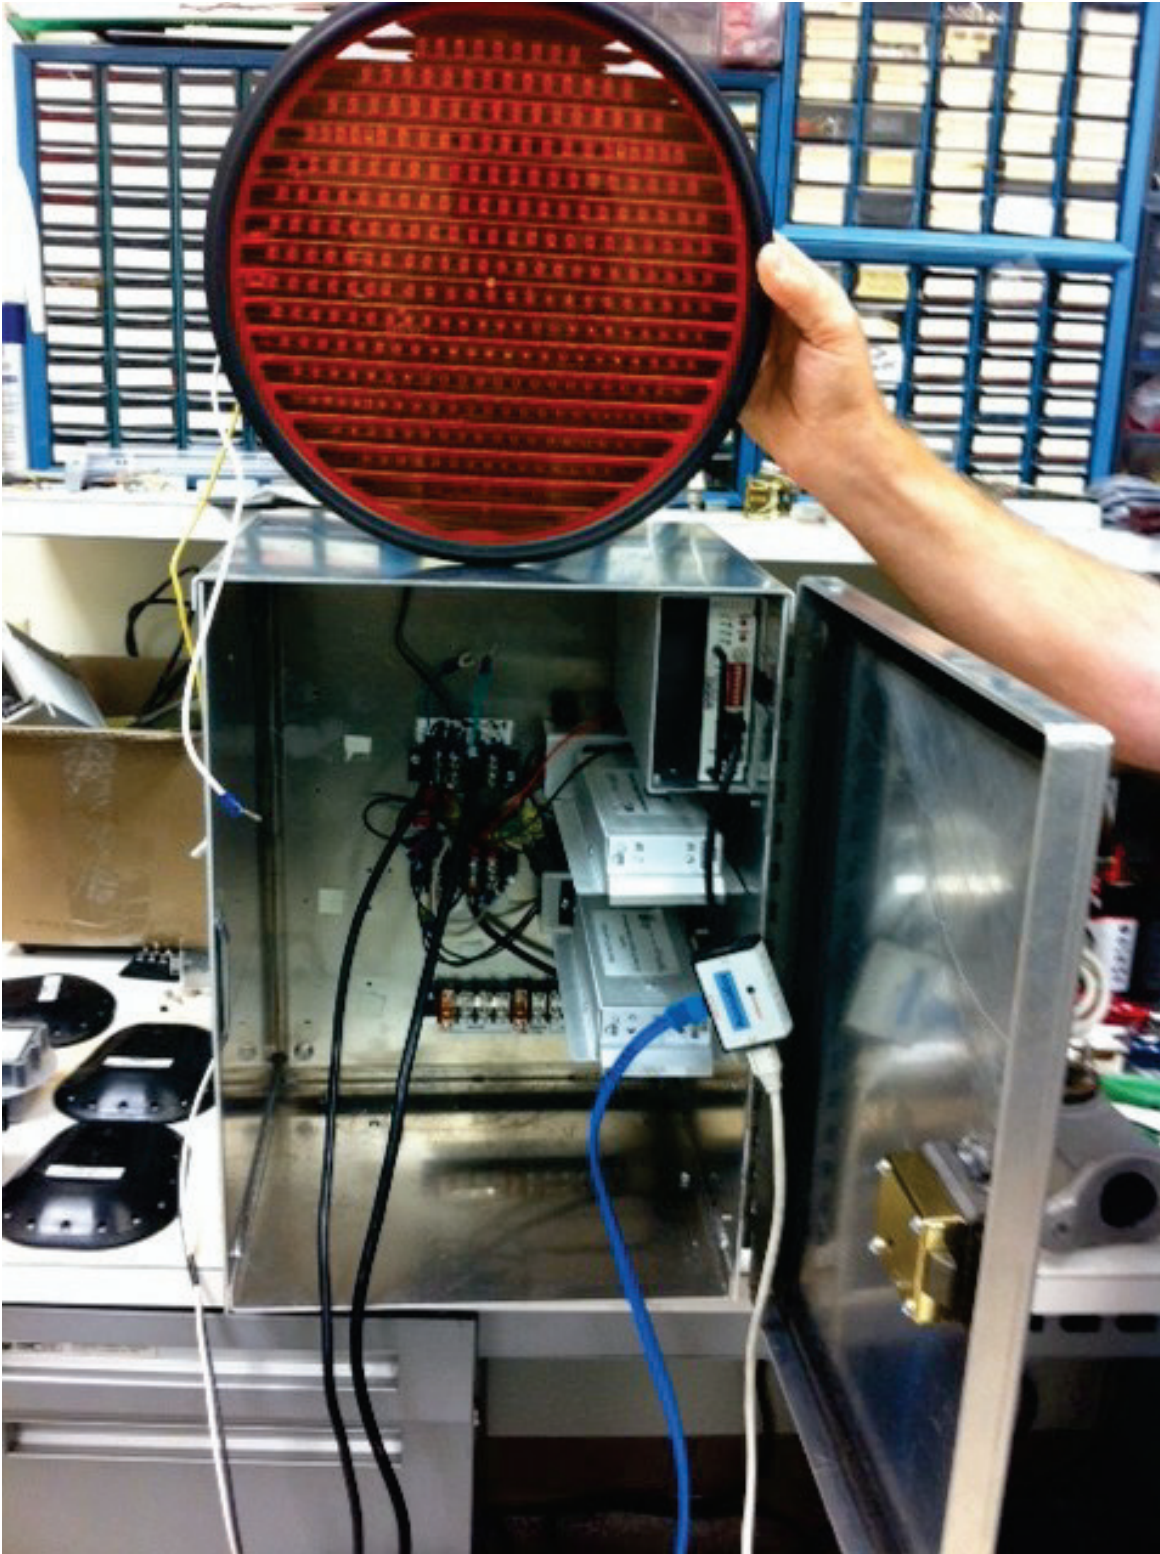
**Figure 11. A Fabricated Flasher Panel to Control the Beacons Using Sensys Sensors.**

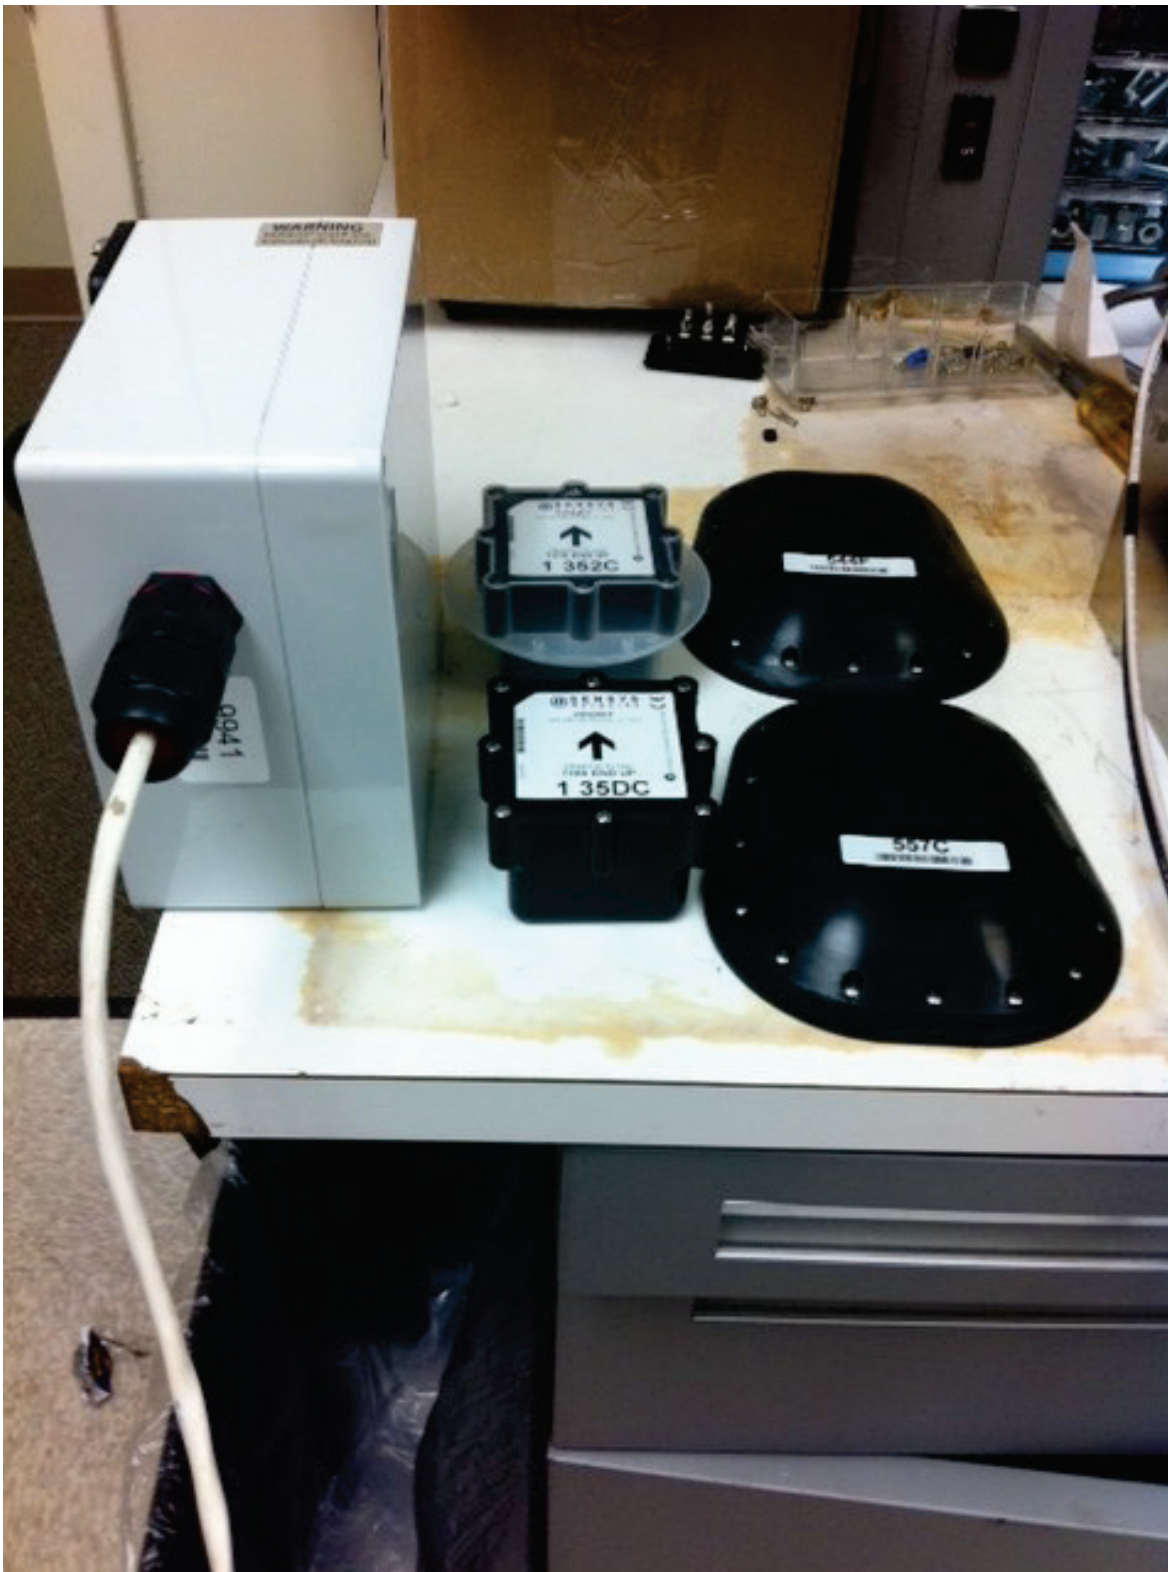
**Figure 12. Four Sensys Sensors and an Access Point Necessary to Operate the Beacon.**

a completely fabricated flasher panel. Figure 12 illustrates four Sensys Sensors and an Access Point for Sensys Sensors. The described methodology can be applicable for the K&K signs. The TAPCO signs may require a customized actuation, because the signs are not triggered by contact closure but by serial communication. TAPCO has a configuration to implement an active Stop sign based on the presence of a vehicle. However, TTI researchers will not test the TAPCO signs due to their proprietary firmware to operate the beacons.

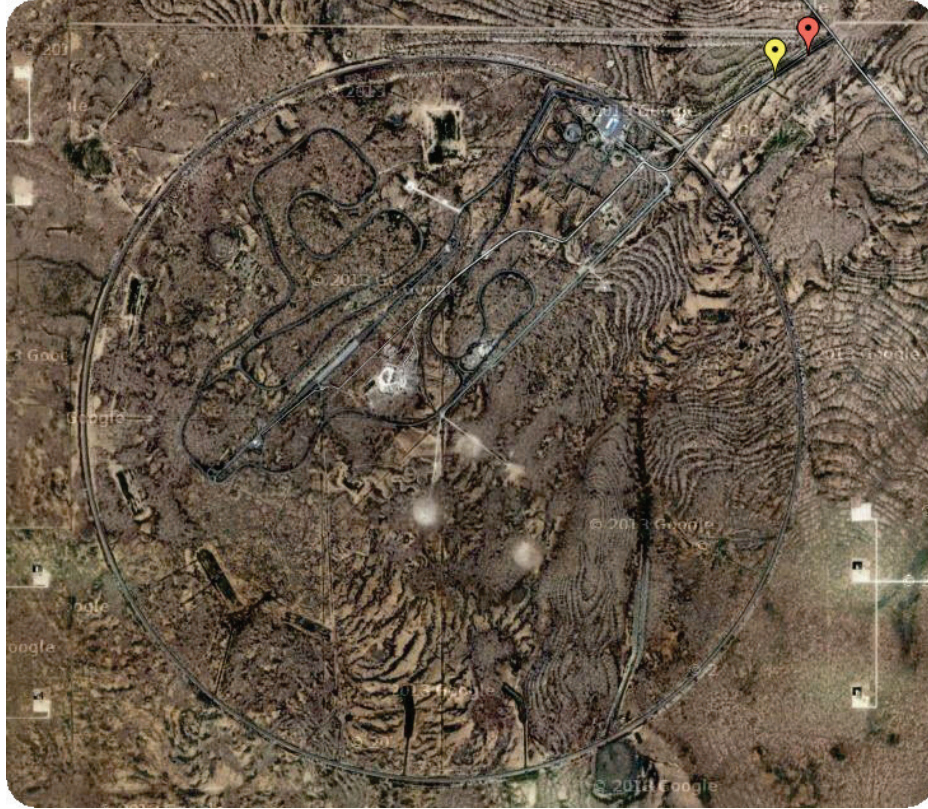
**Figure 17. Pecos Test Track Overview (Courtesy Google Maps).**

The Pecos Test Track is located about 20 miles to the south east of the city of Pecos and about 75 miles to the west of Odessa District Office. [Figure 16](#) illustrates the location of the Pecos Test Track. Pecos Test Track consists of a 9-mile high speed (up to 200 mph) test track, a 10-mile road course, a skid pad, off-road courses, a 1.2-mile serpentine road among other facilities. An aerial photograph of the Pecos facility is illustrated in [Figure 17](#).

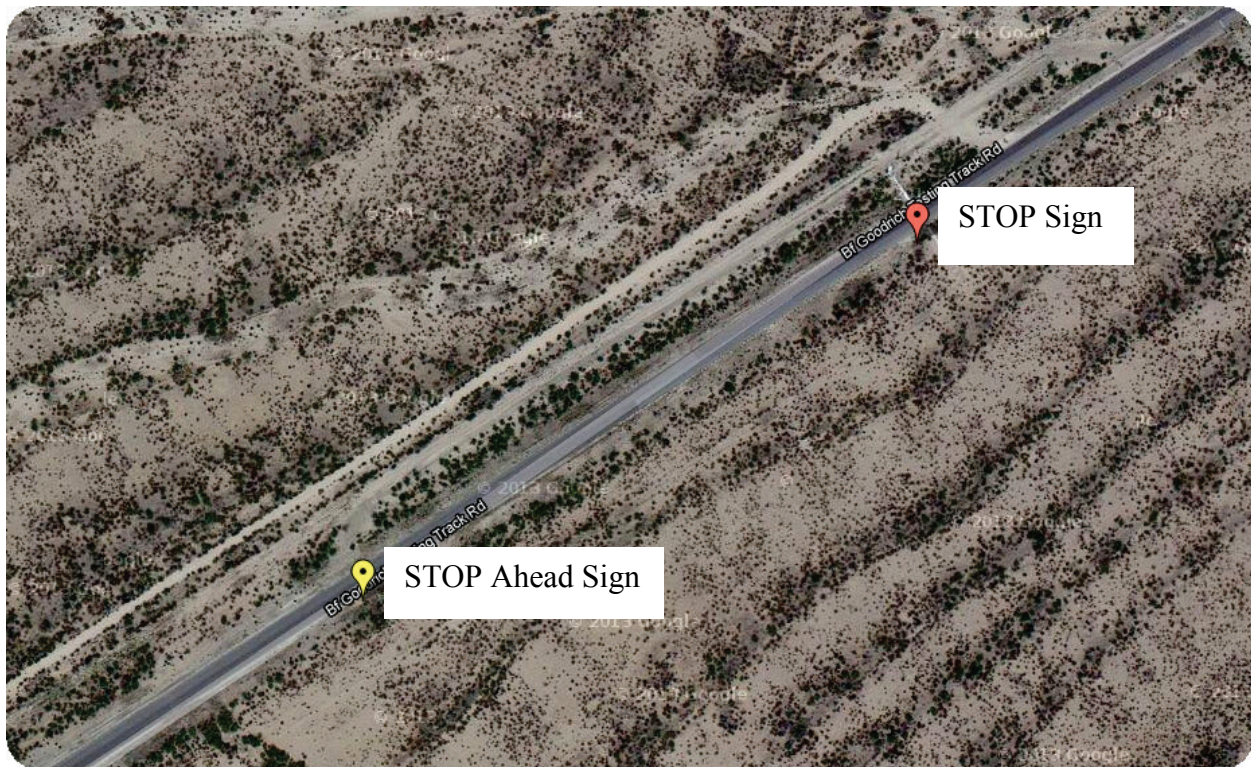
**Figure 18. Layout of the Pecos Test Track Where the Treatment Was Installed (Courtesy Google Maps).**

The Pecos Test Track also has a 2000 feet two lane road at the entrance of the facility. TTI researchers visited the Pecos Test Track and selected this stretch to install the treatment. This stretch of the test track is illustrated in [Figure 18](#).

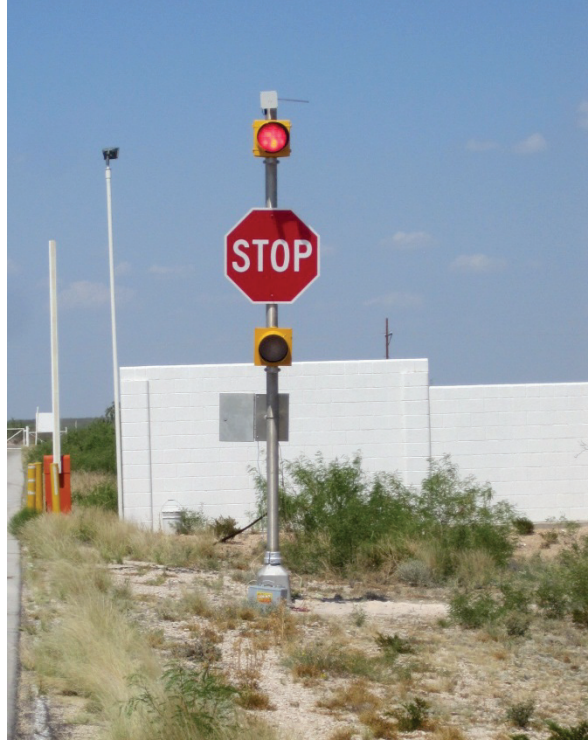
**Figure 19. Stop Sign Installed at Pecos Test Track.**

TTI researchers worked with the TxDOT Odessa District to install two roadside flashing beacon assemblies (RFBA). A Stop sign (R1-1) with red DC flashing beacons and a Stop Ahead sign (W3-1) with yellow DC flashing beacons were installed at the locations identified in [Figure 18](#). Flasher cabinets fabricated by TTI researchers, Sensys Access Points, and repeaters were installed on the sign posts by TxDOT technicians. The two RFBA are illustrated in [Figure 19](#) and [Figure 20](#). One Sensys repeater was installed in the RFBA assembly for the Stop Ahead sign and the second one was installed on a temporary pole ([Figure 21](#)). Sensys sensors were placed on the pavement and vehicles driven over them. This facilitated exhibiting the functionality of the treatment and allowed TTI/TxDOT further use of the sensors in project. Solar panels were not installed as these signs were installed for a demonstration only. TTI researchers used 12 volt batteries to power the flasher cabinets and the beacons.

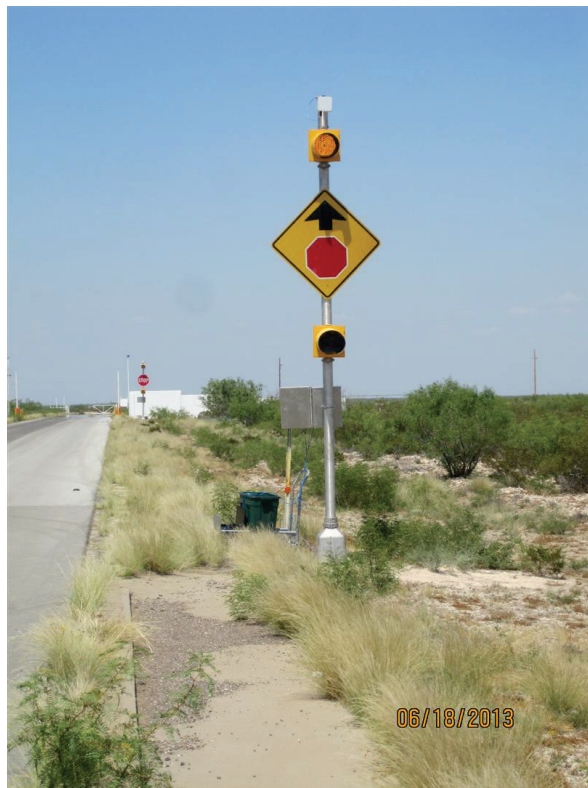
**Figure 20. Stop Ahead Sign Installed at Pecos Test Track.**

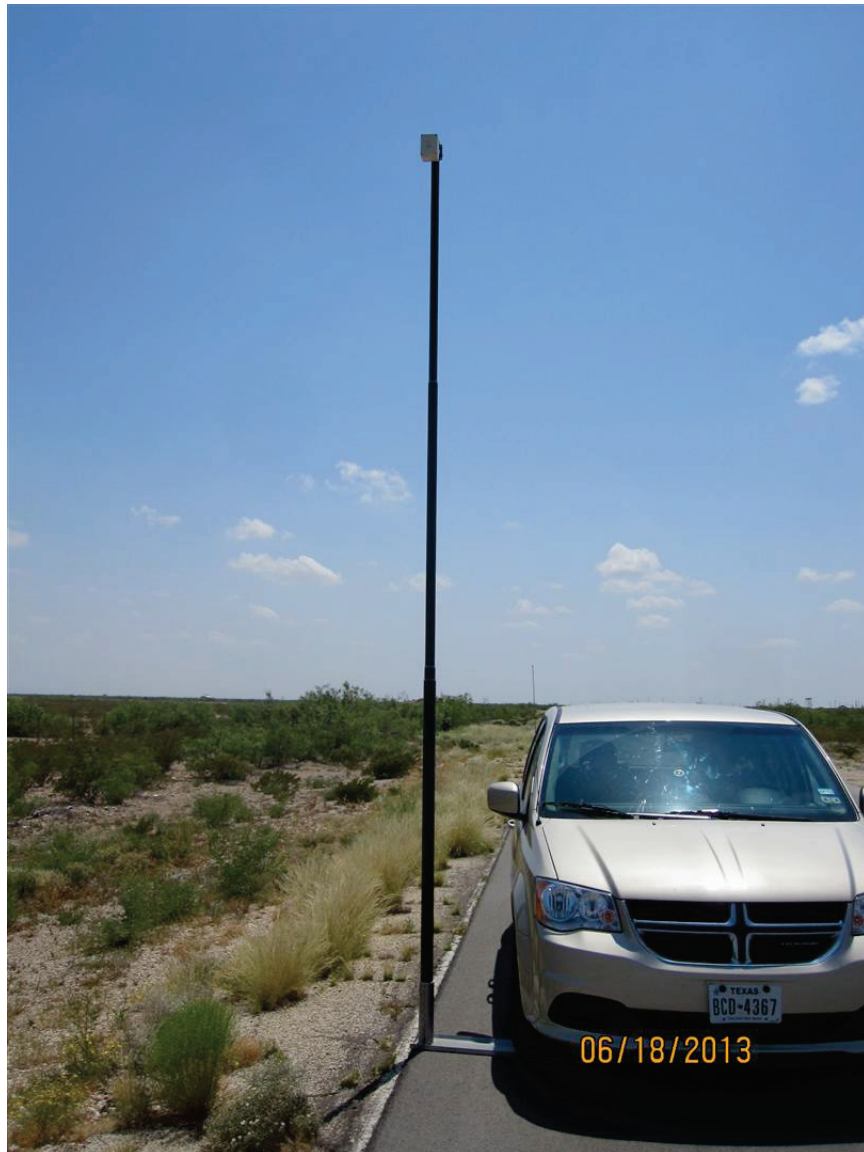
**Figure 21. Sensys Sensors Used for the Treatment.**

The treatment used wireless Sensys detectors. These detectors were magnetometer in nature and transmit vehicle actuation to the access point. When the detectors were located farther than 250 feet from an access point, a repeater was used to transmit the actuation to the access

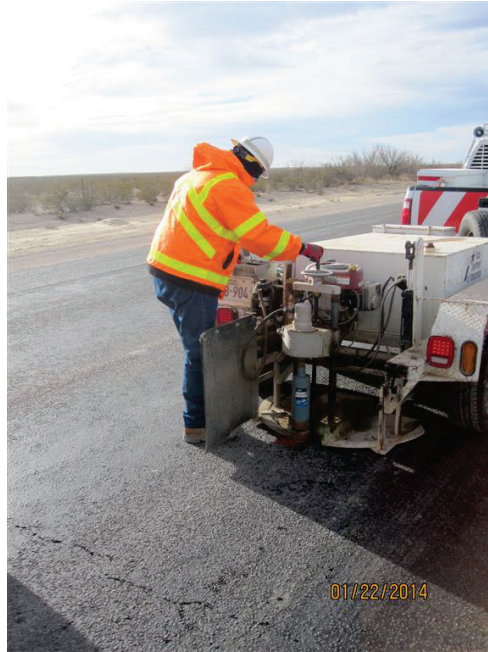
**Figure 24. Core Machine Preparing the Pavement to Install the Sensors.**

The system consisted of two sub-systems. The first sub-system consisted of active beacons on a Stop Ahead sign. This sub-system consisted of a wireless sensor (VSN240-F) installed at a distance of approximately 600 feet upstream of the Stop Ahead sign. A long life repeater (RP240-BH-LL) was installed on the back side of the sign post for JCT 28, which was located at a distance of 1700 feet from the Stop Bar. An Access Point (AP240) was installed on the pole on which the solar panel and cabinet with the batteries was installed near the Stop Ahead sign. The flasher cabinet was then installed on the same pole. Figure 24 to Figure 27 illustrate the system being installed.

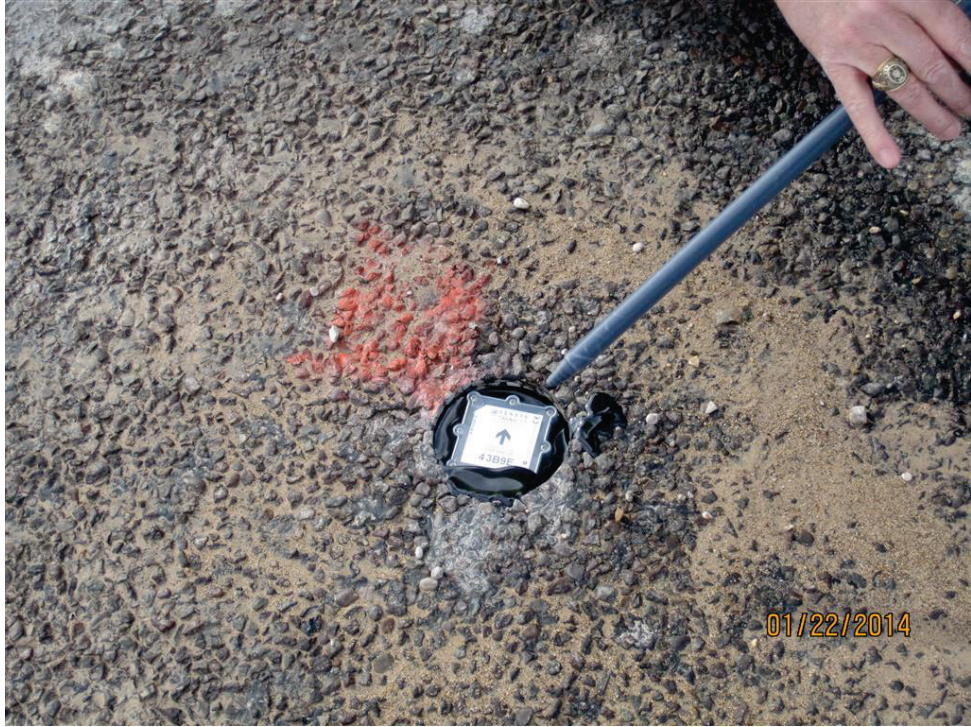
**Figure 25. Wireless Sensor Installed in the Core.**

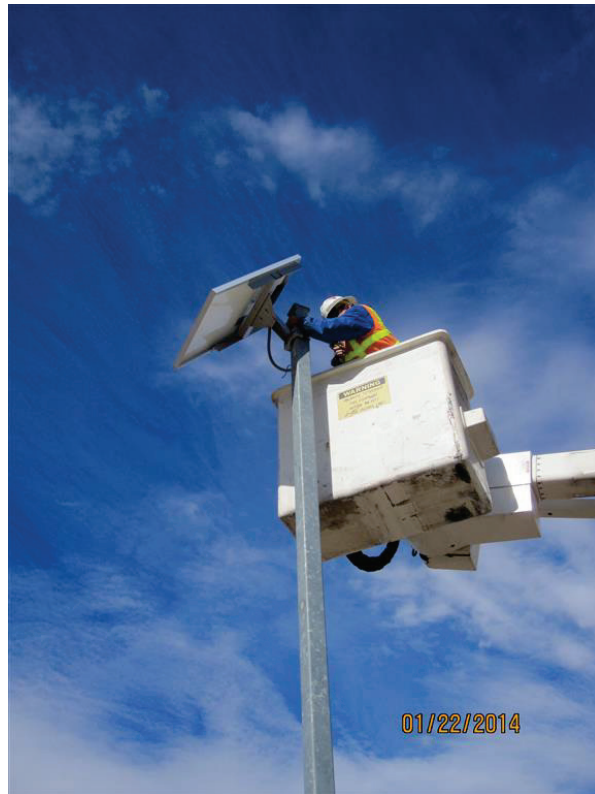
**Figure 26. Access Point Installation on the Solar Panel Pole.**

The second sub-system consisted of active beacons on the stop sign. This sub-system consisted of a wireless sensor (VSN240-F) installed about 50 feet upstream of the Stop Ahead sign and a long life repeater (RP240-BH-LL) installed on the pole with the solar panel near the Stop Ahead sign. The sub-system also had two additional wireless sensors at the Stop Bar (VSN240-T) and an Access Point (AP240) installed on the pole with the solar panel near the Stop sign.

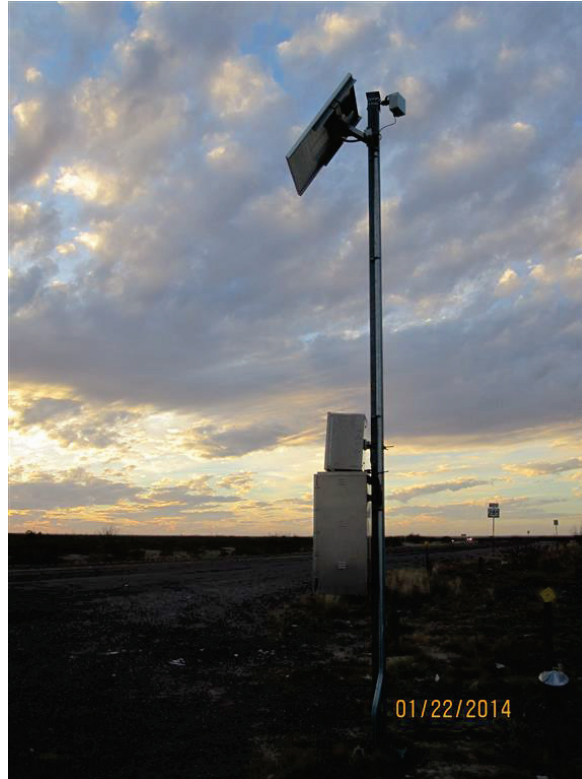
**Figure 27. Flasher Cabinet Installed on the Solar Panel Pole.**

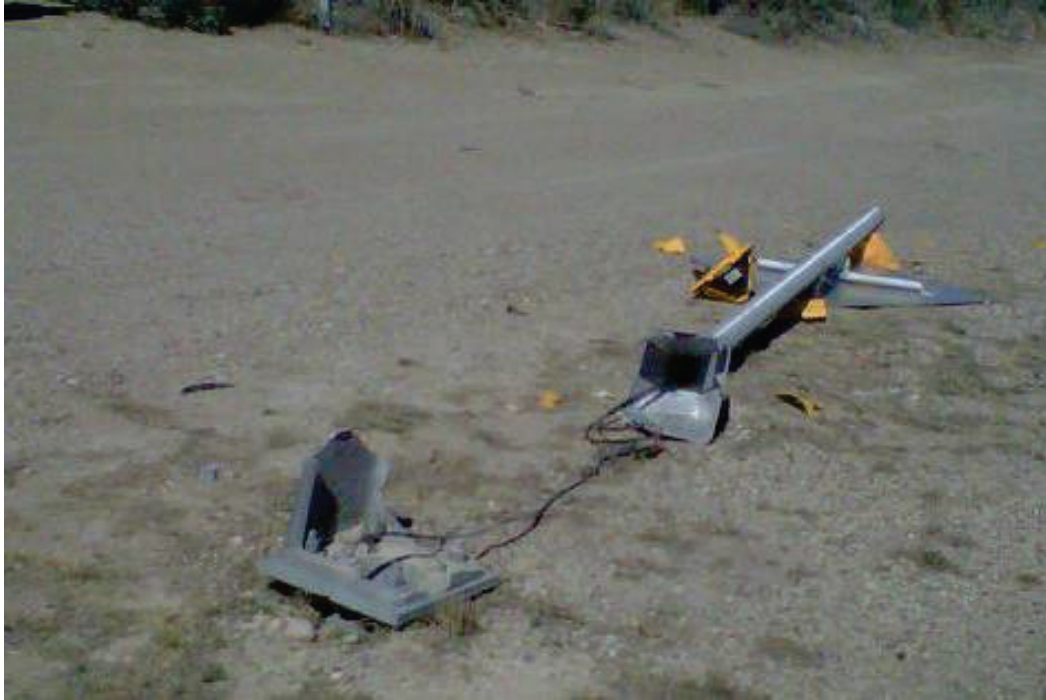
**Figure 29. Stop Ahead Sign Knocked down a Week after Installation of the System.**

Researchers encountered some challenges after the system was installed. The Stop Ahead sign located at 1035 feet was knocked down during the first week of February. This resulted in the system being down. However, it also was an opportunity to test the failsafe feature that was built into the system as the repeater for the Stop sign was missing from the Stop Ahead sign. When the sign was knocked down, the failure mode kicked in and the beacons on the Stop sign were then flashing continuously as designed.

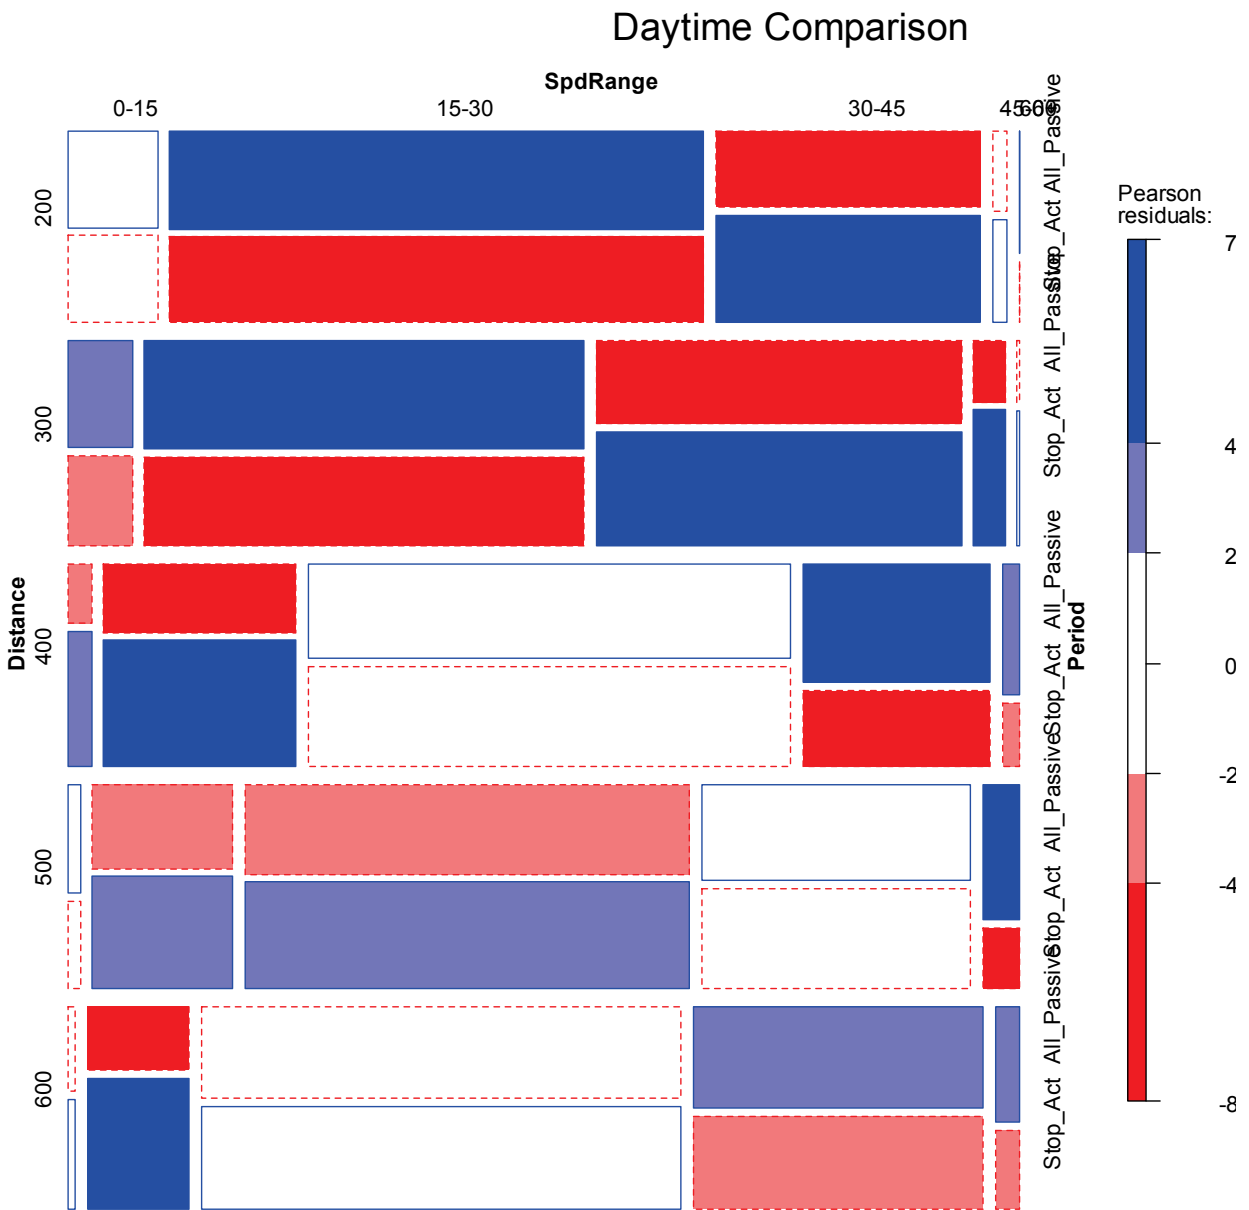
**Figure 32. Daytime Analysis of Case 2 Comparison.**

A comparison of the two treatments in Case 2 for daytime and nighttime is illustrated in [Figure 32](#) and [Figure 33](#). The following can be inferred from the analysis:

1. During daytime, more drivers appeared to reduce speed sooner at 400 feet from the Stop sign when only the Stop sign was active (i.e., when Stop Ahead sign was passive).

2. However, the speed reduction does not continue to 300 feet and 200 feet.
3. During nighttime, both setups have very similar impacts on approaching vehicle speeds.

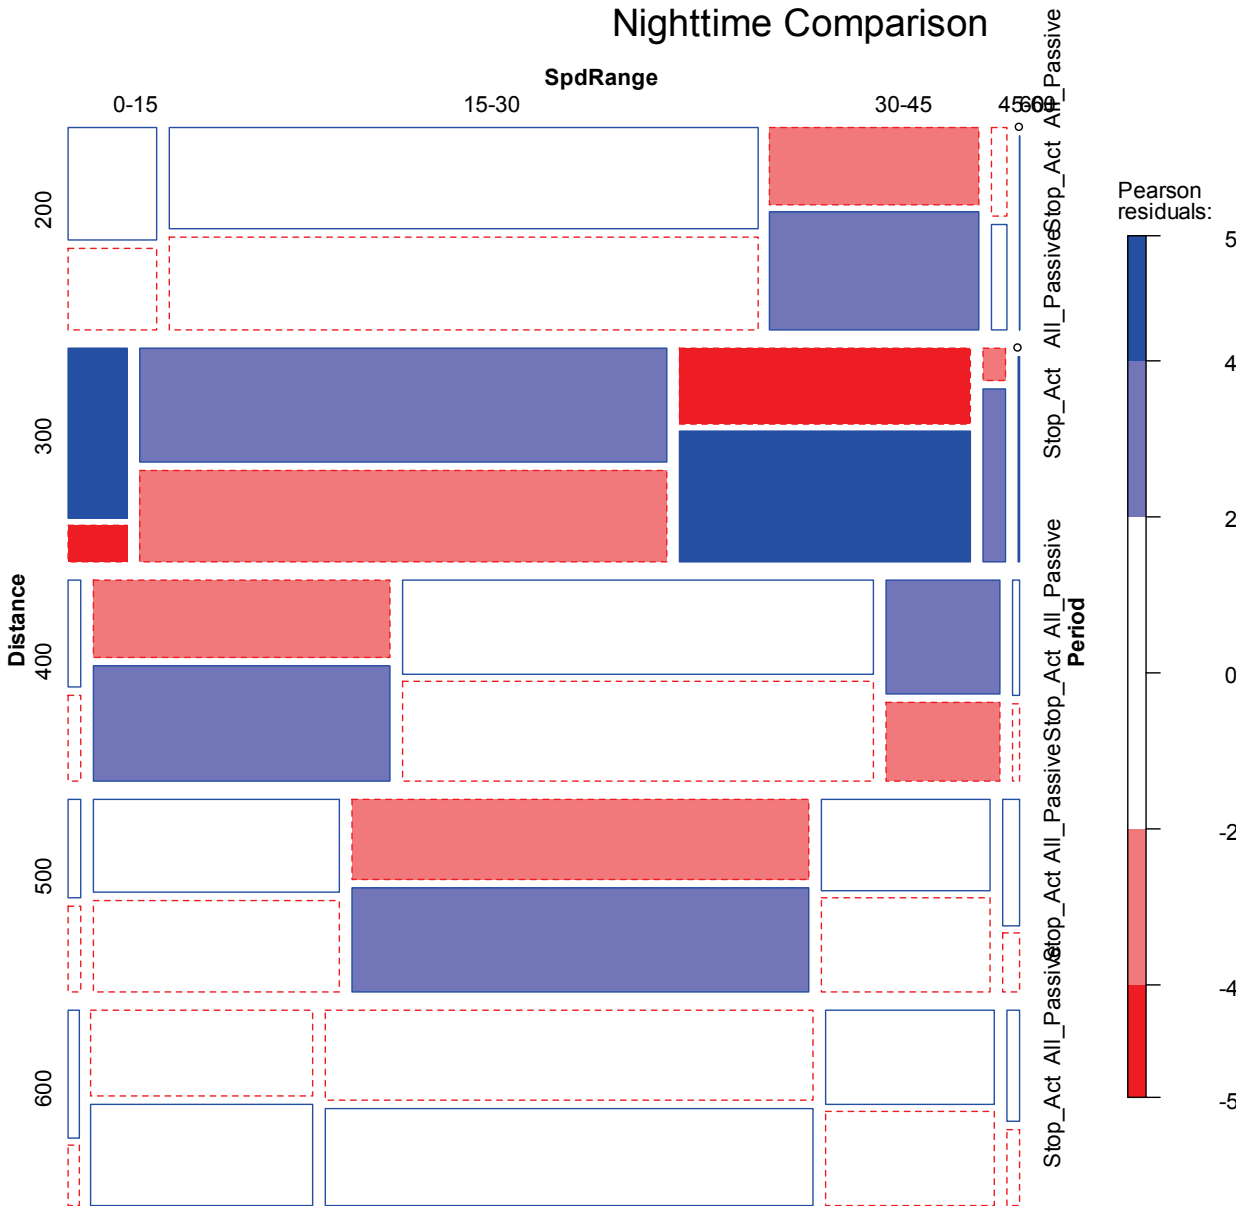
**Figure 33. Nighttime Analysis of Case 2 Comparison.**
