1. Report No. TX-91/990-1		2. Government Accession No.		3. Recipient's Catalog No.	
4. Title and Subtitle ADIEM Development of a Low Cost High Performance Terminal for Concrete Median Barriers and Portable Concrete Barriers				5. Report Date August 15, 1991

FINAL REPORT

Development of a Low Cost High Performance Terminal
for Concrete Median Barriers and Portable Concrete Barriers

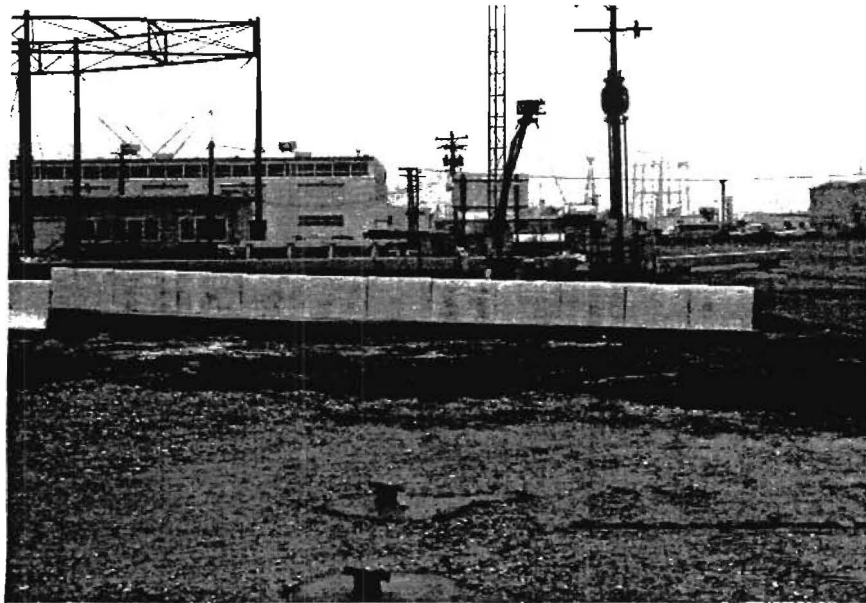
Figure 1. ADIEM terminal for concrete barriers.
(Concrete median barriers, portable concrete
barriers and toll road collection zones.)

The ends of concrete median barriers (CMB's) and portable concrete barriers (PCB's) are a troublesome safety problem. Some solutions such as the sloping concrete wedge have been low-cost, but effectiveness in reducing injuries is questionable. Sand filled barrels and the steel barrel cushions are fairly low-cost, but maintenance is difficult. Further, they require a wide median or roadside which is often not available, especially in constrained construction areas. The excessive width of these two cushions greatly increases the target size of the protective device, resulting in more collisions than would be produced when compared to a narrow cushion. Finally, there are narrow cushions for end treatments in narrow zones that perform quite well in collision circumstances. These, however, are extremely costly. The motivating situation for this work is the fact that there existed no low-cost, high performance, easily maintained end treatments for CMB's and PCB's. This report describes the development and final performance verification of such a terminal. Figure 1 and Table 1 show the final results of this development.

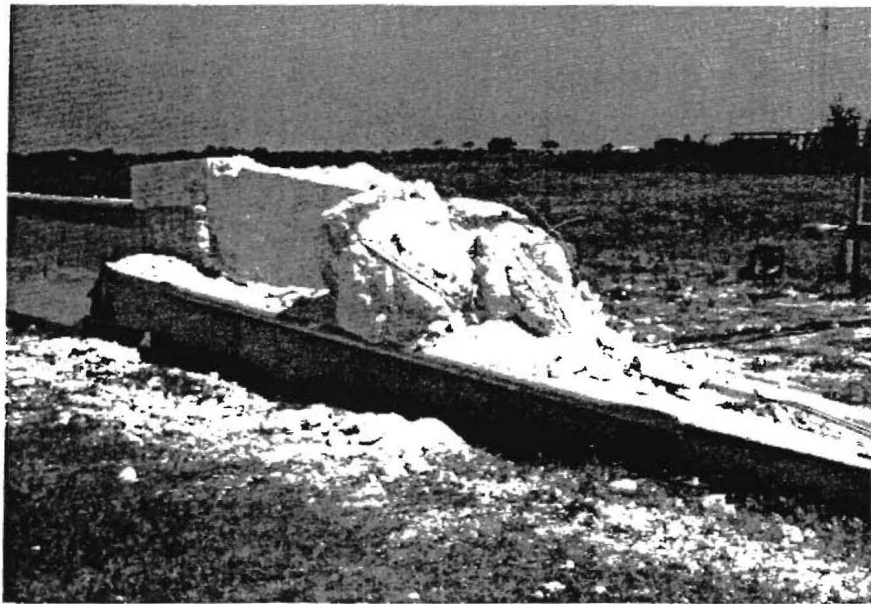
Figure 14. ADIEM impact attenuator after test 9429G-5.

In summary, all requirements of NCHRP 230 were met. The ramping toward the end of the interaction, however, was not the preferred vehicle reaction. Investigation showed a

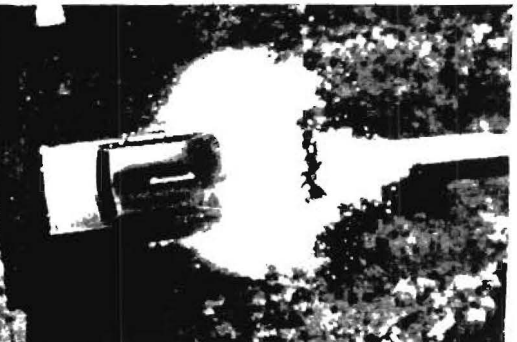
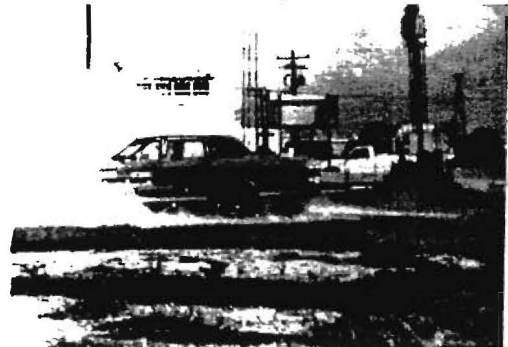
Figure 24. Sequential photographs of test 9901E-1.

Upon impact, the modules began to crush at the design level of resistance. The vehicle remained extremely stable and level as it penetrated the modules. The vehicle penetrated 25.6 ft. (7.8 m) into the terminal. Sequential photographs of the test are shown in Figure 24.

The modules were all crushed to varying degrees. There was no damage to the carrier beam. Minimal amounts of debris and detached pieces of soft concrete remained around the installation after the collision. The carrier beam remained firmly attached to the ground surface and to the PCB.

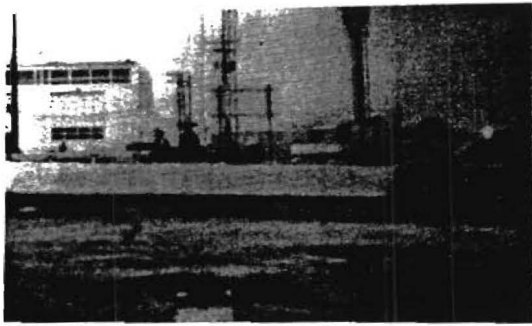
Figure 26. Sequential photographs of test 9901E-2 (Continued).

A summary of the test results and other information pertinent to this test is given in Figure 19. The maximum 0.050 second average acceleration experienced by the vehicle was -11.7 g in the longitudinal direction. Occupant impact velocity in the longitudinal direction was 37.4 fps (11.4 m/s). Although this is above the preferred level of 30 fps it is generally observed that there are no terminals that do better than the 40 fps requirement for small car head-on tests.

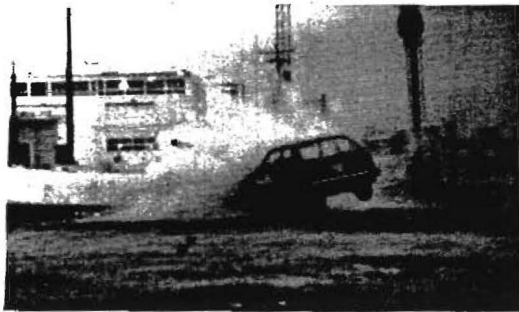
Upon impact, the modules began to crush as designed. The vehicle remained stable and level as it penetrated the first module. As the vehicle penetrated the second module, it began to yaw clockwise. The vehicle continued to yaw clockwise as module crush continued. The vehicle yawed to about ninety degrees as loss of contact between the Honda and the crushed modules occurred. The vehicle penetrated 9.9 ft. (3.0 m) into the attenuator. Sequential photographs of the test are shown in Figure 26.

All terminal modules were crushed to varying degrees. There was no damage to the terminal carrier beam, the base structure. Minimal amounts of debris and small pieces of soft concrete were distributed around the installation. The modules yielded appropriately and the carrier beam remained firmly attached to the ground surface and to the PCB.

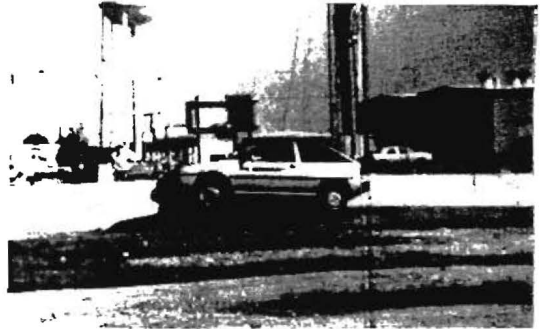
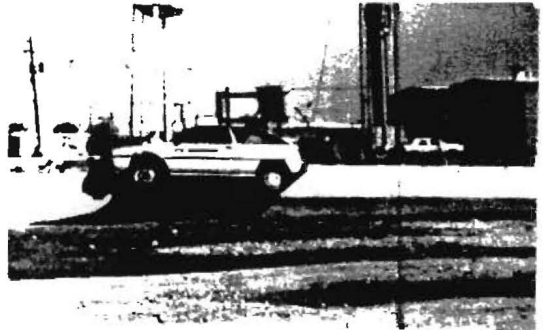
Figure 28. Sequential photographs of test 9901E-3.
(continued).

Upon impact, the vehicle began to redirect. As the vehicle redirected, the left wheels lost contact with the roadway. At approximately 0.140 second, at a vehicle speed of 55.9 mph (89.9 km/h), the rear of the vehicle came into contact with the attenuator. The vehicle began to yaw counter-clockwise and pitch forward as it became parallel to the terminal. The vehicle lost contact with the rail at approximately 0.245 second travelling 53.9 mph at an angle of 2.4 degrees. The brakes were applied to the vehicle as it exited the installation. The vehicle came to rest in a stable and upright condition 140 feet downstream from the point of impact. Sequential photographs of the test are shown in Figure 28.

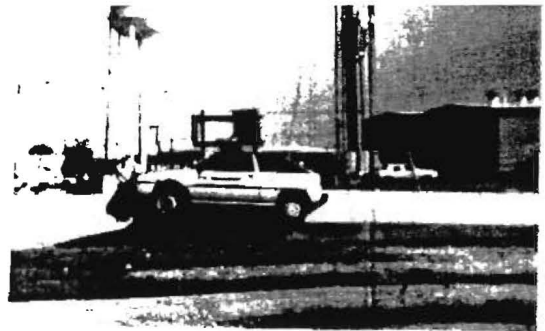
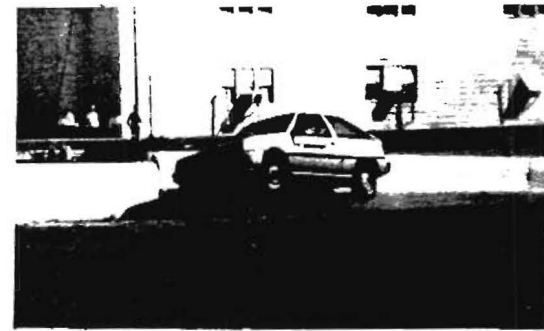
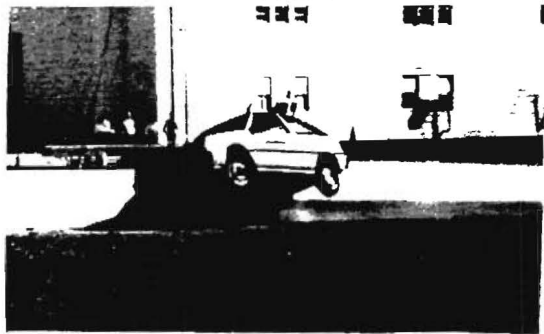
Figure 28. Sequential photographs of test 9901E-3 (continued).

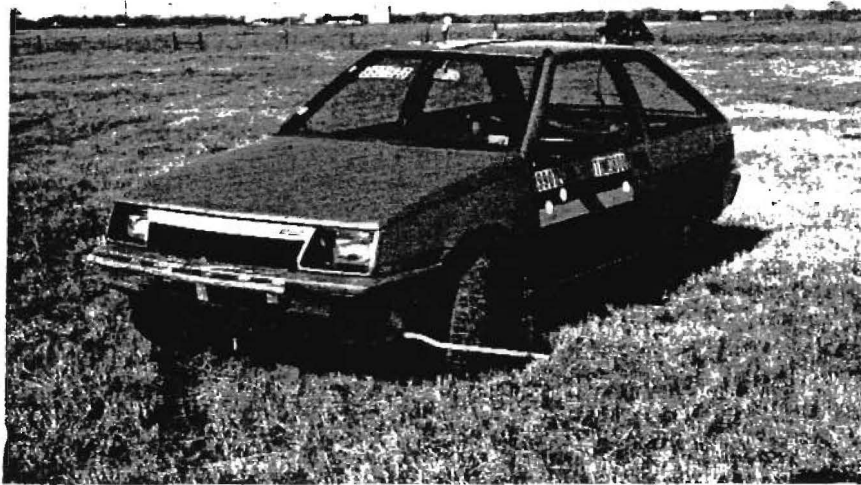
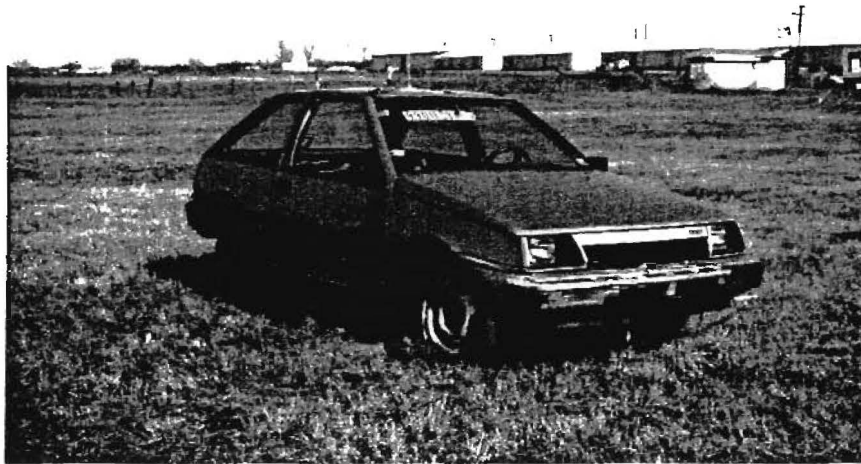
The vehicle received minimal damage. Primary damage was sustained to the right front control arm assembly, and wheel. The subframe and floor pan was bent. There was no

Figure 29. Vehicle after test 9901E-3.

intrusion into the occupant compartment. Post test photographs of the vehicle are shown in Figure 29.

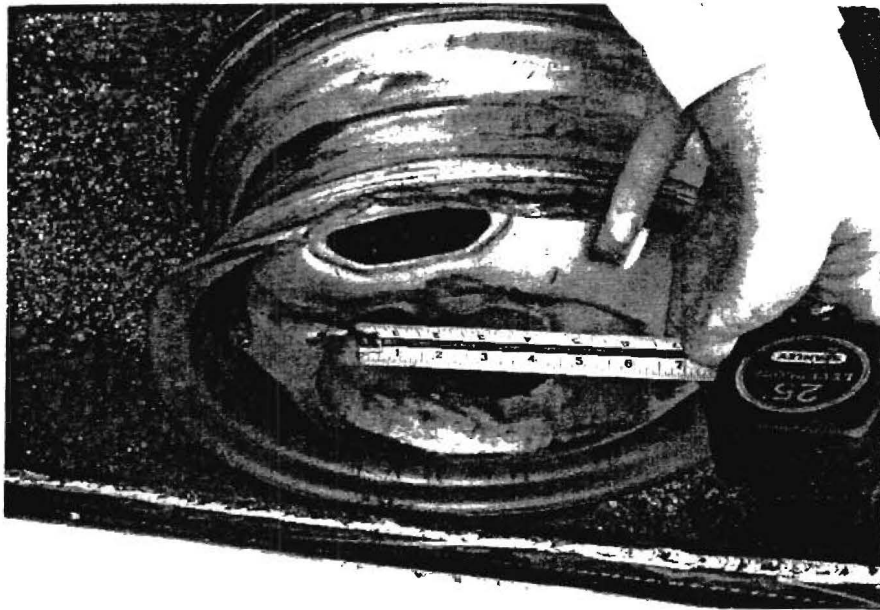
Figure 31. Right front wheel rim from test 9901E-2, E test. (The ruler is pointing to the gouge in the rim from the lower edge of the pipe taper.)

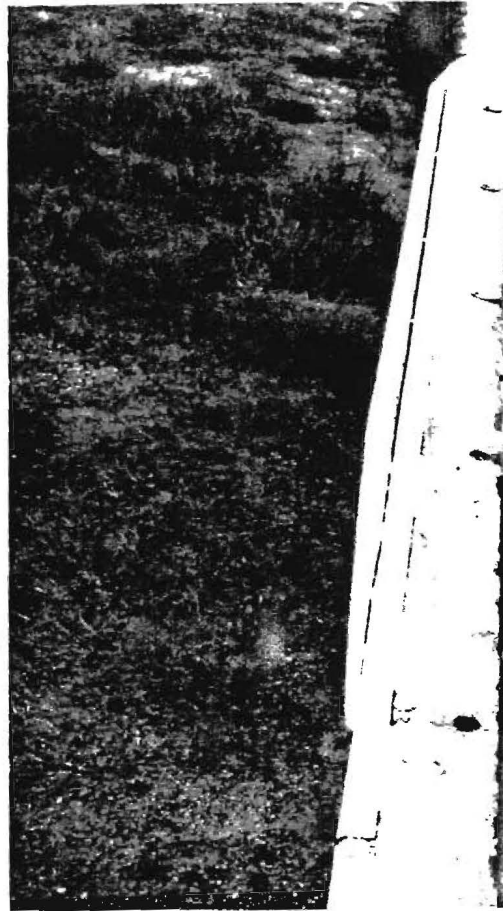
Top View

Side view

Figure 32. Final design of pipe side rail taper.
