| 4. Title and Subtitle<br><b>DEVELOPMENT OF A LOW-PROFILE PORTABLE CONCRETE BARRIER</b> | | 5. Report Date<br><b>November 1991</b> | 6. Performing Organization Code |
| 7. Author(s)<br><b>Todd R. Guidry and W. Lynn Beason</b> | | 8. Performing Organization Report No.<br><b>Research Report 990-4F</b> | |
| 9. Performing Organization Name and Address<br><b>Texas Transportation Institute<br/> The Texas A&amp;M University System<br/> College Station, Texas 77843-3135</b> | | 10. Work Unit No. | 11. Contract or Grant No.<br><b>Study No. 2-8-90/1-990</b> |

Research Report No. 990-4F

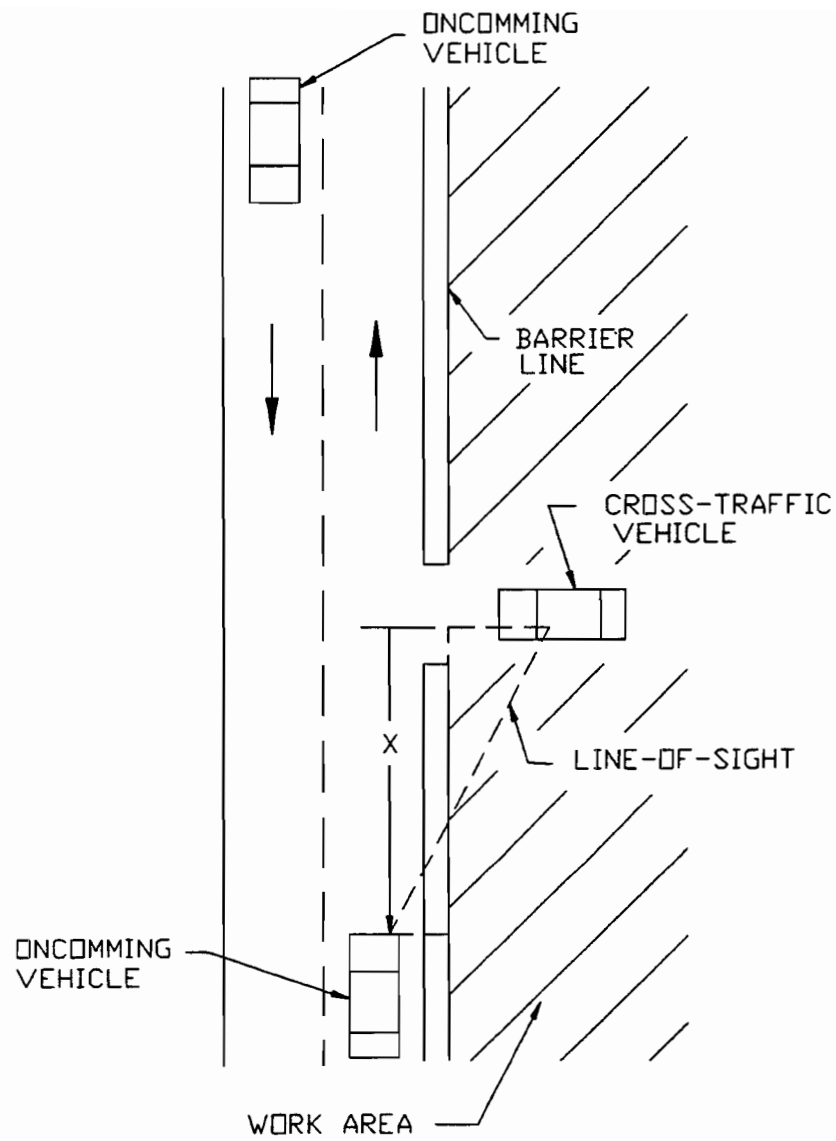
**FIGURE 1 Geometry of sight-distance problem.**

There are many other variables which affect the sight-distance problem including the offset of the oncoming vehicle and the offset of the cross-traffic vehicle to the barrier, as shown in Figure 1. Further, the situation depicted in Figure 1 can occur in conjunction with three different geometric conditions as follows.

Simplified geometric analyses were conducted for each of these geometric conditions and a wide range of offset conditions. It was found that the cross-traffic drivers sight-distance is unlimited as long as the barrier height is less than 24 in. (61 cm-the minimum headlight height) for both constant slope and sag vertical curves. However, in the case of crest vertical curves it was found that the cross-traffic drivers sight-distance is significantly increased by the use of barrier heights less than 24 in.

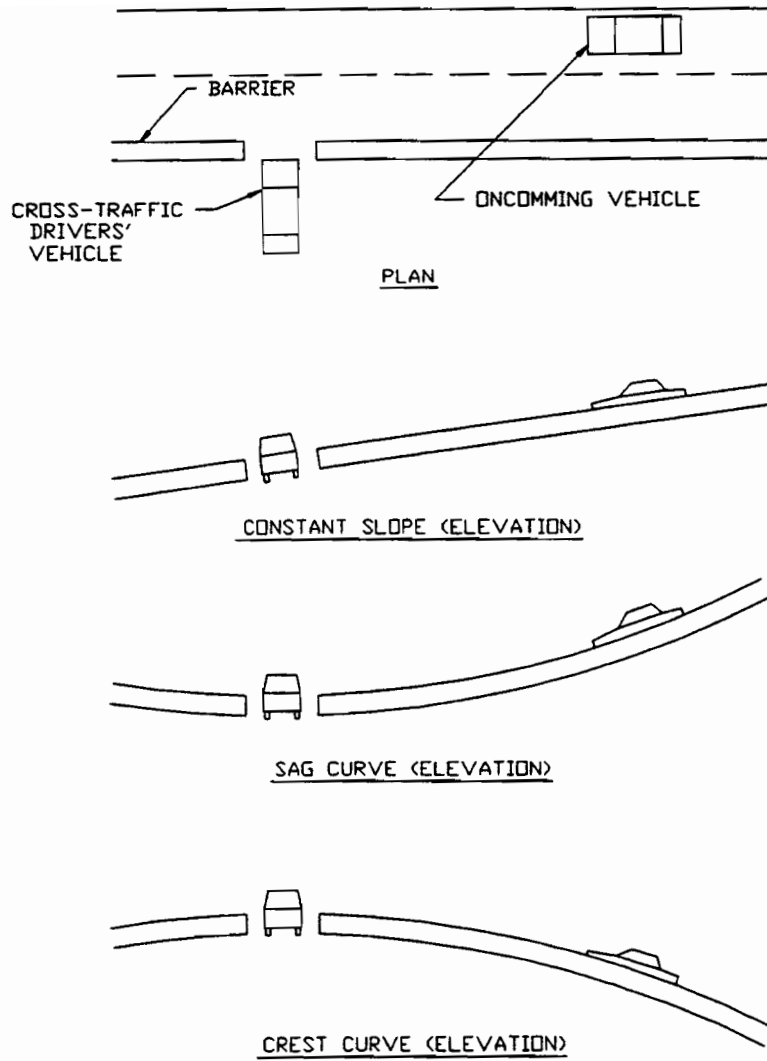
**FIGURE 2 Categories of study.**

1. Constant slope - flat terrain
2. Sag curve
3. Crest curve

These geometric conditions are illustrated in Figure 2.

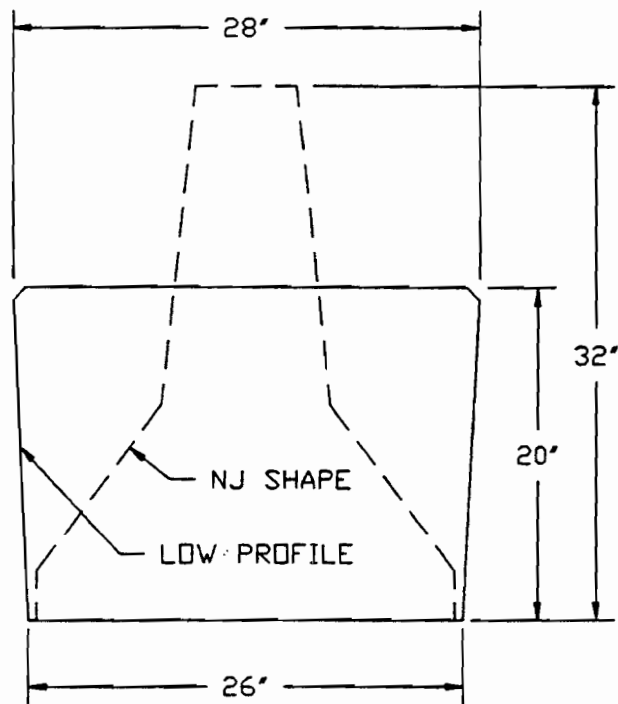
**FIGURE 3 Low-Profile PCB cross-section.**

Based on the above discussions, the barrier height was established at 20 in. (51 cm), the minimum barrier weight was set at 550 lb/ft (745 kg/m), and the slope of the barrier face was set at a negative 1:20. The resulting barrier cross-section is shown in Figure 3. The outline of the New Jersey PCB is also presented in Figure 3 for comparison purposes. The low-profile barrier shape yields an actual weight of approximately 560 pounds per linear foot (834 kg/m).

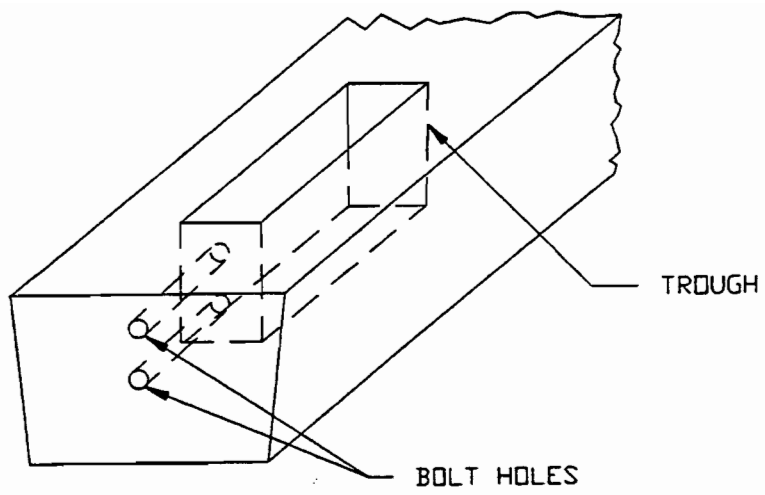
**FIGURE 4 Connection detail.**

Several different connection schemes were considered for the new low-profile PCB including those previously used on many conventional PCBs. However, none of these existing connection details were appropriate. Therefore, a new connection detail was developed as shown in Figure 4. The connection is accomplished by aligning the ends of two barrier segments and

inserting two ASTM A36 bolts through the connection holes which are recessed into a rectangular trough which is cast into the end of each segment. This trough allows the bolts to be removed and inserted freely. When the connection is loaded, a moment develops between the tensile force in the bolts and the compressive force in the extreme concrete fibers as shown in Figure 5. This connection results in a moment capacity slightly in excess of 100,000 ft-lbs (136,000 N-M).

The tolerances in the connection holes were set so that the barrier can be assembled on roadways with moderate vertical and horizontal curves. The barrier connection can tolerate angles up to four degrees in both the horizontal and vertical directions. This means that 20 ft (6.1 m) long barrier segments can be used to turn horizontal curves with radii of curvature of 150 ft (46 m).

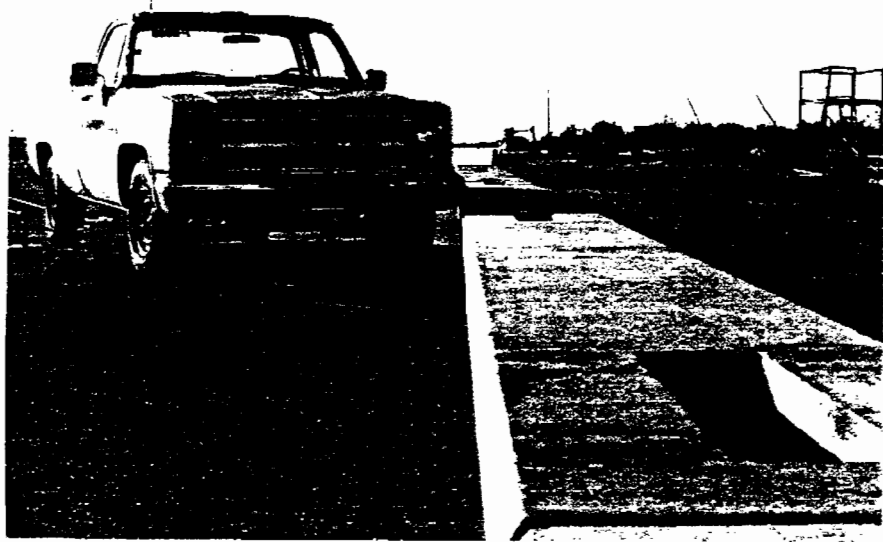
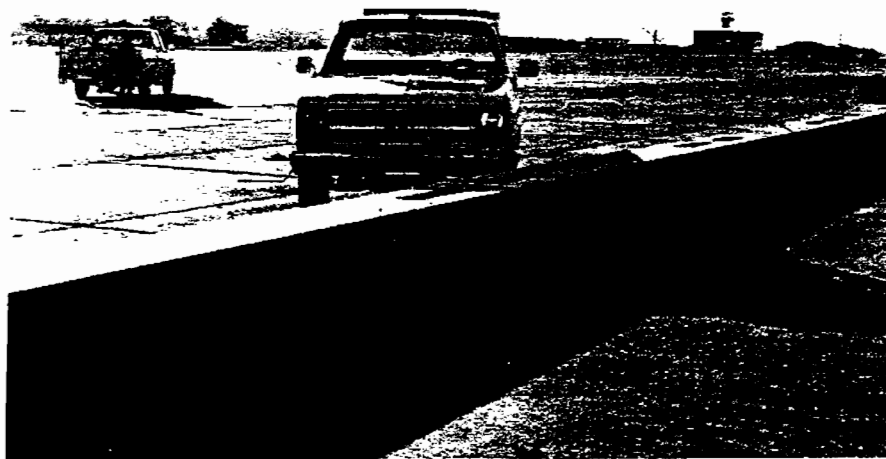
FIGURE 7 Vehicle/barrier geometrics for Test 9901F-1.

Figures 7 and 8. The test inertia weight of the vehicle was 4,500 lb (2,043 kg), and its gross static weight was also 4,500 lb (2,043 kg). The height to the lower edge of the vehicle bumper was 17.5 in. (44.4 cm), and the height to the upper edge was 26.5 in. (67.3 cm). Additional dimensions and information on the vehicle are given in Figure 31 of Appendix D. The vehicle was directed into the barrier using a reverse cable tow and guidance system. The vehicle was free-wheeling and unrestrained just prior to impact.

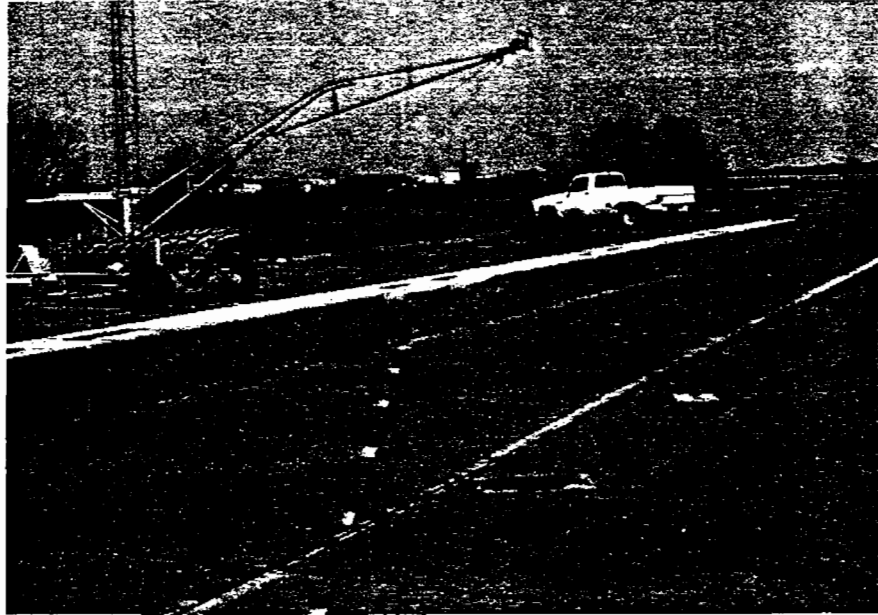
FIGURE 9 Barrier after Test 9901F-1.

The barrier received some damage as shown in Figures 9 and 10. The maximum lateral movement of the barrier was 5.0 in. (12.7 cm) at the impacted (center) joint. At the impacted connection, vehicle bumper interaction resulted in slight damage to the upper edge of the barrier. One

downstream experienced a shallow delamination. These damages exposed no reinforcing steel and are not considered to be structurally significant.

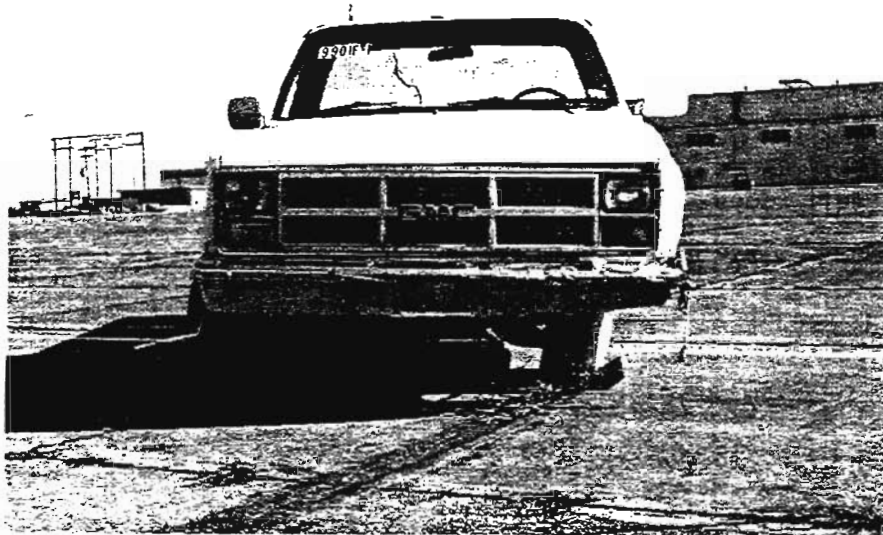
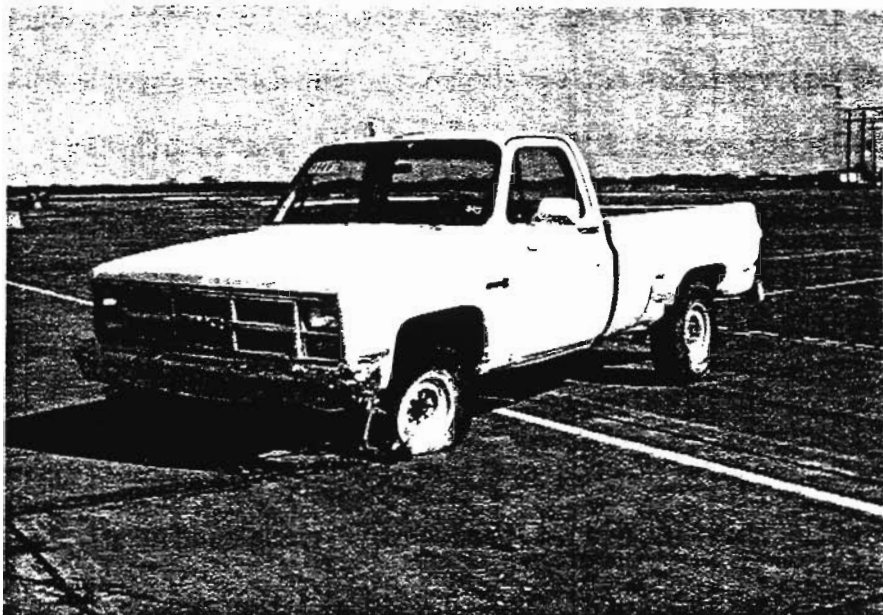
FIGURE 11 Vehicle after Test 9901F-1.

The vehicle (shown in Figures 11 and 12) sustained minimal damage to the left side; however, the floorpan and frame were bent, and the A-arms were damaged. There was also damage to the front bumper, left front quarter panel, left door, left rear quarter panel, and the rear bumper. The wheelbase on the left side was shortened from 131.5 in. (3.3 m) to 120.75 in. (3.1 m).

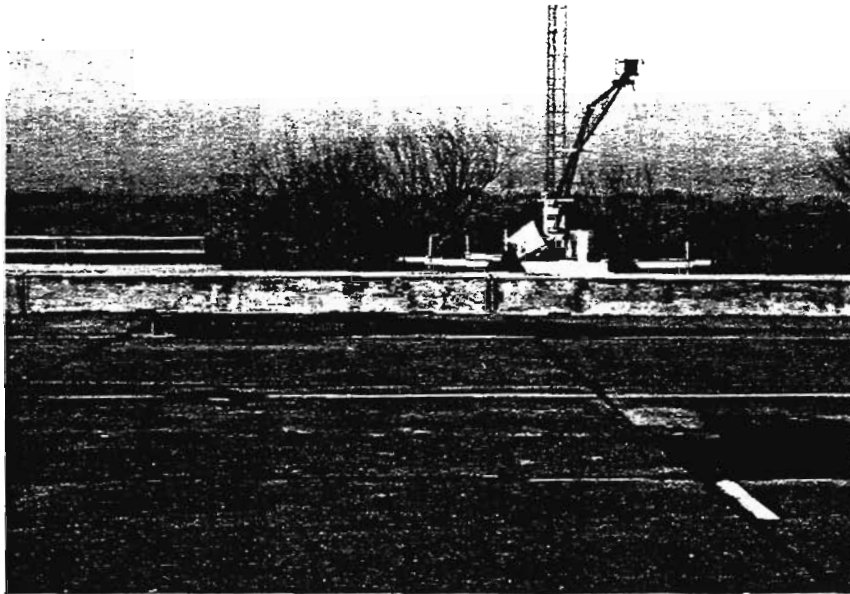
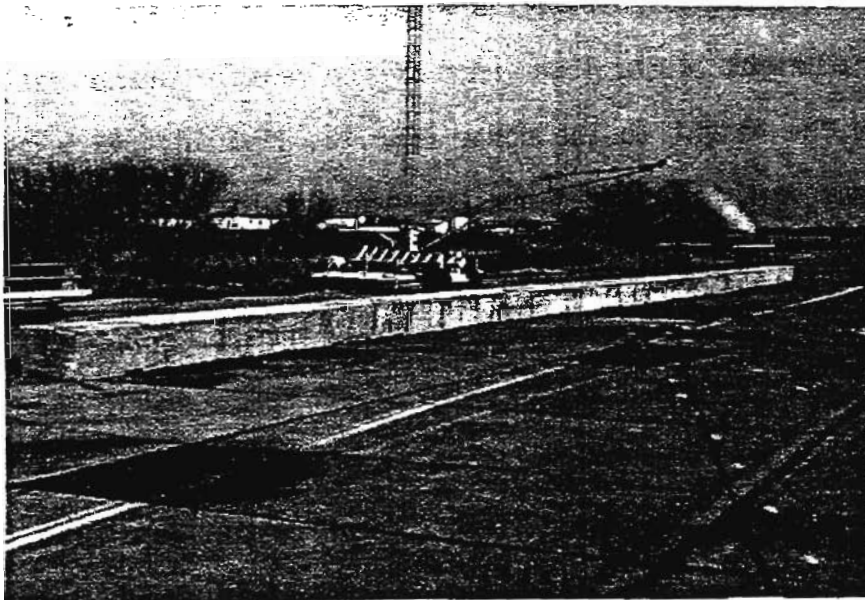
FIGURE 14 Barrier prior to Test 9901F-2.

In this test a 1981 Honda Civic was directed into the low-profile PCB deployed in a temporary configuration. The barrier configuration prior to this test is shown in Figure 14 for Test 9901F-1. Figures 15 and 16 presents the vehicle prior to the impact. The test inertia weight of the vehicle was 1,800 lb (817 kg), and its gross static weight was 1,965 lb (892 kg). The height to the lower edge of the vehicle bumper was 14.0 in. (35.6 cm), and the height to the upper edge was 19.5 in. (49.5 cm). Additional dimensions and information on the vehicle are given in Figure 32. The vehicle was directed into the barrier using a cable reverse tow and guidance system. The vehicle was free-wheeling and unrestrained just prior to impact.

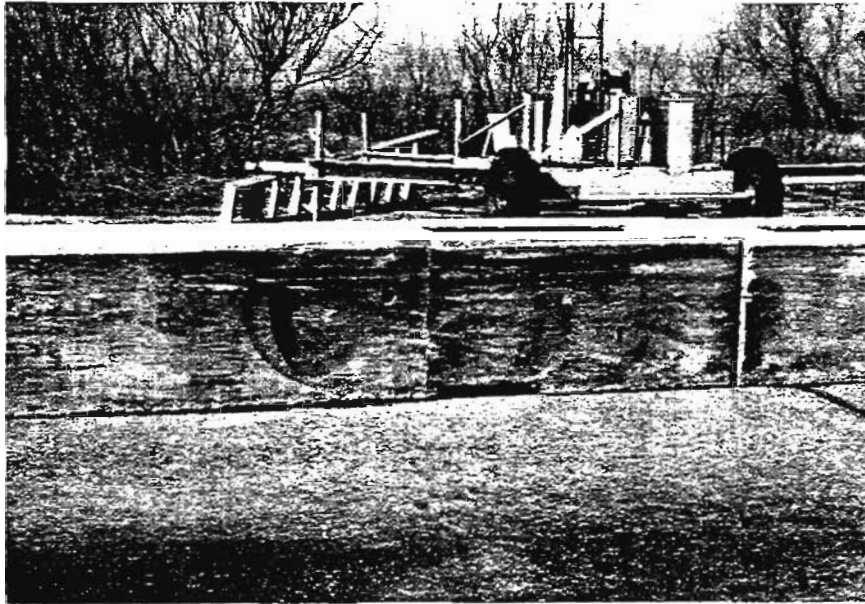
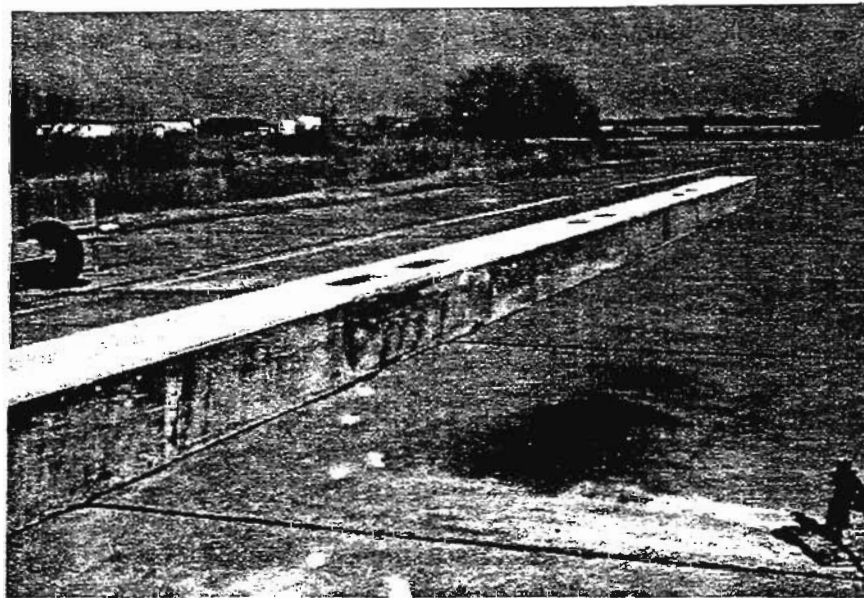
FIGURE 17 Barrier after Test 9901F-2.

The barrier received no significant damage as shown in Figure 17. There was no measurable lateral movement of the barrier. The vehicle sustained moderate damage to the left side as shown in Figure 18. The left strut and stabilizer bar were damaged. There was also damage to the front bumper, grill, left front quarter panel, left door, left rear quarter panel, and the rear bumper.

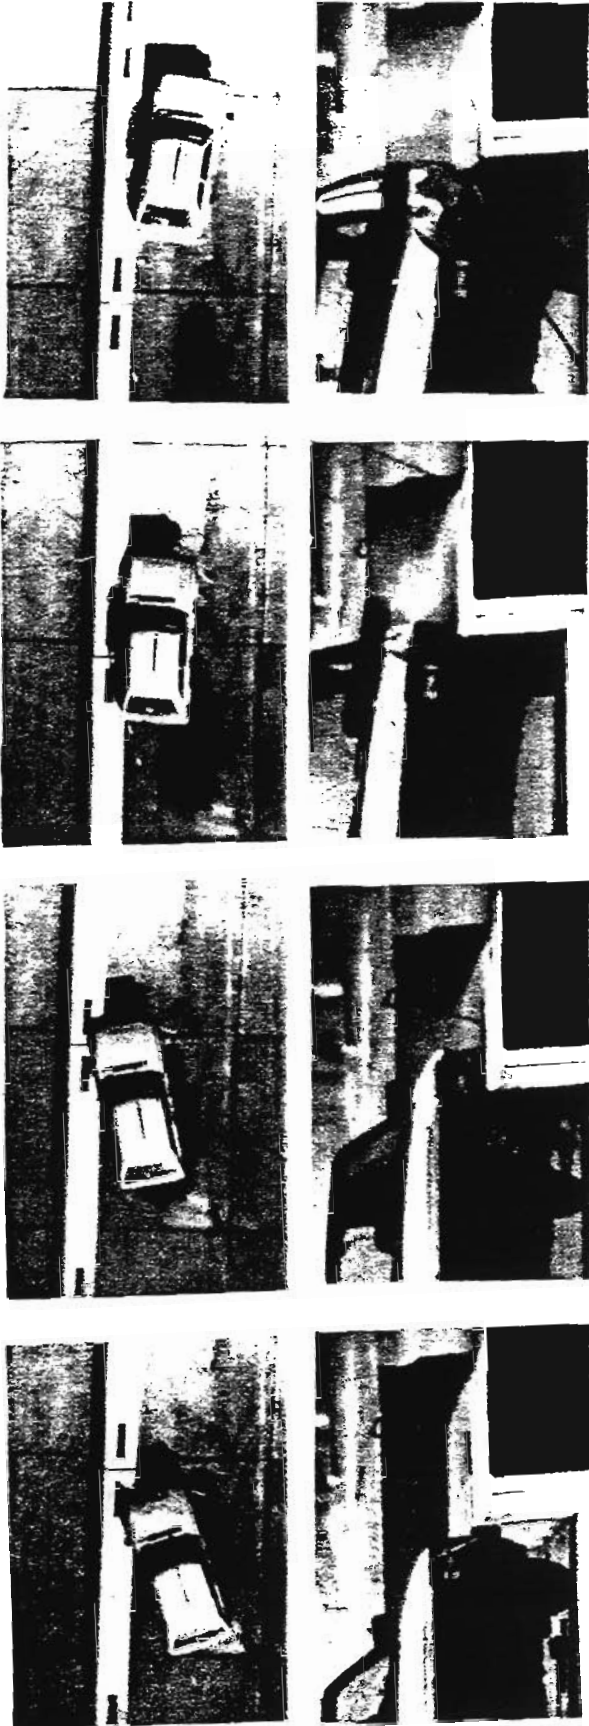
Test No . . . . . 9901F-2  
 Date . . . . . 01/25/91  
 Test Installation . . . . . Low Profile Barrier  
 Installation Length . . . . . 120 ft (37 m)  
 Maximum movement . . . . . 0 in. (0 cm)  
 Vehicle . . . . . 1981 Honda Civic  
 Vehicle Weight  
 Test Inertia . . . . . 1,800 lb (817 kg)  
 Gross Static . . . . . 1,965 lb (892 kg)  
 Vehicle Damage Classification  
 TAD . . . . . 11LD3  
 CDC . . . . . 11FLEK2 & 11LDEW3  
 Maximum Vehicle Crush . . . . . 8.0 in. (20.3 cm)

Impact Speed . . . . . 45.7 mi/h (73.5 km/h)  
 Impact Angle . . . . . 21.3 degrees  
 Speed at Parallel . . . . . 39.6 mi/h (63.7 km/h)  
 Exit Speed . . . . . 38.2 mi/h (61.5 km/h)  
 Exit Trajectory . . . . . 7.4 degrees  
 Vehicle Accelerations  
 (Max. 0.050-sec Avg)  
 Longitudinal . . . . . -4.5 g  
 Lateral . . . . . -9.1 g  
 Occupant Impact Velocity  
 Longitudinal . . . . . 11.7 ft/s (3.6 m/s)  
 Lateral . . . . . 18.6 ft/s (5.7 m/s)  
 Occupant Ridedown Accelerations  
 Longitudinal . . . . . -1.1 g  
 Lateral . . . . . -8.7 g

Data from the electronic instrumentation were digitized for evaluation and post test processing. As stated previously the impact speed was 45.7 mph (73.5 km/h), and the angle of impact was 21.3 degrees. NCHRP 230 describes occupant risk evaluation criteria, and it places limits on these for acceptable performance for tests conducted with 1,800 lb (817 kg) vehicles impacting with angles of 15 degrees (7). These limits do not apply to this set of test conditions but were computed for information only. The occupant impact velocity was 11.7 ft/s (3.6 m/s) in the longitudinal direction and 18.6 ft/s (5.7 m/s) in the lateral direction. The highest 0.010 sec average occupant ridedown accelerations were -1.1 g (longitudinal) and -8.7 g (lateral). These and other pertinent data from this test are presented in Figure 19.

After impact, the vehicle redirected and did not penetrate, vault or roll over the barrier. There was no measurable movement of the barrier. There were no detached elements or debris to show potential for penetration of the occupant compartment or to present undue hazard to other traffic. The vehicle remained upright and stable during the impact with the barrier and after exiting the test installation. There was no deformation or intrusion into the occupant compartment. The vehicle exited the barrier traveling 7.4 degrees away from the barrier. The vehicle trajectory at loss of contact indicates minimum intrusion into the adjacent traffic lanes.

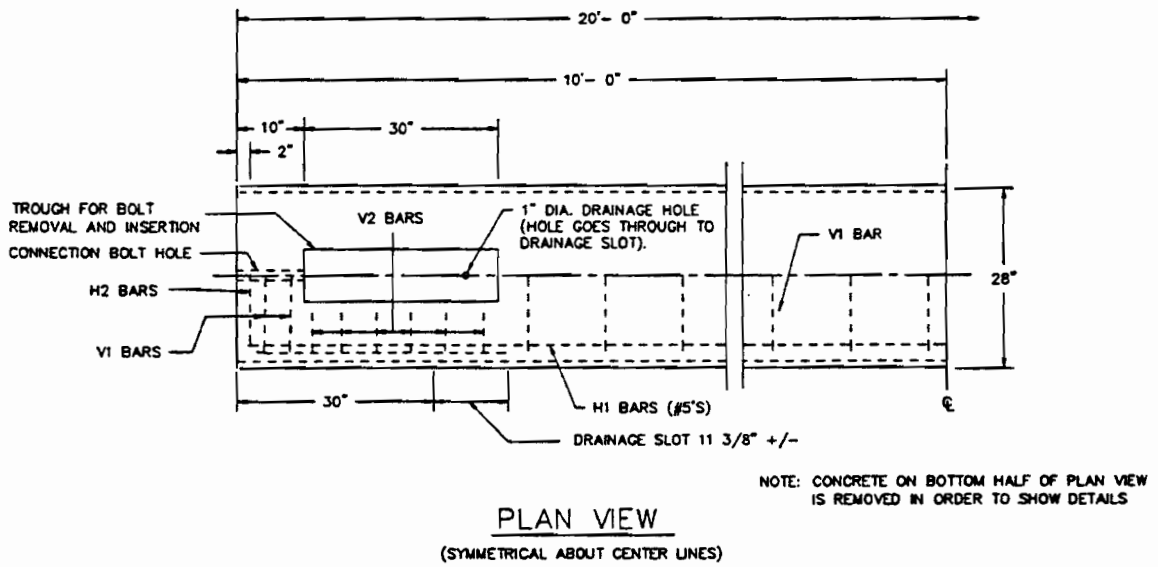
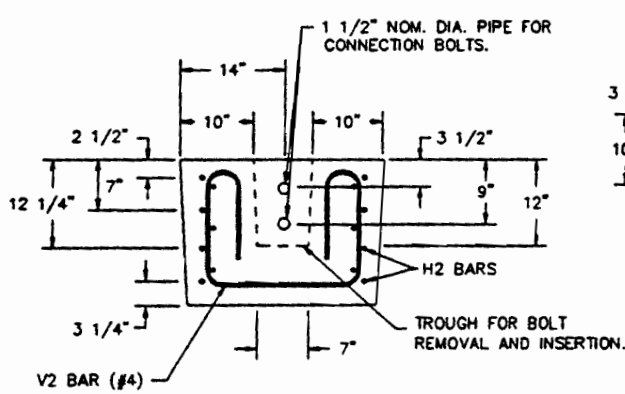
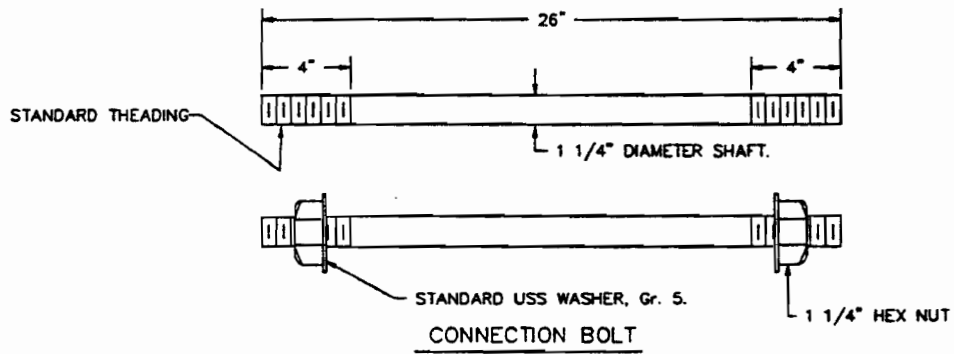
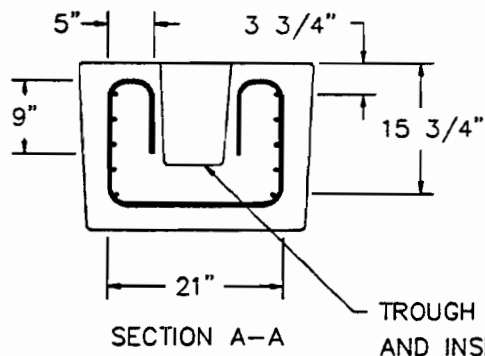
FIGURE 20 Low-Profile construction details.

NOTE: H2 REBAR IS TO BE BENT AT A 3" RADIUS.

NOTE: BOLT MATERIAL IS  
ASTM A36 ROUND BAR.

Welded Wire Fabric  
3x12 - D20 x D20  
60 ksi minimum yield strength

NOTE: THIS WIRE FABRIC ALTERNATIVE CAN  
BE USED IN PLACE OF V1, V2 AND H1 BARS.  
THE H2 BARS SPECIFIED ARE STILL REQUIRED.

Complete fabrication details for the new low-profile barrier are presented in Figure 20 in Appendix A.

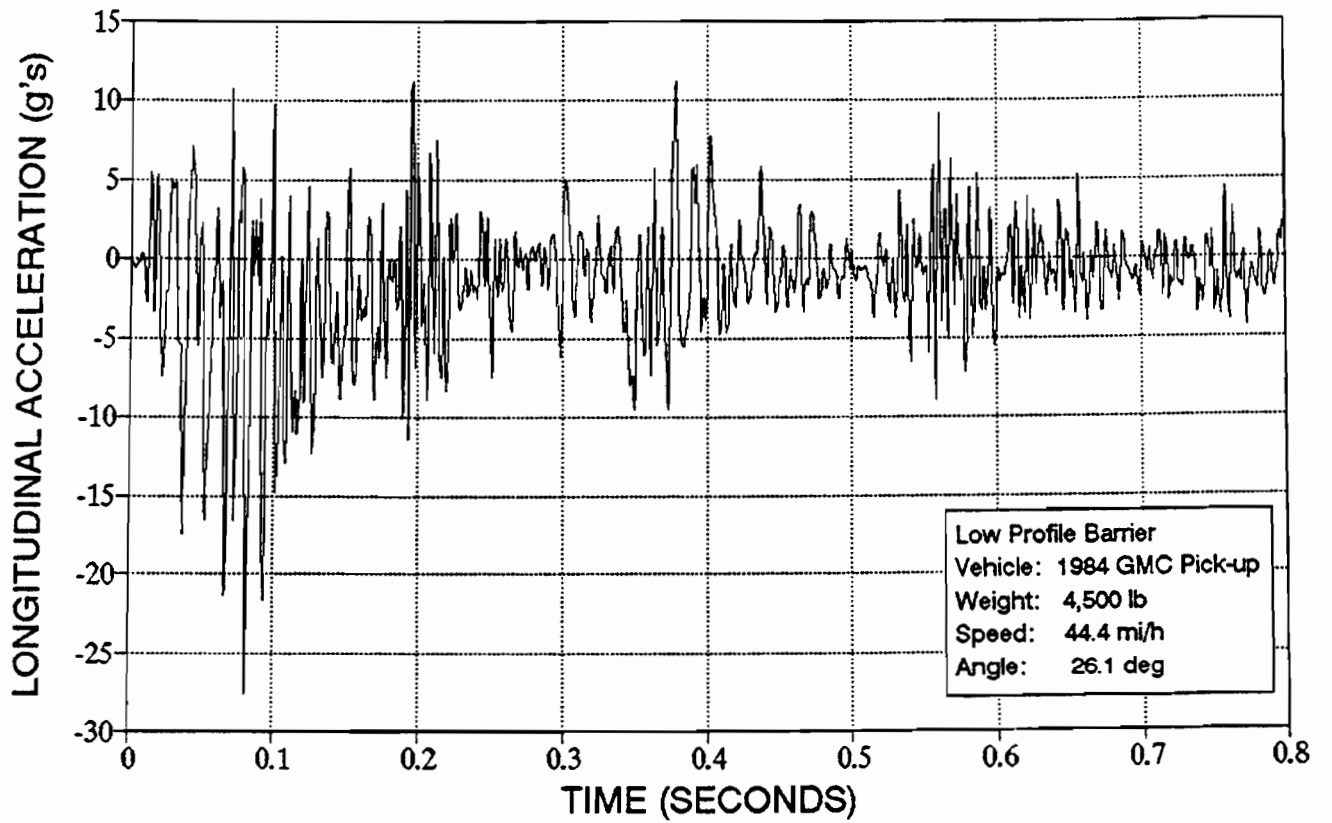
FIGURE 24 Longitudinal accelerometer trace for Test 9901F-1.

Class 180 Filter - At center-of-gravity

Data from the electronic instrumentation were digitized for evaluation and post-test processing. As stated previously, the impact speed was 44.4 mph (73 km/h), and the angle of impact was 26.1 degrees. NCHRP 230 describes occupant risk evaluation criteria, and it places limits on these for acceptable performance for tests conducted with 1,800 lb (817 kg) vehicles (7). These limits do not apply to the tests conducted with 4,500 lb (2,043 kg) vehicles but were computed for information only. The occupant impact velocity was 21.2 ft/s (6.5 m/s) in the longitudinal direction and 16.0 ft/s (4.9 m/s) in the lateral direction. The highest 0.010 sec average occupant ridedown accelerations were -6.0 g (longitudinal) -11.4 g (lateral). These and other pertinent data from this test are presented in Figure 13. Vehicular angular displacements are displayed in Figure 23 in Appendix C. Vehicular accelerations versus time traces filtered at 300 Hz are presented in Figures 24 through 26 in Appendix C. These data were further analyzed to obtain the 0.050 second average vehicle accelerations. The maximum 0.050 second average accelerations measured near the center-of-gravity of the vehicle were -5.6 g (longitudinal) and -7.7 g (lateral).

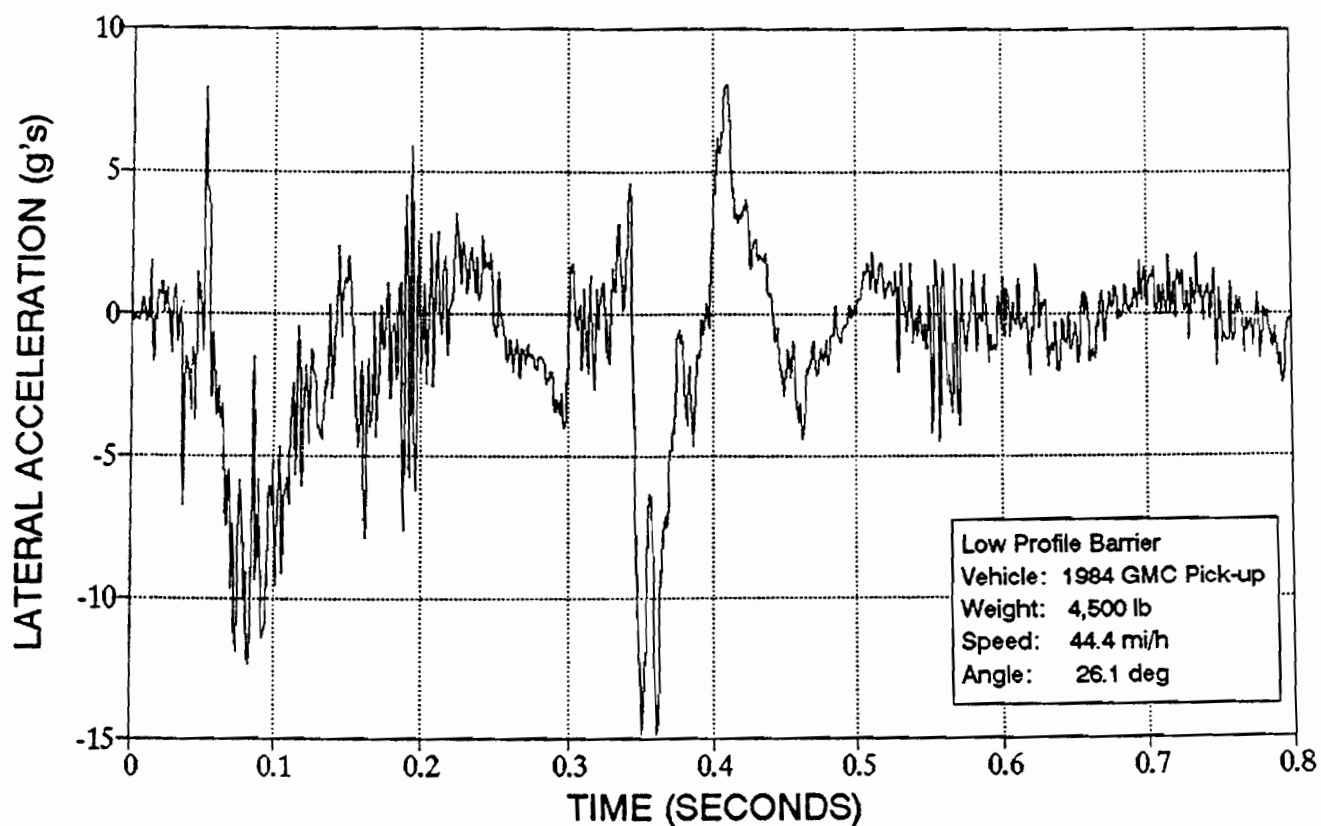
FIGURE 25 Lateral accelerometer trace for Test 9901F-1.

Class 180 Filter - At center-of-gravity

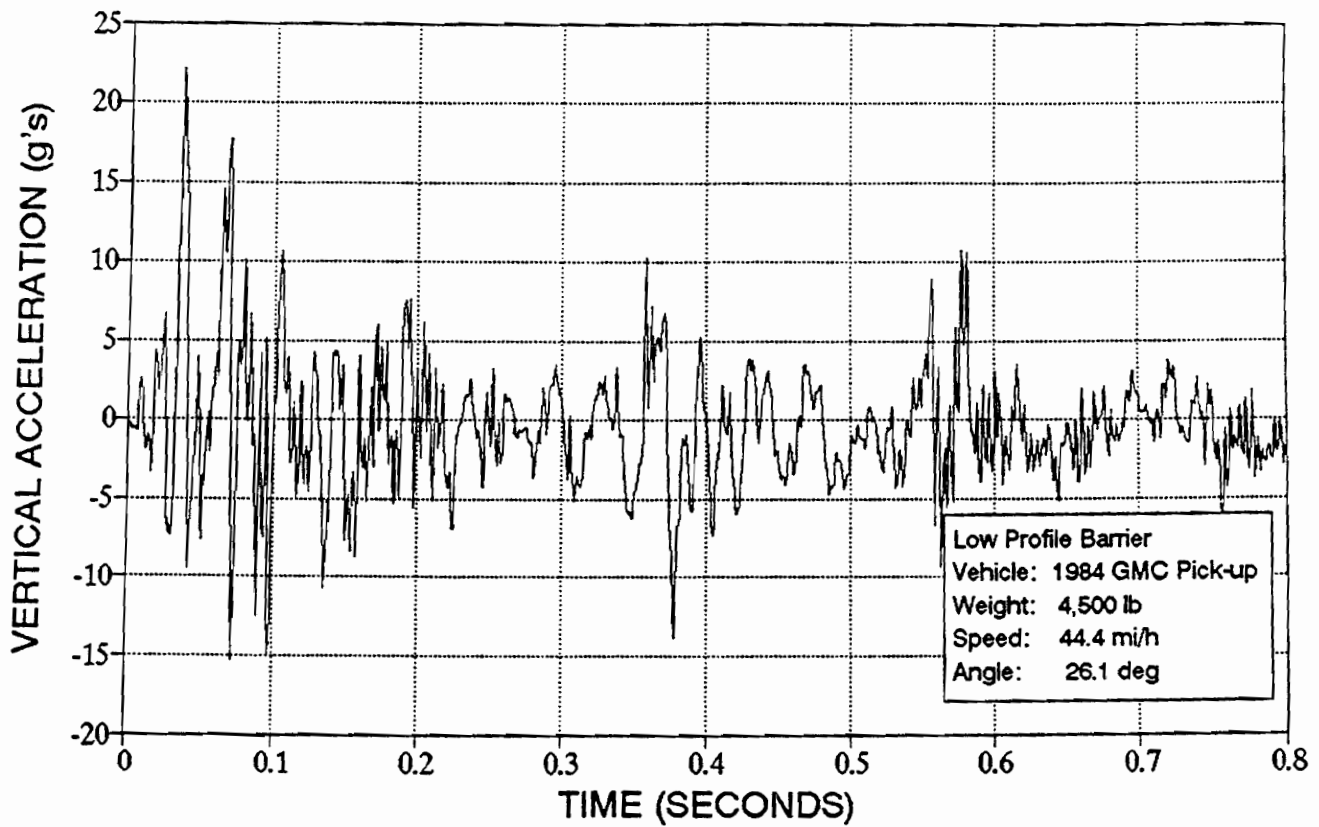
FIGURE 26 Vertical accelerometer trace for Test 9901F-1.

Class 180 Filter - At center-of-gravity

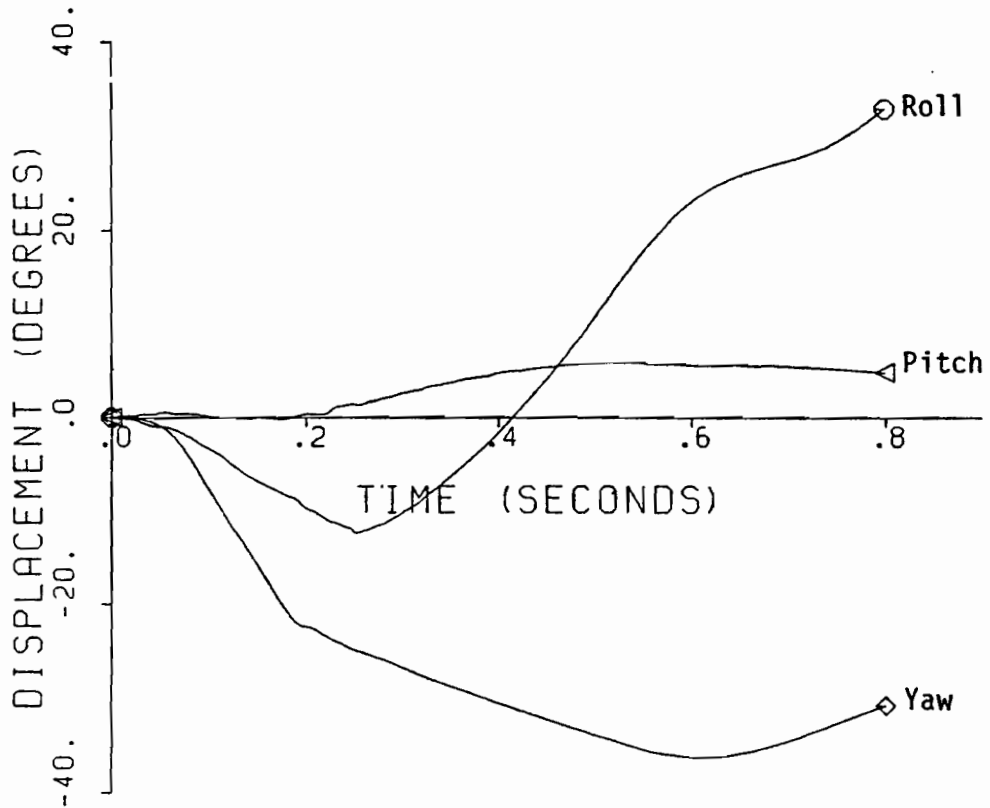
FIGURE 27 Vehicle angular displacements for Test 9901F-2.

Axes are vehicle fixed.  
 Sequence for determining  
 orientation is:

Vehicle angular displacements are displayed in Figure 27 in Appendix C, and vehicular accelerations versus time traces filtered at 300 Hz are

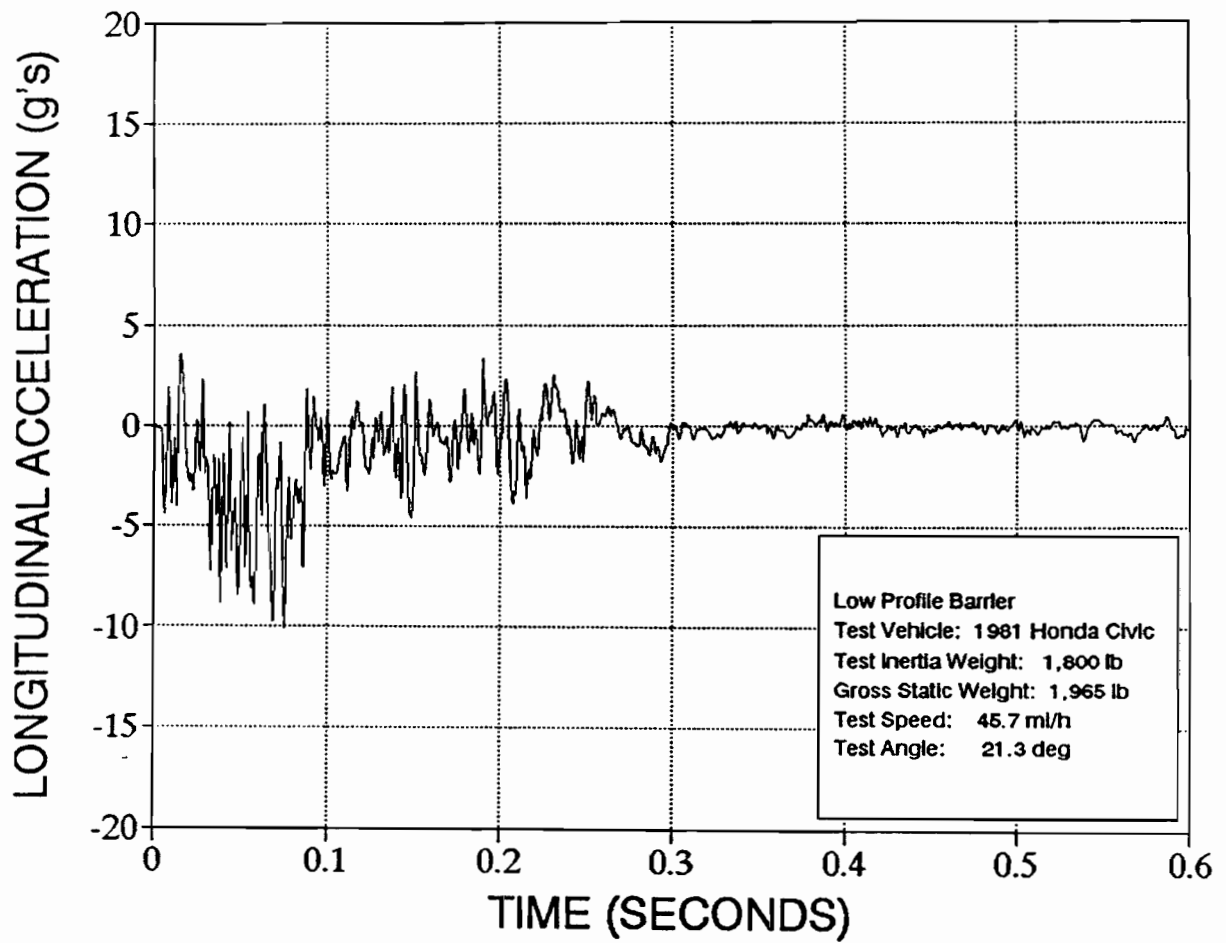
FIGURE 28 Longitudinal accelerometer trace for Test 9901F-2.

Class 180 Filter - Near center-of-grav.

presented in Figures 28 through 30 in Appendix C. The maximum 0.050 second average accelerations measured near the center-of-gravity of the vehicle were -4.5 g (longitudinal) and -9.1 g (lateral).

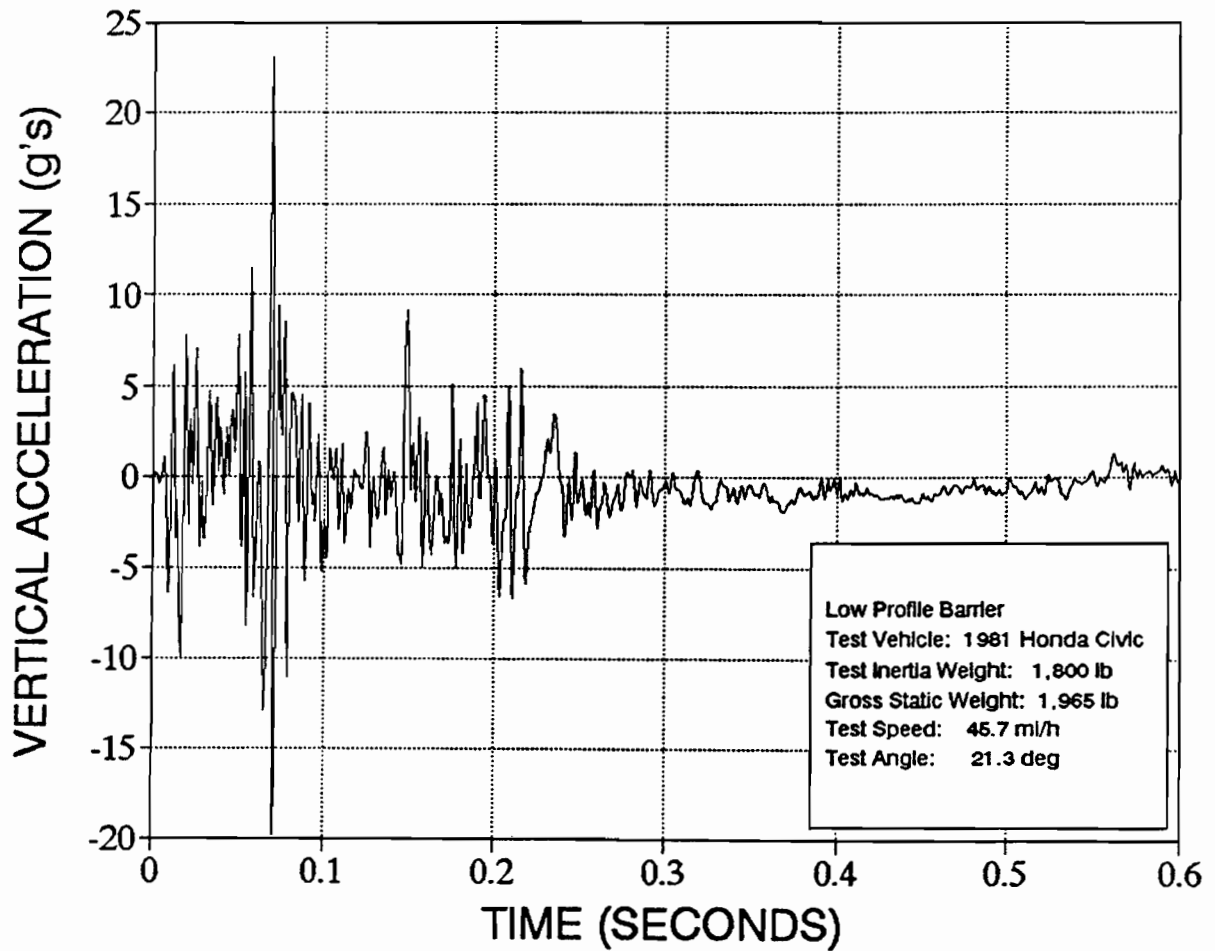
FIGURE 30 Vertical accelerometer trace for Test 9901F-2.

Class 180 Filter - Near center-of-grav.
