1. Report No. TX-91/991-2		2. Government Accession No.		3. Recipient's Catalog No.	
4. Title and Subtitle Comparative Crash Tests Conducted on Seven Different Makes and Models of Truck Mounted Attenuators (TMA's)				5. Report Date August 1991

14. Sponsoring Agency Code	
15. Supplementary Notes Research Study Title: Development of Performance Specifications for Truck Mounted Attenuators

**COMPARATIVE CRASH TESTS CONDUCTED ON
SEVEN DIFFERENT MAKES AND MODELS OF
TRUCK MOUNTED ATTENUATORS (TMA's)**

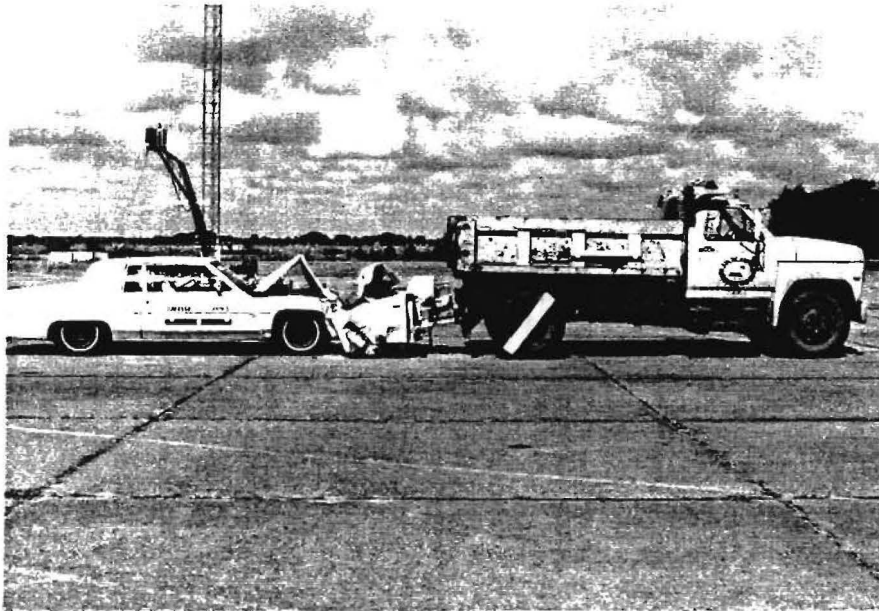
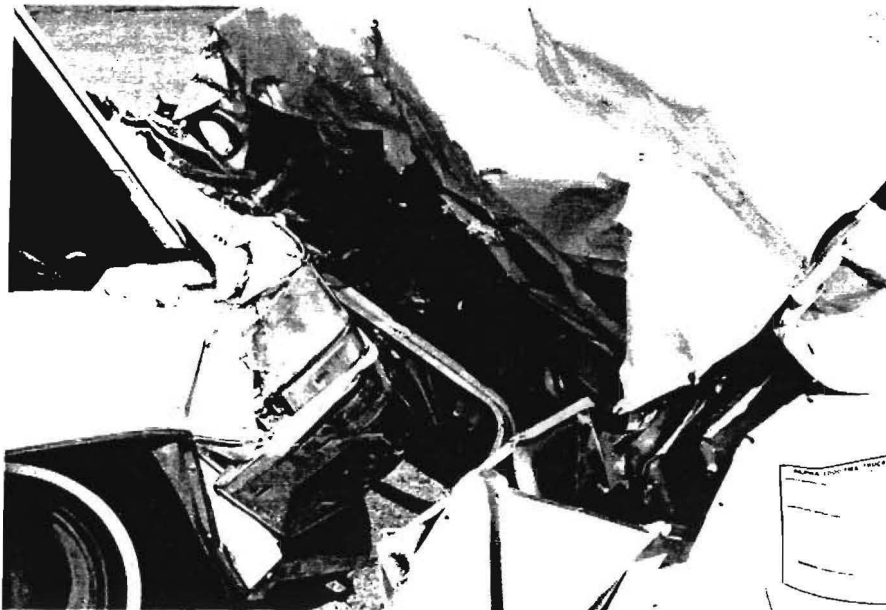
Figure 12. Damage to Energy Absorption TMA (right side).

The Energy Absorption TMA cartridge crushed a total of 61.25 inches during the test. The frame attachment to the cartridge was bent 1.25 inches at the lower left connection. The truck had moved forward a total of 14.8 feet, and although the parking brake was still on, second gear had become disengaged. The impacting vehicle received damage to the bumper, hood, grill, radiator, right and

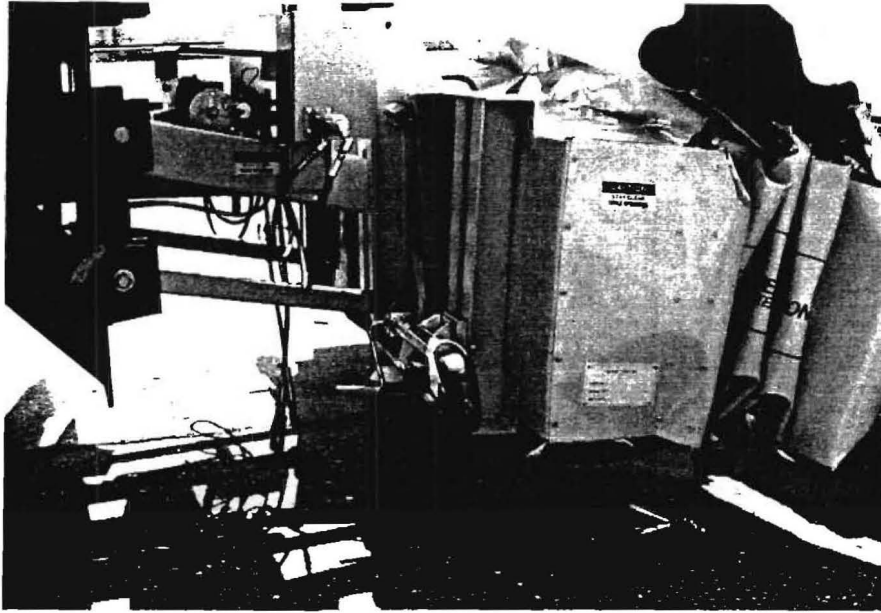
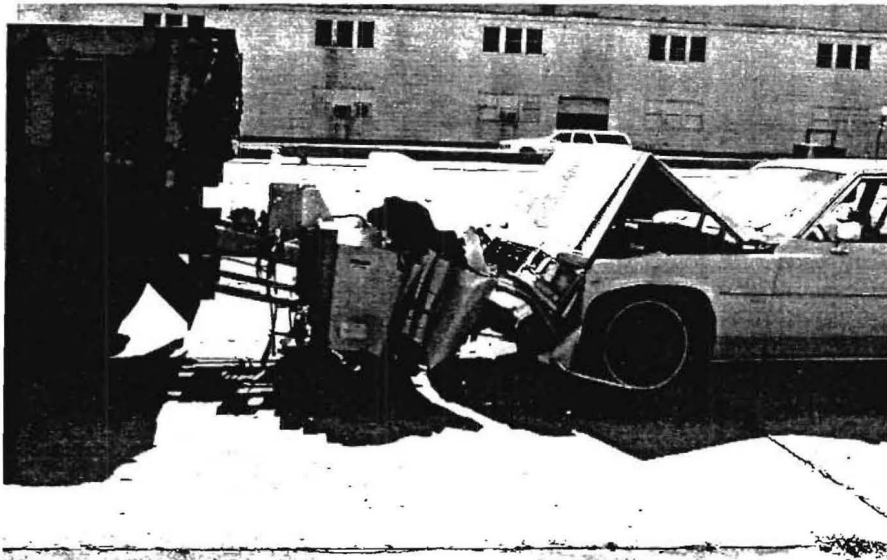
Figure 13. Damage to Energy Absorption TMA (left side).

left front quarter panels, and the left front door. Maximum vehicle crush was 11.0 inches at bumper height. Figures 12 through 14 show damage to the TMA and test vehicle.

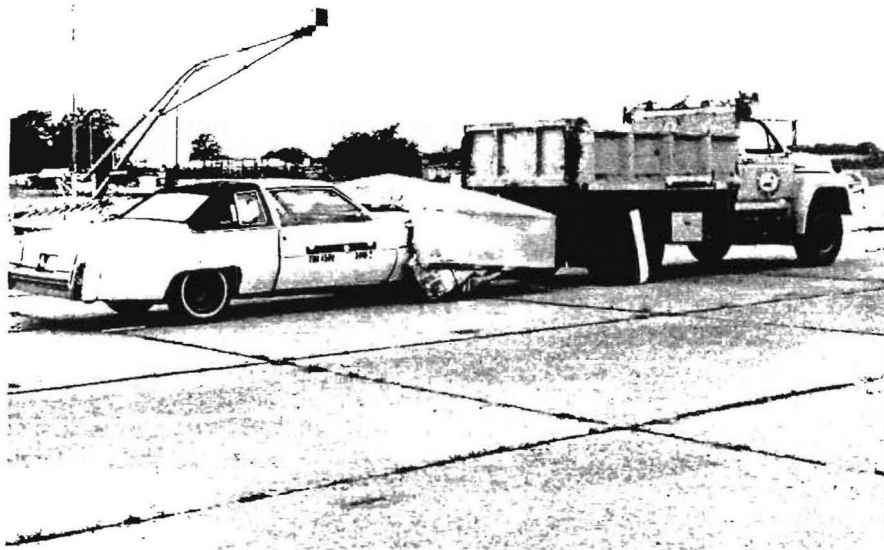
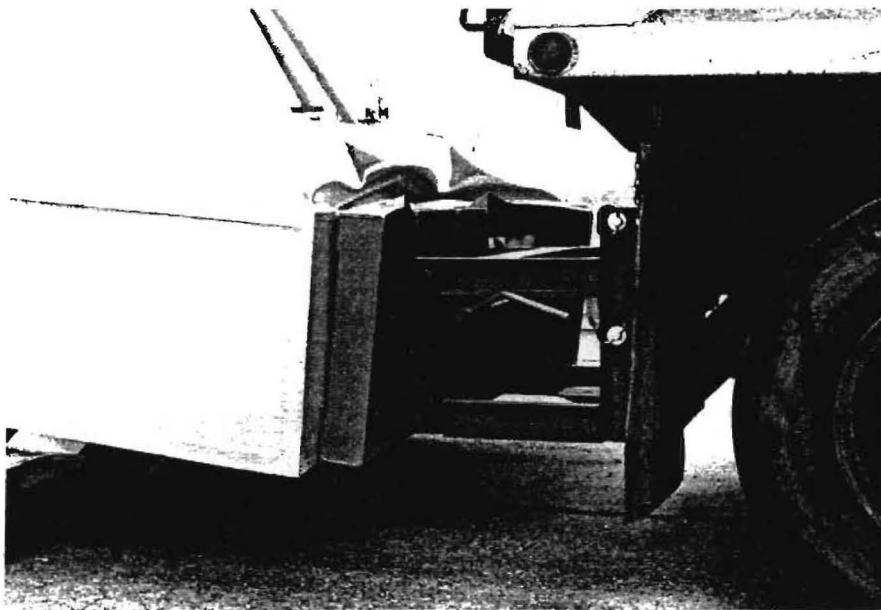
Figure 36. Damage to Hexcel Tx-3000 TMA (right side).

The Hexcel 3000 TMA cartridge crushed a total of 66.50 inches during the test. The frame attachment to the cartridge was bent forward on both sides. On the right side, it was bent forward 4 inches at the upper corner and 2 inches at the lower corner. The left side was bent forward 8 inches at the upper corner and 5 inches at the lower corner. The truck had moved forward a total of 9.8 feet and was still in second gear with the parking brake set. The impacting vehicle received damage to the bumper, hood, right and left front quarter panels and the right and left front doors. Maximum vehicle crush was 6.0 inches at bumper height. Figures 36 through 38 show damage to the TMA and test vehicle.

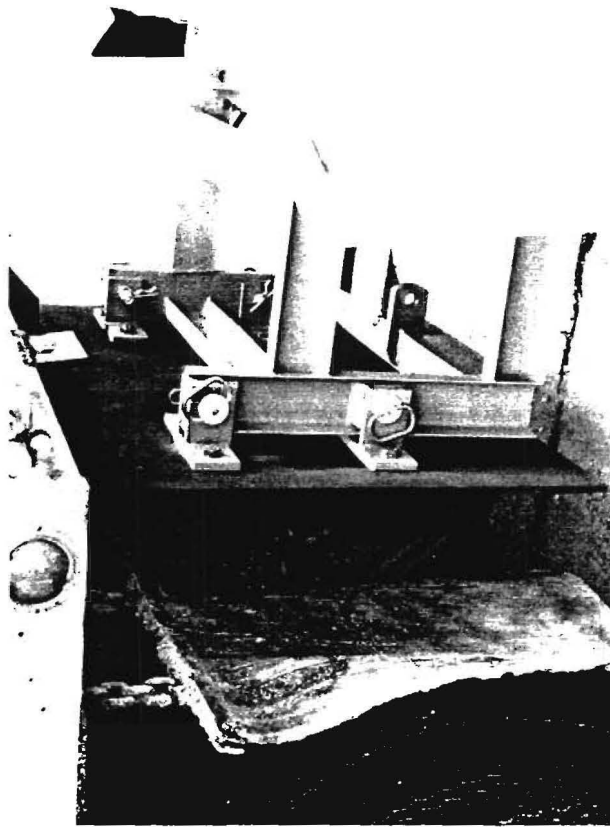
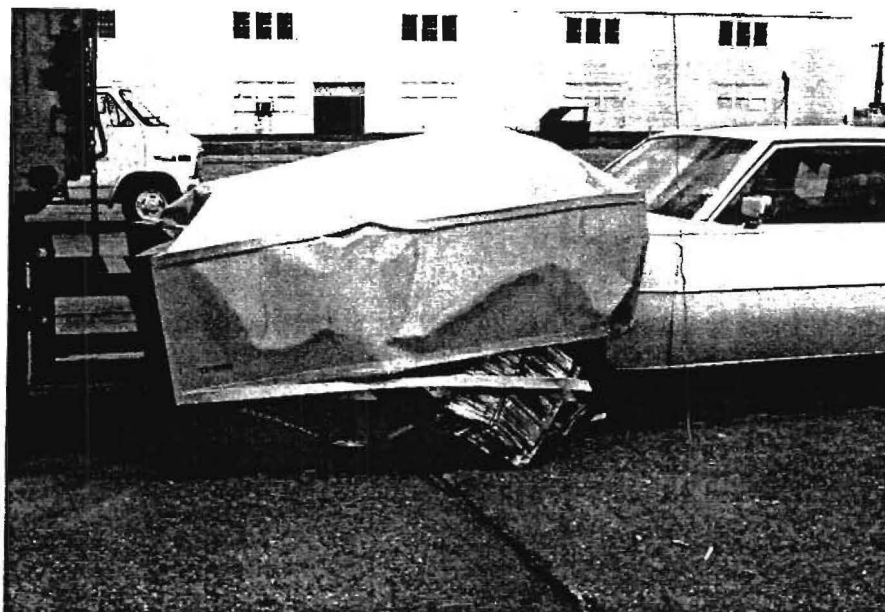
Figure 37. Damage to Hexcel Tx-3000 TMA (left side).

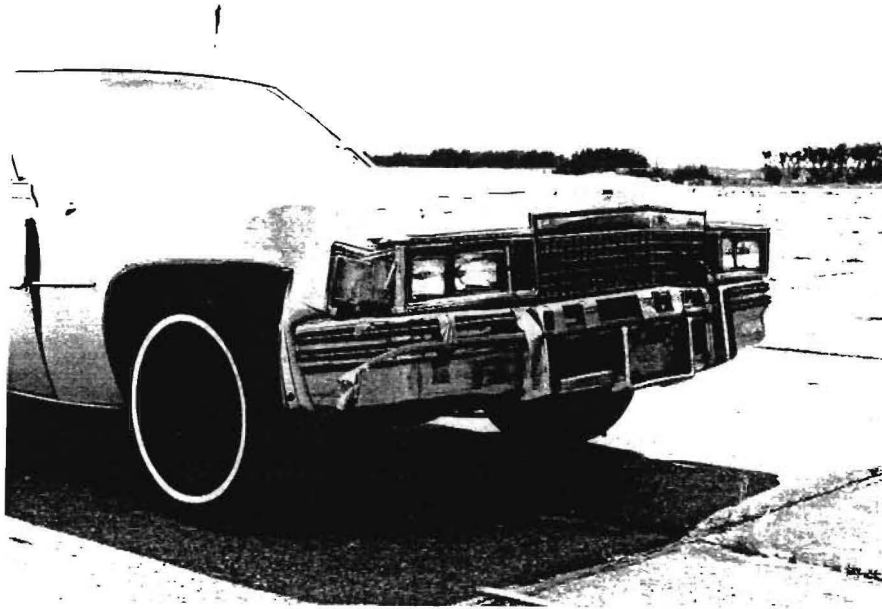
Figure 38. Damage to vehicle after impact with Hexcel Tx-3000 TMA.

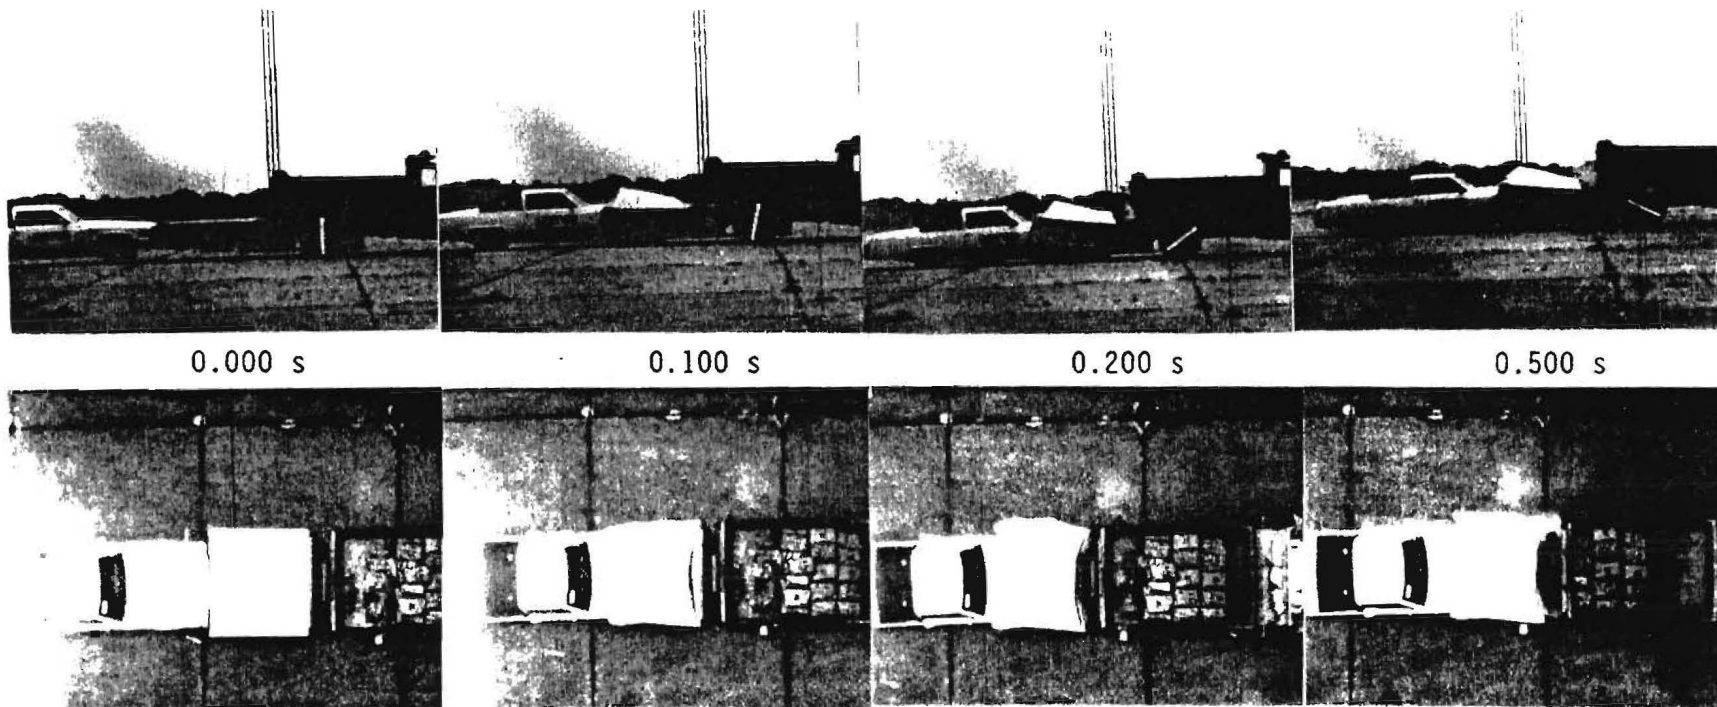
Test No.	09919-2	Maximum Truck Displacement .	9.8 ft (3.0 m)
Date	08/08/89	Maximum TMA Crush	66.50 in (1.7 m)
Test Article	Truck Mounted Attenuator	Vehicle Accelerations	
Manufacturer	Hexcel Corp. (Model 3000)	(Maximum 50 ms Average at c.g.)	
TMA Truck	1981 Ford Dump Truck (#1)	Vehicle Longitudinal	-12.8 g
Weight without TMA .	14,020 lb (6,365 kg)	Vehicle Lateral	-2.0 g
Weight with TMA . . .	14,720 lb (6,683 kg)	Truck Cab Longitudinal . . .	3.7 g
Test Vehicle	1979 Cadillac Coupe deVille	Occupant Impact Velocity	
Weight	4,500 lb (2,043 kg)	Longitudinal	36.4 ft/s (11.1 m/s)
Impact Speed	46.3 mi/h (74.5 km/h)	Lateral	7.7 ft/s (2.3 m/s)
Maximum Vehicle Crush .	6.0 in (15.2 cm)	Occupant Ridedown Accelerations	
Vehicle Damage Classification		Longitudinal	-13.6 g
TAD	12FD2	Lateral	-2.2 g
CDC	12FDEW1

A summary of the test results and other information pertinent to this test are given in Figure 39. The maximum longitudinal 50-msec average acceleration experienced by the impacting vehicle was -12.8 g between 111 and 161 msec. Longitudinal occupant impact velocity was 36.4 ft/s at 129 msec and the maximum longitudinal ridedown acceleration was -13.6 g between 139 and 149 msec. The maximum longitudinal 50-msec average acceleration for the truck was 3.7 g between 115 and 165 msec. The truck reached a maximum speed of 12.2 ft/s (8.3 mph) and moved forward a total of 9.8 ft. The rear truck tires alternated between rolling and skidding during the test. Vehicle angular displacements are plotted in Figure 40, accelerometer traces are displayed in Figures 41 through 43, and the longitudinal accelerometer trace for the truck is shown in Figure 44.

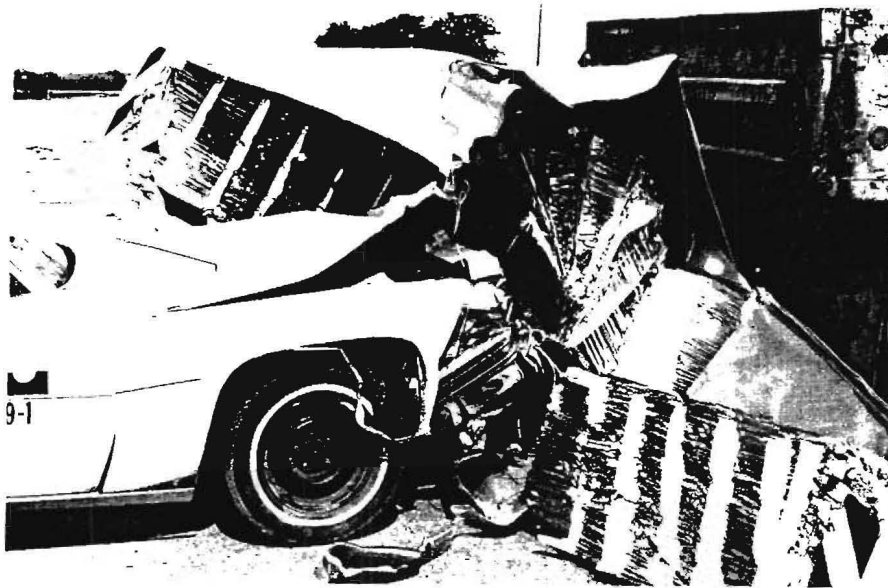
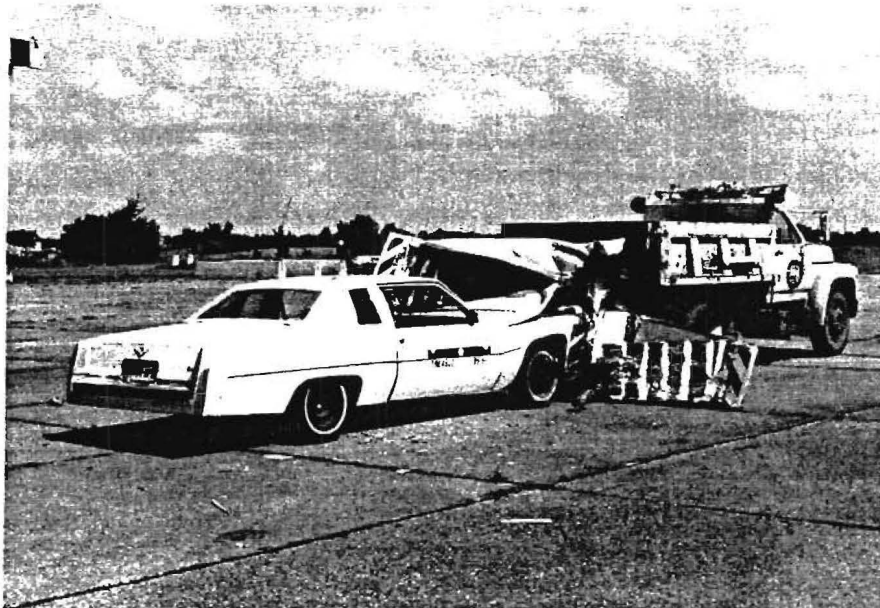
Figure 49. Damage to Hexcel Tx-4000 TMA (right side).

The Hexcel 4000 TMA cartridge crushed a total of 63.25 inches during the test. The frame attachment to the cartridge on the right side was bent forward 5 inches and the locking mechanism was broken. The truck had moved forward a total of 22.8 feet and was still in second gear with the parking brake on. The front of the impacting vehicle was pushed upward and the hood, bumper, grill, radiator, and the right and left front quarter panels and doors were damaged. Also the roof was bent, the left side window was broken and the windshield was cracked. Maximum vehicle crush was 10.0 inches. Figures 49 through 51 show damage to the TMA and test vehicle.

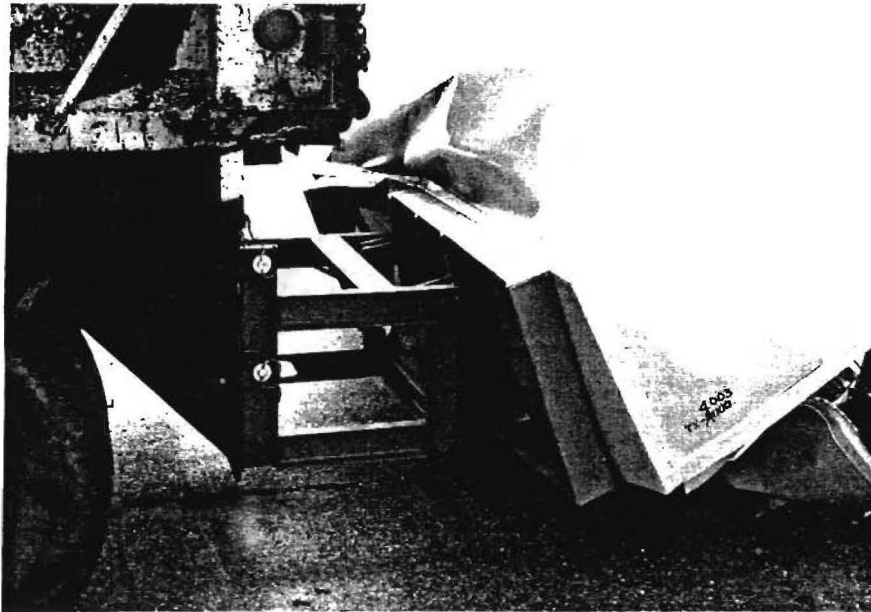
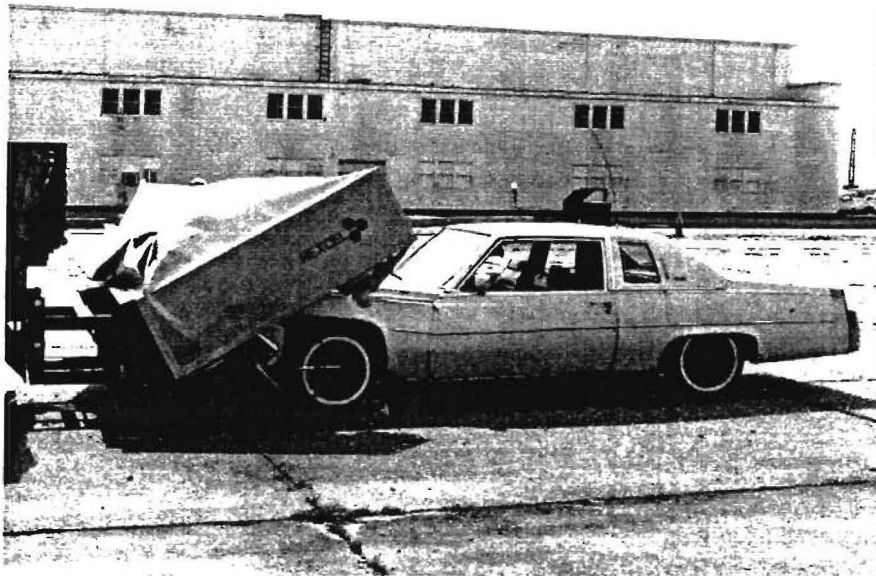
Figure 50. Damage to Hexcel Tx-4000 TMA (left side).

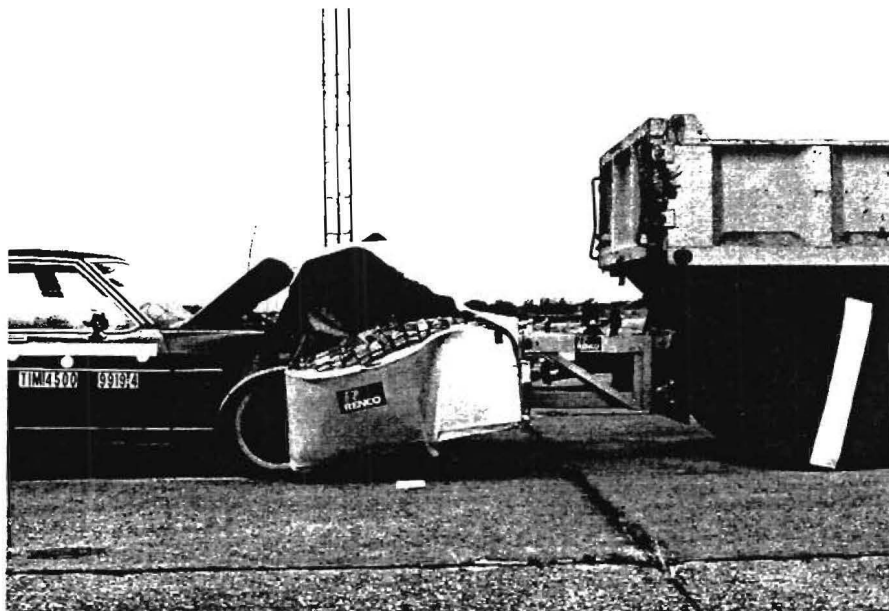
Figure 73. Damage to Renco TMA (right side).

The Renco TMA cartridge crushed a total of 54.00 inches during the test. The frame attachment to the cartridge was not damaged. The truck had moved forward a total of 7.9 feet and was still in second gear with the parking brake on. The impacting vehicle received damage to the bumper, hood, grill, radiator, right and left front quarter panels, right and left front doors, and the windshield was cracked in the lower corners. Maximum vehicle crush was 10.0 inches at bumper height. Figures 73 through 75 show damage to the TMA and test vehicle.

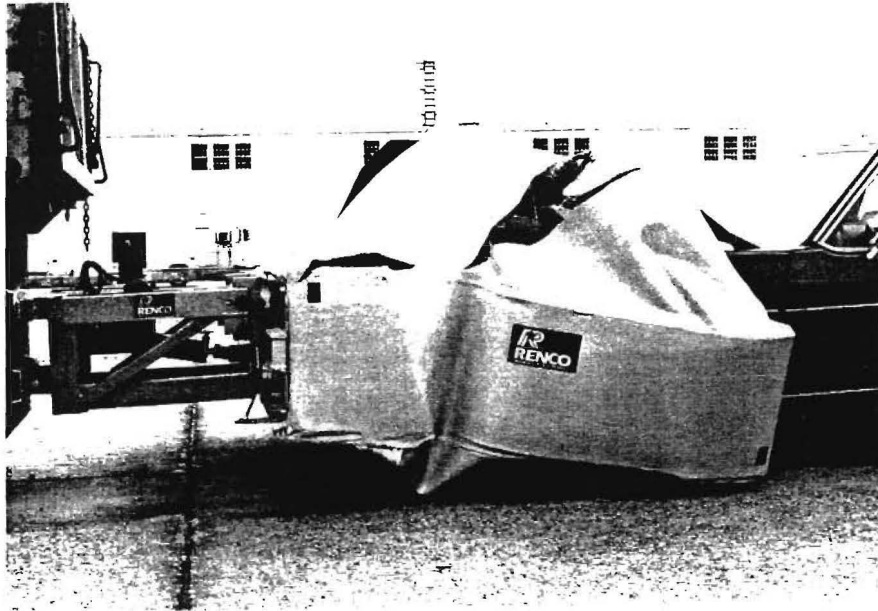
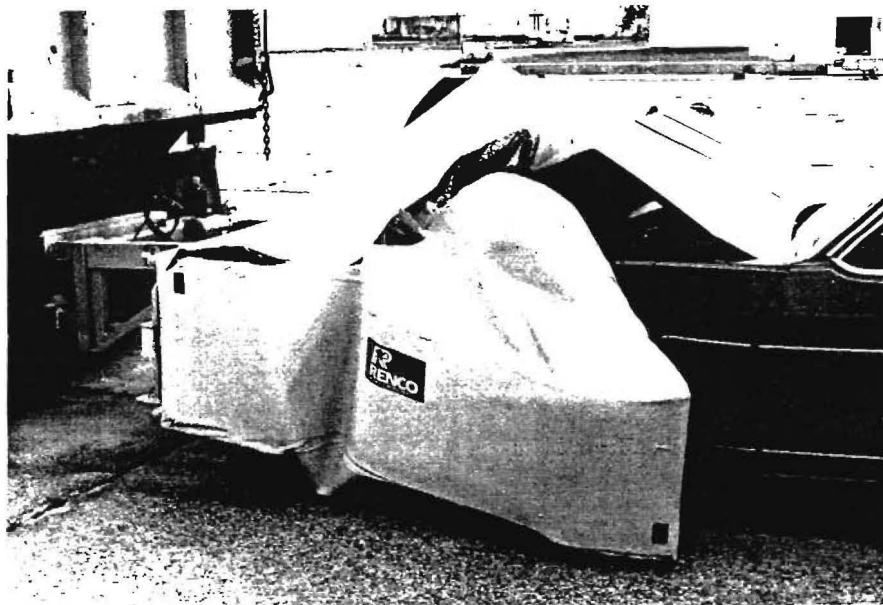
Figure 74. Damage to RENCO TMA (left side).

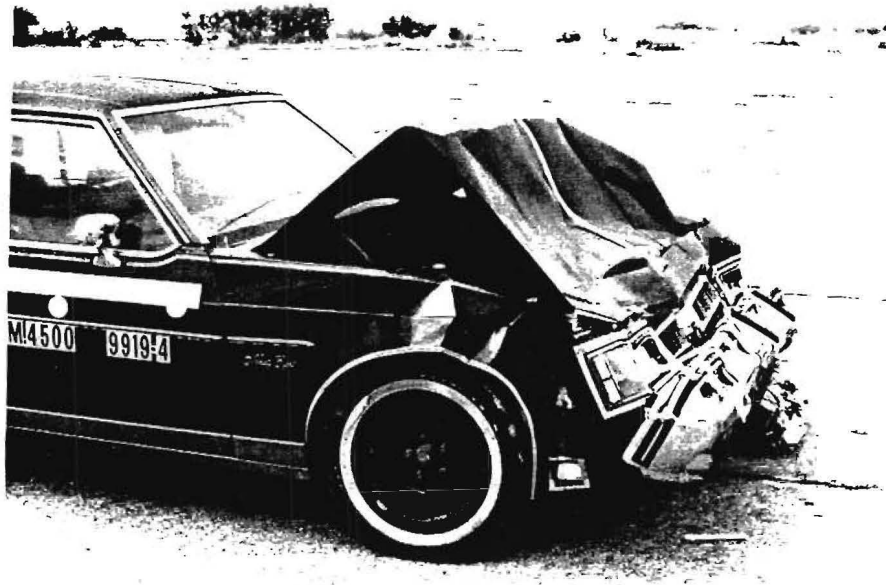
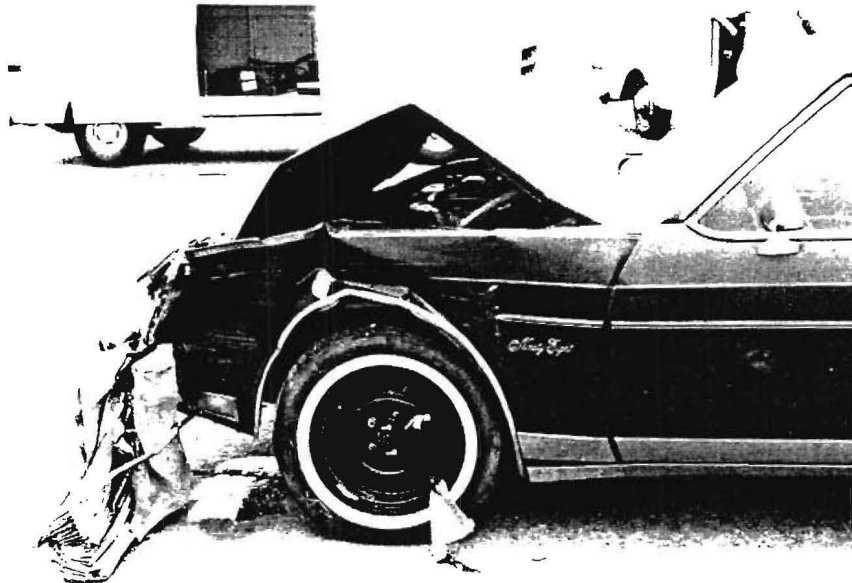
Figure 75. Vehicle after impact with RENCO TMA.

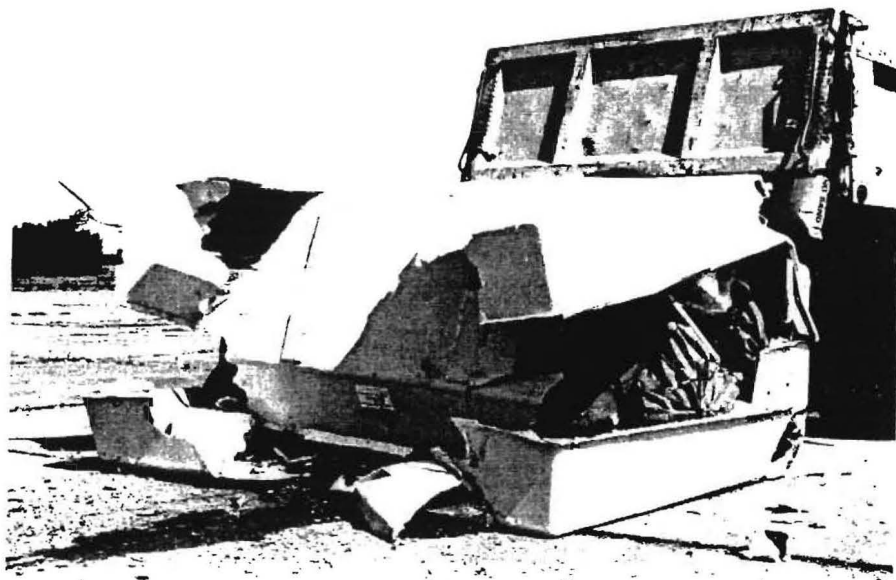
Figure 86. Damage to Marking and Equipment TMA (right side).

The Markings and Equipment Corporation TMA cartridge crushed a total of 53.00 inches during the test. The frame attachment to the cartridge was bent forward 1.5 inches on the left side. The truck had moved forward a total of 13.8 feet and was still in second gear with the parking brake on. The impacting vehicle received damage to the bumper, hood, grill, radiator, right and left front quarter panels and the right and left front doors. The floor pan and subframe of the vehicle was bent and the windshield was cracked in the lower corners. Maximum vehicle crush was 16.0 inches at bumper height. Figures 86 through 88 show damage to the TMA and test vehicle.

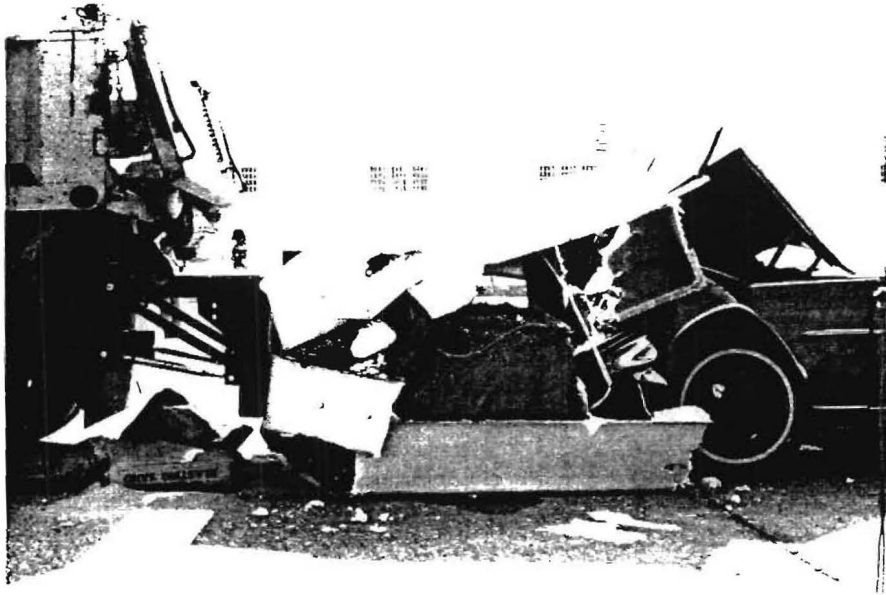
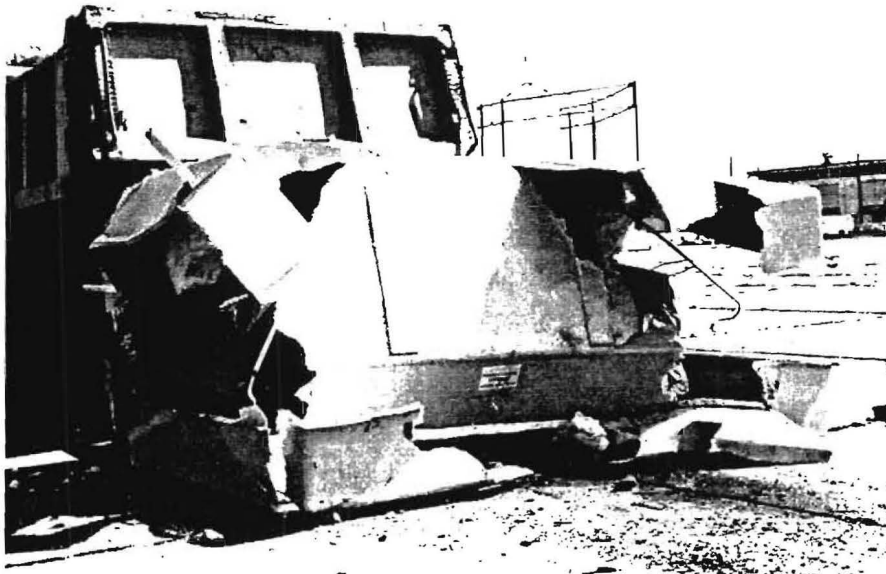
Figure 87. Damage to Marking and Equipment TMA (left side).

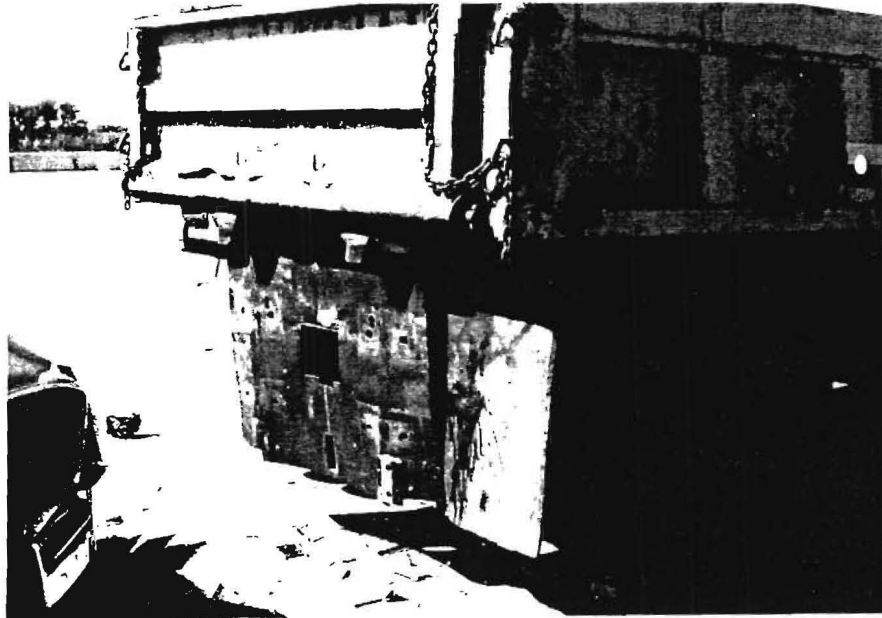
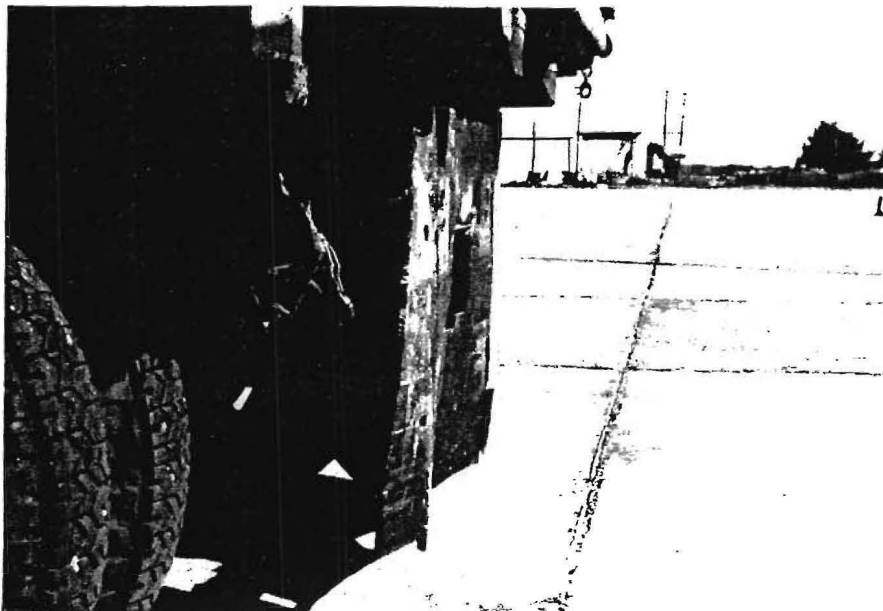
Figure 109. Damage to truck after test 9910-16.

The impacting vehicle received damage to the front bumper, hood, grill, radiator, the right and left front quarter panels, and all four doors. The roof and floorpan were bent and the windshield was broken. The drive shaft and rear axle were also damaged. Maximum vehicle crush was 35.0 inches just above bumper height. The only damage sustained by the dump truck was to the TMA attachment panel. Figures 109 and 110 show damage to the TMA and test vehicle.

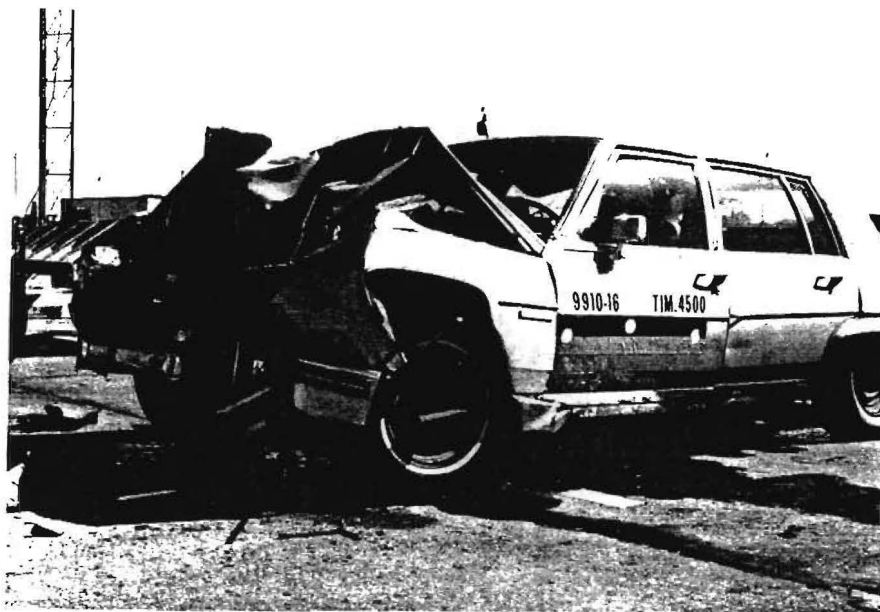
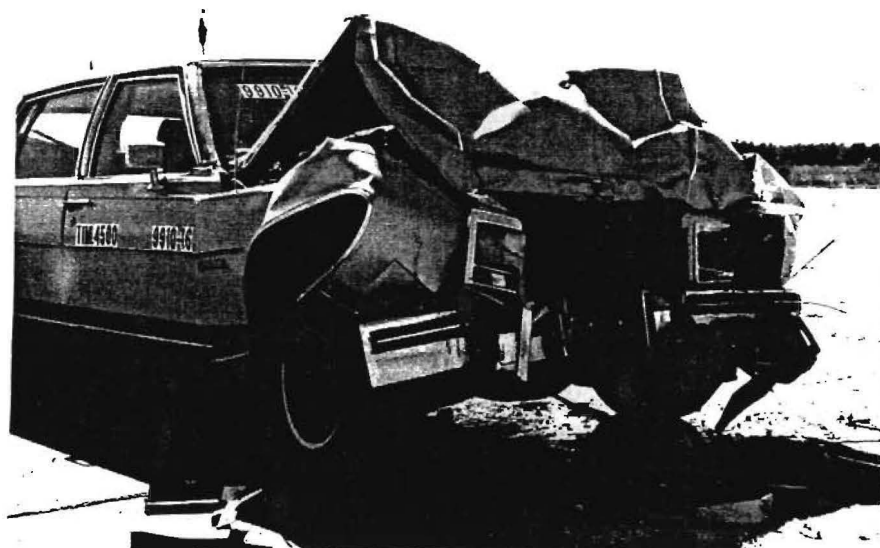
Figure 110. Damage to passenger car after test 9910-16.

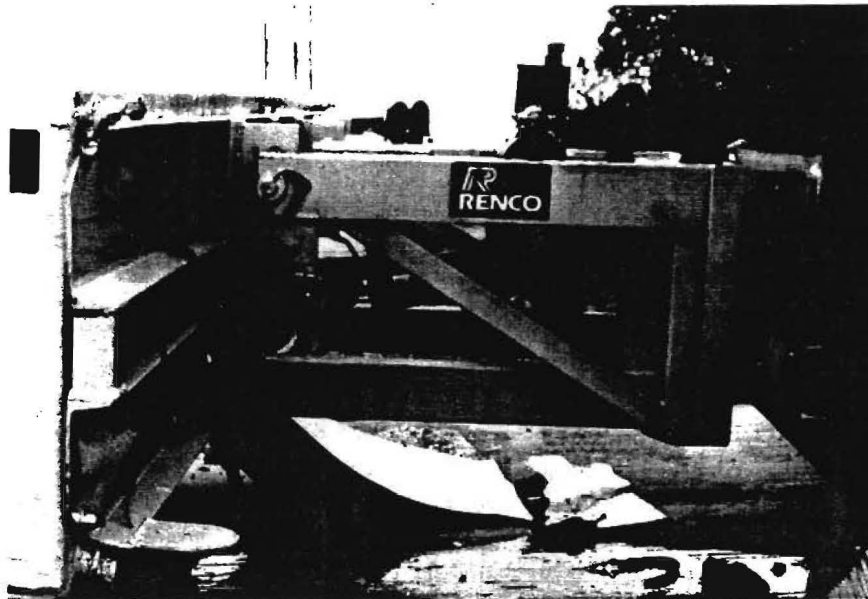
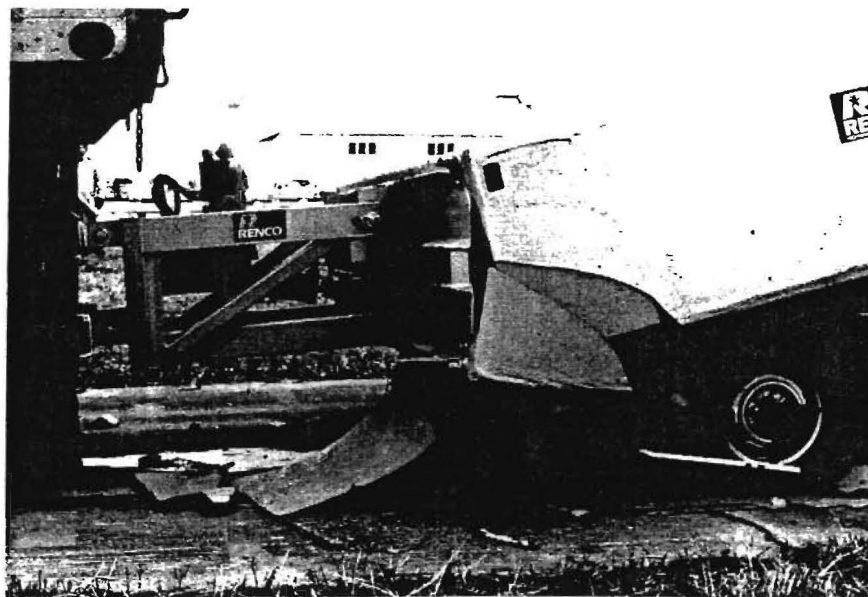
Figure 160. Damage to RENCO TMA mounting hardware (9910-2)

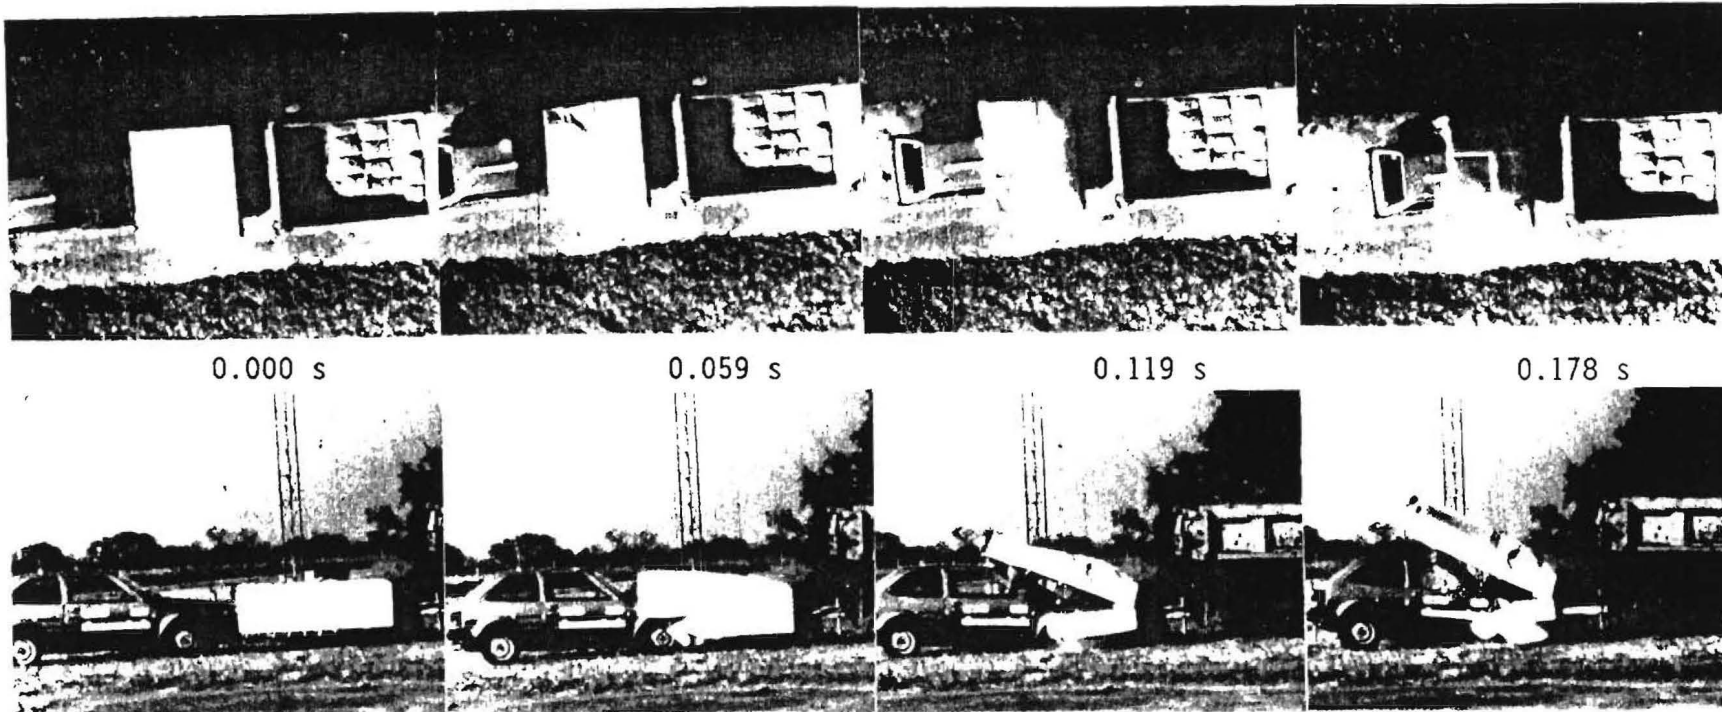
Test No. 09910-1
 Date 12/15/89
 Test Article Truck Mounted Attenuator
 Manufacturer Markings & Equipment
 TMA Truck 1980 Ford Dump Truck (#2)
 Weight without TMA . . . 14,010 lb (6,361 kg)
 Weight with TMA 14,930 lb (6,778 kg)
 Test Vehicle 1981 Honda Civic
 Weight 1,800 lb (817 kg)
 Impact Speed 44.9 mi/h (72.2 km/h)
 Maximum Vehicle Crush . 12.0 in (30.5 cm)
 Vehicle Damage Classification
 TAD 12FD4
 CDC 12FDEW3

Maximum Truck Displacement . N/A (fixed position)
 Maximum TMA Crush 84.0 in (2.1 m)
 Vehicle Accelerations
 (Maximum 50 ms Average at c.g.)
 Vehicle Longitudinal . . . -19.6 g
 Vehicle Lateral -1.5 g
 Truck Cab Longitudinal . . N/A
 Occupant Impact Velocity
 Longitudinal 30.0 ft/s (9.1 m/s)
 Lateral 6.9 ft/s (2.1 m/s)
 Occupant Ridedown Accelerations
 Longitudinal -23.9 g
 Lateral -1.2 g

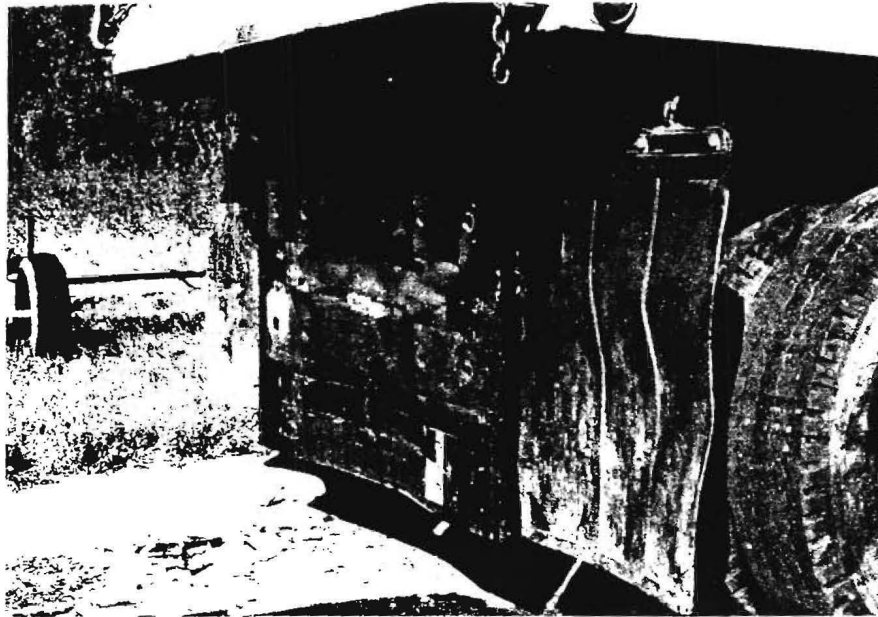
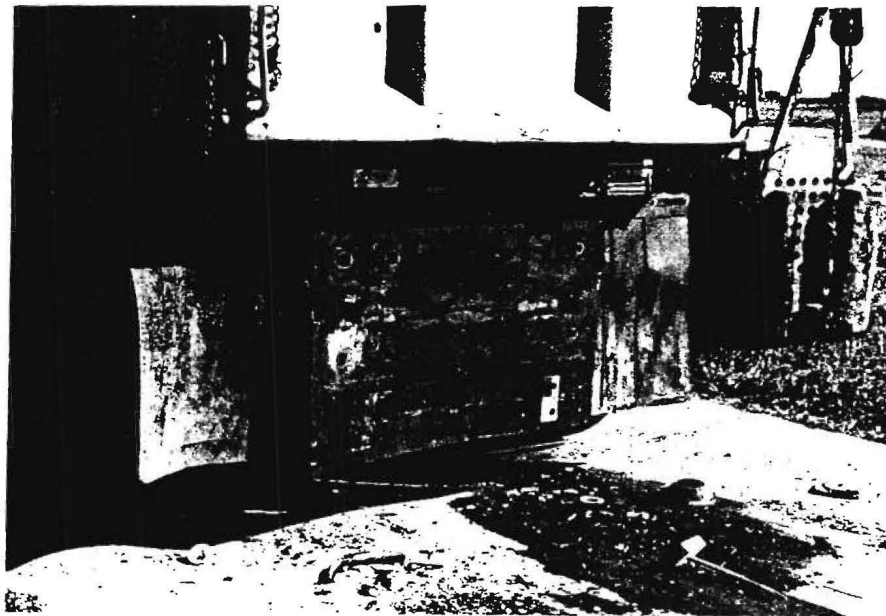
Figure 191 Damage to truck after test 9910-15.

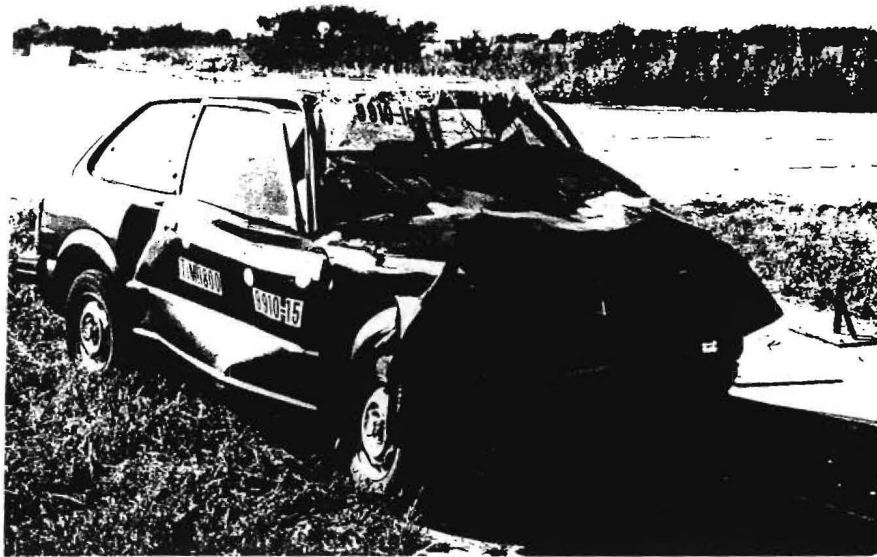
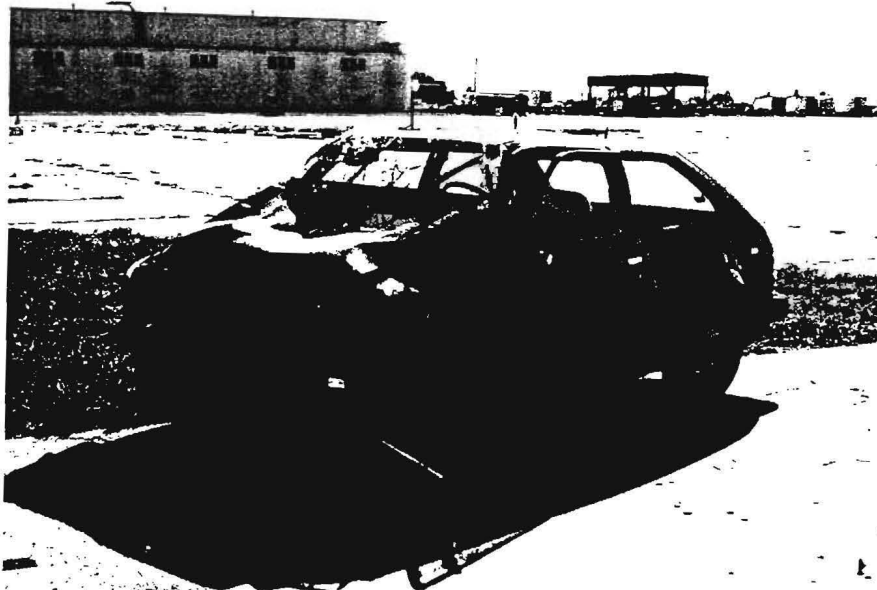
Figure 192 Damage to passenger car after test 9910-15.
