TECHNICAL REPORT 0-6752-1

TxDOT PROJECT NUMBER 0-6752

Short-Term Skid Improvements by Light Texturing with a Milling Machine

August 2014; Published June 2020

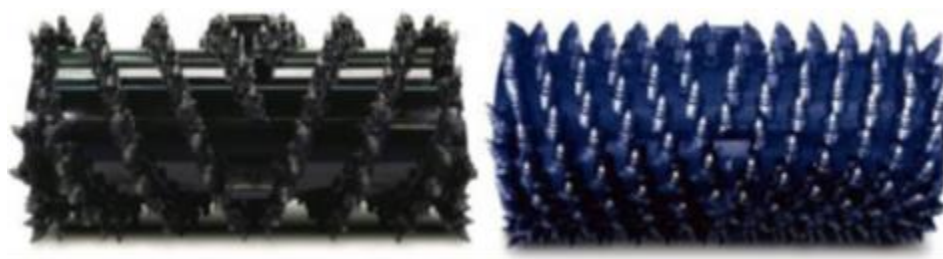
Figure 1. Standard Milling and Micro Milling Drums (4)

In most of the existing applications of light texturing, the micro milling (or fine milling) drum (Figure 1) is used. According to a research by Iowa Highway Research Board (3), the light texturing using standard milling practices yielded a relatively coarse textured surface that is objectionable to a substantial number of motorists.

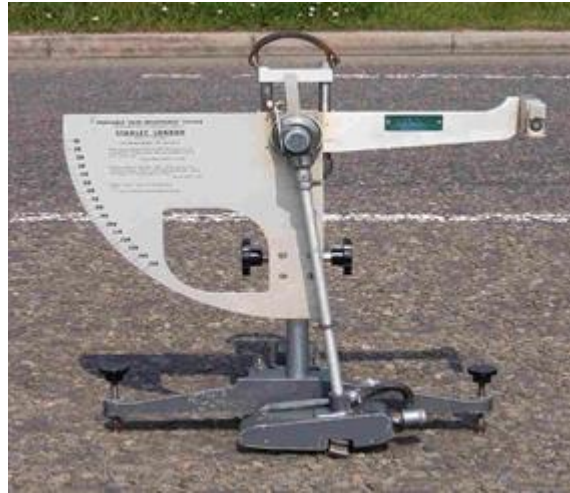
Figure 9. British Pendulum Tester

The test method is covered in ASTM E-303. The test result is reported as the British Pendulum Number (BPN). BPN is measured directly using a drag pointer. The greater the friction between the rubber slider and the test surface, the greater the BPN. The average slip speed decreases as the friction increases because the average velocity of the slider relative to the test surface is a function of the friction. Usually, the typical slip speed is assumed to be 6 mph (10 km/h) for the BPT. BPT is fitted with a scale that measures the recovered height in terms of the BPN over a range of 0 to 140. BPN mainly depends on the microtexture because the slip speed is

very low. The British Pendulum Number (BPN) is approximately 100 times the coefficient of friction (23).

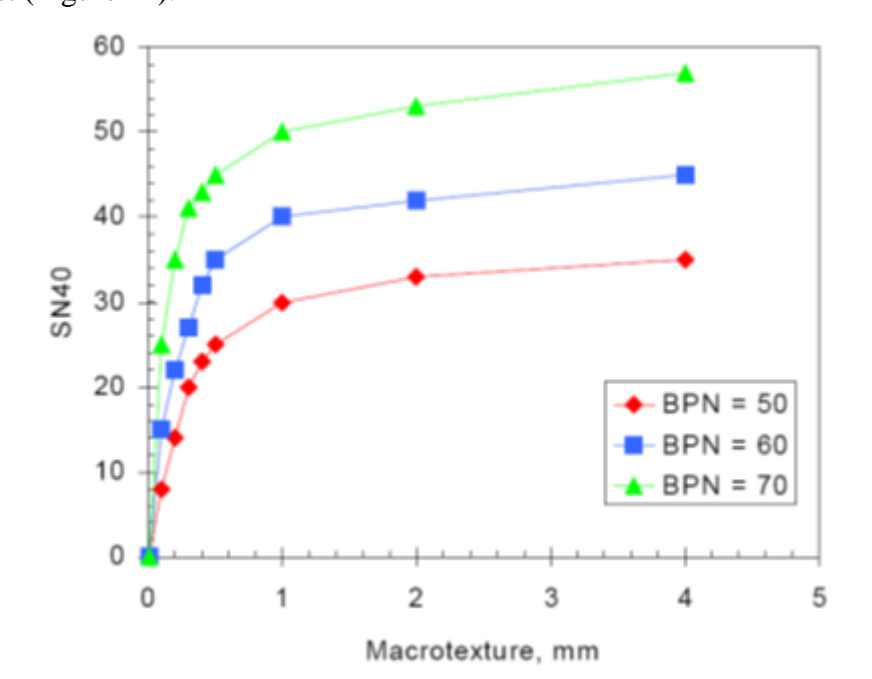
Figure 14. Effect of micro- and macrotexture on skid resistance (21)

A power law relationship exists between the macrotexture and the skid number at 65 kph (40 mph). This relationship is also affected by the microtexture as measured using the British Pendulum Test (Figure 14).

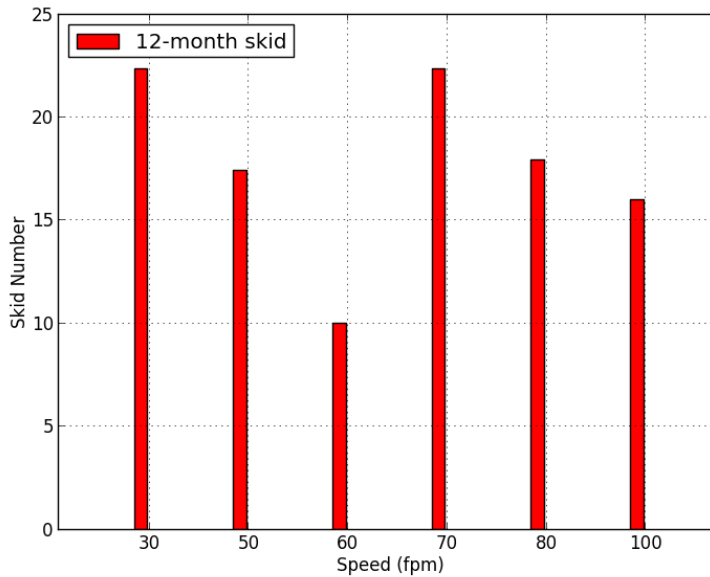
For this analysis, test sections were grouped into categories according to the milling machine forwarding speed. The results are presented in Figure 43 through 46, which shows the macro-texture and friction values at the end of the research period. Average Mean Profile Depth (MPD) and Skid Number (SN) values for all the sections constituting each speed category were plotted sequentially. Although many factors (e.g., climate, traffic, and pavement condition prior to the milling) influence the results shown in these figures, some general trends regarding the macro-texture and friction performance over time can be seen. Test sections with milling speed equal or higher than 70 feet per minute (fpm) showed the highest texture and friction levels. Test sections with HMA surface showed an increase in SN when the machine speed increases. However, this trend is not observed in the sections with seal coat surface.

Figure 43. 18-month average MPD (HMA surface) of different forwarding speeds

Figure 44. 18-month average skid number (HMA surface) of different forwarding speeds

Figure 45. 12-month average macrotexture (seal coat surface) of different forwarding speeds

Figure 46. 18-month average skid number (seal coat surface) of different forwarding speeds

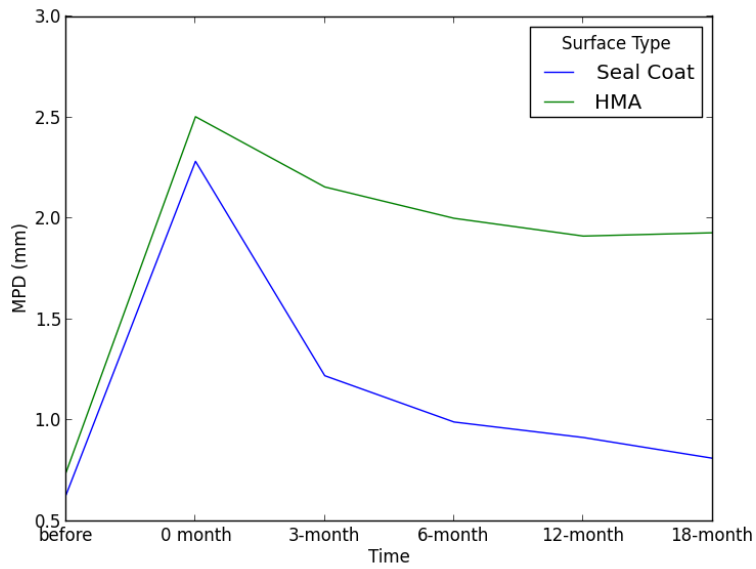
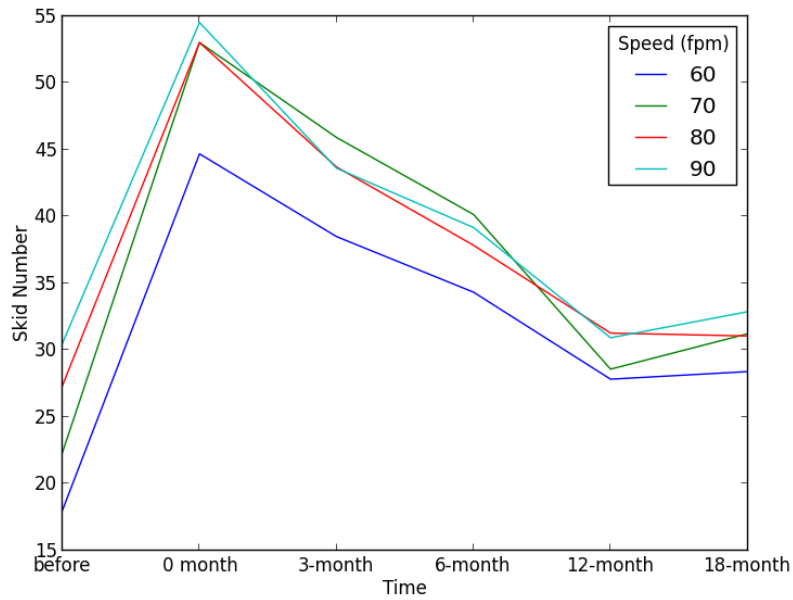
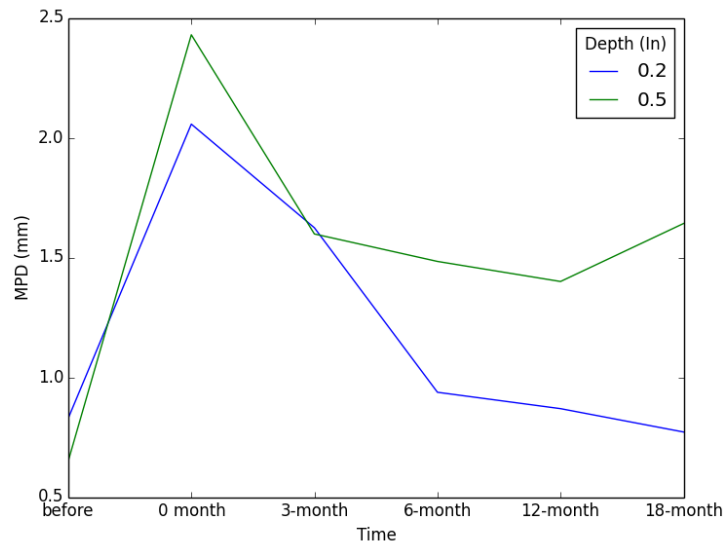
Figures 47 through 54 provide an indication of the durability of macro-texture and skid number for the different locations, forwarding speeds, cutting depths and surface types based on the texture and friction values obtained during the 18-month research period. These figures illustrate the reduction in texture depth and friction for each test location over time. As Figure 47 and 48 show, the sections with HMA surface exhibited higher level of texture depth and friction than the sections with seal coat surface. The HMA surface sections experienced texture depth losses of 0.5 mm and skid number losses of 20 at the time of 18 months after the milling. The sections with seal coat surface exhibited texture depth losses of 1.5 mm and skid number losses of 20 during the same time period. Because of the very limited number of test sections of each climate type and surface type, the effect of climate on texture and friction loss could not be determined. The data also illustrate the importance of using forwarding speed to maintain high levels of friction over time.

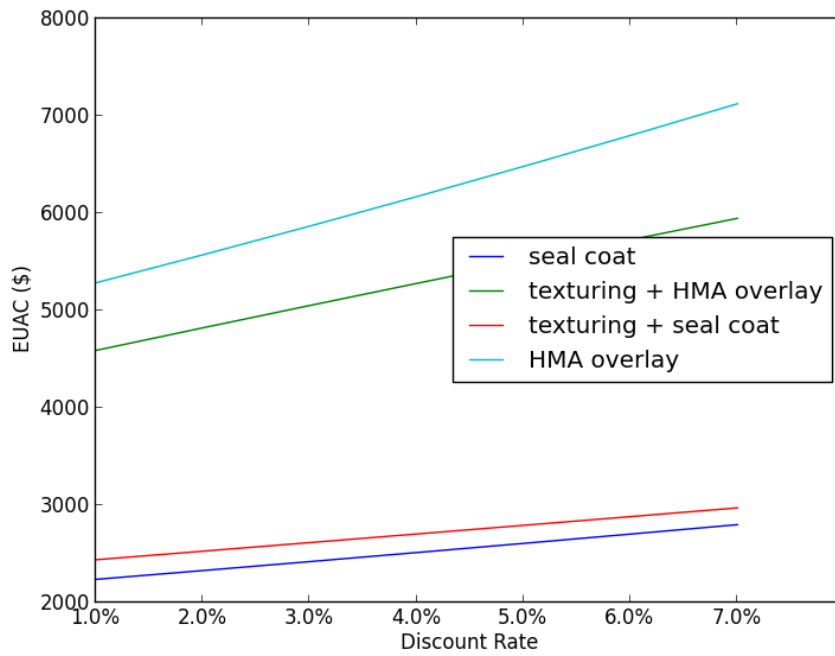
A life-cycle cost analysis based on TxDOT historical cost was carried out on the four strategies discussed above. With the discount rate being 4%, the cost analysis showed that the first strategy with overlay of an estimated life of 10 years has an equivalent uniform annual cost (EUAC) of approximately \$6,165 per lane mile. The second strategy of seal coat with estimated life of 7 years has EUAC of \$2,508 per lane mile. The strategy of combining light texturing and overlay together has an EUAC of \$5,272 and the last strategy has an EUAC of \$2,699. This implies that applying light texturing to delay a HMA overlay project would cost about 15% less than placing the overlay directly. As shown in Figures 57 and 58, the difference between strategies 2 and 4 is small with the fourth strategy performing slightly better than the second strategy. Overall, the analysis suggests that delaying overlay placement for a few years with a light texturing can keep the skid resistance at a reasonable level and save money at the same time. The light texturing method, therefore, appears to be cost effective as a short term correction technique for pavement with skid problems. This would be particularly useful in situations where there are many competing lane miles for limited resources. It would also alleviate an immediate concern while a more permanent solution is planned.

Figure 57. Life-cycle cost analysis using different discount rates

Figure 58. Life-cycle cost analysis using different analysis periods

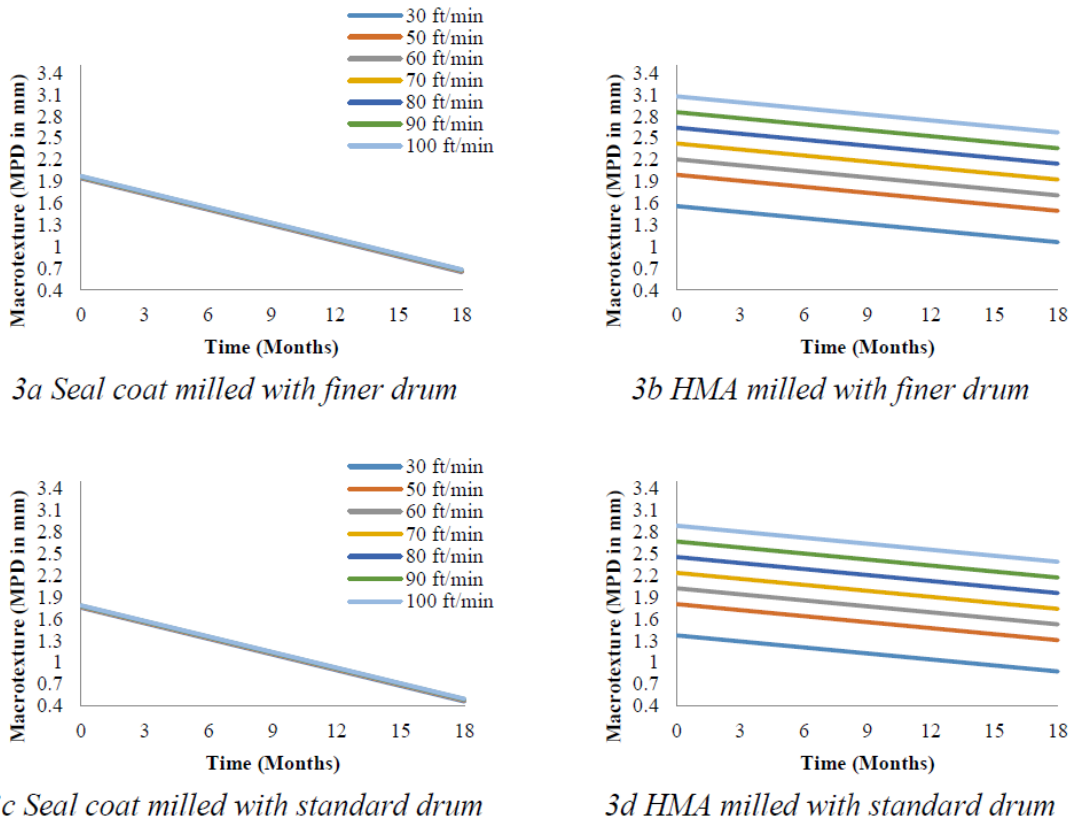
resistance. Figures 60 and 61 show the deterioration trends of skid resistance and macrotexture corresponding to both HMA and seal coats. These deterioration trends were evaluated in more detail to ascertain the influence of drum type and milling speed.

Figure 60. Deterioration of skid resistance

Figure 61. Deterioration of macrotexture

An analysis of the skid resistance measurements over time on the sections evaluated as part of the study indicate that milled seal coats deteriorate more rapidly than HMA sections. The data suggests that milling operations on average provide an additional service life of about 12 months on seal coats, whereas milling on HMA sections extends the service life beyond 18 months. Linear extrapolation of the skid number data on the HMA sections indicate that these values would fall below 20 after about 2 years.
