**A METHODOLOGY FOR BUMP DETECTION USING INERTIAL PROFILE  
MEASUREMENTS**

**THE UNIVERSITY OF TEXAS AT ARLINGTON  
TRANSPORTATION INSTRUMENTATION  
LABORATORY**

**RESEARCH REPORT 0-4479-1  
Research Project Number 0-4479**

**Date: April 2005**

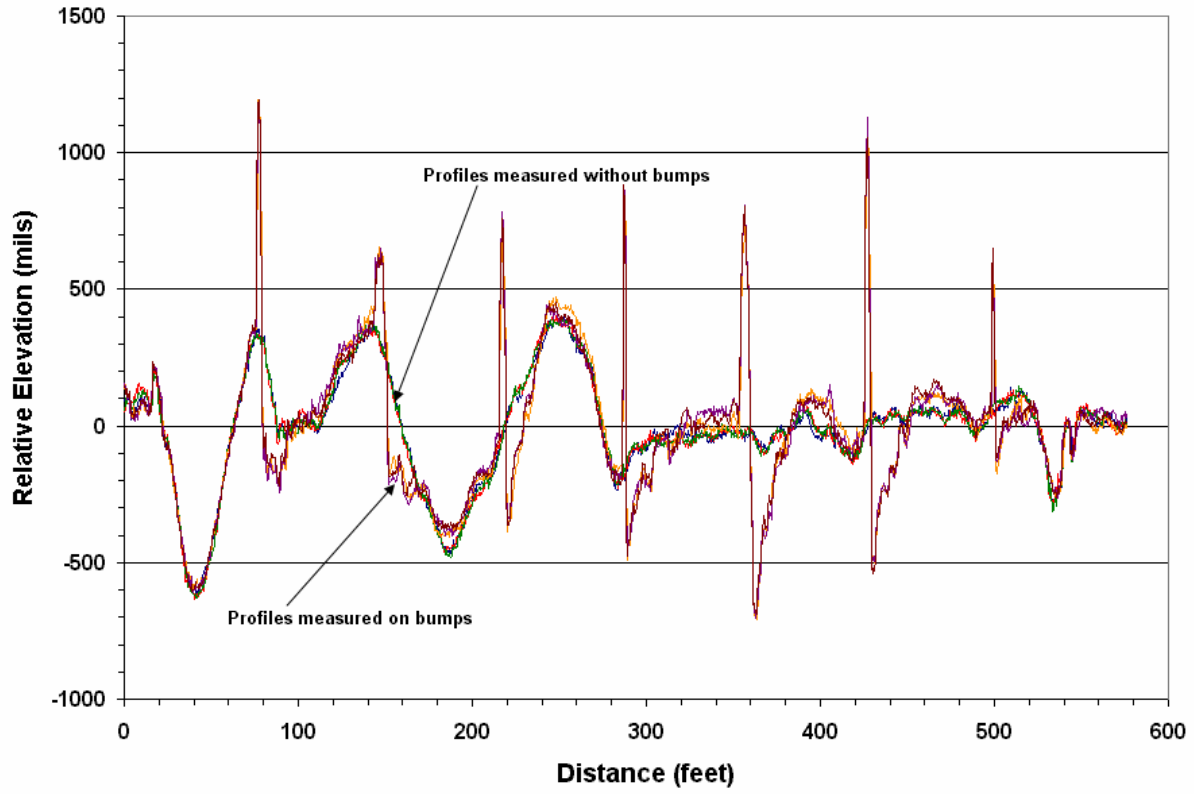
**Figure 1.1** Examples of profiles measured with and without the artificial bumps

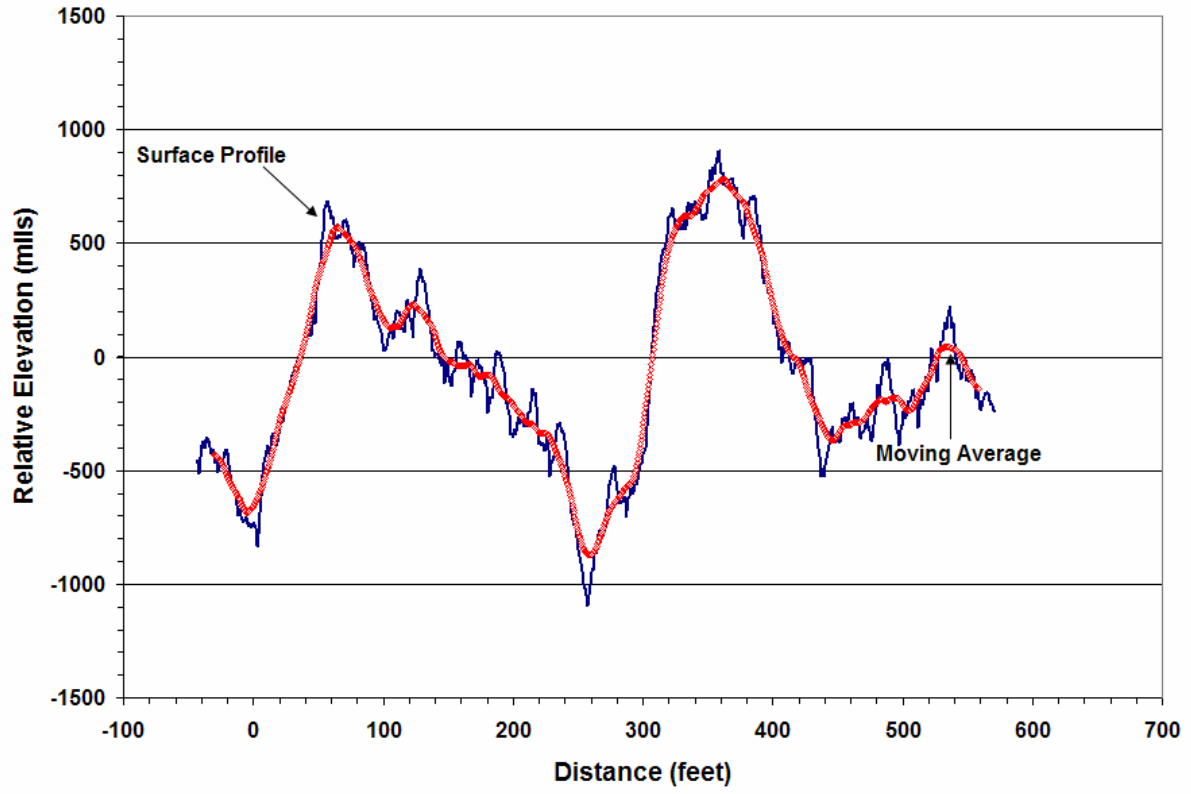
**Figure 1.2 Measured and Moving Average Profiles**

For the data shown, relative elevations were recorded at 6-inch intervals. The elevations are plotted in [Figure 1.2](#) along with the moving averages determined using a base length of 25 ft.

[Figure 1.2](#) shows locations within the section where the profile significantly deviates from the moving average. For the problem of finding rough areas, a higher deviation from the moving average indicates a greater likelihood of a surface defect at the given location. Fernando and Bertrand (2002) examined the correlation between the deviations of the measured profile from the moving average, and the locations of bumps as determined from a simulation of the profilograph response to the measured profile. The results from this simulation are given in [Figure 1.3](#), which shows the locations of bumps within the section investigated. These bumps are plotted as dots at the top of the figure, where the measured and moving average profiles are also shown. Note that the bumps track the locations of peaks in the measured profile. The peak deviations that coincide with the bump locations ranged from about 134 to 217 mils, with an average deviation of 165 mils from the moving average.

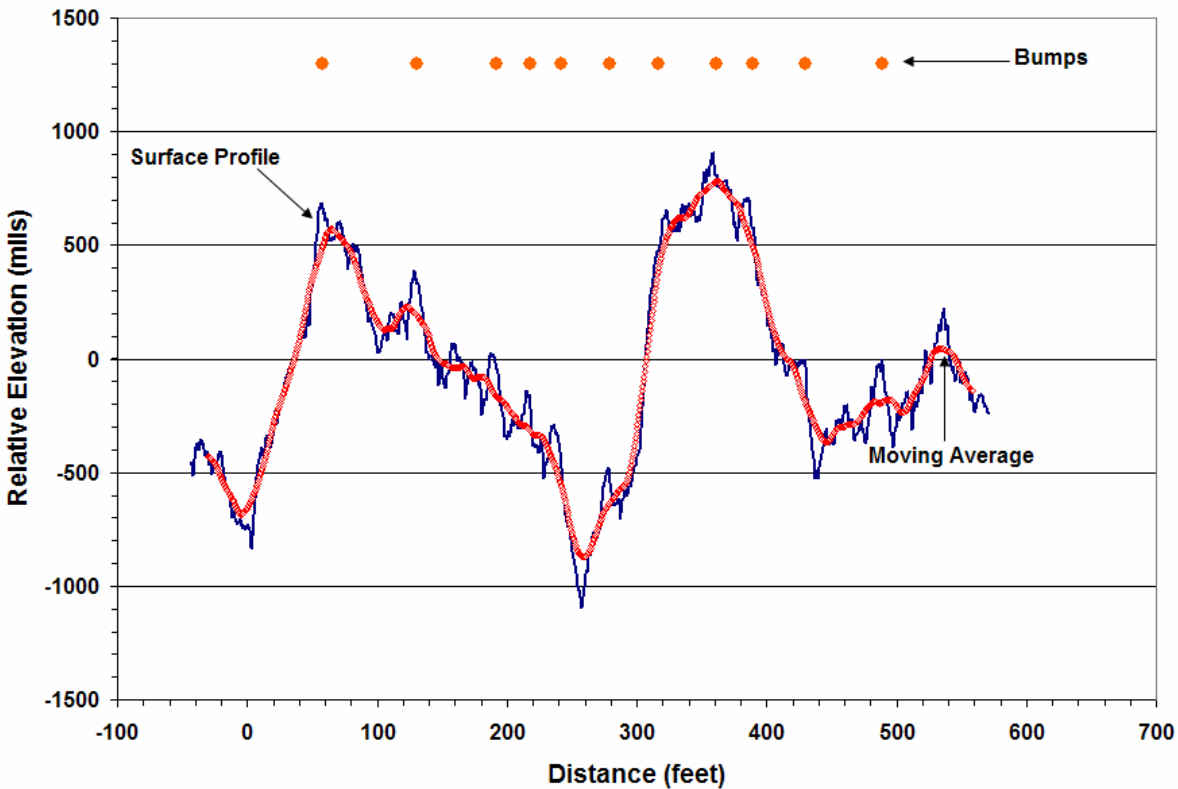
**Figure 1.3 Bump Locations from Profilograph Simulation vs. Peak Deviations**

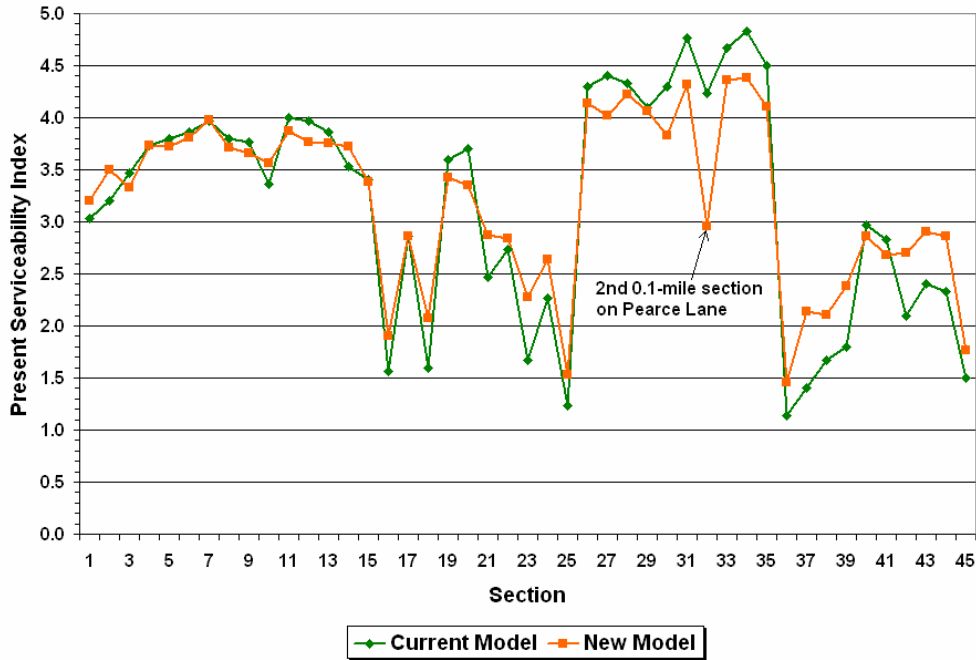
**Figure 2.2 Comparisons between Current and New SI Models on Austin Test Sections**

As noted in the figure, the SIs computed between the current and new model on the second 0.1 mile section of Pearce Lane were significantly different (4.2 vs. 3.0) and had changed from a previous reading of 4.26 in less than three months. In further investigations, it was found that a pothole had formed in the left wheel path of this section (see Figure 2.3). The section was re-measured, this time driving to the right of the pothole, resulting in more consistent readings (current SI of 4.7 vs. new SI of 4.2).

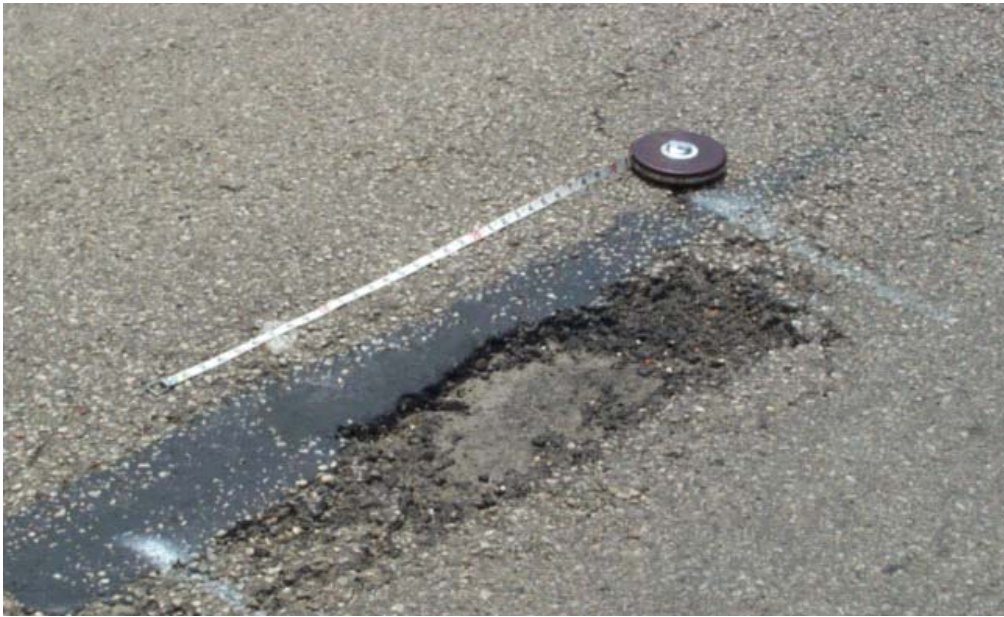
**Figure 2.3 Pot Hole in Wheel Path of the Second 0.1 mile Section along Pearce Lane**

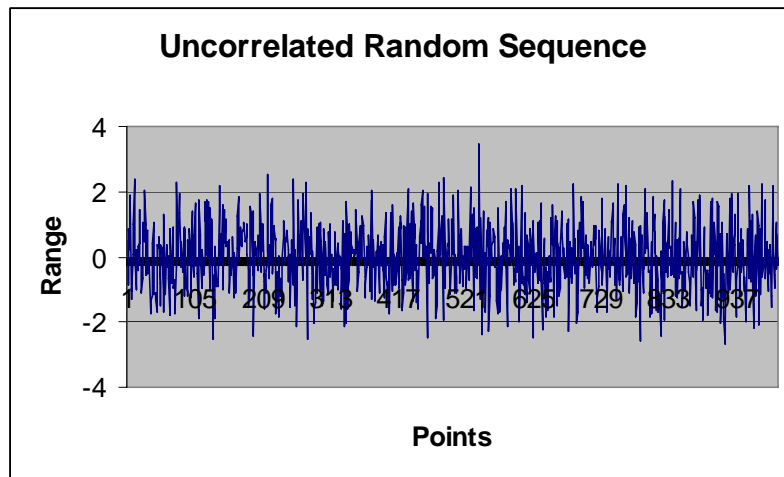
**Figure 2.6 Random Data Sequence**

Ideally, uncorrelated or random data should not have any correlation. For a large finite number,  $N$ , of random numbers, it can be shown (Ifeachor and Jervis, 2002) that the variance of the values approach  $1/N$ . A set of  $N$ , random data points generated by the Matlab function `rand()`, are illustrated in Figure 2.6. Figure 2.7 illustrates the autocorrelation for the data of Figure 2.6. Note that the value is a maximum of one for a zero lag, and then the values are distributed about zero. The cross correlation between the data of Figure 2.6 and a second similar set is shown in Figure 2.8. Also illustrated is the 95% confidence interval. That is, in ‘the long run’, about 95% of the points will fall within the illustrated range. In Figure 2.8, it is noted that at least three out of the 1000 data values exceed the 95% range.

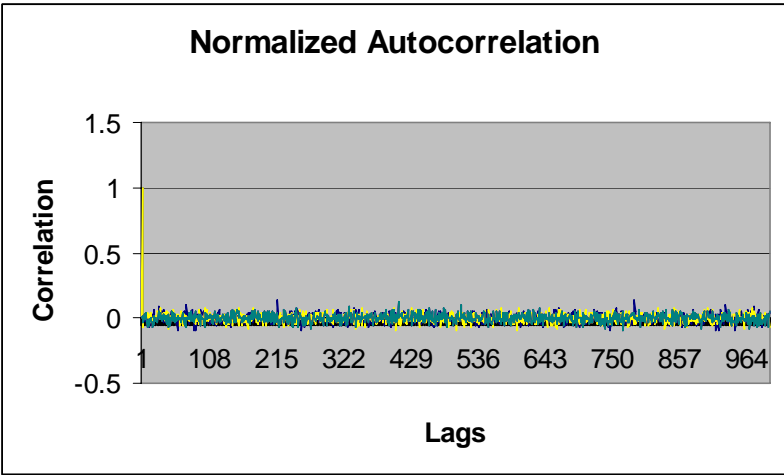
**Figure 2.7** Autocorrelation of the Data in Figure 2.6

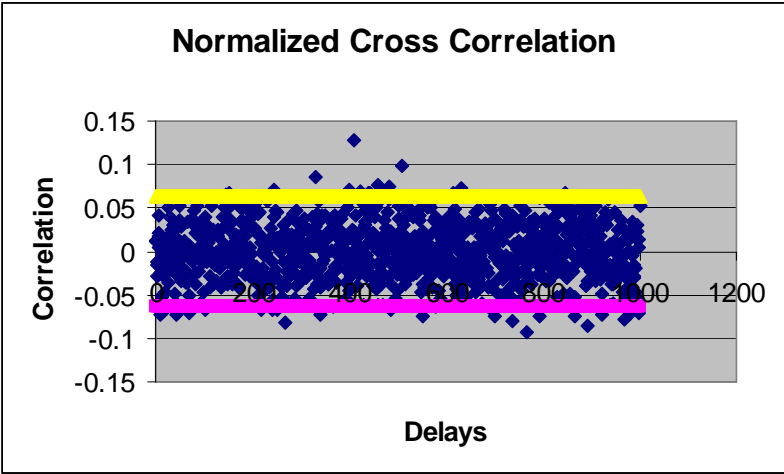
**Figure 2.8** Cross Correlation of Two Data Random Sequences

From the above discussion, it would seem possible to use the cross correlation between a bump or dip with road profile as a possible means of identifying the magnitude and location of similar shapes in a pavement profile. Cross correlation used for this purpose is considered in the [next section](#).

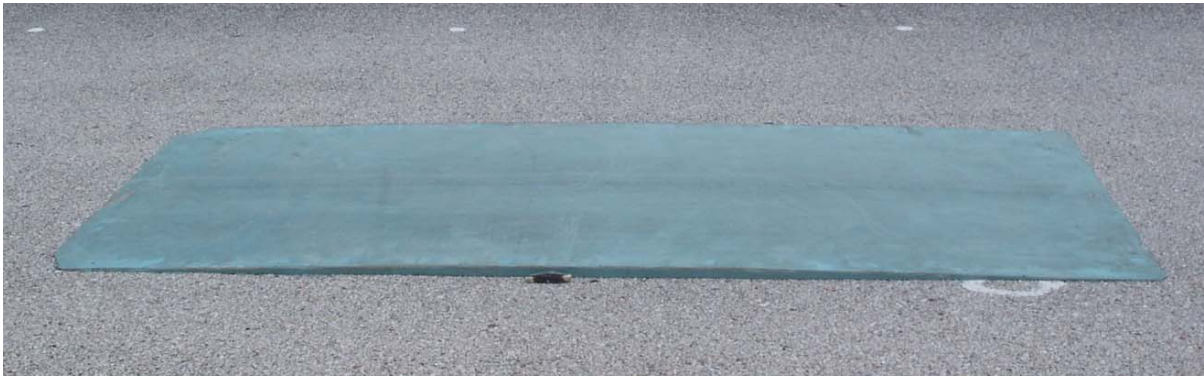
**Figure 2.9 Photo of Bump 5 on Pavement Test Section**

The artificial bumps developed by previous research at TTI as discussed in [Chapter 1 \(Table 1.1\)](#) were investigated to determine if one of these could be used for the cross correlation. Each bump was profiled and inserted into various smooth profiles. A spline function was used for joining the ends of each bump into the middle of each profile. Although any of the bumps would have worked, bump 5 of [Table 1.1](#) was selected as the ‘typical’ bump or bump signature as it seemed to consistently have one of the smoother transitions when inserting the bump into various profiles for study. [Figure 2.9](#) depicts bump 5 located on one of the test sections at the Texas A&M Riverside Campus. [Figure 2.10](#) provides a profile of this bump.

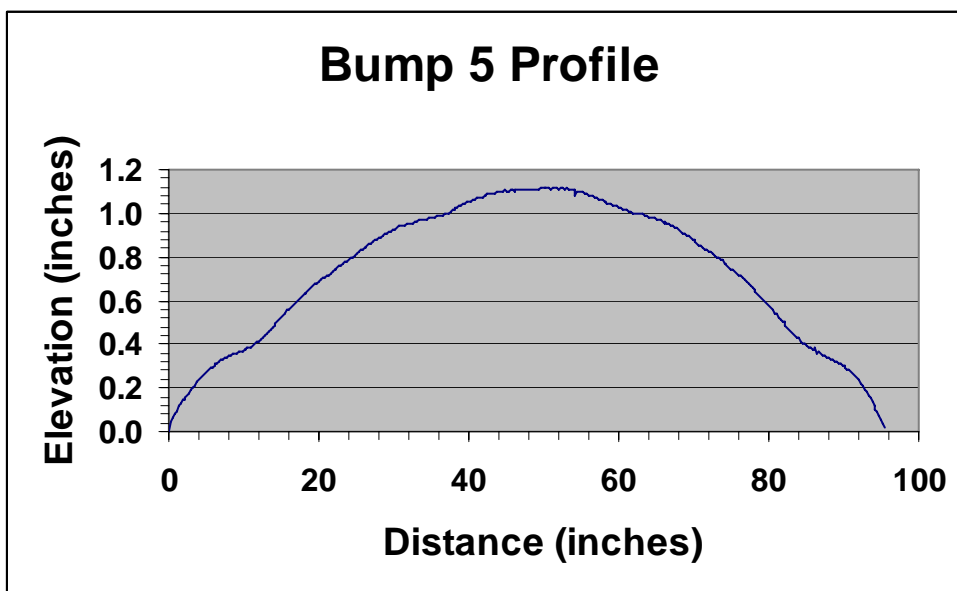
**Figure 2.10 Bump 5 Profile.**

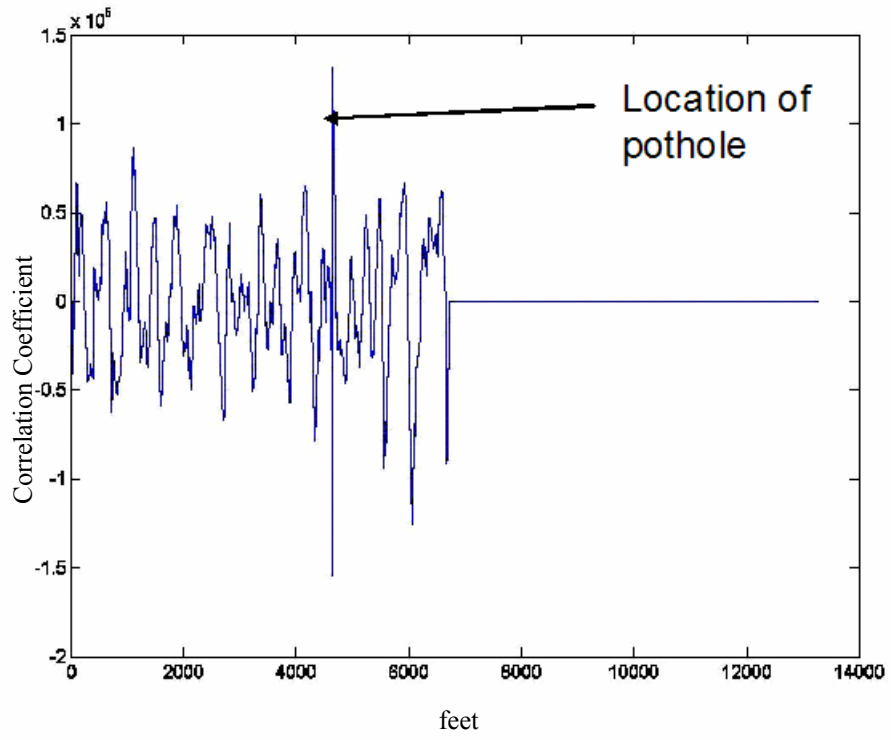
**Figure 2.11 Cross Correlation Results.**

This bump was then cross correlated with the profile from the section on Pearce Lane that included the pothole. [Figure 2.11](#) illustrates the cross correlation results. The sharp peak illustrated in the cross correlation results depicts the location of the bump. With each point representing approximately 0.5 feet, the location of the peak was found to be at the exact location of the pothole.

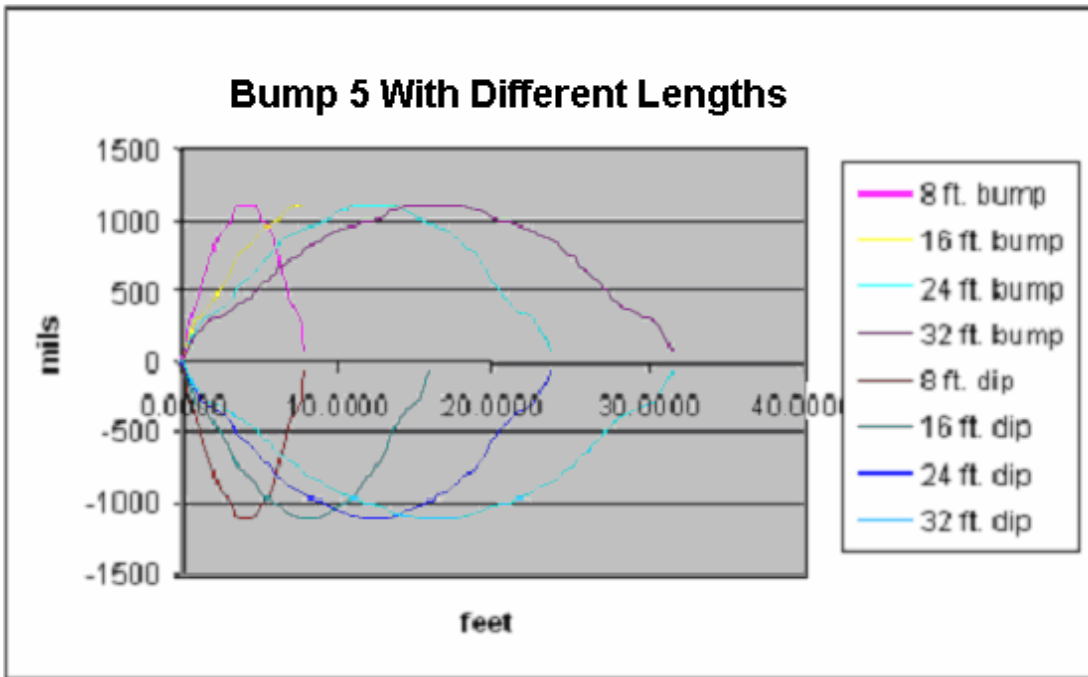
**Figure 3.1 Bump 5 with Varying Lengths**

For investigating the effects of the simulated bumps, a set of profiles with bumps and dips were generated by changing the amplitude and length of bump 5 and inserting this bump into a smooth profile from Pearce Lane. The first set of profiles were generated by inserting each bump into the Pearce Lane profile, changing the amplitude of bump 5 to 0.125, 0.25, 0.5, 0.75, 1.0 and 2.0 times its original height of 1.116 inches, or 140, 279, 558, 837, 1116, and 2232 mils. In a similar manner, a second set of bumps were made, this time holding the original amplitude constant and varying the lengths to two, three, and four times the original length of eight feet, resulting in a set of 1116-mil bumps of 8, 16, 24, and 32 feet in length. The process was repeated to generate dips by reversing the amplitudes. The bumps are illustrated in [Figures 3.1](#) and [3.2](#). The dips are illustrated in [Figures 3.1](#) and [3.3](#). For each profile generated, the current SI, the IRI, and new SI were computed. The SI, IRI, and NSI statistics for the various combinations are illustrated in [Tables 3.1](#) to [3.3](#).

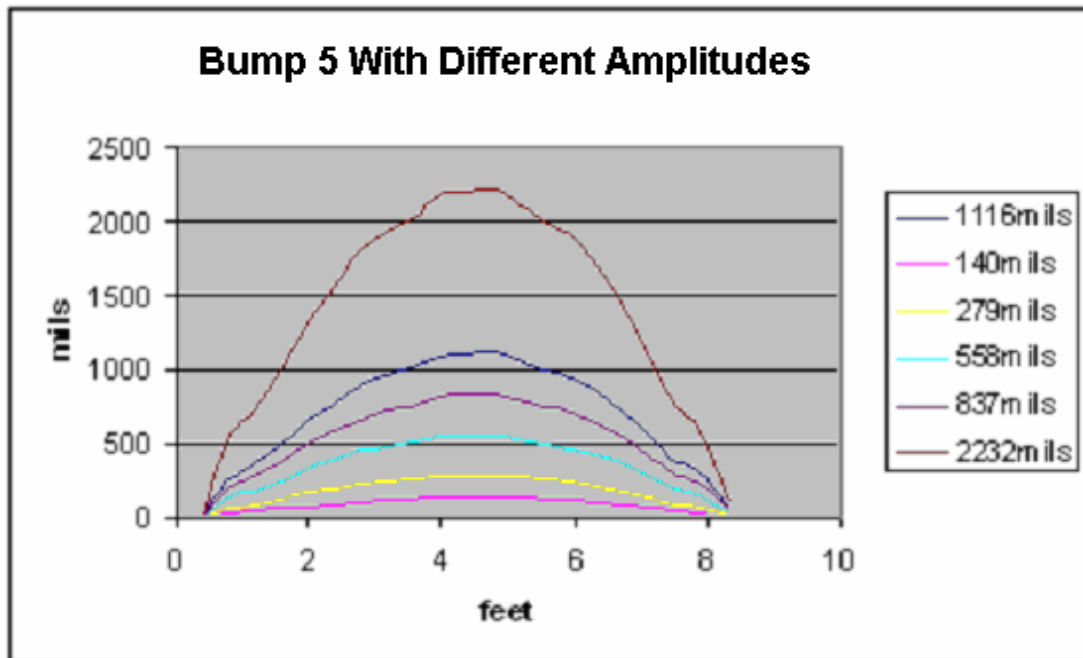
**Figure 3.2 Bump 5 with Varying Amplitudes**

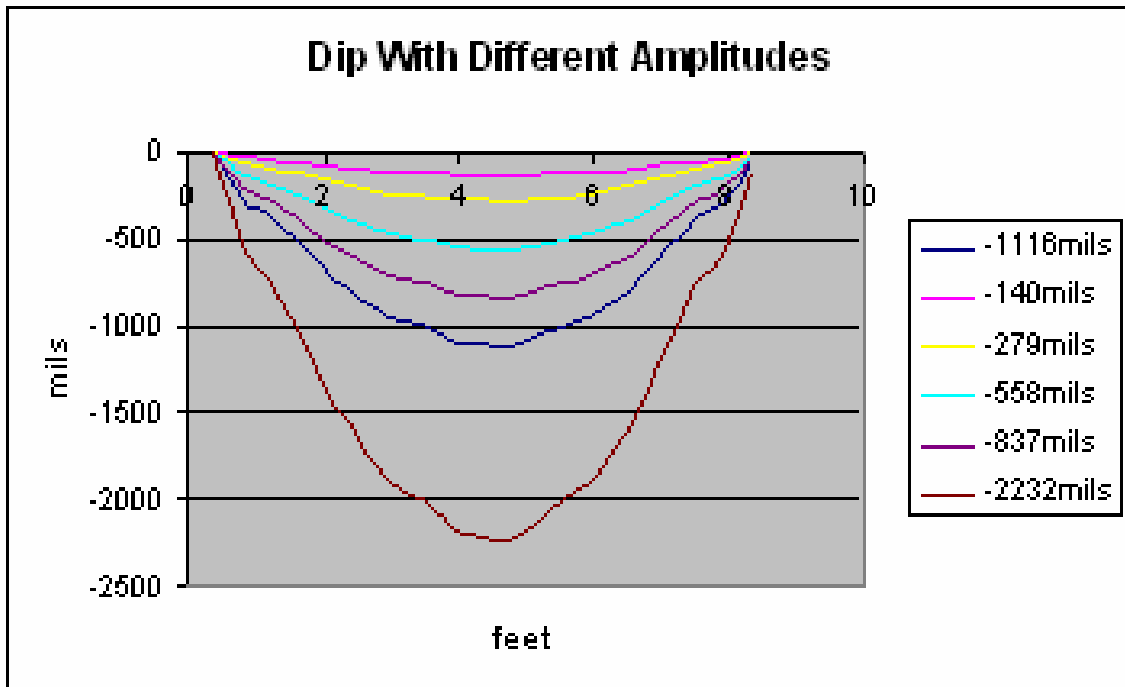
**Figure 3.3 Reversing Bump 5 for Generating Dips**

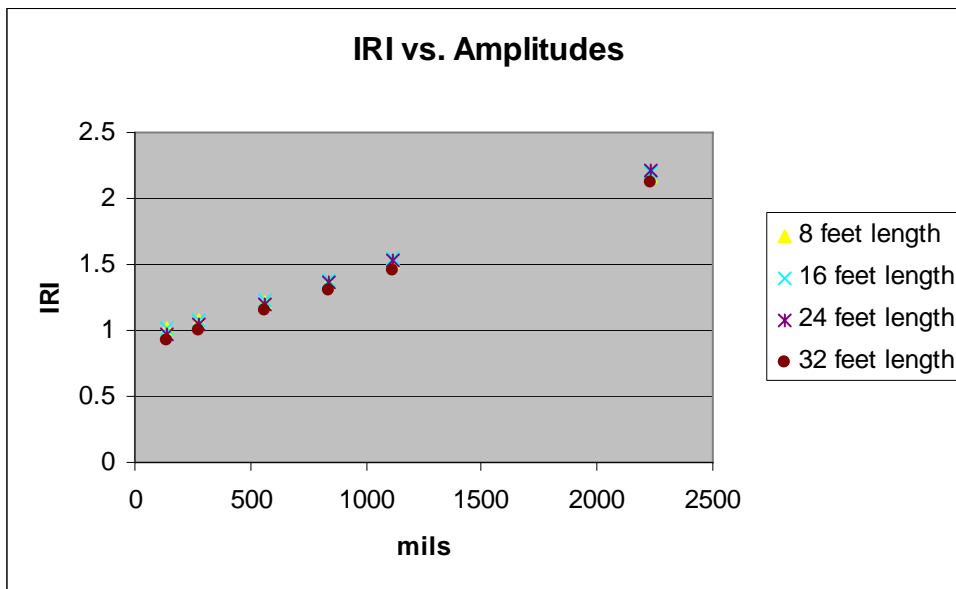
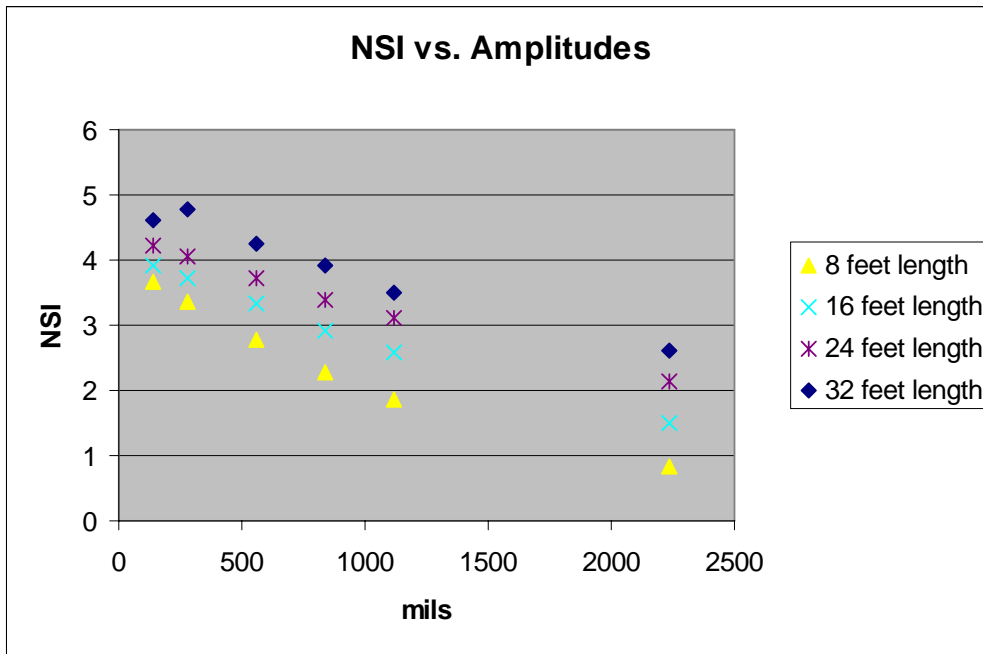
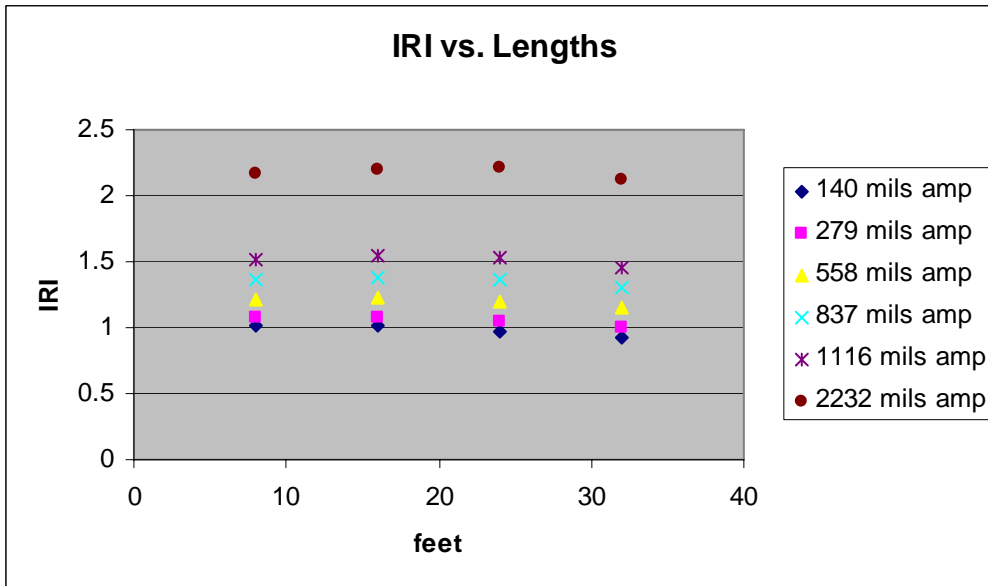
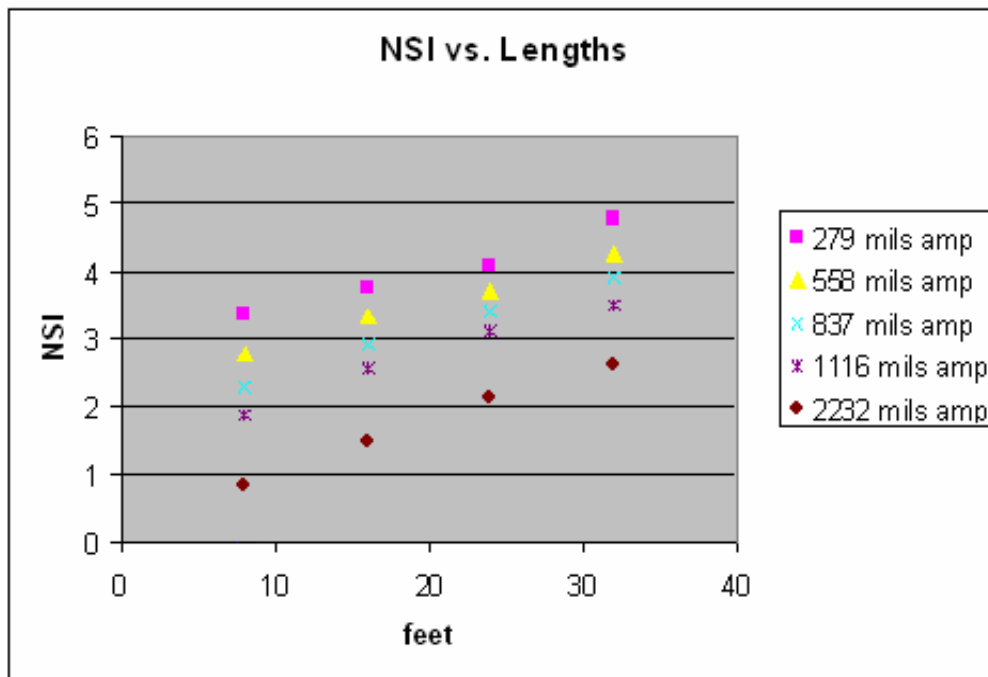
**Figure 3.4 IRIs of Artificial Bump Profiles with Varying Amplitudes**

**Figure 3.5 NSIs of Artificial Bump Profiles with Varying Amplitudes**

**Figure 3.6 SIs of Artificial Bump Profiles with Varying Lengths**

**Figure 3.7** IRIs of Artificial Bump Profiles with Varying Lengths

**Figure 3.8** NSIs of Artificial Bump Profiles with Varying Lengths

The values in Tables 3.1-3.3 and corresponding plots in Figures 3.4-3.8 illustrate the effect of the amplitude and wavelength variations on SI, IRI, and NSI. In particular, note in Figure 3.4 that IRI (and thus SI) changes with bump amplitude, but very little by bump wavelengths, (Figures 3.6 and 3.7). On the other hand, NSI changes with both amplitude and length, as may be observed in Figures 3.5 and 3.8. From these results, it can be concluded that the new SI equation seems much better at distinguishing length variations for the range indicated than IRI or the current SI.

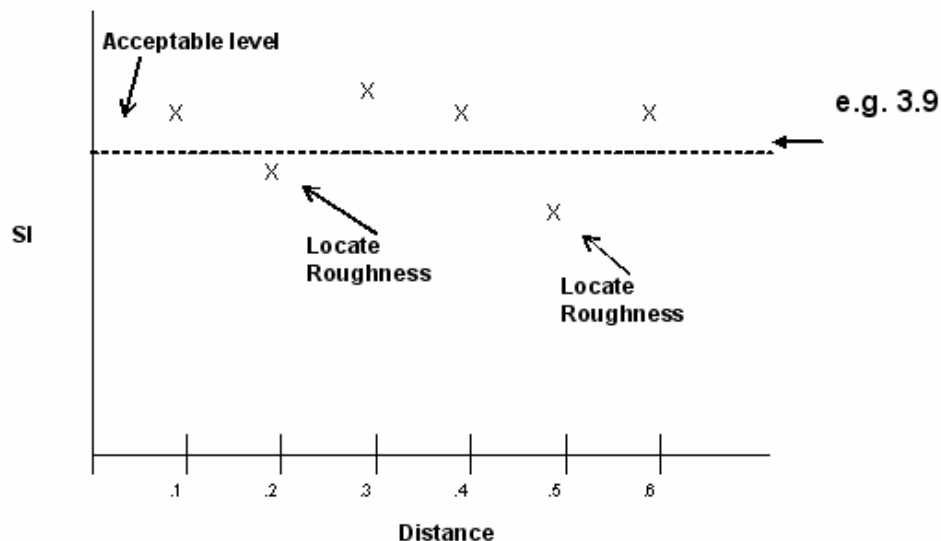
**Figure 3.10 Identification of Areas for Cross Correlation Analysis**

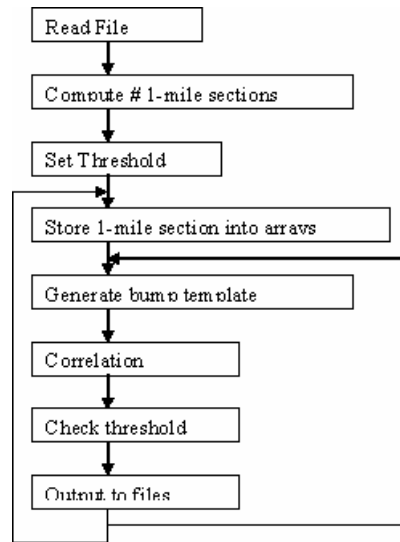
**Figure 4.5 Template Analysis Program Flow**

As previously discussed, a program written in Matlab was developed to implement the template analysis method. The analysis program, after reading the profile of the pavement section of interest, first determines the number of one mile sections in the profile. The program then performs a cross correlation between the profile for each one mile section with the appropriate bump template. As noted in previous chapters, the template is derived from the artificial bump 5. A cubic spline function is used to generate the 4-, 12-, 16-, 20- and 24-foot templates of the same general shape as the eight-foot bump. After the program finishes running the correlation, it then examines the PSI values and denotes or outputs those locations where the correlation values exceed a specified threshold. The analysis flow chart of this Matlab code is provided in [Figure 4.5](#) below.

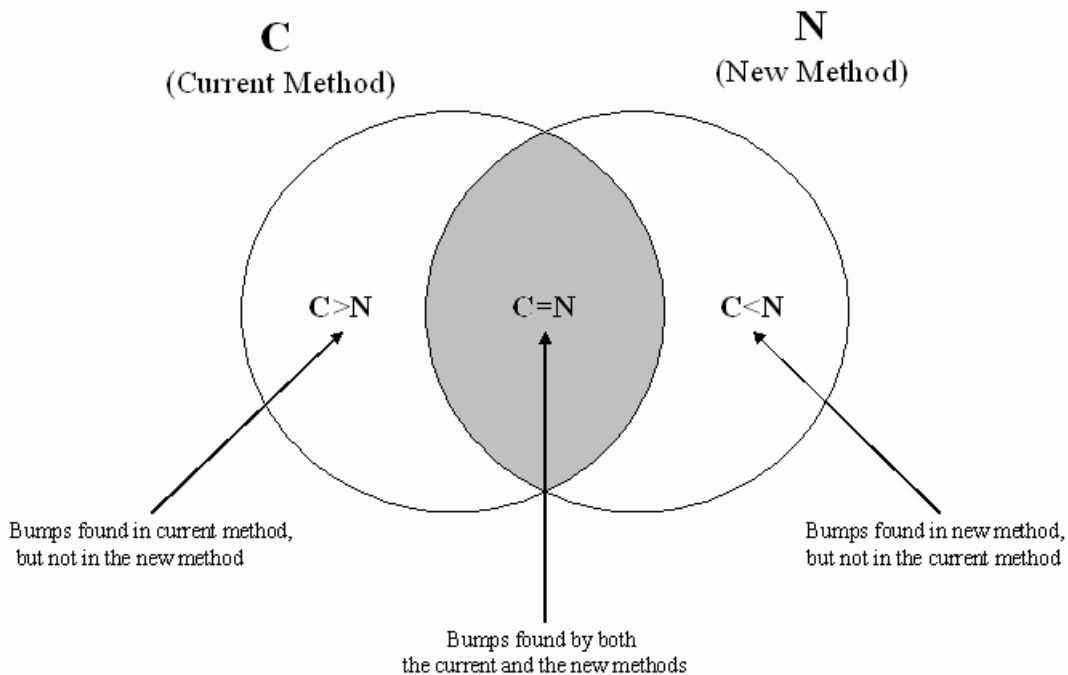
**Figure 4.8 Relationship of Proportional Bumps Found by the Current Method and the New Method**

From the tables, it is noted that, for most cases, the closest NSI level to where  $C > N$  and  $C < N$  lines cross is from 3.73 to 3.75.

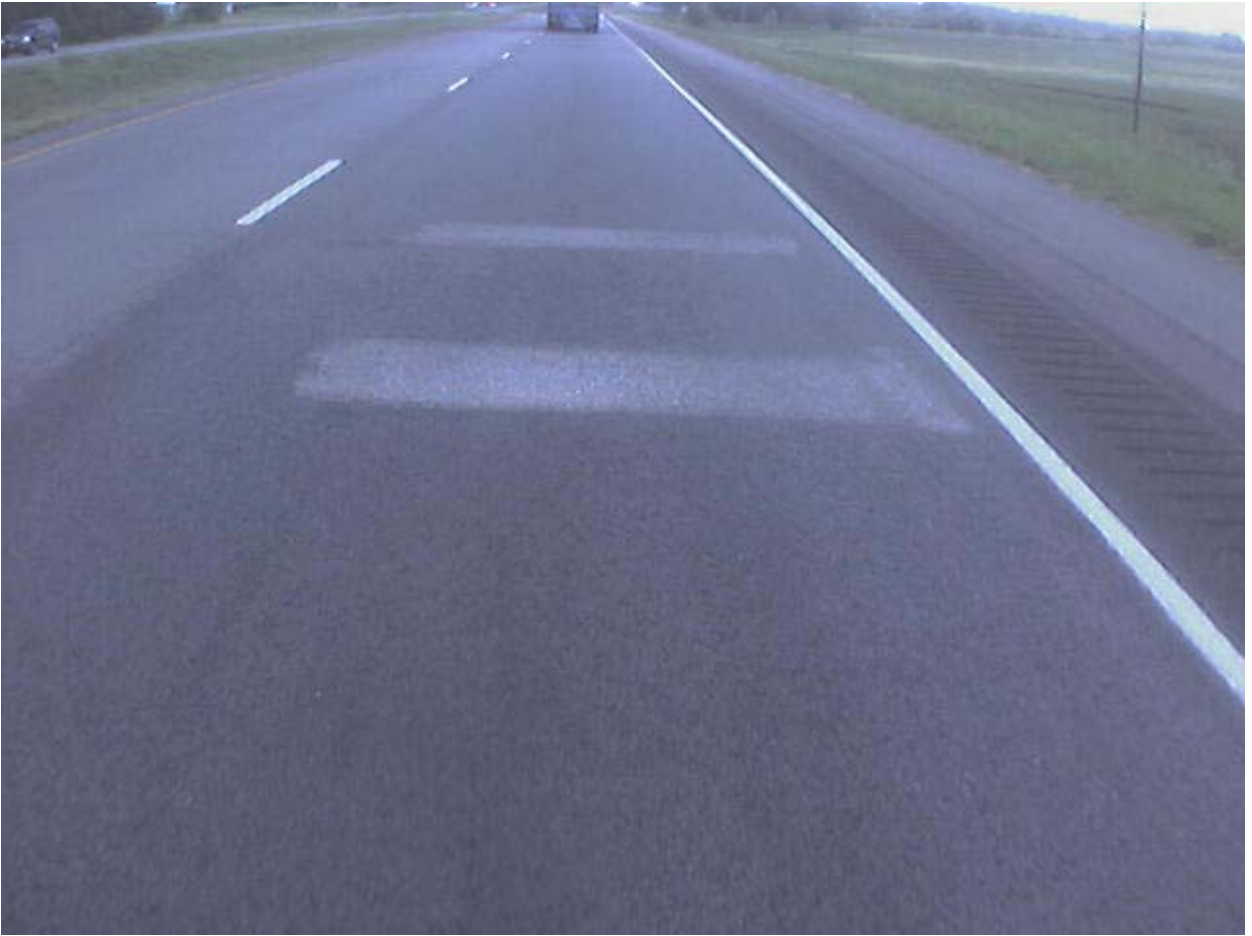
**Figure A.2 Grind Spots along R1 Lane of US290 about 4147 ft from Start of Profile Survey**

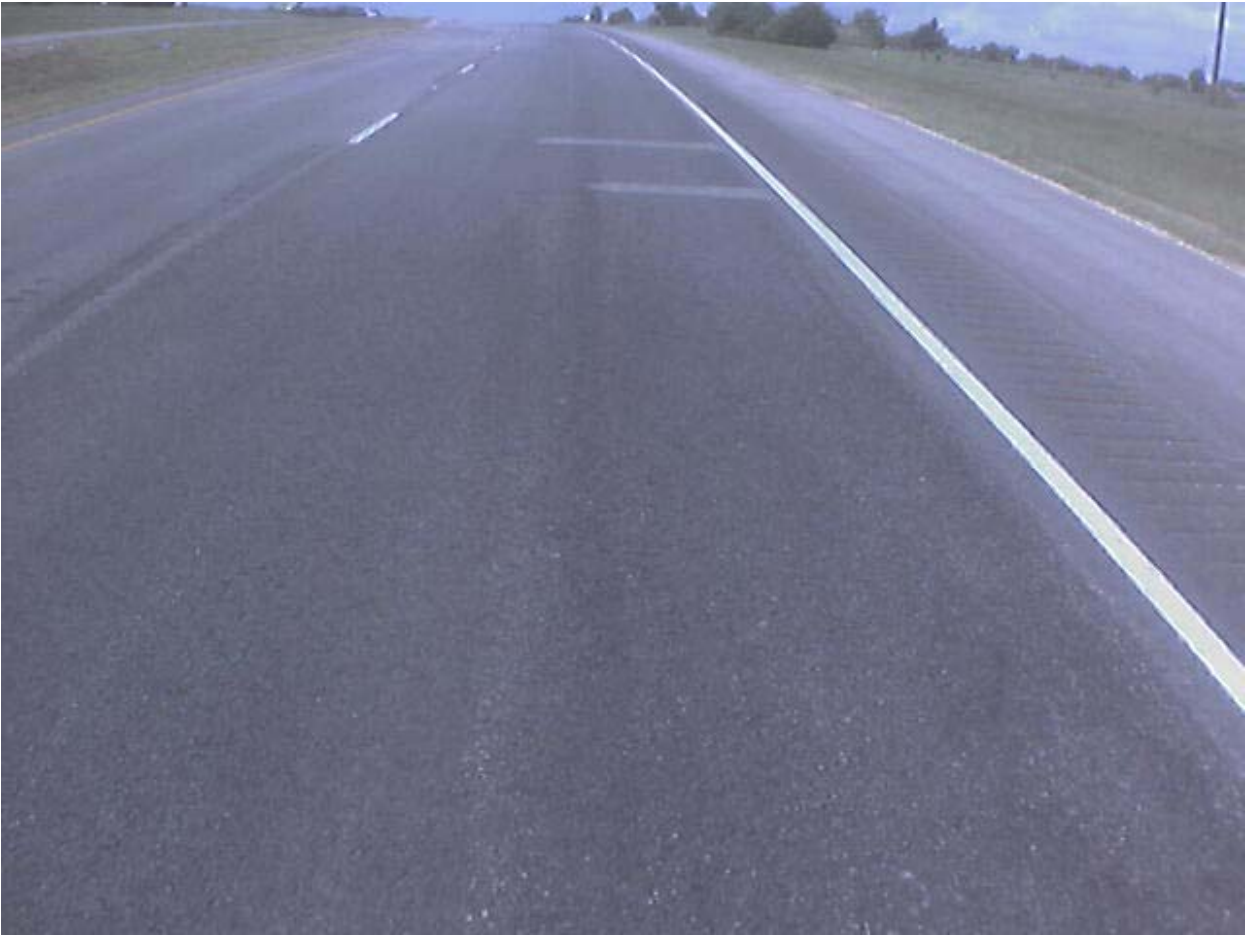
**Figure A.3 Grind Spots along L1 Lane of US290 about 19,674 ft from Start of Survey**

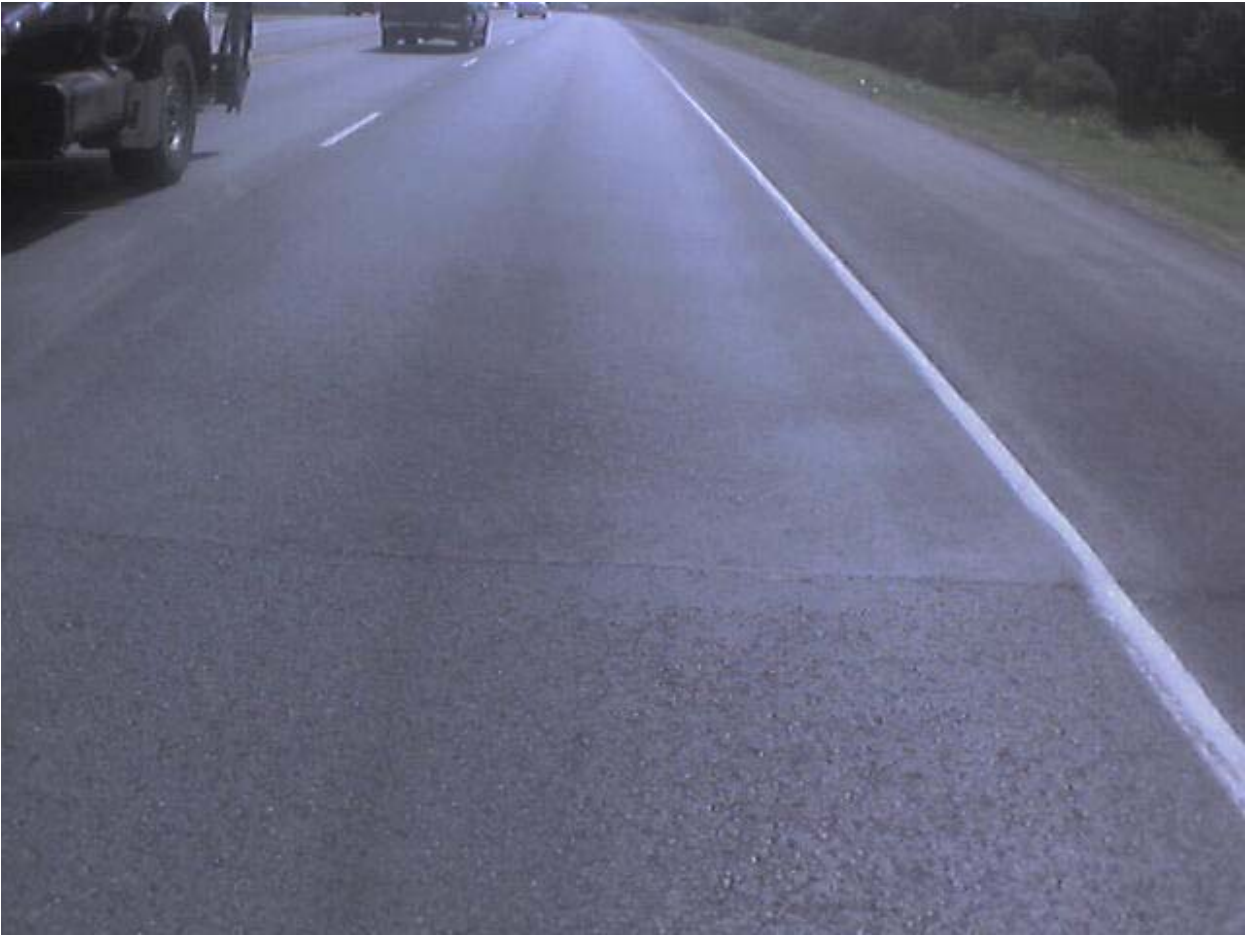
**Figure A.4 Beginning of Overlaid Area on K1 Lane about 12,453 ft from Start of Survey**

<sup>E</sup> Overlay placed between 12,453 and 12,861 ft on K1 lane

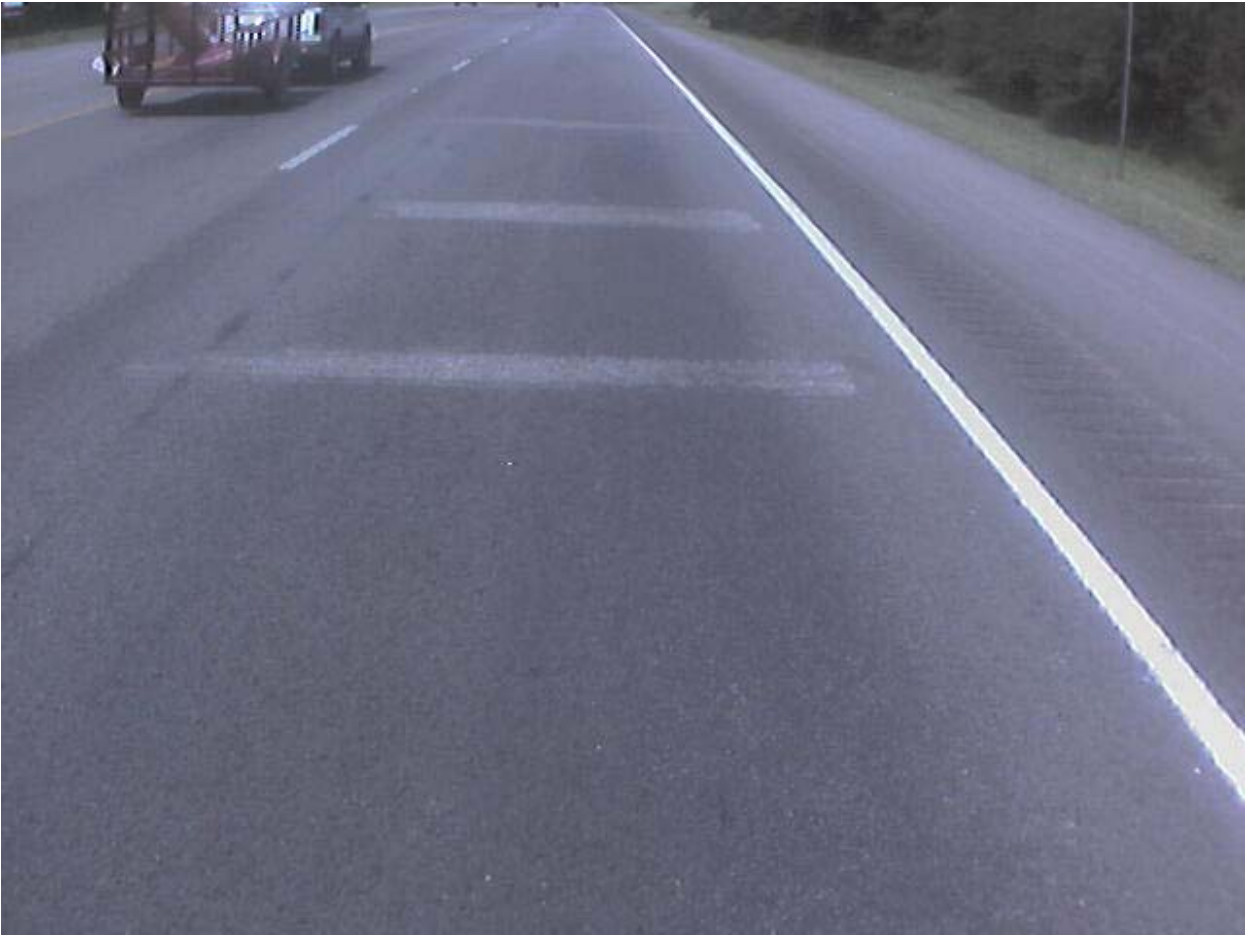
**Figure A.5 Grind Spots along K6 Lane of US290 about 14,888 ft from Start of Survey**
