1. Report No. FHWA/TX-08/5-4385-01-1		2. Government Accession No.		3. Recipient's Catalog No.	
4. Title and Subtitle PILOT IMPLEMENTATION OF BUMP DETECTION PROFILER				5. Report Date Published: December 2007

PILOT IMPLEMENTATION OF BUMP DETECTION PROFILER

Report 5-4385-01-1

Project Title: Pilot Implementation of Bump Detection Profilers for CRCP Construction

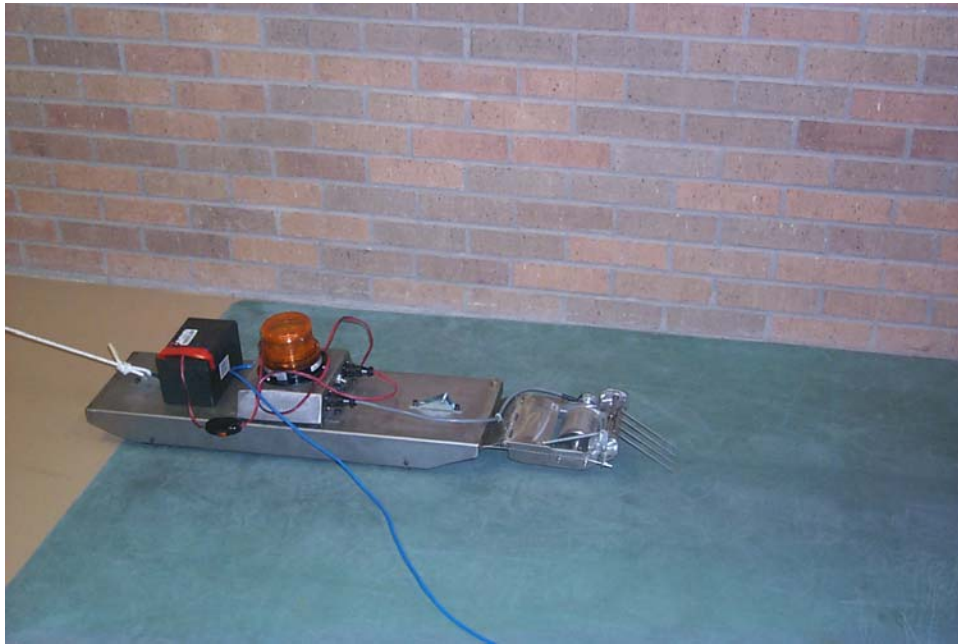
During the fall of 2005, the first version of the production unit was completed and tested in a sandbox constructed for the test at the Texas A&M Riverside Campus. The parts needed for the instrumentation were also obtained, wired and mounted within the sliding profiler unit. The system was then brought to UTA where the bump algorithm was tested by pulling the device down the hall outside the UTA Transportation Instrumentation Lab. Figure 1 illustrates the device being tested at UTA.

Figure 1 Testing Unit at UTA Lab

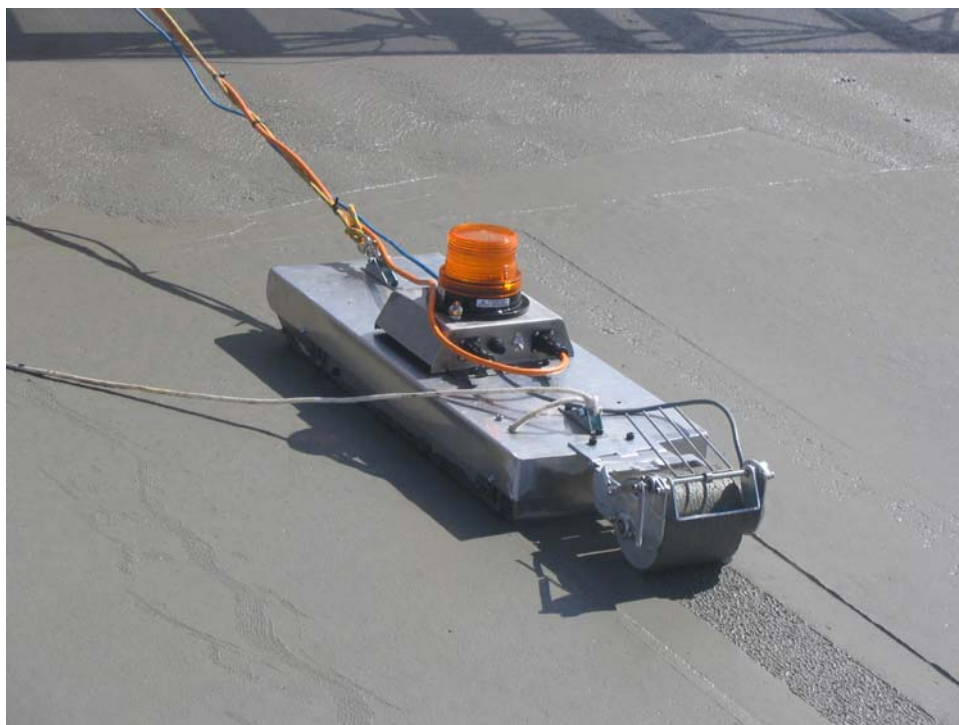
As discussed above, following the test made on SH 360, the sliding profiler was redesigned reducing the weight and increasing the surface area of the sliding carriage. The unit was then taken to a construction job in El Paso on February 14th, 2006. The construction job was on a Dan Williams Co. paving project on Loop 375. The test involved mounting the sliding profiler on a work bridge and pushing it along on fresh concrete. Figure 2 illustrates the redesigned carriage. The heavier part of the marker assembly was removed and the marker portion was pushed back and not operative. The marker assembly was later completely removed.

Figure 2 Sliding Profiler on El Paso Tests after Hwy 360 Adjustments

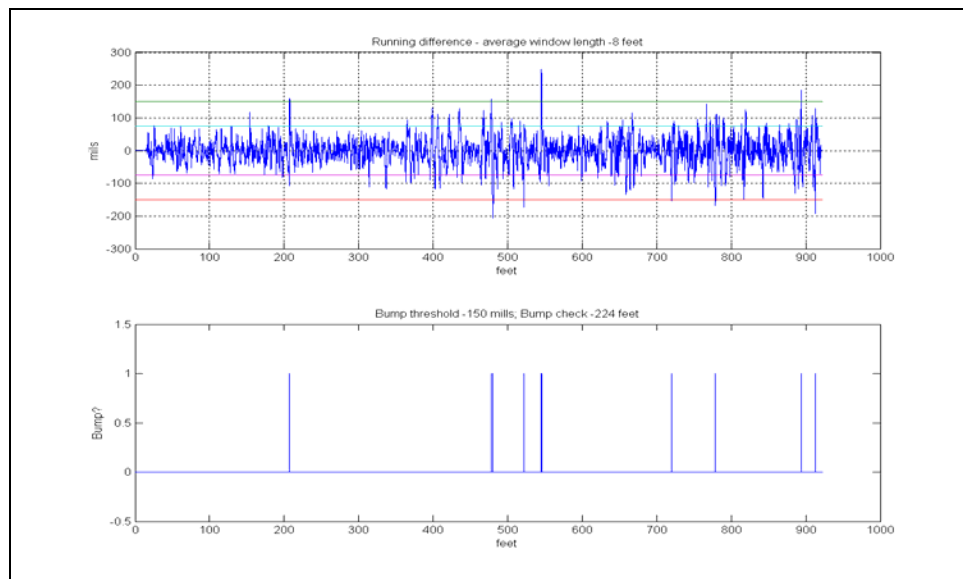
The data were recorded and then later processed with the bump threshold set to 150 mils as specified in the ride quality procedure. Figure 3 illustrates the bumps found for the 150 mils setting and the differences between points and the eight foot running average used in the sliding profiler's bump detection procedure.

Figure 3 El Paso Points Differences between Running Average (Bump Detection set to 150 mils)

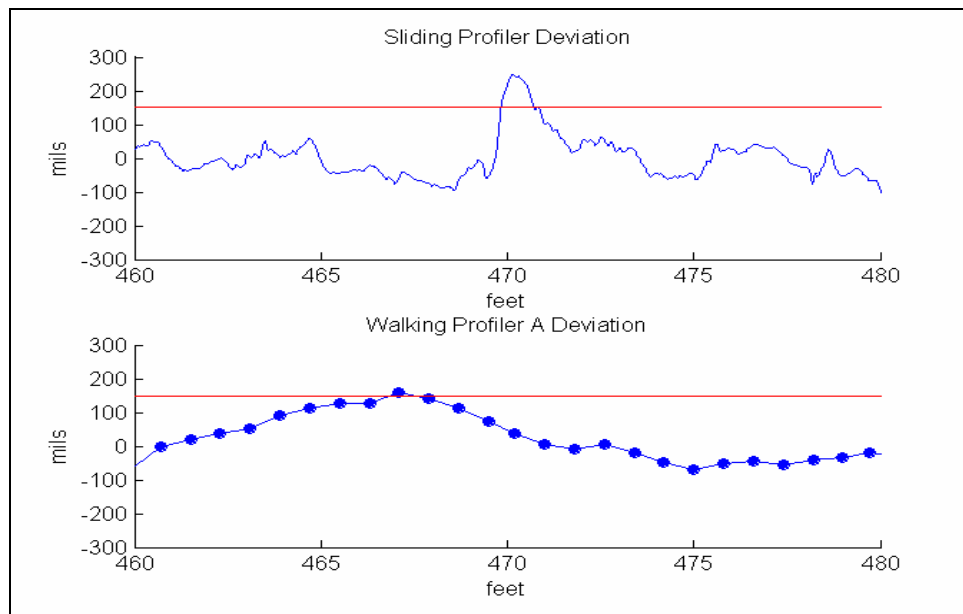
A comparison between the two detection methods is shown in the next figure. Because of the bump detection method used, the Sliding Profiler bump detection readings are always offset by about four feet. Note that the Walking Profiler detected a bump at 467 feet, and the Sliding Profiler detected a significant bump at 469 feet as illustrated in Figure 4.

Figure 4 Comparison of El Paso 2 Bump Location and El Paso 1 Deviation at Same Point

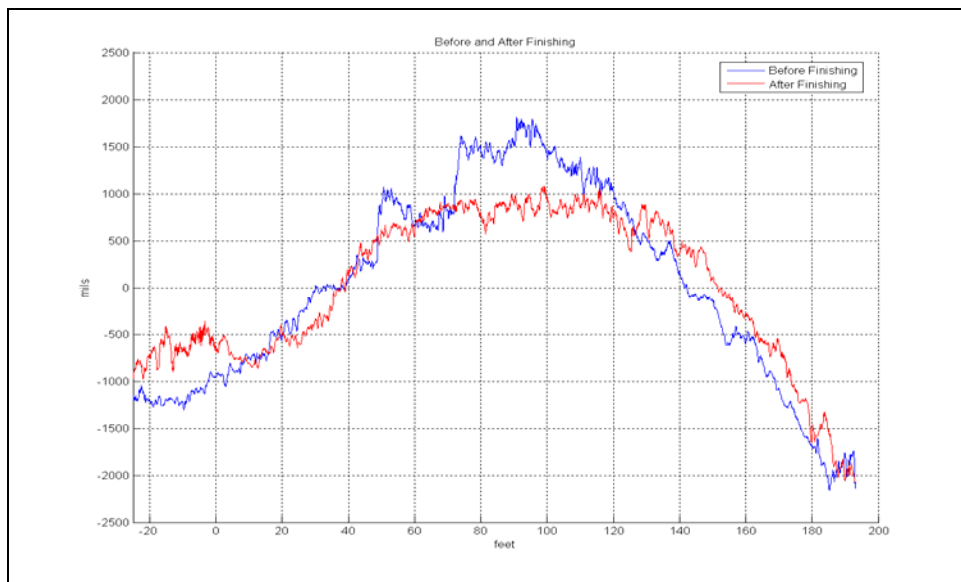
pavement, which had now been worked by the finishers, and the profiler was run over the section a second time. In both cases, a large number of bumps were noted. It was unknown if this was due to actual bumps, the bump settings or because of jerking caused by pushing the work bridge. Two workers, one on either side of the bridge would push the bridge. Additionally, if one end started before the other, the work bridge would not only jerk, but also result in pulling the profiler unit slightly to the right or left. A bump would typically be noted soon (six to eight feet) after the bridge would start up again. The data from the two runs were later plotted for comparison. The approximately same starting location was obtained by using a combination of the GPS coordinates and the distance count. Once the same beginning and end were established, the linear trend was removed and plotted in Figure 5 below.

Figure 5 Decatur Section Before and After Finishing

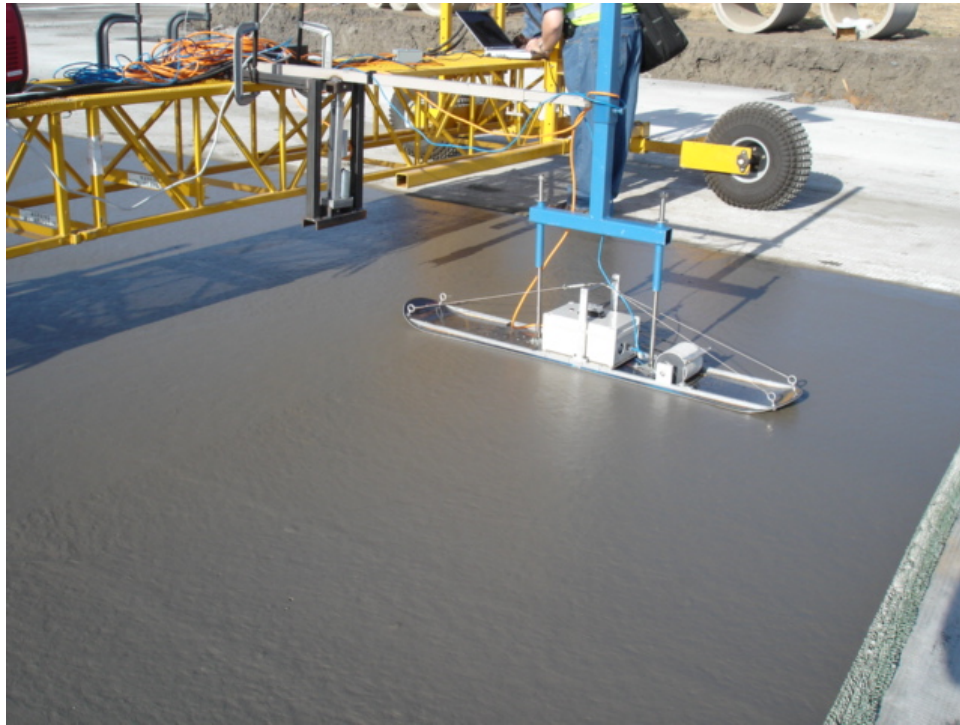
The last set of tests was made on an Abrams's construction project on SH 161 in Grand Prairie in the Dallas District in August of 2006. For these runs, the sliding profiler was attached to a motorized work bridge in hopes there would be less jerking actions. The work bridge was positioned behind the finishers. The sliding profiler was pulled for about 300 feet where about six bumps were noted by the flashing light.

Figure 6 Sliding Profiler Attached to a Motorized Work Bridge

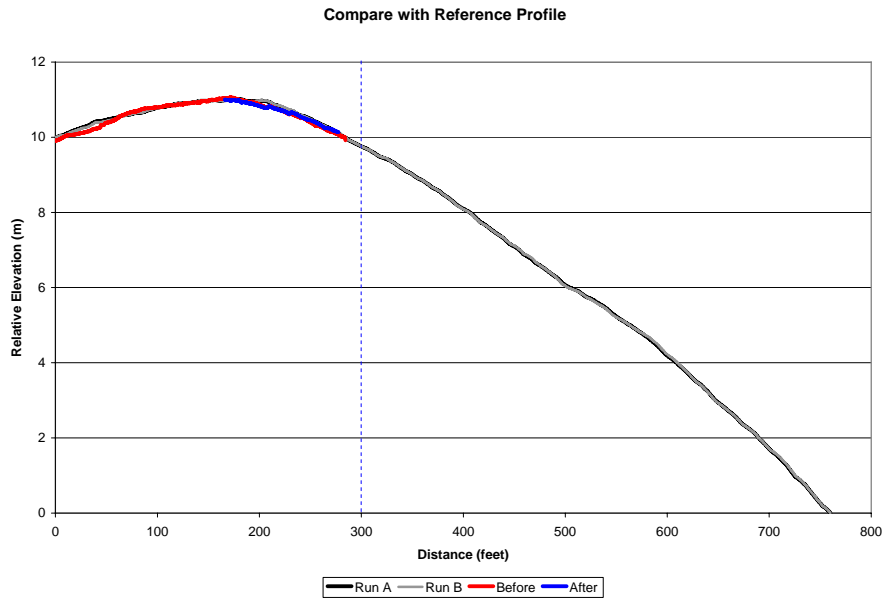
Later during the month, after the concrete had dried, the walking profiler was brought to the site and a reference profile was taken over the entire section. Figure 7 illustrates an overlay of the reference profile and data collected by the sliding profiler. The blue plot illustrates the 100 foot section where the pavement was rerun after the bump was detected.

Figure 7 Comparison of Sliding Profiler with Reference Profile

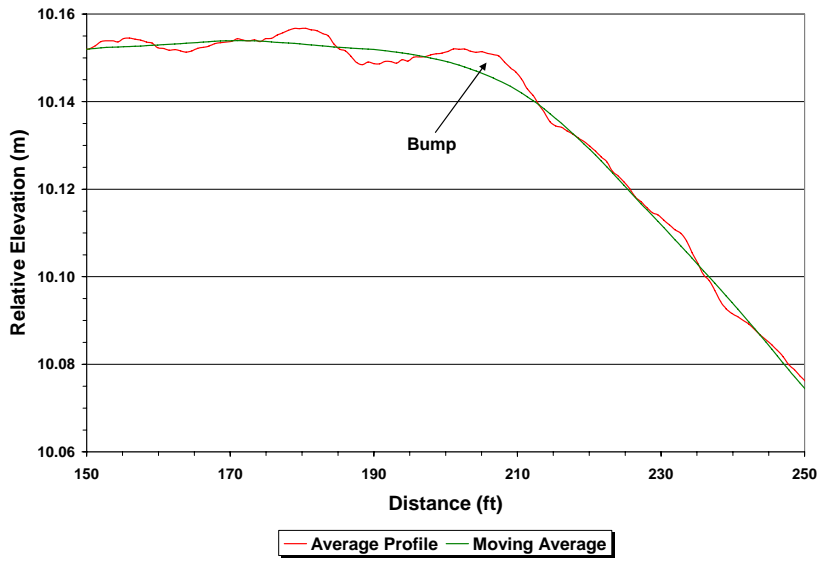
Figure 8 illustrates a bump found in the reference profile at approximately the same location as the bump noted by the sliding profiler during operations. Figure 9 illustrates a plot of the profile from the sliding profiler after reworking the bump area but still showing a bump in approximately the same area as found in the reference profile and during measurements.

Figure 8 Bump Illustrated on Pavement

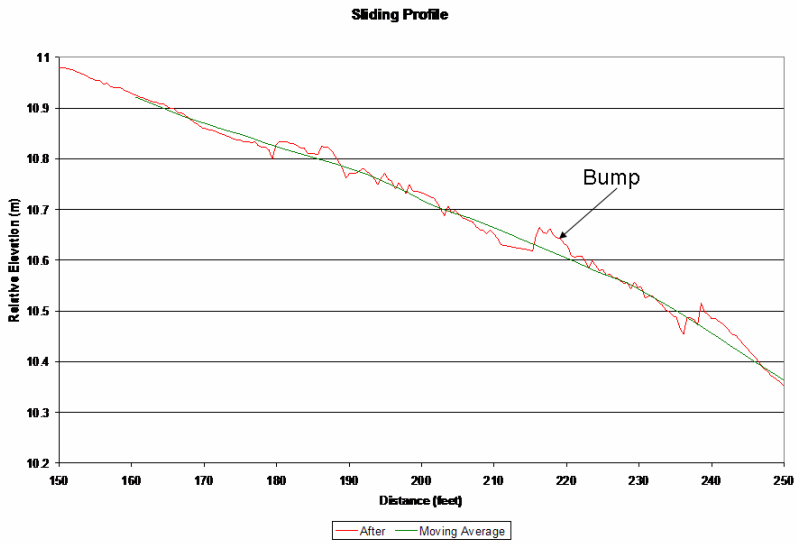
Figure 9 Bump Found in Sliding Profiler Data

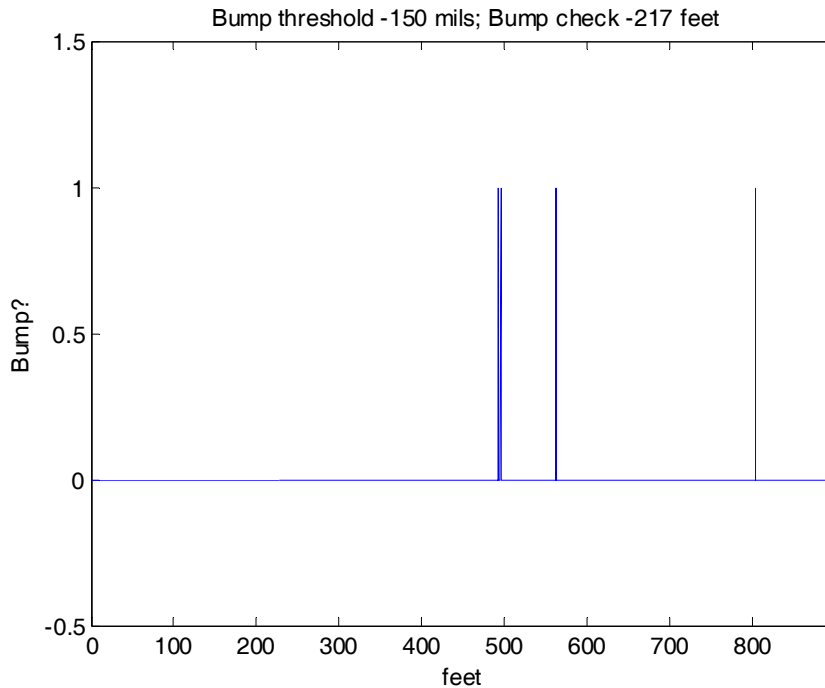
In a project wrap-up meeting on December 20, 2006, with David Head and other interested TxDOT personnel, the problems of introducing false bumps because of jerks when using the work bridge was discussed. UTA researchers developed a simple jerk removal procedure that was applied to the El Paso data. This procedure eliminated some of the false bump readings. Figure 14 shows that the number of bumps detected during the El Paso data runs changed from eight to three for the 150-mils bump setting (See Figure 3). In Figure 10, the first bump is the same one found in the reference profile taken by the Walking Profiler. The second bump indicated is at approximately the location where the work bridge was moved behind the finishers. Differences between the Walking Profiler and Sliding Profiler results may be due to changes in the concrete surface brought about by tining and curing. Note that the test with the Sliding Profiler was done on wet concrete while the test with the Walking Profiler was done after the concrete has hardened.

Figure 10 Bump Detected Using Jerk Procedure

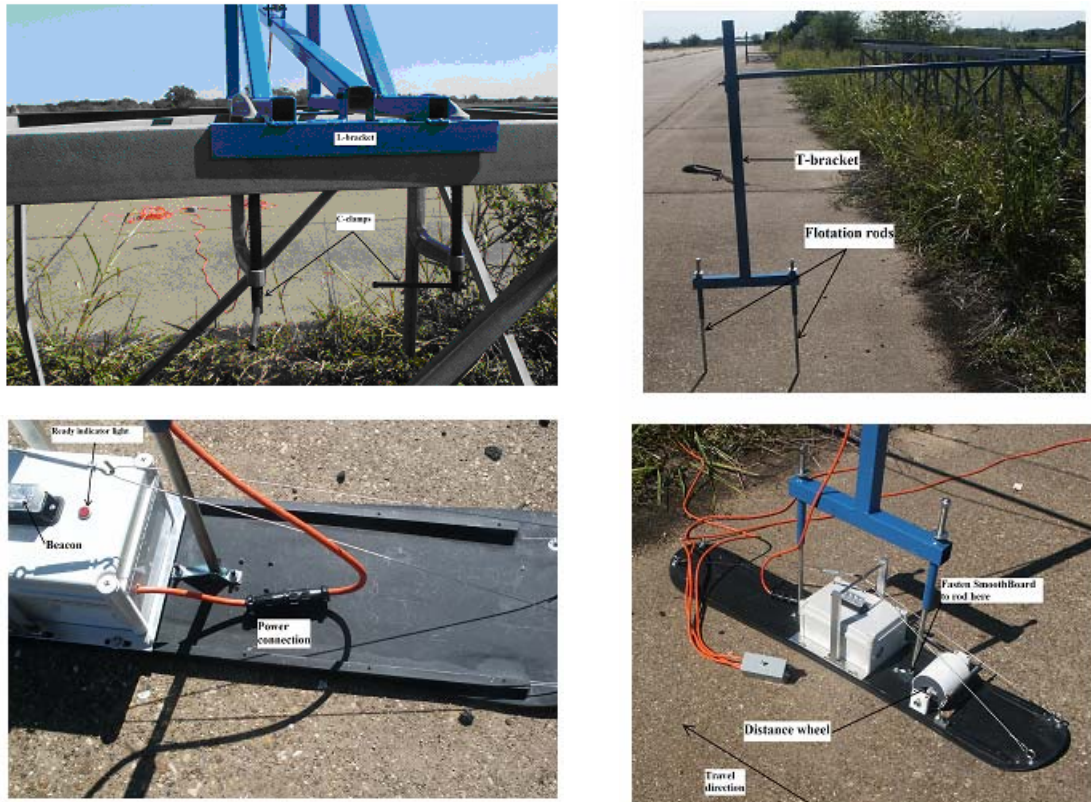
Three sliding profiler devices including hardware for attachments and an instruction manual were delivered to TxDOT. Figure 11 illustrates the sliding profiler delivered to TxDOT along with hardware used for attachment of the sliding profiler to an autofloat, work bridge or paver.

Figure 11 Sliding Profiler and Connection Hardware
