TxDOT Report 5-6944-01-IPR1

**Implementation of Unmanned Aerial Systems Using Close-range Photogrammetry Techniques (UAS-CRP) for Quantitative (Metric) and Qualitative (Inspection) Tasks Related to Roadway Assets and Infrastructures: Final Report**

Report Date:	Submitted: February 2019; Published: December 2021
Project:	5-6944-01
Project Title:	Implementation of Unmanned Aerial Systems using close-range photogrammetry techniques (UAS-CRP) for quantitative (metric) and qualitative (inspection) tasks related to roadway assets and infrastructures

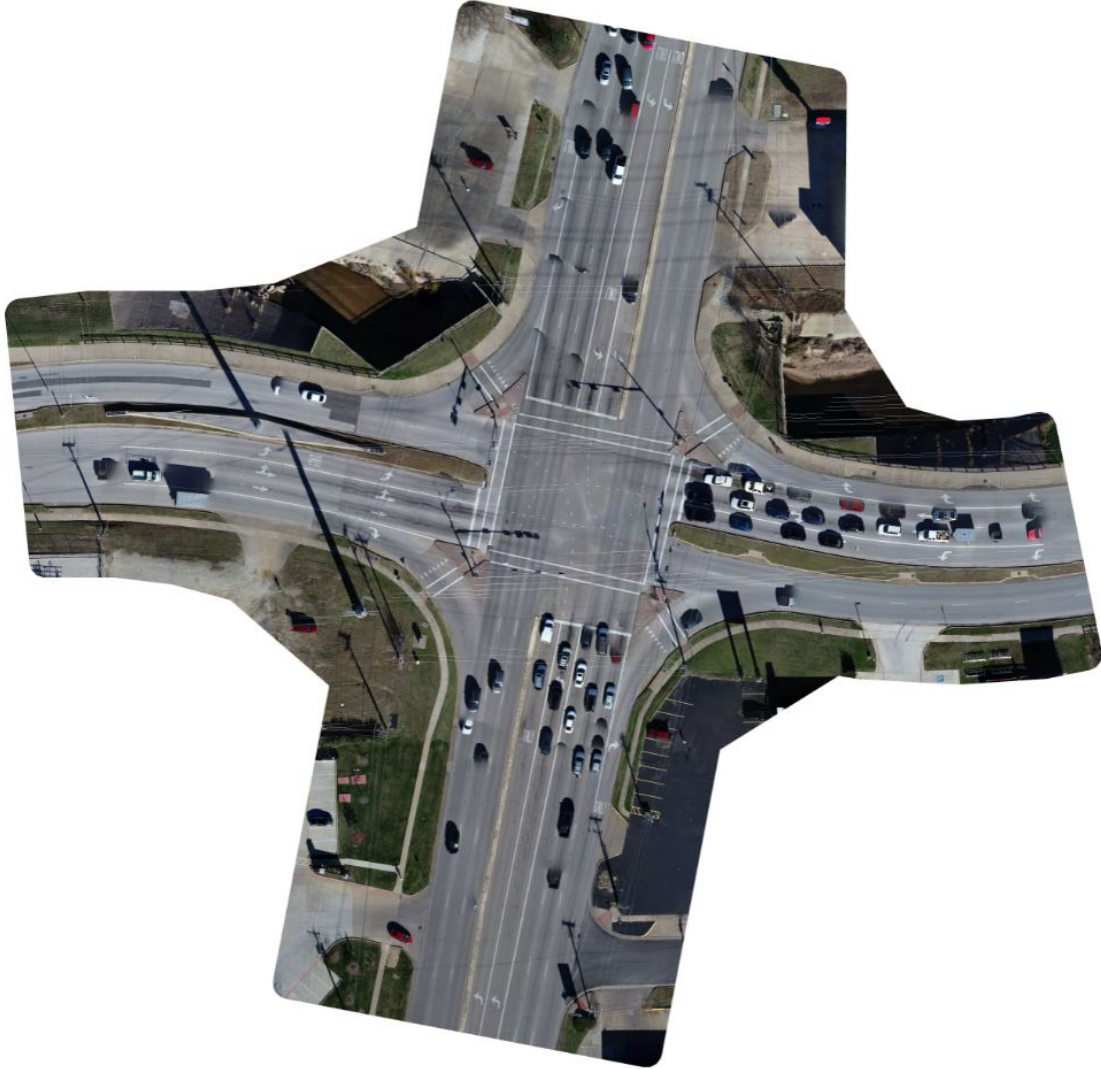
The Tyler intersection has heavy traffic with complicated airspace due to the presence of overhead utility lines, guy wires, wooden utility poles, and large metal utility poles. Before the mapping, it was necessary to secure permission, from the owners of the adjacent properties, to take off and land from outside TxDOT's right of way. Aerial imagery data collected at the Tyler intersection was used to create the orthomosaic as shown in Figure 5.

**Figure 5. Orthomosaic of the Tyler intersection generated from the aerial images**

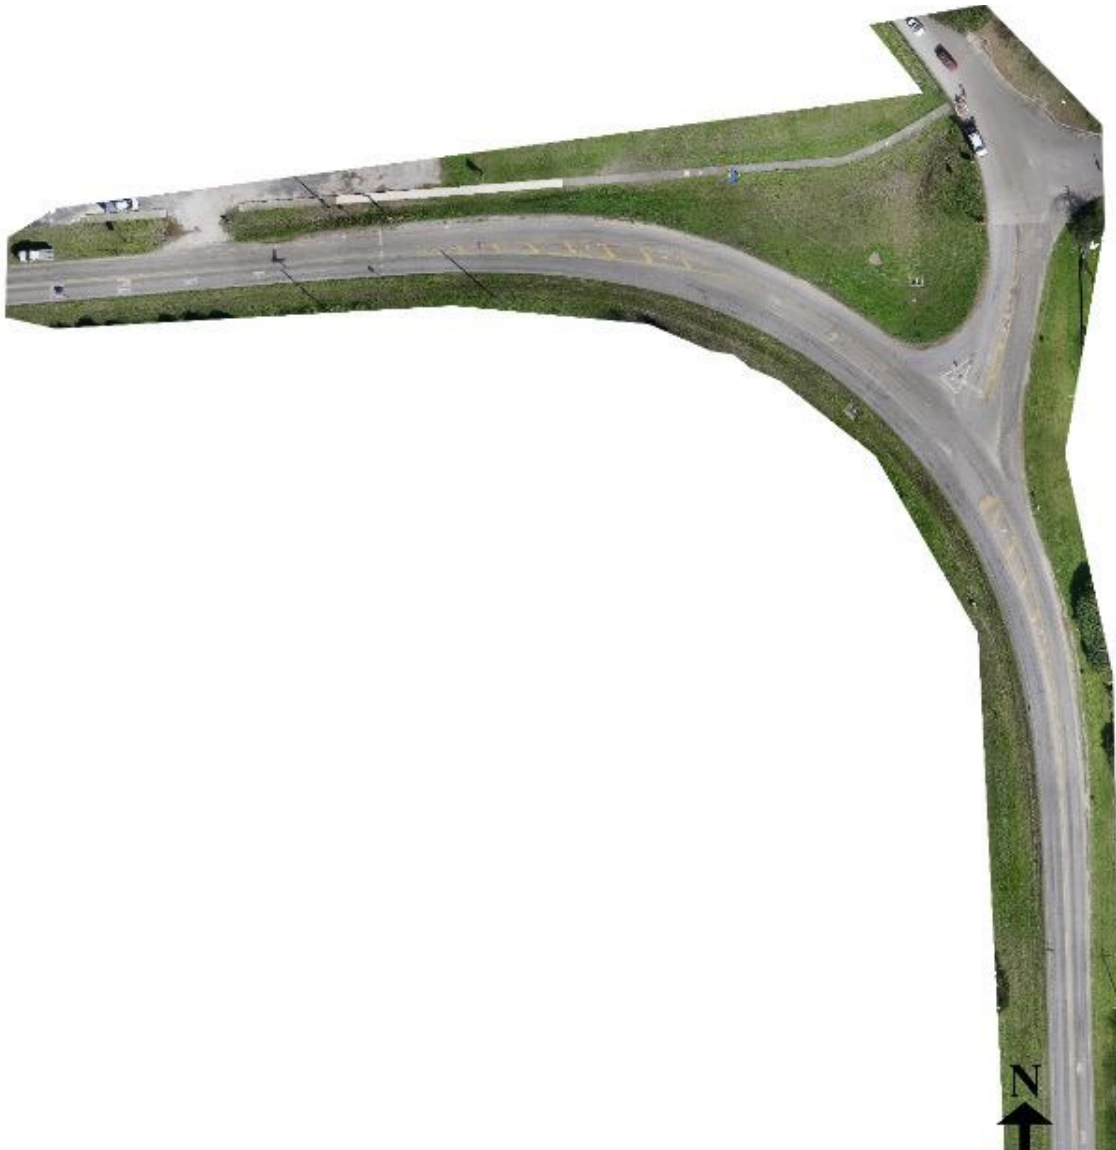
**Figure 7. Orthomosaic of the Seguin intersection area developed from the aerial images**
