| 4. Title and Subtitle<br><b>CORROSION PROTECTION FOR BONDED INTERNAL TENDONS<br/>IN PRECAST SEGMENTAL CONSTRUCTION</b> | | 5. Report Date<br><b>October 1999</b> | |
| 7. Author(s)<br><b>J. S. West, R. P. Vignos, J. E. Breen, and M. E. Kreger</b> | | 8. Performing Organization Report No.<br><b>Research Report 1405-4</b> | |

**CORROSION PROTECTION FOR BONDED INTERNAL TENDONS  
IN PRECAST SEGMENTAL CONSTRUCTION**

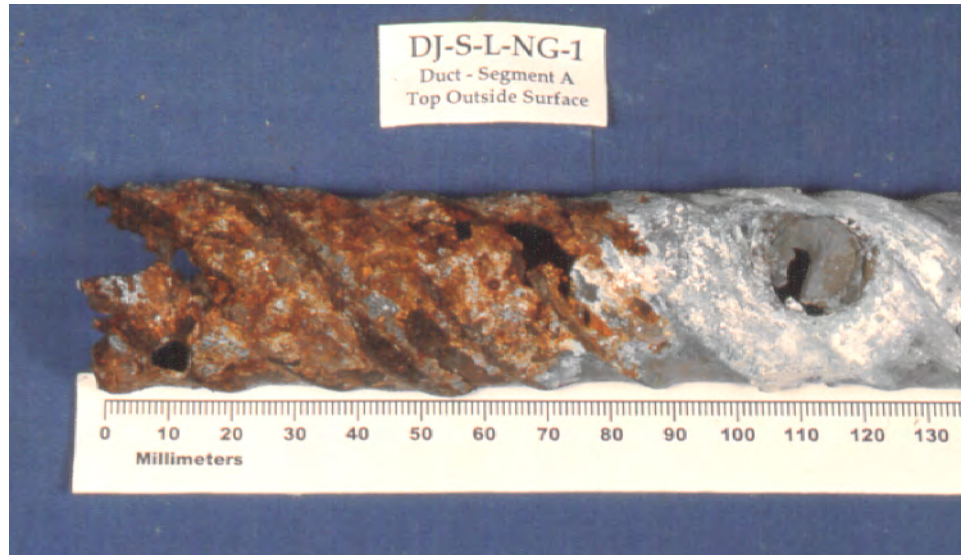
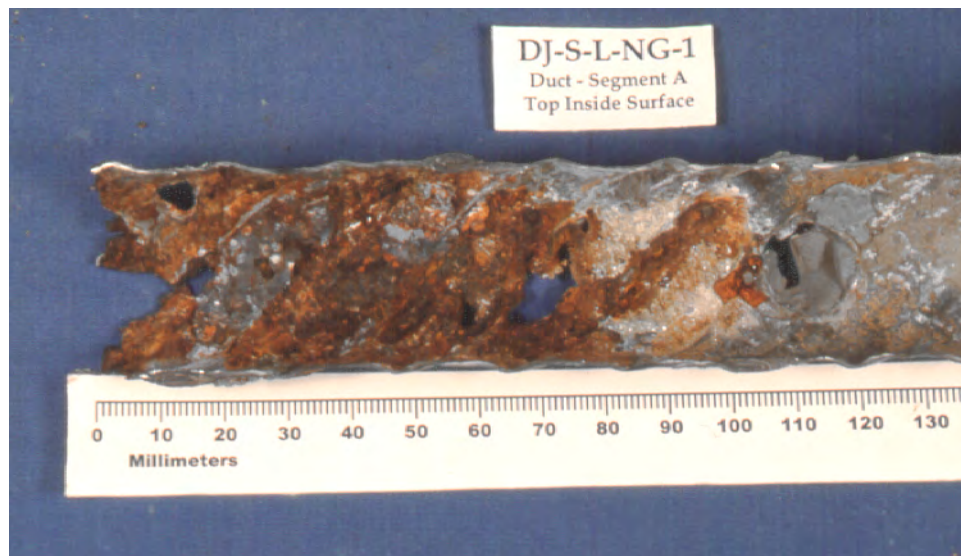
(a) Outside Surface of Duct (joint location at left end)

(b) Inside Surface of Duct (joint location at left end)

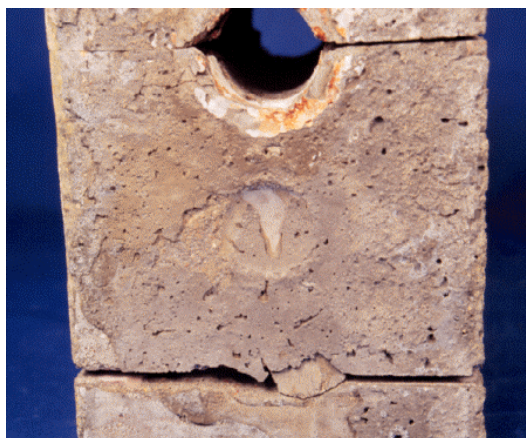
The concrete surface of the match-cast dry joint was intact with no voids or cracks. Significant grout leakage occurred during grouting, and approximately 80% of the joint surface was covered with grout, as shown in Figure 4.15. Rust and salt stains are present on the face of the joint around the duct opening.

**Figure 4.15 – Grout Infiltration Into Joint: Specimen DJ-S-L-CI-1**

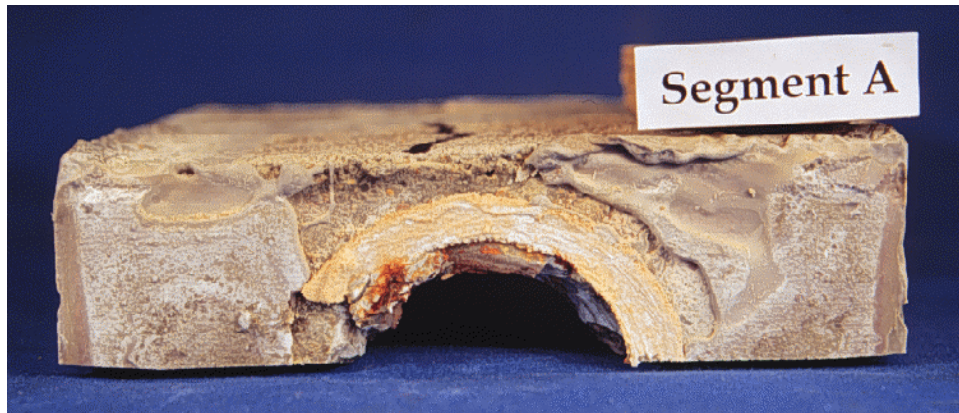
The side and bottom perimeter of the joint were intact and appeared filled with epoxy. A thin void was visible at the joint on the top surface. Sections through the joint at the mid-height, bar cut line and strand cut line showed it to be completely filled with epoxy and free from voids or cracks. However, the gasket appears to have prevented complete bonding of the segments immediately above the duct opening. As a result, the top portion of the specimen above the strand cut line separated at the joint during autopsy. When the face of the joint was examined, incomplete epoxy coverage was revealed as shown in Figure 4.18. Salt and rust stains were visible on the joint.

**Figure 4.18 – Incomplete Epoxy Coverage in Epoxy/Gasket Joint (EG-S-M-NG-2)**

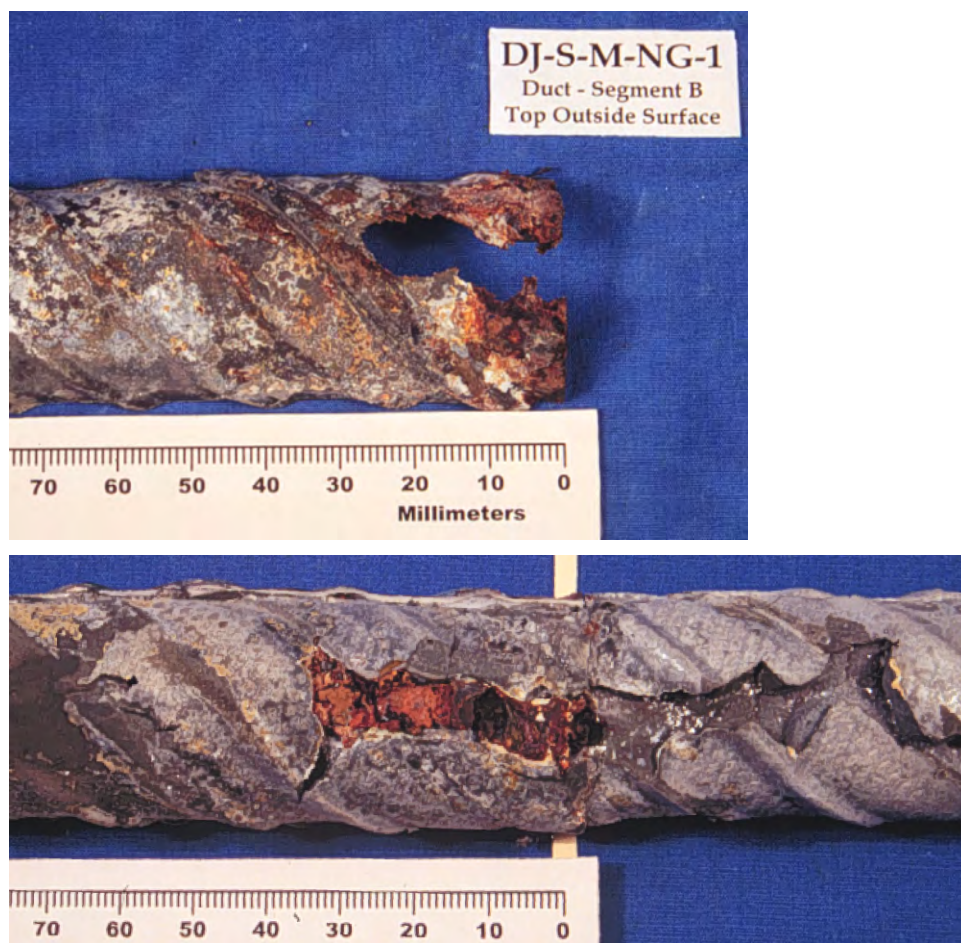
Normally, if the void does not expose the prestressing tendon, it is not deemed a concern. However, during the forensic examination it was discovered that five specimens had holes corroded through the galvanized steel duct at the location of a void. In two of these specimens, large holes in the duct corresponded directly to the voids in shape and size. An example of this is shown in Figure 5.6 for specimen DJ-S-M-NG-1. These findings suggest that the presence of a void in the grout may lead to more severe corrosion of the galvanized steel duct. The duct is intended to provide corrosion protection for the tendon, and any holes in the duct resulting from corrosion action effectively eliminate the duct as a protection barrier for the tendon.

**Figure 5.6 – Hole in Duct Corresponding to Grout Void**
