| 4. Title and Subtitle<br><br>Long-Term Post-Tensioned Column Exposure Test Specimens: Final Evaluation | | 5. Report Date<br><br>October 2003 | |
| 7. Author(s)<br><br>R. M. Salas, J. S. West, A. J. Schokker, J. E. Breen, and M. E. Kreger | | 8. Performing Organization Report No.<br><br>Research Report 0-1405-8 | |
| 9. Performing Organization Name and Address<br><br>Center for Transportation Research<br>The University of Texas at Austin<br>3208 Red River, Suite 200<br>Austin, TX 78705-2650 | | 10. Work Unit No. (TRAIS) | |

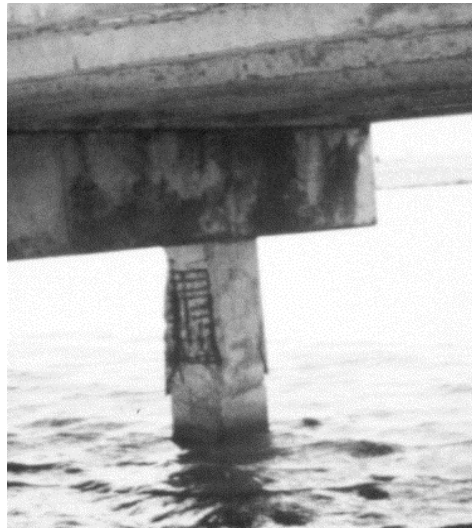
**(b) Coastal Saltwater Exposure  
"Attack from Below"**

**Figure 1.2 Typical Corrosion Damage in Bridge Substructures<sup>2</sup>**

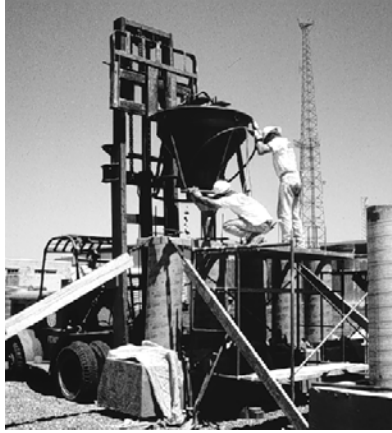
***Column Reinforcement on Foundation***

***Pouring Column Concrete***

**Figure 2.13 Column Construction<sup>3</sup>**

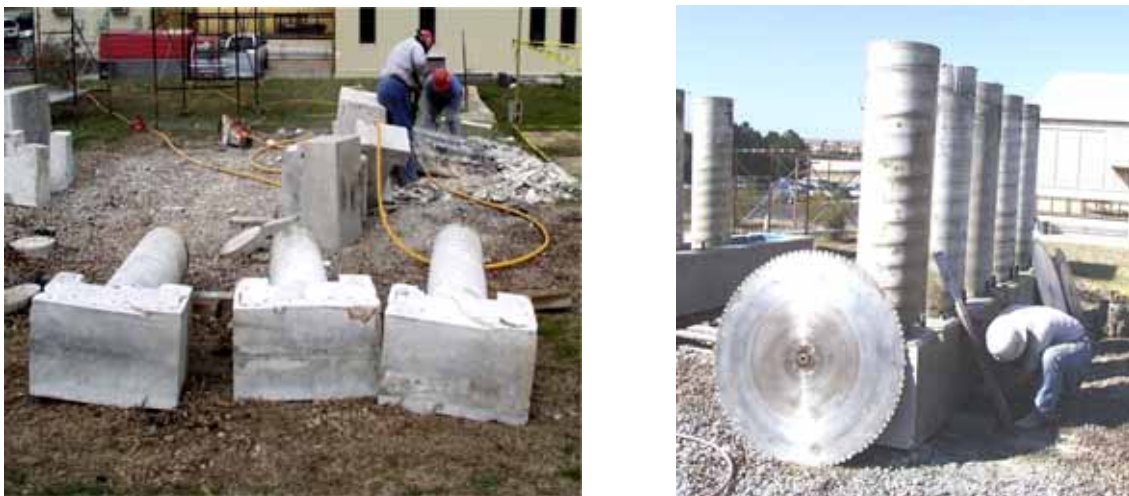
Prior to concrete removal, column specimens sharing the same foundation were separated by saw cutting as shown in Figure 4.1. Due to special saw cutting equipment requirements, saw cutting had to be contracted with an external concrete demolition company.

Figure 4.1 Saw Cutting of Column Foundation<sup>1</sup>

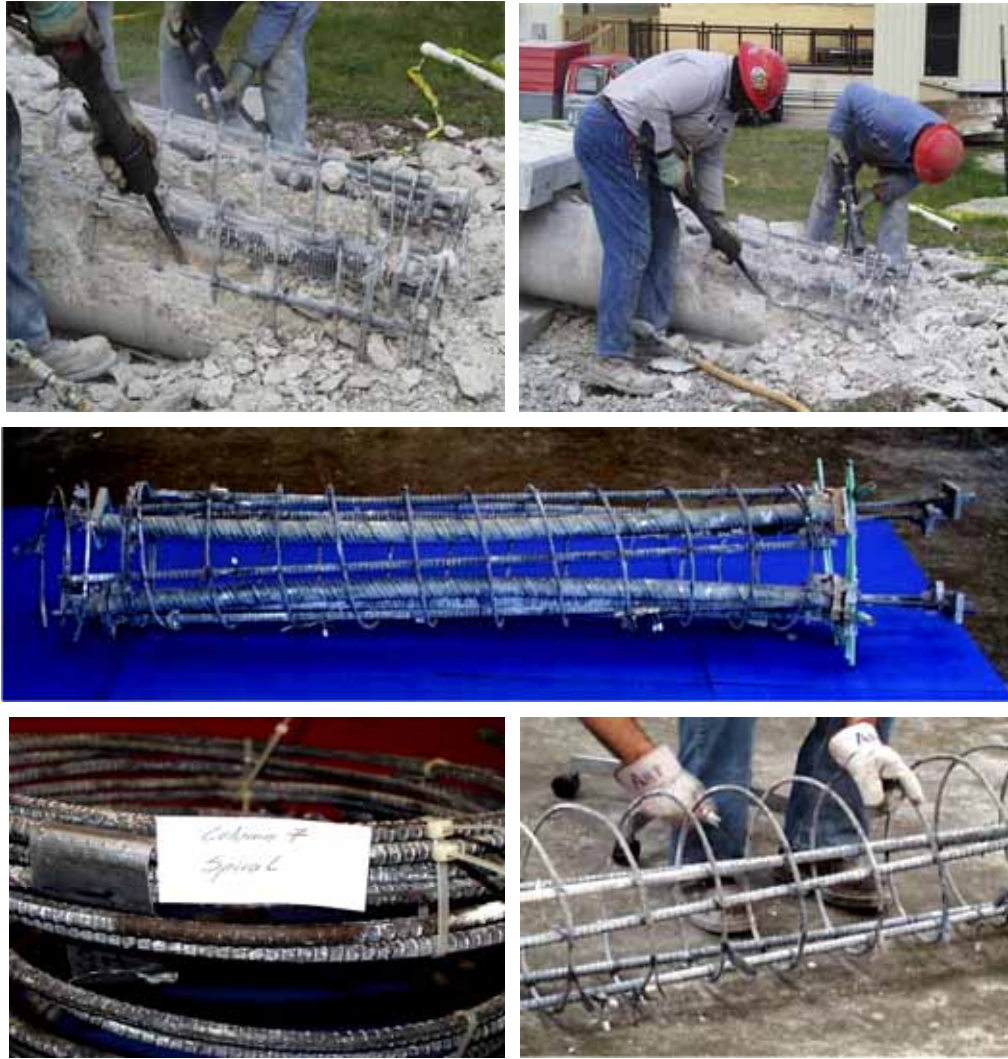
All specimens (ten in total) were autopsied at the end of six and a half years of continuous exposure testing. After concrete was removed from each column, mild steel reinforcement, post-tensioning ducts and high-strength post-tensioning bars were carefully inspected and rated according to the corrosion rating scheme explained in the following section. During autopsy, ducts were cut open in half longitudinally, and grout samples were taken at different locations to investigate chloride ingress to the post-tensioning bar level. Anchorages and bar splices were also inspected for signs of corrosion in the areas exposed to concrete and at the crevices, where steel pieces in the post-tensioning system were in contact.

**Figure 4.2 Concrete Removal and Reinforcement Dismantling<sup>1</sup>**

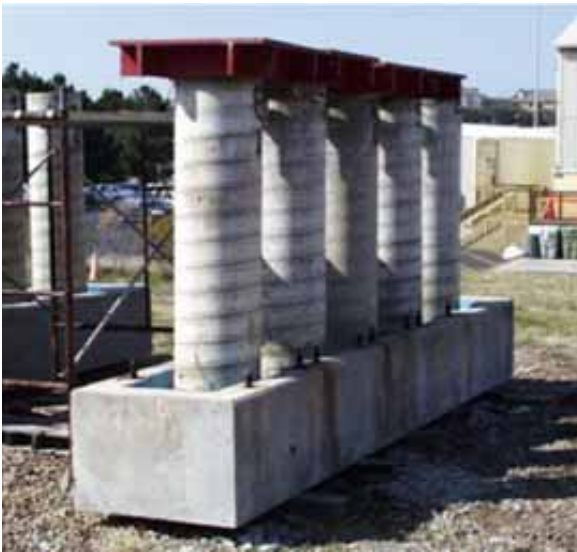
Tie down bars had uniform corrosion at the column base level, which stained the foundation, but no severe pitting was observed on these high-strength bars.

Figure 4.6 Specimen Condition at the End of Testing<sup>1</sup>

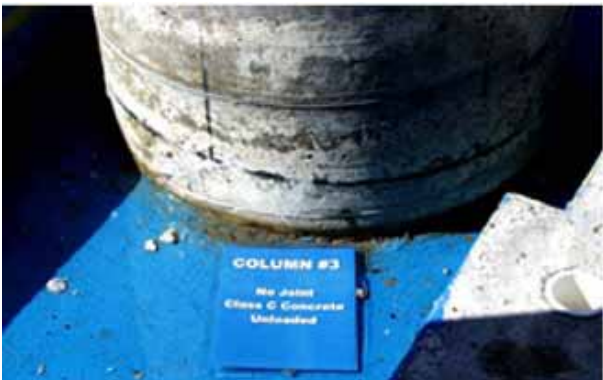
Figure 4.7 Condition of Specimen NJ-TC-N at the End of Testing<sup>1</sup>

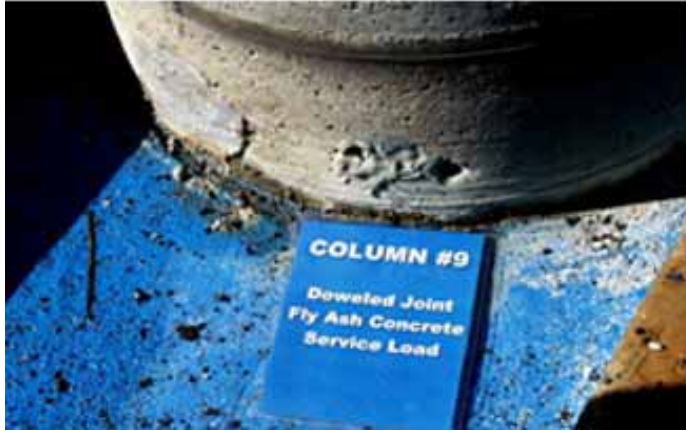
Spiral reinforcement had moderate corrosion in the North side (non-dripper side) at the four-inch level from the column base. Light corrosion was also concentrated in the spiral North side in the center four two-inch segments from the four-inch height up to a height of 30 inches.

**Figure 4.11 Condition of Specimen DJ-FA-S at the End of Testing<sup>1</sup>**

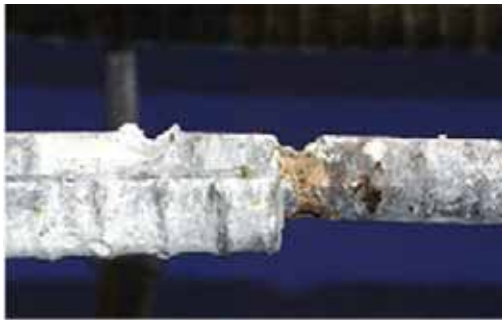
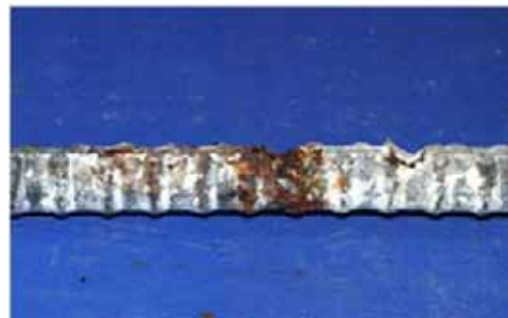
Dowels showed in general light to moderate corrosion in the two-inch segment at the column base (joint location). Dowel #1 showed the heaviest corrosion and area loss in this region, as shown in Figure 4.12.

***Dowel #1***

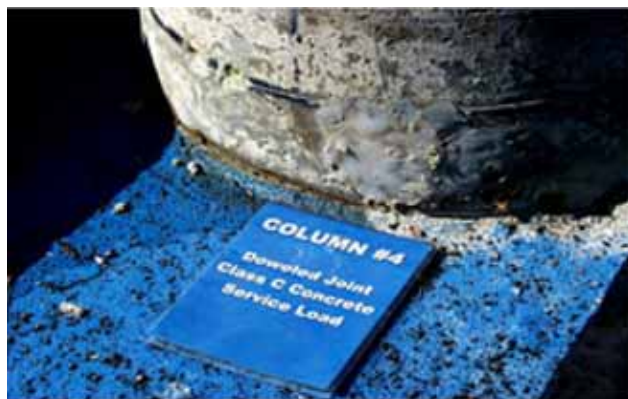
Figure 4.13 Condition of Specimen DJ-TC-S at the End of Testing<sup>1</sup>

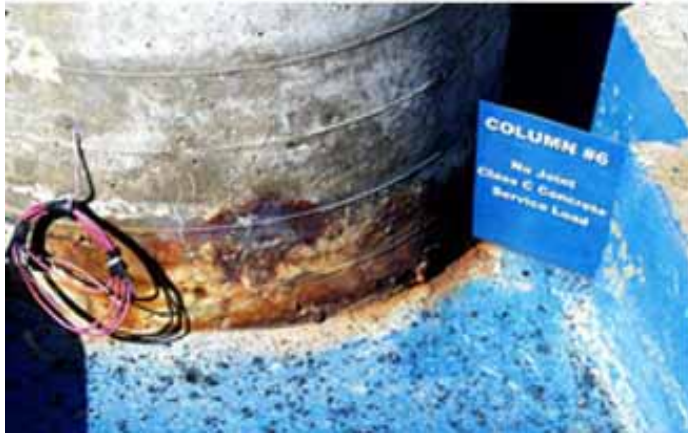
No signs of cracking or spalling were visible on the column surfaces. Rust stains extended the first 5 inches, from the column base, as shown in Figure 4.15. No other signs of corrosion were visible in the specimen.

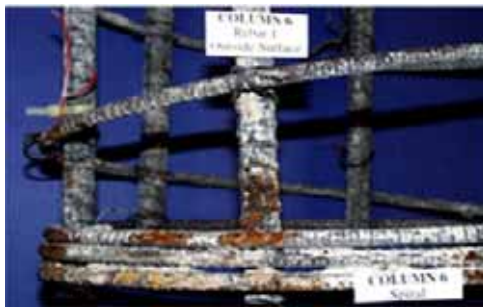
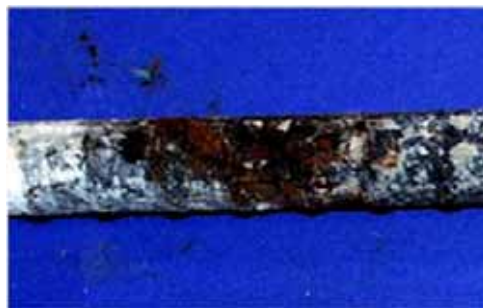
Rebar corrosion was concentrated in the first four inches from the column base. Rebar #1 showed the most severe corrosion with light pitting, while the other bars only had light to moderate corrosion. See Figure 4.16. The specimen did not have dowels.

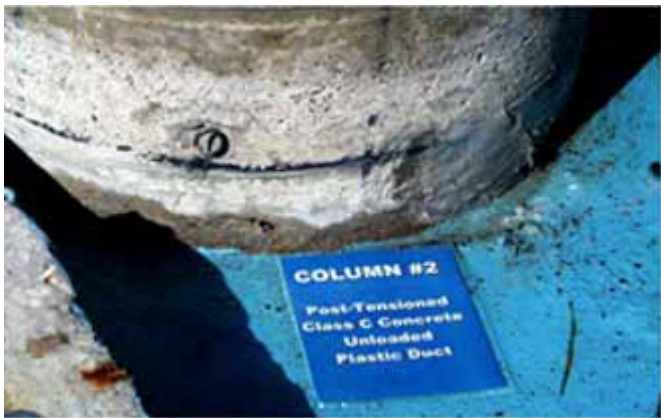
Figure 4.17 Condition of Specimen PT-TC-N-PD at the End of Testing<sup>1</sup>

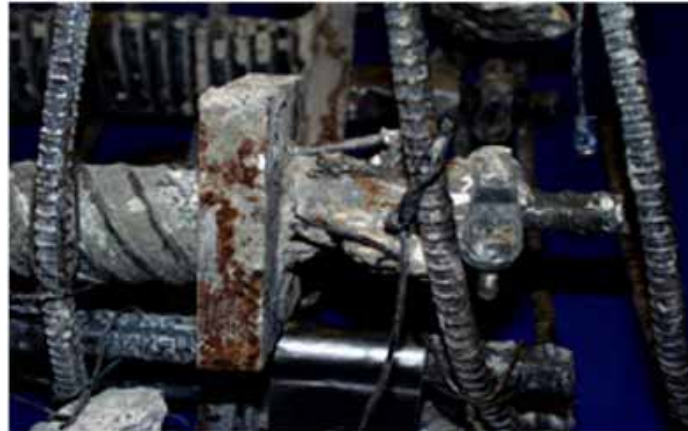
**Figure 4.19 PT Bar Top Anchorage Condition for Specimen PT-TC-N-PD¹**

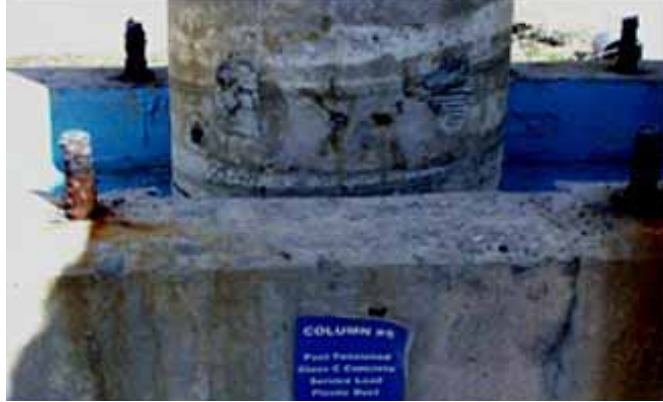
Figure 4.21 Condition of Specimen PT-TC-S-PD at the End of Testing<sup>1</sup>

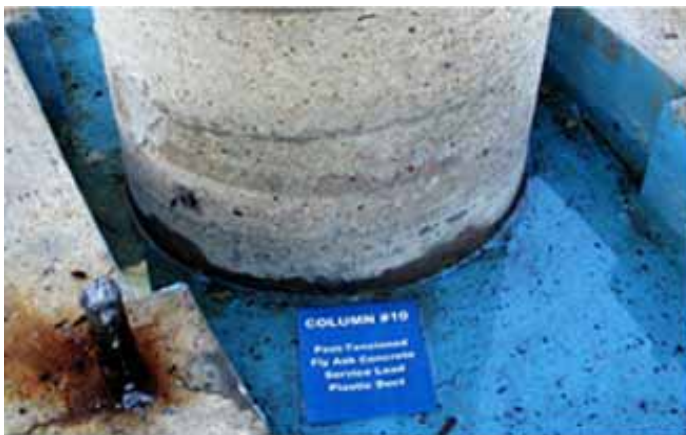
Figure 4.24 Condition of Specimen PT-FA-S-PD at the End of Testing<sup>1</sup>

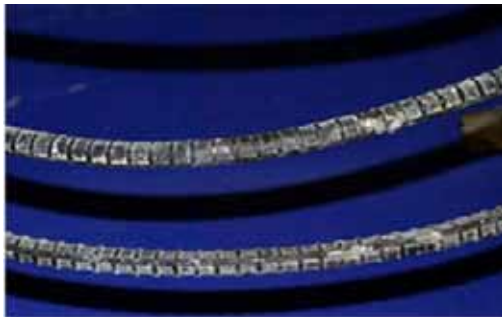
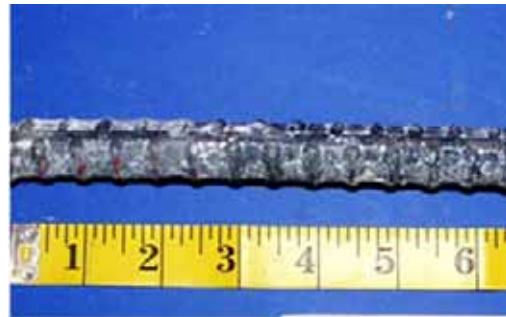
Figure 4.28 Reinforcement Condition for Specimen PT-TC-S-EB<sup>1</sup>

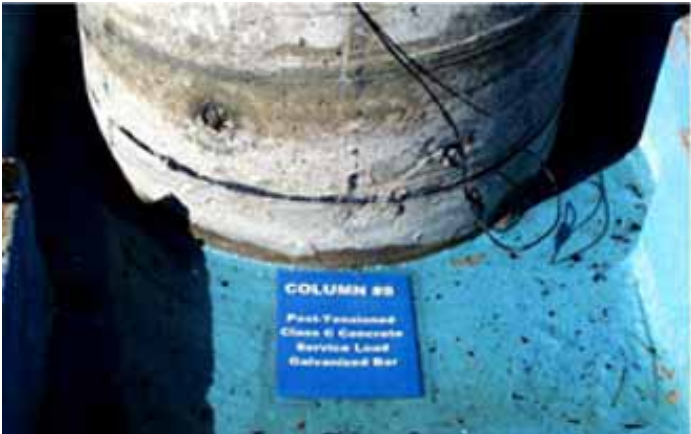
Figure 4.30 Condition of Specimen PT-TC-S-GB at the End of Testing<sup>1</sup>

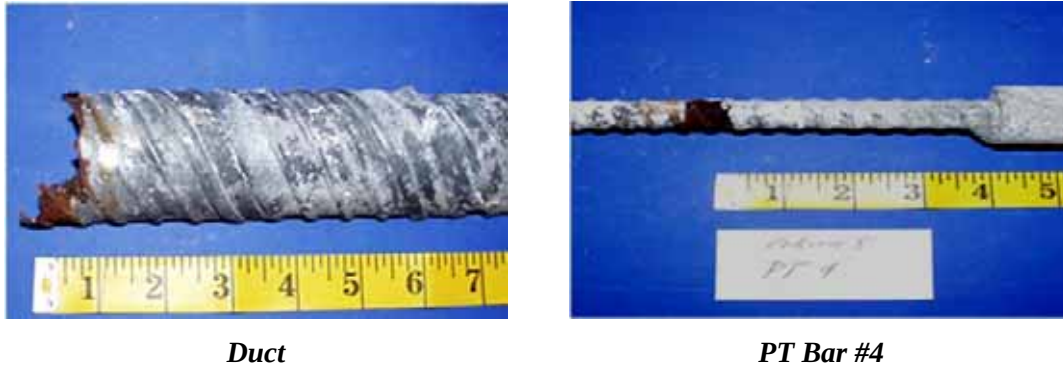
Figure 4.32 shows that ducts were corroded with extensive area loss in the first two inches from the column base level, at the rubber gasket location.

**Figure 4.32 Reinforcement Condition for Specimen PT-TC-S-GB<sup>1</sup>**

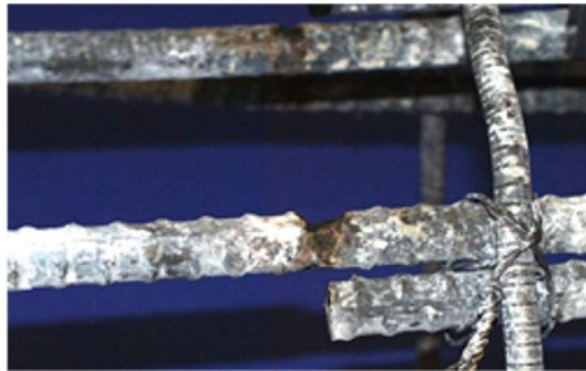
The wicking effect (migration of chlorides upward in the concrete from ponded base) was typically observed in the first 18 inches from the base of the columns. Spiral, rebar, duct dowel and post-tensioned bar corrosion was very severe at or near the column-foundation interface and decreased with increasing column height.

**Figure 5.1 Typical Corrosion and Section Loss Found on Dowels at the Column-Foundation Interface<sup>1</sup>**

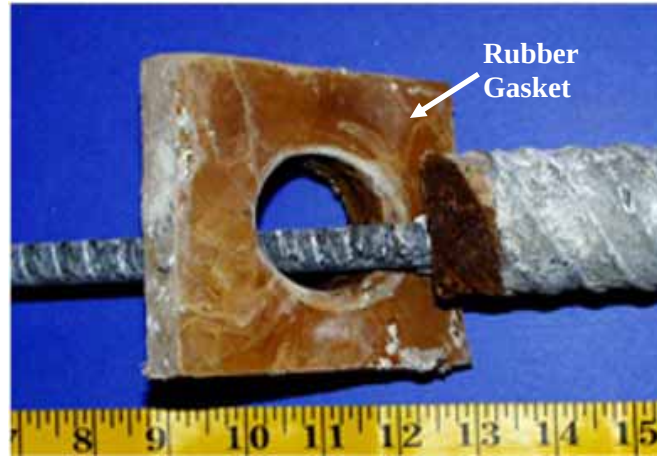
Figure 5.2 Duct Corrosion Found Inside Rubber Gaskets<sup>1</sup>
