| 4. Title and Subtitle<br><br><b>Evaluation and Rehabilitation of Historic Metal Truss Bridges:<br/>A Case Study of an Off-System Historic Metal Truss Bridge in<br/>Shackelford County, Texas</b> | | 5. Report Date<br><b>March 2003</b> | |
| 7. Author(s)<br><br>D.R. Maniar, M. D. Engelhardt, and D.E. Leary | | 8. Performing Organization Report No.<br><br>Research Report 1741-3 | |

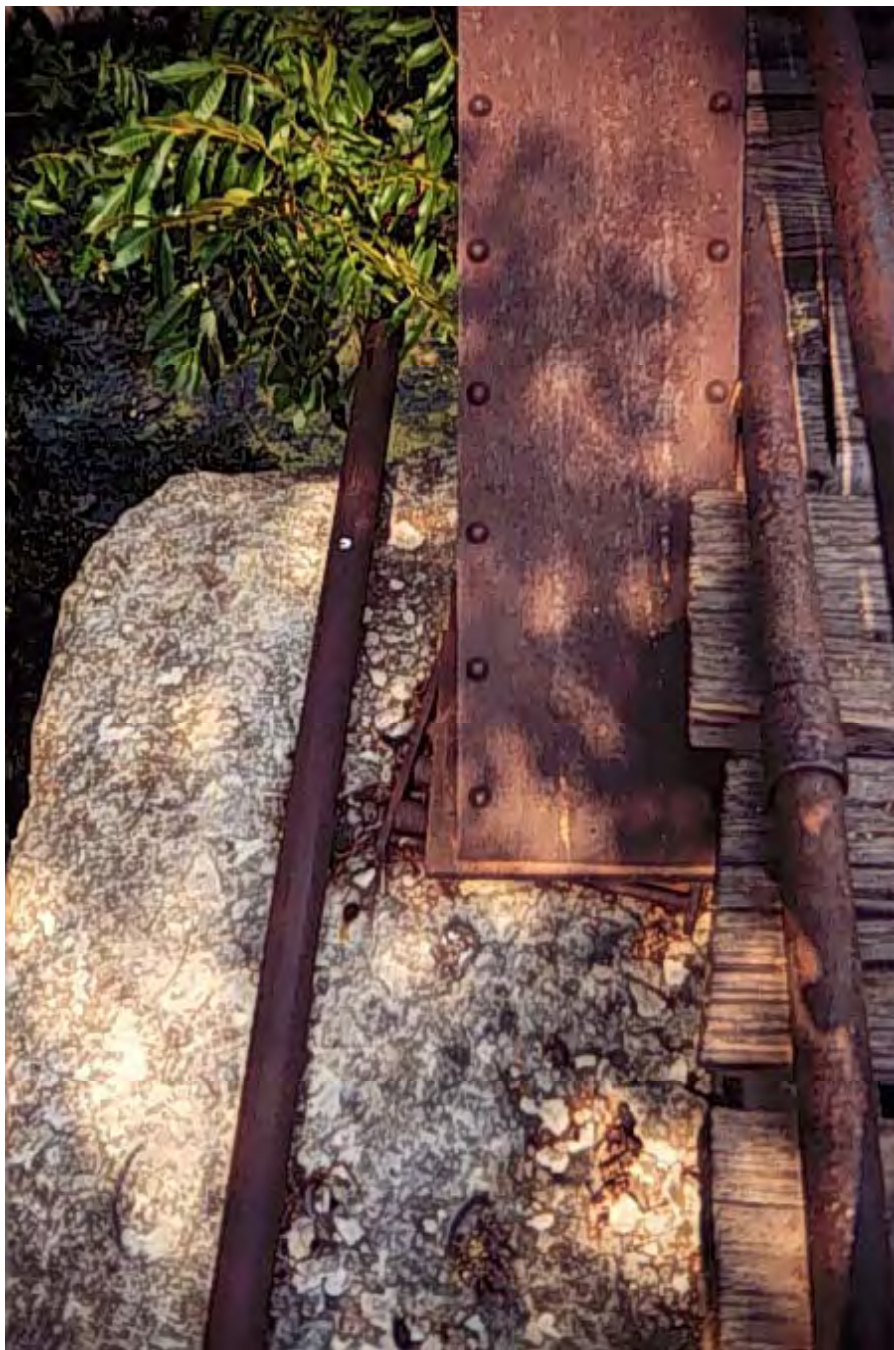
**Figure A.7: Roller support at southwest corner of main truss span**

Metal elements of the main truss span, including the floor beams and truss members showed only minor corrosion, with little or no loss of cross-section. No large displacements, distress or damage was found on truss members except at one hanger. This tension hanger had a kink at the middle. All joints appear in good condition except the southwest roller support. This roller support is dislocated from its original position (Figure A.7).

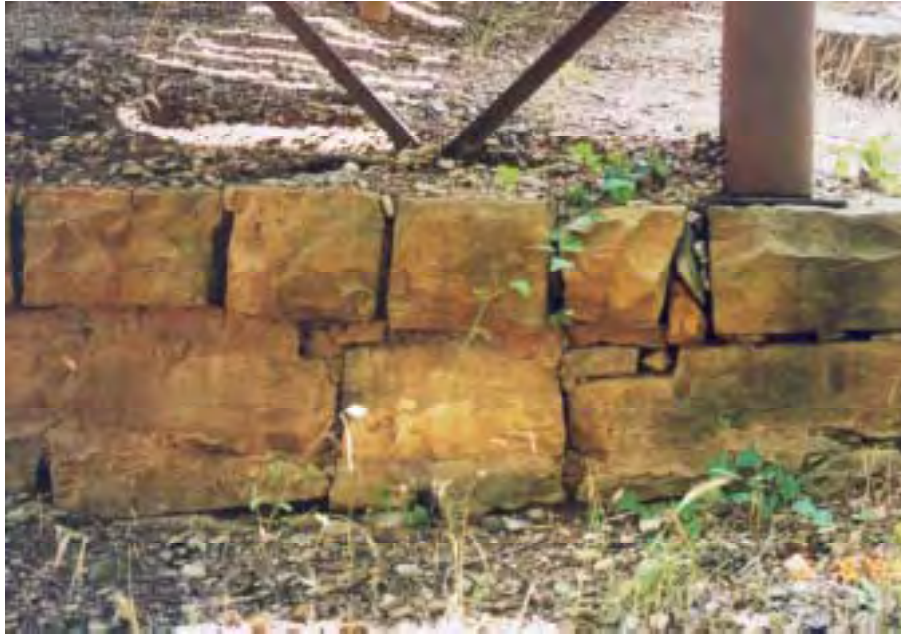
**Figure A.34: Deteriorated foundation of metal bents for north approach span**

Foundations for metal bents are not visible at most locations. At one bent of the north approach, the foundation is visible as it is projecting above the ground. The masonry joints of this foundation are open. This suggests the possibility that the foundations of all bents may have open joints. The south approach span abutment has many stones dislocated from their original positions. All the joints of the abutment are filled with soil. The north approach abutment is not visible due to the metal retaining plate.

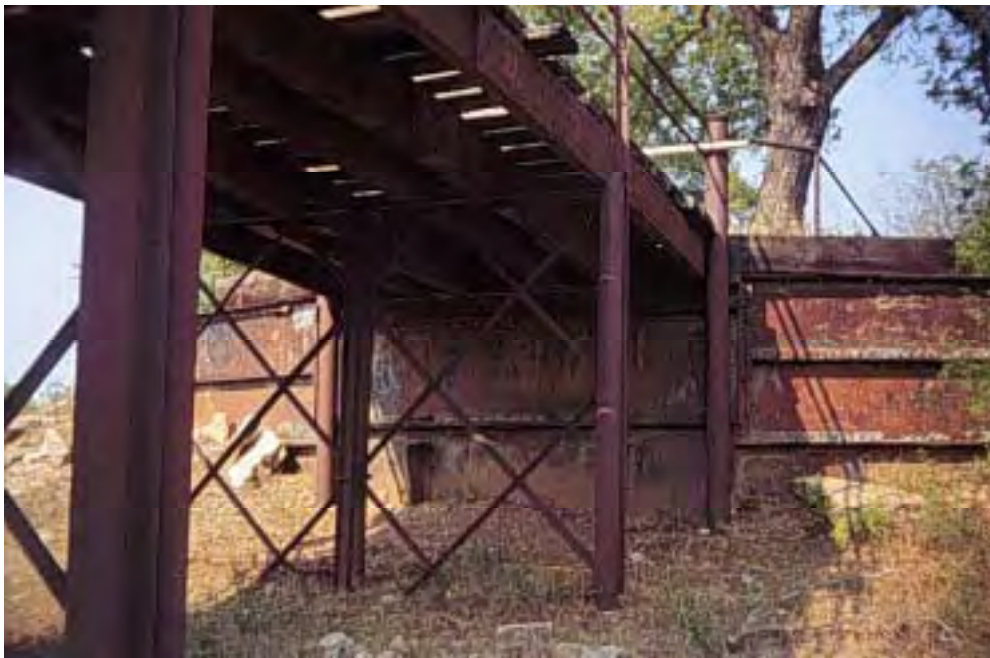
**Figure A.37: Metal retaining wall at the north abutment**

This metal retaining wall is heavily corroded. This plate appears to be taken out from another structure and then added to this bridge.

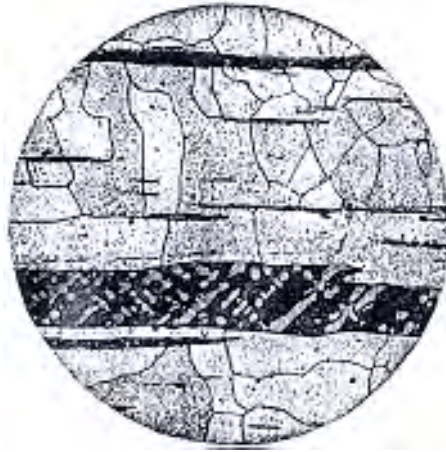
**Figure C.1: Longitudinal section of wrought iron**

Structurally, the base metal and the slag are in physical association, in contrast to the chemical or alloy relationship that generally exists between the constituents of other metals. The appearance of a longitudinal section of wrought iron under high magnification is as shown in Figure C.1. The slag appears as many irregular black lines of varying thickness and the crystalline nature of the pure iron can also be plainly seen. The photomicrograph of the appearance of the transverse section of wrought iron can be seen in Figure C.2. The structure is in every way similar to that seen in the longitudinal section except that the slag here appears as irregular dark areas corresponding to the cross-section of the slag fibers.

The grain size of hot-worked wrought iron may be controlled by continuing the working until the temperature has decreased to about 1300°F (704°C). The fibrous structure of wrought iron is exhibited in a tensile test by a jagged, fibrous fracture and in a nickbend test by a longitudinal fibrous fracture. If there is any appreciable amount of carbon in the iron, it shows at the junctions of the ferrite polyhedra as dark, irregular particles of pearlite, the amount of this constituent varying from zero to about 12 percent of the area as the carbon content varies from zero to 0.1 percent.
