Technical Report Documentation Page

PERFORMANCE ASSESSMENT BY USING NONDESTRUCTIVE TESTING RESULTS

CTR Research Report: 0-4185-3
Report Date: June 2003, Revised February 2004, Second Revision August 2005,
Third Revision 2006
Research Project: 0-4185
Research Project Title: *Correlation of Field Performance to Hamburg Wheel Tracking Results*
Sponsoring Agency: Texas Department of Transportation
Performing Agency: Center for Transportation Research at The University of Texas at Austin

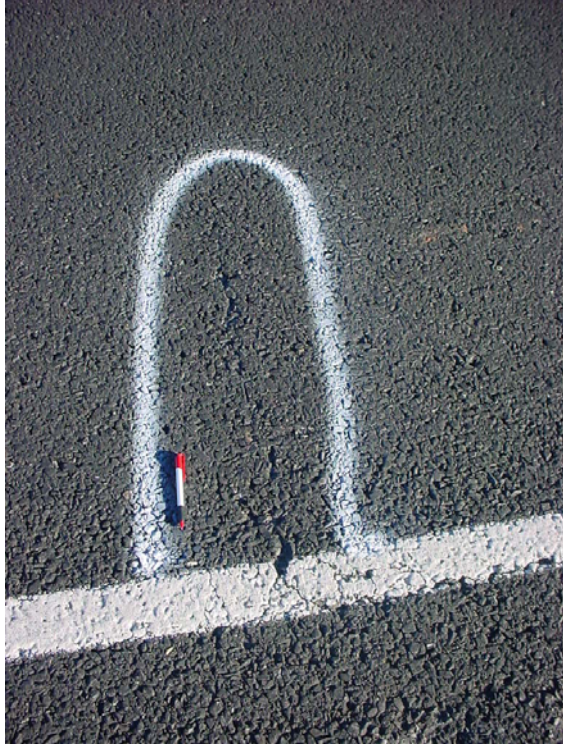
Low: Cracks with low severity or no spalling; mean unsealed crack width of $\frac{1}{4}$ " or less. (See Figure 3.1)

Figure 3.1 Low-level transverse crack

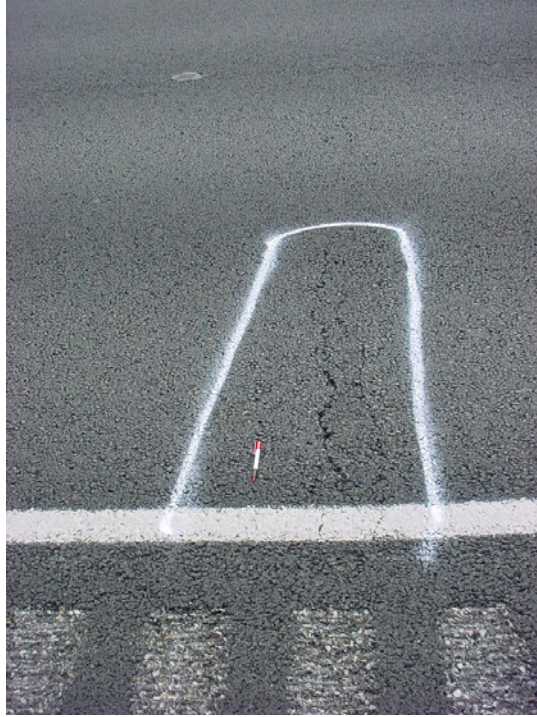
Moderate: Cracks with moderate severity spalling; mean unsealed crack width of greater than $\frac{1}{4}$ "; low severity random cracking near the crack. (See Figure 3.2)

Figure 3.2 Moderate-level transverse crack

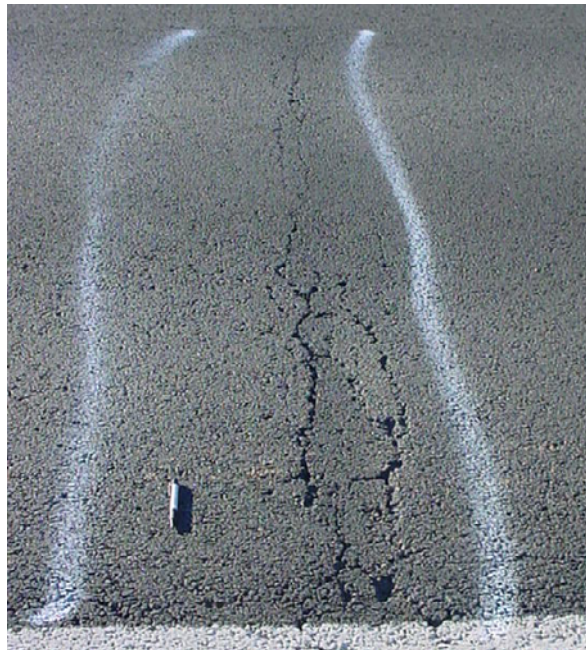
High: Cracks with high severity spalling; moderate or high severity random cracking near the crack. (See Figure 3.3)

Figure 3.3 High-level transverse crack

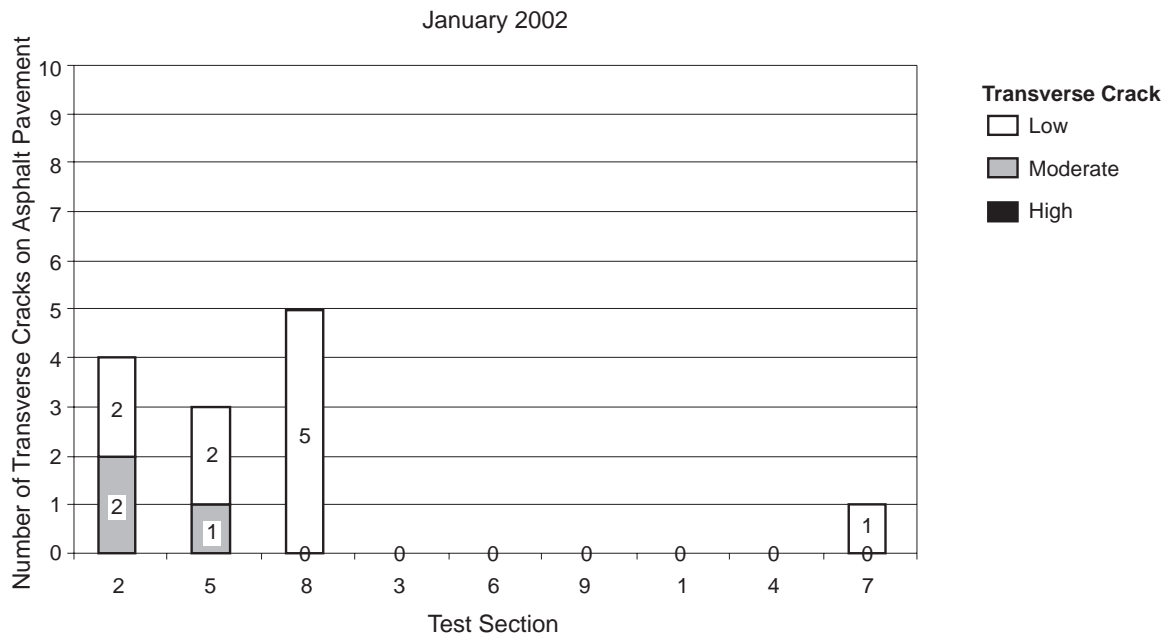
In Figures 3.4 and 3.5, the numbers of transverse cracks on asphalt concrete overlay on January 2002 and November 2002 are shown. The comparison of these figures clearly shows that for all sections except Section 3, the number of distresses increased from January 2002 to November 2002.

Figure 3.4 Number of transverse cracks on asphalt pavement detected on January 2002 survey

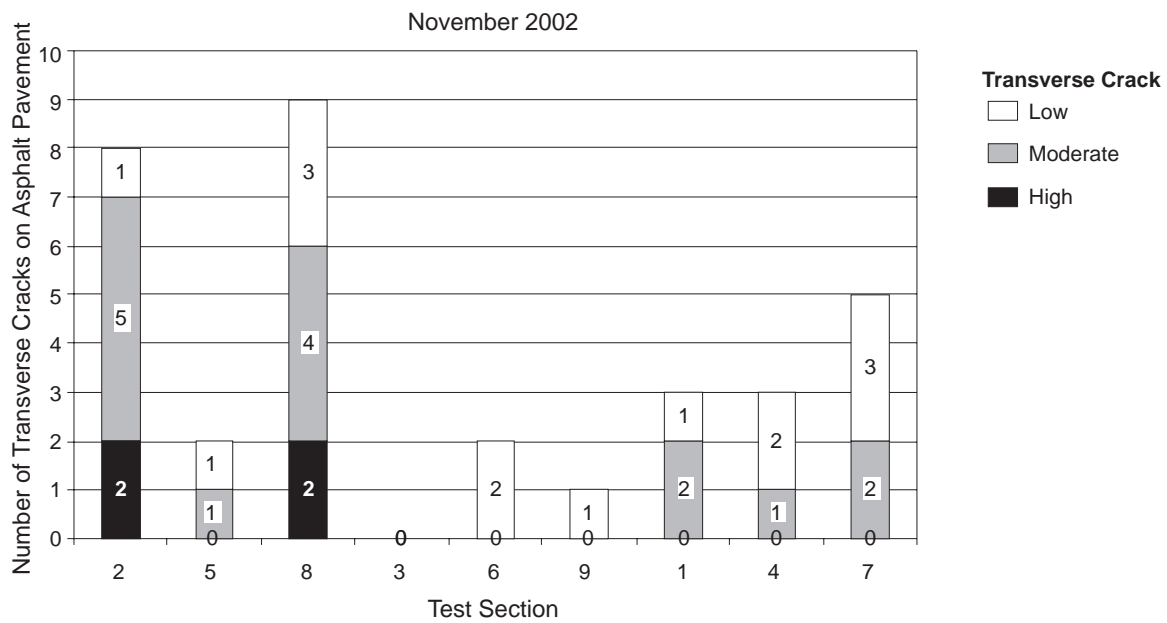
Figure 3.5 Number of transverse cracks on asphalt pavement detected on November 2002 survey

In both Figures 3.5 and 3.6 it is seen that the maximum number of cracks occurred on the asphalt sections that include sandstone and the minimum number of cracks occurred on the sections that include quartzite. The total number of cracks that occurred in the sections with gravel aggregate is in between the total number of cracks that occurred in the sections with sandstone and quartzite aggregates. These observations show that the type of aggregate used in the test sections seems to affect the crack formation on the pavement with time, and that the best results are achieved on the sections where quartzite was used. In Figure 3.6 it can be seen that until November 2002 the best performance in terms of transverse cracking was seen in Section 3 (Superpave with quartzite aggregate), where no cracking was observed so far.

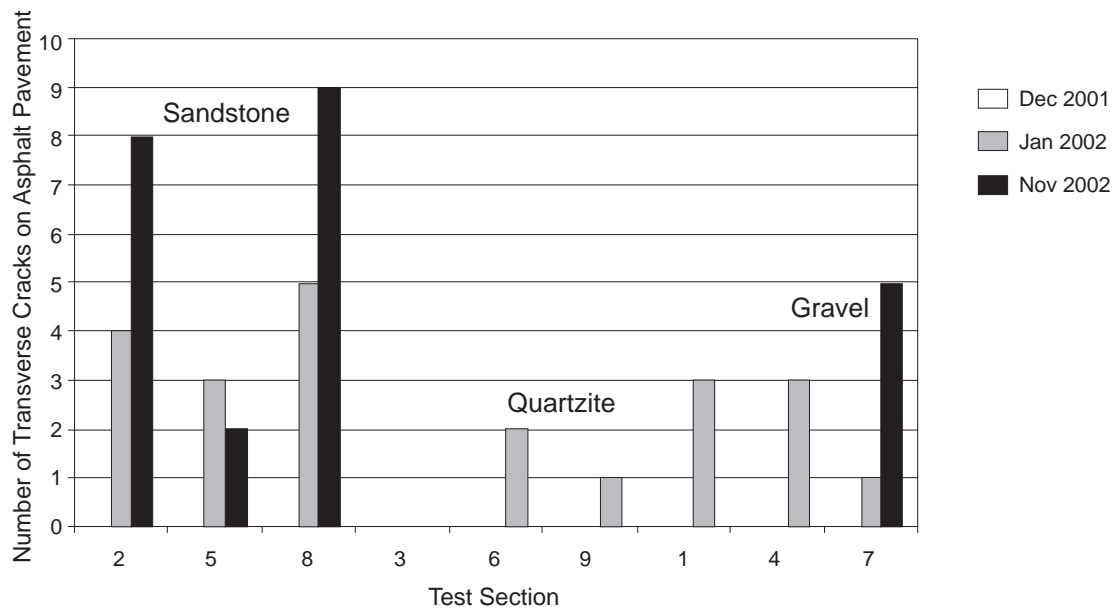
Figure 3.6 Number of transverse cracks on asphalt pavement for each section at different surveys

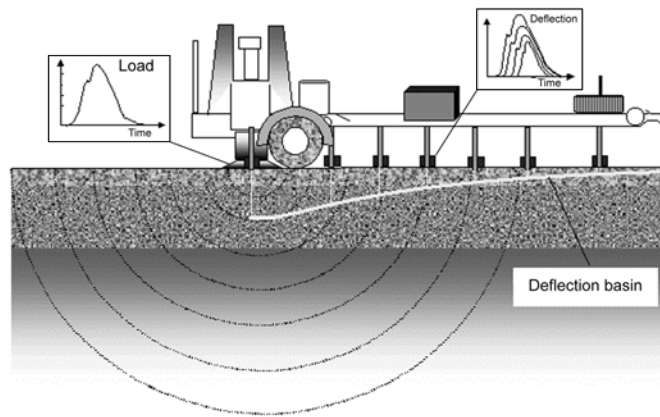
The deformation of the structure is referred to as a deflection basin. Figure 5.1 illustrates a typical FWD configuration with the deflection basin exaggerated to indicate the relative deflection beneath the FWD load. The magnitude and shape of the deflection basin is an indicator of the structural capacity of the pavement. FWD uses a series of user-positioned velocity sensors to automatically determine the amplitude and shape of this deflected basin. The deflection response, when related to the applied loading, can provide information about the strength and condition of the various elements of the pavement structure.

Figure 5.1 FWD configuration

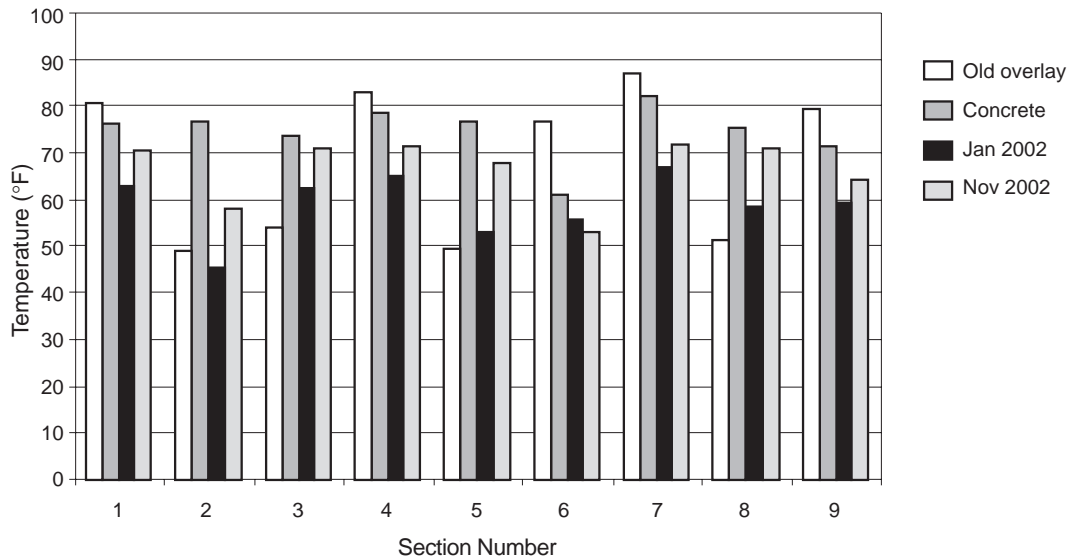
consistently collected at each FWD drop. Figures 5.2 and 5.3 show the means and standard deviations of these air temperatures for the different sections respectively. Temperatures ranged from 45 °F to 86 °F, the highest standard deviations apparent during the November 2002 FWD testing.

Figure 5.2 Mean air temperatures during FWD testing

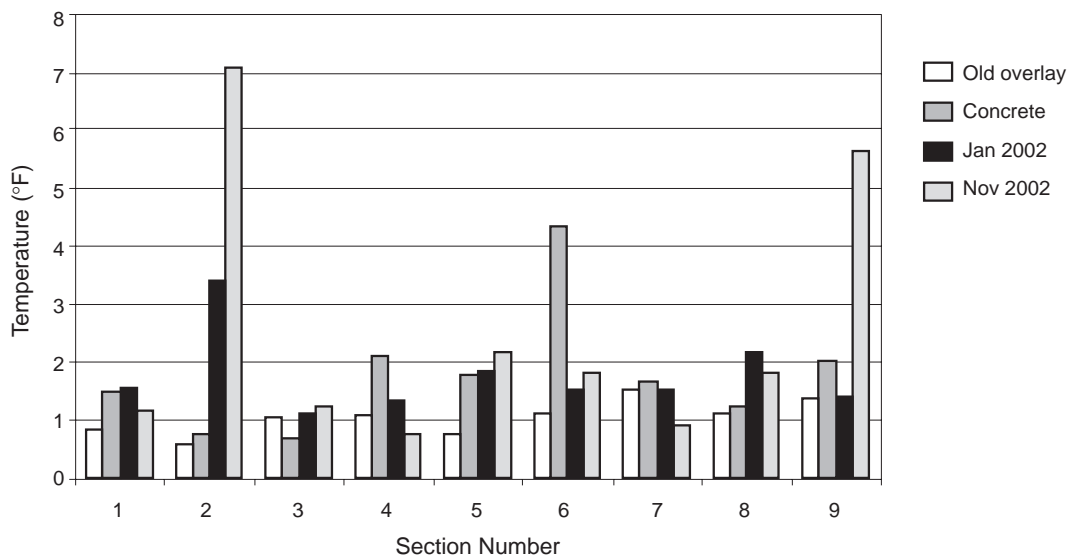
Figure 5.3 Standard deviation of air temperatures during FWD testing

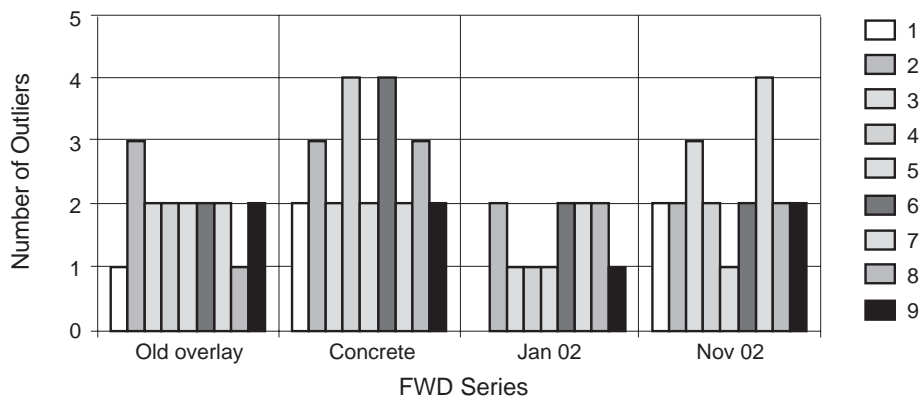
Figure 5.4 illustrates and ranks the number of outliers apparent on each of the nine sections evaluated for the different FWD series. From this figure it is clear that the greatest number of irregular deflections were apparent from the FWD tests on the concrete pavement after milling the old overlay. It is interesting to note that there was a marked decrease in the number of irregularities after the construction of the new overlay (January 2002) but that the irregularities apparent increased in November 2002. Note that there were no outliers identified for Section 1 in January 2002.

Figure 5.4 Number of outliers identified on the nine sections

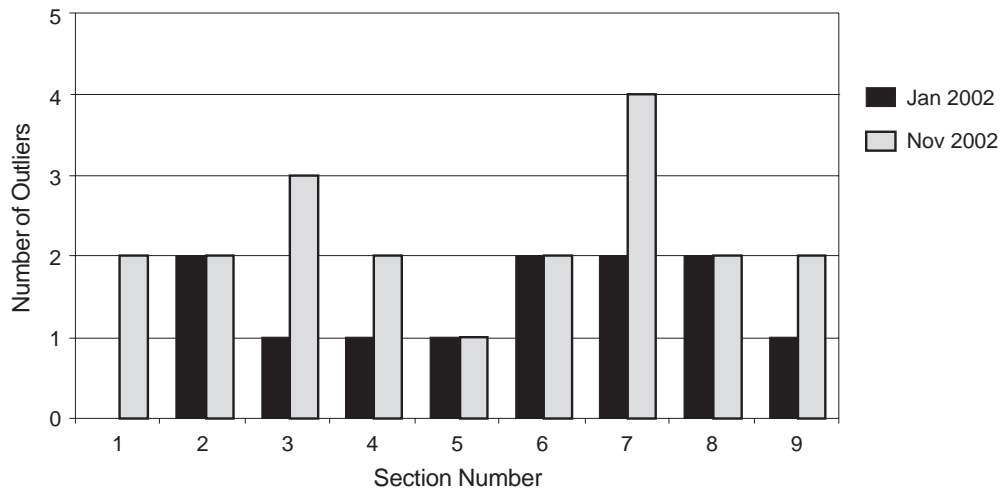
Figure 5.5 indicates the difference in irregularities apparent between January 2002 and November 2002. There was an increase in the number of irregularities observed for Sections 1, 3, 4, 7, and 9. With the exception of Section 3, all of these are on the eastbound lane of IH-20.

Figure 5.5 Number of outliers identified on the nine sections between January and November 2002

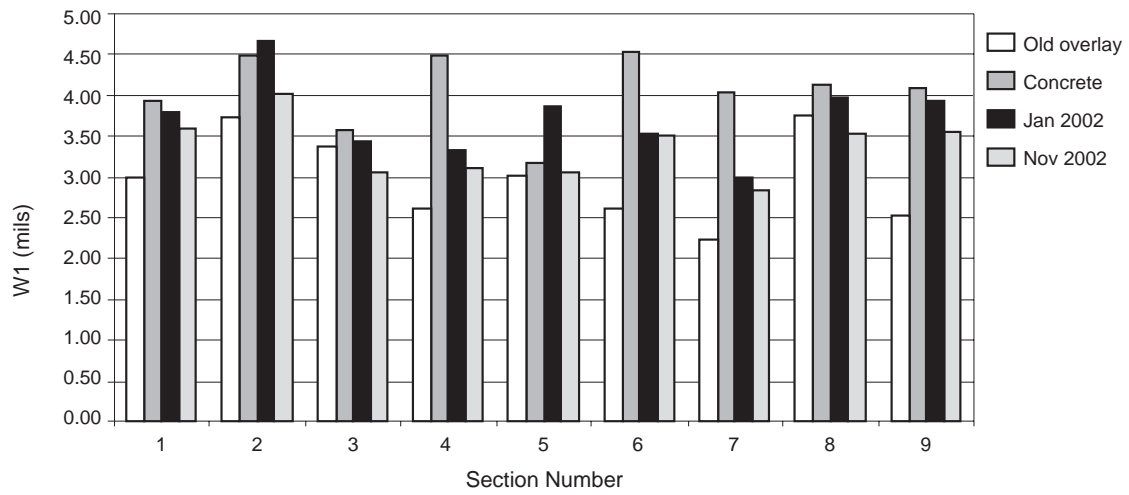
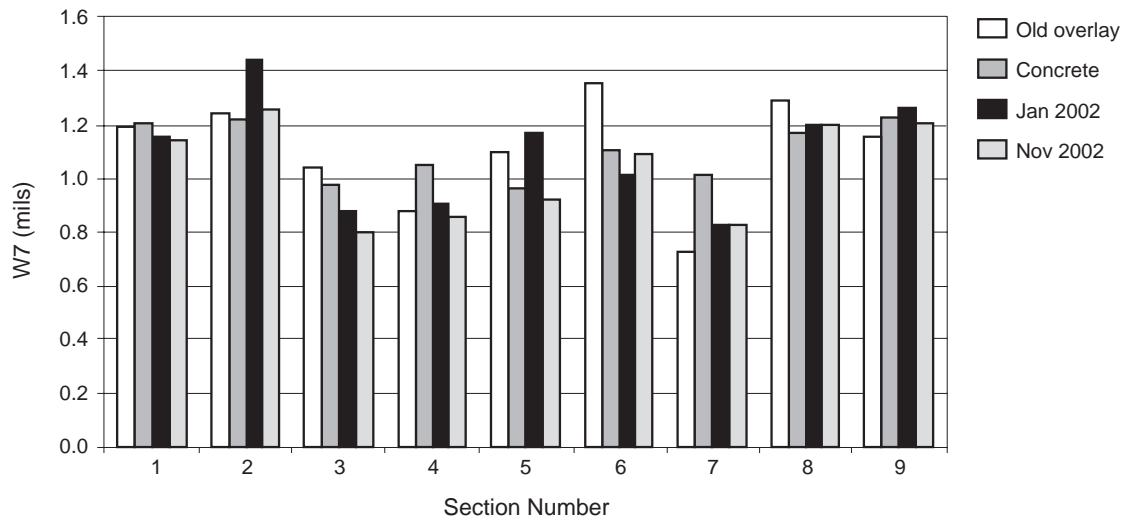
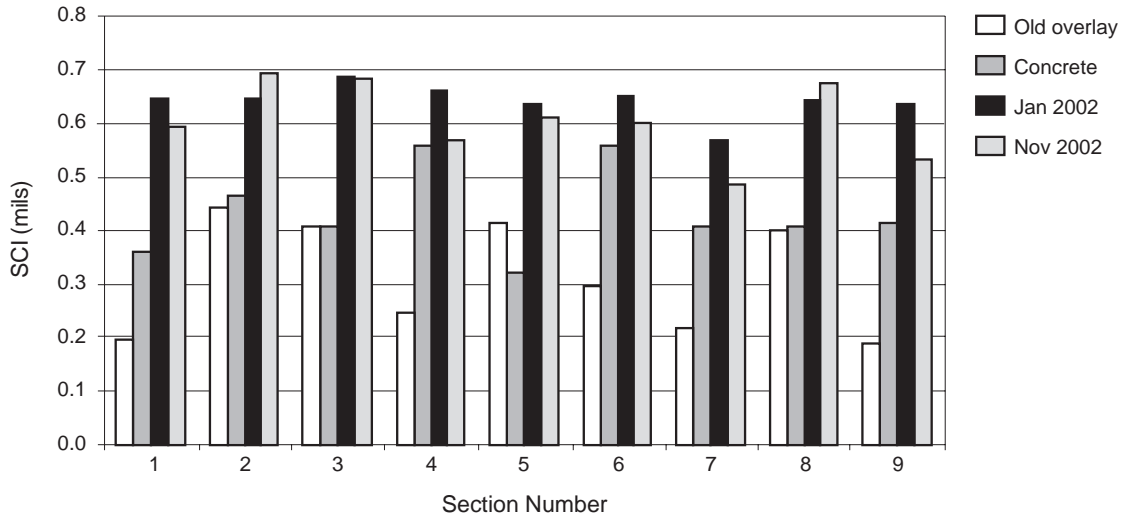
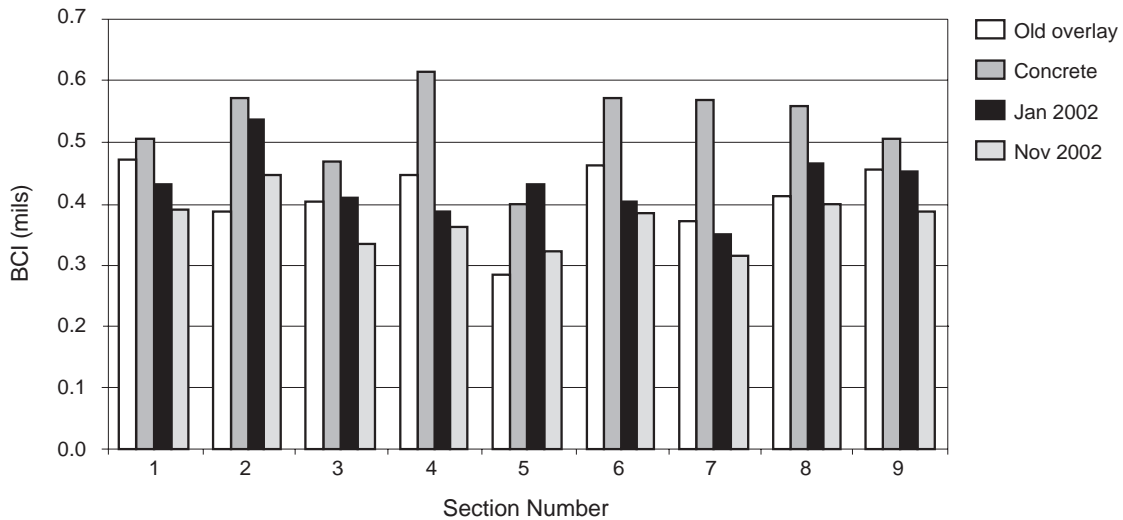
Figures 5.6 through 5.9 illustrate the mean deflection parameter data as tabulated. These results are discussed later in the chapter.

Figure 5.6 Mean W1 FWD deflections for sections evaluated

Figure 5.7 Mean W7 FWD deflections for sections evaluated

Figure 5.8 Mean SCI for sections evaluated

Figure 5.9 Mean BCI for sections evaluated

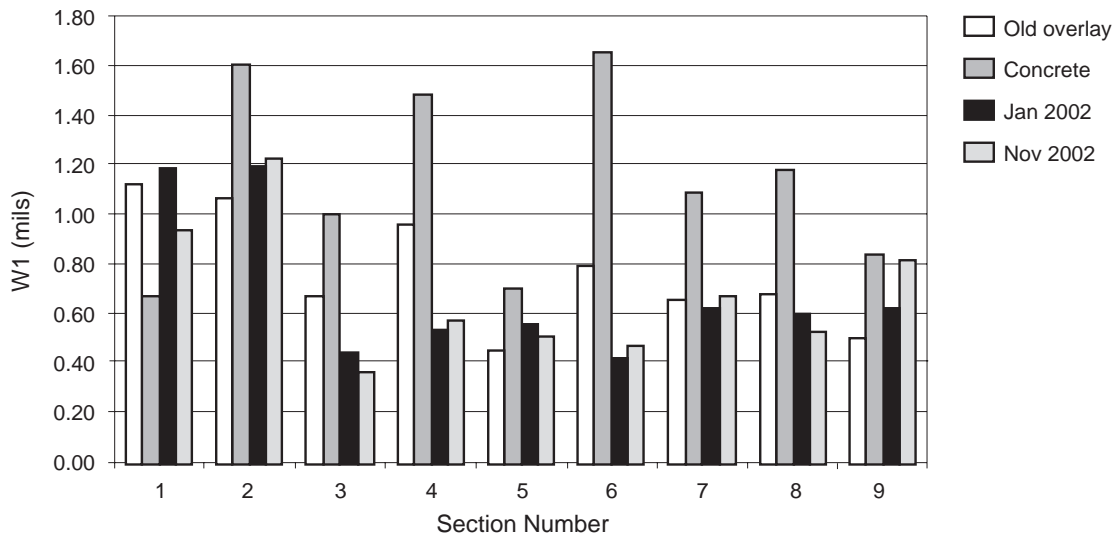
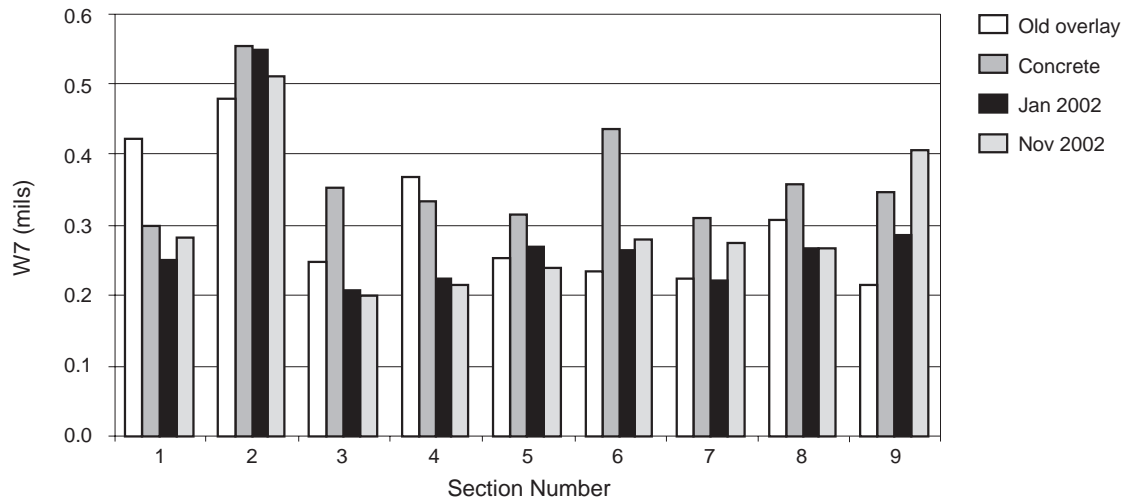
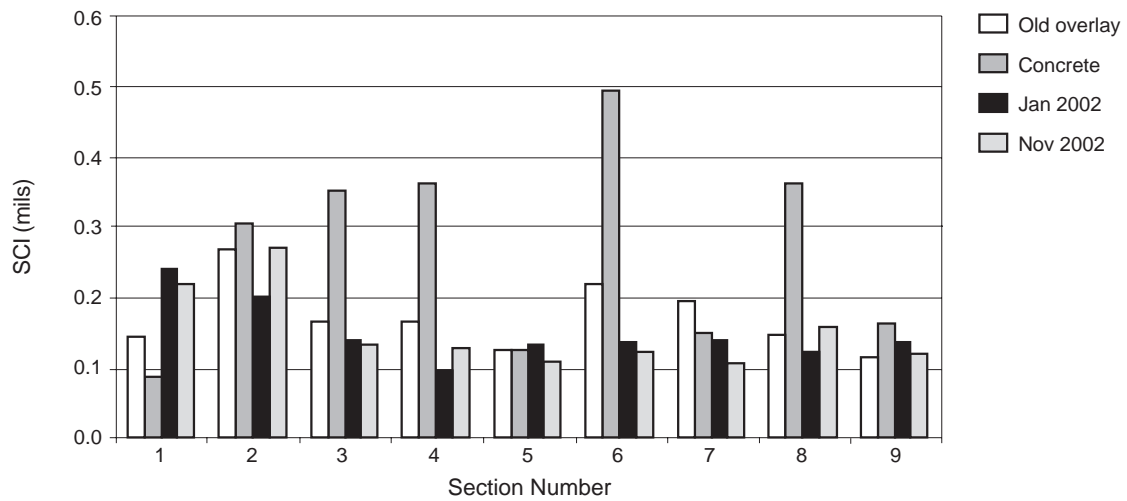
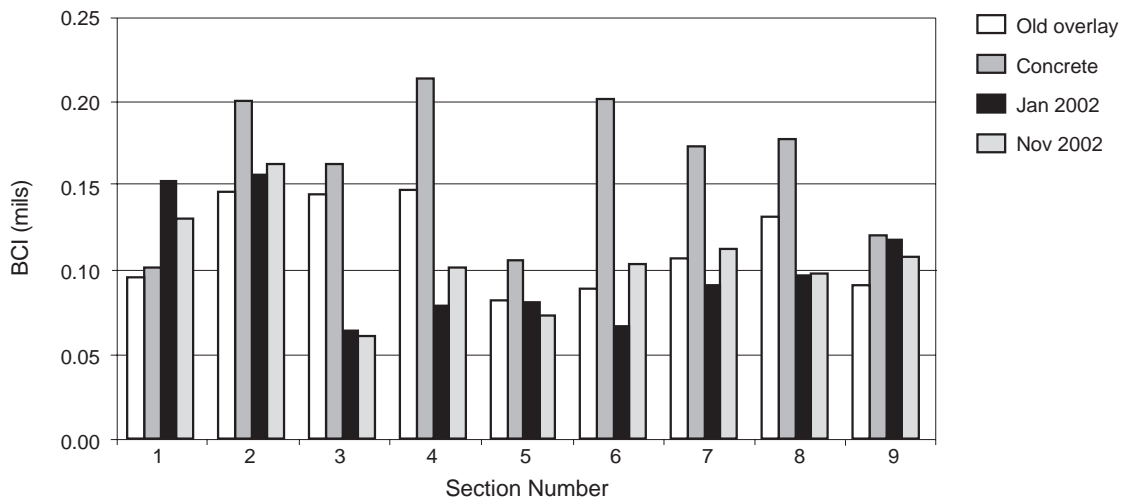
Figures 5.10 through 5.13 illustrate the standard deviations of the deflection parameter data as tabulated. From these it is clear that the highest standard deviations are associated with the FWD tests directly on the concrete pavement. The results are discussed later in the chapter.

Figure 5.10 Standard deviations of W1 FWD deflections of sections as evaluated

Figure 5.11 Standard deviations of W7 FWD deflections of sections as evaluated

Figure 5.12 Standard deviations of SCI of sections as evaluated

Figure 5.13 Standard deviations of BCI of sections as evaluated

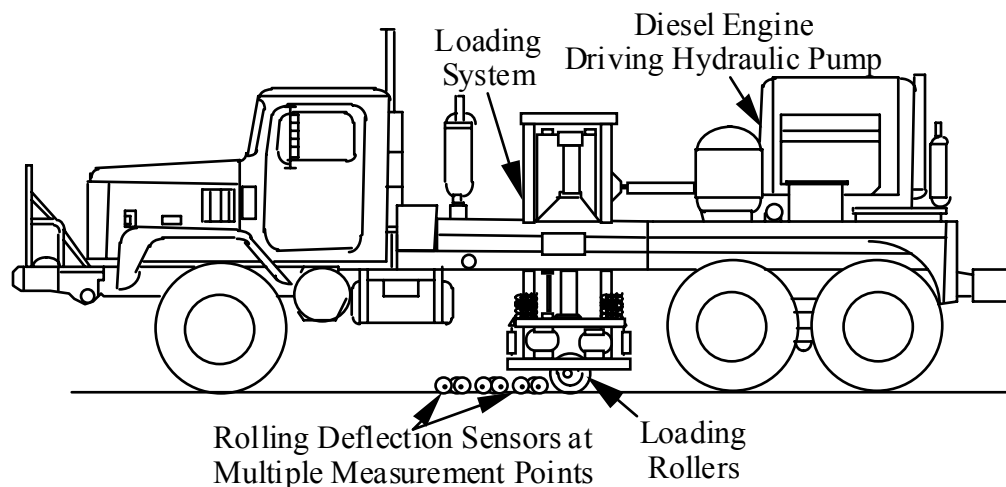
Researchers at The University of Texas at Austin first developed the rolling dynamic deflectometer (RDD) in the late 1990s. A comprehensive description of the RDD is given in *Development of a Rolling Dynamic Deflectometer for Continuous Deflection Testing of Pavements* (Bay and Stokoe 1998). The RDD as described in this report is a research prototype device that was converted from a Vibroseis, a geophysical exploration tool. A schematic diagram of the RDD is shown in Figure 6.1. This device was developed under Research Project 0-1422 with the cooperation of the Texas Department of Transportation and the Federal Highway Administration.

Figure 6.1 Schematic diagram of the major components of the RDD
(after Bay 1997)

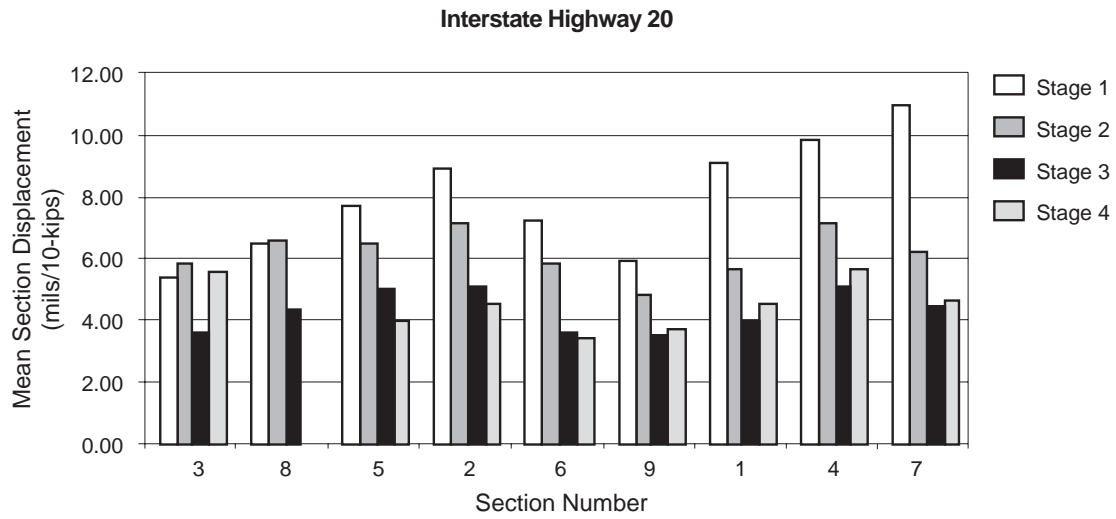
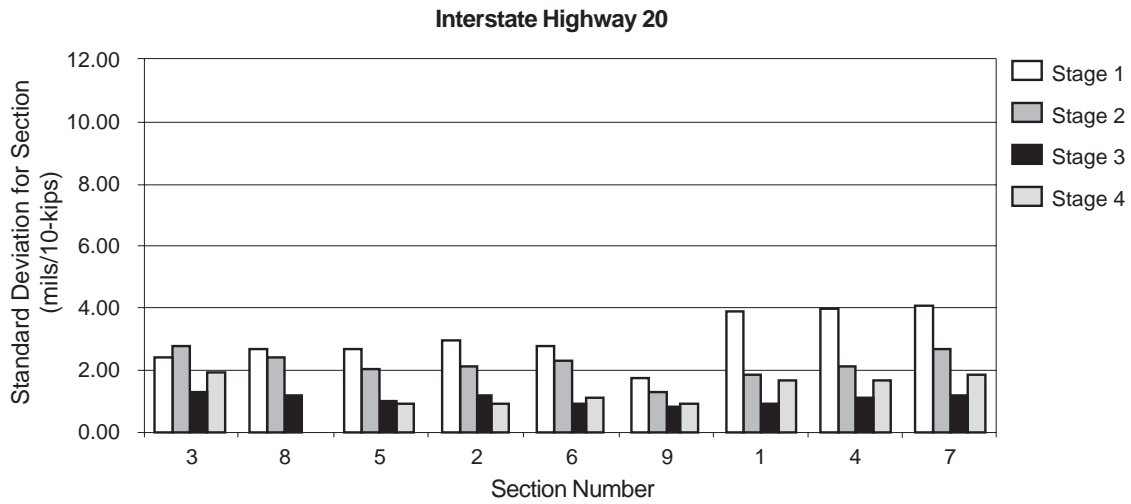
Based on the sensor #1 deflection profiles shown in Figures 6.6 to 6.14, the summary statistics for the different mix design were calculated and shown in Table 6.3. The same information is also shown graphically in Figure 6.15.

a) Mean Displacement

b) Standard Deviation

Figure 6.11 Summary statistics of the RDD continuous deflection profile

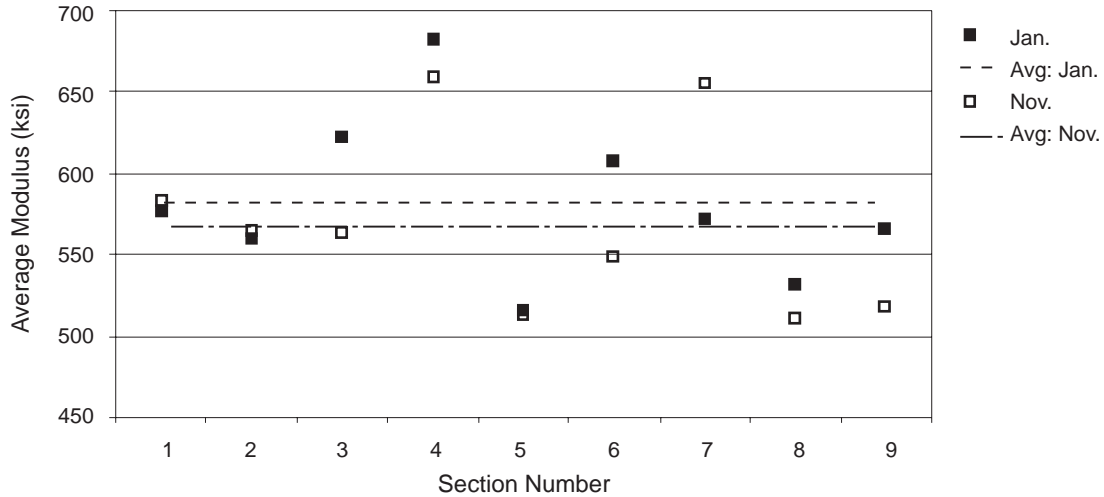
Figure 7.3 shows the difference in the average moduli measurements done on the different sections in January and November 2002. It can be seen that on average for all the sections evaluated, the moduli values decreased slightly from January to November 2002 and that with the clear exception of Section 7, the average moduli values generally decreased for the different sections from January to November. This is contrary to expectations since the modulus of asphalt generally increases with ageing over time and densification under trafficking.

Figure 7.3 Mean January and November 2002 PSPA measurements on IH-20 sections

To explore this finding further, a statistical analysis of the difference between the modulus measurements in January and November 2002 was done applying a t-test with the null hypothesis being that there was no difference between the mean moduli in January and November at the 95 percent confidence level and assuming unequal variances. Results of these analyses are shown in Table 7.2. From the table it can be seen that the null hypothesis is rejected on Section 3, on the westbound lanes and Sections 6, 7, and 9 eastbound.
