1. Report No. FHWA/TX-06/0-4185-4		2. Government Accession No.		3. Recipient's Catalog No.	
4. Title and Subtitle  PAVEMENT PERFORMANCE EVALUATION BY USING FIELD DATA				5. Report Date November 2004; Revised January 2006 and April 2006

## **Pavement Performance Evaluation by Using Field Data**

CTR Technical Report:	0-4185-4
Report Date:	November 2004; Revised April 2006
Research Project:	0-4185
Research Project Title:	Correlation of Field Performance to Hamburg Wheel Tracking Device Results
Sponsoring Agency:	Texas Department of Transportation
Performing Agency:	Center for Transportation Research at The University of Texas at Austin

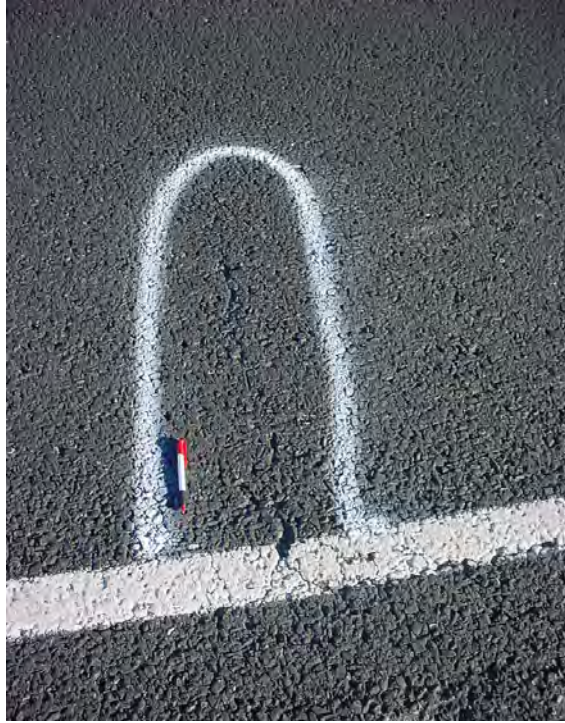
**Low:** Cracks with low severity or no spalling; mean unsealed crack width of  $\frac{1}{4}$ " or less. (See Figure 2.1)

*Figure 2.1. Low-level transverse crack*

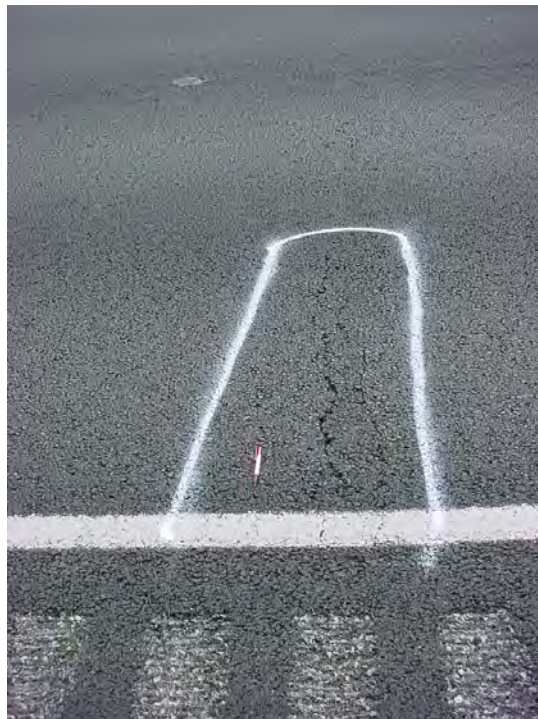
**Moderate:** Cracks with moderate severity spalling; mean unsealed crack width of greater than  $\frac{1}{4}$ "; low severity random cracking near the crack. (See Figure 2.2)

*Figure 2.2. Moderate-level transverse crack*

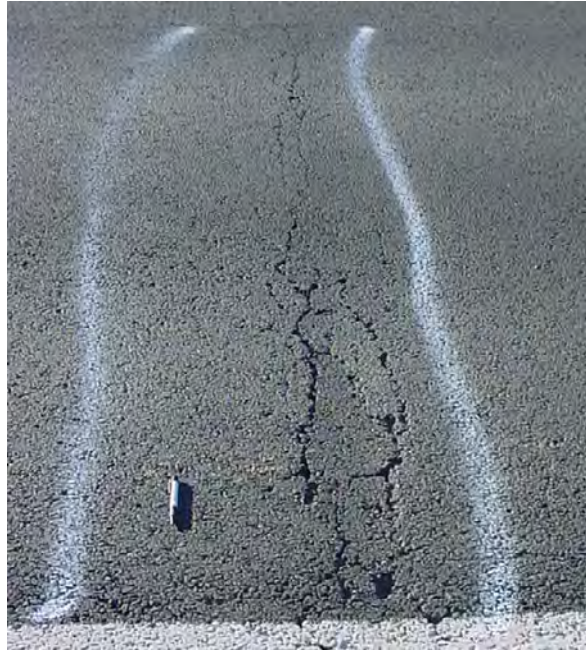
**High:** Cracks with high severity spalling; moderate or high severity random cracking near the crack. (See Figure 2.3)

*Figure 2.3. High-level transverse crack*

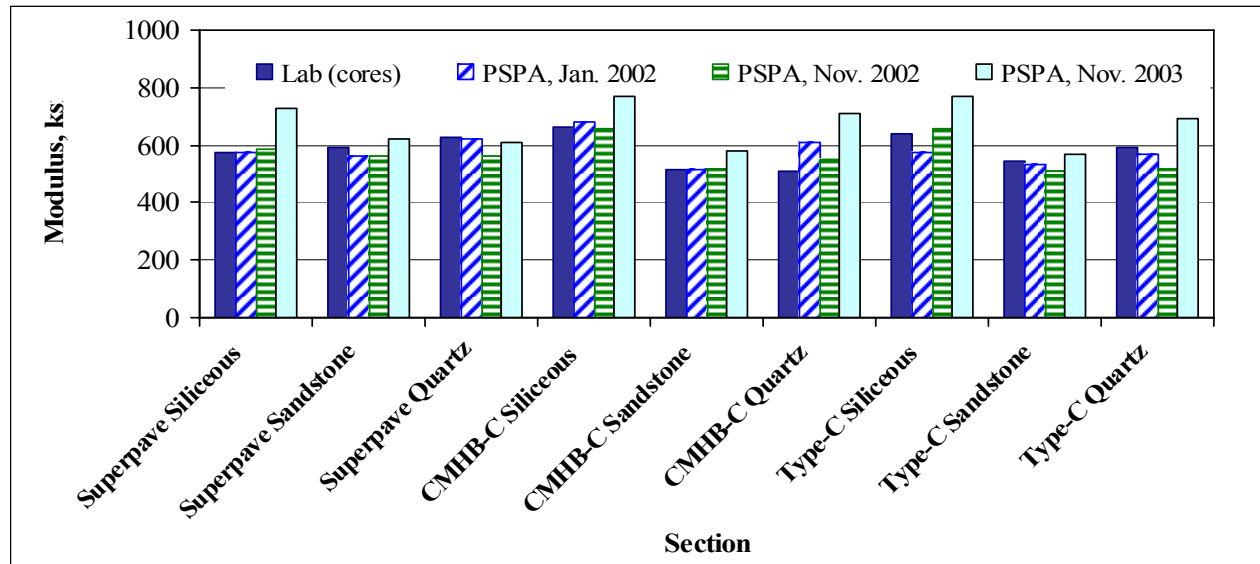
Figure 7.1. Comparison of average moduli measurements done on the different sections
